# Preliminary and Detailed Site Investigation

## Te Kowhai East Development

### Te Kowhai East Limited Partnership

**SLR Consulting New Zealand Limited**

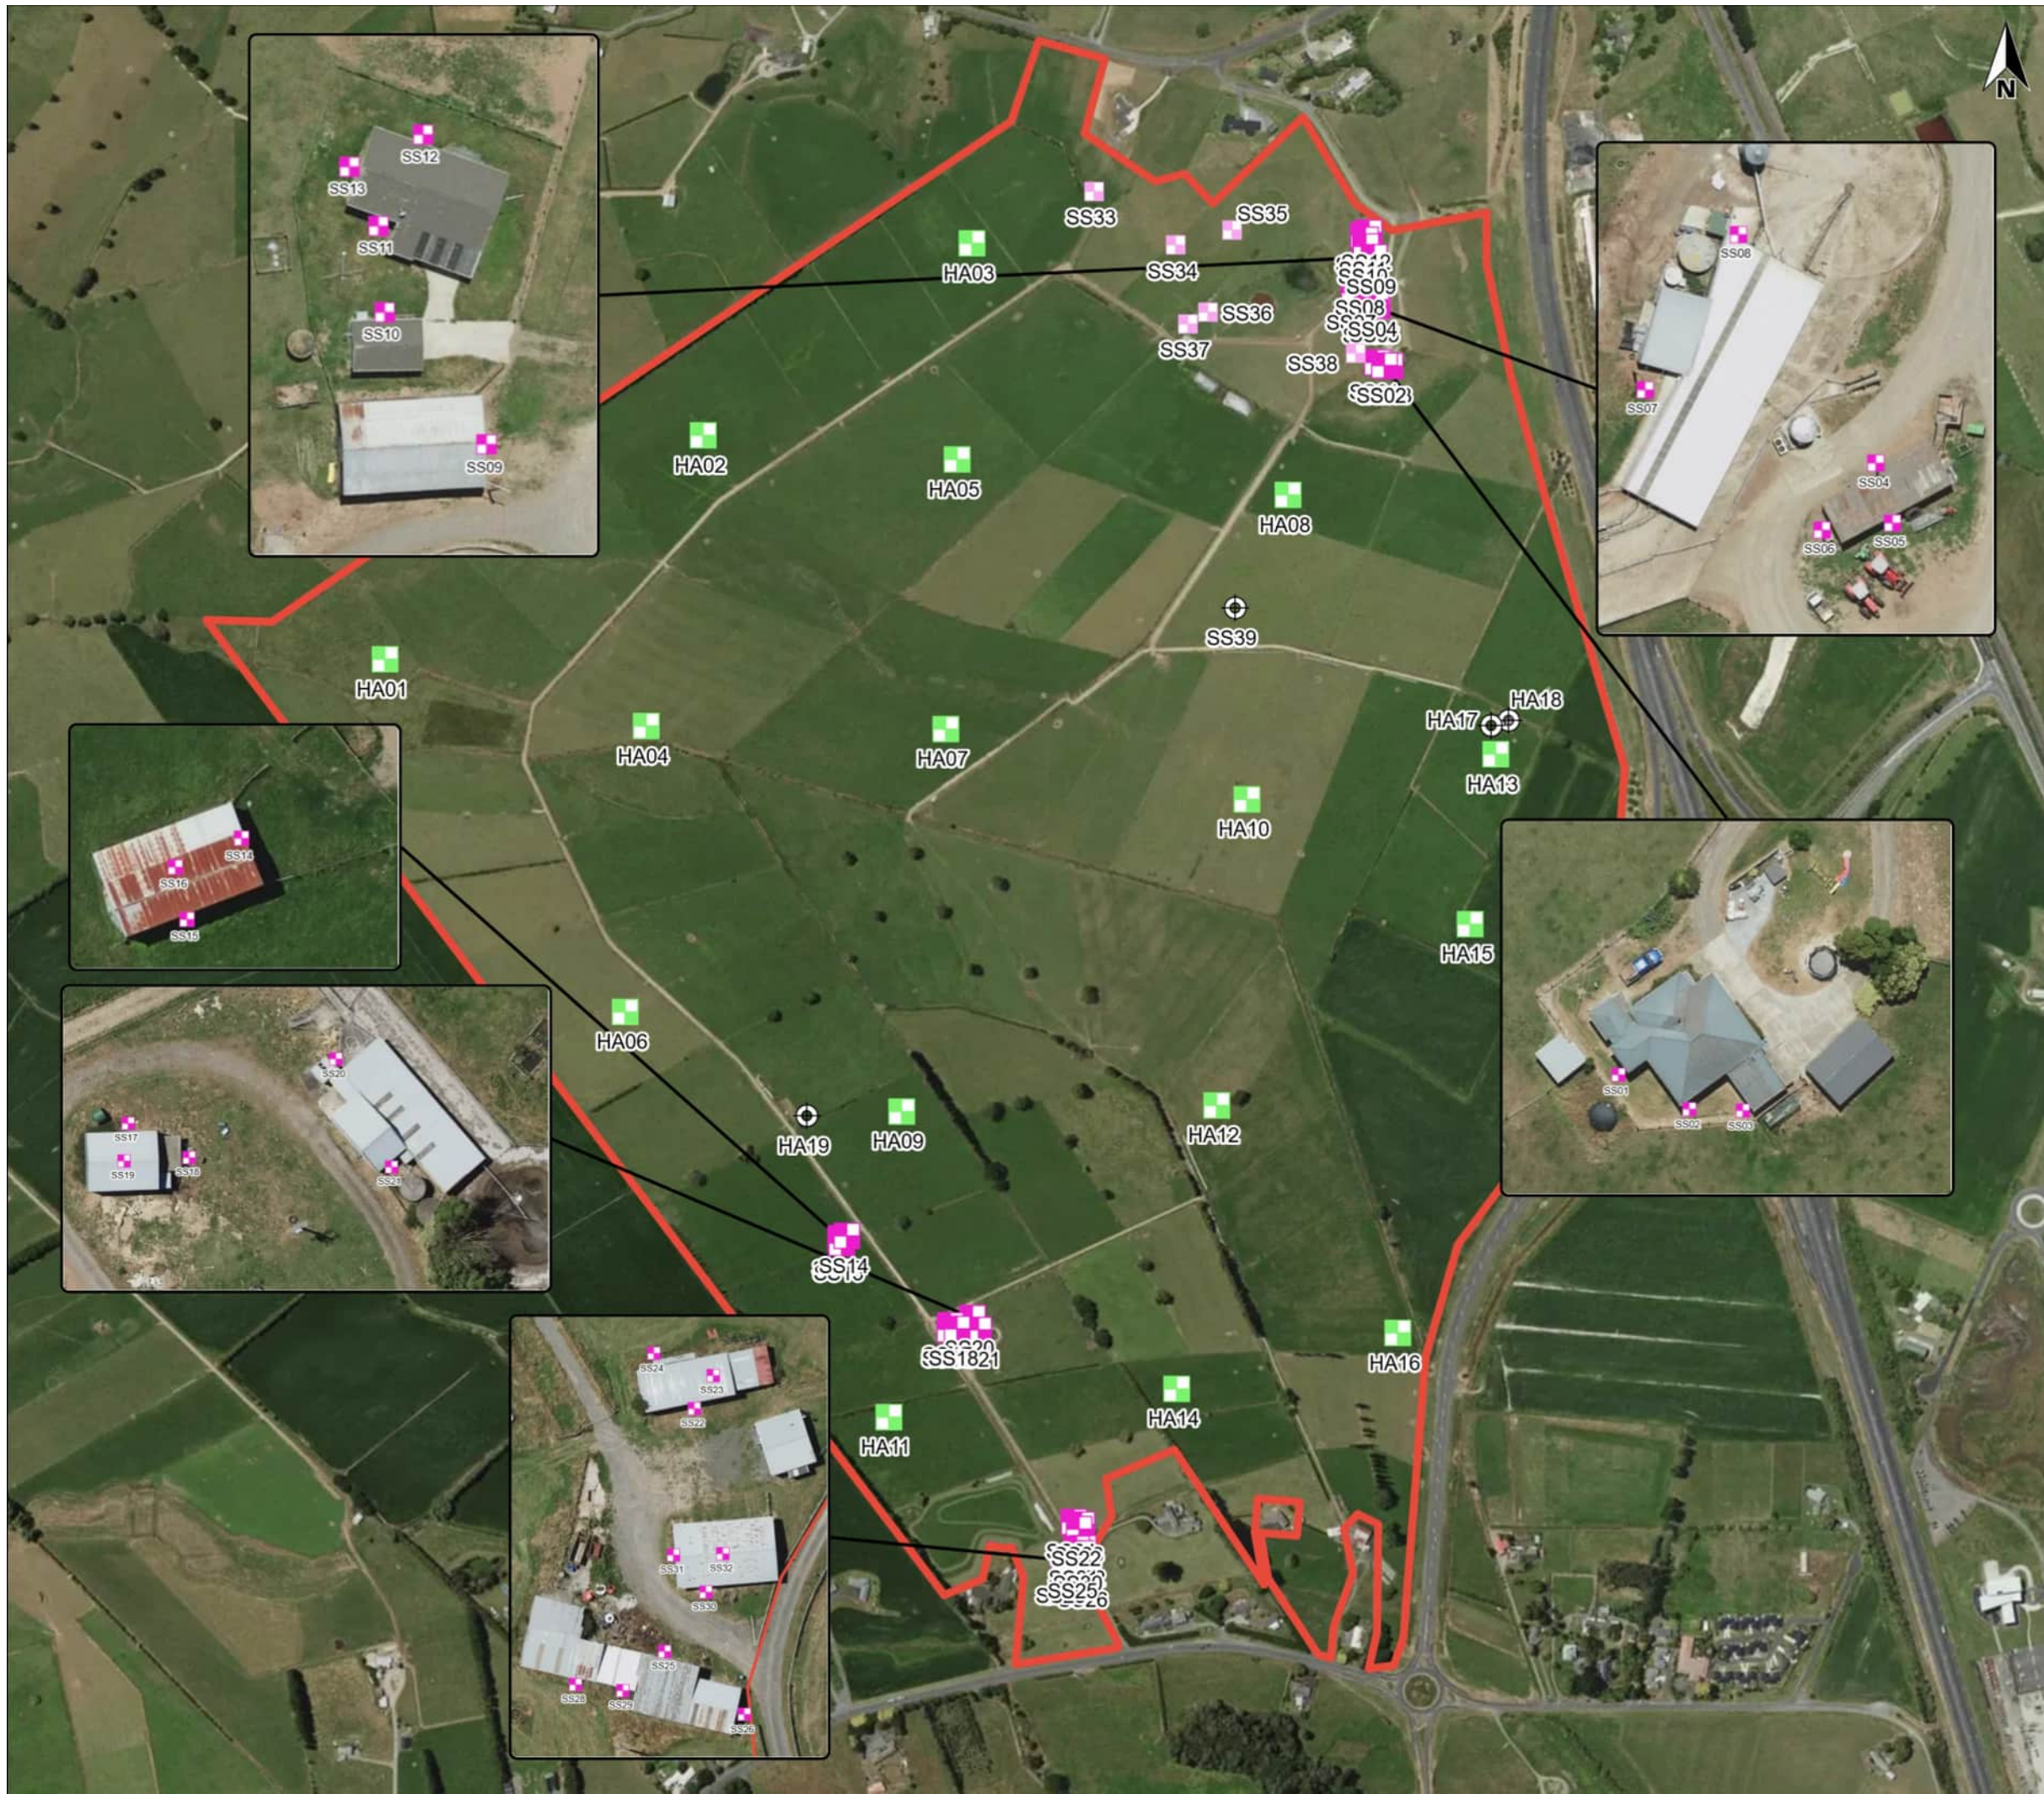
- Legend**
- Surface Soil Samples (Paddocks)
  - Soil Samples (Historical Structures Pre-2000)
  - Soil Samples (Current Structures Pre-2000)
  - Tyre Storage Soil Samples
  - Site Boundary

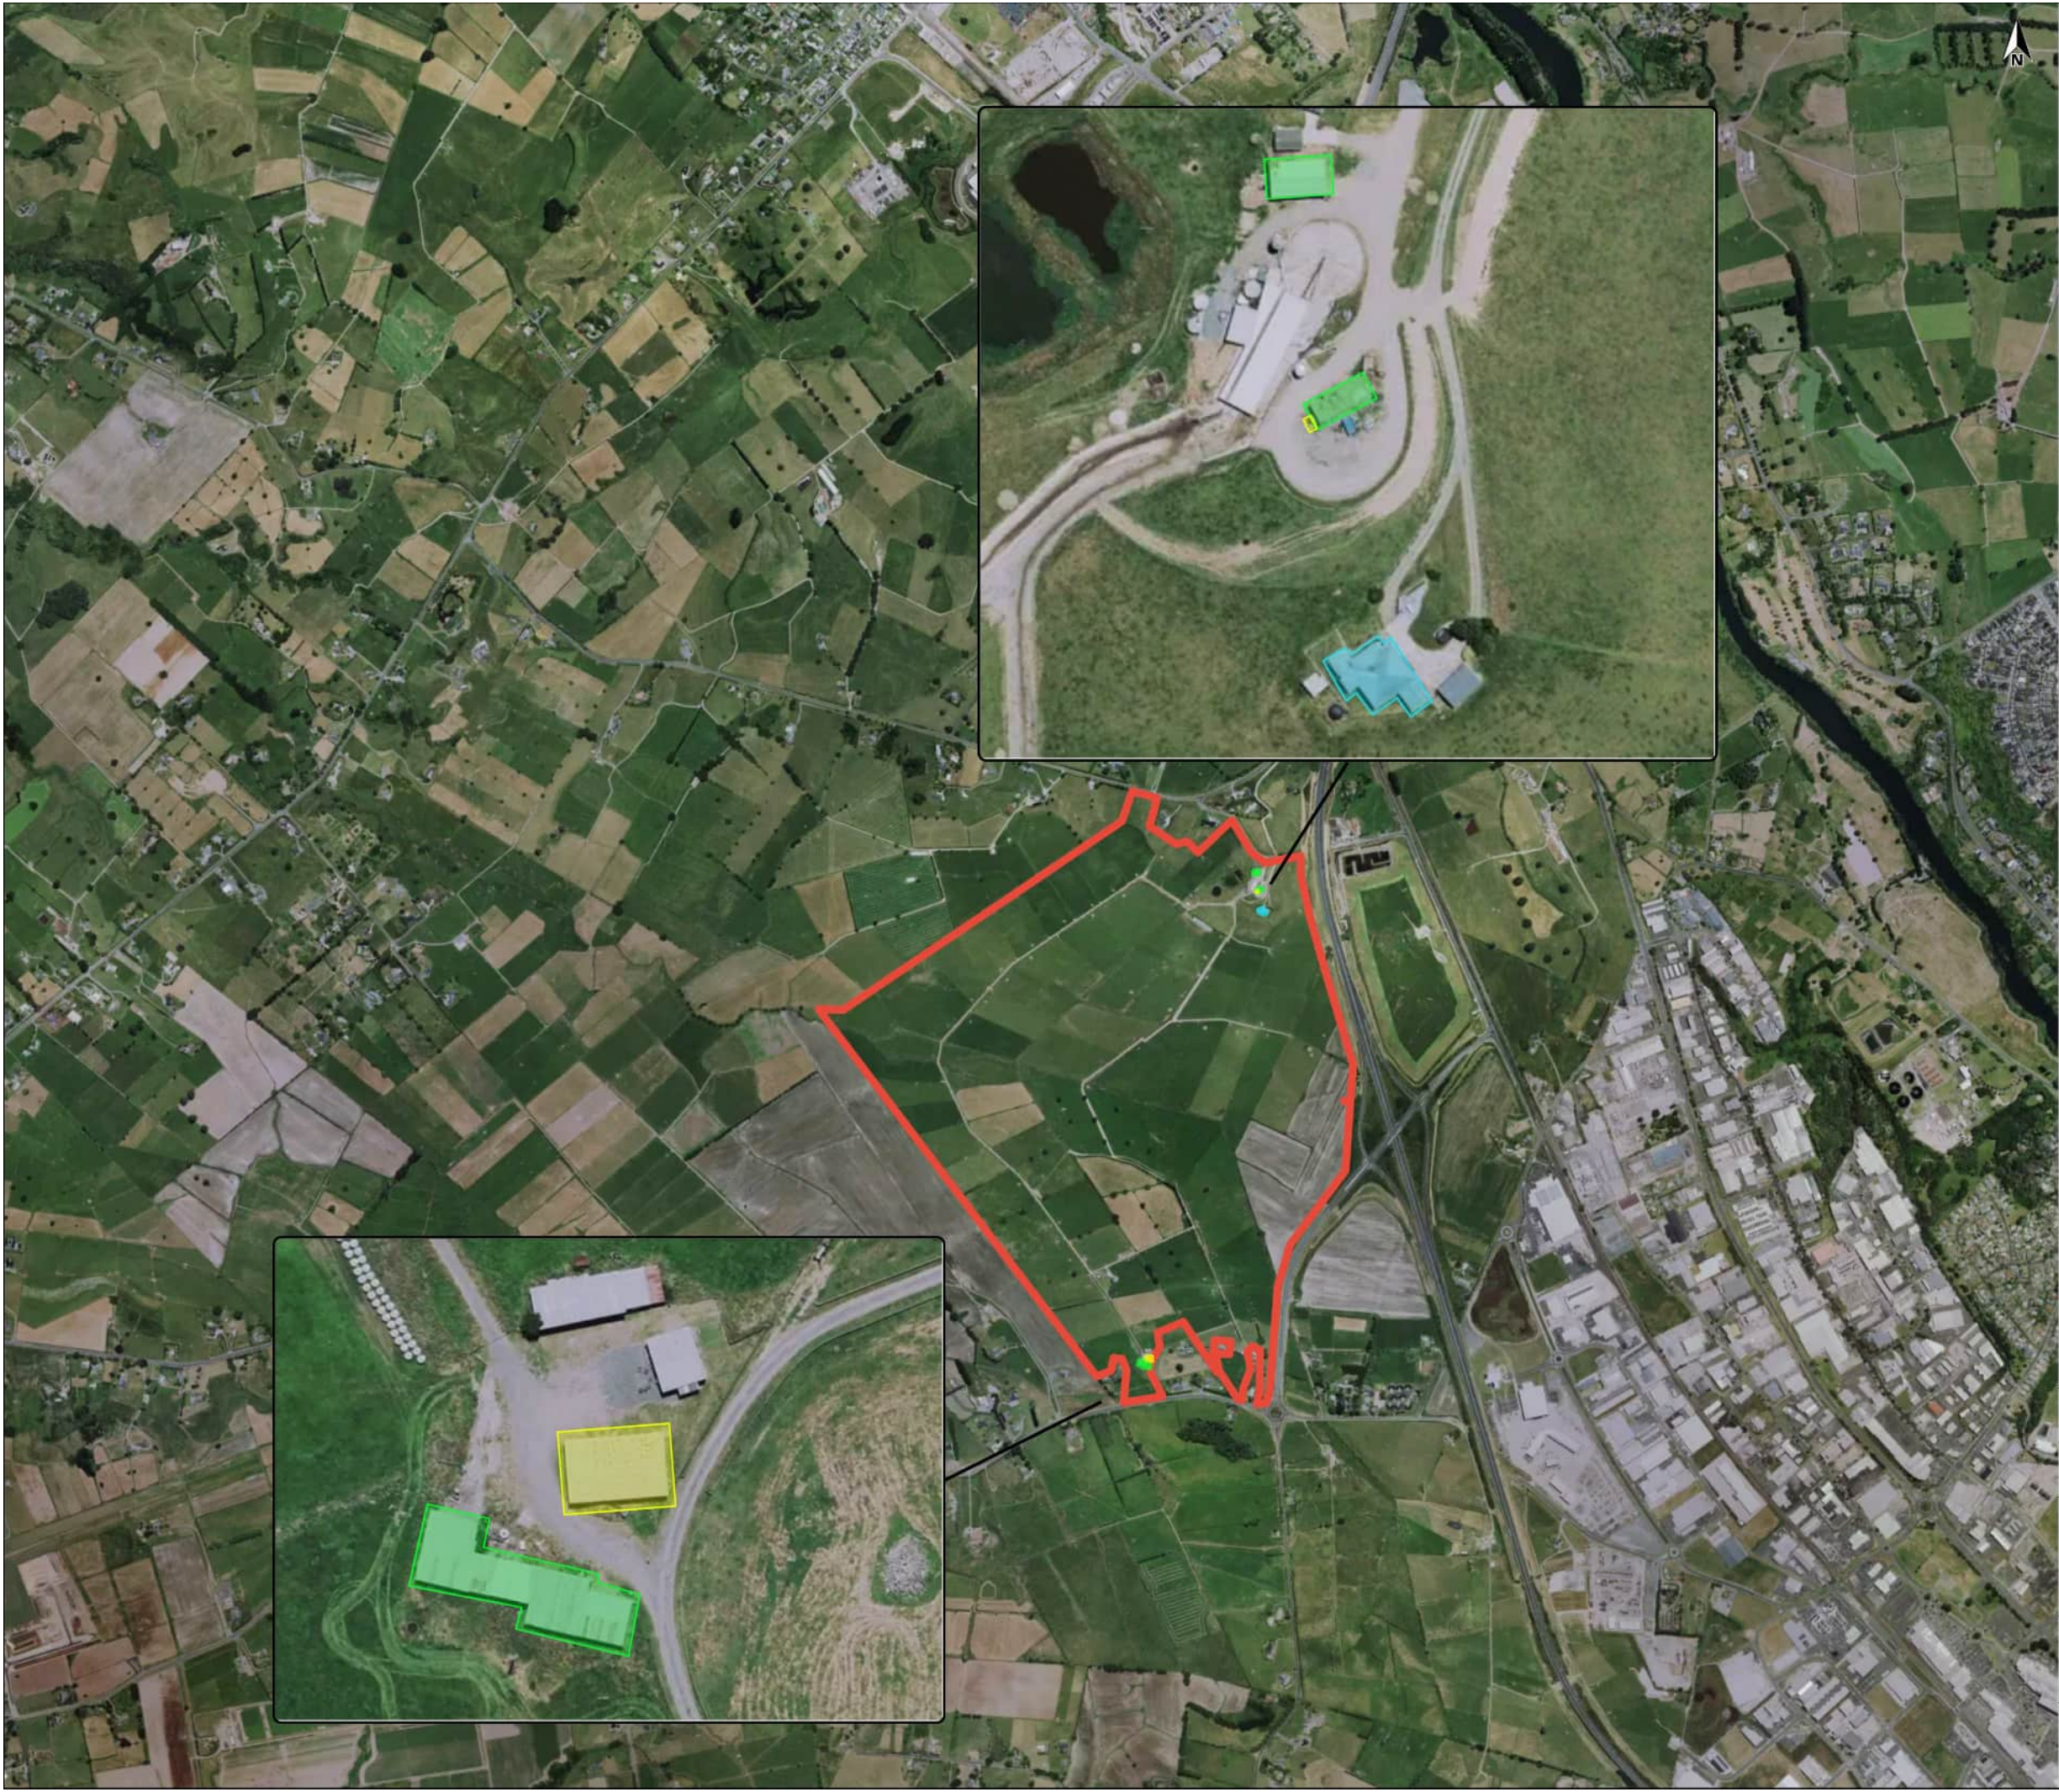
Soil sampling across the investigation area has confirmed isolated concentrations of heavy metals above published background and Eco SGV criteria, and localised concentrations of TPH above Eco SGV criteria, confirming that these areas have been subject to HAIL activities E1: *Asbestos products manufacture or disposal*, F8: *Transport depots or yards*, and I: *Land that has been subject to the intentional or accidental release of a hazardous substance*. Therefore, these isolated investigation areas are considered to be a 'Piece of Land' under Regulation 5(7) of the NESCS.

- Legend**
- HAIL F8 – Transport depots or yards
  - HAIL I – Land Subject to Intentional or Accidental Release of Hazardous Substance (Heavy Metals)
  - HAIL E1 and HAIL I – Asbestos Products & Land Subject to Intentional or Accidental Release (Heavy Metals)
  - Site Boundary

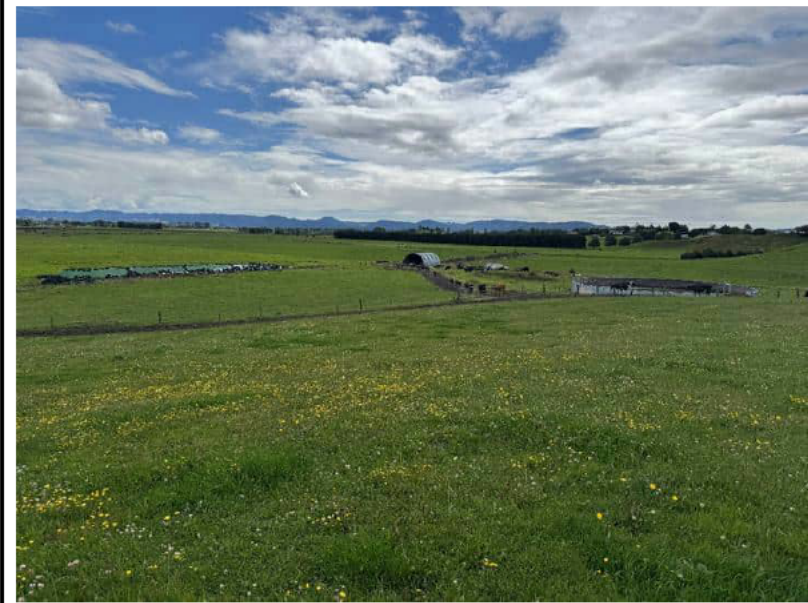
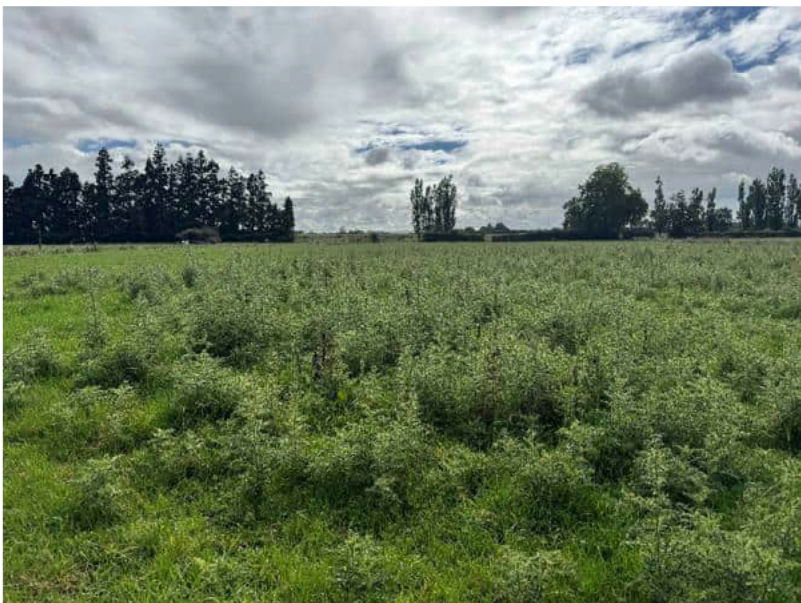
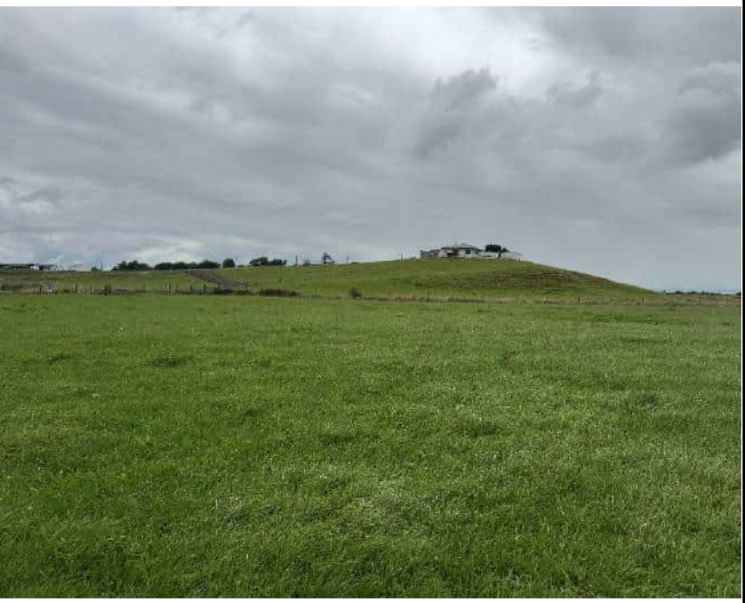
| <p>Photo 1: General view of site, looking west (27 January 2026).</p> A wide-angle photograph of a green field with yellow wildflowers in the foreground. In the distance, there are farm buildings and a line of trees under a blue sky with scattered white clouds. | <p>Photo 2: General view of site, looking west (27 January 2026).</p> A photograph of a field with dense green vegetation and shrubs. A line of trees is visible in the background under a cloudy sky. | <p>Photo 3: General view of site, looking north (27 January 2026).</p> A photograph of a green field with a small white building on a hill in the distance. The sky is overcast with grey clouds. |

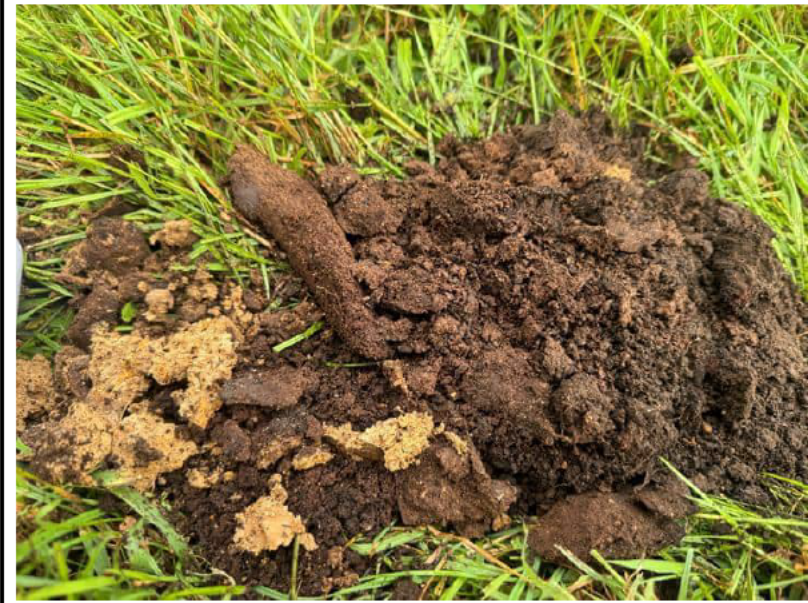
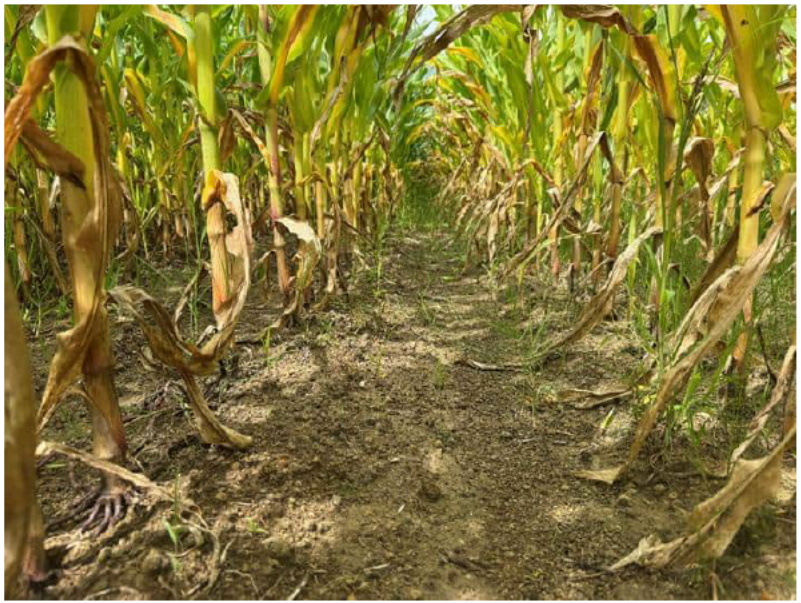
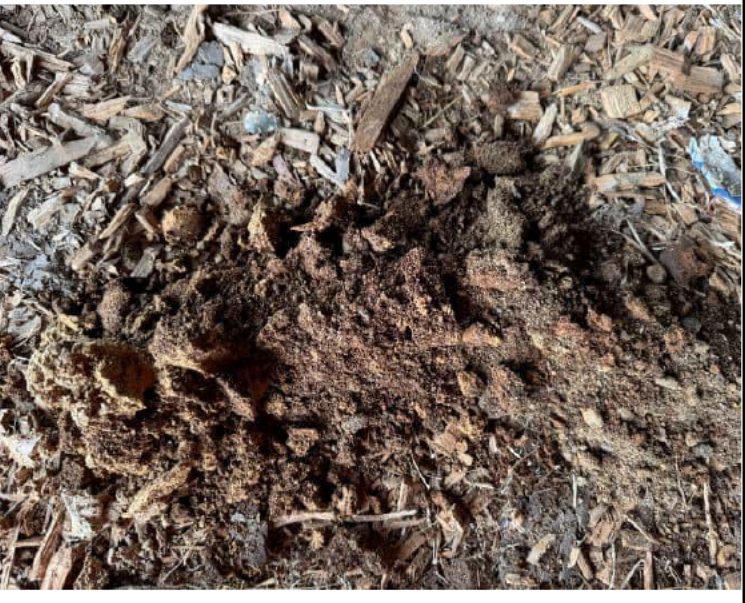
| <p>Photo 4: General soil profile observed during sampling works across the site (27 January 2026).</p> A close-up photograph of a soil profile. It shows a dark brown, moist soil layer on top of a lighter, yellowish-brown, crumbly layer, with green grass growing around the edges. | <p>Photo 5: Corn field and location of sample HA15 (27 January 2026).</p> A photograph of a cornfield with rows of corn plants. The ground is dry and dusty, and some leaves are yellowed. | <p>Photo 6: Wood chip covering the surface within the farm sheds (27 January 2026).</p> A close-up photograph of a pile of dark brown soil and wood chips. The wood chips are small and light-colored, mixed with the dark soil. |

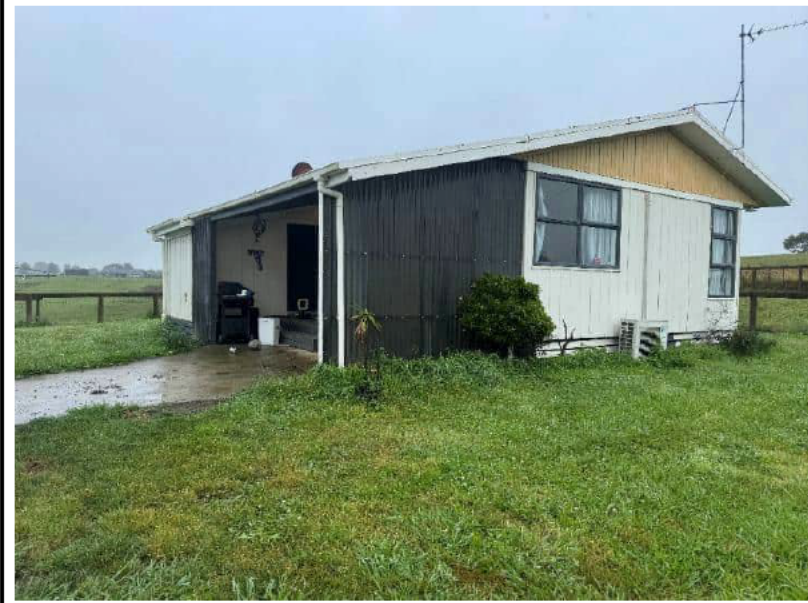
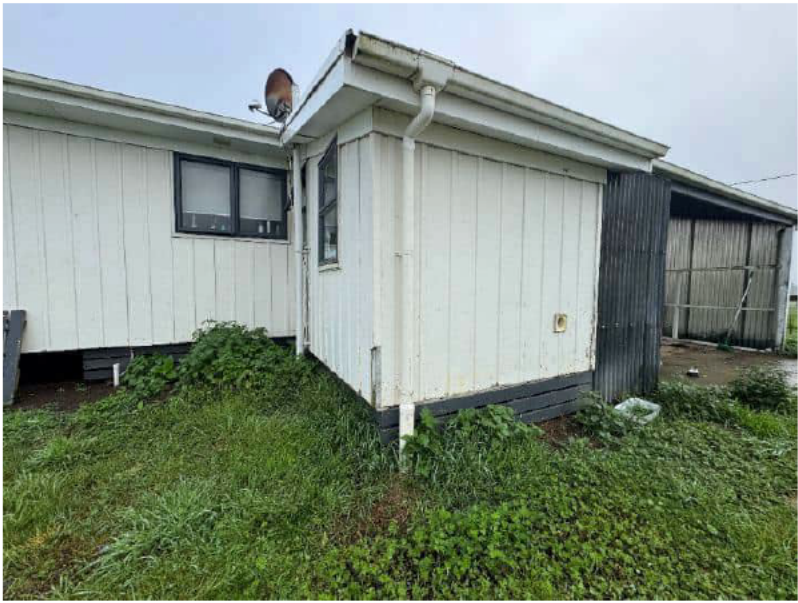
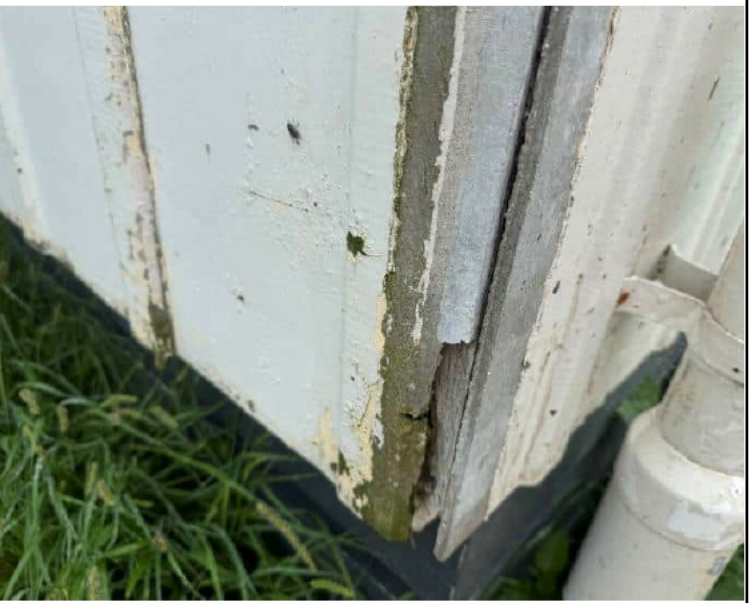
- The residential dwellings in the northern cluster contained building materials consistent with potential asbestos-containing materials. Several damaged sections were observed. Paint flakes were present on the ground near the dwelling.

| <p>Photo 7: Residential dwelling located in the north of the site, facing west (<i>sample locations SS10 – SS13</i>) (22 January 2026).</p> | <p>Photo 8: Residential dwelling located in the north of the site, facing south (<i>sample locations SS10 – SS13</i>) (22 January 2026).</p> | <p>Photo 9: Potential asbestos in building materials (22 January 2026).</p> |

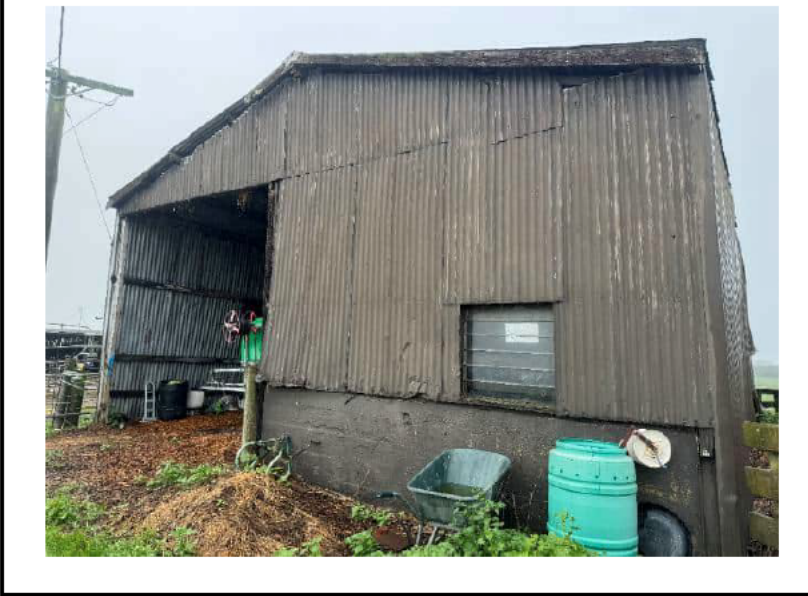
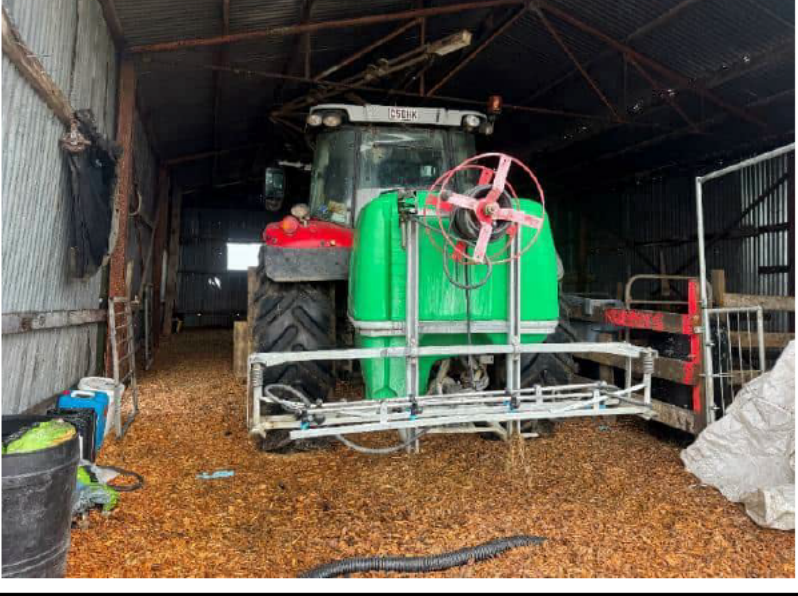
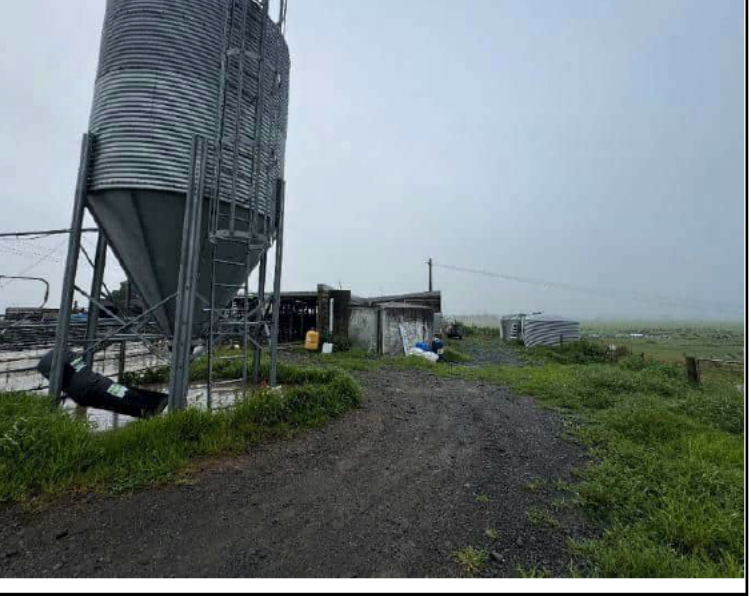
| <p>Photo 10: Farm shed located in the north of the site, facing west (<i>Feature 1 and sample location SS09</i>) (22 January 2026).</p> | <p>Photo 11: Farm equipment stored within the shed (<i>Feature 1</i>) (22 January 2026).</p> | <p>Photo 12: Milking sheds located in the north of the site, facing south (<i>Feature 7</i>) (22 January 2026).</p> |

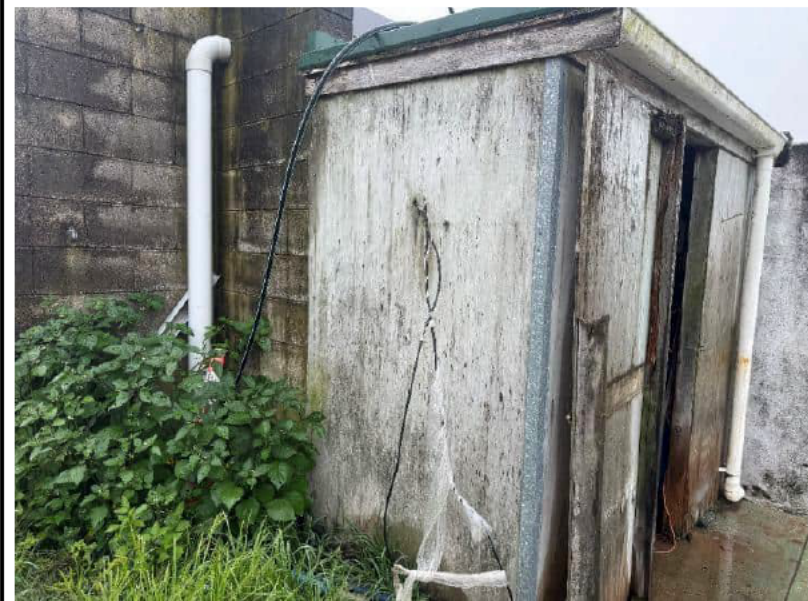
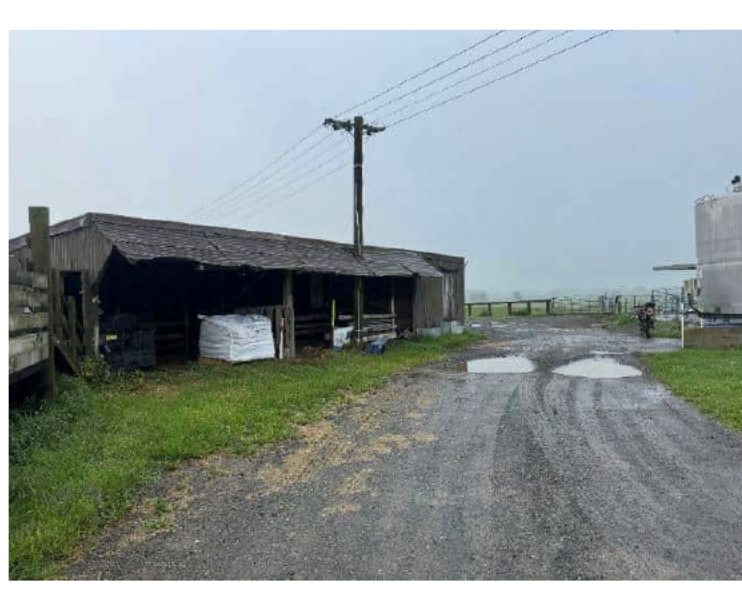
| <p>Photo 13: Rear of milking shed with potential lead-based paint (sample location SS08) (22 January 2026).</p> | <p>Photo 14: Small quantity of fertilisers stored within the milking shed (22 January 2026).</p> | <p>Photo 15: Storage shed located in the north of the site, facing south (sample locations SS04 – SS06) (22 January 2026).</p> |

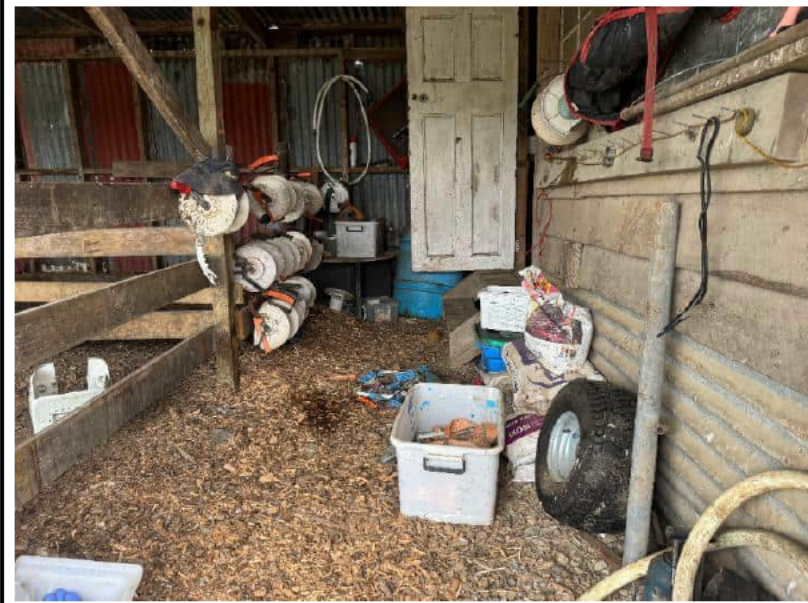
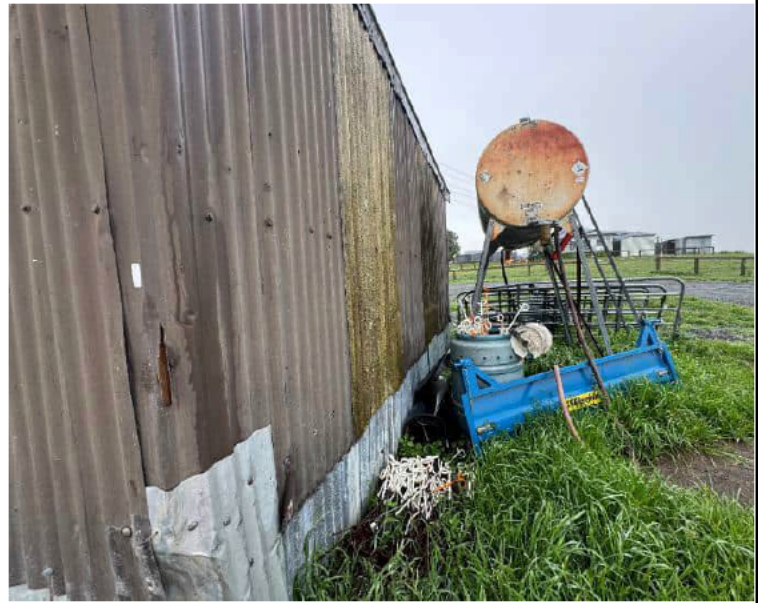
TPH were detected at two locations above the Eco SGV for SS06, located beneath an above-ground storage tank (AST) used for refuelling activities, and SS32, located within a shed used for farm machinery storage. The hydrocarbon contamination is considered consistent with historical minor leaks and drips associated with fuel handling and machinery operation. There was no evidence of separate-phase hydrocarbons at either location, and analytical results indicate the contamination is dominated by relatively immobile middle to heavy hydrocarbon fractions (C10-C14 & C15-C36), which exhibit low solubility, strong adsorption to soil, and limited potential for migration. Given that the identified TPH impacts appear to be localised and confined to shallow soils, and that significant concentrations of lighter, more mobile hydrocarbons were not detected, the potential for contaminant migration to groundwater or surface water is considered low. The impacted areas are not located near significant ecological receptors or surface water bodies, with the nearest pond situated approximately 80 m northwest of SS06 and the nearest stormwater catchment swale located approximately 90 m south of SS32. Given the limited extent, localised nature, and low mobility of the contamination, and noting that affected soils would likely be mixed and redistributed during future earthworks, the identified hydrocarbon impacts are considered unlikely to present a significant risk to the environment.

| <p>Photo 16: Storage shed located in the north of the site, facing south (sample locations SS04 – SS06) (22 January 2026).</p> | <p>Photo 17: Storage shed located in the north of the site, facing south (sample locations SS04 – SS06) (22 January 2026).</p> | <p>Photo 18: Above ground fuel tank located adjacent to a storage shed (sample location SS06) (22 January 2026).</p> |

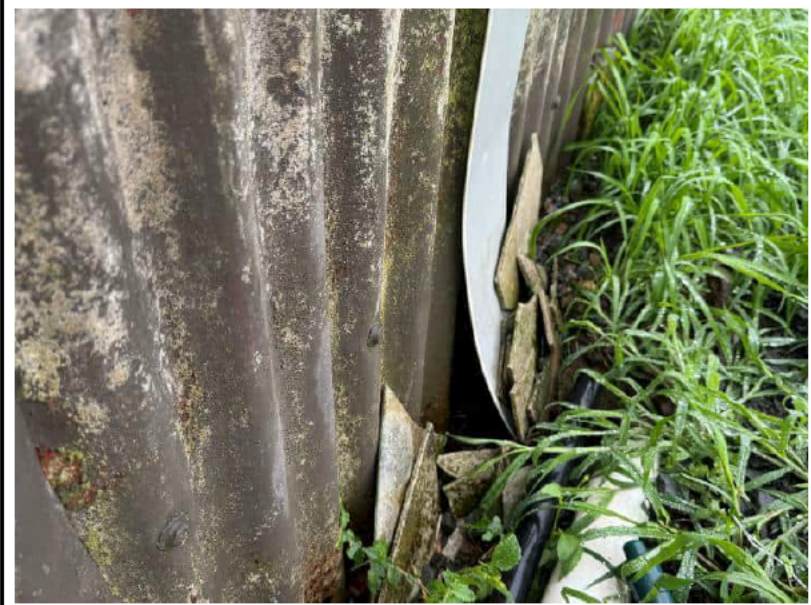
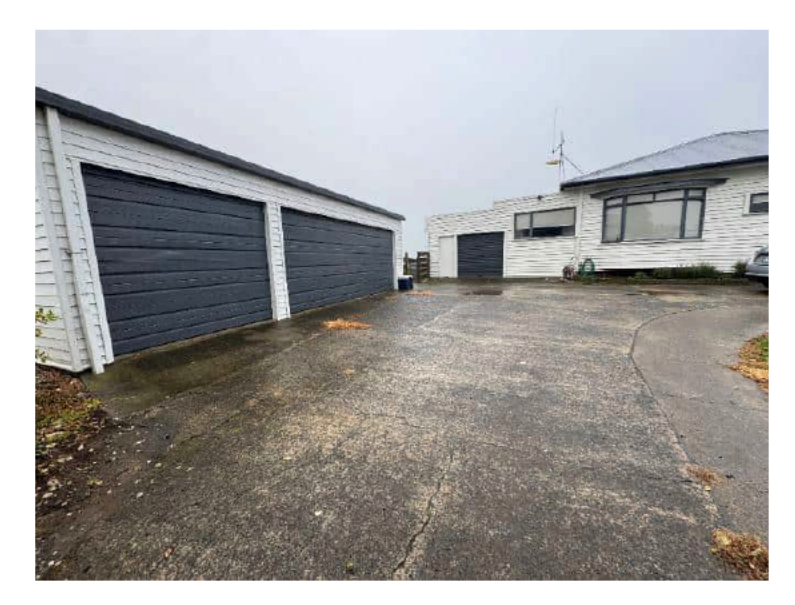
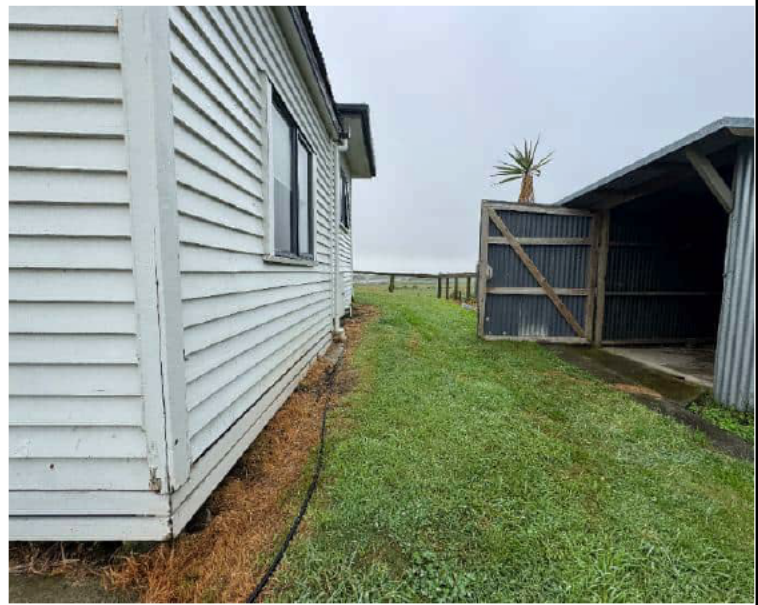
- Materials consistent with potential asbestos-containing materials were observed on the rear side of a farm/storage shed in the southern cluster. Broken board materials were also observed next to a farm/storage shed in the northern cluster, adjacent to the milking shed.

| <p>Photo 19: Potential asbestos in building materials located at the rear of the storage shed (<i>sample location SS05</i>) (22 January 2026).</p> | <p>Photo 20: Residential dwelling with garage located in the north of the site (<i>Feature 1</i> and <i>sample locations SS01 – SS03</i>), facing south (22 January 2026).</p> | <p>Photo 21: Shed located to the west of the residential dwelling (<i>Feature 1</i>) (22 January 2026).</p> |

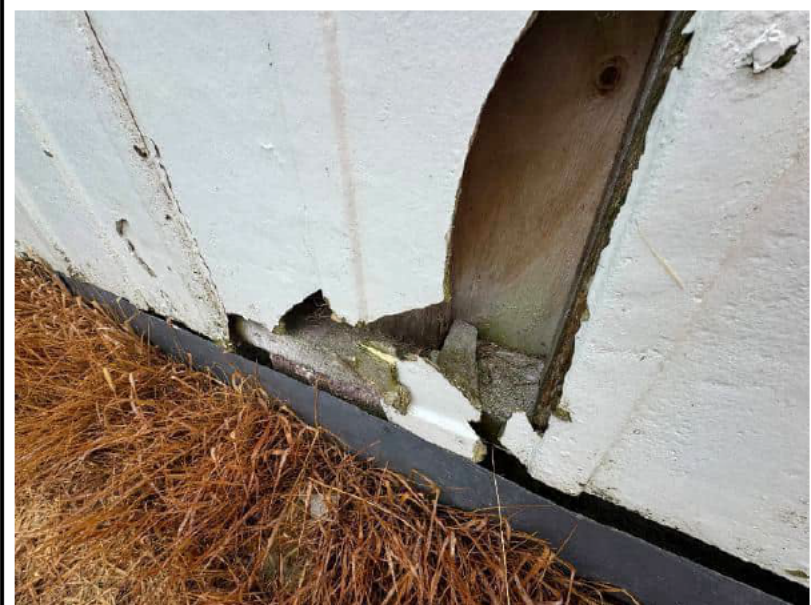
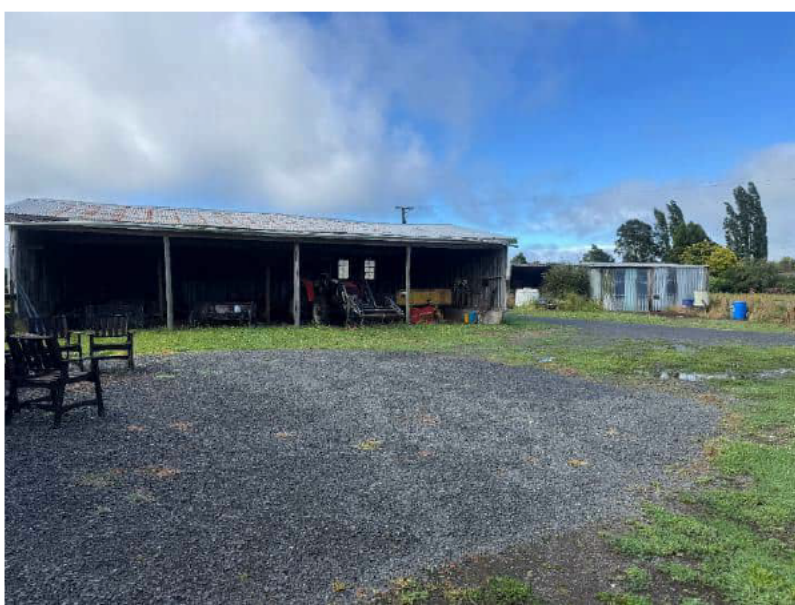
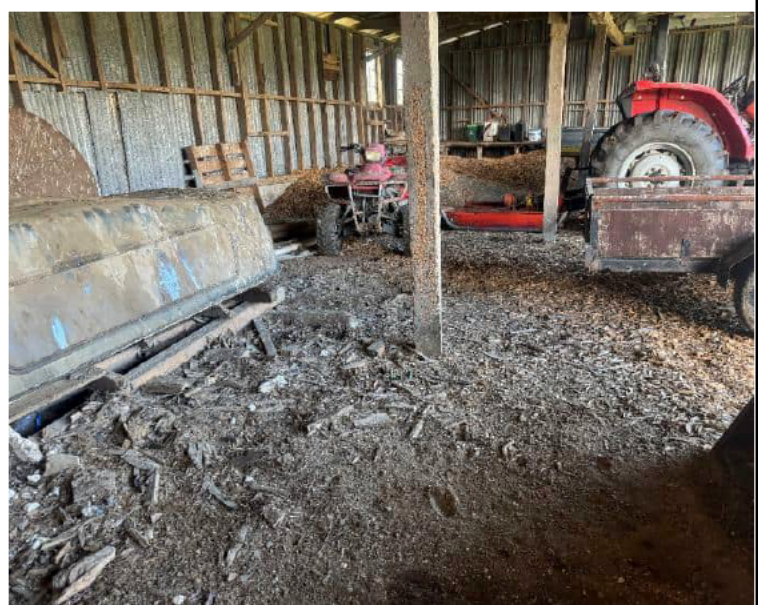
- Asbestos was detected in one soil sample (SS03) as chrysotile; the reported form was loose fibres; however, the concentrations were below the laboratory limit of reporting (LOR) and human health guideline for commercial / industrial land use. Asbestos was not detected in any other sample analysed.

| <p>Photo 22: Potential asbestos in building materials located at the southern face of the dwelling (<i>sample location SS03</i>) (22 January 2026).</p> | <p>Photo 23: Farm shed located in the south of the site, facing south (<i>sample locations SS30-SS32</i>) (22 January 2026).</p> | <p>Photo 24: Farm shed located in the south of the site (<i>sample locations SS32</i>) (22 January 2026).</p> |

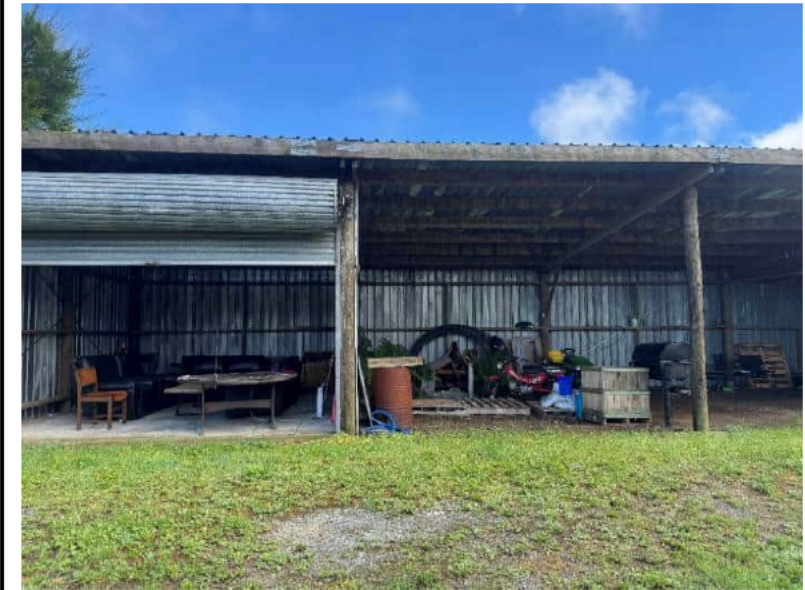
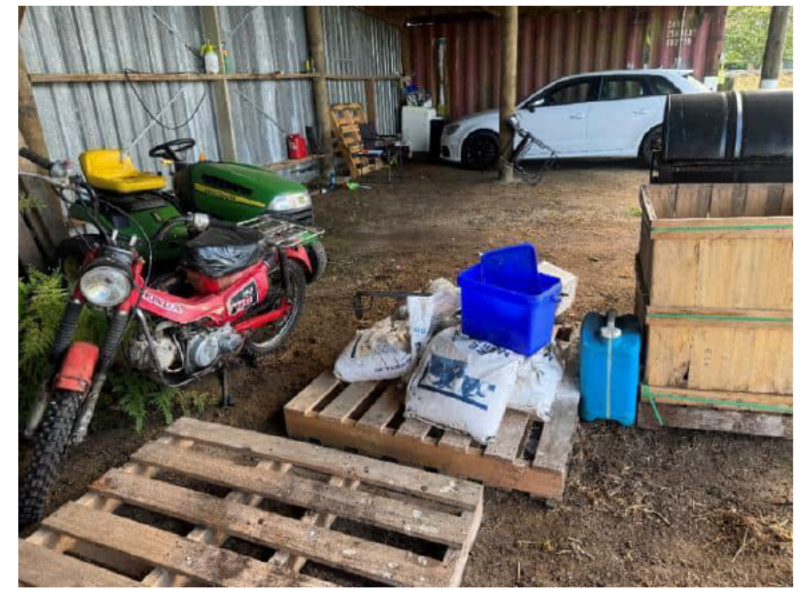
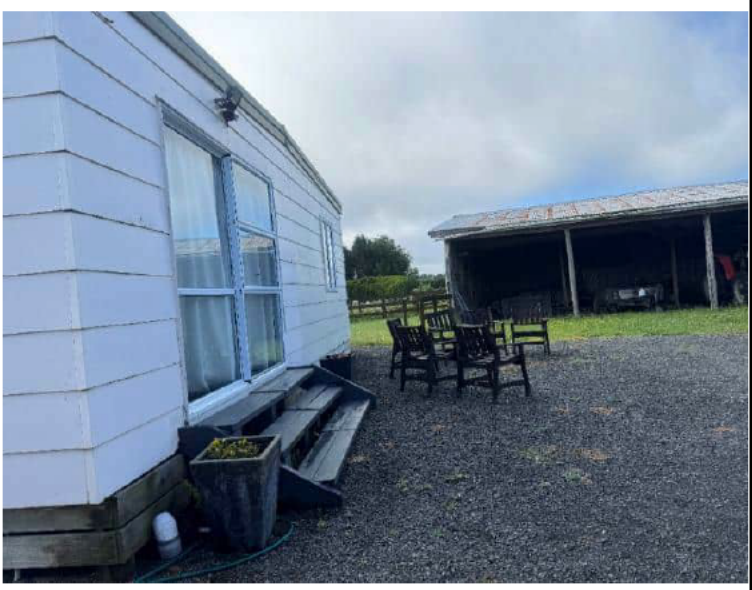
| <p>Photo 25: Storage shed located in the south of the site, facing north (<i>sample locations SS22 – SS24</i>) (22 January 2026).</p> | <p>Photo 26: Storage shed located in the south of the site, facing north (<i>sample location SS23</i>) (22 January 2026).</p> | <p>Photo 27: Residential dwelling located in the south of the site, facing south (22 January 2026).</p> |

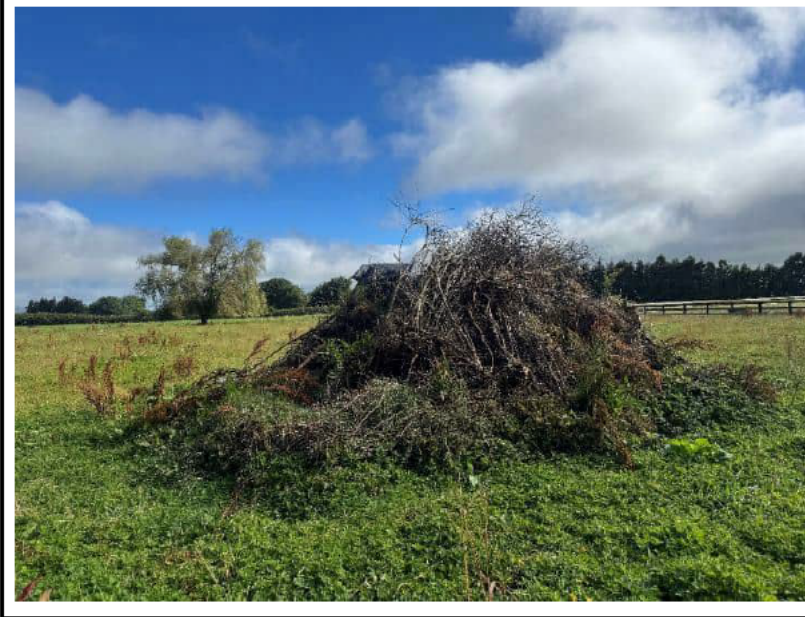
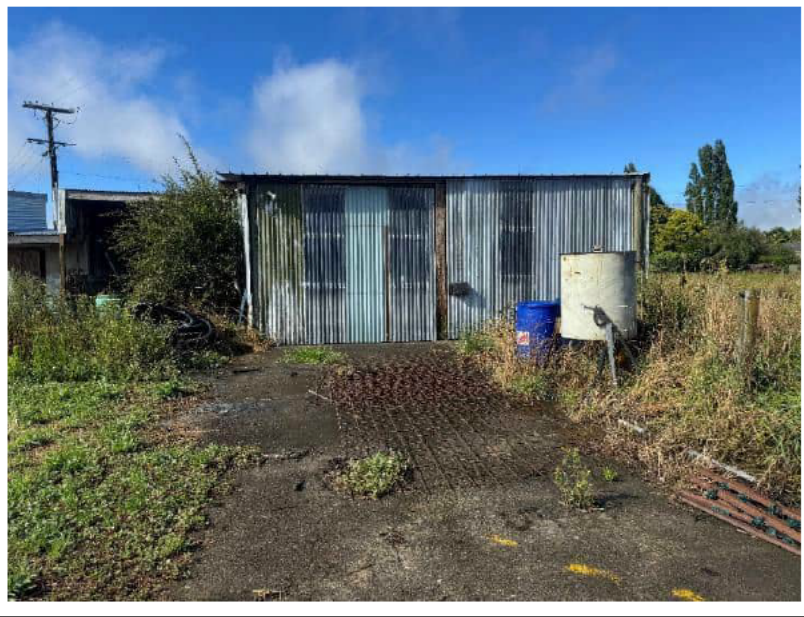
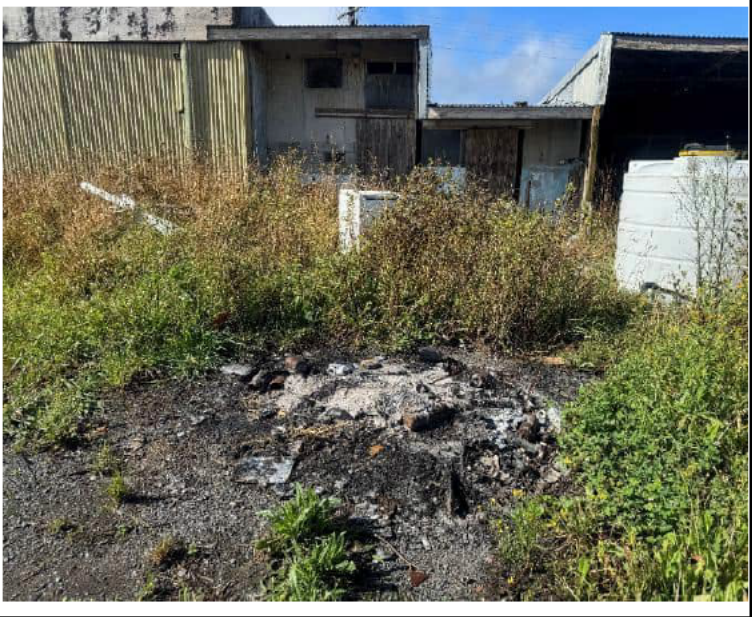
| <p>Photo 28: Pile of vegetation located in the south of the site (22 January 2026).</p> | <p>Photo 29: Farm shed located in the south of the site, facing south (<i>sample locations SS25 – SS29</i>) (22 January 2026).</p> | <p>Photo 30: Burn pit located adjacent to a farm shed located in the south of the site (22 January 2026).</p> |
