# Preliminary and Detailed Site Investigation

## Te Kowhai East Development

### Te Kowhai East Limited Partnership

**SLR Consulting New Zealand Limited**

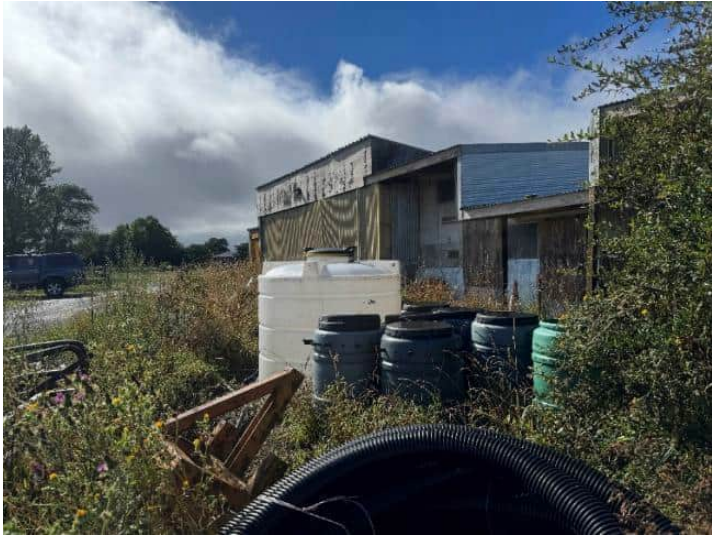
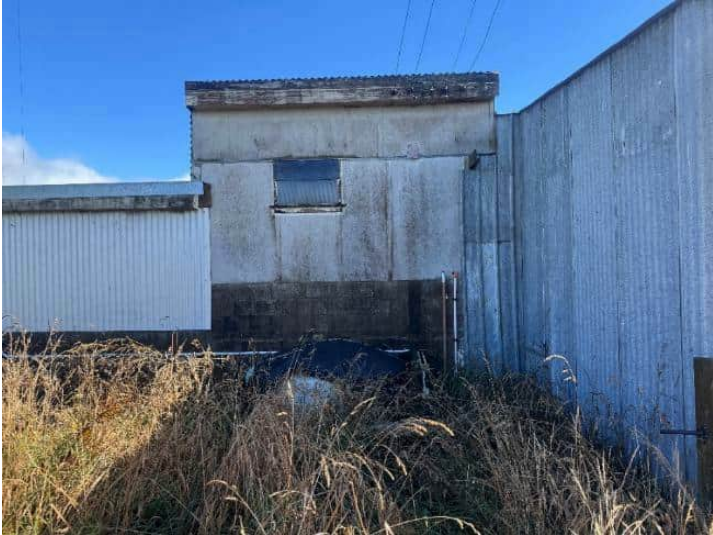
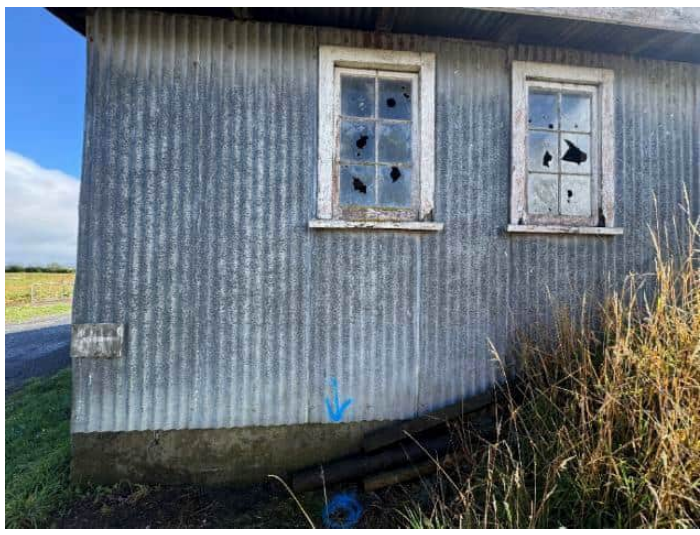
| <p><b>Photo 31: Empty drums and various farm tools located in the south of the site (22 January 2026).</b></p> | <p><b>Photo 32: Potential asbestos in building materials located at the southern face of the farm shed (sample location SS29) (22 January 2026).</b></p> | <p><b>Photo 33: Rear of farm shed with potential lead based paint (sample location SS28) (22 January 2026).</b></p> |

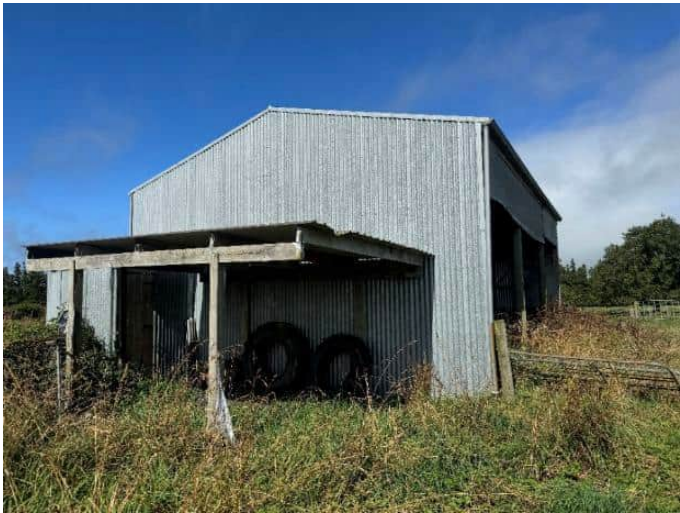
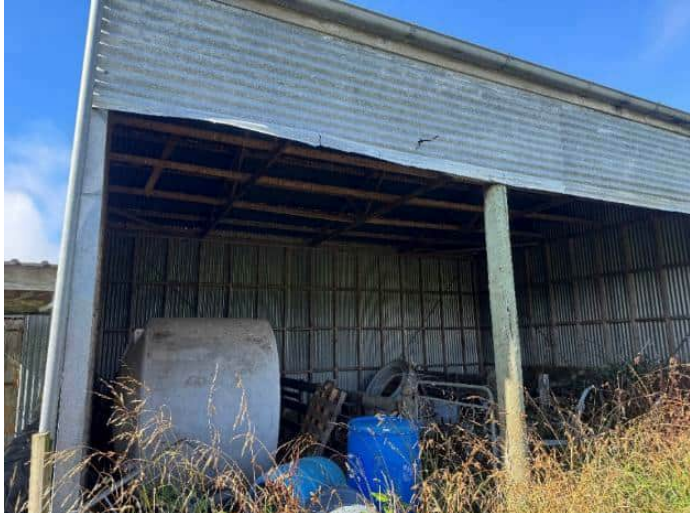
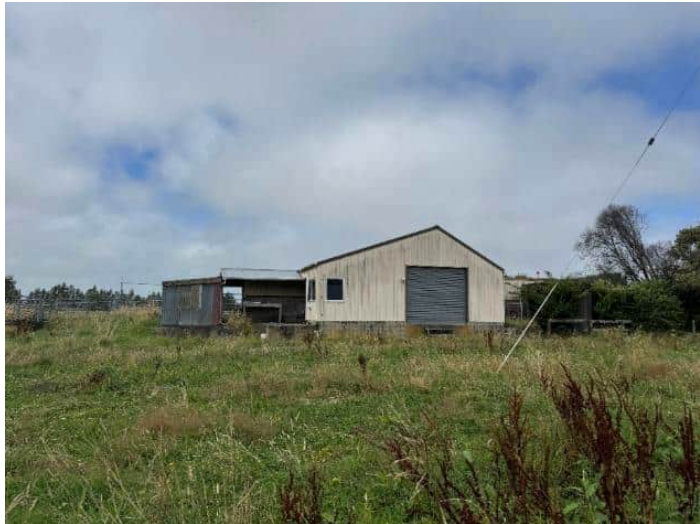
| <p><b>Photo 34: Storage shed located in the south of the site, facing west (sample locations SS17 – SS19) (22 January 2026.)</b></p> | <p><b>Photo 35: Storage shed located in the south of the site (sample locations SS17 – SS19) (22 January 2026.)</b></p> | <p><b>Photo 36: Former milking shed located in the south of the site, facing east (Feature 9 and sample locations SS20, SS21) (22 January 2026).</b></p> |

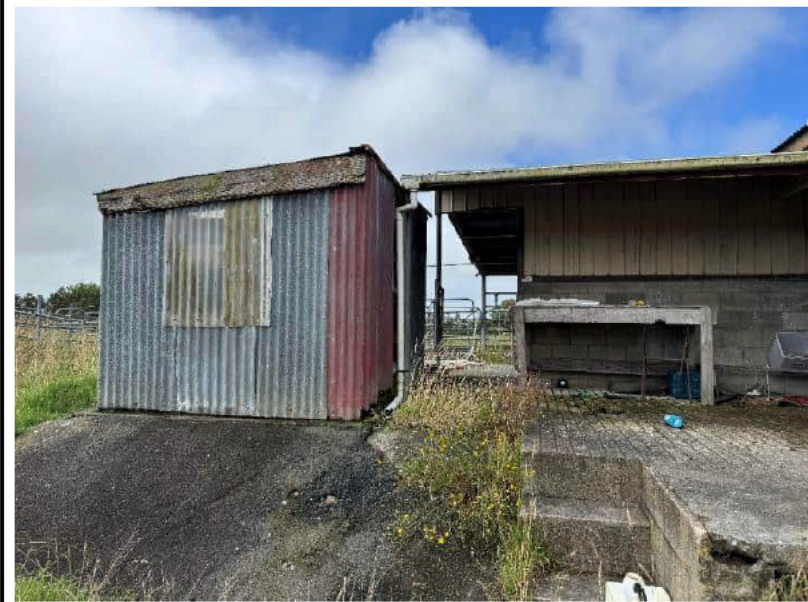
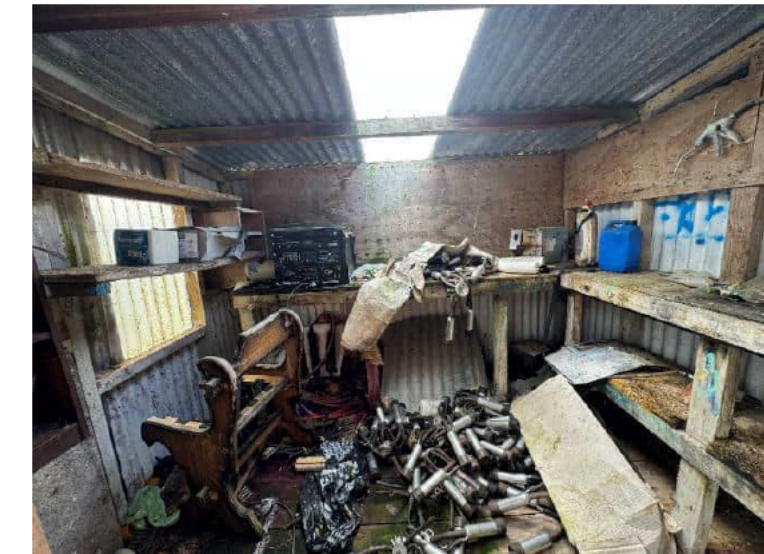
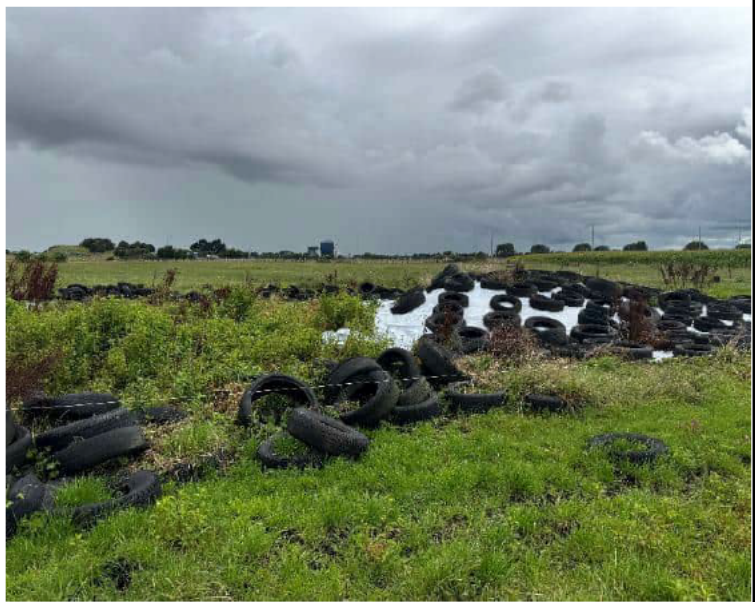
| <p>Photo 37: Shed located adjacent to a former milking shed (<i>Feature 9</i>) (22 January 2026).</p> | <p>Photo 38: Farm tools stored within a former milking shed (<i>Feature 9</i>) (22 January 2026).</p> | <p>Photo 39: Storage of tyres located in the east of the site (<i>sample location HA17, HA18</i>) (27 January 2026).</p> |

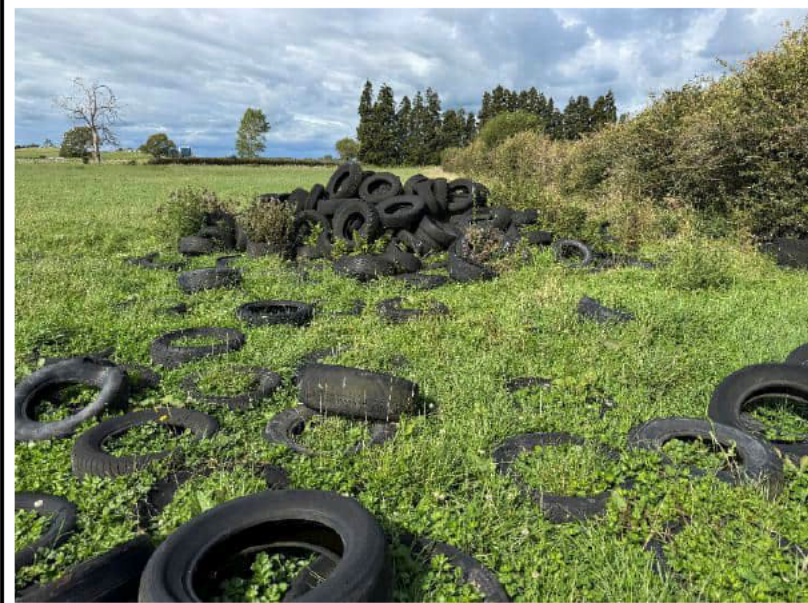
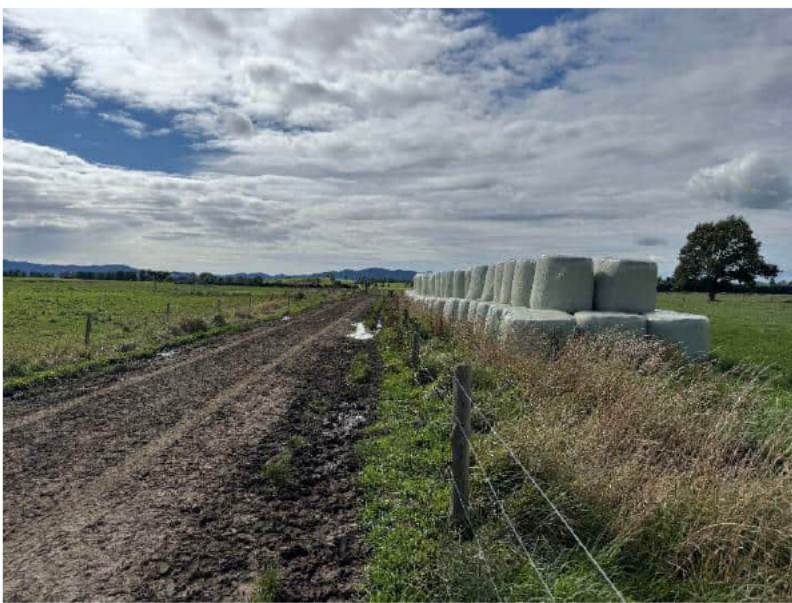
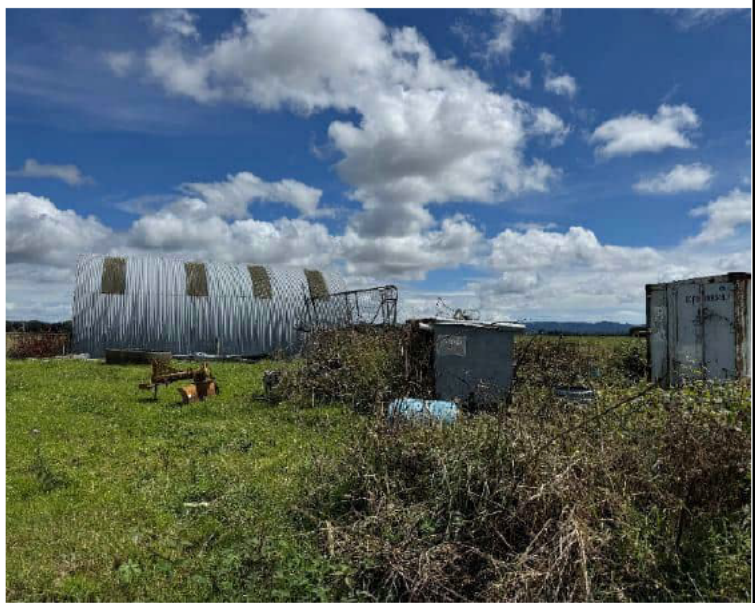
| <p>Photo 40: Second tyre storage located in the south of the site (<i>sample location HA19</i>) (27 January 2026).</p> | <p>Photo 41: Hay storage located in the south of the site (27 January 2026).</p> | <p>Photo 42: Farm structures located in the north of the site (27 January 2026).</p> |

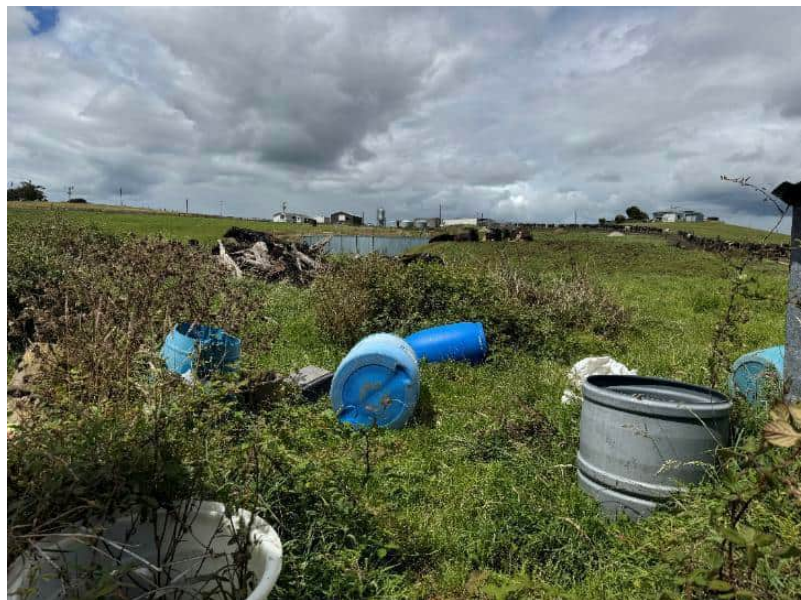
**Photo 43: Various items on the ground adjacent to farm structures located in the north of the site (*sample locations SS36 and SS37*). (27 January 2026).**

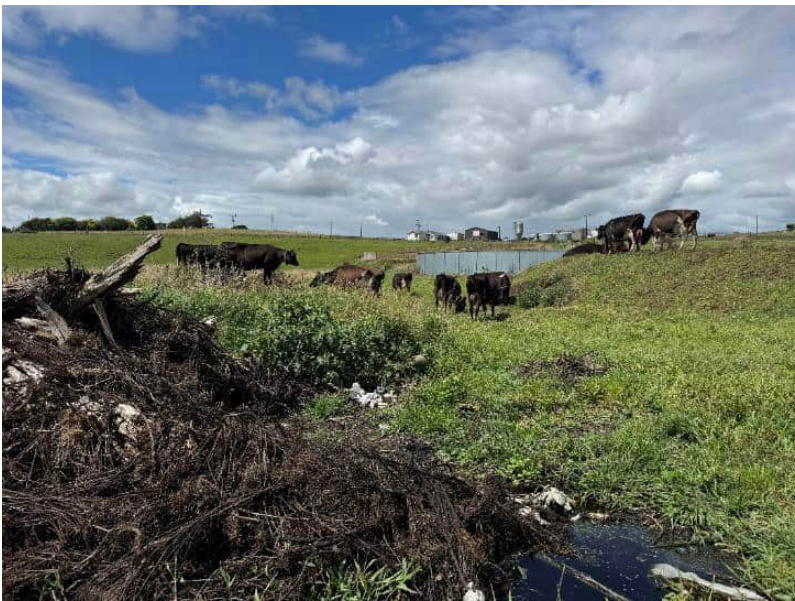
- Two burn pits were observed on the Site, located adjacent to farm/storage sheds in both structural clusters.
- Tyre storage was observed at two locations on the Site.

**Photo 44: Second burn pit located in the north of the site 27 January 2026).**
