PROJECT	KIWI PROPERTY GROUP LIMITED					
TITLE	DRURY CENTRE PROJECT GEOTECHNICAL INVESTIGATION LOCATIONS GIS SHEET 3 OF 5					
DOCUMENT	PROJECT No. 510611	WBS 002	TYPE FIG	DISC GG	NUMBER 0003	REVISION A

PROJECT :  
**133 Fitzgerald Road - Drury**

# APPENDIX D: AURECON EARTHWORKS QA AND CERTIFICATION

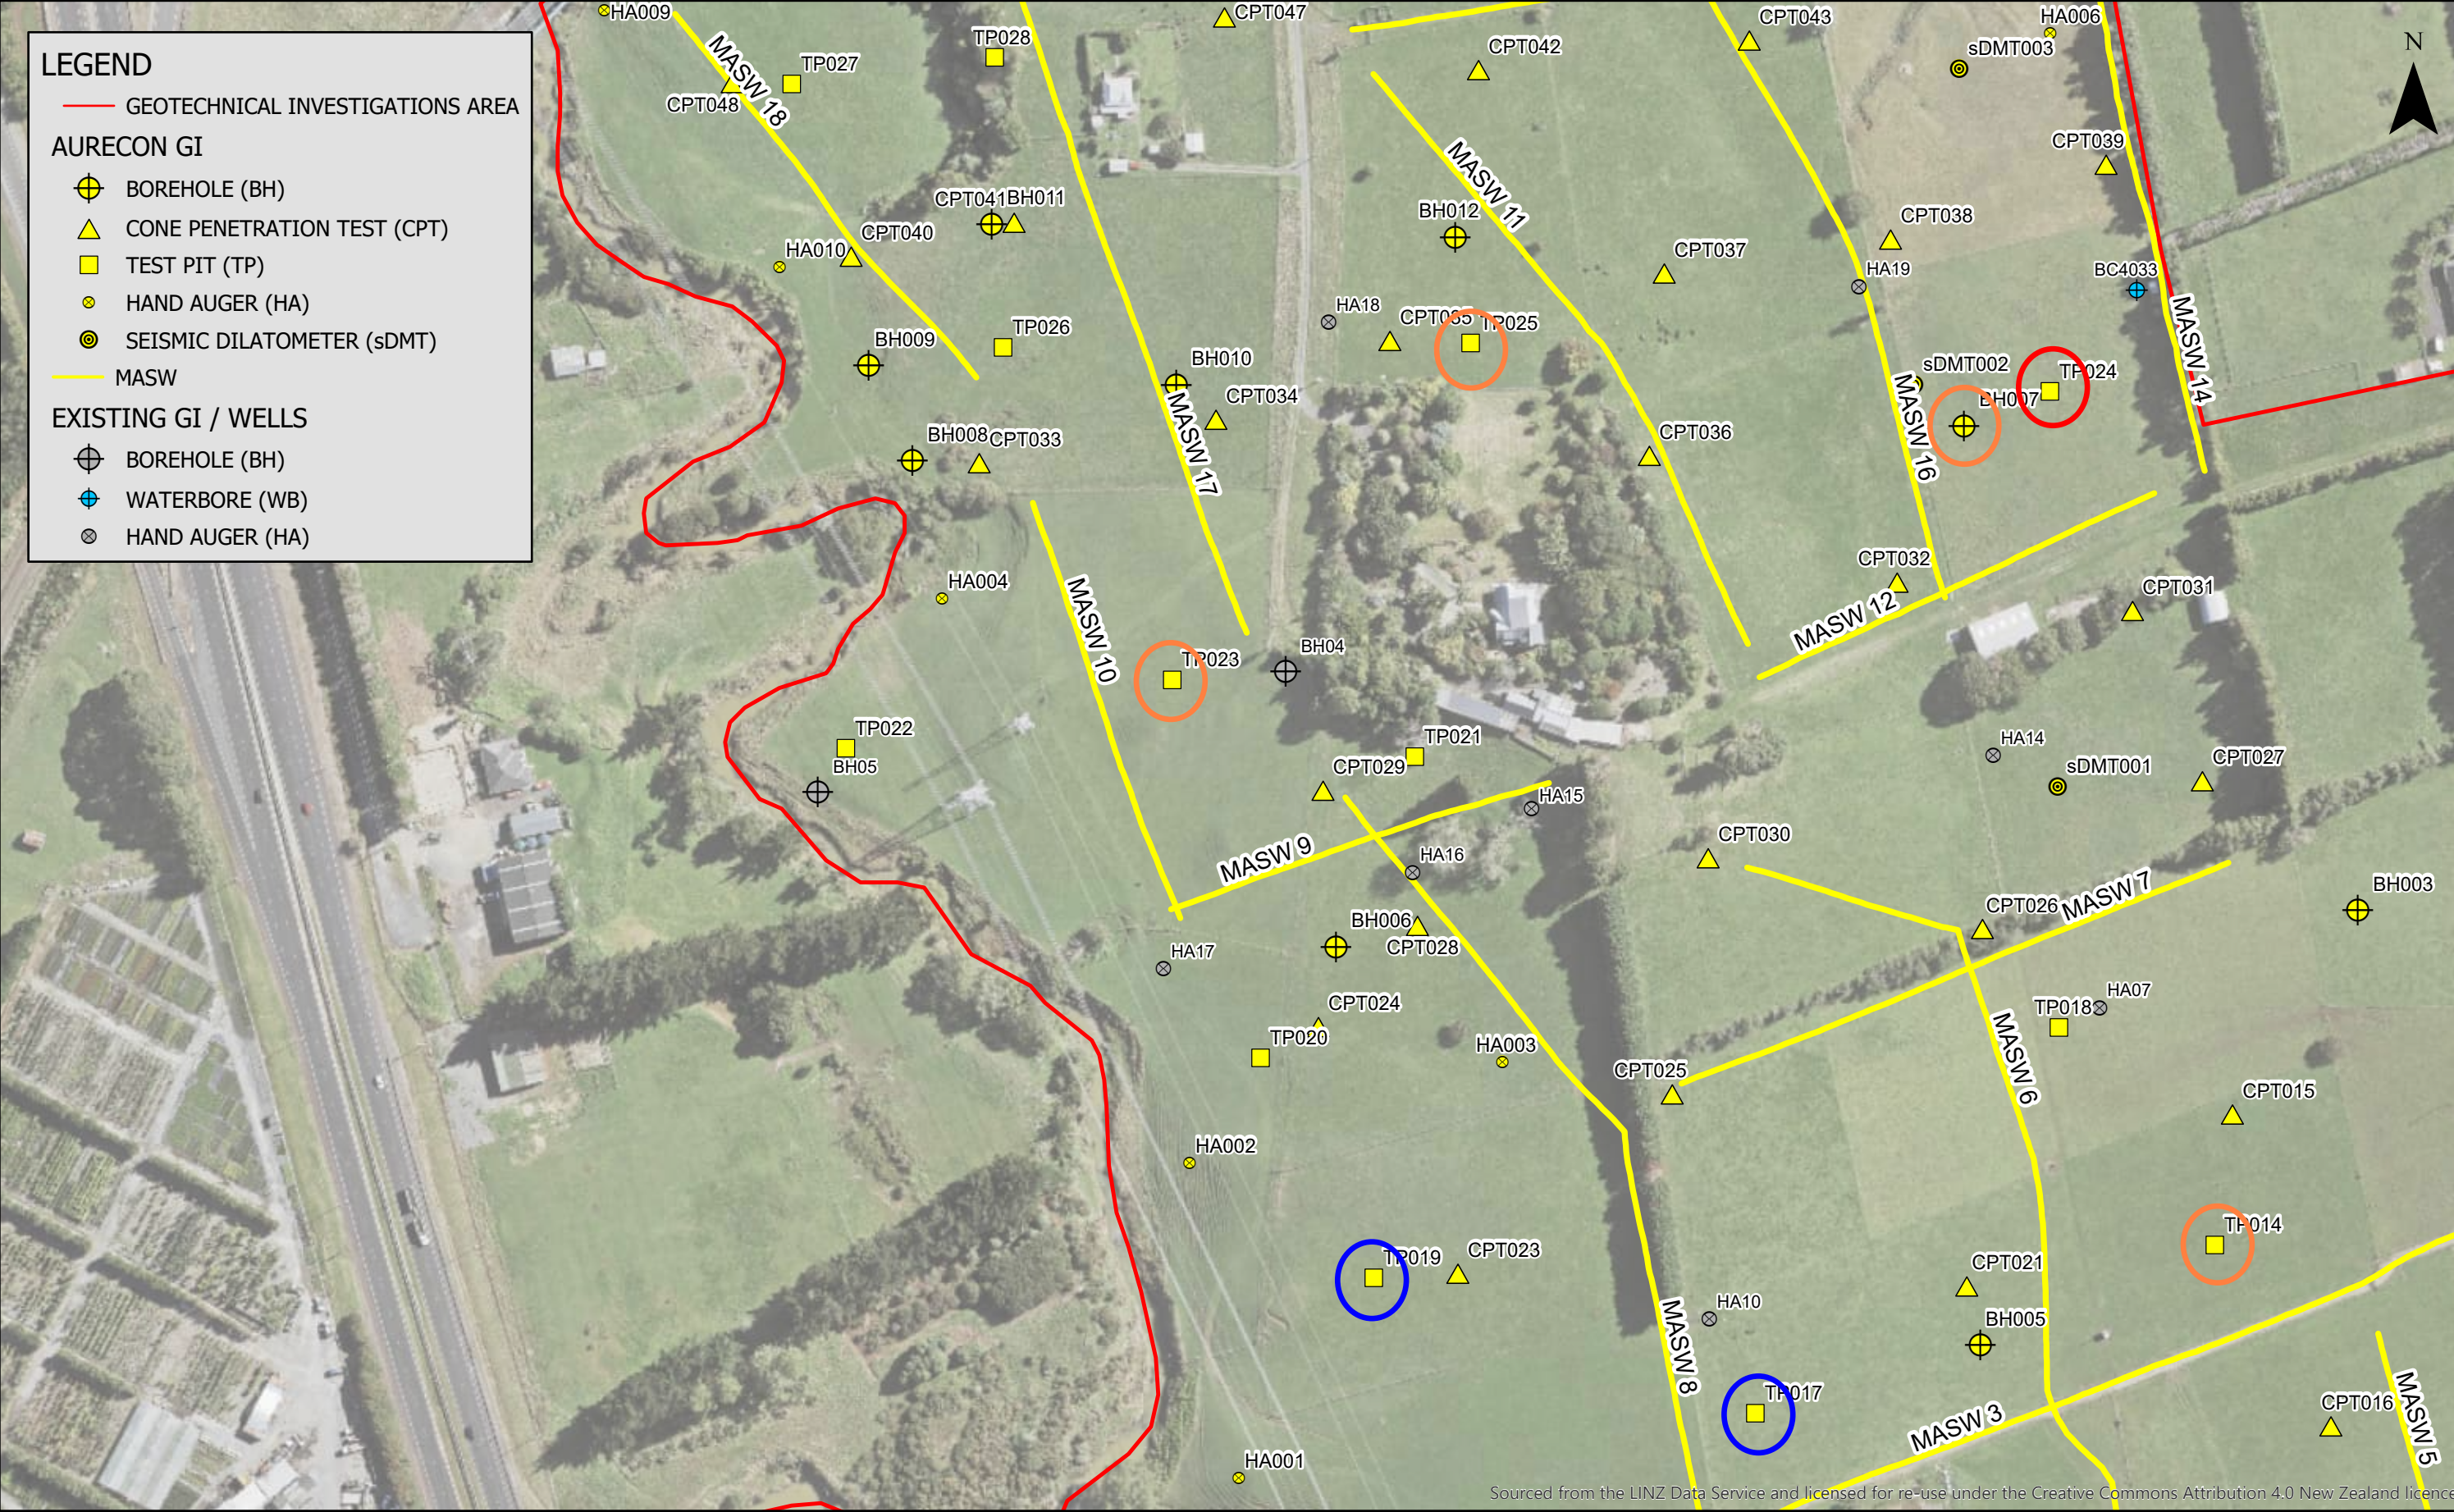
REV	DATE	REVISION DETAILS	APPROVED
A	31-03-21	GEOTECHNICAL INVESTIGATION LOCATIONS	J KUPEC

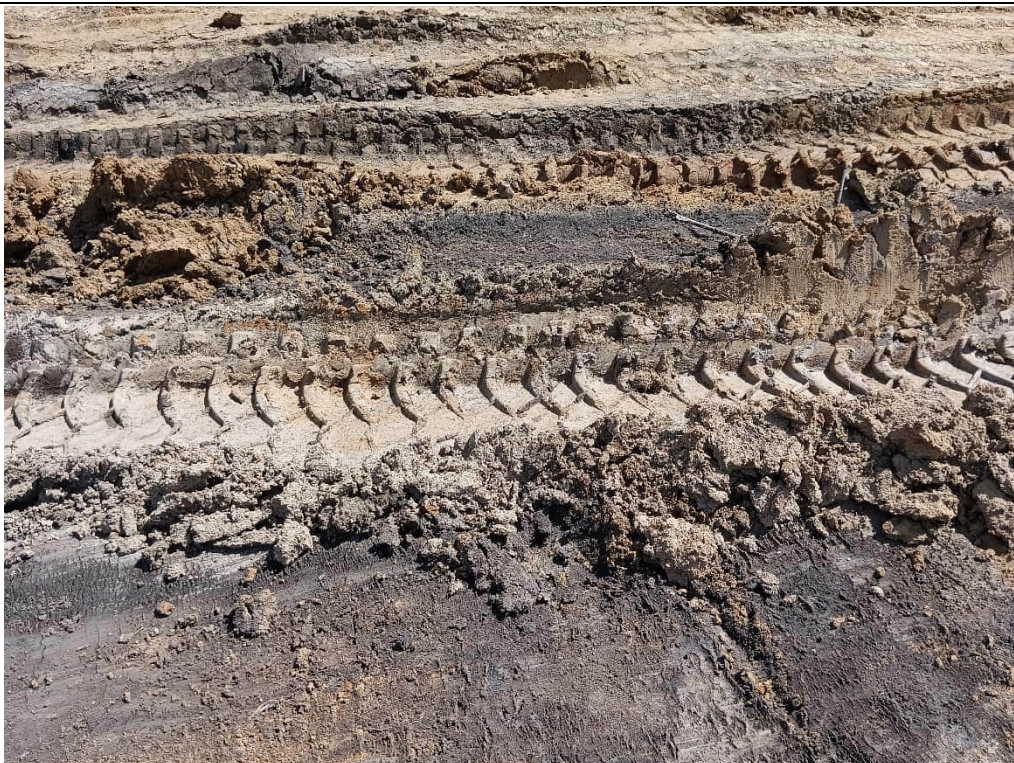
<b>Photo No.</b> 5	<b>Date:</b> 11/10/22

<b>Description:</b>  View of the soils underneath the topsoil. Sandy SILT with minor clay.

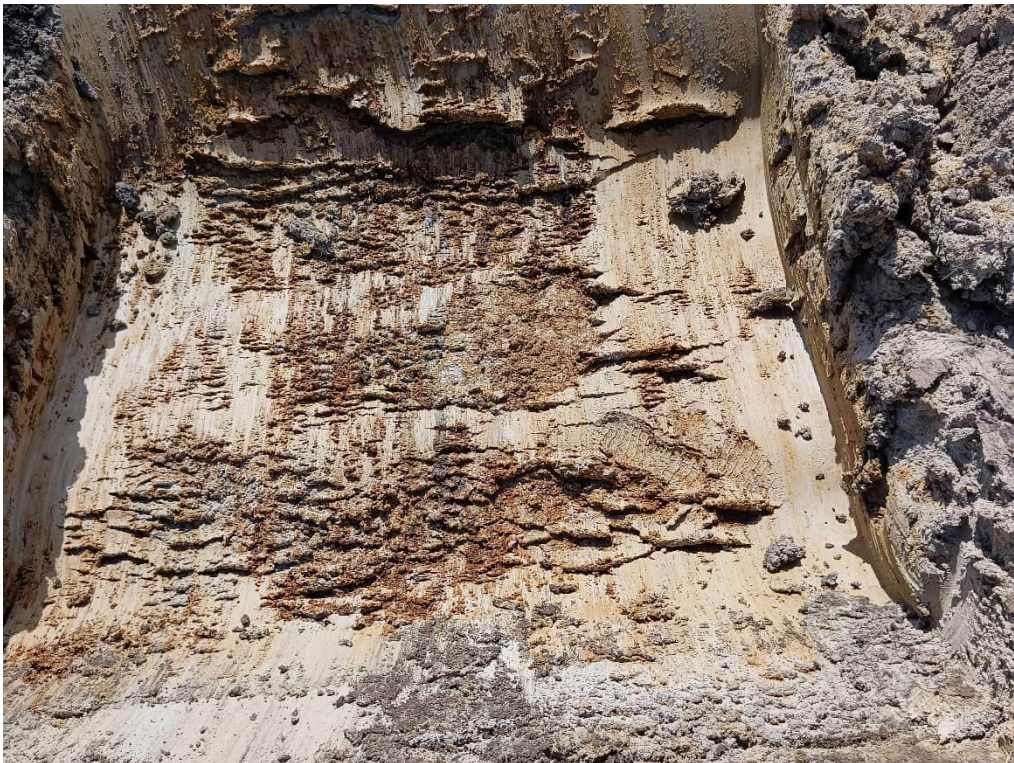
<b>Photo No.</b> 6	<b>Date:</b> 11/10/22

<b>Description:</b>  View of the base of the soft spot at 0.5m below the surrounding area.  Ross Reid planned to conduct shear vanes and scala testing on 12 October.  Perch water seeped into the pit, unable to test.

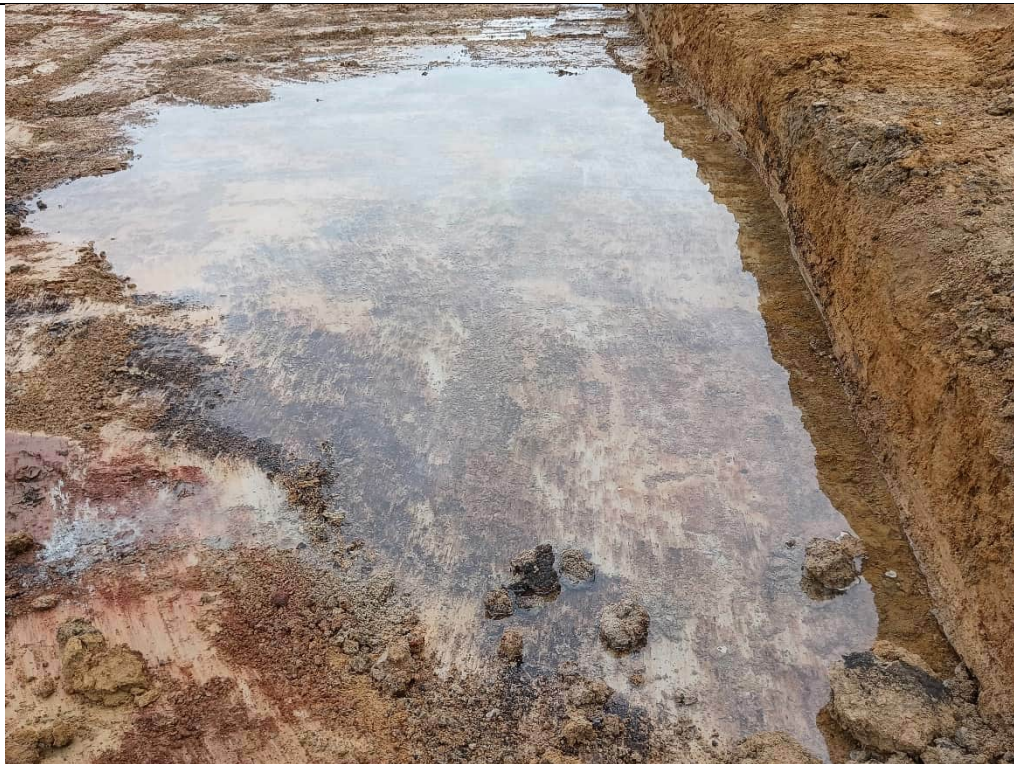
<b>Photo No.</b> 6	<b>Date:</b> 12/10/22

<b>Description:</b>  View of the area 1A9 undercut soft spot being waterlogged towards south eastern corner.

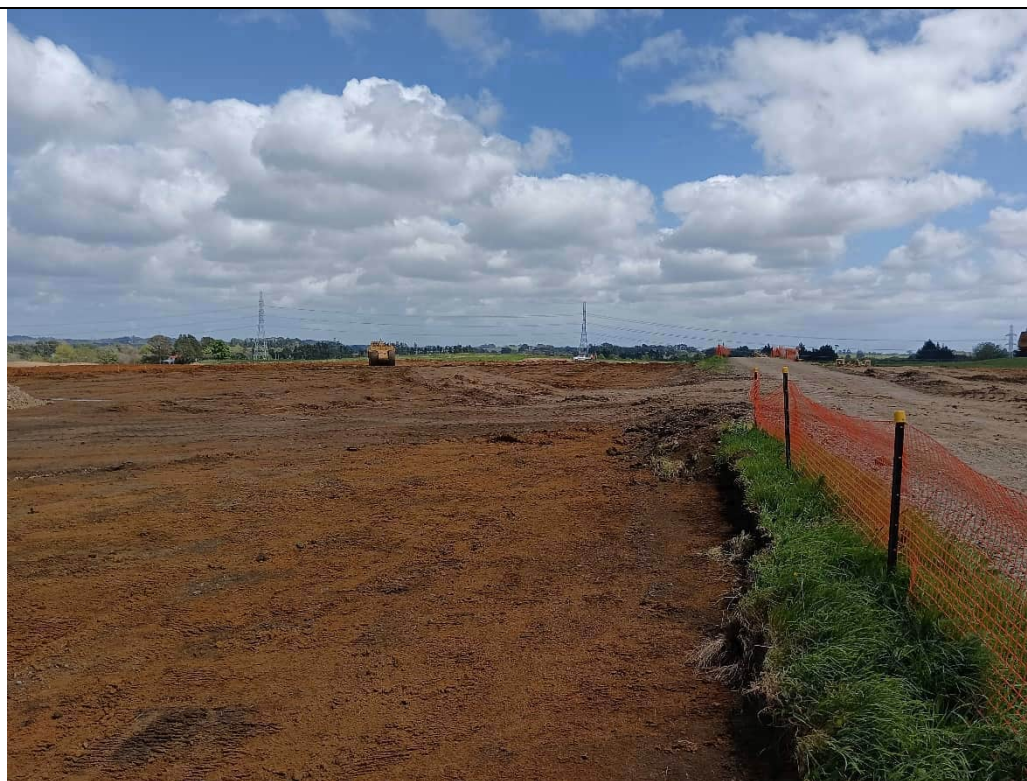
No soft spots are heaving observed during the inspection.

Approximately 3.0m cut to be actioned in the current area of inspection.

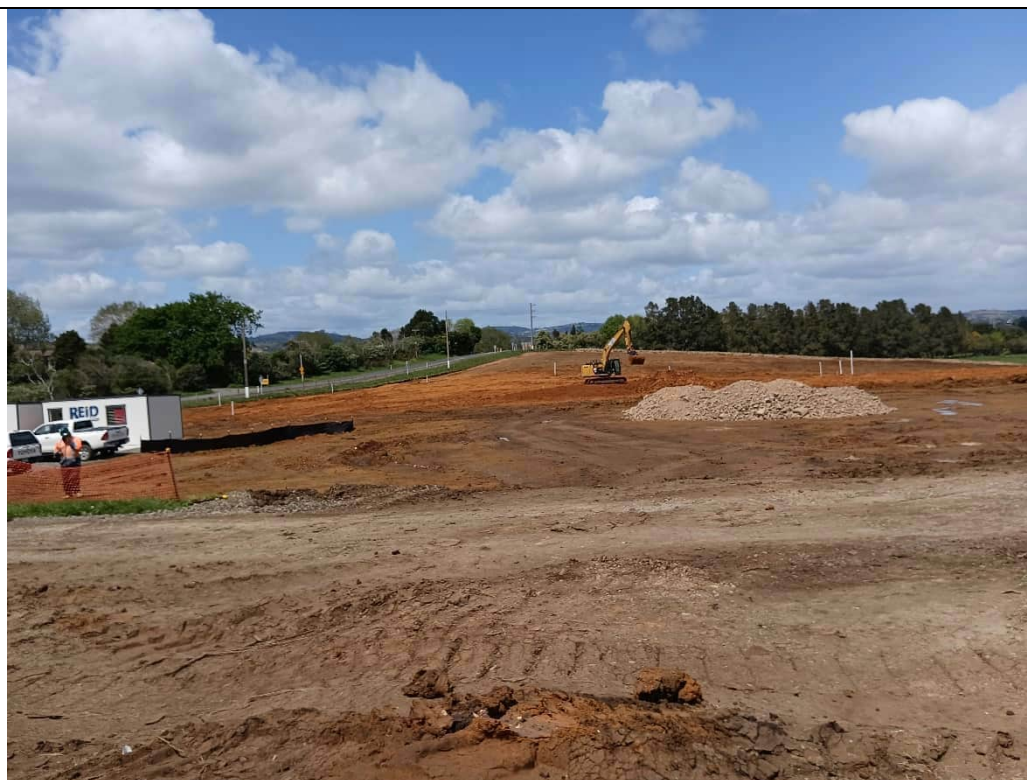
View of the area A8 facing south towards A9.

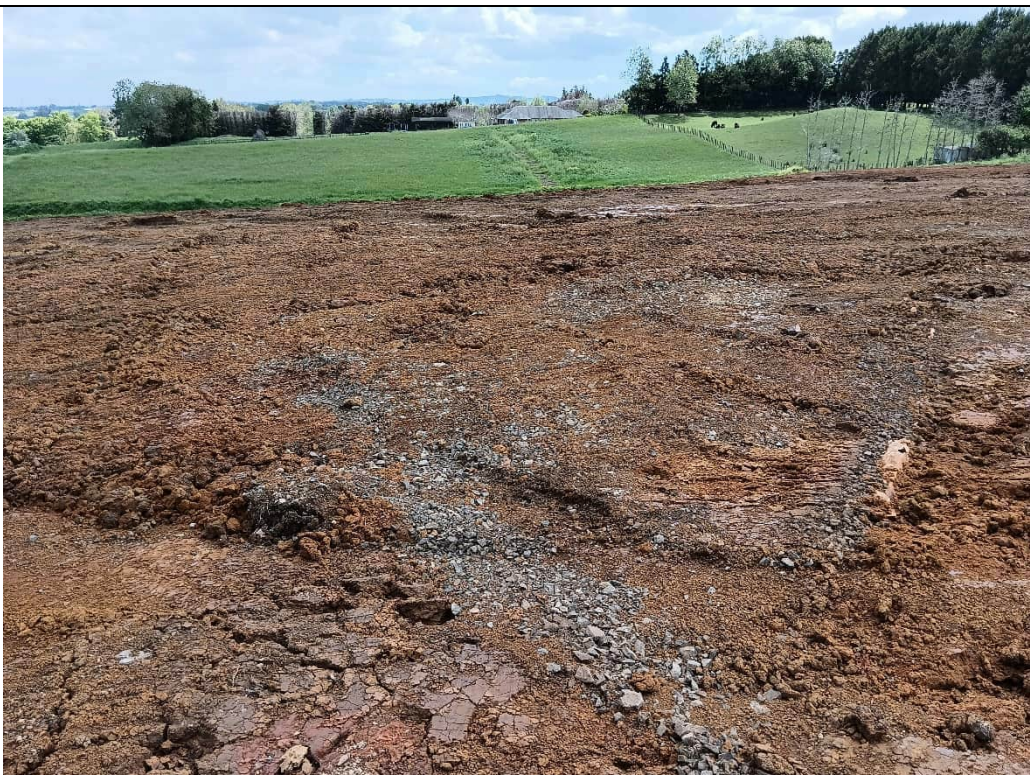
<b>Photo No.</b> 2	<b>Date:</b> 26/10/22

<b>Description:</b> View of the gravel scattered below the topsoil was observed across the strip site.

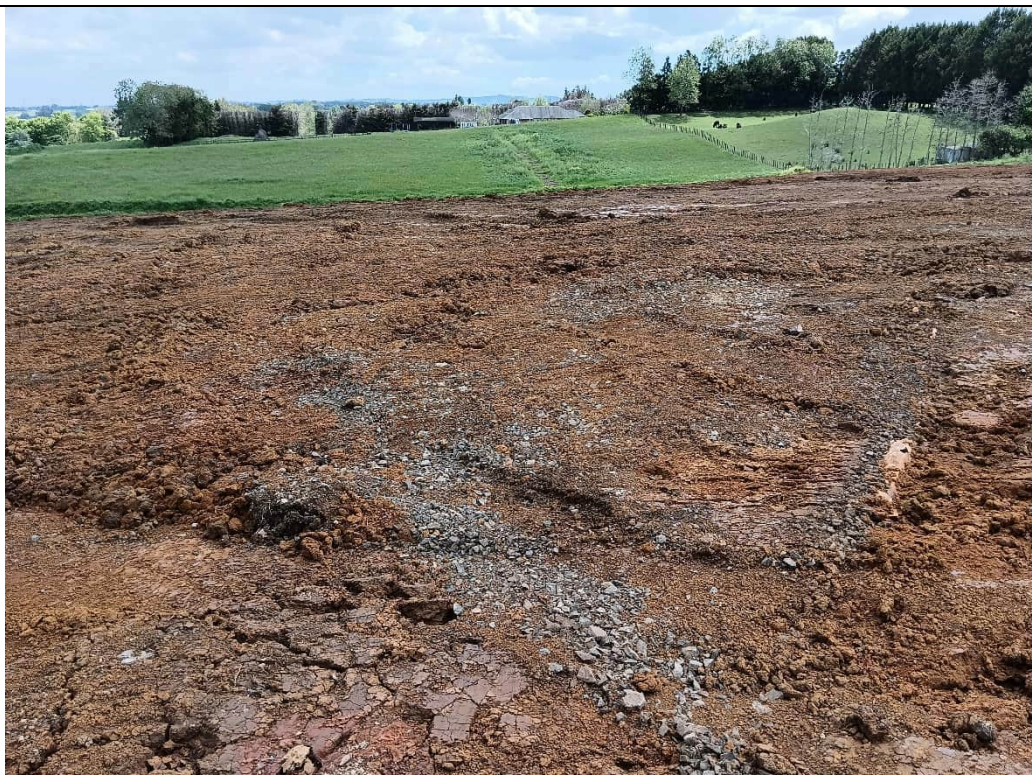
<b>Photo No.</b> 2	<b>Date:</b> 26/10/22

<b>Description:</b> View of the gravel scattered below the topsoil was observed across the strip site.

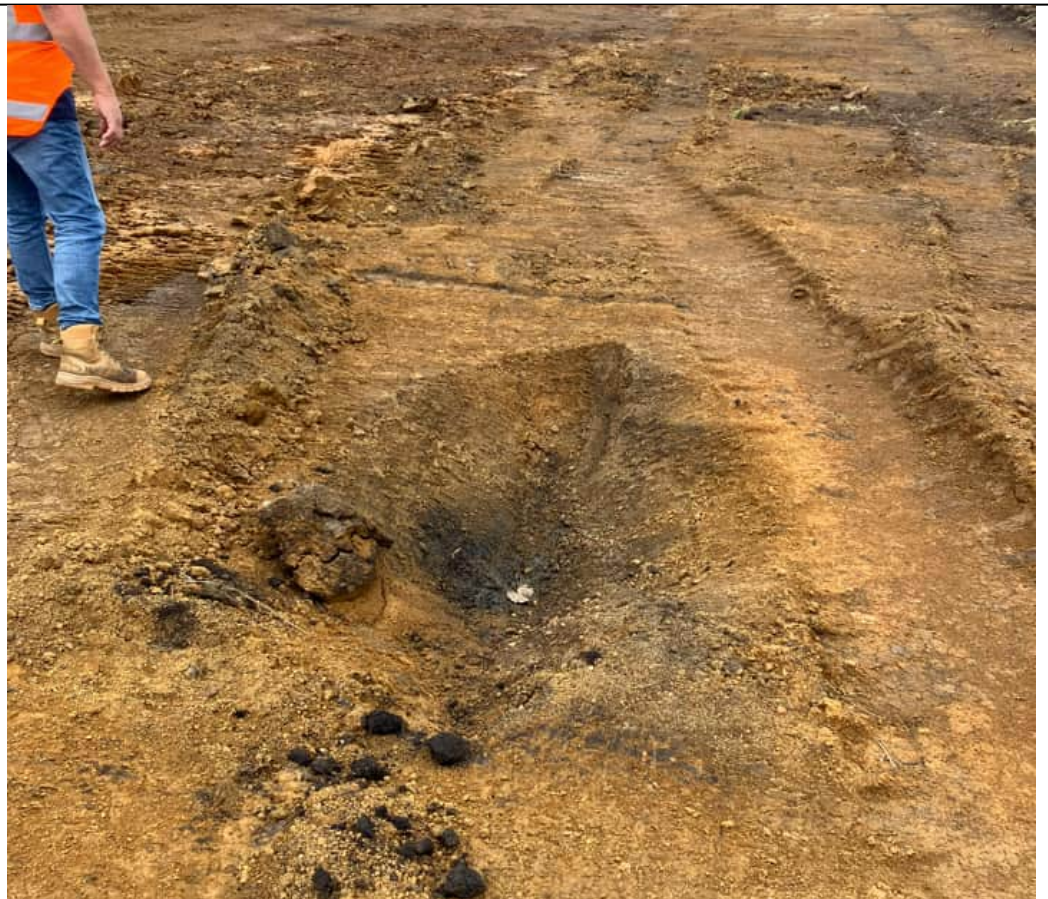
Isolated soft spot removed.

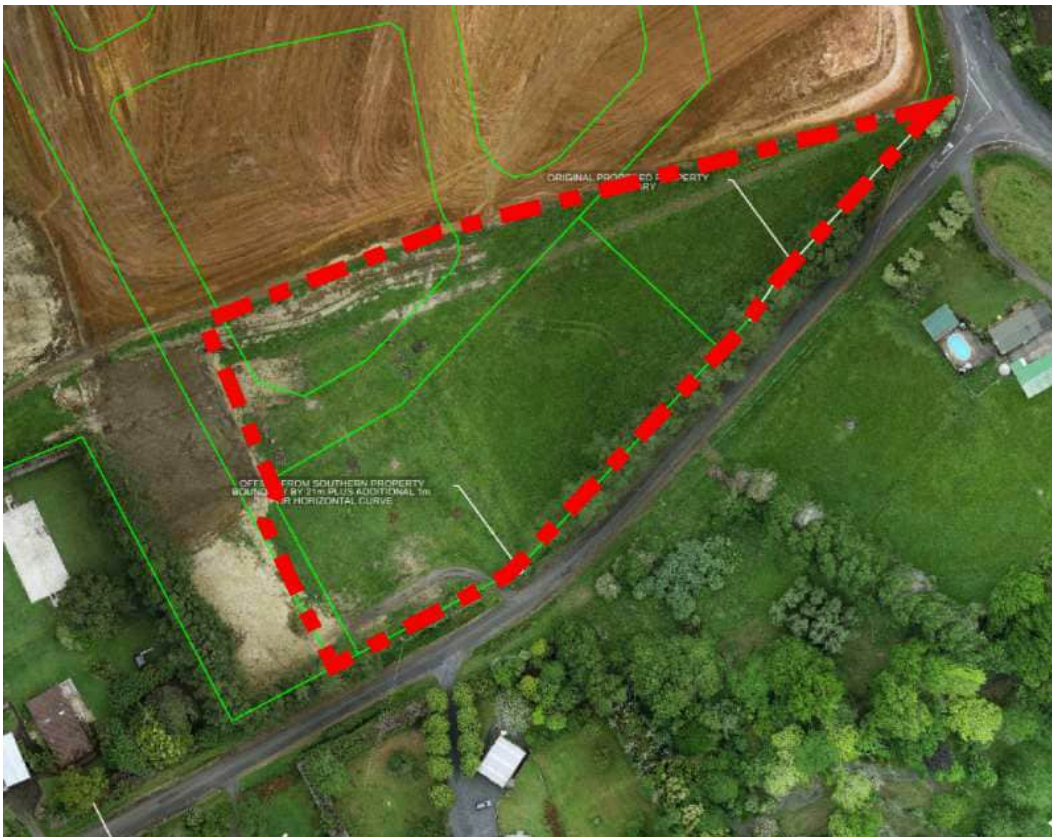
PHOTOGRAPHS			
<b>Client Name:</b> Kiwi Property Group		<b>Site Location:</b> 133 Fitzgerald Road, Drury	<b>Project No.</b> 510611
<b>Photo No.</b> 1	<b>Date:</b> 19/01/23	 	
<b>Description:</b> Topsoil strip progress underway.			
<b>Photo No.</b> 2	<b>Date:</b> 19/01/23	 	
<b>Description:</b> Topsoil strip complete.

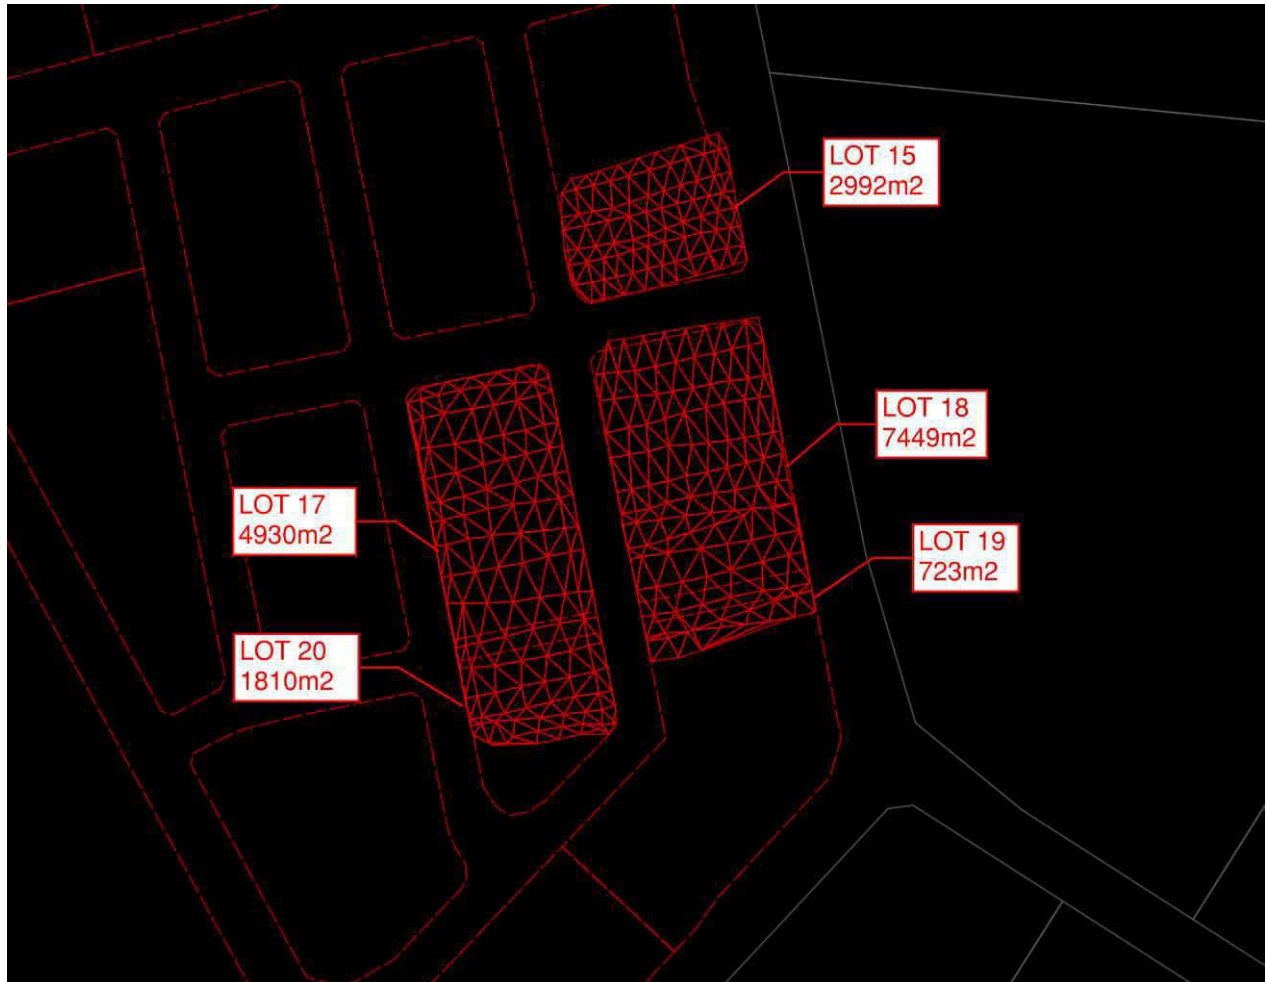
**Figure 1: Extent of works observed**

The site features including finished surface areas inspected is presented in the photos appended to this report.

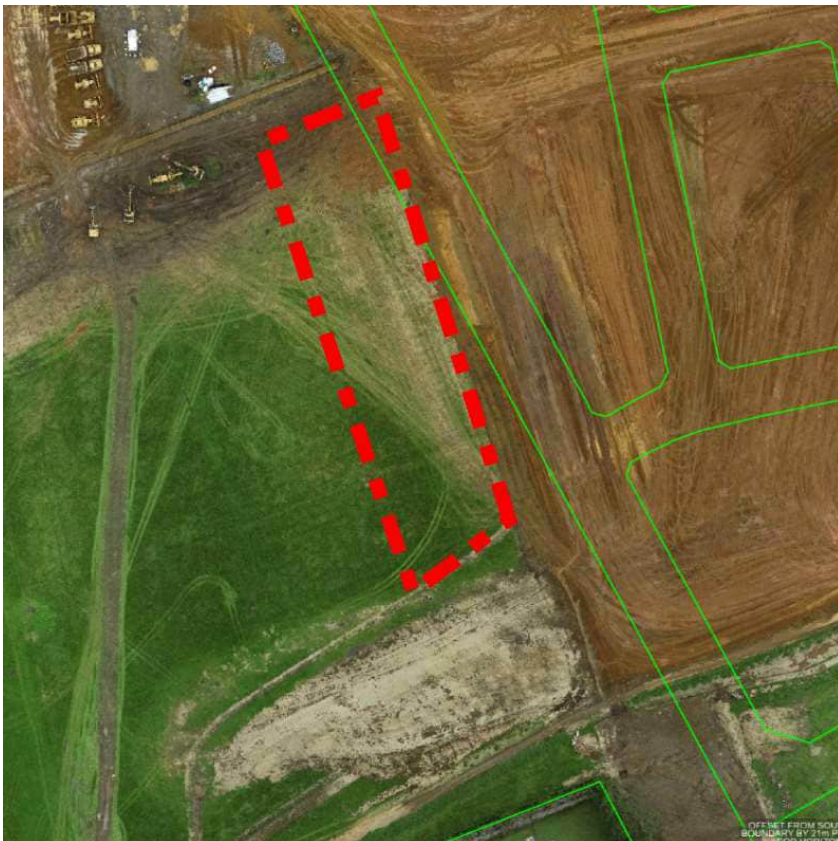
**Figure 1: Extent of works observed**

- Earthworks can proceed in this area.

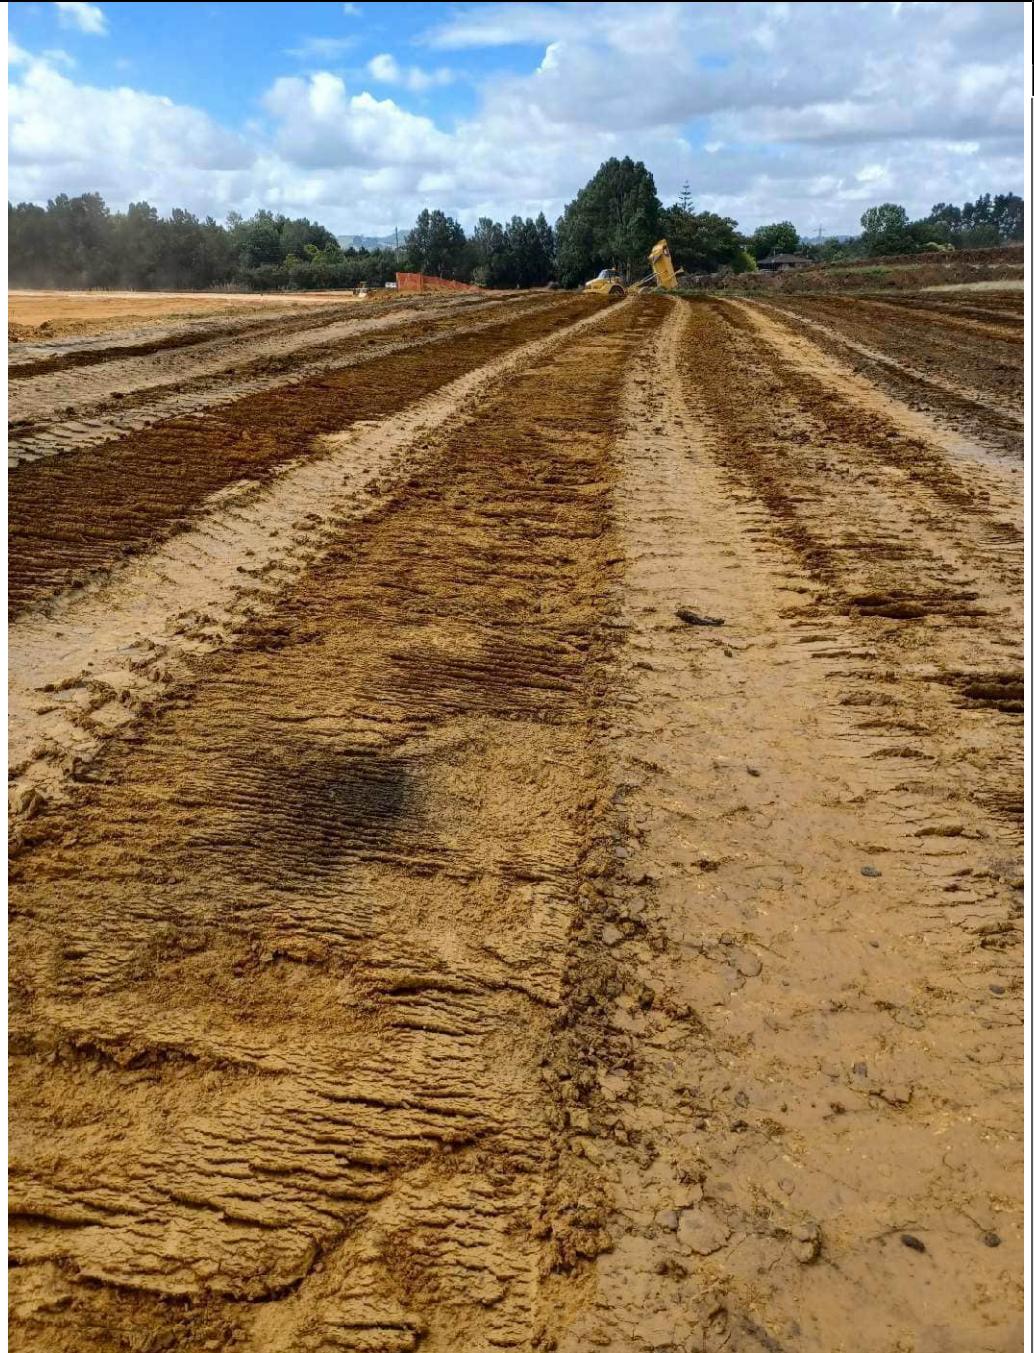
Area of topsoil striped.

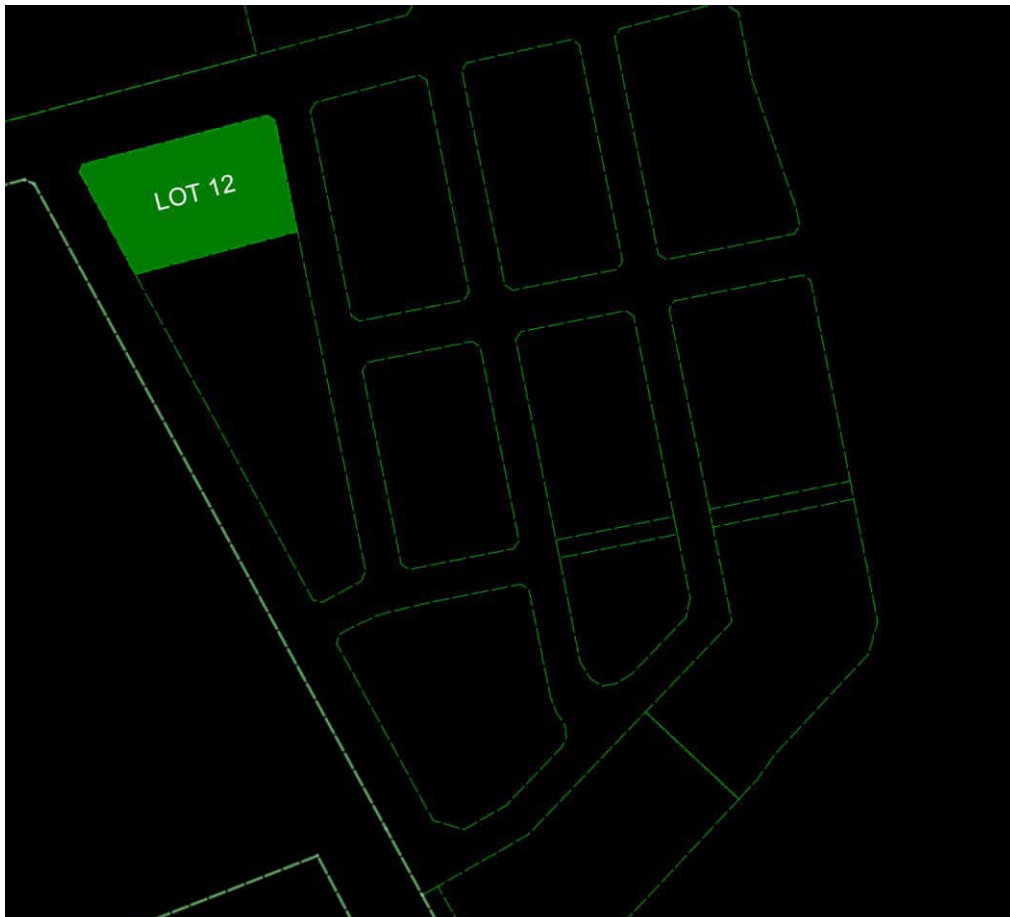
**Figure 1: Extent of works observed (green hatch)**

- The site features including finished surface areas inspected is presented in the photos included in this report.

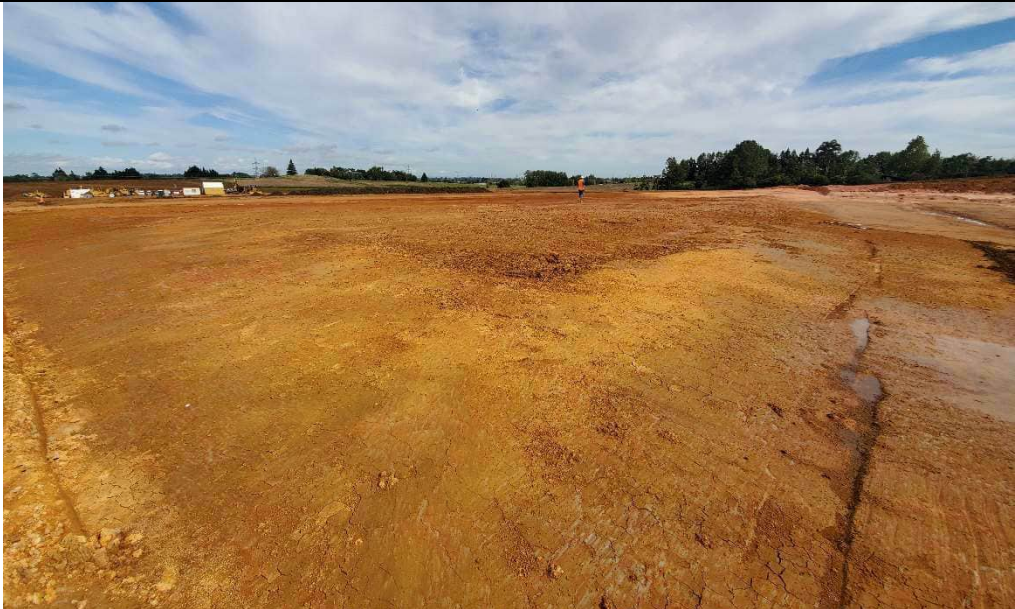
PHOTOGRAPHS			
<b>Client Name:</b> Kiwi Property Group		<b>Site Location:</b> 133 Fitzgerald Road, Drury	<b>Project No.</b> 510611
<b>Photo No.</b> 1.1	<b>Date:</b> 20/02/23

<b>Description:</b>  Lot 13  Finished subgrade level. Insitu material.  Some surface water.

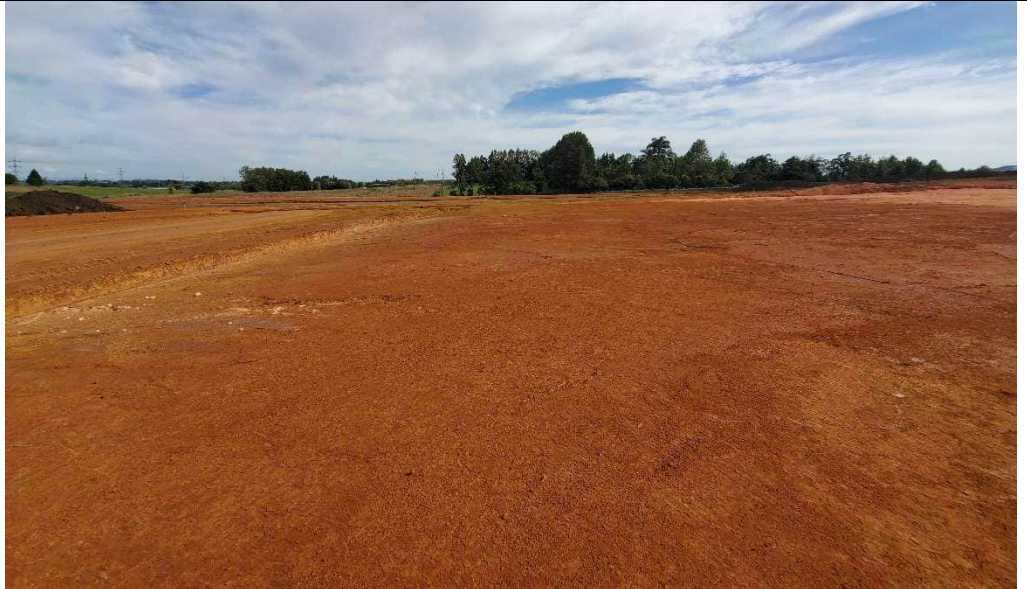
<b>Client Name:</b>  Kiwi Property Group		<b>Site Location:</b>  133 Fitzgerald Road, Drury	<b>Project No.</b>  510611
<b>Photo No.</b> 1.2	<b>Date:</b> 20/02/23

<b>Description:</b>  Lot 13  Finished subgrade level. Engineering fill.

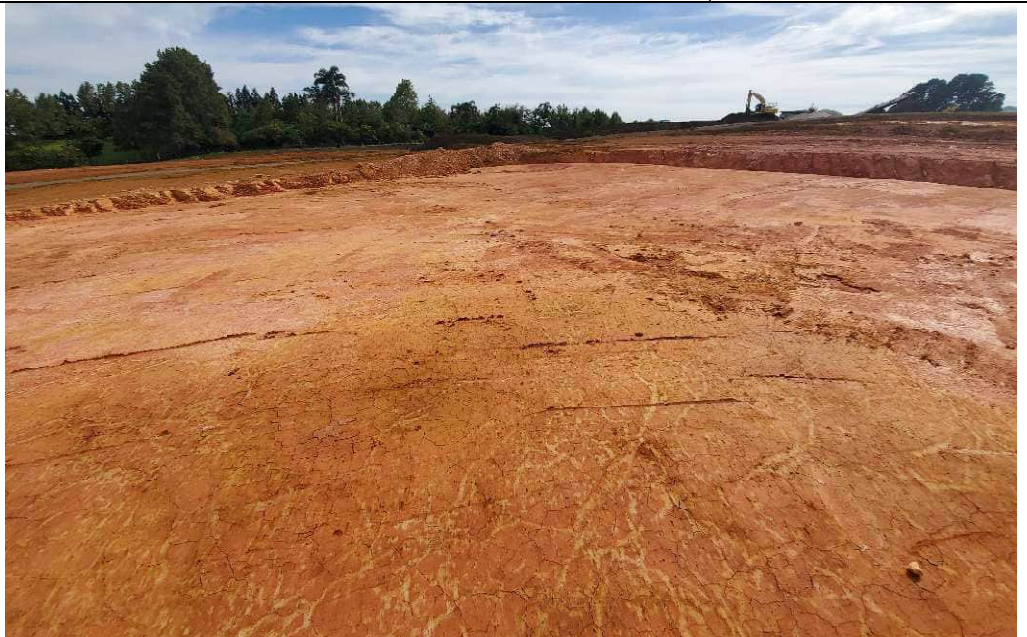
<b>Client Name:</b>  Kiwi Property Group		<b>Site Location:</b>  133 Fitzgerald Road, Drury	<b>Project No.</b>  510611
<b>Photo No.</b> 1.3	<b>Date:</b> 20/02/23

<b>Description:</b>  Lot 13  Finished subgrade level. Insitu material – dried clay

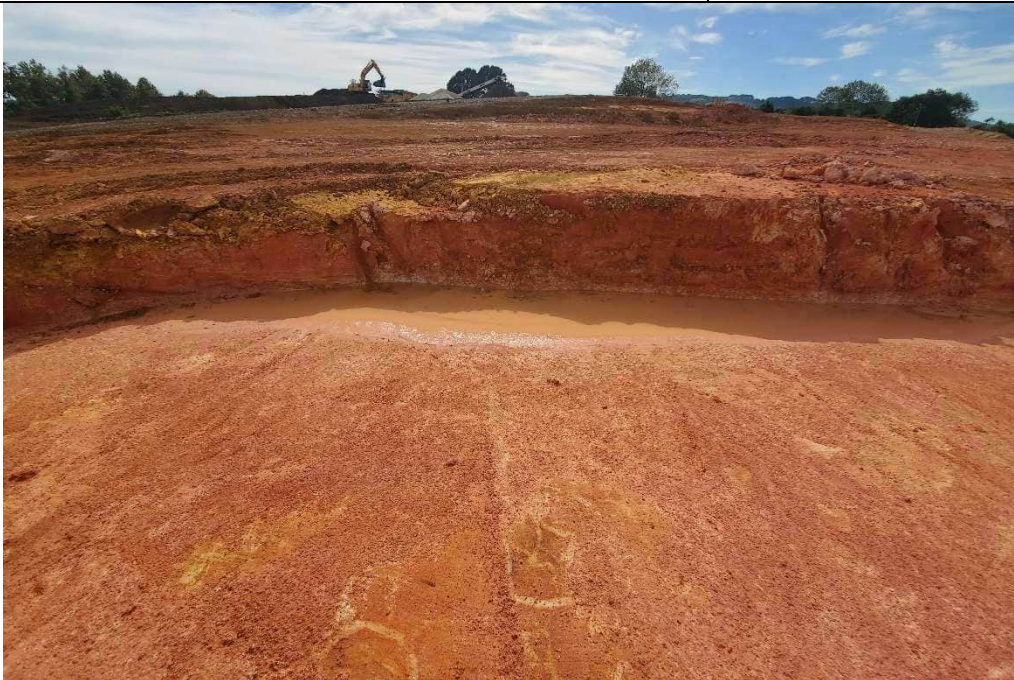
<b>Client Name:</b>		<b>Site Location:</b>	<b>Project No.</b>
Kiwi Property Group		133 Fitzgerald Road, Drury	510611
<b>Photo No.</b>	<b>Date:</b>

1.4	20/02/23		
<b>Description:</b>			
Lot 13			
Low point with gathered surface water.

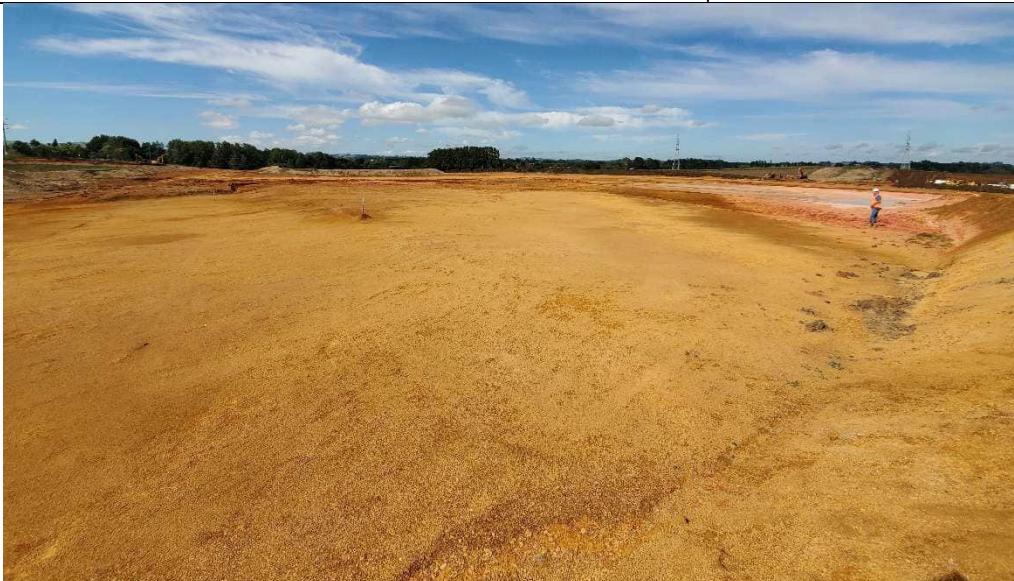
<b>Client Name:</b> Kiwi Property Group		<b>Site Location:</b> 133 Fitzgerald Road, Drury	<b>Project No.</b> 510611
<b>Photo No.</b> 2.1	<b>Date:</b> 20/02/23

<b>Description:</b>  Lot 14  Finished subgrade level

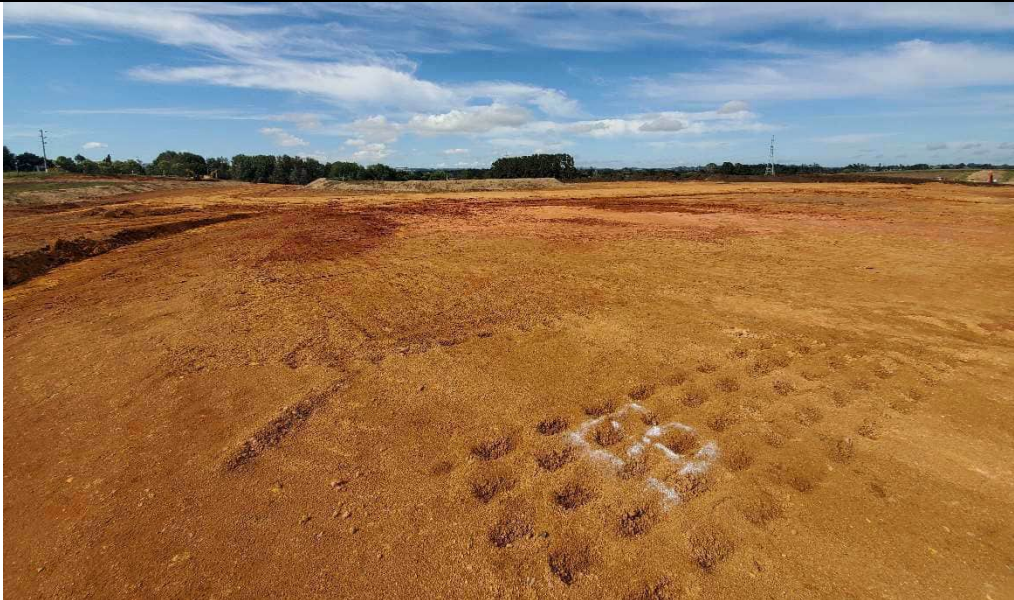
<b>Client Name:</b>  Kiwi Property Group		<b>Site Location:</b>  133 Fitzgerald Road, Drury	<b>Project No.</b>  510611
<b>Photo No.</b> 2.2	<b>Date:</b> 20/02/23

<b>Description:</b>  Lot 14  Finished subgrade level

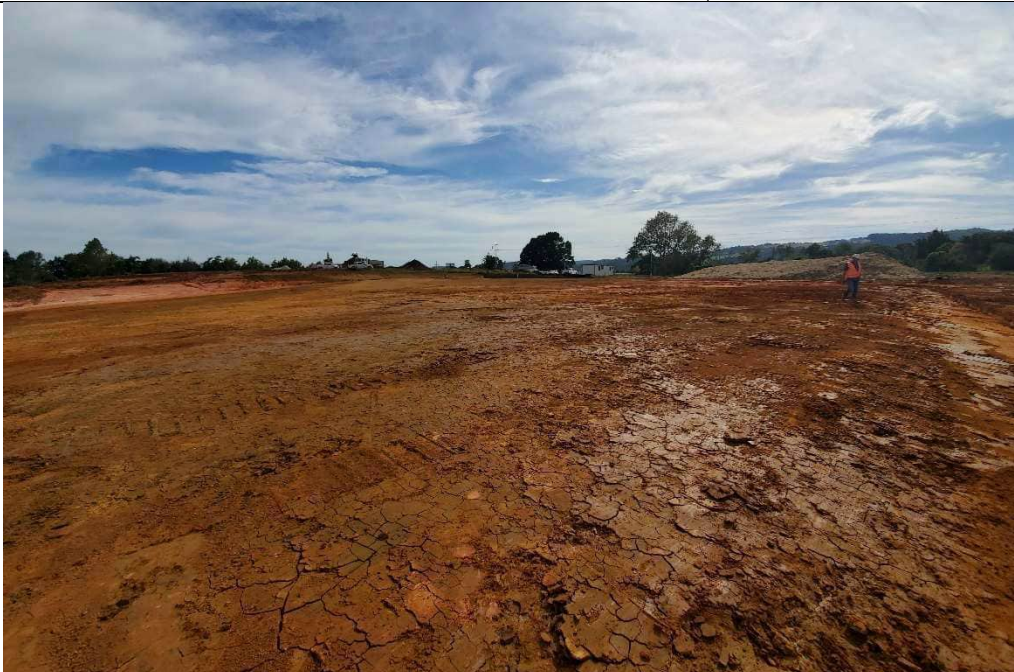
<b>Client Name:</b> Kiwi Property Group		<b>Site Location:</b> 133 Fitzgerald Road, Drury	<b>Project No.</b> 510611
<b>Photo No.</b> 2.3	<b>Date:</b> 20/02/23

<b>Description:</b> Lot 14  Finished subgrade level

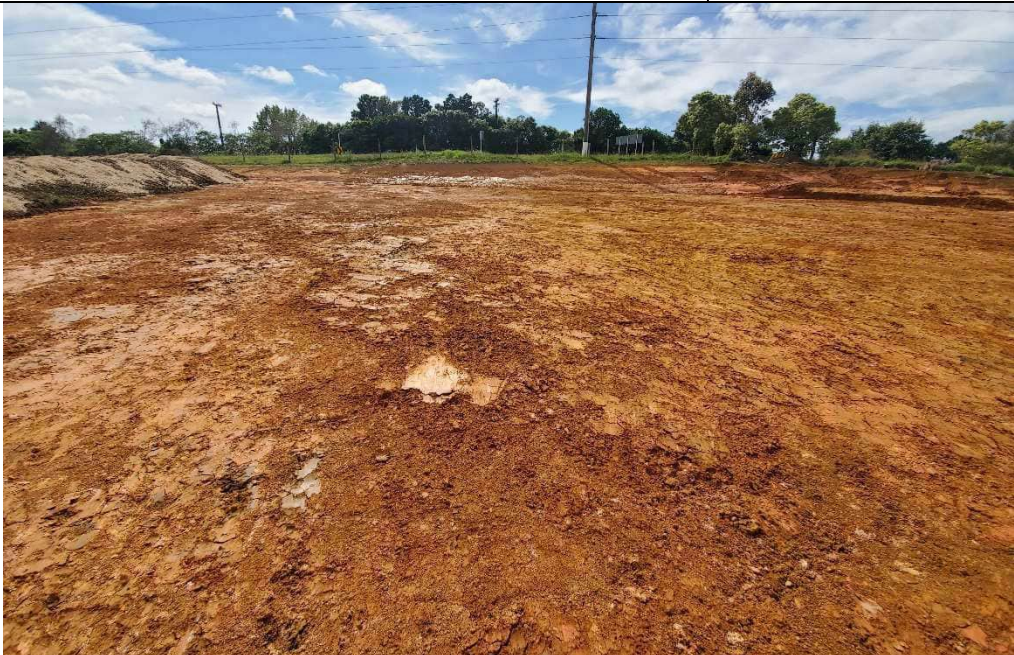
<b>Client Name:</b>  Kiwi Property Group		<b>Site Location:</b>  133 Fitzgerald Road, Drury	<b>Project No.</b>  510611
<b>Photo No.</b> 3.1	<b>Date:</b> 20/02/23

<b>Description:</b>  Lot 19  Final subgrade level (looking towards north)

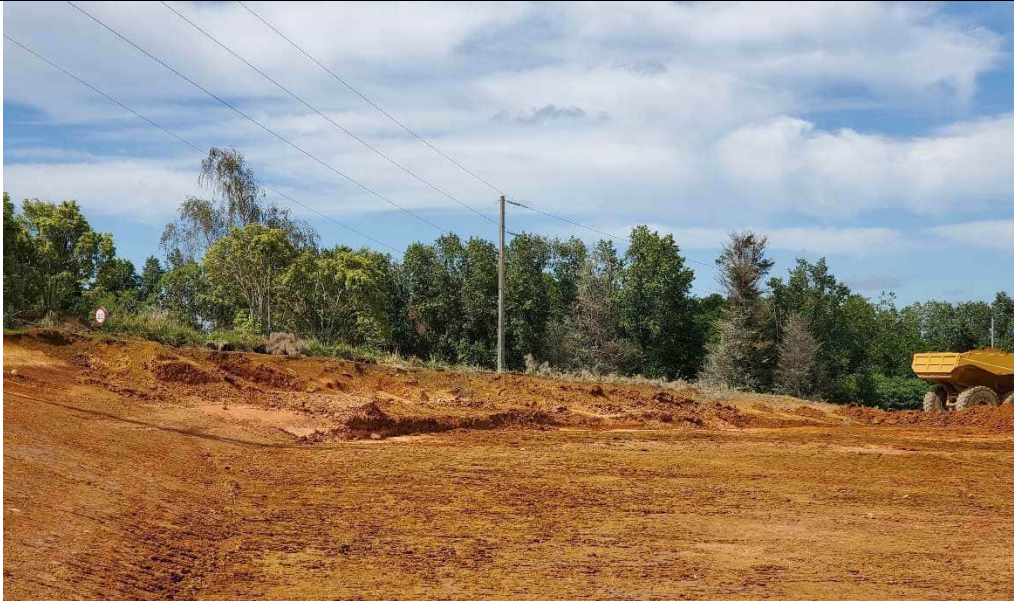
<b>Client Name:</b> Kiwi Property Group		<b>Site Location:</b> 133 Fitzgerald Road, Drury	<b>Project No.</b> 510611
<b>Photo No.</b> 3.3	<b>Date:</b> 20/02/23

<b>Description:</b>  Lot 19  Batter still to be completed			
<b>Client Name:</b> Kiwi Property Group		<b>Site Location:</b> 133 Fitzgerald Road, Drury	<b>Project No.</b> 510611
<b>Photo No.</b> 4.1	<b>Date:</b> 20/02/23

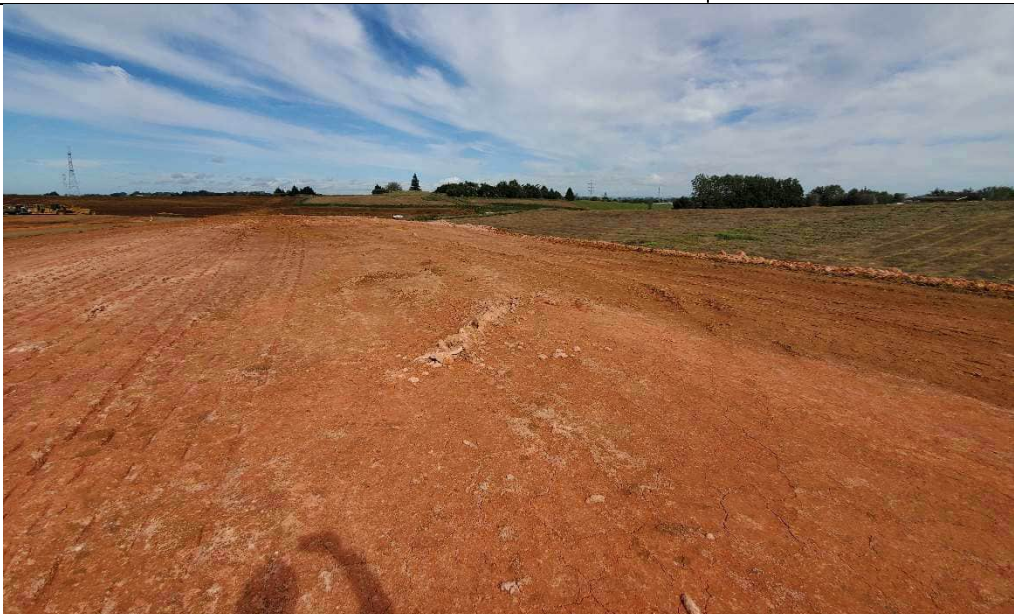
<b>Description:</b>  Backfill platform final subgrade level to road level.
