PROJECT	KIWI PROPERTY GROUP LIMITED					
TITLE	DRURY CENTRE PROJECT GEOTECHNICAL INVESTIGATION LOCATIONS GIS SHEET 3 OF 5					
DOCUMENT	PROJECT No. 510611	WBS 002	TYPE FIG	DISC GG	NUMBER 0003	REVISION A

PROJECT :  
**133 Fitzgerald Road - Drury**

# APPENDIX D: AURECON EARTHWORKS QA AND CERTIFICATION

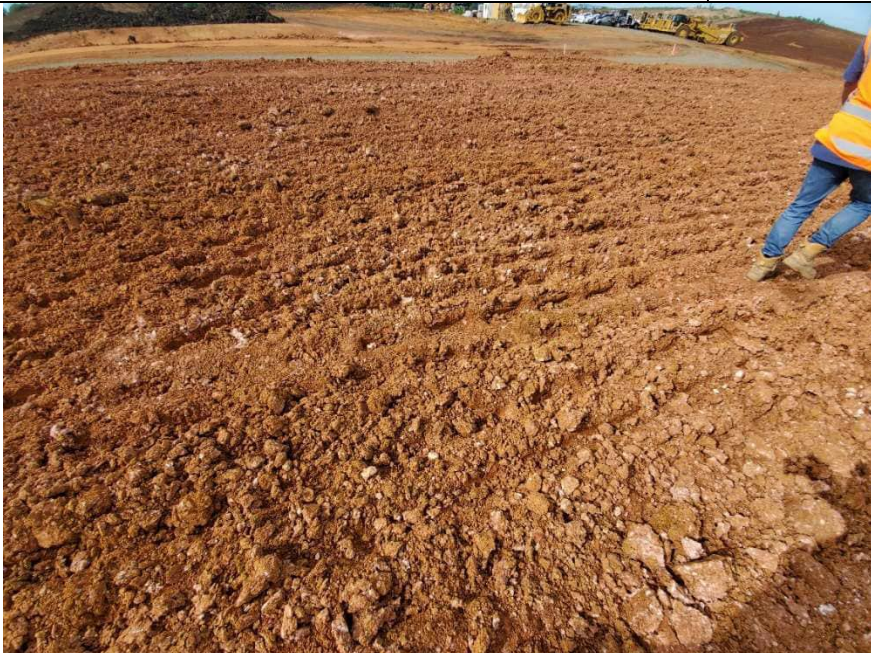
<b>Client Name:</b>  Kiwi Property Group		<b>Site Location:</b>  133 Fitzgerald Road, Drury	<b>Project No.</b>  510611
<b>Photo No.</b> 4.2	<b>Date:</b> 20/02/23

<b>Description:</b>  Backfill platform final subgrade level.  Tracks from compaction of fill.

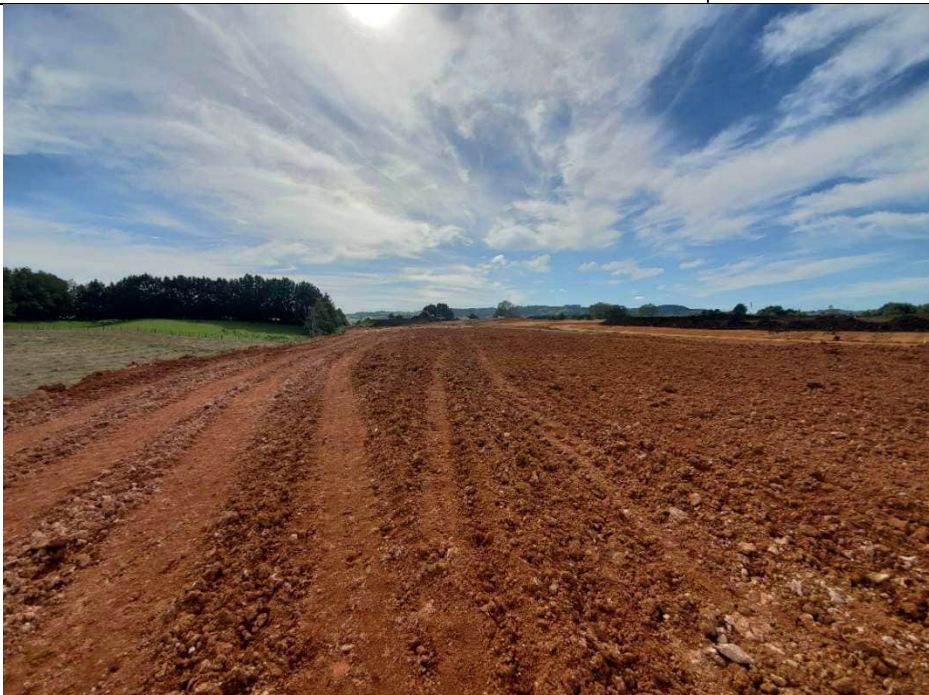
<b>Client Name:</b> Kiwi Property Group		<b>Site Location:</b> 133 Fitzgerald Road, Drury	<b>Project No.</b> 510611
<b>Photo No.</b> 4.3	<b>Date:</b> 20/02/23

<b>Description:</b>  Backfill platform final subgrade level.  Tracks from compaction of fill.

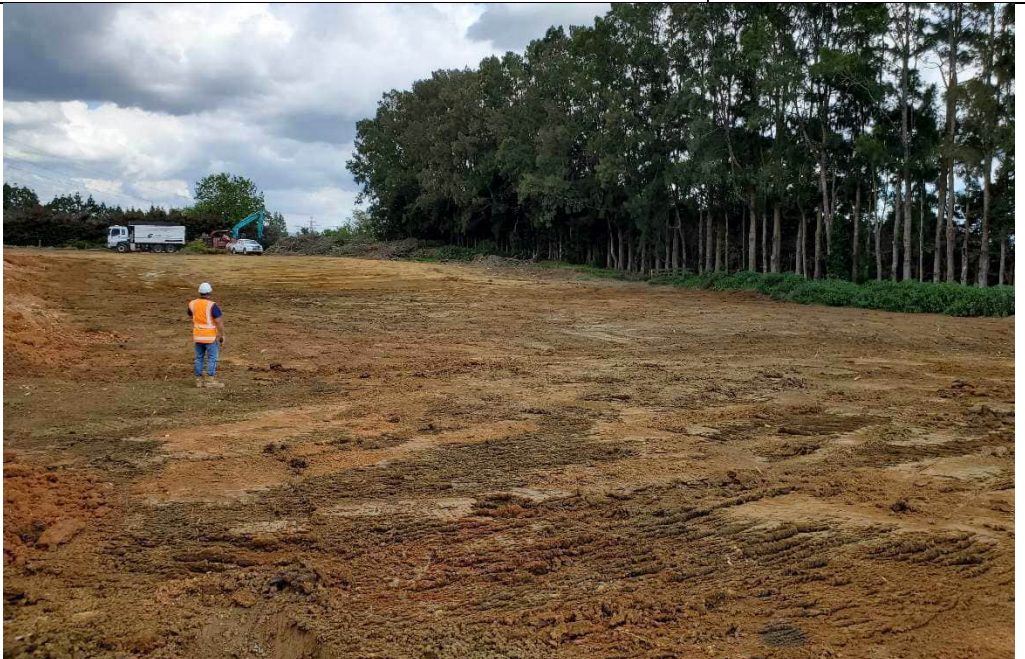
<b>Client Name:</b>  Kiwi Property Group		<b>Site Location:</b>  133 Fitzgerald Road, Drury	<b>Project No.</b>  510611
<b>Photo No.</b> 1	<b>Date:</b> 21/02/23

<b>Description:</b>  Topsoil stripped at site.

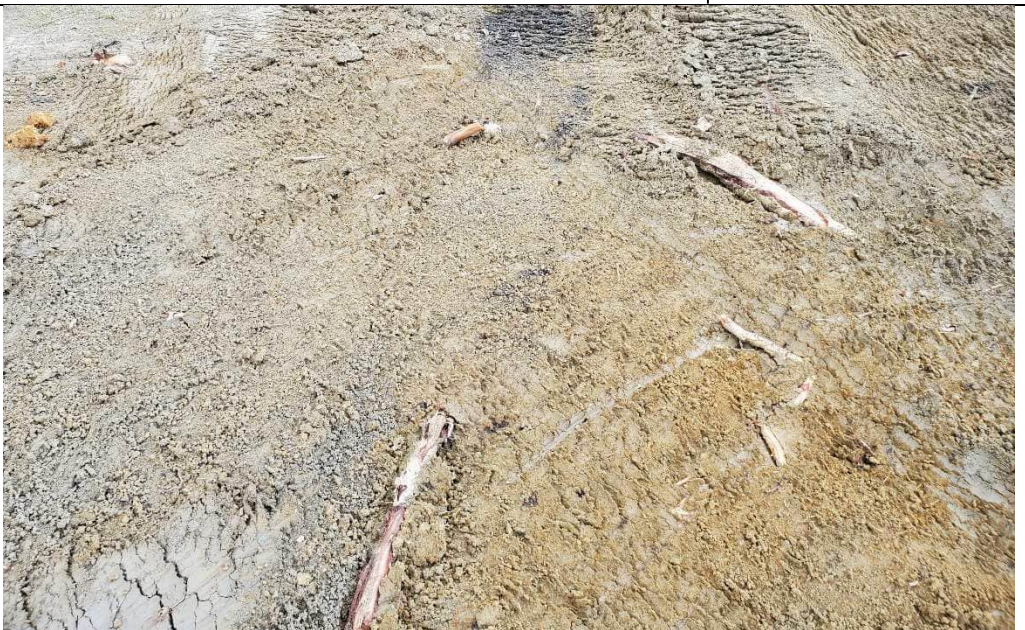
<b>Client Name:</b>  Kiwi Property Group		<b>Site Location:</b>  133 Fitzgerald Road, Drury	<b>Project No.</b>  510611
<b>Photo No.</b> 2	<b>Date:</b> 21/02/23

<b>Description:</b>  Evidence of roots still beneath ground along removed treeline.

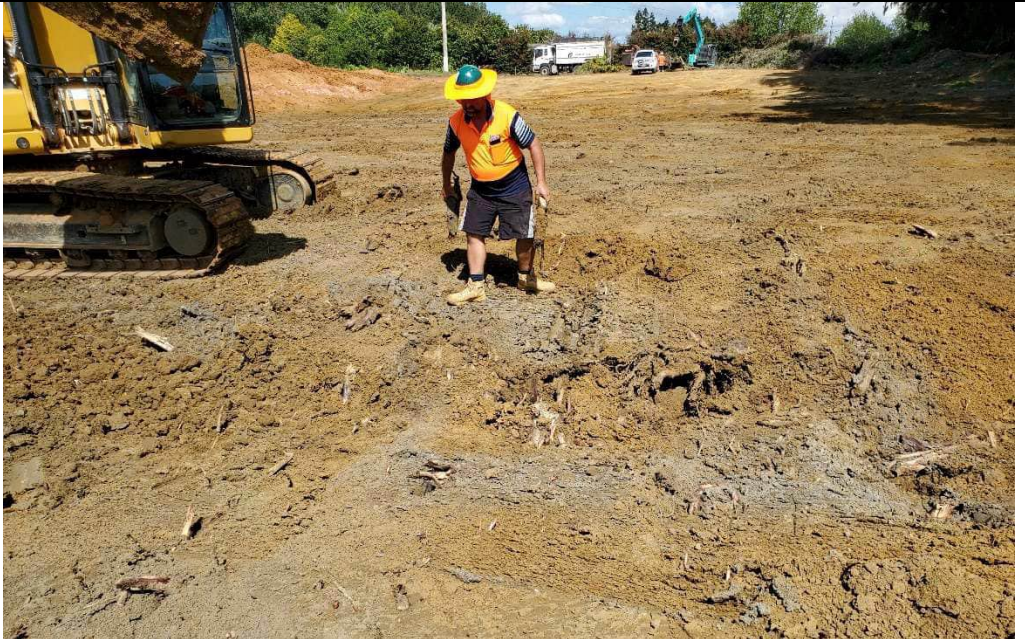
<b>Client Name:</b>  Kiwi Property Group		<b>Site Location:</b>  133 Fitzgerald Road, Drury	<b>Project No.</b>  510611
<b>Photo No.</b> 3	<b>Date:</b> 21/02/23

<b>Description:</b>  Tree root in the process of being removed.

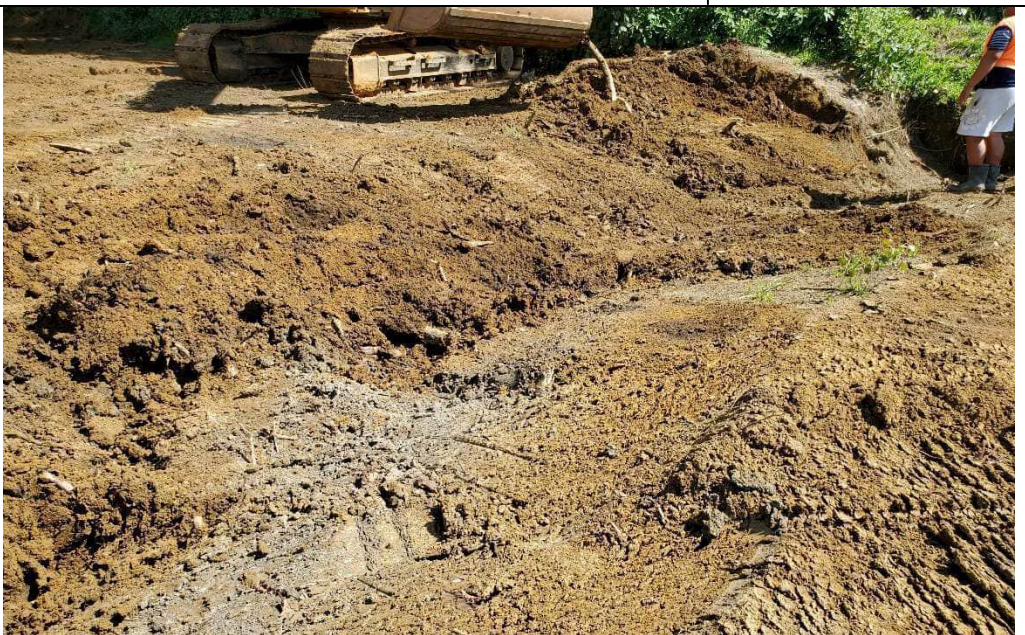
<b>Client Name:</b> Kiwi Property Group		<b>Site Location:</b> 133 Fitzgerald Road, Drury	<b>Project No.</b> 510611
<b>Photo No.</b> 4	<b>Date:</b> 21/02/23

<b>Description:</b> Disturbed soil along treeline from digging up roots.

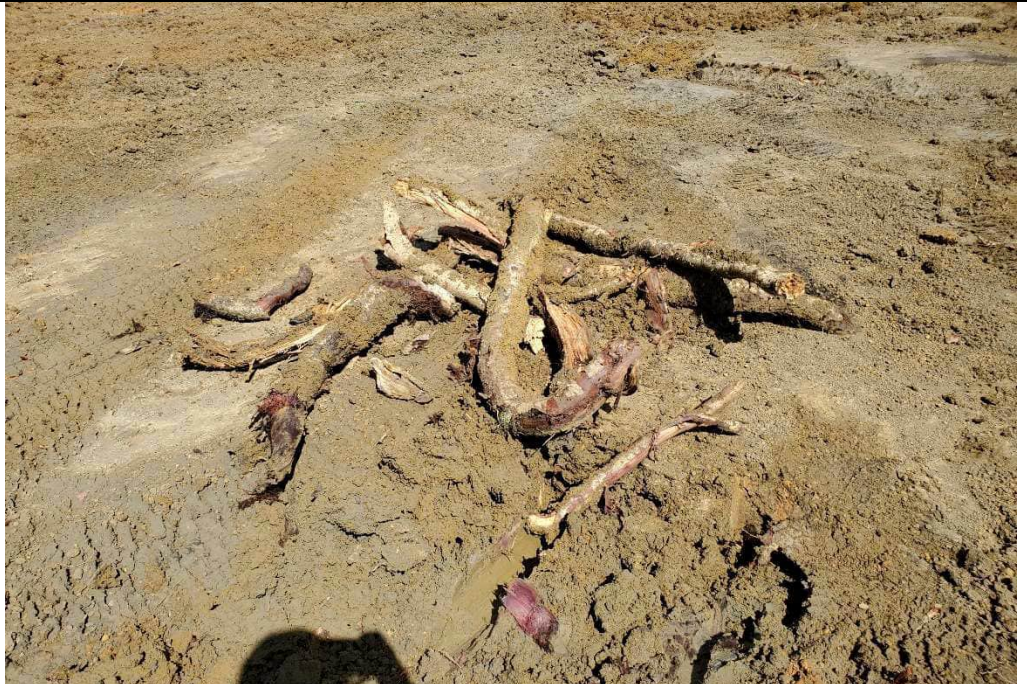
<b>Client Name:</b>  Kiwi Property Group		<b>Site Location:</b>  133 Fitzgerald Road, Drury	<b>Project No.</b>  510611
<b>Photo No.</b> 5	<b>Date:</b> 21/02/23

<b>Description:</b>  Tree roots removed.

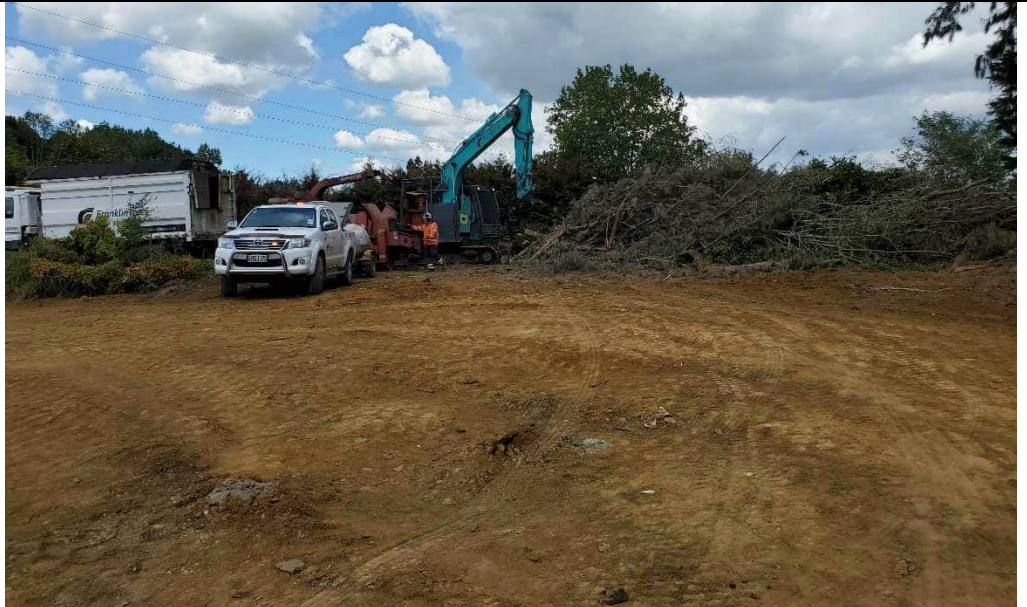
<b>Client Name:</b>  Kiwi Property Group		<b>Site Location:</b>  133 Fitzgerald Road, Drury	<b>Project No.</b>  510611
<b>Photo No.</b> 7	<b>Date:</b> 21/02/23

<b>Description:</b>  Rubbish and unsuitable pile being removed from site.

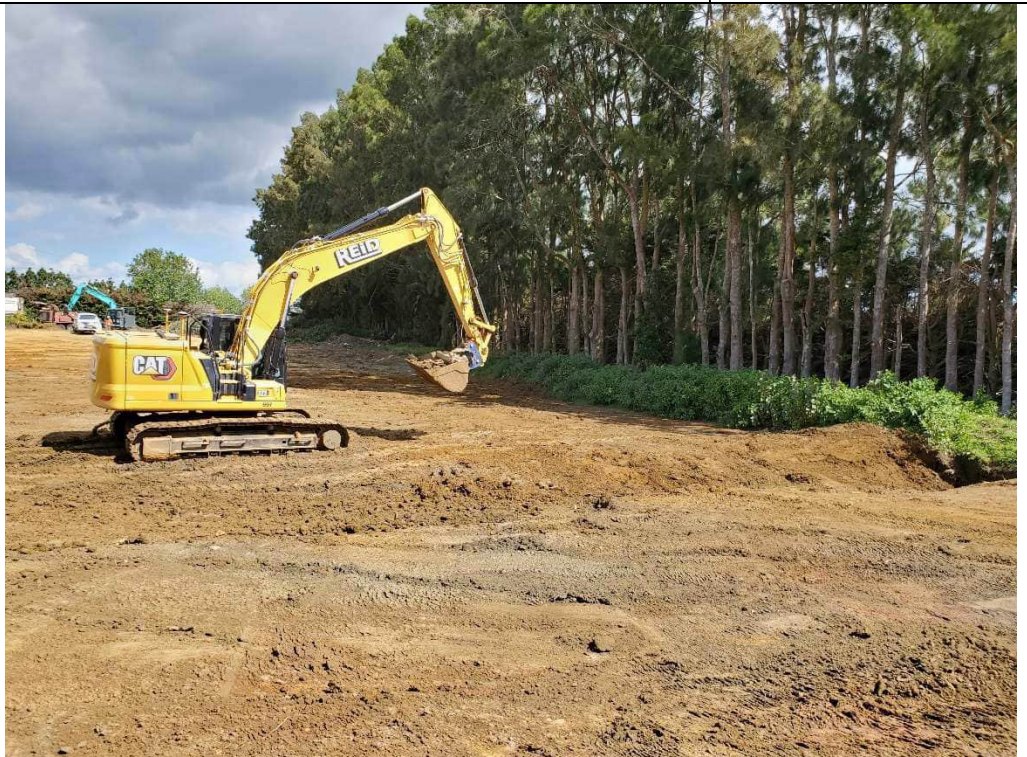
<b>Client Name:</b>  Kiwi Property Group		<b>Site Location:</b>  133 Fitzgerald Road, Drury	<b>Project No.</b>  510611
<b>Photo No.</b> 8	<b>Date:</b> 21/02/23

<b>Description:</b>  Tree line and bushes on one side of site to be removed at a later stage.

- Approximately 0.3 ha of topsoil had been stripped in area between Lot 7 and Lot 22 (A10) and loaded to a stockpile, refer to **Figure 1: Extent of works observed**.
  - The underlying subgrade was firm underfoot, with no observable soft spots.
  - Decently sized tree roots were spotted where the treeline previously existed. Tree roots were removed via digger during the inspection, leaving disturbed soil where the roots once were.
  - Contractors in the process of removing rubbish and unsuitable soil as a result of removing pre-existing farmhouse.
  - Bushes located up against treeline on the perimeter of the lot to be removed at a later stage of earthworks to avoid disruption to neighbours.

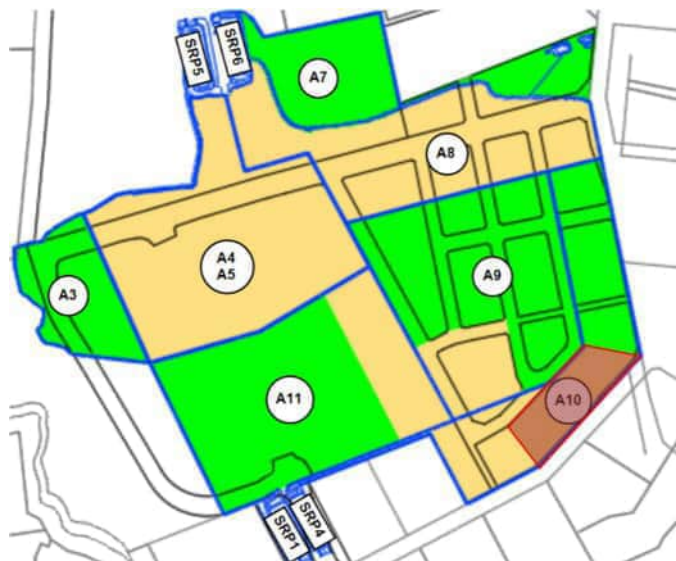
**Figure 1: Extent of works observed**

- Approximately 0.88 ha has been trimmed to finish subgrade level on half of Lot 19 and half of Lot 22 refer to **Figure 1: Extent of works observed.**
  - Underlying subgrade was firm underfoot, and there were no observable soft spots.
  - Subgrade consisted of clayey material which have been dried up as evident by cracking.
  - Some medium sized boulder observed in the ground, have been marked to be removed in Lot 22.

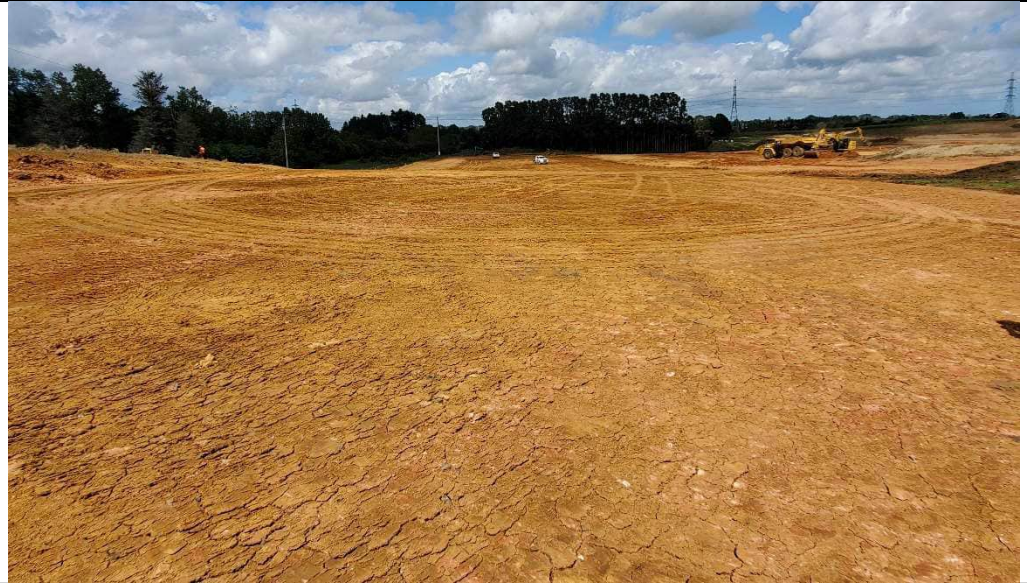
Final Subgrade level  
from top of Lot 19.

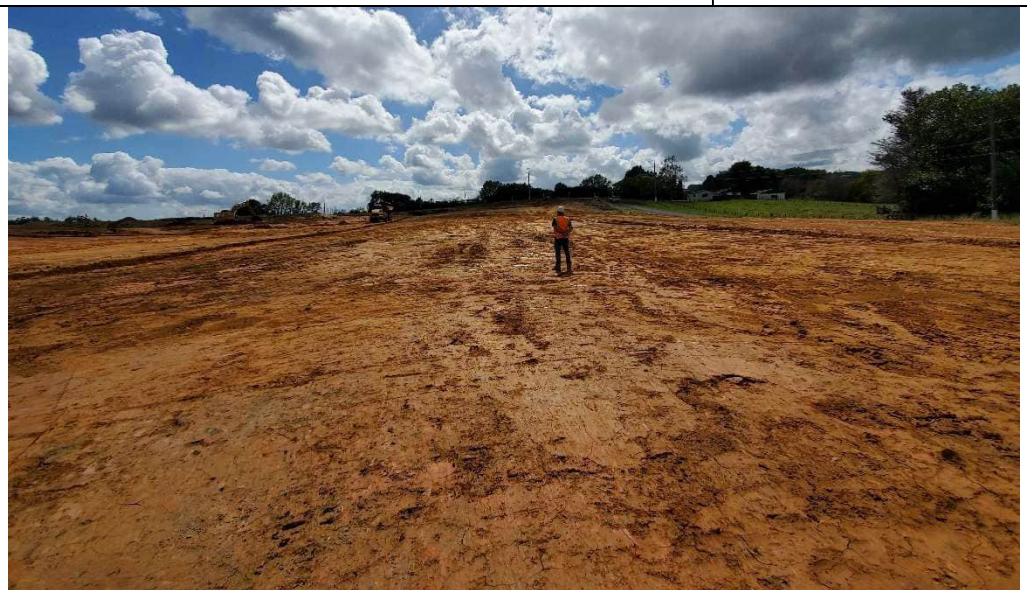
Final Subgrade level  
from bottom of Lot 22.

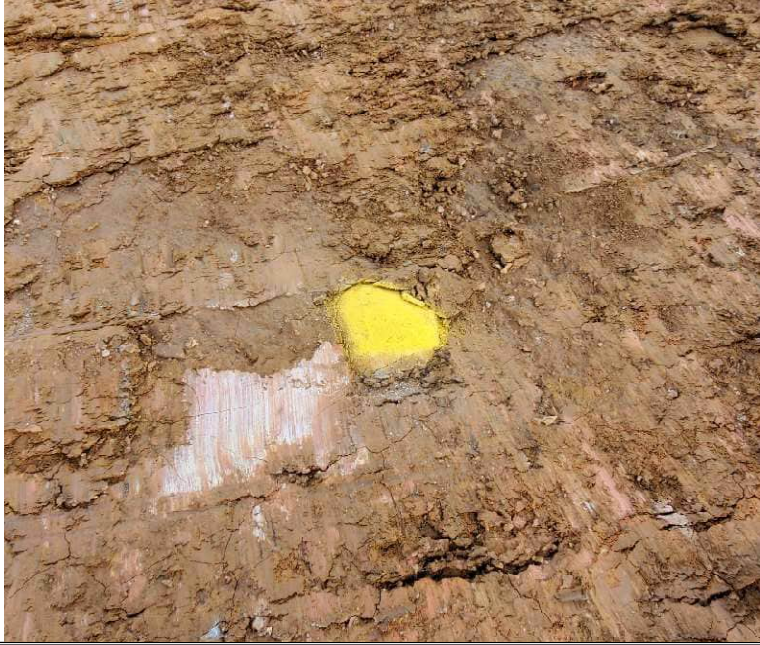
<b>Client Name:</b> Kiwi Property Group		<b>Site Location:</b> 133 Fitzgerald Road, Drury	<b>Project No.</b> 510611
<b>Photo No.</b> 3	<b>Date:</b> 22/02/23

<b>Description:</b> Boulder in Lot 22 marked for removal.

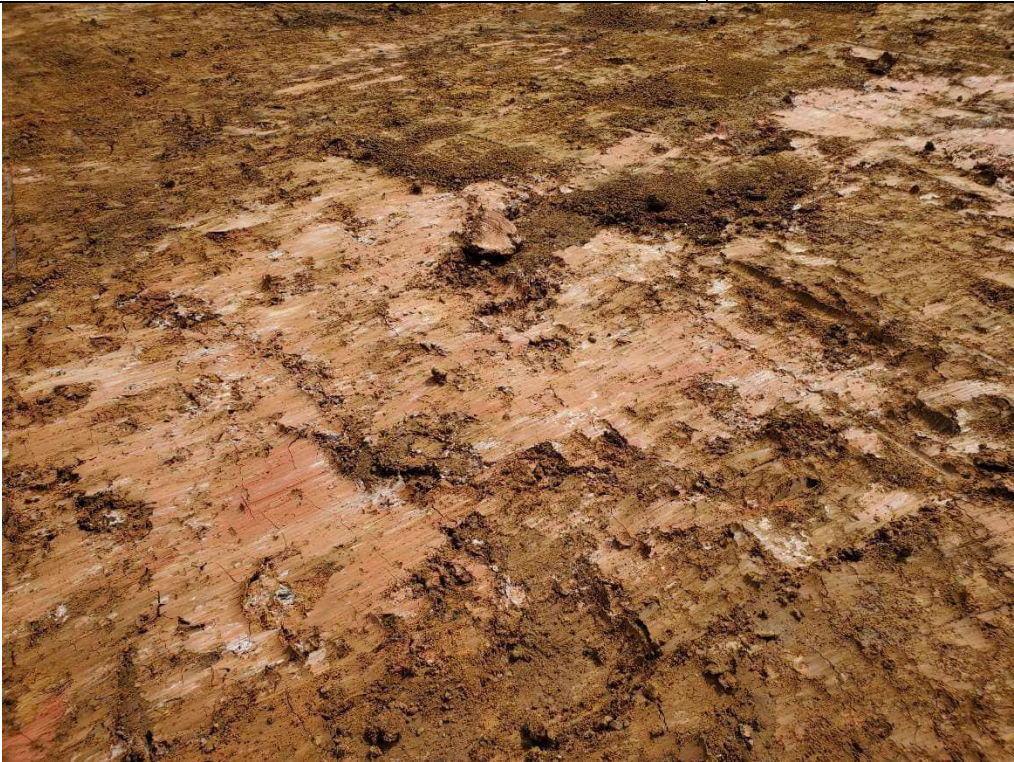
<b>Client Name:</b> Kiwi Property Group		<b>Site Location:</b> 133 Fitzgerald Road, Drury	<b>Project No.</b> 510611
<b>Photo No.</b> 4	<b>Date:</b> 22/02/23

<b>Description:</b> Soil present in subgrade.

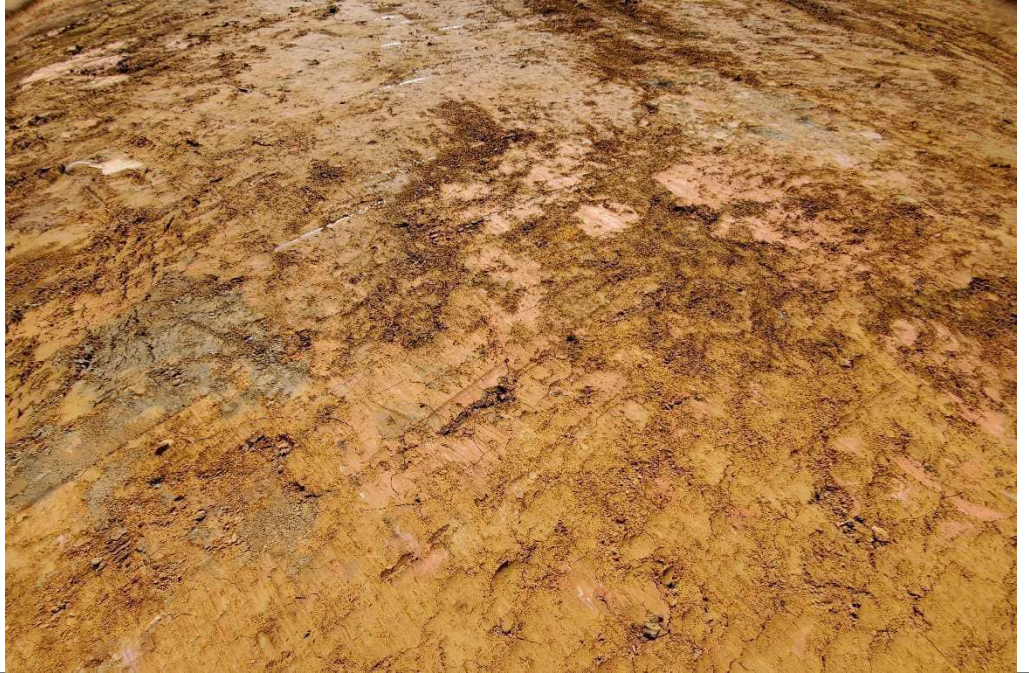
<b>Client Name:</b> Kiwi Property Group		<b>Site Location:</b> 133 Fitzgerald Road, Drury	<b>Project No.</b> 510611
<b>Photo No.</b> 5	<b>Date:</b> 22/02/23

<b>Description:</b> Soil present in subgrade.

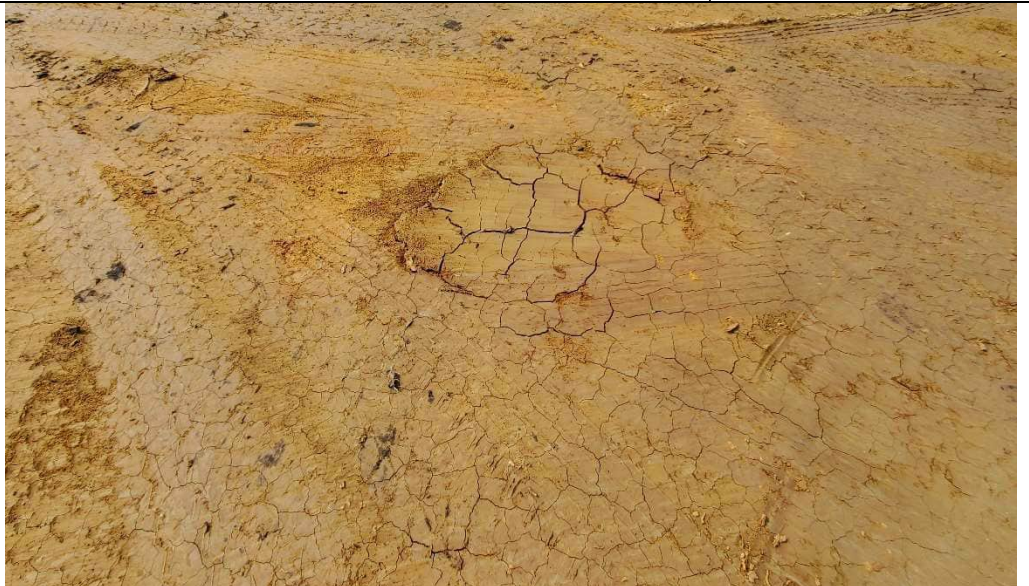
<b>Client Name:</b> Kiwi Property Group		<b>Site Location:</b> 133 Fitzgerald Road, Drury	<b>Project No.</b> 510611
<b>Photo No.</b> 6	<b>Date:</b> 22/02/23

<b>Description:</b> Cracking of subgrade, evidence of clayey soil.

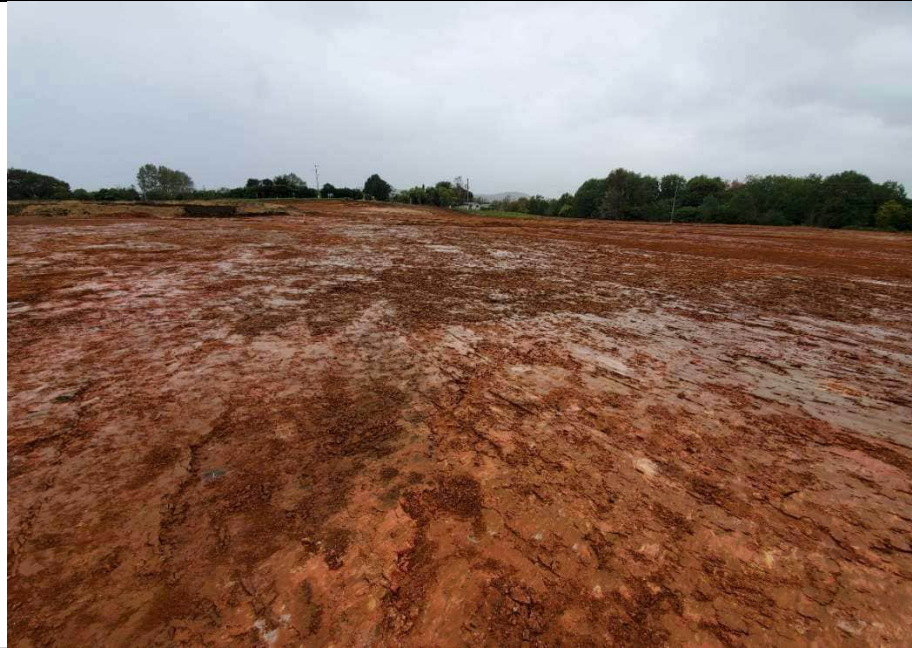
Lot 21  
Final Subgrade level.

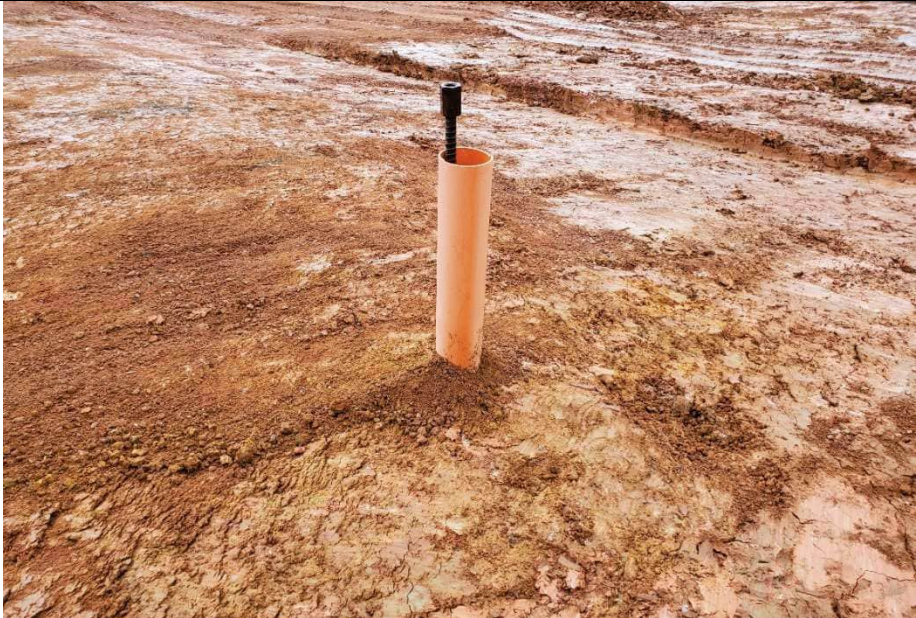
<b>Client Name:</b> Kiwi Property Group		<b>Site Location:</b> 133 Fitzgerald Road, Drury	<b>Project No.</b> 510611
<b>Photo No.</b> 3	<b>Date:</b> 24/02/23

<b>Description:</b>  Lot 21 Settlement Plate.

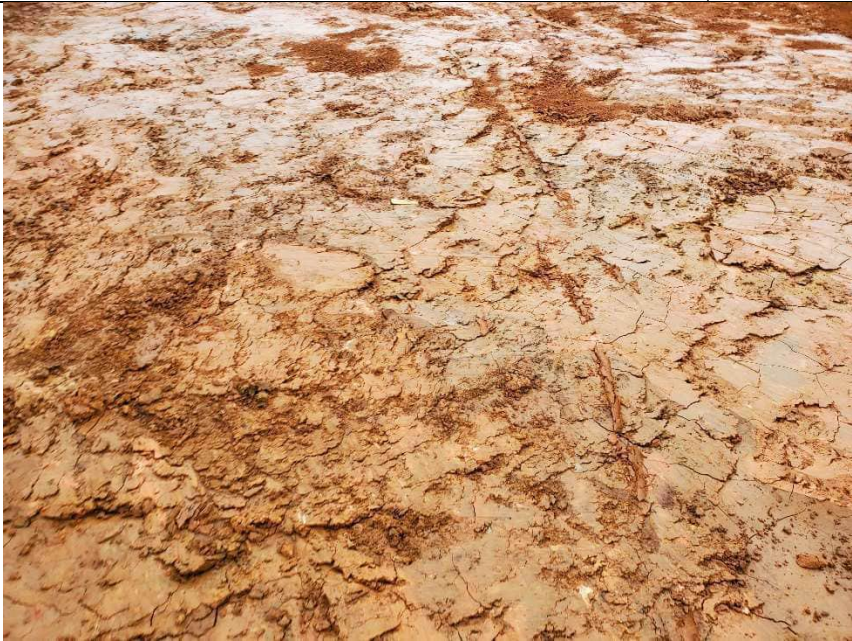
<b>Client Name:</b> Kiwi Property Group		<b>Site Location:</b> 133 Fitzgerald Road, Drury	<b>Project No.</b> 510611
<b>Photo No.</b> 4	<b>Date:</b> 24/02/23

<b>Description:</b>  Lot 21 Subgrade soil.

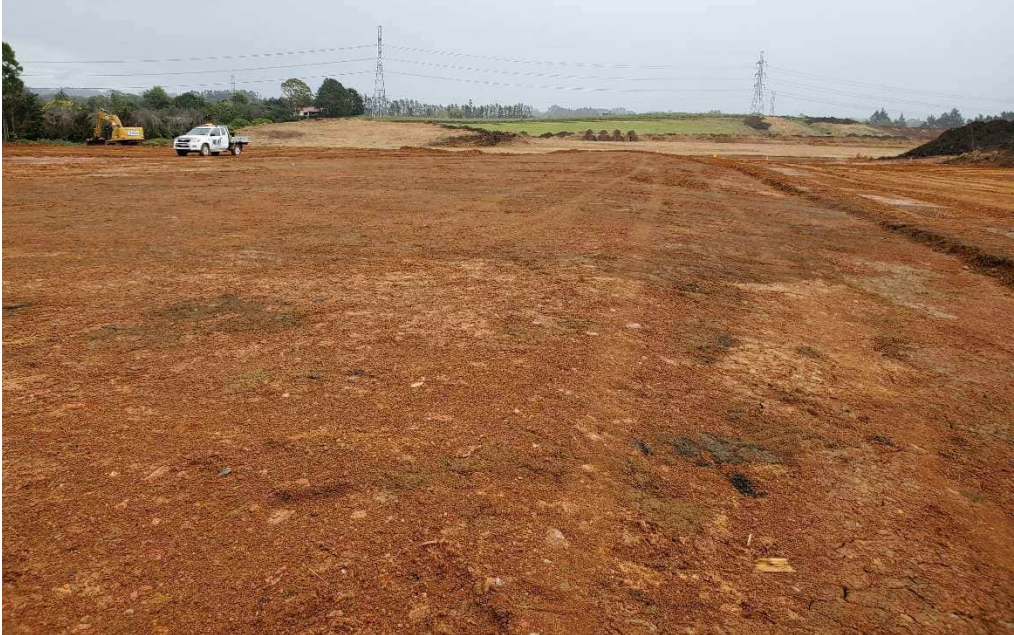
<b>Client Name:</b> Kiwi Property Group		<b>Site Location:</b> 133 Fitzgerald Road, Drury	<b>Project No.</b> 510611
<b>Photo No.</b> 5	<b>Date:</b> 24/02/23

<b>Description:</b> Lot 21 Final subgrade level.

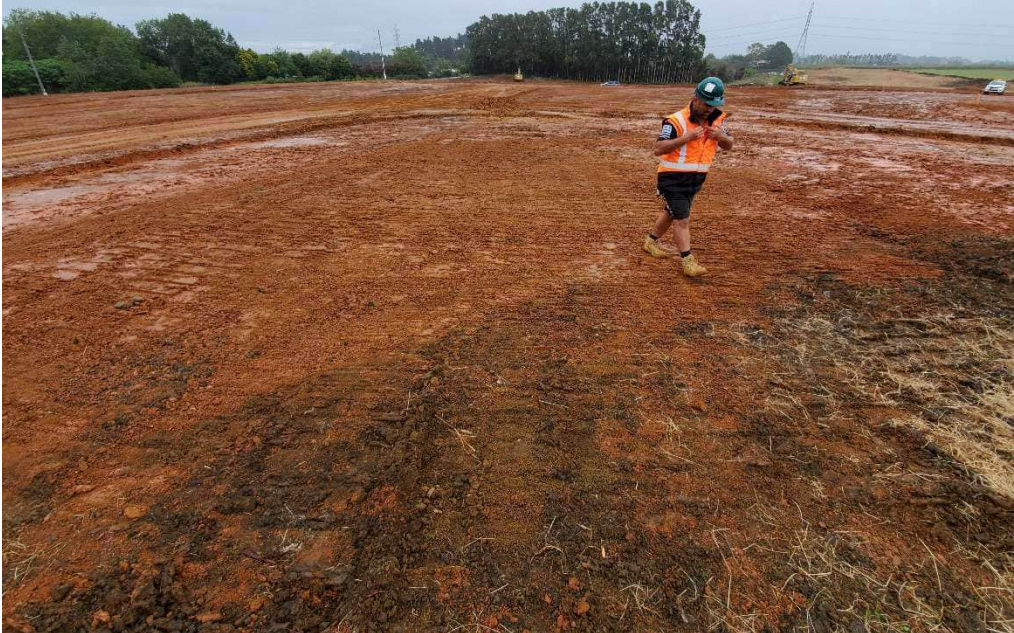
<b>Client Name:</b> Kiwi Property Group		<b>Site Location:</b> 133 Fitzgerald Road, Drury	<b>Project No.</b> 510611
<b>Photo No.</b> 6	<b>Date:</b> 24/02/23

<b>Description:</b> Lot 20 Final subgrade level.

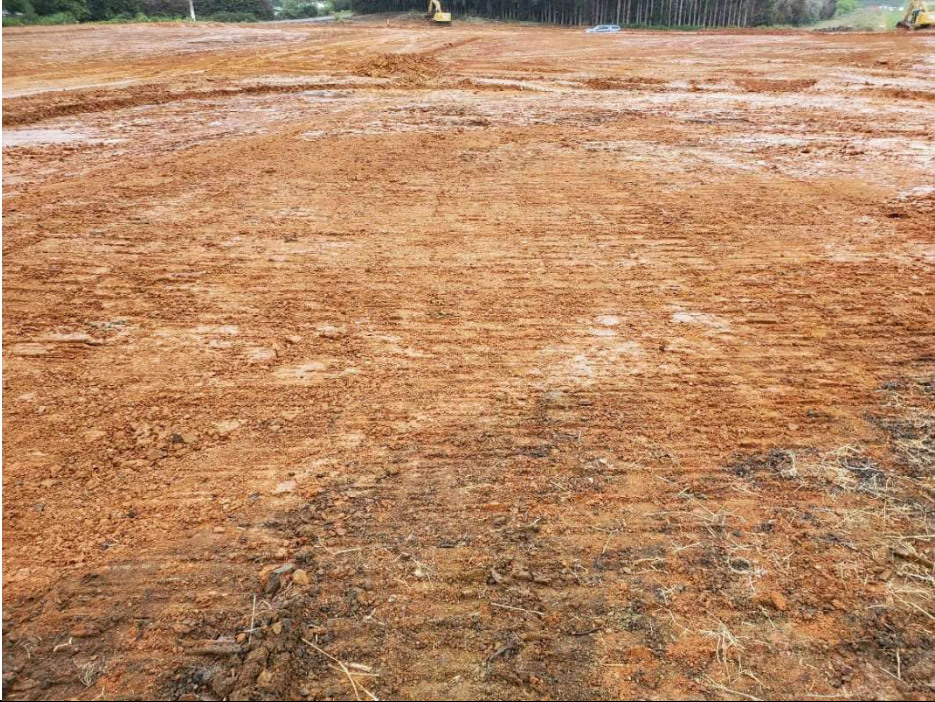
<b>Description:</b>  Lot 20 Final subgrade level.					
<b>Client Name:</b> Kiwi Property Group		<b>Site Location:</b> 133 Fitzgerald Road, Drury		<b>Project No.</b> 510611	
<b>Photo No.</b> 6	<b>Date:</b> 24/02/23

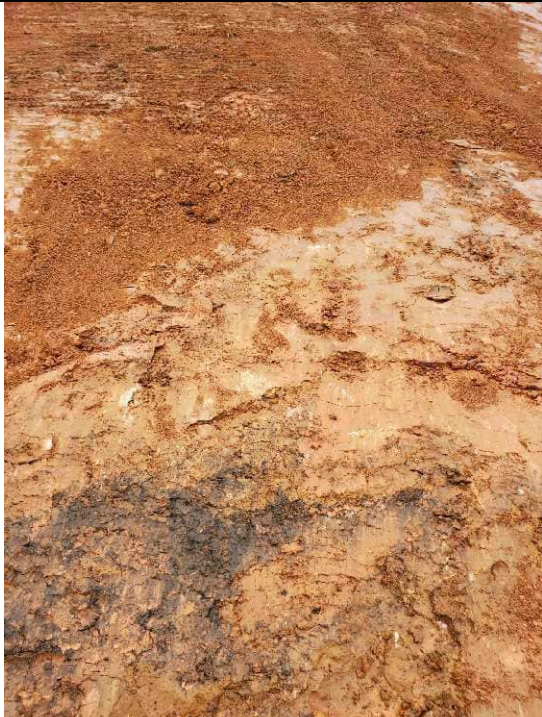
<b>Description:</b>  Lot 20 Subgrade soil.

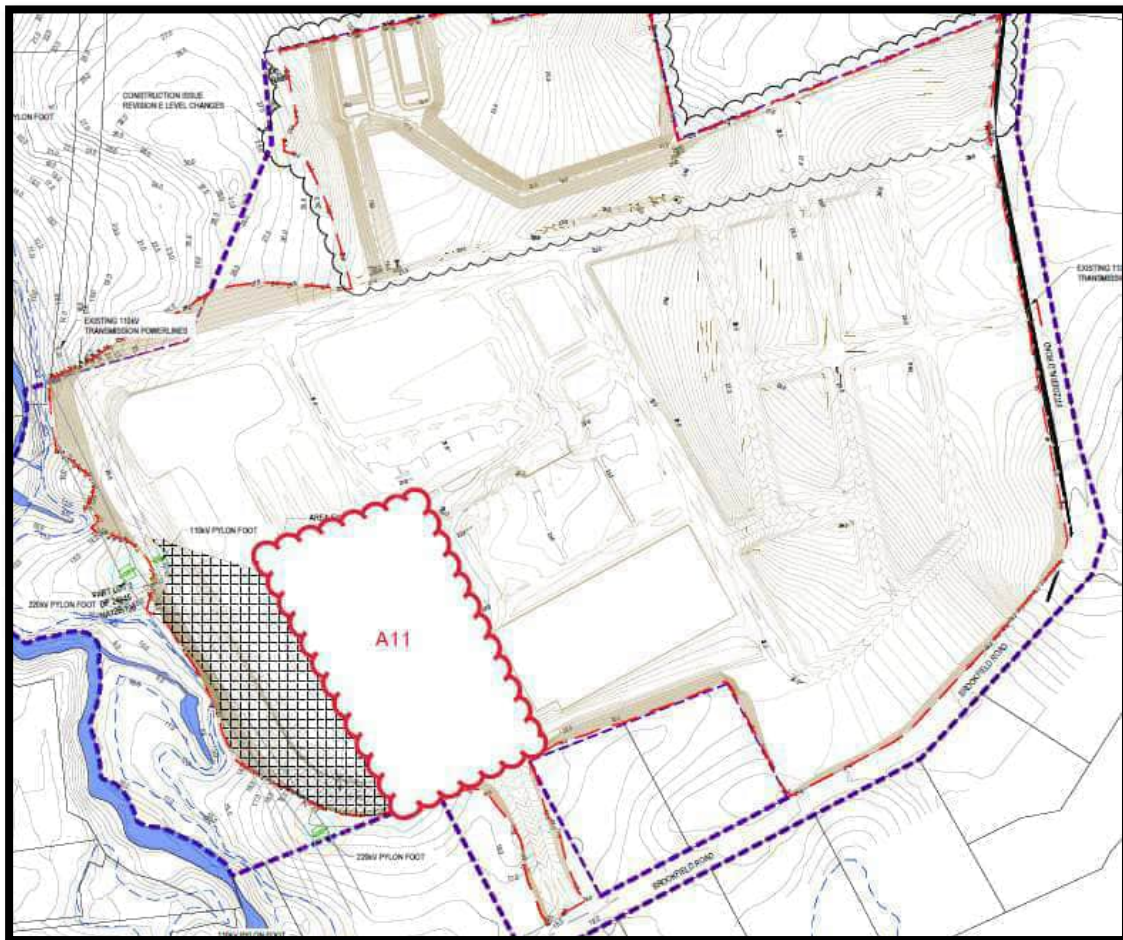
**Figure 1: Extent of works observed**

- Area A11 – Underlying subgrade was firm underfoot, uniformly graded, and free of organics. This area is to be filled.
