Arataki Residential Project

Arataki and Brookvale Roads, Havelock North

# GEOTECHNICAL INVESTIGATION REPORT

Job No. NAP2024-0007AC | Version 0

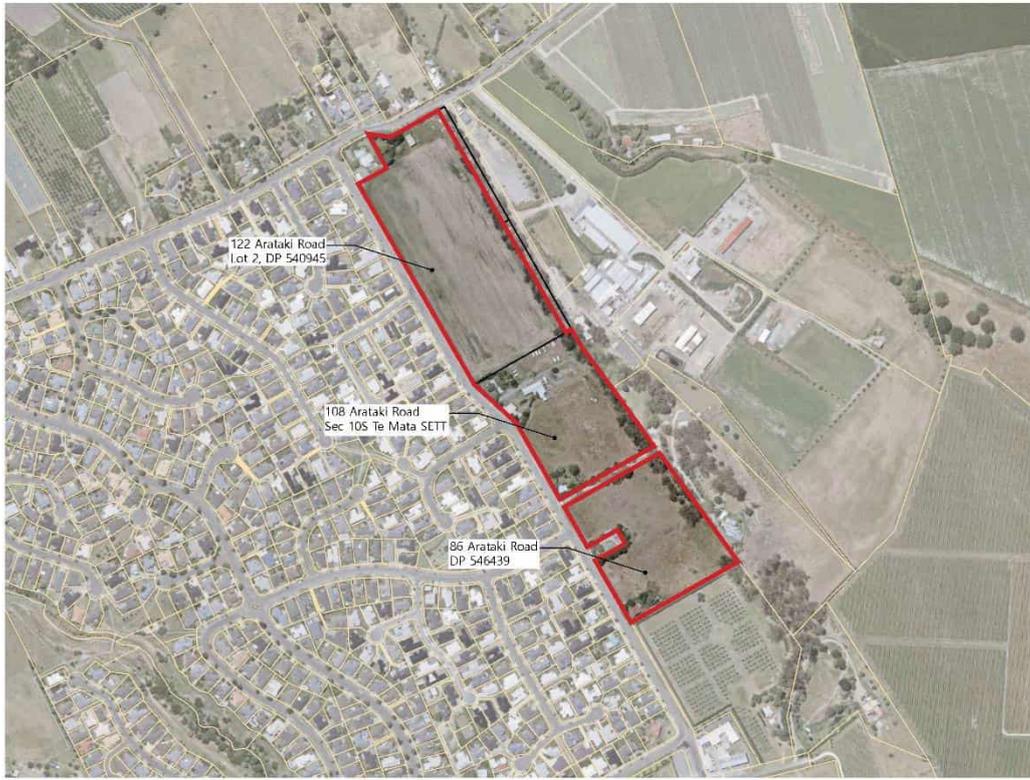
Figure 1: Site Location Plan (Image supplied by Woods)

The site subject to this substantive application is located at 86, 108, 122 Arataki Road, Havelock North, Hawkes Bay (referred to as “the Site”), as depicted in Figure 1 below. Comprising a total area of approximately 11ha, the site is held in three separate titles, all owned by CDL. This site is located at the eastern edge of the existing urban area of Havelock North, approximately 2.5 kilometres from the Havelock North Village Centre.

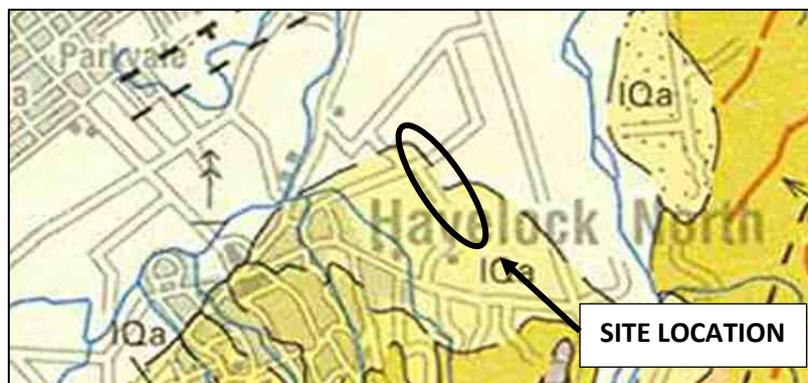
Figure 2: Regional Geology (sourced from GNS, Geological Map 8)

Some superficial depths of fill may be present as a result of previous and existing land use activities.

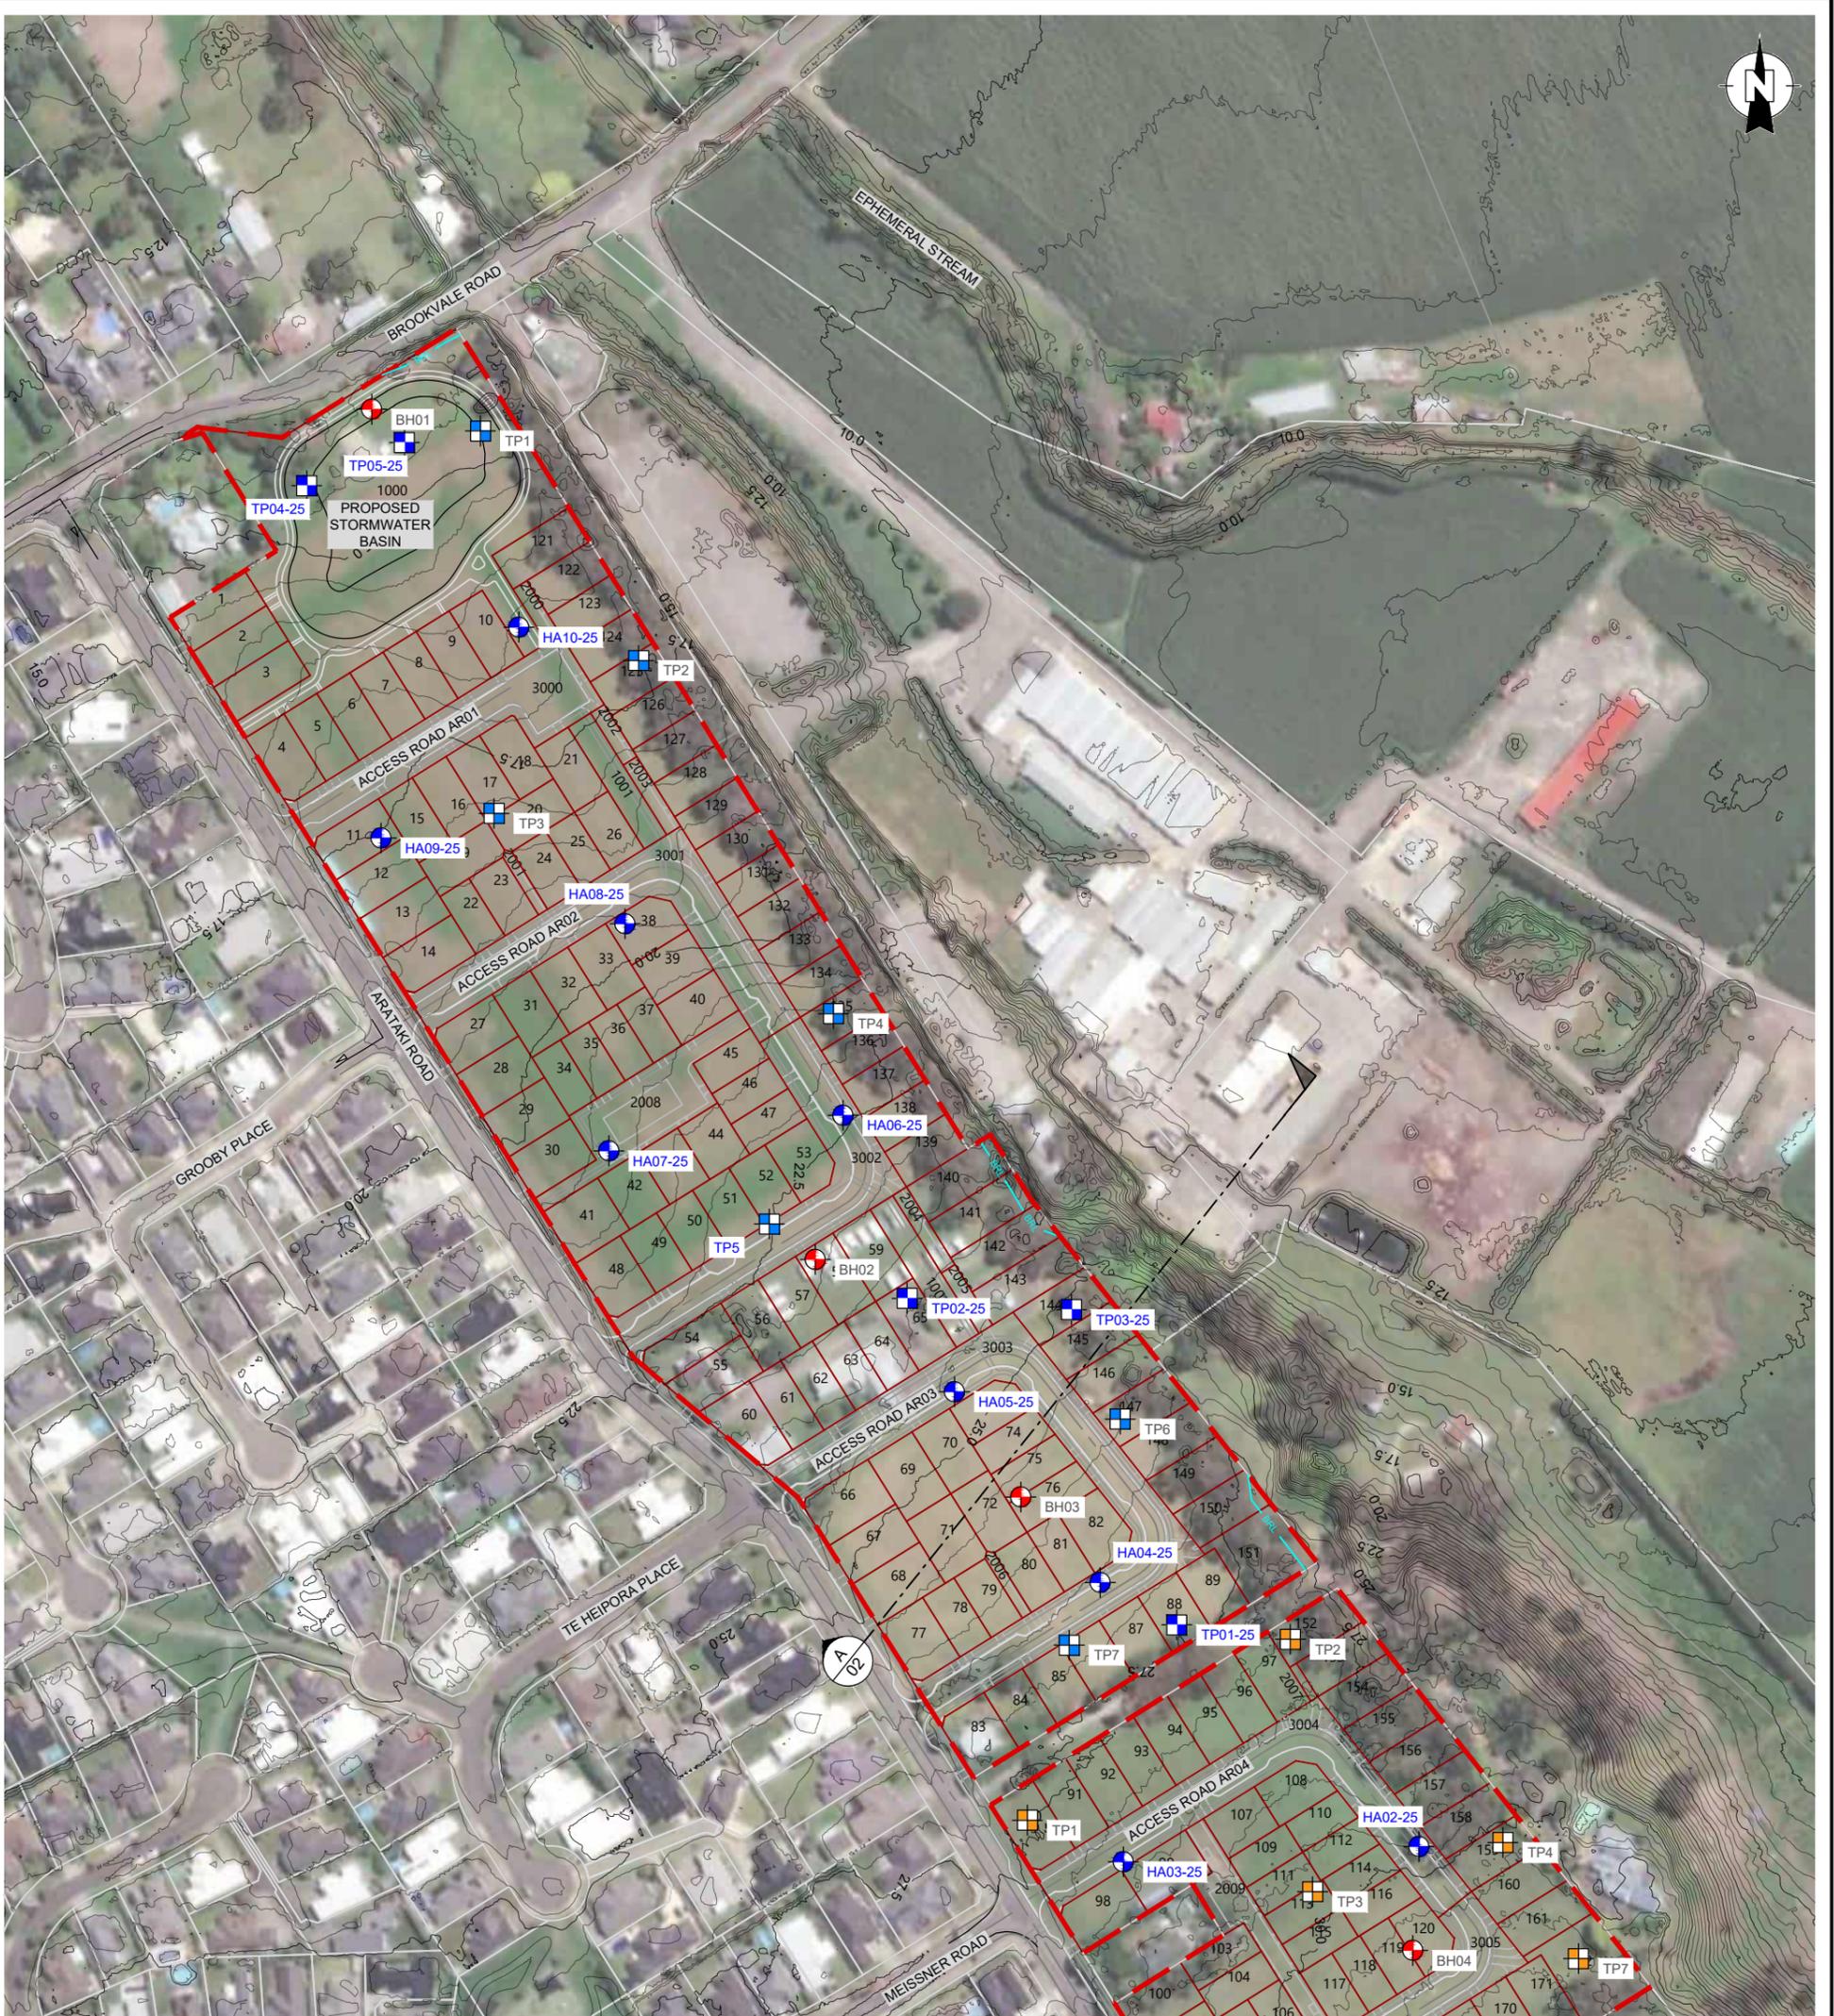
The current general landform, together with associated features located within and adjacent to the site is presented on the attached Geotechnical Investigation Plan as shown in **Drawing 01**.

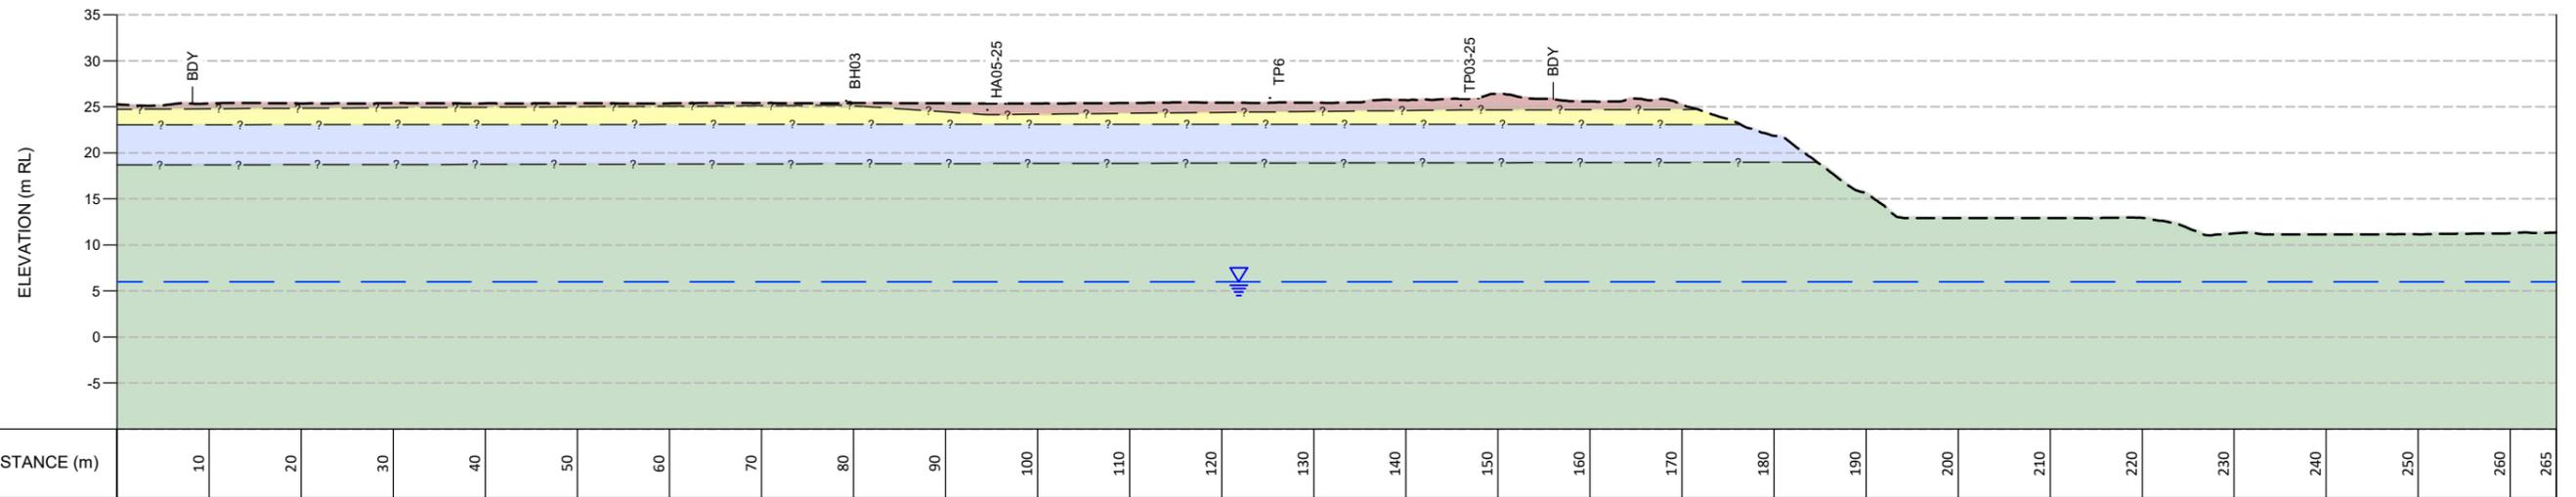
CROSS SECTION A

The ground conditions encountered and inferred from the investigations were generally consistent with the published geological information for the area and can be generalised according to the following subsurface sequences, as presented on Table 1 and presented on the appended Cross Section A as **Drawing 02**.

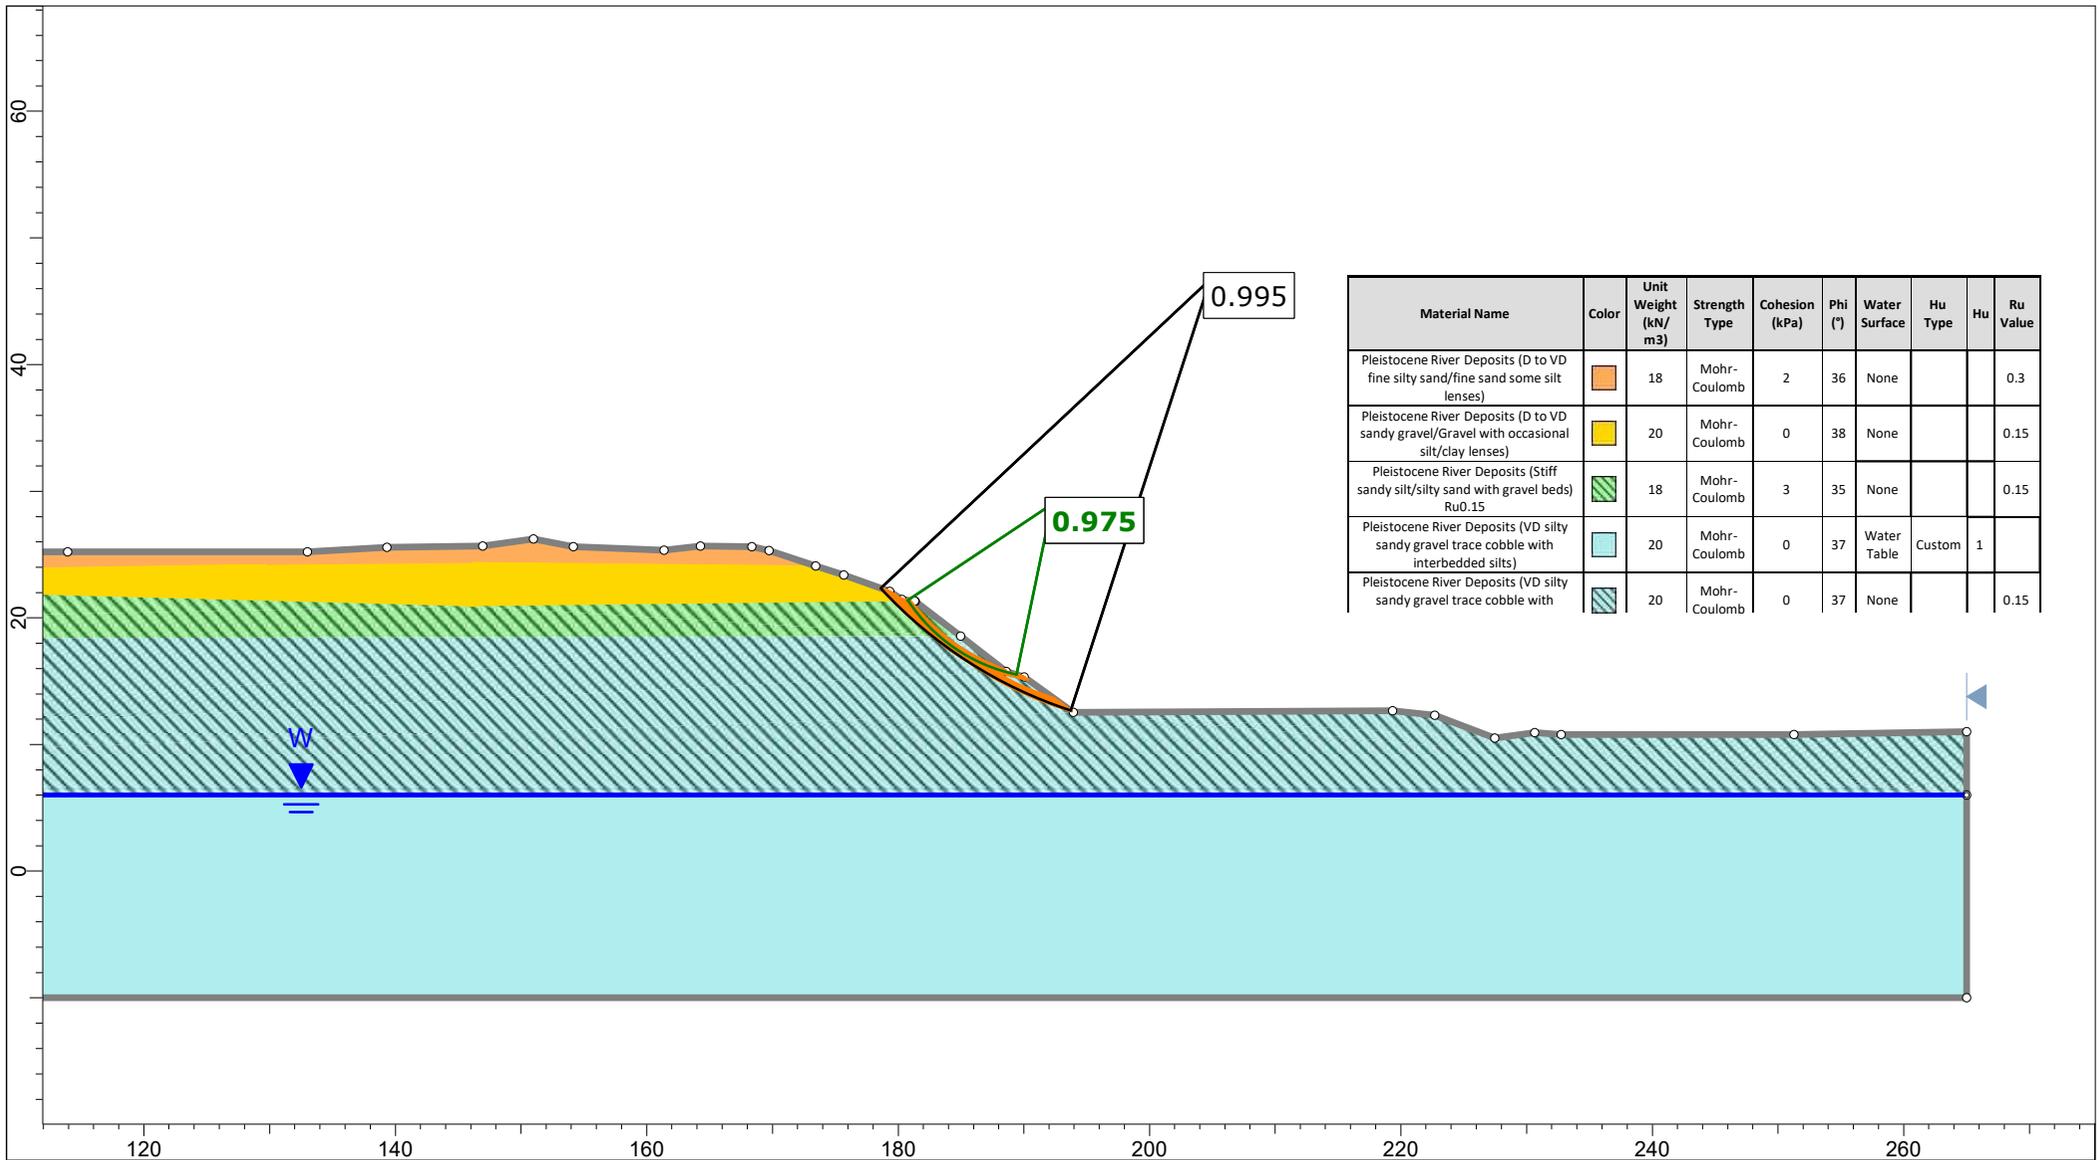
Material Name	Color	Unit Weight (kN/m <sup>3</sup> )	Strength Type	Cohesion (kPa)	Phi (°)	Water Surface	Hu Type	Hu	Ru Value
Pleistocene River Deposits (D to VD fine silty sand/fine sand some silt lenses)	Orange	18	Mohr-Coulomb	2	36	None			0.3
Pleistocene River Deposits (D to VD sandy gravel/Gravel with occasional silt/clay lenses)	Yellow	20	Mohr-Coulomb	0	38	None			0.15
Pleistocene River Deposits (Stiff sandy silt/silty sand with gravel beds) Ru0.15	Green with diagonal lines	18	Mohr-Coulomb	3	35	None			0.15
Pleistocene River Deposits (VD silty sandy gravel trace cobble with interbedded silts)	Light blue with diagonal lines	20	Mohr-Coulomb	0	37	Water Table	Custom	1	
Pleistocene River Deposits (VD silty sandy gravel trace cobble with)	Dark blue with diagonal lines	20	Mohr-Coulomb	0	37	None			0.15

Project	Arataki and Brookvale Roads, Havelock North		
Group	Cross Section A	Scenario	Back Analysis
Client	CDL Land New Zealand Ltd	Company	CMW Geosciences
Date	10/04/2025	File Name	Slope Stability - KB.slmd

Slope stability analyses were undertaken using the Morgenstern-Price method of slices under both circular and translational failure mechanisms using the proprietary software Rocscience Slide.

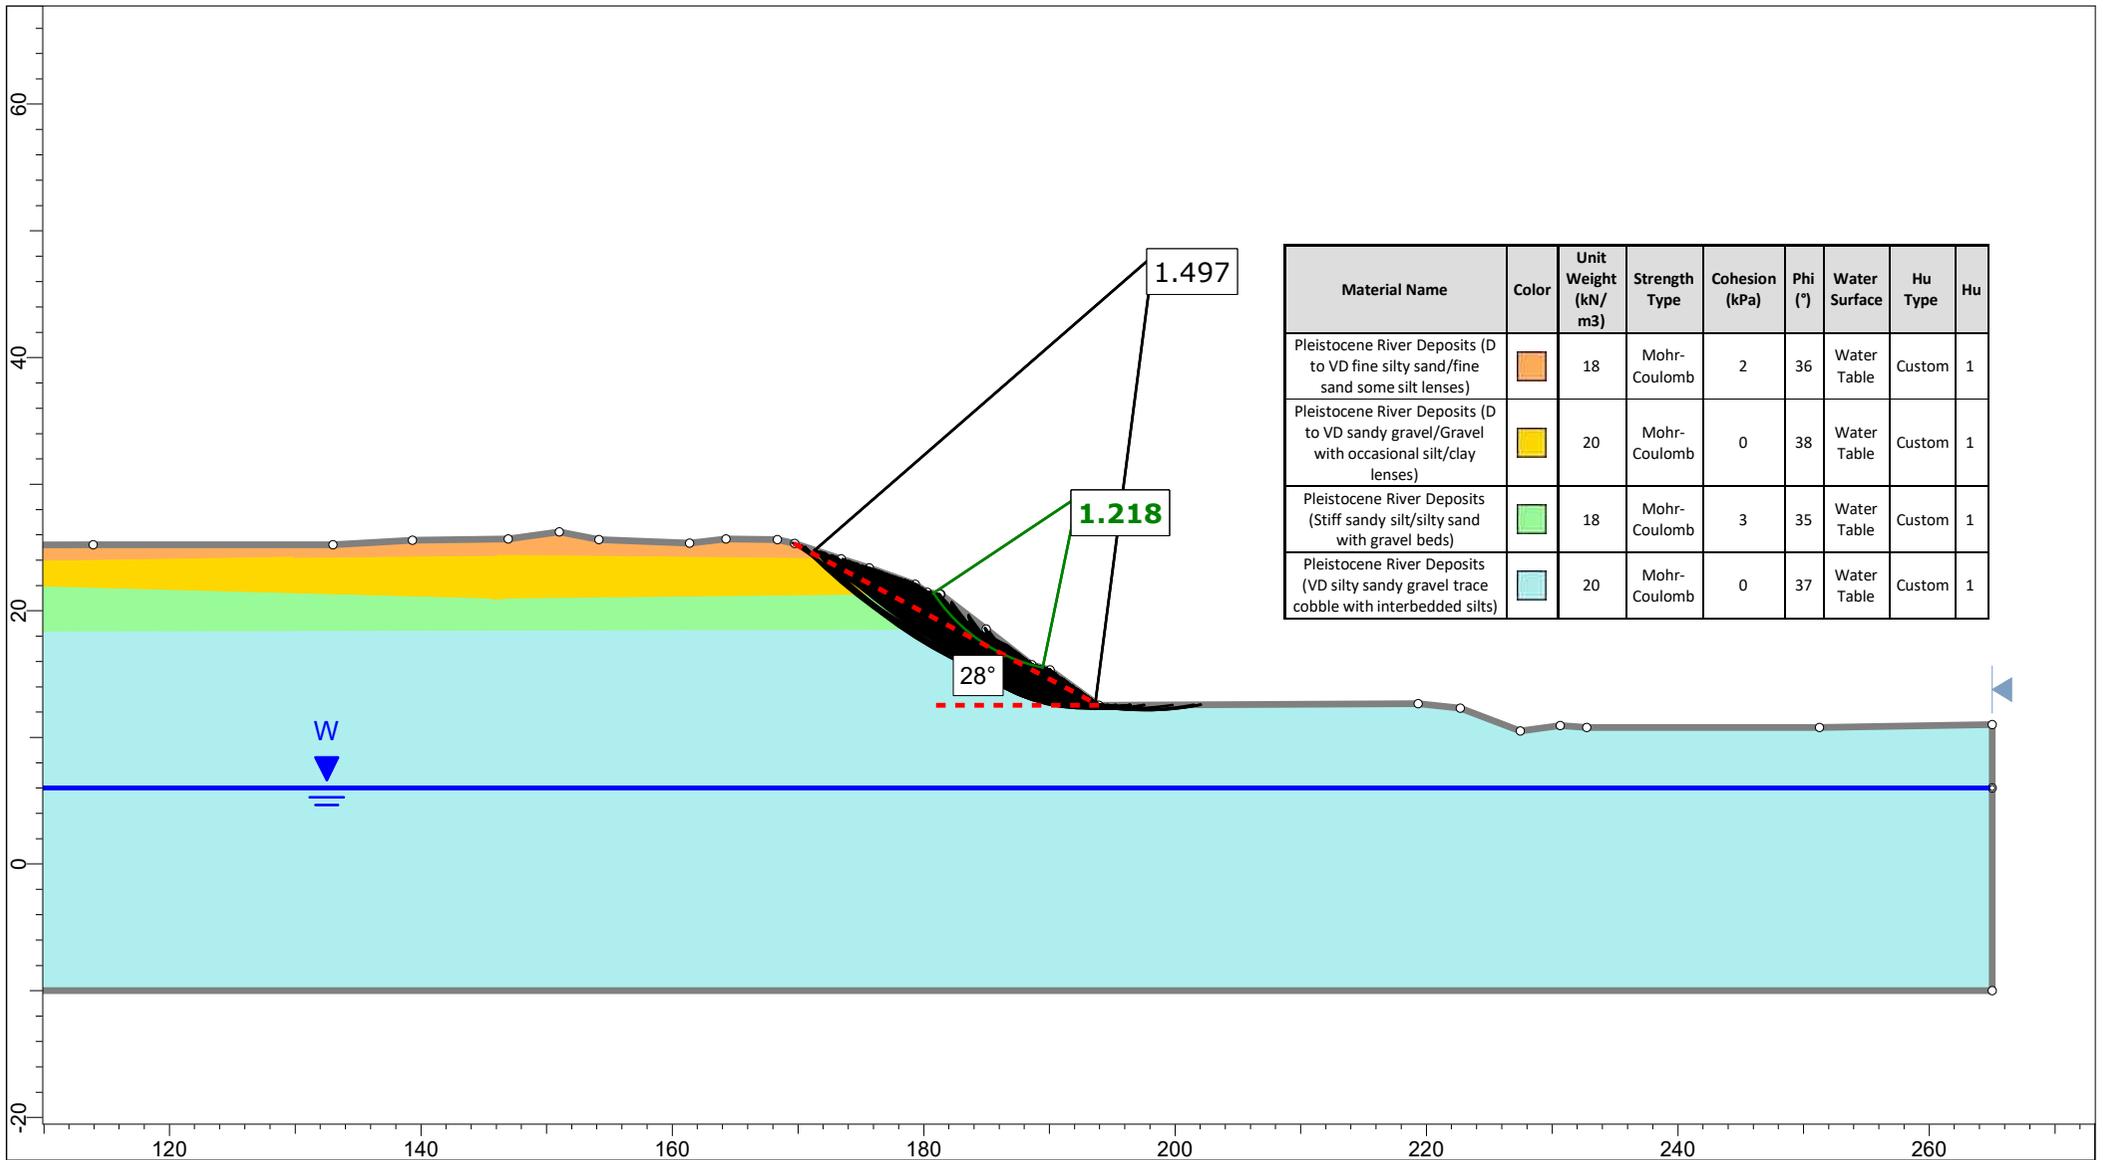
Material Name	Color	Unit Weight (kN/m <sup>3</sup> )	Strength Type	Cohesion (kPa)	Phi (°)	Water Surface	Hu Type	Hu
Pleistocene River Deposits (D to VD fine silty sand/fine sand some silt lenses)	Orange	18	Mohr-Coulomb	2	36	Water Table	Custom	1
Pleistocene River Deposits (D to VD sandy gravel/Gravel with occasional silt/clay lenses)	Yellow	20	Mohr-Coulomb	0	38	Water Table	Custom	1
Pleistocene River Deposits (Stiff sandy silt/silty sand with gravel beds)	Light Green	18	Mohr-Coulomb	3	35	Water Table	Custom	1
Pleistocene River Deposits (VD silty sandy gravel trace cobble with interbedded silts)	Light Blue	20	Mohr-Coulomb	0	37	Water Table	Custom	1

Project		Arataki and Brookvale Roads, Havelock North	
	Group	Cross Section A	Scenario	Prevailing
	Client	CDL Land New Zealand Ltd	Company	CMW Geosciences
	Date	10/04/2025	File Name	Slope Stability - KB.slmd

Results show the requisite FoS under prevailing long term and transient elevated groundwater conditions are achieved at a setback equivalent to a 1(V):2(H) projection line from the toe of the slopes. Requisite FoS were not achieved on the downslope side of this projection line.

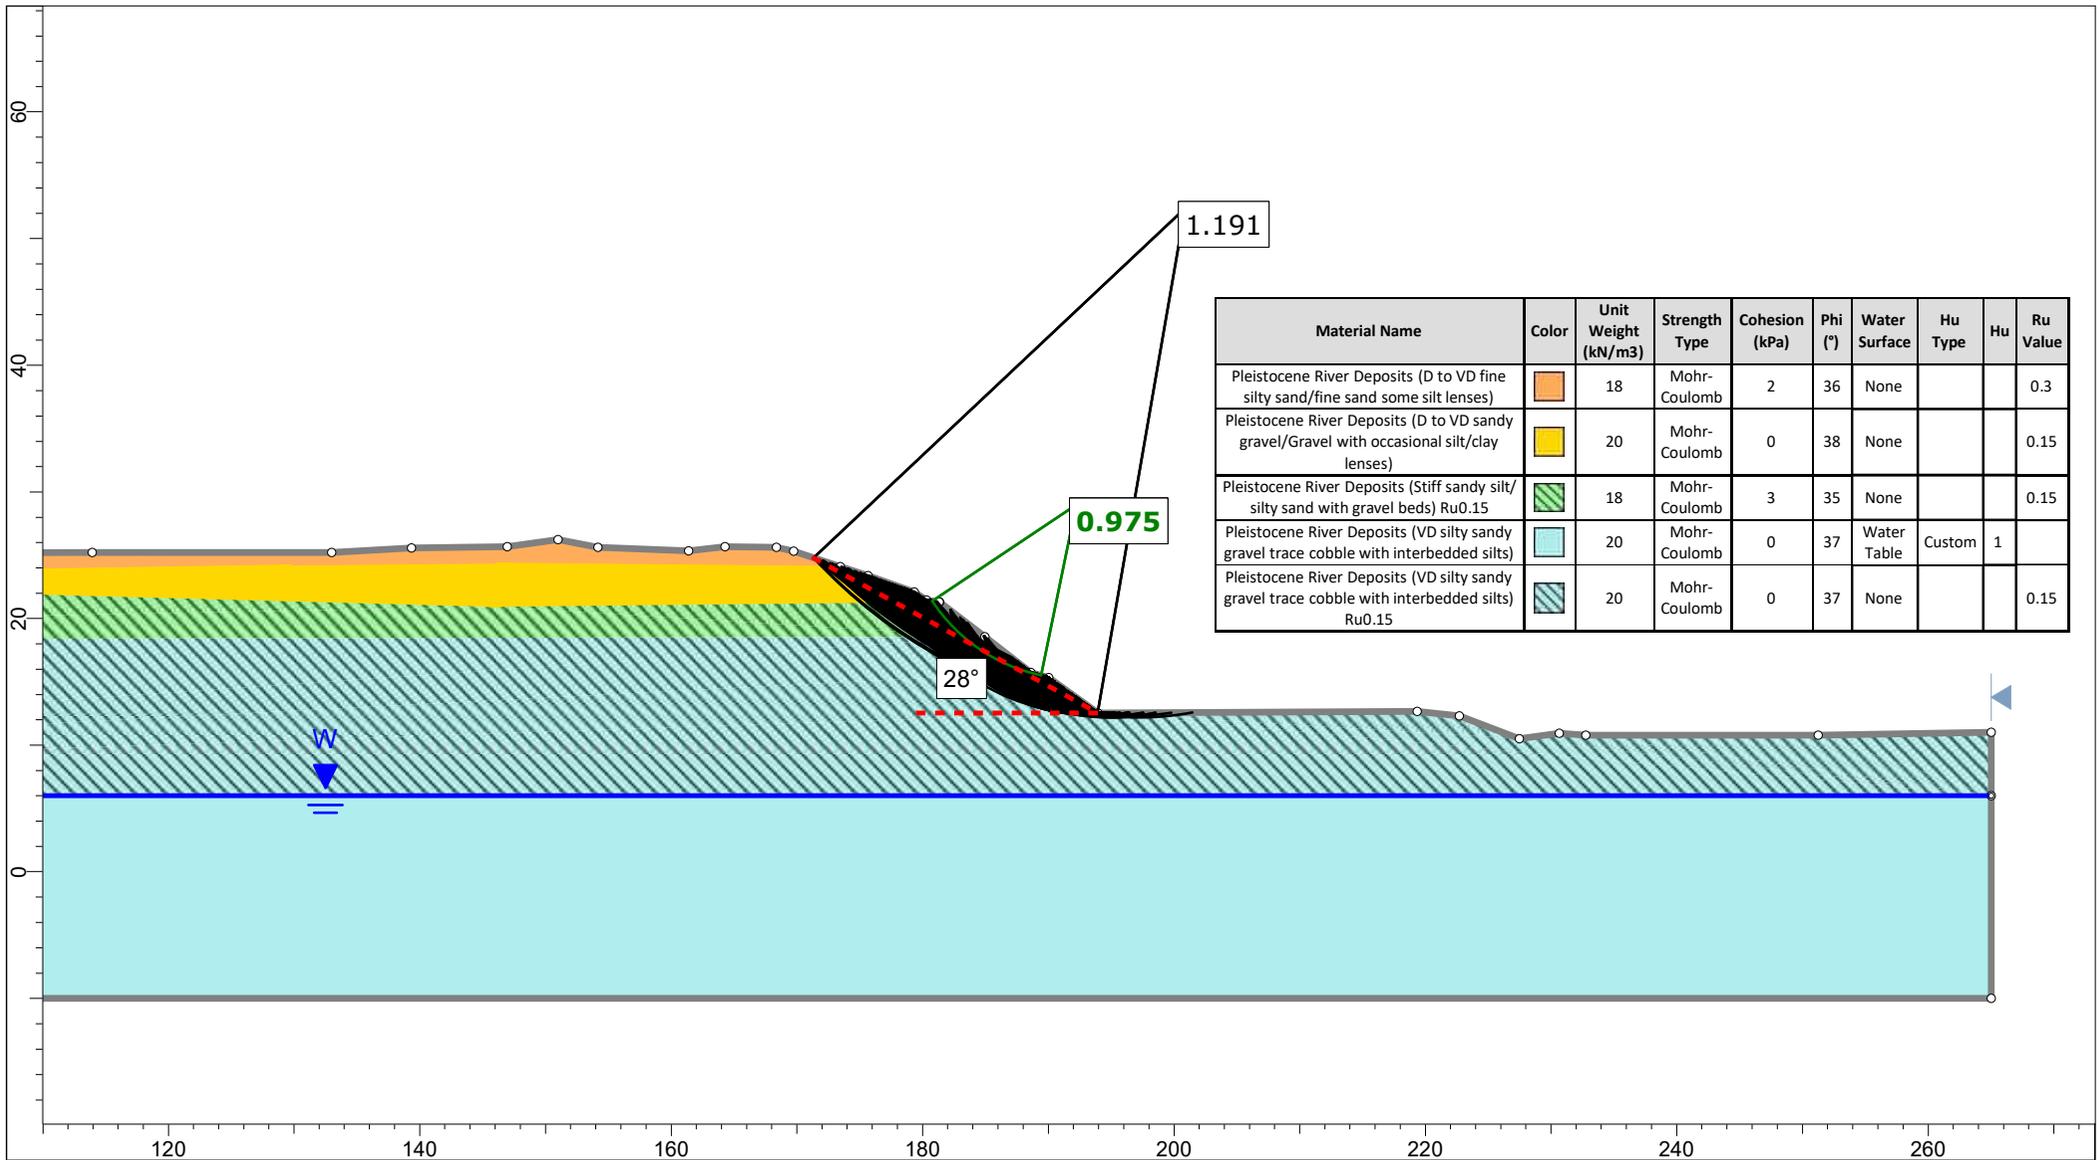
Material Name	Color	Unit Weight (kN/m <sup>3</sup> )	Strength Type	Cohesion (kPa)	Phi (°)	Water Surface	Hu Type	Hu	Ru Value
Pleistocene River Deposits (D to VD fine silty sand/fine sand some silt lenses)	Orange	18	Mohr-Coulomb	2	36	None			0.3
Pleistocene River Deposits (D to VD sandy gravel/Gravel with occasional silt/clay lenses)	Yellow	20	Mohr-Coulomb	0	38	None			0.15
Pleistocene River Deposits (Stiff sandy silt/silty sand with gravel beds) Ru0.15	Green with diagonal lines	18	Mohr-Coulomb	3	35	None			0.15
Pleistocene River Deposits (VD silty sandy gravel trace cobble with interbedded silts)	Light blue with diagonal lines	20	Mohr-Coulomb	0	37	Water Table	Custom	1	
Pleistocene River Deposits (VD silty sandy gravel trace cobble with interbedded silts) Ru0.15	Dark blue with diagonal lines	20	Mohr-Coulomb	0	37	None			0.15

Project		Arataki and Brookvale Roads, Havelock North	
Group	Cross Section A	Scenario	Transient
Client	CDL Land New Zealand Ltd	Company	CMW Geosciences
Date	10/04/2025	File Name	Slope Stability - KB.slmd

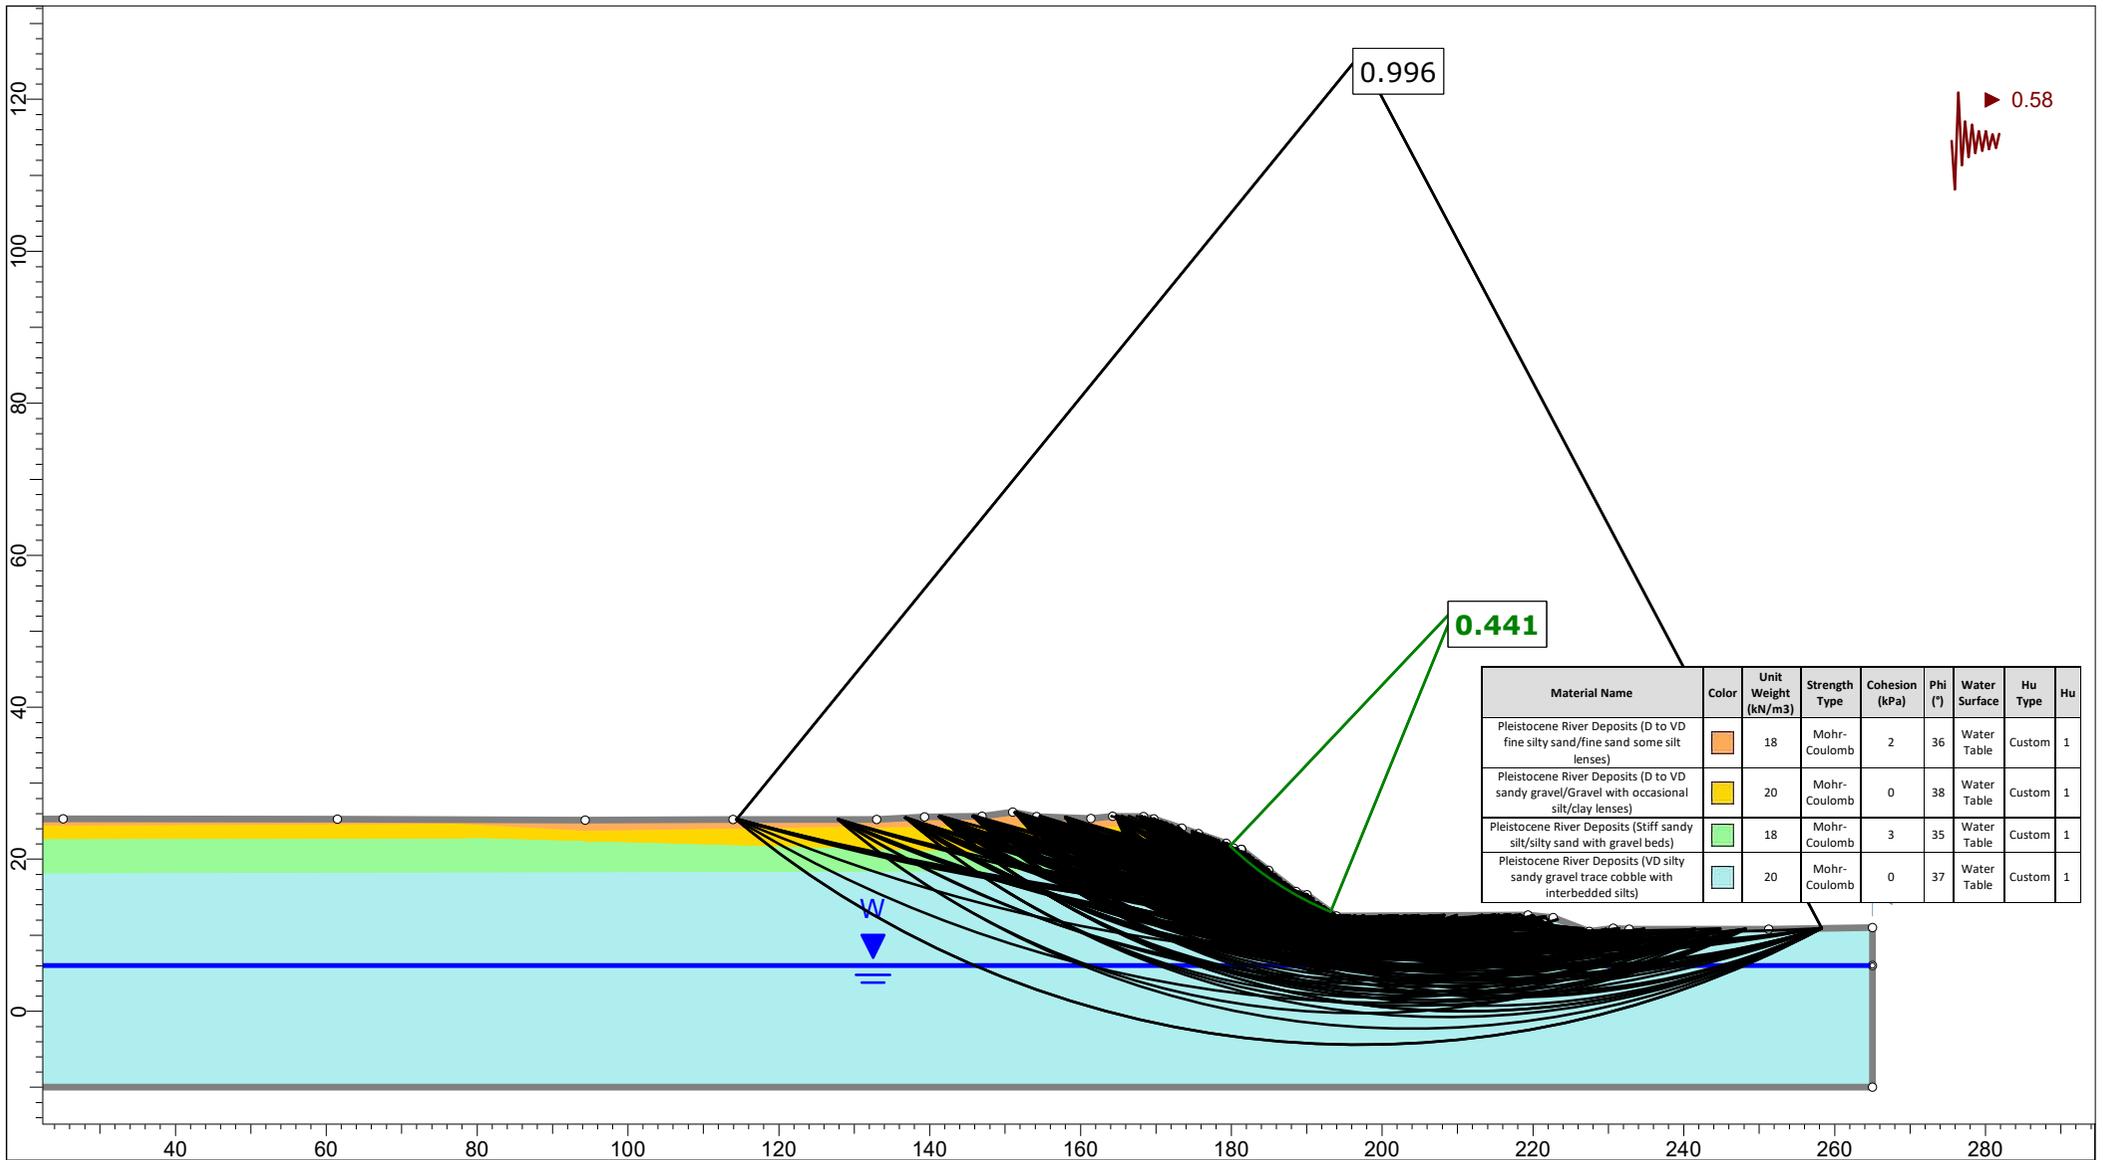
Material Name	Color	Unit Weight (kN/m <sup>3</sup> )	Strength Type	Cohesion (kPa)	Phi (°)	Water Surface	Hu Type	Hu
Pleistocene River Deposits (D to VD fine silty sand/fine sand some silt lenses)	Orange	18	Mohr-Coulomb	2	36	Water Table	Custom	1
Pleistocene River Deposits (D to VD sandy gravel/Gravel with occasional silt/clay lenses)	Yellow	20	Mohr-Coulomb	0	38	Water Table	Custom	1
Pleistocene River Deposits (Stiff sandy silt/silty sand with gravel beds)	Light Green	18	Mohr-Coulomb	3	35	Water Table	Custom	1
Pleistocene River Deposits (VD silty sandy gravel trace cobble with interbedded silts)	Light Blue	20	Mohr-Coulomb	0	37	Water Table	Custom	1

Project	Arataki and Brookvale Roads, Havelock North		
Group	Cross Section A	Scenario	Seismic
Client	CDL Land New Zealand Ltd	Company	CMW Geosciences
Date	10/04/2025	File Name	Slope Stability - KB.slmd

Under ULS seismic loading, based on the yield accelerations presented in Table 5 above, seismic displacements are predicted to be less than 50mm upslope of the 1(V):2(H) setback, with this decreasing to 25mm upslope of the 1(V):2.2(H) setback. Displacements in the order of 50mm are likely to require specific foundations design, with displacements less than 25mm considered minor and need not be considered in future foundation design.

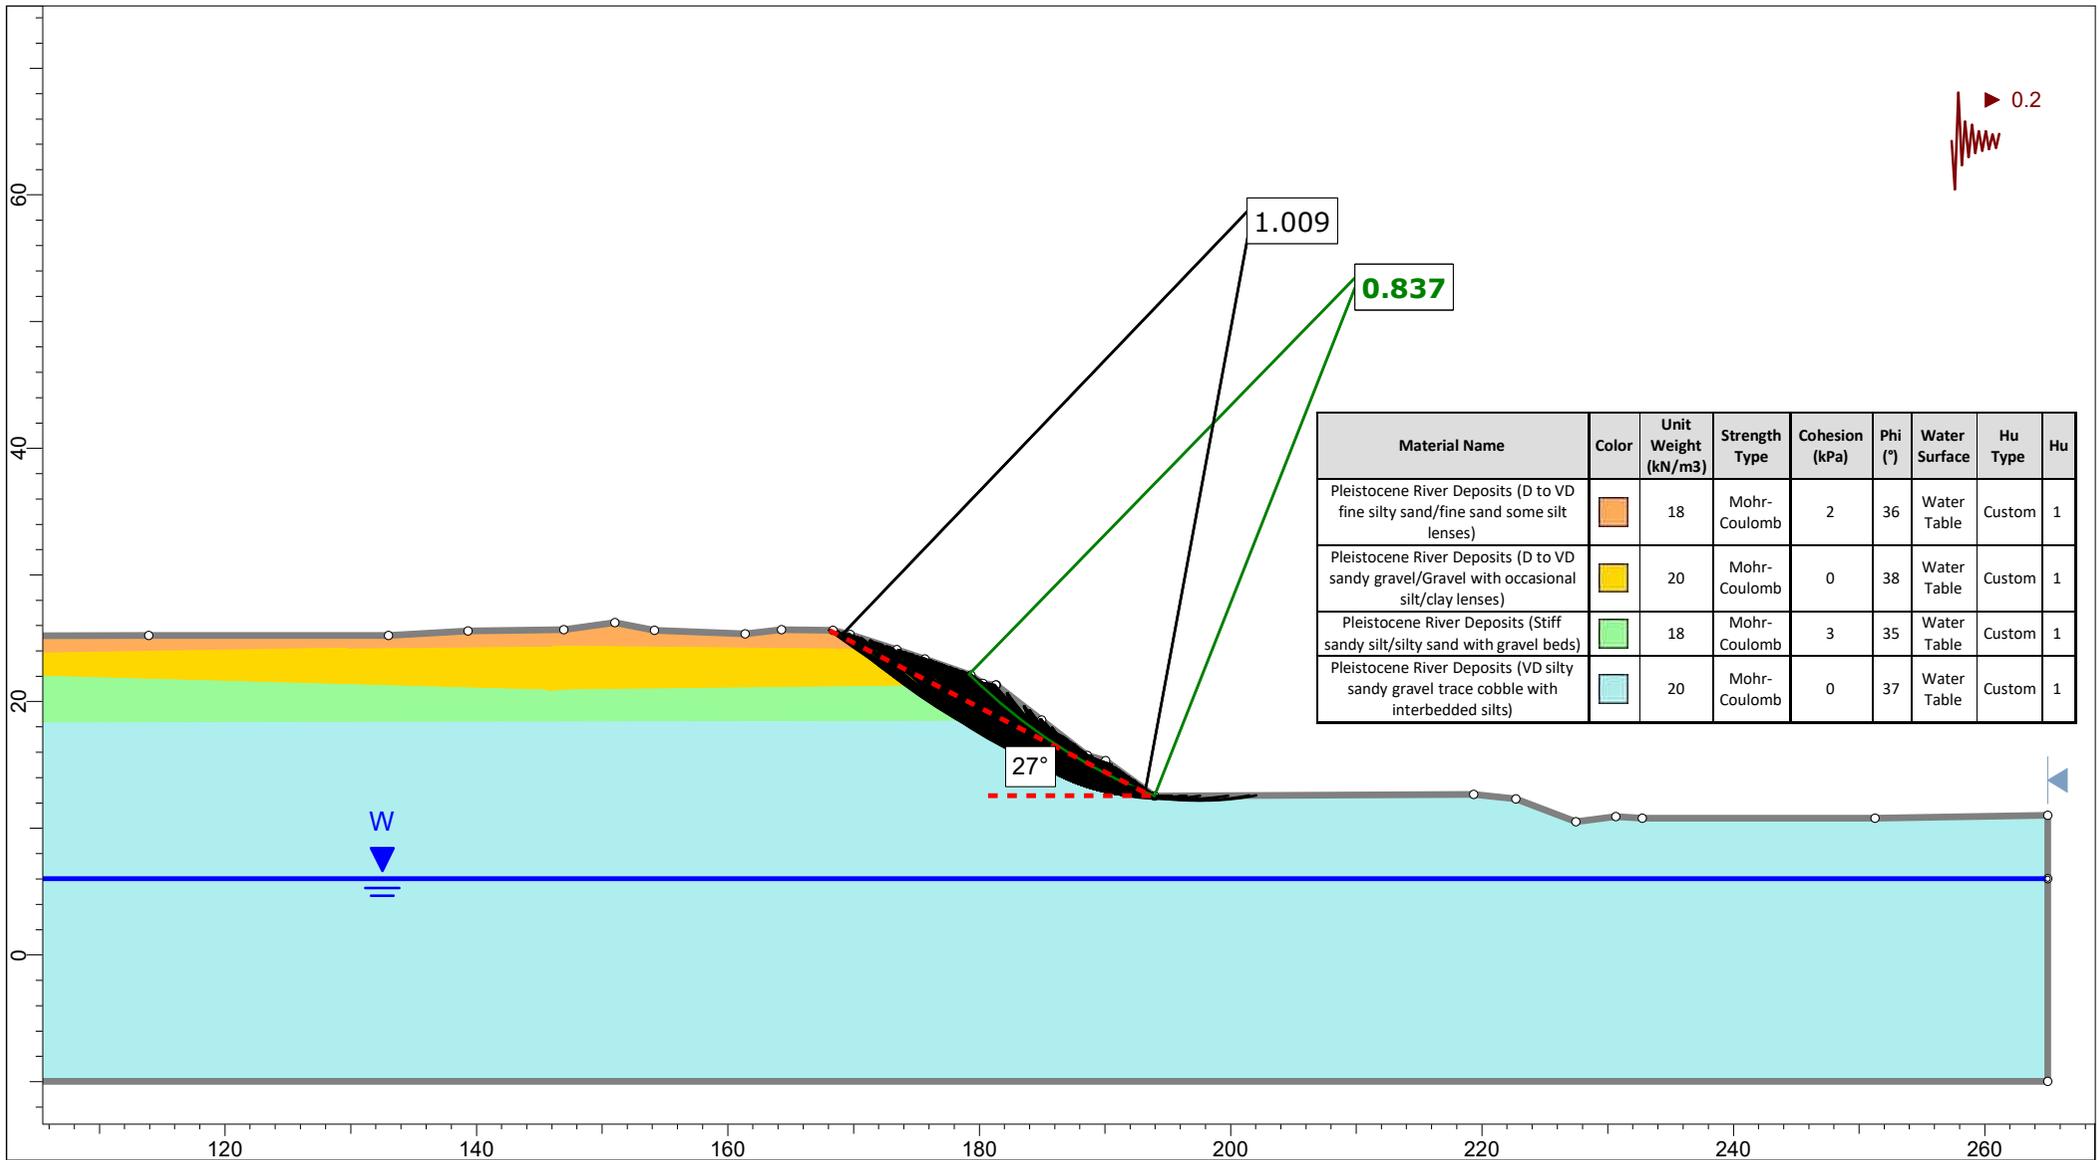
Material Name	Color	Unit Weight (kN/m3)	Strength Type	Cohesion (kPa)	Phi (°)	Water Surface	Hu Type	Hu
Pleistocene River Deposits (D to VD fine silty sand/fine sand some silt lenses)	Orange	18	Mohr-Coulomb	2	36	Water Table	Custom	1
Pleistocene River Deposits (D to VD sandy gravel/Gravel with occasional silt/clay lenses)	Yellow	20	Mohr-Coulomb	0	38	Water Table	Custom	1
Pleistocene River Deposits (Stiff sandy silt/silty sand with gravel beds)	Light Green	18	Mohr-Coulomb	3	35	Water Table	Custom	1
Pleistocene River Deposits (VD silty sandy gravel trace cobble with interbedded silts)	Light Blue	20	Mohr-Coulomb	0	37	Water Table	Custom	1

Project		Arataki and Brookvale Roads, Havelock North	
	Group	Cross Section A	Scenario	Seismic Yield 1:2
	Client	CDL Land New Zealand Ltd	Company	CMW Geosciences
	Date	10/04/2025	File Name	Slope Stability - KB.slm

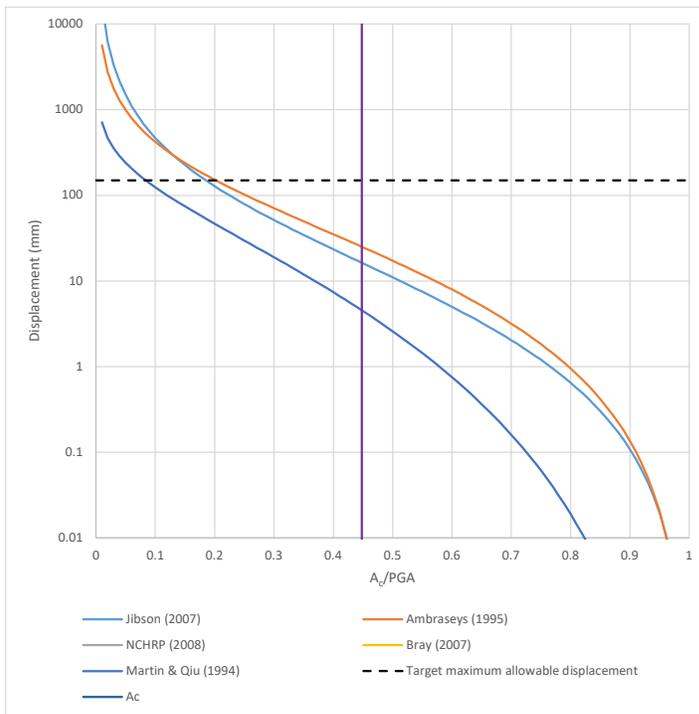
Displacements Limit **150 mm**

CLIENT:	CDL Land New Zealand Ltd	DESIGNER:	MK
	PROJECT:	Arataki and Brookvale Roads, Havelock North	CHECKED:	KB
	TITLE:	COSEISMIC DISPLACEMENTS (1V:2H)	REVISION:	7
			DATE:	10/04/2025
			PROJECT:	NAP2024-0007

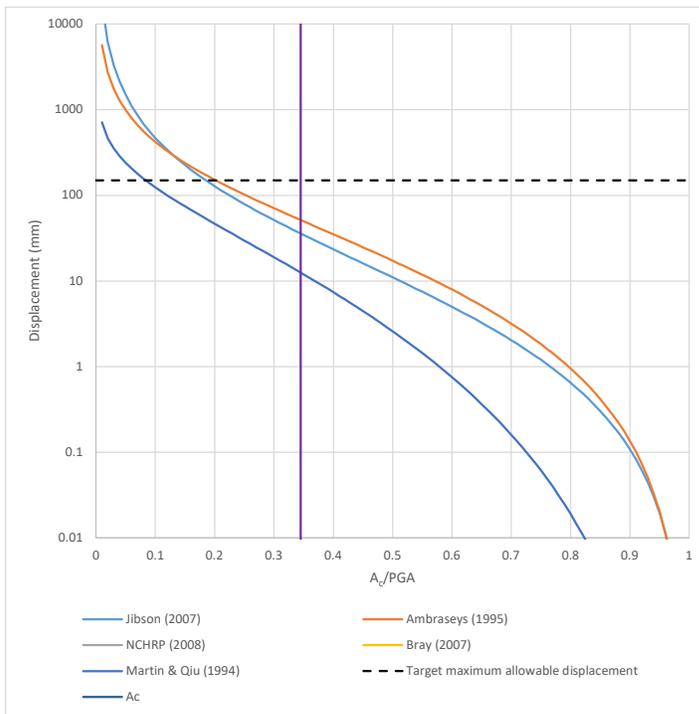
Displacements Limit 150 mm

CLIENT:	CDL Land New Zealand Ltd	DESIGNER:	MK
	PROJECT:	Arataki and Brookvale Roads, Havelock North	CHECKED:	KB
	TITLE:	COSEISMIC DISPLACEMENTS (Worst Case)	REVISION:	7
			DATE:	10/04/2025
			PROJECT:	NAP2024-0007
