DOWNTOWN CARPARK SITE DEVELOPMENT, AUCKLAND: FAST TRACK ARCHAEOLOGICAL ASSESSMENT

Prepared for Precinct Properties New Zealand Ltd

October 2025

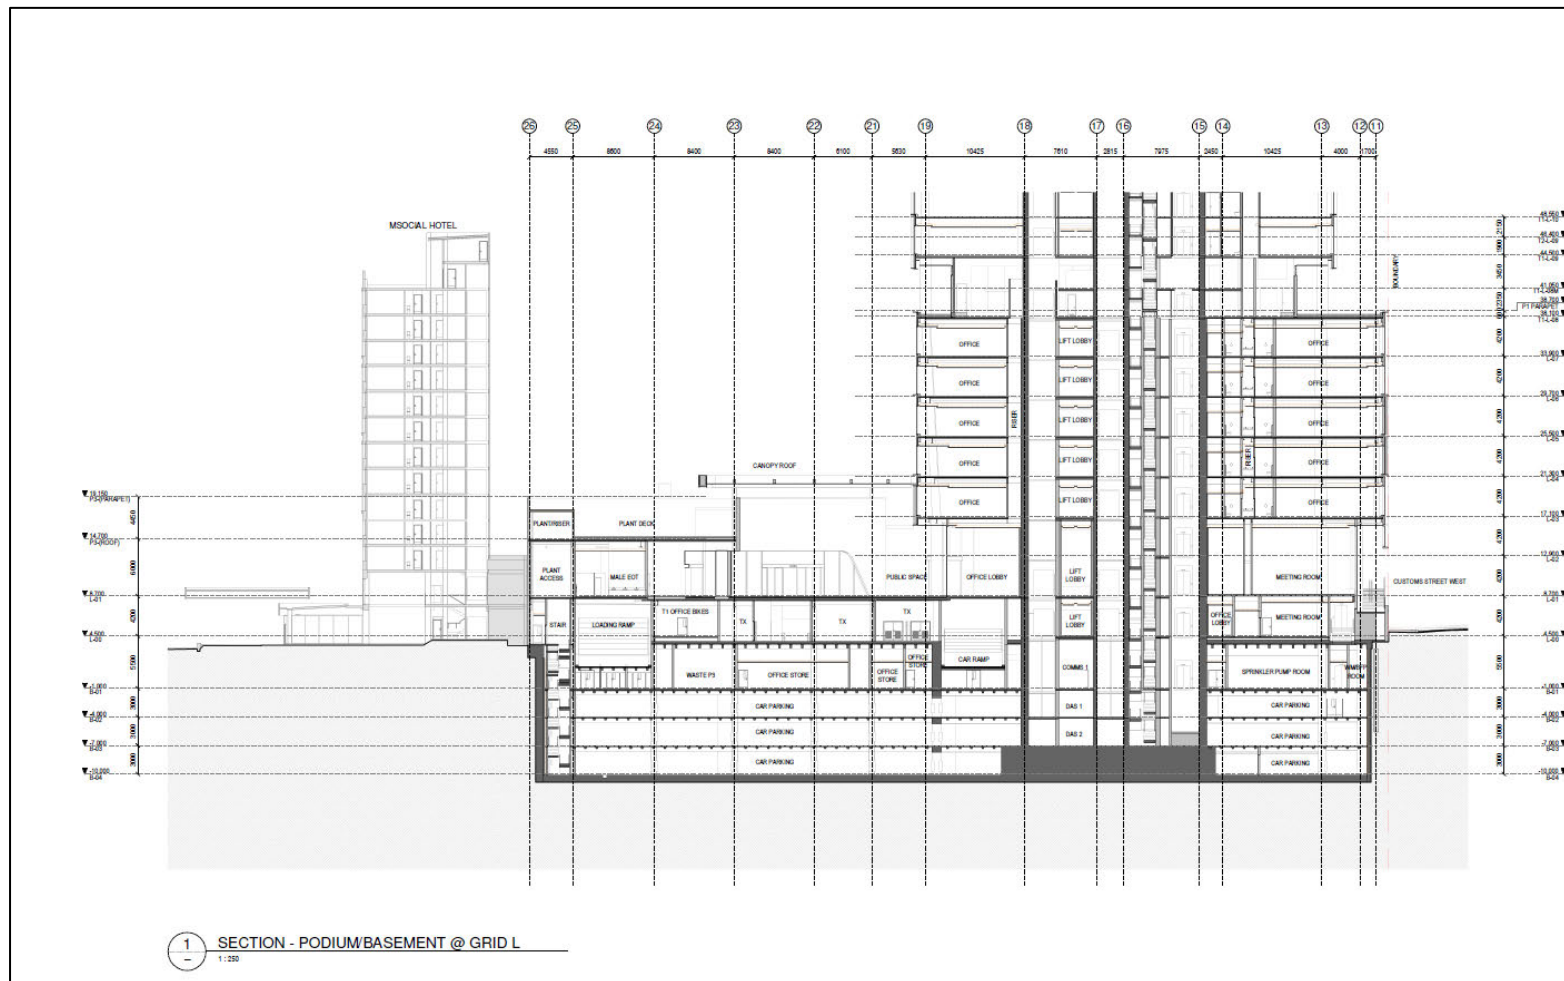
Figure 2. Plan of the Podium Basement Section of the proposed development (source: Warren and Mahoney)

Precinct Properties NZ Ltd ("**Precinct**") is proposing the development of the Downtown Carpark Site into an integrated mixed-use precinct ("**Project**"), located at 2 Lower Hobson Street in the Auckland City Centre ("**Site**") (Figure 1). The Site is currently occupied by a multi-storey carpark that was constructed in 1970, which will be demolished to allow the development. The proposed development consists of the construction of two new multi-storey towers, landscaping works, footbridge connections and podium construction and basement levels (Figure 2 and Figure 3).

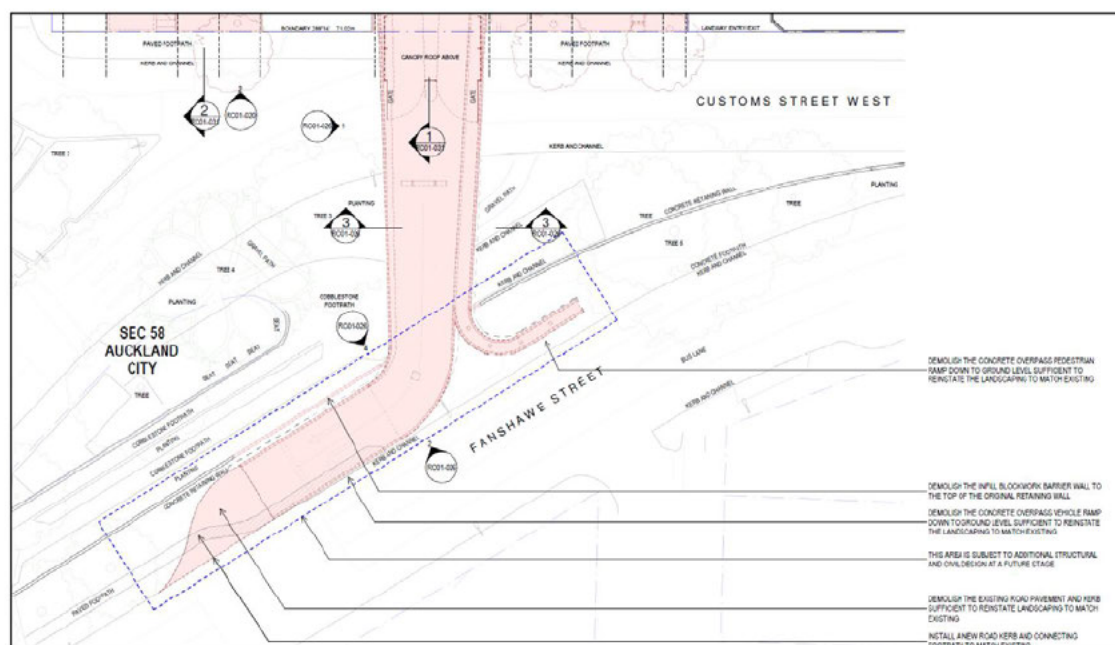
Figure 4. Plan showing the proposed demolition and remediation works for the existing vehicle ramp to Fanshawe Street (source: Warren and Mahoney)

The proposed works will also require the removal (demolition) of the existing vehicle ramp to Fanshawe Street and remediation works as shown in Figure 4 and the removal (demolition) of the existing pedestrian overbridge over Lower Hobson Street (Figure 5). The Project area also includes the properties at 209 Quay Street, 29 Customs Street (Aon House), and 188 Quay Street (HSBC Tower), although subsurface disturbance is not proposed at these properties. The legal descriptions of the properties are Lot 9 DP 60151, Lot 7 DP 77037, Lot 1 DP 78340, Lot 5 DP 63972, Lot 1 DP 183125 and the road reserves of Customs Street West, Lower Hobson Street, Sturdee Street and Fanshawe Street (also shown in Figure 1) ("**Project Area**").

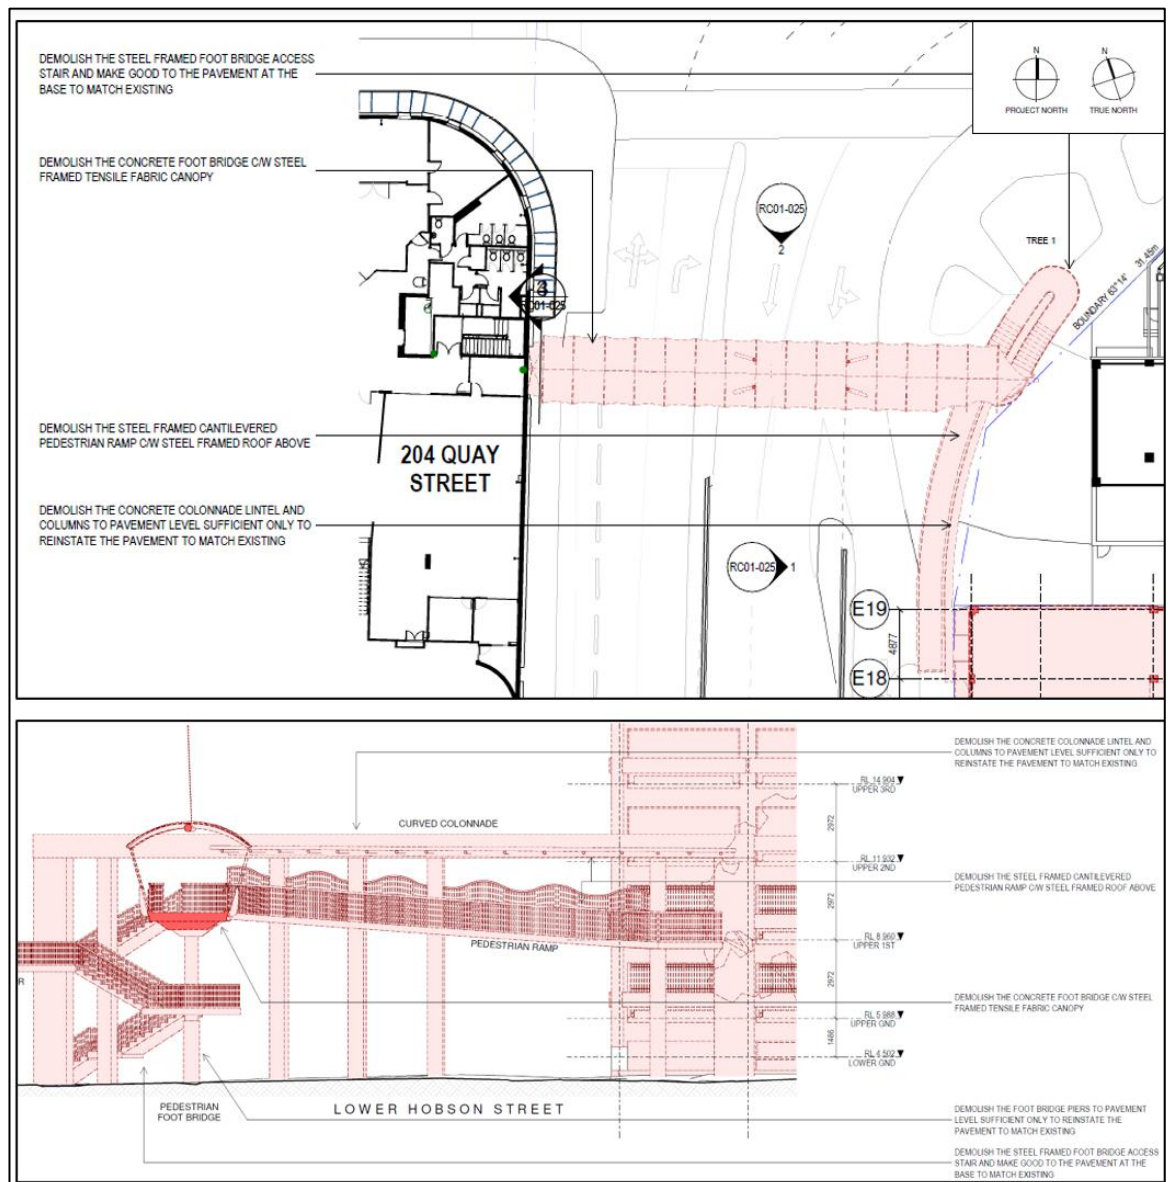
Figure 5. Plan of the Pedestrian overbridge to be demolished and works at 204 Quay Street (source: Warren and Mahoney)

The existing pedestrian overbridge over Lower Hobson Street will be demolished. The works will only be carried out to the level of the pavement and no impacts to archaeology are expected during the works.

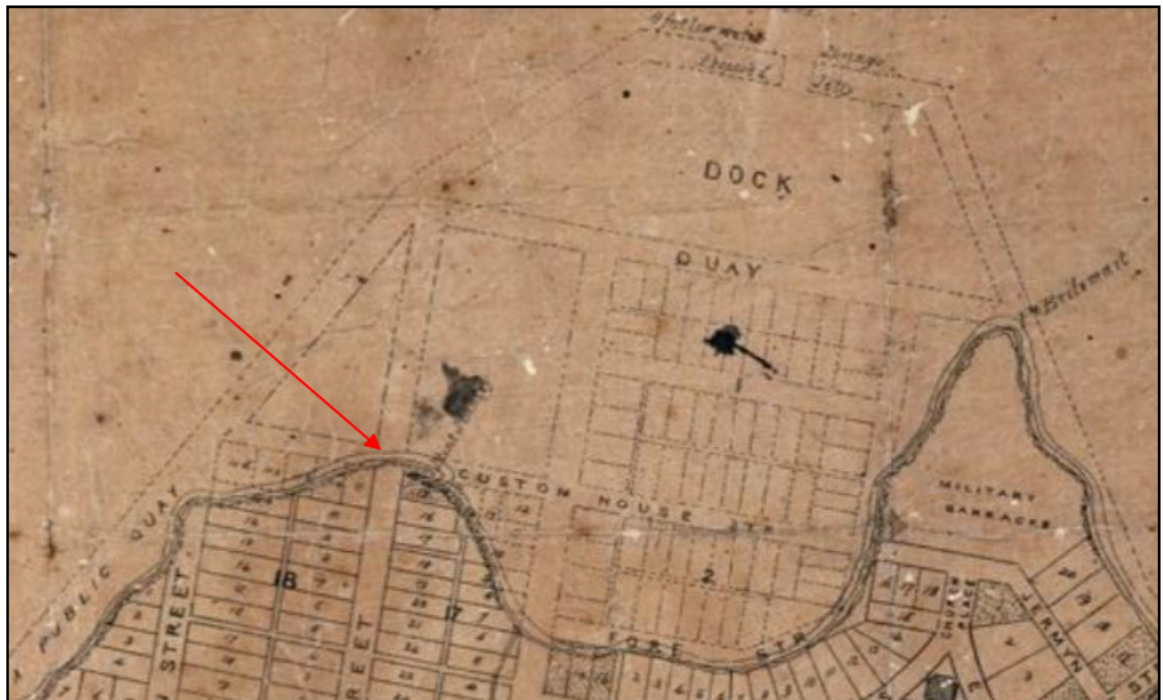
Figure 8. Detail from plan dated 1841, based on Felton Mathew's plan of the town of Auckland, with Smales Point indicated by red arrow (source: Auckland Libraries Heritage Collections, NZ Map 4611)

Reclamation to provide additional land and deeper harbours was actually intended from the earliest days of the establishment of Auckland and plans for the reclamation of Commercial Bay had been considered by the government Surveyor-General Felton Mathew as early as 1841, as can be seen in Figure 8, which is based on the original town plan by Felton Mathew showing proposed reclamation at Commercial Bay. His original plan of Auckland showed proposed reclamation of the entire bay up to Quay Street along with the extension of Queen Street and formation of Customhouse Street. Figure 9 shows the reclamations that were later carried out in relation to the original shoreline and the current Project Area, which is to north of what was Smales Point. The reclamations were undertaken in several stages. By c.1850, minor reclamation had been undertaken to create Fore Street (later Fort Street) along the foreshore of Commercial Bay, and further improvements were made soon afterwards with the erection of the 1,400 foot (c.427m) long Queen Street wharf, which replaced the former Queen Street jetty constructed in c.1846 (Matthews & Matthews 2009: 5; Macready and Clough 2012: 14 & 63).

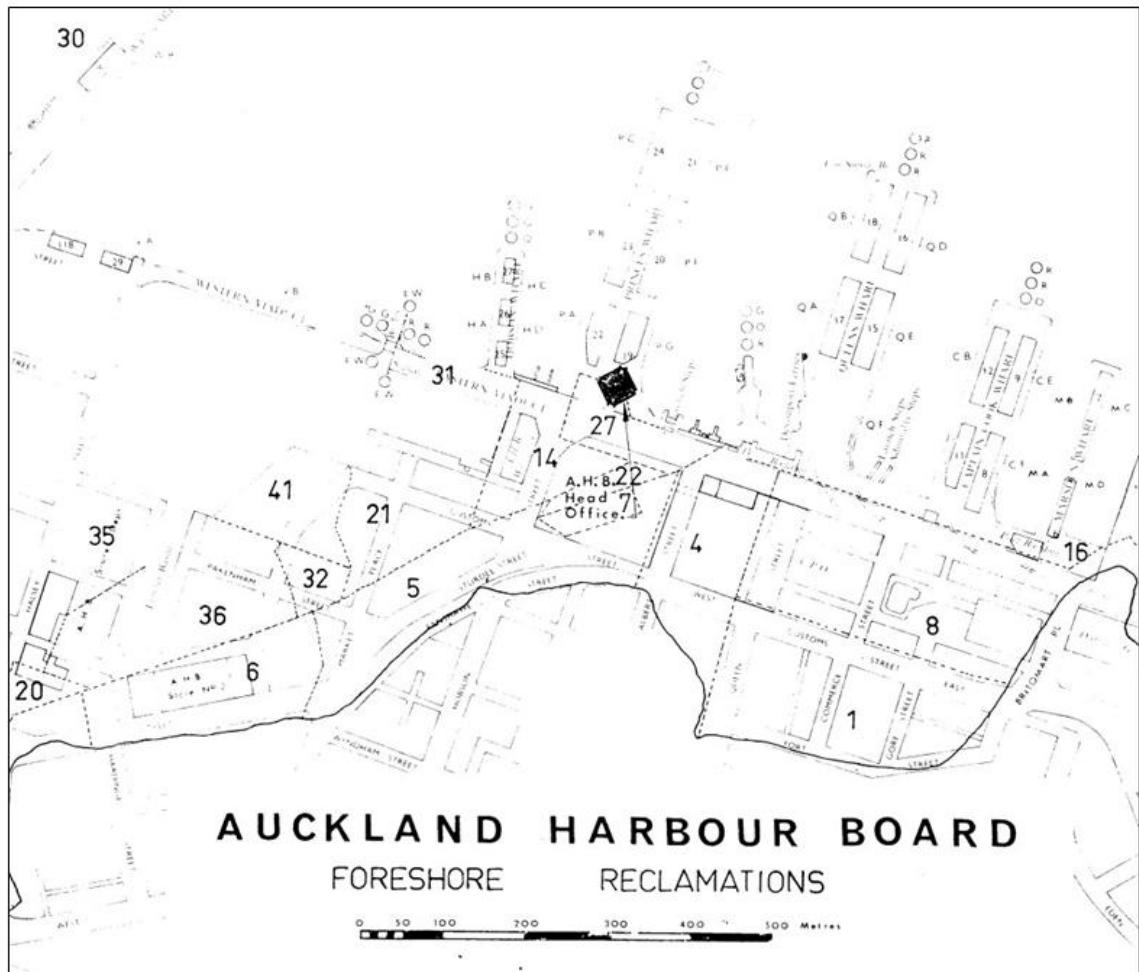
Figure 10. Auckland Harbour Board plan showing the original shoreline (solid line) and numbered foreshore reclamations, with the Auckland Graving Dock site indicated by no. 7 (1878-79) and no. 22 (1915) (source: Auckland Harbour Board plan E851/9)

As noted above, the plans for the demolition included removal of the stones from the old graving dock and an article from the *New Zealand Herald* dated 19 May 1915 stated that this was required as 'preparatory to the making of the road along the waterfront to render the Hobson Wharf more easy access from Queens Wharf'. By November 1915 it was reported that the roading of the area reclaimed at the former site of the graving dock was about completed with the surrounding walls removed and that the Harbour Board would soon be putting the newly created sections up for lease (*Auckland Star* 13 November 1915). The reclamation associated with the closure of the graving dock is indicated by reference number 22 on the plan in Figure 10.

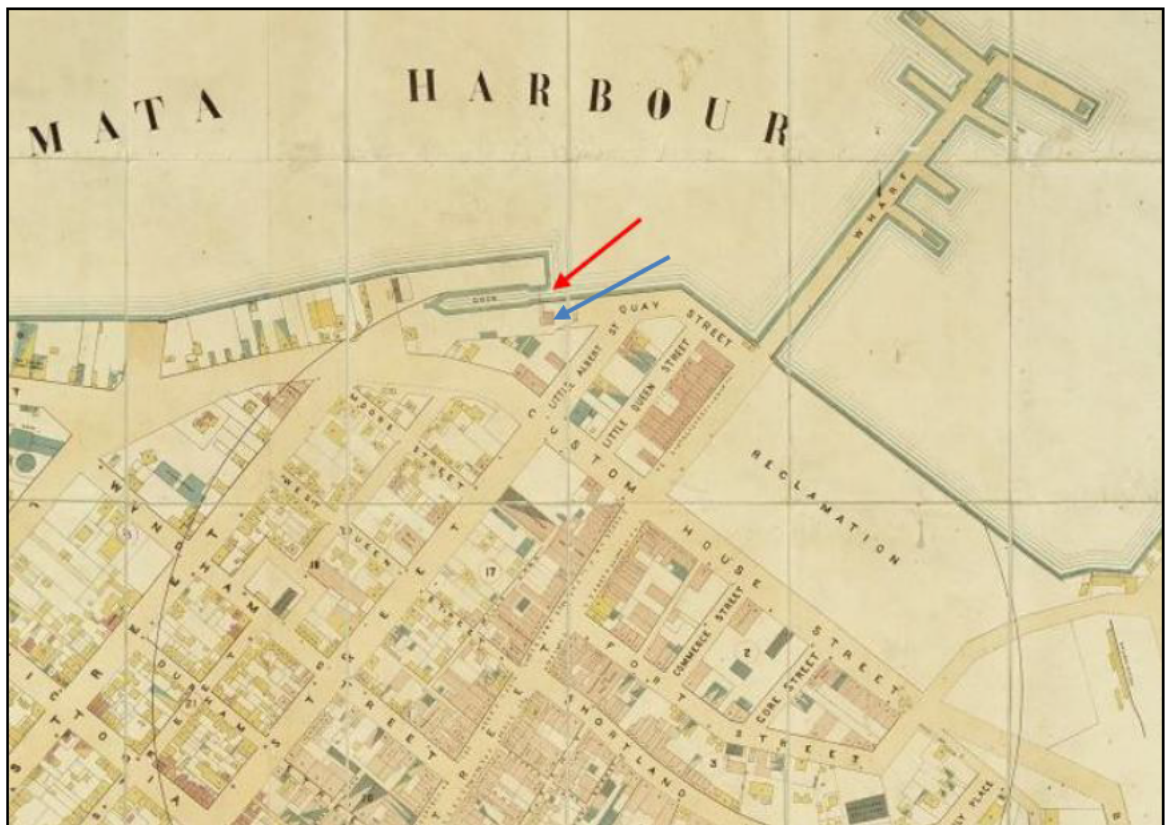
Figure 12. Map of Auckland in 1882, showing the Auckland Graving Dock, indicated by red arrow, and engine and boiler house indicated with blue arrow (source: Auckland Libraries Heritage Collections, NZ Map 91)

The graving dock was constructed during 1878–1879 (reclamation 7 on the plan in Figure 10) and the map from 1882 in Figure 12 shows the location of the dock and the surrounding area. A photograph dating from the late 1870s in Figure 13, shows the reclamation works to the east of the graving dock with the engine and boiler house visible and a later photograph in Figure 14 from the 1890s shows the completed graving dock. It is interesting to note that the Auckland Graving Dock was also used for recreational purposes by the Auckland Swimming Club, who used the water-filled dock for swimming competitions which, as can be seen in the photograph taken in 1902 in Figure 15, were popular events attended by the public.

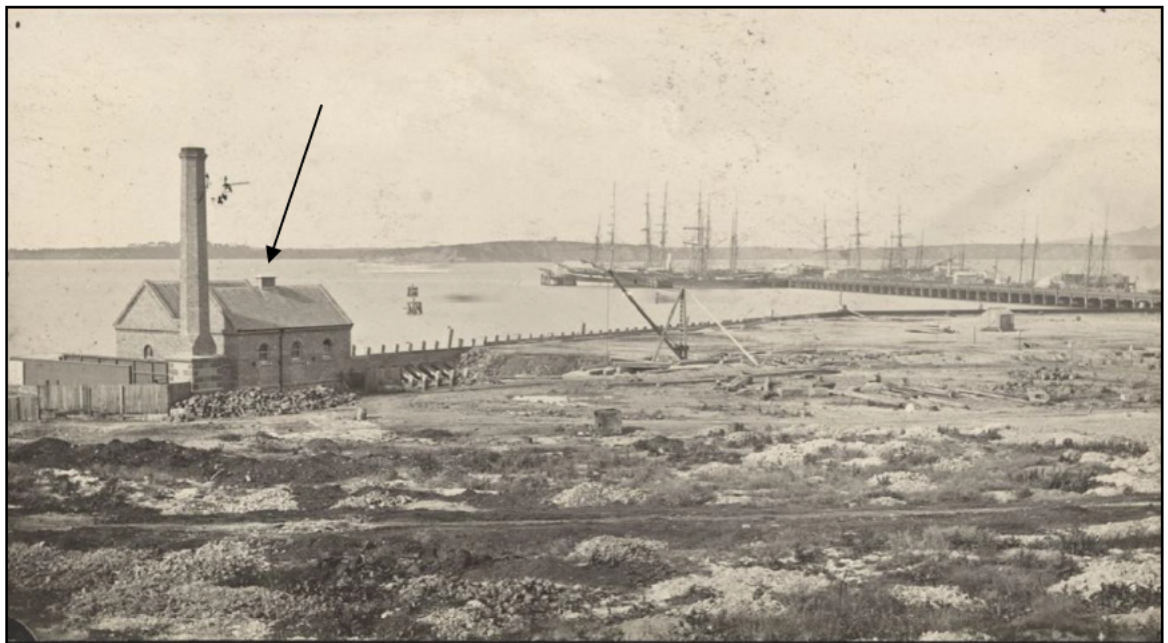
Figure 13. Photograph taken in the late 1870s from the foot of Hobson Street looking towards Queens Wharf, showing recently reclaimed land with the engine and boiler house of the Auckland Graving Dock indicated by arrow (source: Auckland Libraries Heritage Collections, 1043-122)

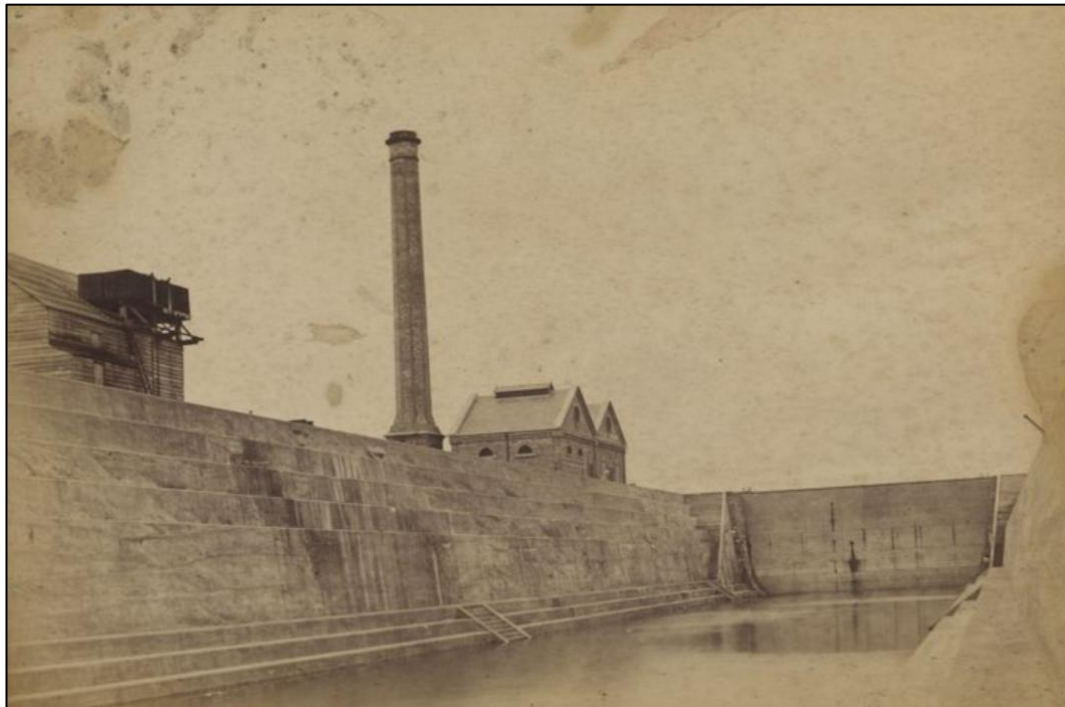
Figure 14. Photograph of the Auckland Graving Dock and engine and boiler house dating to the 1880s (source: Auckland Libraries Heritage Collections, 1677-056)

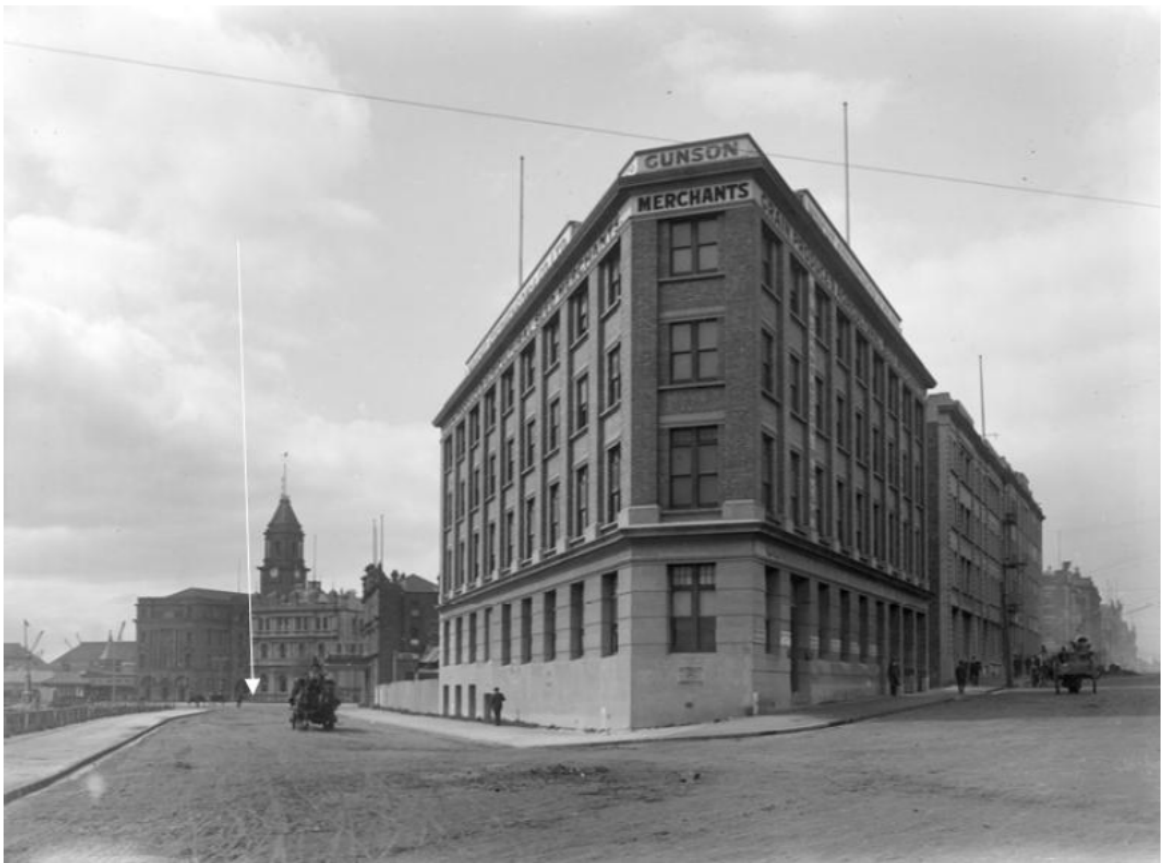
Figure 16. Upper photograph dated 1916 showing the newly reclaimed land at the former graving dock site (white arrow) and the Gunson Building (yellow arrow). Lower photograph dated 1917 showing the newly constructed part of Sturdee Street (indicated by arrow) with the Gunson Building shown (source: upper, Auckland Libraries Heritage Collections, 1-W1330 ; lower, Auckland Libraries Heritage Collections, 1-W1607)

Photographs show that no substantial development occurred at the site of the former graving dock for many years with the exception of the construction of Sturdee Street, as shown in the photographs from 1916 and 1917 in Figure 16. These photographs also show the presence of a large triangular-shaped building, the Gunson Building adjacent to Sturdee Street and Customs Street West, and it is noted that the lot containing this building is partially located within the current Project Area. The Gunson Building was constructed between 1906 and 1912, which was prior to the demolition of the graving dock, as can be

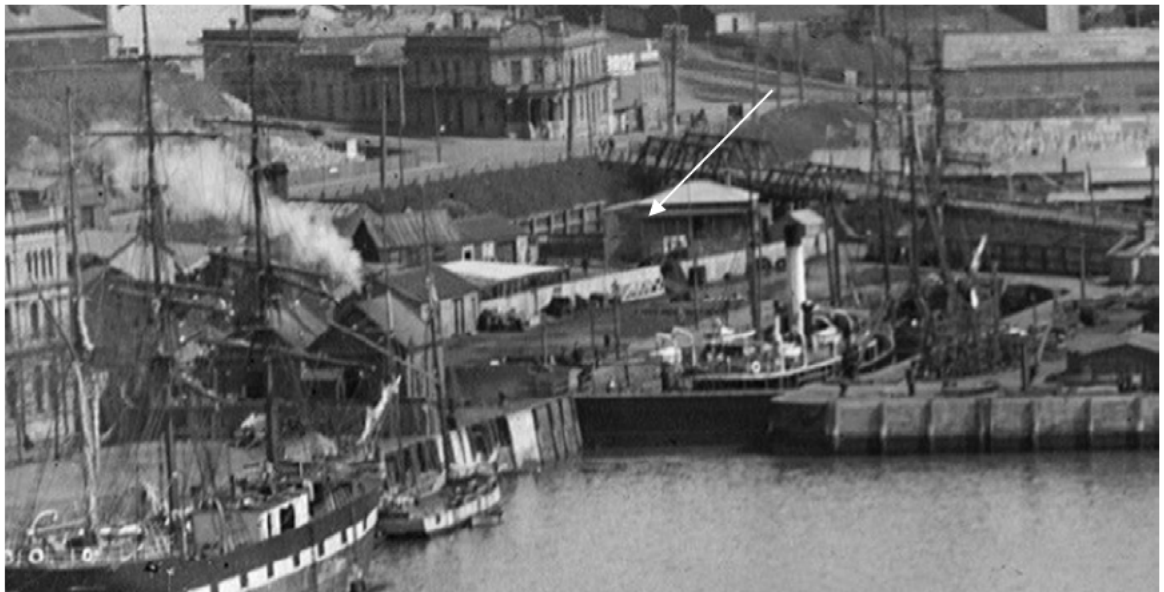
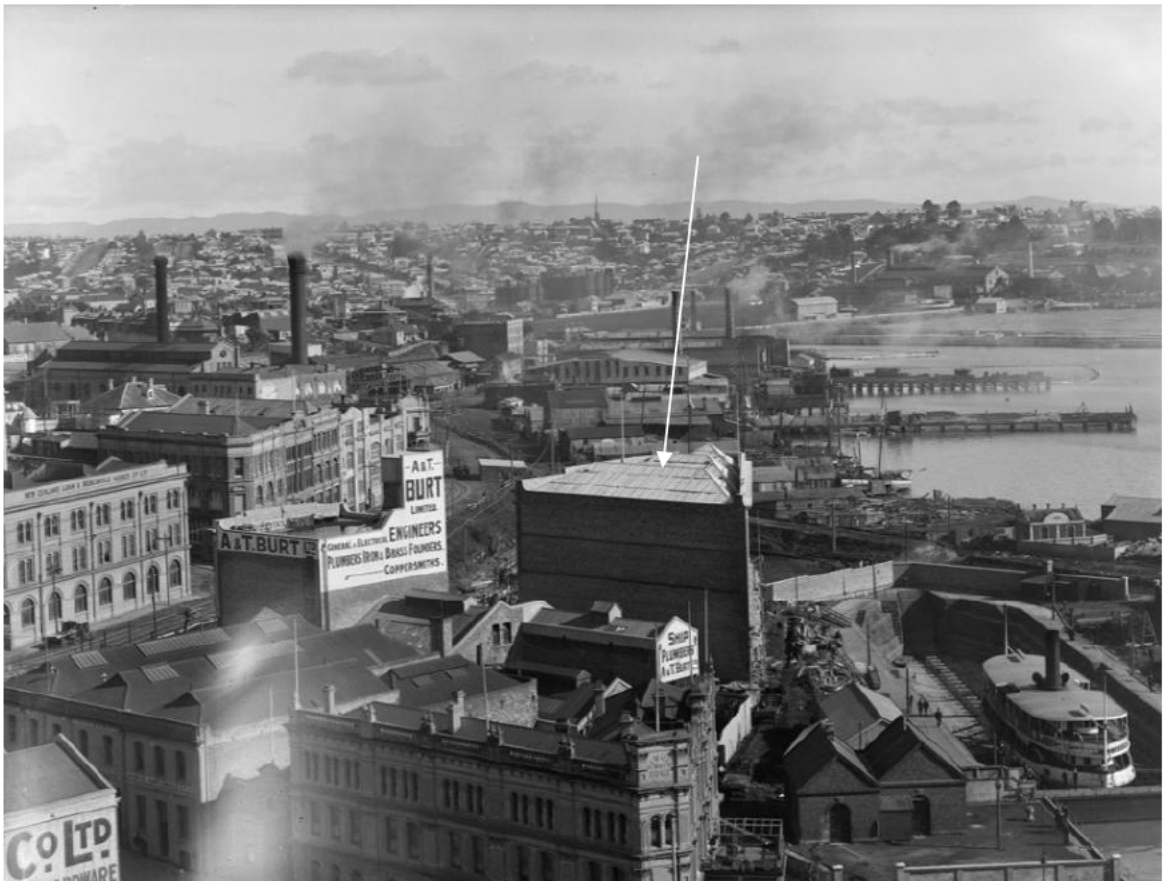
Figure 17. Upper photograph dated 1906 and lower photograph dated 1912, showing the Auckland Graving Dock with boats in for repairs and location of the Gunson Building prior to and after construction indicated by white arrows (source: Auckland Libraries Heritage Collections – upper 1-W0570 and lower 1-W0985)

seen in the two photographs from these years showing the location (Figure 17) – the 1906 photograph showing the area prior to the construction of the Gunson building with an open area adjacent to the graving dock and some small buildings present which for the most part appear to be constructed of wood; and the 1912 photograph showing the newly constructed Gunson Building. The Gunson Building was associated with the Gunson family business as grain and seed merchants, established by William Gunson in 1881. His son James became managing director of the company in 1902. James Gunson was a well-known public figure in early 20th century Auckland, serving as Mayor from 1915 to 1925, when he retired. During his time as the Mayor of Auckland he oversaw a number of improvements to the city, including infrastructure, purchase of the city's tramways, the establishment of the Auckland Electric Power Board, widening and paving of many city streets, the absorption of Point Chevalier into the city and establishment of the Auckland Zoological Park. He also served as chairman of the Auckland Harbour Board from 1911 to 1915 (Stacpoole 1996).

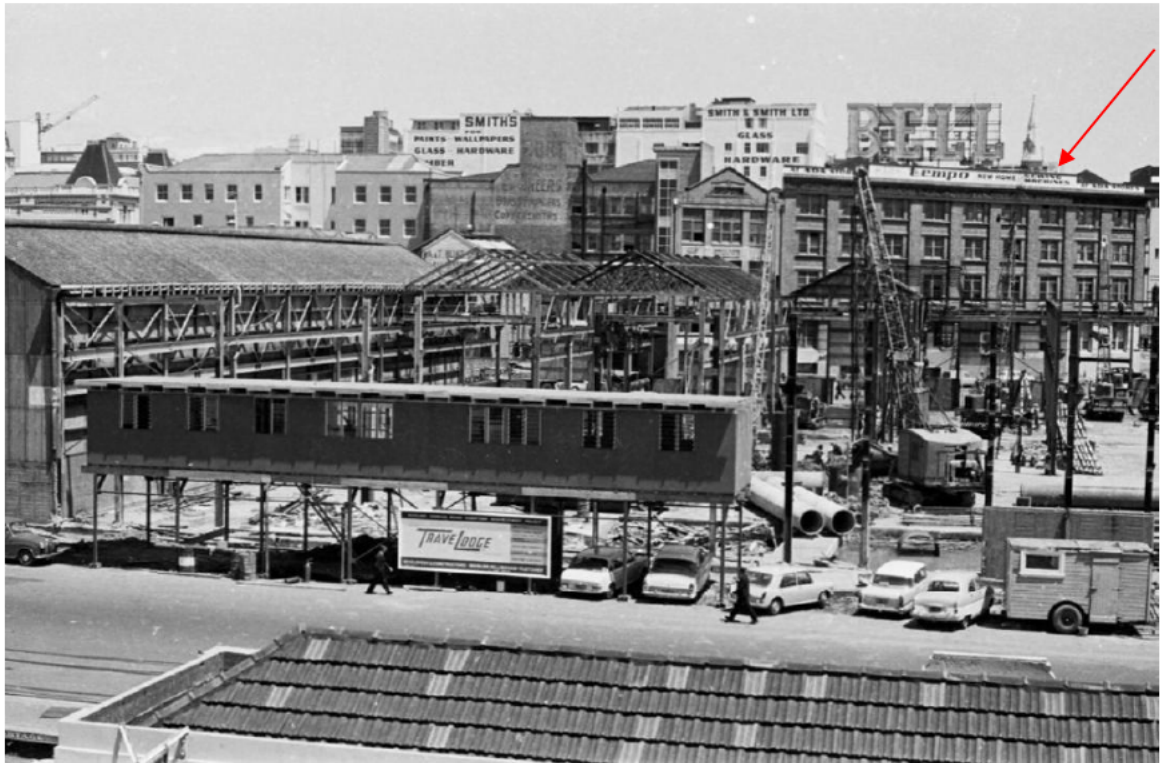
Figure 20. Photograph dated 1968 showing the demolition of the World War II warehouses as part of the construction of the Travelodge Hotel, with the Gunson Building visible in the background and indicated by red arrow (source: Auckland Libraries Heritage Collections, 786-A26-04)

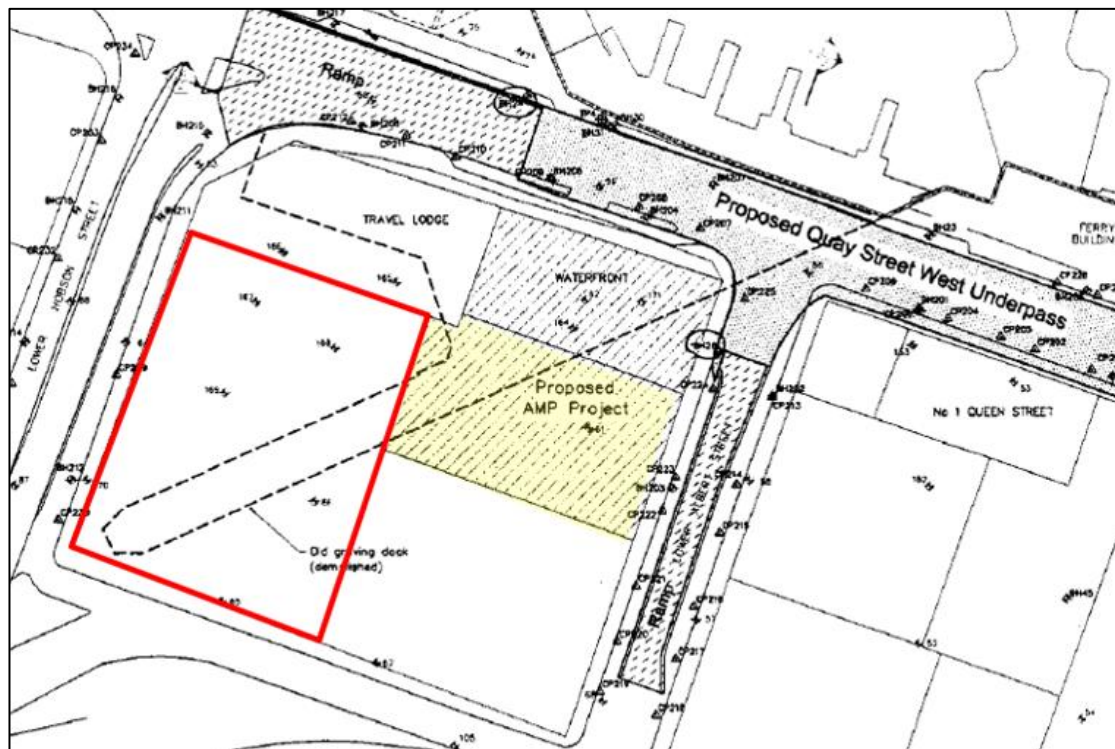
Figure 29. Plan showing the project area for the 2000 investigation for the AMP project (shaded yellow) in relation to the existing Downtown Carpark (outlined in red) (source: Clough and Prince 1999: 2)

There have been a number of archaeological investigations in the general area surrounding the current Project Area. However, this is the closest, being situated to the east of the existing carpark building (Figure 29). The works consisted of archaeological monitoring for the AMP Waterfront Tower that was undertaken between June and September 2000 (Clough et al. 2001). It was noted that the area included in the archaeological investigation had been previously modified by development in the late 1970s, including construction of the Downtown Terminal Building.

The works were situated on land reclaimed in the 1870s and also partially on reclaimed land dating to 1915. The works were also expected to affect the Auckland Sailors Home, which was built in 1887 and demolished in 1973/4. The earthworks on the site consisted of excavating a 50m x 50m pit down to the rock layer, which was encountered at depths between 5m and 7m. It was noted that archaeological excavation was restricted to minor investigations of rubbish pits and features for recording, as they were exposed during excavations for the AMP tower, due to safety restrictions.

The results of the monitoring included identification of features relating to the Auckland Graving Dock, including a short section of the southern inner wall (c.1.2m in length) consisting of large basalt and scoria boulders with Portland cement mortar. As well, the foundations of the Engine and Boiler House, which were described in the works specifications ‘to be carried down to the rock’ were identified, as were remnants of the inner and outer walls of the timber coffer dam consisting of totara and kauri piles and a system of contiguous brick culverts that emptied the graving dock. Features that were not encountered included the rear wall of the Engine and Boiler House, the majority of the Graving Dock structure and the 50ft (15.7m) discharge pipe. The results were summarised as follows, indicating that additional evidence of the dock would be expected:

‘Excavations revealed only a minor section of the graving dock. However, significant sections of the engine and boiler house basement/foundations, including a number of culverts and cast-iron suction pipes were exposed. The remains demonstrate the quality of design, workmanship and engineering in Auckland at that time and indicate that the archival works specifications for the construction, brought to light during research (above) were generally adhered to. The “3ft thick concrete floor” of the engine/boiler house was not evident and must have been removed during the construction of the 1970s and there was no sign of the pump well. This and other features must still be buried in the unexcavated western portion of the site” (Clough et al. 2001: 36).

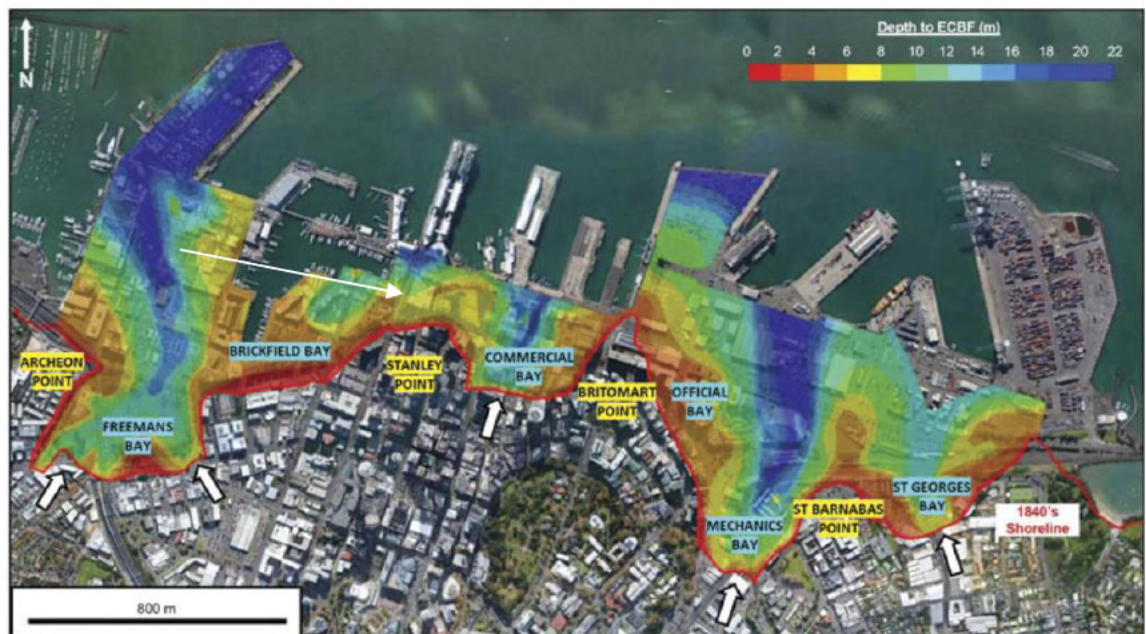
Figure 32. Aerial plan showing the depth to East Coast Bay Formation Rock with the Project Area indicated by the white arrow (source: Lee and Wotherspoon 2016. Dynamic Characteristics of Auckland Central Business District Reclaimed Zones published in NZ Geomechanics News Issue 92-December 2016)

The geology in the general area consists of reclamation fill over Tauranga Group rocks which are sediments of the last five million years, mainly of volcanic pumice and recent marine sediments with Waitemata Group East Coast Bays Formation rock expected at 5m to 11m below the existing ground level (Figure 32). The reclamation fill is highly variable and ranges from fine-grained clays and silts through to boulders, which were both locally sourced and imported and would include dredged materials along with debris from earlier seawalls and structures. It is expected that the fill will be deeper at the graving dock location, which runs northeast to southwest across the Project Area, as shown in Figure 33 (Tonkin & Taylor 2021).

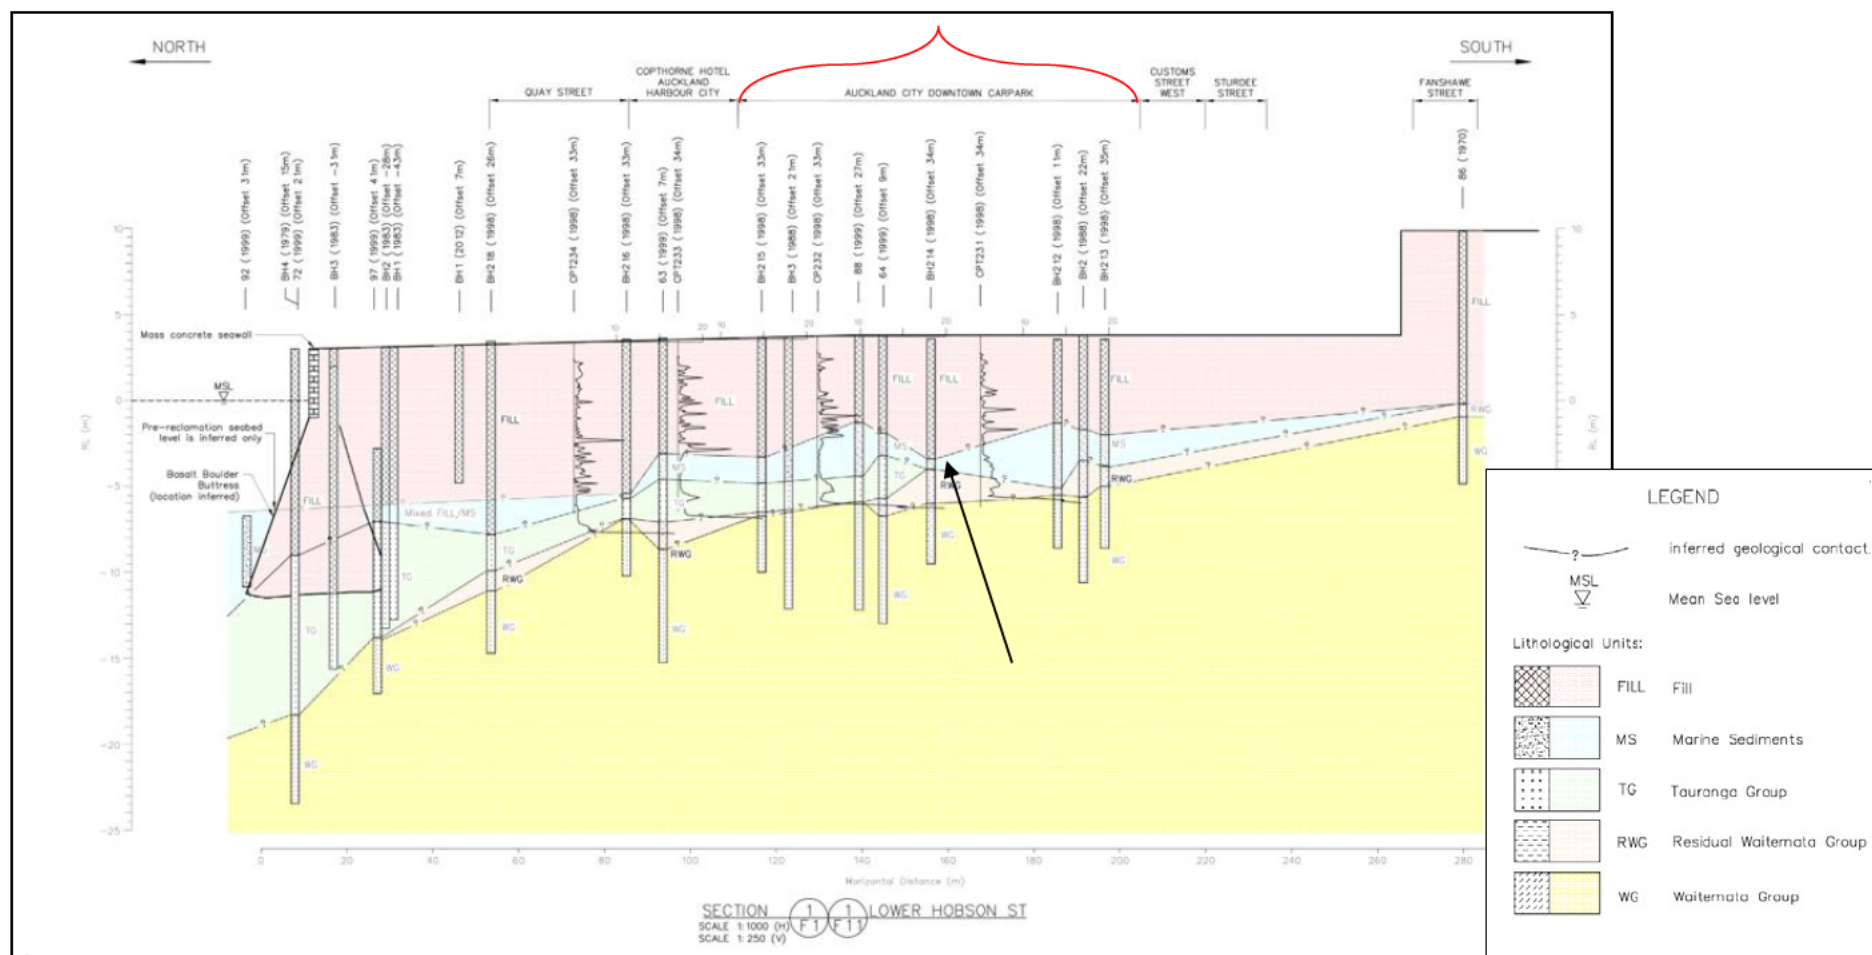
Figure 33. Depths of fill and underlying geology under the Downtown Carpark (within red brackets) and surrounding area with deeper fill probably associated with the graving dock indicated by arrow (Tonkin & Taylor 2021)

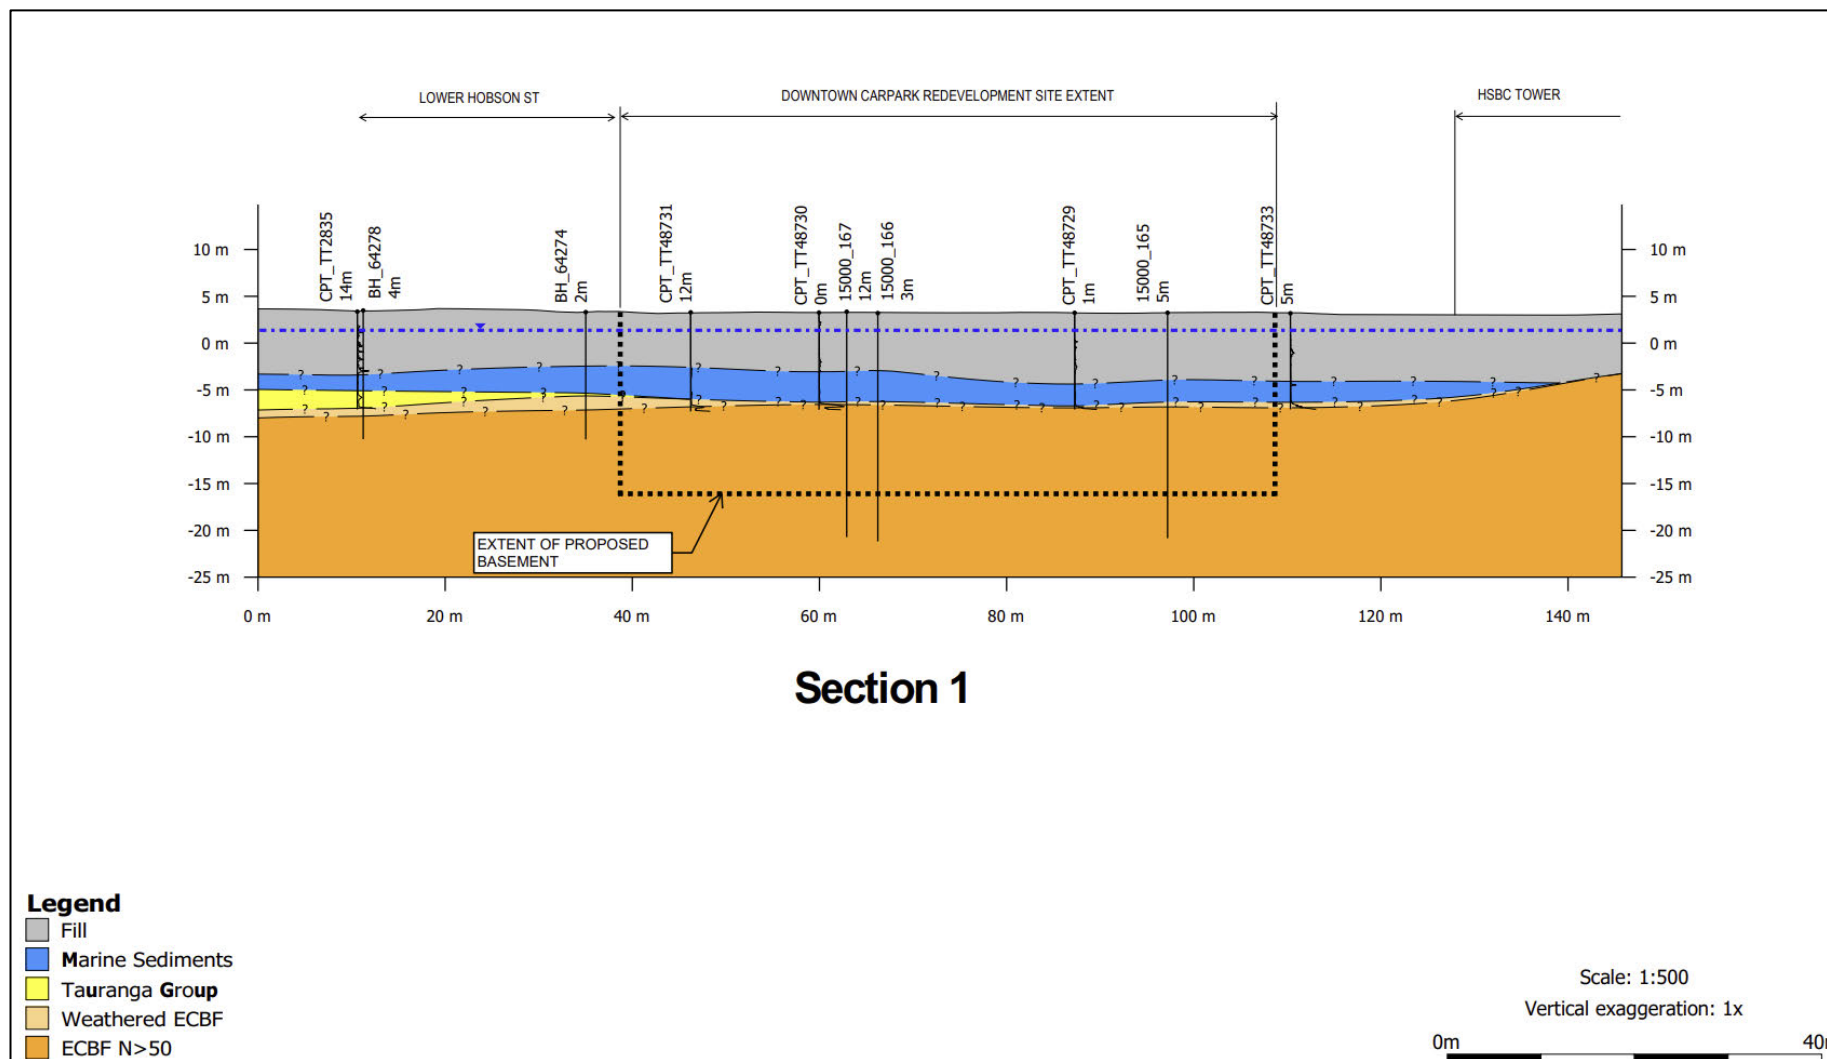
Figure 34. Proposed excavation depth for the redevelopment works with the Project Area (Downtown Carpark) indicated (source: Tonkin & Taylor)

The Project will include extensive excavation through the reclamation fill down to and into the base rock layer to a depth of c.16m below the existing ground surface as shown in Figure 34. This will require the removal of all fill and marine sediments with a minimum of 9m below the interface with the underlying rock surface (East Coast Bays Formation). Thus, any surviving remains of the Auckland Graving Dock (R11/3458) would be destroyed by the proposed works. It is also noted that the existing Downtown Carpark structure is situated on an on-grade concrete slab with a split basement level beneath the northern half of the building, which would suggest that the southern part of the Project Area may have a lower degree of previous subsurface impacts where it would be more likely for archaeological remains to have survived.

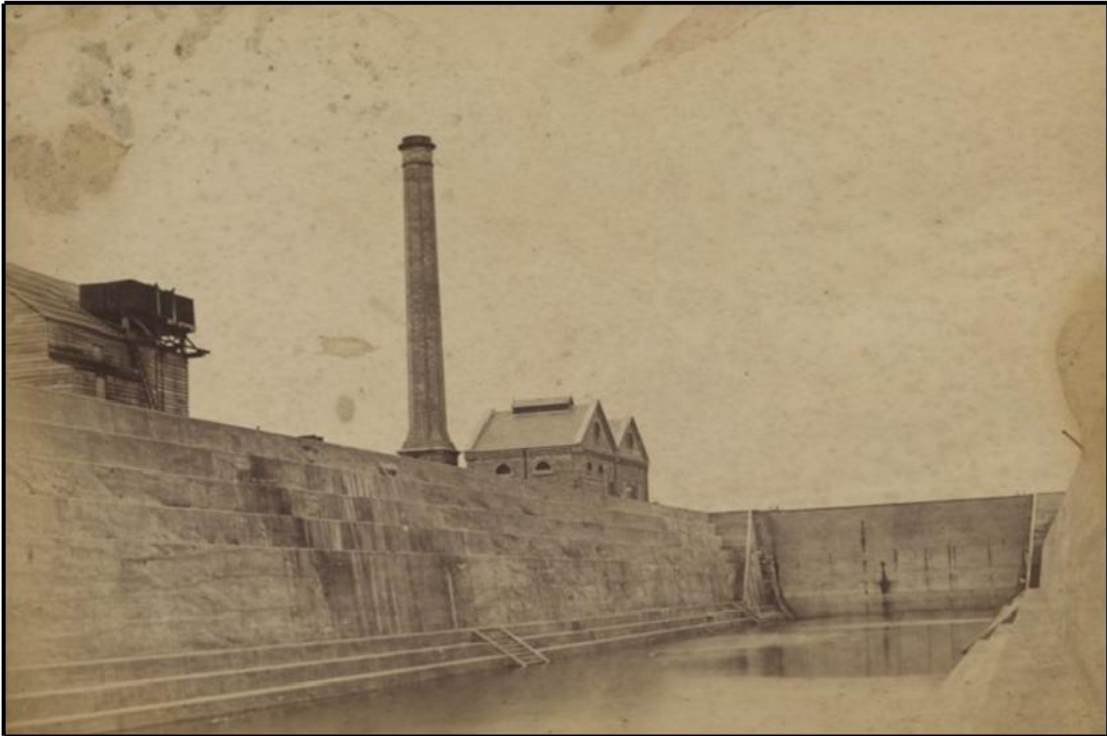
Photograph of the Auckland Graving Dock with engine and boiler house visible (source: Auckland Libraries Heritage Collections 1677-056)

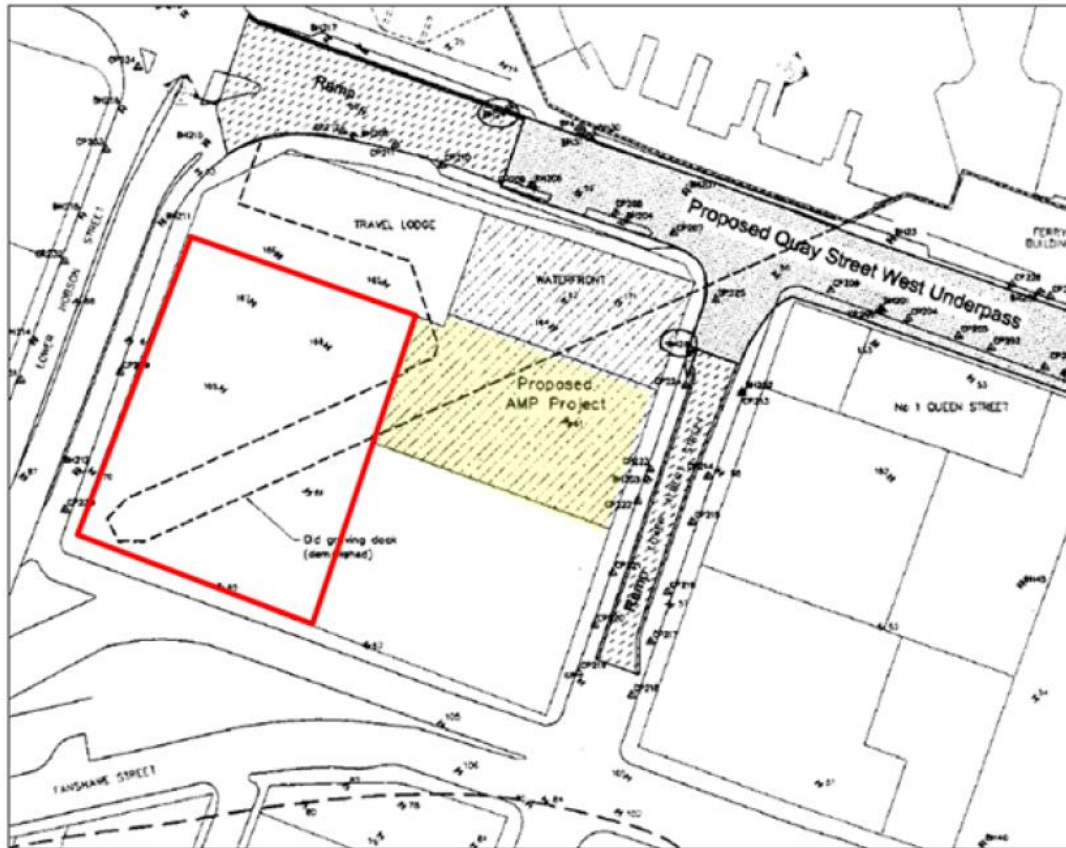
Plan taken from Clough 2001 showing the outline of the Auckland Graving Dock with 2000 investigation at the Waterfront Tower Shaded yellow and the Downtown Carpark outlined in red
