5 December 2025

PRELIMINARY SITE INVESTIGATION - BELMONT QUARRY - FIRTH BLOCK, NORTHERN GULLY AND SOUTHERN GULLY

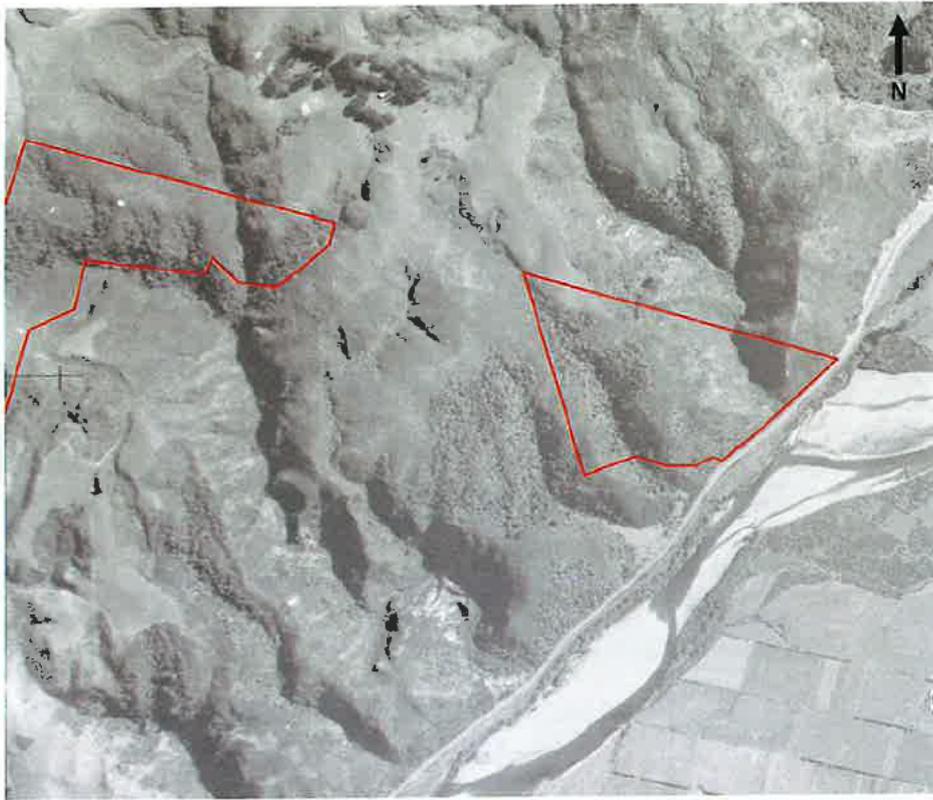
Photograph 1: 1942 sourced from Retrolens

Date	Reference	Description
1942	Photograph 1	An aerial image only partially showing the Northern Gully was able to be obtained from Retrolens. Firth Block and the eastern area of Northern Gully are both covered by dense bush. Belmont Quarry is observed to the south of the sites. The Southern Gully is not visible in the 1942 aerial image.
1957	Photograph 2	No significant changes to Firth Block are observed. An expansion of Belmont Quarry, outside of the Firth Block site boundary towards the south, has been observed extending further to the northwest. Two tracks are observed to intersect the northwestern corner of the Northern Gully. Another track external to the site meets the eastern boundary of the Northern Gully. The Southern Gully appears to be covered with vegetation. An access track is present, running from the western corner of the site before diverging into two tracks, one linking to the Northern Gully and one exiting along the eastern boundary of the site.

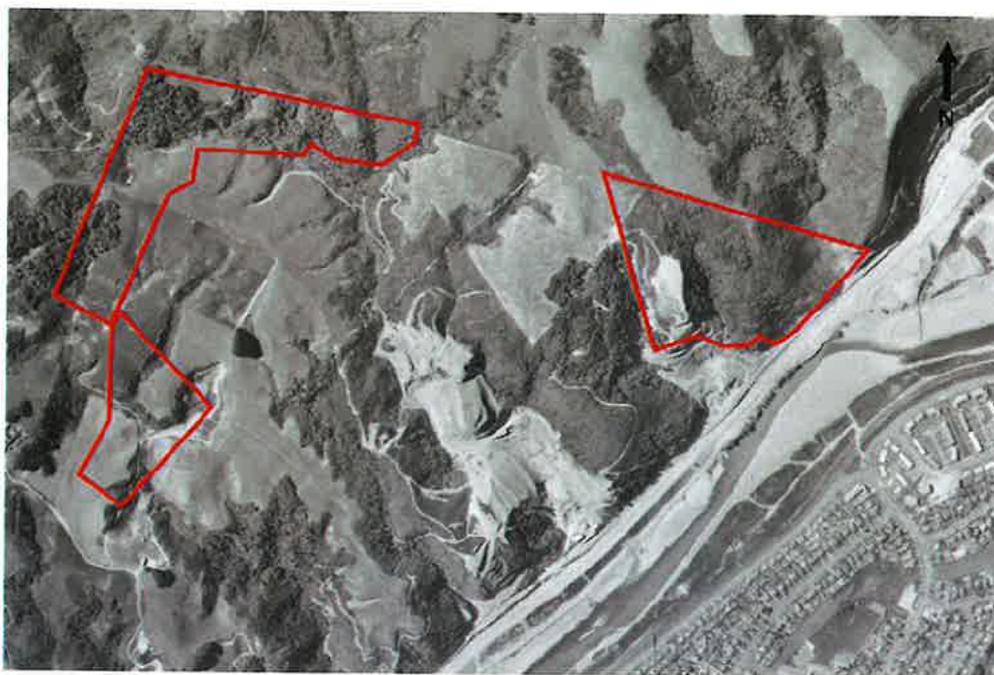
Photograph 3: 1966 sourced from Retrolens

1966	Photograph 3	Firth Block is depicted as bush across the centre and northeastern area of the site. The southwestern area of Firth Block comprises a terraced quarry area. The northwestern corner of the site appears to have been developed to include a track and farmland. The Northern Gully comprises an area of dense bush to the north of the site with the southern portion of the site developed into farmland with tracks.

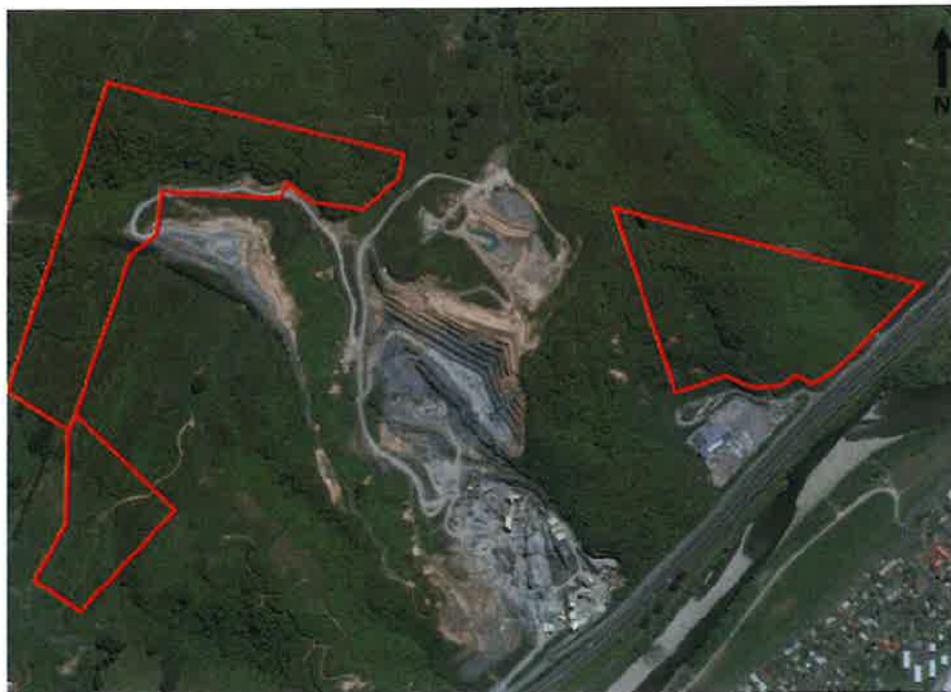
Photograph 6: 2004 sourced from Google Earth Pro

2004	Photograph 6	<p>Firth Block comprises dense bush cover.</p> <p>The track intersecting the Northern Gully has been further developed to the northwest of the site, leading from the quarry. A terraced quarry face intersects the central east of the site. The previously observed track and area of development across the western boundary of the site now comprises vegetative cover.</p> <p>No significant changes to the Southern Gully are observed.</p>
2009	Photograph 7	<p>No significant changes to Firth Block are observed.</p> <p>The track and terraced areas across the central north and central east of the Northern Block is observed to have more vegetative cover.</p> <p>No significant changes are observed in the Southern Gully, there appears to be increased vegetation cover.</p>
2011	Photograph 8	<p>No significant changes to Firth Block are observed.</p> <p>In the Northern Gully, further quarry development is observed to the southeast and further vegetative cover is observed in the central north. A road to the west of the Northern Gully slightly intersects the site boundary.</p> <p>No significant changes are observed in the Southern Gully.</p>

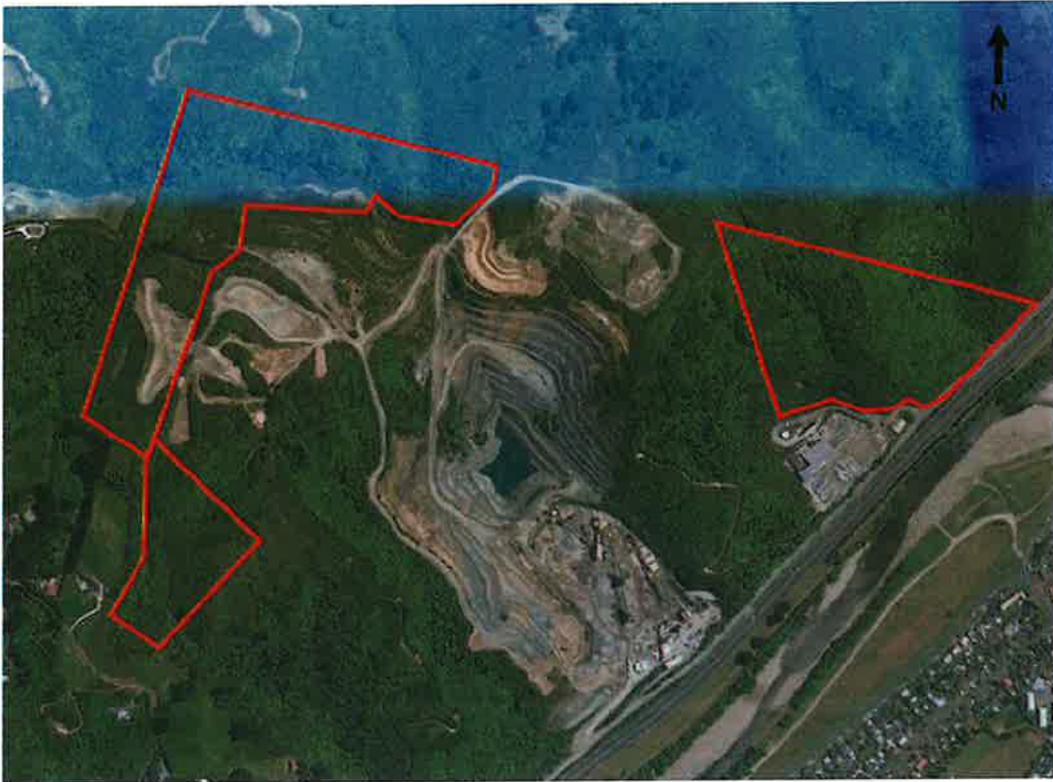
Photograph 9: 2012 sourced from Google Earth Pro

2012	Photograph 9	<p>No significant changes to Firth Block are observed.</p>

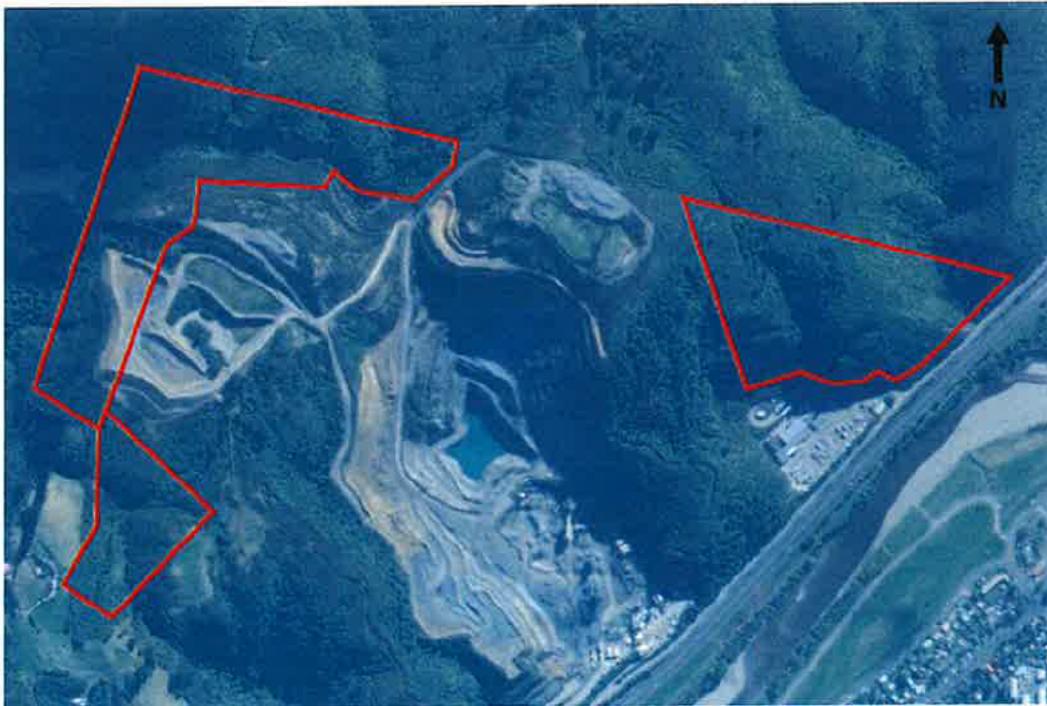
Photograph 10: 2014 sourced from Google Earth Pro

Date	Reference	Description
		<p>The quarry area to the southeast of the Northern Gully has further expanded in a western direction and more vegetative cover is visible in the central north area.</p> <p>No significant changes are observed in the Southern Gully.</p>
2014	Photograph 10	<p>No significant changes to Firth Block are observed.</p> <p>The quarry area to the south of the Northern Gully has further expanded to the west and more vegetative cover is visible in the central north area.</p> <p>No significant changes are observed in the Southern Gully.</p>
2015	Photograph 11	<p>No significant changes to Firth Block are observed.</p> <p>The quarry area to the south of the Northern Gully is observed to have had soil disturbance. The central northern area comprises dense bush.</p> <p>Soil disturbance, associated with activities within Belmont Quarry, is visible in the northeastern portion of the site. No other significant changes observed.</p>

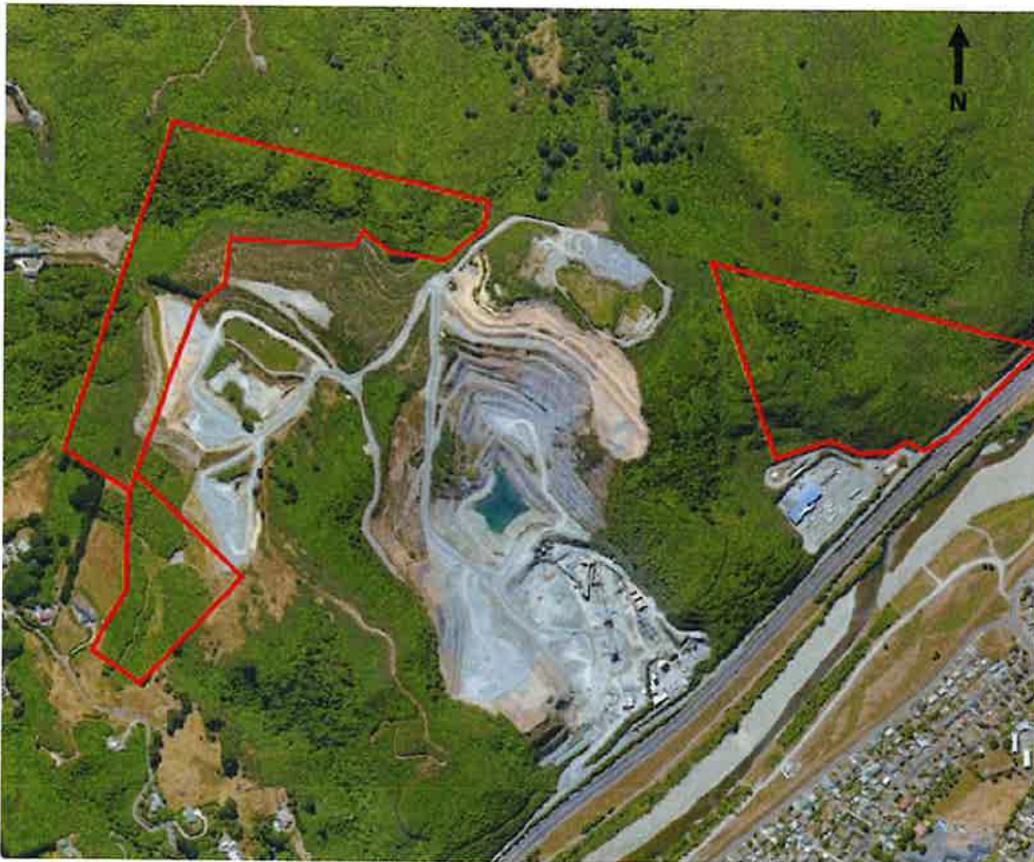
Photograph 12: 2016 sourced from Google Earth Pro

2016	Photograph 12	<p>No significant changes to Firth Block are observed.</p> <p>The quarry area in the southern portion of the Northern Gully is observed to be partially covered with what appears to be gravels.</p> <p>Soil disturbance is still visible on the northern boundary. A cleared area of vegetation, potentially paved, is visible in the sites centre southwest of the area of soil disturbance. No other significant changes observed.</p>
2018	Photograph 13	<p>No significant changes to Firth Block are observed.</p> <p>The quarry area to the south of the Northern Gully is observed to be partially covered with what appears to be covered with some vegetation in places.</p> <p>No earthworks are now being undertaken in the Southern Gully which is now fully covered in vegetation.</p>
2019	Photograph 14	<p>No significant changes to Firth Block are observed.</p> <p>The previous quarry area to the south of the Northern Gully comprises vegetative cover over visible terraces.</p> <p>No significant changes are observed in the Southern Gully.</p>

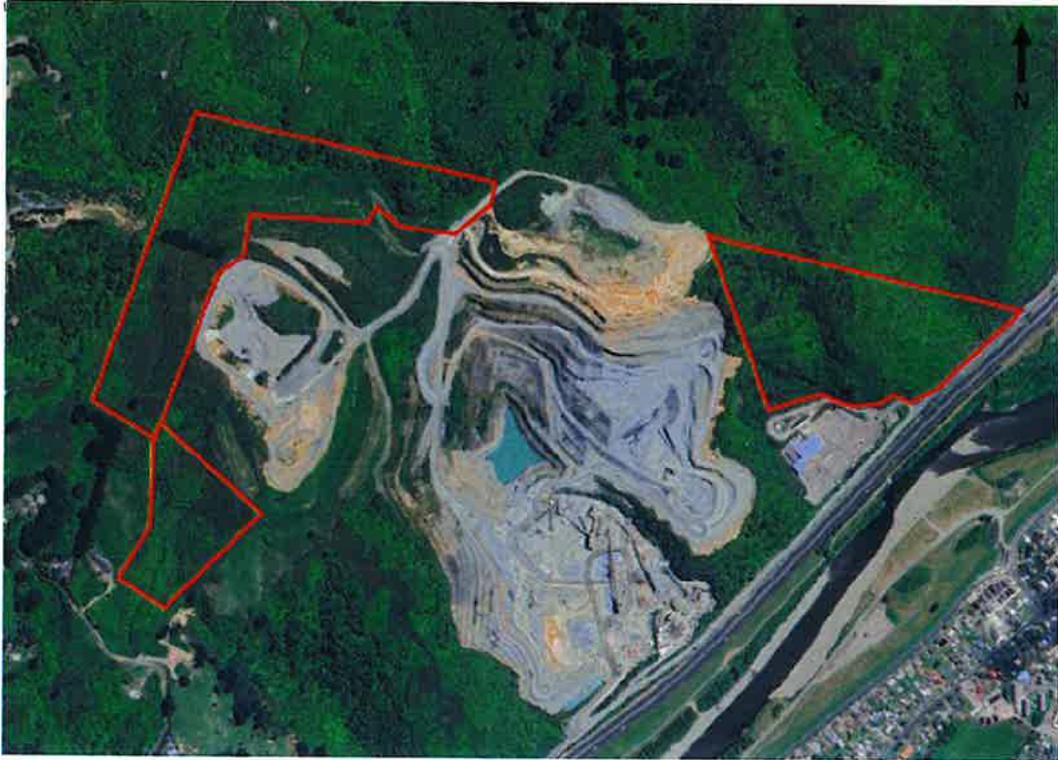
Photograph 15: 2022 sourced from Google Earth Pro

2022	Photograph 15	<p>No significant changes to Firth Block are observed.</p> <p>Dense vegetation is observed to the south of the Northern Gully. A track is observed to intersect the east of the Northern Gully with the northern portion of Belmont Quarry.</p> <p>No significant changes are observed in the Southern Gully.</p>
2025	Photograph 16	<p>No significant changes to Firth Block are observed.</p> <p>The quarry area has been further developed and slightly intersects the central eastern area of the Northern Gully.</p> <p>No significant changes are observed in the Southern Gully</p>

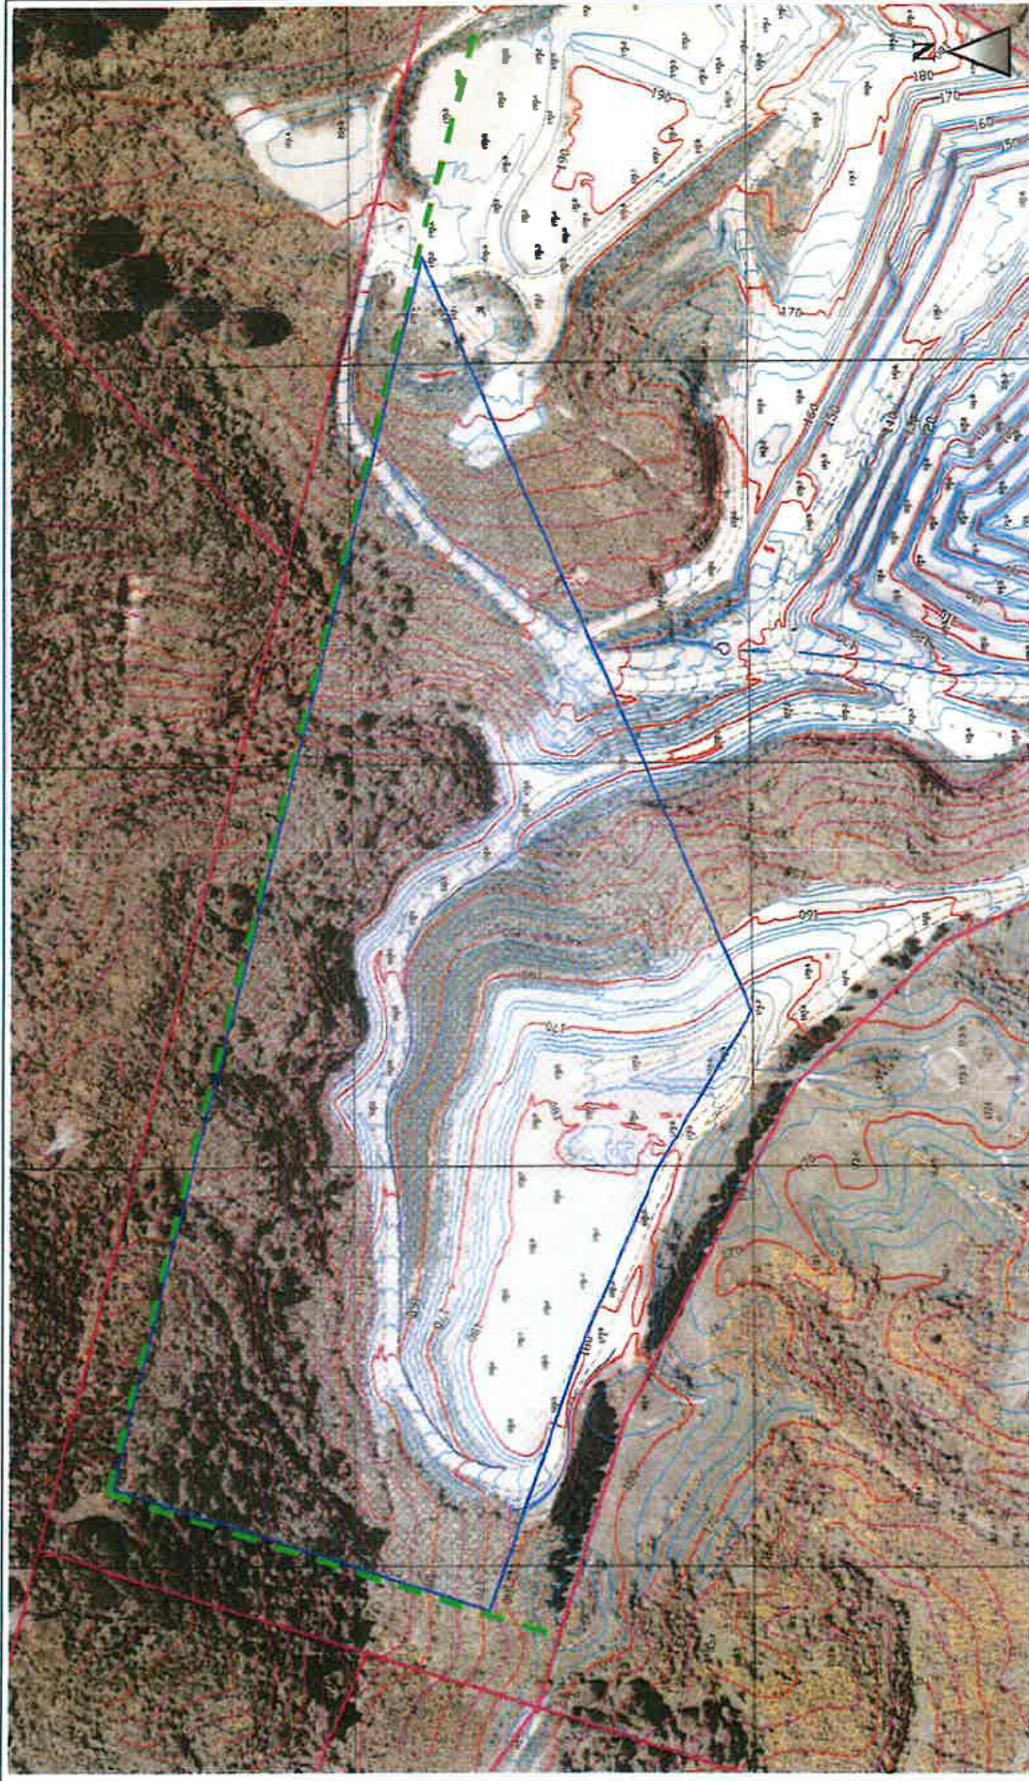
Appendix 2 - Area Proposed to be Filled

- Buffer Strip - 25m in accordance with Rule 6D 2.1.1 (k) of Hutt City District Plan.
- Maximum extent of area upon which overburden is to be deposited.

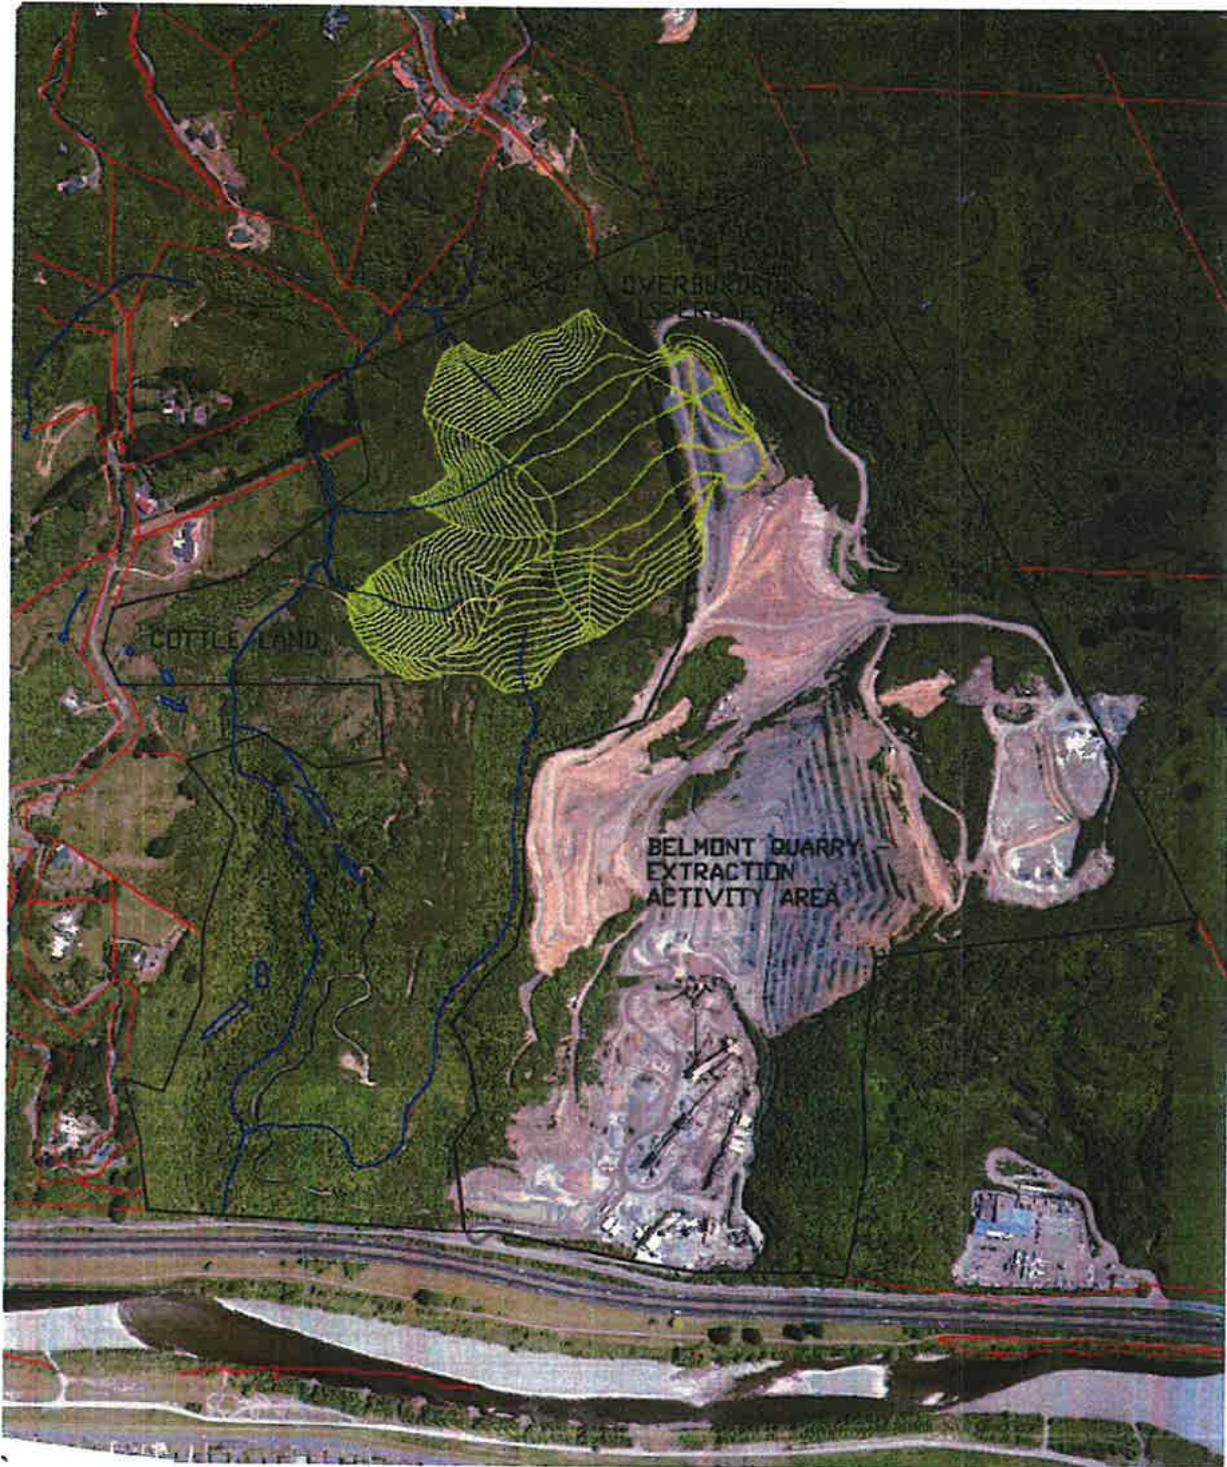
Figure 1: Location of Cottle Land and the proposed overburden disposal area.

Winstone seeks to dispose of approximately 1.3 million m³ of overburden material on the Cottle land in the disposal area indicated in Figure 1. The operation will be undertaken progressively over several seasons and is expected to take 12 years to complete, followed by contouring and rehabilitation.

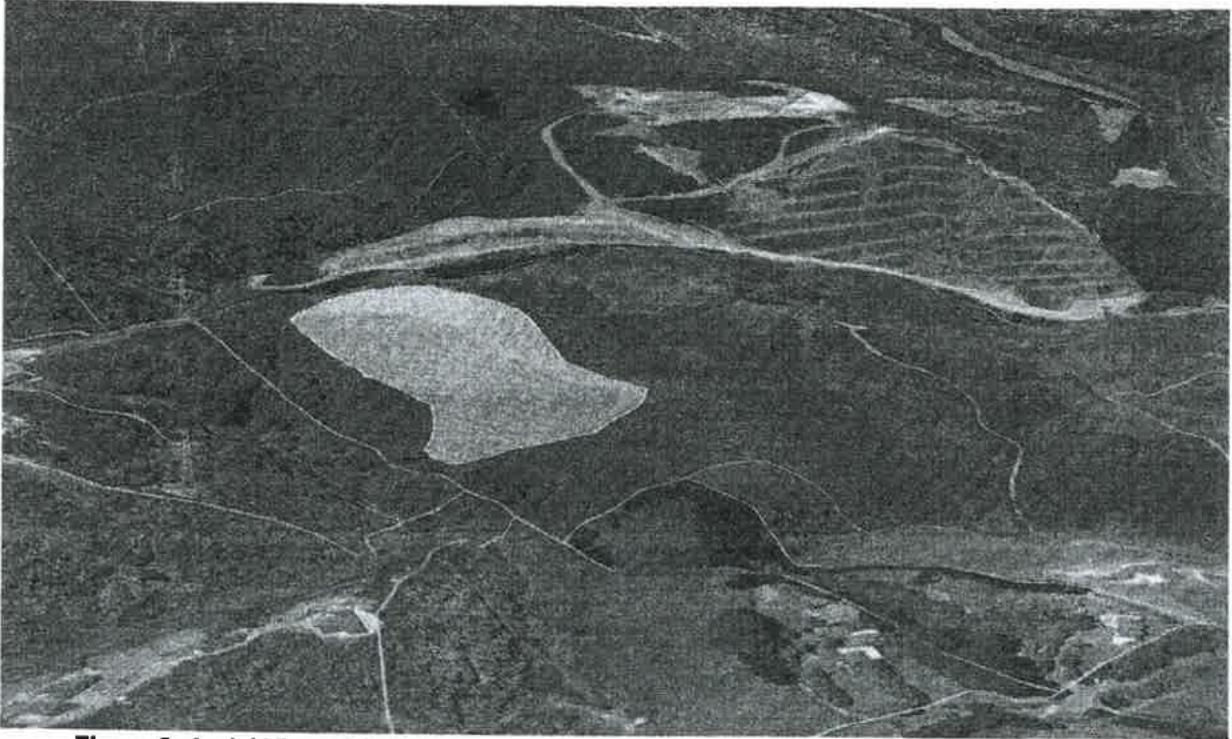
Figure 2: Aerial View of Stage 1 of Proposed OBDA (Looking East Towards Existing Quarry)

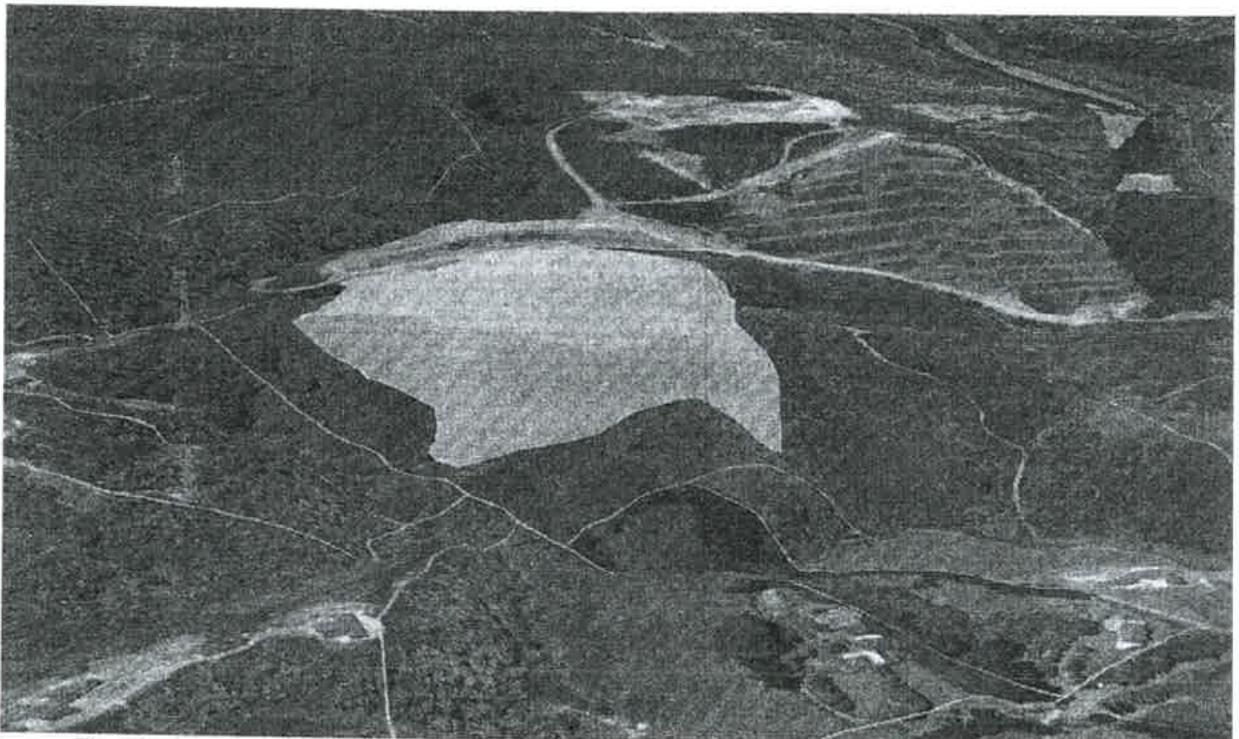
Figure 3: Aerial View of Stage 2 of Proposed OBDA (Looking East Towards Existing Quarry)

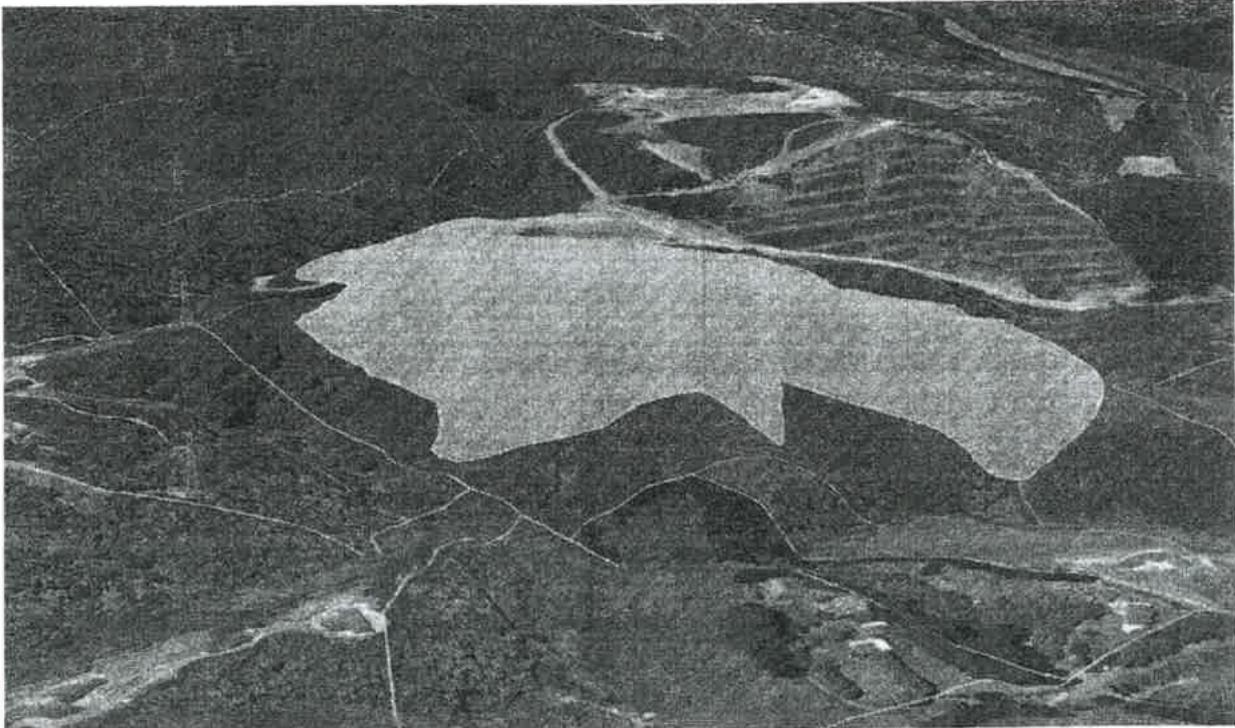
Figure 4: Aerial View of Stage 3 of Proposed OBDA (Looking East Towards Existing Quarry)

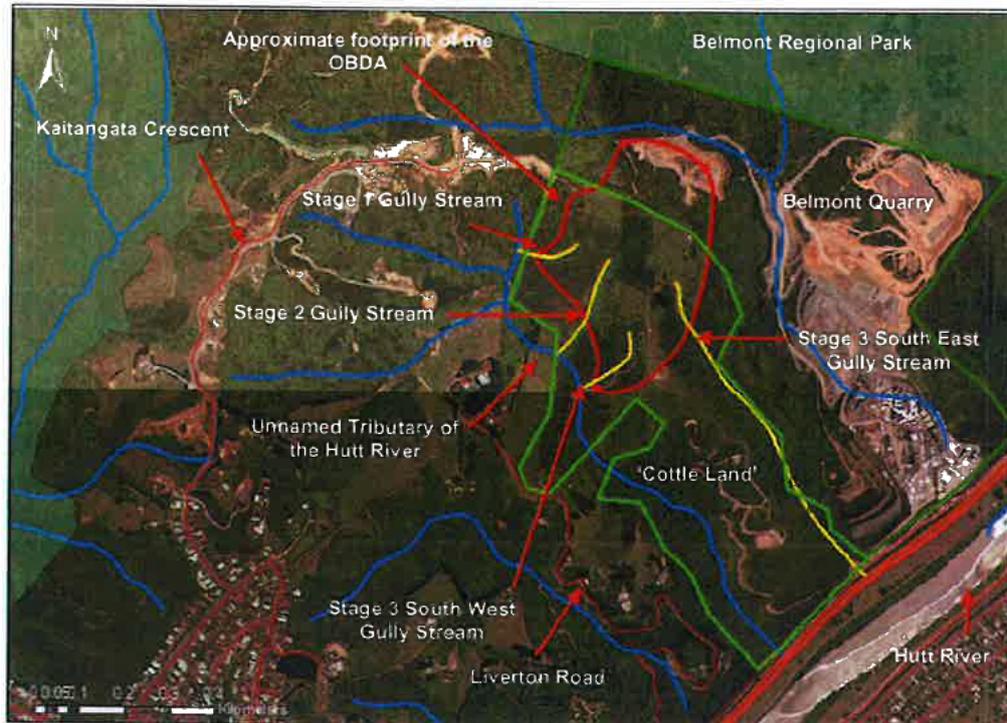
Figure 1: The application site is located in the foothills along the western side of the Hutt Valley (on the north western side of State Highway 2). The 'Cottle Land' property boundary is outlined in bright green. The OBDA will have a footprint of 14.6ha (as indicated approximately in red) and will be located at the north western end of the 'Cottle Land'. The permanently flowing unnamed tributary of the Hutt River is indicated in blue and is located in the south western side of the property. Four ephemeral streams are indicated in yellow.

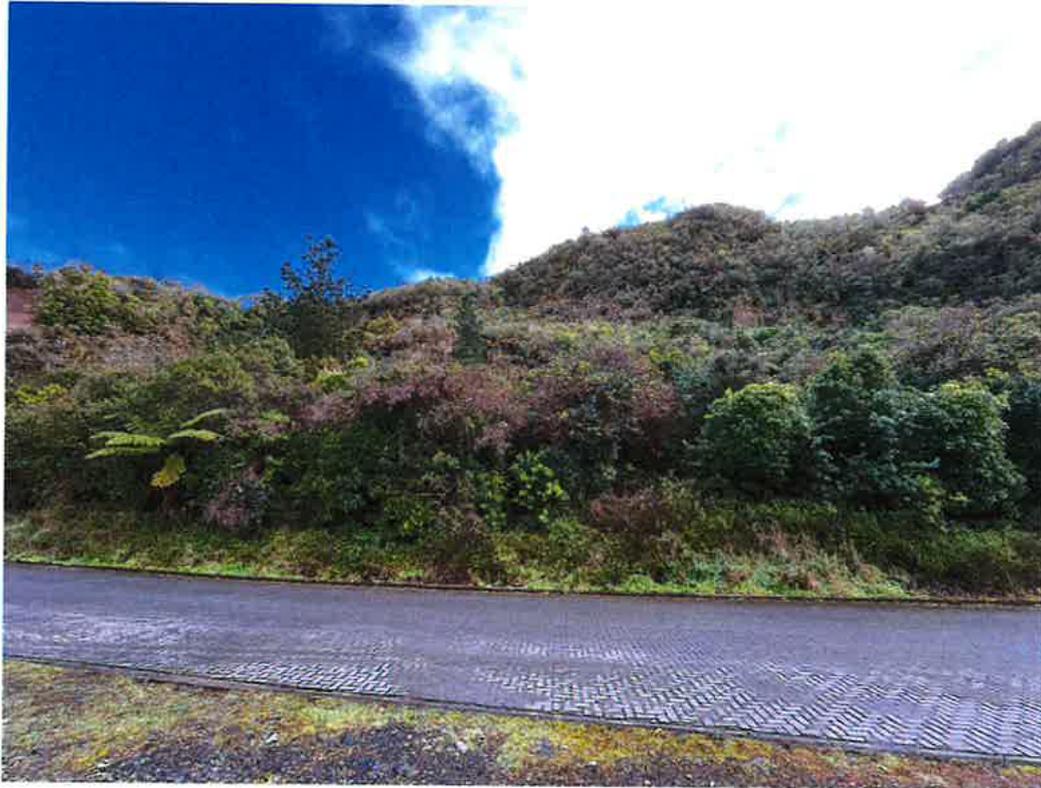
Firth Block was observed to comprises steep, densely covered slopes with mature, bush cover in the form of mixed vegetation (Photographs 1 and 2). A line of dead trees borders the southwestern site boundary (Photograph 3).

Photograph 1: Firth Block (in the background) from Firth Belmont Masonry, looking north.

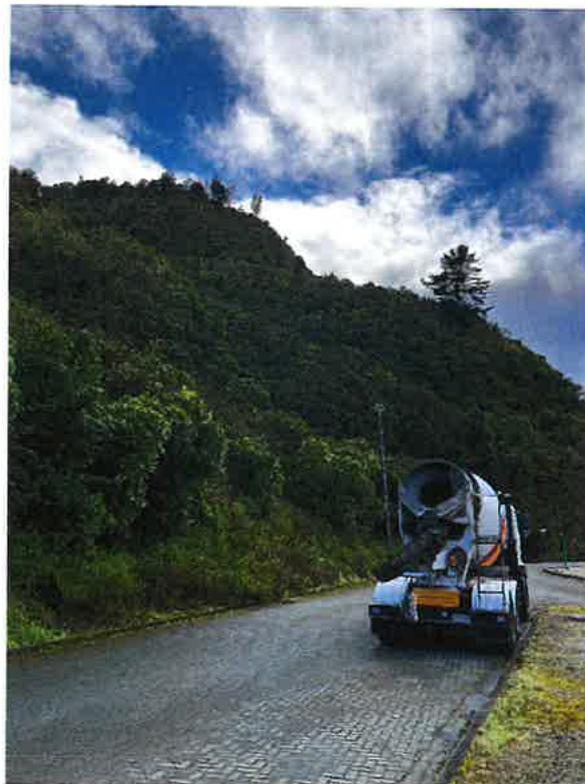
Photograph 2: Firth Block (in the background) from Firth Belmont Masonry, looking northeast.

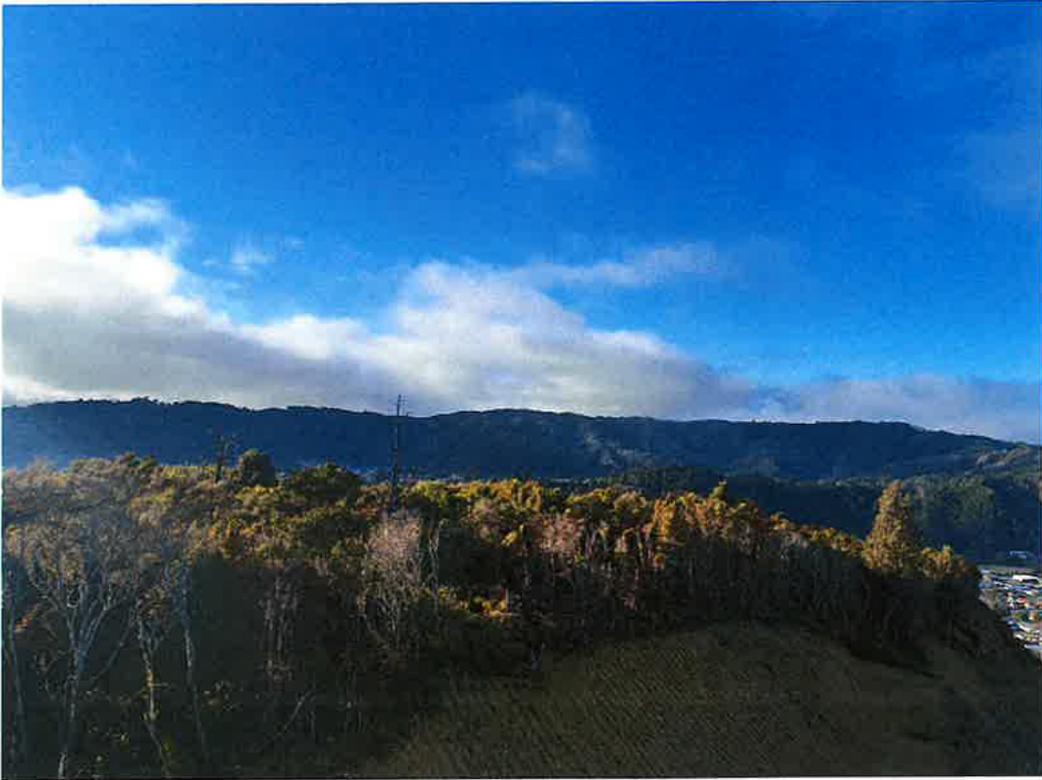
Photograph 3: Firth Block overview from northwestern corner of the site boundary, looking southeast.

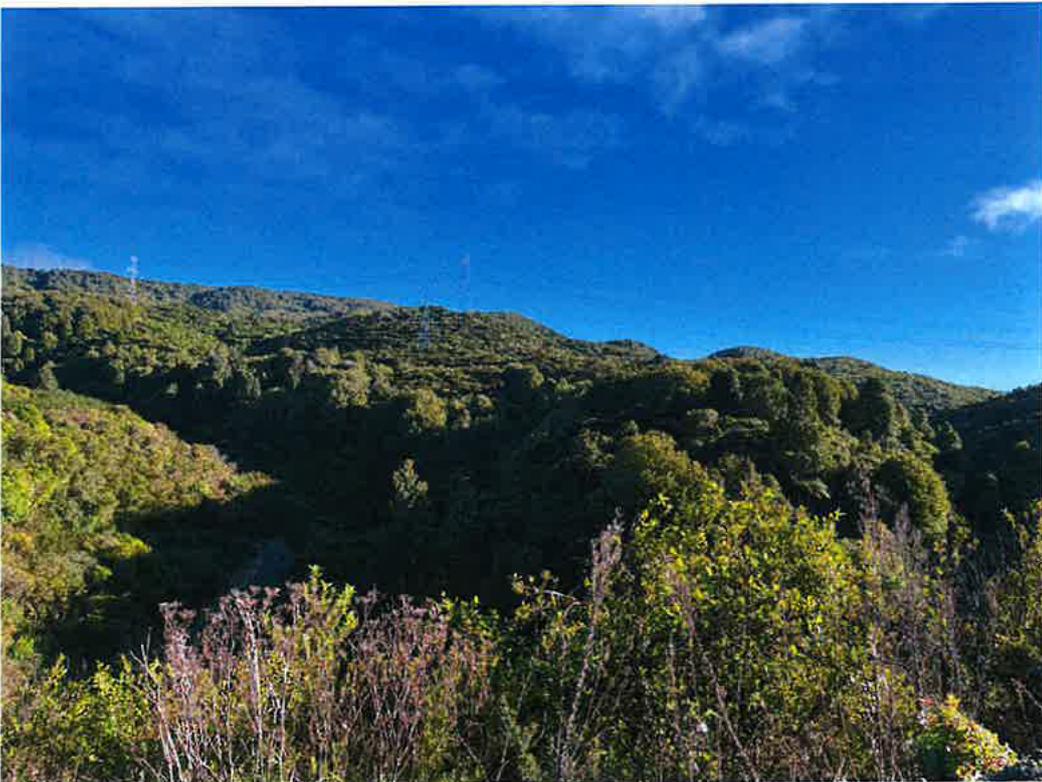
The northern area of the Northern Gully was observed to comprise dense mature bush of mixed vegetation (Photograph 4 and 5), which descends into a what appears to be a shallow stream. A walkable

Photograph 4: Overview of Northern Gully, looking north.

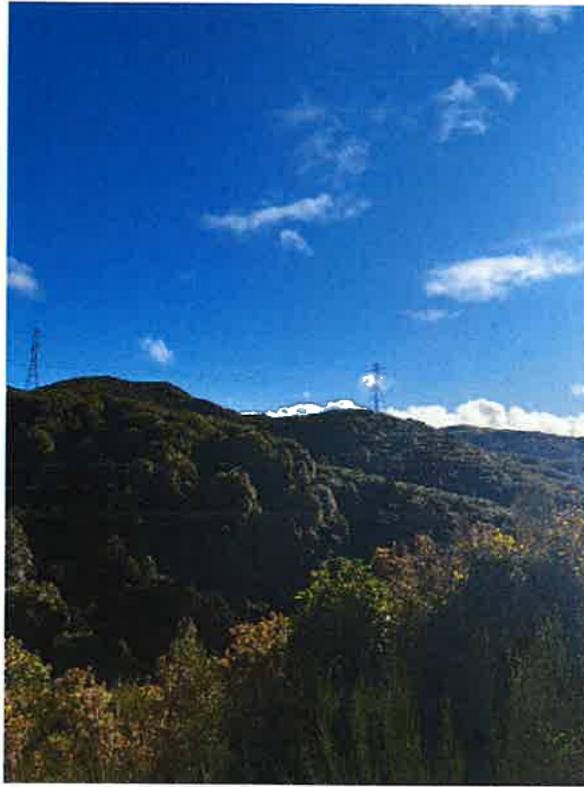
Photograph 5: Northern Gully, looking north.

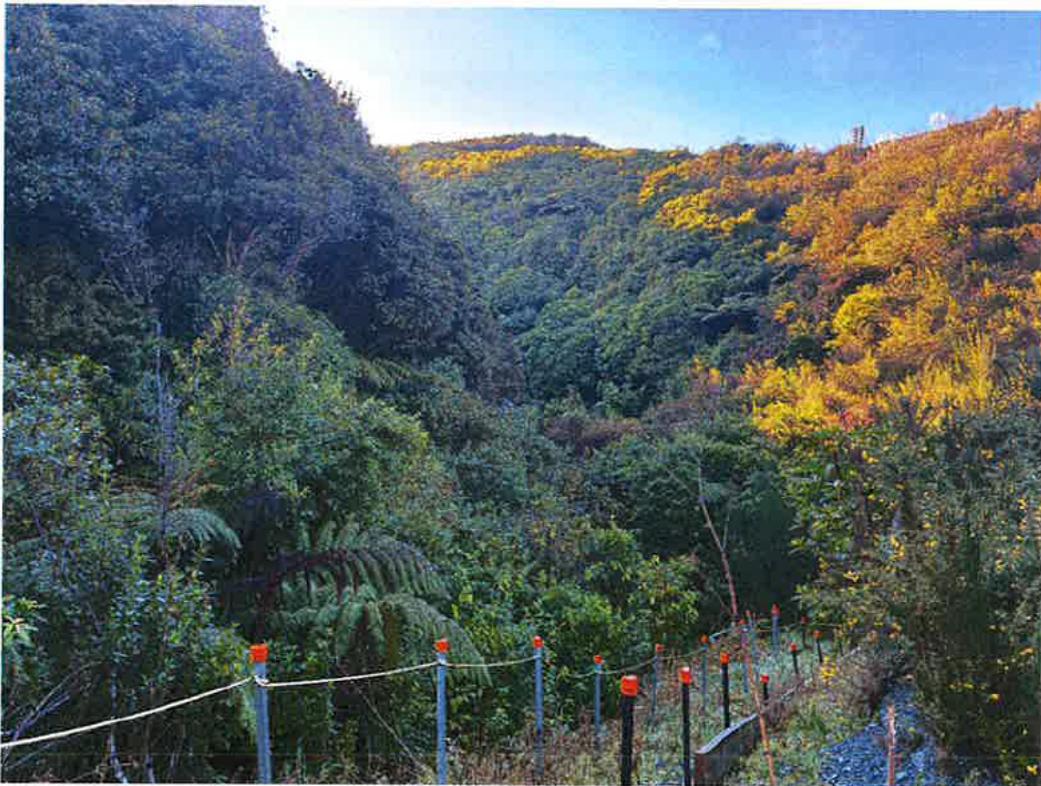
Photograph 6: Track descending to a stream within Northern Gully, looking northeast.

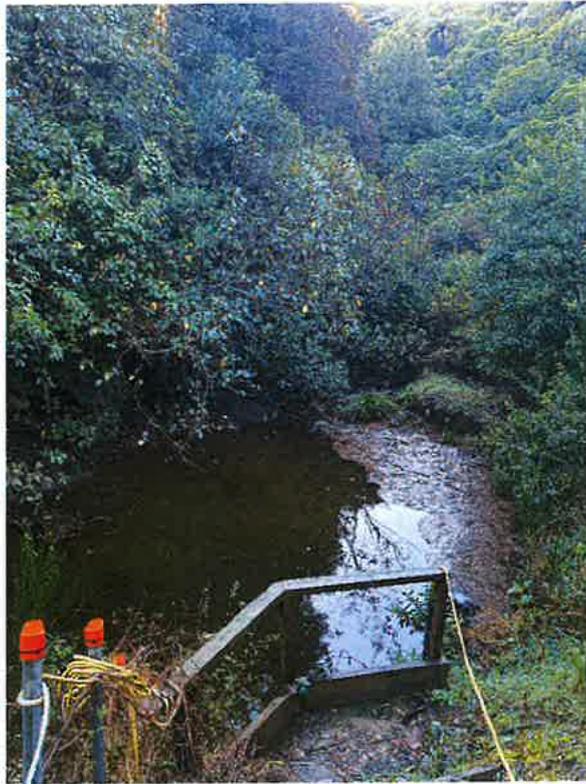
Photograph 7: Stream within Northern Gully, looking north.

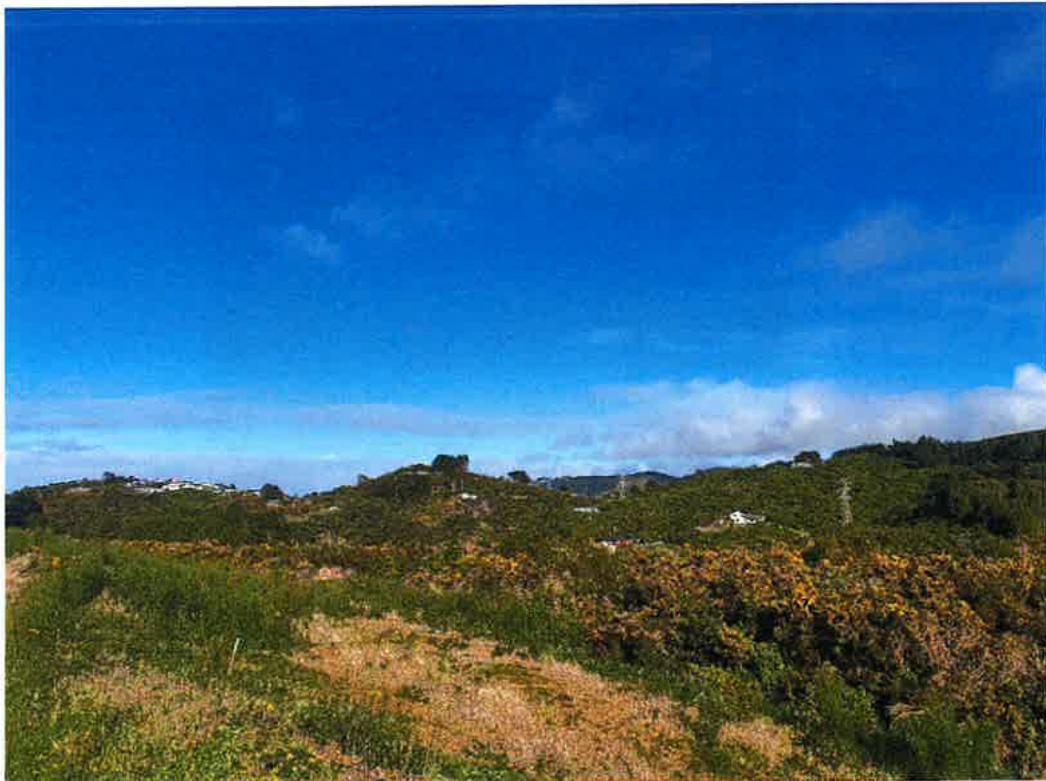
Photograph 8: Northern Gully, looking west.

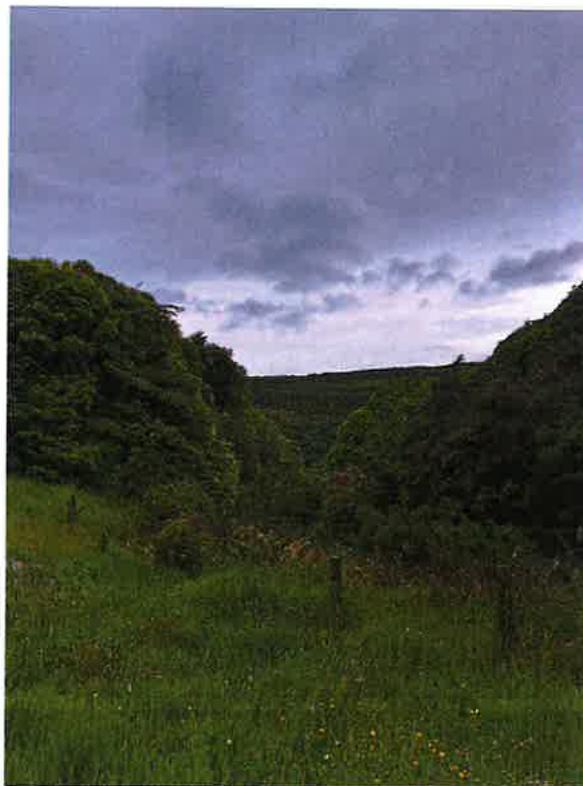
Photograph 9: Southern Gully, looking north.

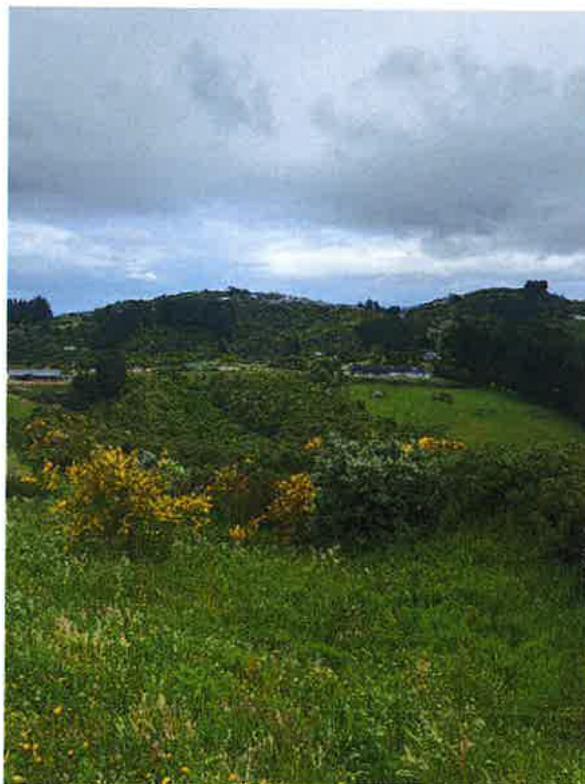
Photograph 10: Southern Gully, looking south.
