Delmore Subdivision - Orewa

Wetland and Culvert Assessment

VINEWAY LIMITED

WWLA1147 | Rev. 2

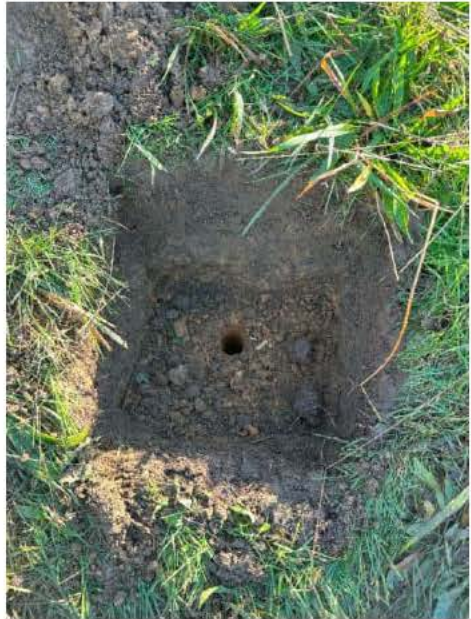
<p>Photograph 7: Site 3B test pit.</p>	  <p>Photograph 8: Site 3B core.</p>

Site # and Soil Description	Soil Photo	
<p>Mottle Colour (10YR - Value/Chroma) - 6/8 (5%)</p> <p>3A 0 - 300 mm. TOPSOIL, silt. Dark grey. Dry and friable. Matrix Colour (10YR - Value/Chroma) – 4/1 Oxidised rhizospheres on roots 300 - 700 mm. Silty CLAY. Brownish yellow, dry and highly plastic. Matrix Colour (10YR - Value/Chroma) – 6/6 700 - 1000 mm. Silty CLAY. Light yellowish brown, with light grey inclusions and brownish yellow mottles. Dry and highly plastic. Matrix Colour (10YR - Value/Chroma) – 6/4 with 7/1 inclusions Mottle Colour (10YR – Value/Chroma): Mottles – 6/8</p>	  <p>Photograph 5: Site 3A test pit.</p>	  <p>Photograph 6: Site 3A core.</p>
<p>3B 0 - 300 mm. TOPSOIL, silt. Dark grey. Dry and friable. Matrix Colour (10YR - Value/Chroma) - 4/1 300 - 700 mm. Silty CLAY. Brownish yellow, dry and highly plastic. Matrix Colour (10YR - Value/Chroma) – 6/6 700 - 1000 mm. Silty CLAY. Light yellowish brown, with light grey inclusions and brownish yellow mottles. Dry and highly plastic. Matrix Colour (10YR - Value/Chroma):– 6/4 with 7/1 inclusions Mottle Colour (10YR – Value/Chroma): Mottles – 6/8 (5%)</p> <p>Oxidised rhizospheres on roots</p>

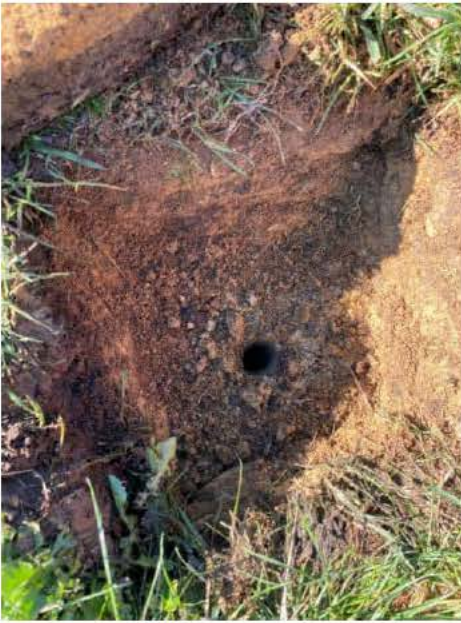
<p>Photograph 12: Site 6 test pit.</p>

Site # and Soil Description	Soil Photo	
<p>6</p> <p>0 -250 mm Silty TOPSOIL with minor clay, yellowish brown, with rootlets, dry. Dark reddish yellow mottles Matrix Colour (10YR - Value/Chroma) - 5/4 Mottle Colour (10YR - Value/Chroma) - 7/8 (1-5%)</p> <p>250 – 350 mm Silty clay, brownish yellow, moist. High plasticity. Matrix Colour (10YR - Value/Chroma) - 6/6</p> <p>350 mm – 1 m Clayey SILT. dark greyish brown, with dark brown mottles, moist, moderate plasticity. Matrix Colour (10YR - Value/Chroma) - 4/2 Mottle Colour (10YR - Value/Chroma) - 3/3 (5%)</p>

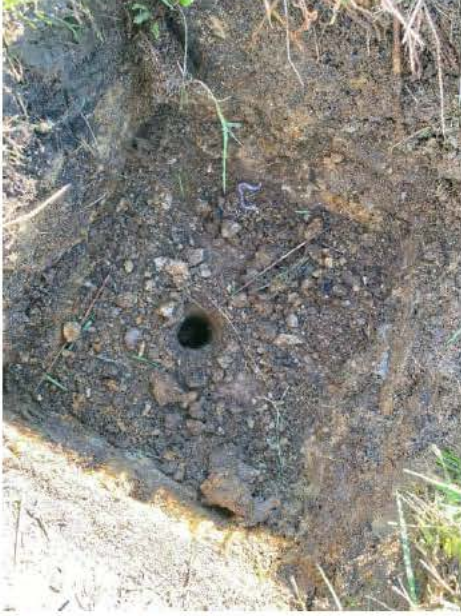
<p>Photograph 14: Site 7 test pit.</p>

<p>Photograph 13: Site 6 topsoil.</p>
<p>7</p> <p>0 – 100 mm TOPSOIL, SILT, dark greyish brown, slightly damp, yellowish-brown mottles, rootlets. Matrix Colour (10YR - Value/Chroma) - 4/2 Mottle Colour (10YR - Value/Chroma) – 5/8 (10%)</p> <p>100 – 200 mm PEAT layer, some charcoal, black slightly damp. Matrix Colour (10YR - Value/Chroma) – 2/1</p> <p>200 – 500 mm Clayey SILT, 5/6 yellowish brown. 5/8 yellowish brown mottles. 10% dry with low plasticity. Matrix Colour (10YR - Value/Chroma) – 5/6 Mottle Colour (10YR - Value/Chroma) – 5/8 (10%)</p> <p>500 mm – 1 m Clayey SILT, 7/2 light grey with 5/8 yellowish brown streaks and mottles. Dry with moderate plasticity. Matrix Colour (10YR - Value/Chroma) – 7/2 Mottle Colour (10YR - Value/Chroma) - 5/8 (10%) Oxidised rhizospheres on roots</p>

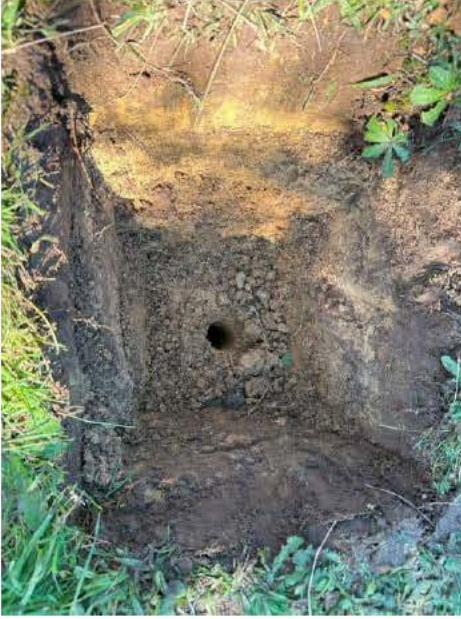
<p>Photograph 16: Site 8 test pit.</p>

Site # and Soil Description	Soil Photo	
<p>8</p> <p>0 - 100 mm.</p> <p>TOPSOIL, silt with minor clay, very dark brown. Moderate moisture and low plasticity.</p> <p>Matrix Colour (10YR - Value/Chroma): – 2/2</p> <p>100 - 600 mm.</p> <p>Silty CLAY. Yellowish brown, some moisture and moderately plastic.</p> <p>Matrix Colour (10YR - Value/Chroma): – 5/8</p> <p>600 - 1000 mm.</p> <p>Silty CLAY, yellow with light grey streaks. Some moisture, moderate to high plasticity.</p> <p>Matrix Colour (10YR - Value/Chroma): – 7/6</p>

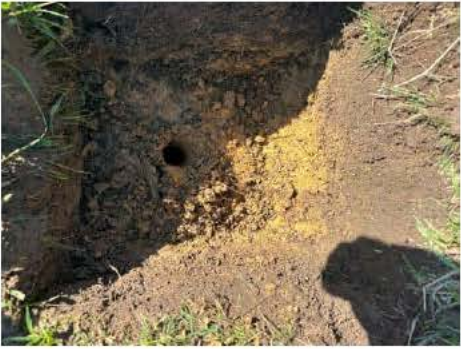
<p>Photograph 18: Site 9 test pit.</p>

<p>Photograph 17: Site 8 core.</p>
<p>9</p> <p>0 - 300 mm.</p> <p>TOPSOIL, Clayey SILT. Yellowish brown, some moisture and some plasticity.</p> <p>Matrix Colour (10YR - Value/Chroma): – 5/8</p> <p>300 - 600 mm.</p> <p>Silty CLAY. Yellow with light grey streaks. Some moisture and moderate to high plasticity.</p> <p>Matrix Colour (10YR - Value/Chroma) – 7/6</p> <p>600 - 1000 mm.</p> <p>Silty CLAY. Brownish yellow, dark orange inclusions. Moderately moist, low plasticity.</p> <p>Matrix Colour (10YR - Value/Chroma) – 6/6</p>

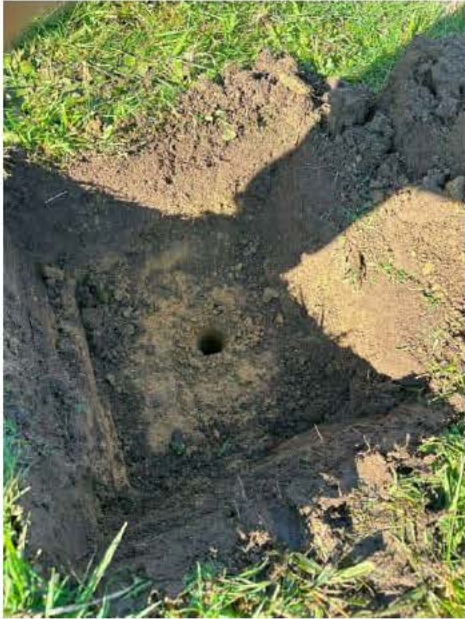
<p>Photograph 20: Ssite 10A Test pit.</p>

Site # and Soil Description	Soil Photo	
<p>10A</p> <p>0 - 300 mm.</p> <p>TOPSOIL, Clayey SILT. Dark brown. Some moisture, low plasticity.</p> <p>Matrix Colour (10YR - Value/Chroma):- 3/2</p> <p>300 - 600 mm.</p> <p>Clayey SILT. Brownish yellow, some moisture, low to moderate plasticity.</p> <p>Matrix Colour (10YR - Value/Chroma) – 6/8</p> <p>600 – 1000 mm.</p> <p>Silty CLAY, light grey with light orange, brown streaks. Moderately moist, moderate to highly plastic.</p> <p>Matrix Colour (10YR - Value/Chroma) – 7/1</p>

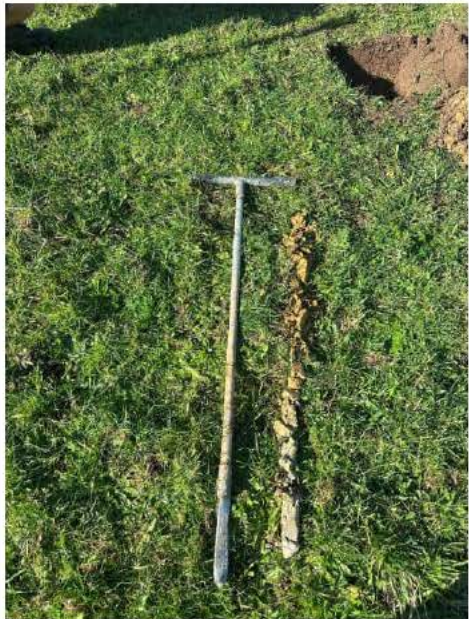
<p>Photograph 21: Site 10A core.</p>
<p>10B</p> <p>0 - 300 mm.</p> <p>TOPSOIL, silt, very dark grey, rootless, some dark yellowish-brown mottles.</p> <p>Matrix Colour (10YR - Value/Chroma) – 3/1</p> <p>Mottle Colour (10YR – Value/Chroma) - 3/6 (2%)</p> <p>300 – 500 mm.</p> <p>Clayey SILT, yellowish brown with brownish yellow mottles and grey inclusions. Dry with low plasticity.</p> <p>Matrix Colour (10YR - Value/Chroma)– 5/4</p> <p>Mottle Colour (10YR – Value/Chroma) - 6/8 (2%)</p> <p>500 – 1000 mm.</p> <p>Clayey SILT. 7/3 very pale brown and dry with yellowish brown mottles 5/8 and streaks, dry with moderate plasticity.</p> <p>Matrix Colour (10YR - Value/Chroma) - 7/3</p> <p>Mottle Colour (10YR – Value/Chroma) – 5/8 (2%)</p>

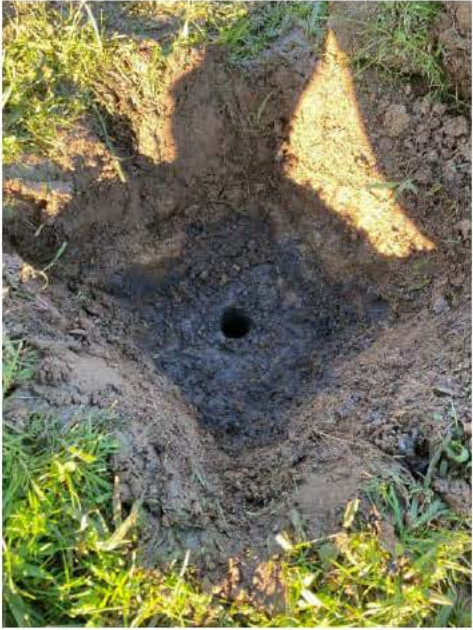
<p>Photograph 28: Site 12 test pit.</p>

Site # and Soil Description	Soil Photo	
<p>12</p> <p>0 - 200 mm.</p> <p>TOPSOIL, Silt. Dark grey with dark yellowish-brown mottles. Dry and friable.</p> <p>Matrix Colour (10YR - Value/Chroma) - 4/1</p> <p>Mottle Colour (10YR - Value/Chroma) - 3/6 (5%)</p> <p>200 - 400 mm.</p> <p>Clayey SILT, with peat. Dark grey. Dry and moderately plastic.</p> <p>Matrix Colour (10YR - Value/Chroma) - 2/1</p> <p>Mottle Colour (10YR - Value/Chroma) - 3/6 (5%)</p> <p>400 - 1000 mm</p> <p>Silty CLAY, black with dark yellowish-brown. Moist and highly plastic.</p> <p>Matrix Colour (10YR - Value/Chroma) - 2/1</p> <p>Oxidised rhizospheres observed on roots.</p> <p>Groundwater encountered at 900 mm</p>

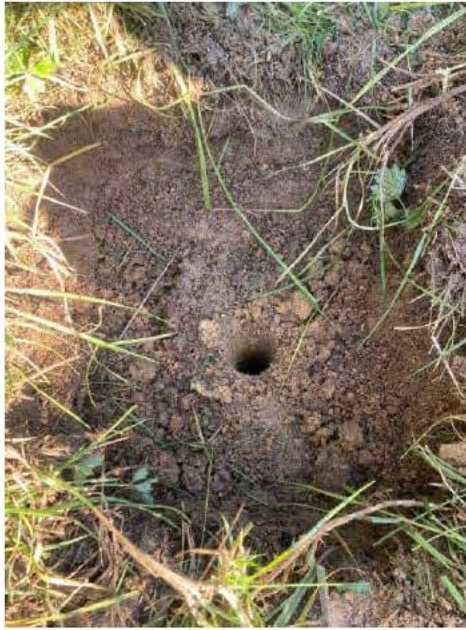
Site # and Soil Description	Soil Photo	
<p>14</p> <p>0 - 300 mm.</p> <p>TOPSOIL, silt. Dark greyish brown with dark yellowish-brown mottles. Dry and moderate plasticity.</p> <p>Matrix Colour (7.5YR - Value/Chroma) - 4/2</p> <p>Mottle Colour (7.5YR - Value/Chroma) - 4/6 (10%)</p> <p>300 - 1000 mm.</p> <p>Clayey SILT. Brownish yellow with light grey streaks, dry, moderate plasticity when moistened.</p> <p>Matrix Colour (10YR - Value/Chroma) - 6/6</p> <p>Streak Colour (10YR - Value/Chroma) - 7/1</p> <p>Oxidised rhizospheres on roots</p>

<p>Photograph 32: Site 14 test pit</p>	  <p>Photograph 33: Site 14 core</p>
<p>15A</p> <p>0 - 150 mm.</p> <p>TOPSOIL, Silt. Very dark greyish brown. Dry, friable.</p> <p>Matrix Colour (10YR - Value/Chroma) - 3/2</p> <p>150 - 400 mm.</p> <p>SILT with minor clay. Dark greyish brown. No mottles but rhizospheres were present. Dry and friable.</p> <p>Matrix Colour (10YR - Value/Chroma) - 4/2</p> <p>400 - 500 mm.</p> <p>Clayey SILT. Yellowish brown with some mottles yellowish brown. Dry.</p> <p>Matrix Colour (10YR - Value/Chroma) - 5/4</p> <p>Mottle Colour (10YR - Value/Chroma) - 5/8 (5%)</p> <p>500 - 800 mm.</p> <p>Clayey SILT, minor sand. Yellowish brown. Dry, moderately plastic.</p> <p>Matrix Colour (10YR - Value/Chroma) - 5/4</p> <p>800 - 1000 mm.</p> <p>Silty CLAY, minor sand. Yellowish brown. Dry, highly plastic.</p> <p>Matrix Colour (10YR - Value/Chroma) - 5/6</p> <p>Oxidised rhizospheres on roots</p>	  <p>Photograph 34: Site 14 test pit</p>

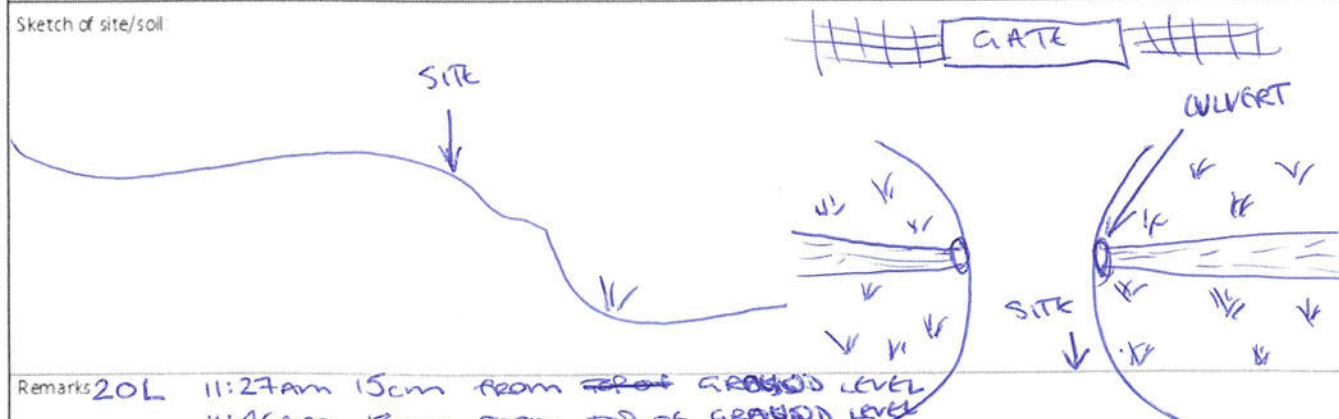
Remarks 20L 11:27am 15cm from ~~top~~ GROUND LEVEL
 11:46am 18cm from ~~top~~ GROUND LEVEL
 15:27pm 35cm from ~~top~~ GROUND LEVEL

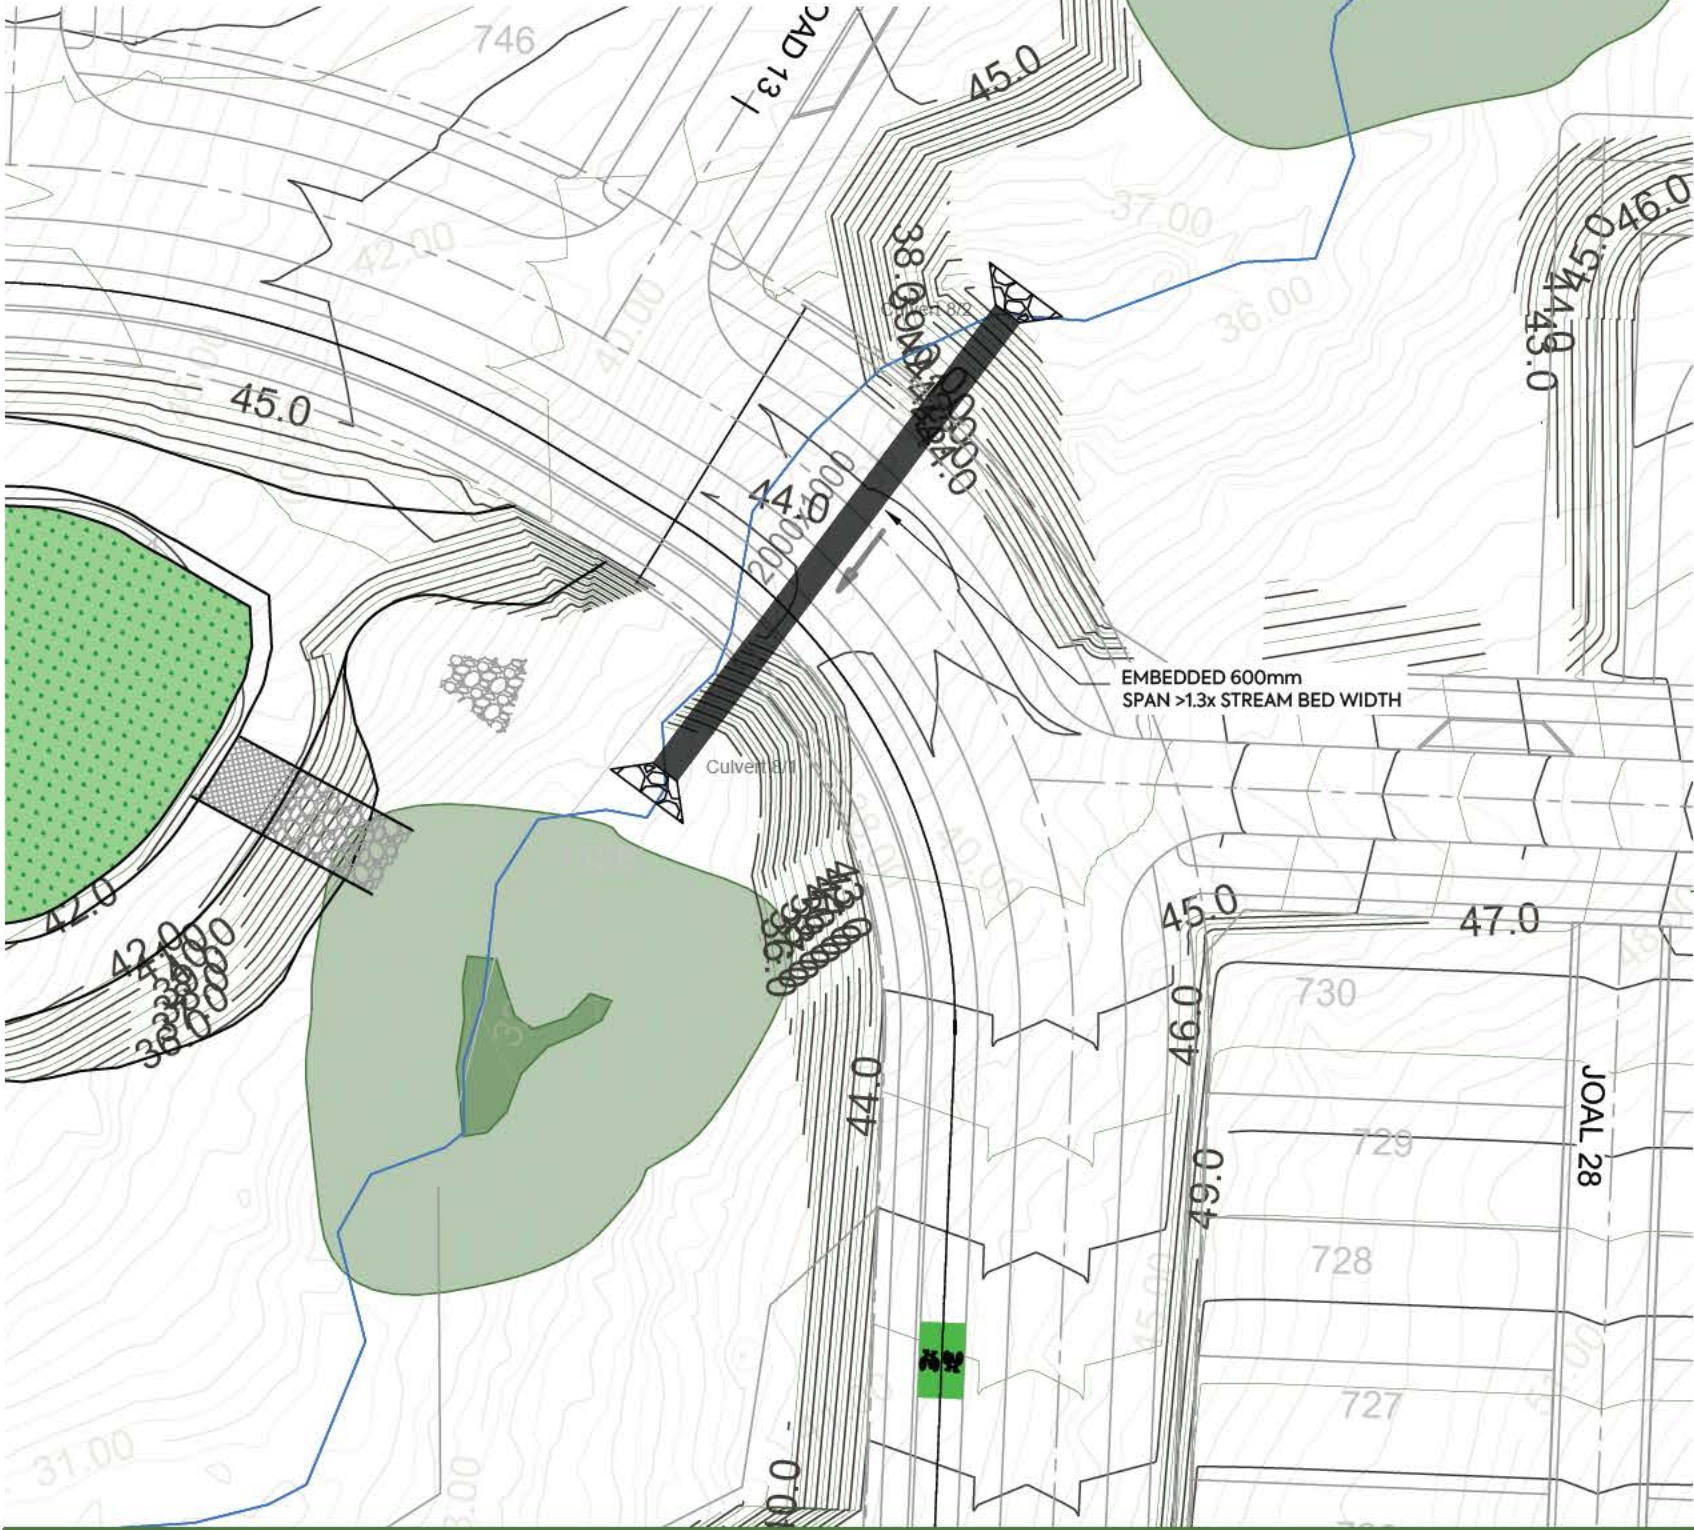
Culvert 08 - LONGSECTION

CULVERT INFORMATION

INLET/OUTLET STRUCTURE = FLARED WINGWALL
INLET PRE-DEV VELOCITY = 1.6m/s
INLET POST-DEV VELOCITY = 0.6m/s
OUTLET PRE-DEV VELOCITY = 1.2m/s
OUTLET POST-DEV VELOCITY = 0.6m/s
RIPRAP Ø = 150mm
RIPRAP LENGTH = 2m
RIPRAP WIDTH = 6m
