# PRELIMINARY SITE INVESTIGATION SL1 HOUCHENS BLOCK

**Prepared for Ohaupo Land LP and Chinamans Hill Ltd**

**Prepared by Swiftsure Consultants Ltd**

**12 November 2025**

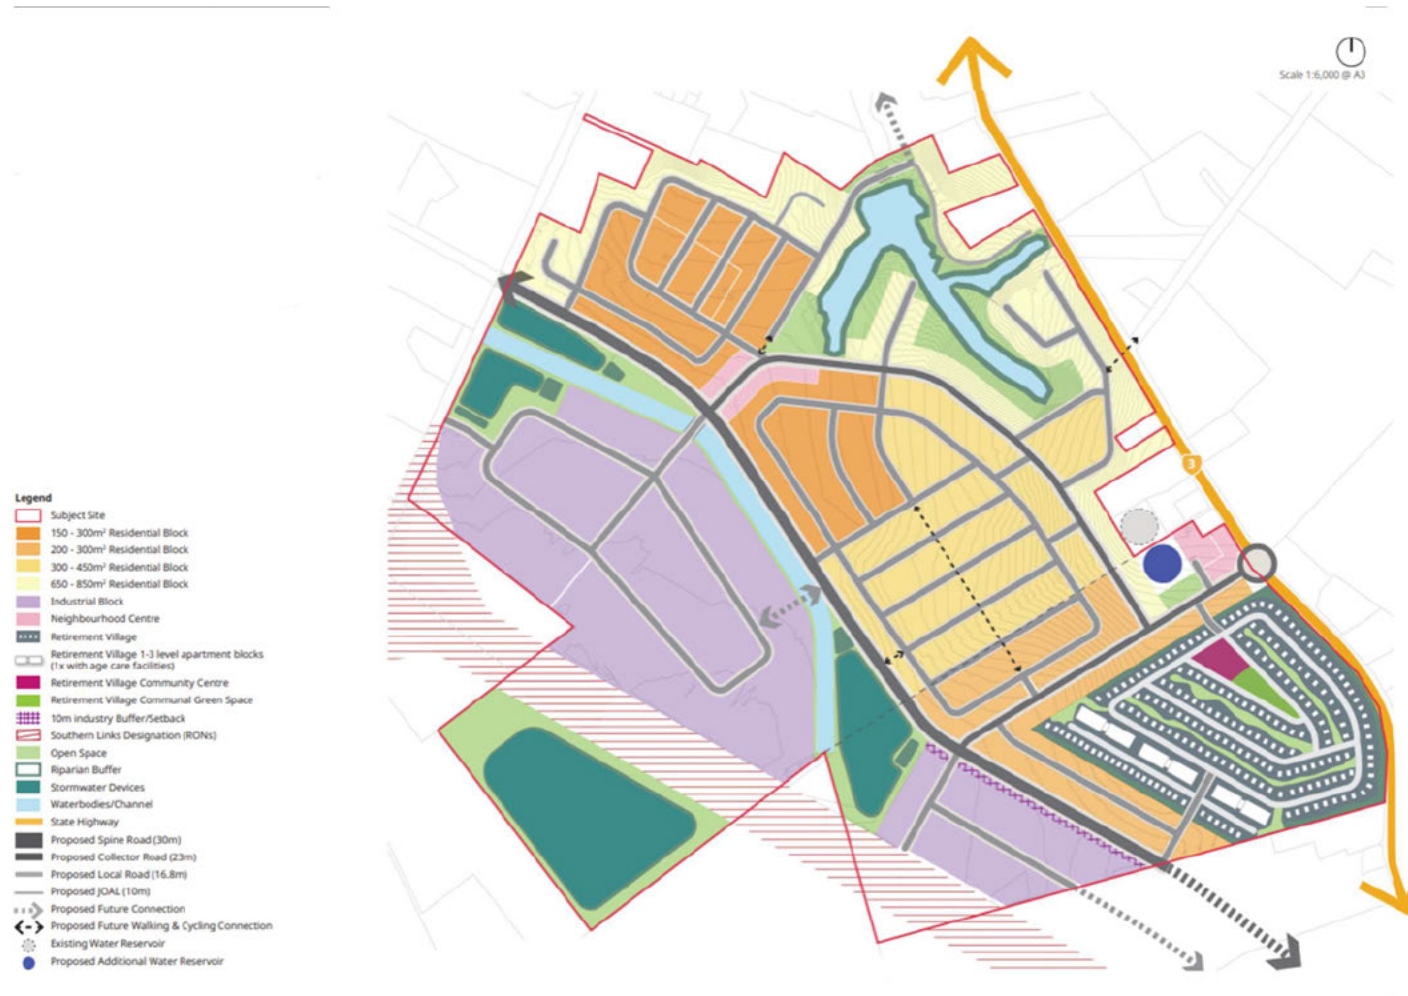
**Figure 3: Masterplan of Houchens Block**

The ‘SL1 Houchens Development’ is a combined residential and industrial development that comprises circa 145 hectares, which will be split into a mix of residential densities and industrial development. The residential component comprises circa 55ha of net residential, including 1,300 residential units of varying typologies (including single detached, duplex, terraced apartment), a 400-unit retirement village, along with two supporting mixed-use neighbourhood centres, open spaces, waterbodies and infrastructure devices including wetlands. The SL1 Houchens Development includes a net 25ha of industrial, generating between 24 – 47 industrial sized lots for industrial activities.

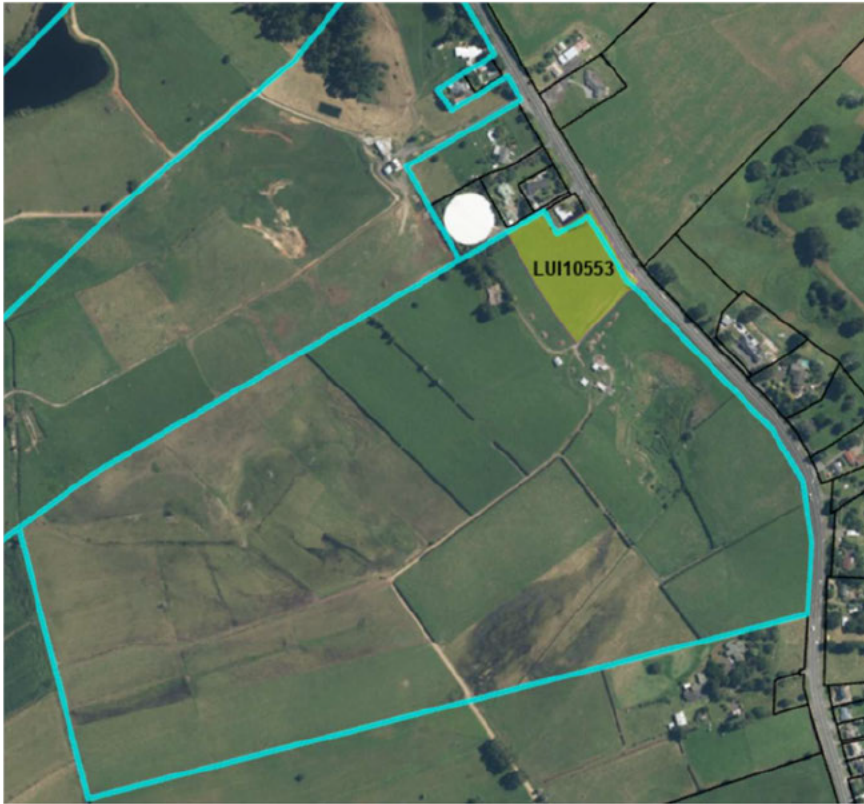
The response stated that the site does appear on the Land Use Information Register. The area shaded yellow above (LUI10553) appears on the Land Use Information Register with a classification of 'Unverified HAIL' due to past land use for HAIL activity 'A10. Persistent pesticide bulk storage or use (unknown period)' associated with 3134 Ōhaupō Road - Historic Horticulture Activity.

This site is included on the register for land use information only; the council advised that they do not hold soil investigation reports regarding the presence or otherwise of hazardous substances in the soil.

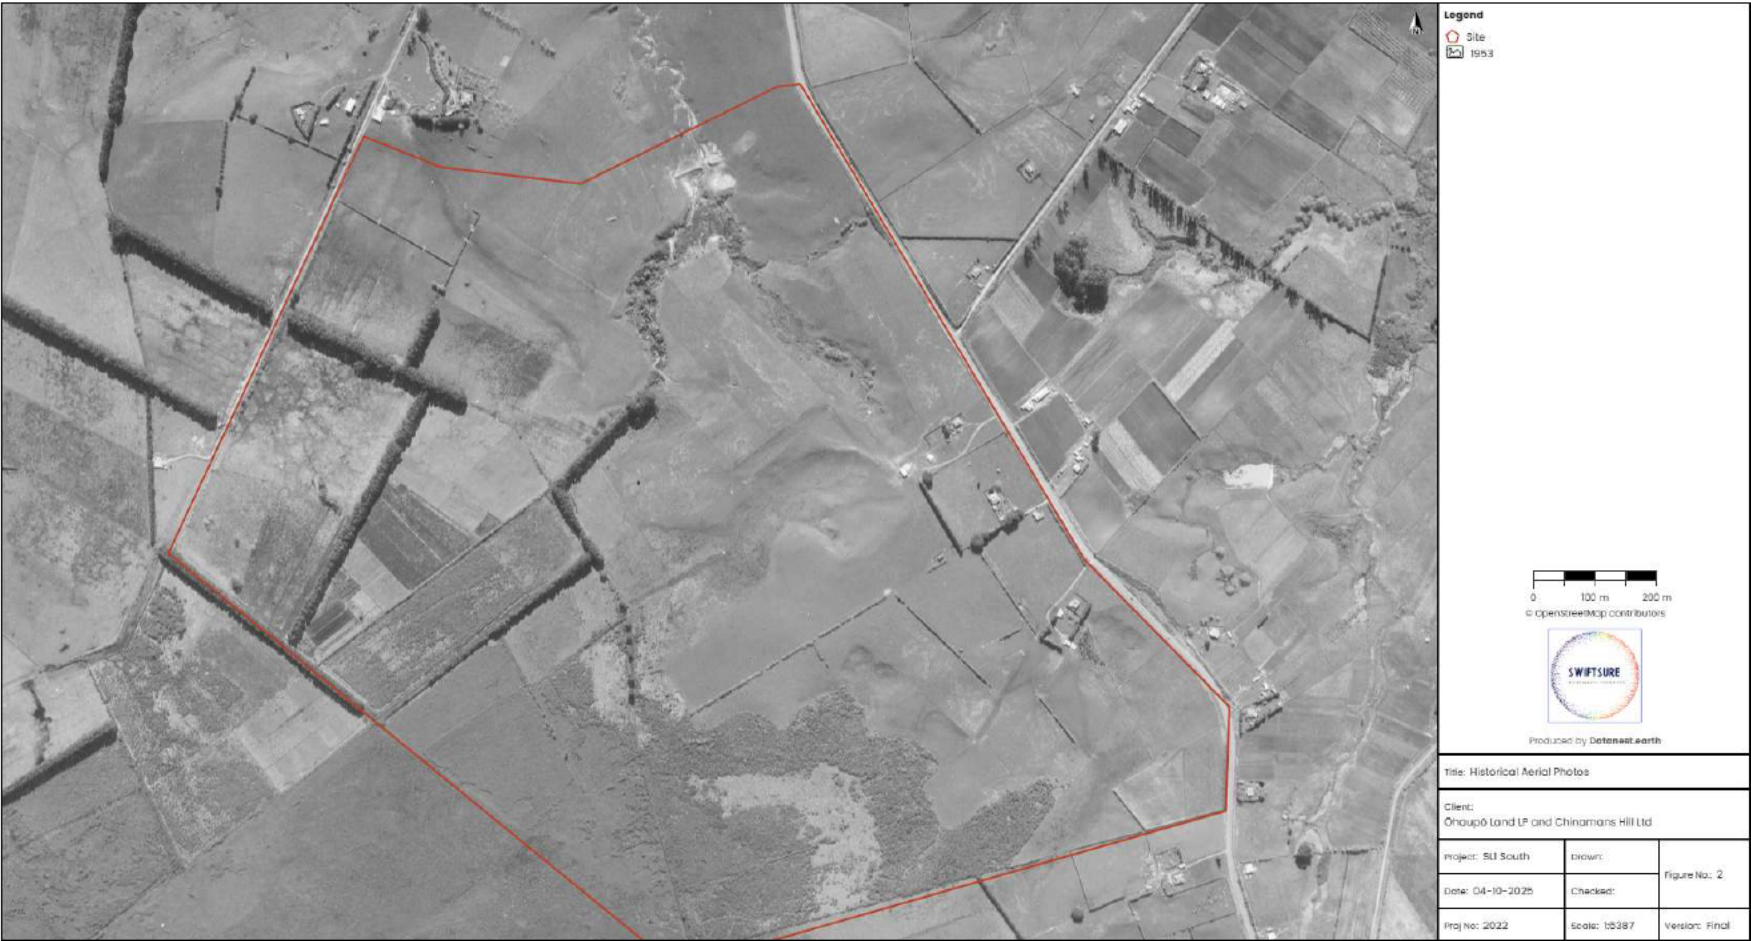
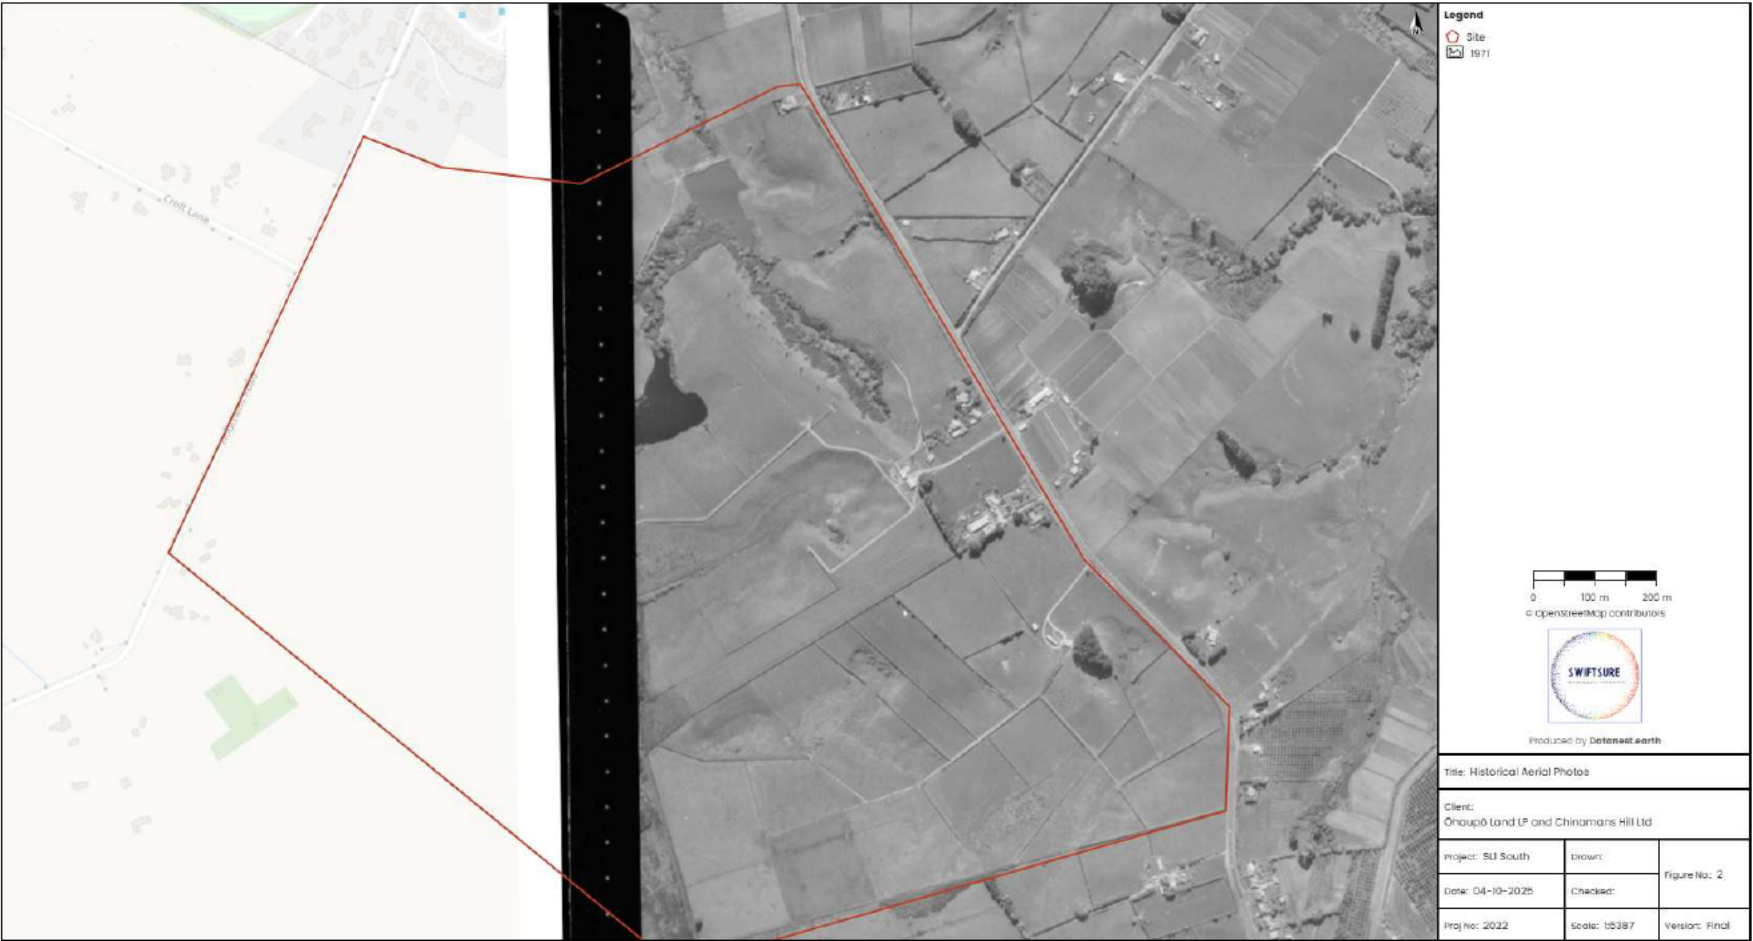
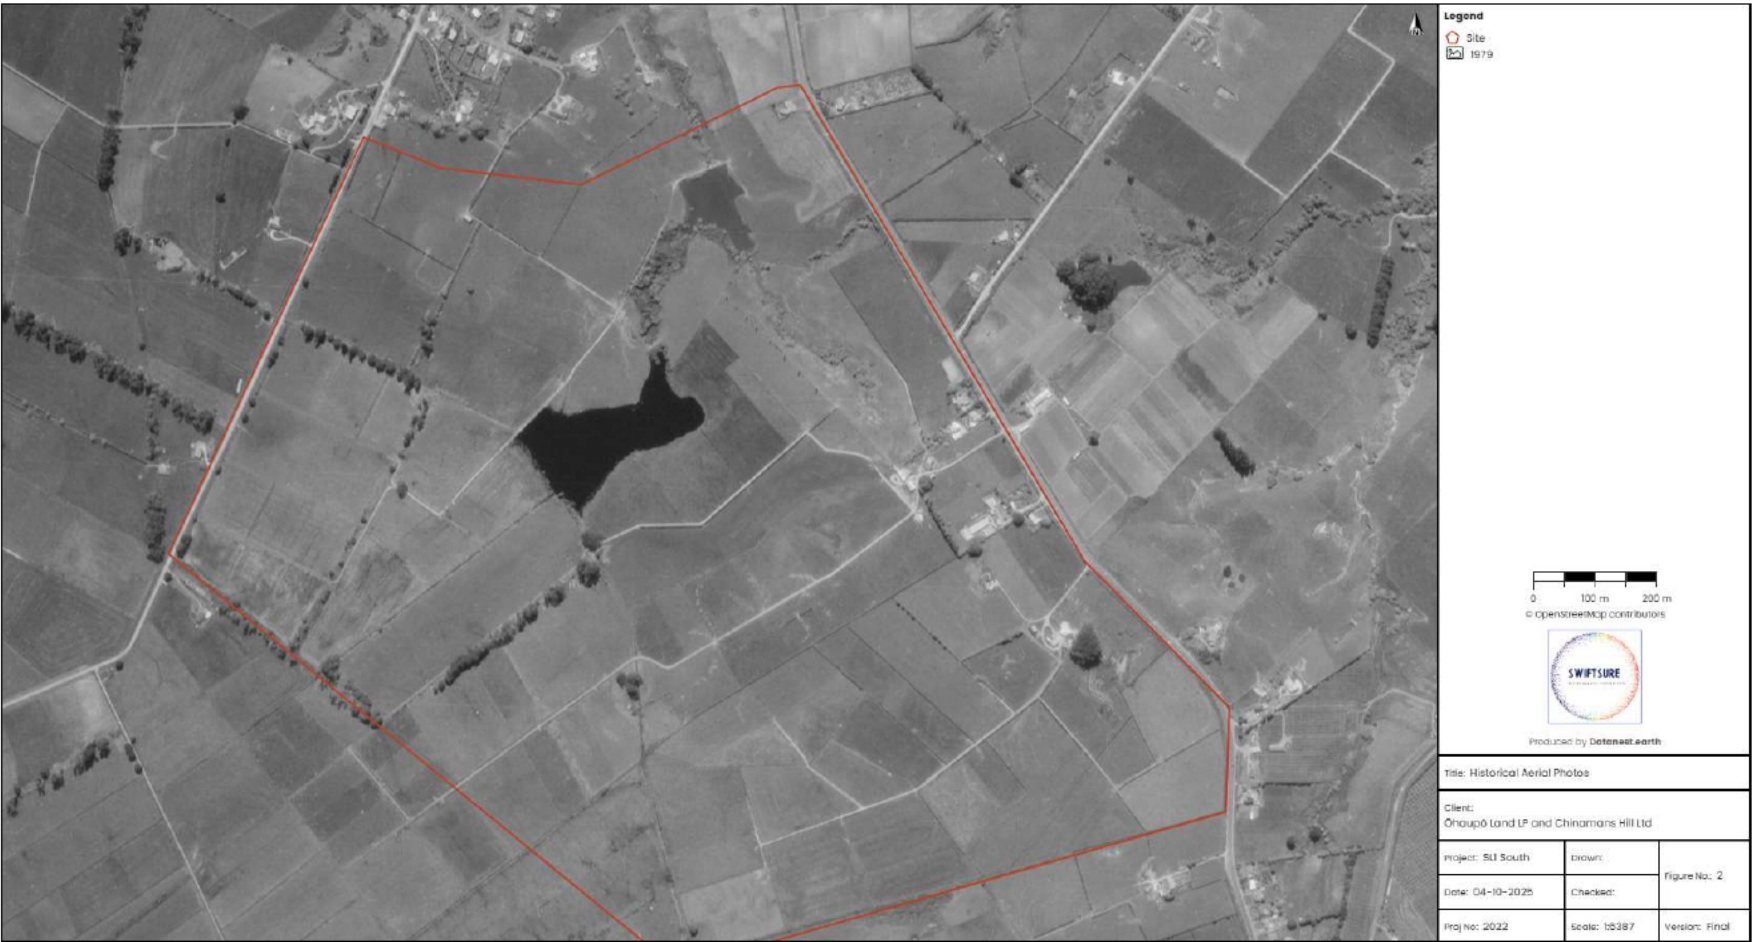
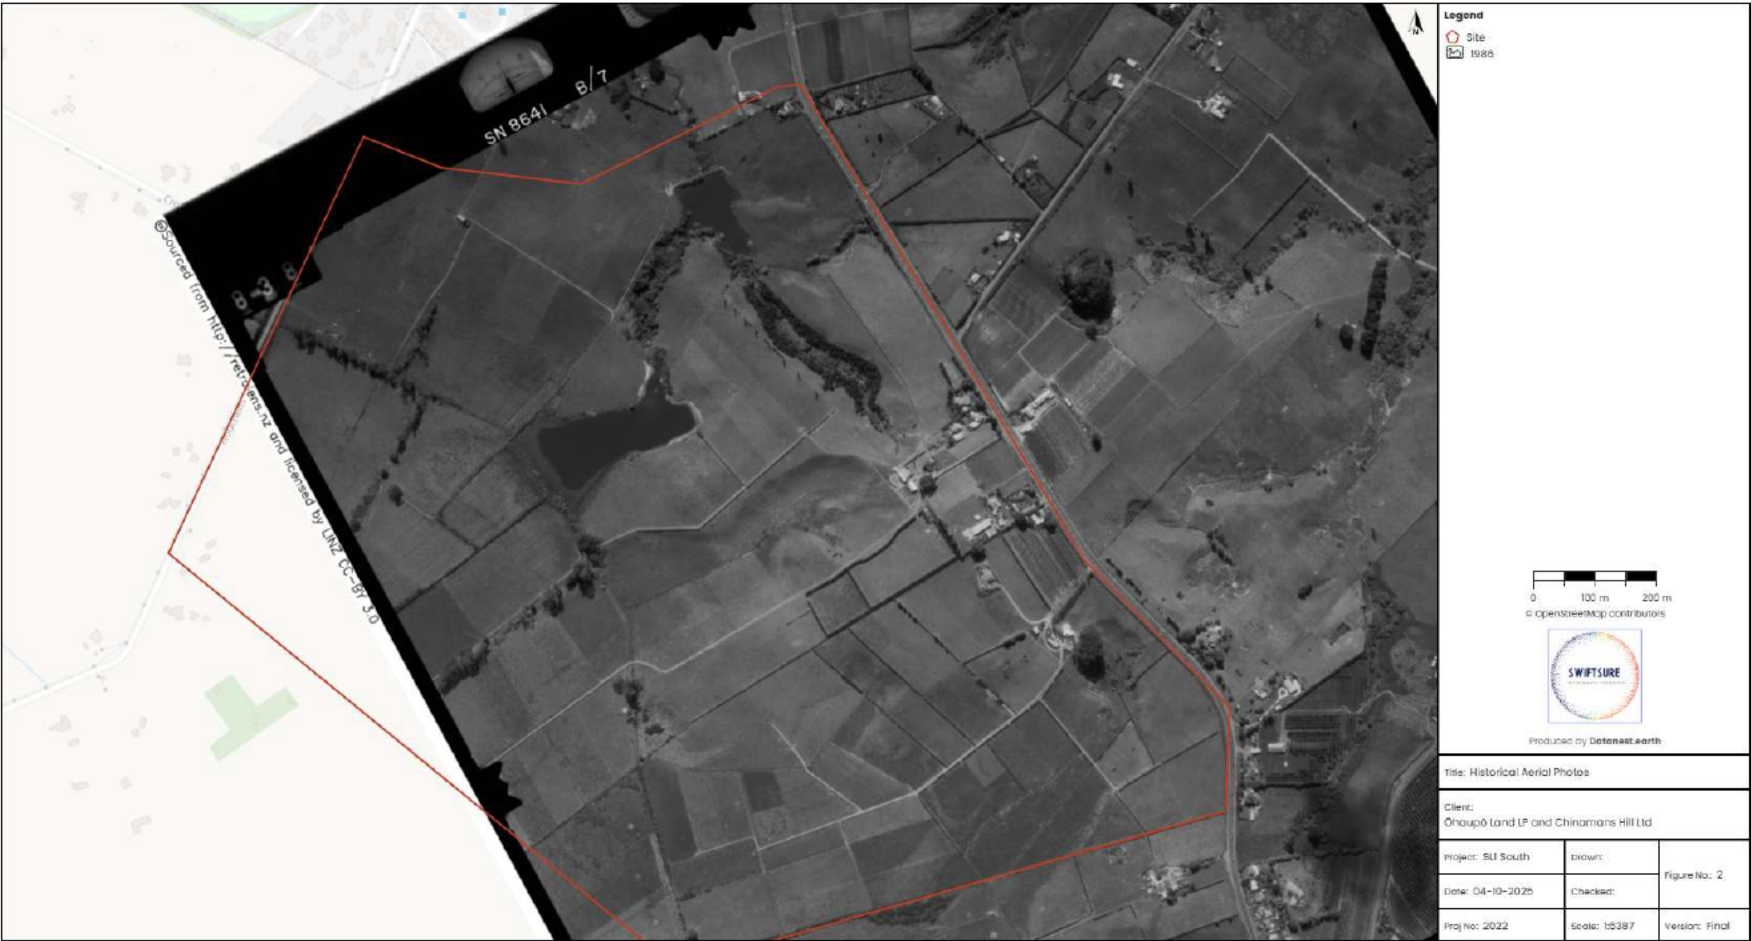
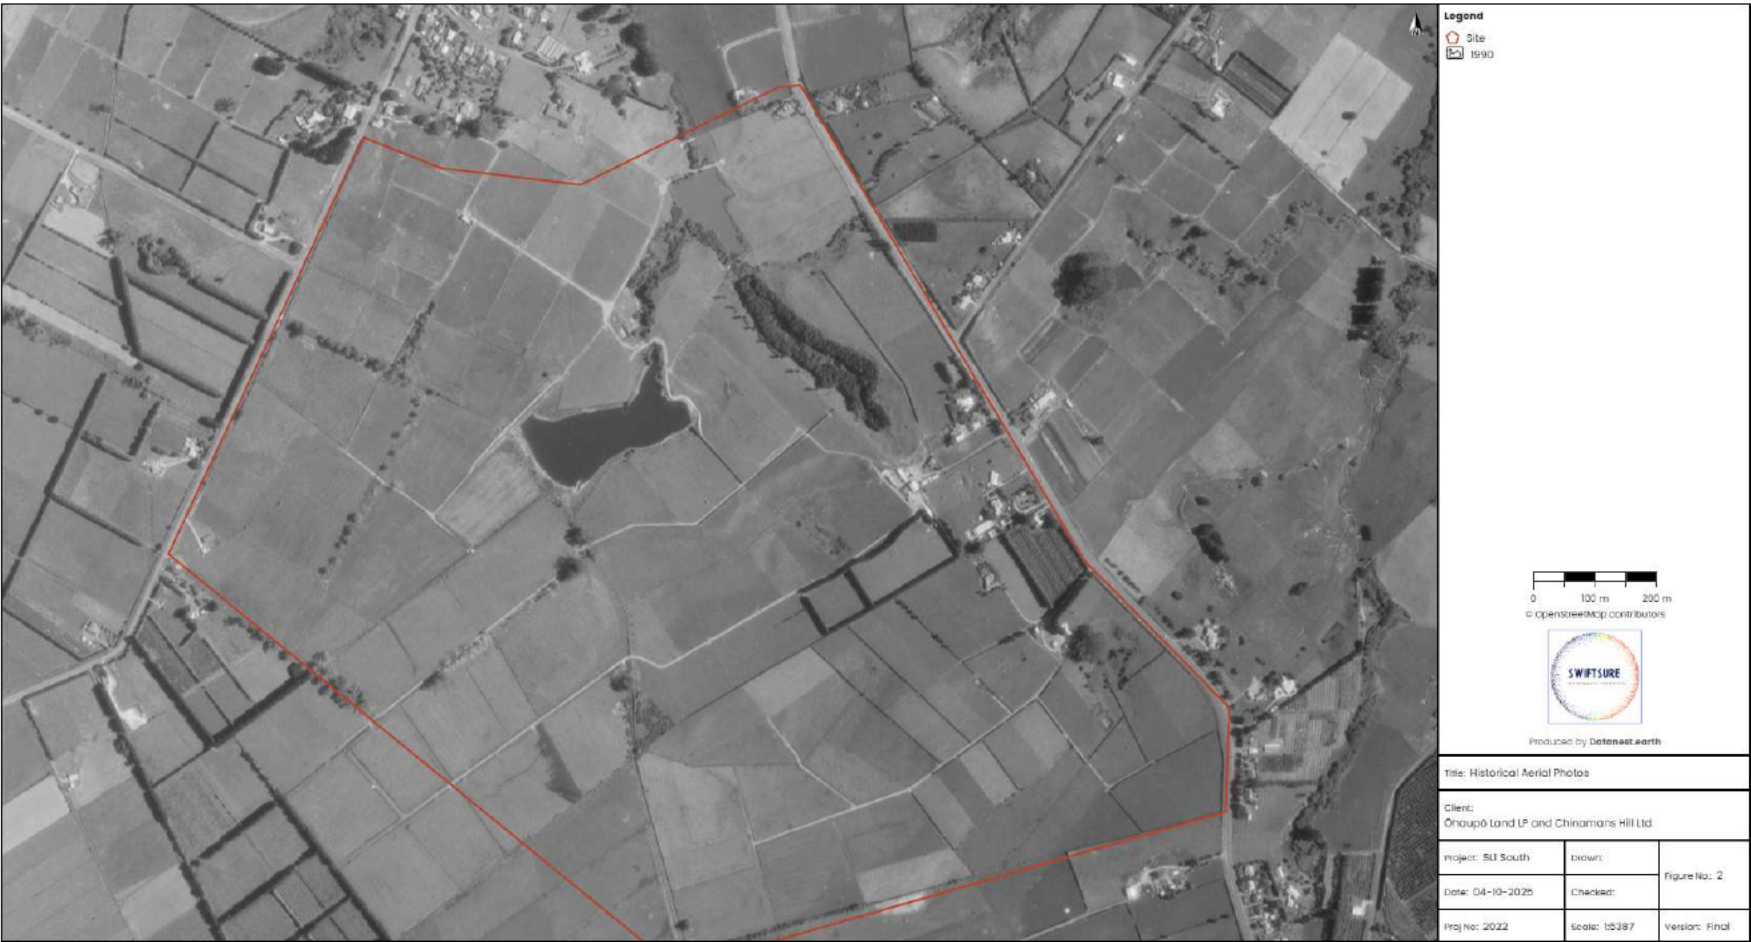
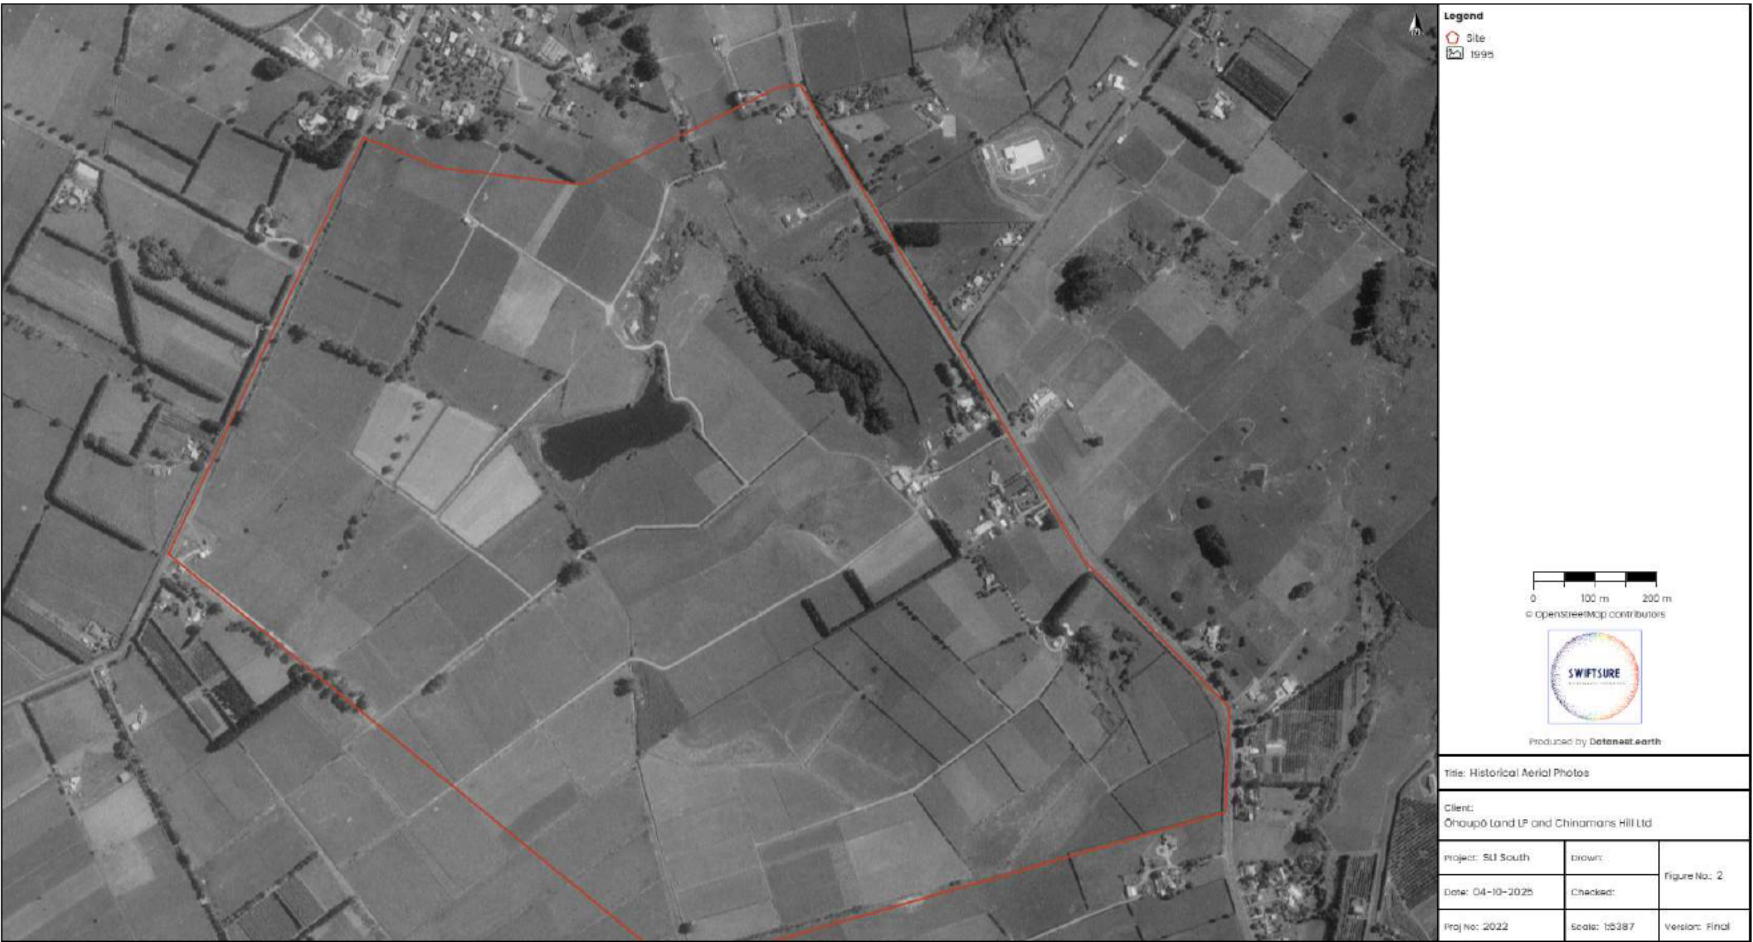
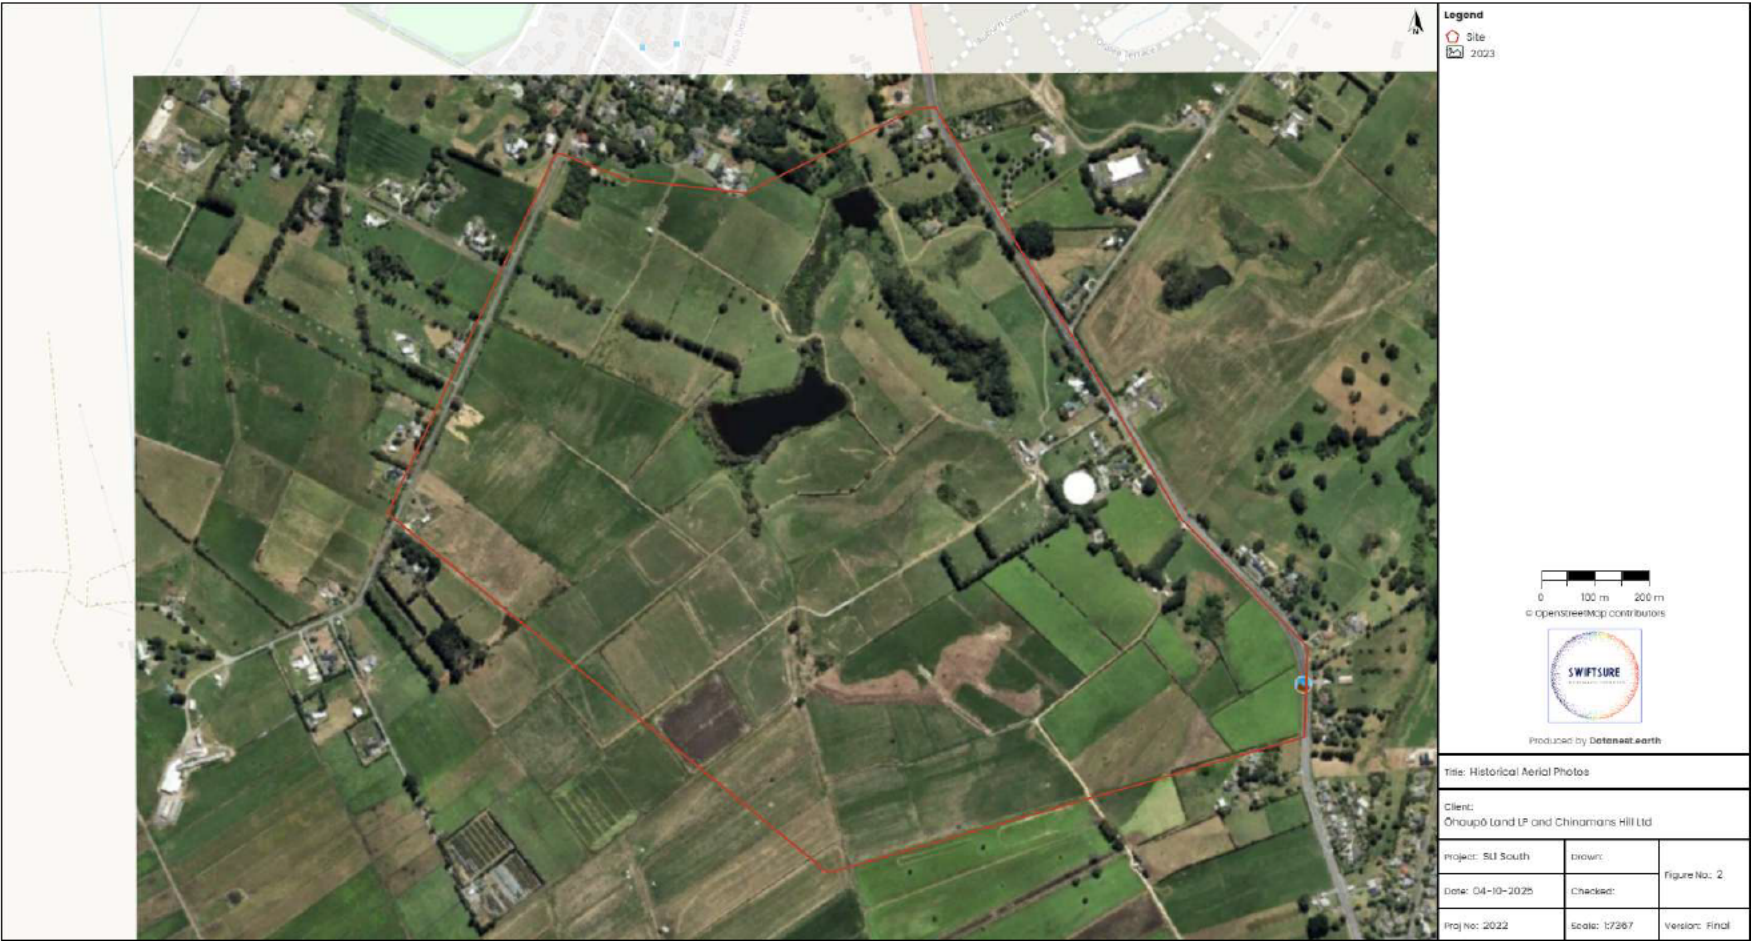
## **APPENDIX A:** Historical Aerial Photographs

| Year | Key Information |
|---|---|
| 1941 | The site is predominantly covered in wetland scrub. |
| 1943 | Evidence of clearing of wetland scrub and conversion to agricultural use. There are several clusters of structures present - To the south of the site is an 'L-shaped' structure'. To the east of the site off Ōhaupō Road are structures at the end of the drive, a larger (possibly house) halfway down the drive and another house bordered by hedgerows adjacent to the road. One of these structures is a milking shed which is still present today. |
| 1953 | Most of the site looks to have switched to agricultural use and is fully converted by the 1971 image. Far drains are now evident likely associated with the agricultural use. An additional structure is now located along the driveway off Ōhaupō Road. The larger structure adjacent to the milking shed has been removed. Two additional structures replace it. |
| 1971 | (Partial image). A pond is now evident in the centre of the site. A new dwelling has been constructed north of the site adjacent to Ōhaupō Road (now 3044 Ōhaupō Road). Several additional farm buildings are now located in this area. Additional farm buildings are also present along the third driveway off Ōhaupō Road as well as animal pens. This is the location of another milking shed still present today. |
| 1979 | Evidence of the construction of two ponds in the base of the valley. A house has been constructed at the end of the middle driveway – this is still present today. |
| 1986 | A small orchard/market garden is present at (what is now 3124 Ōhaupō Road). The site continues to be used for agricultural use. |
| 1990 | The orchard/market garden is still present. As are the various farm buildings. There are no other discernible changes. |
| 1995 | There are no discernible changes. |
| 2008 | By 2008, the large water tank is now evident on Ōhaupō Road. The orchard/market garden has been removed. there are no other discernible changes. |
| 2023 | There are no discernible changes. |

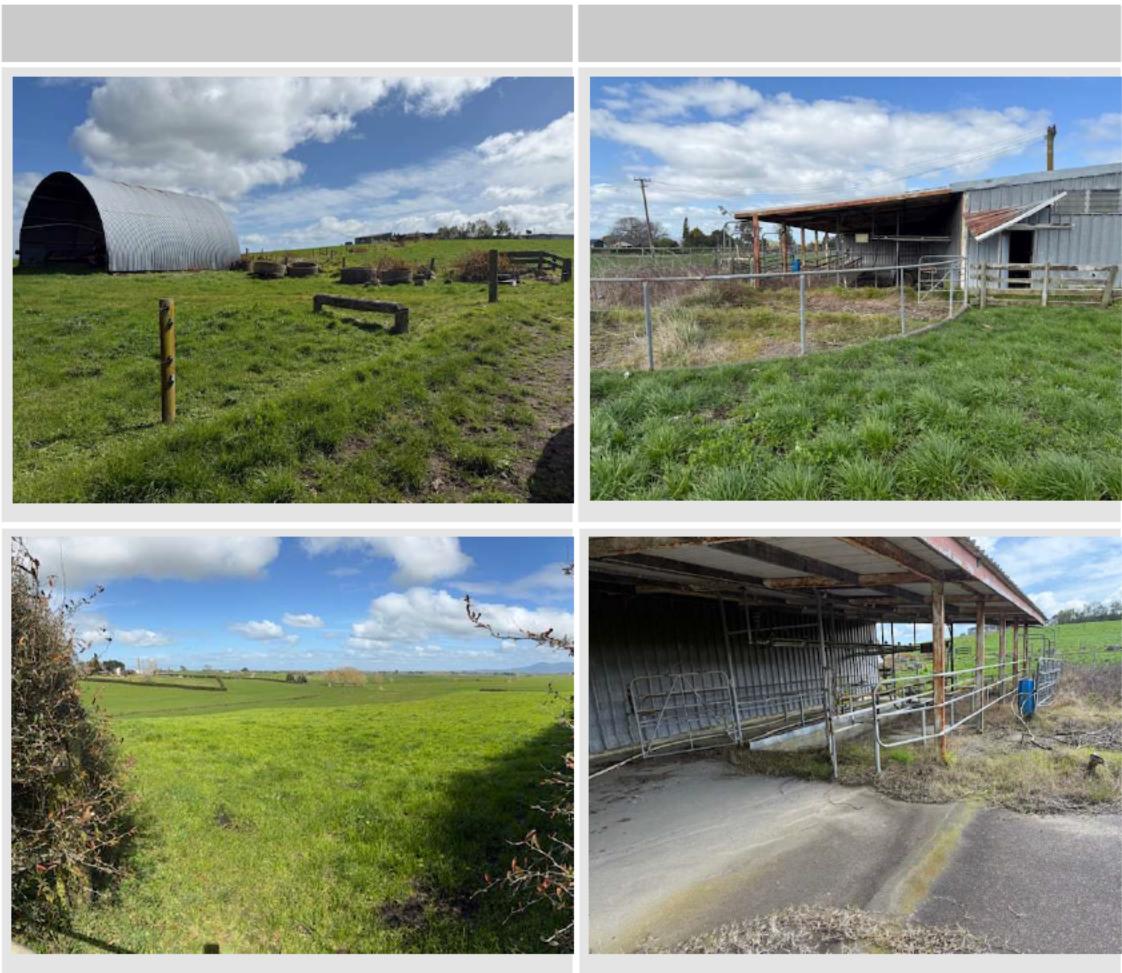
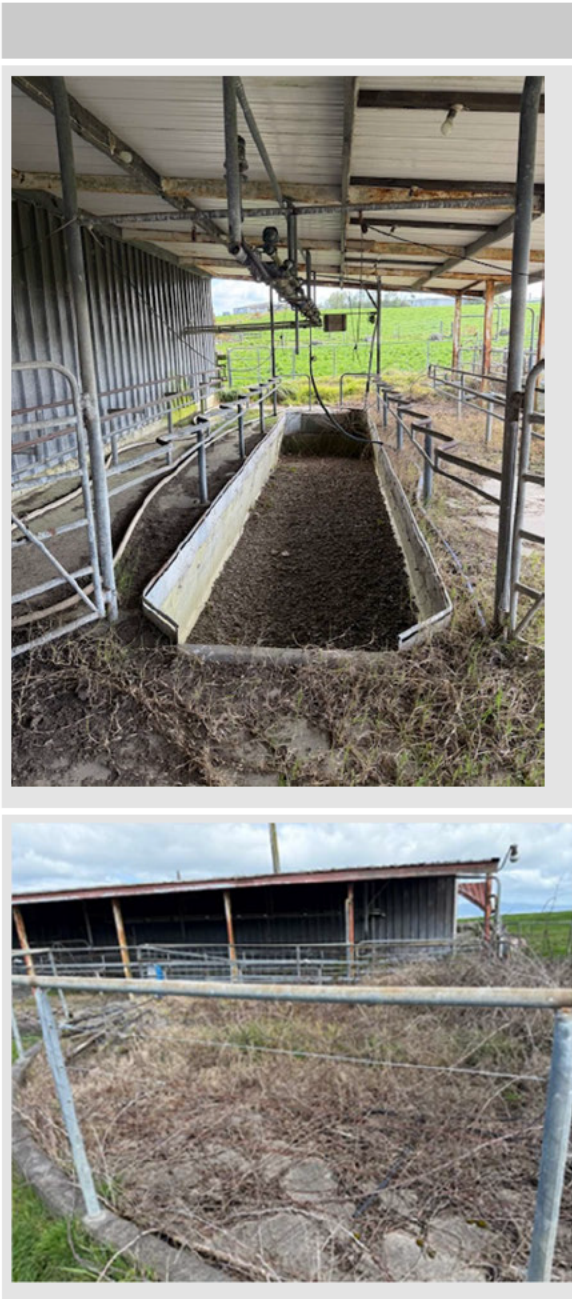
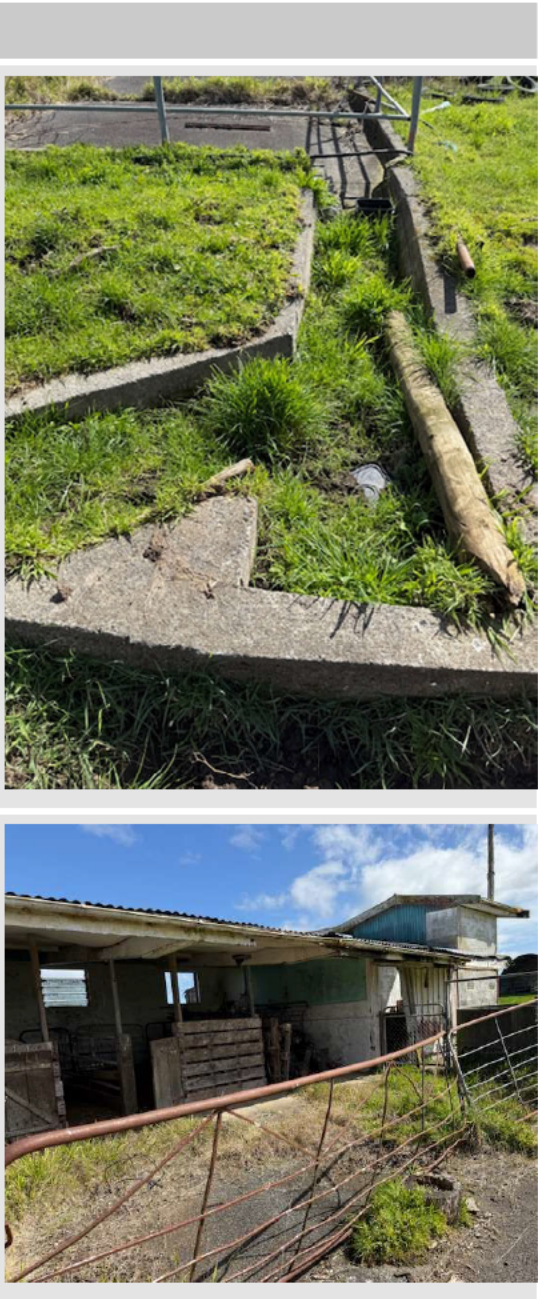
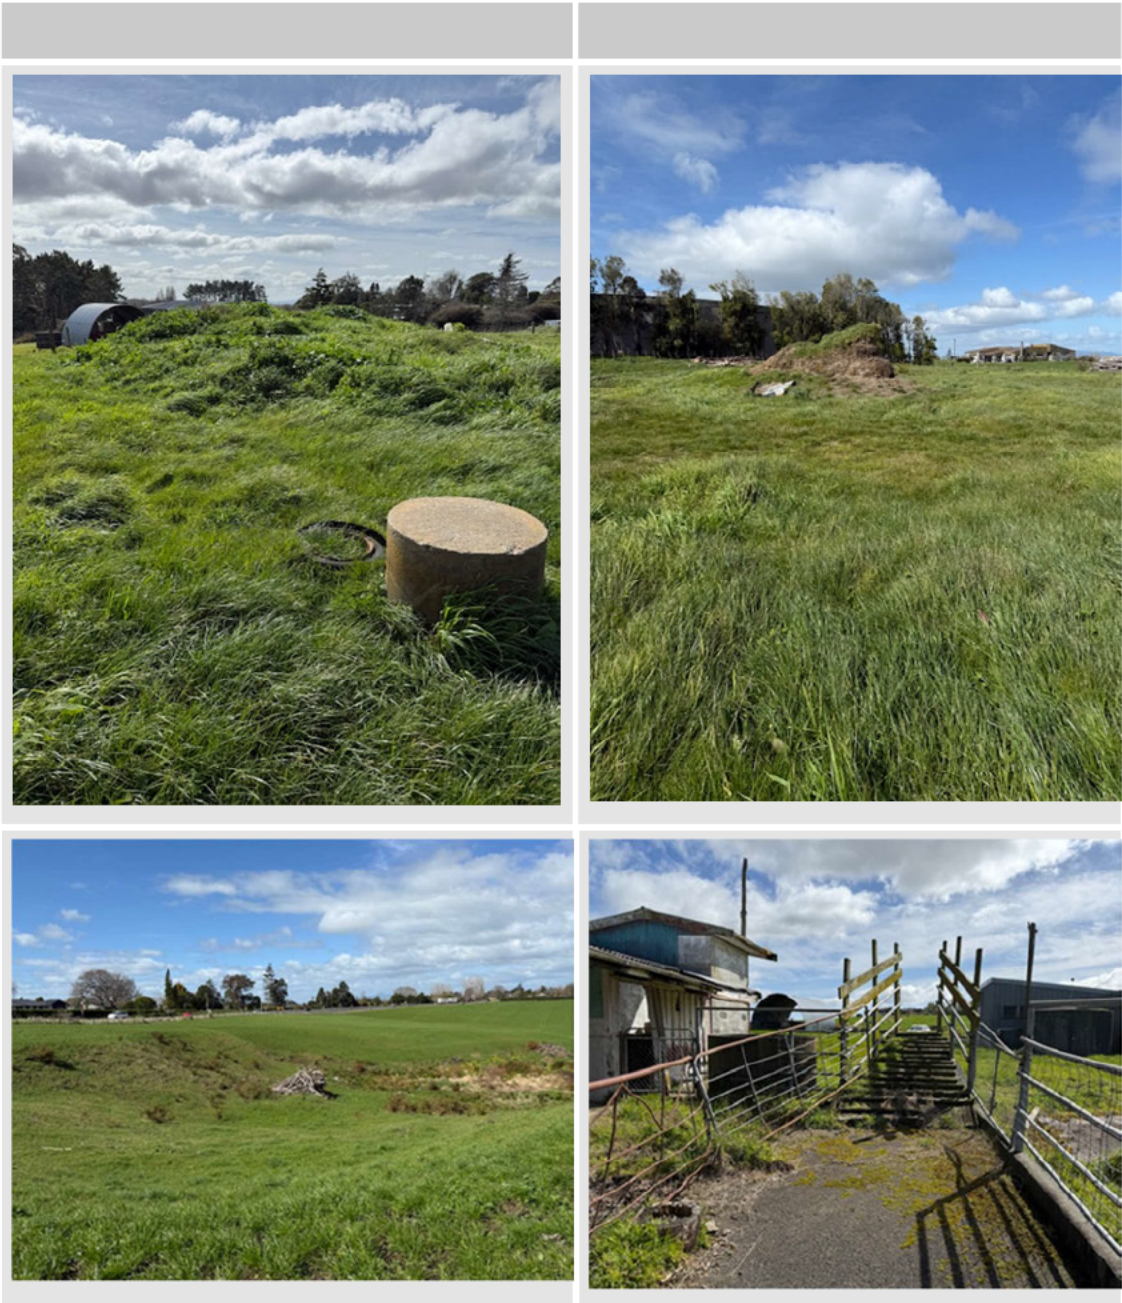
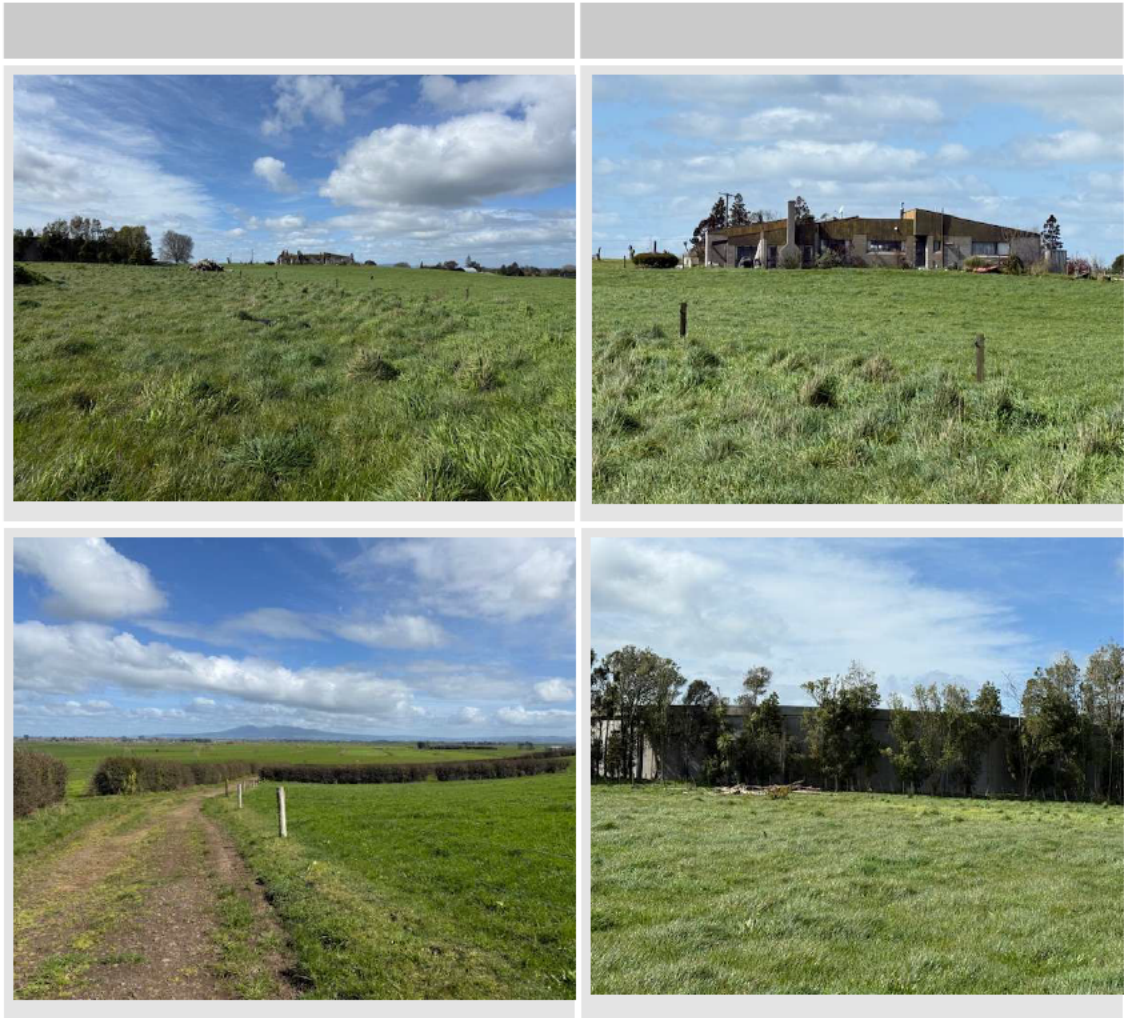
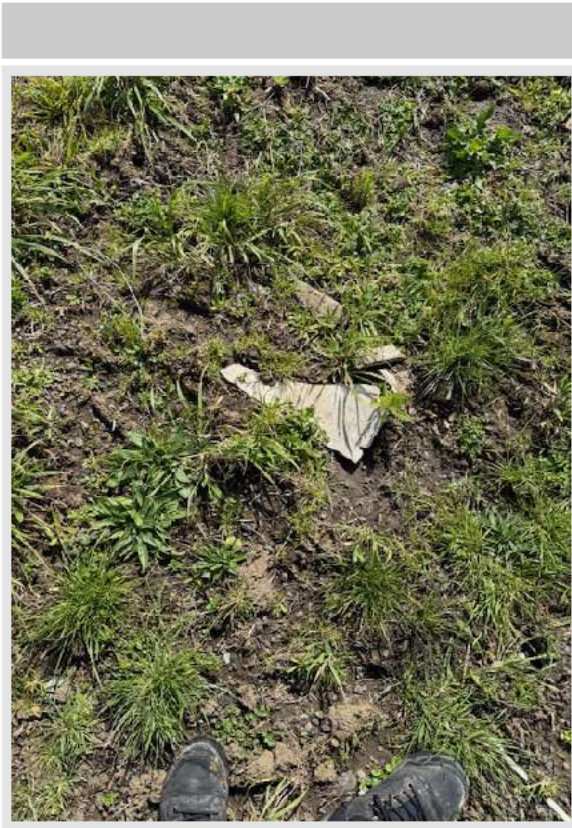
## **APPENDIX B:** Site Photographs

Two large ponds are located at the base of a valley in the northern section of the site, receiving runoff via a farm drain from the south. The southeastern portion of the property slopes toward a low-lying wetland area. Recently felled trees were observed along the main driveway entrance at 3134 Ōhaupō Road.

Development within the site is concentrated near Ōhaupō Road. Structures in this area include a disused dairy shed, hay barn, storage shed, workshop, and a newer milking shed, all situated near the end of the main driveway. These buildings are in poor and deteriorated condition and appear to contain suspected asbestos-containing materials (ACMs). Animal holding pens and a loading ramp were also noted. Several containers of hazardous substances—including cleaning agents, fuel, and pesticides—were observed, along with farm machinery and general equipment. A homemade above-ground fuel tank containing diesel was located inside one of the sheds. The surrounding area was overgrown and unused.

To the northwest of the water tank, a second dairy shed, holding pen, and loading ramp were observed. This shed was also in a dilapidated condition and appeared to contain suspected ACMs. ACM debris was visible on the floor, along with waste materials, drums, containers, and general rubbish. A nearby hay shed was similarly deteriorated, and the area contained farm machinery, chemicals, and fuel. ACM debris was also observed in the adjacent paddock. Recent minor earthworks appeared to have been carried out, with small stockpiles of building materials and suspected ACM noted.

Overall, the risk of widespread contamination is assessed as low to moderate, reflecting the site's predominantly rural land use. However, localised contamination hotspots may exist around former farm structures, chemical storage areas, and earthwork stockpiles. Targeted soil testing and validation are recommended prior to any earthworks, redevelopment, or disturbance of these areas to confirm soil quality and manage potential risks appropriately.
