# Aquatic Ecology Impact Assessment

Graymont South-Western Pit

Prepared for:  
Graymont NZ LTD

Prepared by:  
Stantec NZ

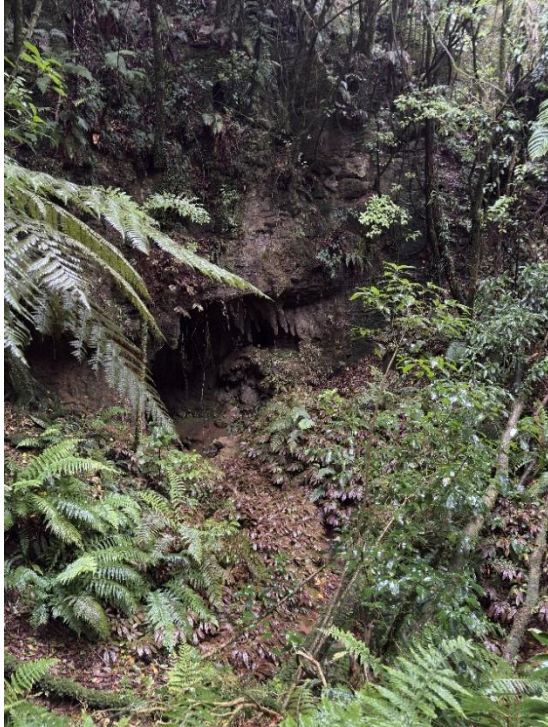
In 2026 Stantec completed a rapid habitat assessment at the Camelot Stream submergence site, resulting in a 'Good' condition category. The detailed assessment is provided in Appendix B. The site is in a headwater site, draining agricultural land, however native riparian vegetation is present adjacent to the watercourse within the incised gully upstream of the Camelot Cave entrance.

*Photo 1: Camelot Stream at submergence*

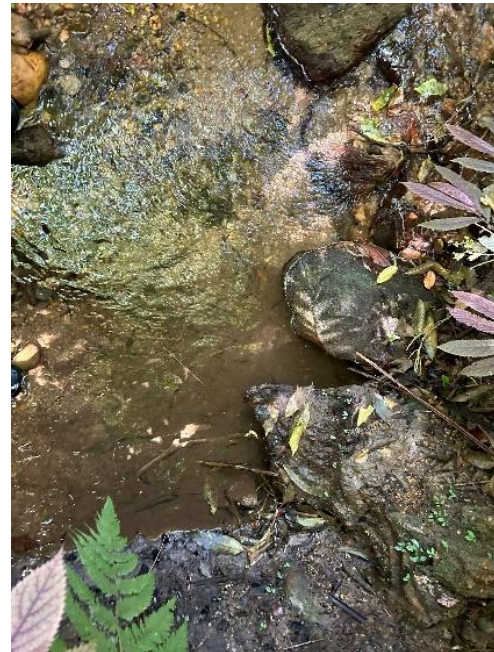
*Photo 4: Sediment accumulation at edge of Camelot Stream*

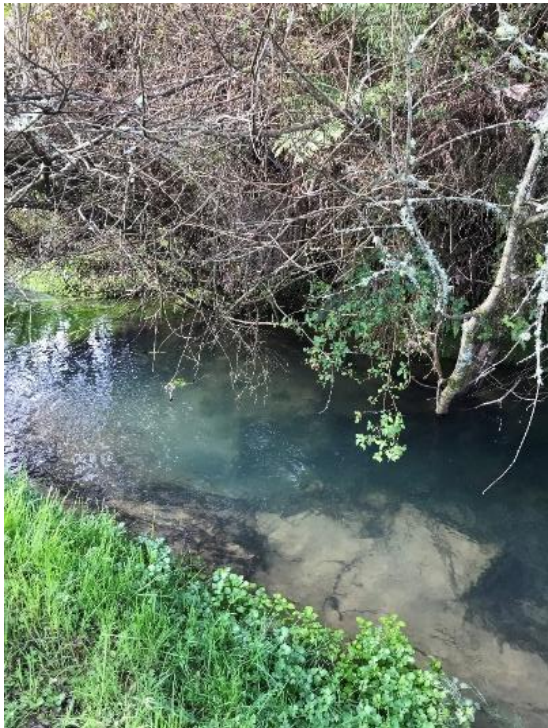
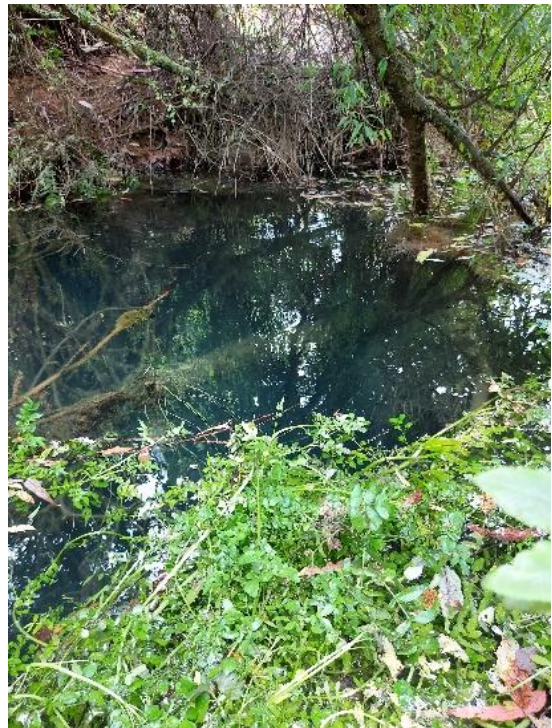
Pōtea Spring has been determined as the resurgence site for Camelot Stream and therefore the main receiving surface waterway for infiltration within the Project Site. The spring source is a large (~4-5m deep) pool with clear water observed during the site surveys in 2020 and 2026.

*Photo 5: Pōtea Spring, stream resurgence*

*Photo 6: Pōtea Spring, stream resurgence*

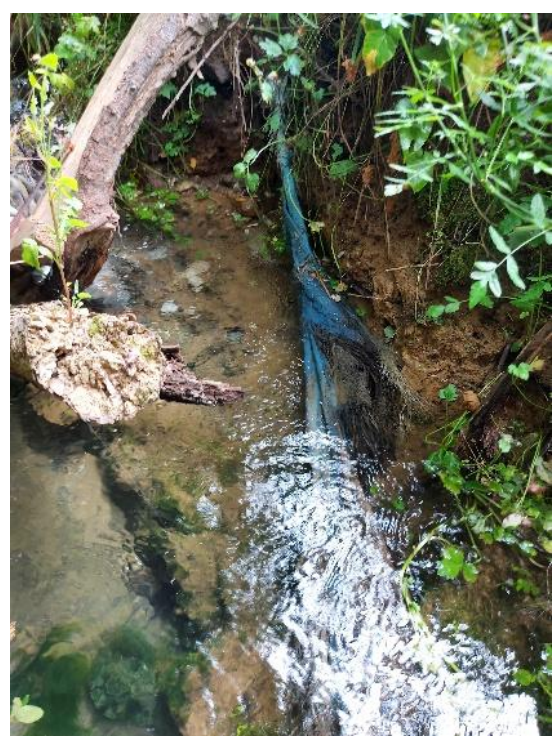
PDP noted during its surveys (PDP, 2024) that the condition of Pōtea Spring and its downstream channel is mixed. While the spring itself is in good condition, with established riparian vegetation, no stock access and clear water under base flow conditions, the Pōtea Spring channel has an old vehicle embedded within both the bank and the channel substrate (true left bank), with exposed wires and vehicle body visible (see Appendix A for photos). It was also recorded that there was evidence of historical dumping of materials within the channel (such as plastic material) (PDP, 2024).

*Photo 8: Rubbish debris within channel banks and bed downstream of Pōtea Spring*

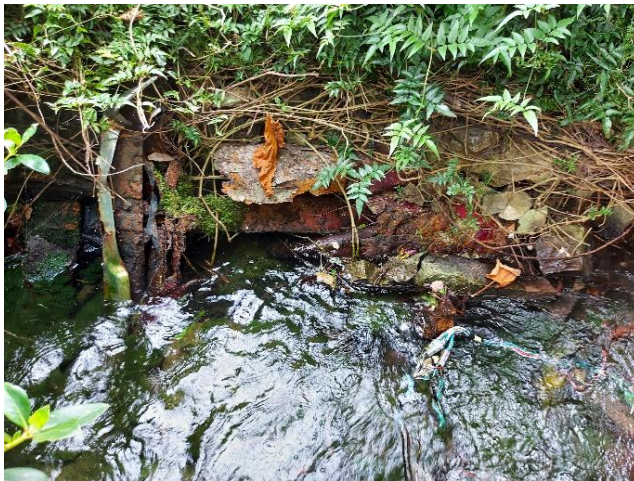
*Photo 9: Vehicle debris within channel banks downstream of Pōtea Spring*

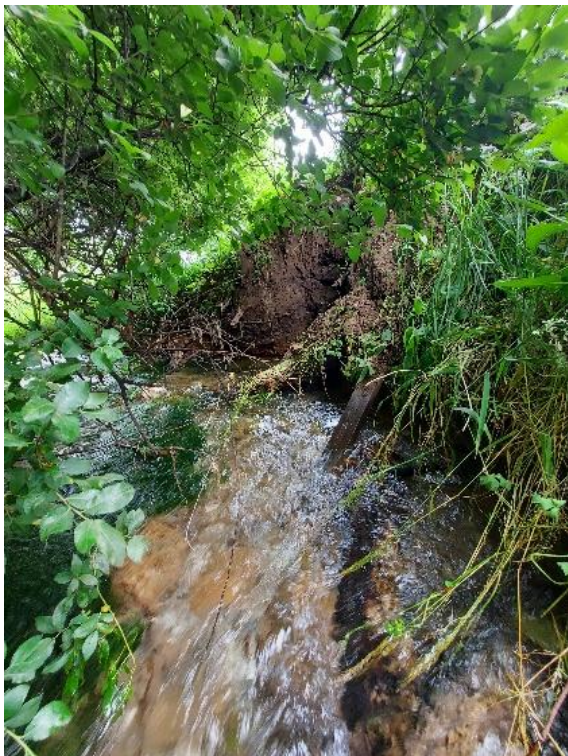
*Photo 11: Active erosion of channel banks downstream of Pōtea Spring*

To provide ecological betterment for potential residual impacts to Camelot Stream and Pōtea Spring, habitat restoration of source stream catchments to the west of the site is proposed. As detailed in the Betterment Plan and summarised in Section 6.4, these locations will be protected with fencing, native planting, sediment and erosion control, and pest/predator control. This will result in a reduction in sediment entering the subsurface karst environment upgradient of the proposed project area and will improve the ecological condition and biodiversity values of these areas. To provide ecological betterment for Pōtea Spring, native riparian restoration of the springhead is proposed.

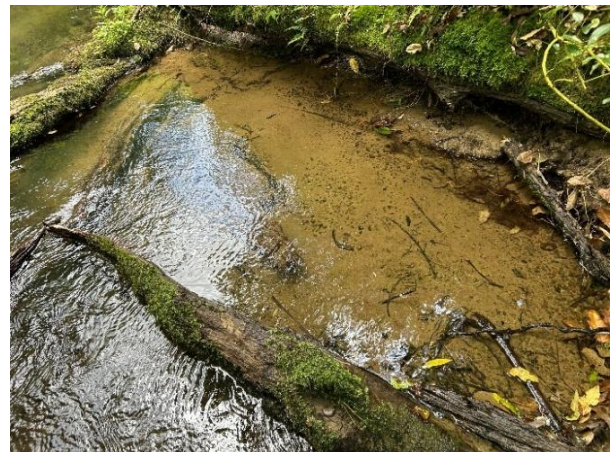
*Photo 17: Woody debris within the channel altering flow and promoting local sediment deposition, approximately 80m upstream, facing upstream.*

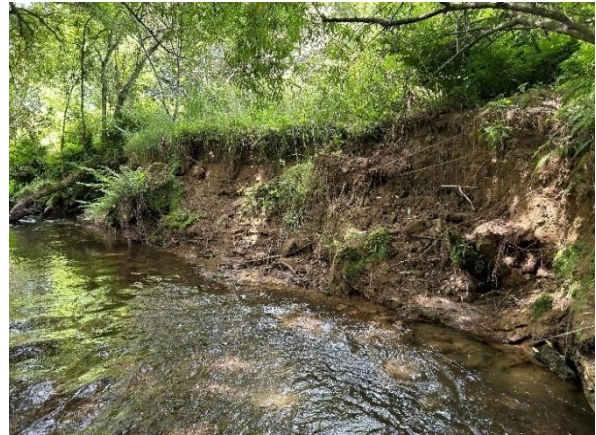
*Photo 19: Erosion of Mangawhitikau Stream bank, approximately 20 m upstream of Pōtea Spring. Photograph facing upstream.*

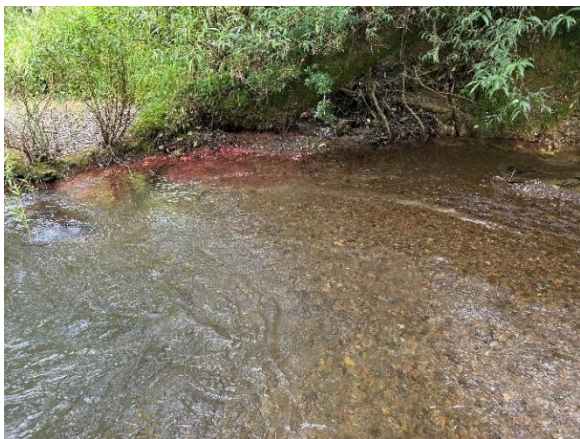
*Photo 22: Exposed willow roots (pink) along the Mangawhitikau Stream, approximately 20 m downstream of Pōtea Spring.*

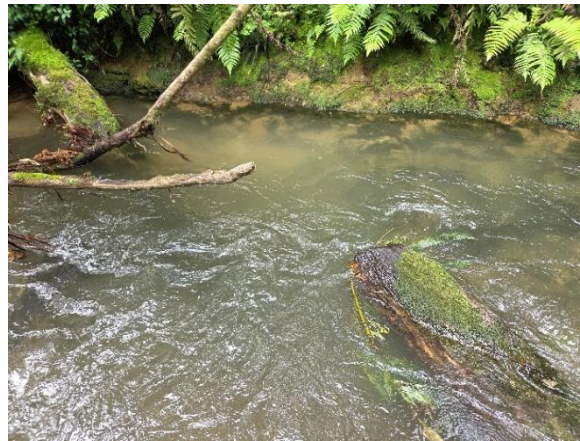
*Photo 25: Approximately 100 m downstream of Pōtea Spring. Water is noticeably more turbid than upstream.*
