# Belmont Quarry Development – Part B

Substantive Application  
Appendix B.3.A – PSI/DSI – OBDA  
Winstone Aggregates

## **PRELIMINARY AND DETAILED SITE INVESTIGATION - BELMONT QUARRY – PROPOSED OVERBURDEN DISPOSAL AREA**

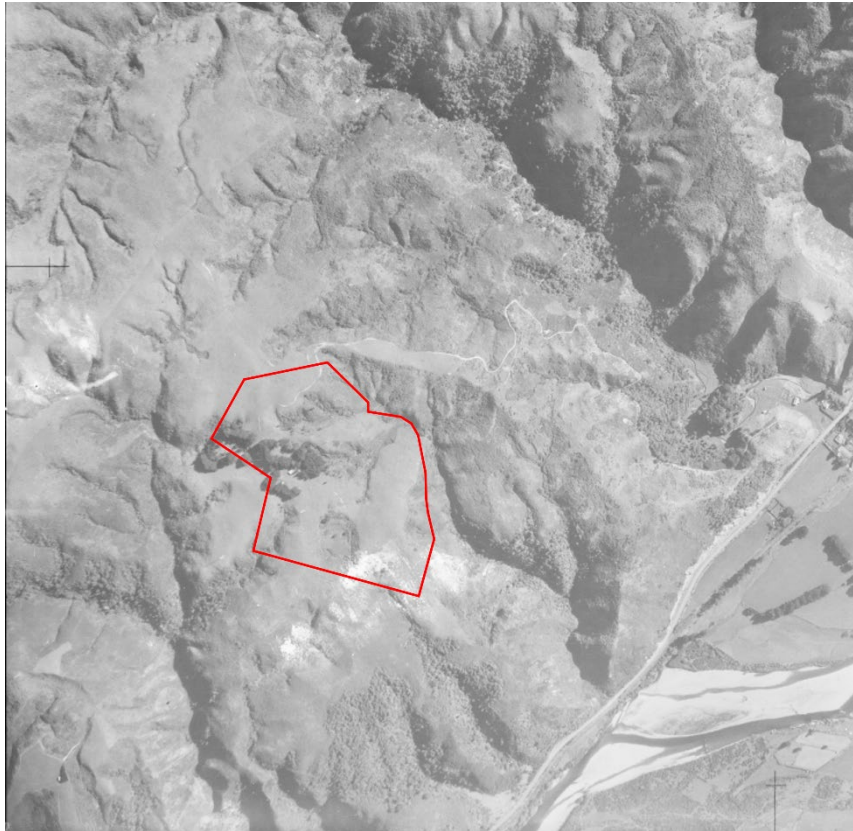
| Date | Description |
|---|---|
| 1942 | The site and surrounding area appear to be predominately grassed and in pastoral use. A small building and coppice of trees are visible in the western portion of the site. The site appears to be part of a wider farm, with an access track running from the site's northern boundary to farm buildings (including an animal race and associated buildings). |

**Historical Aerial Photograph 1: 1942 (Retrolens)**

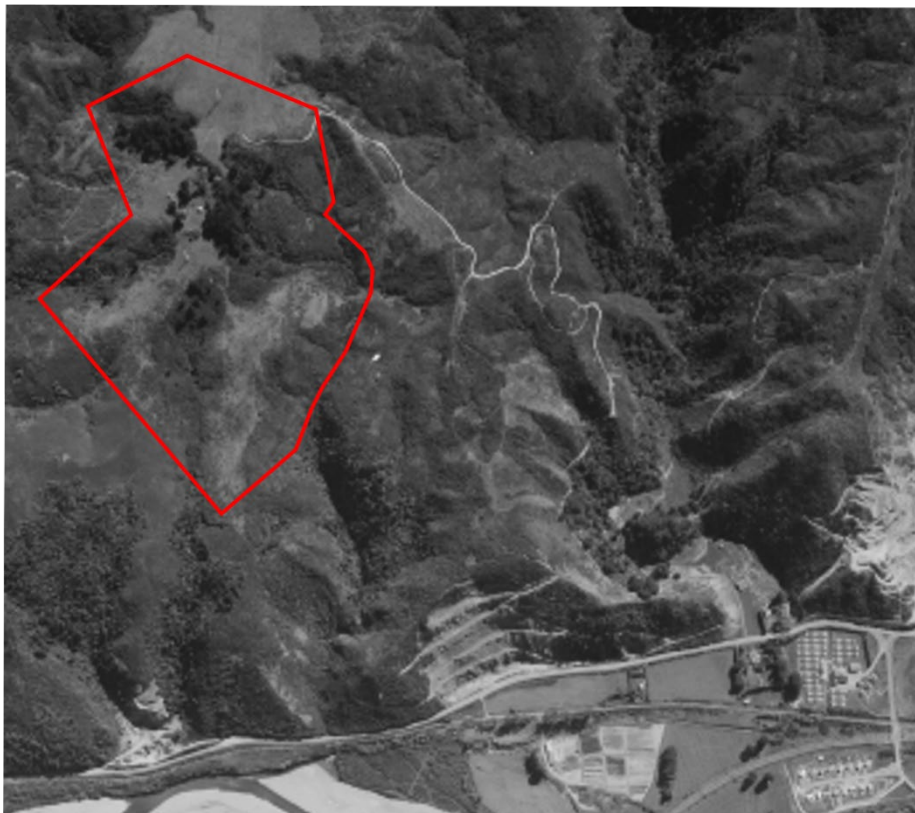
| Date | Description |
|---|---|
| 1957 | Dense vegetation cover is present across most of the site. Three pylons are visible in the north-western, central and south-western areas of the site. No other significant changes were observed. |

**Historical Aerial Photograph 2: 1957 (Retrolens)**

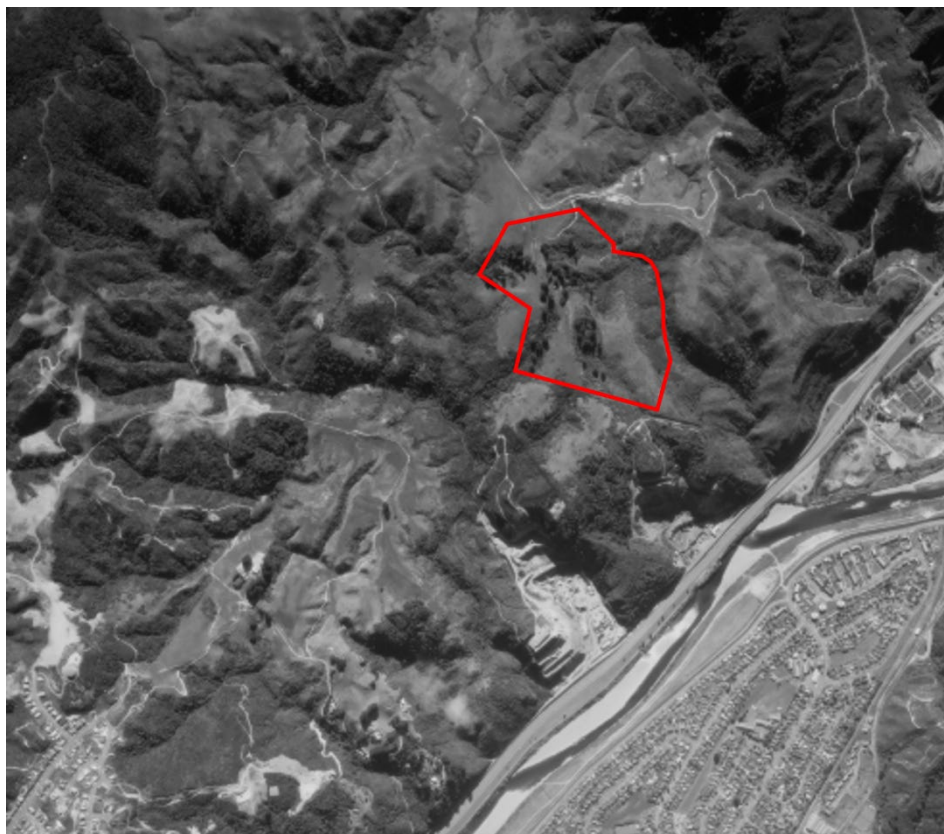
| Date | Description |
|---|---|
| 1984 | The onsite structures are no longer present. No other significant changes were observed. |

**Historical Aerial Photograph 4: 1984 (Retrolens)**

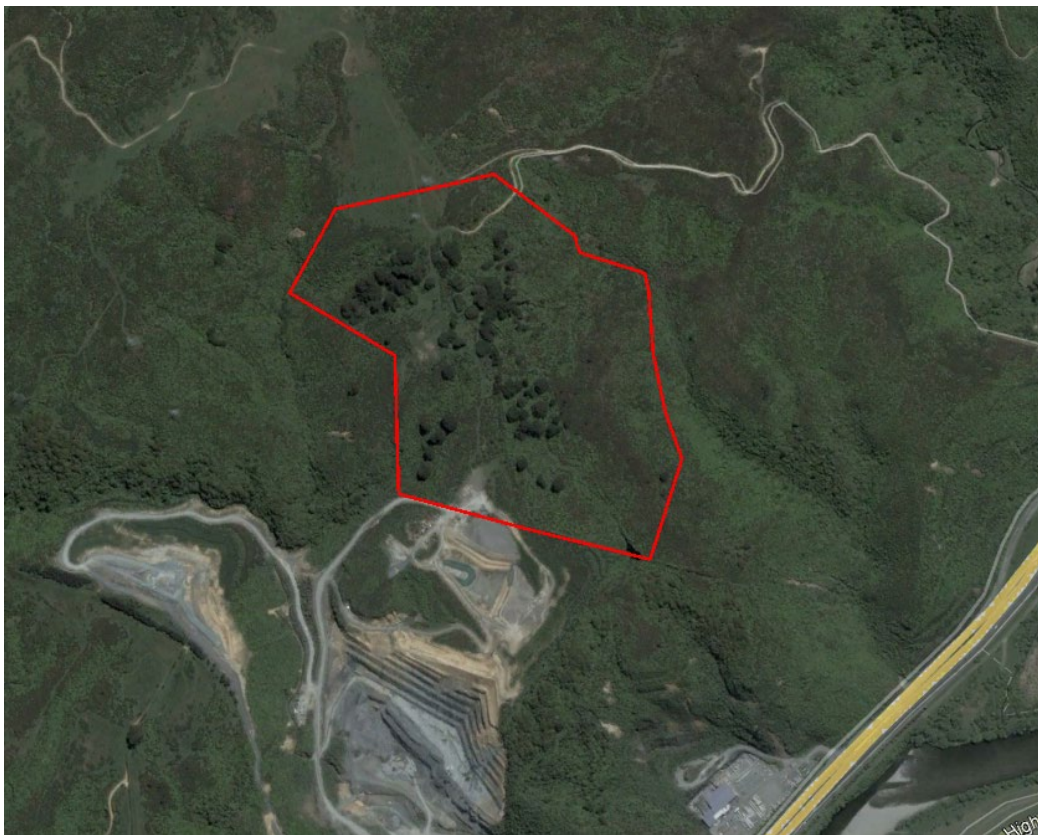
| 2004 | Increased ground disturbance associated with Belmont Quarry is visible in the south-western portion of the site. The access track to the north appears to be more defined. No other significant changes were observed. |

**Historical Aerial Photograph 6: 2004 (Google Earth Pro)**

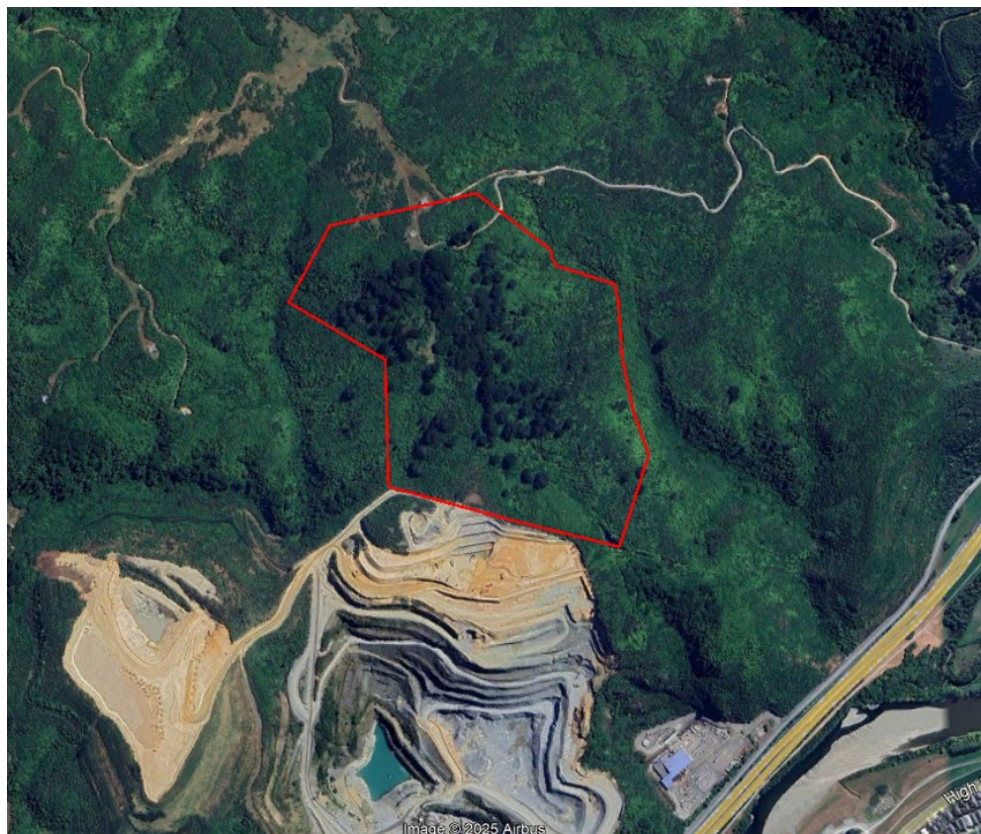
| 2024 | No significant changes observed from the 2009 aerial image. |

**Historical Aerial Photograph 10: 2024 (Google Earth Pro)**

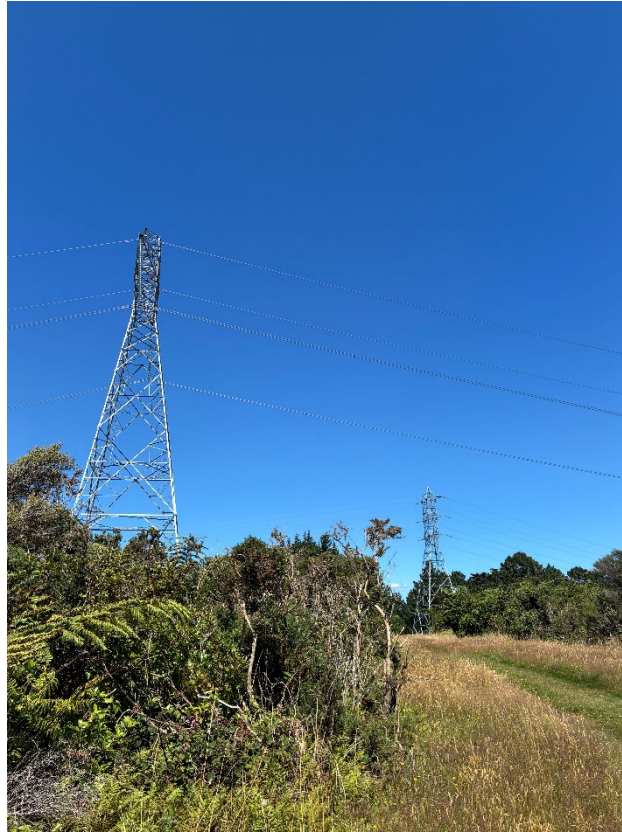
**Photograph 1: View of onsite pylons, looking north.**
