# **Appendix F      Geotechnical Assessment**

**Hinuera Solar Farm**

# GEOTECHNICAL INVESTIGATION REPORT

Job No. HAM2025-0095AB | Version 2

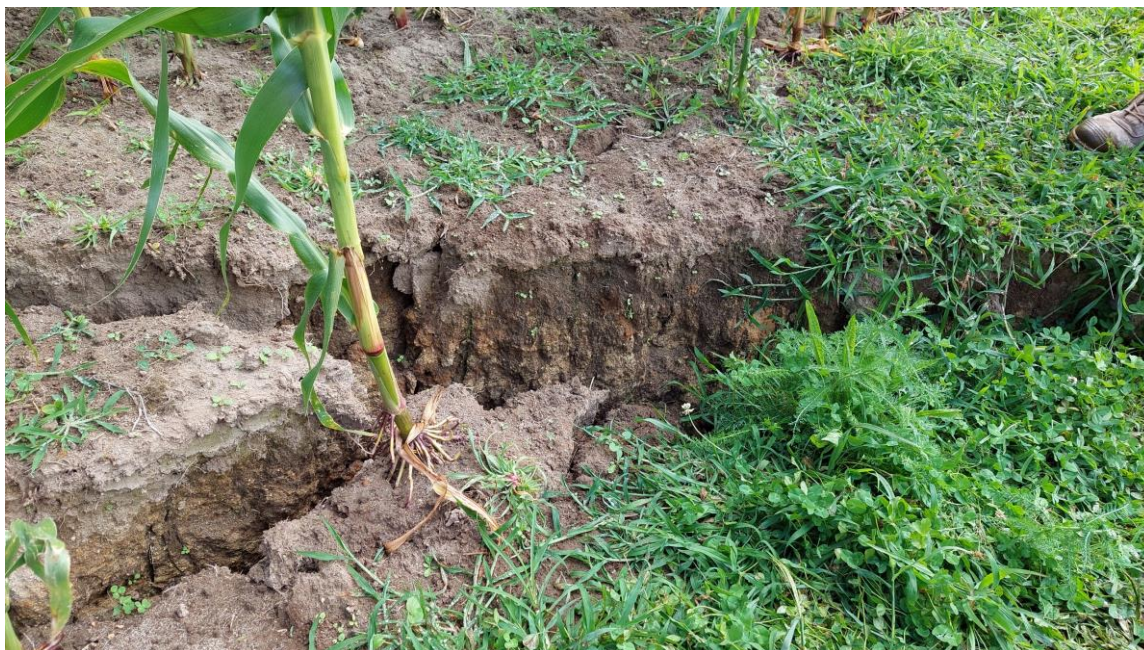
Figure 3: Surface displacement along the Kerepehi Fault following the 2023 earthquake (near Te Aroha township)

The Kerepehi Fault is the one of the most active faults in the region with the last major seismic event occurring in 2023 with a Magnitude 4.8 and a vertical displacement of approximately 0.6m.

Previous studies of the Kerepehi Fault<sup>9</sup> referenced by the database, indicate the Okoroire segment of the Kerepehi Fault as having a recurrence interval of >10,000 years for characteristic seismic ruptures ranging from Mw 5.5 to 7.0. Paleoseismic data for the last 25,000 ( $\pm 2,500$ ) years indicates an average slip rate of 0.08-0.4mm per year, that is to say, low risk.

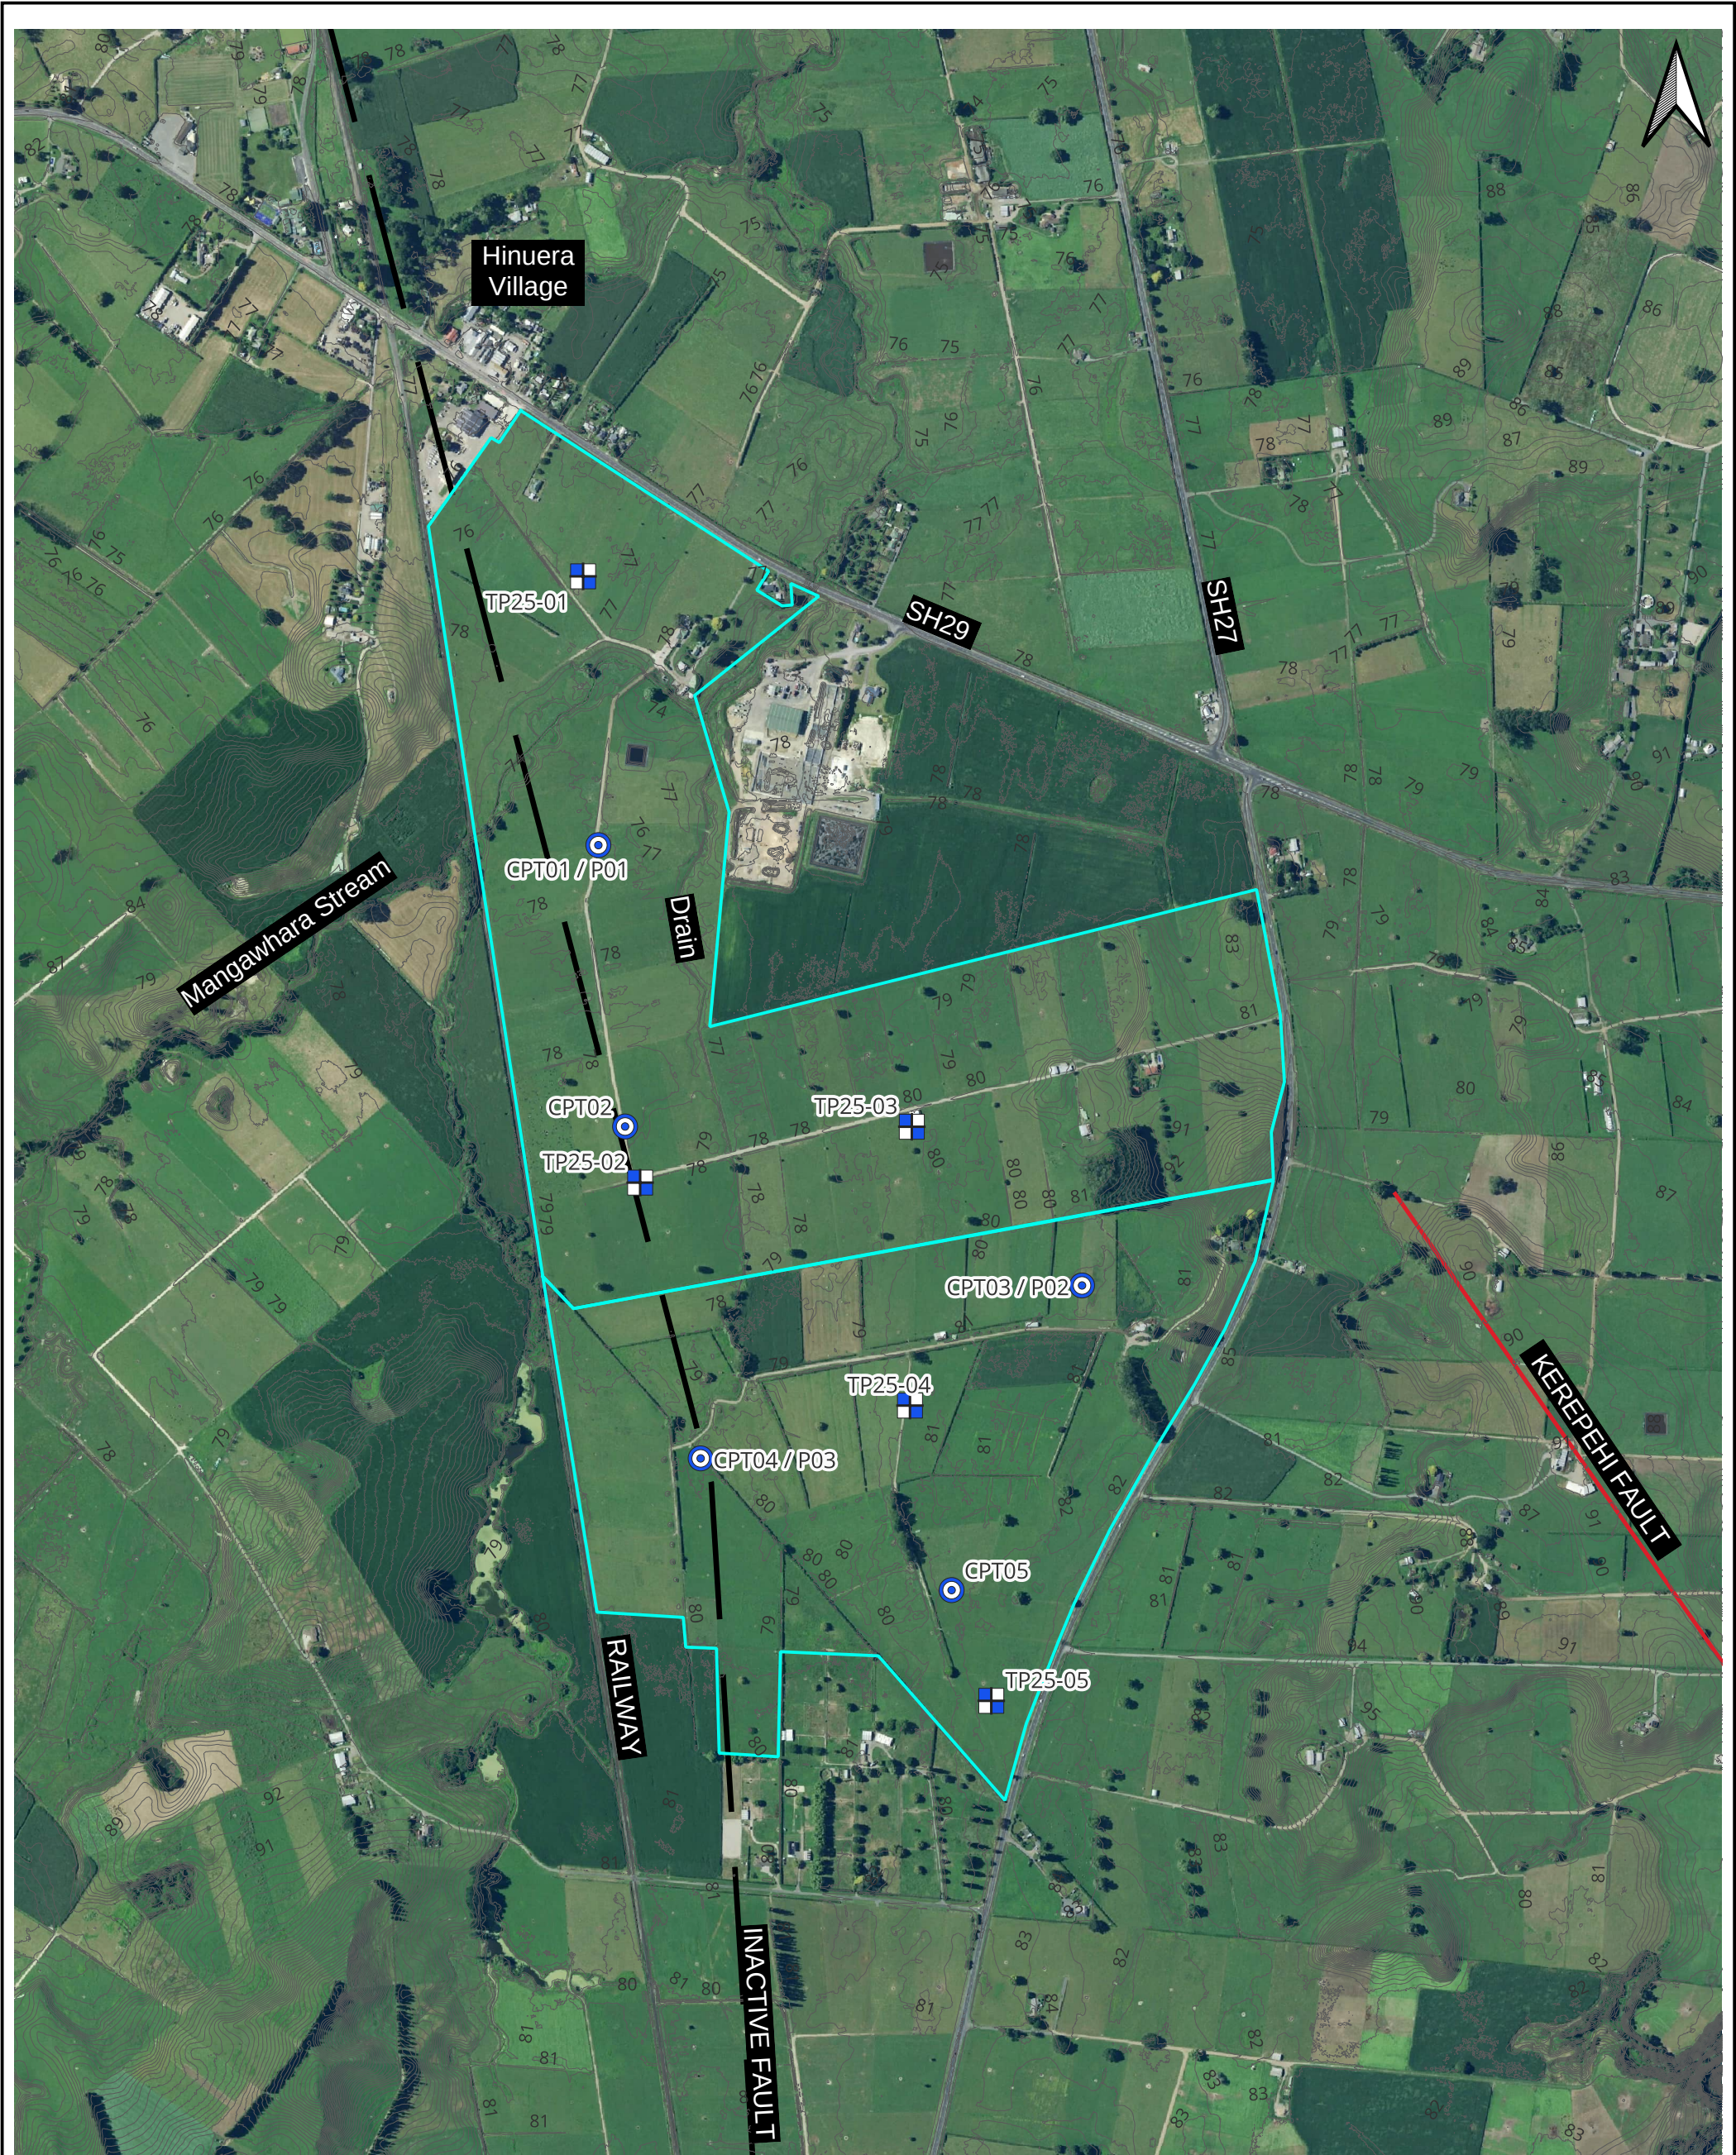
## Drawings

LEGEND:

- Boundary
- CMW
- OpenGround
- HAM2025-0095 - OpenGround Locations
- CPT
- TP
- Contours
- GNS 250K Geology
- New Zealand mainland
- Faults
- Inactive Faults

- Undertook a walkover survey of the site to assess the general landform and site conditions;
- Five Cone Penetrometer Tests, denoted CPT01 to CPT05, were pushed to depths of between 12.3 and 20m. Results of the CPT's, presented as traces of tip resistance (qc), friction resistance (fs) and friction ratio are presented in **Appendix C**;
- Five Test Pits, denoted TP01 to TP05, were excavated using a 12-tonne excavator to depths of between 2.5 and 3.4m below existing ground levels (target depth was 5m though they all collapsed early due to shallow groundwater). In situ shear vane tests were carried within the test pits walls where fine grained soils were encountered and Dynamic Cone (Scala) Penetrometer Probe tests (DCP) were carried out adjacent to the test pits where granular soils were encountered. Engineering logs and photographs of the test pits are also presented in **Appendix D**;
