During the review of the available information, it was noted that due to the age of the current and former site buildings there was potential for ground contamination from the historic use of lead-based paints and potentially asbestos containing building materials. In addition, historical horticulture land use was noted on neighbouring properties, therefore contamination associated with spray-drift may have occurred at the site.

The site was visited and a site inspection and walk over was carried out by Focus Environmental Services Limited personnel on 15<sup>th</sup> of August 2022. During the site inspection, potential spray race operations, two areas of refuse burning and three areas of potential asbestos containing materials in a degraded condition were noted.

Due to the elevated levels of arsenic, cadmium, lead, zinc and asbestos fibres detected, the site at 279 Airfield Road, Ardmore will require remediation of the affected soils prior to being redeveloped. The estimated volume of soil requiring remediation is 58.4m<sup>3</sup>. It should be noted that this volume may change during the remedial process.

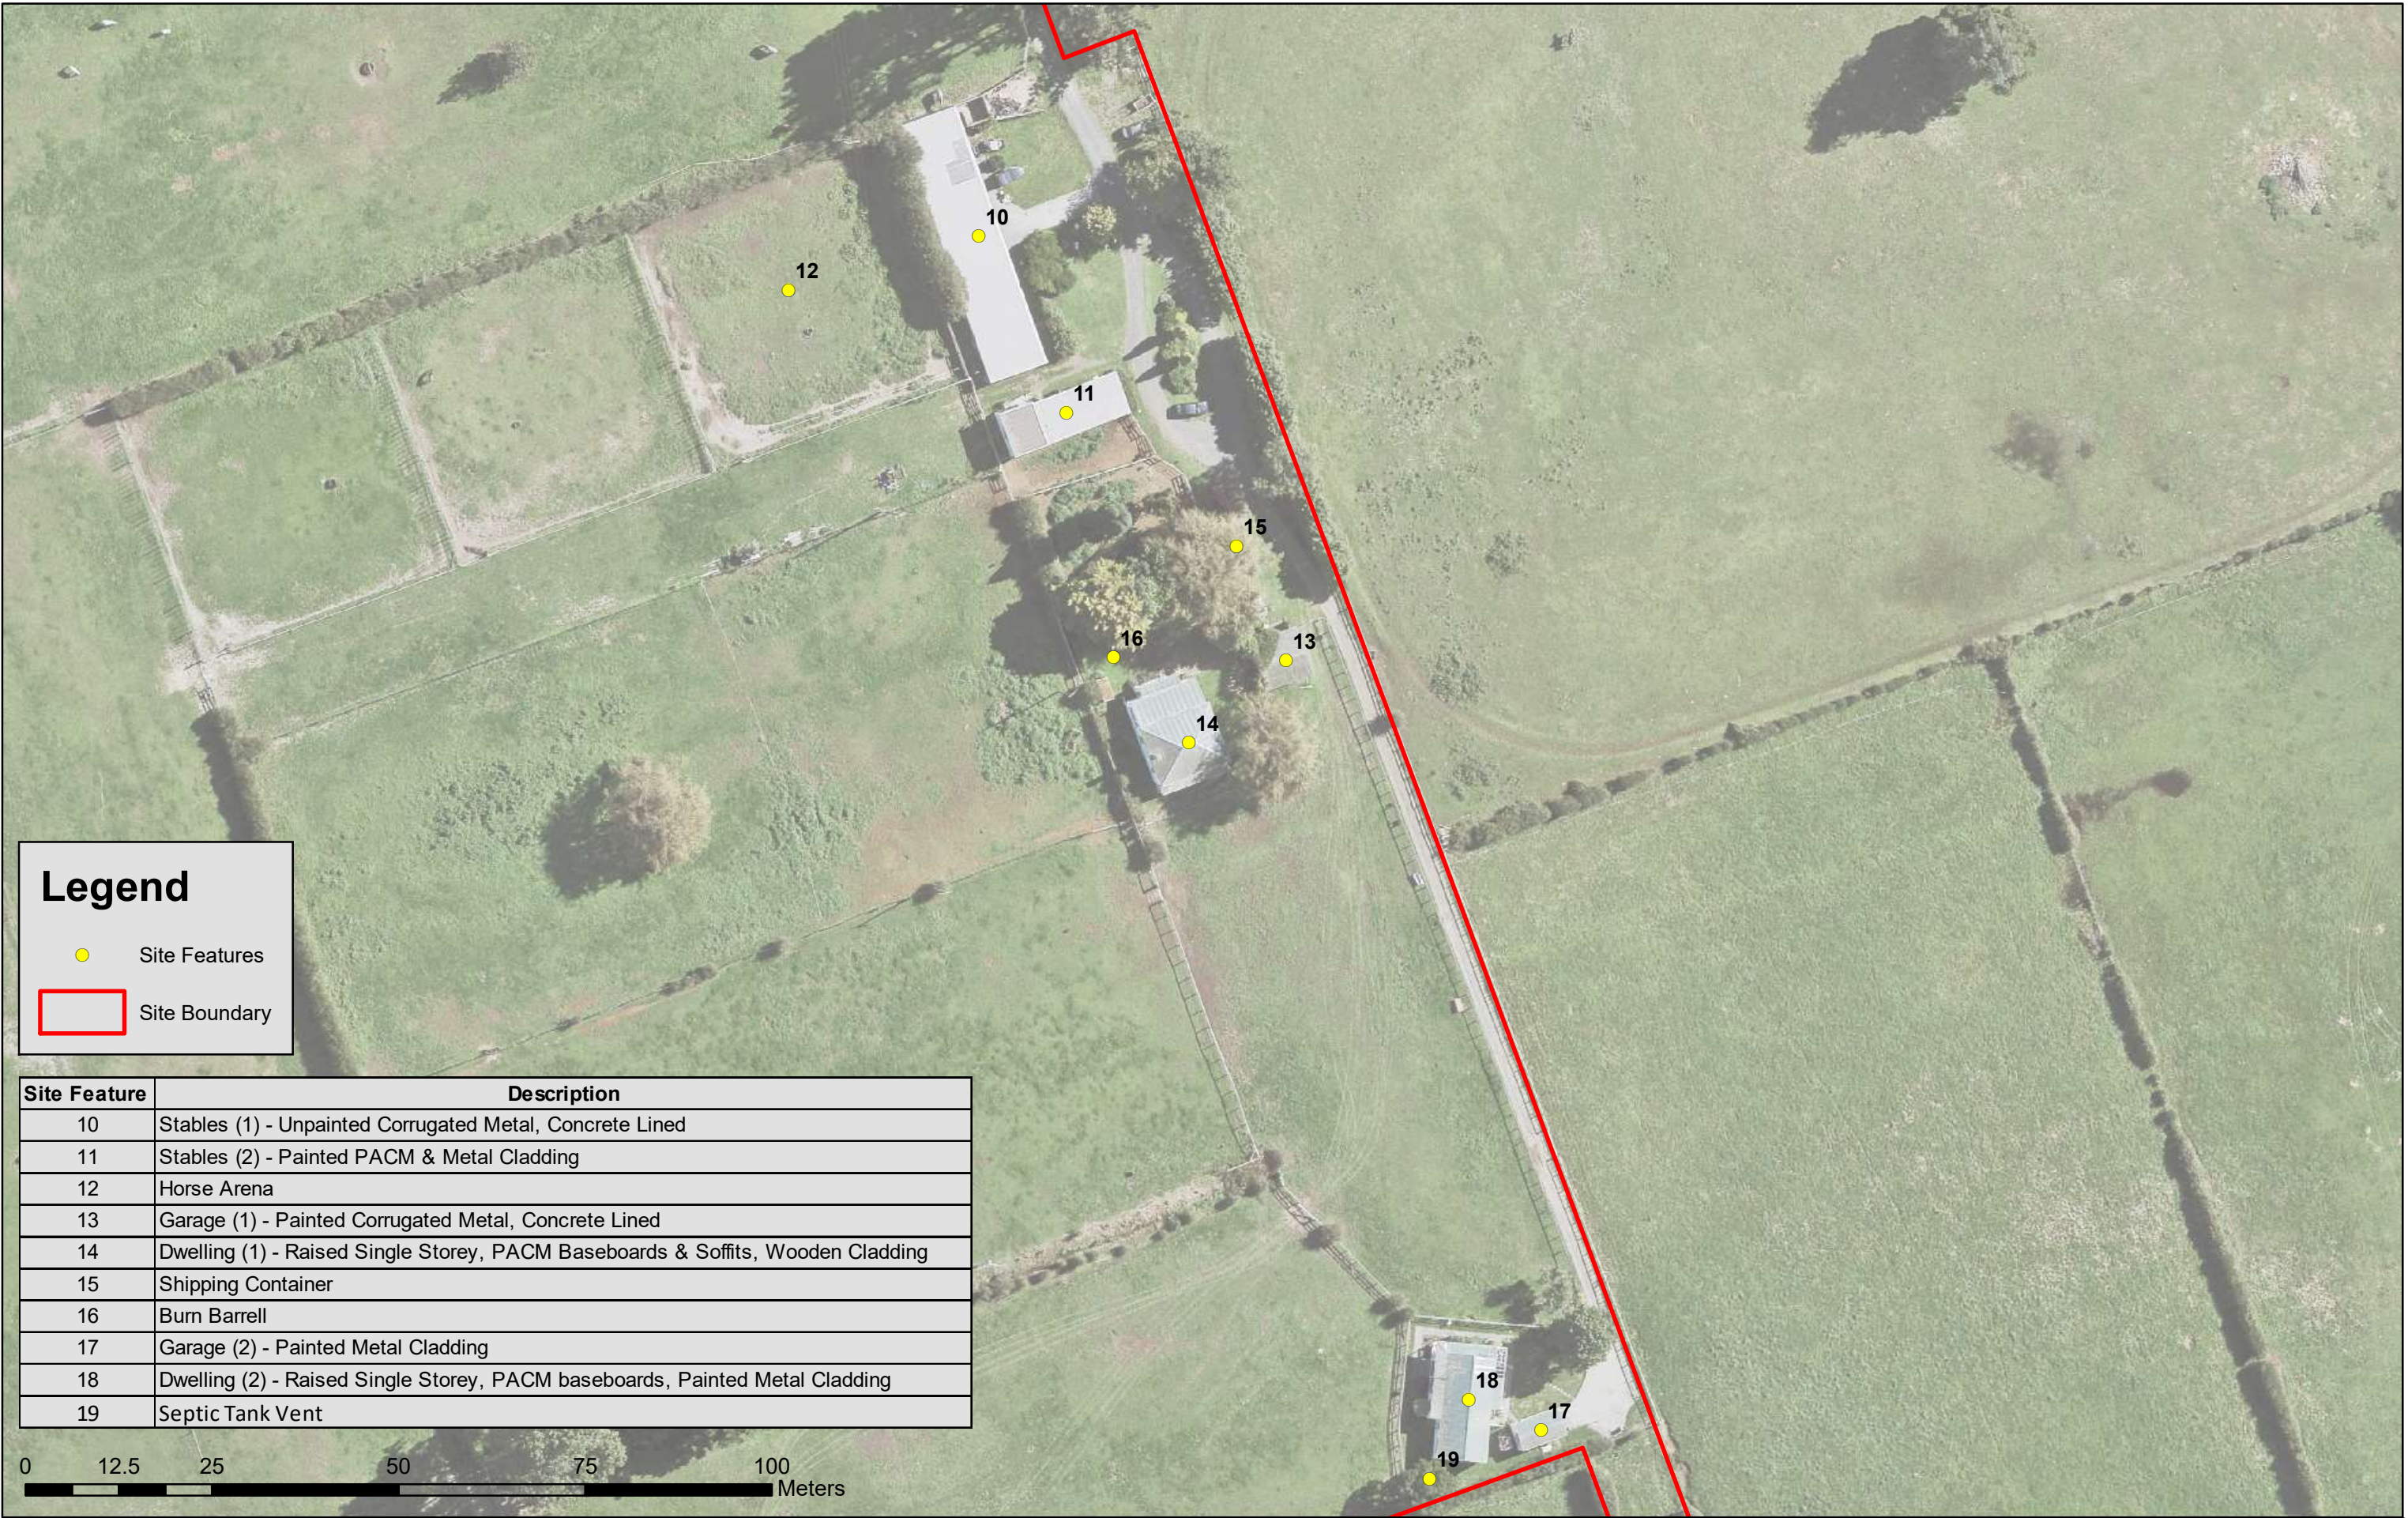
Site Feature	Description
10	Stables (1) - Unpainted Corrugated Metal, Concrete Lined
11	Stables (2) - Painted PACM & Metal Cladding
12	Horse Arena
13	Garage (1) - Painted Corrugated Metal, Concrete Lined
14	Dwelling (1) - Raised Single Storey, PACM Baseboards & Soffits, Wooden Cladding
15	Shipping Container
16	Burn Barrell
17	Garage (2) - Painted Metal Cladding
18	Dwelling (2) - Raised Single Storey, PACM baseboards, Painted Metal Cladding
19	Septic Tank Vent

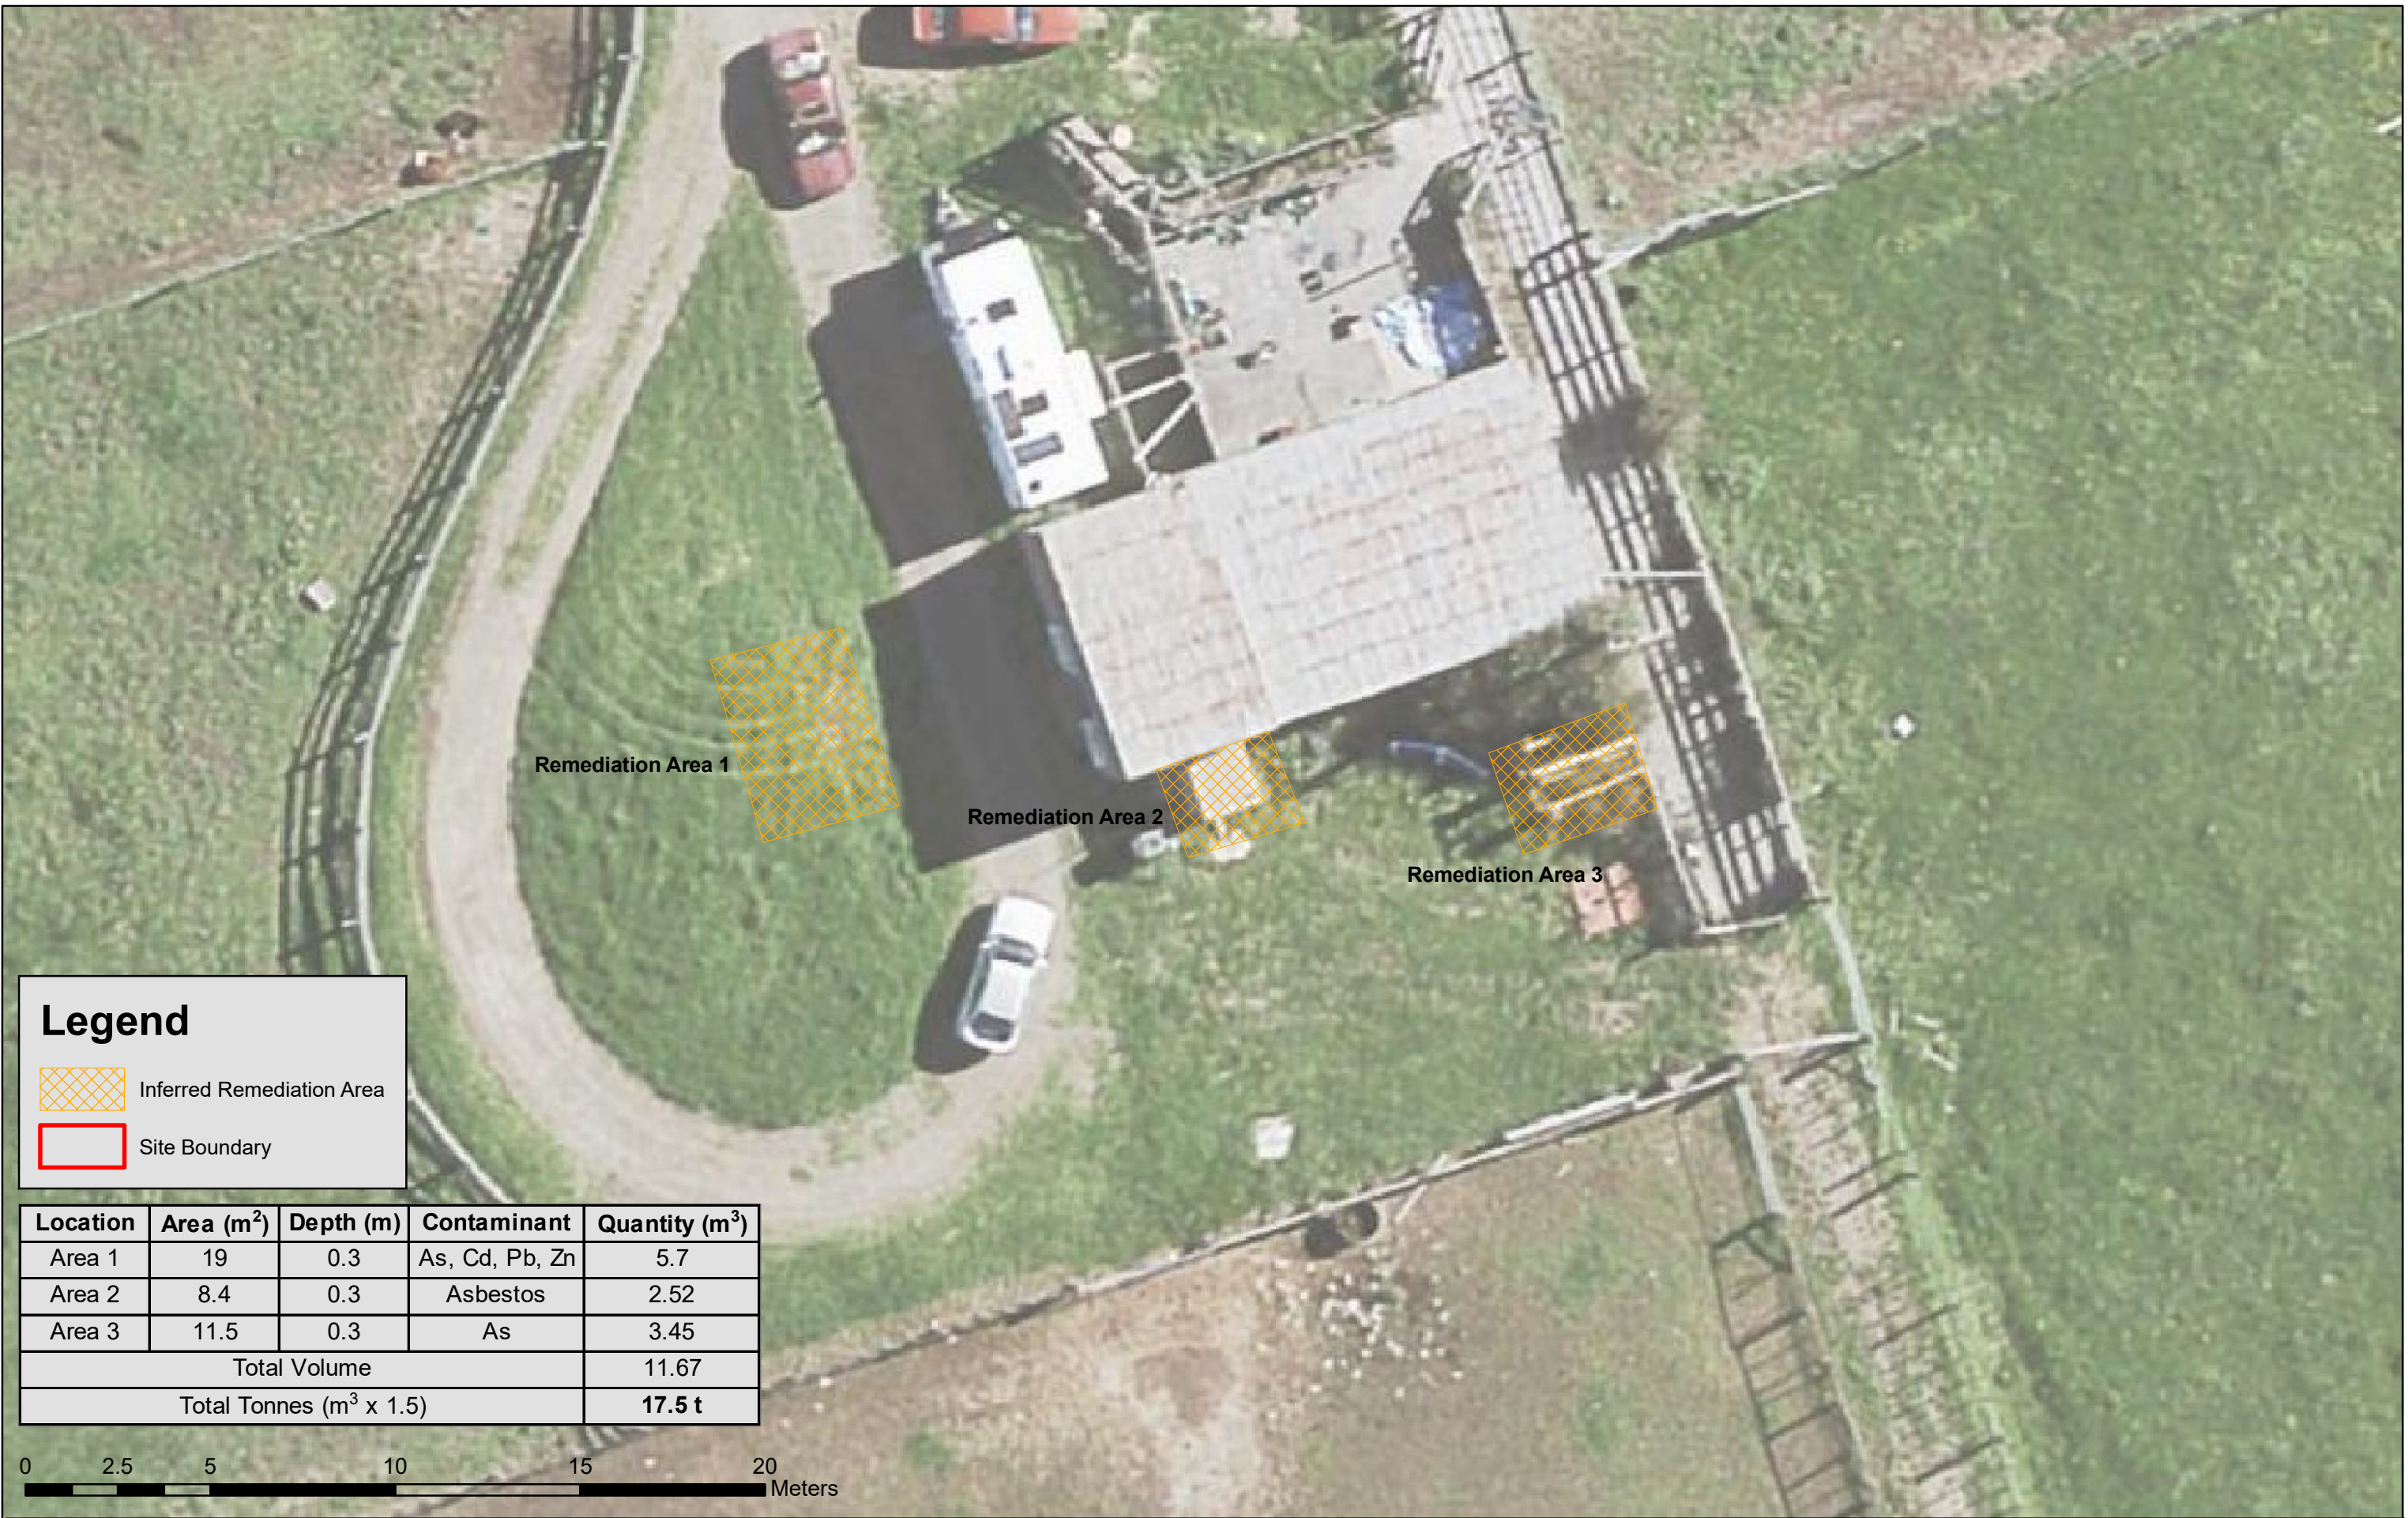
The inferred extent of the contaminated soil at the site is presented in Figures 5 & 5-1. This estimate is based on the sampling and results available following the site investigation and it should be noted that the volume may increase or decrease following inspection and validation sampling.

Location	Area (m <sup>2</sup> )	Depth (m)	Contaminant	Quantity (m <sup>3</sup> )
Area 1	19	0.3	As, Cd, Pb, Zn	5.7
Area 2	8.4	0.3	Asbestos	2.52
Area 3	11.5	0.3	As	3.45
Total Volume				11.67
Total Tonnes (m <sup>3</sup> x 1.5)				17.5 t

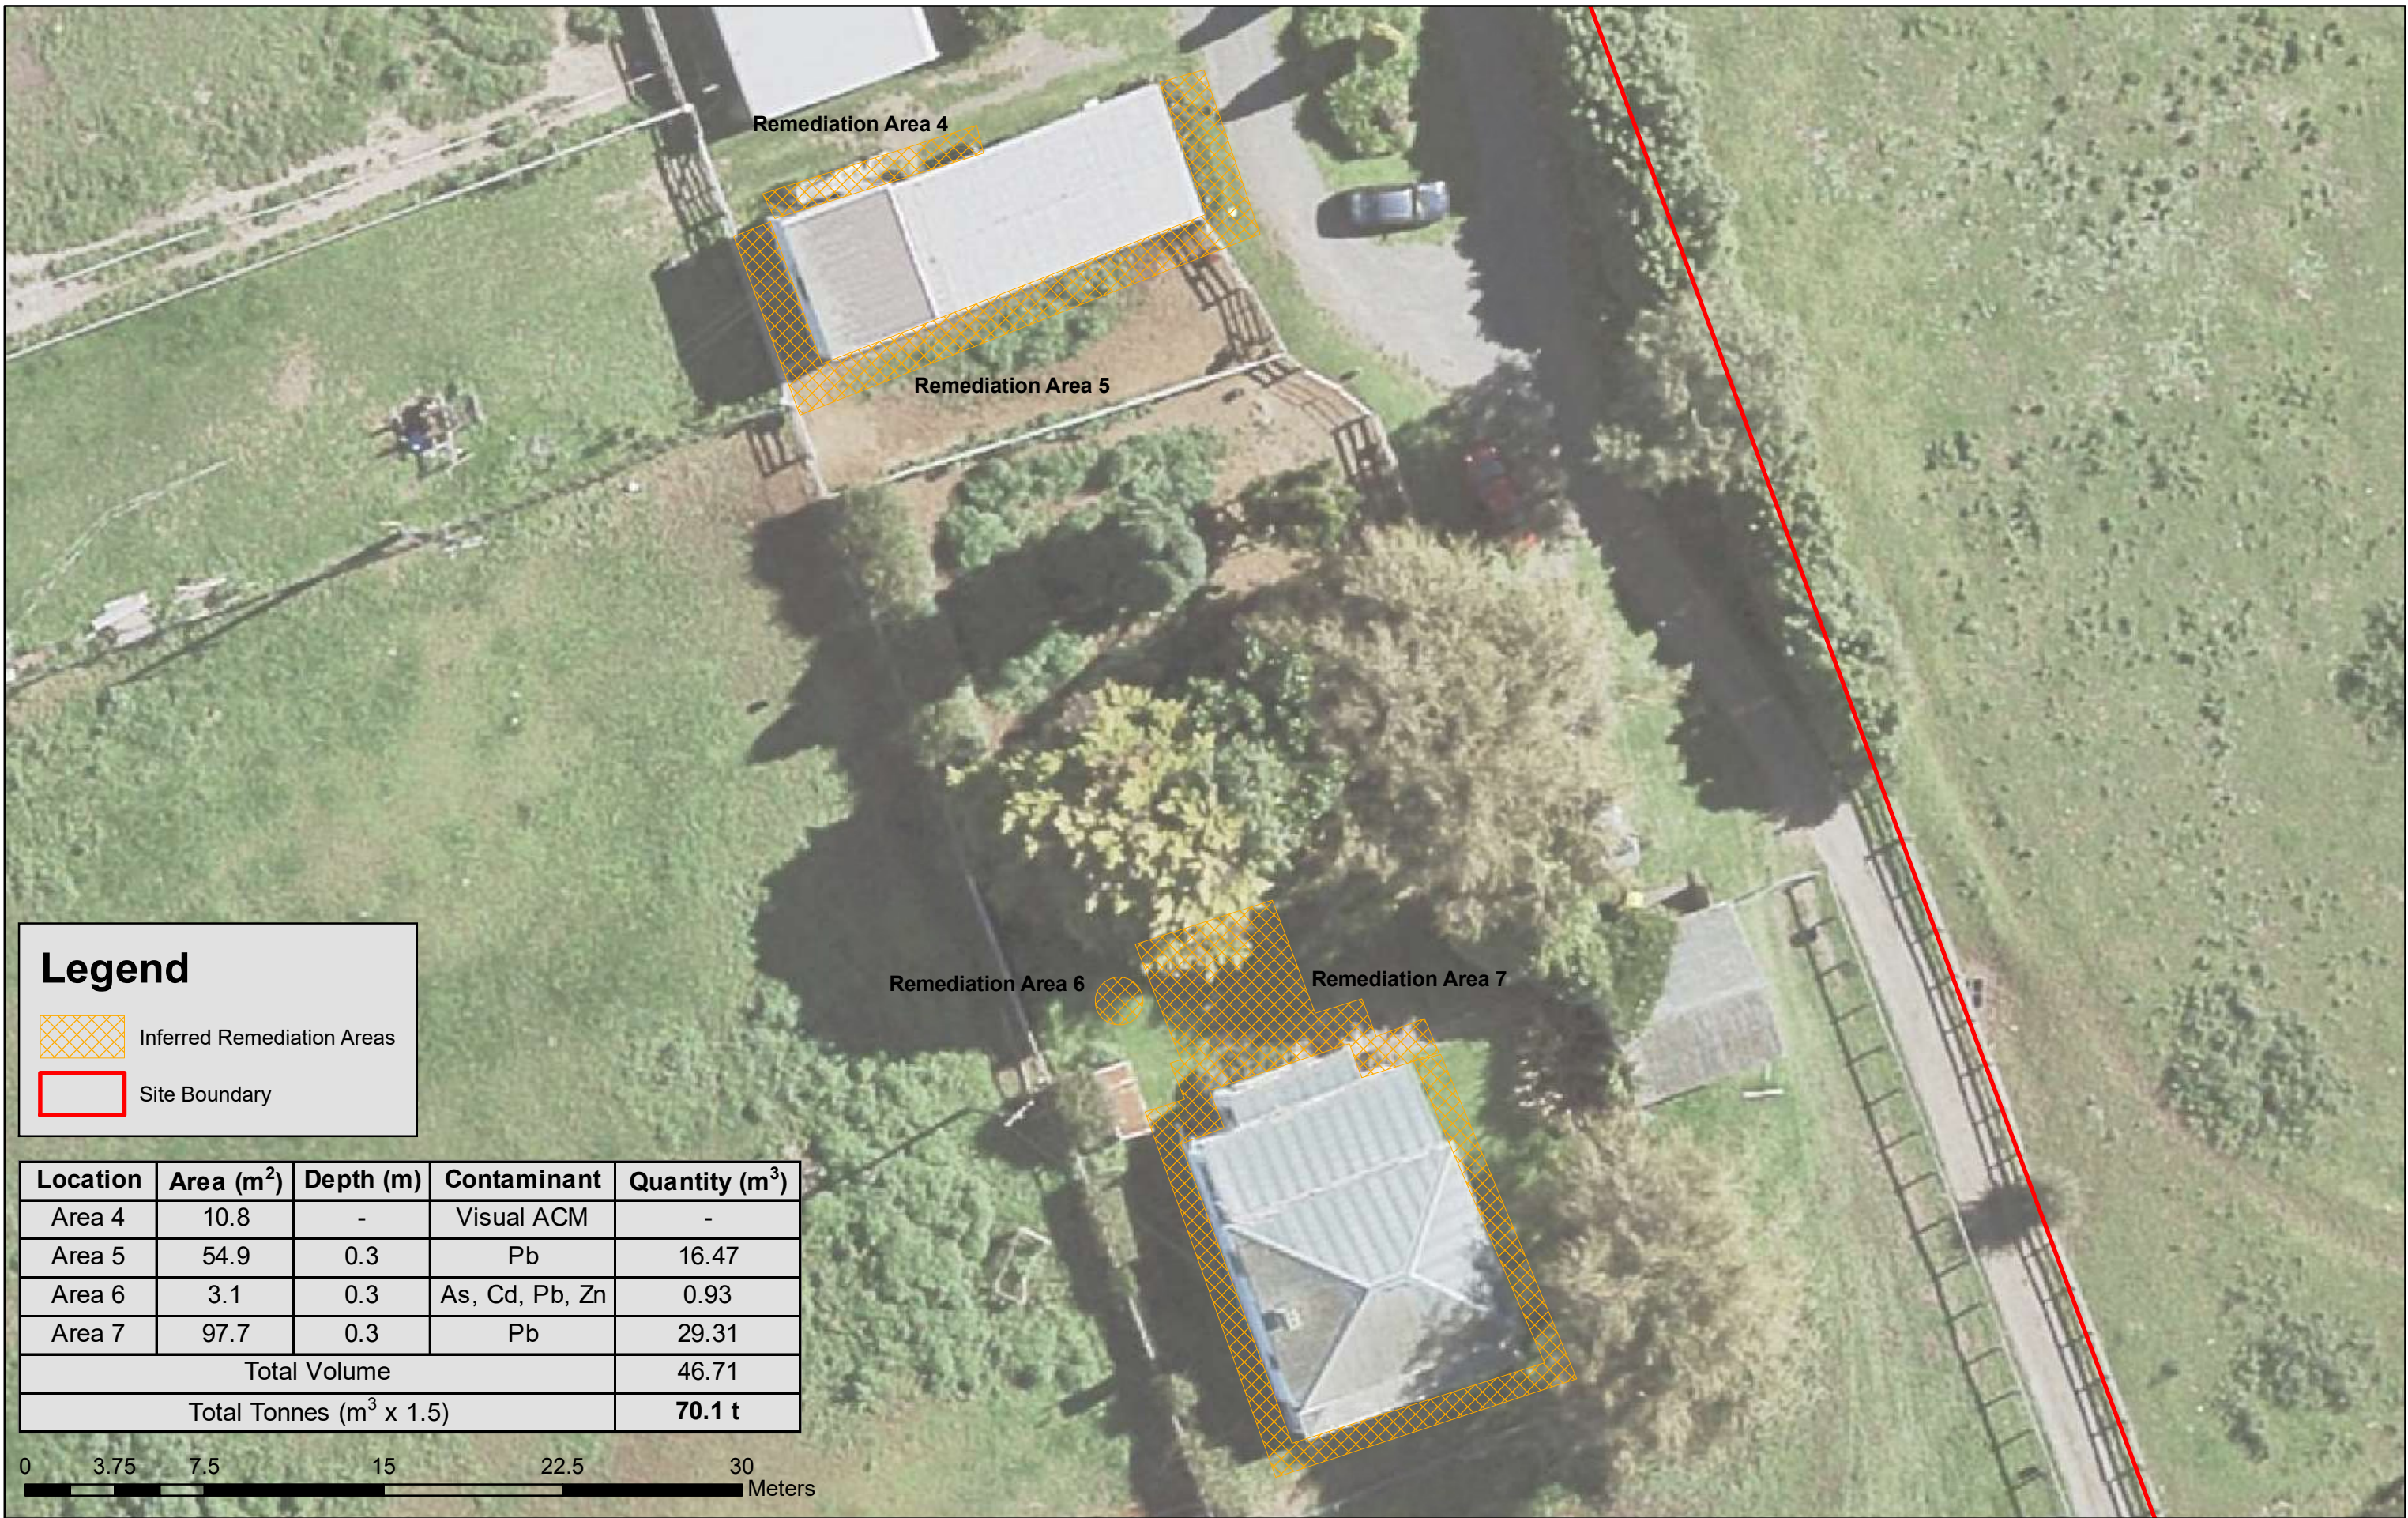
Location	Area (m <sup>2</sup> )	Depth (m)	Contaminant	Quantity (m <sup>3</sup> )
Area 4	10.8	-	Visual ACM	-
Area 5	54.9	0.3	Pb	16.47
Area 6	3.1	0.3	As, Cd, Pb, Zn	0.93
Area 7	97.7	0.3	Pb	29.31
Total Volume				46.71
Total Tonnes (m <sup>3</sup> x 1.5)				70.1 t

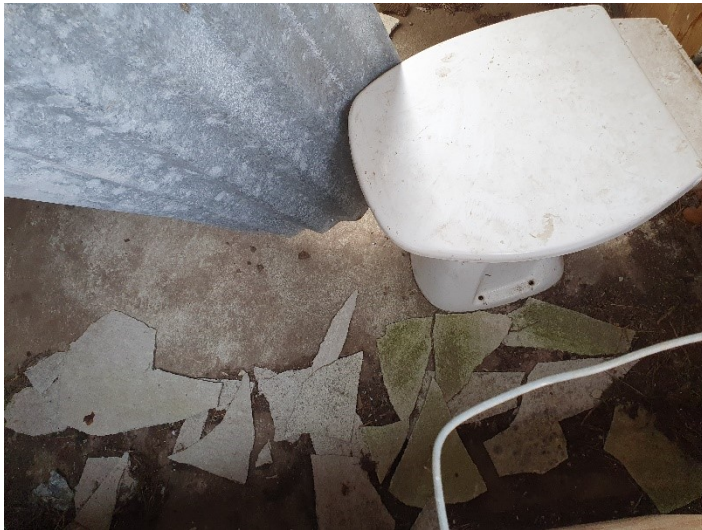
A toilet constructed of unpainted plywood and PACM cladding was located to the south of the livestock shed. Minor damage was observed to the PACM cladding with fragments visible on the ground both on the exterior and interior of the toilet.

Toilet Interior – PACM Fragments

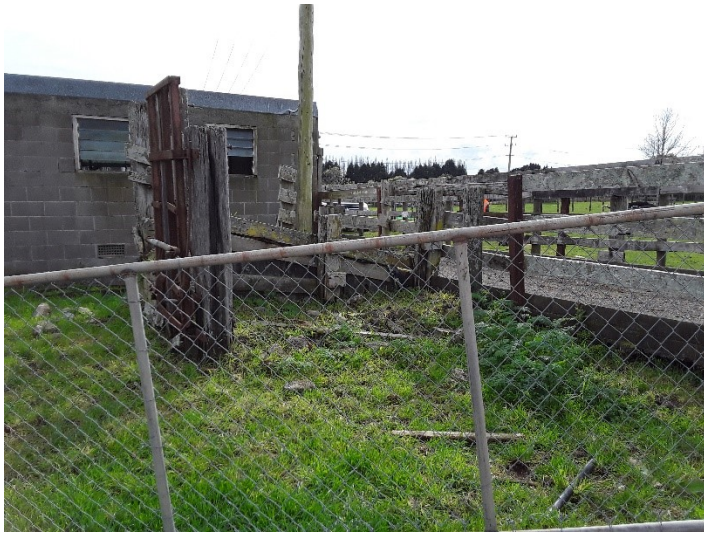
Elevated concentrations of arsenic, cadmium, lead and zinc were detected in the site soils in the locations of the two burn piles. In addition, elevated concentrations of arsenic were detected in the spray race/stock loading area (2). Elevated concentrations of lead were detected in the areas around the stables (2), HB05 and the dwelling (1). Furthermore, elevated concentrations of asbestos fibres and visual evidence of asbestos were identified in the area of the outdoor toilet, and visual evidence of asbestos was observed in contact with the soils on the northern side of the stables (2).

Livestock Spray Race/Loading Area (2)

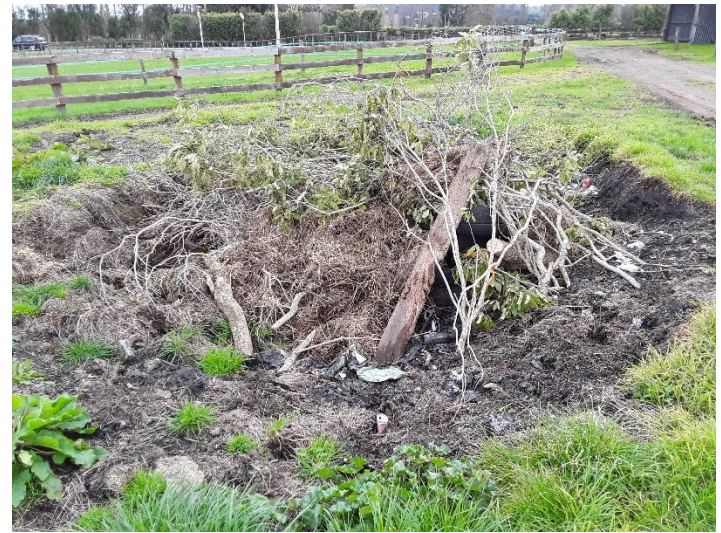
In the centre of the turning area a burn/refuse pit was located. It was comprised of vegetation, hay, tyres, brick, plastics and general rubbish.

Burn/ Refuse Pit

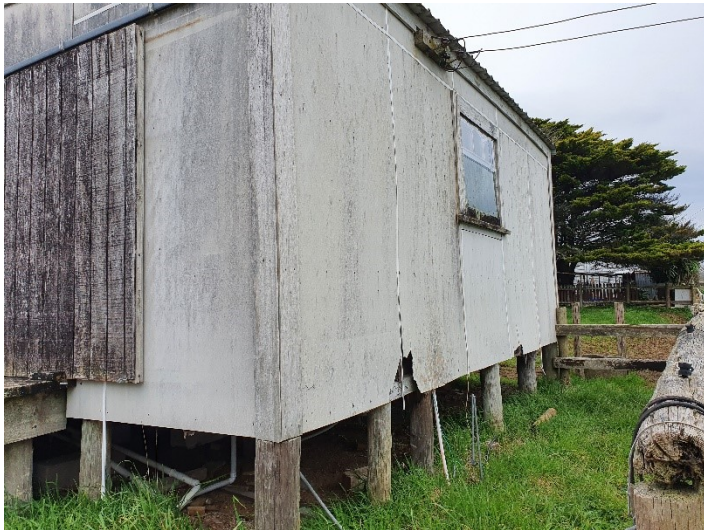
External PACM products of the site structures are likely restricted to the exterior toilet cladding, the exterior cladding of the stables (2), the baseboards and soffits of dwelling (1), and the baseboards of dwelling (2). With the exception of the exterior toilet cladding, and exterior cladding of the stables (2), these materials appeared painted and in relatively good condition, and are considered unlikely to present as a source of ground contamination in their current state.

Stables (2) - Minor Damage to PACM  
Cladding

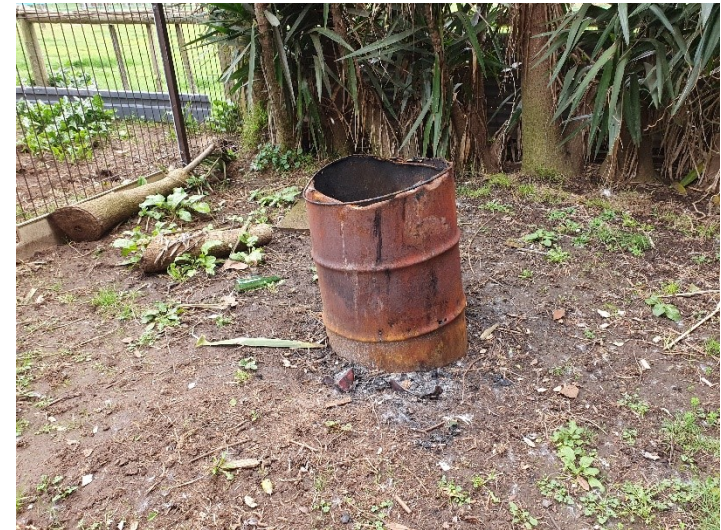
A small burn barrel was located in the yard area of the dwelling (1), with burnt wood and aluminium cans observed.

Burn Barrell

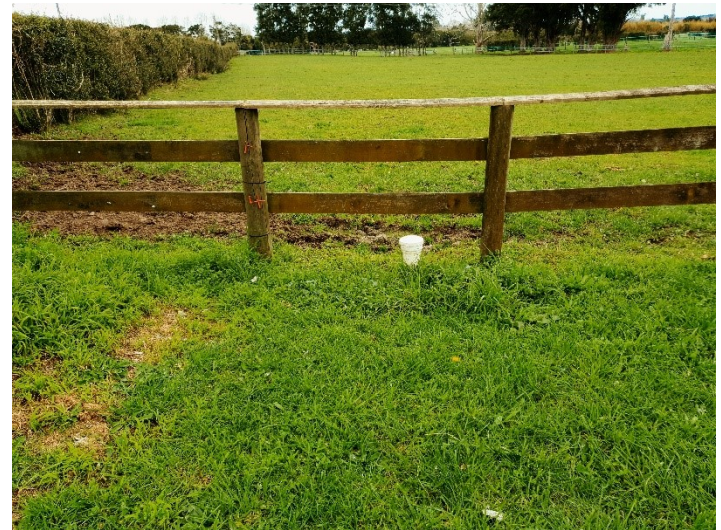
Septic Tank Vent

It is recommended that the septic tank present onsite is to be removed by a trained operator in accordance with industry best practice. Additionally, the contaminants of concern associated with domestic tanks are primarily microbiological (E.Coli and Faecal Coliforms) and, if present in the soils surrounding the tank, are likely to naturally attenuate following the removal of the septic tank, and therefore pose no long term risk to human health or the environment.
