Title: Maitai River - Gibbs-Dennes Reach					
Date	Version	Description	Prepared by:	Reviewed by:	Authorised by:
12/01/2024	0.1	Draft for comment	A Horne	I Fuller	J Hodson
02/04/2024	1.0	Finalised document	A Horne	I Fuller	J Hodson
22/08/2024	2.0	Finalised document – Revision 2	R Frogner	J Hodson	J Hodson

Nelson City Council (NCC) have engaged Tonkin & Taylor Ltd (T+T) to undertake an assessment of options for the ongoing management of the section of Maitai River between Gibbs Bridge and Dennes Hole (Gibbs-Dennes Reach). Particularly, in response to the long-term evolution of this reach. The property owner along the true right bank of this reach has raised their concerns regarding the erosion of the true right bank with NCC and has expressed a desire for it to be remedied.

**PROJECT** MAITAI RIVER - GIBBS-DENNES REACH

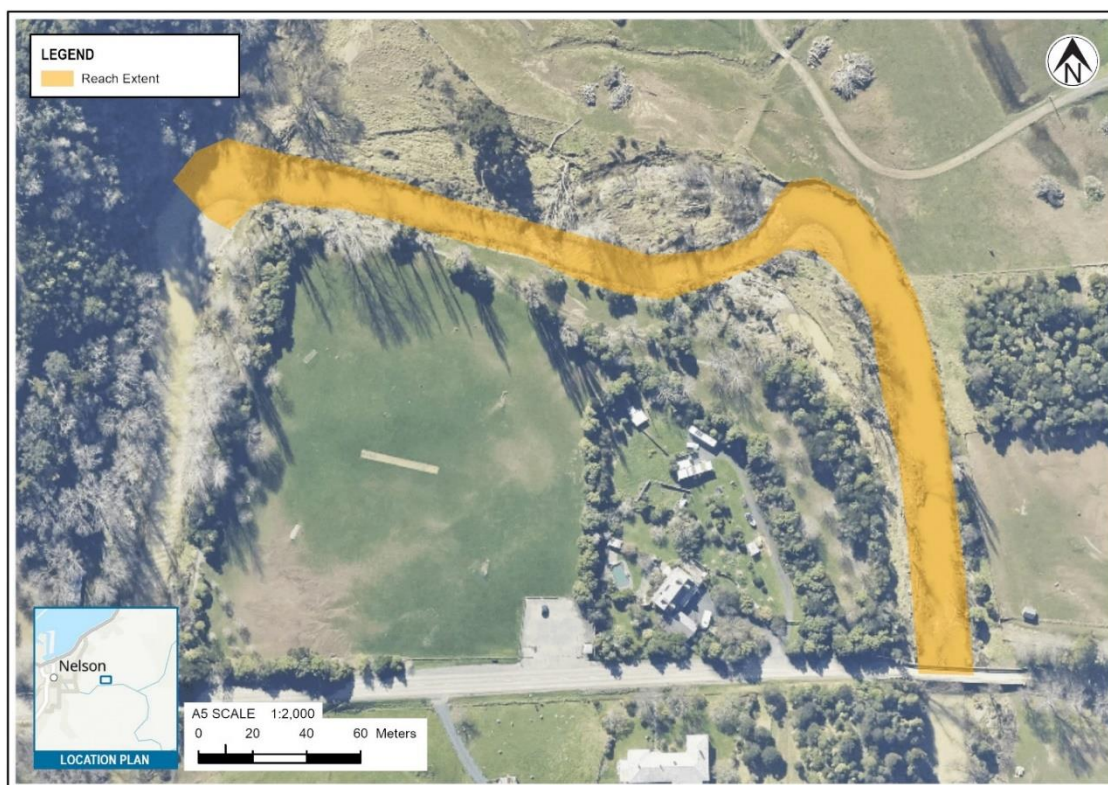
Figure 2.1: The Matai River Gibbs-Dennes Reach from Gibbs Bridge to Dennes Hole.

The Gibbs-Dennes Reach is located from Gibbs Bridge to Dennes Hole (Figure 2.1, Figure 2.2), approximately 1.1 km up the Maitai Valley Road from the Nile Street junction. The Maitai River has actively been eroding and depositing sediment in this reach, where the river bends, and the flow direction changes from north to west. Figure 2.3 shows the evolution of the Gibbs-Dennes Reach from 1940s to 2022, with both deposition and erosion occurring at the site. Figure 2.4 shows the active river channel migration overtime, with the active river channel delineated from aerials, overlaying the August 2022 aerial.

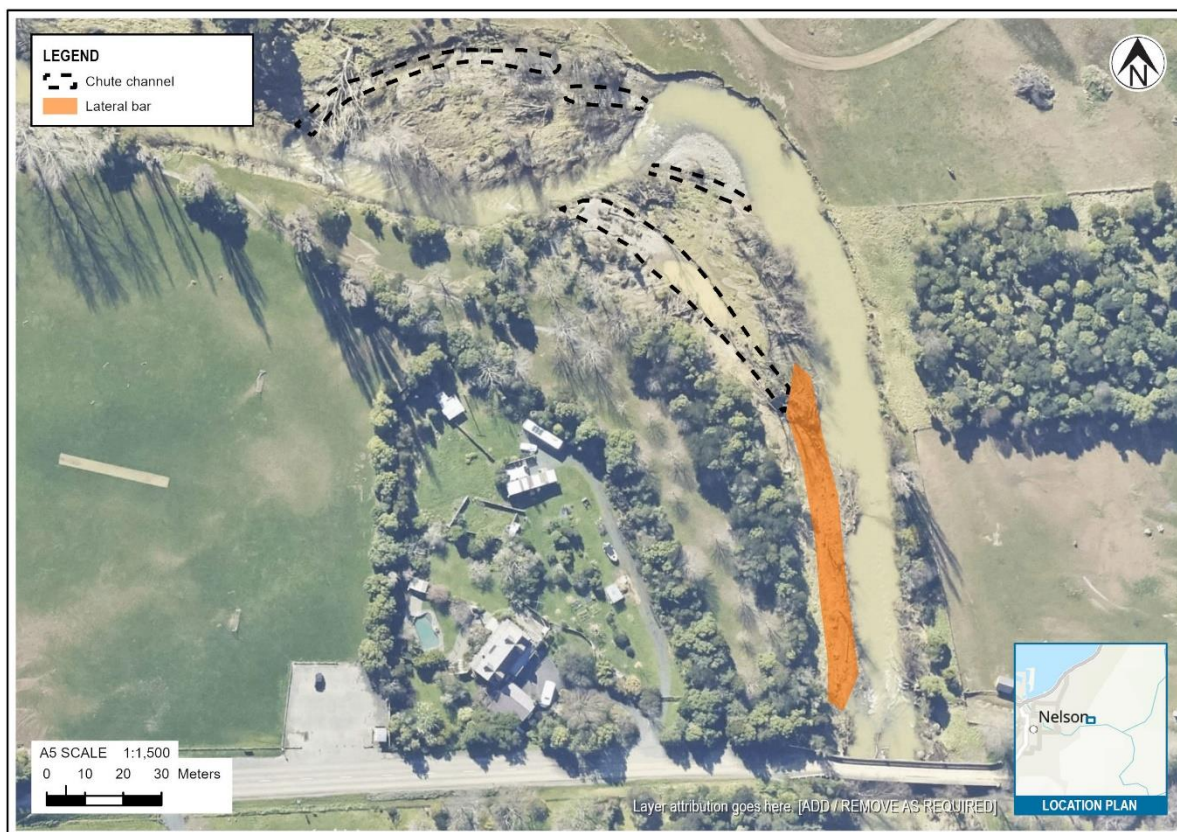
Figure 2.6: Plan of the upper Gibbs – Dennes reach, showing the lateral bar and chute channel.

Chute channels have formed on the inside of the bend as a result of channel migration, shown in Figure 2.6. There is a point bar between the chute and the main river channel, which has been developing with river migration (Figure 2.6). There are also lateral bars in the reach. Both are temporary sediment storage features of the river, which become sediment sources when activated during high flow events, where erosion and re-working are prevalent. However, vegetation is establishing on the point and lateral bars, “locking” sediment in place, which limits and will continue to limit sediment re-working.

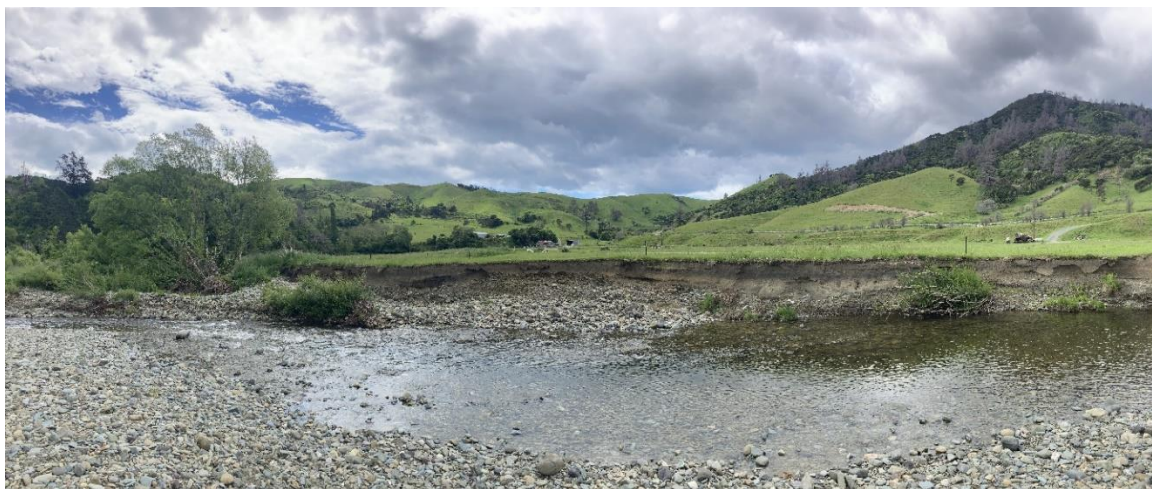
*Figure 2.7: Panoramic view of the corner where the Maitai river flows west. It shows the composition of the river bank, the floodplain on the true right of the river and the riparian vegetation.*

The banks of the stream in this reach are typically vegetated, although at the corner where the river bends west, a face of the bank was exposed (Figure 2.7). The bank is composed of topsoil (300 mm thick, silt dominant), overlying sandy silt (500 – 700 mm thick), overlying imbricated moderately sorted gravels with some sand in 1.5-2 m high banks (Figure 2.7). The soil is tightly packed and has a high friction angle as the banks are near vertical and are currently stable in normal flows. These riverbanks are a source of sediment in the Gibbs-Dennes Reach.

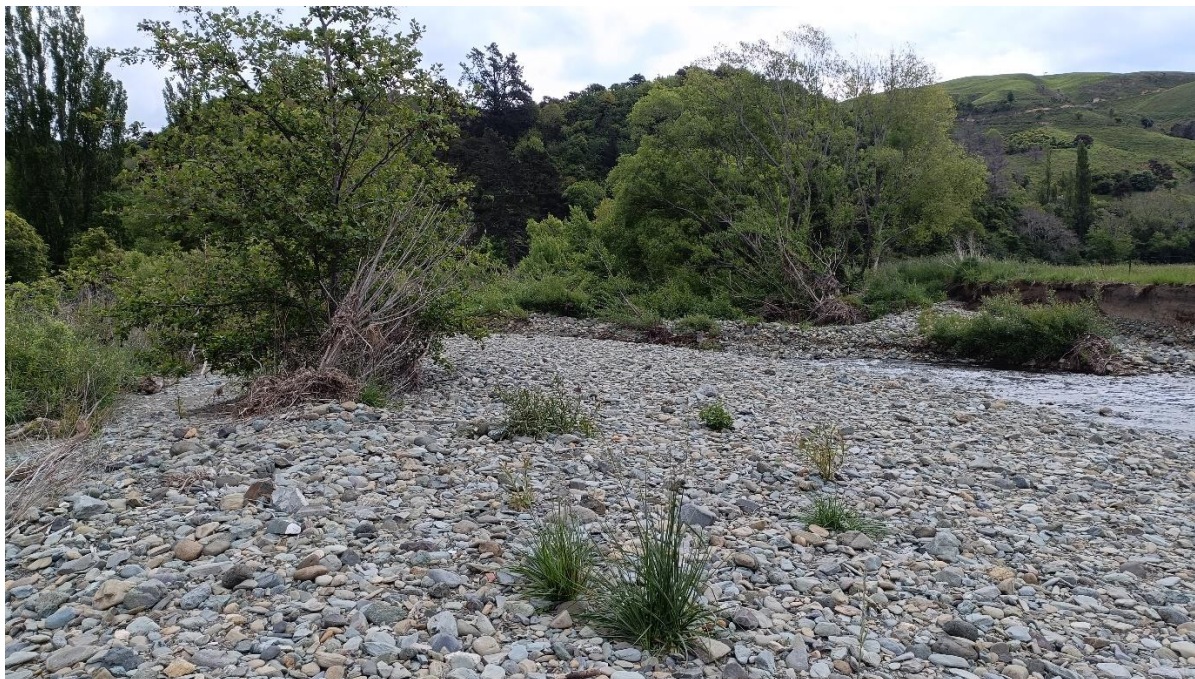
*Figure 2.9: Over-loose bed at the point bar with the Gibbs-Dennes Reach.*

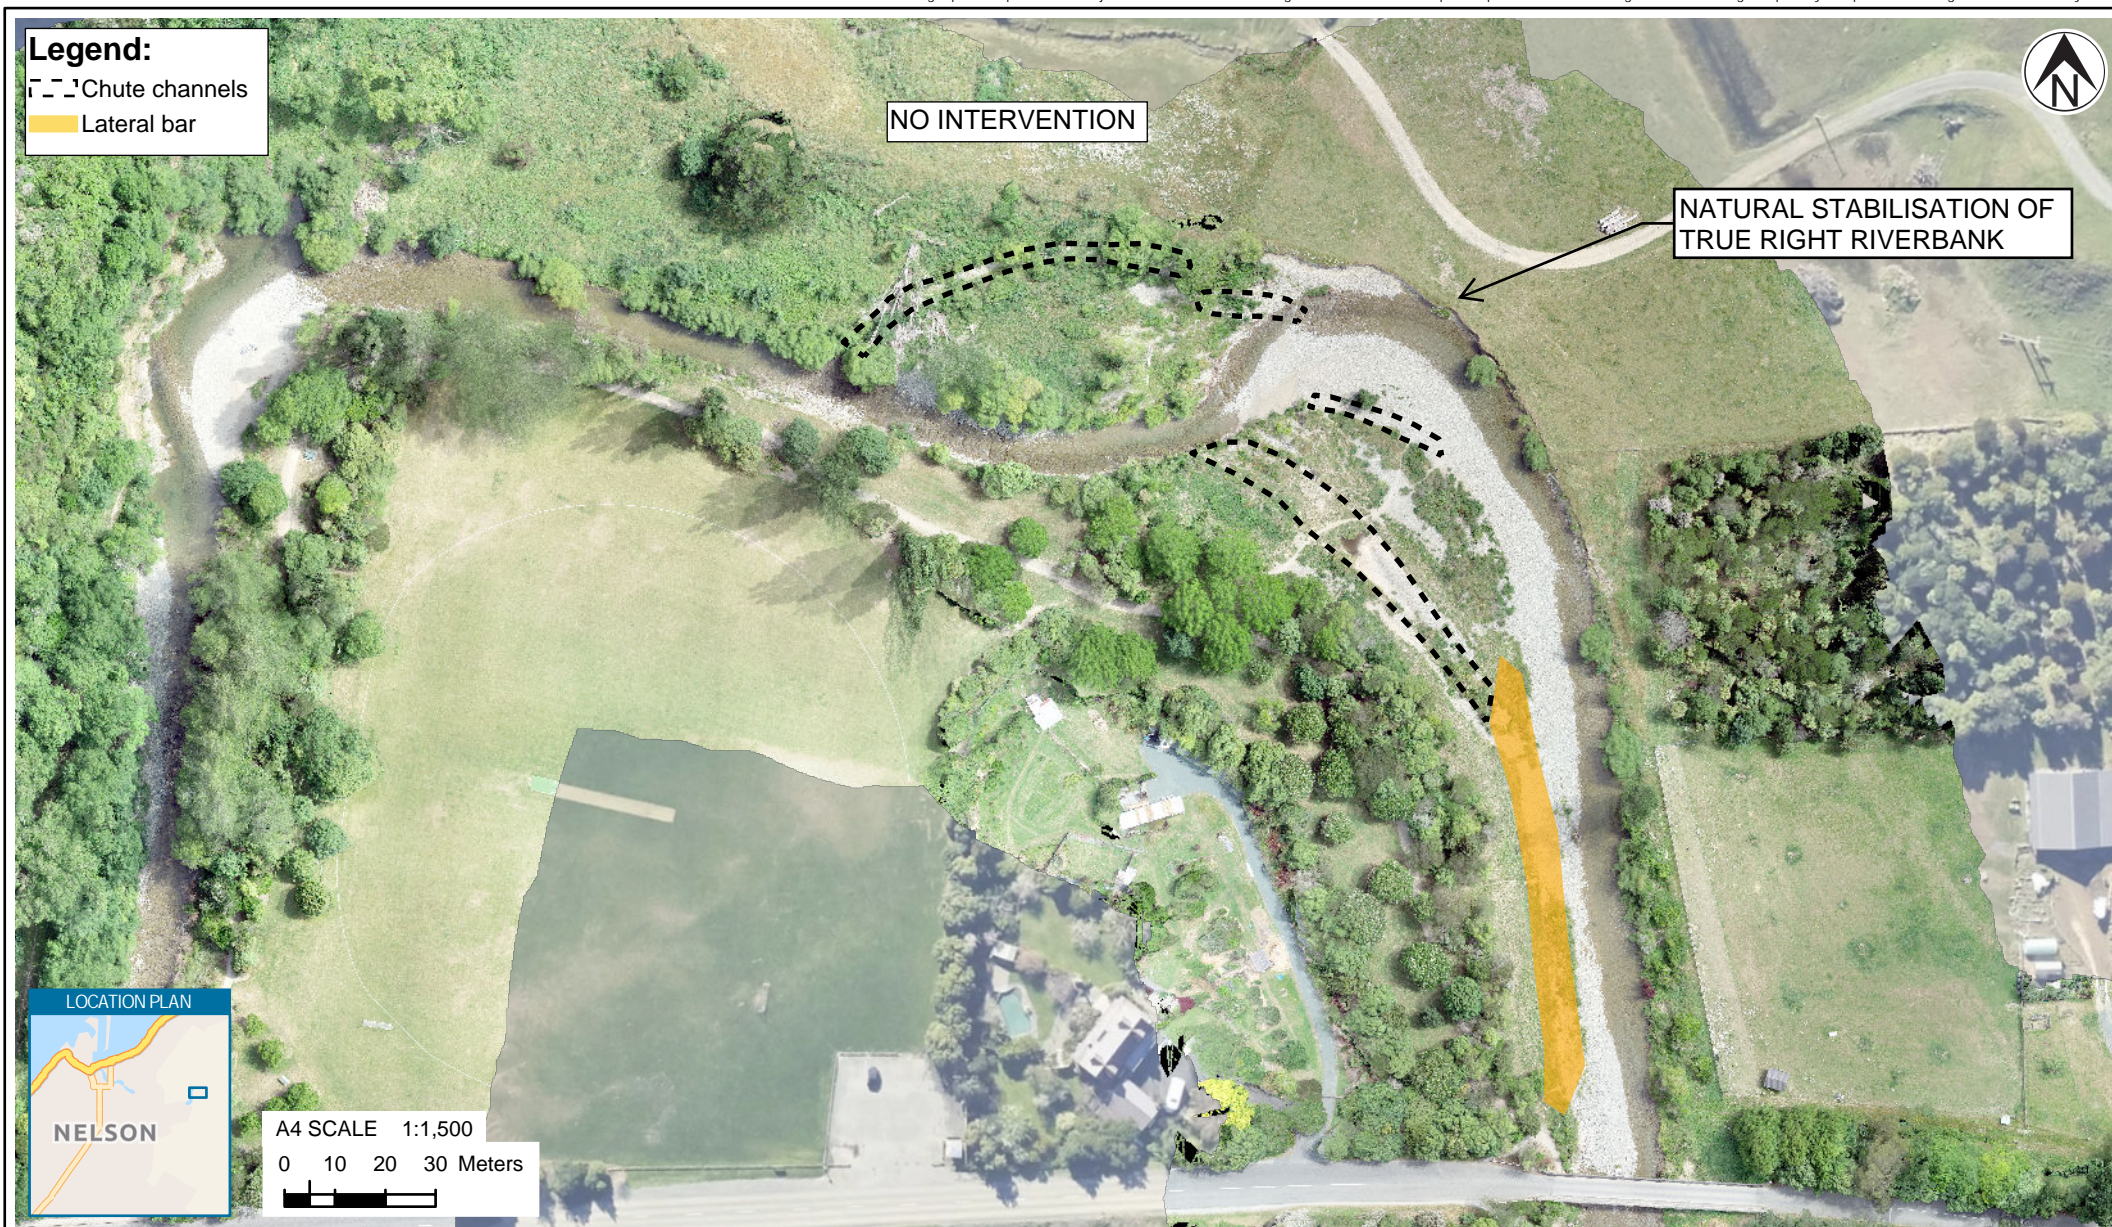
**FIG No.** FIGURE 1.

**TITLE** OPTION A - NO INTERVENTION

**Option A – Option 1 – Do Nothing:** This option consists of no intervention and letting the river stabilise the true right bank naturally, recognising there is a limit to how far north the river will continue to migrate. While this option does not halt the erosion currently occurring on the true right bank, it is a nature-based solution that allows natural river processes to mitigate the erosion of the true right bank in time. This option has the least amount of negative effect to downstream areas and has the potential to increase the ecological value of the reach.
