Lake Pūkaki Reservoir Hydro Storage and Dam Resilience Works

Engineering Structures Assessment

Meridian Energy Limited

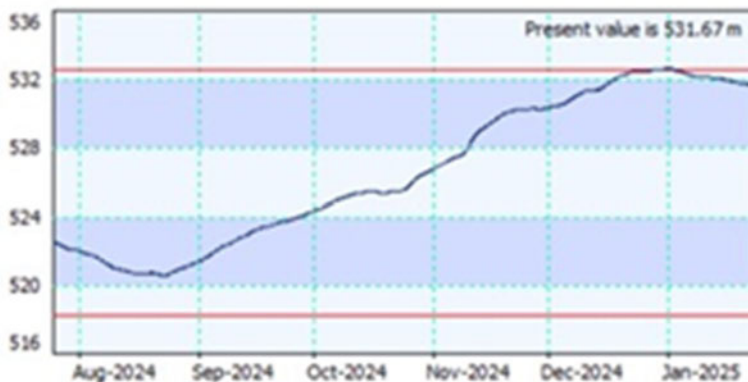
Figure 2 Lake level at the time of site visit (Source: [Meridian website](#)).

A site visit to Lake Pūkaki was completed on the 23rd and 24th of January 2024. The lake level on these dates was approximately 531 m RL as shown in Figure 2.

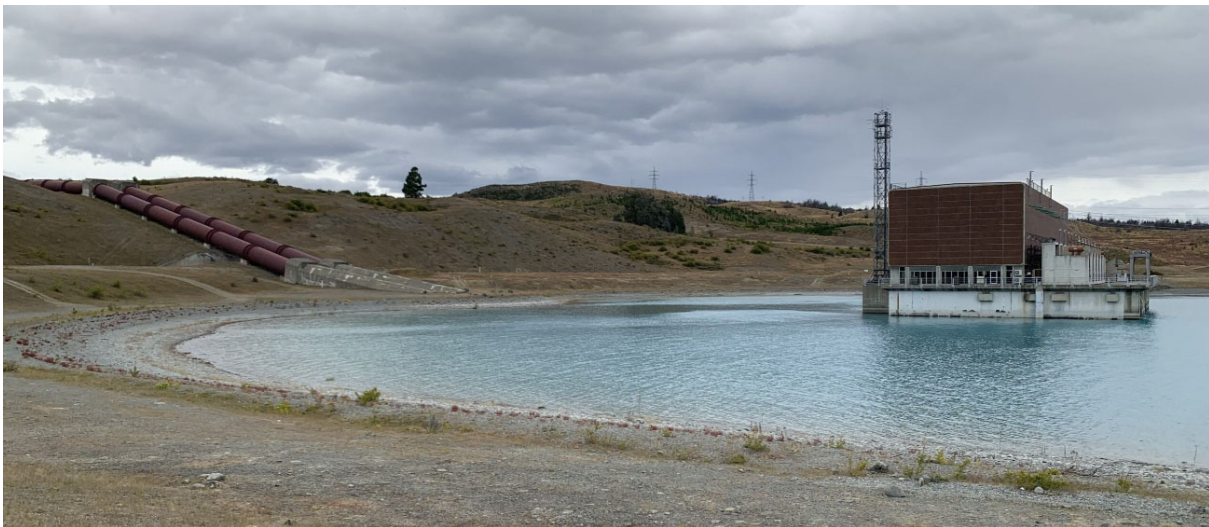
Figure 4 Site visit photo of Tekapo B Power Station showing the two penstocks.

The Tekapo B Power Station is a 46 m-high structure situated within a tailrace pond and within the lake's current operating water levels. Commissioned in August 1977, it houses two 80 MW generators which are supplied with water via two large penstocks which are fed from Lake Tekapo via the Tekapo Canal. The peak discharge flowrate through the power station is limited to 130 m³/s (typically occurring at high tailwater conditions). Tekapo B Power Station and the associated infrastructure is owned by Genesis Energy Limited.

The station is surrounded by water when the discharge is operational (refer to Figure 44) and has been designed for a Lake Pūkaki operational water level range of 14.3 m, with the lowest operational tailwater level at around 518.0 m RL.

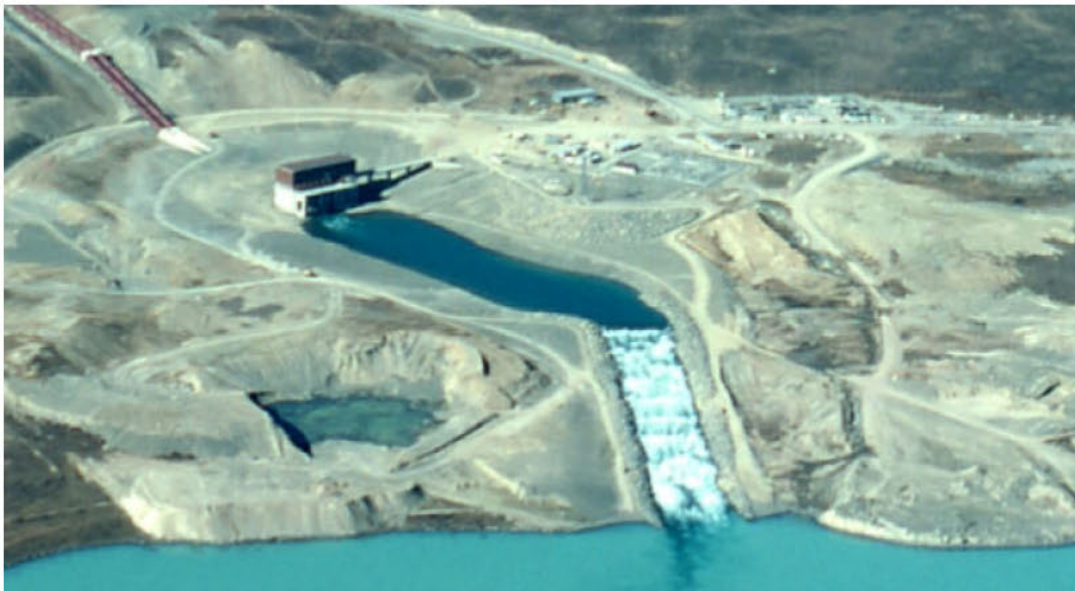
Figure 6 Lake Pūkaki at 504.3 m RL showing the full extent of the tailrace and weir.

Figure 6 shows an aerial view of the weir and chute in operation in the 1970's with Lake Pūkaki water level at around 504.3 m RL.

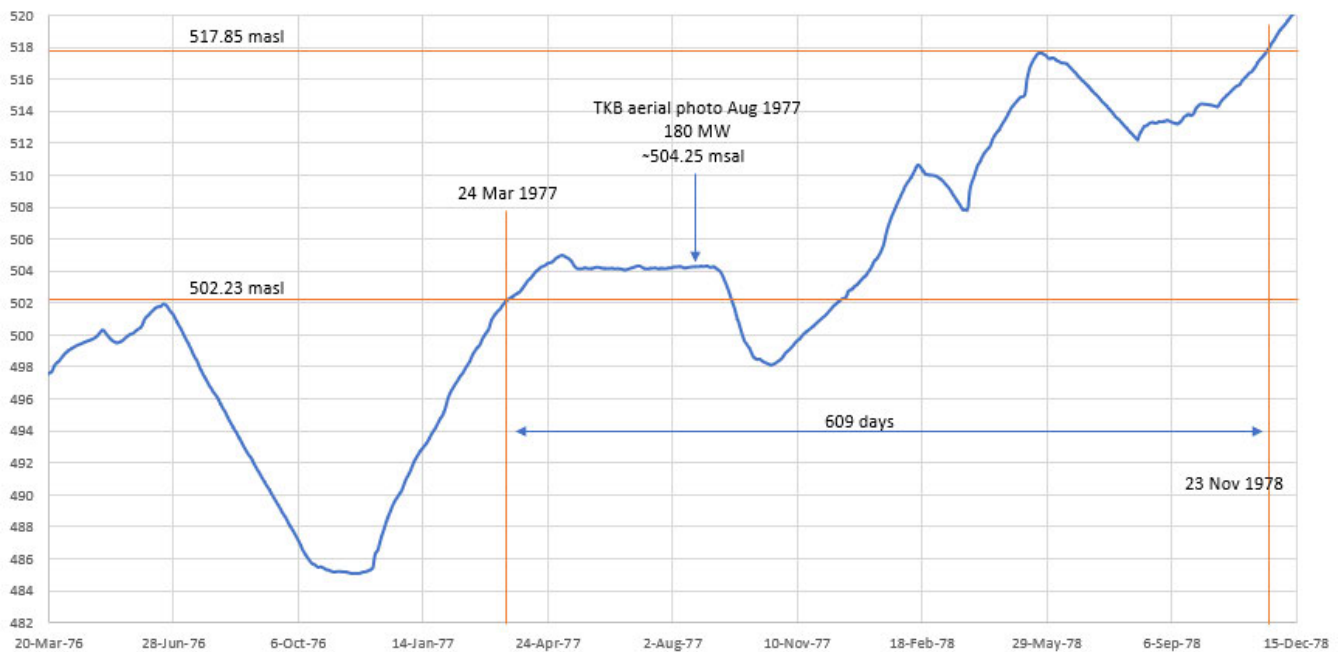
Figure 8 Lake level records from 1976 – 1978 showing 15 months following the August 1977 commissioning of Tekapo B power station where the lake was operated below 518.0 m RL, i.e. up until 23 Nov 1978.

Lake level records show the last time the lake level was below 518.0 m RL was immediately following the commissioning of the Tekapo B Power Station in August 1977. Figure 8 indicates that the power station operated below 518.0 m RL for approximately 609 days (or 20 months). Since that time the weir and chute have been submerged, although at low lake levels the structure remains visible below the surface (See Appendix B)

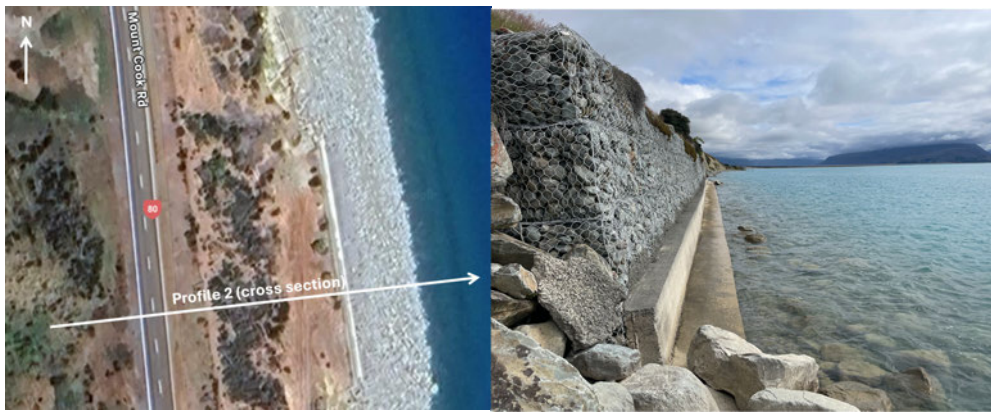
Figure 9 shows an aerial view of the site and a site photo, and the shoreline profile is shown in Figure 10.

Figure 9 Left: Aerial image of the Gabion retaining wall between SH 80 RS 17 RP 12.64 – 12.7 (Source: Google Maps). Right: Photo taken of the gabion retaining wall facing north.

As shown in the shoreline survey profile in Figure 10, the concrete base of the gabion retaining wall is situated at approximately 532.0 m RL, and the lakebed slopes down at a gradient of approximately 25%, levelling out at approximately 512.0 m RL. From the photos in

Figure 9, riprap protection is provided for the toe of the wall however the vertical/lateral extent of the protection is unknown.

The gabion wall is unlikely to be directly affected by a reduced lake level as it is located well above the existing operating range. Depending on the duration spent at lake levels below 518.0 m RL and the level reached, there may be some localised bed erosion if the lake level drops below the extent of existing riprap due to wave action. Due to the distance between the gabion retaining wall and the lake shoreline at these lower levels, and the expected short duration at levels below 518.0 m RL (most likely days or weeks with a likely maximum of up to four months), the potential for erosion will be sufficiently far from the wall (80m +) that it will not affect the retaining wall integrity.

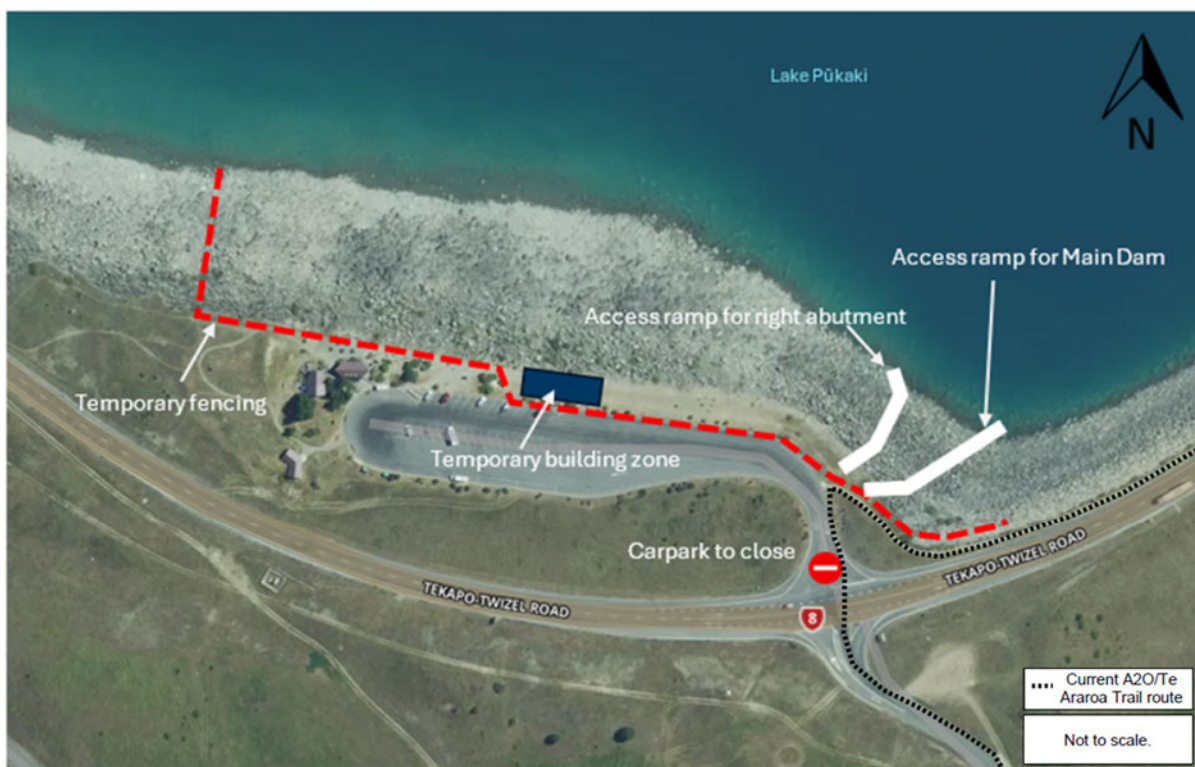
Figure 19 Construction Traffic Routes and Proposed Diversions for the A20 Trail

- Rip-rap rock will be transported via truck from the existing stockpiles to the project designated stockpiles for temporary storage prior to placement. This potentially impacts the A2O and TA route in several locations. In addition, creating a safe construction work zone will require the closure of the existing carpark to the west of the dam and the western most access route to the Pines freedom camping area.–These closures, will also potentially impact the A2O and TA route (see Figure 18 and 19).

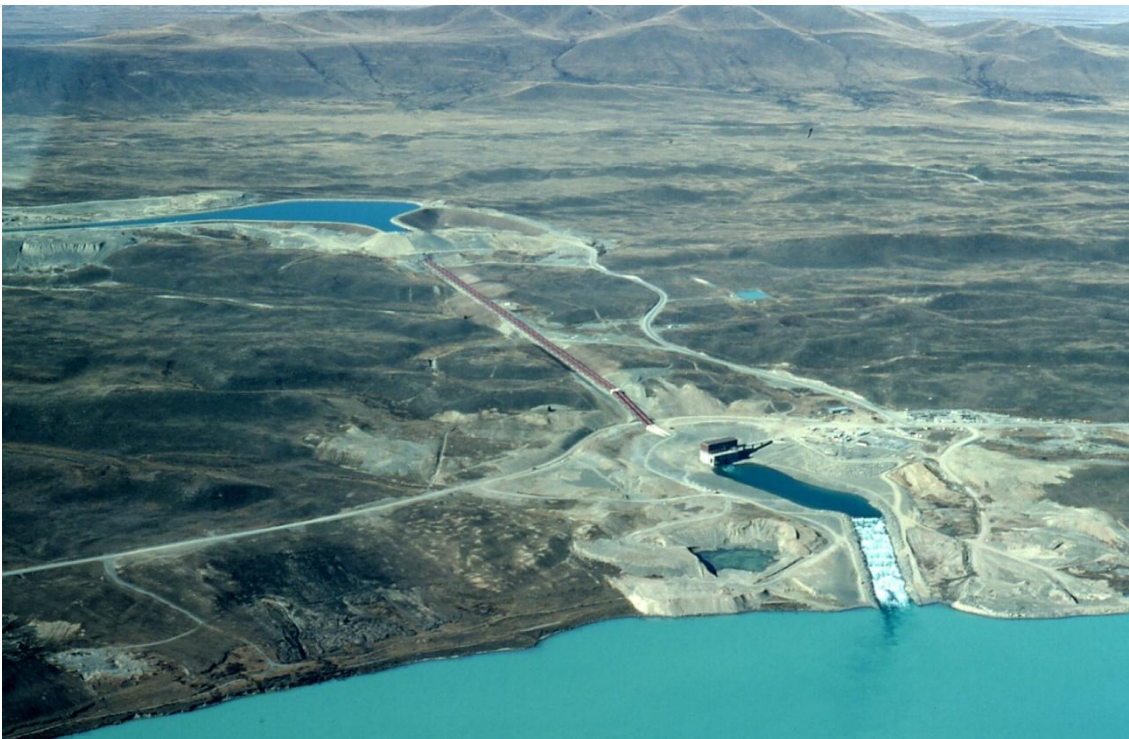
The tailrace weir and rock chute formed a temporary structure which was used in the late 1970's to allow Tekapo B Power Station to generate power before the level of Lake Pūkaki was raised with the completion of the Pūkaki High Dam (see Figure 1.1). The weir and chute structure discharged into Lake Pūkaki.

Figure 1.1: Tekapo B Power Station and Canal with temporary tailrace weir and rock chute in operation at bottom right corner of photograph (August 1977)

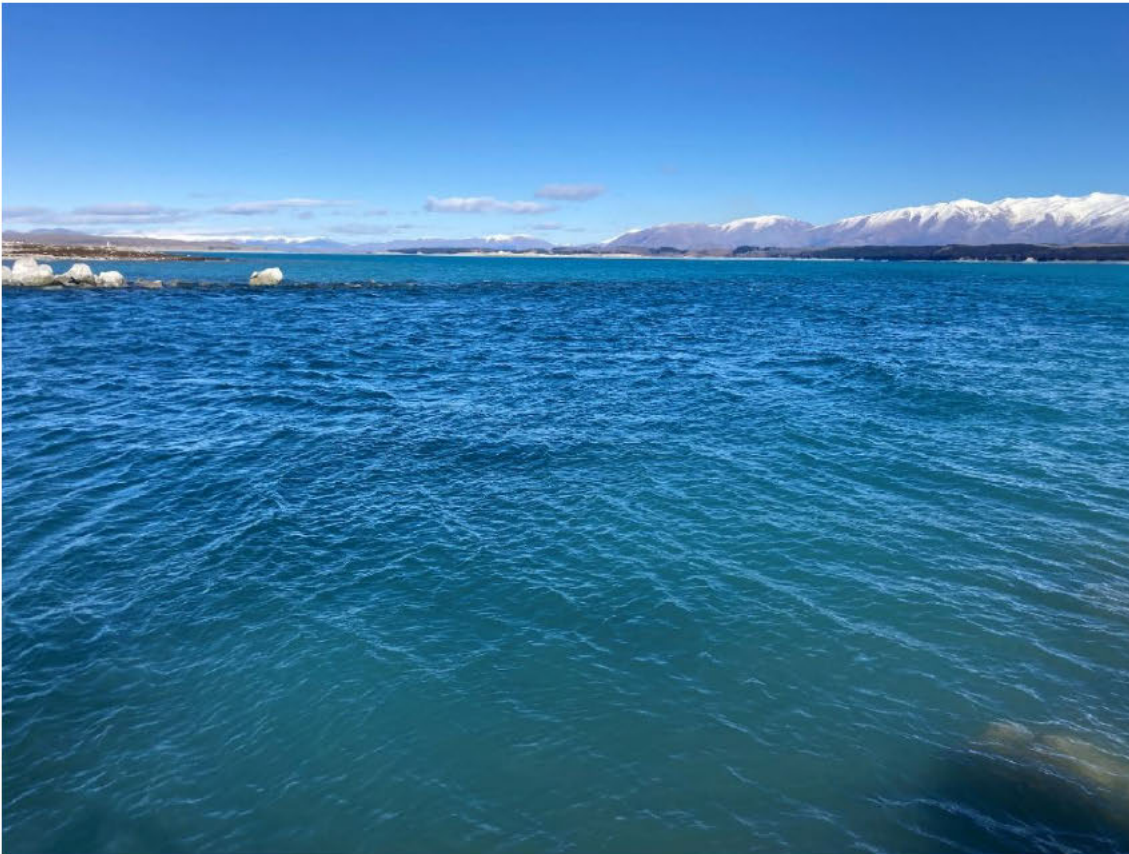
Figure 1.2: Tekapo B Power Station temporary weir and rock chute structure on 20 August 2024 - Lake Pūkaki level at RL 520.65 m

The Pūkaki High Dam was commissioned in early 1979 and the lake filled to allow operation in the consented operating range of RL 518.0 m to RL 532.5 m. Currently the temporary tailrace structure is permanently submerged although, at low lake levels, the structure remains visible below the surface (see Figures 1.2 and 1.3).

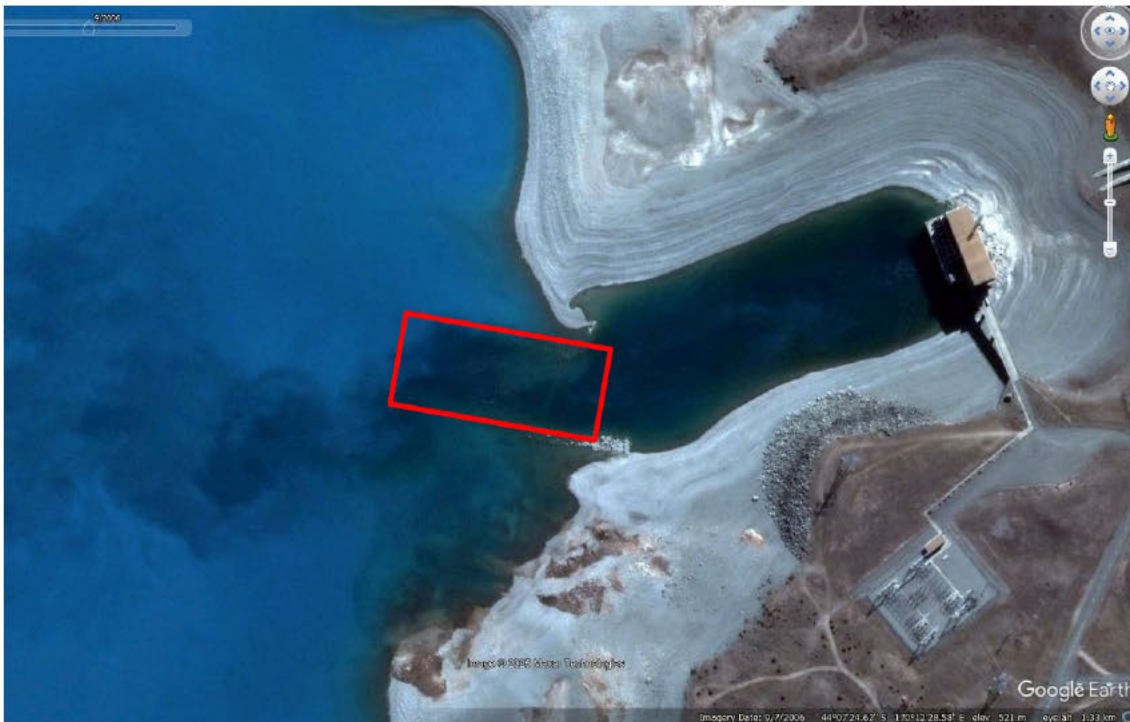
Figure 1.3: Aerial view from Google Earth of Tekapo B Power Station tailrace channel showing outline of submerged weir and rock chute structure (marked by red box)

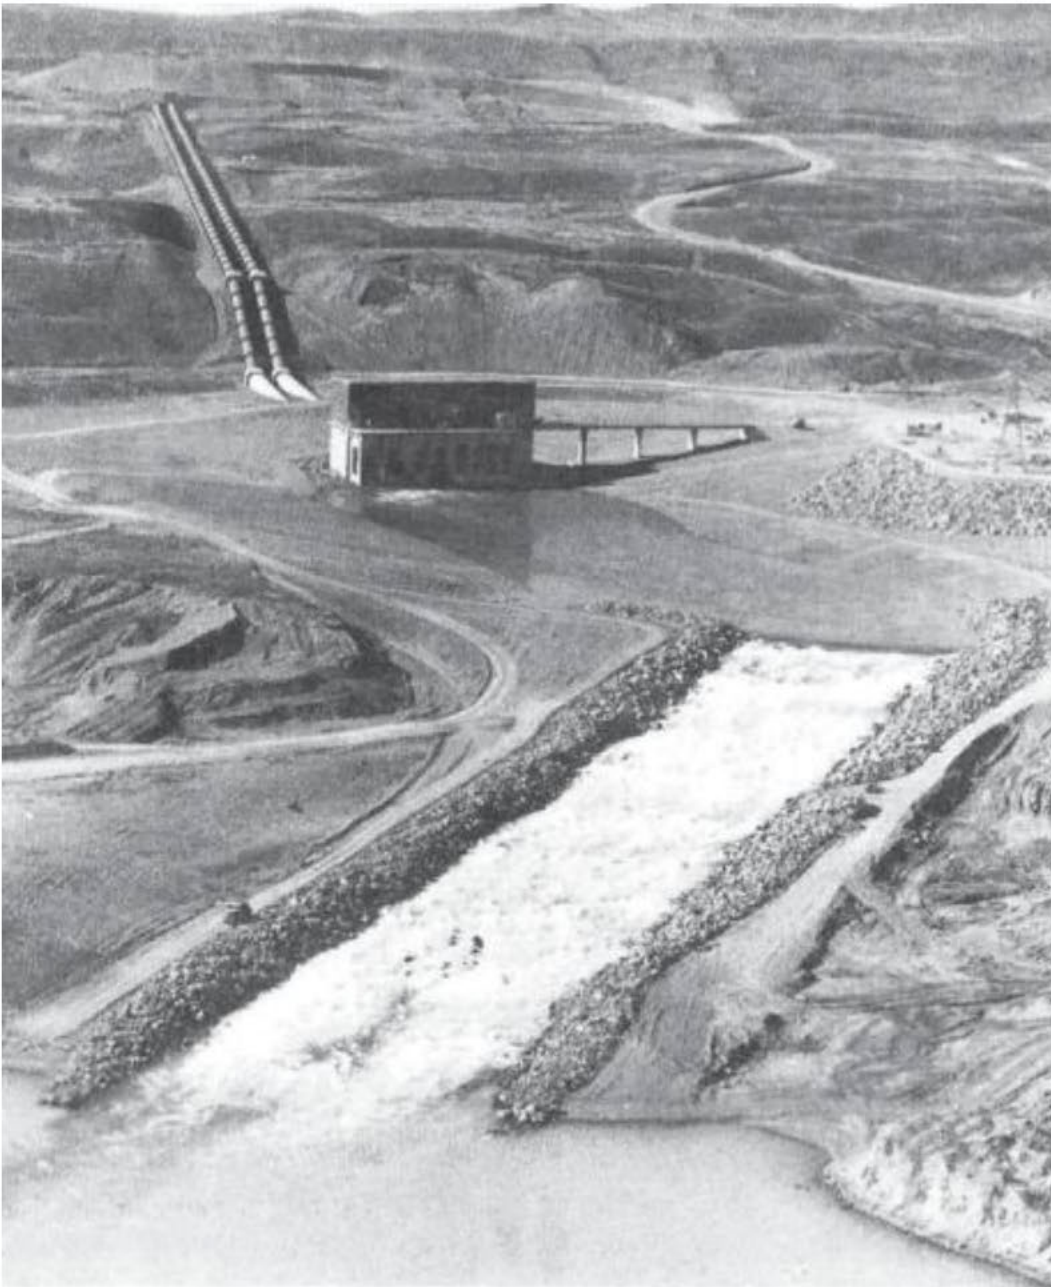
The weir and chute structure is comprised of three linked components (refer drawings T38/01/6-8 in Appendix A). Figure 2.1 shows an oblique aerial view of the structure in operation at a discharge of 100 m³/s.

Figure 2.1: Oblique aerial view of Tekapo B Power Station temporary tailrace channel in operation discharging 100 m³/s into Lake Pūkaki (date and time of photograph unknown but lake level inferred from as-built drawings to be below level of sill 11 at RL 502.23 m)

- Various design formulae for the stability of rock-lined channel were considered: Isbash, Oliver, Shield's entrainment function, and Hartung and Scheuerlein. The latter expression was discarded as it assumed tightly wedged stones on steep slopes where self-aeration of the flow is significant (note Figure 2.1 shows highly aerated flow conditions at a discharge of 100 m³/s). The other three design formulae were applied with most confidence being placed in Isbash's equation which predicts the maximum average flow velocity under which a boulder will remain stable. The use of these design formulae required a hydraulic resistance relationship to be adopted. Two resistance relationships were considered (Strickler and Straub) which both relate the Manning's n channel roughness coefficient for a natural channel to the d_{75} size of the bed material to the power of one sixth. i.e.

The paper noted that the flow proved to be sub-critical over the length of the chute with flow depths in the range of 0.5-1.5 m. Energy dissipation appeared to be evenly distributed over the whole channel as seen in Figure 2.1 with the flow aerated on the surface (as indicated by the white water). Figure 3.4 provides a close-up view of the aerated flow between concrete sills 4 and 5 while Figure 3.5 shows a view of the channel bed at the same location.

When the lake level drops to RL 517 m, the chute flow beyond the weir crest behaves as ramp-type flow (USBR, 2007) (Pagliara & Chiavaccini, 2006) as shown in Figures 2.1 and 3.4 before a sharp transition to the backwater profile corresponding to the constant lake level occurs. The flow behaviour at a lake level of RL 518 m would be very similar although the distance over which the ramp-type flow occurs would be lesser.

With aerated flow conditions as seen in Figures 2.1 and 3.4, the tendency would therefore be for the chute (or ramp-type) flow to exhibit a high Froude number ($Fr \rightarrow 1$) sub-critical flow regime.

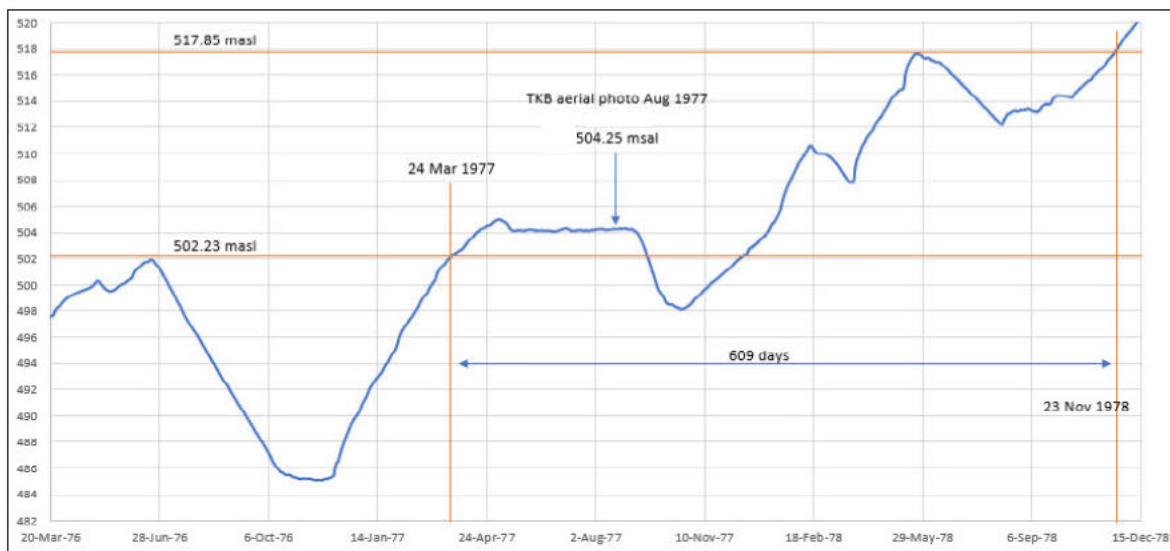
Figure 3.1: Historic lake level record for Lake Pūkaki from March 1976 to December 1978

Figure 3.1 shows the historic lake level record for the period over which Lake Pūkaki was being filled. The level of RL 502.23 m coincides with the bottom end of the chute component of the temporary tailrace outlet where the bed slope increases sharply to 8:1 (horizontal to vertical). The level of Lake Pūkaki remained above this level for 609 days except for a brief period from September to November 1977 when the lake level dropped back down to a minimum of about RL 498 m.

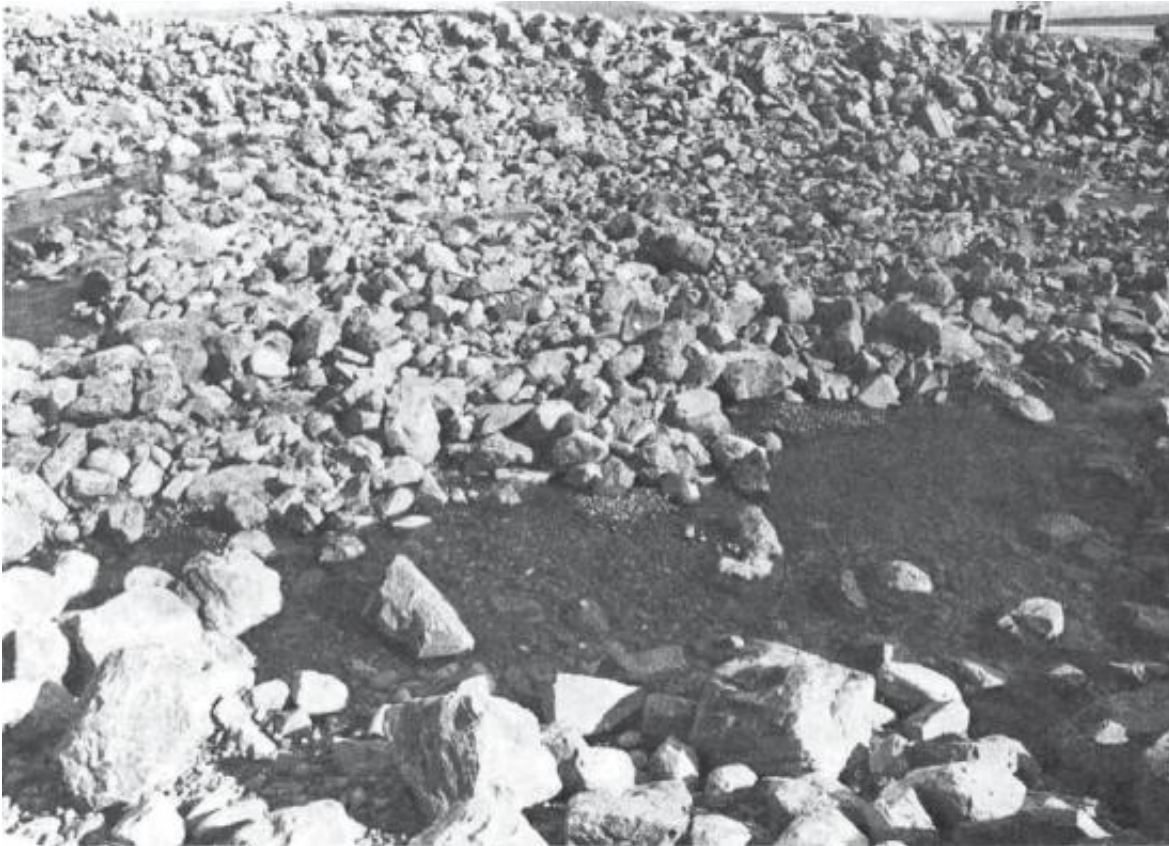
Figure 3.5: View of rock-lined bed between concrete sills 4 and 5 on the chute component of the Tekapo B Power Station temporary tailrace channel

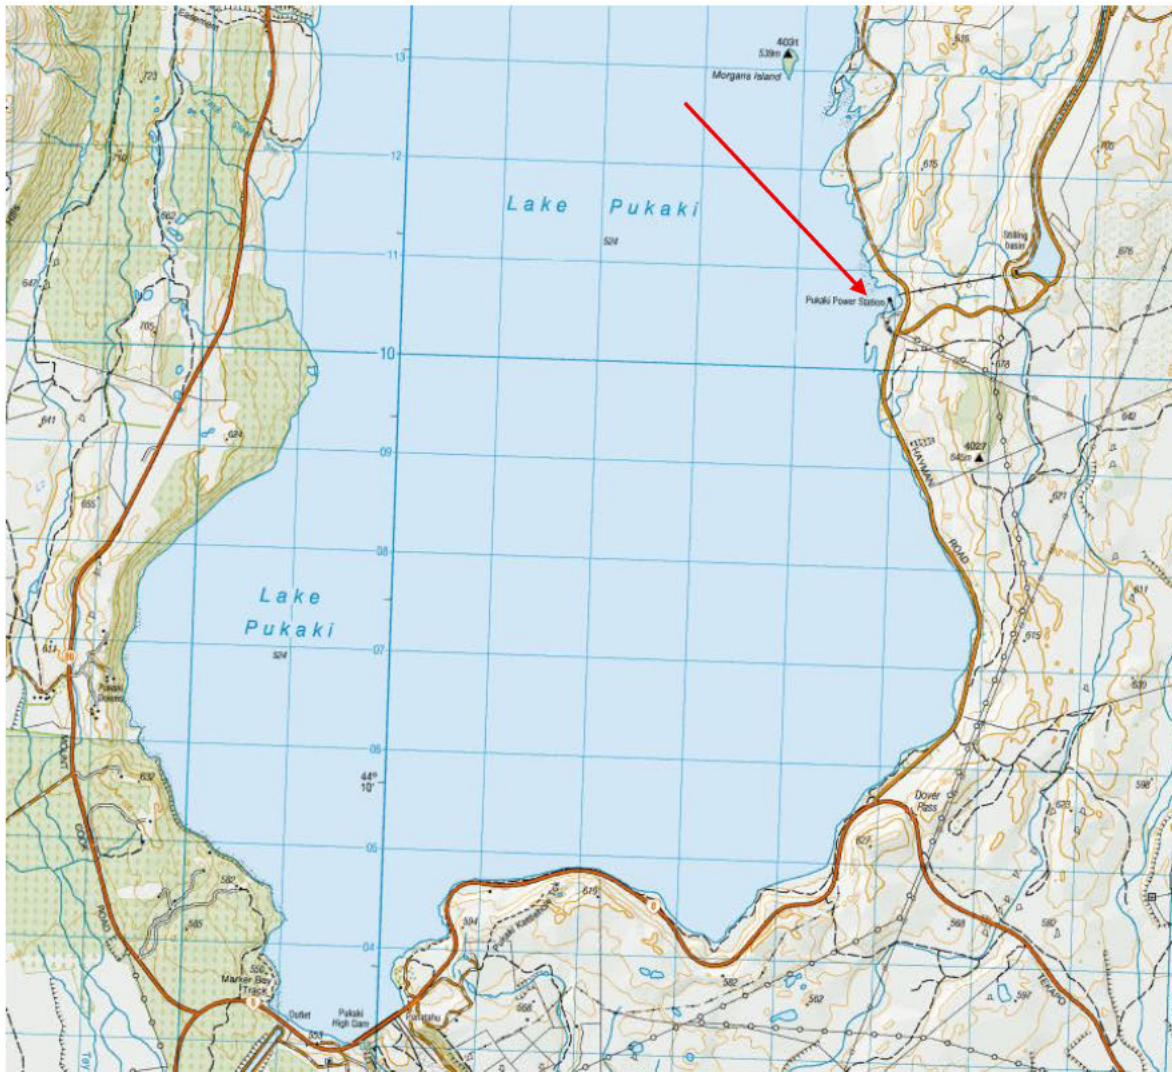
Figure 5.3 shows an extract of the 1:50,000 scale topographic map covering the southern part of Lake Pūkaki (the grid lines on the map indicate the north-south and east-west directions). The orientation of the eastern lakeshore at the site of Tekapo B Power Station means that the original temporary tailrace outlet will largely be sheltered from waves generated by northerly winds except for waves that are diffracted around the headland to the north. However, any diffracted waves will be smaller than the corresponding wave heights in open water for waves generated by wind coming from this direction.

The critical wind direction for wind generated waves affecting the rock chute on the original Tekapo B Power Station temporary tailrace (if the chute structure is exposed due to contingent storage drawdown of Lake Pūkaki) is from the northwest. This direction is marked by the red arrow in Figure 5.3. The waves generated by waves from this direction are likely to be higher than from a northerly direction as the 1% annual exceedance probability (AEP) wind speed frequency of ≈ 34 m/s is higher than the corresponding frequency for northerly winds (≈ 28 m/s) (Damwatch, 2018).

The straight-line fetch length for north-westerly winds at the location of the original Tekapo B Power Station temporary tailrace is approximately 9 km.

Figure 5.3: Extract of 1:50,000 scale topographic map of Lake Pūkaki and Tekapo B Power Station (labelled 'Pūkaki Power Station' along eastern lakeshore in top right of image)

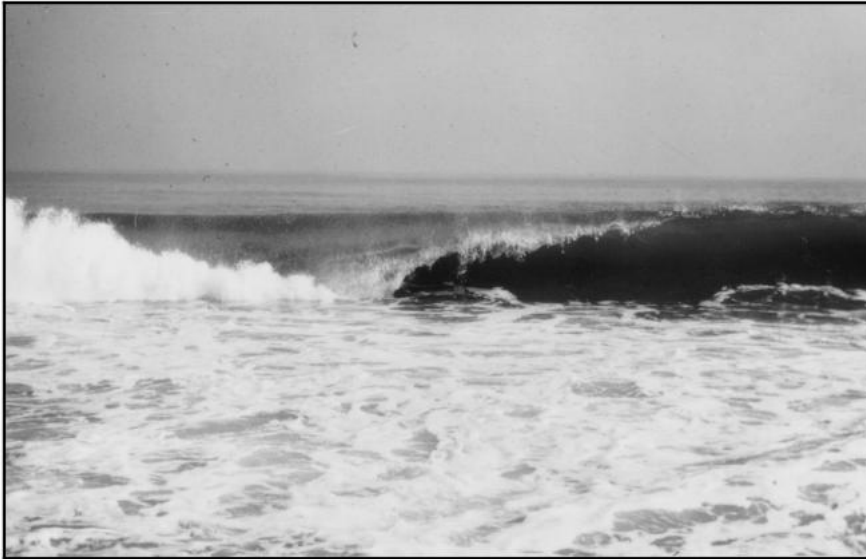
3-5 seconds will therefore break within the bay between sills 5 and 6 at a lake level of RL 513 m and impinge on the rock lining material.

Figure 5.7: Example of plunging type breaking wave which could potentially impact on Tekapo B Power Station temporary tailrace chute in a north-westerly windstorm event affecting Lake Pūkaki
