5 December 2025

PRELIMINARY AND DETAILED SITE INVESTIGATION - DRY CREEK - BELMONT QUARRY

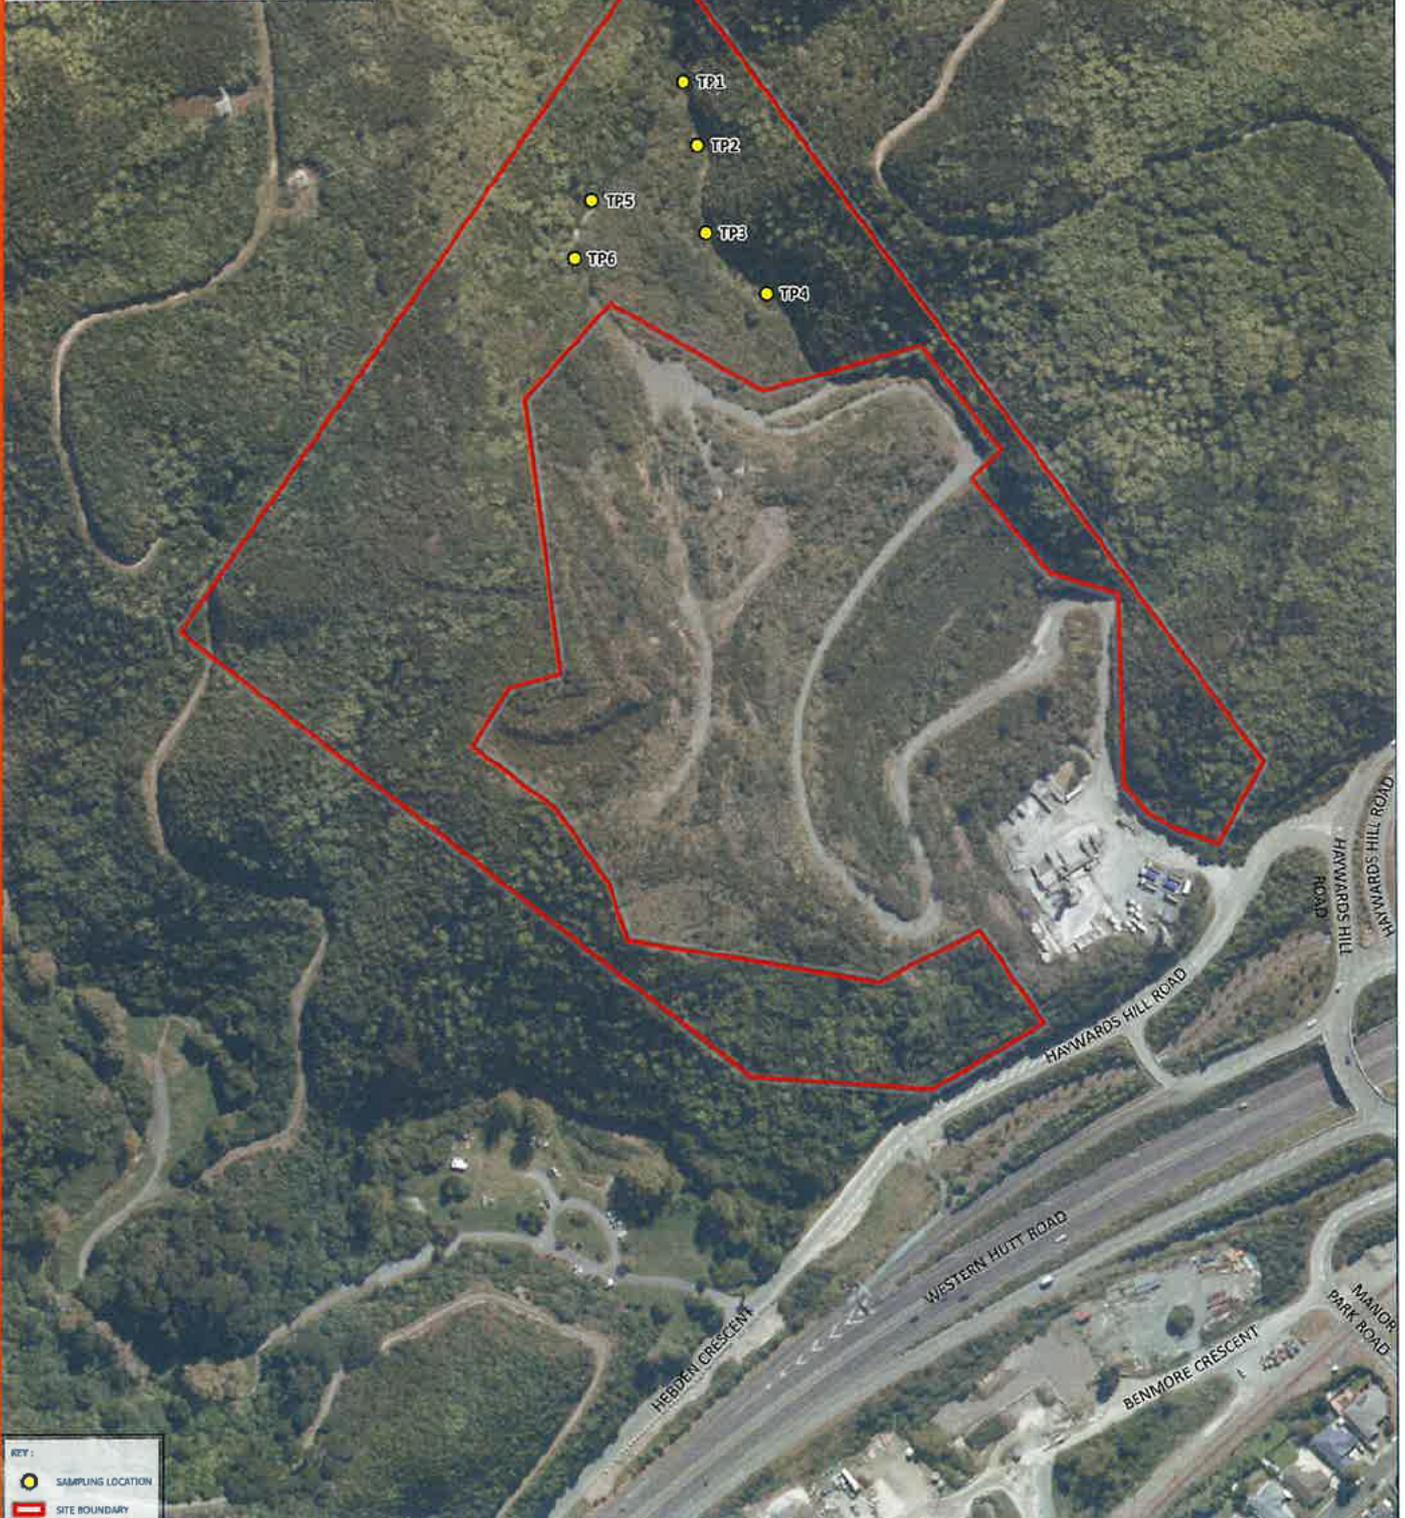
Appendix B: Figure

The original sampling plan intended to sample across a broad grid. However, due to the steep topography and dense vegetation the sampling plan was adapted. The adapted plan was undertaken to target accessible areas of the site where filling activities were undertaken, identified in the historical aerial photographs. Therefore, targeted soil sampling was undertaken along the periphery of the observed cleanfill boundary with the Belmont Regional Park to determine the presence of heavy metals, PAHs and asbestos associated with fill material. The sampling locations are outlined in Figure 1 (Appendix B).

Sampling was undertaken at six targeted locations at surface level (0.0 m bgl) and to 0.3 m bgl to investigate potential contaminants associated with historical cleanfill and to characterise the soils.

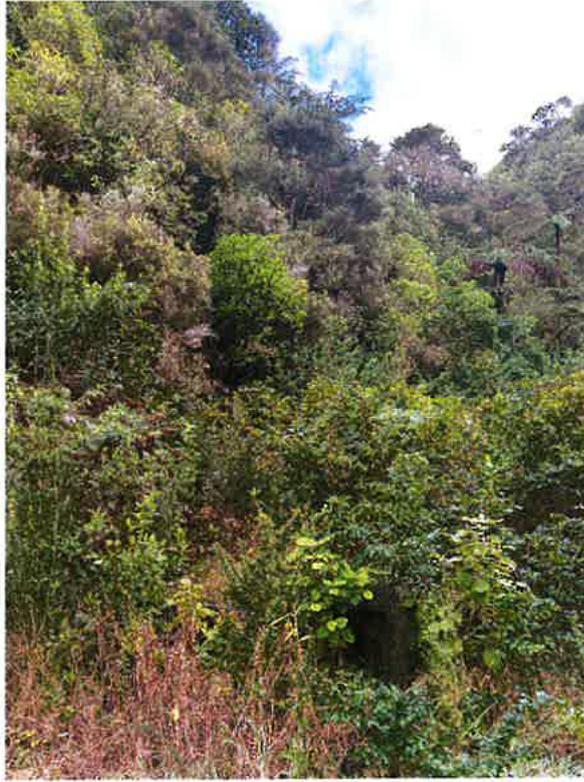
Photograph 1: Overview of slope and vegetation from TP1.

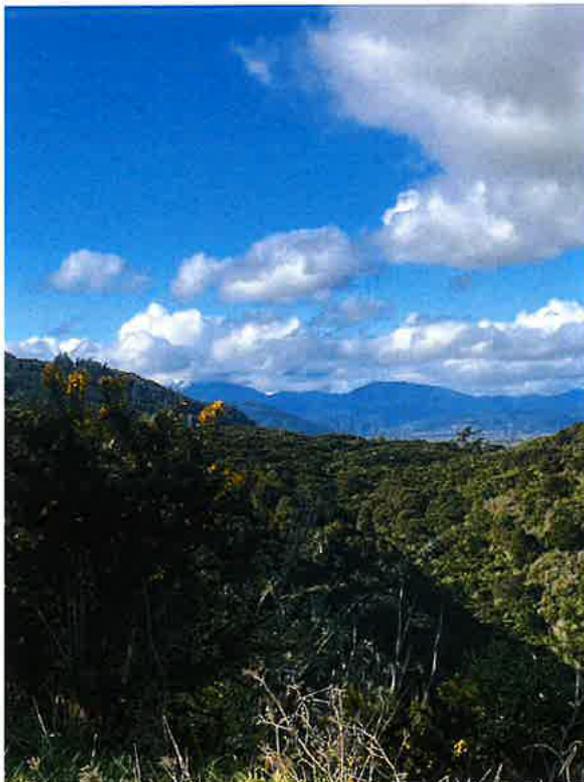
Photograph 2: General overview of the site looking east from central site boundary.

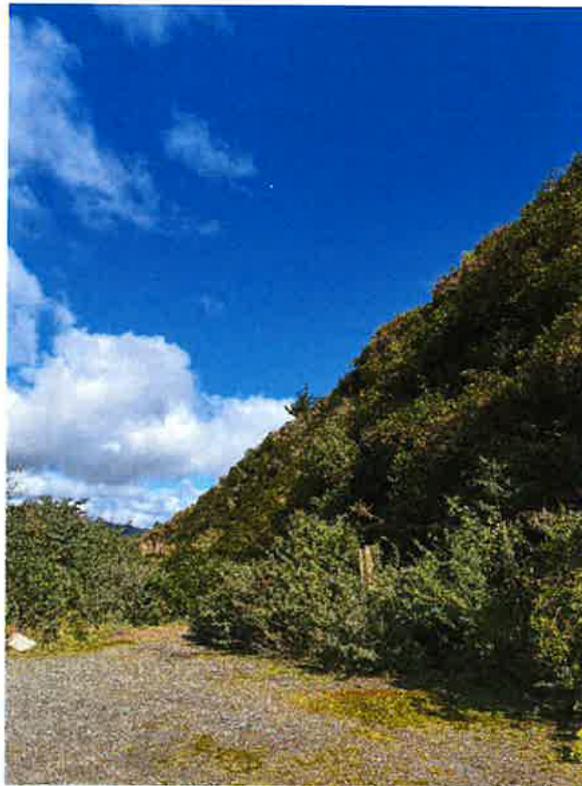
Photograph 3: Overview of the site looking west from central site boundary.

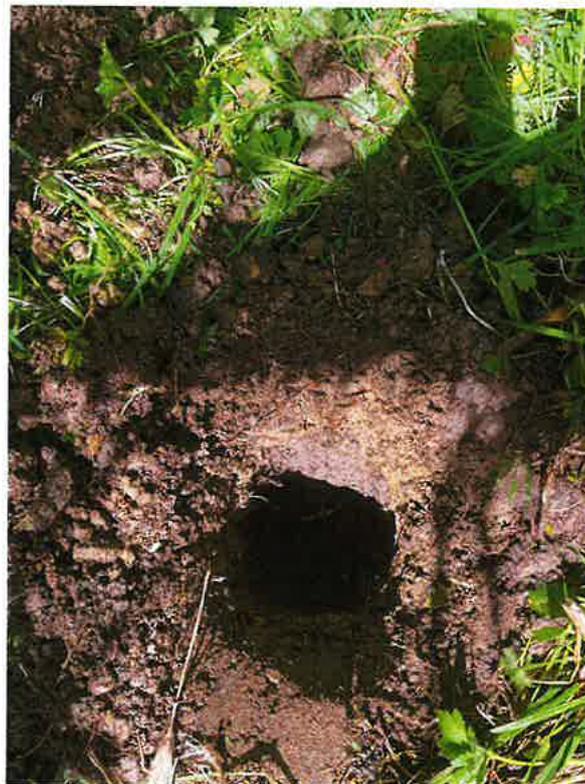
The lithology across the site was generally comparable and photographs are located in Appendix C. The topsoil encountered at TP1 (0.0 m and 0.3 m bgl) comprised a brown sandy gravel (Fill), the gravel was medium, angular to sub angular. A brown silty slightly gravelly clay was encountered within TP2 (0.0 m and 0.3 m bgl), TP3 (0.0 m bgl) and TP4 (0.0 m and 0.3 m bgl). TP3_0.3 encountered a dark grey gravelly sandy clay with occasional brick fragments observed. TP5 (0.0 m and 0.3 m bgl) comprised a brown silty sandy clay matrix with large bricks and asphalt noted. TP6 comprised a grey silty clayey gravel, the gravel was noted to be hardfill overlying weathered rock at 0.3 m bgl.

Photograph 4: General overview of soil conditions.

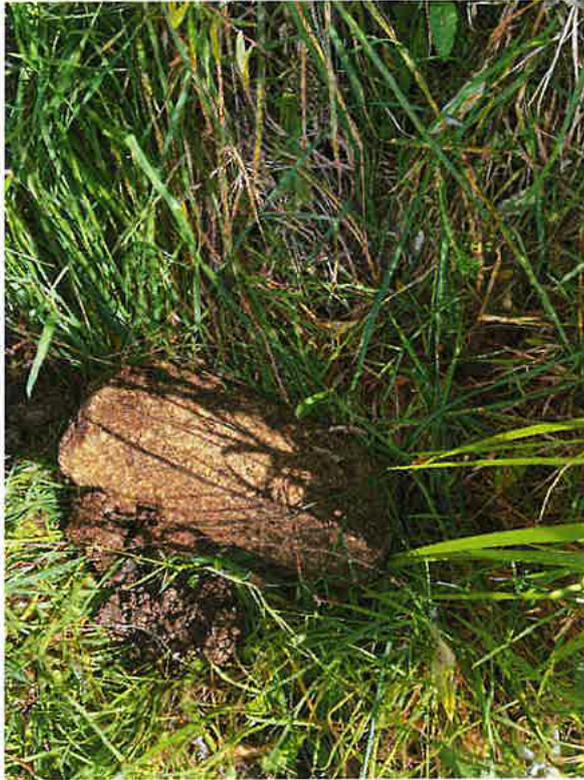
- ∴ No staining or olfactory evidence of contamination was noted on any soil material.
- ∴ No ACM or fragments of asbestos.
- ∴ No specific evidence of material unsuitable for the cleanfill – the asphalt and bricks that were encountered are acceptable cleanfill material (in accordance with the Cleanfill Management Plan as indicated in Section 5.3). Groundwater was not encountered within any of the test pits.

Photograph 5: Example of brick encountered.

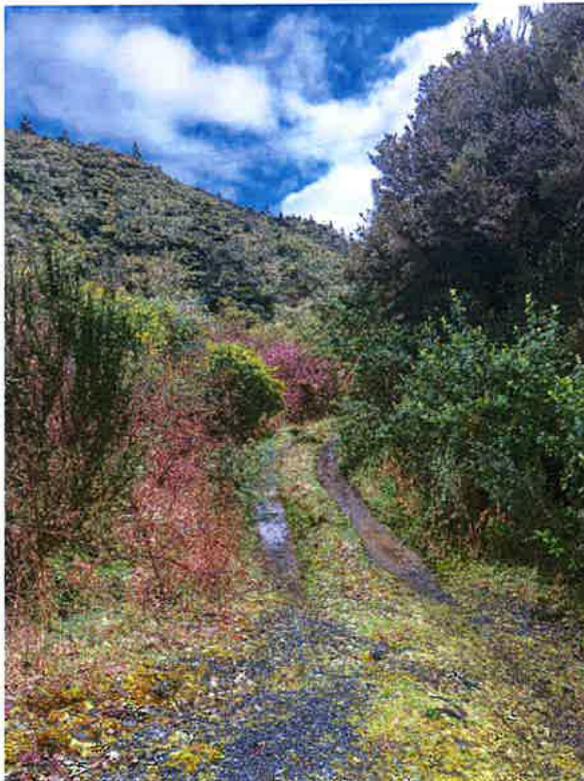
Photograph 6: Overview of an access track looking north towards TP1 – TP4.

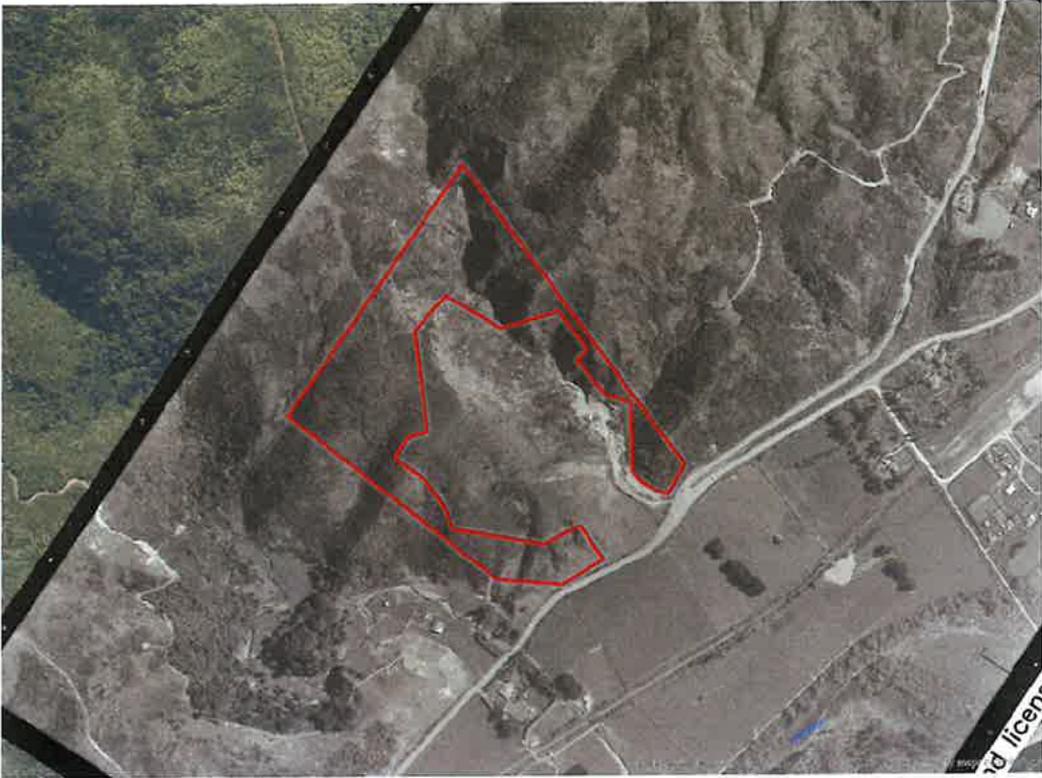
Historical Aerial Photograph 1 (Retrolens): 1947

Table 1: Historical Aerial Photograph Review		
Date	Reference	Description
1947	Historical Aerial Photograph 1	The site is undeveloped and appears to be vegetated with a stream in the northern area of the site. The wider property appears to have an access track present, entering the site from Hebden Crescent to the south.
1957	Historical Aerial Photograph 2	The site remains undeveloped with some access tracks present bisecting the northern corner of the site. Quarrying has begun on the wider property.
1967	Historical Aerial Photograph 3	There is now an established access track around the northwestern area of the site. The majority of the site is still covered with vegetation.

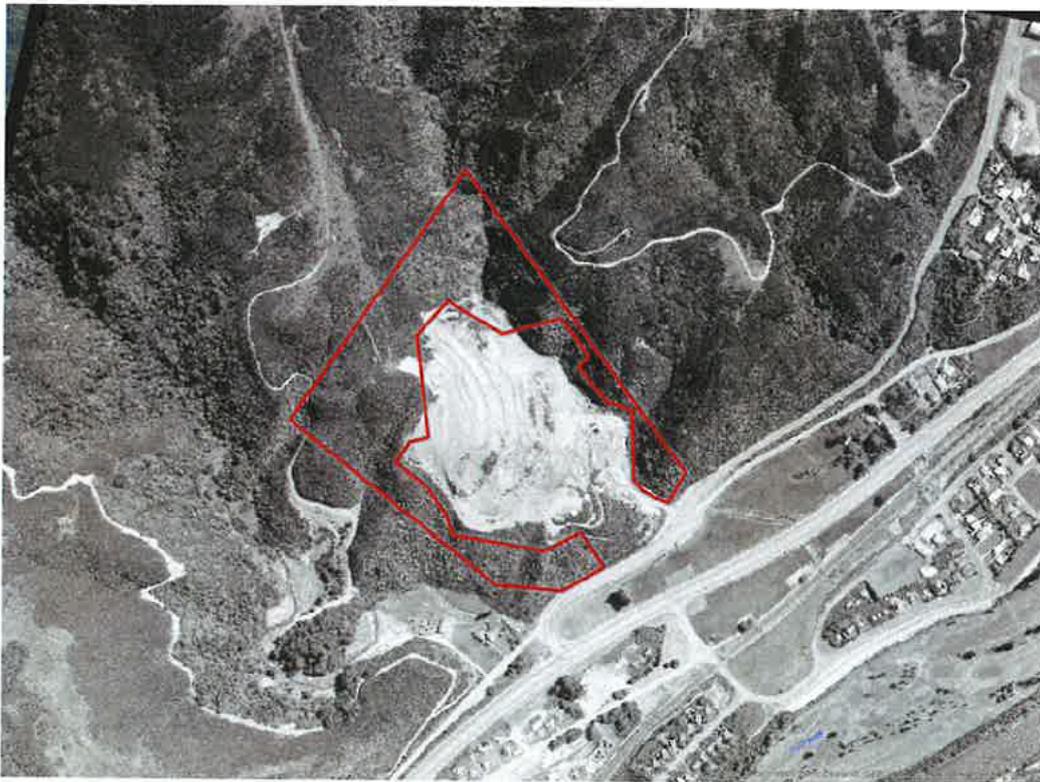
Historical Aerial Photograph 4 (Retrolens): 1979

Quarrying activities are now present across the majority of the wider property.
1979	Historical Aerial Photograph 4	There is minor soil disturbance around the central northern boundary. The access track observed in 1967 is no longer visible. The areas along the northern, eastern and western boundaries are still vegetated.
1988	Historical Aerial Photograph 5	An established access road is present between the quarried portion of the property and the centre of the northwestern site boundary. No other significant changes observed from the previous aerial image.
1995	Historical Aerial Photograph 6	There is increased soil disturbance within the northwestern portion of the site, with the access road reestablished.
2005	Historical Aerial Photograph 7	Most of the site is now revegetated with no soil disturbance taking place. An access road within the northwestern area of the site is still visible. Some parts of the quarry/cleanfill in the wider property have been revegetated.

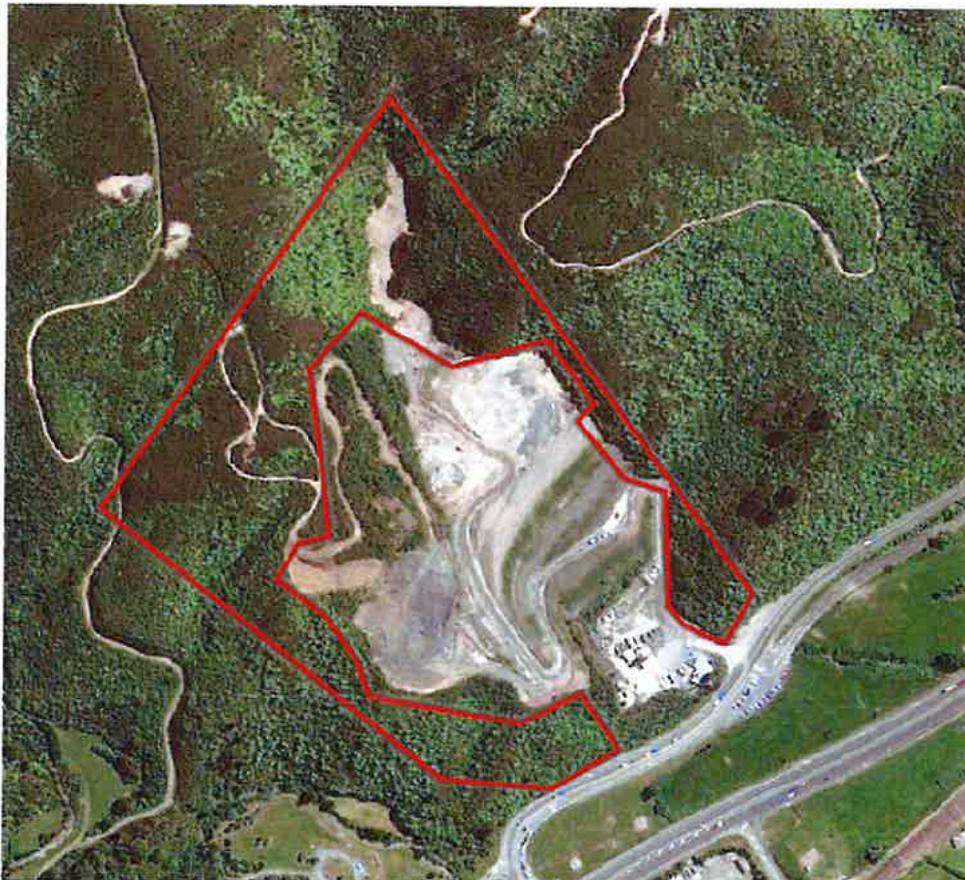
Historical Aerial Photograph 8 (Google Earth): 2009

2009	Historical Aerial Photograph 8	The gully towards the northern corner of the site has been partially cleared. No other significant changes observed from the previous aerial image.
2013	Historical Aerial Photograph 9	The northern area of the site has been excavated and possible filling is evident and a circular pit observed in the northern corner of the site, the exact use of the circular pit is not clear. The access road in the western area of the site is still present. More parts of the cleanfill in the wider property have been revegetated with the earlier revegetation becoming denser/established.
2014	Historical Aerial Photograph 10	The pit, present in 2013 is no longer visible. No other significant changes observed from the previous aerial image.
2016	Historical Aerial Photograph 11	The northern corner of the site appears to have been revegetated and recontoured with some bare, exposed areas and access ways.

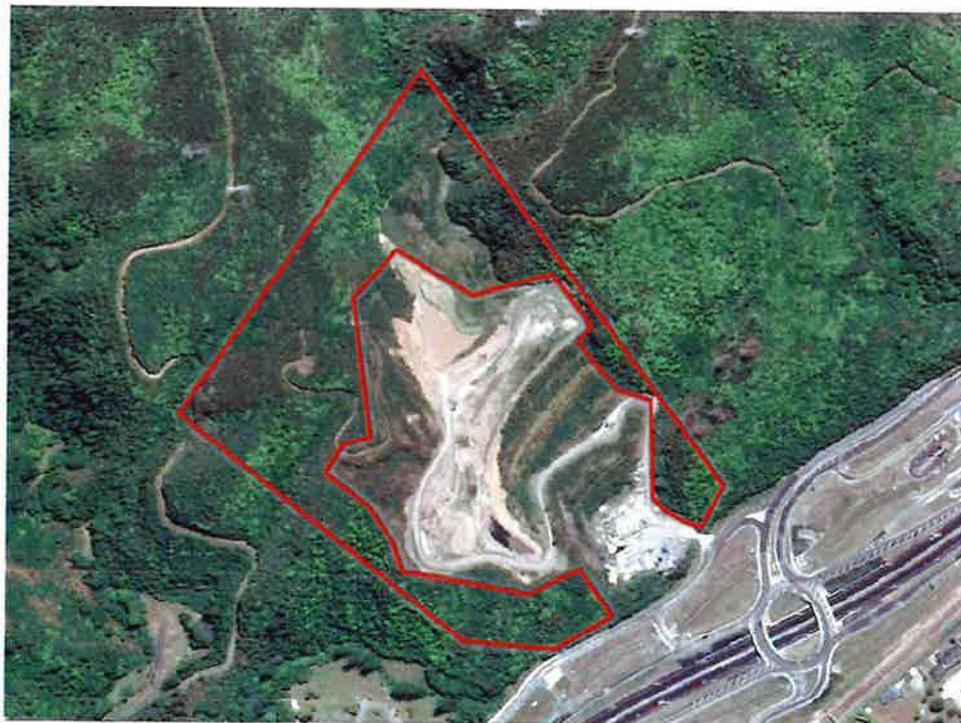
Historical Aerial Photograph 12 (Google Earth): 2017

2017	Historical Aerial Photograph 12	The majority of the site has been revegetated. The access tracks in the western portion of the site no longer appear accessible.
2019	Historical Aerial Photograph 13	Increased revegetation is present across the site, no other significant changes observed from the previous aerial image.
2022	Historical Aerial Photograph 14	The site is predominately covered with vegetation, the access track to in the northern portion of the site appears to have been reestablished. The cleanfill operation in the wider property appear to have been scaled back and started to be revegetated.
2024	Historical Aerial Photograph 15	The site is predominantly covered in vegetation, the access road present within the central northern area of the site appears to be overgrown. The cleanfill operation in the wider property appear to have ceased completely with the exception of the southeast corner, which appears to be still used for commercial/industrial purposes.

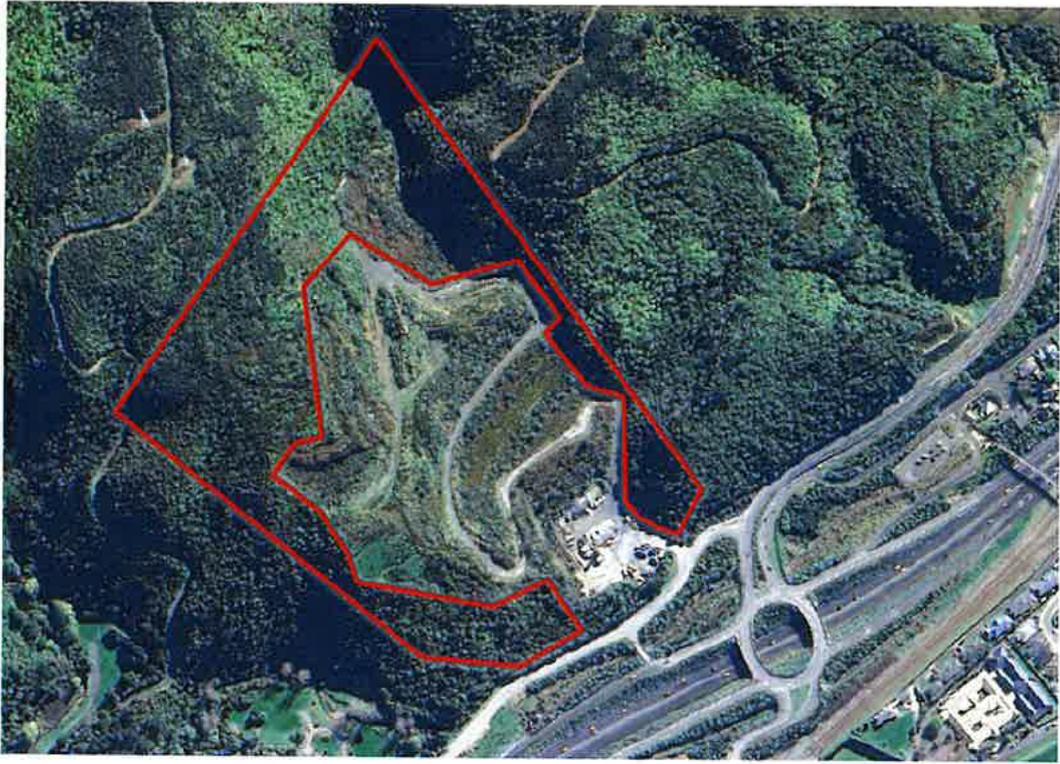
Historical Aerial Photograph 15 (Google Earth): 2024

A site walkover was undertaken on 13 August 2025, photographs from this visit are provided in Appendix C. The site was reflective of the most recent aerial photograph (Historical Aerial Photograph 15) and comprised steep, vegetated slopes.
