## Proposed Subdivision

Ohaupo Land and Chinamans Hill, Southern Links, Hamilton

# GEOTECHNICAL DESKTOP REPORT

Chinamans Hill and Ohaupo Land Partnership Ltd

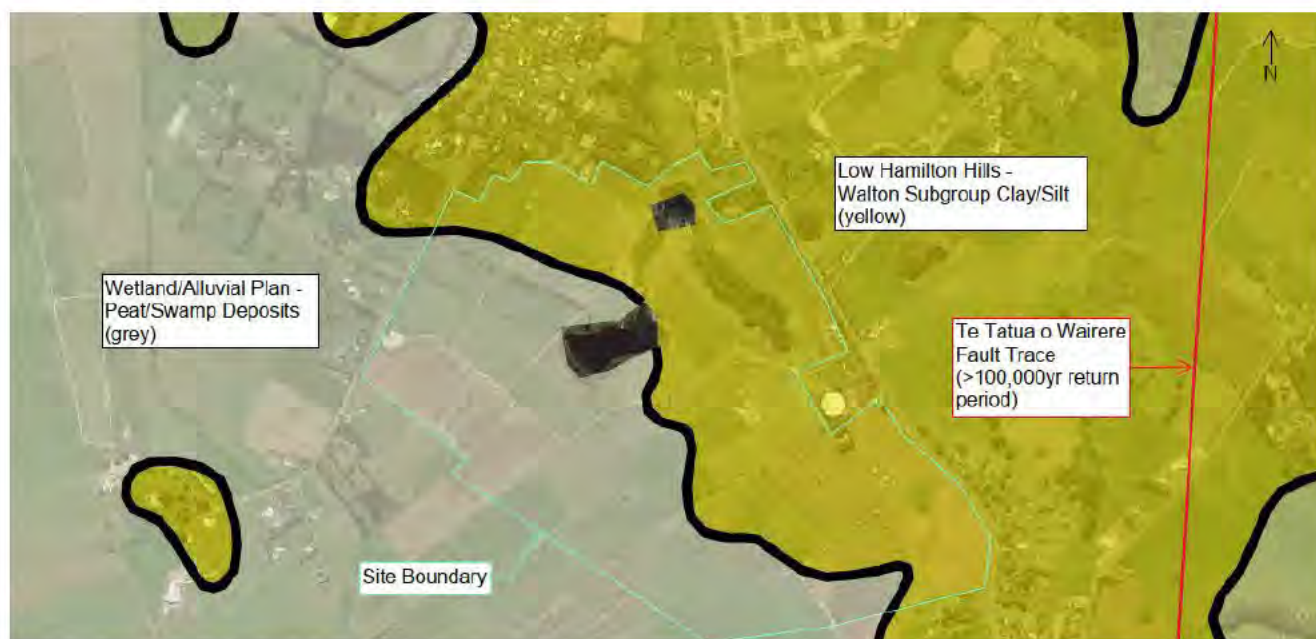
Figure 2: Regional Geology (GNS Geology Map)<sup>1</sup>

Published geological maps<sup>1</sup> for the area depict the regional geology as comprising soils belonging to the Piako Subgroup, Hinuera Formation and Walton Subgroup, as illustrated on **Figure 2** below.

Note that while Hinuera Formation is not shown on Figure 2, nearby testing in the area indicates there will likely be a layer of Hinuera Sands and silts between the Walton subgroup and the Piako Subgroup (Peat) at the base of the hills.

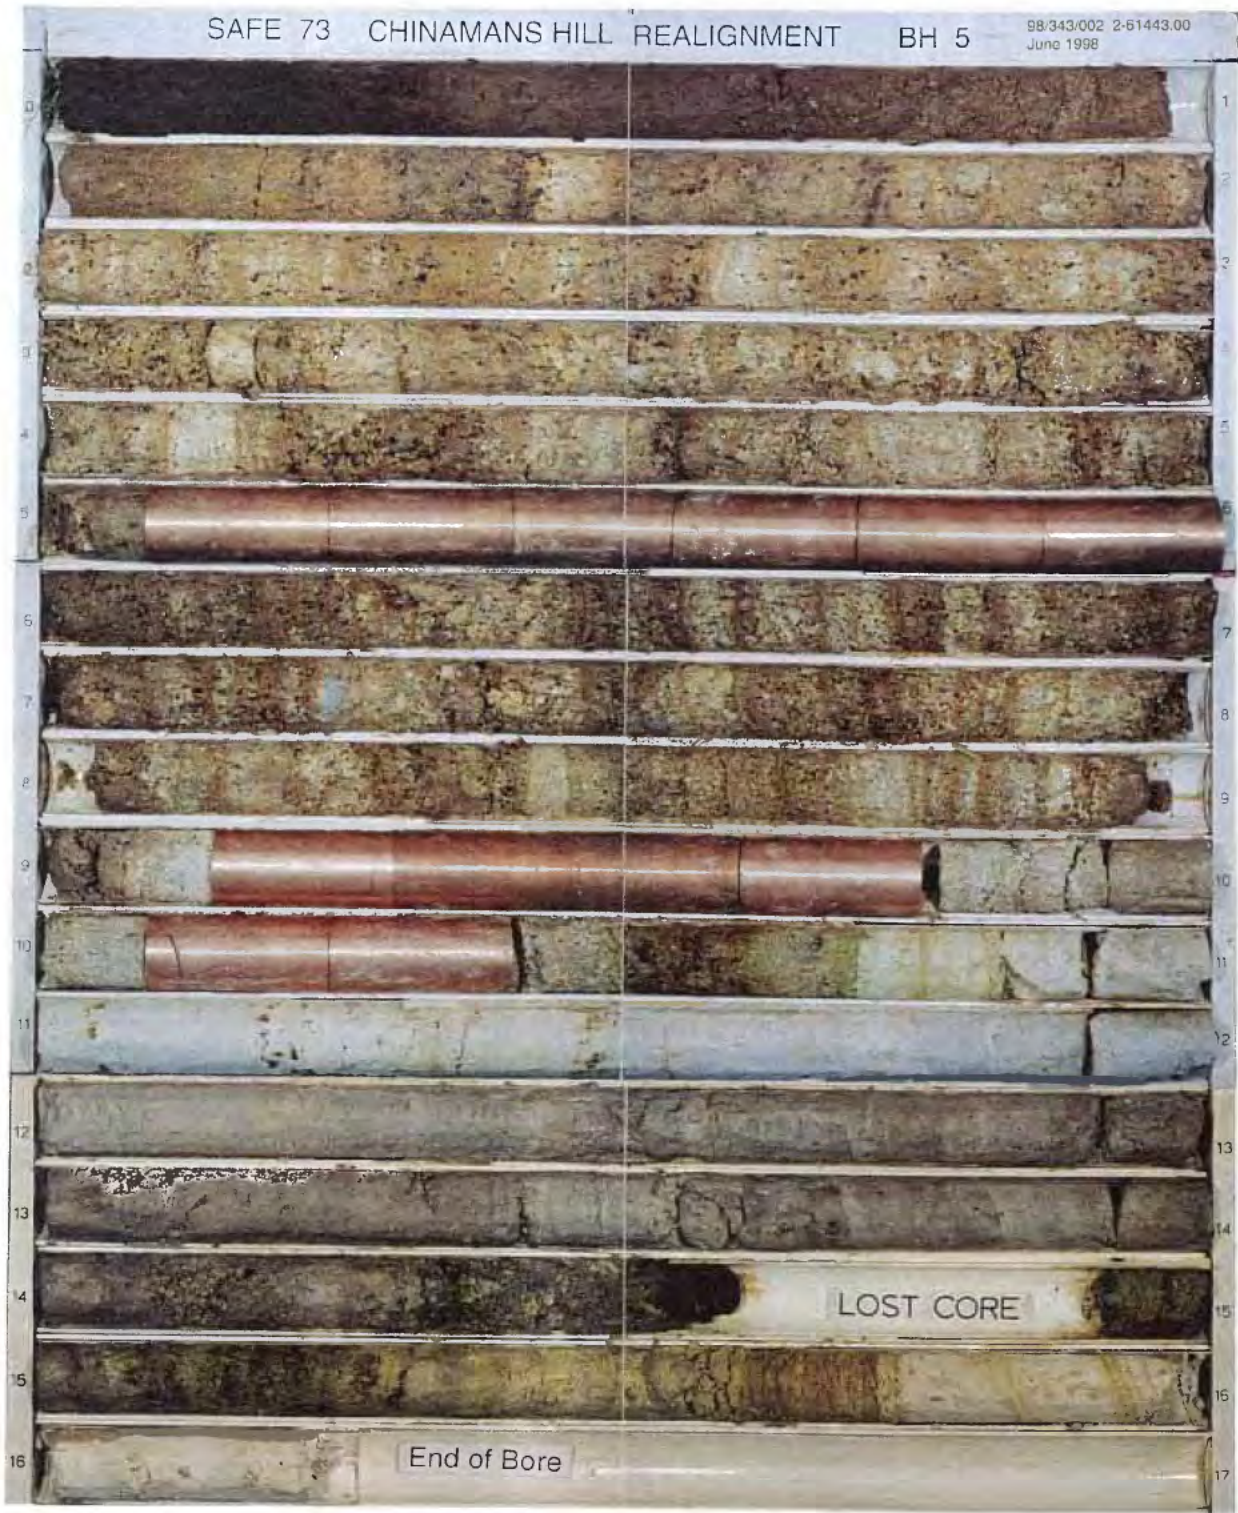
| BORE HOLE LOG | | | | BORE HOLE NO: 6 | | |
|---|---|---|---|---|---|---|
| PROJECT: SAFE 73 | | LOCATION: CHINAMANS HILL REALIGNMENT | | PROJECT NO: 251443.00 | | |

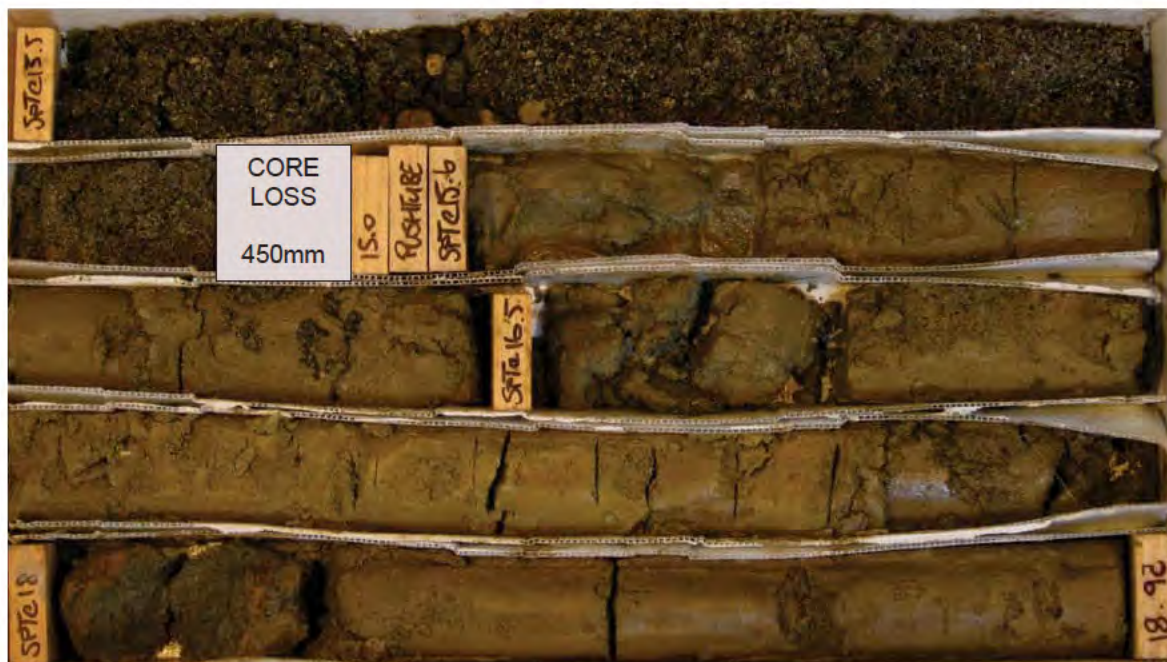
| Project | Southern Links | Box | 3 & 4 of 4 |

| Job no. | 60164546 | Depth<br>(below ground level) | From 13.50m to 19.95m of 19.95m |

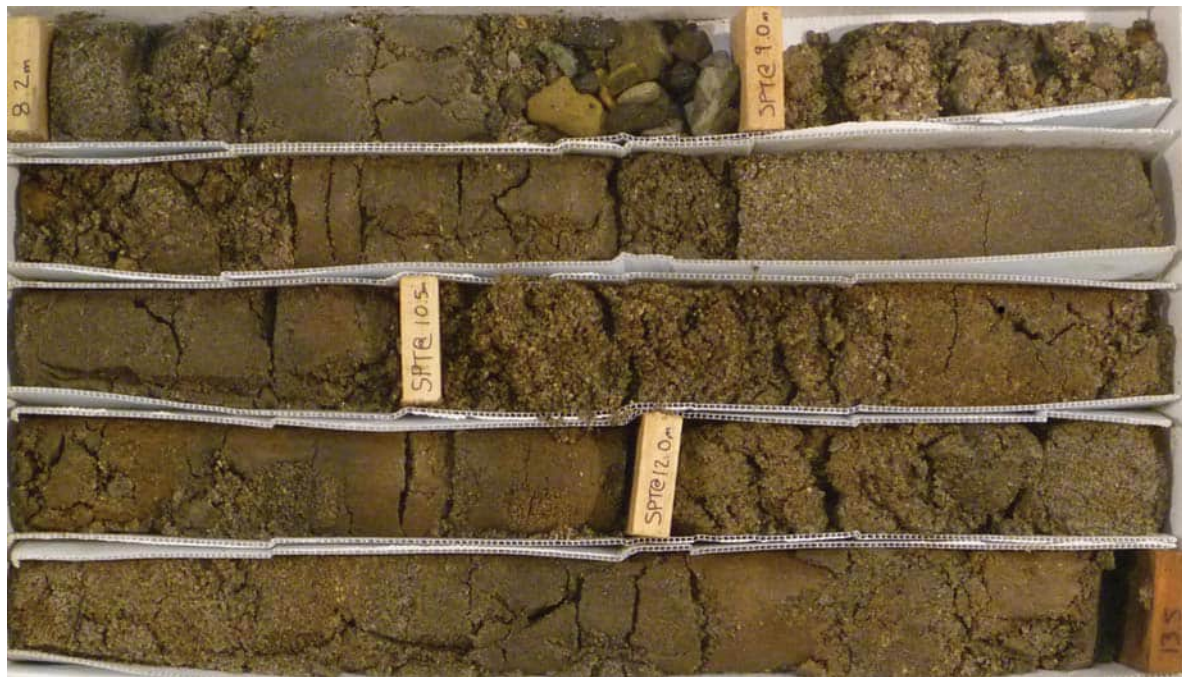
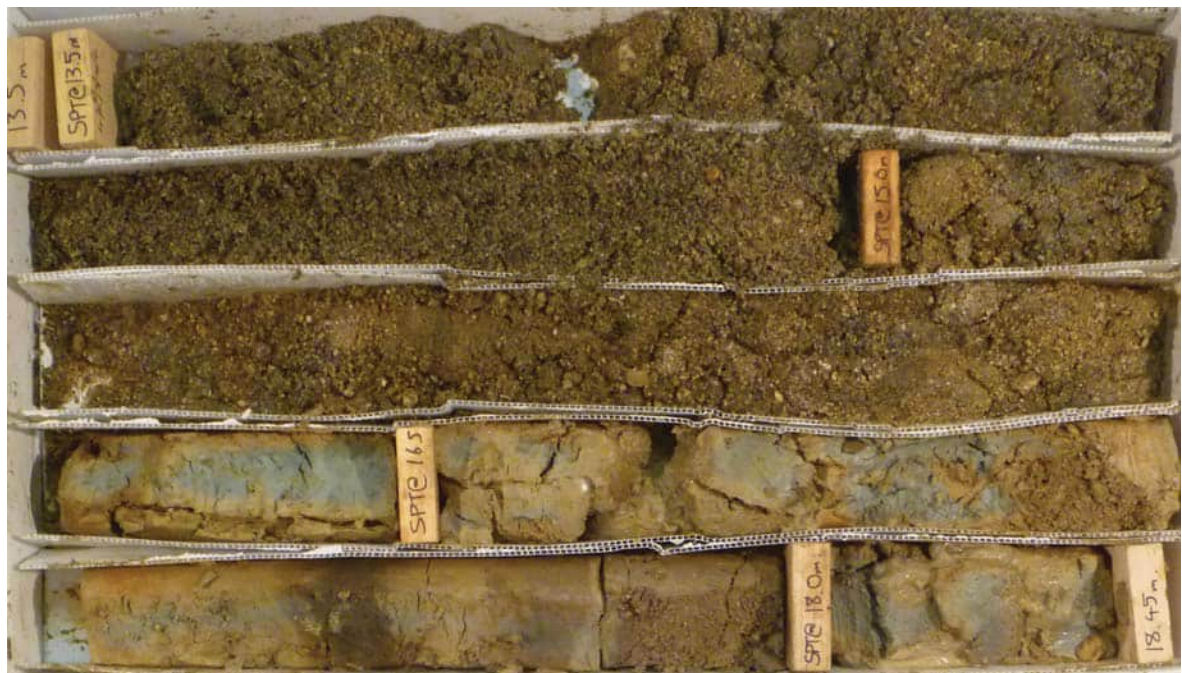
| <b>Project</b> | Southern Links | <b>Box</b> | 3 & 4 of 7 |

| <b>Job no.</b> | 60164546 | <b>Depth<br/>(below ground level)</b> | From 8.2m to 18.45m of 25.95m |
| <b>Location</b> | Southern end of Houchens Road | <b>Notes</b> | Date photographed: 14/02/2012 |

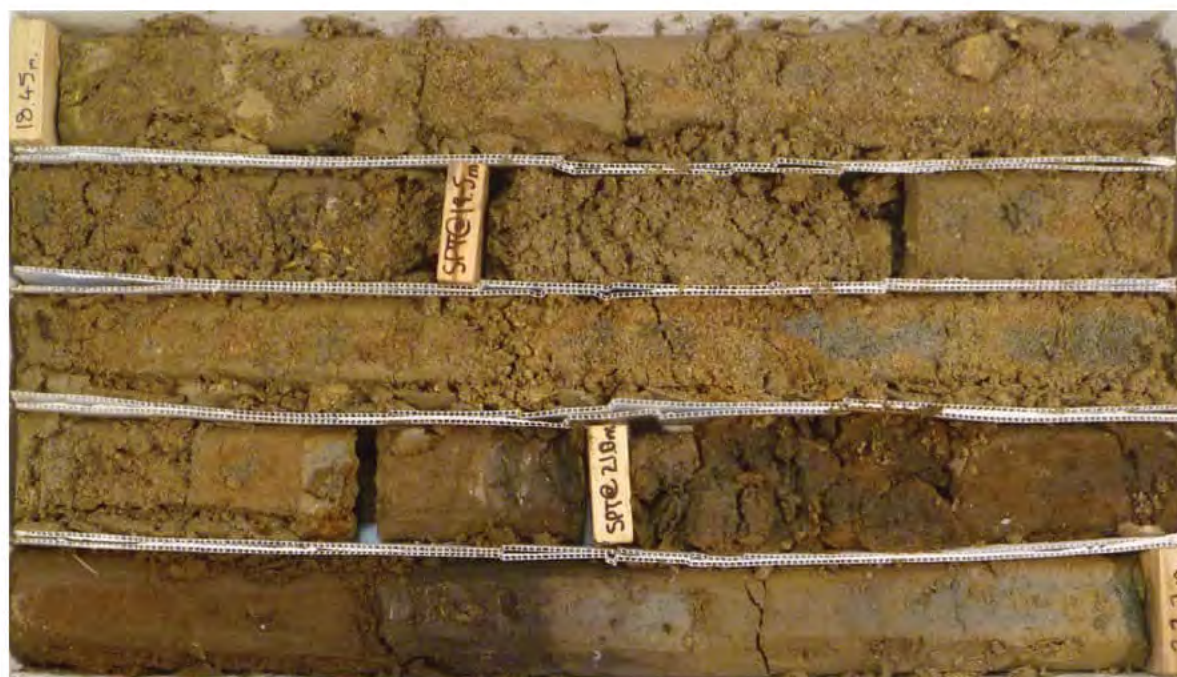
| <b>Project</b> | Southern Links | <b>Box</b> | 5 & 6 of 6 |

| <b>Job no.</b> | 60164546 | <b>Depth<br/>(below ground level)</b> | From 18.45m to 25.95m of<br>25.95m. |

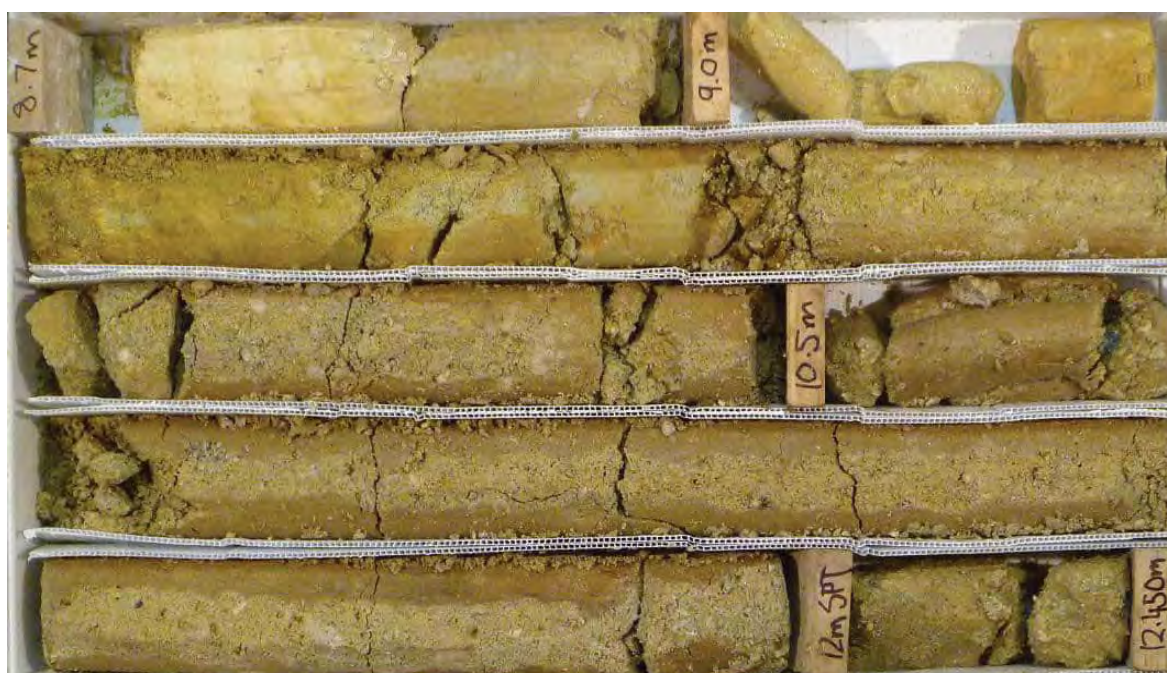
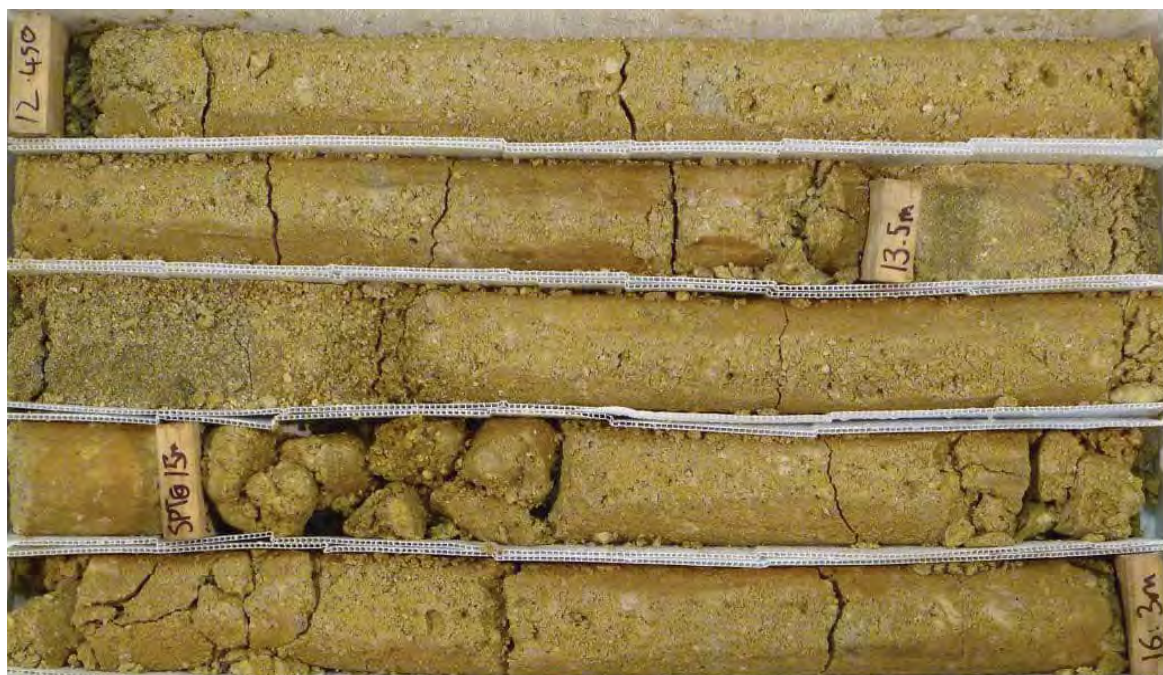
| <b>Project</b> | Southern Links | <b>Box</b> | 3 & 4 of 7 |

| <b>Job no.</b> | 60164546 | <b>Depth<br/>(below ground level)</b> | From 8.7m to 16.3m of 25.95m |
| <b>Location</b> | Base of slope west of SH3 | <b>Notes</b> | Date photographed: 14/02/2012 |

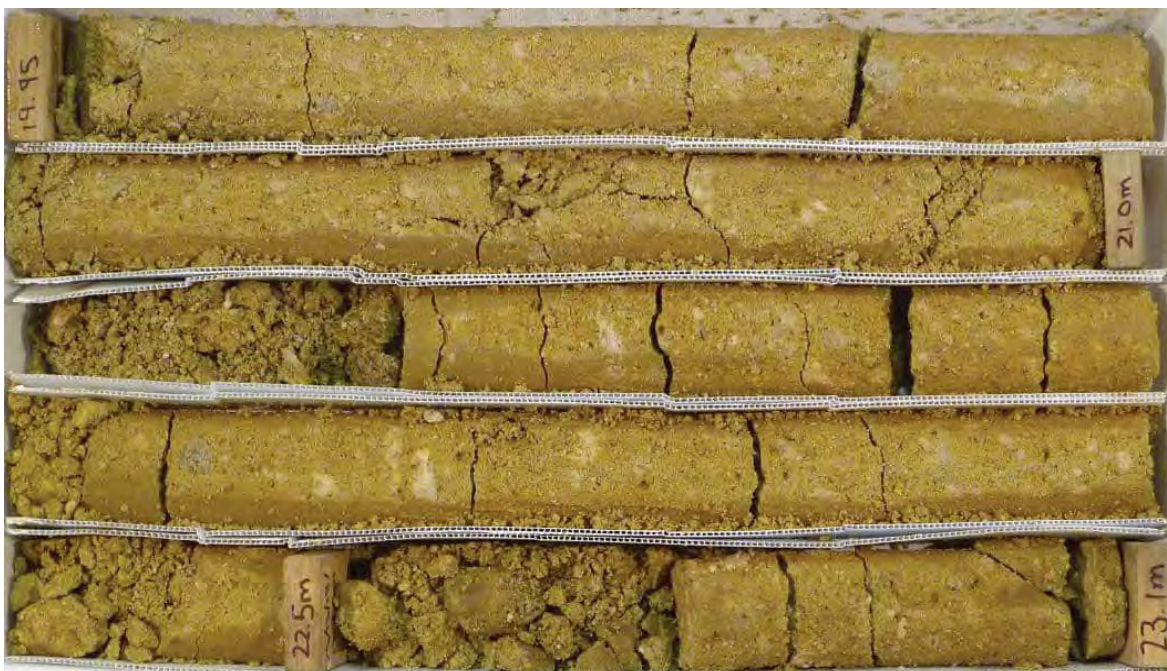
| <b>Project</b> | Southern Links | <b>Box</b> | 5 & 6 of 7 |

| <b>Job no.</b> | 60164546 | <b>Depth<br/>(below ground level)</b> | From 16.3m to 23.1m of 25.95m. |
| <b>Location</b> | Base of slope west of SH3 | <b>Notes</b> | Date photographed: 14/02/2012 |

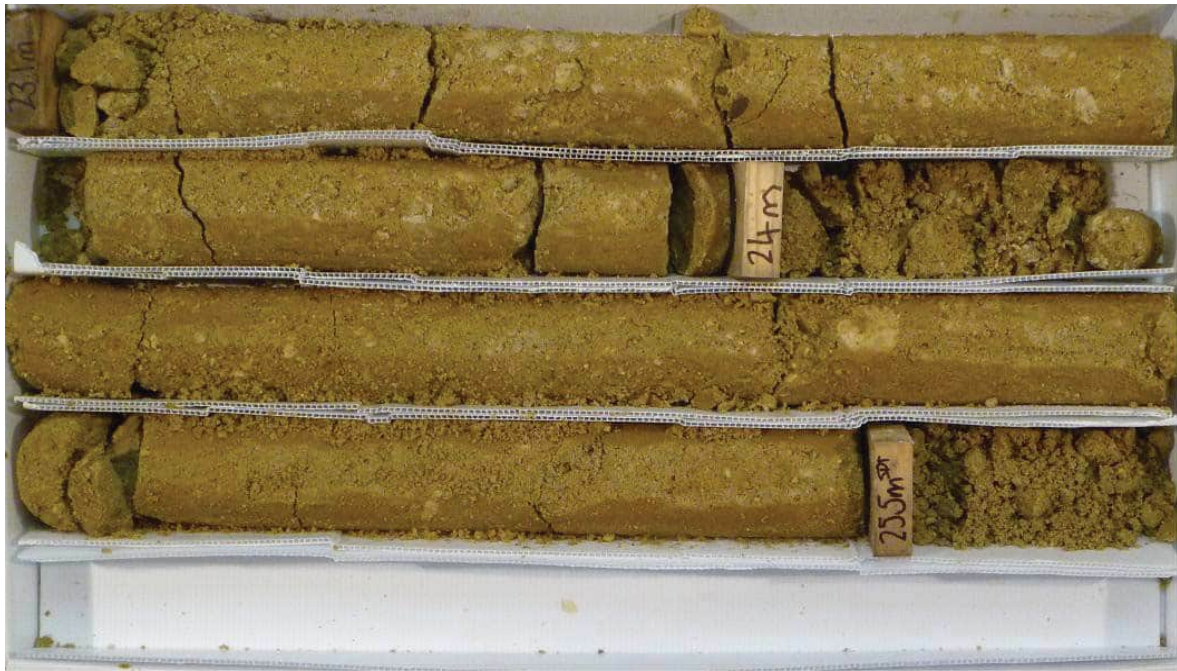
| <b>Project</b> | Southern Links | <b>Box</b> | 7 of 7 |

| <b>Job no.</b> | 60164546 | <b>Depth<br/>(below ground level)</b> | From 23.1m to 25.95m of 25.95m. |

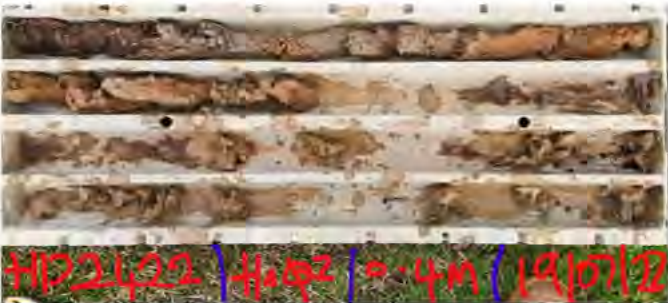
| | | End of log at 4 m - target depth achieved. | | | | | | | | | | | | | | | | |
| | | |

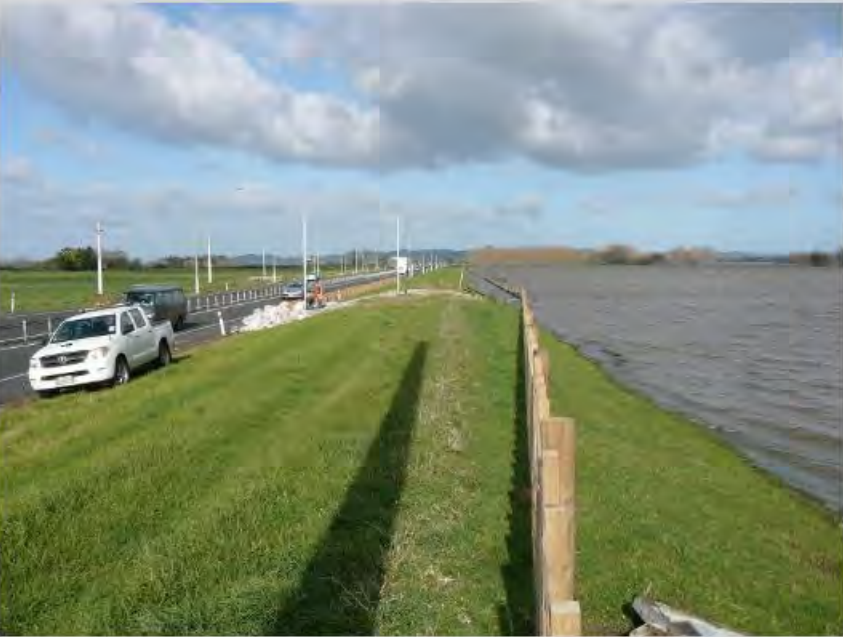
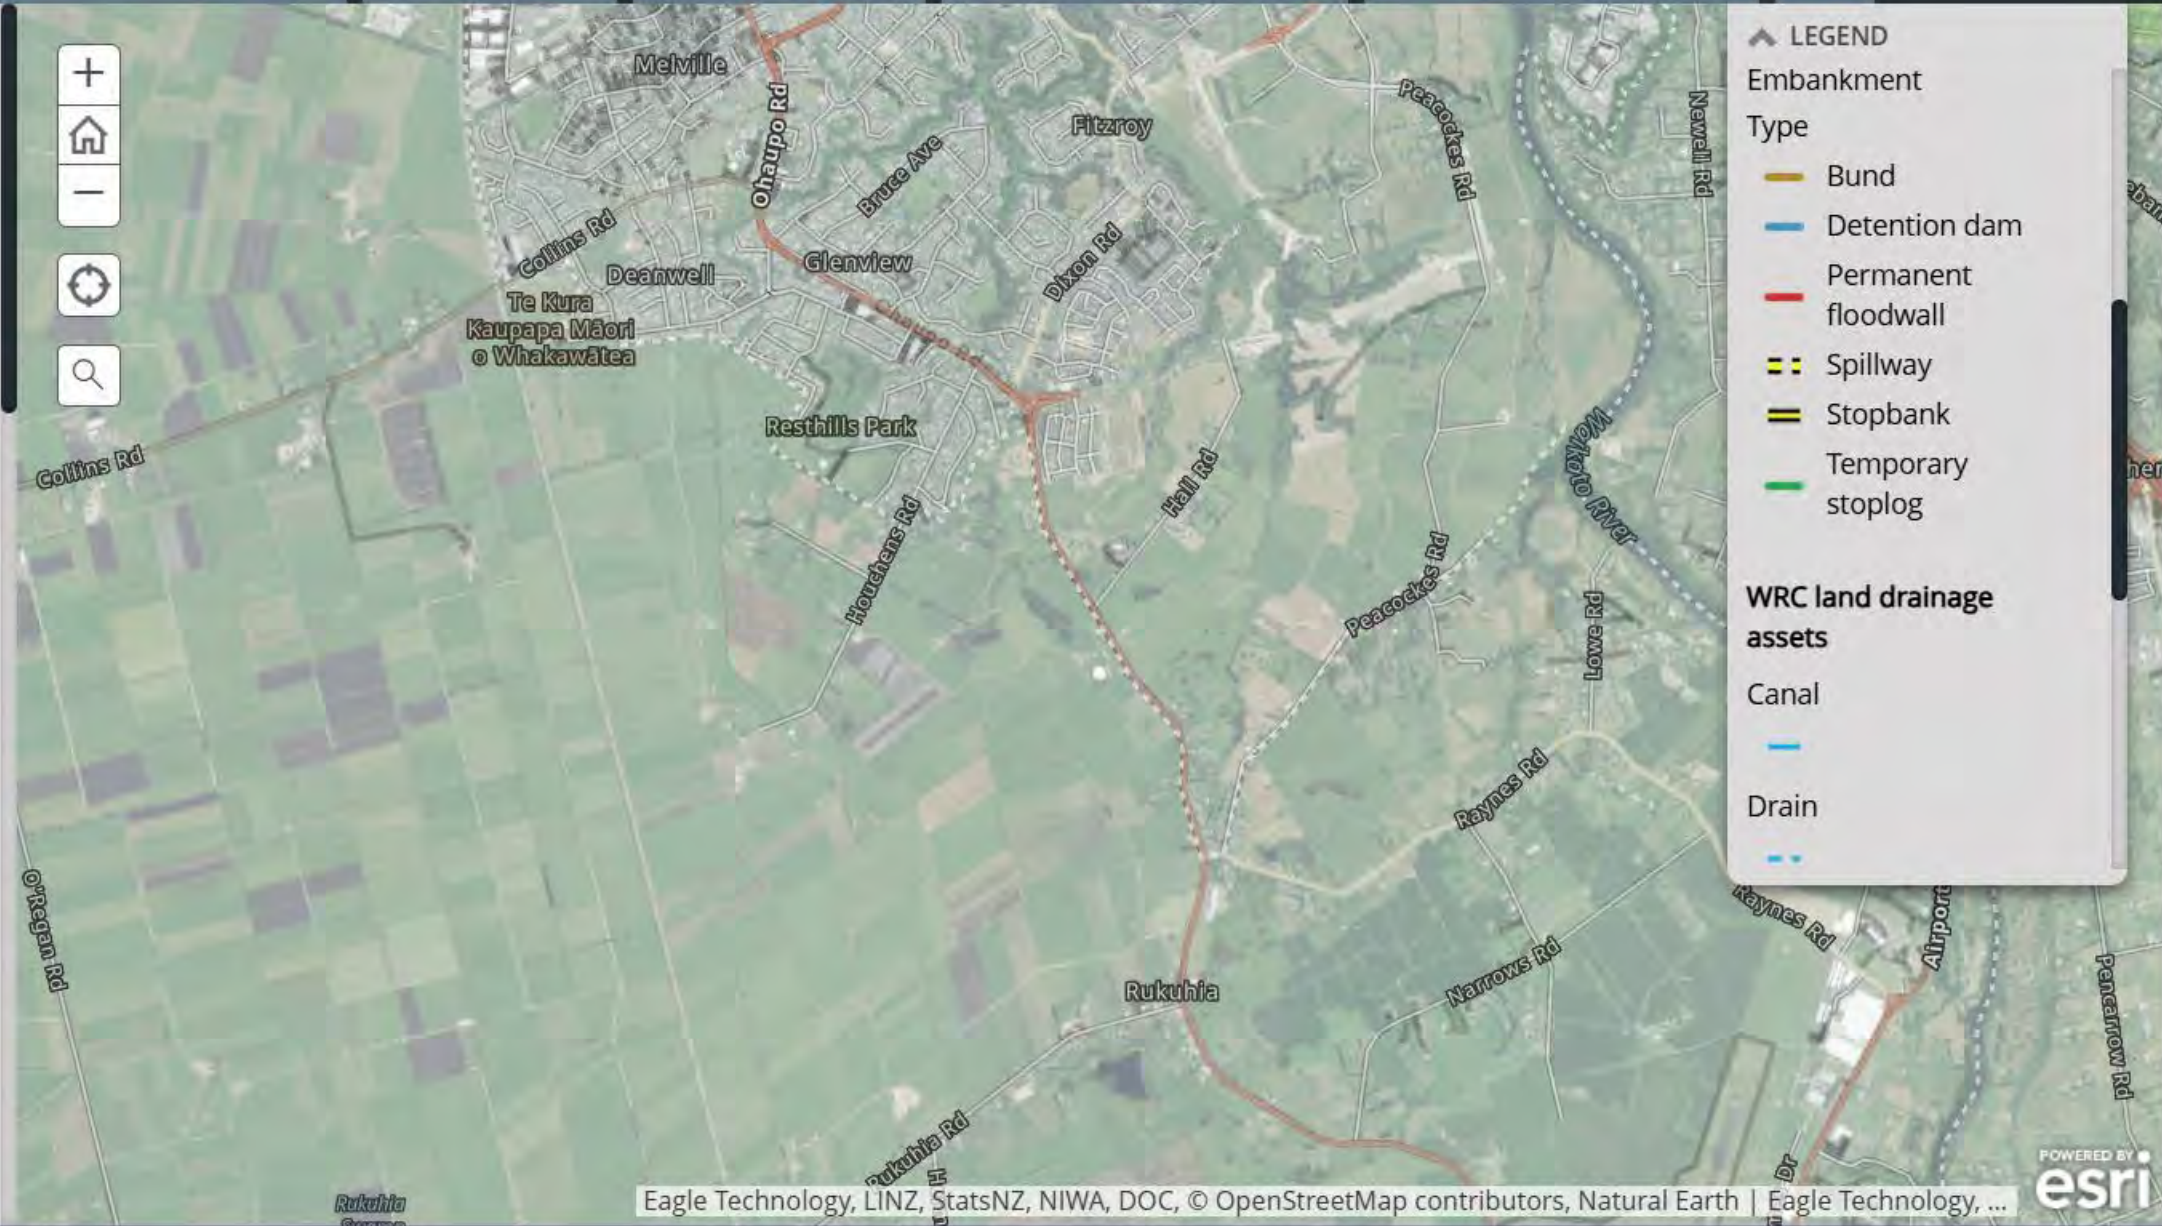
## Flood Management

Waikato Regional Council owns and maintains many flood protection schemes. These schemes significantly reduce the risk of river flooding to many low lying areas, through measures such as stopbanks, floodgates and channel maintenance. Each stopbank is designed to provide a certain level of protection - this may be to the 1% AEP event, or it may only be to the 10% AEP event. When a flood event occurs that is greater than the design level, the river may overtop the stopbank and cause flooding. In addition, there is always a small chance that a stopbank will fail (breach). The level of risk that remains for defended properties is known as "residual risk".
