Drill hole ID: BH2B\_1152  
Client: Pro Drill Ltd  
Run Number(s): 01, 03  
Tool Type(s): ABI40-2G Acoustic Televiwer  
OBI40-2G Optical Televiwer

Drill hole ID: BH2B\_1153

Drill hole ID: BH2B\_1154  
Client: Drill Force NZ Ltd  
Run Number(s): 01, 02, 04  
Tool Type(s): ABI40-2G Acoustic Televiwer  
OBI40-2G Optical Televiwer  
QL40-CAL Mechanical Calliper

Drill hole ID: BH2B\_1111  
Client: Drill Force Ltd  
Run Number(s): 01, 02, 03, 04  
Tool Type(s): ABI40-2G Acoustic Televiwer  
OBI40-2G Optical Televiwer  
QL40-CAL Mechanical Calliper

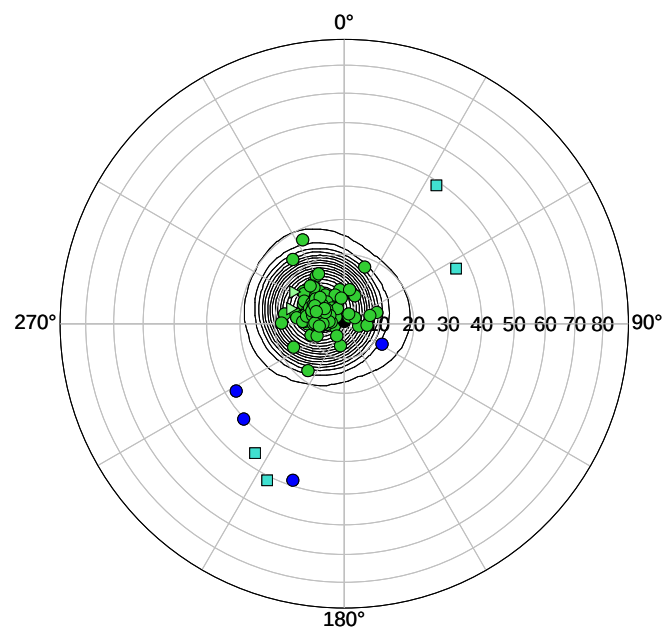
### Stereoplot - Polar Projection Dip

Schmidt Plot - Upper (Northern) Hemisphere - Structures - True  
Depth: 7.34 m to 39.71 m

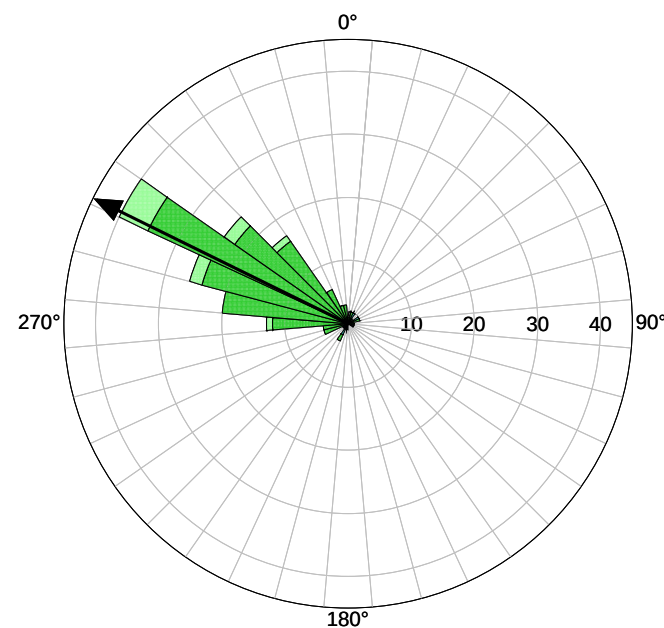
### Rose Diagram - Azimuth

Depth: 7.34 m to 39.71 m

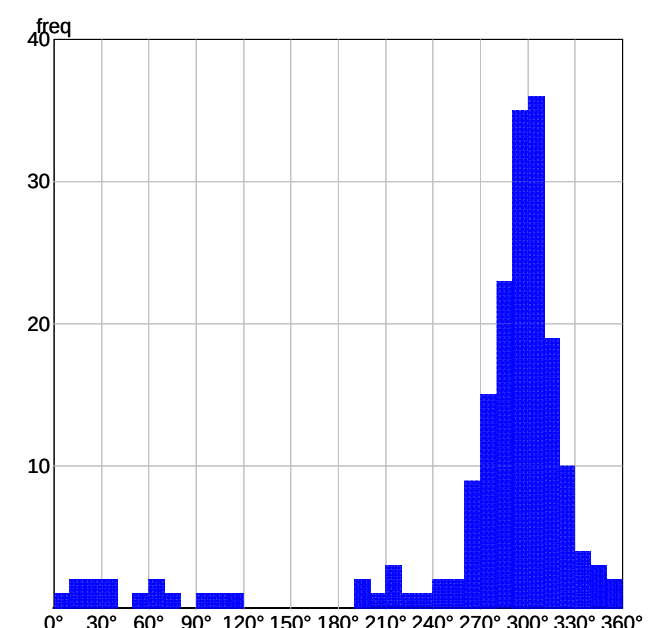
### Histogram - Azimuth

Depth: 7.34 m to 39.71 m

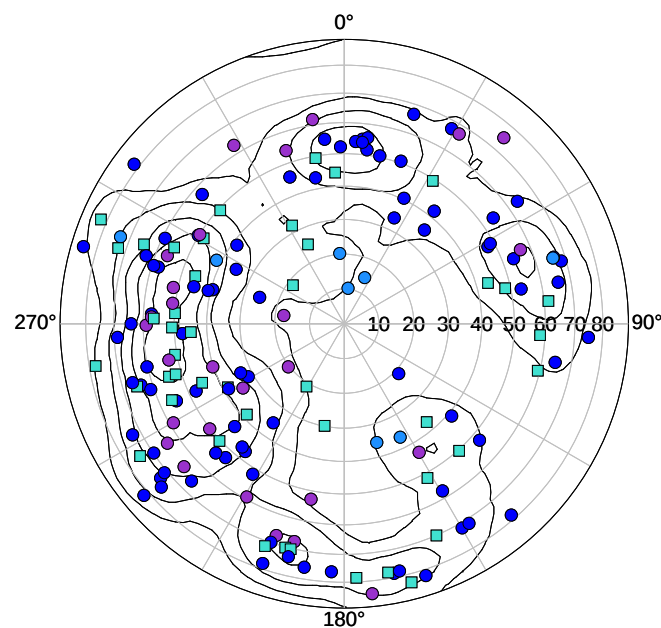
Stereoplot - Polar Projection Dip

Schmidt Plot - Upper (Northern) Hemisphere - Structures - True  
Depth: 3.50 m to 40.30 m

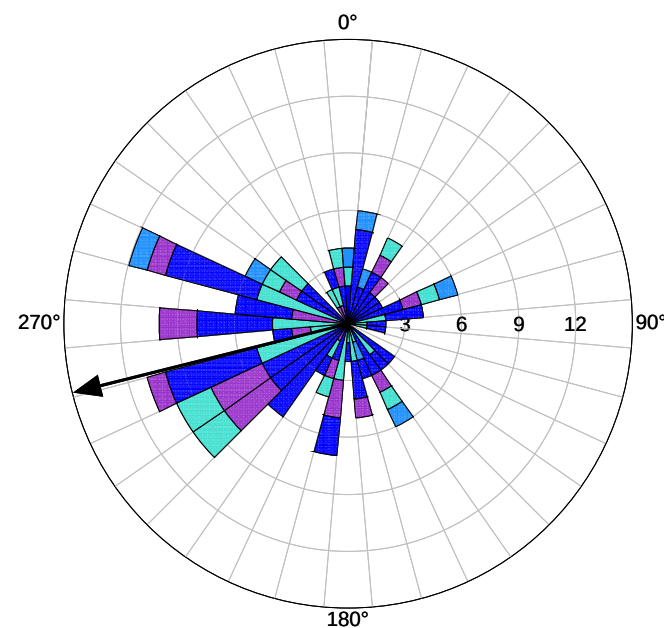
Rose Diagram - Azimuth

Depth: 3.50 m to 40.30 m

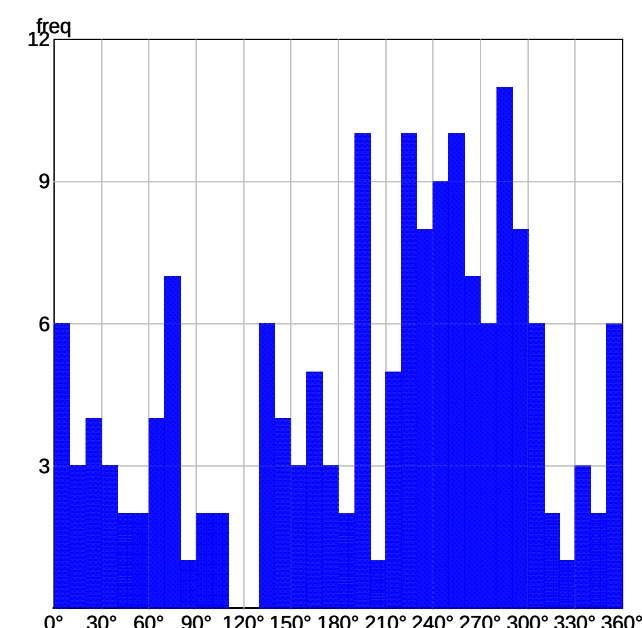
Histogram - Azimuth

Depth: 3.50 m to 40.30 m

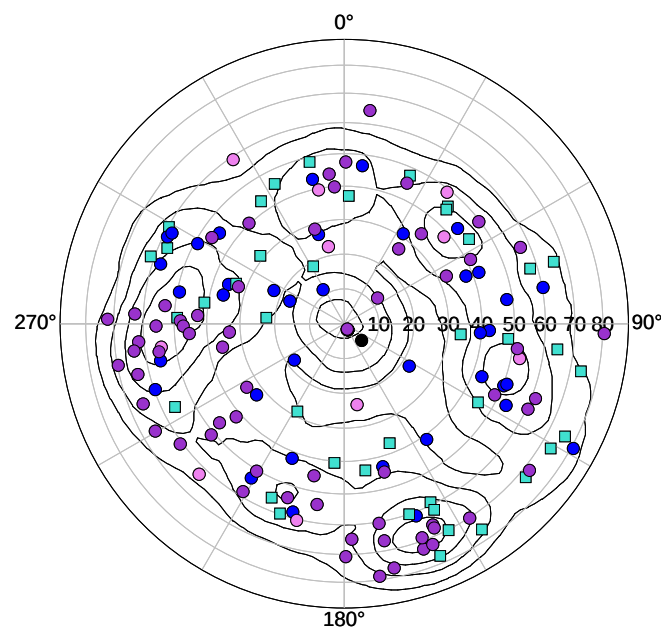
### Stereoplot - Polar Projection Dip

Schmidt Plot - Upper (Northern) Hemisphere - Structures - True  
Depth: 2.85 m to 38.85 m

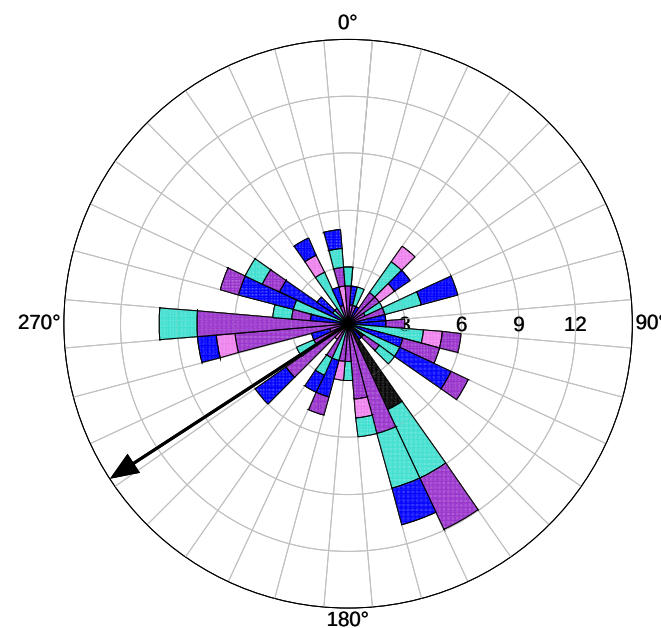
### Rose Diagram - Azimuth

Depth: 2.85 m to 38.85 m

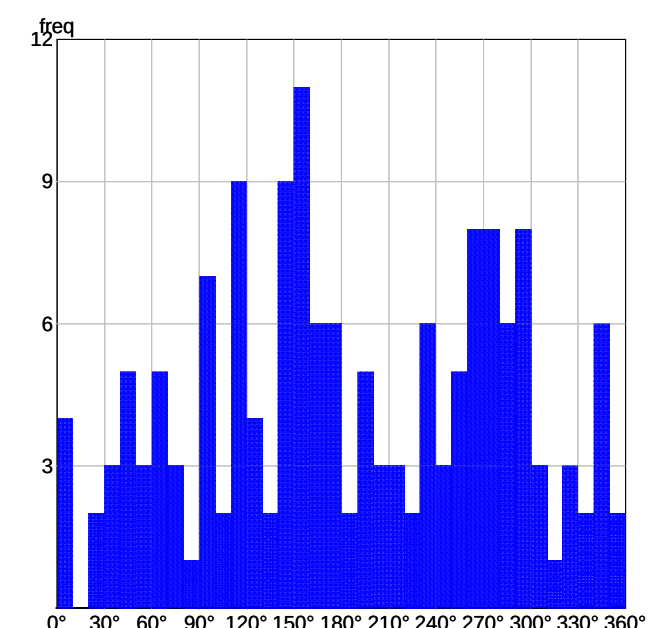
### Histogram - Azimuth

Depth: 2.85 m to 38.85 m

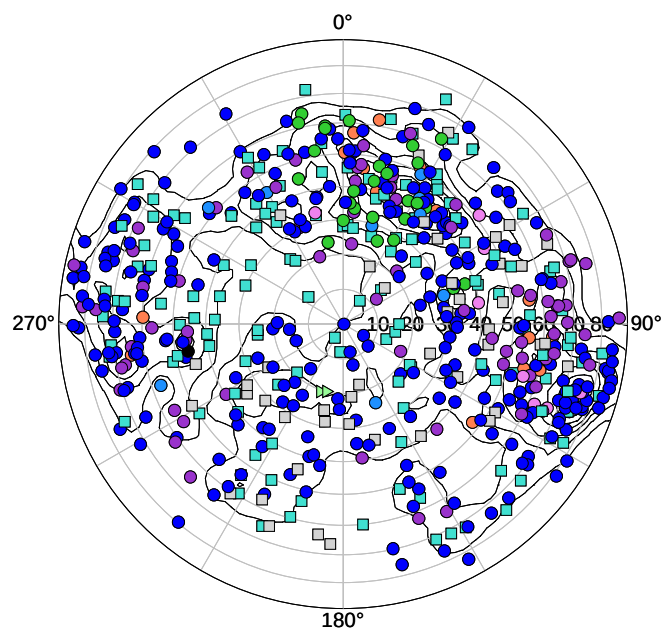
### Stereoplot - Polar Projection Dip

Schmidt Plot - Upper (Northern) Hemisphere - Structures - True  
Depth: 1.24 m to 90.00 m

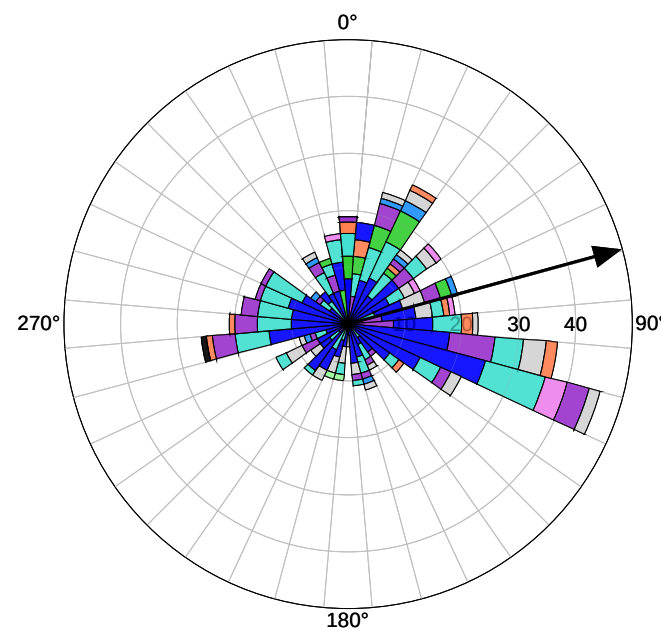
### Rose Diagram - Azimuth

Depth: 1.24 m to 90.00 m

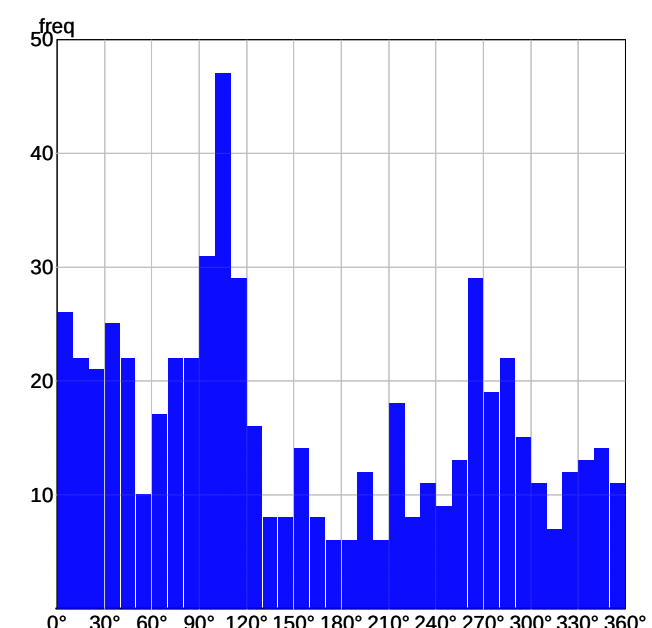
### Histogram - Azimuth

Depth: 1.24 m to 90.00 m
