## 11. SKIFIELD REVEGETATION

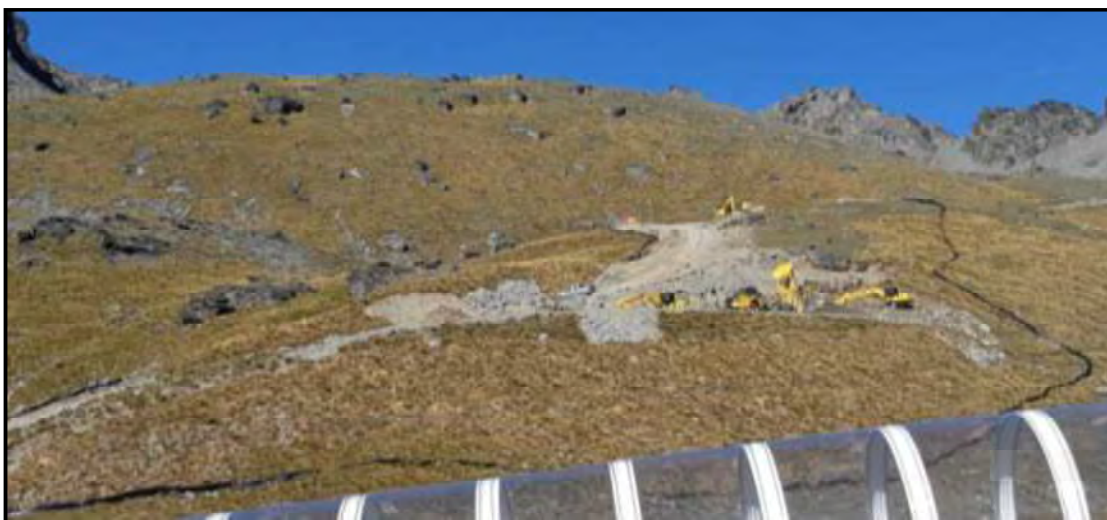
**Figure 71. Sugar Bowl trail 2020 under construction. The area enclosed by the black fence and the track above has been reshaped and revegetated by machines and is hardly distinguishable from the untouched tussock grassland.**

Over the years various methods of restoration have been used with varying success. One of the more successful restoration projects was early on where a spur was removed to form the first car park. A skilful machine operator removed tussocks from the area to be cut and replaced them on the finished slopes behind. The large area re-tussocked was only visible from the undisturbed tussockland if you were aware of the change. This method has been used this year on the new Sugar Bowl trail with a similar result. (Refer Figure 71 below).

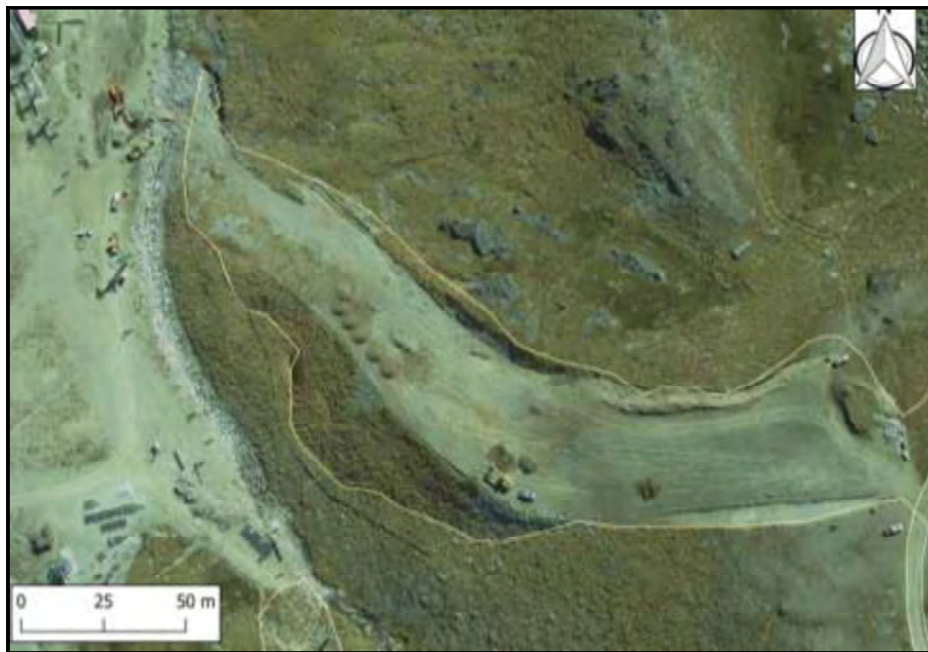
Figure 74. Aerial view of the recent work (refer Figure 71 above) with reworked area outlined in yellow and replanted area the slope below the skin trail. Note piles of saved top soil and replanted tussocks on the trail.

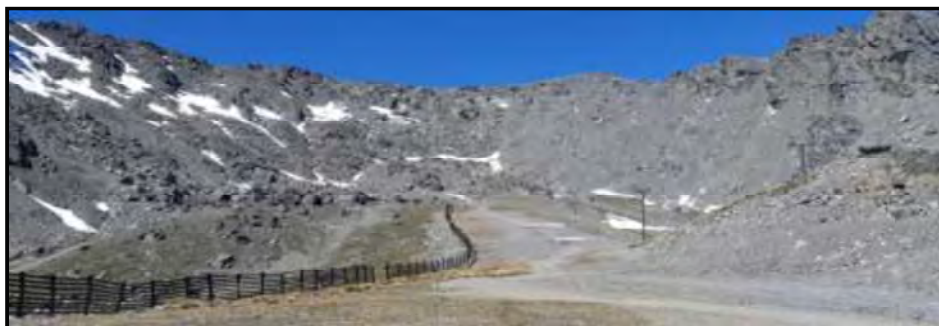
Figure 75. Experimental hand transplanting and hand seeding along the fence, upper Sugar Bowl. View uphill. Several hand planted plots can be seen up the fence line and at the right.

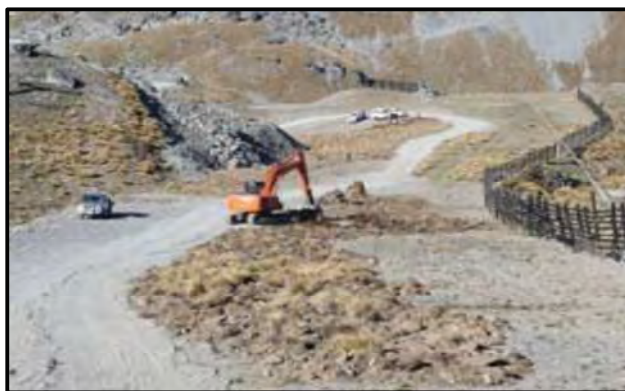
Figure 76. Further rehabilitation taking place in 2020 on the same site as Figure 75 above but the opposite view, here looking down the site. In foreground tussock clumps are being placed by digger and lower on the corner, seen as bare ground in figure 75. Later hand work is carried out to ensure plants are upright and well bedded in.

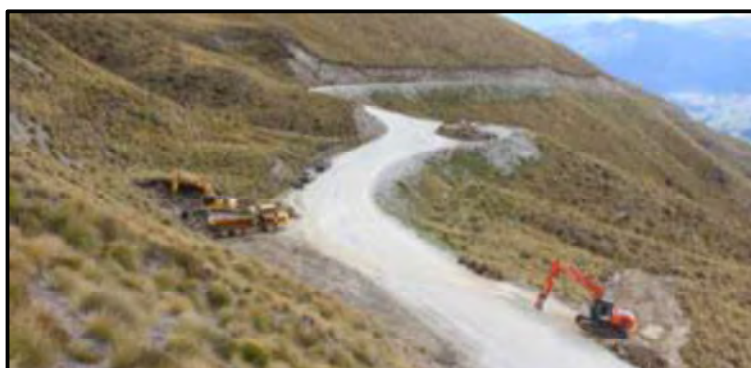
Figure 77.  
Car park 4 development  
2015 before modification.  
Below and above the  
existing road.

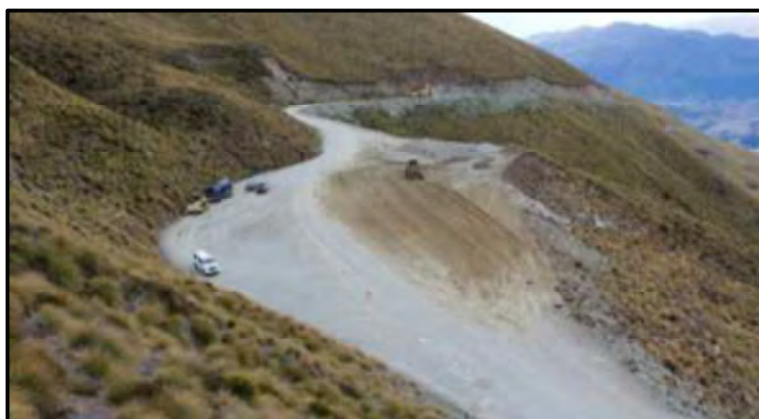
Figure 78.  
Note the rehabilitation below  
the road and beside the parked  
vehicles. Also the far corner  
has been cut and replanted.

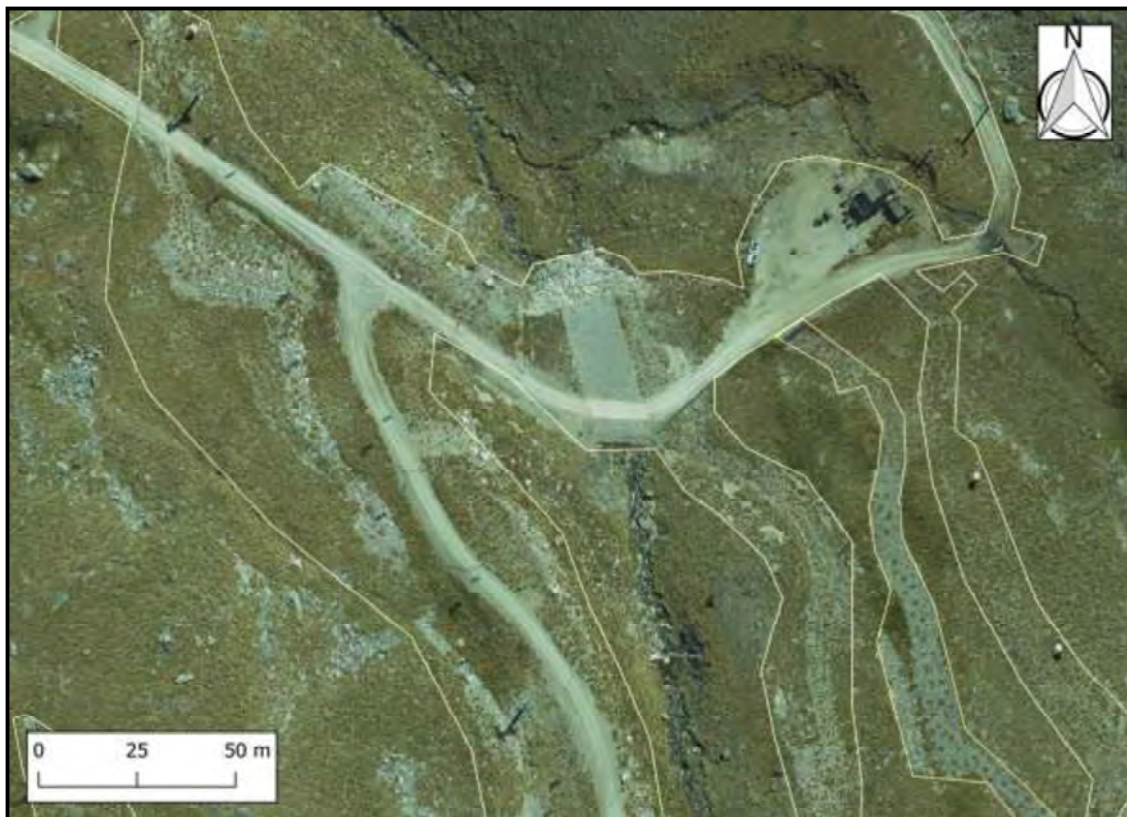
Figure 79. Shows the areas referred to above. Rastus Burn centre, old Sugar Bowl lift top right, Alta road centre bottom. The surveyed areas are to the left of the Alta road junction where spaced tussock shows to the left of the stone drain compared with the denser tussock left of the yellow line. All the area within the yellow line has been re-worked several times since at least 2011. Overall revegetation and its recovery has been good with further improvement expected. The yellow lines enclose re-worked areas with the widely spaced tussocks marking an old 4WD and walking track from time before the Alta road was made.

An area restored tussock area (*Chionochloa macra*) beside the Alta road and above the lower Alta wetland was sampled to compare the species numbers and their relative coverage. The undisturbed grassland was 90% *Chionochloa macra* with litter 5%, *Poa colensoi*, *Raoulia grandiflora*, *Epilobium atriplicifolium*, *Raoulia subsericea*, *Rytidosperma pumila*, *Scleranthus uniflorus*, *Uncinia fuscovaginata* and lichens.

The adjacent replanted area had widely spaced tussock where rock and rubble was about 90% cover. Species present as well as the replaced tussock were *Epilobium tasmanicum*, *Carex wakatipu*, *Epilobium atriplicifolium*, *Raoulia subsericea*, *Rytidosperma pumila*, *Scleranthus uniflorus* and *Polytrichum* sp. This area had been reworked several times and was an example of restoration that was not ideal and where insufficient tussocks had been used but that in time would recover to become similar to the undisturbed areas as had occurred in other similar areas below. On one of these areas below the road the public had formed an unofficial access track to the car park that was causing some erosion by opening up the ground cover.

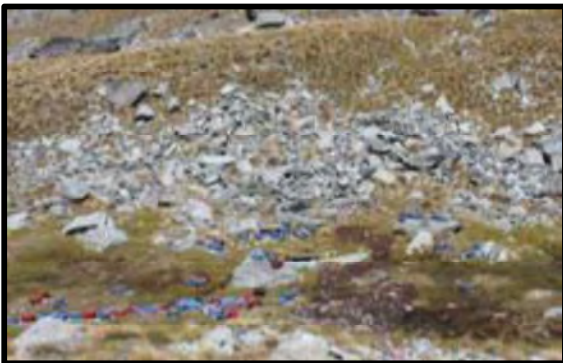
Figure 81. Cut squares of vegetation are carefully Removed in baskets and placed on wet ground Below (red & green baskets).

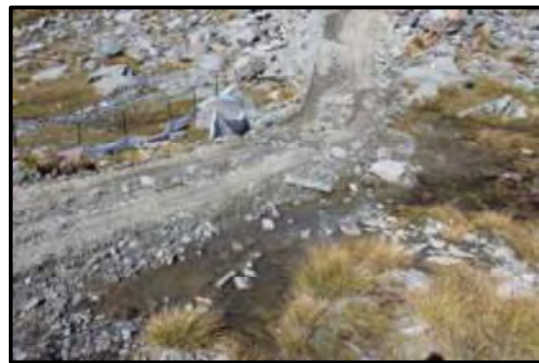
Figure 82. Same area after trench dug, pipeline laid and buried. To orient oneself note large rock upper centre left. Lower centre in Fig. 81.

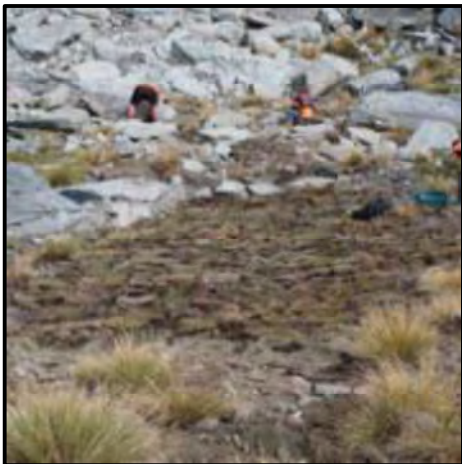
Figure 83. After two months all vegetation that had been removed was relocated and placed like a patchwork quilt, over the reformed ground and packed into place.
