# Belmont Quarry Development – Part F

Substantive Application  
Appendix F.1.B.13 – Land Exchange Application  
- Land Contamination Reports  
Winstone Aggregates

## **PRELIMINARY SITE INVESTIGATION - BELMONT QUARRY - FIRTH BLOCK, NORTHERN GULLY AND SOUTHERN GULLY**

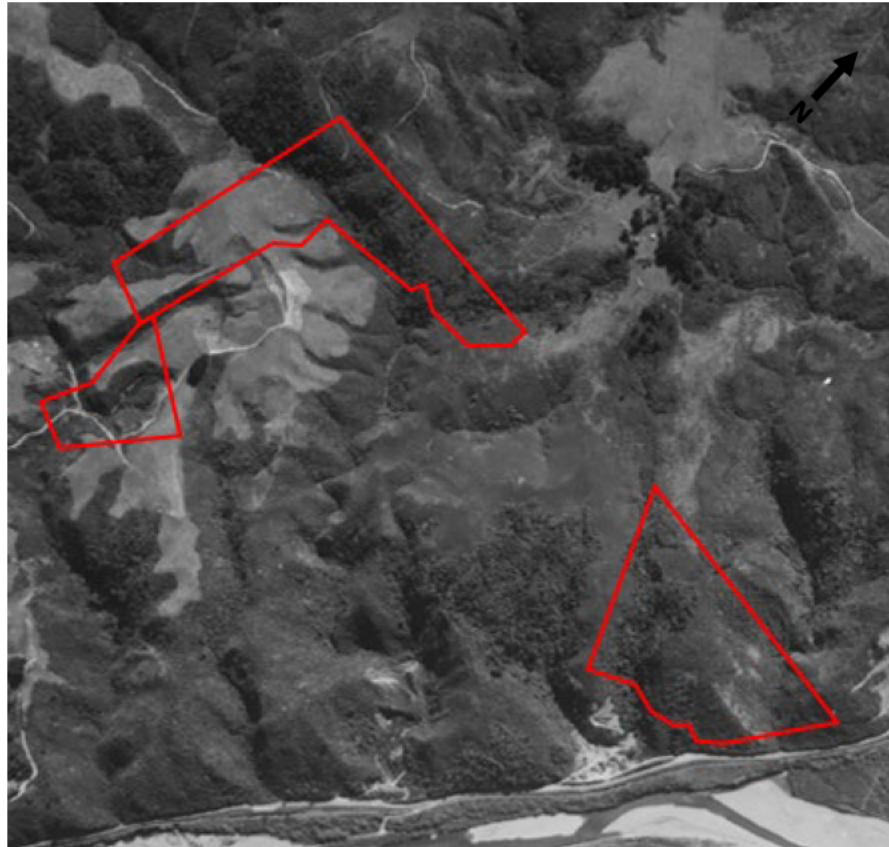
**Photograph 2: 1957 sourced from Retrolens**

| Date | Reference | Description |
|---|---|---|
| 1957 | Photograph 2 | No significant changes to Firth Block are observed. An expansion of Belmont Quarry, outside of the Firth Block site boundary towards the south, has been observed extending further to the northwest.<br><br>Two tracks are observed to intersect the northwestern corner of the Northern Gully. Another track external to the site meets the eastern boundary of the Northern Gully.<br><br>The Southern Gully appears to be covered with vegetation. An access track is present, running from the western corner of the site before diverging into two tracks, one linking to the Northern Gully and one exiting along the eastern boundary of the site. |

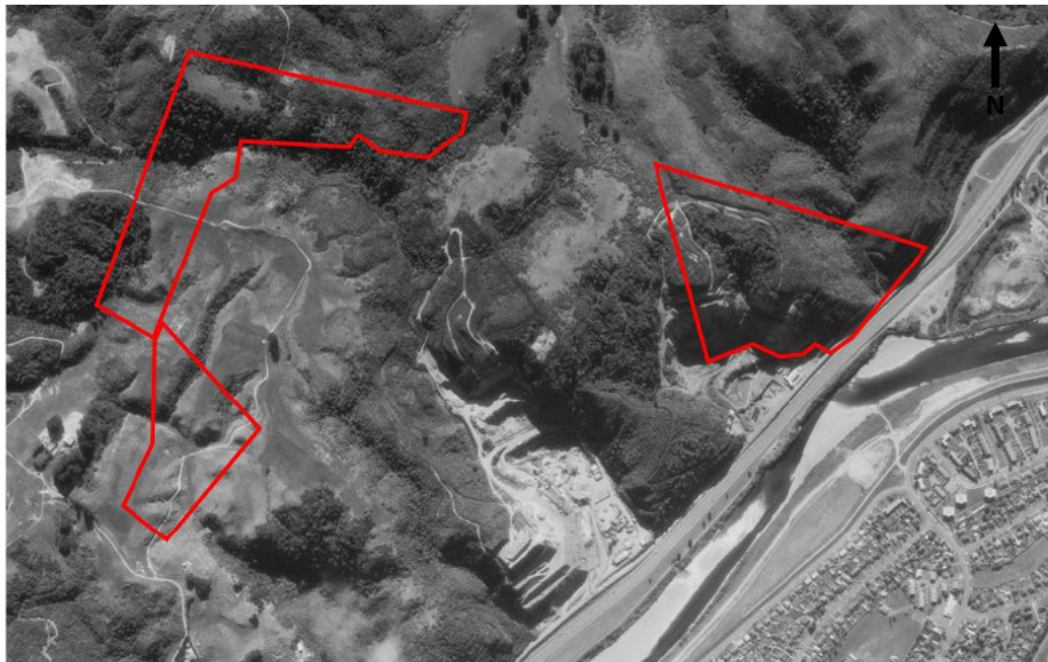
**Photograph 4: 1984 sourced from Retrolens**

| Date | Reference | Description |
|---|---|---|
| 1984 | Photograph 4 | <p>More vegetation is observed across the southwestern portion of Firth Block. A track across the northwest of the site is observed.</p> <p>A track appears to intersect the central portion of the Northern Gully from east to west.</p> <p>To the south of the sites, Belmont Quarry has undergone further expansion.</p> <p>No significant changes to the Southern Gully are observed.</p> |

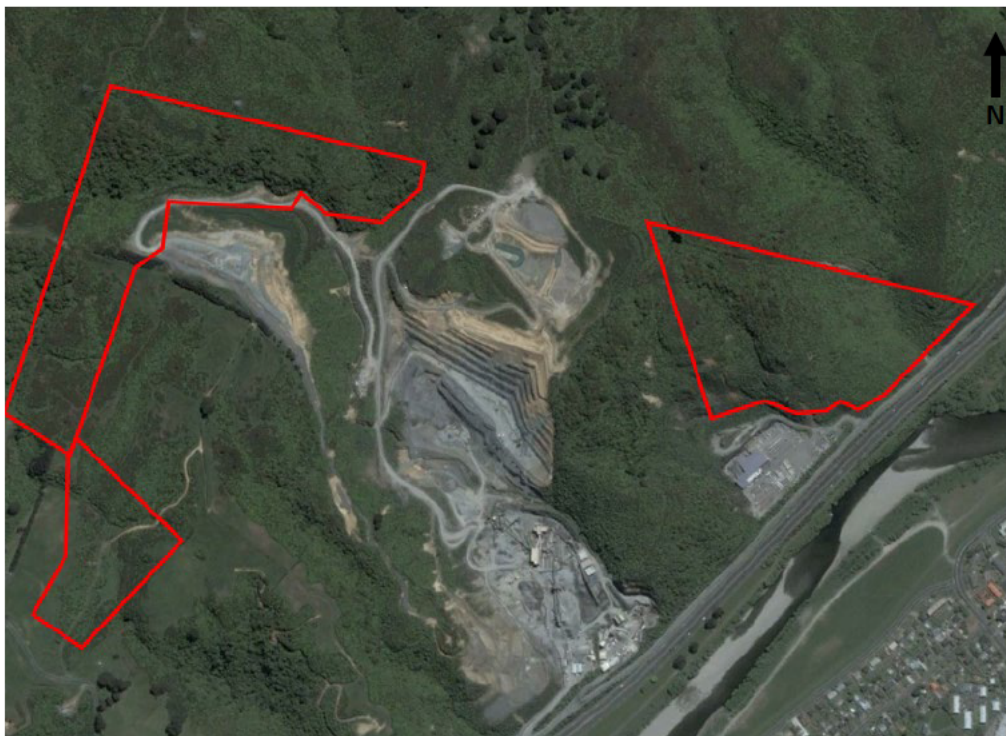
Photograph 6: 2004 sourced from Google Earth Pro

| Date | Reference | Description |
|---|---|---|
| 2004 | Photograph 6 | <p>Firth Block comprises dense bush cover.</p> <p>The track intersecting the Northern Gully has been further developed to the northwest of the site, leading from the quarry. A terraced quarry face intersects the central east of the site. The previously observed track and area of development across the western boundary of the site now comprises vegetative cover.</p> <p>No significant changes to the Southern Gully are observed.</p> |

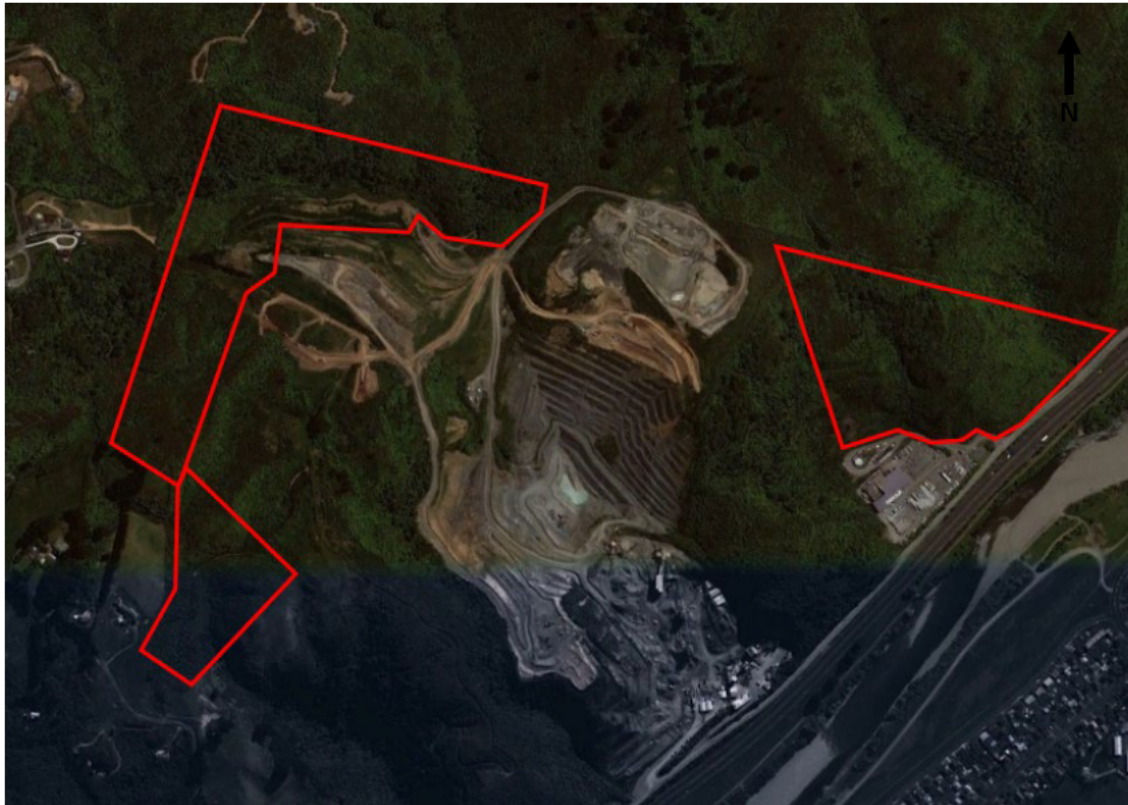
**Photograph 7: 2009 sourced from Google Earth Pro**

| Date | Reference | Description |
|---|---|---|
| 2009 | Photograph 7 | <p>No significant changes to Firth Block are observed.</p> <p>The track and terraced areas across the central north and central east of the Northern Block is observed to have more vegetative cover.</p> <p>No significant changes are observed in the Southern Gully, there appears to be increased vegetation cover.</p> |

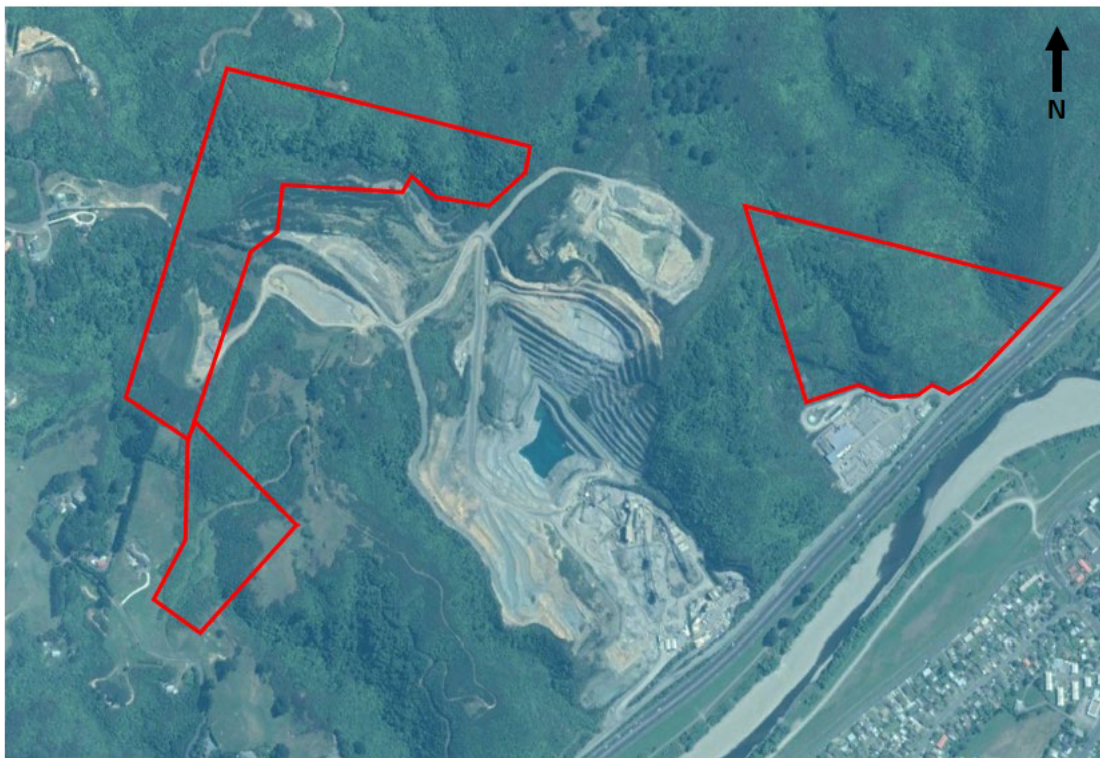
**Photograph 8: 2011 sourced from Google Earth Pro**

| Date | Reference | Description |
|---|---|---|
| 2011 | Photograph 8 | <p>No significant changes to Firth Block are observed.</p> <p>In the Northern Gully, further quarry development is observed to the southeast and further vegetative cover is observed in the central north. A road to the west of the Northern Gully slightly intersects the site boundary.</p> <p>No significant changes are observed in the Southern Gully.</p> |

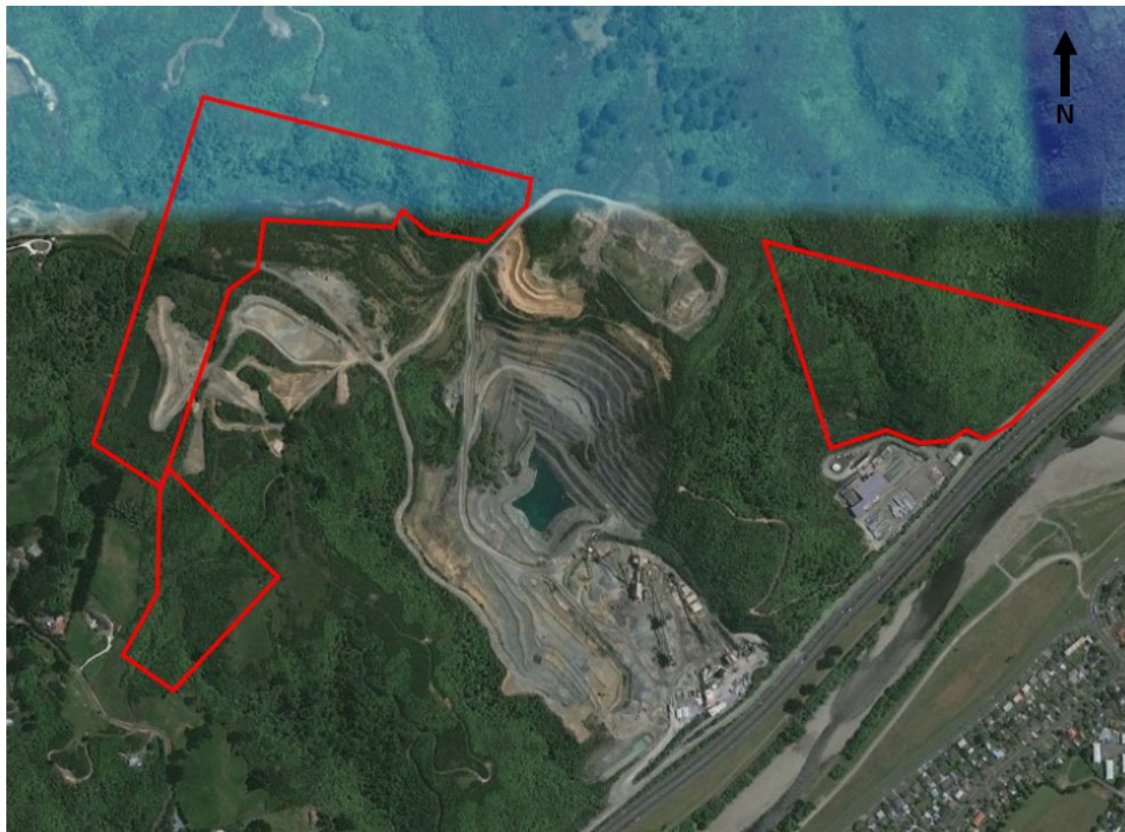
Photograph 9: 2012 sourced from Google Earth Pro

| Date | Reference | Description |
|---|---|---|
| 2012 | Photograph 9 | <p>No significant changes to Firth Block are observed.</p> |

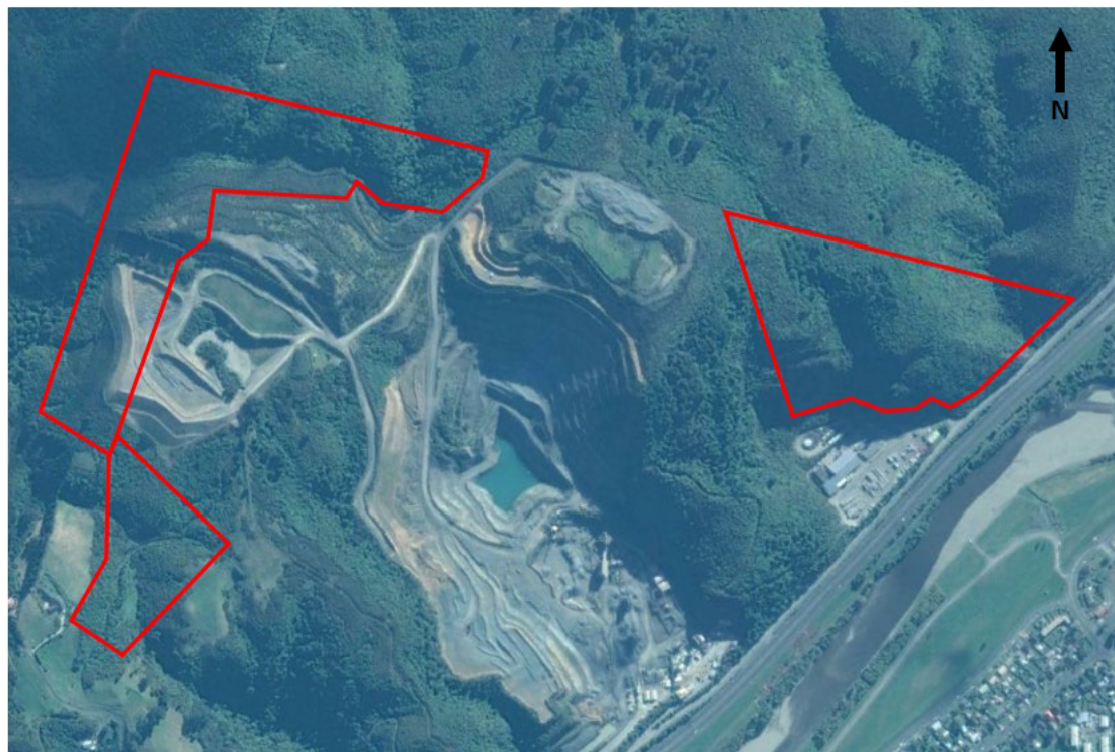
Photograph 10: 2014 sourced from Google Earth Pro

| Date | Reference | Description |
|---|---|---|
| 2014 | Photograph 10 | <p>No significant changes to Firth Block are observed.</p> <p>The quarry area to the south of the Northern Gully has further expanded to the west and more vegetative cover is visible in the central north area.</p> <p>No significant changes are observed in the Southern Gully.</p> |

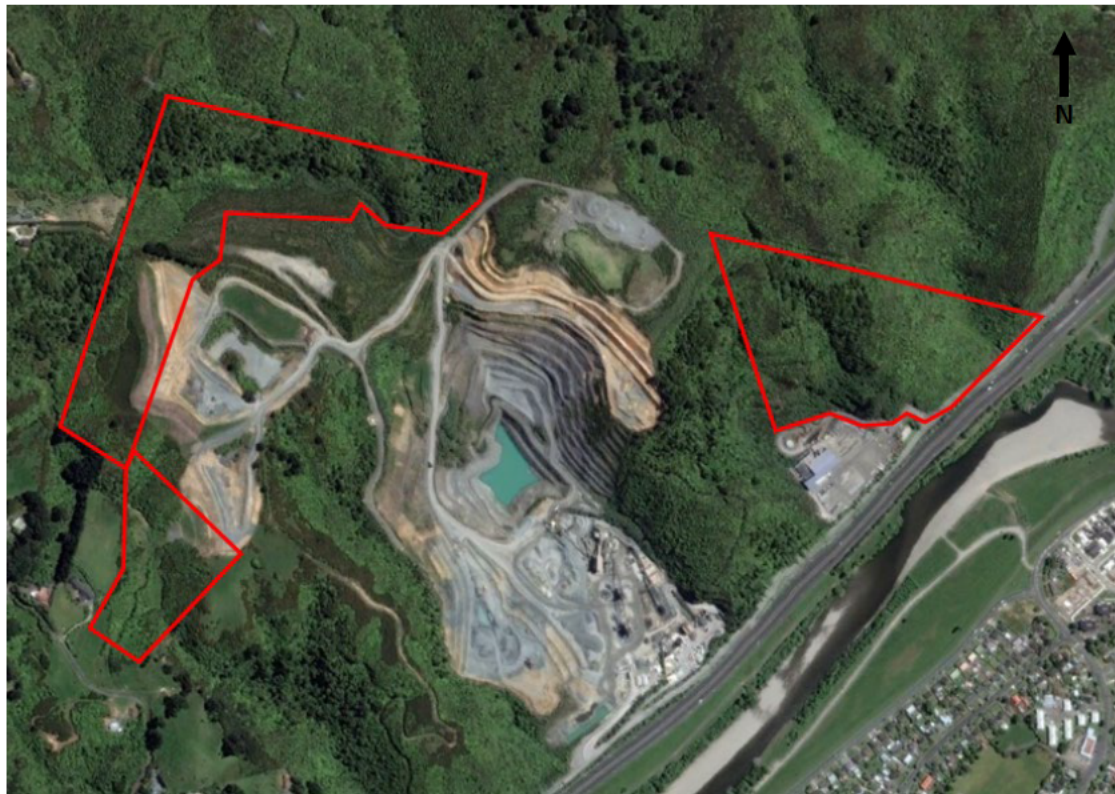
**Photograph 11: 2015 sourced from Google Earth Pro**

| Date | Reference | Description |
|---|---|---|
| 2015 | Photograph 11 | <p>No significant changes to Firth Block are observed.</p> <p>The quarry area to the south of the Northern Gully is observed to have had soil disturbance. The central northern area comprises dense bush.</p> <p>Soil disturbance, associated with activities within Belmont Quarry, is visible in the northeastern portion of the site. No other significant changes observed.</p> |

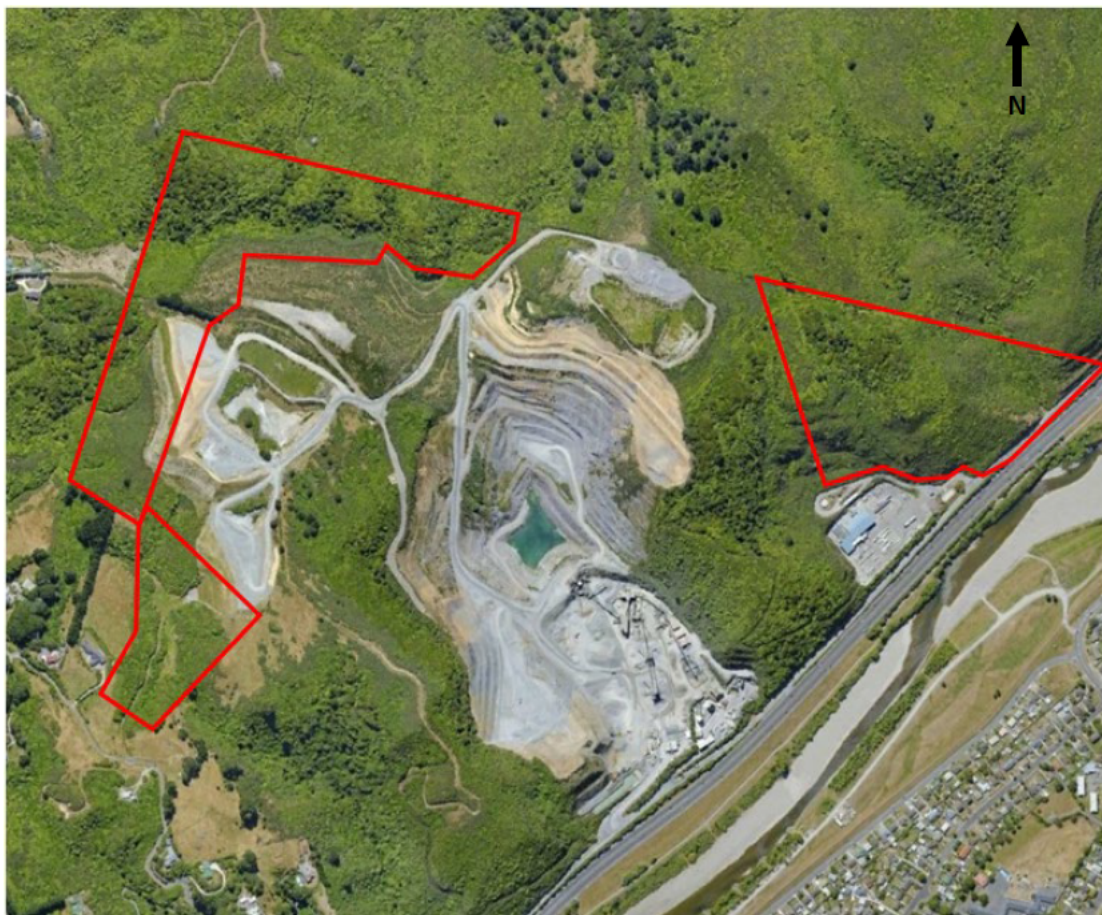
**Photograph 12: 2016 sourced from Google Earth Pro**

| Date | Reference | Description |
|---|---|---|
| 2016 | Photograph 12 | <p>No significant changes to Firth Block are observed.</p> <p>The quarry area in the southern portion of the Northern Gully is observed to be partially covered with what appears to be gravels.</p> <p>Soil disturbance is still visible on the northern boundary. A cleared area of vegetation, potentially paved, is visible in the sites centre southwest of the area of soil disturbance. No other significant changes observed.</p> |

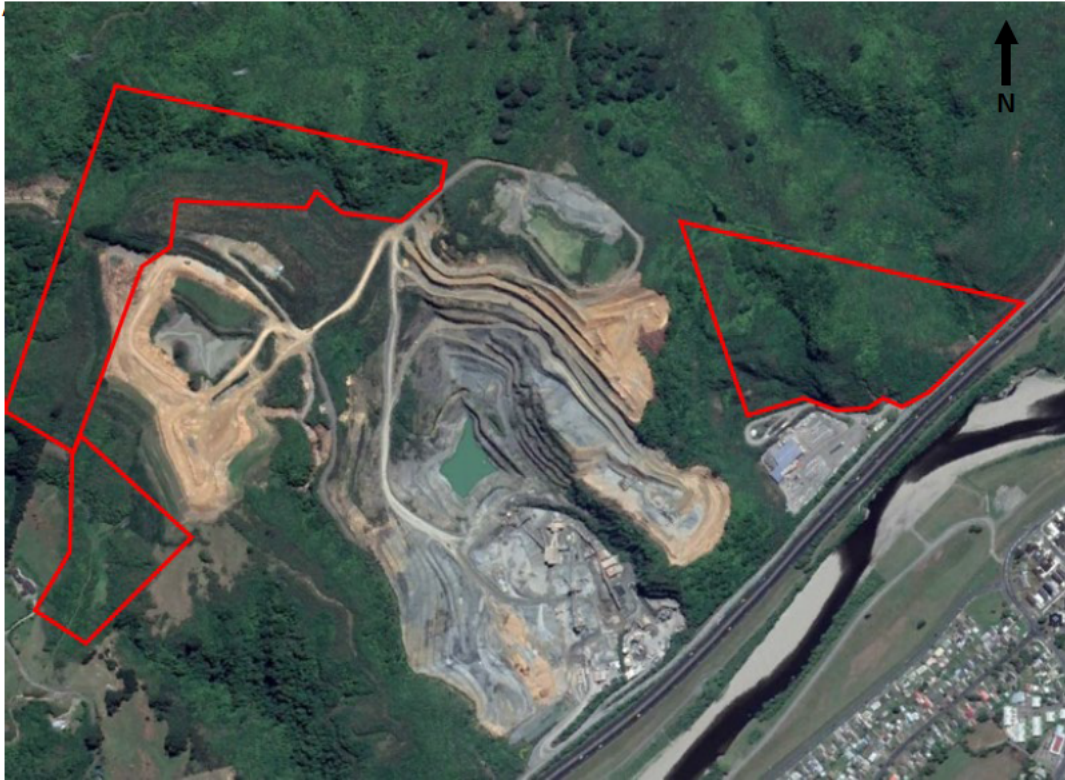
Photograph 13: 2018 sourced from Google Earth Pro

| Date | Reference | Description |
|---|---|---|
| 2018 | Photograph 13 | <p>No significant changes to Firth Block are observed.</p> <p>The quarry area to the south of the Northern Gully is observed to be partially covered with what appears to be covered with some vegetation in places.</p> <p>No earthworks are now being undertaken in the Southern Gully which is now fully covered in vegetation.</p> |

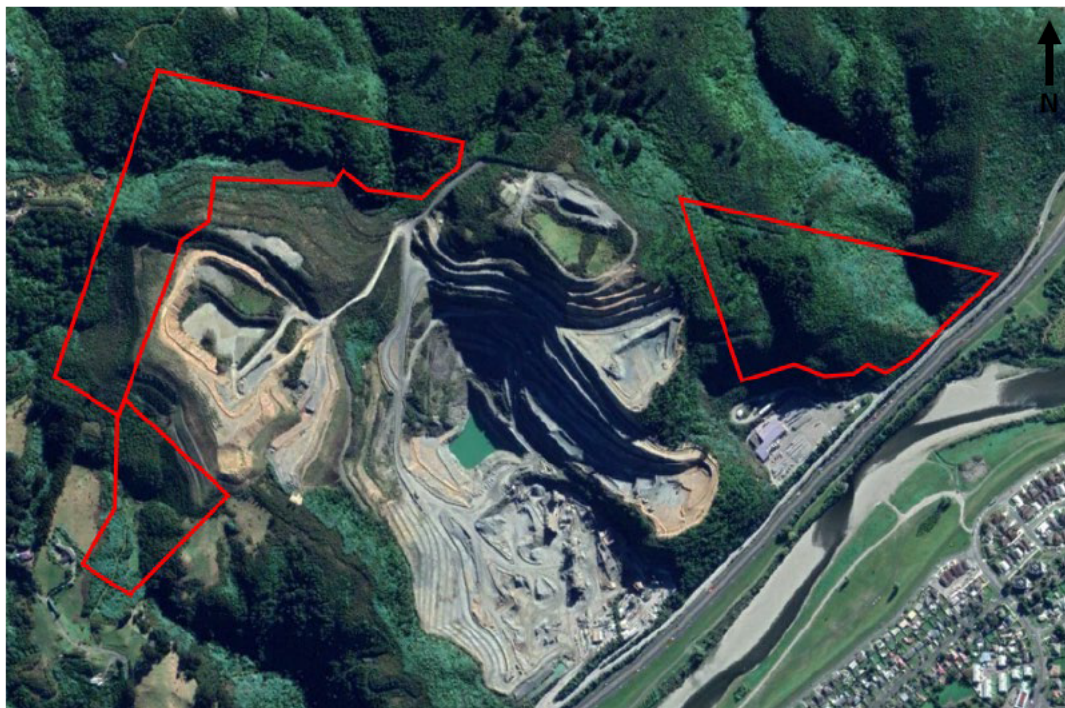
Photograph 14: 2019 sourced from Google Earth Pro

| Date | Reference | Description |
|---|---|---|
| 2019 | Photograph 14 | <p>No significant changes to Firth Block are observed.</p> <p>The previous quarry area to the south of the Northern Gully comprises vegetative cover over visible terraces.</p> <p>No significant changes are observed in the Southern Gully.</p> |

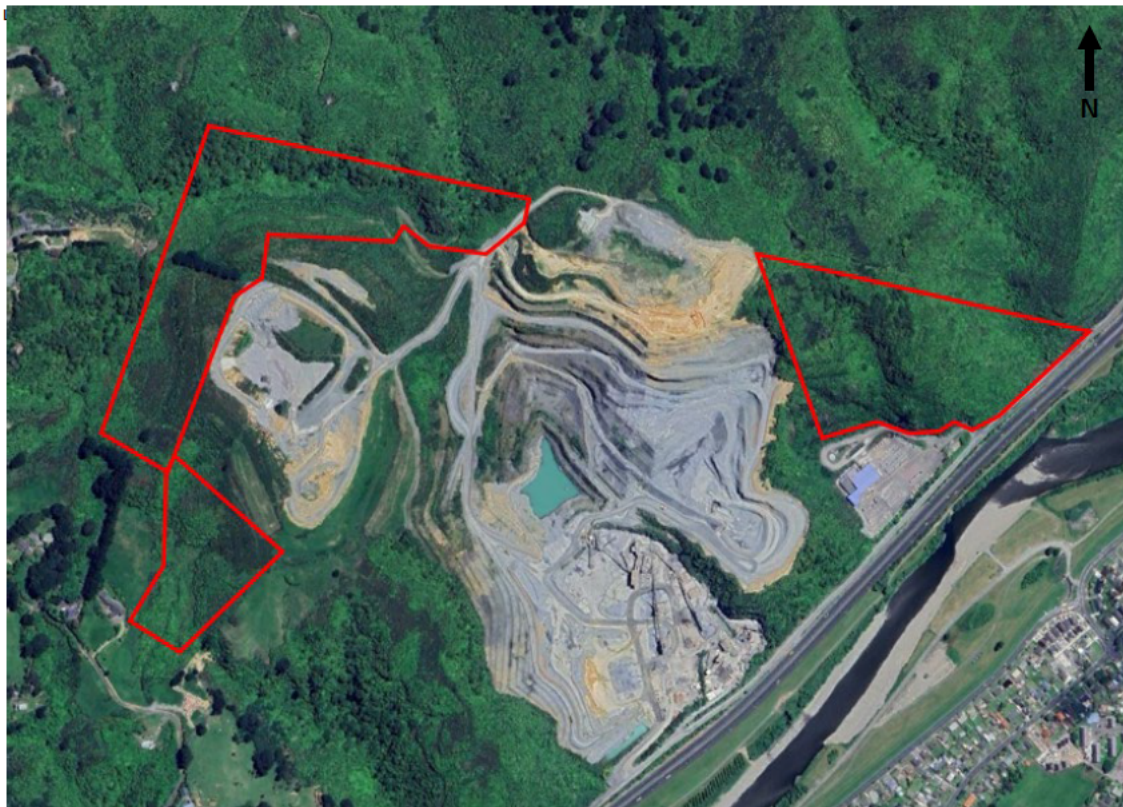
**Photograph 15: 2022 sourced from Google Earth Pro**

| Date | Reference | Description |
|---|---|---|
| 2022 | Photograph 15 | <p>No significant changes to Firth Block are observed.</p> <p>Dense vegetation is observed to the south of the Northern Gully. A track is observed to intersect the east of the Northern Gully with the northern portion of Belmont Quarry.</p> <p>No significant changes are observed in the Southern Gully.</p> |

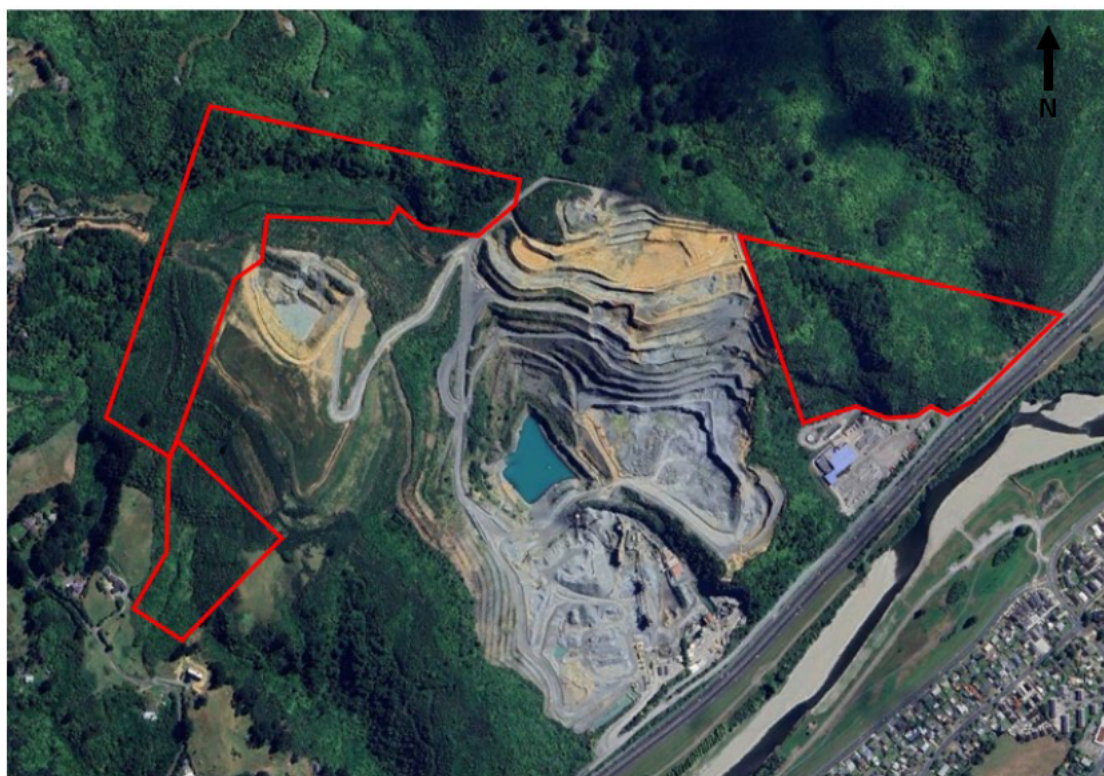
**Photograph 16: 2025 sourced from Google Earth Pro**

| Date | Reference | Description |
|---|---|---|
| 2025 | Photograph 16 | <p>No significant changes to Firth Block are observed.</p> <p>The quarry area has been further developed and slightly intersects the central eastern area of the Northern Gully.</p> <p>No significant changes are observed in the Southern Gully</p> |

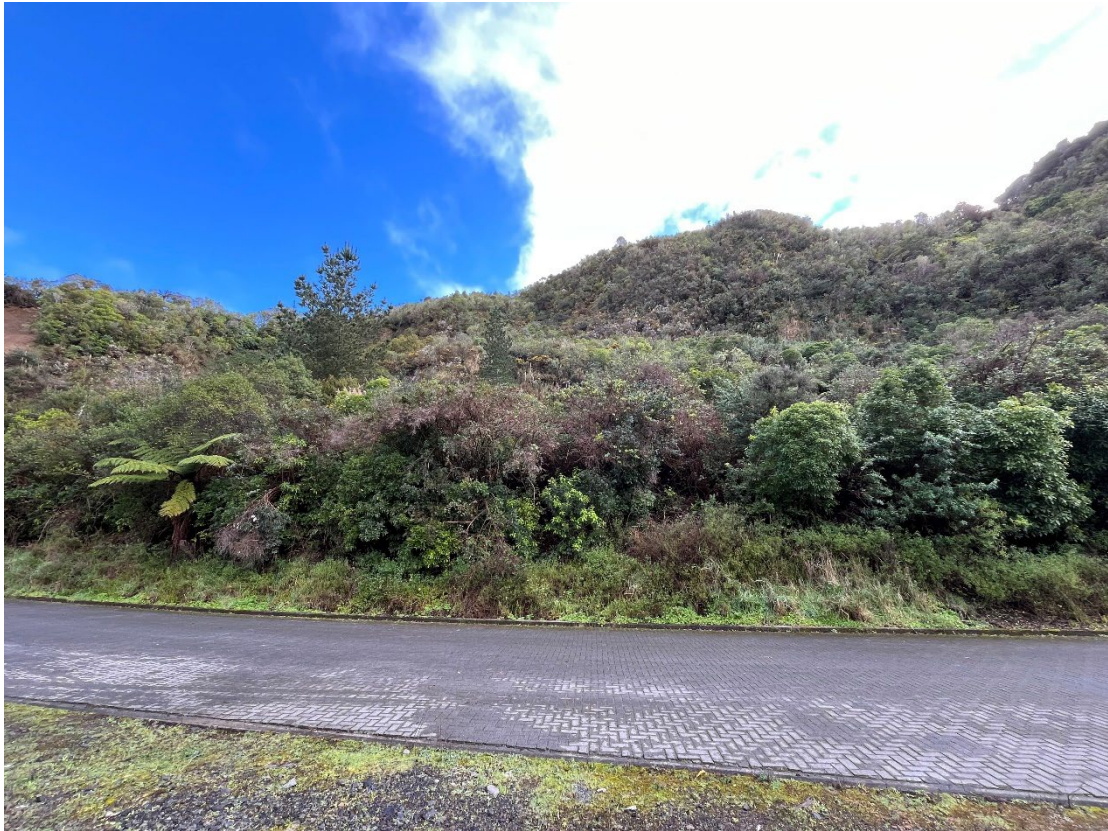
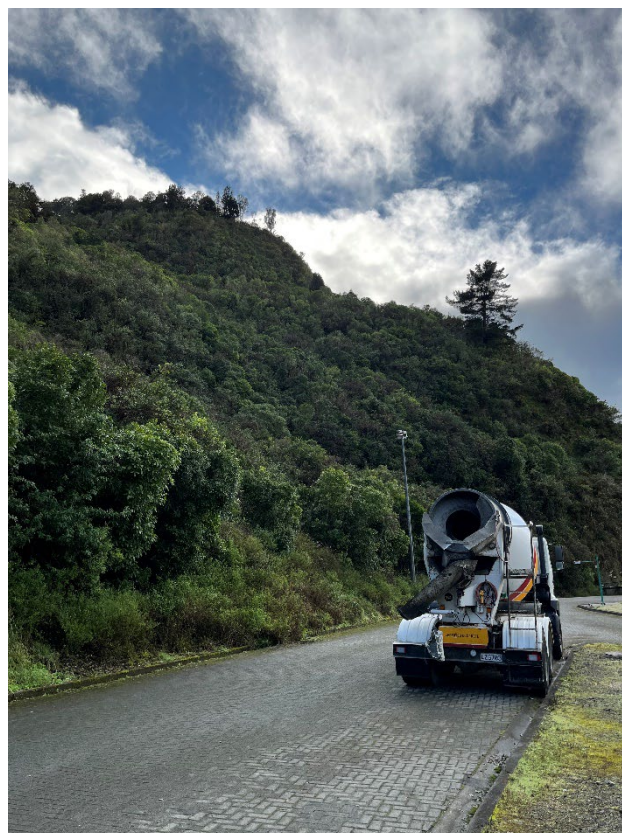
Firth Block was observed to comprises steep, densely covered slopes with mature, bush cover in the form of mixed vegetation (Photographs 1 and 2). A line of dead trees borders the southwestern site boundary (Photograph 3).

**Photograph 1: Firth Block (in the background) from Firth Belmont Masonry, looking north.**

**Photograph 2: Firth Block (in the background) from Firth Belmont Masonry, looking northeast.**

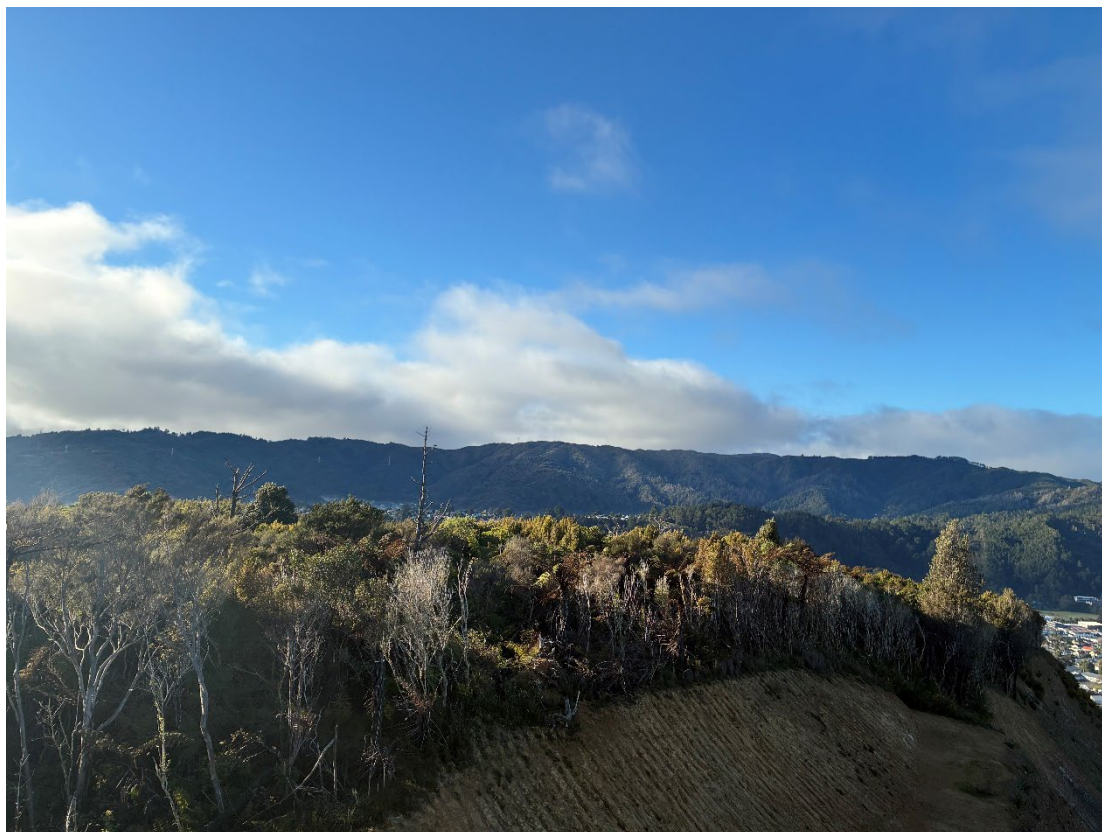
**Photograph 3: Firth Block overview from northwestern corner of the site boundary, looking southeast.**

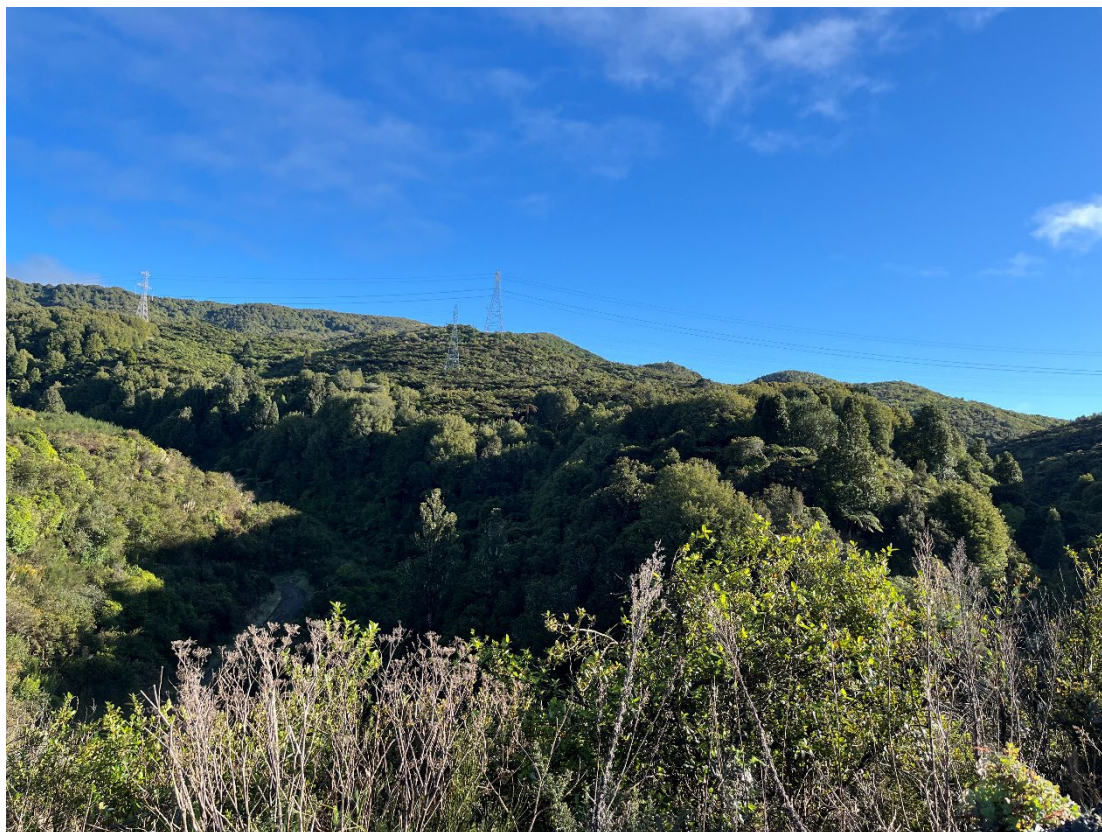
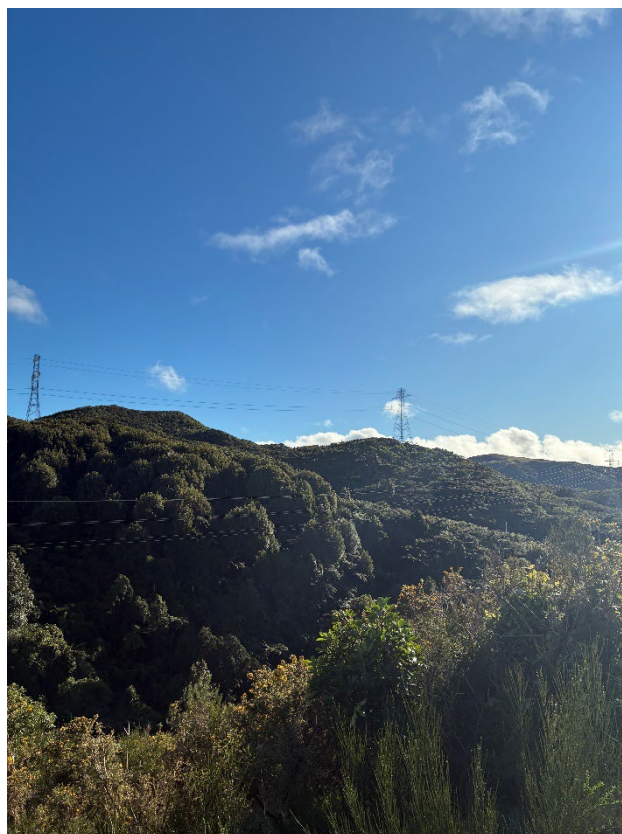
The northern area of the Northern Gully was observed to comprise dense mature bush of mixed vegetation (Photograph 4 and 5), which descends into a what appears to be a shallow stream. A walkable

**Photograph 4: Overview of Northern Gully, looking north.**

**Photograph 5: Northern Gully, looking north.**

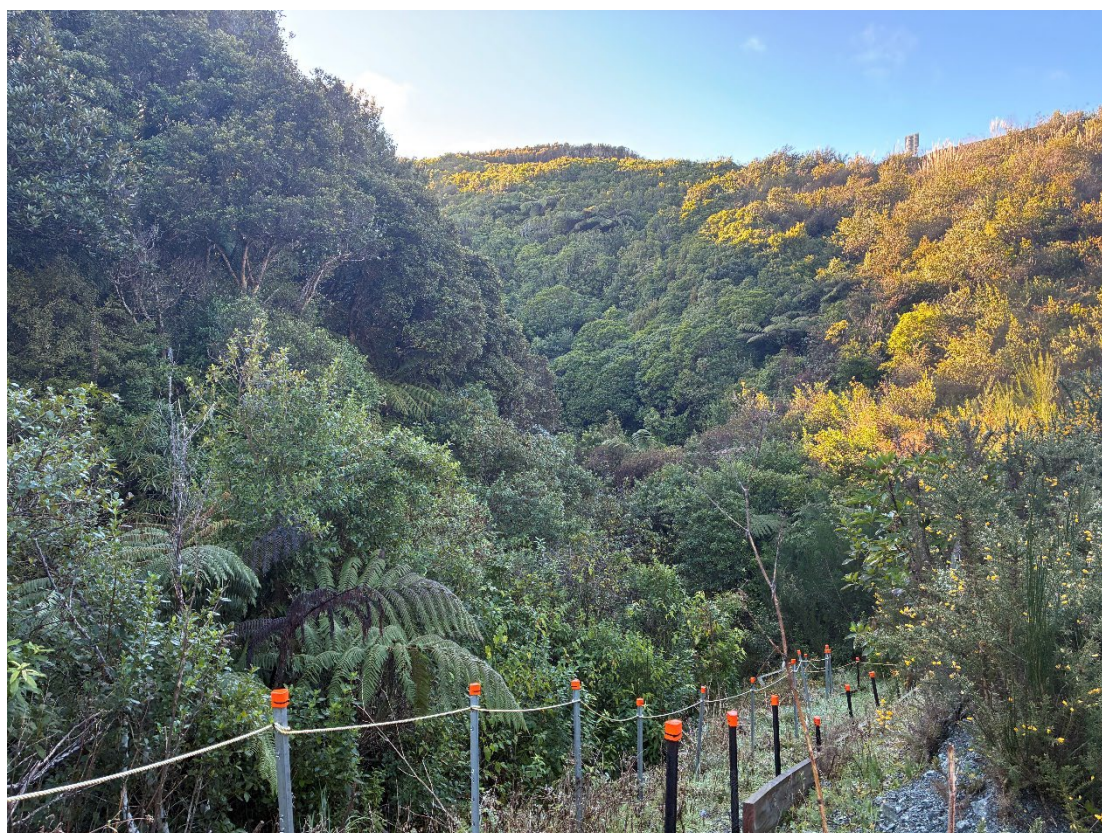
**Photograph 6: Track descending to a stream within Northern Gully, looking northeast.**

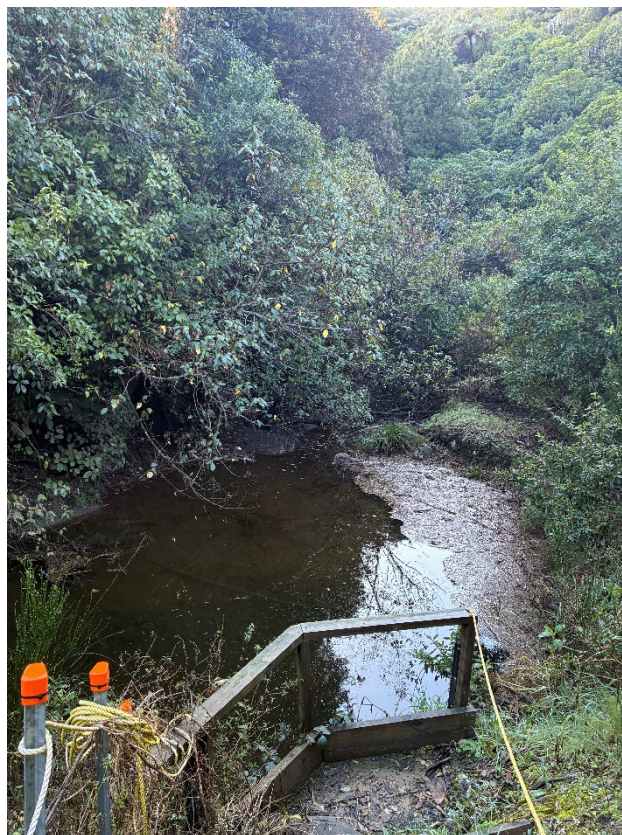
**Photograph 7: Stream within Northern Gully, looking north.**

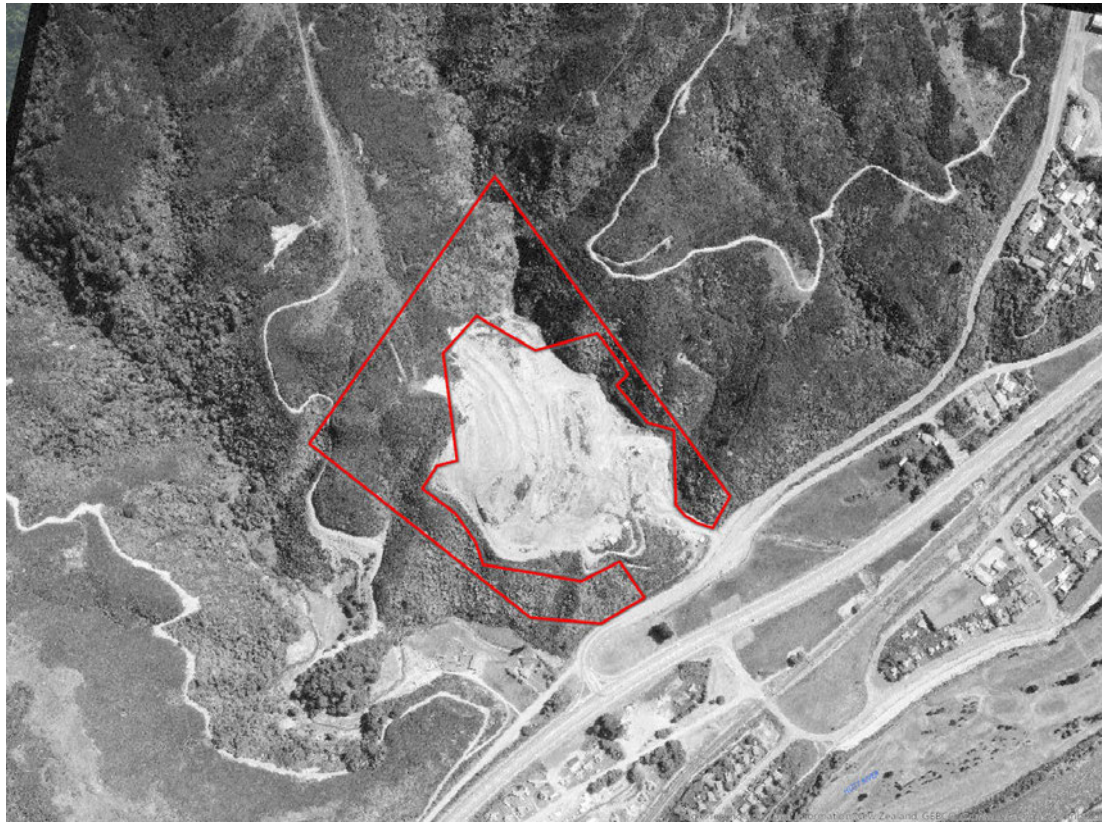
**Historical Aerial Photograph 4 (Retrolens): 1979**

| 1979 | Historical Aerial Photograph 4 | There is minor soil disturbance around the central northern boundary. The access track observed in 1967 is no longer visible. The areas along the northern, eastern and western boundaries are still vegetated. |

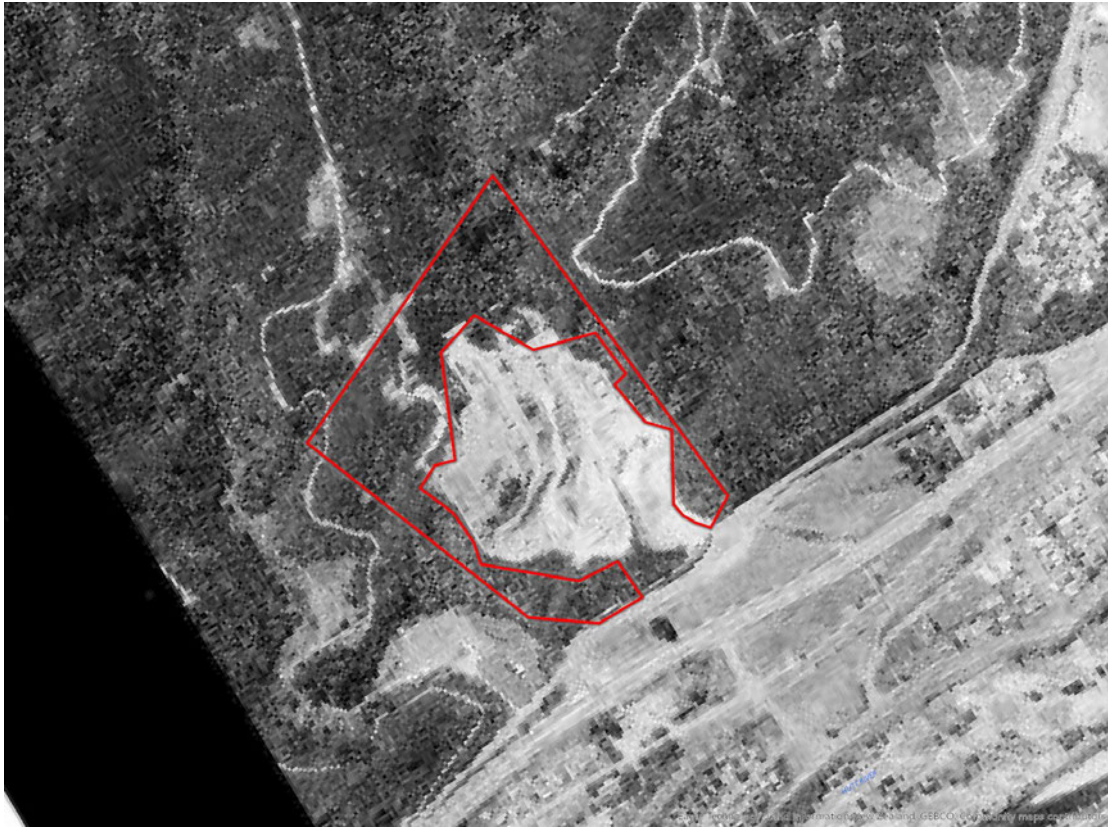
**Historical Aerial Photograph 5 (Retrolens): 1988**

| 1988 | Historical Aerial Photograph 5 | An established access road is present between the quarried portion of the property and the centre of the northwestern site boundary. No other significant changes observed from the previous aerial image. |

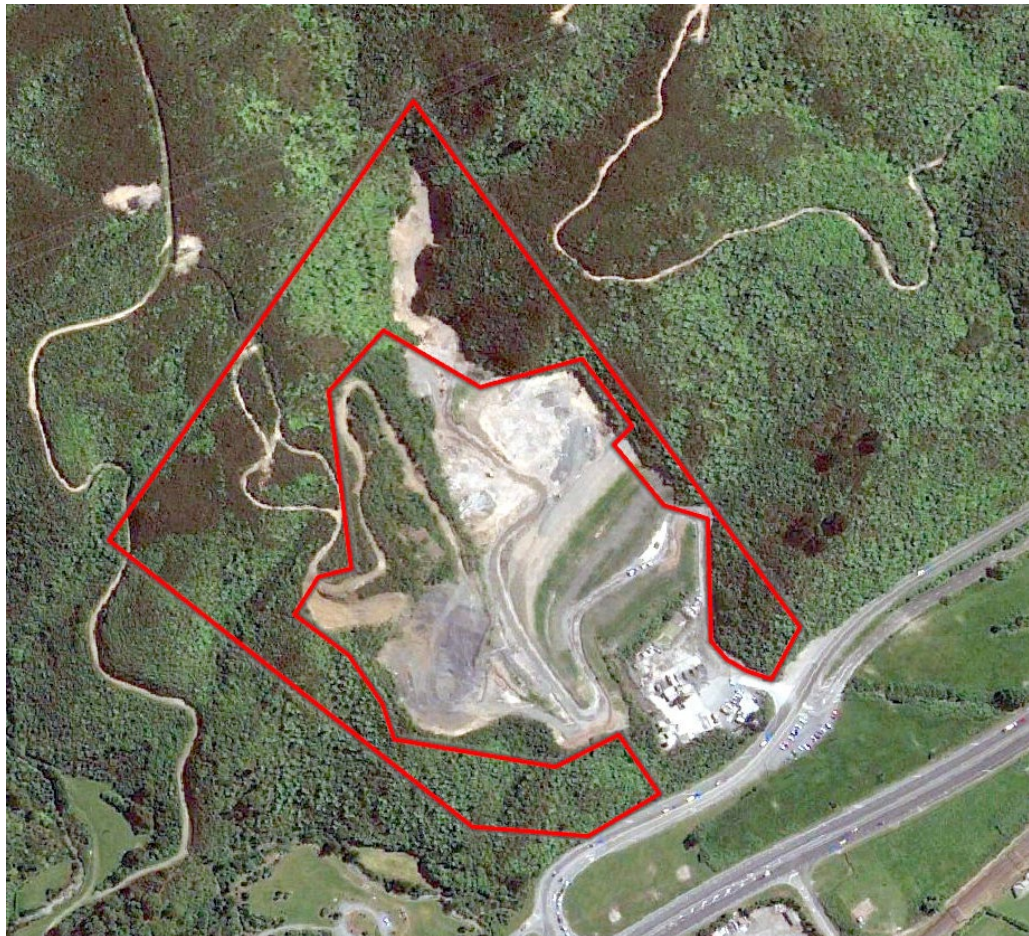
**Historical Aerial Photograph 8 (Google Earth): 2009**

| 2009 | Historical Aerial Photograph 8 | The gully towards the northern corner of the site has been partially cleared. No other significant changes observed from the previous aerial image. |

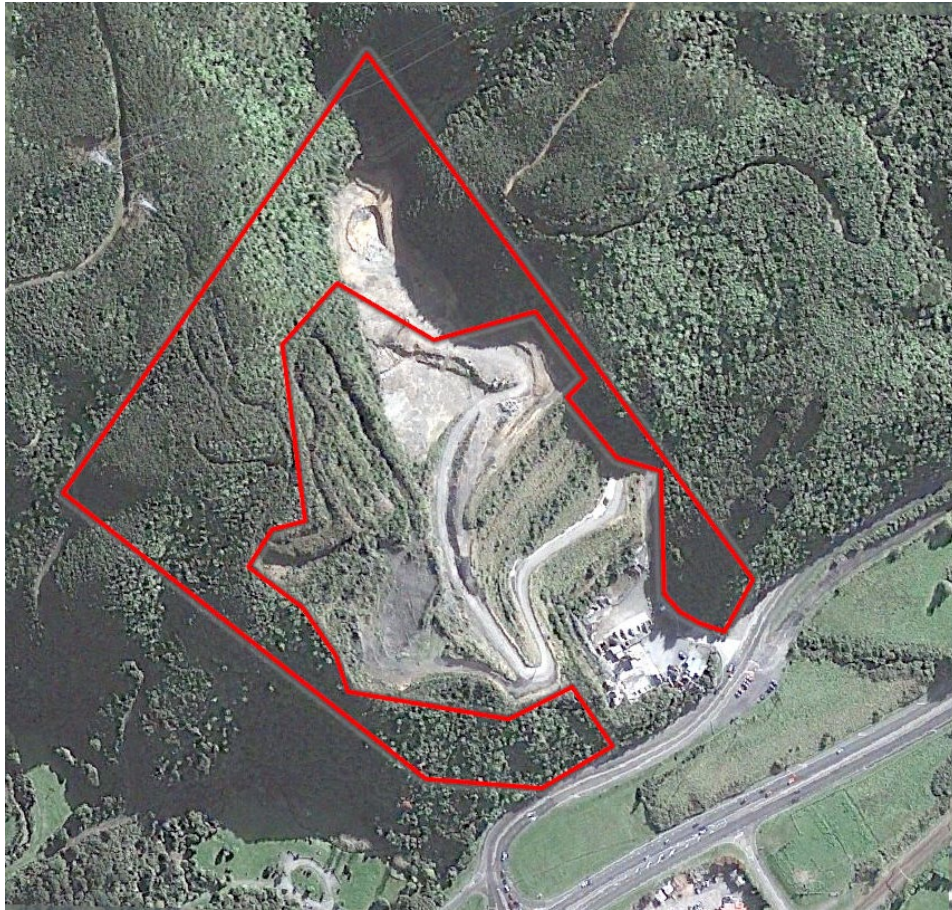
**Historical Aerial Photograph 9 (Google Earth): 2013**

| 2013 | Historical Aerial Photograph 9 | The northern area of the site has been excavated and possible filling is evident and a circular pit observed in the northern corner of the site, the exact use of the circular pit is not clear. The access road in the western area of the site is still present.<br><br>More parts of the cleanfill in the wider property have been revegetated with the earlier revegetation becoming denser/established. |

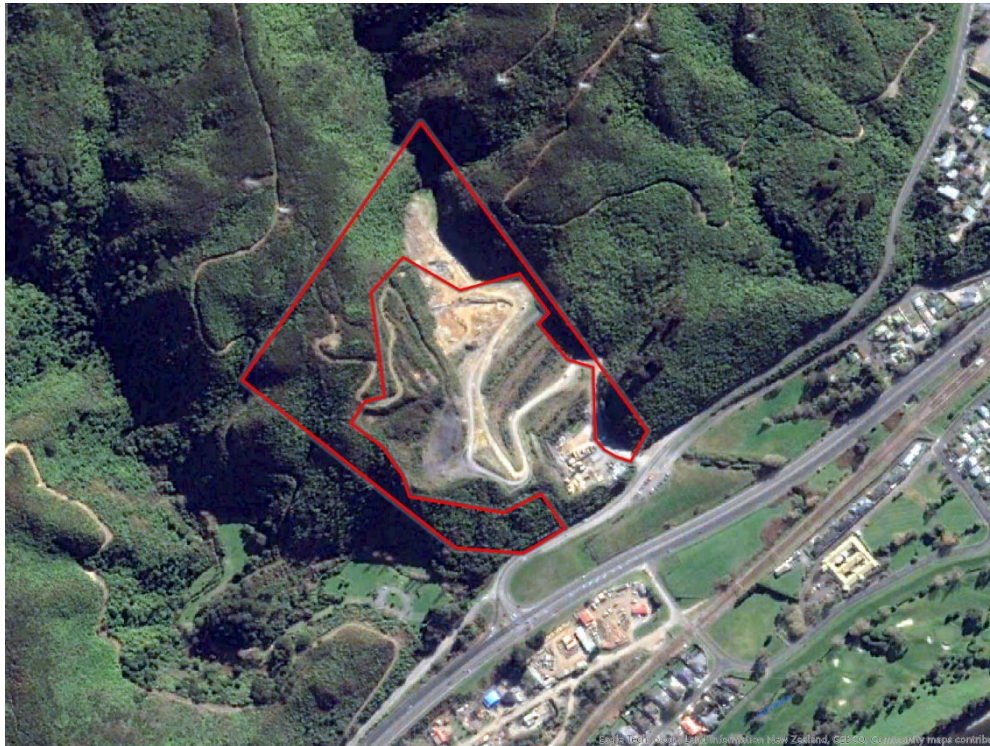
**Historical Aerial Photograph 10 (Google Earth): 2014**

| 2014 | Historical Aerial Photograph 10 | The pit, present in 2013 is no longer visible. No other significant changes observed from the previous aerial image. |
