# Belmont Quarry Development – Part F

Substantive Application  
Appendix F.1.B.13 – Land Exchange Application  
- Land Contamination Reports  
Winstone Aggregates

## **PRELIMINARY SITE INVESTIGATION - BELMONT QUARRY - FIRTH BLOCK, NORTHERN GULLY AND SOUTHERN GULLY**

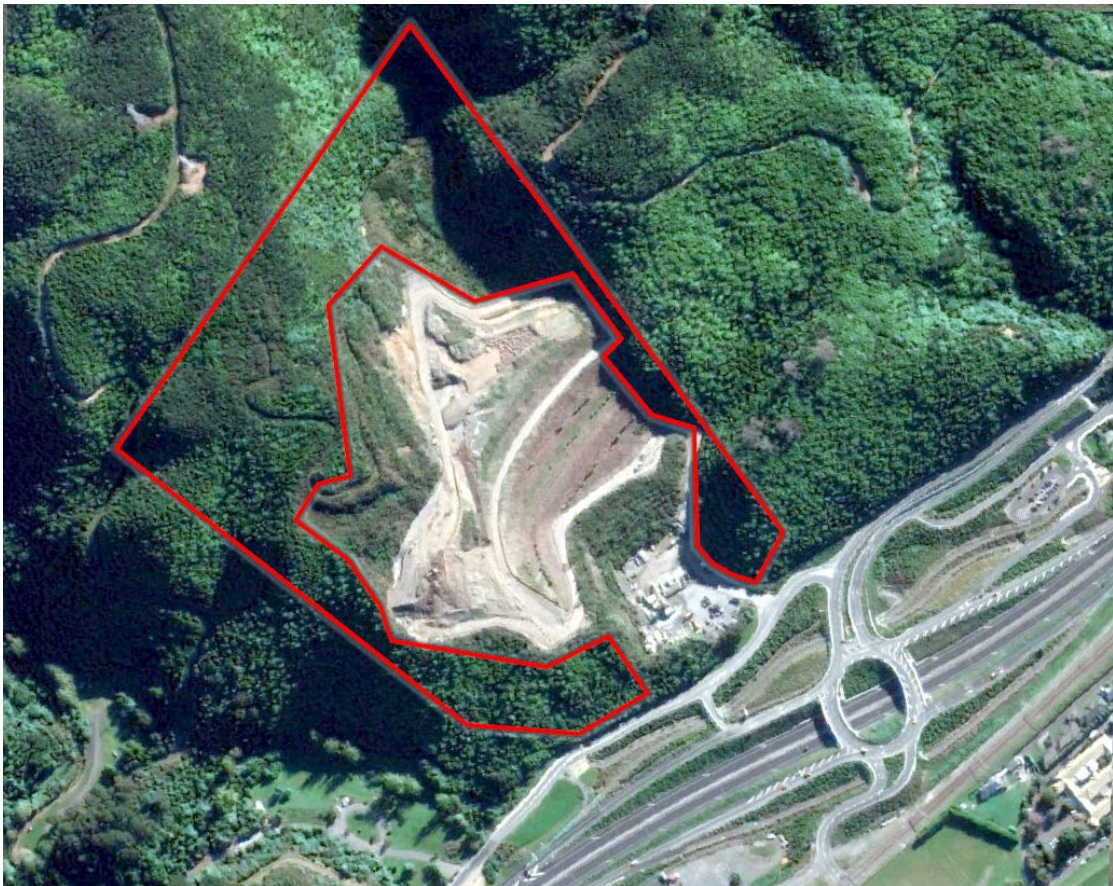
**Historical Aerial Photograph 13 (Google Earth): 2019**

| 2019 | Historical Aerial Photograph 13 | Increased revegetation is present across the site, no other significant changes observed from the previous aerial image. |
