## Arboricultural Assessment

Site Address: 88, 130 and 132 Upper Ōrewa Road and 53A,  
53B and 55 Russell Road, Orewa

Purpose of Report: Arboricultural Assessment of Proposed  
Vineway Fast Track Act – Residential Housing  
Proposal – Revised Design

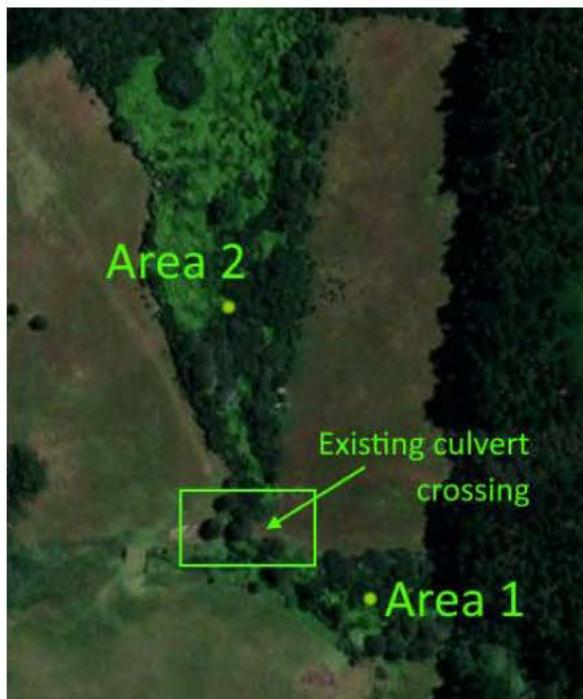
Figure 4 – Aerial image showing Areas 1 & 2

An existing culvert and farm crossing currently travels between Areas 1 & 2 from east to west, with a new road and associated infrastructure proposed to service new residential lots to the northeast. Vegetation removal is proposed to facilitate the 9.41 metre footprint of the new bridge/culvert, as well as the removal of an existing culvert, with new planting proposed to enhance Areas 1 & 2 to mitigate the loss of vegetation within the road access/ earthworks footprint. An estimated 250m<sup>2</sup> of vegetation is to be removed for the new road connection.

Further recommendations are provided in Sections 8.0 and within the Draft Tree Management Plan (Draft TMP) in terms of addressing any works within the RPZ of retained vegetation or to address wider arboricultural fringe effects.

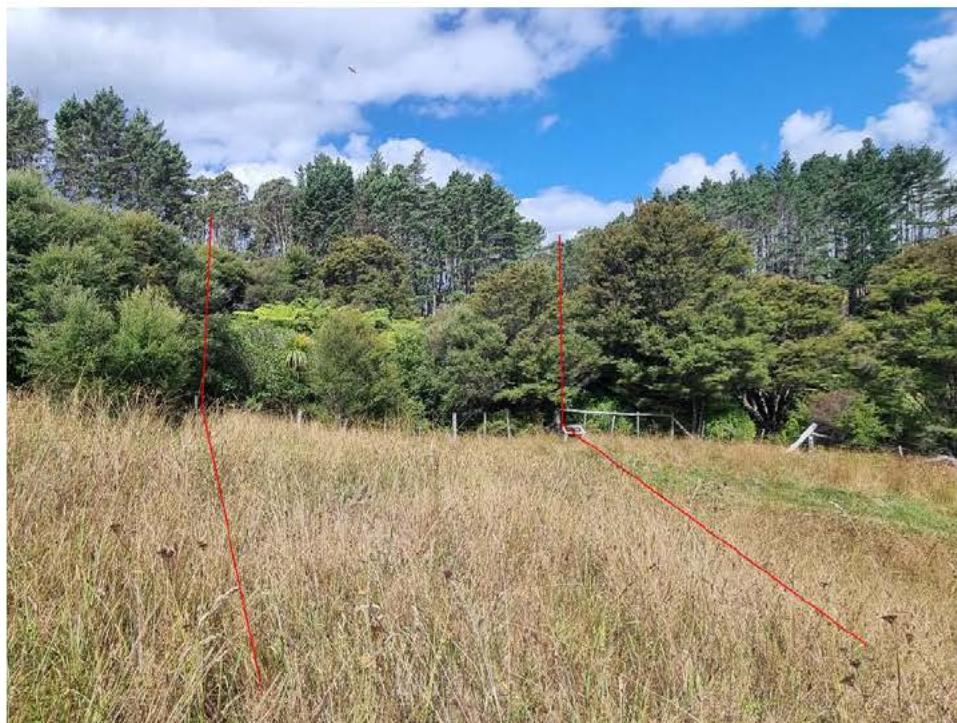
Figure 5 – Snip of proposed bridge/culvert crossing clearance (approximately 250m2)

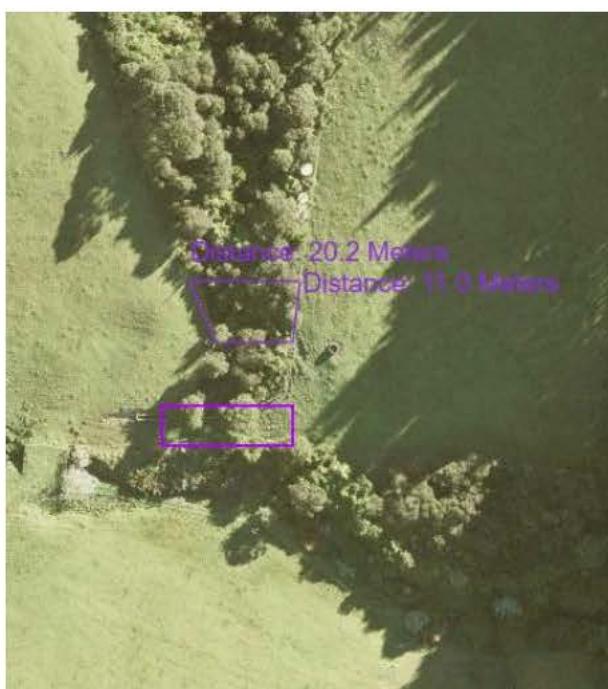
Figure 6 – Two areas of clearance marked on Council GIS

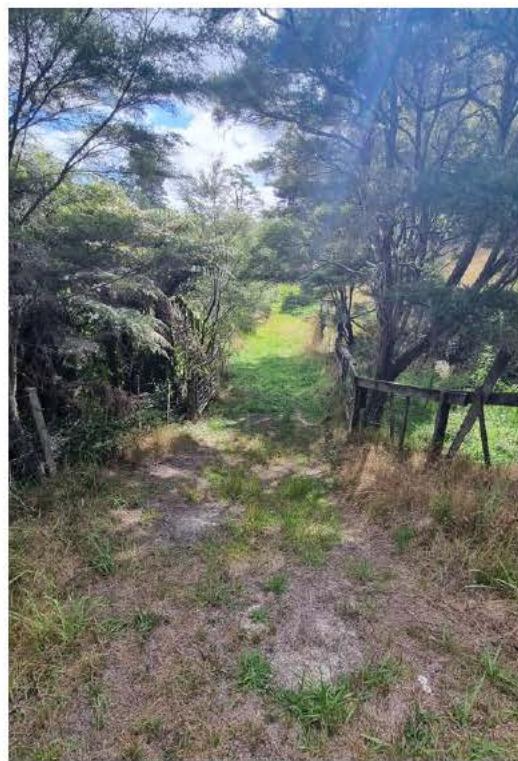
**Figure 7 – Existing culvert crossing (Area 2)**

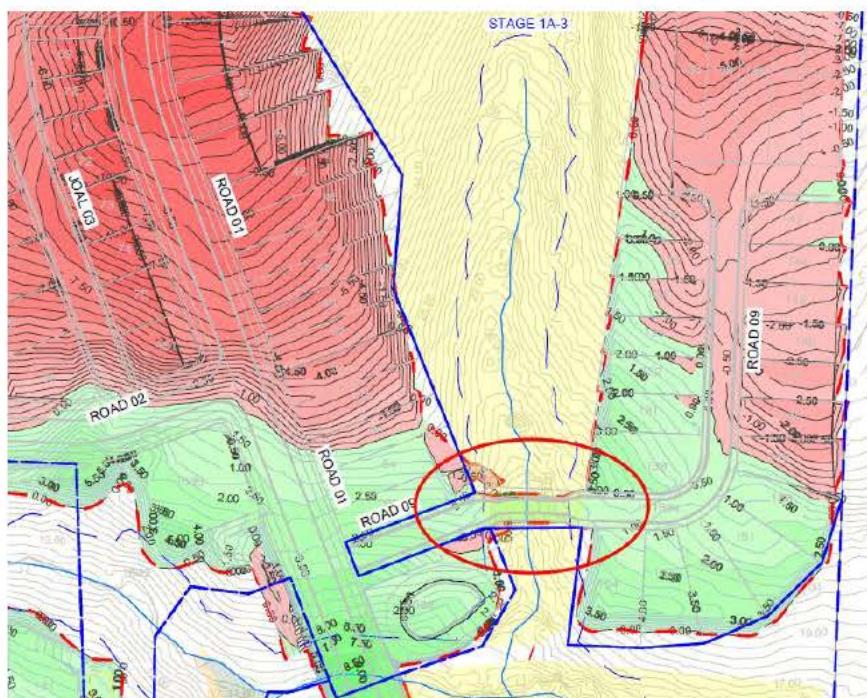
**Figure 8 – Snip of earthworks plan showing proposed crossing point**

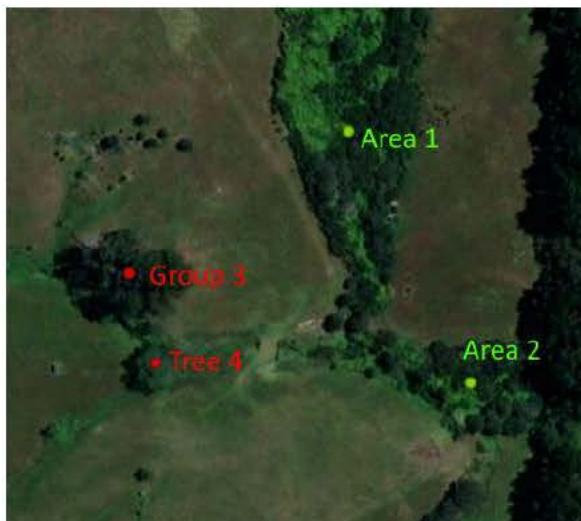
Group 3 is identified as a stand of exotic vegetation, dominated by large Gum trees (*Eucalyptus sp.*), with Tree 4 a Monterey Cypress. It is anticipated that these trees are removed. The trees stand on an embankment to the north of the adjacent stream, with some trees within 20m of the existing stream and some beyond the 10m setback. Those trees within the 20m setback are subject to Rule E15.4.1 (A19).

Figure 9 – Aerial showing Group 3 & Tree 4

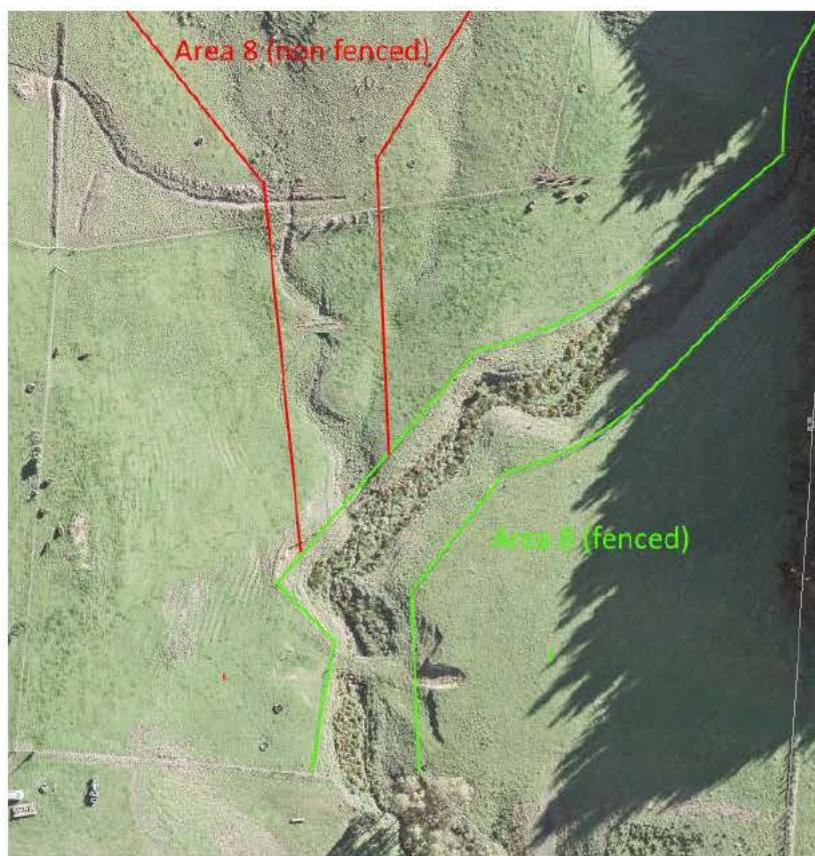
Areas 6 – 8 are identified as vegetation growing adjacent to the stream network running north to south to the northwest of Group 3. The area is currently partially fenced, with minimal enhancement planning undertaken, with the remaining vegetation dominated by Willow and other exotic species. These areas are subject to Chapter E15. of the AUP and will be enhanced with new plantings. These areas are to be retained and subject to additional planting as part of the Project (see landscape plan prepared by Greenwood Associates). While retained vegetation in this area is minimal, all works within the PRZ of such vegetation should be undertaken in accordance with the recommended measures outlined in the Draft TMP.

Figure 10 – Image showing fenced and non-fenced portions of Area 8

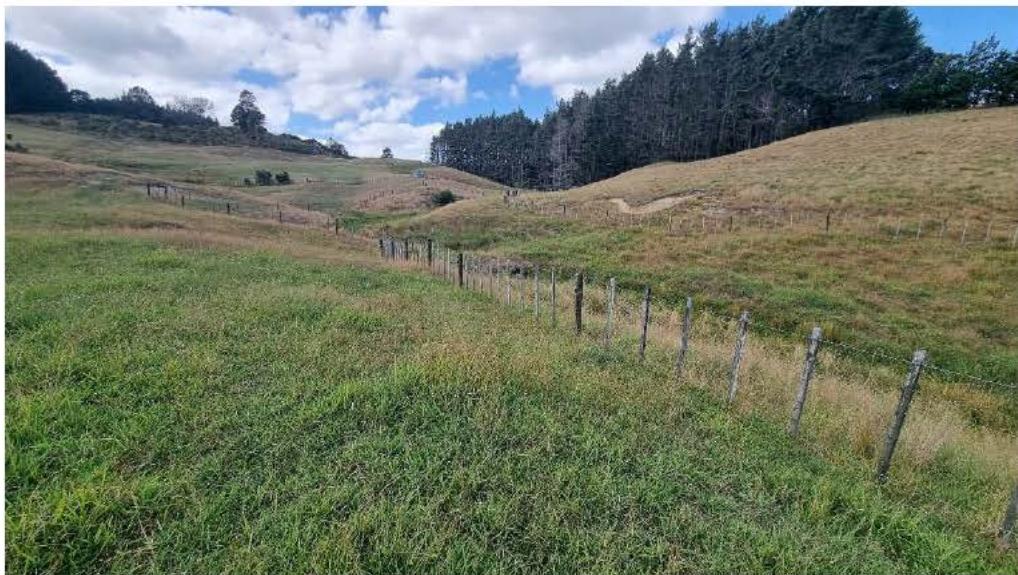
Figure 11 – View of Area 8 (fenced portion). Area 8a can be seen in the distance to the northeast.

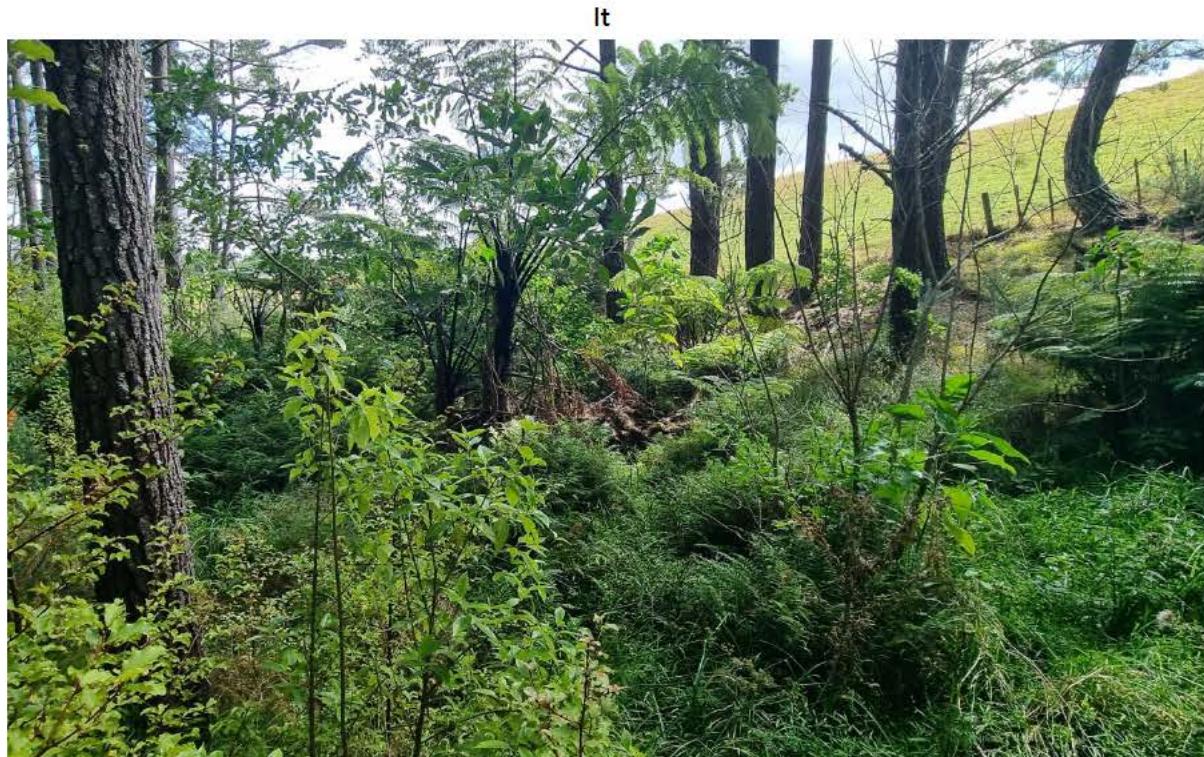
Area 8a was previously identified as a large Monterey Pine block with an understorey of both pest plants and emerging pioneer indigenous species. It is understood that Monterey Pine trees in this area have since been removed.

Figure 12 – Stream area within Area 8a

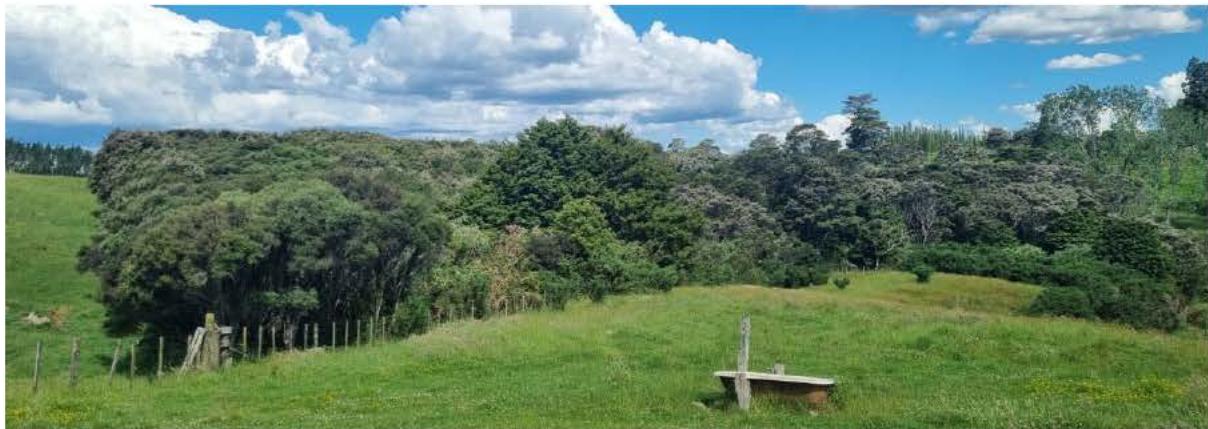
A small portion of vegetation within this area (on the neighbouring property) will require removal to enable the construction of the new NOR 6 road layout, and facilitate the proposed lot layout at the boundary interface, which includes a stormwater pond and north-south facing dwelling lots. It is recommended that an earthworks setback (from the edge of the consent notice boundary) of at least 3.0m is applied where works are required adjacent to the northern boundary of this neighbouring bush area. This recommendation is due to the extent of cut/fill earthworks, coupled with the proposed road stub proposed as part of the NOR 6 alignment, a setback will enable the installation of erosion and sediment control measures to be suitably distanced from the PRZ of this vegetation, to minimise negative arboricultural effects relating to ground level changes and overland flow alterations. Vegetation removal is to be limited as much as practicable, with further protection measures and specific methodologies to be included as part of the TMP where necessary. It is

**Figure 13 – View of Area 9 located on the adjoining property (3 Russell Road)**

considered that adequate mitigation for the small area of vegetation that is removed will be provided through the extensive replanting within the wider site.

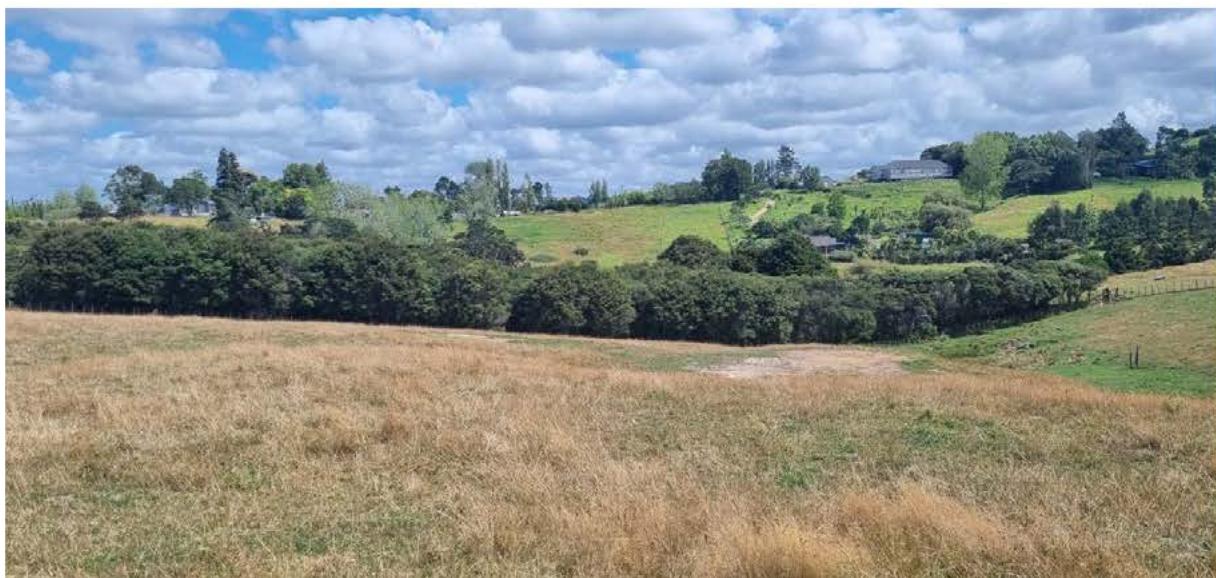
**Figure 14 – View of Area 9 showing existing ground contours**

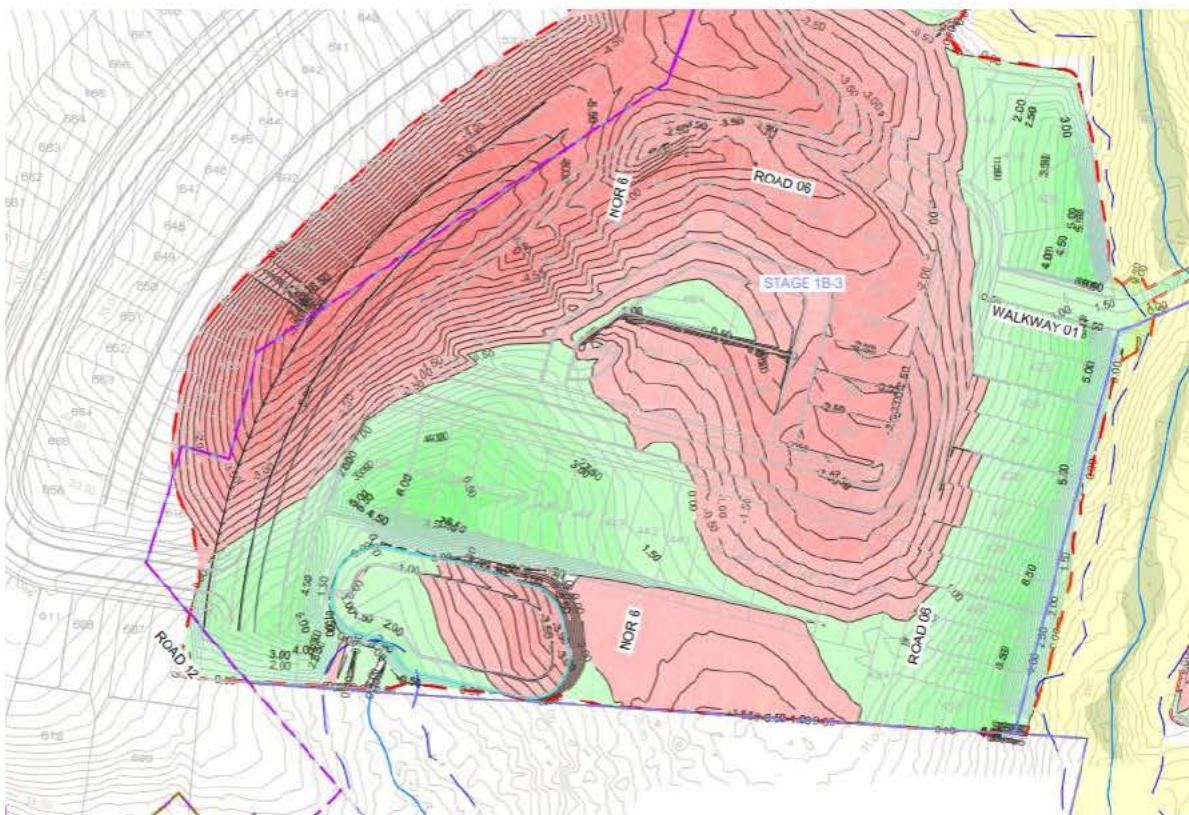
Figure 16 – Earthworks Plan showing proposed cut/fill works adjacent to Area 9

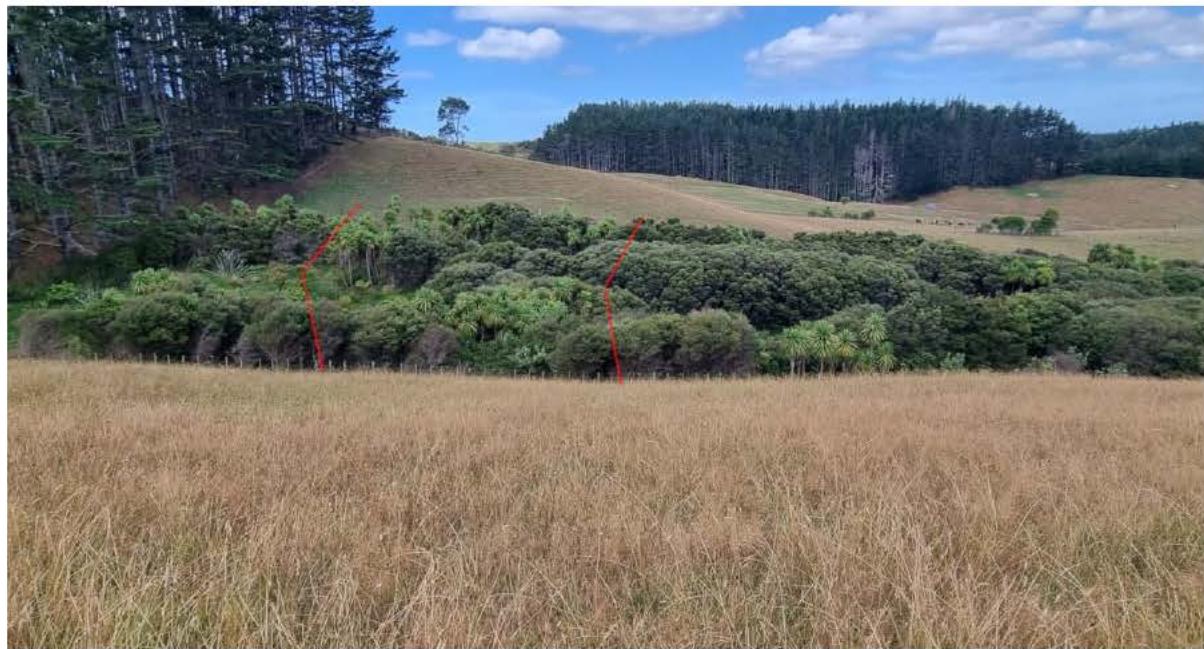
This area is to be largely retained and protected as part of the Project, with an area of vegetation clearance required as part of the creation of the NOR 6 road. The vegetation to be removed stands within Area 11, approximately 21.52m south of the northern boundary with 47 Ara Hills Drive, being adjacent to Area 19a.

The vegetation within this location is dominated by Manuka, Tī Kouka and Karamū (*Coprosma robusta*), having been likely planted within the last 10 years. Approximately 1292m<sup>2</sup> of vegetation is proposed for removal as part of the NOR 6 works. The remaining vegetation within these areas is to be retained and protected, with tree protection measures provided as part of the TMP. Further recommendations are also provided in Section 6.0.

**Figure 17 – Anticipated clearance extent through Area 11 as part of the NOR 6 works**

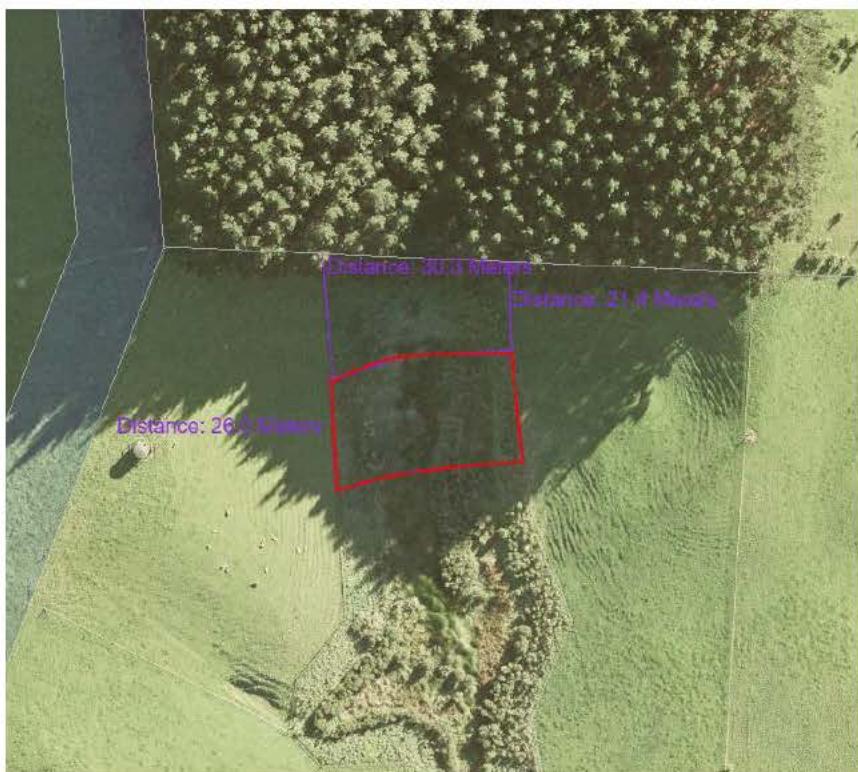
**Figure 18 – Aerial view of approximate clearance extent for NOR 6 works (Calculations via Auckland Council GIS Maps)**

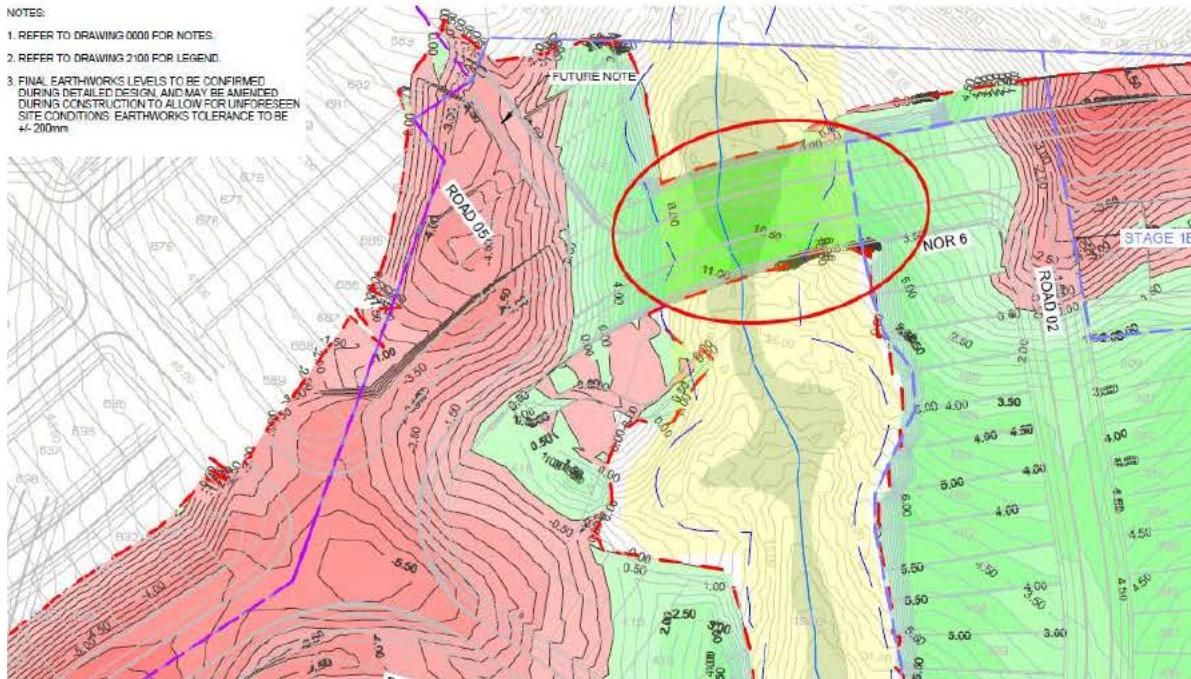
Figure 19 – Snip taken from Earthworks Plan showing NOR 6 road section crossing Area 11

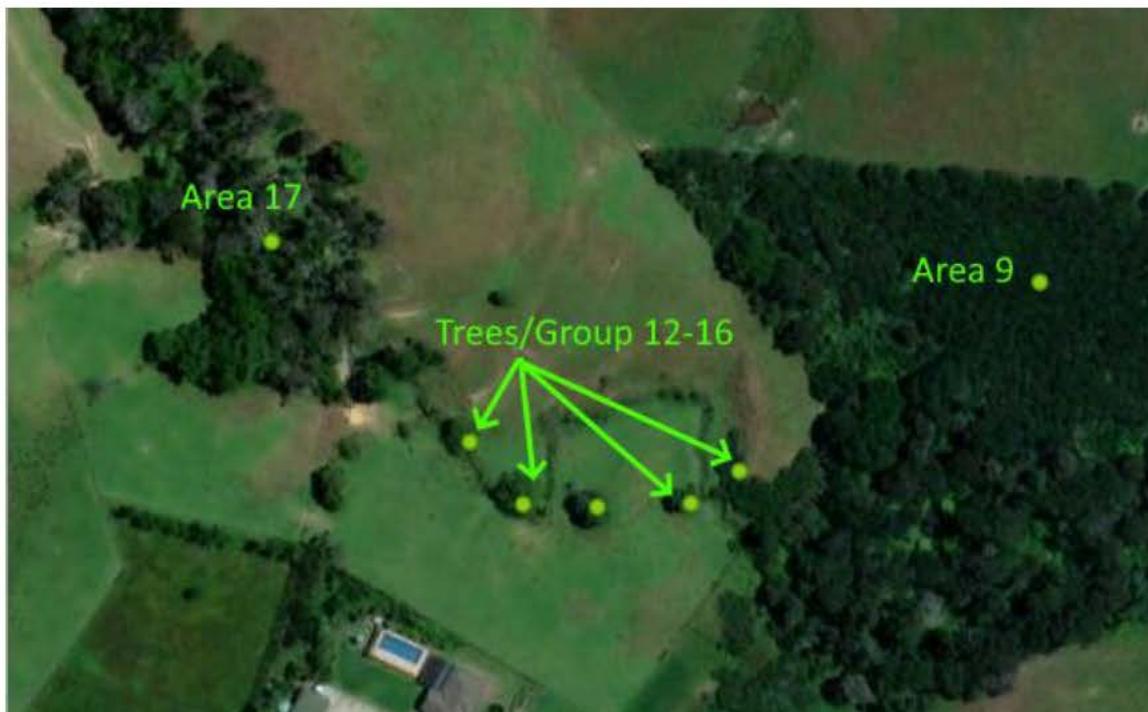
Trees 12 - 16 are located adjacent to the existing stream to the south of the proposed earthworks area. The trees will not be effected as part of the Project layout and as such are proposed for retention.

Figure 21 – Image showing locations of Trees/Groups 12 - 16

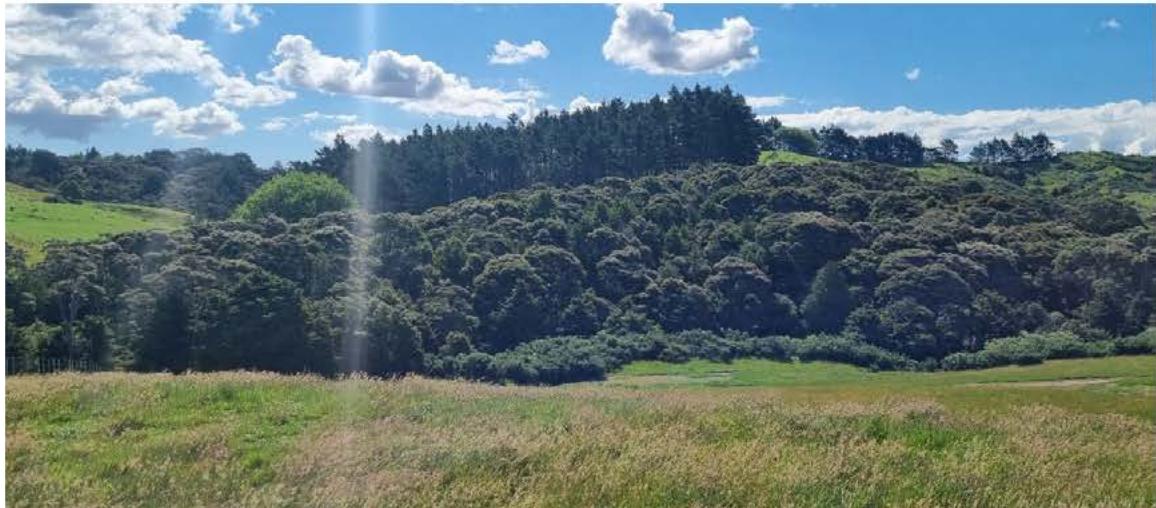
Area 17 is identified as a regenerating indigenous bush area, dominated by Totara, Manuka, Kanuka, Ponga (*Cyathea dealbata*) and Tānekaha (*Phyllocladus trichomanoides*). This area is to be retained, with earthworks required on the western side to form the proposed road network coupled with the removal of an existing culvert and to the north and east as part of the formation of the new residential lots.

Figure 22 – Main portion of Area 17, as viewed from the east

An earthworks setback of is recommended to the north and east, with the works to the west largely within the footprint of the existing farm track (bush edge largely defined by a seven-wire fence). This is recommended to ensure works occur beyond the PRZ of existing vegetation, with the consent notice boundaries not a true reflection of the current environment. Further recommendations of works adjacent to and within the PRZ of this Area is to be included in the TMP.

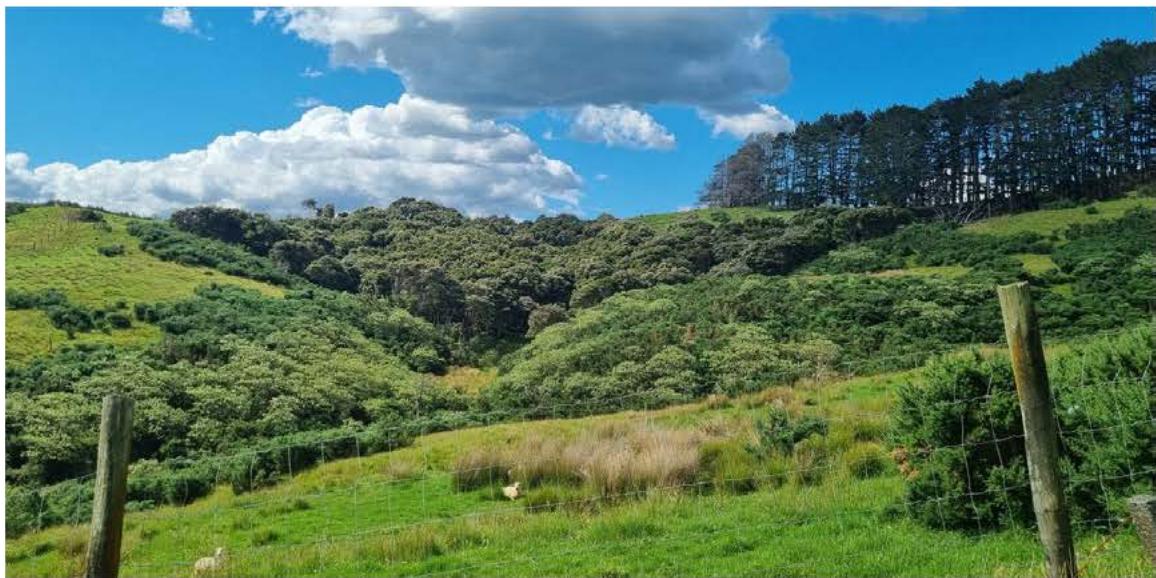
Areas 18 and 21 are directly north of Area 17 and consist almost entirely of pest plants (including Gorse & Woolly Nightshade (*Solanum mauritianum*)), with the occasional regenerating Mahoe or Ti Kouka. All pest plants are to be removed within the catchment, with indigenous plant species replacement and enhancement planting proposed. Where indigenous trees/vegetation is to be retained, all adjacent earthworks should be undertaken in accordance with the recommended TMP protection measures included in the Draft TMP.

Figure 23 – Area 18 looking north from adjacent to Area 17 (Area 20 seen at top of image)

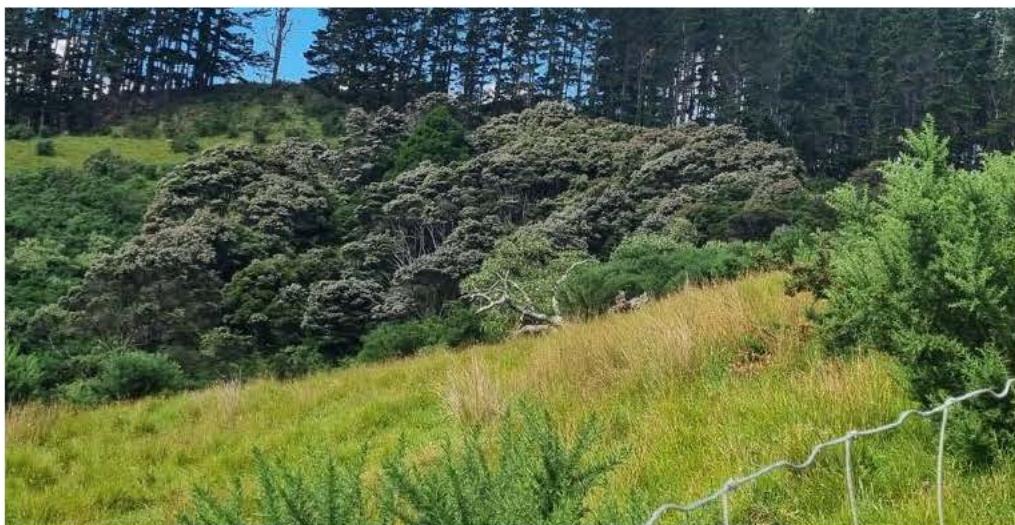
Areas 19 - 22 are identified as remnant indigenous bush areas, dominated by Manuka, Kanuka and Ponga, with a mature Rimu (*Dacrydium cupressinum*) growing within Area 19. These bush areas are to be retained and protected. A walking track is proposed along the perimeter of part of this area.

Figure 24 – Area 19 to the northeast. Canopy of Rimu tree can be seen in the centre of the remnant.

It is recommended that any PRZ works proposed as part of the walking track networks are to be assessed and included as part of the TMP, to ensure any impacts on Area 19,20 & 22 as part of the construction of the proposed walking track areas are minimised. It is noted that Area 22 and a portion of 21 is covered by a SEA-T overlay. Pest plant species will be removed from all areas (mainly Gorse).

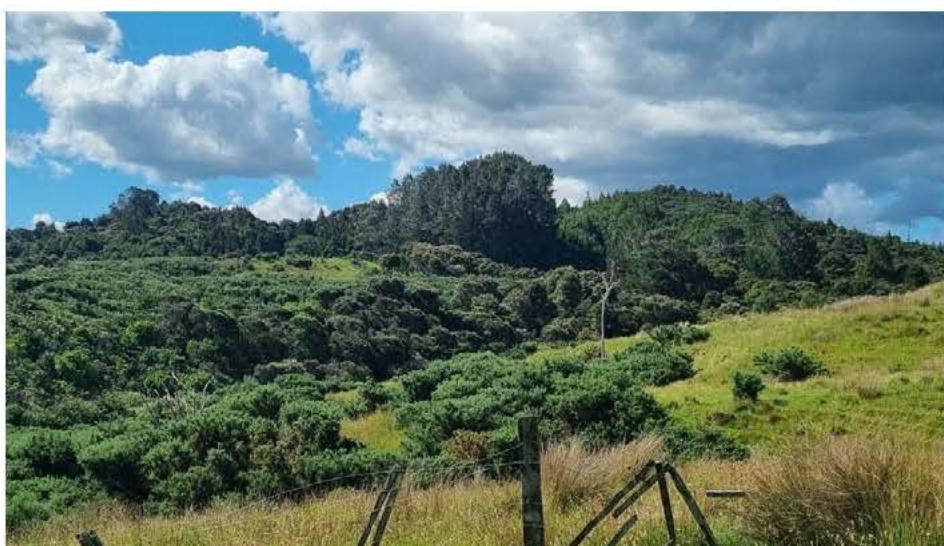
Figure 25– Area 22 seen from the central portion of the site, pest plant species will be removed adjacent to this grouping (Area 21)

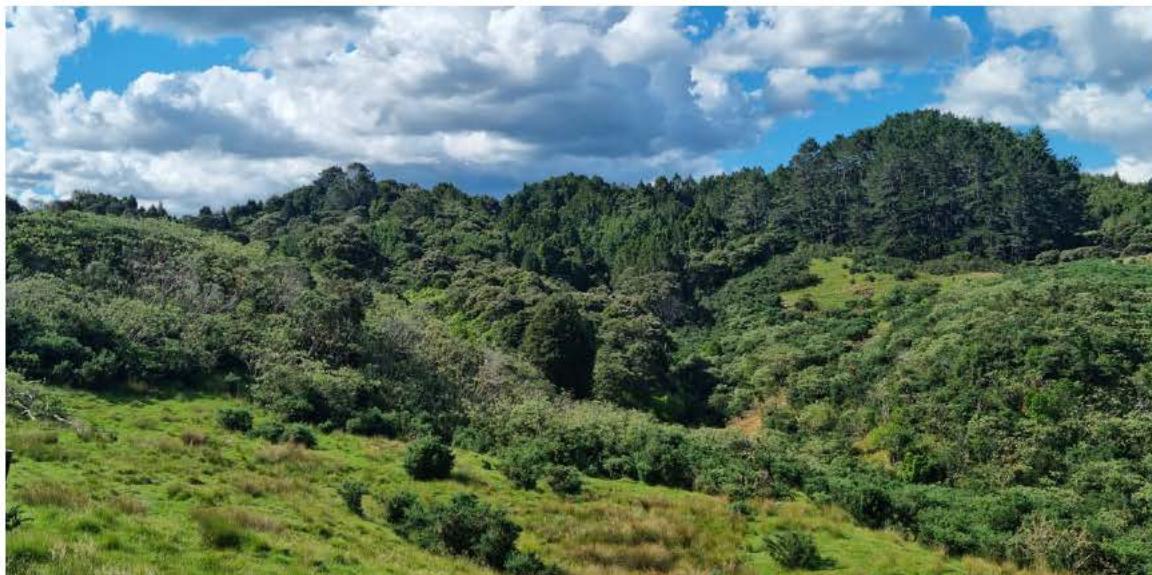
Figure 26 – Area 21 seen to the northwest

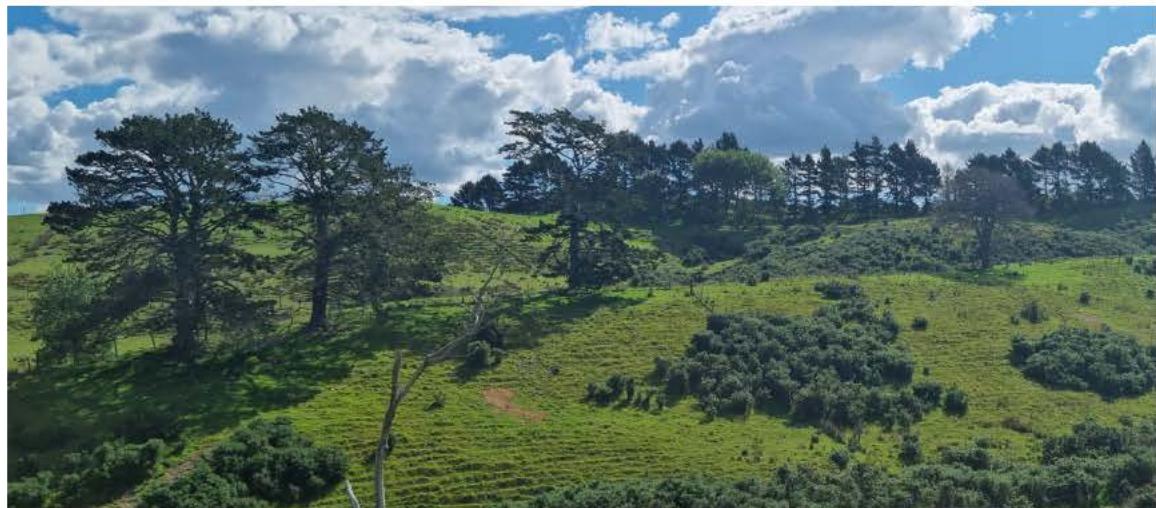
Group 23 is identified as a grouping of three (3) Monterey Pine trees growing along the ridgeline to the northwest of Area 17, a fourth tree, identified as a dead English Oak (*Quercus robur*) is also growing further west. These trees are non-protected specimens and are proposed for removal.

Figure 27 – Group 23 growing on the ridgeline (adjacent to the proposed access road)

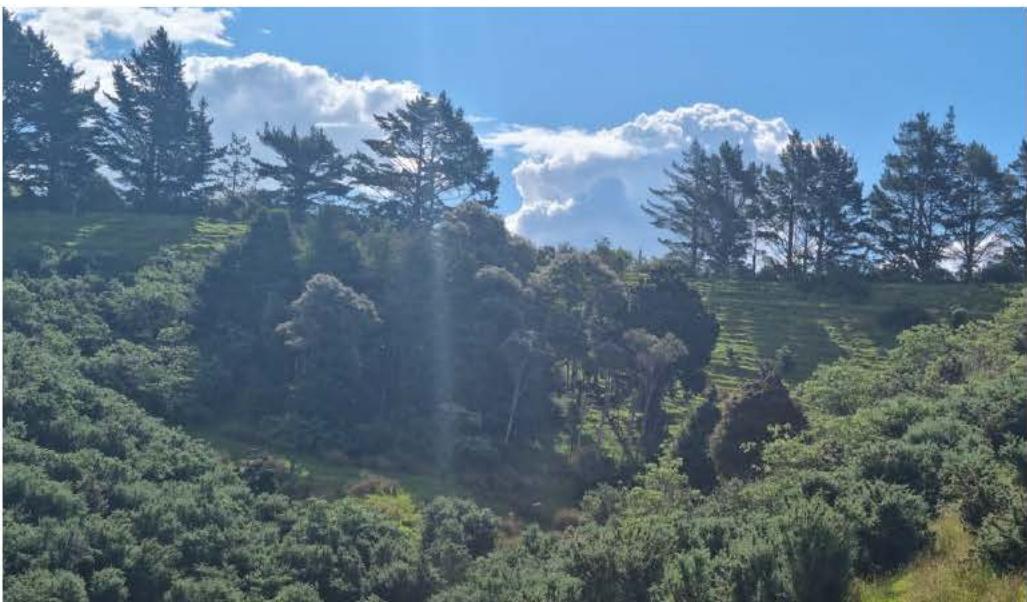
Group 24 is identified as a small cluster of indigenous vegetation growing in a small gully system near the northwest boundary of the project area. The vegetation consists of a mixture of Totara, Manuka,

Kanuka and other pioneer indigenous species. This area will be retained and protected as part of the Project. Pest plant species will be cleared around the grouping.

**Figure 28 – Group 24 to be retained and protected.**

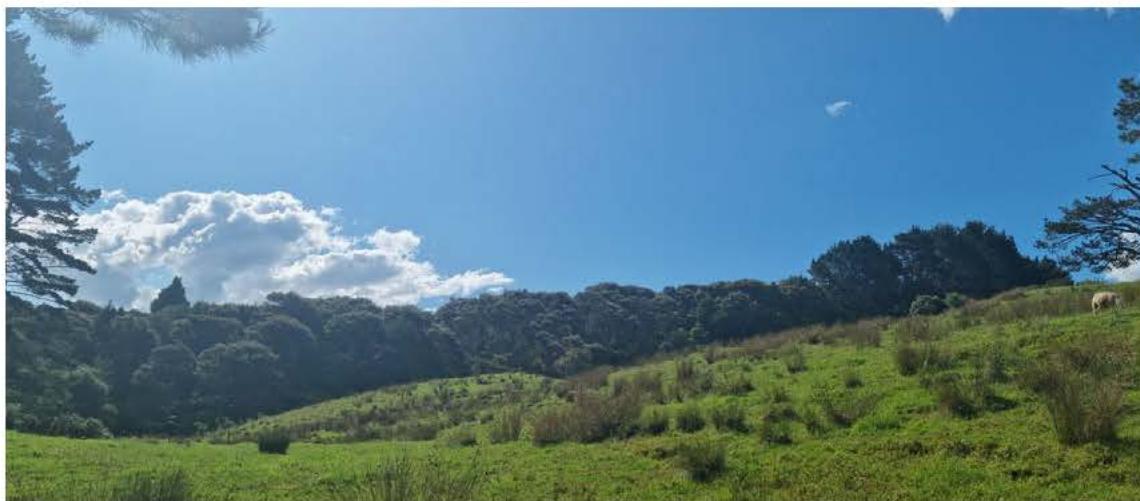
Area 25 is identified as an area of dense indigenous vegetation growing on the neighbouring property to the West (955 Weranui Road) and is subject to protection, covered by an SEA-T overlay. It is noted the vegetation making up the wider stand is within the project area and is not subject to the SEA-T overlay. This area as defined as part of Area 26, with a snip of the Area extents provided in Figure 27.

**Figure 24– Group 25 located on neighbouring property to the West (955 Werau Road) (a portion of the vegetation nearest to this area identified as being part of Area 26)**

A setback from the boundary of at least 10m for any earthworks is recommended to ensure ongoing protection. This is to ensure edge effects on the neighbouring vegetation is minimised, including ensuring erosion and sediment controls do not impact PRZ.

It is also recommended that all works adjacent to this area are to be undertaken in accordance with the TMP, with management details to be prepared at the detailed design stage, to incorporate best arboricultural practice.

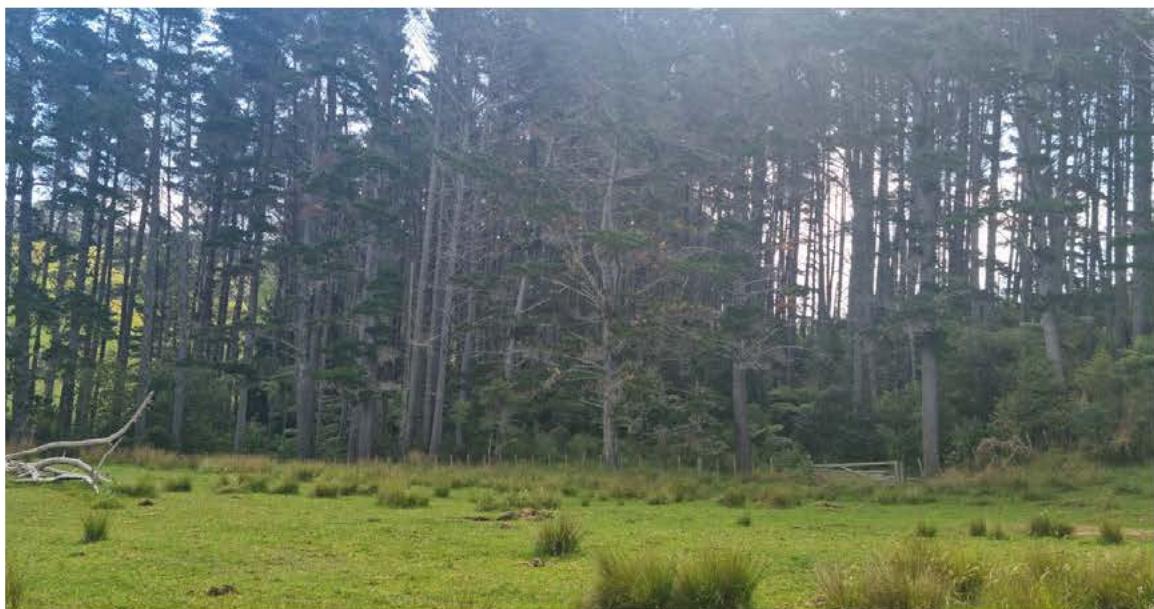
Figure 26 – View of the Monterey Pine forest section of Area 26 (see Figure 18 for an image of the indigenous vegetation adjacent to the western boundary)

With the exception of the pest plants and Monterey Pine row to the north, forested vegetation within Area 26 is to be retained, with works adjacent to Part B as part of the residential lot creation. A new, widened culvert and access roadway is proposed between the southeast portion of Area 26 and the southwest corner of Area 17.

It is recommended that all construction works adjacent to these areas is to be defined and assessed as part of preparing the TMP.

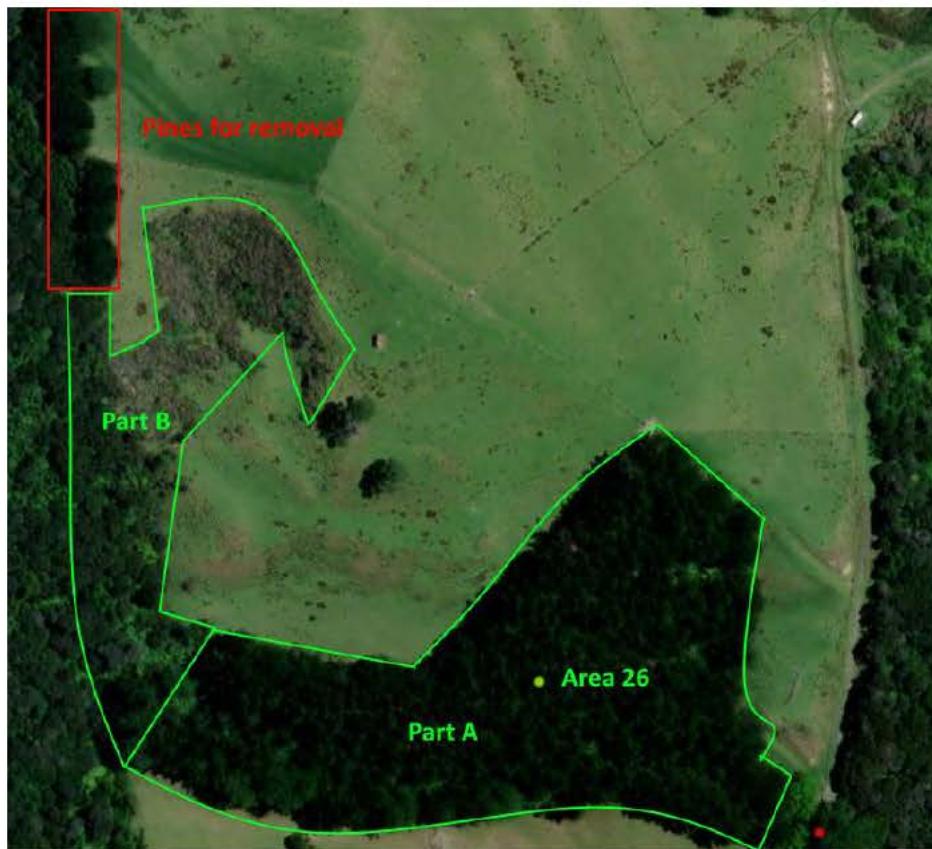
Figure 27 – Illustration of Part A & B areas of Area 26. Monterey Pine trees to be removed also shown.

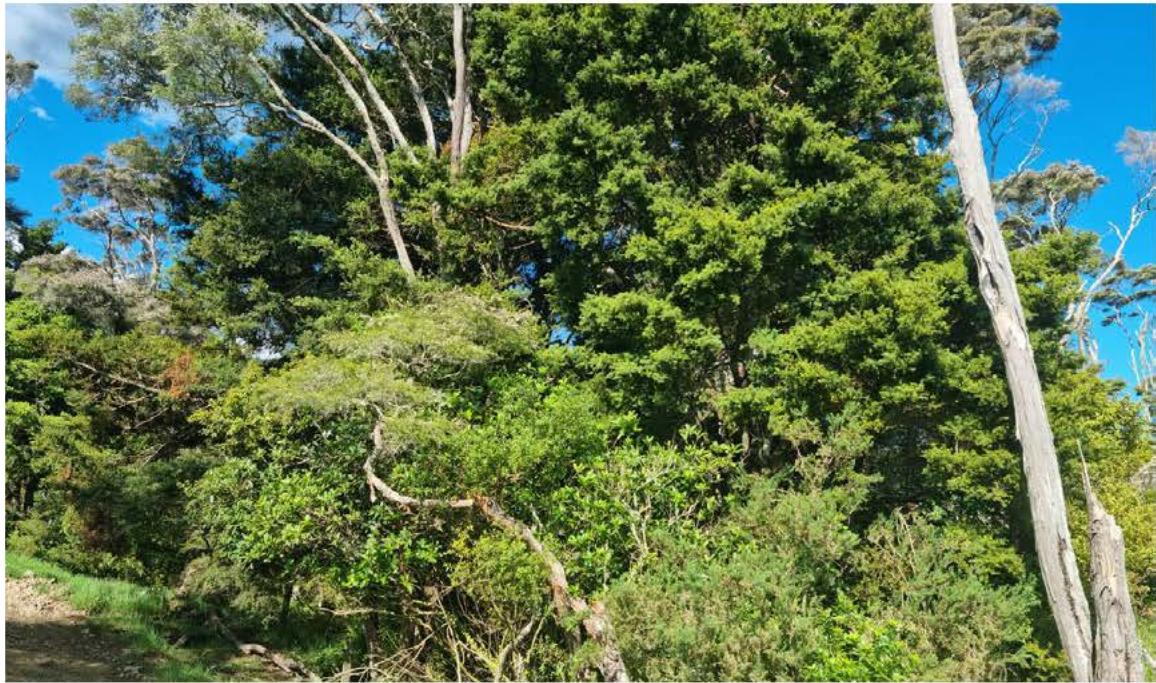
Area 27 is identified as a mixture of exotic vegetation (Willow) and indigenous vegetation (predominately Totara and Manuka) to be removed to enable the construction of the new road access, removal of the existing culvert, and the removal of an existing pipe bridge between Areas 26 and 17.

**Figure 28 – View of Area 27 to the east of the existing farm track. Portion to be removed for new roadway and associated infrastructure.**

Care must be undertaken to minimise the extent of tree removal, and to ensure vegetation overhanging the proposed works footprint and directly adjacent to the PRZ is adequately protected. It is recommended that all works are undertaken in accordance with TMP conditions and set out in the Draft TMP.

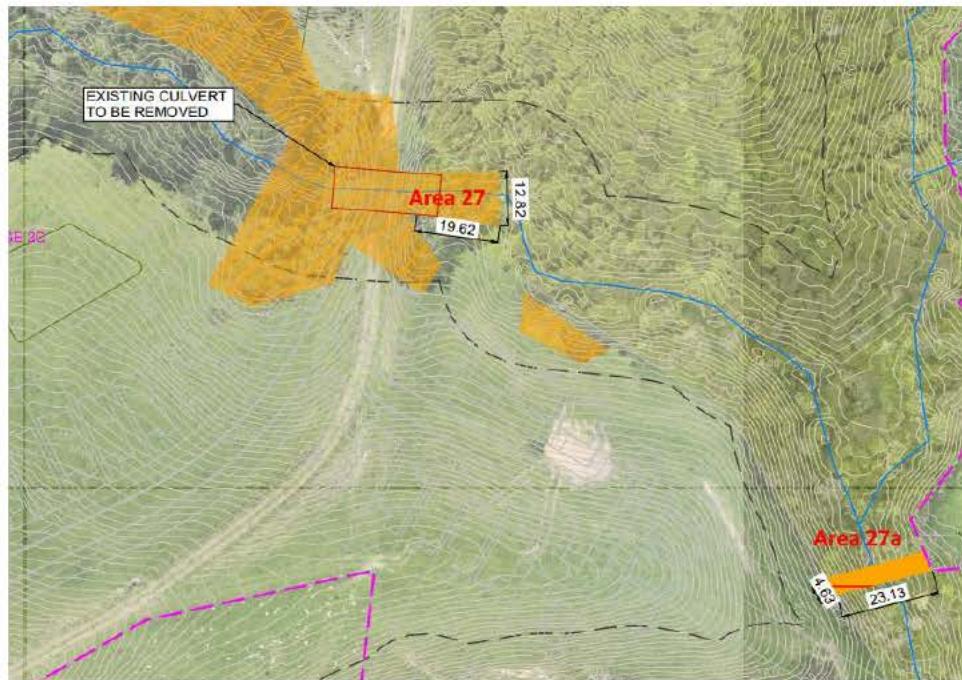
**Figure 29 – Anticipated extent of vegetation clearance proposed to enable the removal of the existing culvert, pipe bridge works (27A) and road infrastructure.**

Care must be undertaken to minimise the extent of tree removal, with care taken to ensure vegetation overhanging the proposed works footprint and directly adjacent to the protected root zone is adequately protected. It is recommended that all works are undertaken in accordance with Draft TMP conditions.

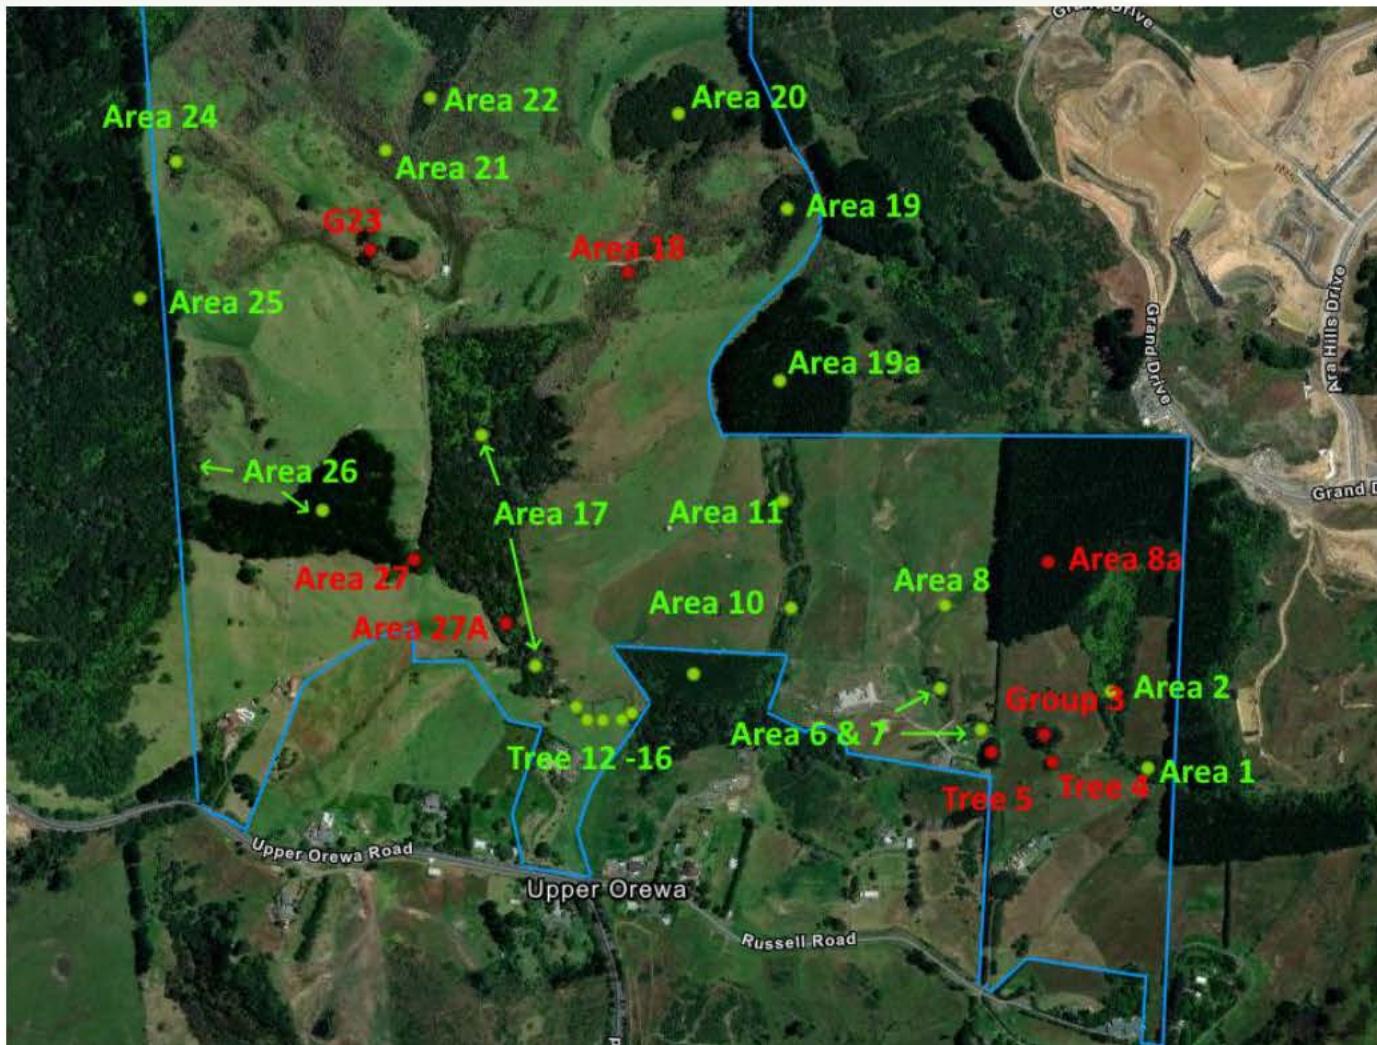
Figure 1 – Tree Location Plan (blue lines show Project extent)
