Appendix B12.4.3

Contaminated Site Investigation

Hunua Quarry Pit Development – Combined Preliminary & Detailed Site Investigation

Fletcher Concrete and Infrastructure Limited

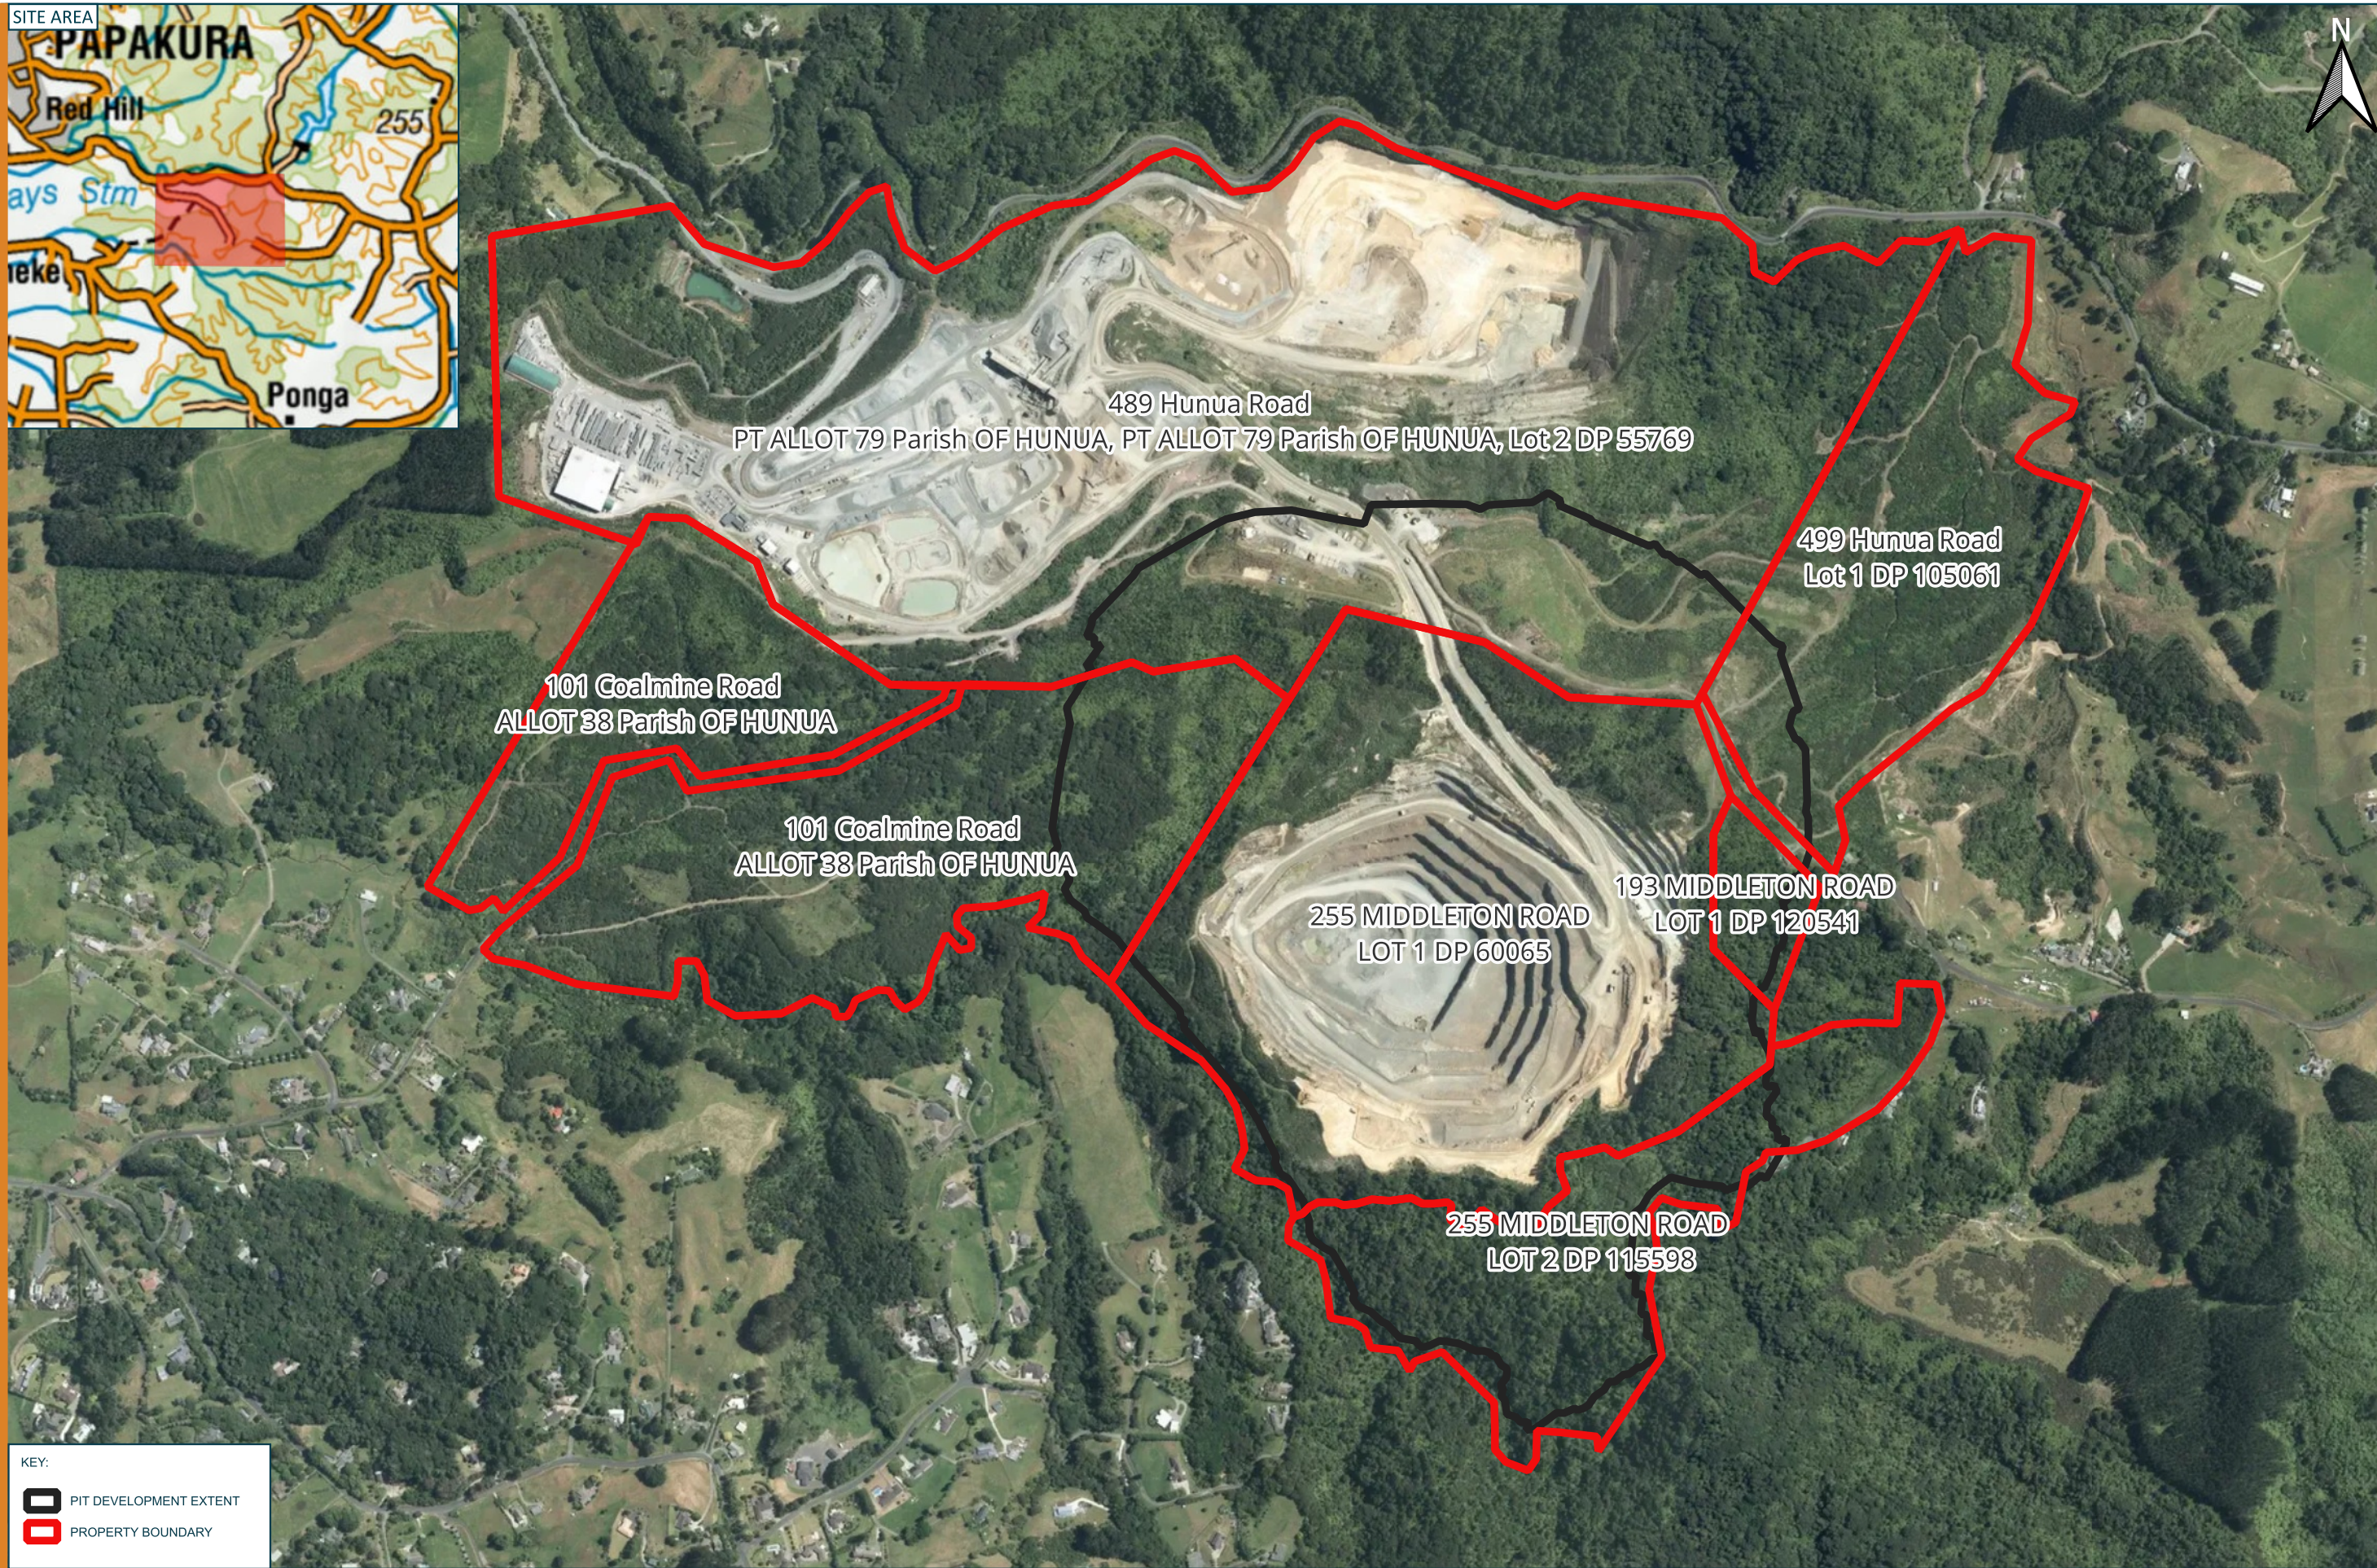
The investigation area makes up 50 ha of these land parcels. A plan of these parcels in relation to the proposed pit development is shown in Figure 1. The proposed pit development will occur in eight indicative stages to be undertaken over an approximate 50-80 year period; initially extending the existing Symonds Hill pit to the south and east (Stages 1 to 6, which is indicatively planned to be undertaken within the first 35 years of the proposed pit development), followed by areas to the north (where some historical overburden placement and native replanting has been undertaken) and west (Stages 7 and 8, which is indicatively planned to be undertaken approximately 35-50 years after the start of the proposed pit development).

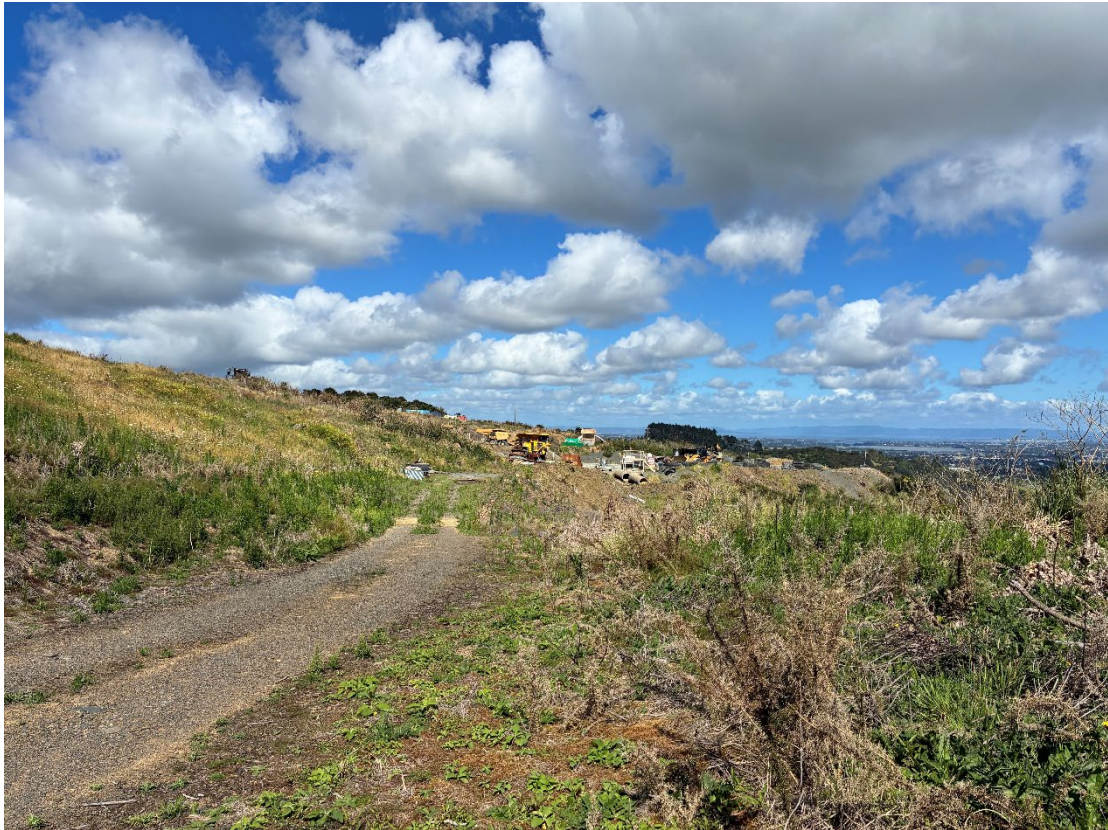
Photograph 3: Looking west, overview of the OBDA where samples PMS03-PMS07 were collected with the Graveyard area the background.

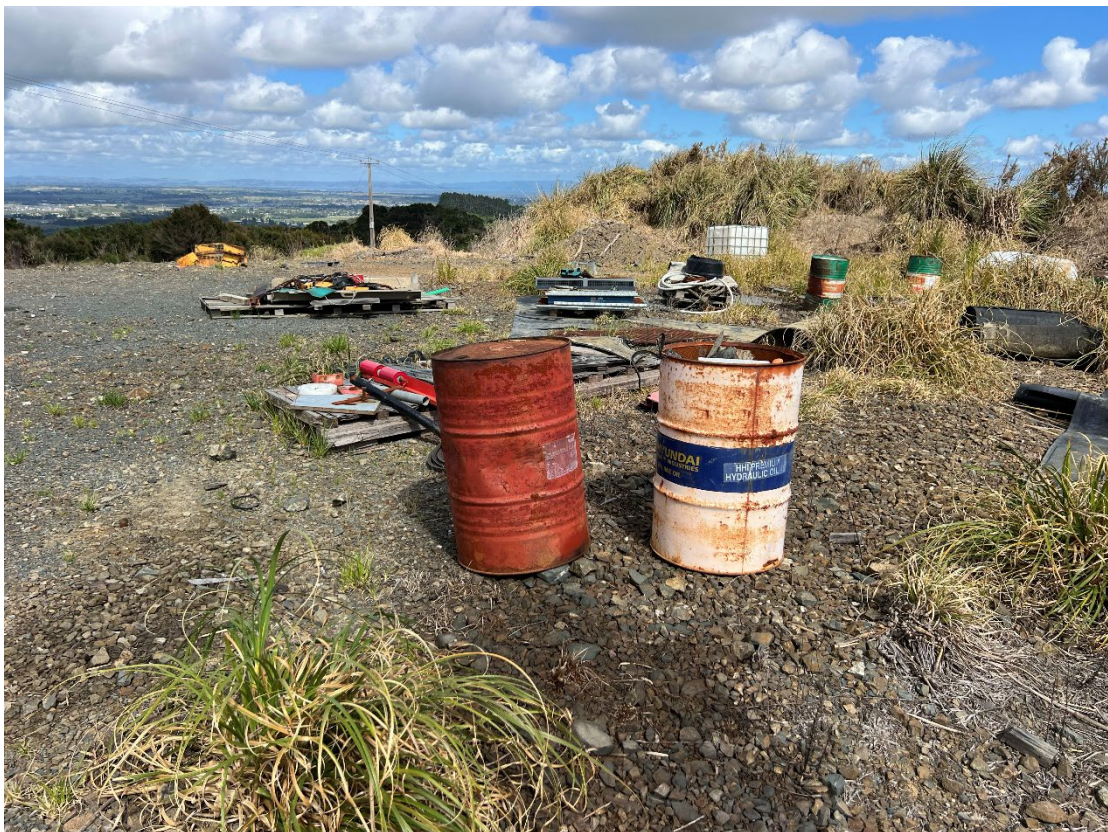
Photograph 4: Extension of the Graveyard area with weathered hydrocarbon staining next to empty metal drums where PMS08 was sampled.

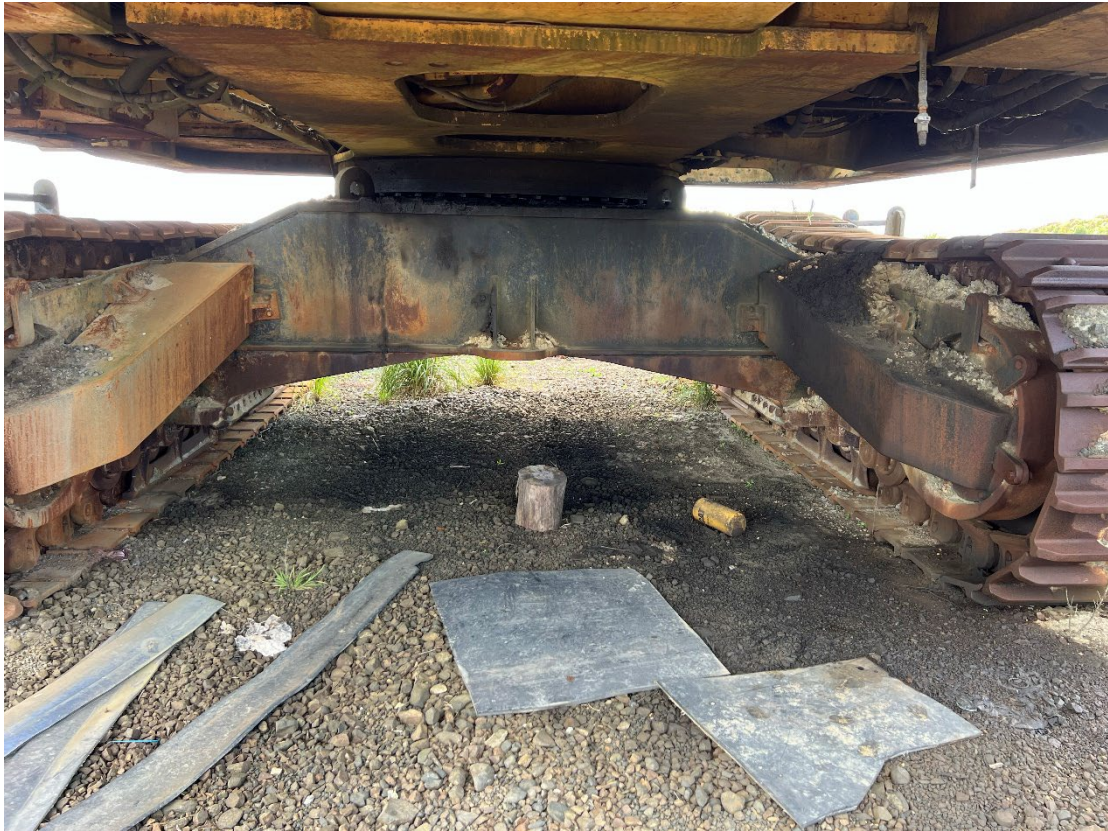
Photograph 5: Extension of the Graveyard area with weathered hydrocarbon staining under heavy machinery where PMS09 was sampled.

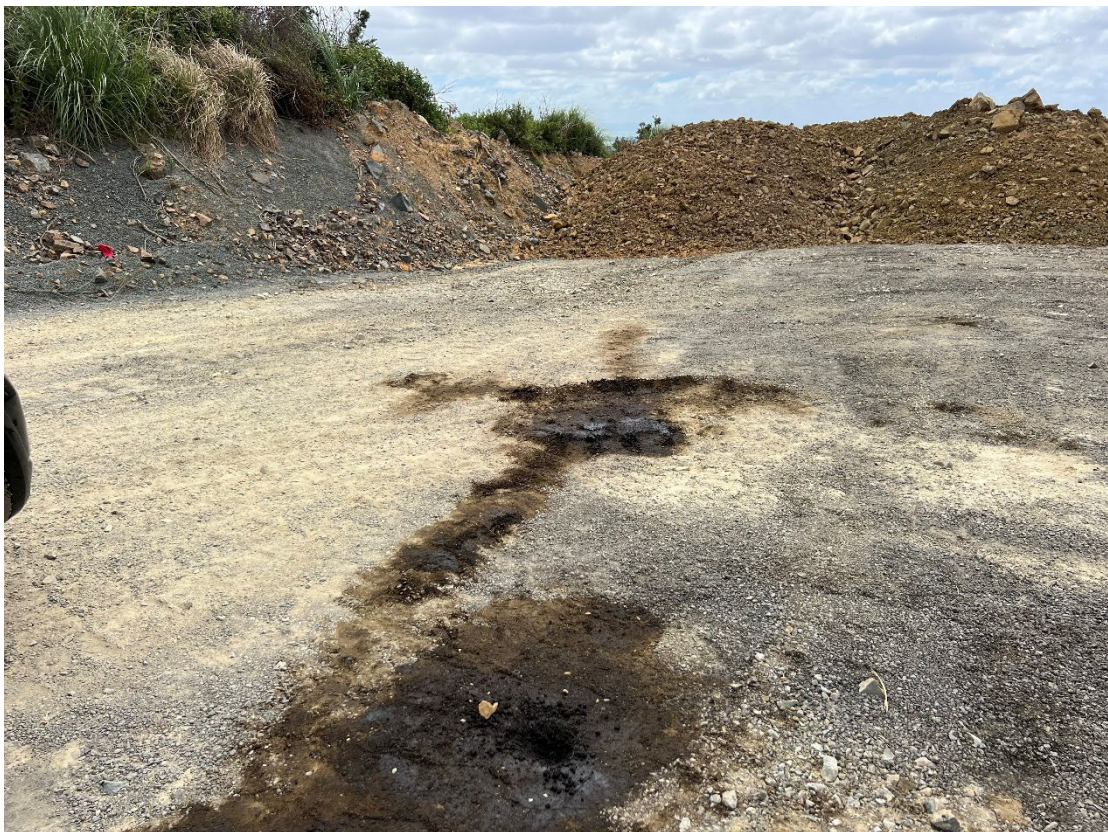
During the site walkover, PDP staff observed dump trucks stockpiling material, assumed to be overburden from the quarry pit, within the western portion of the Graveyard area. Fresh hydrocarbon staining was also observed on the ground near the stockpiled material, presumably from the temporary servicing/repairs of heavy machinery that were being undertaken during the site walkover at the Graveyard as there was a broken-down vehicle at the half-dome structure at the C+R Rack that is used for heavy vehicle maintenance.

Photograph 6: Overview of the western portion of the Graveyard area where fresh hydrocarbon staining was observed and PMS10 was collected. The stockpile of material (assumed overburden) that was observed to be dumped by a truck during the site walkover is in the background.

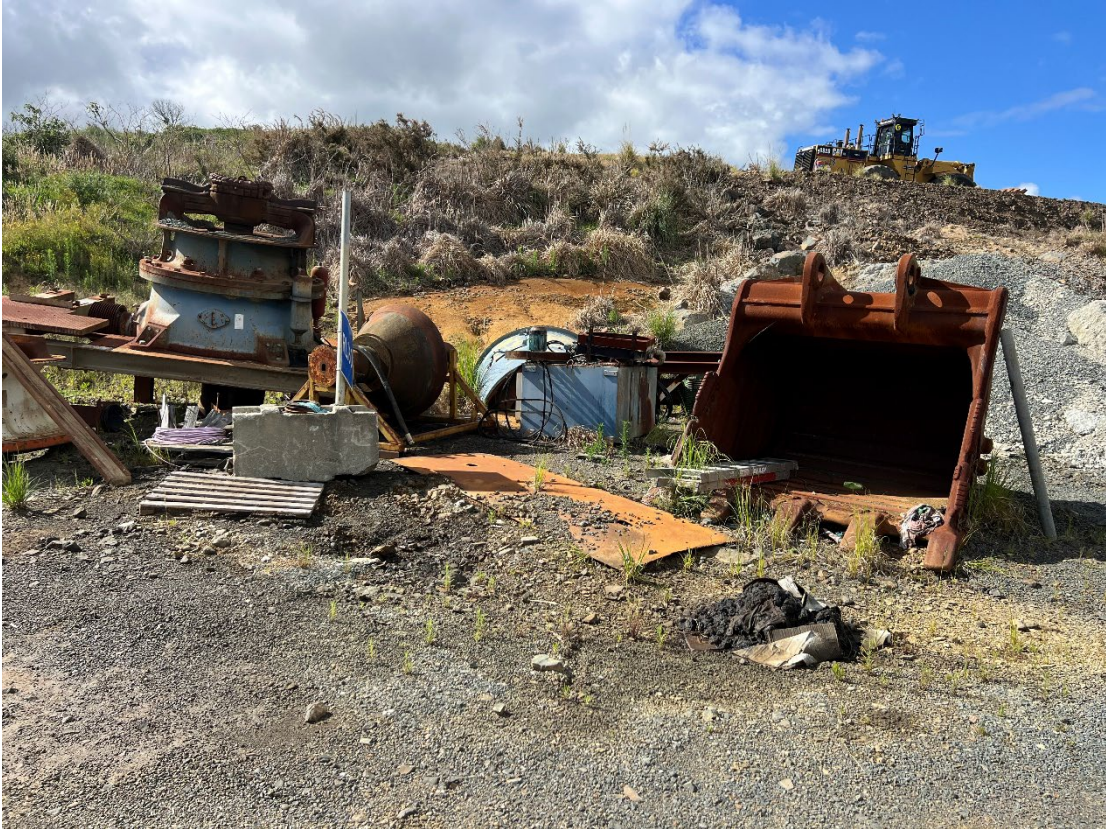
The Graveyard area consists of compacted hardfill gravel and is generally tidy with the exception of miscellaneous rusted metal items scattered across its eastern portion. A small pile of hydrocarbon material was also observed in this area.

Photograph 7: Overview of the eastern portion of the Graveyard area where discarded metal and weathered hydrocarbon staining was observed and PMS11 collected.

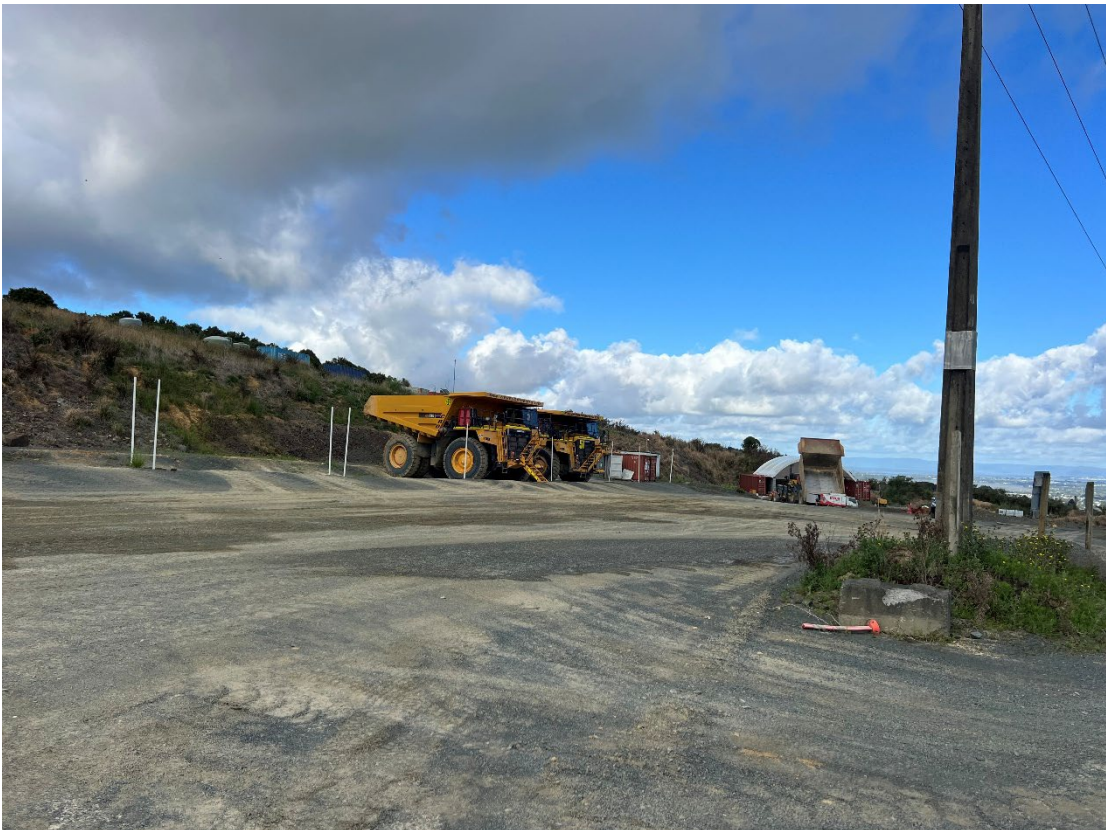
Photograph 8: Looking southwest at heavy machinery and the half-dome vehicle maintenance structure at C+R Rack.

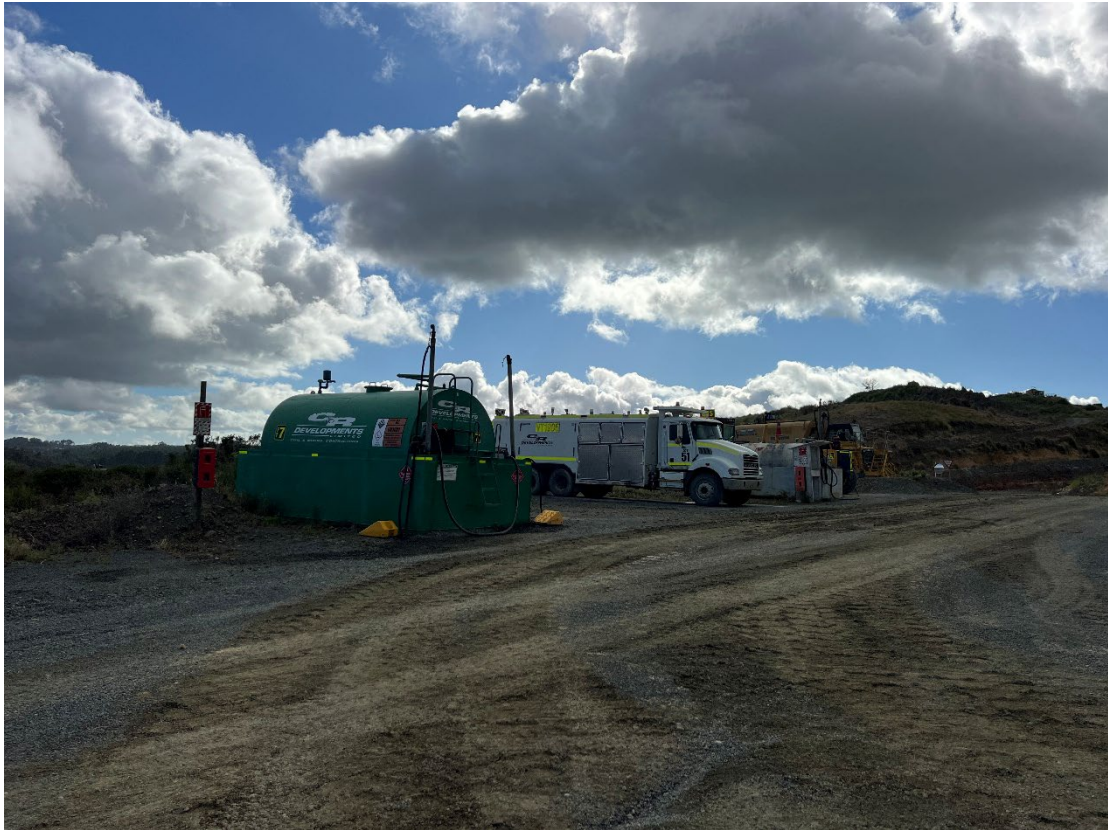
The bunded ASTs are located within the northeastern portion of the C+R Rack area. The bottom of both bunds appeared to have a thin layer of liquid with an oily sheen on the surface. Hydrocarbon staining was observed on the ground outside of both bunds, which appears to have originated from the bunds' discharge valves.

Photograph 9: Looking northeast at 2x bunded ASTs located in the C+R Rack.

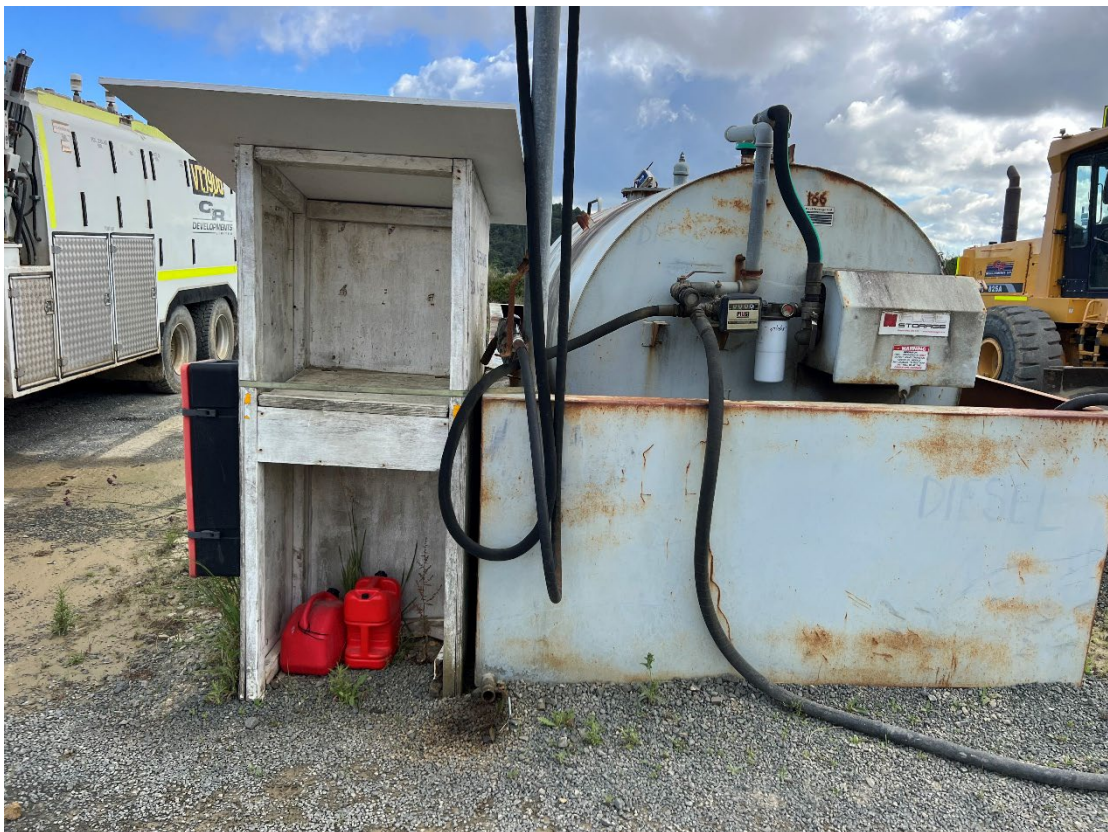
Photograph 10: Looking northeast at the eastern AST with hydrocarbon staining on the ground where PMS12 was taken.

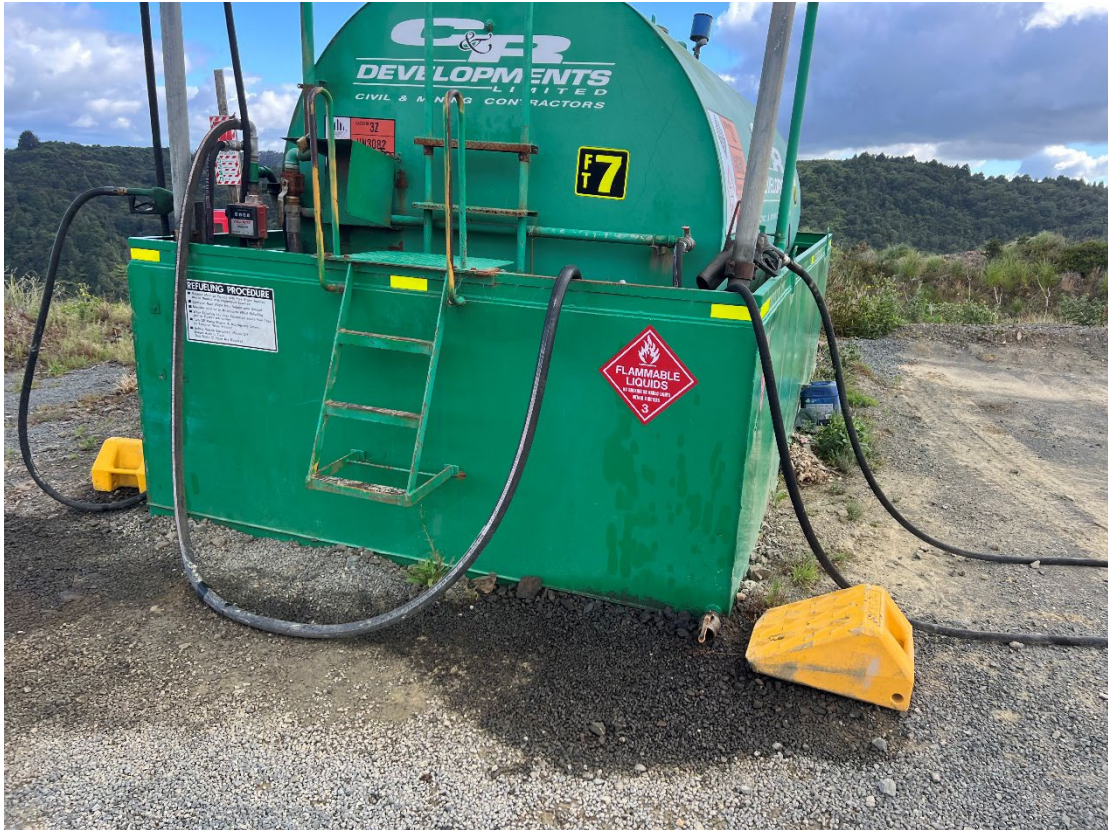
Photograph 11: Looking northeast at the western AST with hydrocarbon staining on the ground where PMS13 was taken.

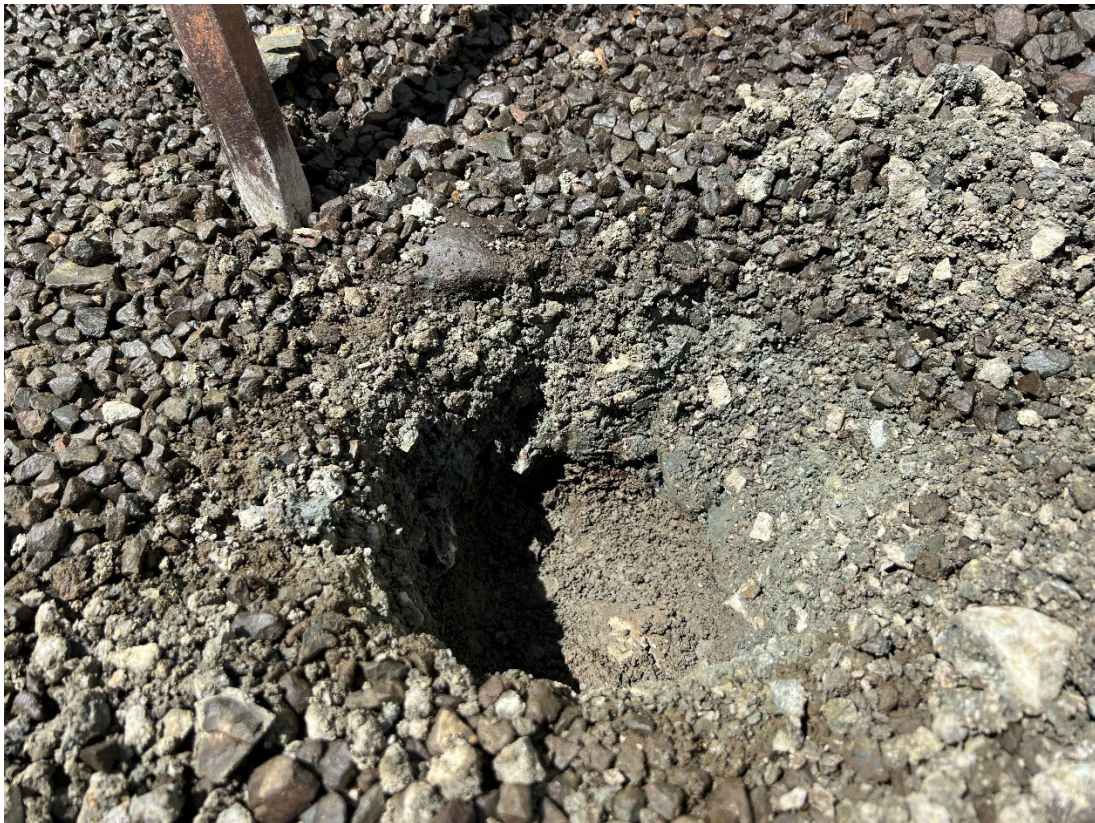
Photograph 12: Soil profile at 0.2 m bgl for PMS13.

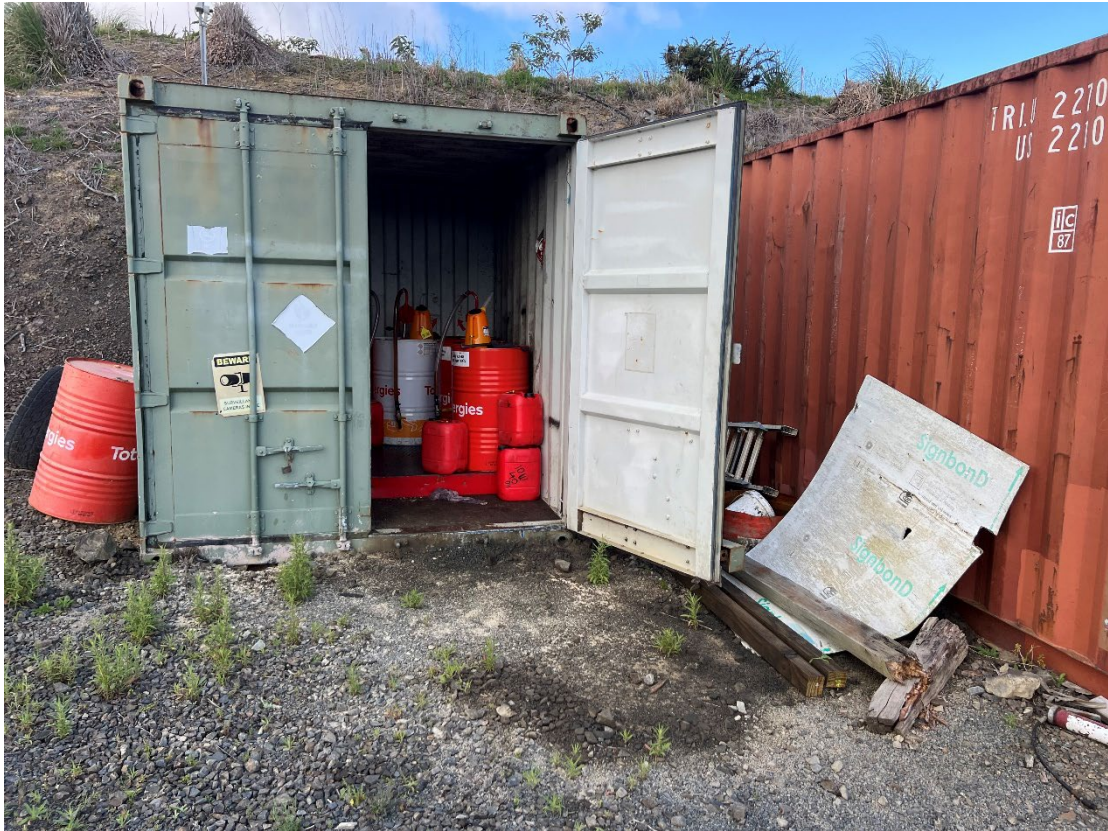
Various coolants and oil (engine, hydraulic and transmission) in drums and jerry cans were observed in a small shipping container to the east of the half-dome. Hydrocarbon staining was also observed on the ground in the vicinity of this shipping container.

Photograph 13: Looking southwest at a small shipping container used for coolant and oil storage with hydrocarbon staining on the ground where PMS14 was taken.

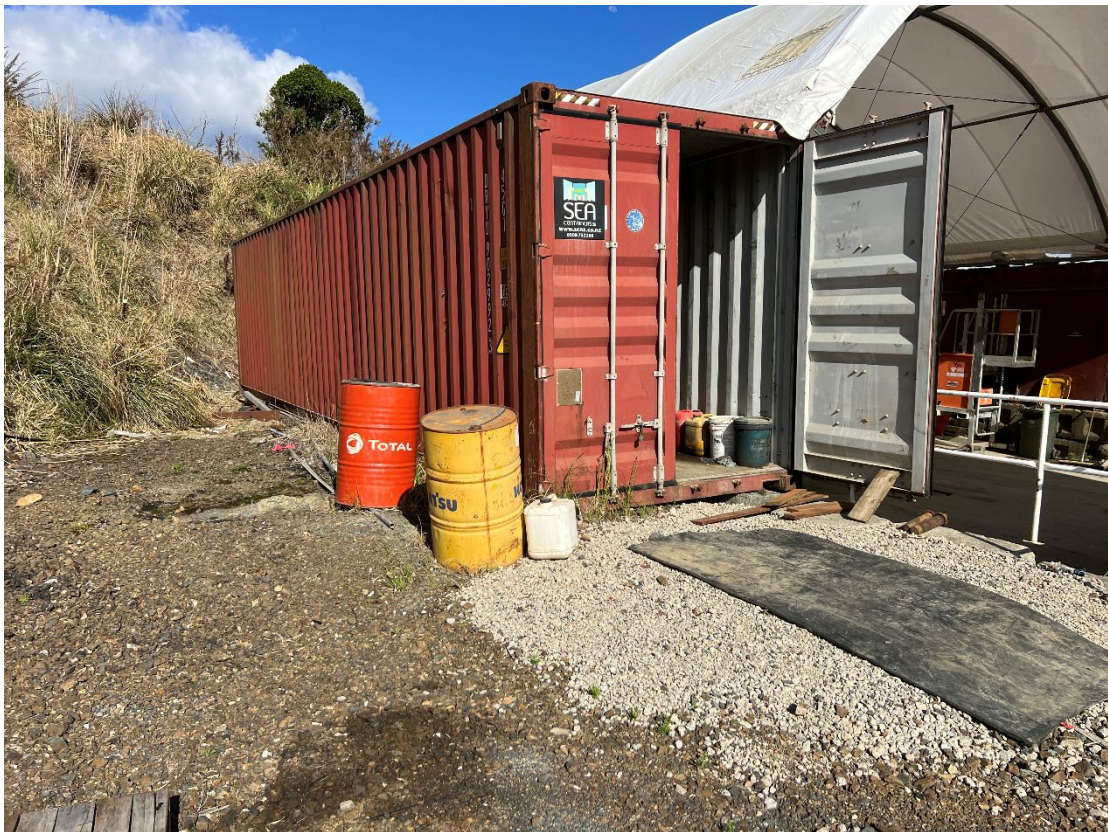
A shipping container to the south of the half-dome appeared to be used for tool storage; however, several empty metal drums along with hydrocarbon staining were also observed on the ground outside of this container. Another shipping container to the north of the half-dome was locked and its interior was not inspected as part of the site walkover; however, no hydrocarbon stains were observed around this container.

Photograph 14: Looking west at a shipping container adjacent to the vehicle maintenance structure with empty miscellaneous metal drums and hydrocarbon staining on the ground outside where PMS15 was sampled.

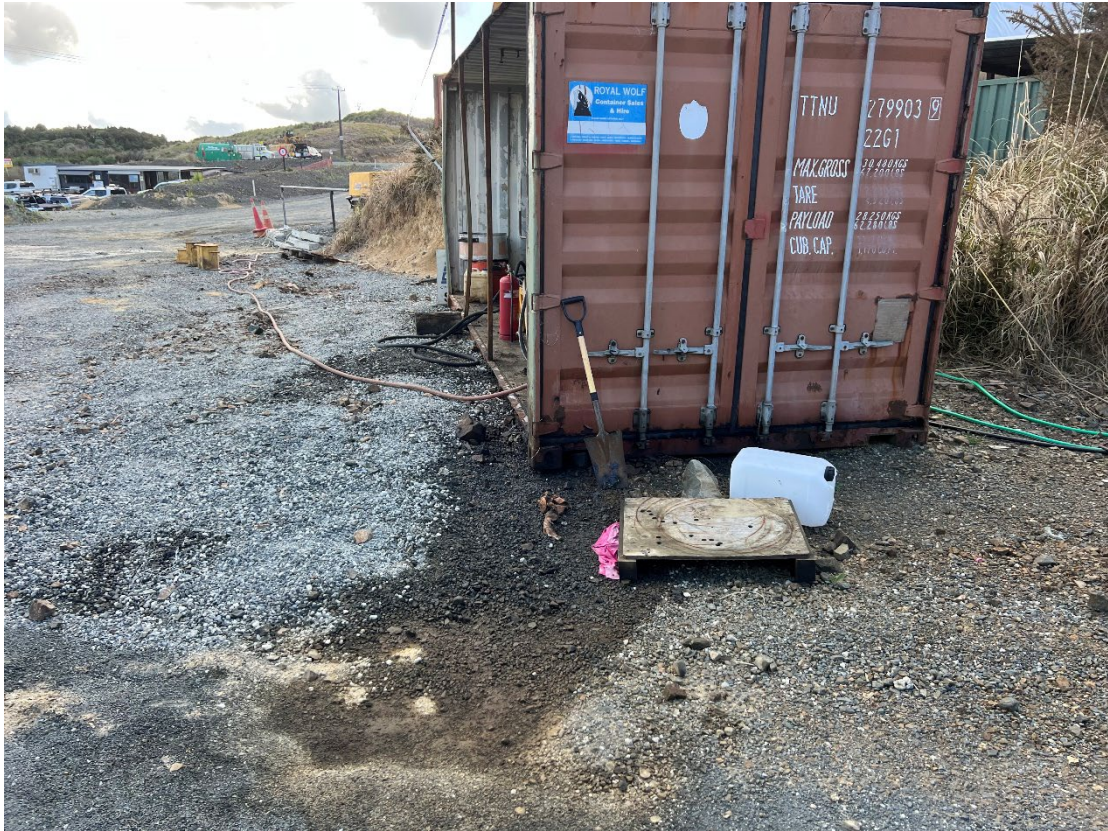
Following a discussion with Mr. Russell, it was confirmed that waste oil from vehicle maintenance is temporarily stored in a bunded intermediate bulk container (IBC) within the shipping container to the northwest of the half-dome. Hydrocarbon staining was observed on the ground in the vicinity of this shipping container.

Photograph 15: Looking southeast at a shipping container (near the northwestern corner of the vehicle maintenance structure) where waste oil is temporarily stored with hydrocarbon staining on the ground where PMS16 was taken.

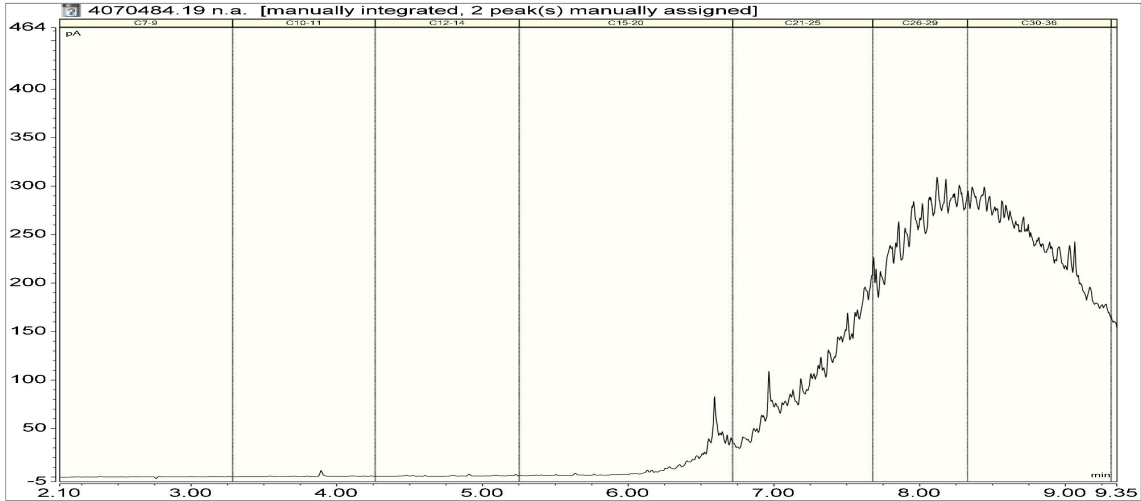
4070484.19
PMS10_0.1 08-Jan-2026
Client Chromatogram for TPH by FID

¹⁵ Note that while soil sample PMS10_0.1 has a TPH C₁₅-C₃₆ concentration of 28,000 mg/kg and the estimated Tier 1 soil acceptance criteria for TPH C₁₅-C₃₆ is noted to be in exceedance of 20,000 mg/kg, it is unlikely to pose an unacceptable human health risk to commercial/industrial land users. However, at 20,000 mg/kg residual separate phase is expected to have formed in the soil matrix and some aesthetic impact may be noted.
