**Remarkable Ski Area
Upgrade and Doolans
Expansion Freshwater
Ecological Impact
Assessment**

**Prepared for NZ Ski
Limited**

May 2026

Prepared by e3Scientific for NZSki Limited

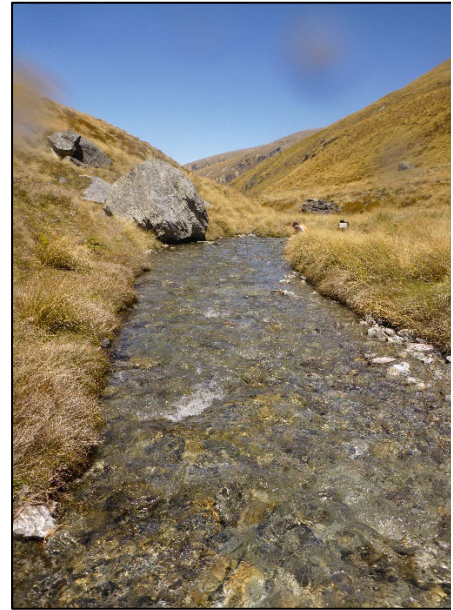
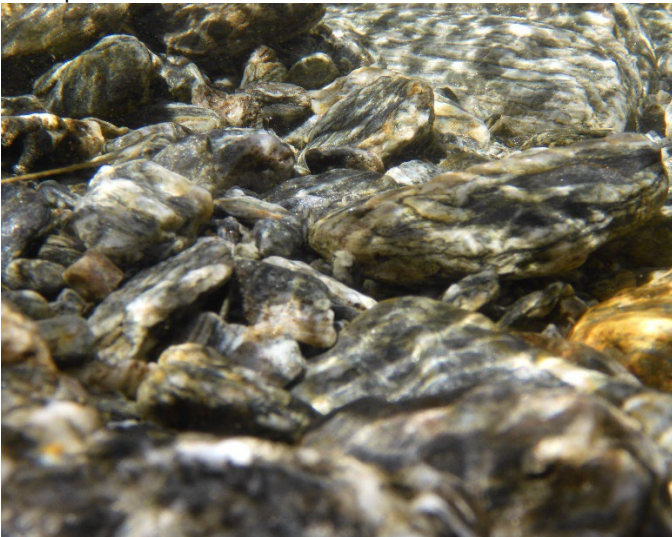
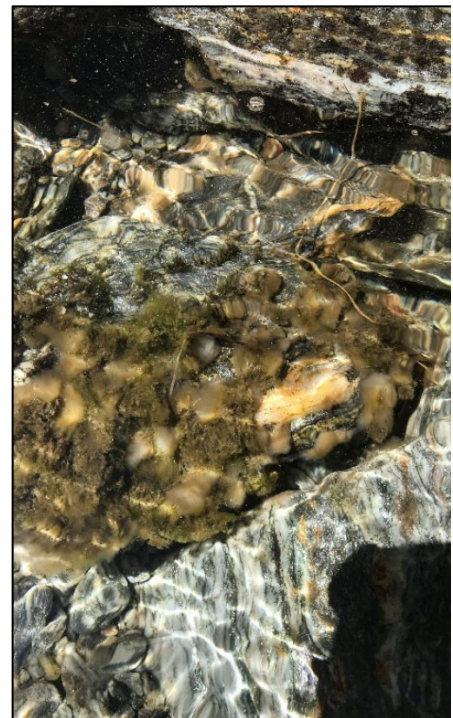
Figure 6: Representative images of habitat.

The streambed characteristics were consistent with an undeveloped alpine catchment with predominantly large substrates present and exposed bedrock in steeper sections (Figure 6; Appendix A). Although the environment was open with no tree cover to shade the watercourses, algal cover was limited, most likely due to the cold, low nutrient water present. Submerged bryophytes (moss) were present at a number of locations; however, submerged moss habitat was only included within the area sampled at DC3, Trib A and Trib C (Figure 6; Appendix A). Didymo was observed to be present at the DC Weir site in January 2026 which

may be new arrival in the catchment as none was observed or identified within eDNA samples at DC1, DC2 or DC3 in April 2025; however, these sites were upstream, so this was not confirmed. The proposed weir site had a higher proportion of gravels and algal cover than the upstream sites assessed (Table 5). The RHA habitat scores were good across the sites; however, the natural lack of shade and some areas of erosion led to lower scores at all sites and the weir site had a low score for hydraulic heterogeneity as it was one long riffle habitat (Table 5).

Didymo was not observed nor identified via eDNA in any of the waterways sampled in the Doolan's Basin in April 2025. Didymo was observed and identified in the eDNA results from the DC Weir site in the January 2026 sampling round but not at the tarns. Didymo is now widespread throughout much of the South Island where human activities such as fly fishing are more prevalent. Care should be

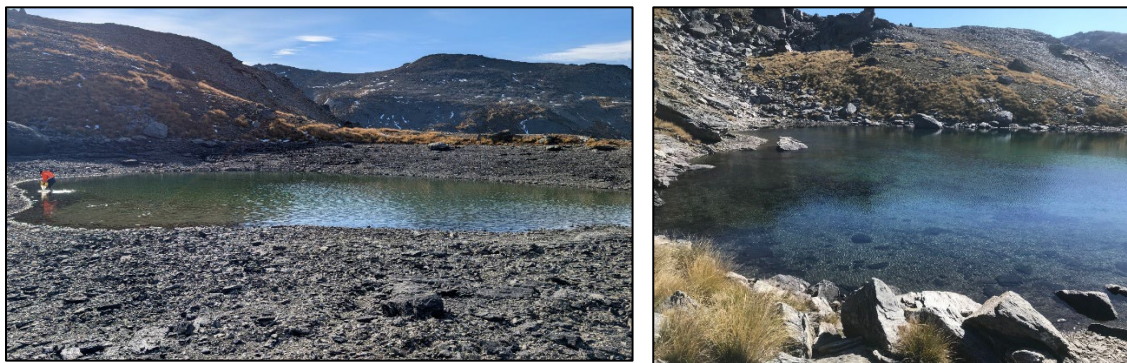
Figure 7: Images of Tarn 3 in April 2025 (left) and January 2026 (right).

Within the Doolans Basin the total mapped wetland area is 58.8 hectares (ha) and the total tarn area of the four tarns in the basin cover 3.3 ha. The tarn habitat varied between the three tarns assessed. Tarn 1 has an elevation of 1650 m a.s.l., was large and deep with gravels around the littoral edge and outlet. Sandy silt covered deeper areas and small tufts of brown algae were present on some boulders. Tarn 2 has an elevation of 1750 m a.s.l., had a turf bed of short macrophytes (potentially *Lilaeopsis ruthiana*) with areas of filamentous algae cover and a sandy/silty bed in deeper areas. Tarn 3 has an elevation of 1700 m a.s.l., had low water levels at the time of the April 2025 assessment and the bed comprised mainly of sand with some areas of stunted macrophyte present and areas of brown algae. In January 2026 Tarn 3 had much more water present, this appears to have caused the inundation of early succession terrestrial plants leading to them dying off and algae growing on top of them presumably utilising nutrients being released from the decaying plants (Figure 7).

Of the three Tarns, Tarn 3 was considered to have the lowest habitat diversity due to a lack of macrophytes and deep water.

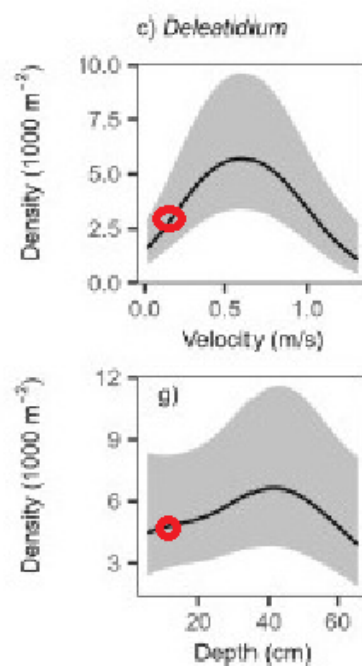
Figure 9: Predicted macroinvertebrate foodscape (Modified from Stoffels *et al.* 2026).

Further evidence indicating a minor effect on macroinvertebrates associated with the proposed flow reduction and depth is provided in research by Stoffels *et al.*, (2026). This work examined the effects of flow rate and water depth on the density of macroinvertebrates in the Upper Selwyn River. The study found a minor change in mayfly (*Deleatidium*) densities where flow rates and depth changes were analogous to the proposed changes associated with the Doolans Creek water take (see Figure 9). Furthermore, macroinvertebrate abundance in Doolans Creek is naturally significantly lower than the Selwyn River. It therefore follows that a reduction in flow rate and water level in this location is likely to have a minor effect on macroinvertebrate density within the foodscape.
