# GEOTECHNICAL INVESTIGATION REPORT

Milldale Stages 14-17 Water Infrastructure Facility

Fulton Hogan Land Development Ltd  
AK26-027AC Rev.1

31 July 2026

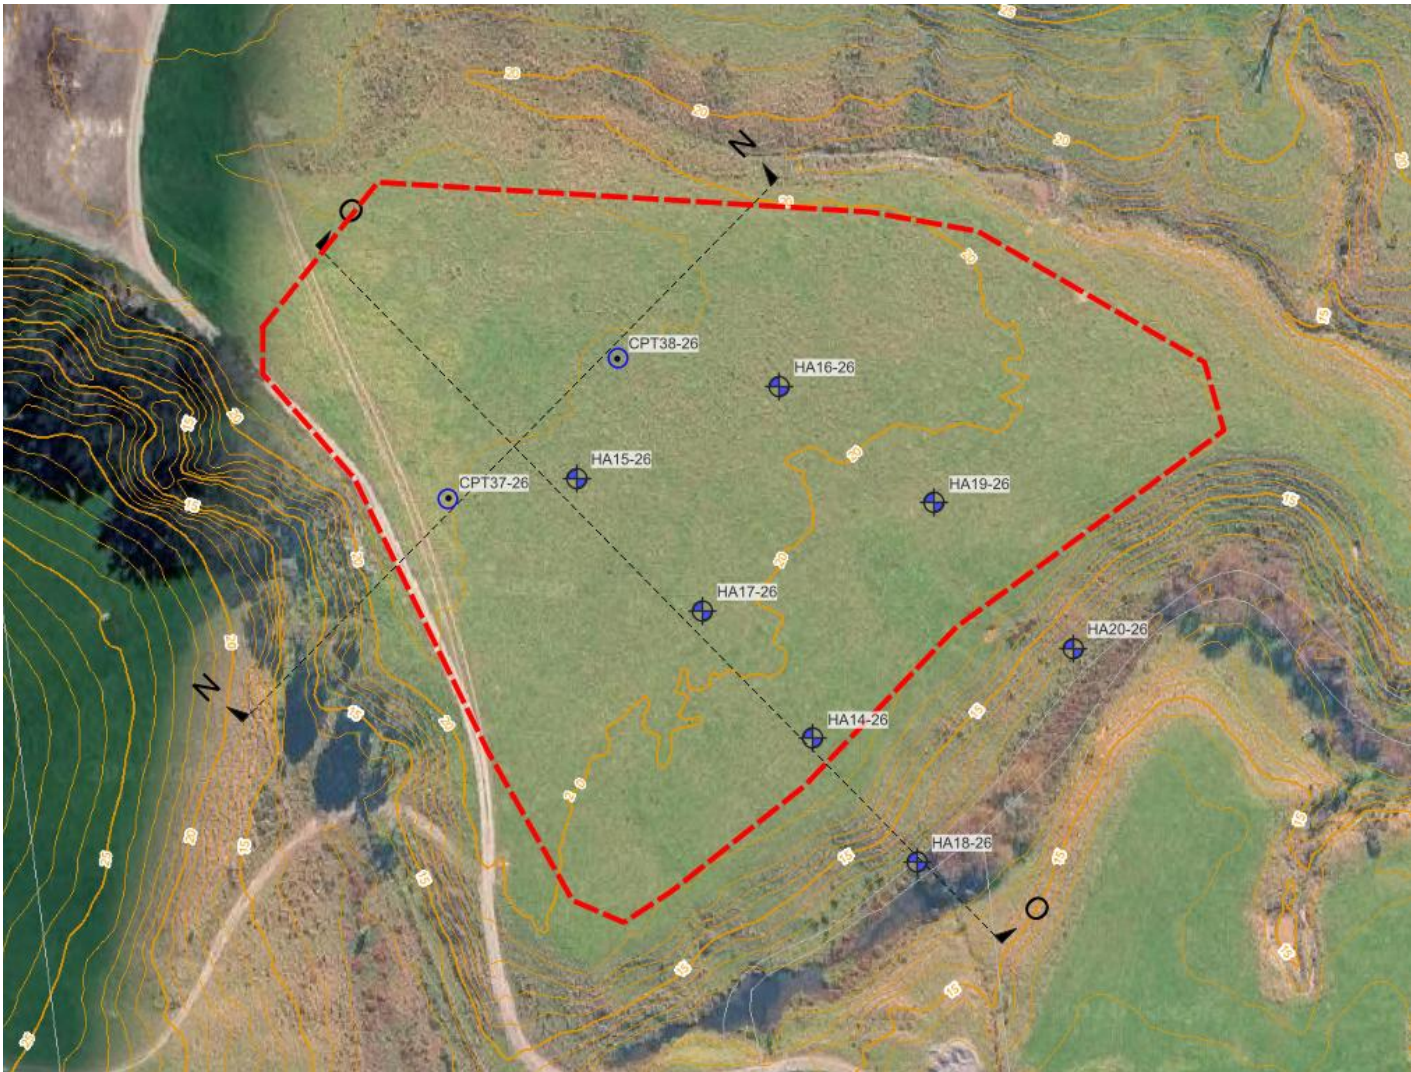
Figure 4 Site Investigation Plan and Cross Section Locations

Two geological cross sections (Section O and N) have been produced at the locations noted on Figure 4 and shown on Drawings 36 and 37.

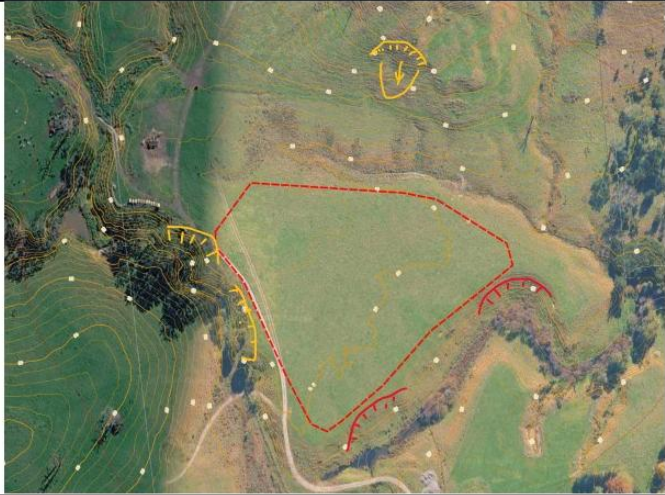
Plan

| Landslide Hazard Scenarios | |
|---|---|
| Maximum Credible | Shallow underslip to the south into the Orewa River |
