# Belmont Quarry Development – Part B

Substantive Application  
Appendix B.11 – Archaeological Assessment  
Winstone Aggregates

# **WELLINGTON BELMONT QUARRY, PROPOSED OBDA: ARCHAEOLOGICAL ASSESSMENT**

Prepared for Winstone Aggregates  
A Division of Fletcher Concrete and Infrastructure Ltd  
July 2026

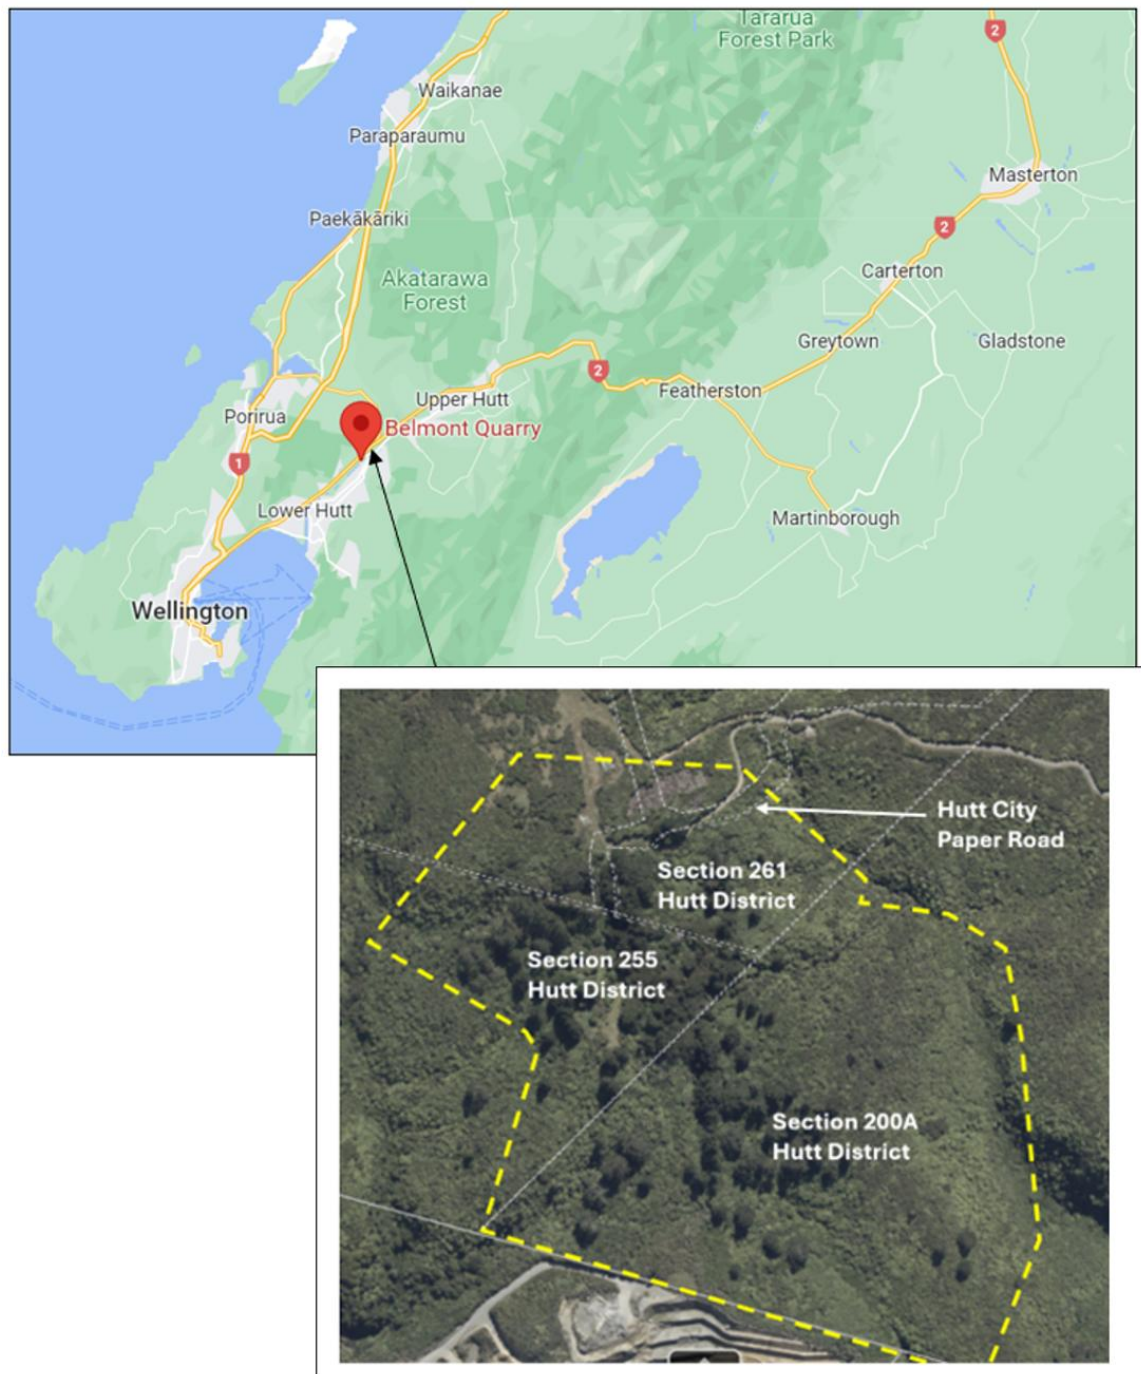
**Figure 1. Upper map showing the proposed OBDA in the greater Wellington region and lower aerial plan showing the properties containing the proposed OBDA (note that the paper road has not been included in the land swap<sup>1</sup>) (source: Upper- Google Maps and lower Hutt City District Council Online Maps)**

5. To ensure a long-term solution for overburden management, a new OBDA adjacent to the existing quarry footprint (Figure 1) is proposed to be developed. The selected OBDA location is situated within the Belmont Regional Park, adjacent to the existing Quarry operational area. This location has been identified as the most suitable due to its operational, environmental and logistical advantages. Its adjacency to the quarry operation allows for a direct haul route, minimising transport distances, fuel use and emissions.

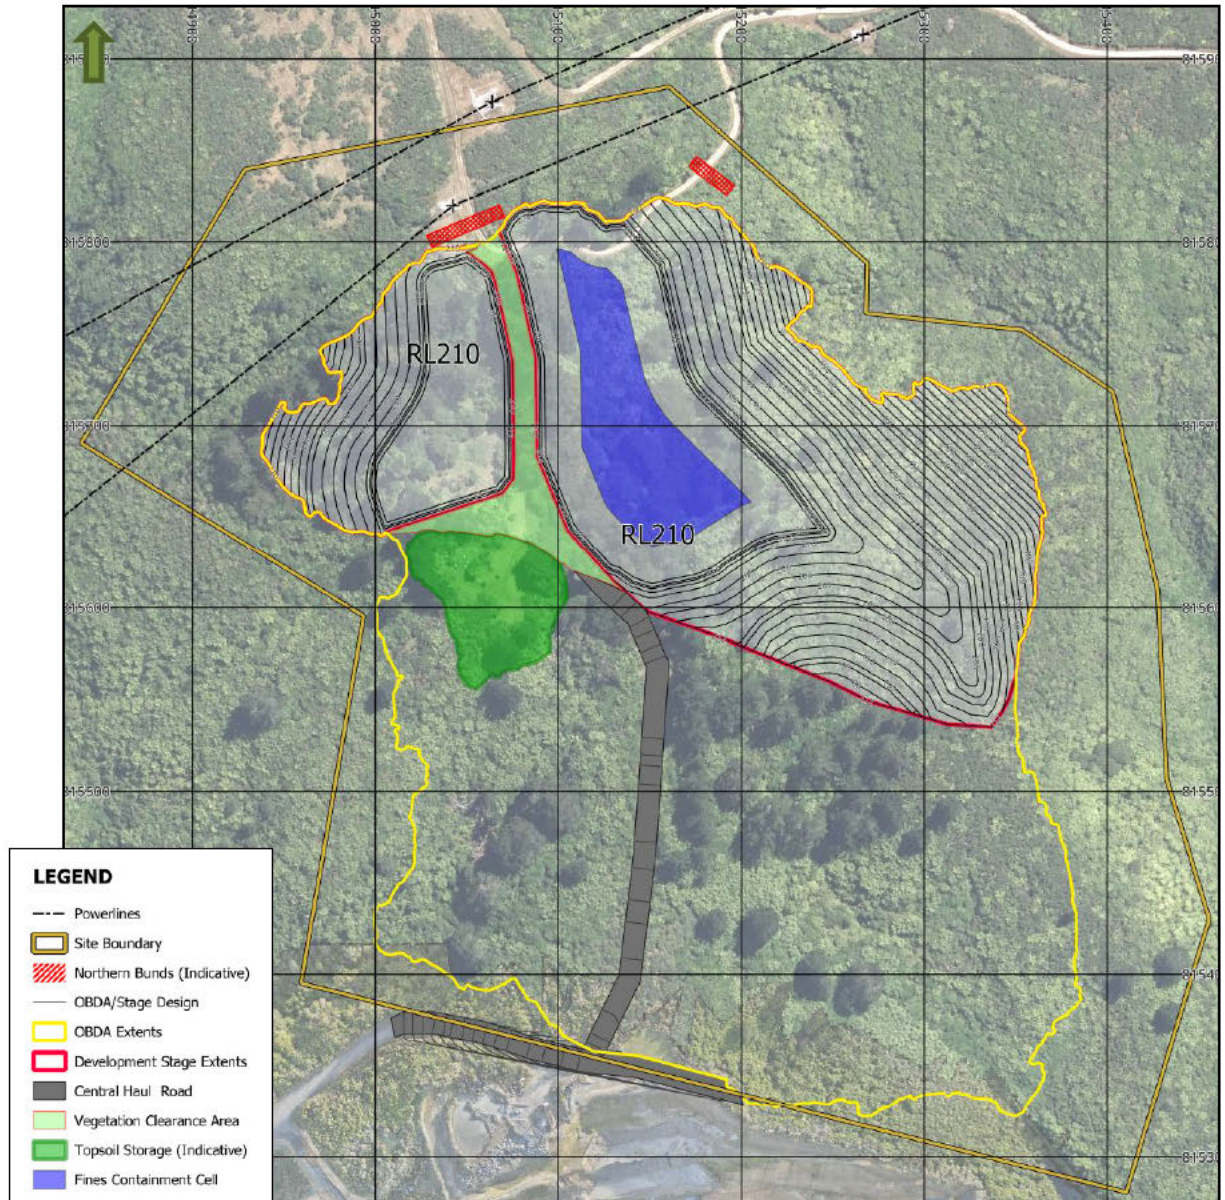
**Figure 6. Plan showing the enabling works for Stage 3 (source: Winstone Aggregates)**

shown in Figure 5. The enabling works for Stage 3 (Figure 6) extend only slightly outside of those for Stage 2.

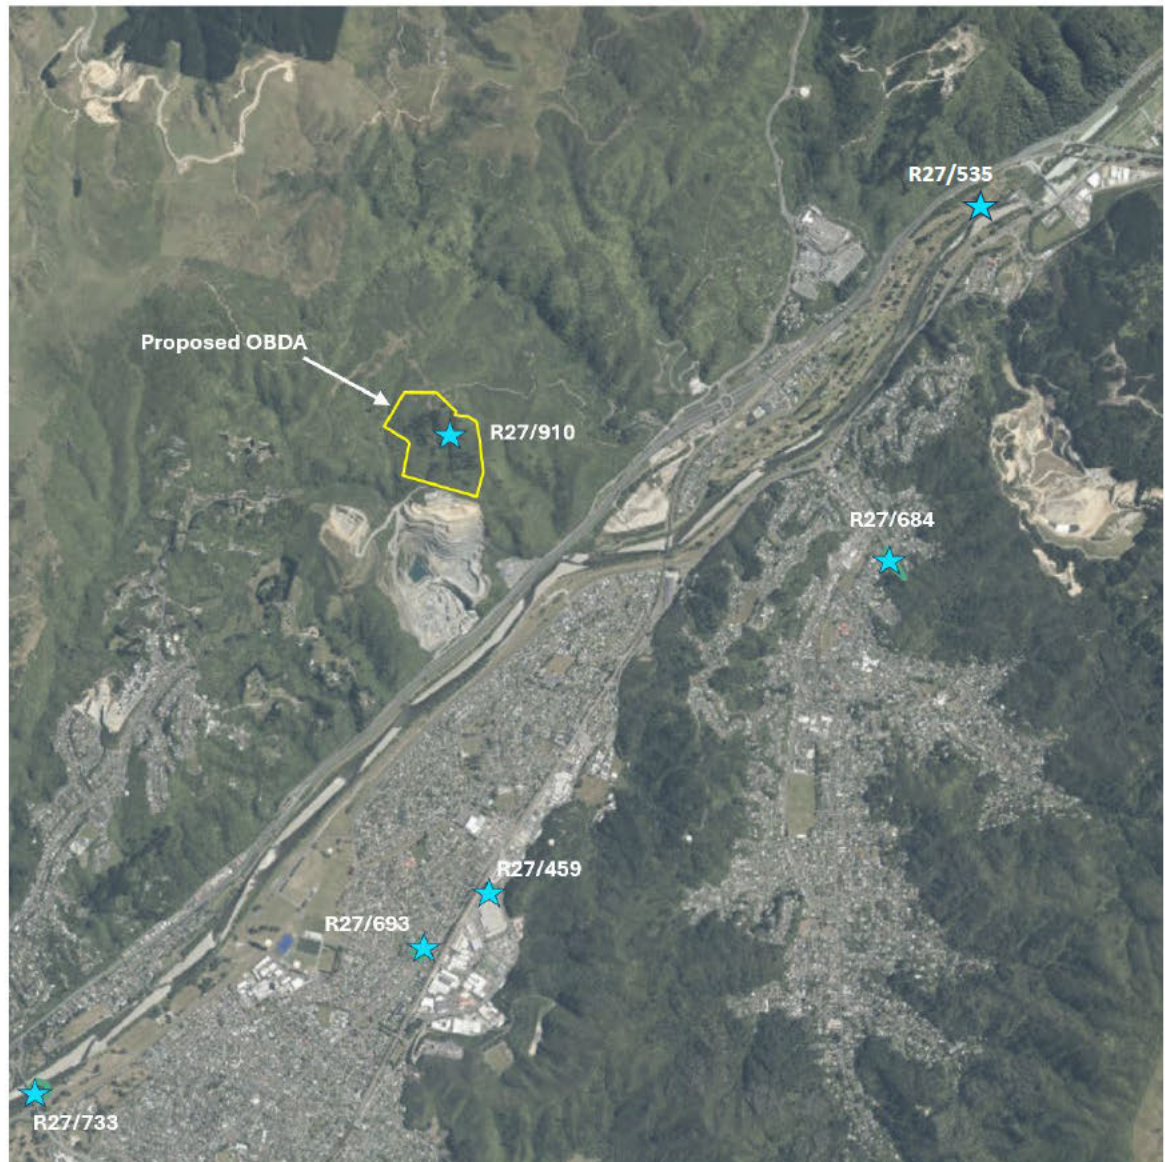
**Figure 15. Map showing the locations of recorded sites (blue stars) within the proposed OBDA and in the general area (between c.2000m and c. 4000m) outside of Belmont Regional Park with proposed OBDA outlined in yellow (source: NZAA Archsite Website)**

33. There are no other recorded sites located in close proximity to the proposed OBDA. A total of five sites have been recorded at distances between c.2000-4000m outside of the boundaries of Belmont Regional Park and are described below with locations shown in Figure 15. Ten additional sites have been recorded within Belmont Regional Park with the closest being located c. 3000m to the west of the proposed OBDA. The ten sites within the park are also described below and the locations are shown in Figure 16. As well, a brief summary of the recorded sites is provided in Table 1.

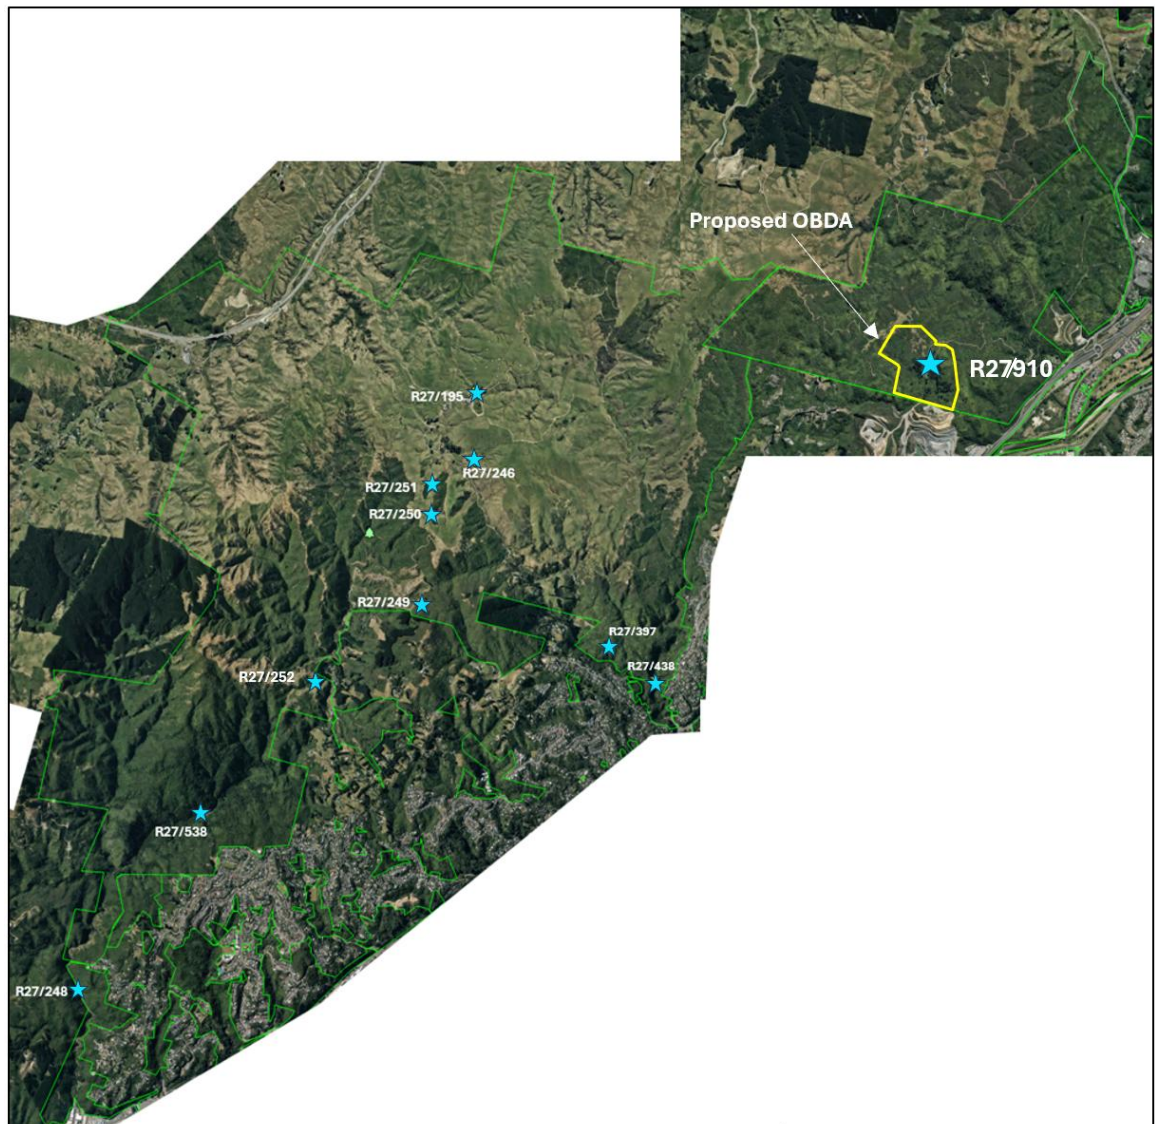
**Figure 16. Aerial plan showing the recorded site within the proposed OBDA which is outlined in yellow and the additional ten recorded sites (indicated by blue stars) within the Belmont Regional Park (source: Google Maps)**

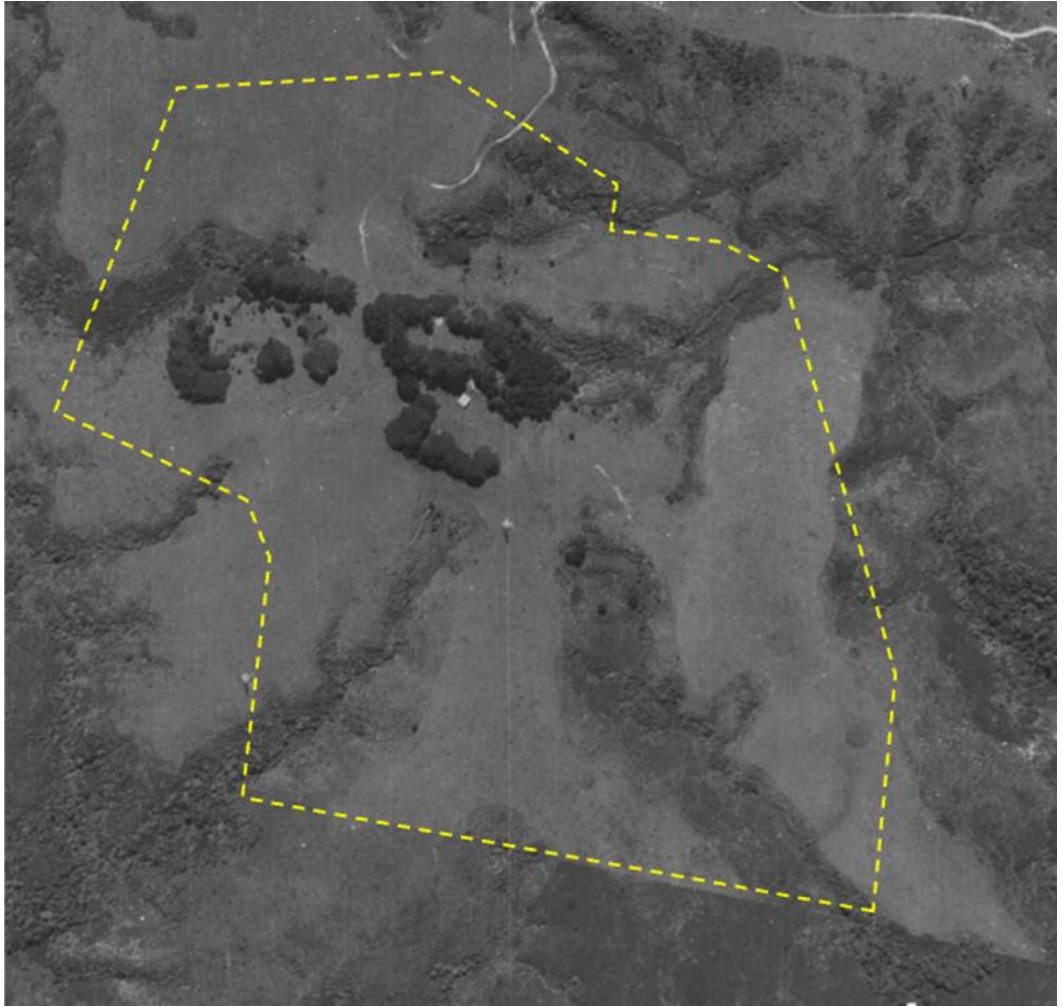
57. Aerial photographs were reviewed to provide additional information on the land use and extent of quarrying in the proposed OBDA. The aerial photograph dated 1941 in Figure 19 shows the proposed OBDA for the most part consists as open high ground with vegetated gullies. There are also one or possibly two structures visible, although the nature of the buildings cannot be discerned from the image. The 1966 aerial photograph in Figure 20 shows the same areas with little change in the proposed OBDA. The

**Figure 19. Aerial photograph dated 1941 (Crown 163 182 19) showing the proposed OBDA (yellow dashed outline) with buildings visible (sourced from: <http://retrolens.nz> and licensed by LINZ CC-BY 3.0)**

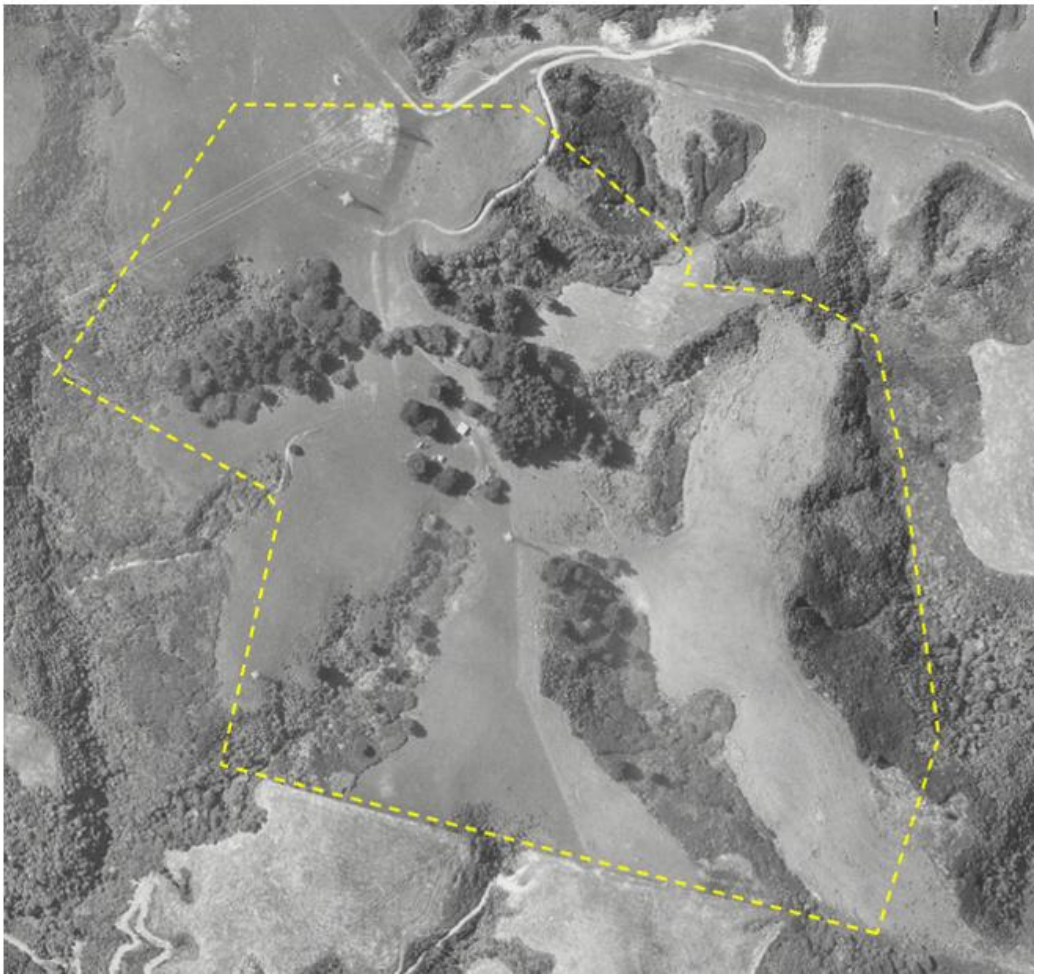
**Figure 20. Aerial photograph dated 1966 (Crown 1407 3292 42) showing the proposed OBDA (yellow dashed outline) with buildings still visible (sourced from: <http://retrolens.nz> and licensed by LINZ CC-BY 3.0)**

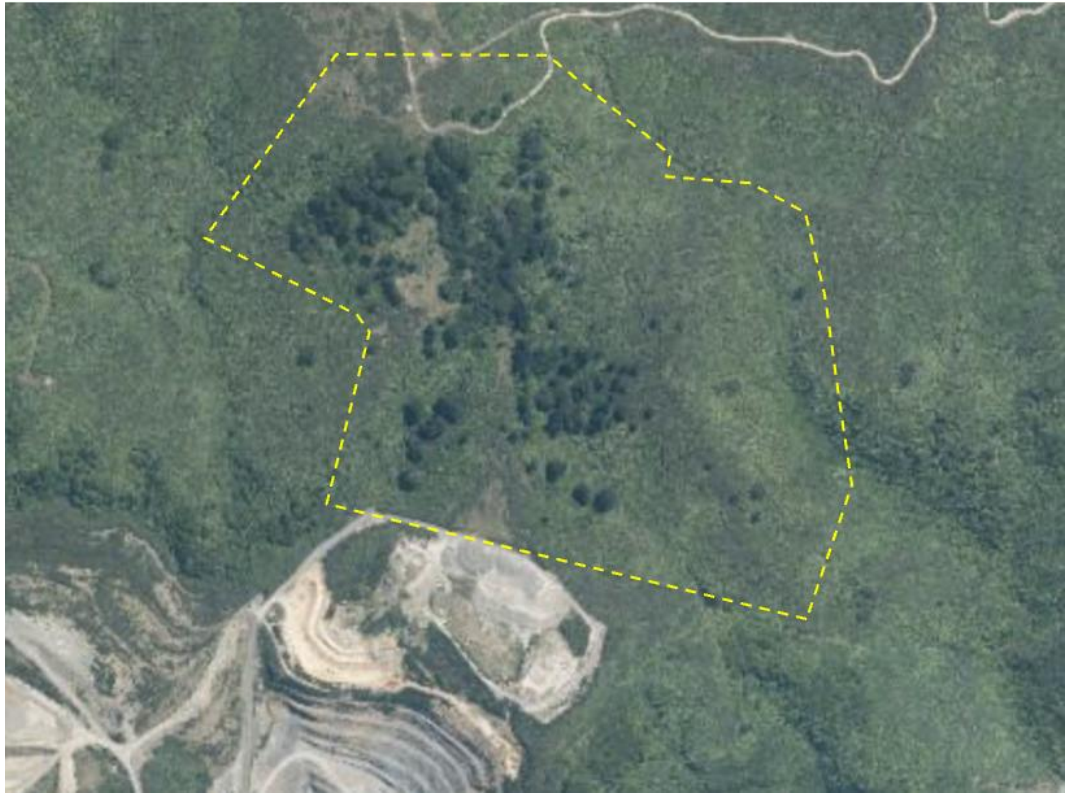
2005 aerial photograph in Figure 21 shows that the structures in the proposed OBDA have been removed and a small area of ground disturbance is visible in the southern part of the OBDA.

**Figure 21. Aerial photograph dated 2005 showing the proposed OBDA (outlined by yellow dashed line) with buildings no longer visible (source from: Google Earth)**

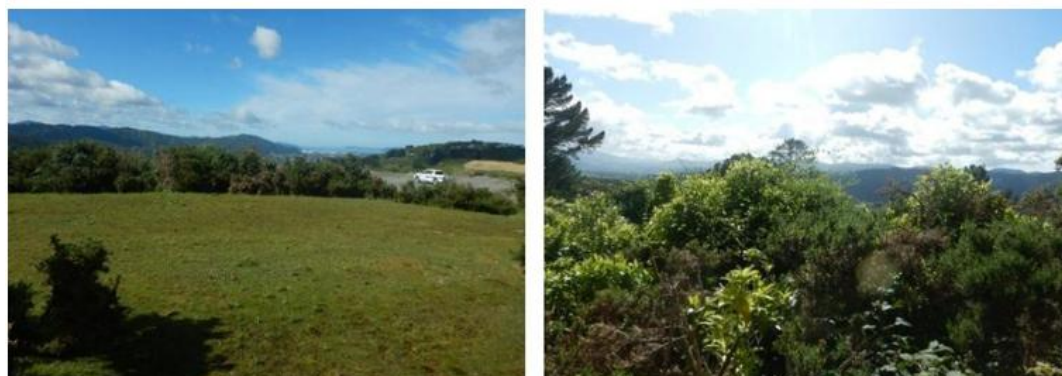
59. Entry to the OBDA was attempted from the northern point of the quarry through an area of grassed land that had been previously modified (Figure 22, left). The surrounding area was found to be covered by very thick scrub and also with very steep hillsides, also shown in Figure 22 (right), and it was decided that a full walkover survey could not be safely undertaken.

**Figure 22.** Left photograph showing the modified area where entry to the proposed OBDA was accessed, looking southwest; and right photograph taken during the survey showing the thick vegetation cover, looking east

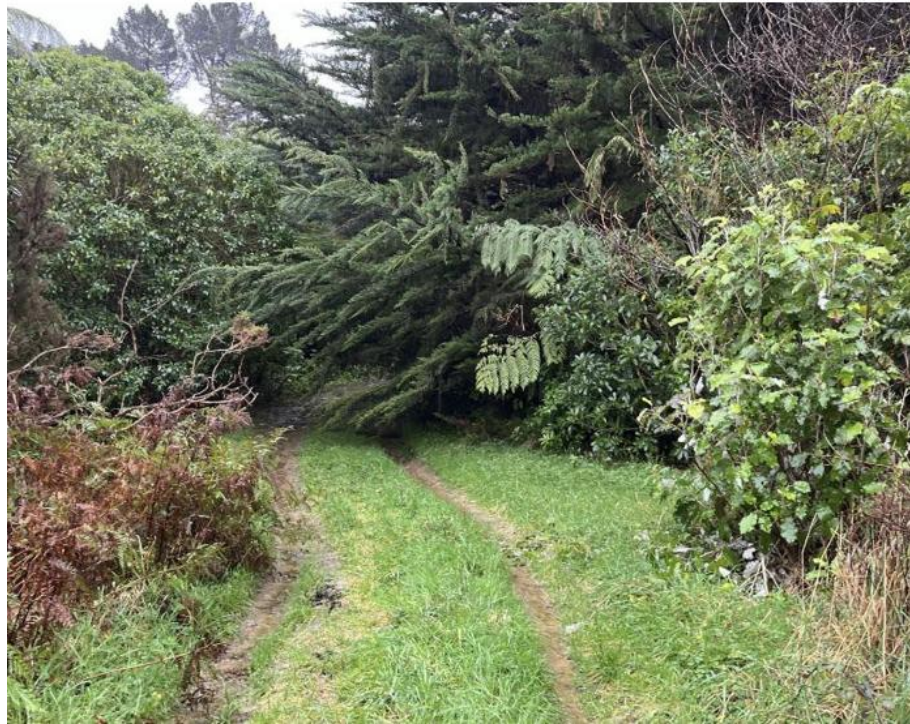
**Figure 23. View of the grassed access track in the proposed OBDA looking north taken during the 2025 site visit**

60. The OBDA was entered from the north along the ridge and the area where structures were observed in early aerial photographs was visited. The area was accessed by a grassed vehicle track with large trees on either side. This opened onto some cleared areas containing tall grass and areas of scrubby vegetation. The area was walked over but no evidence of the former structures was observed. As well, no evidence of features or deposits on the ground surface were visible. However, it is noted that the thick vegetation cover hindered visibility over much of the survey area. Finally, it was noted that one of the open grassed areas contained beehive boxes, and this area was only observed from a distance. Photographs taken during the site visit are shown in Figure 23 – Figure 26.

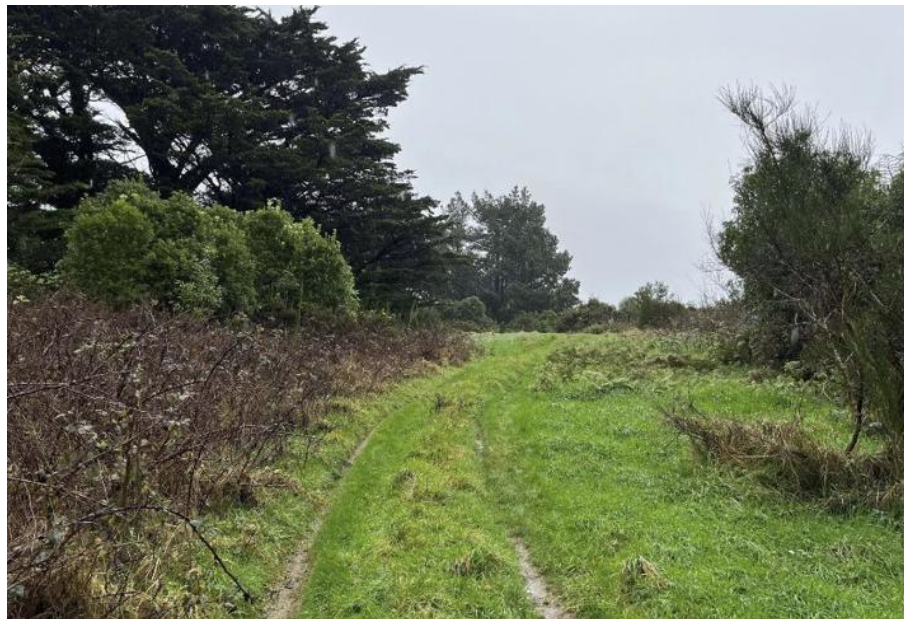
**Figure 24. View of the southern end of the access track leading to the open area in the proposed OBDA, looking south taken during the 2025 site visit**

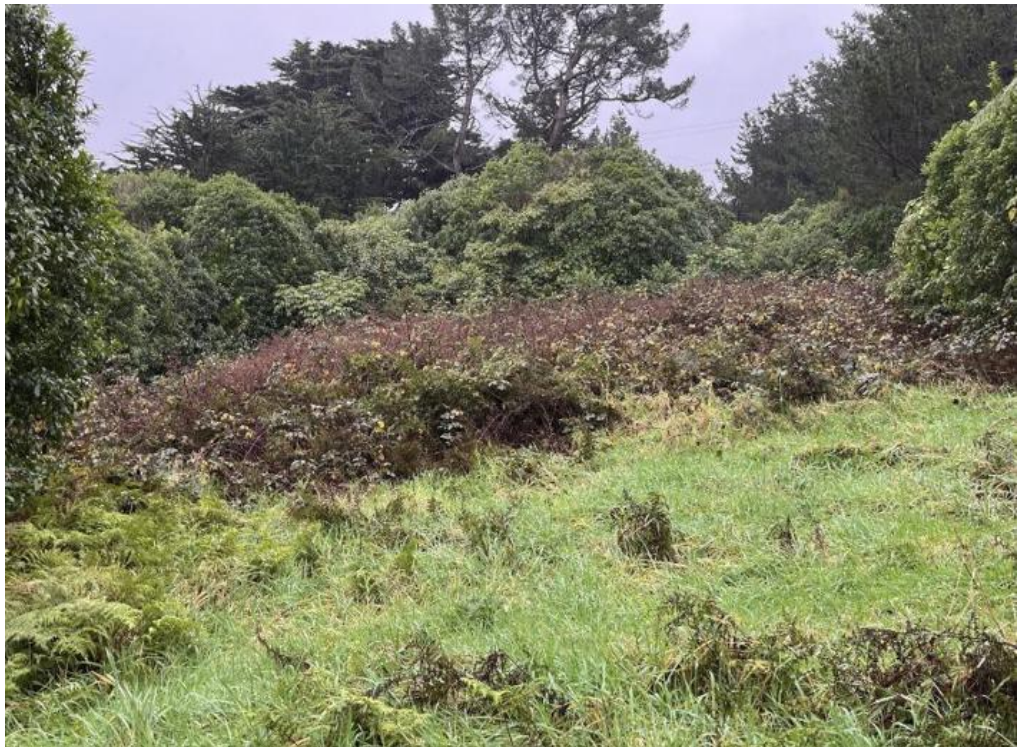
**Figure 25. View of an area covered by thick grass and surrounding vegetation in the proposed OBDA, looking south taken during the 2025 site visit**

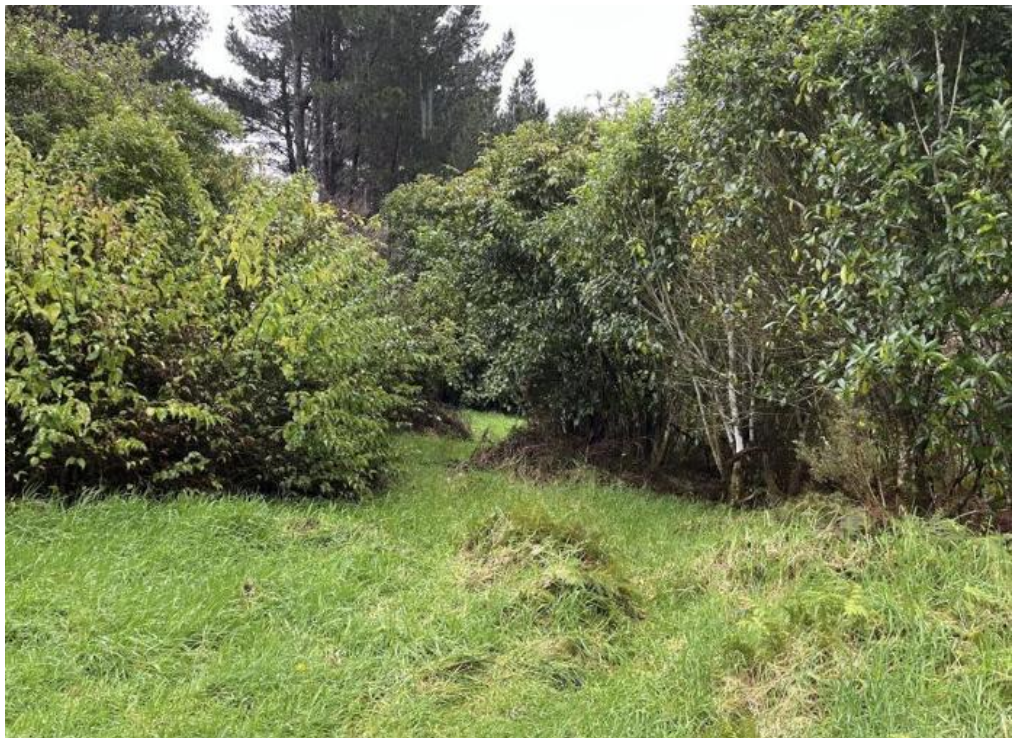
**Figure 26. View of an open area with thick grass and surrounding thick vegetation in the proposed OBDA, looking west taken during the 2025 site visit**

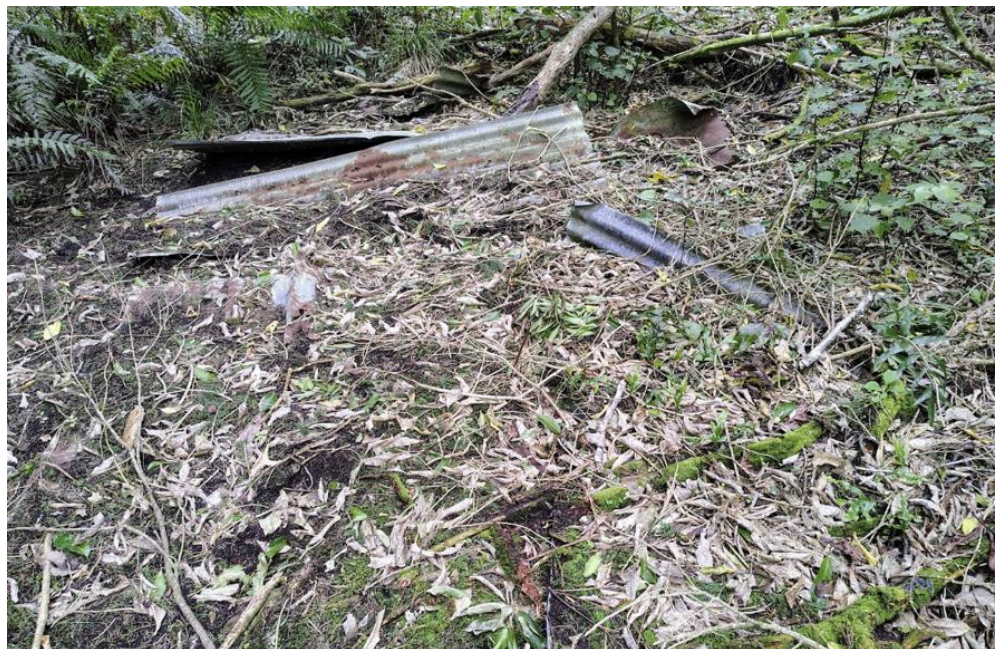
61. The proposed OBDA was visited on 18 March 2026 in good weather conditions. The location of the recorded archaeological site was inspected first. On arrival corrugated iron was found spread across the site as well as inside the collapsed building. The building was found to have a concrete foundation made from mixed grade poured in layers. Corrugated iron cladding surrounded the concrete. The location is accurately marked on the R27/910 site record form. Based on the inspection of the material used in the construction, the structure is post 1900. Just to the east of the building an alternating reinforced concrete and wood post fence was identified, also of post 1900 construction. Photographs are shown in Figure 27- Figure 30.

Figure 27. View of corrugated metal sheeting at site R27/910, looking west

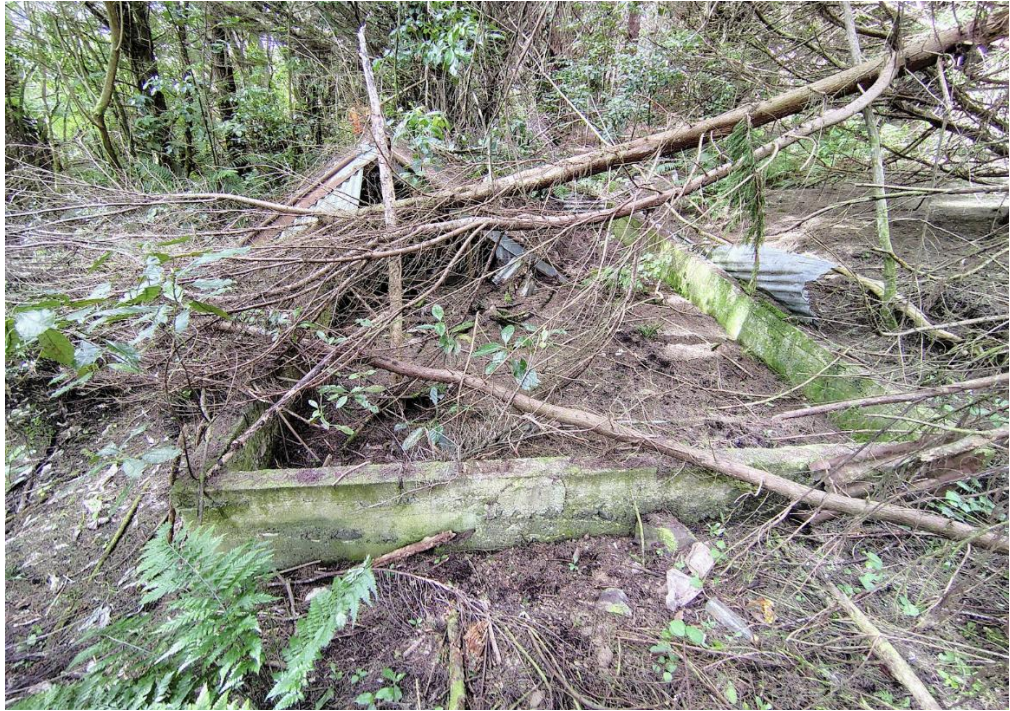
**Figure 28. View of the collapsed farm building (R27/910), looking south**

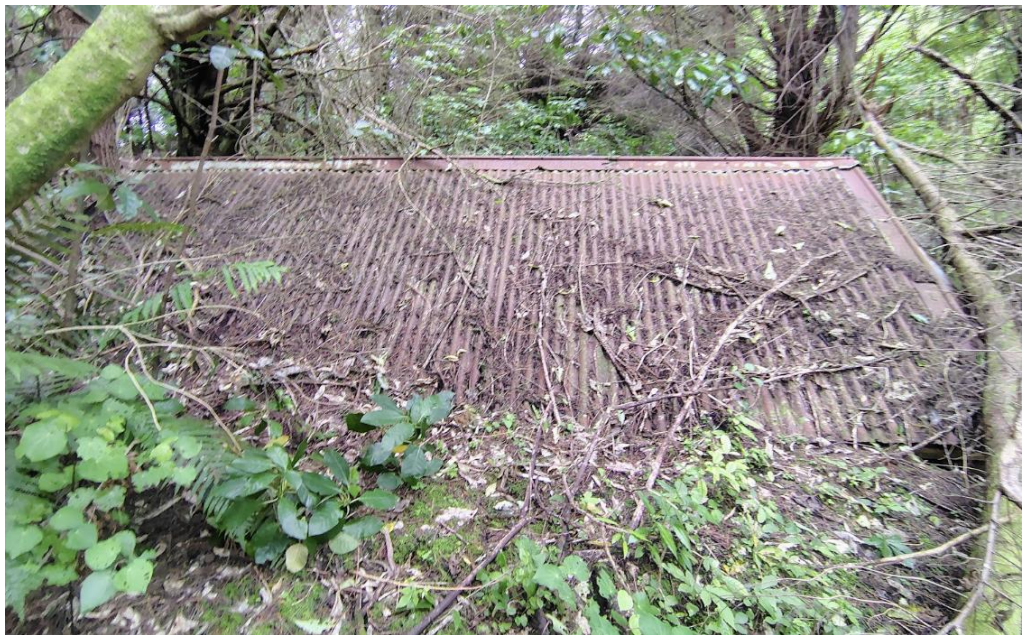
**Figure 29. View of the corrugated metal roof of the collapsed farm building, looking east**

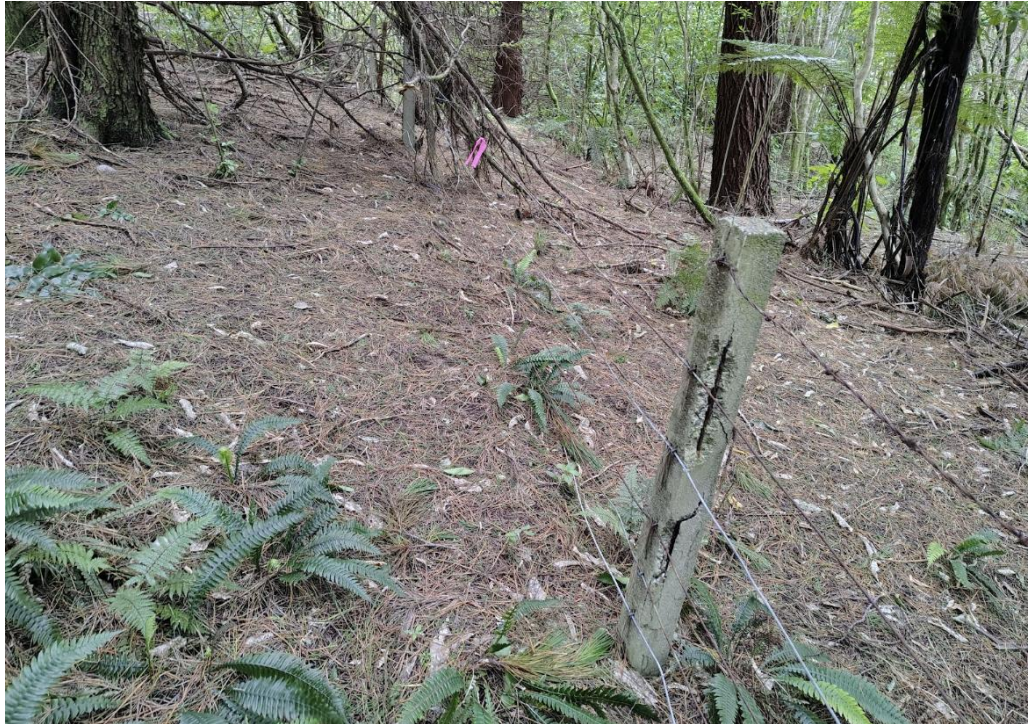
**Figure 30. View showing the fence near site R27/910 with concrete post in the foreground, looking north**

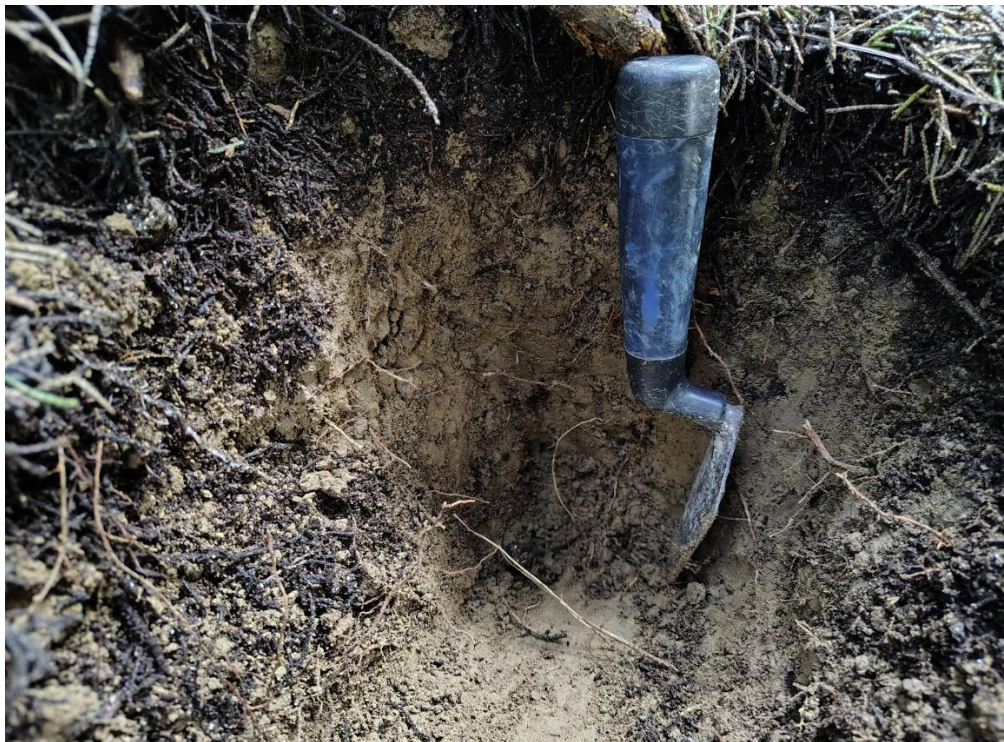
63. Three test pits were undertaken during the survey with detailed photographs shown in Figure 31 – Figure 33 and locations shown in Figure 34. Test pits 1 and 3 showed a medium brown silty topsoil with a lighter brown silty subsoil underneath. Test pit 2 showed similar soils but also contained gravel/ aggregate inclusions which may represent the track leading to the collapsed building.

**Figure 31. Detail of test pit 1 located to the west of the collapsed farm building**

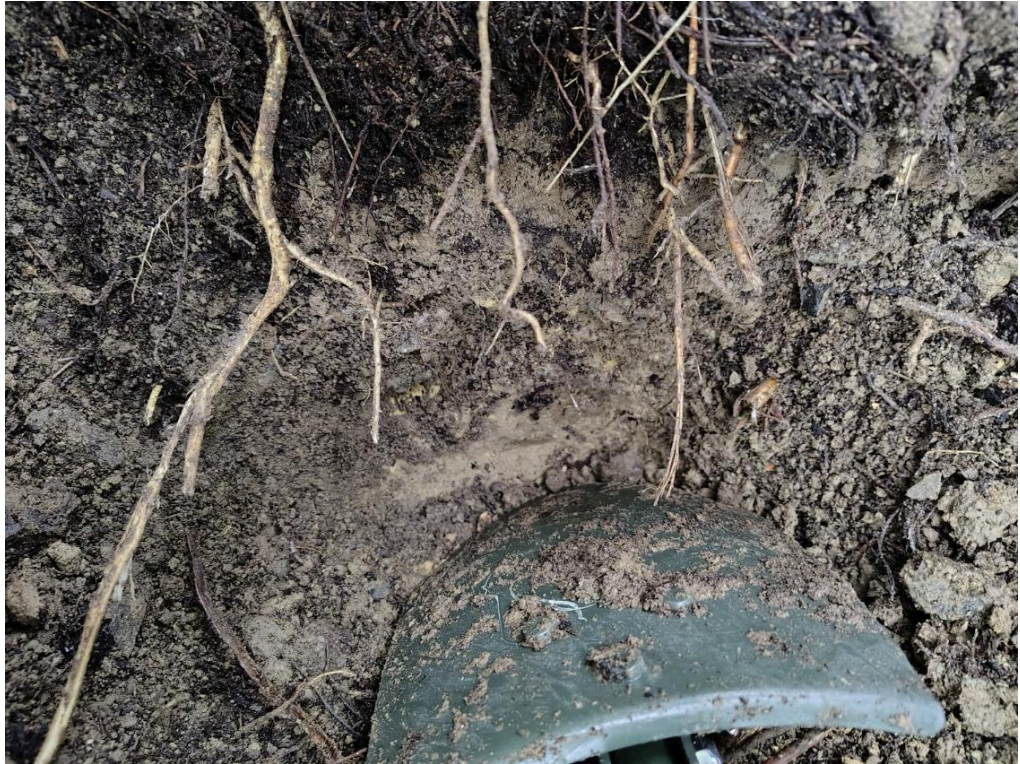
**Figure 32. Detail of test pit 2 located to the south of the collapsed farm building**

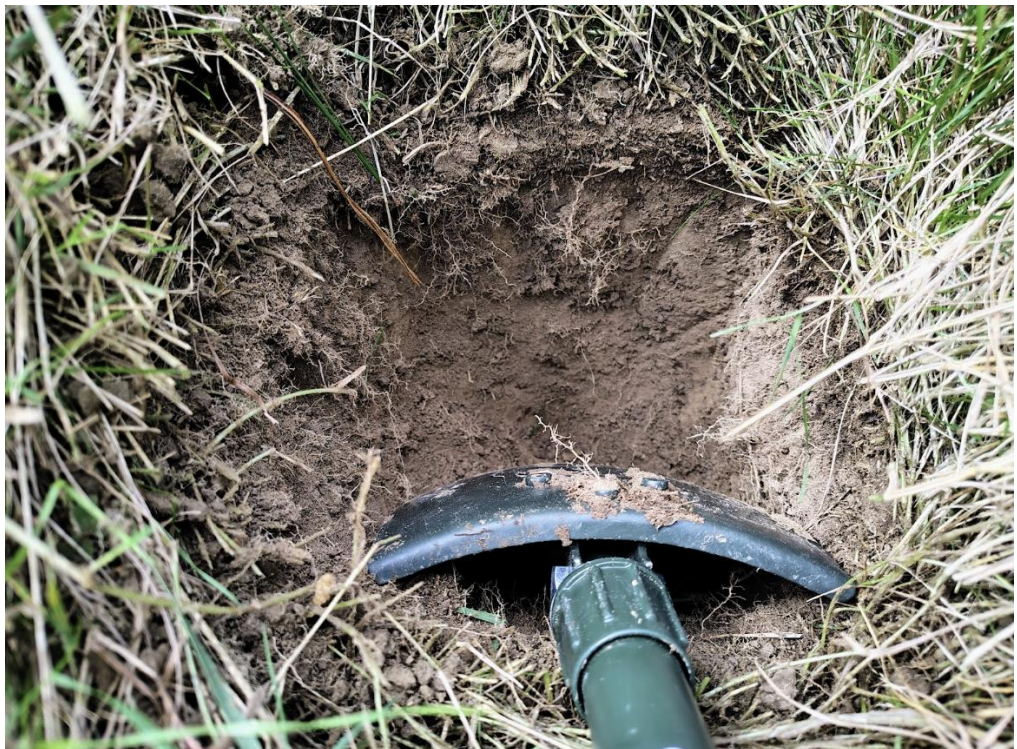
**Figure 33. Detail of test pit 3 showing clean soil**

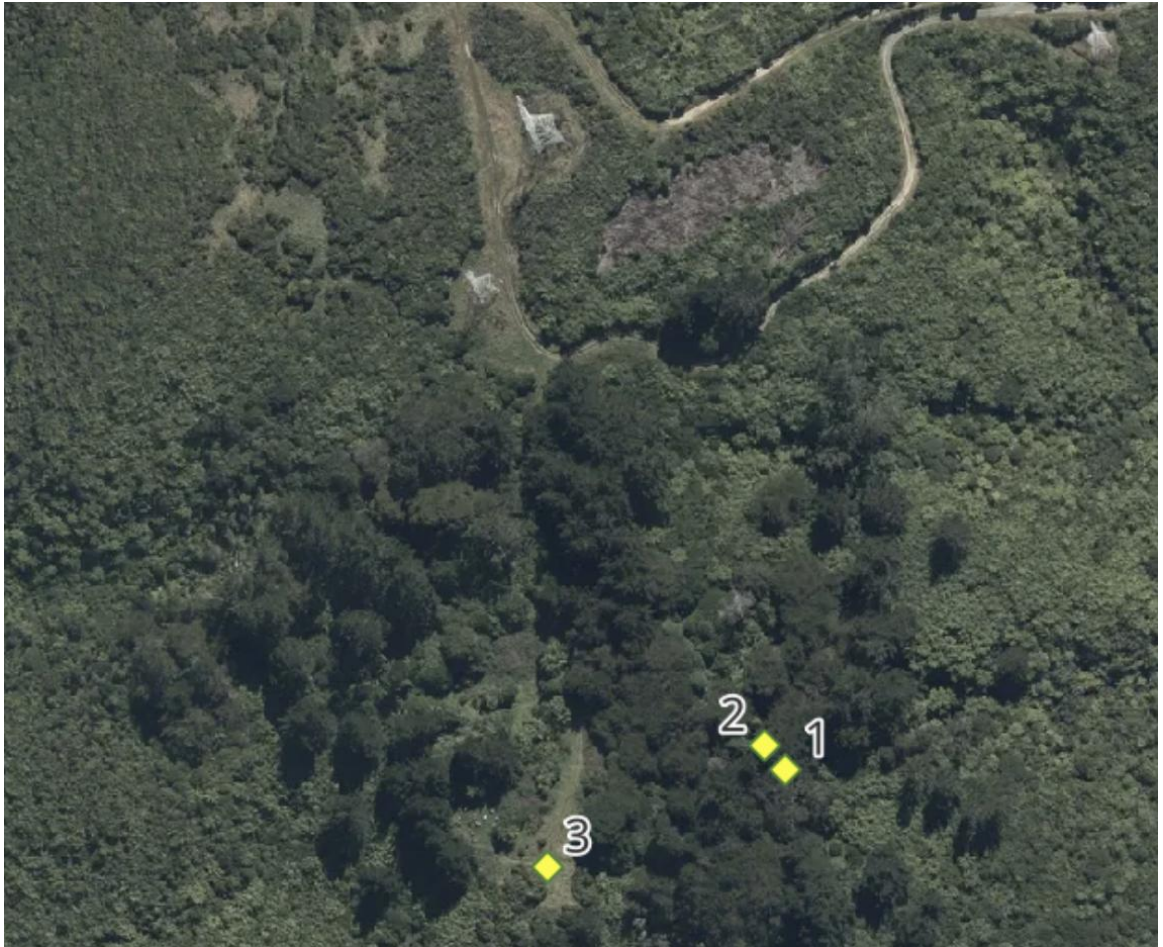
**Figure 34. Aerial plan showing the locations of the three test pits undertaken during the 2026 field survey**
