# **PROPOSED DRURY CENTRE DEVELOPMENT FAST TRACK STAGE 2: ARCHAEOLOGICAL ASSESSMENT**

Prepared for Kiwi Property Holdings No. 2 Ltd

March 2025

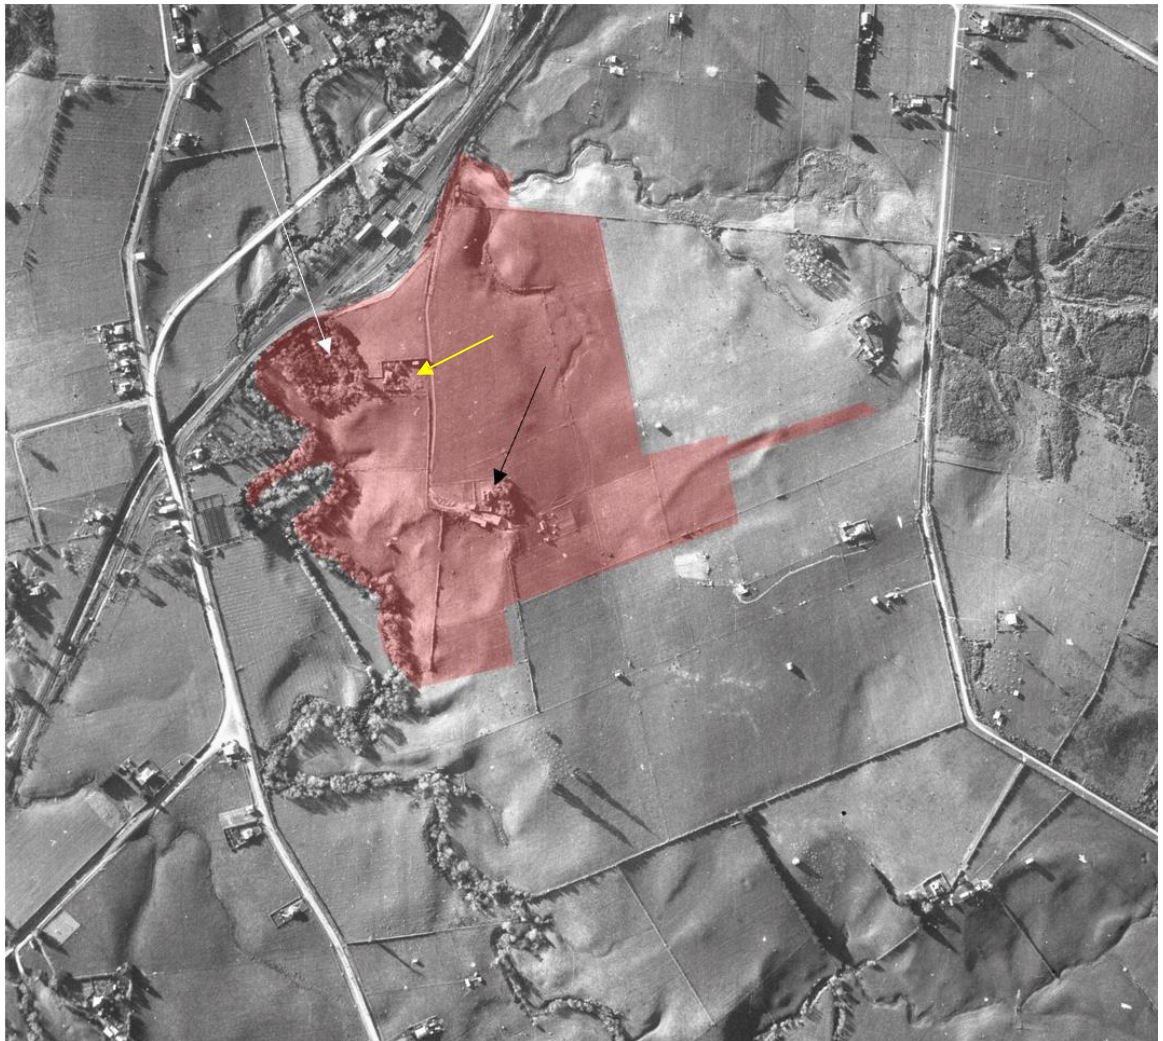
**Figure 10. Aerial photograph dated 1942 (Crown 192 274 1) with the properties in the Stage 2 area shaded red and the Flanagan Homestead indicated by black arrow, the house at 108 Flangan Road by yellow arrow. It should be noted that the area in the northeast indicated by the white arrow is the area where the Hingaia Stream was later diverted (sourced from: [http:// retrolens.nz](http://retrolens.nz) and licensed by LINZ CC- BY 3.0)**

Aerial photographs were also reviewed to gather information on land use from the 1940s onwards. As can be seen in the aerial photograph dated 1942 in (Figure 10), the Stage 2 area contained two residences, the Flanagan Homestead and the house at 108 Flanagan Road, believed to be dated to the early 20th century, according to local informants. The aerial photograph also shows the area that is now on the eastern side of the Hingaia Stream that was formerly on the western side of the stream prior to the stream being diverted. As can be seen this area was covered by vegetation, which was also present in 1969, as can be seen in the aerial photograph from that year in Figure 11. Later aerial photographs show that after the stream diversion the area was modified through clearance of the vegetation and possibly some earthworks (Figure 12). It is noted that this area was identified as possibly having been used during the New Zealand Wars period as part of a military camp. Based on the modifications seen in the aerial photographs it is likely that if any such remains were present they would have been damaged or destroyed by these works in the 1980s, although the presence of remnant deposits cannot be completely discounted.

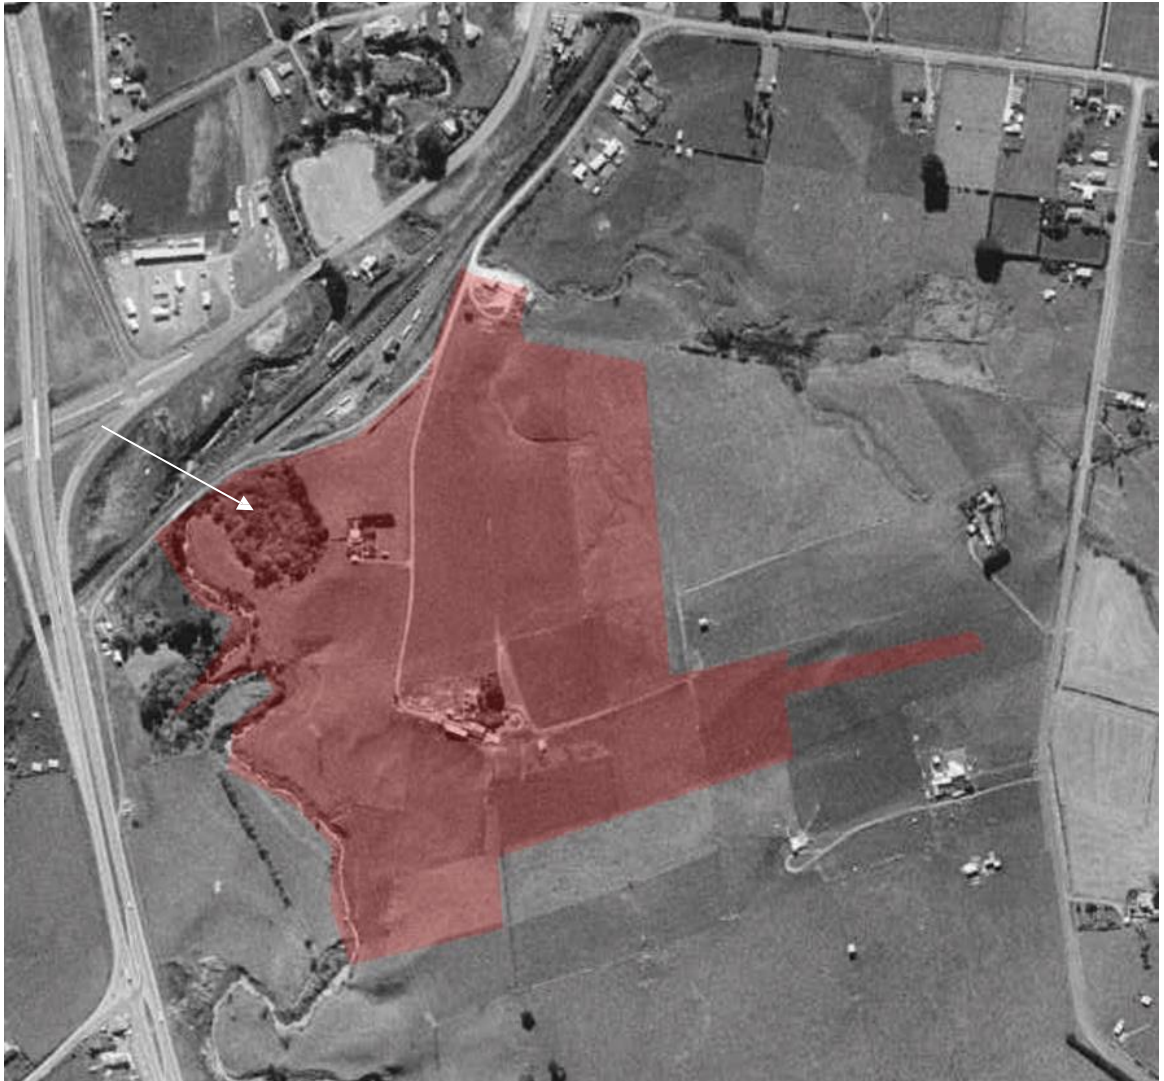
**Figure 11. Aerial photograph dated 1969 (Crown 1875 5048 19) with the properties in the Stage 2 area shaded red and the area where the Hingaia Stream was diverted indicated by white arrow (source from: [http://: retrolens.nz](http://retrolens.nz) and licensed by LINZ CC- BY 3.0)**

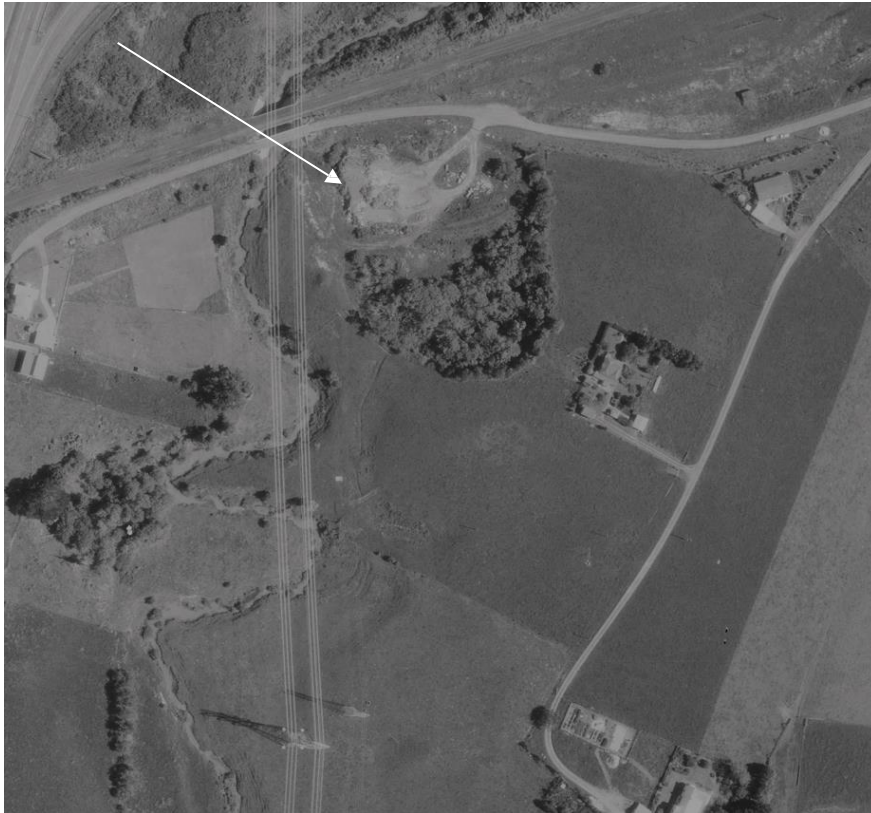
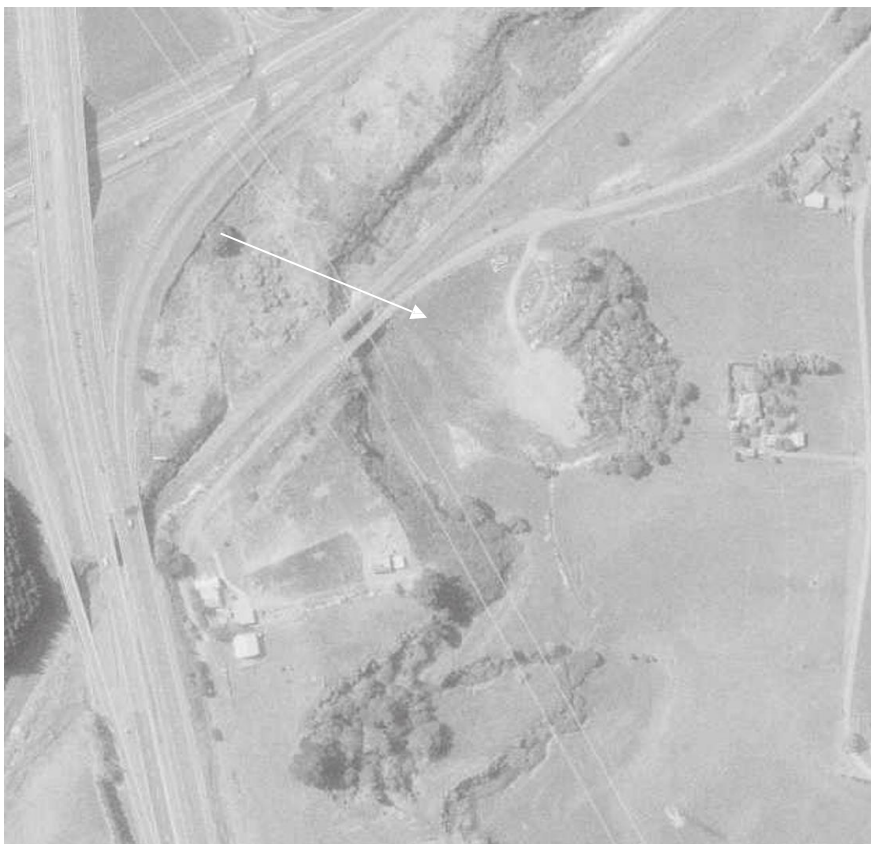
**Figure 12. Upper aerial photograph dated 1981 (Crown 5926A) and lower dated 1988 (Crown 8772 V9) with the area where the Hingaia Stream was diverted indicated by arrow (sourced from: <http://retrolens.nz> and licensed by LINZ CC- BY 3.0)**

This is a small triangular-shaped lot at the northern end of the Stage 2 area. As can be seen in aerial photographs dated to the 1980s in Figure 12, it contained a house, now demolished. The ground was for the most part heavily modified and made up largely of gravel and modern rubbish. Test Pit 1 was situated in this lot at coordinates E1773371 N5891427  $\pm$  3m. The test pit measured 20cm in depth with a topsoil of light yellowish-brown slightly clayey silt from 0-15cm (bs) over a thin slightly clayey dark yellowish-brown silt from 15-20cm (bs) which overlay a yellowish-orange silty clay. Photographs are provided in Figure 22 and Figure 23. No archaeological features/deposits were encountered.

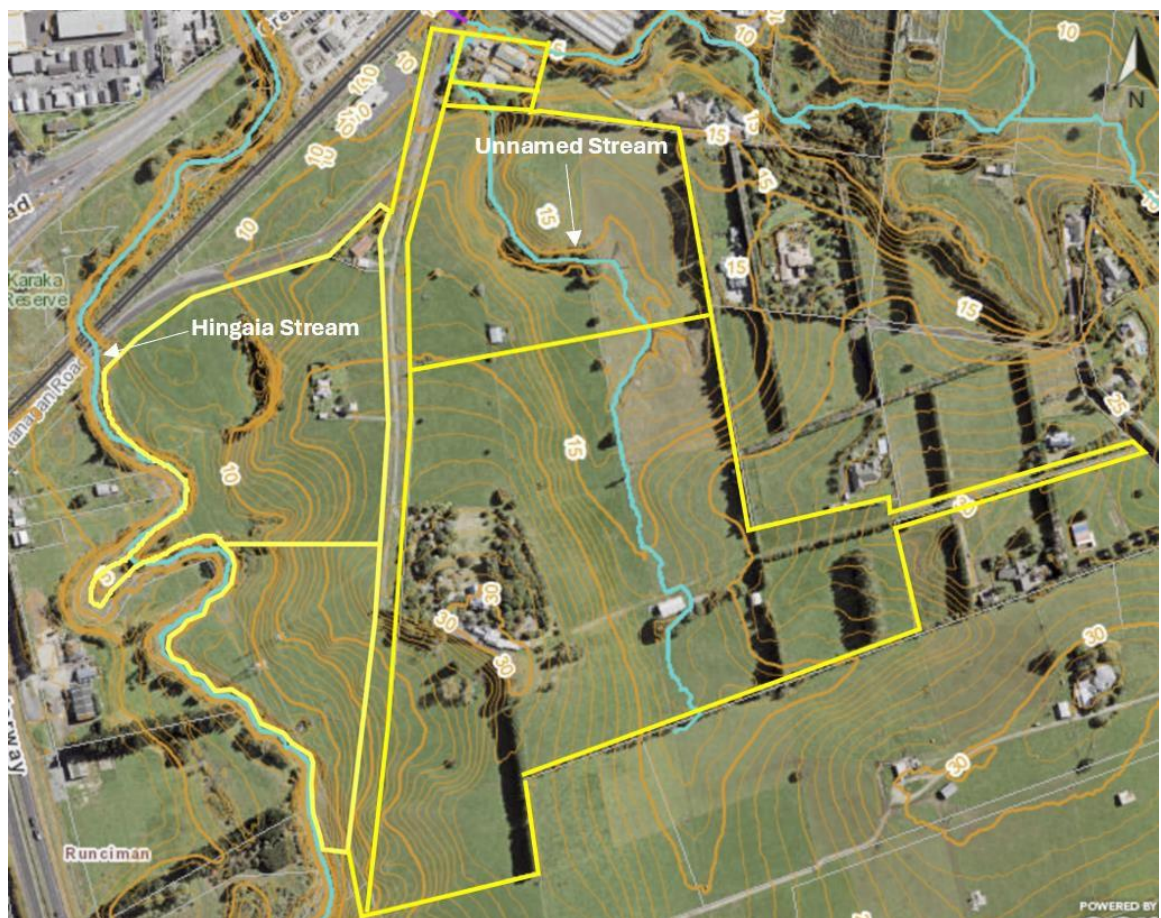
Figure 14. Aerial plan of the properties in the Stage 2 area (outlined in yellow) with contours with the Hingaia Stream and the unnamed stream indicated by arrows (source: Auckland Council GeoMaps)

The aerial plan in Figure 14 shows the topography of the Stage 2 area. As can be seen on the plan the Hingaia Stream marks the western boundary and is the most low-lying part of the Stage 2 area, between 5 and 10m asl, apart from the very northern tip at 64 Flanagan Road which borders an unnamed stream. This stream flows through the eastern part of the Stage 2 area. The most highly elevated part of the Stage 2 area is at 30m asl, which is the former location of the Flanagan Homestead. As can also be seen in the aerial photograph the majority of the Stage 2 area consists of farm paddocks, apart from the areas containing residential structures or outbuildings.

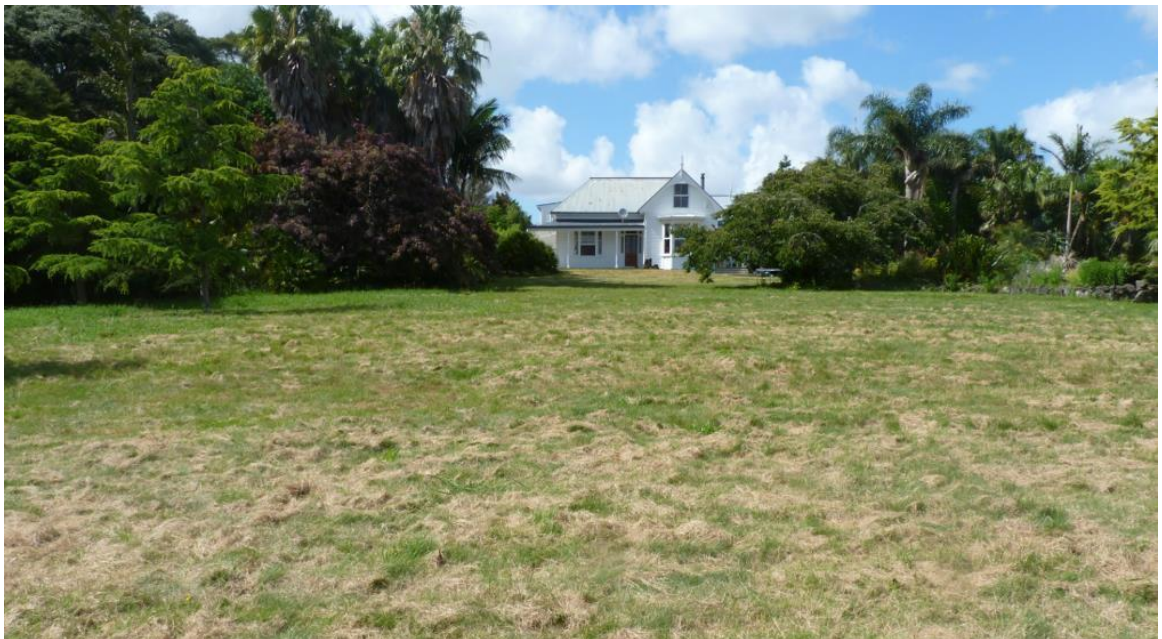
The Flanagan Homestead location was visited on 11 January 2019. The central part of the farm contains a ridge oriented north-south. The ridge is in pasture apart from the area that contains the Flanagan Homestead which is situated on a high point along the northern part of the ridge. The grounds of the homestead were found to contain landscaped areas as well as a large flat expanse of grassed lawn. A photograph taken during the site visit is shown in Figure 15.

**Figure 15. Photograph of the Flanagan Homestead and front lawn (looking south) (photo: 2019)**

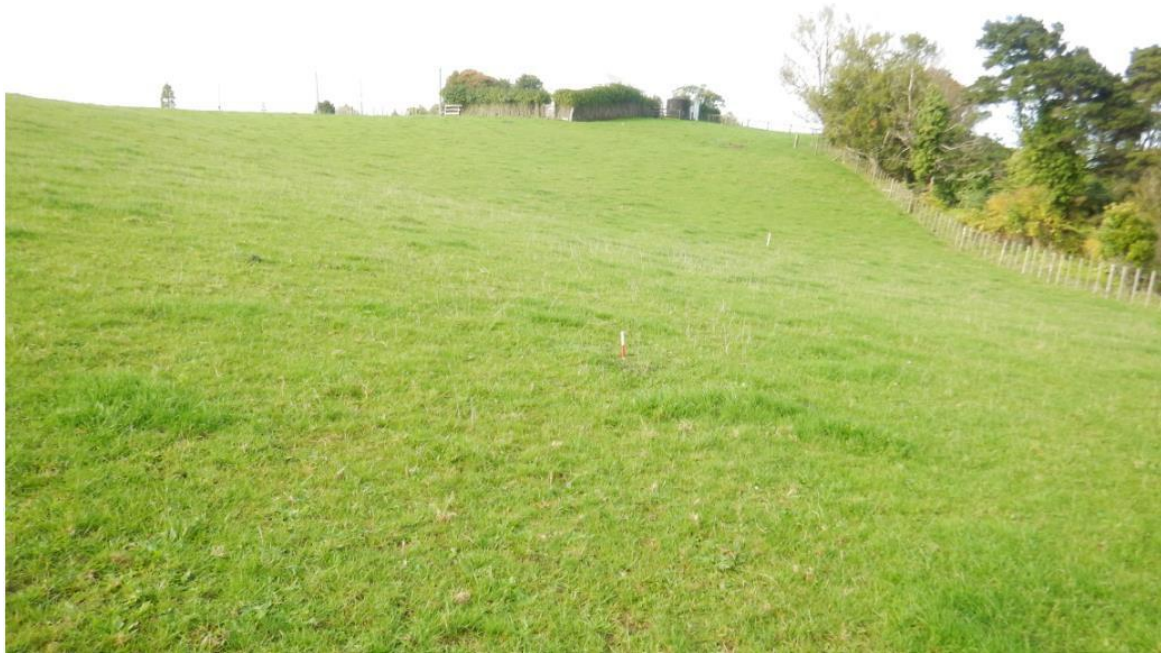
**Figure 17. General view of the northern part of the sewer main alignment where test pits 4, 5 and 6 were located, looking south (photo: 2019)**

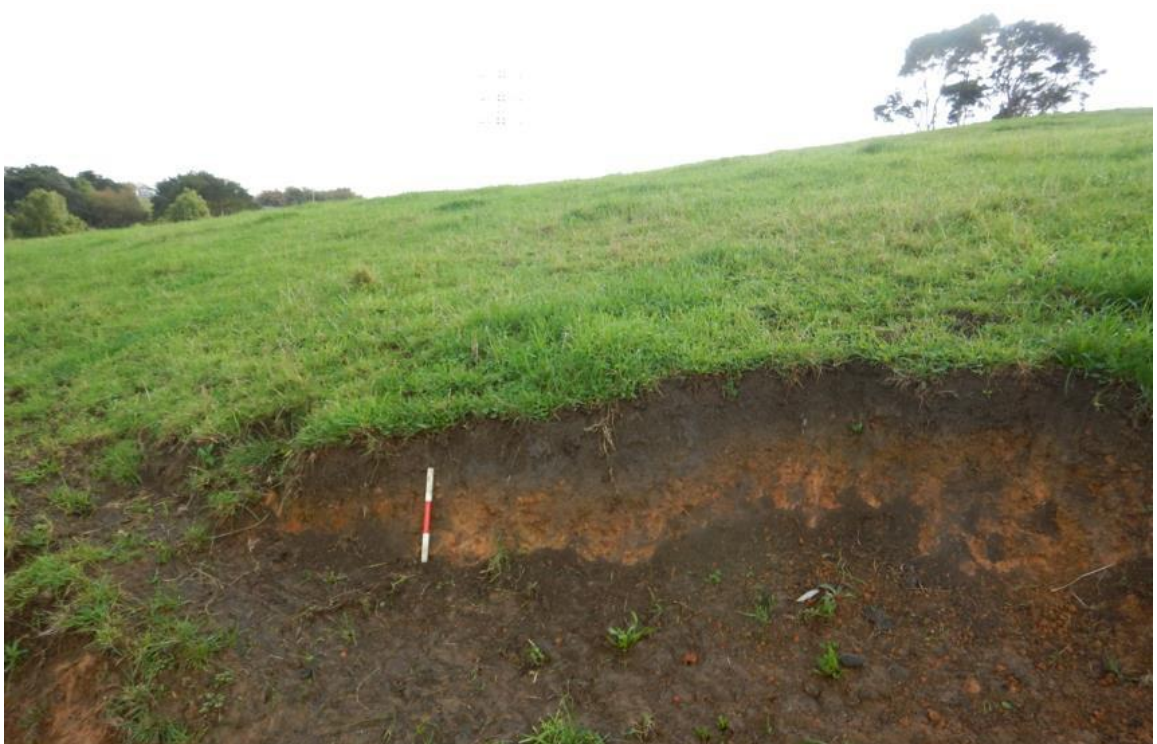
**Figure 18. Photograph showing the exposed soil face near the gully to the west of the central part of the proposed sewer main alignment, looking north (photo: 2019)**

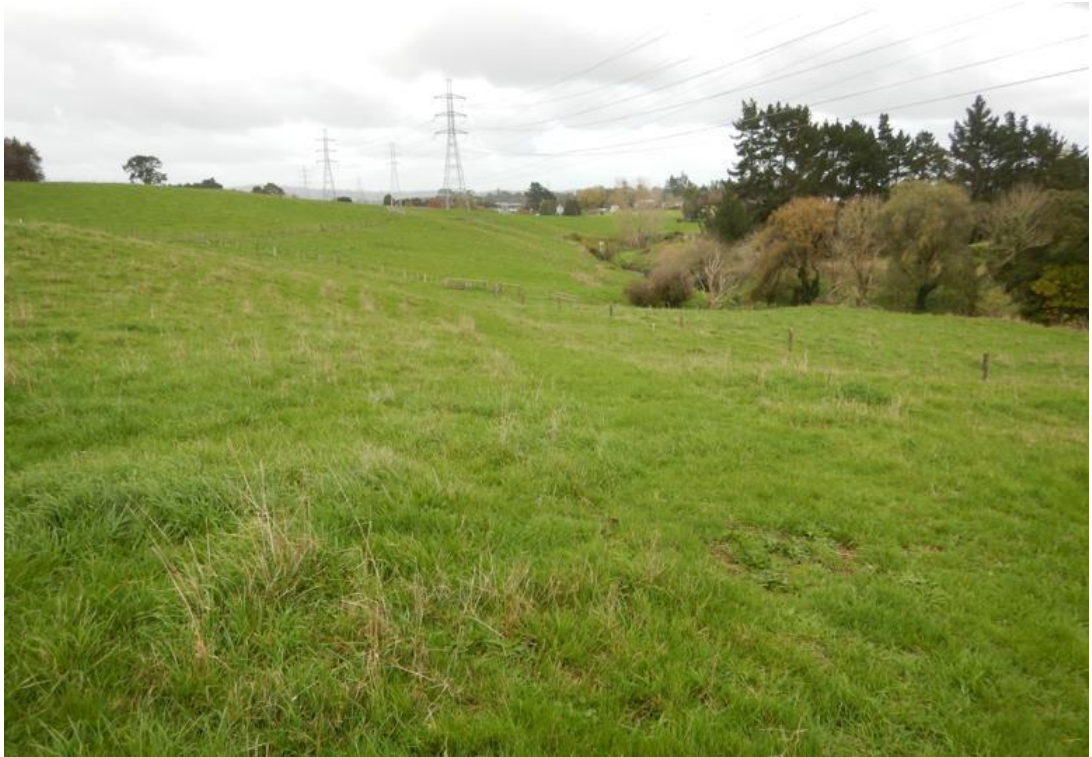
**Figure 19. Photograph showing a view of the southern part of the proposed sewer main alignment, looking south (photo: 2019)**

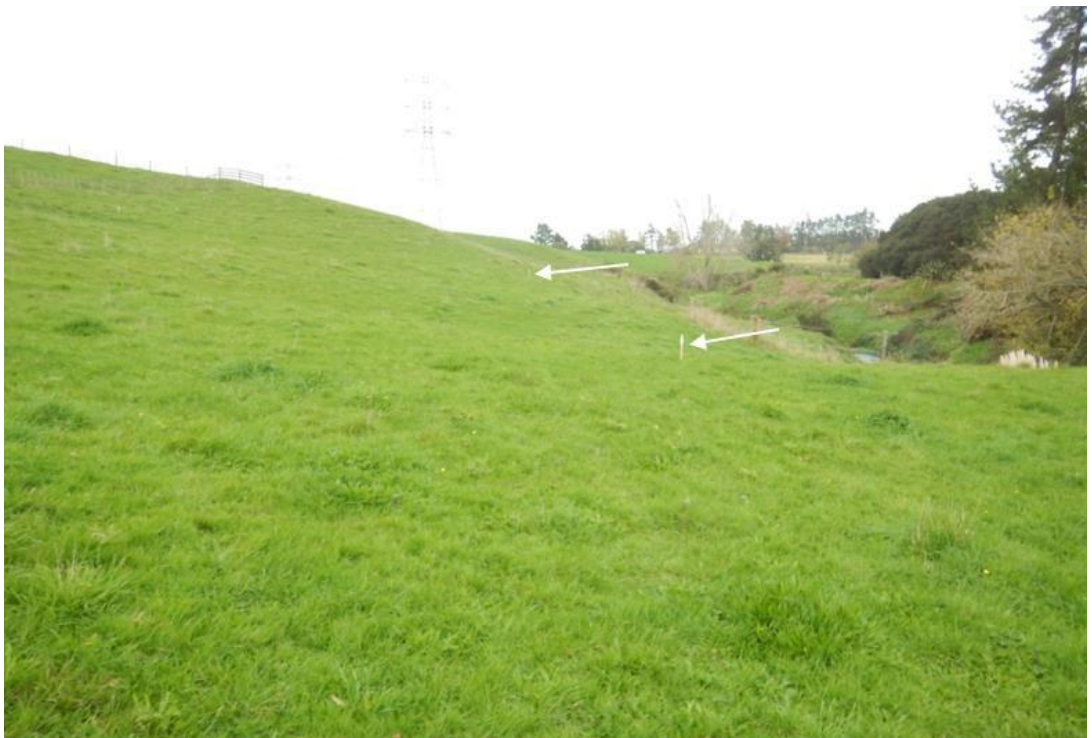
**Figure 20. Photograph showing the southern part of the alignment near the Hingaia Stream with the western edge of the alignment marked by white posts (indicated by arrows), looking south (photo: 2019)**

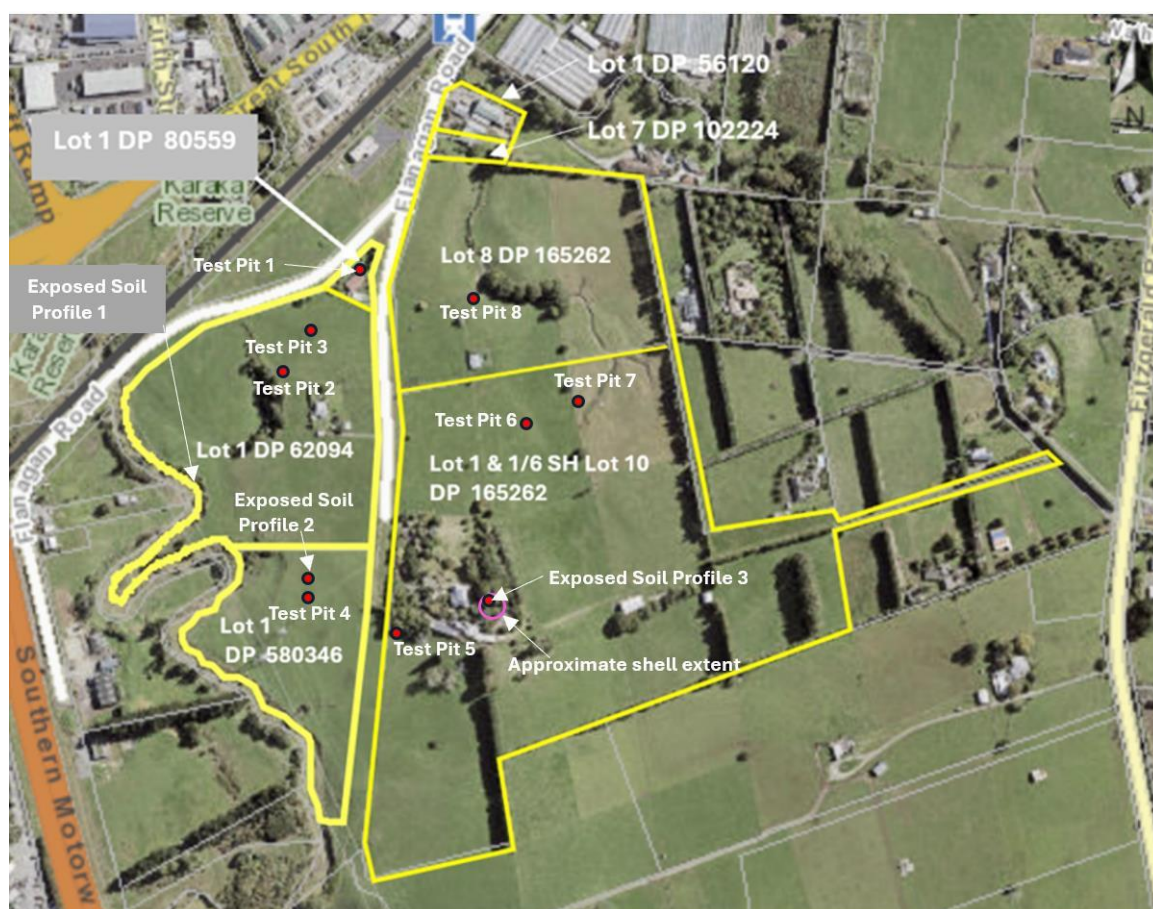
Figure 21. Aerial plan showing the locations of the test pits and areas of exposed soil for the 2024 survey of the properties in the Stage 2 area (source: Auckland Council GeoMaps)

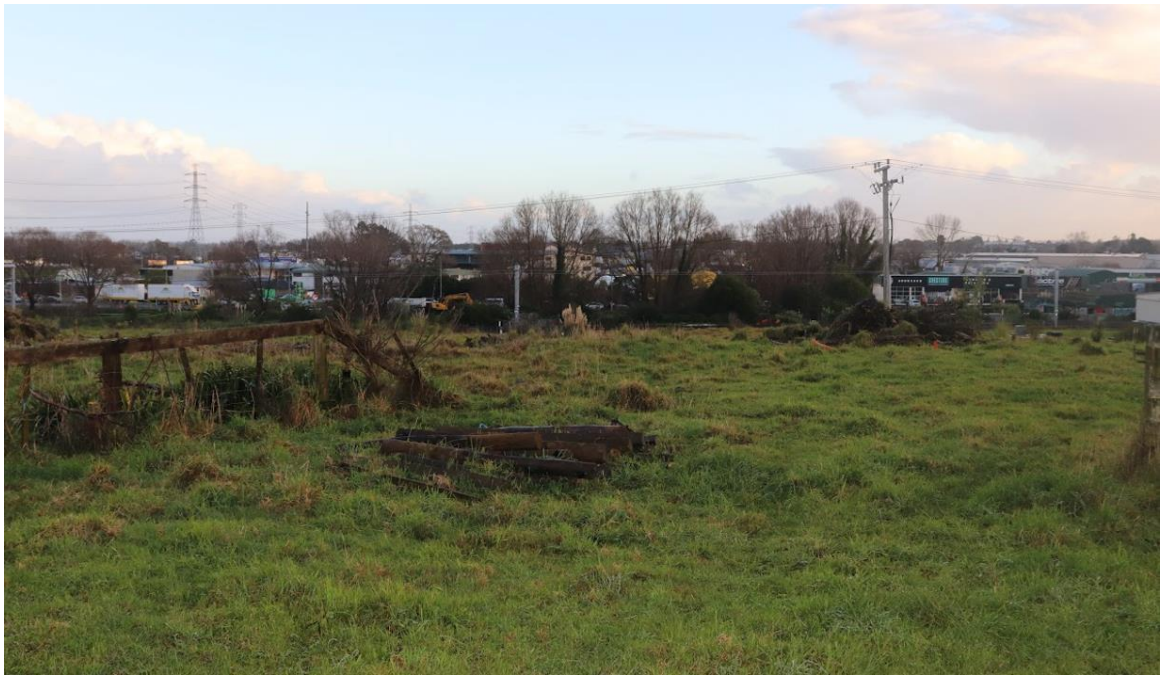
Figure 22. Photograph taken looking north showing a view of Lot 1 DP 80559

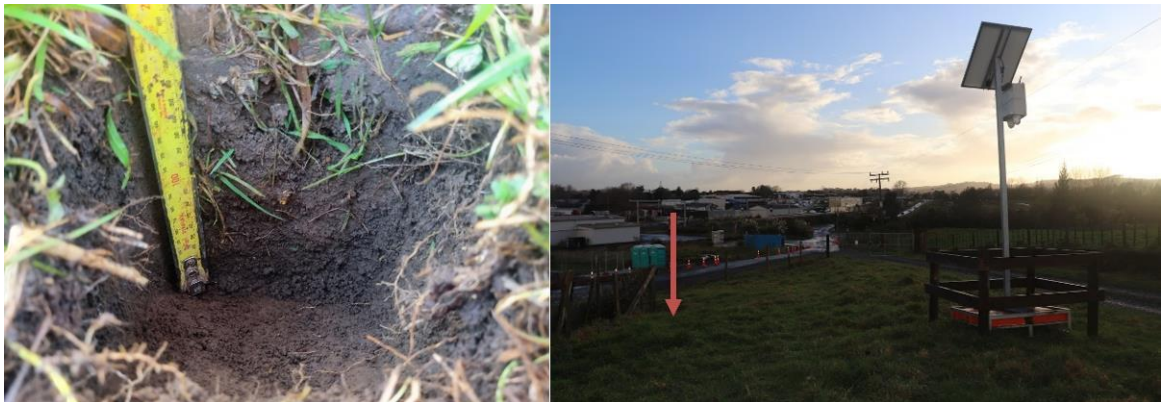
Figure 23. Left photograph showing the detail of test pit 1 and right photograph showing the general location of test pit 1, looking northeast

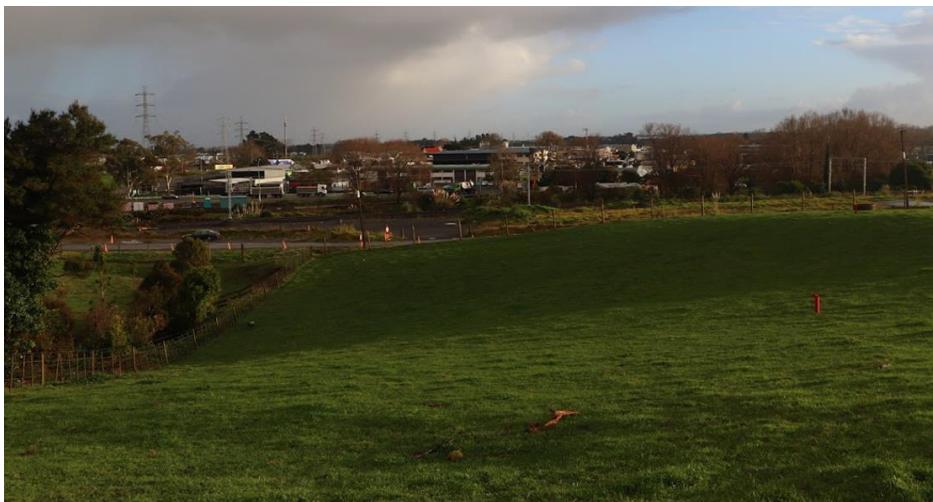
Figure 24. Photograph showing a view of the northern paddock in Lot 1 DP 62094, looking west

This lot was found to be made up of two paddocks, consisting of northern (Figure 24) and southern fields (Figure 25). The northern paddock contained large grass fields with a house footprint visible on the fence line running east to west (Figure 26). Two test pits were located in this lot. Test pit 2 was located at coordinates E1773238 N5891323  $\pm$ 3m. The test pit showed thin slightly greyish-brown clayey silt topsoil from 0-5cm (bs) over a disturbed mixed clay and silt layer from 5-15cm (bs). At 15cm (bs) a silty yellowish-orange clay was encountered. Test pit 3 was located at coordinates E1773264 N5891379  $\pm$ 3m. The test pit showed a greyish-brown slightly clayey silt topsoil from 0-15cm (bs) over a mixed clayey silt layer, probably a result of ploughing from 15-26cm (bs) which overlay a natural yellowish-orange clay. An exposed profile was also located in this lot (exposed profile 1) located at coordinates E1773158 N5891220  $\pm$ 3m. The exposed profile showed a dark yellowish-brown slightly clayey silt grass turf topsoil from 0-10cm (bs) over a yellowish-brown slightly clayey silt subsoil from 10-25cm (bs) over a silty clay yellowish-orange silty clay. Detailed photographs of the test pits and exposed soil profile are shown in Figure 27 - Figure 29. No archaeological features/deposits were encountered.

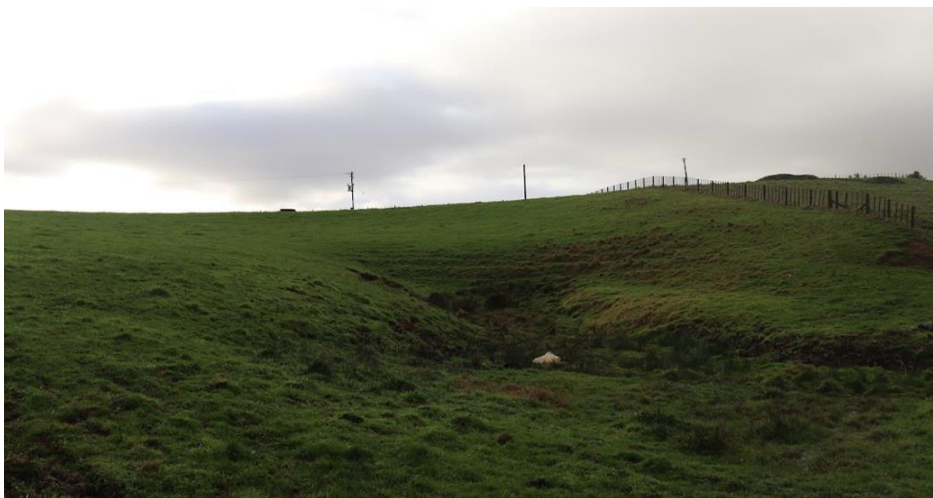
Figure 25. Photograph showing a view of the southern paddock in Lot 1 DP 62094, looking southeast

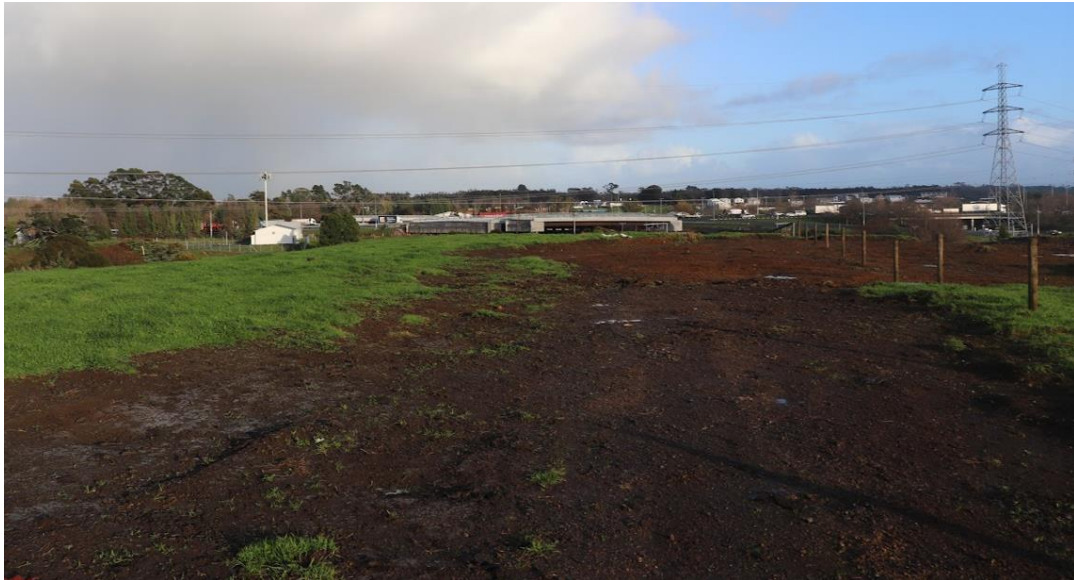
**Figure 26. Photograph showing the location of the former house in Lot 1 DP 62094**

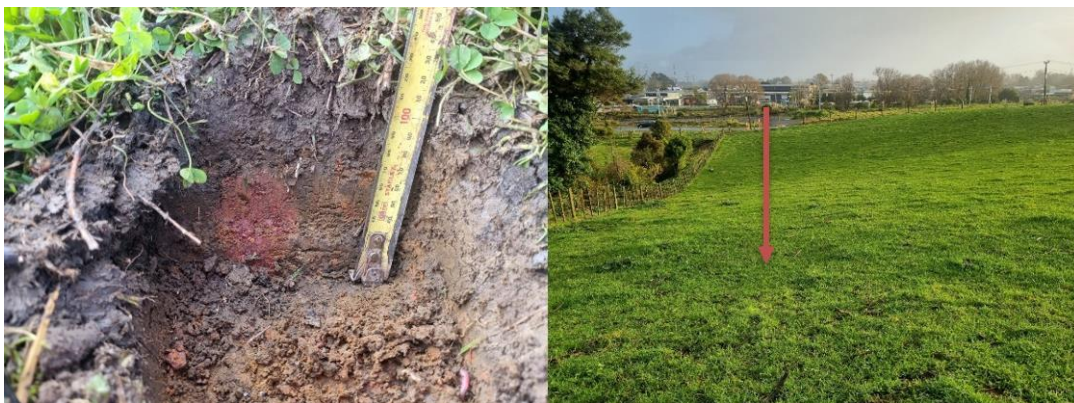
**Figure 27. Left photograph showing detail of test pit 2 and right photograph showing the general location of test pit 2, looking northwest**

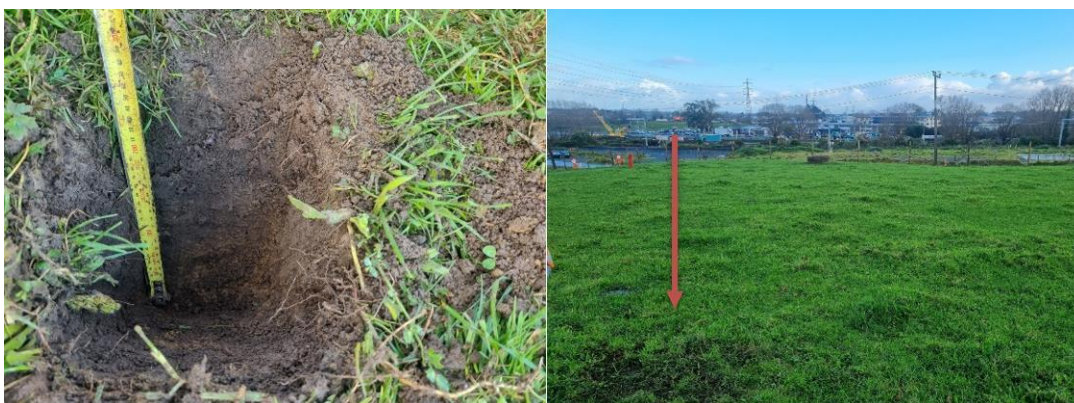
**Figure 28. Left photograph showing the detail of test pit 3 and right photograph showing the general location of test pit 3, looking northwest**

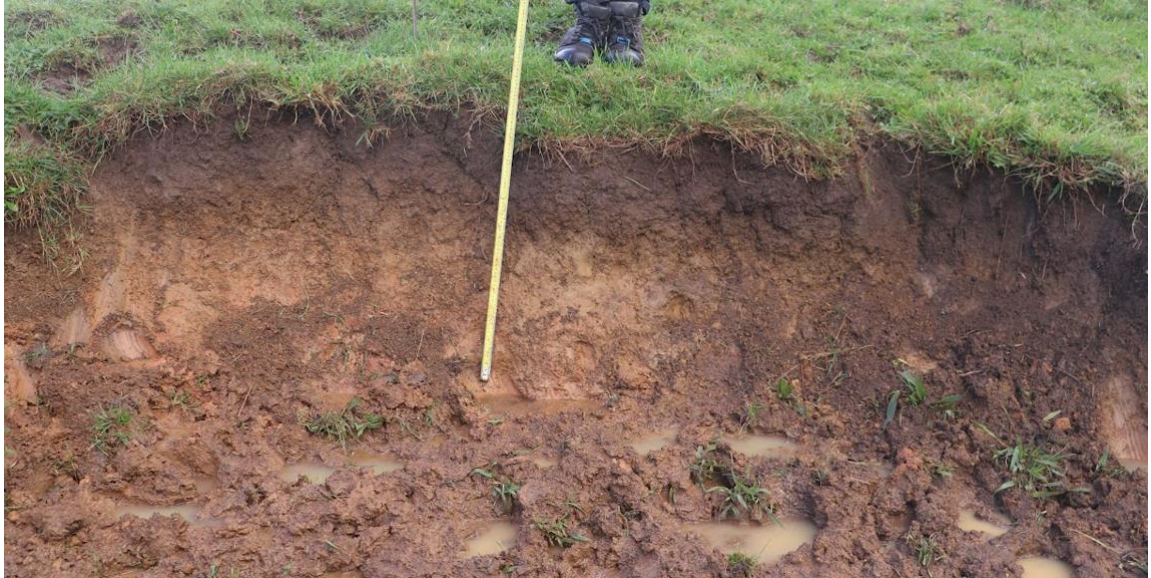
**Figure 29. West facing profile exposed in the southern paddock of Lot 1 DP 62094**

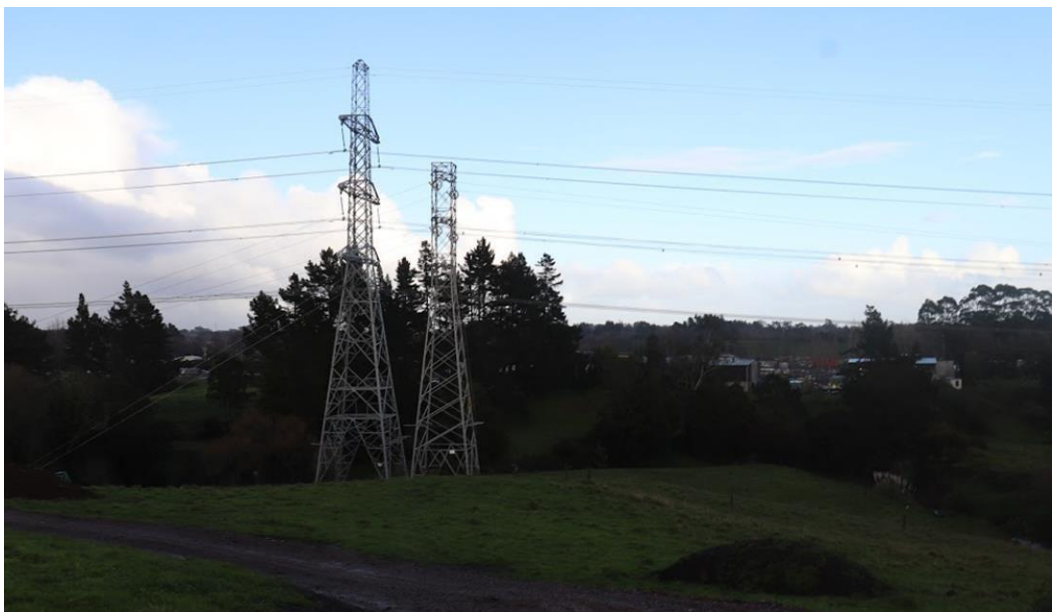
**Figure 30. Photograph showing a view of Lot 1 DP 580346, looking southwest**

This lot consisted of a grass field with a gravel road cut through the paddock running north-south. One test pit was located in this lot, Test Pit 4 at coordinates E1773257 N5891119 +/- 3m. The test pit showed a very pale greyish brown slightly clayey silt topsoil from 0-5cm (bs) over a pale greyish-brown silty clay, which continued to 24cm (bs) where the test pit was stopped. An area of exposed soil (exposed profile 2) was also observed at coordinates E1773270 N5891142 +/- 3m which showed a yellowish-brown slightly clayey silt topsoil from 0-10cm (bs) over a mixed yellowish-orange and grey silty clay, which appeared to have been previously disturbed. Photographs are shown in Figure 30 - Figure 32. No archaeological features/deposits were encountered.

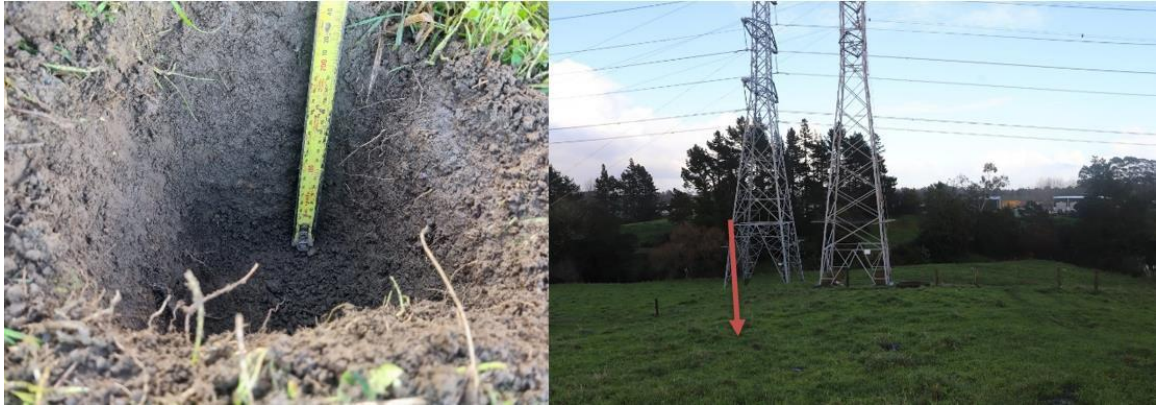
**Figure 31. Left photograph showing detail of test pit 4 and right photograph showing general location of test pit 4, looking southwest**

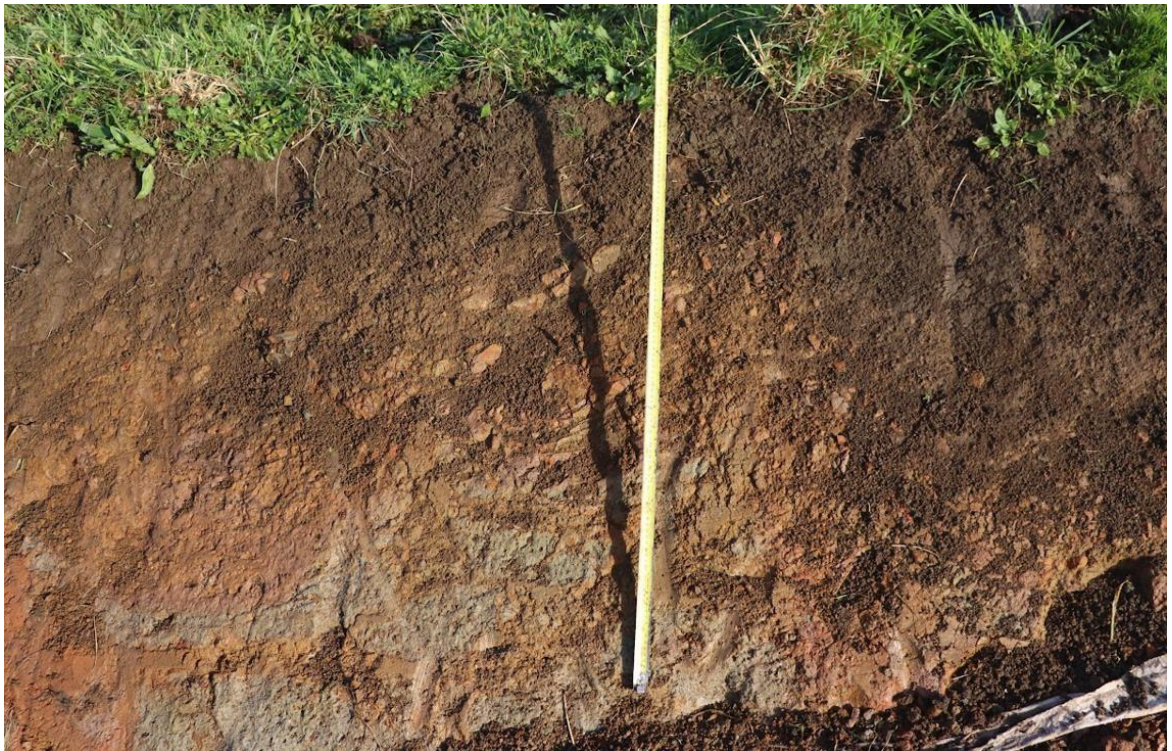
**Figure 32. Photograph showing the east facing profile exposed by the gravel road in Lot 1 DP 580346**

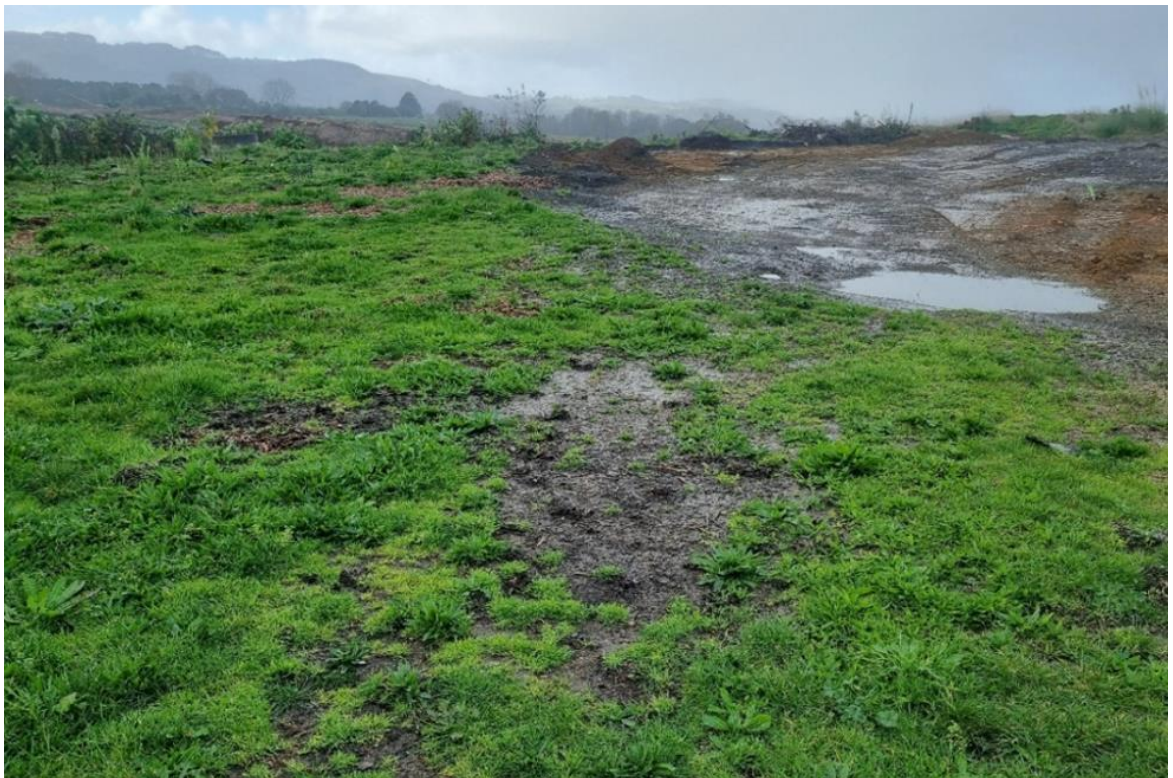
**Figure 33. Photograph showing general view of the southern part of Lot 1 DP 165262, looking southeast**

This Lot appeared to be heavily modified by farming and residential activities and also included the remains of the garden and house footprint of the Flangan Homestead (R12/1125) with general views taken during the survey shown in Figure 33 - Figure 35. The house itself had been lifted and was on blocks in a neighbouring lot awaiting relocation.

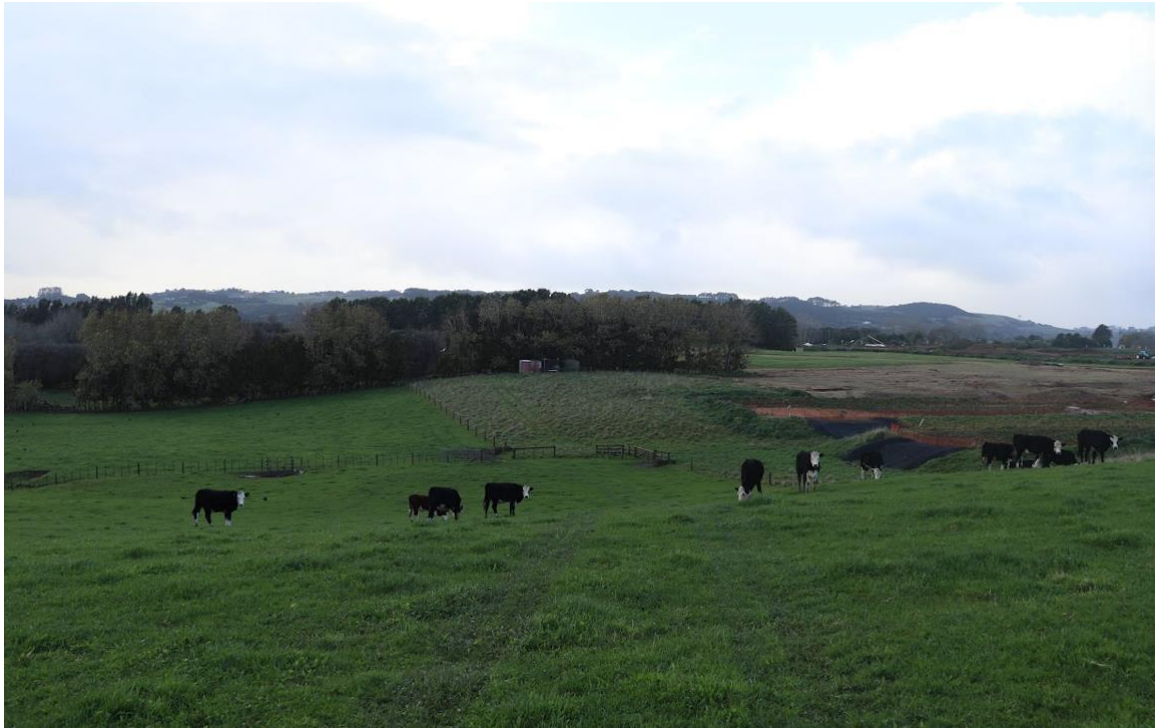
**Figure 34. Photograph showing a view of the paddock in Lot DP 165262, looking southeast**

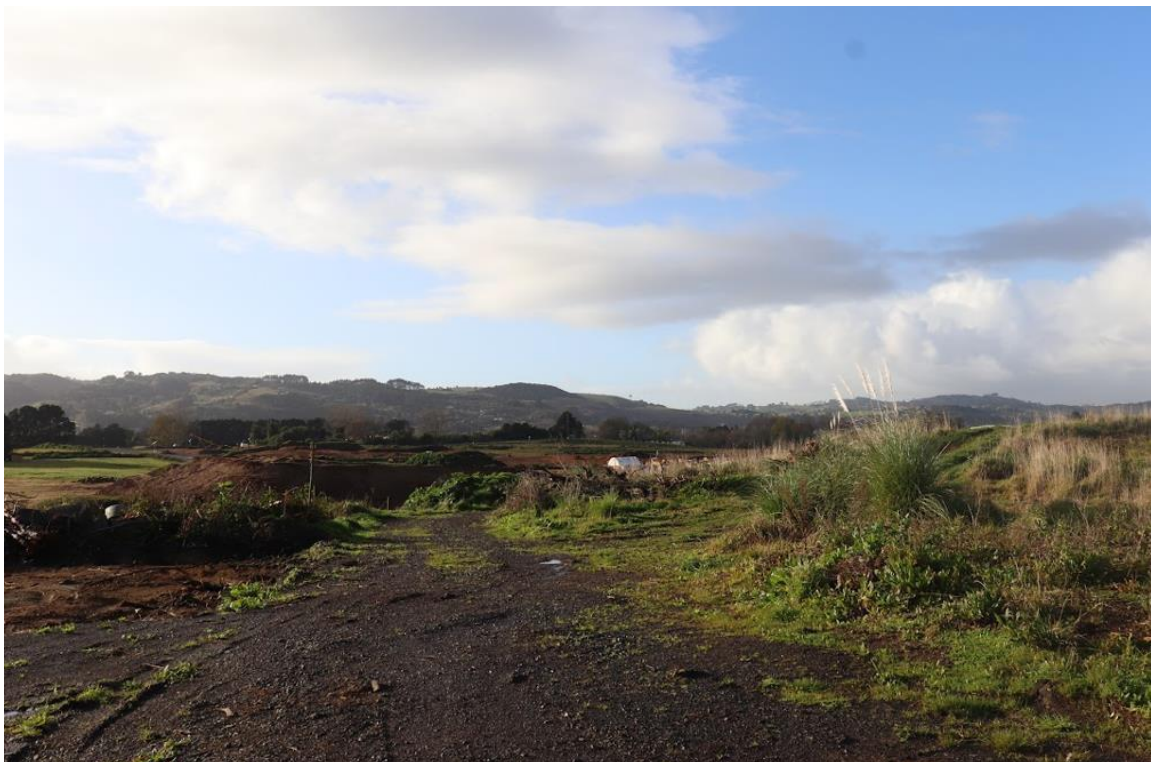
**Figure 35. Photograph showing a view of Lot 1 DP 165262, looking east**

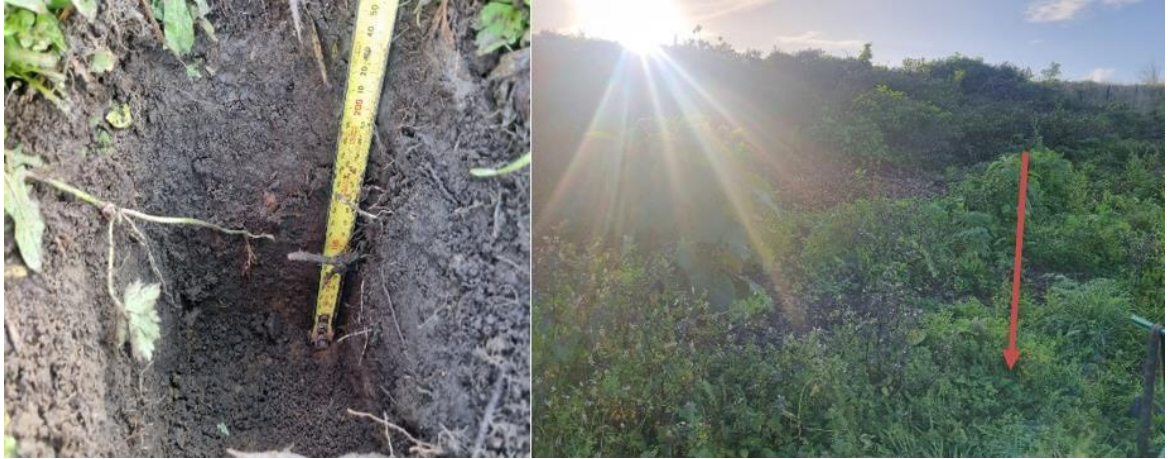
**Figure 36. Left photograph showing the detail of test pit 5 and right photograph showing the general location of test pit 5, looking northeast**

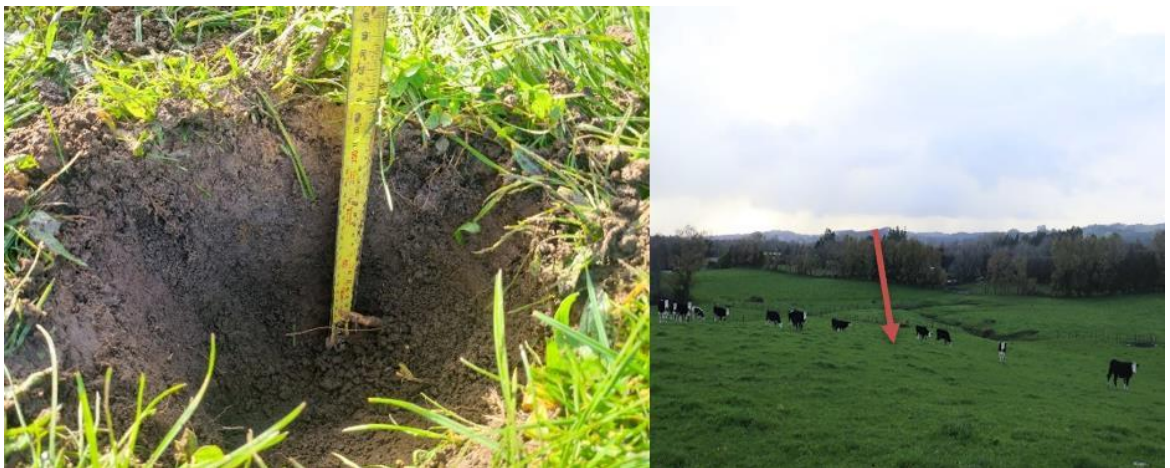
**Figure 37. Left photograph showing the detail of test pit 6 and right photograph showing the general location of test pit 6, looking northeast**
