# **PROPOSED DRURY CENTRE DEVELOPMENT FAST TRACK STAGE 2: ARCHAEOLOGICAL ASSESSMENT**

Prepared for Kiwi Property Holdings No. 2 Ltd

March 2025

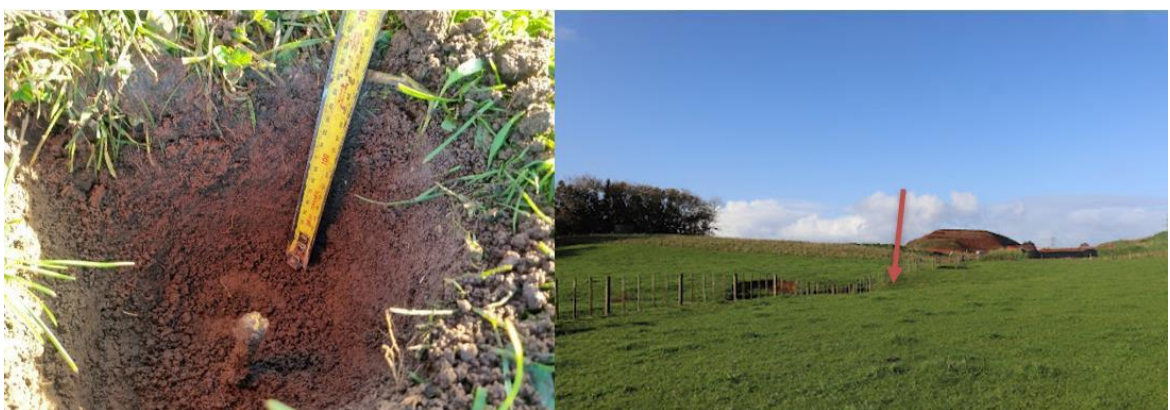
**Figure 38. Left photograph showing detail of test pit 7 and right photograph showing the general location of test pit 7, looking southeast**

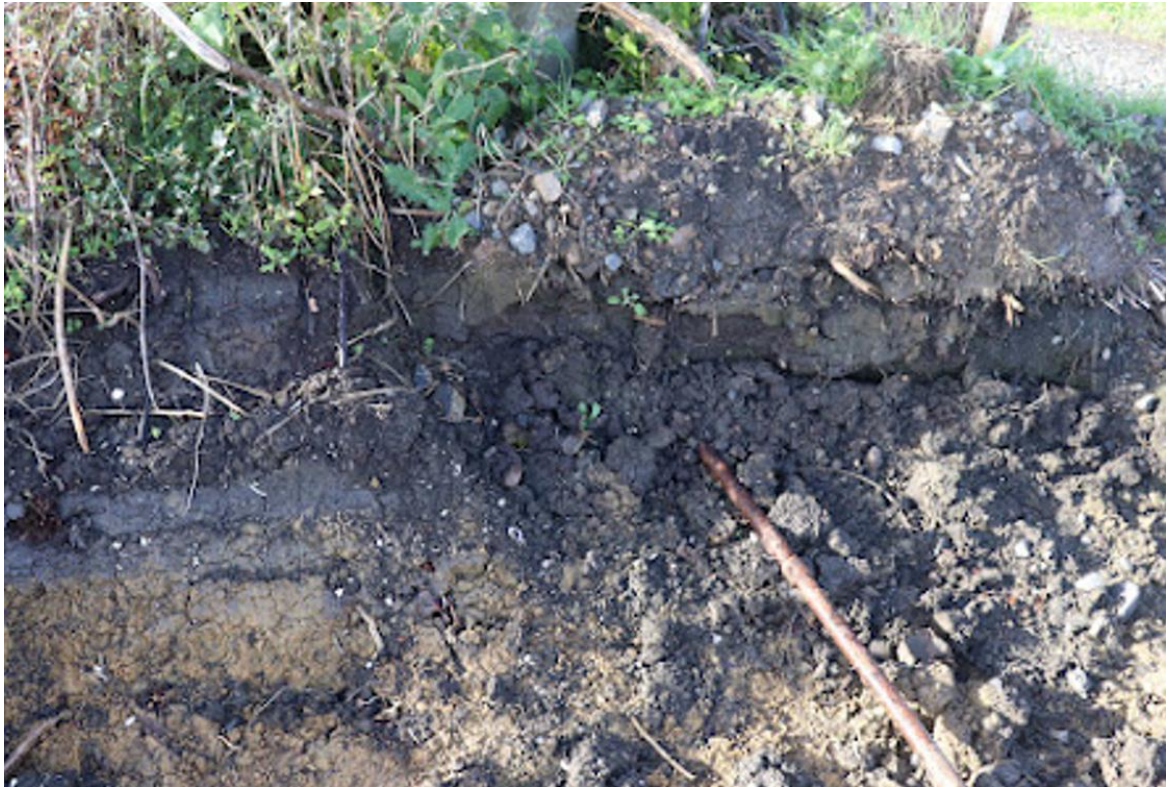
An area of exposed shell was identified along the southwestern extent of a soil profile exposed in the grounds of the former Flanagan Homestead at coordinates E1773419 N5891128. The midden contained both shell and bone, primarily fish and small mammal (Figure 39 - Figure 40). Probing in the area suggested the midden may extend over an area c.17m by 17m. The nature of the midden was not able to be determined during the survey and it may be associated with use by the occupants of the house or may be the remains of an earlier feature associated with Māori occupation and settlement. It has not been recorded as a separate site to R12/1125.

**Figure 39. West facing profile (exposed profile 3) showing shell located in the grounds of the Flanagan Homestead in Lot 1 DP 165262**

Value	Assessment
Condition	The homestead itself is in good condition. An exposed section of intact shell midden has been identified near the former location of the house which appears to be in good condition. The condition of the remainder of the subsurface remains is unknown.
Rarity	Few early homesteads or other places have been identified as surviving from the early phase of settlement at Drury.
Contextual value	The site is part of the early European settlement landscape of the Drury area and will be retained in the local area.
Information potential	The homestead can provide evidence of c.1880s residential construction techniques and materials. Archaeological investigation of any associated subsurface remains has the potential to provide information on the lifestyle of the occupants of the homestead and early settlers in the Drury area. If the midden is determined to pre-date European settlement it could provide information on Māori occupation and settlement of the area through archaeological investigation.

If resource consent is granted, it is recommended that a condition requiring archaeological monitoring of preliminary earthworks as shown by the red outlined area in Figure 44 to investigate and record subsurface remains of site R12/1125; for vegetation clearance and planting in the black outlined areas on Figure 45 and Figure 46; and for topsoil stripping for the stormwater pond in the yellow outlined area in Figure 46 to identify if any additional archaeological sites are present.

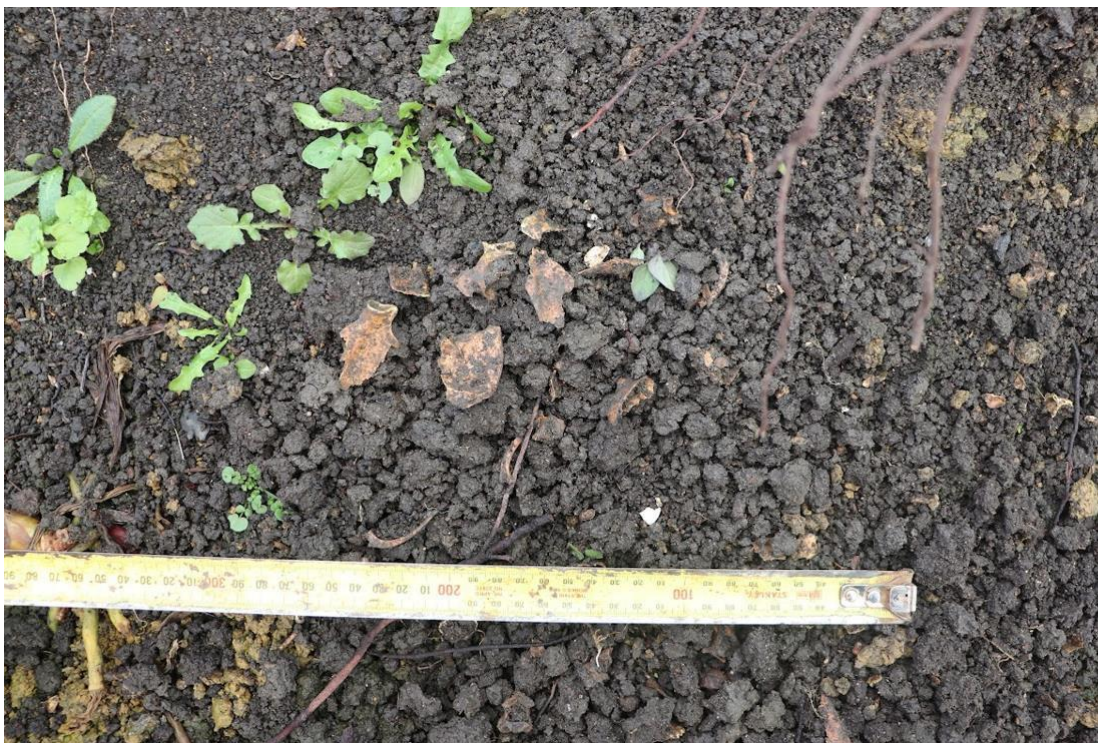
**Figure 40. Example of bone (provisionally identified as fish and or small mammal) in the grounds of the Flanagan Homestead in Lot 1 DP 165262**

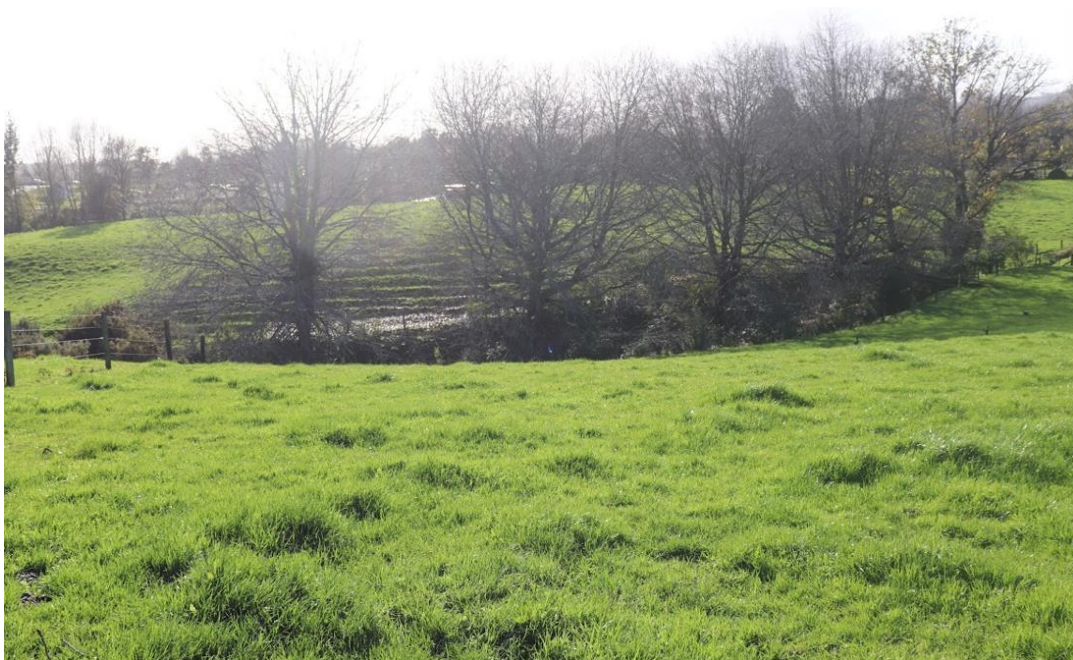
**Figure 41. Photograph showing a view of Lot 8 DP 165262, looking northeast**

Parts of Lot 8 DP 165262 were being used for stock grazing at the time of the survey, with cattle situated in the southern paddock and with the remainder consisting of grassed paddocks (Figure 41). One test pit was located in Lot 8 DP 165262 at coordinates E1773389 N5891425 +-3m. The test pit showed a light grey/pale brown slightly clayey silt in topsoil from 0-10cm (bs) over a pale greyish-yellow silty clay from 10-22cm (bs) where the test pit was stopped (Figure 42). It is also noted that the Flanagan Homestead had been moved onto Lot 8 DP 165262 from its original location in Lot 1 DP 165262, awaiting relocation (Figure 43). The property containing Lot 1 DP 56120 and Lot 7 DP 102224 was not entered but was viewed from the property boundary and found to contain a house and a number of outbuildings. No archaeological features/deposits were encountered.

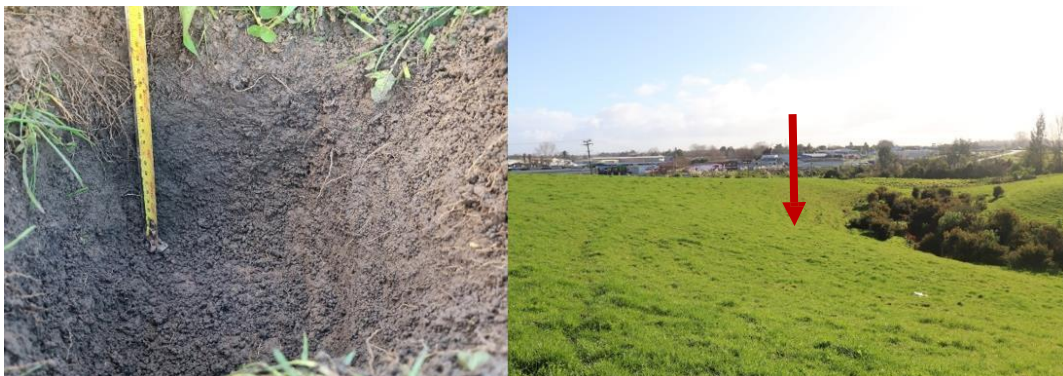
**Figure 42. Left photograph showing the detail of test pit 8 and right photograph showing the general location of test pit 8 indicated by red arrow, looking northeast**

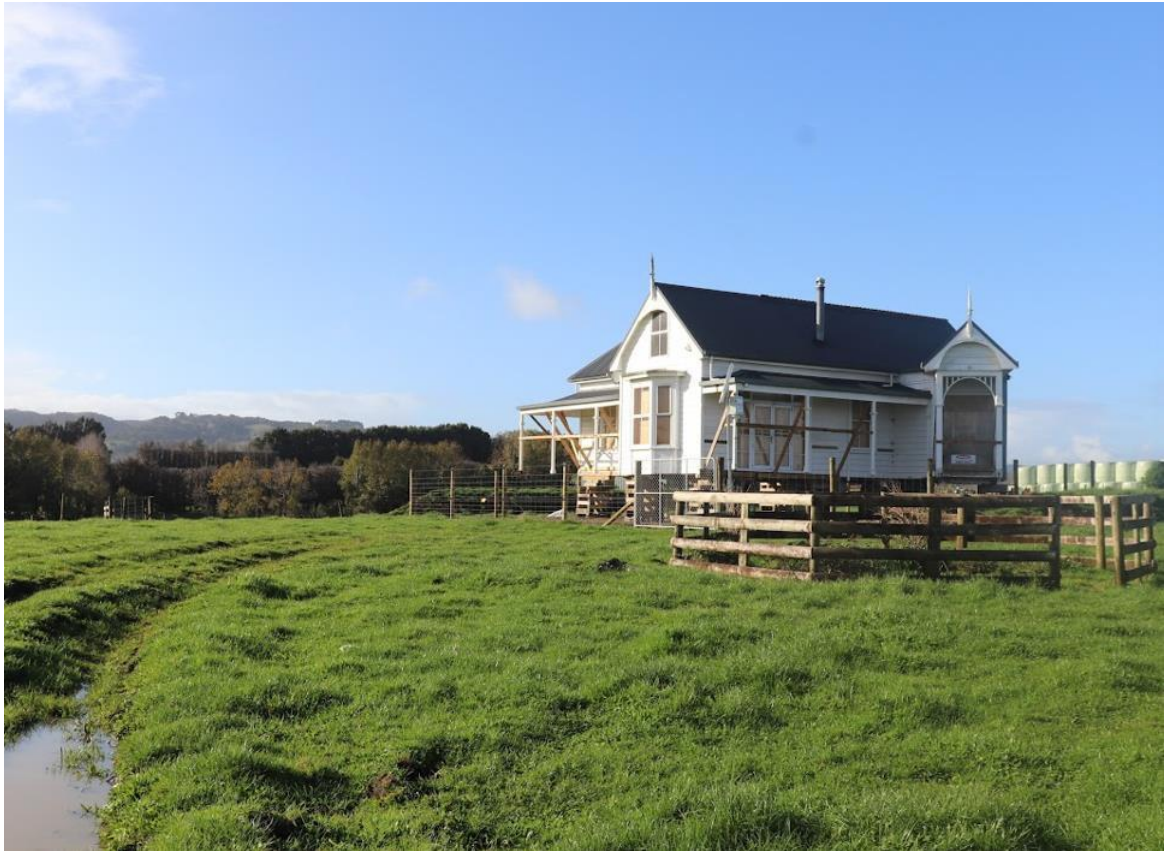
**Figure 43. Photograph showing the Flanagan Homestead awaiting relocation, looking southeast**

The Flanagan Homestead (R12/1125) has been uplifted and removed from its original location, and will be relocated elsewhere within Drury Centre in the future. However, a shell midden relating either to the homestead or to earlier Māori settlement will be directly affected and other archaeological remains such as building foundations, refuse pits, a well, and the remains of associated outbuildings may also be exposed during earthworks. Any unavoidable adverse effects on archaeology can be mitigated through the recovery of archaeological information relating to the 19th century occupation of the house (and of Māori settlement and occupation, if the recently discovered shell midden is found to pre-date European settlement) through archaeological monitoring, investigation and recording. An authority has been applied for and issued under the HNZPTA and archaeological monitoring will be carried out to record and investigate the subsurface remains of archaeological site (R11/1125) and to determine if any additional sites are present.

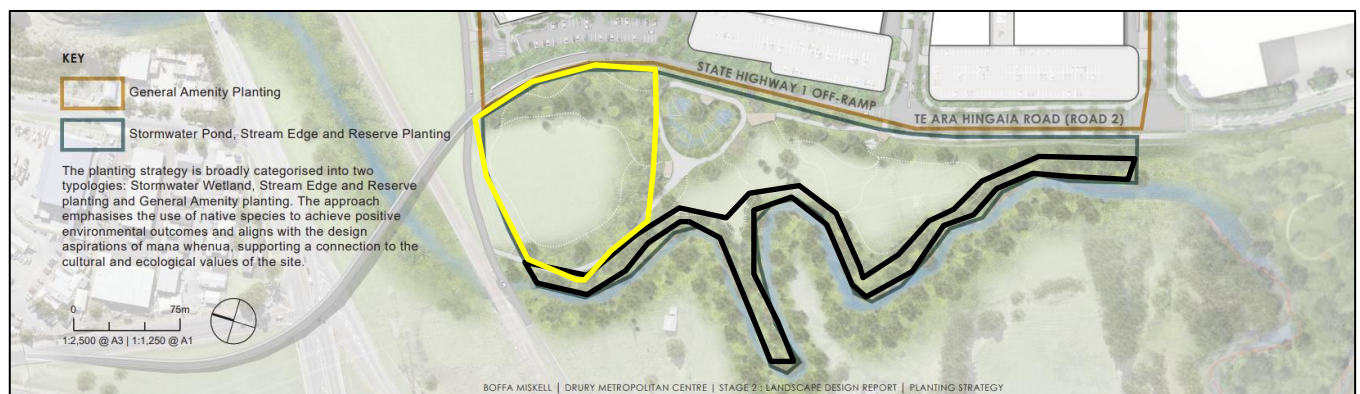
**Figure 46. Plan showing the proposed stormwater pond (yellow outlined area) and stream edge and riparian planting with area within 10m of the Hingaia Stream (outlined in black) and area of archaeological potential associated with the New Zealand Wars period outlined in yellow where vegetation clearance and planting should be monitored by an archaeologist (source: Boffa Miskell)**

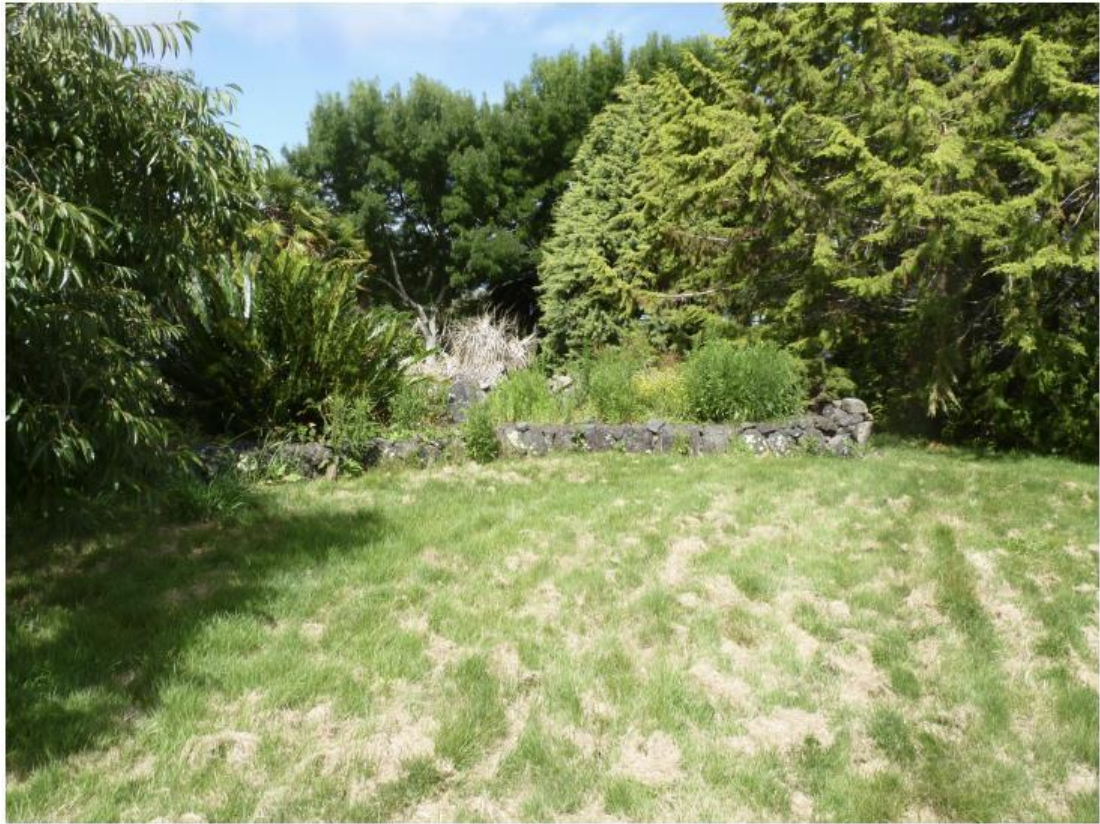
Photograph by Ellen Cameron taken on January 17 2019 Example of a low garden stone wall in the front garden of the Flanagan Homestead

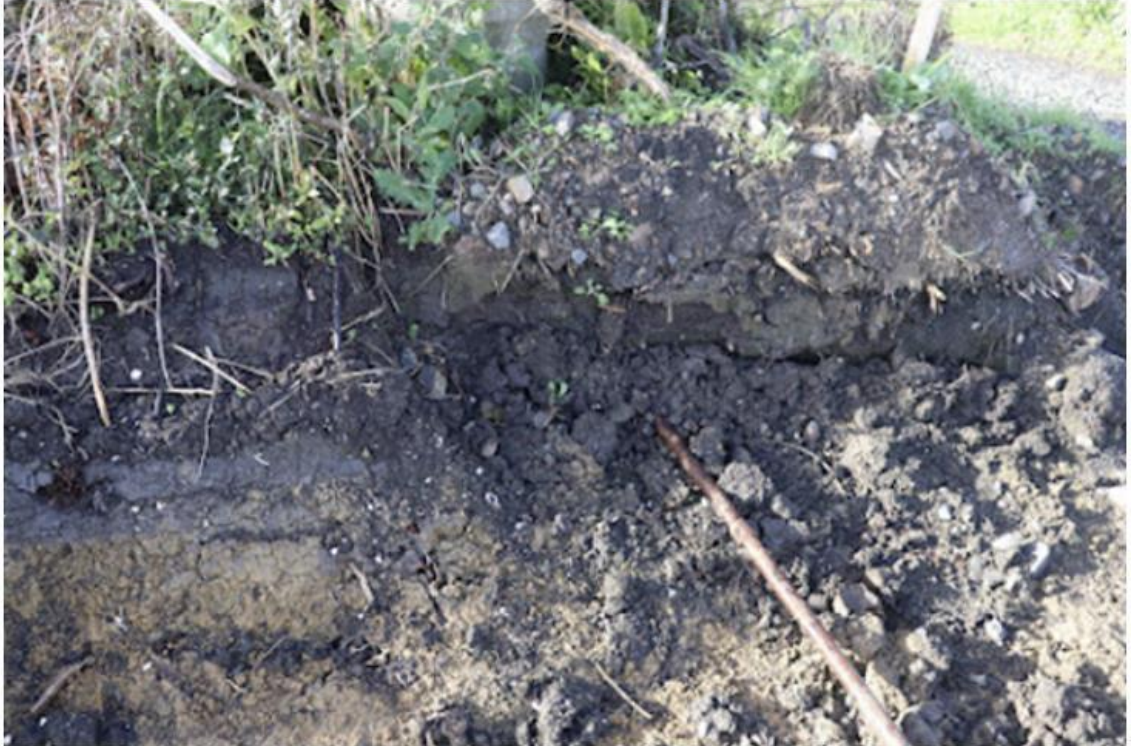
Photograph showing shell midden exposed in the grounds of the Flanagan Homestead, taken on 2 July 2024.

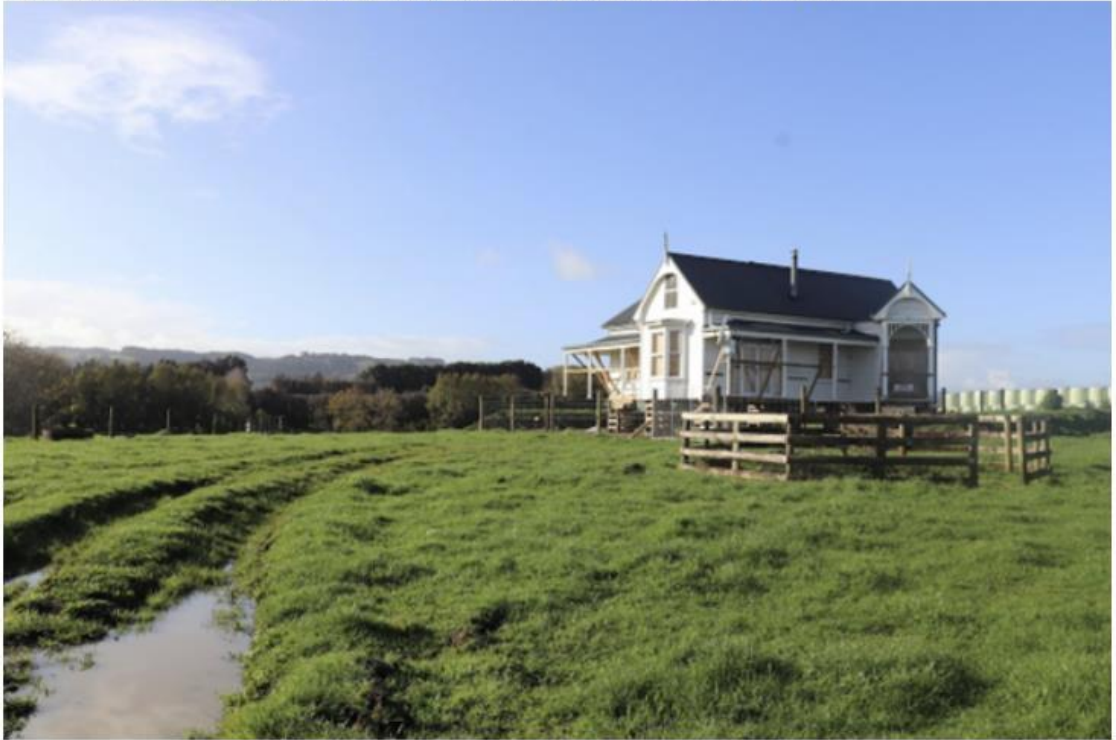
Flanagan Homestead after removal from its original location, photograph taken on 2 July 2024
