Arataki Subdivision

Ecology Report
Prepared for CDL

15 July 2025

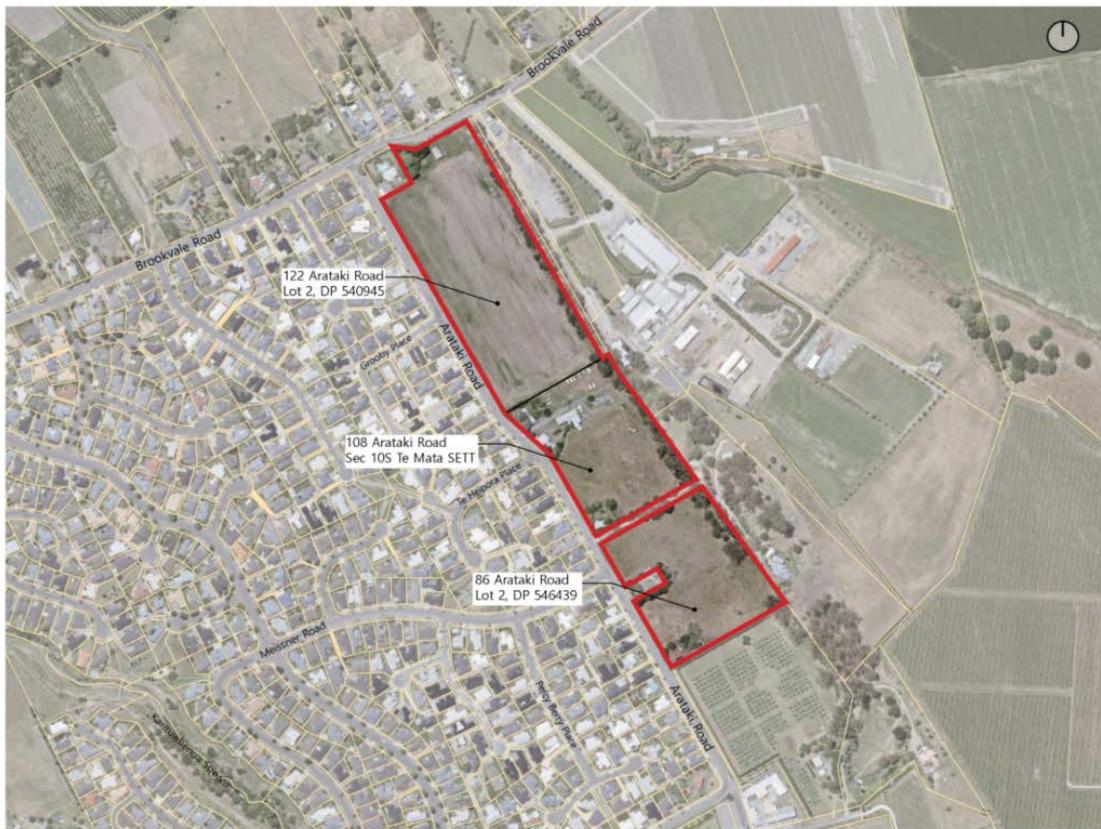
Figure 1. The Application Site, Arataki Road.

The site subject to this substantive application is located at 86, 108, 122 Arataki Road, Havelock North, Hawkes Bay (**site**). Comprising a total area of approximately 11ha, the site is held in three separate titles, all owned by CDL Land New Zealand Limited (**CDL**). The site is located at the eastern edge of the existing urban area of Havelock North, approximately 2.5 kilometres from the Havelock North Village Centre.

The site has a gentle crossfall from south to north and is currently used for grazing purposes. A scattering of buildings is present within the site. Vegetation (predominantly exotic species) is largely limited to garden areas around these buildings and a shelter belt alongside the eastern boundary. The site sits upon a natural terrace and the landform is elevated above the rural property to the east by approximately 6m.

The site is generally bounded by Brookvale Road to the north and Arataki Road to the west. The land to the south is used as an olive orchard, and the land to the east is used for rural and light industrial purposes. Access to the site is provided via five existing crossings along Arataki Road.

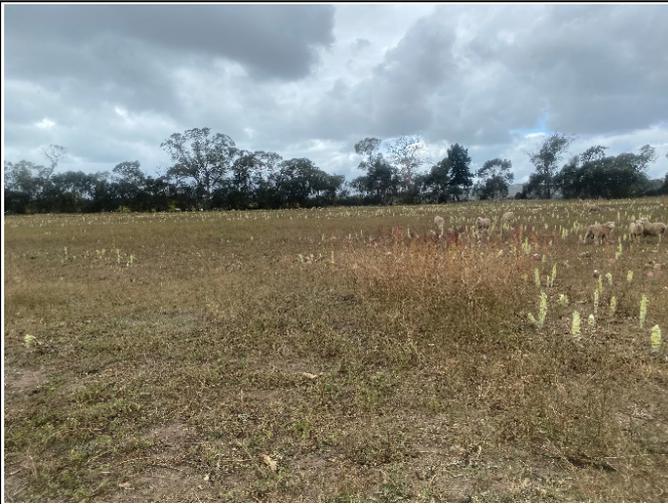
Photo 1. Site, grazed with crop of turnips. 15 April 2025.

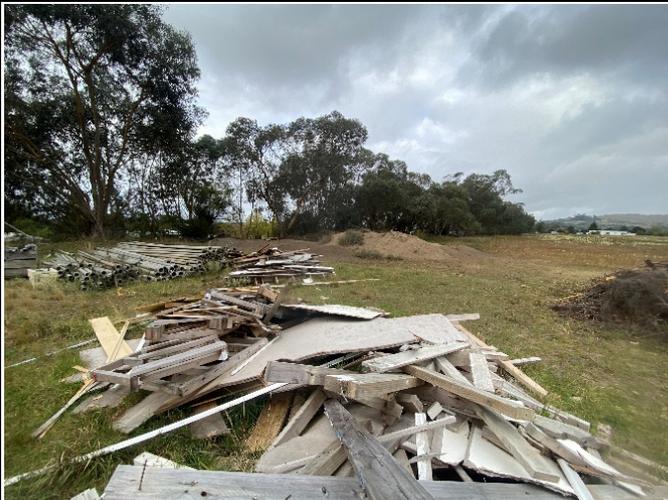
Photo 2. Debris at north end of site, potential lizard habitats.

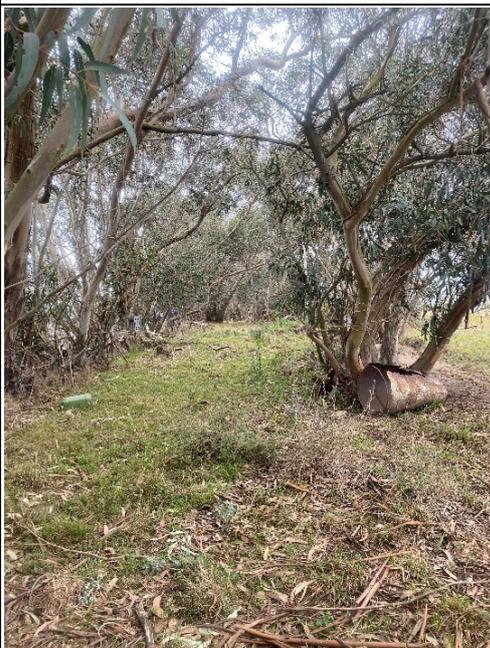
Photo 3. Groundcover and debris under eucalypts on eastern boundary.

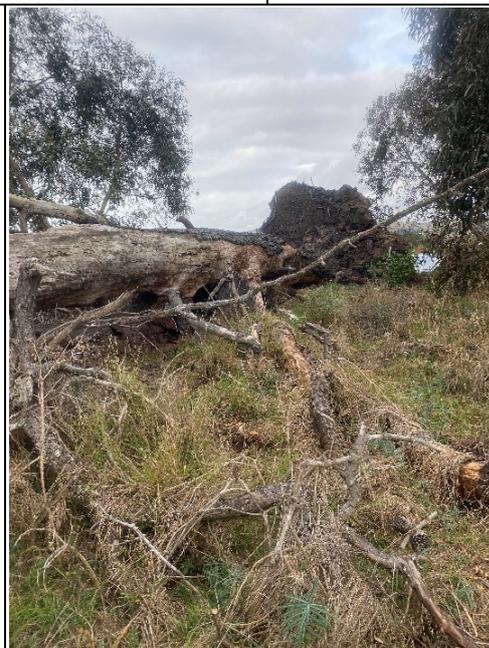
Photo 4. Fallen tree in eucalypt area, potential refuge habitat.

The rough pasture, fallen branches and other debris below the trees may provide habitat for skinks, although none were detected in our tracking tunnel survey. We do not recommend further surveys or capture and relocation. Given the findings of our assessment, we recommend that staged habitat removal is an appropriate fauna management method to facilitate the proposed development. This can occur by intensifying grazing in these areas, and hand removal of light debris followed by machine removal of heavy debris. This will degrade habitats within the normal permitted farm management activities whilst allowing an opportunity for any potential lizards near the boundary to move to more favorable refuge cover outside the boundary. This approach is precautionary given that no lizards have been detected. It does not involve any relocating, handling or moving lizards. This approach is aligned with preliminary feedback received from the Hawke's Bay Regional Council ecologist. In our assessment this approach will manage potential effects on indigenous herpetofauna to a Very Low level.

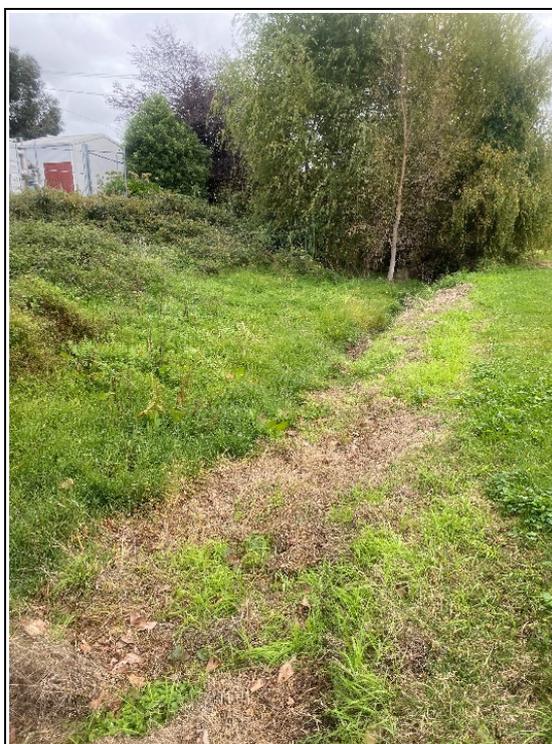
Photo 5. Site 1. Upstream of proposed discharge point, Brookvale Road.

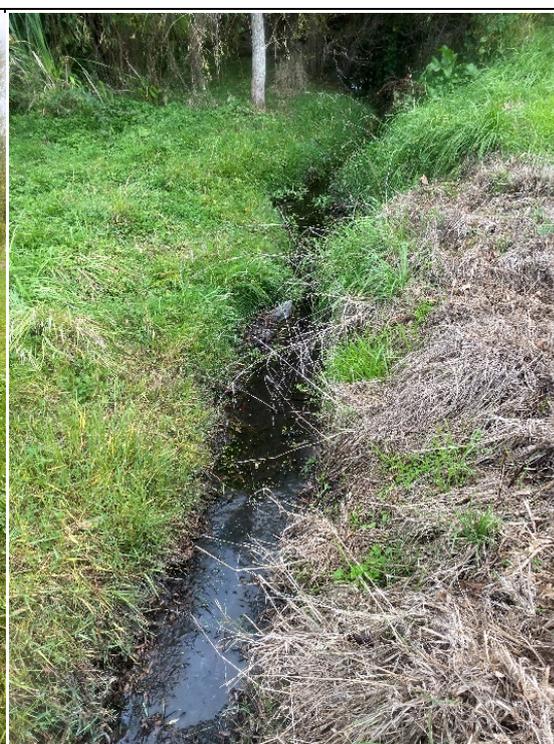
Photo 6. Site 1. Upstream of proposed discharge point, Brookvale Road.

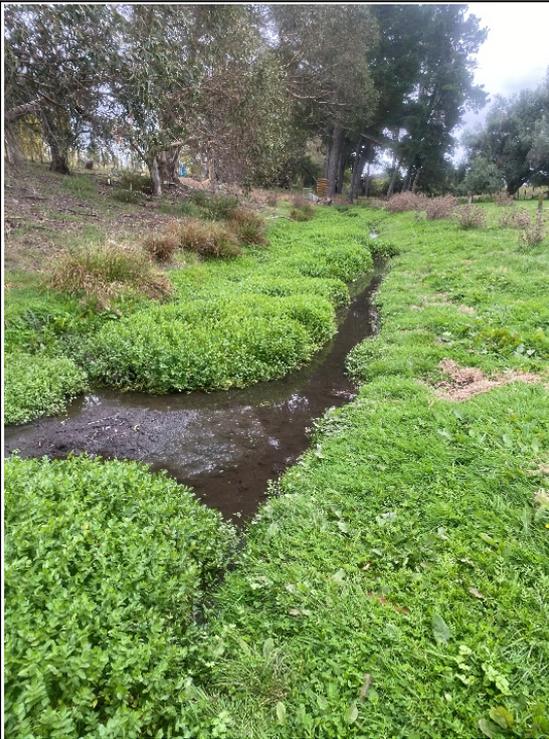
Photo 7. Site 2. Downstream of proposed discharge point, Brookvale Road.

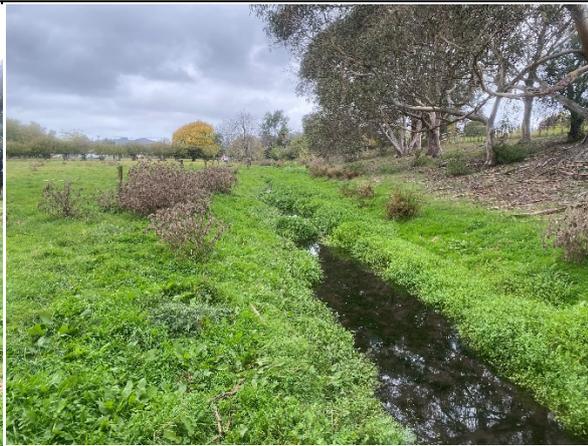
Photo 8. Site 2. Downstream of proposed discharge point, Brookvale Road.

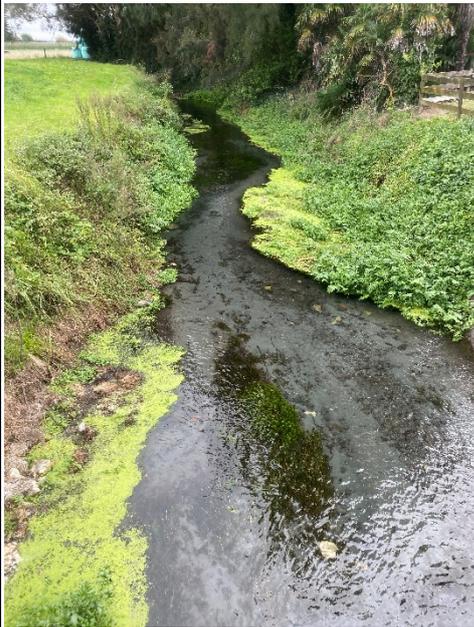
Photo 9. Site 3. Downstream of proposed discharge point, Thompson Road.

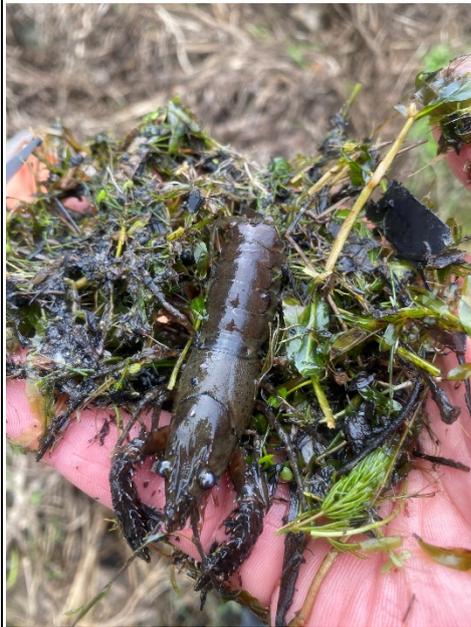
Photo 10. Site 3. Koura, Thompson Road.

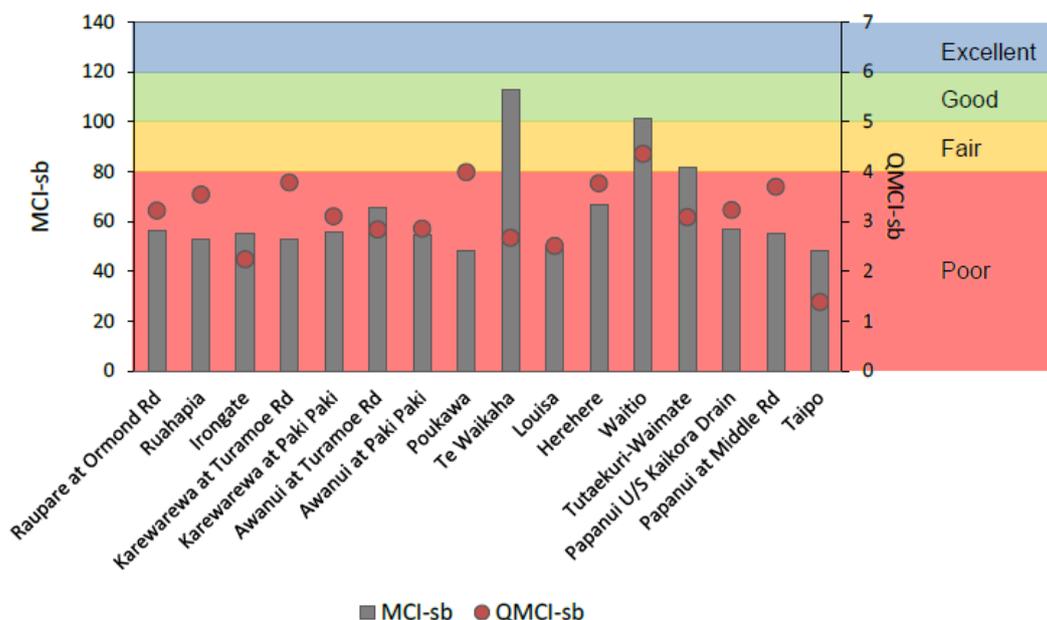
Figure 3. Macroinvertebrate community index results from Hawkes Bay Regional Council (2016).

Macroinvertebrates indicated consistently poor conditions in lowland streams in the area, with 13 out of 16 sampling sites being in the poor range for Macroinvertebrate Community Index and 15/16 for Quantitative Macroinvertebrate Community Index. The Herehere and Louisa Streams were the nearest and most similar sites to the receiving environment to the Arataki development and had MCI-sb scores of 65.7 and 49.8 respectively, and low values for other metrics.

This evidence indicates that water quality factors (probably associated with landuse activities) are having adverse effects on stream ecosystems including a reduction in sensitive species.

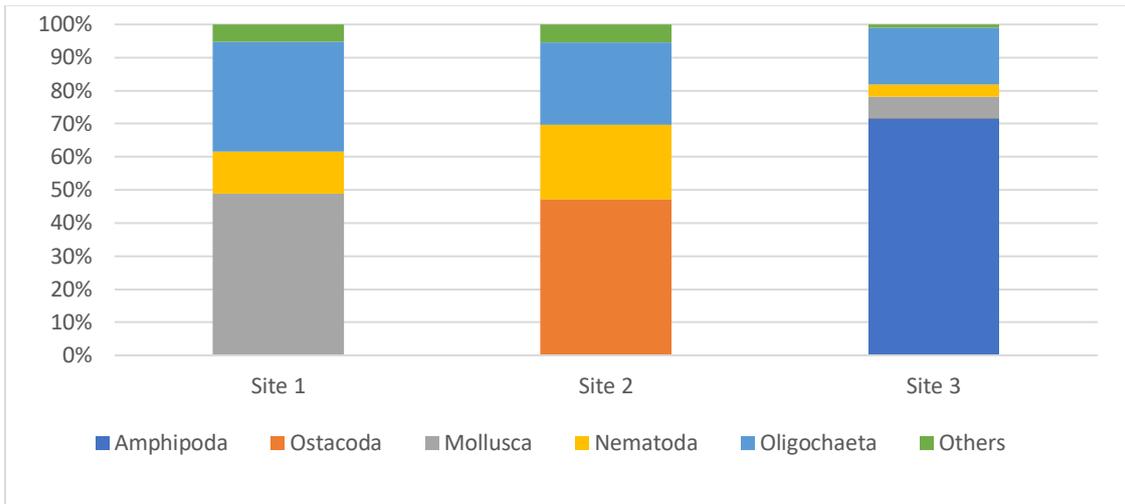
Figure 4. Macroinvertebrate Community Composition. Site 1 is upstream of Brookvale Road, Site 2 is downstream of Brookvale Road and the proposed stormwater discharge from the Arataki subdivision, and Site 3 is in the Mangateretere Stream.

-	-	Longfin eel (r)
	-	-	Inanga (c)
	-	-	Koura (a)
Macroinvertebrates			
No. of Taxa	12	13	14
EPT Richness	0	0	0
% Insecta	1.8	0.3	0.6
MCI-sb	51	57	44
Composition	Mollusca 48% Oligochaeta 33% Nematoda 13%	Ostracoda 47% Oligochaeta 25% Nematoda 22%	Amphipoda 72% Oligochaeta 17%

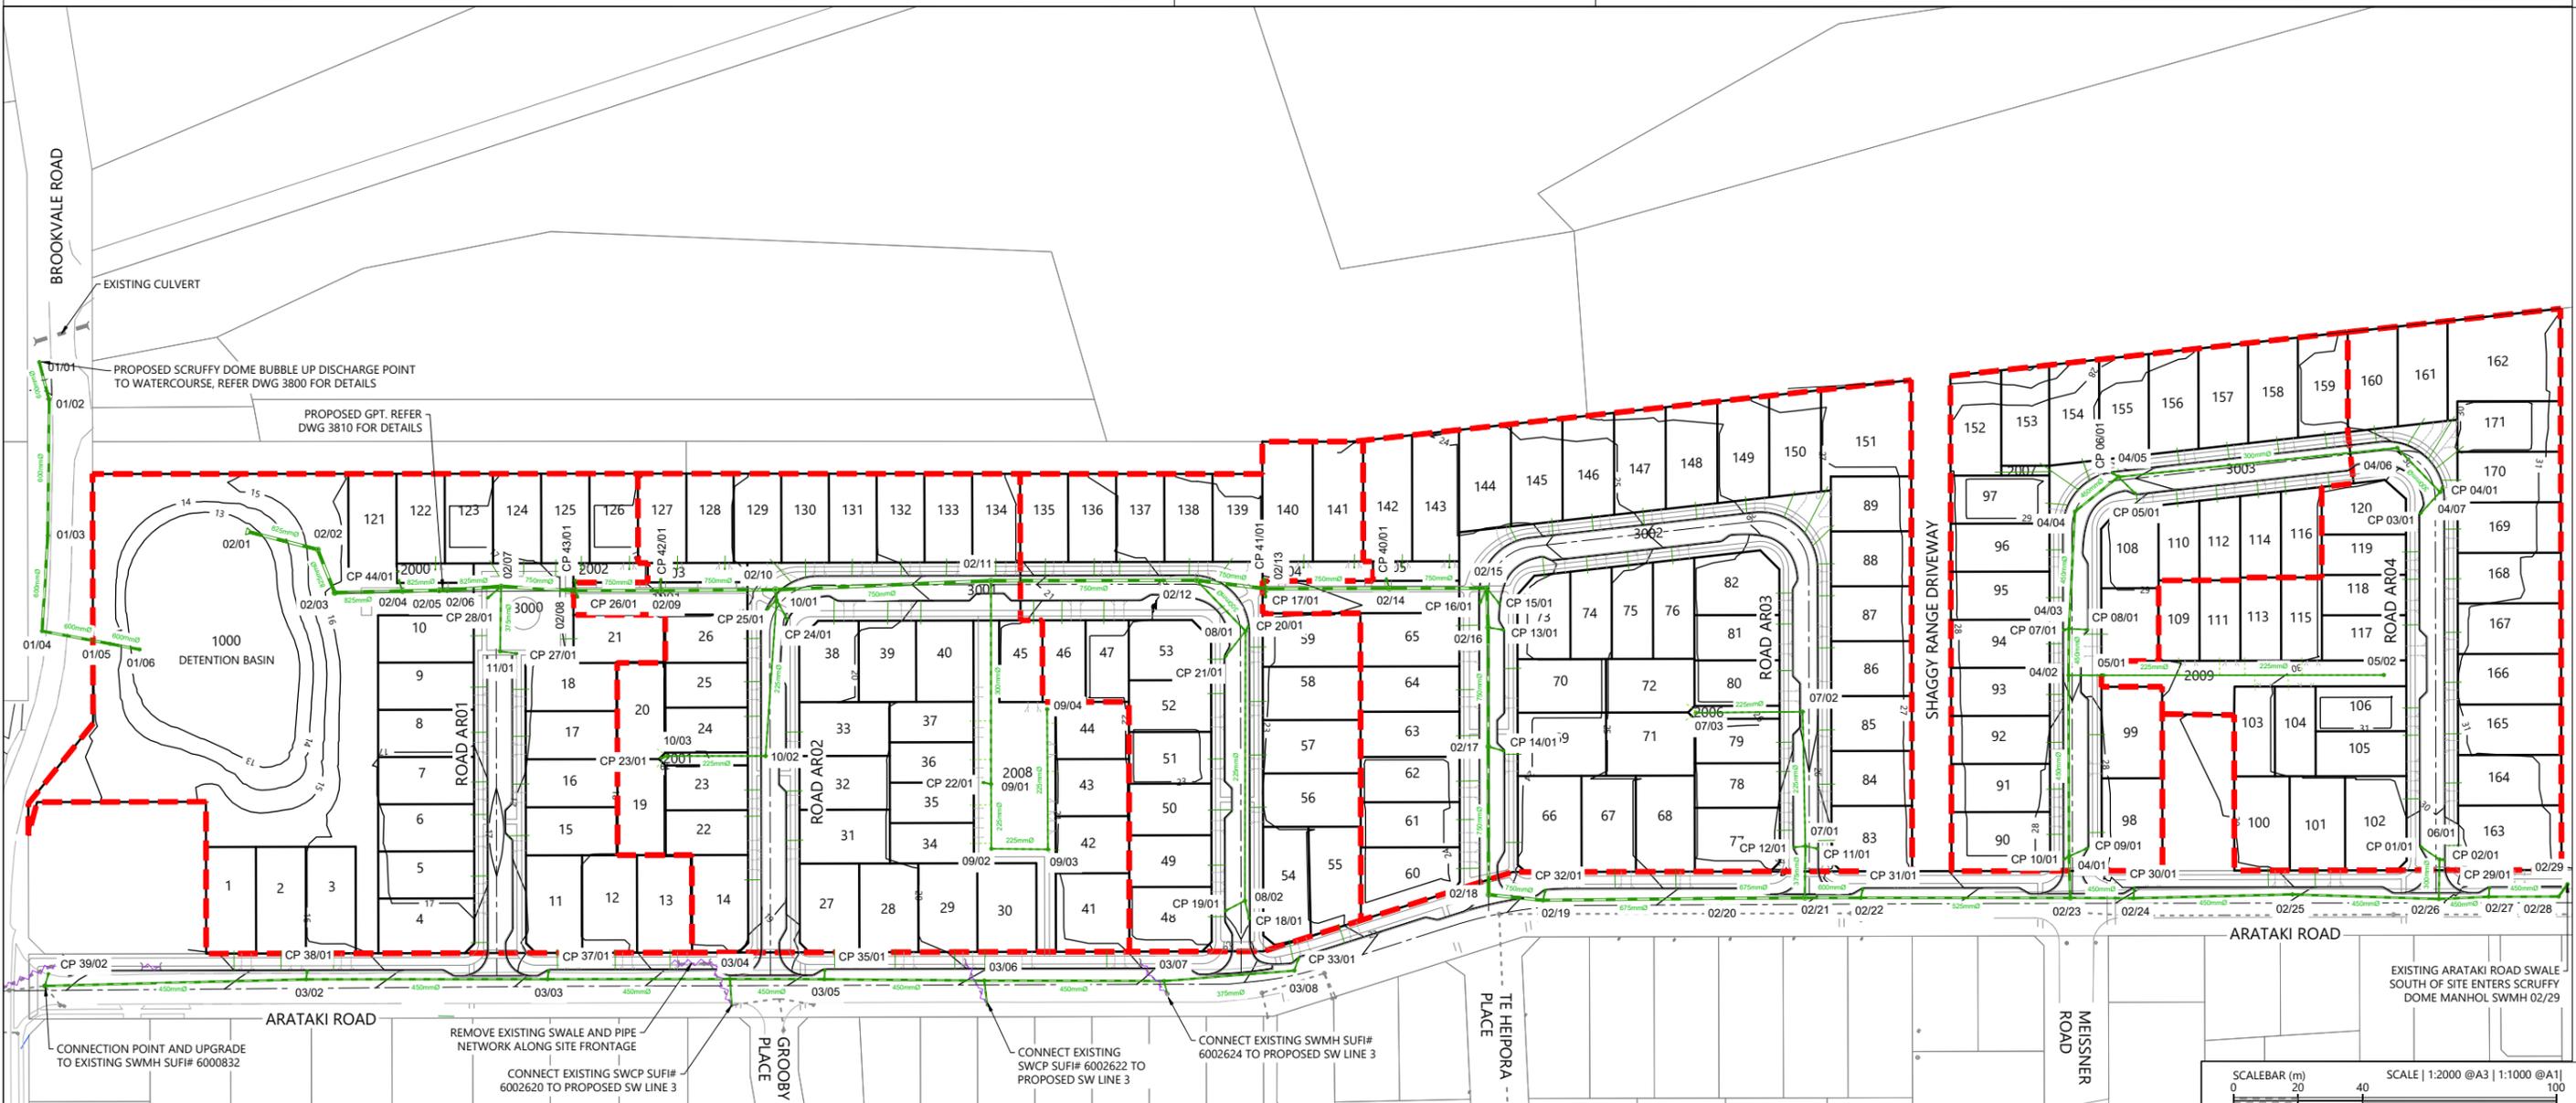
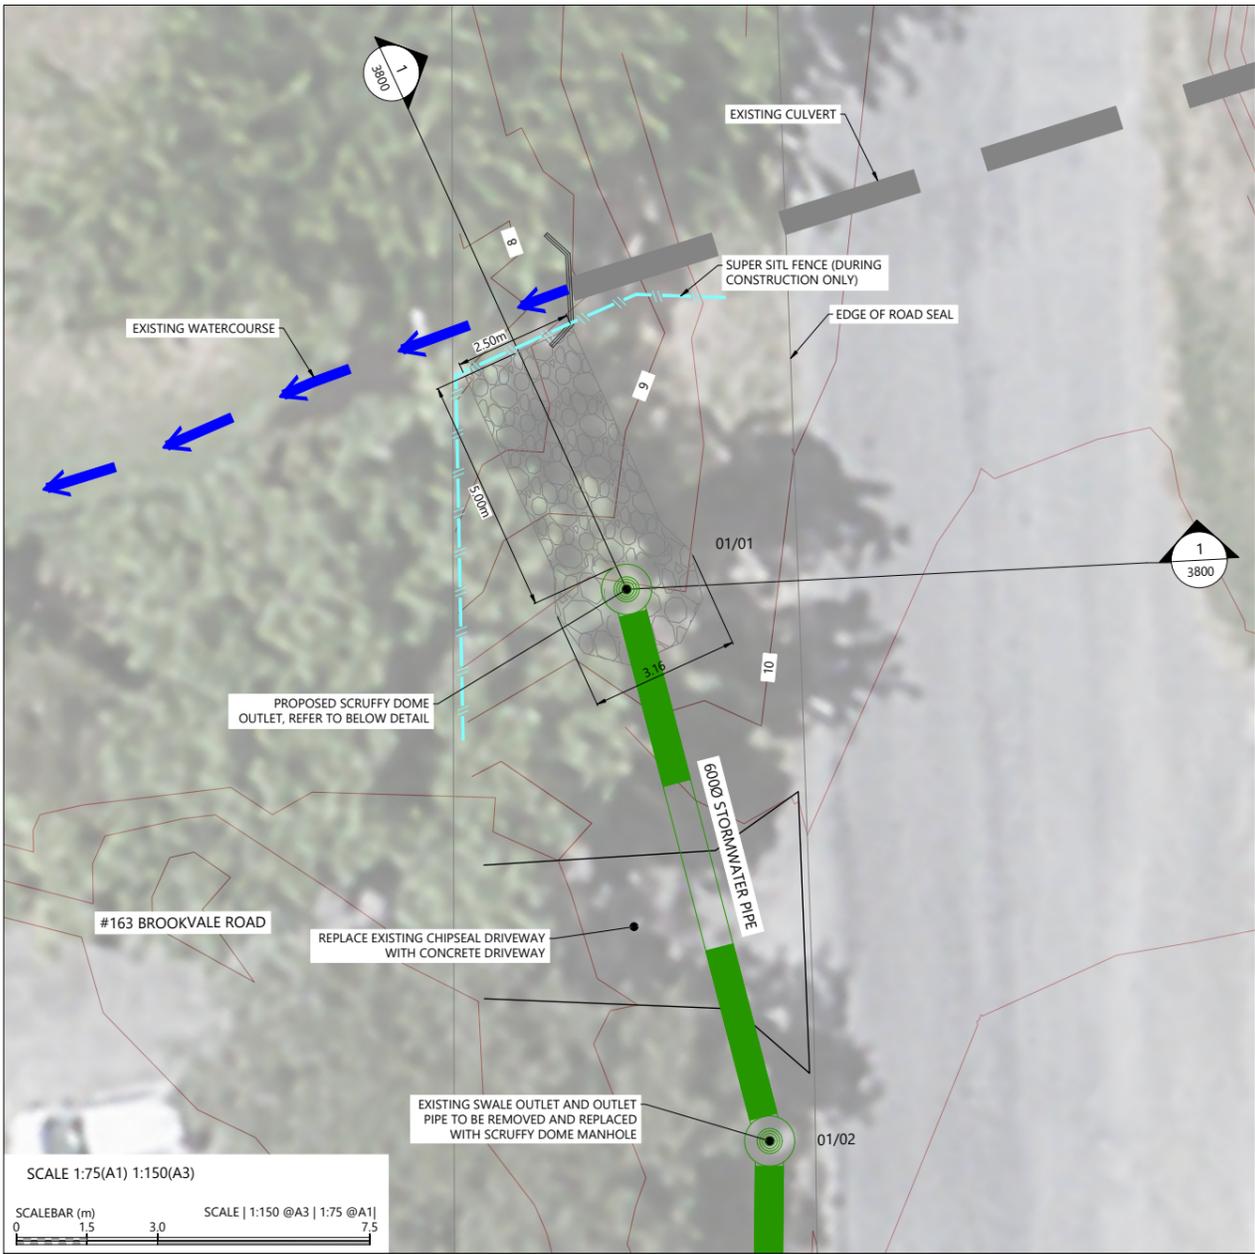
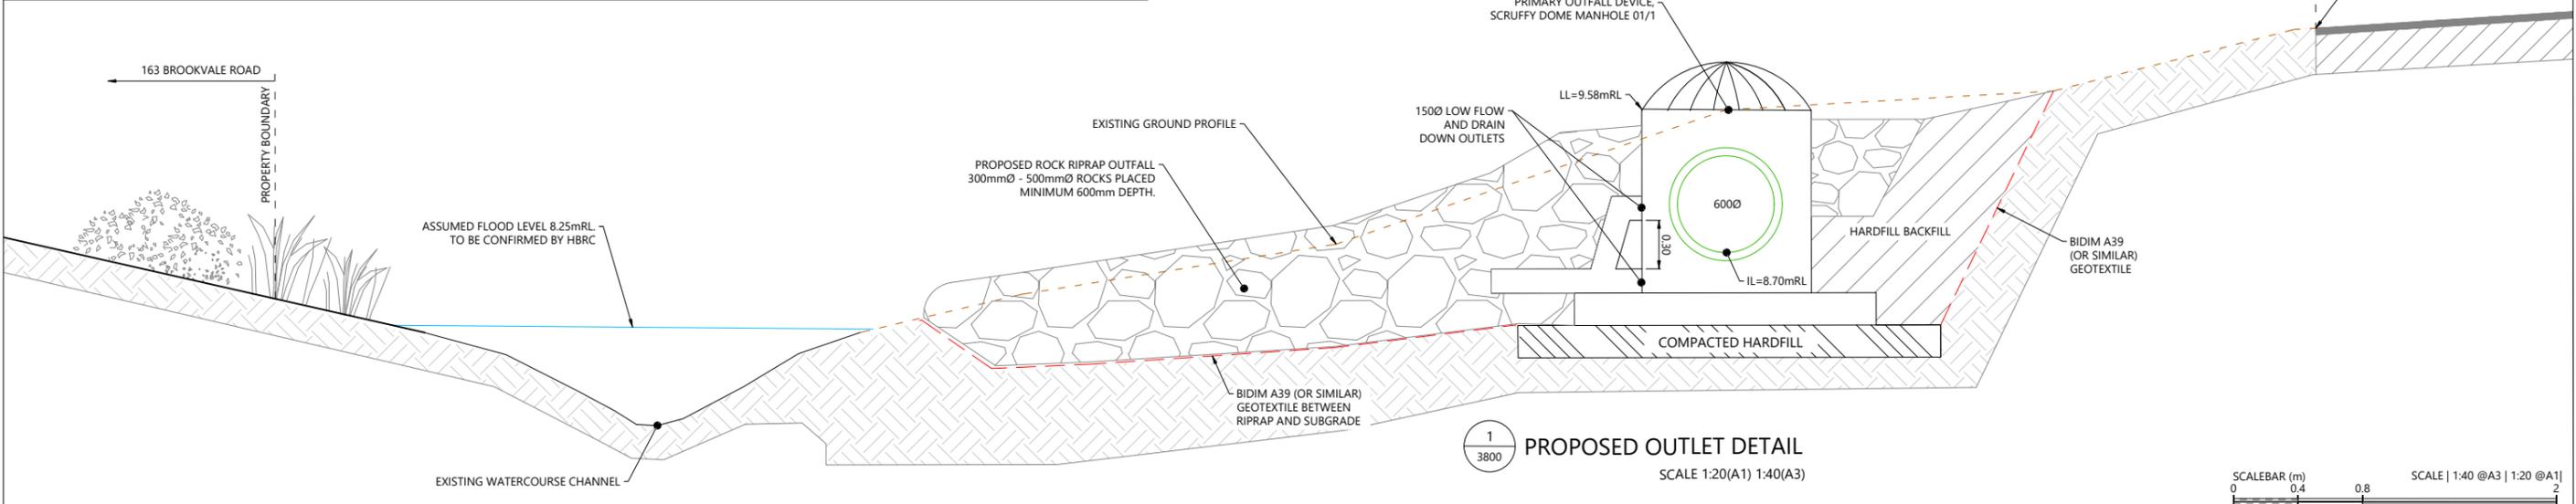
Appendix 3: Stormwater Outlet Design

STATUS	ISSUED FOR DISCUSSION	REV
SCALE	1:2000 @ A3	1
COUNCIL	HASTINGS DISTRICT COUNCIL	
DWG NO	P24-244-00-3000-DR

The proposed stormwater outlet is located on the north side of Brookvale Road. Some ornamental shrubs and flaxes are present here.
