FAST-TRACK CONSENT: LAKE PŪKAKI CONTINGENT STORAGE ACCESS AND ROCK ARMOURING WORKS

Landscape Assessment

November 2025

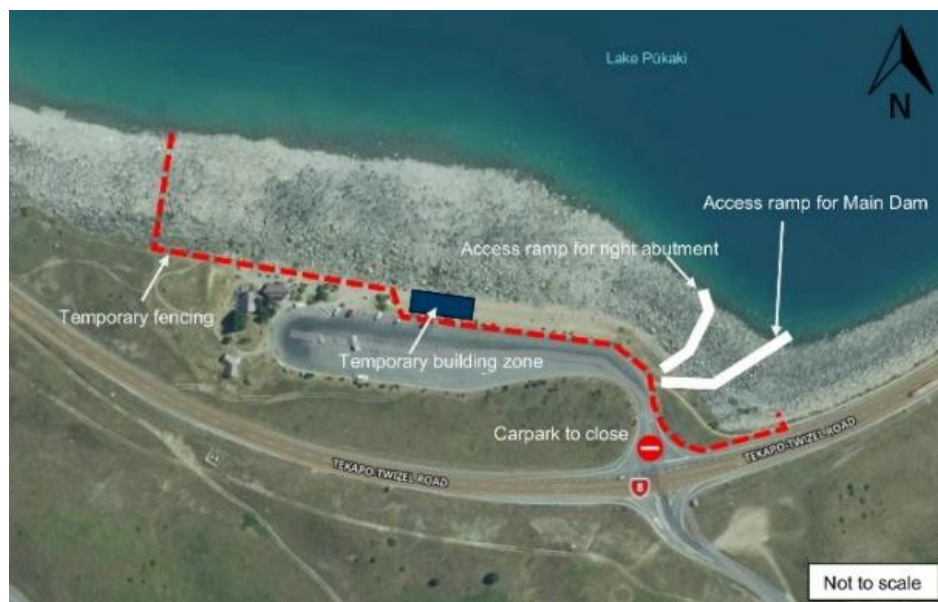
Figure 5: Site layout during construction works

Installing the armouring will require the installation of a number of temporary elements to enable construction. This will include fencing and a series of construction benches and groynes to be built as working platforms for 45-tonne and 20-tonne excavators. Transferring rock to site will be via 27-tonne road trucks. Figures 5 and 6 below illustrate the locations of the two proposed temporary building zones (image source: Rip-Rap Placement Construction Methodology).

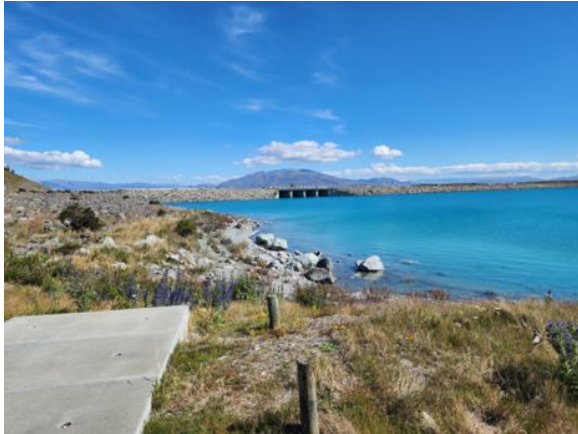
Figure 7: View from A2O cycle trail looking southwest towards SH8, Left Abutment, Gate 19 and Main Dam on the right side of Gate 19.

The dam slopes, which descend below the level of the road, are a relatively minor element in the overall landscape alongside the vast expanse of Lake Pūkaki within its surrounding mountainous setting, including Aoraki/Mount Cook and the Main Divide. Although the embankments are obvious visible elements in the foreground or midground of many viewpoints along the shoreline, (e.g. from the Visitor Information Centre, or from viewpoints along the A2O trail), these embankment slopes are generally perceived as an expected and therefore acceptable part of the road (SH8) and surrounding hydroelectric infrastructure such as Gate 19, the Pūkaki Spillway and Gate 18/Pukaki Outlet. These embankments do not obstruct the available scenic views to the surrounding landscape as illustrated in photo Figures 7 and 8 below.

The lake level during the January site visit was recorded at 531.37 m RL (as shown in Figures 7 and 8 below) which is understood to be at the upper end of storage levels (the maximum consented water level is 532.5m RL). The lake level during the later site inspection in September 2025 was at 523 m RL as presented in Appendix A of the Graphic Attachment. The proposed modifications to the dam slopes will occur between 517.3 to 510.5m RL which is substantially lower than the lake level observed during the site visit, where the changes would be concealed from view below water level.
