Arboricultural Assessment

Site Address: 2 Lower Hobson Street, Auckland CBD

Purpose of Report: Arboricultural assessment of the proposal to demolish the existing Downtown Carpark Building and develop the site into a mixed-use precinct

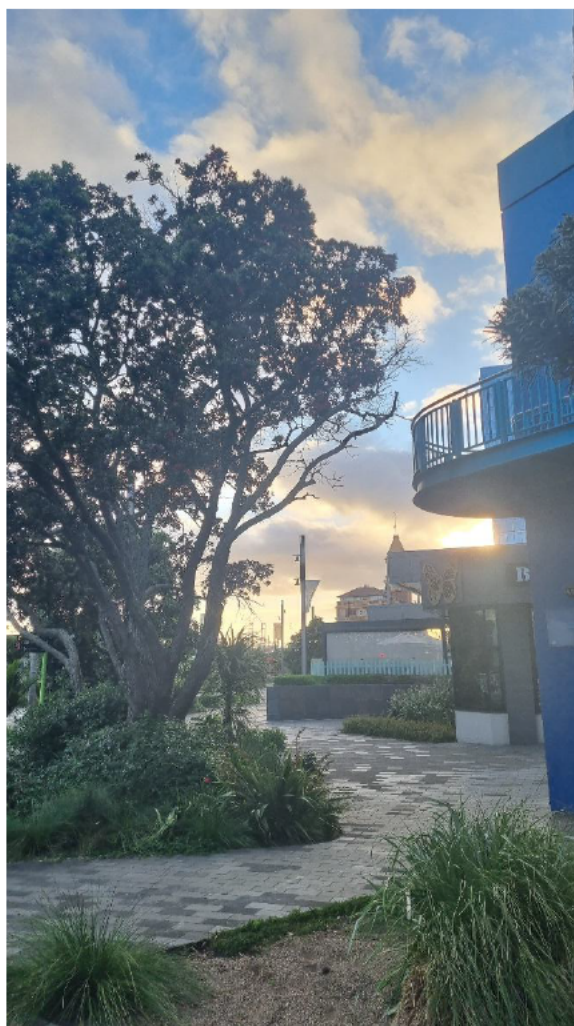
Tree 1 is identified as a recently relocated Pohutukawa (*Metrosideros excelsa*) growing immediately to the north of the Lower Hobson Street Footbridge. This tree can be retained and will not be affected based on the demolition plans, with adequate space around the stair structures and footbridge to undertake the demolition works. However, works would technically be required within the PRZ of the subject to demolish the above ground structure (based on the

AUP defined canopy radius measurement). However, no physical works (earthworks or excavations) are required.

Figure 3 – View of Tree 1 adjacent to the footbridge staircase to be demolished

As discussed in the previous section, demolition of the footbridge staircase and exit ramp are located within the PRZ/TPZ of Trees 1 & 3. As these works are to occur above ground, no root zone disturbance will occur, but care must be taken to minimise canopy conflicts. The existing footings of both structures to be demolished are not located within either the TPZ or PRZ of the two trees. However, the bridge structure itself, at the aerial level, is technically located within the PRZ/SRZ. As such fencing and the recommended tree protection measures outlined in Section 4.0 afford the tree adequate protection for the duration of the demolition works.

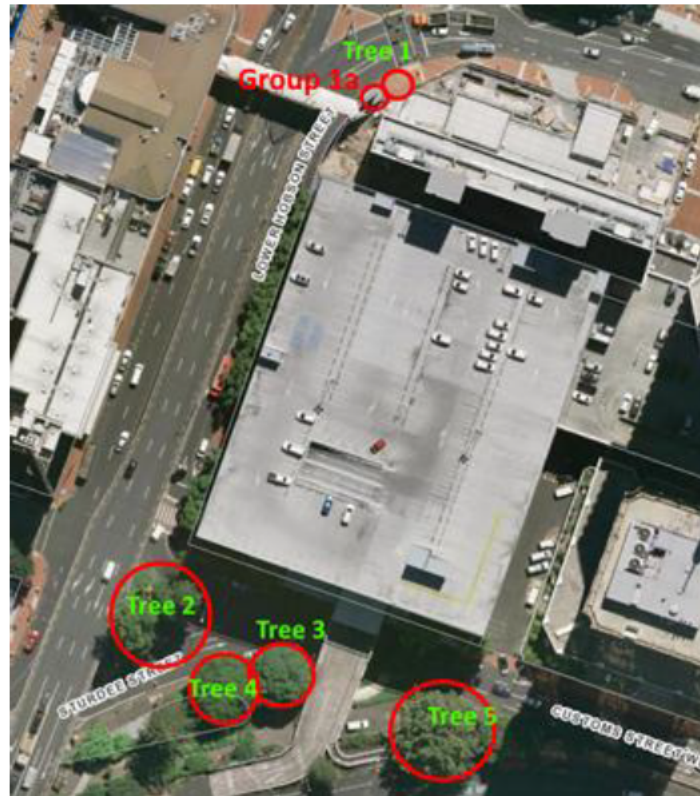
A list of trees within the Site is provided in this section (and shown on Figure 4 further below). Further technical information is also provided in Appendix A of this report.

Figure 4 – Tree Location Plan

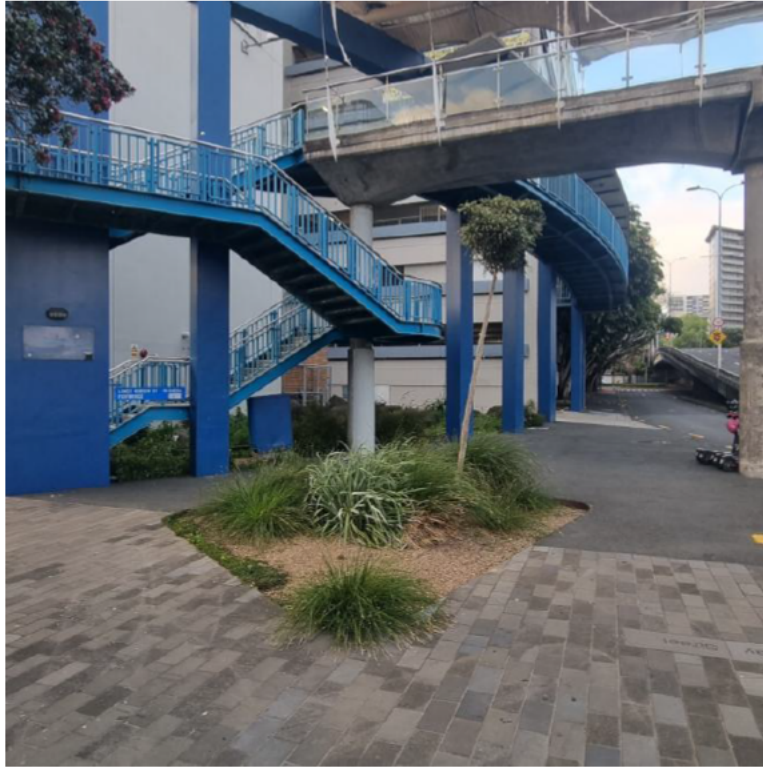
Group 1a is identified as an area of low vegetation coupled with one (1) Lancewood (*Pseudopanax crassifolius*). This vegetation is growing in a formal street garden. As part of the proposed works, this garden area is proposed for removal, to enable an alternative entrance to the adjoining M Social Building (196/200 Quay Street). The Lancewood is proposed for temporary uplift and storage, to be returned to its current growing location as part of the wider landscape works. This tree does not meet the relevant criteria for protection (being less than 4.0m in height and 400mm in girth).

Figure 5 – Group 1a proposed for removal/relocation

Group 1a is proposed for removal to facilitate the temporary alternative access for the MSocial rear entry. It is recommended that the Lancewood tree is temporary uplifted and stored at an offsite location for the duration of the works and then replanted following the completion of the demolition works. This activity is to be undertaken by a specialist transplant contractor, to be approved by the works arborist. The low ground cover species can be replaced with new specimens on a like for like basis at re-instatement. The proposed temporary removal of one (1) Lancewood tree (part of Group 1a) is a Permitted Activity (E17.4.1 (A9)).

Following the re-instatement of the garden, the new or relocated plants are to be maintained for a period of one year. If any plants fail within this period, they are to be replaced with new specimens of a similar size.

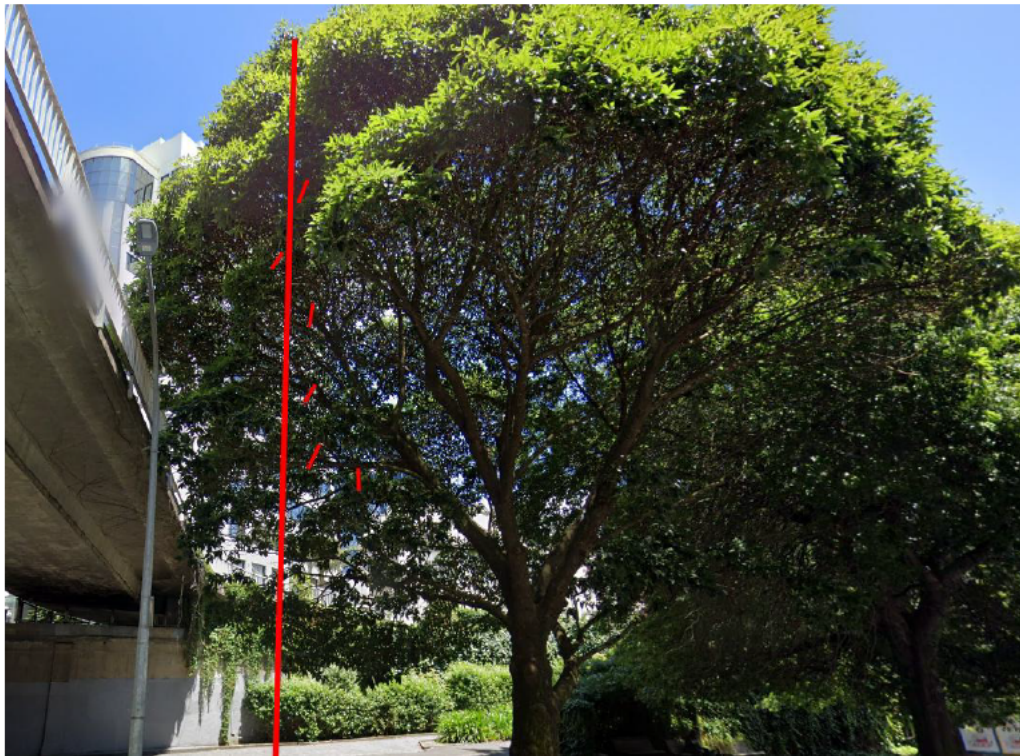
A marked-up image is provided below to illustrate the anticipated pruning of Tree 3 to enable the demolition of the Fanshawe Street ramp. The extent of pruning is estimated at 15% (2.5m from the bridge structure) of the tree's canopy and as such would be assessed as a permitted activity in accordance with standard E17.6.1, provided branch severance is limited to limbs up to 100mm in diameter.

Figure 6 – Anticipated Pruning Locations to enable the 2.5m of clearance.

It is recommended that all pruning works are undertaken by an Auckland Council approved qualified arborist, under the direction of a suitably qualified works arborist.

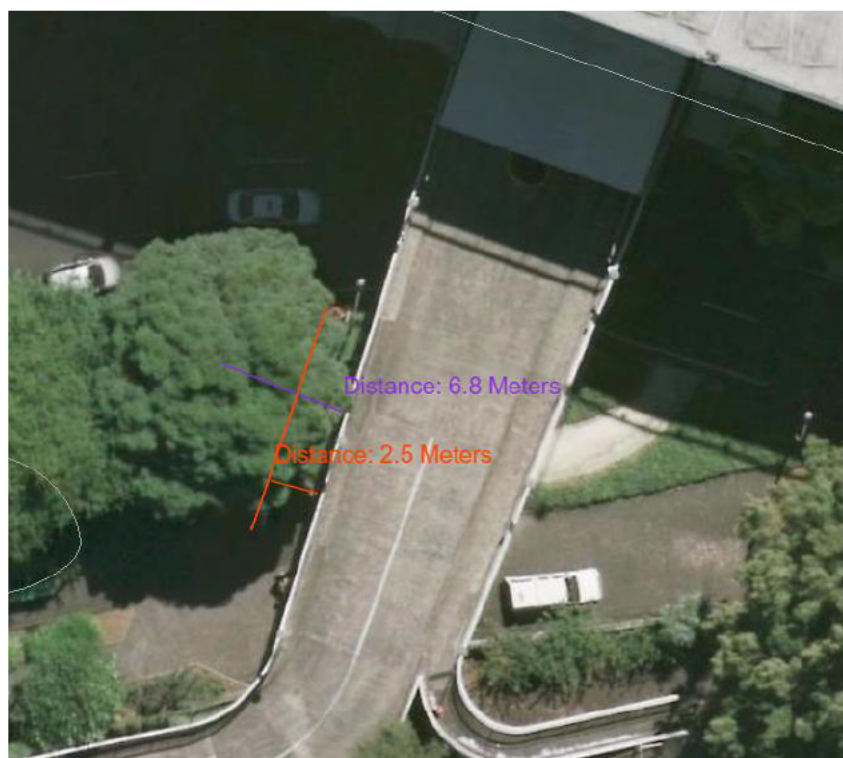
Figure 7 – GIS Image showing anticipated clearance extent.

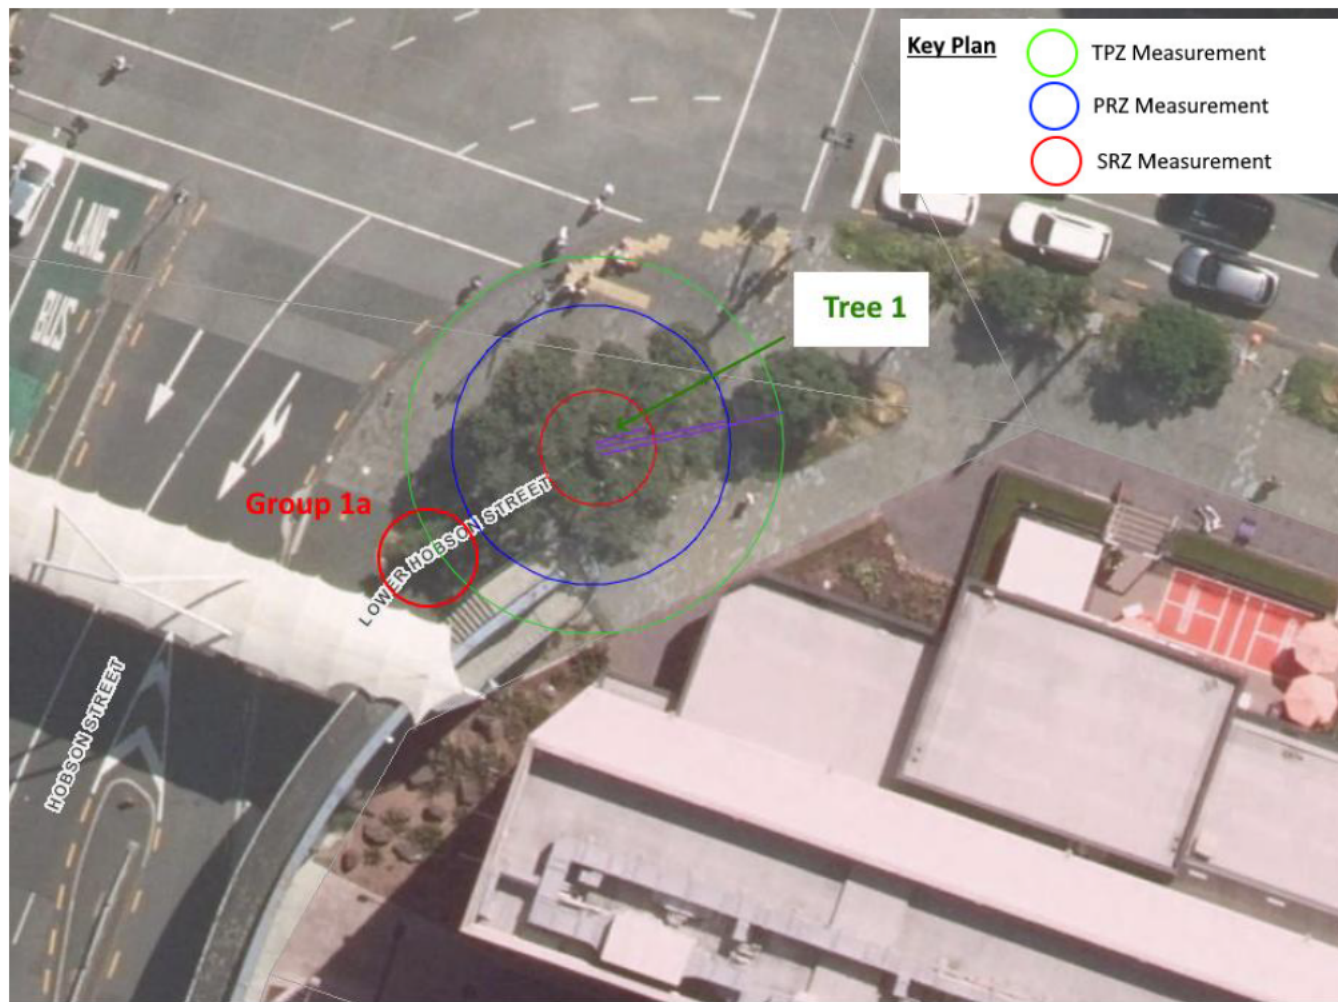
Figure 4 – Relevant Technical Measurements (Tree 1)
