Delmore Subdivision, Ōrewa

Preliminary Site Investigation (Ground Contamination)

VINEWAY LTD

WWLA1147 | Rev. 4

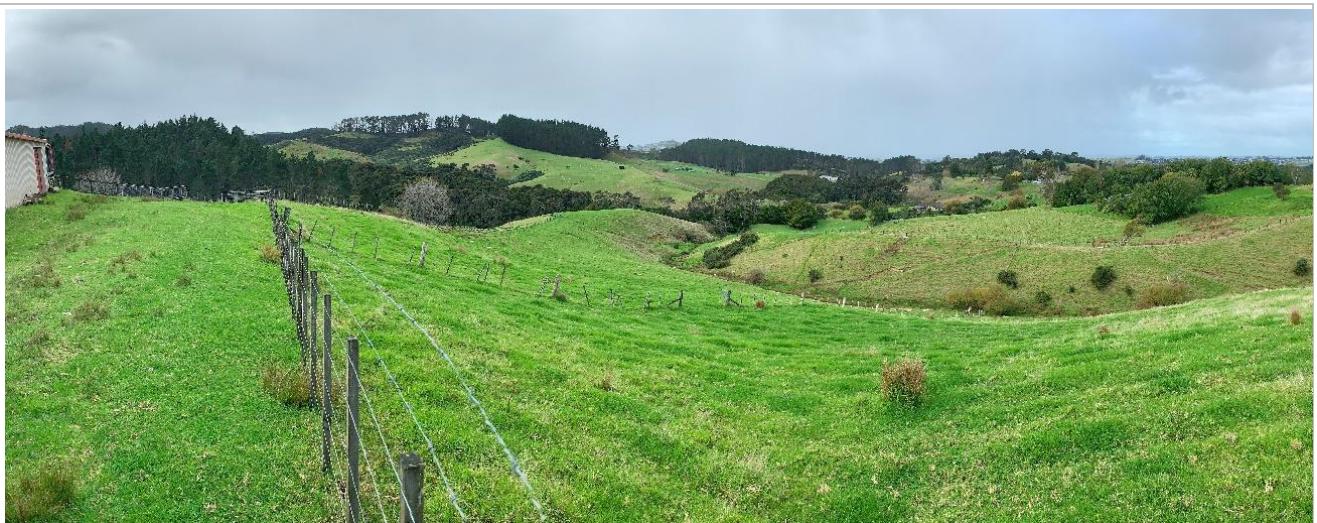
Photograph 1. View to northeast from the accessway to 130 Upper Ōrewa Road showing general topography.

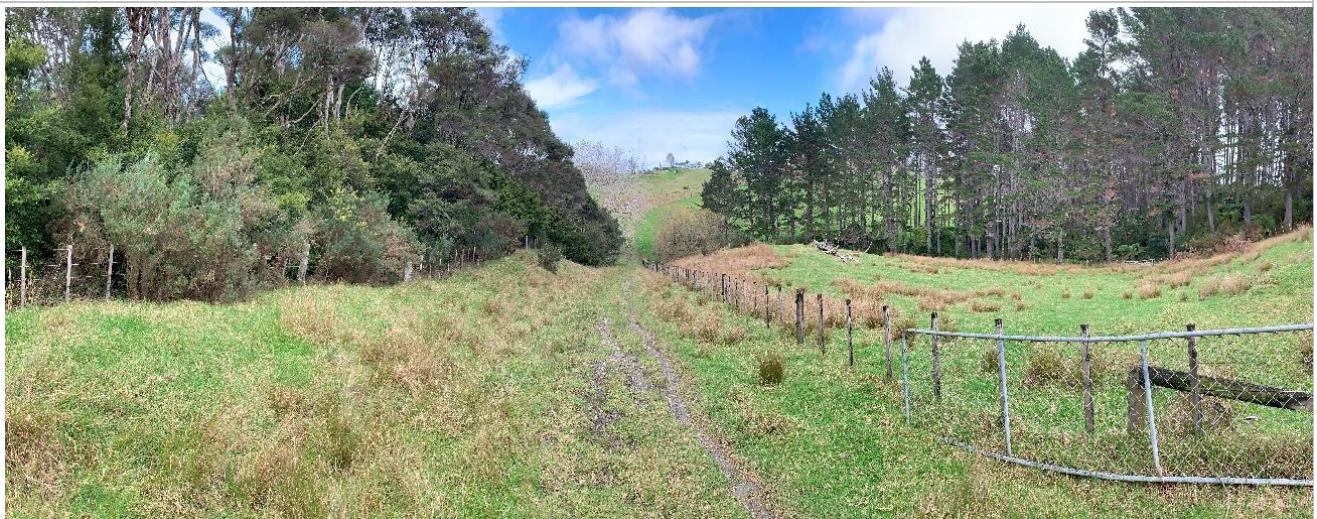
- As described in the preceding sections, the site comprises 6 adjoining properties located on the northern side of Upper Ōrewa and Russell Roads.
- All of the properties were being used for rural and rural residential purposes with pasture being the dominant use (see **Photograph 1**). Several small stands of both plantation forestry (pine) and native bush are present across the wider site (see **Photograph 2**).

Photograph 2. View of the south from accessway to 130 Upper Ōrewa Road showing stands of both native and plantation forestry.

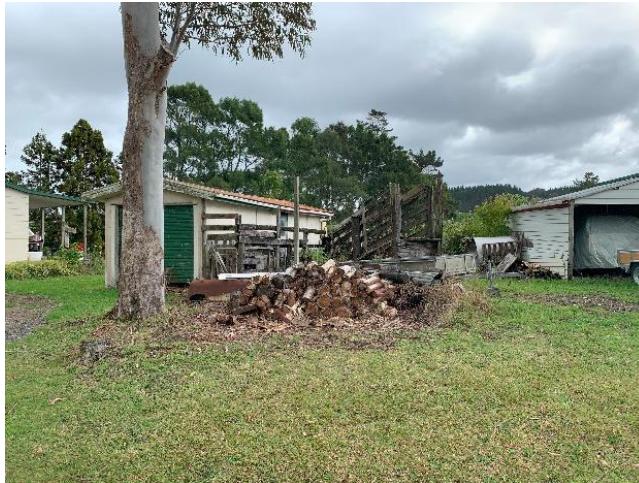
- Except for 55 Russell Road all dwellings and sheds were observed to be constructed of inert building materials: brick, stained wooden cladding, modern weatherboard systems or profiled steel products (see **Photograph 6**, **Photograph 15**, **Photograph 18** and **Photograph 24**). A single garage on 55 Russell Road was observed to be clad with fibre cement board, a suspected asbestos containing material (ACM), see **Photograph 5**.

Photograph 5. Example of sheds between dwellings at 55 Russell Road, single garage to left is clad with suspected ACM.

Land use and HAIL Activity	Potential Contaminants	Potential likelihood and magnitude of contamination	HAIL Assessment
Asbestos building materials <i>Activity E1. Asbestos products manufacture or disposal including sites with buildings containing asbestos products known to be in a deteriorated condition.</i>	Asbestos	<p>The majority of structures currently or previously present on the site were either:</p> <ul style="list-style-type: none"> • Constructed before asbestos was in common use - pre-1940s buildings on 88 Upper Ōrewa Road; or • Constructed after asbestos was in common use - predominantly >2000s era buildings present on the site today; or • Were not observed to include (ACM) on their exterior - barns and sheds are constructed of steel or wooden materials. <p>Suspected ACM material was only observed on a single garage at 55 Russell Road. The materials were observed to be intact but unpainted. Being unpainted means they have the potential to shed fibres to ground during natural weathering processes.</p>	HAIL Activity E1 does not apply to the site as the limited ACM was observed to be intact.

Following demolition and removal of the existing dwellings and other buildings (garages, sheds, barns etc.) surficial soil and debris (to the lesser of 300 mm depth or top of natural insitu soils) across the footprint of each former structure, and a halo 2 m wide on all sides around it, shall be either:

- a. Excavated and disposed offsite to a consented Class 1 landfill if physically / geotechnically unsuitable for reuse; or*
- b. Tested by a suitably qualified and experienced contaminated land professional (SQEP), as defined in the Users' Guide to the National Environmental Standard for Assessing and Managing Contaminants in Soil to Protect Human Health, 2012, to confirm its suitability for reuse onsite or disposal to alternative offsite facilities. All sampling and testing must be undertaken in accordance with the Contaminated Land Management Guidelines No.5: Site Investigation and Analysis of Soils (Ministry for the Environment, revised 2021).*

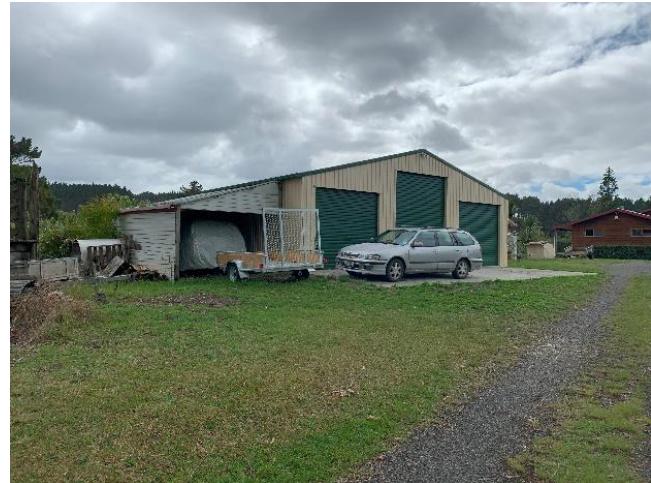
Photograph 6. Example of sheds between dwellings at 55 Russell Road.

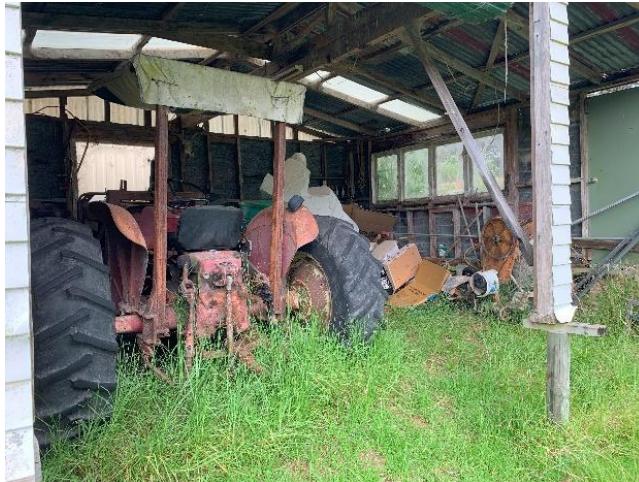
Photograph 7. Contents of shed (behind sheds in Photograph 6) at 55 Russell Road.

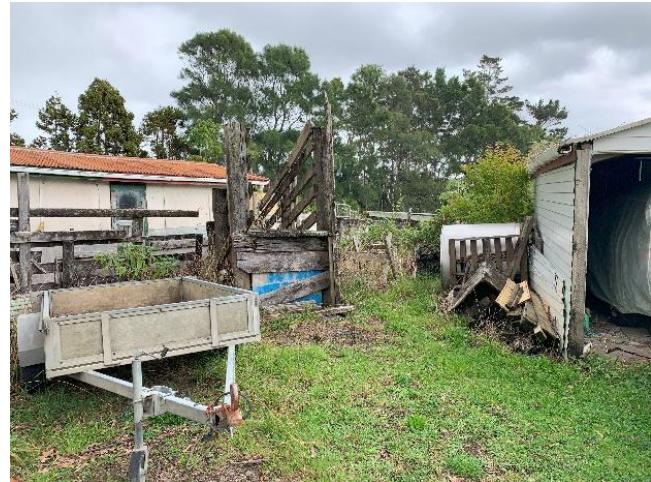
- Small stockyards are present on 53b and 55 Russell Road and 88 and 130 Upper Ōrewa Road (see examples in **Photograph 8**, **Photograph 19** and **Photograph 24**). However, no evidence of livestock dipping facilities was observed in relation to the stockyards (or elsewhere on the properties).

Photograph 8. Closeup of stock yard and materials stored at 55 Russell Road.

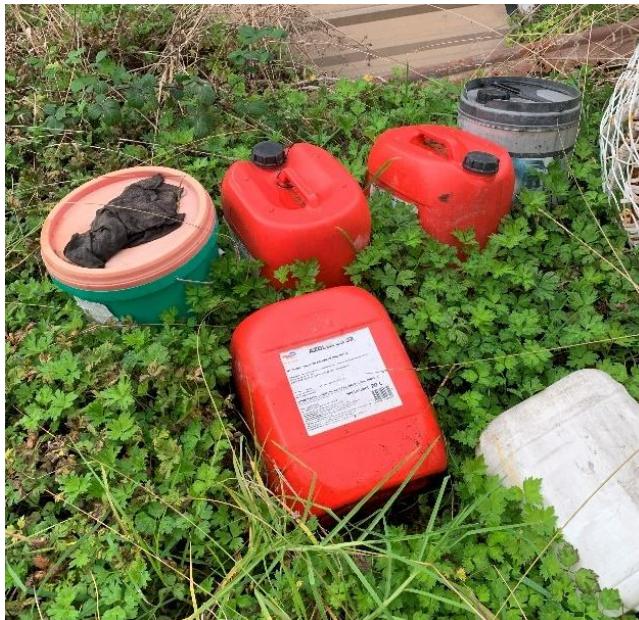
- Several small ponds are present across the wider site, apparently utilised for water supply for stock watering purposes.
- No evidence of onsite disposal of wastes (e.g. farm dumps) was observed. But storage of fuel and/or oil at residential volumes was noted in some localised areas (see **Photograph 9**, **Photograph 10** and **Photograph 15**).

Photograph 9. Containers of waste oil being stored adjacent to sheds at 55 Russell Road.

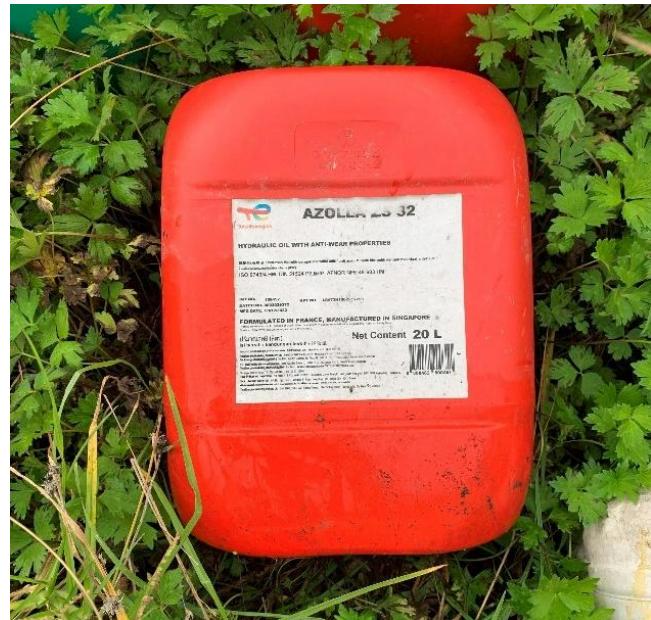
Photograph 10. Closeup of waste oil being stored adjacent to sheds at 55 Russell Road.

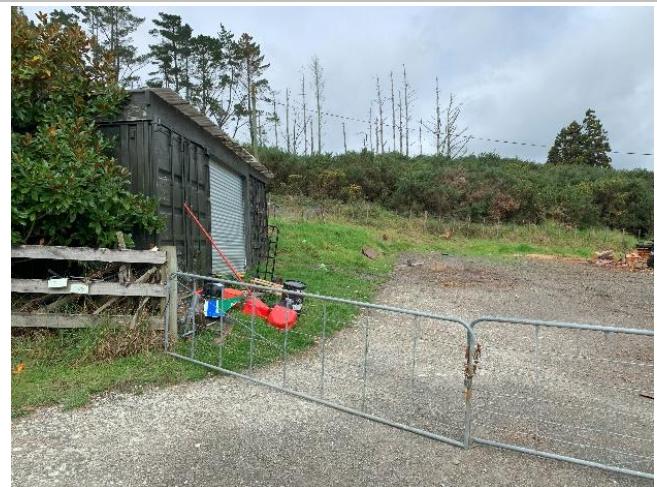
Photograph 15. Fuel and oil containers at wood cutting and splitting area at 53b Russell Road.

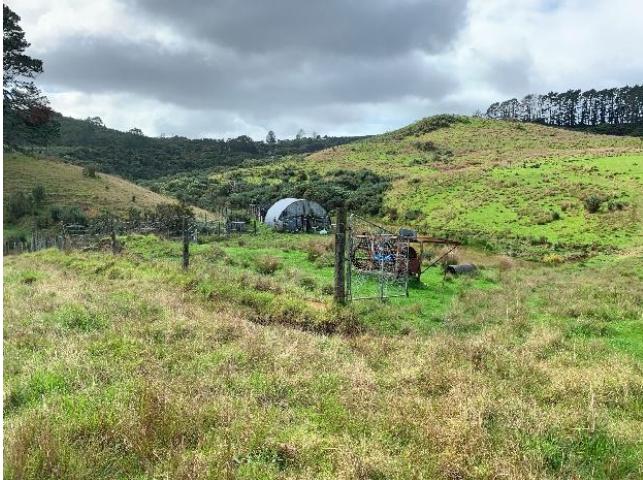
- A half round bard and associated stockyard at 130 Upper Ōrewa Road is configured for handling deer with facilities indicating that animal treatments were administered by oral or pour on application (see **Photograph 18** to **Photograph 22**).

Photograph 18. View to north over half round barn and stockyard at 130 Upper Ōrewa Road.

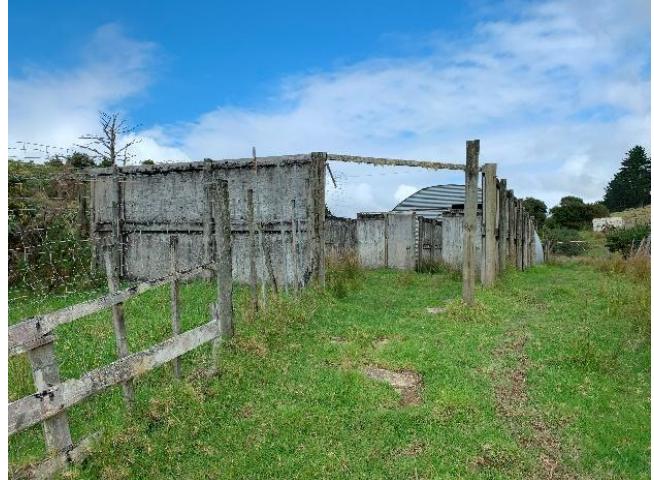
Photograph 19. View to south over half round barn and stockyard at 130 Upper Ōrewa Road.

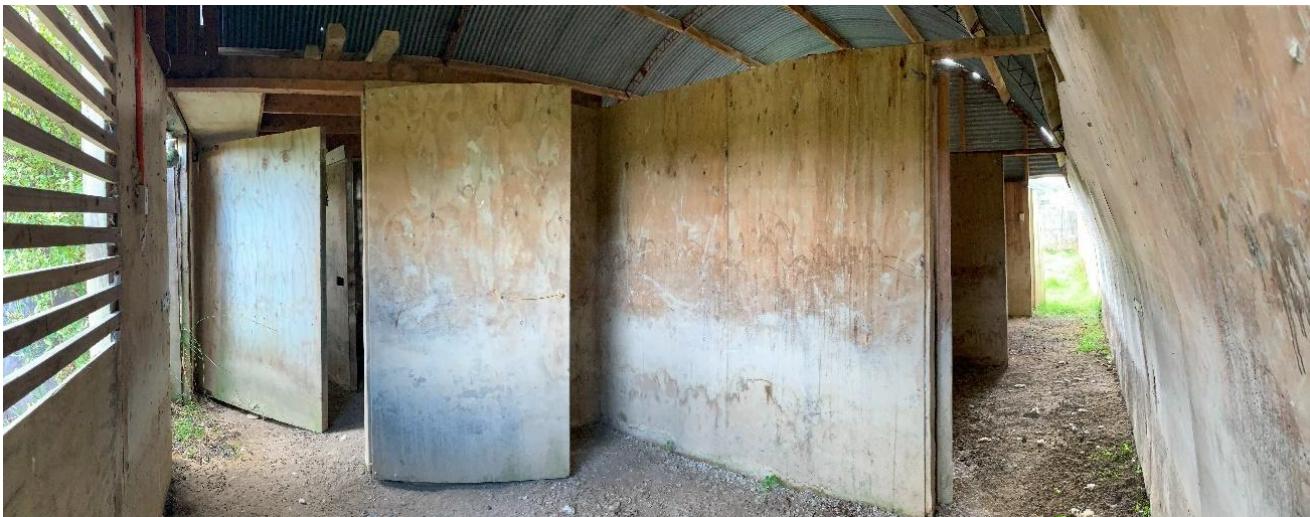
Photograph 20. View of the interior of the half round barn at 130 Upper Ōrewa Road.

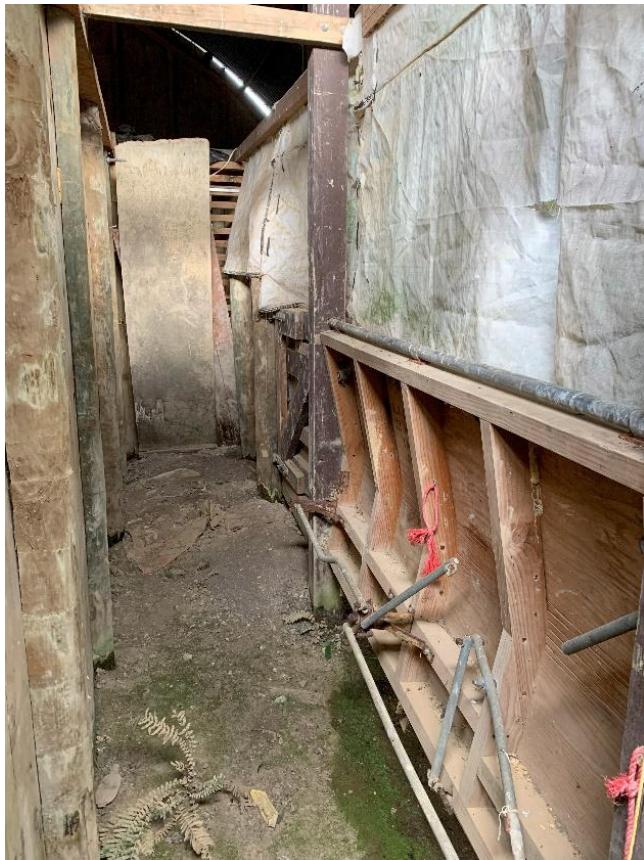
Photograph 21. Stock handling facilities in half round barn at 130 Upper Ōrewa Road.

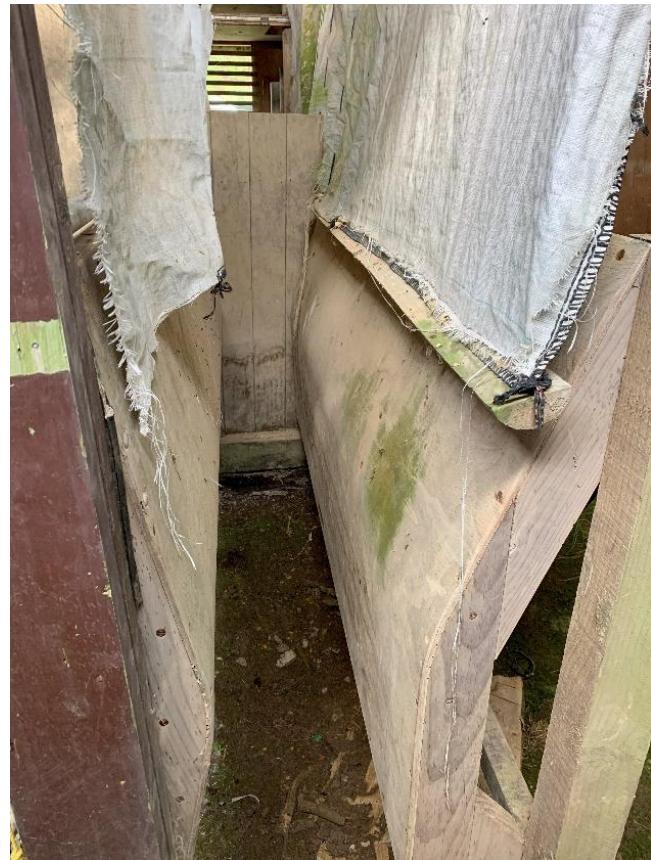
Photograph 22. Stock handling facilities in half round barn at 130 Upper Ōrewa Road.

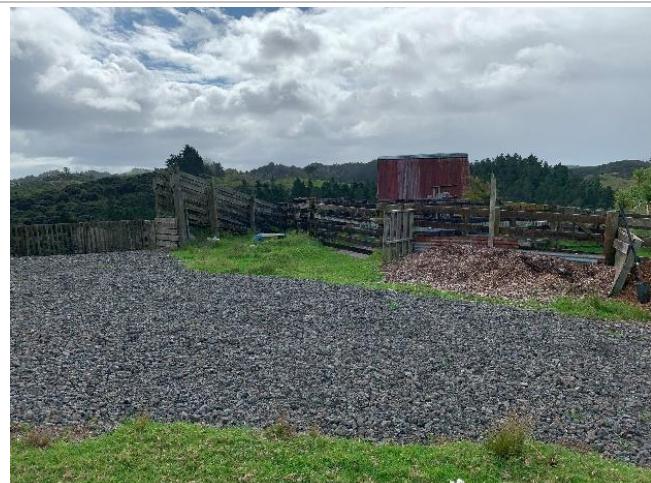
Photograph 24. View to over stockyard at 132 Upper Ōrewa Road.

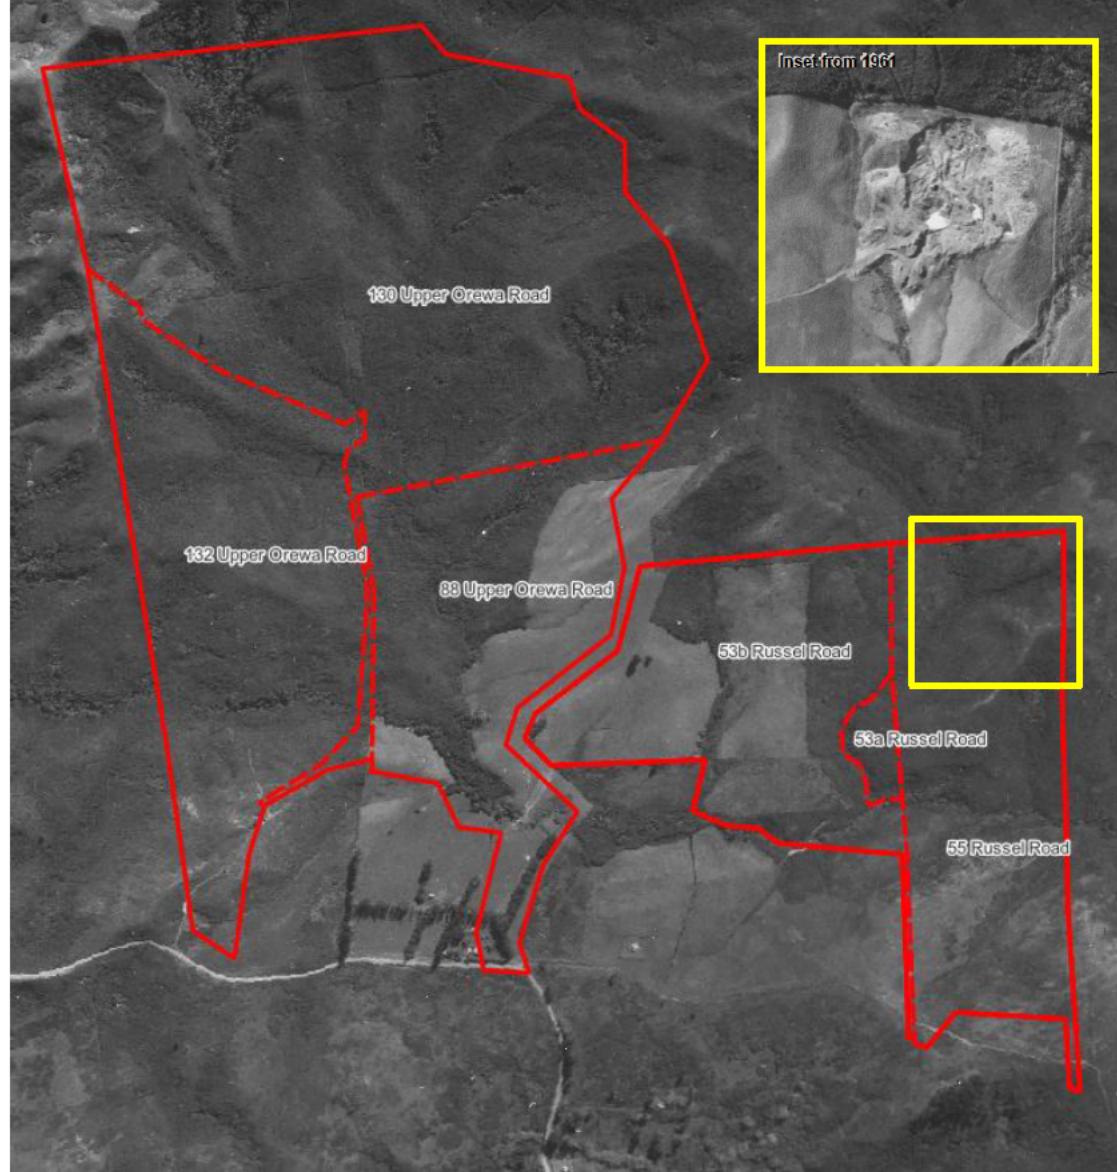
Photograph date (source)	Activities
1940 Retrolens (SN143/83/38)

<p>Notable activities or changes:</p> <ul style="list-style-type: none"> The property was primarily undeveloped, comprising a mixture of pasture and regenerating bush at this time. Upper Ōrewa Road has been formed but Russell Road appears to be a farm track. A single dwelling and shed were present on the road frontage of 88 Upper Ōrewa Road, otherwise structures are limited to occasional small barns or sheds. <p>A quarry was developed near the northeastern corner of 55 Russell Road in the 1950s (see inset in yellow outline). Quarrying of limestone rock has been a common activity in this area, both historically and currently. As shown in inset, no permanent structures were associated with the quarrying activity. The access road to the quarry crossed to the west exiting via 88 Upper Ōrewa Road.</p>

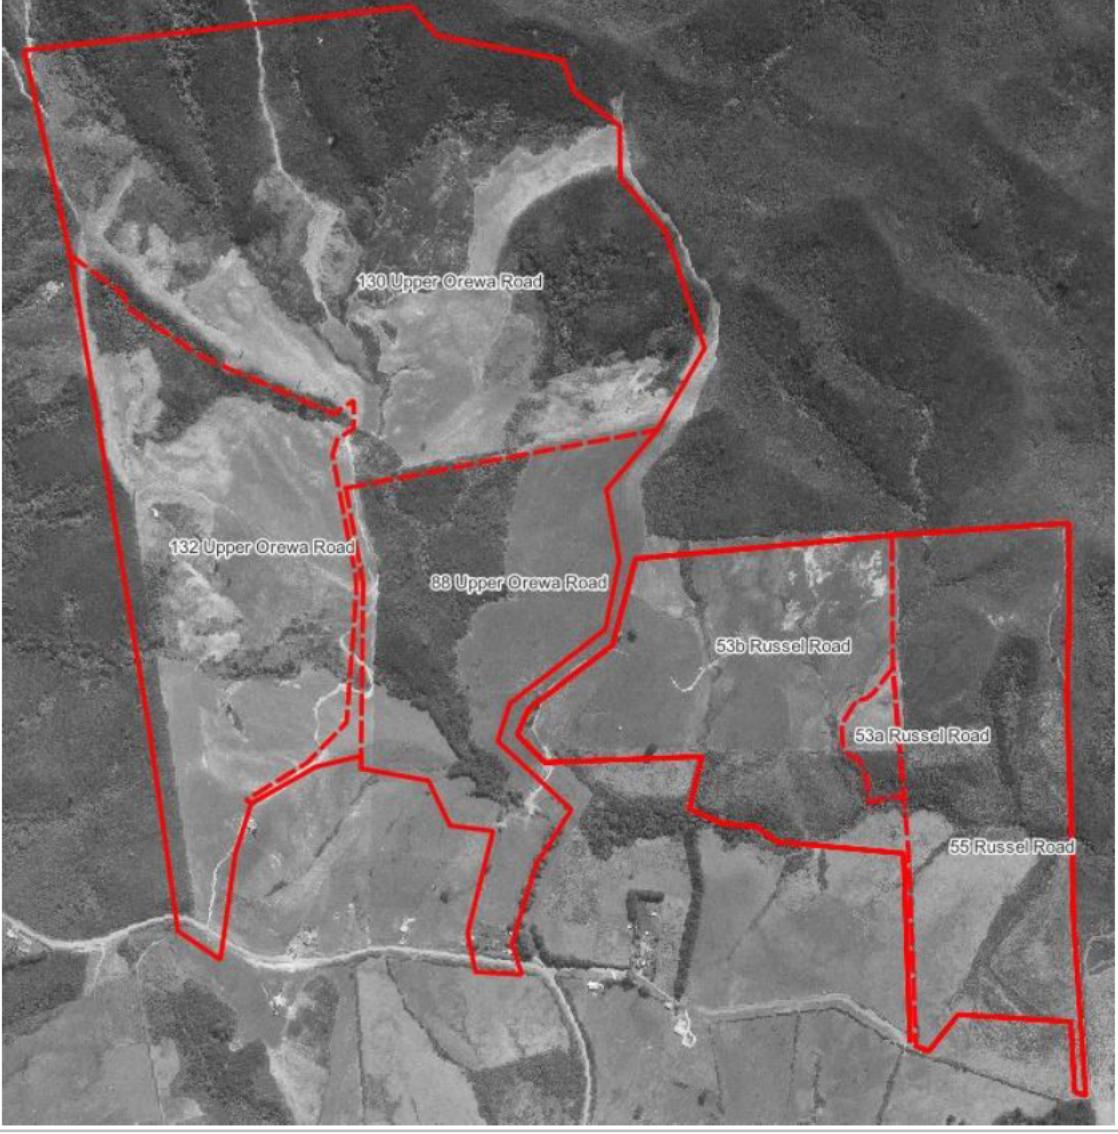
Photograph date (source)	Activities
1963 Retrolens (SN1565/C/5)

<p>Notable activities or changes:</p> <ul style="list-style-type: none"> • Much of the regenerating bush has been cleared with pastoral use becoming dominant • Russell Road has now been formed. • Quarry operations have ceased on 55 Russell Road and the accessway appears to have fallen into disuse. • A large shed or barn, accessed from Upper Ōrewa Road, has been constructed near the southern end of 132 Upper Ōrewa Road.

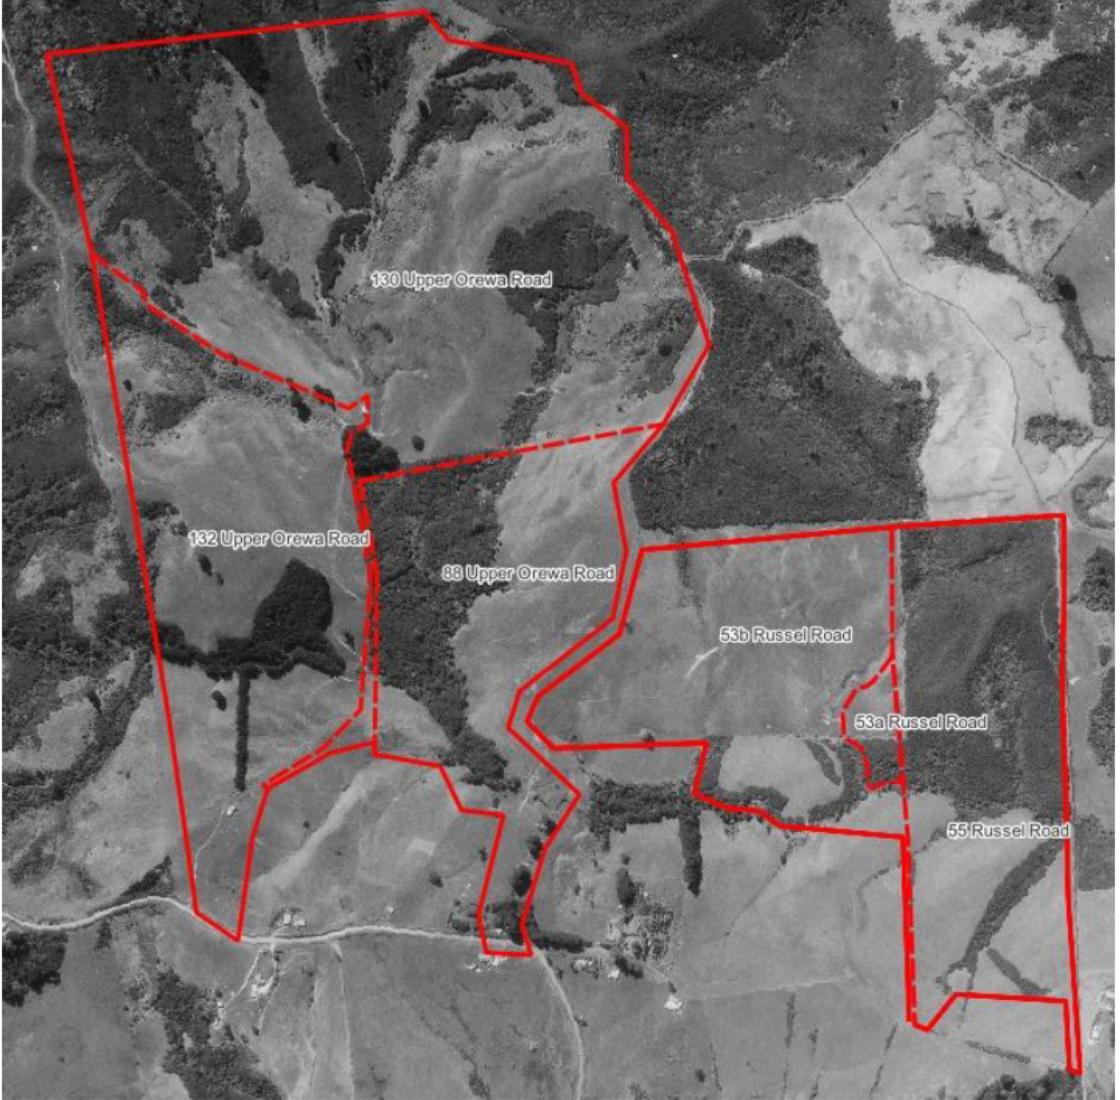
Photograph date (source)	Activities
1981 Retrolens (SN5783A/F/18)

- A large shed or barn has been constructed in northeastern corner of 132 Upper Ōrewa Road, where it adjoins the southern end of 130 Upper Ōrewa Road. It is not clear from this image which property the structure was associated with.
- An area of plantation forest has been established near the centre of 132 Upper Ōrewa Road.

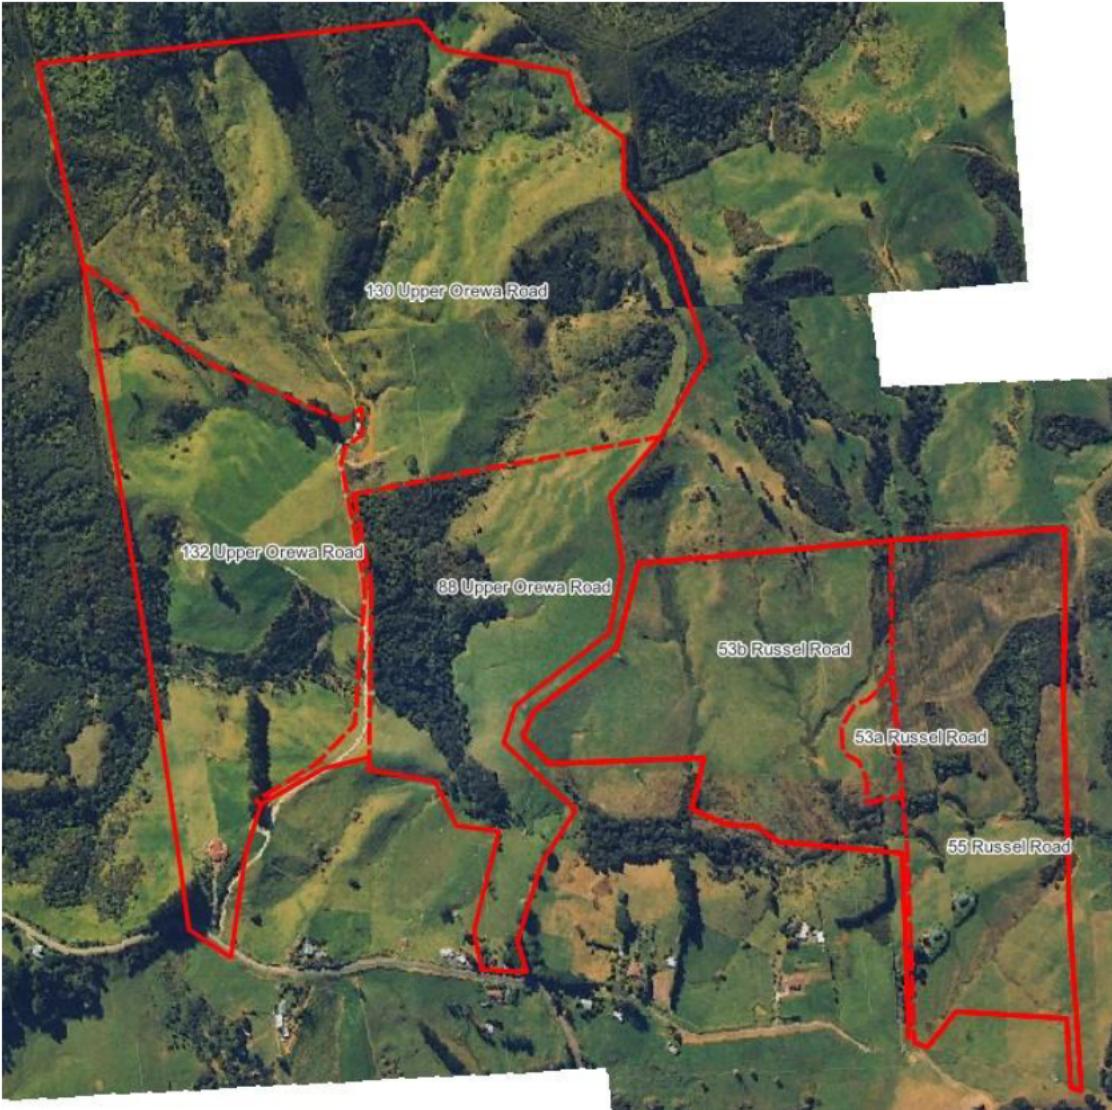
Photograph date (source)	Activities
1996 GeoMaps

<p>Notable activities or changes:</p> <ul style="list-style-type: none"> • Dwellings have been constructed near the southern end of the following properties: <ul style="list-style-type: none"> 55 Russel Road - a dwelling was first constructed in the mid-1980s (between 1981 and 1988); and 132 Upper Ōrewa Road – a dwelling was first constructed in the late 1980s-early 1990s. • The northern portion of 55 Russel Road has been cleared of scrub / bush.

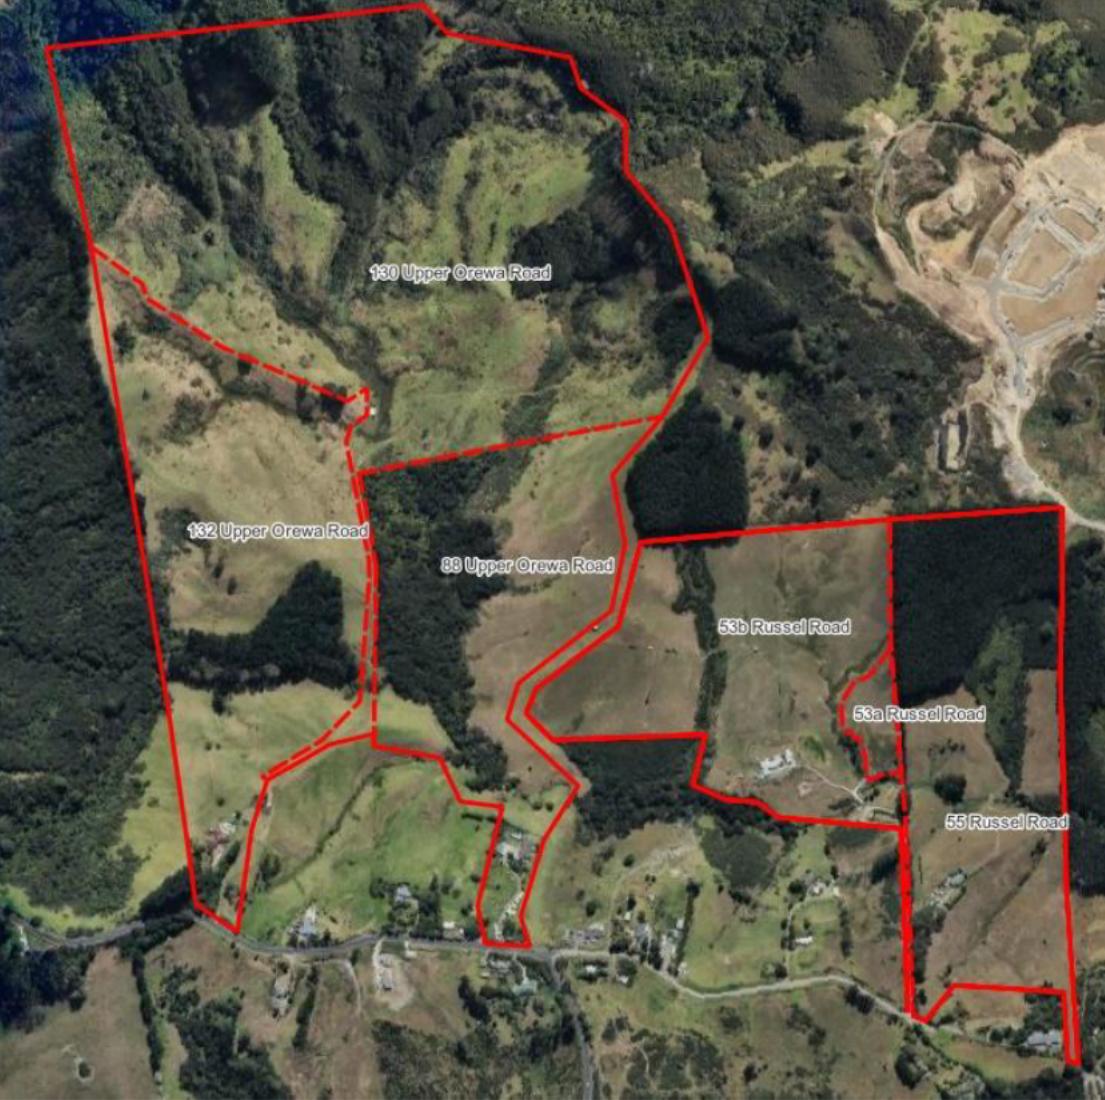
Photograph date (source)	Activities
2023 Google Earth

- 53b Russell Road - an accessway and building platform were constructed at near the southern end of this property in 2013. The property was occupied by a shed (near its southeastern corner) and various smaller structures (possibly tiny houses) until a main dwelling and adjacent minor dwelling were constructed in 2017. A small residential orchard was established near the building platform for the dwellings in 2015.

- 132 Upper Ōrewa Road – the original barn near the southern end of the property was replaced by more modern farm sheds in the 1990s or 2000s, these sheds are now located outside of the property, immediately adjacent to its eastern boundary.
