Assessment of Effects on Archaeology

Alternative to the Brynderwyn Hills – Brynderwyn Hills section

10722-PTA-2B0-PE-RPT-0006

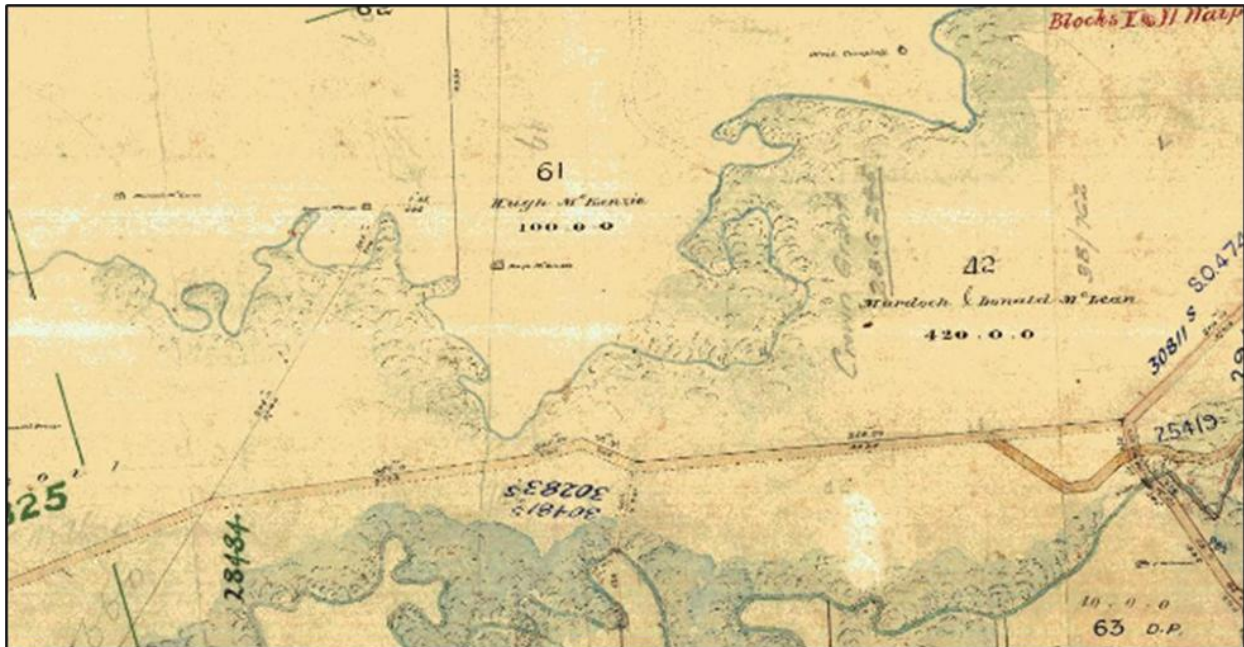
Figure 3: Detail of SO 698 (c. 1864) showing approximate locations of pre-1900 Nova Scotian buildings and bridges.

North of the Brynderwyn Hills, several cottages as well as farm buildings and bridges associated with the Nova Scotian settlement of Waipū were identified. These are represented by small sketches of buildings on early survey plans with the occupier also noted (Figure 3). Typically, the location of these buildings was eyeballed and not accurately surveyed, therefore the locations must be regarded as approximate. In several instances names are replicated, this may represent inter-map error or is a result of the historically attested process of moving cottages on sledges to new locations.

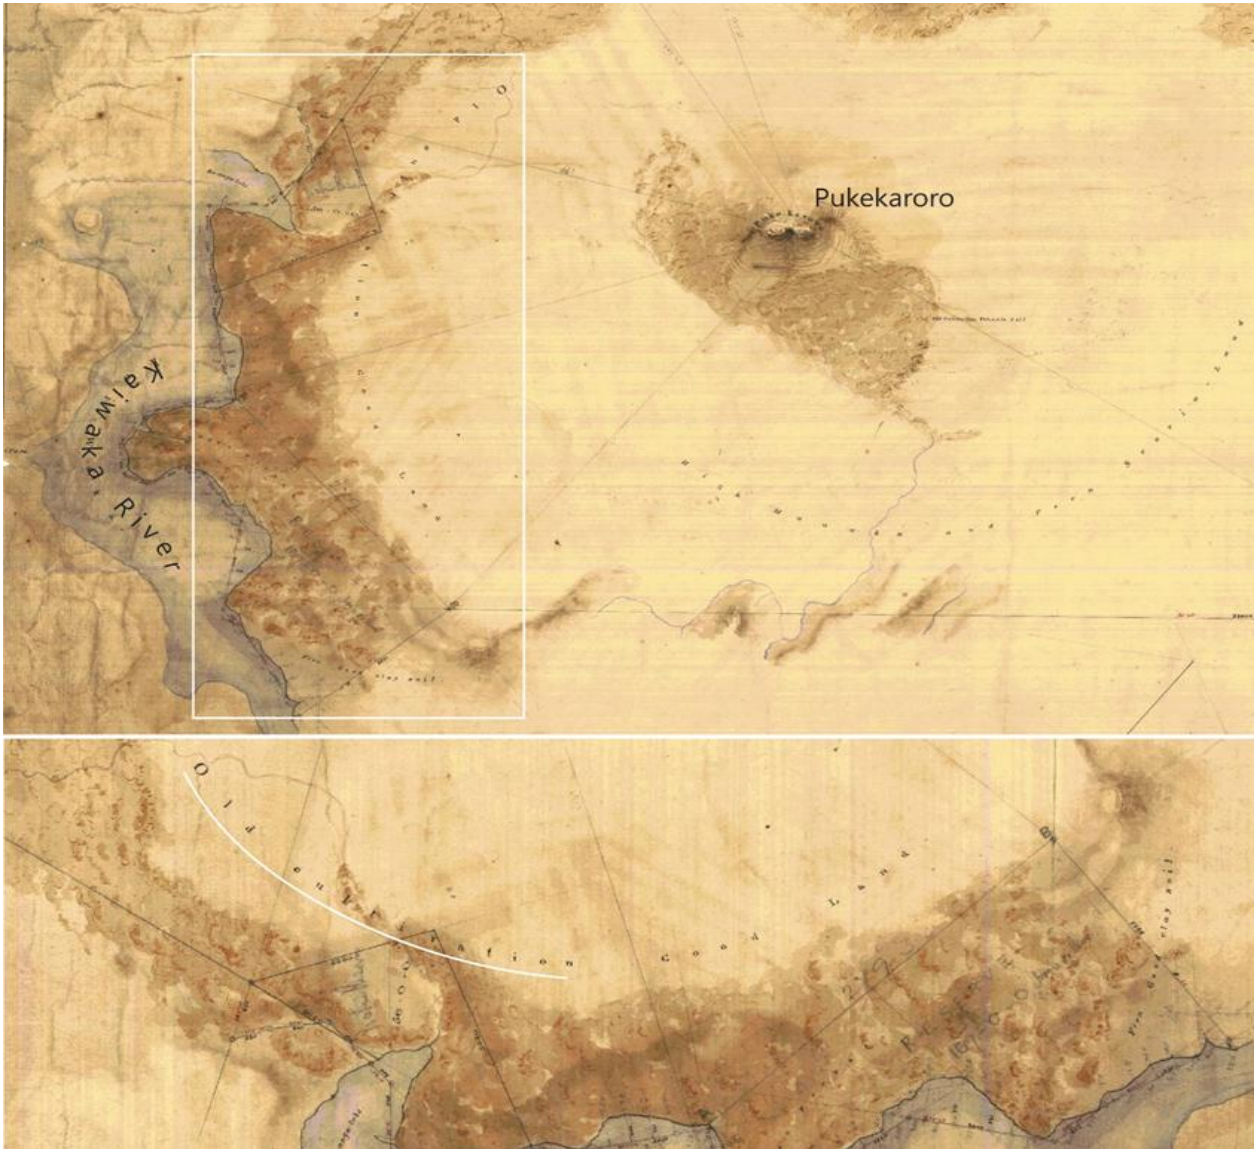
Figure 5: ML 13065 showing “Old cultivation Good Land” west of Pukekaroro.

Review of old maps and plans did not result in the identification of further historic-era sites south of the Brynderwyns. However, the presence of Māori cultivations is noted in association with good soils near the southern extent of the Proposed Designation (Figure 5). The precise location of cultivations is unclear, but this indicates the likely presence of such sites on similar soil in the vicinity.

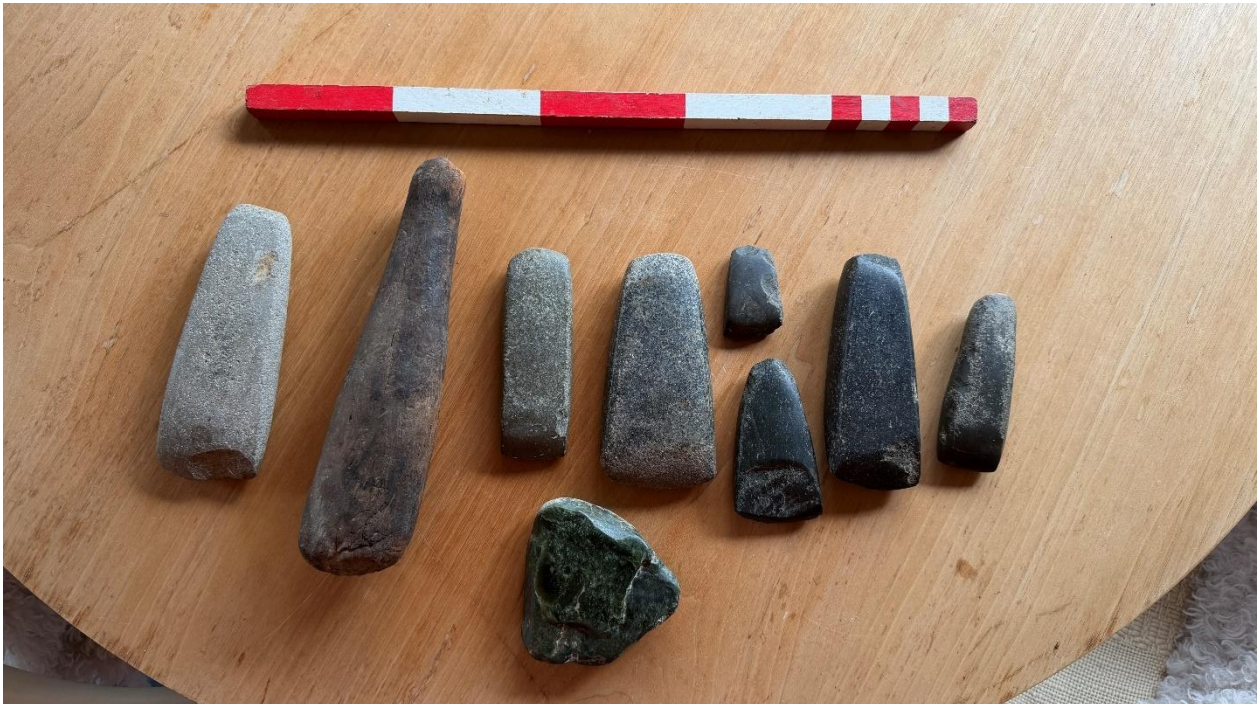
Several taonga – seven toki (adze), one patu muka (flax beater) and one small block of polished pounamu – have been found in the eco village at the southern termination, just outside of the Proposed Designation and are held by Te Uri o Hau. Five of the toki appear to be basalt, one is probably gabro and the other is probably pakohe (argillite) from the northern South Island. Two, including the probable pakohe toki, are quite small, indicating they have been curated for several generations, becoming progressively smaller as they are sharpened and reshaped. These have not been recorded as an archaeological site but are indicative of the potential for finds along the Proposed Designation.

Figure 7: Taonga found in the general vicinity of pā Q08/651 – probable gabro toki on left, patu muka second from left, probable pakohe toki third from right on bottom. Photo scale = 0.5 m.

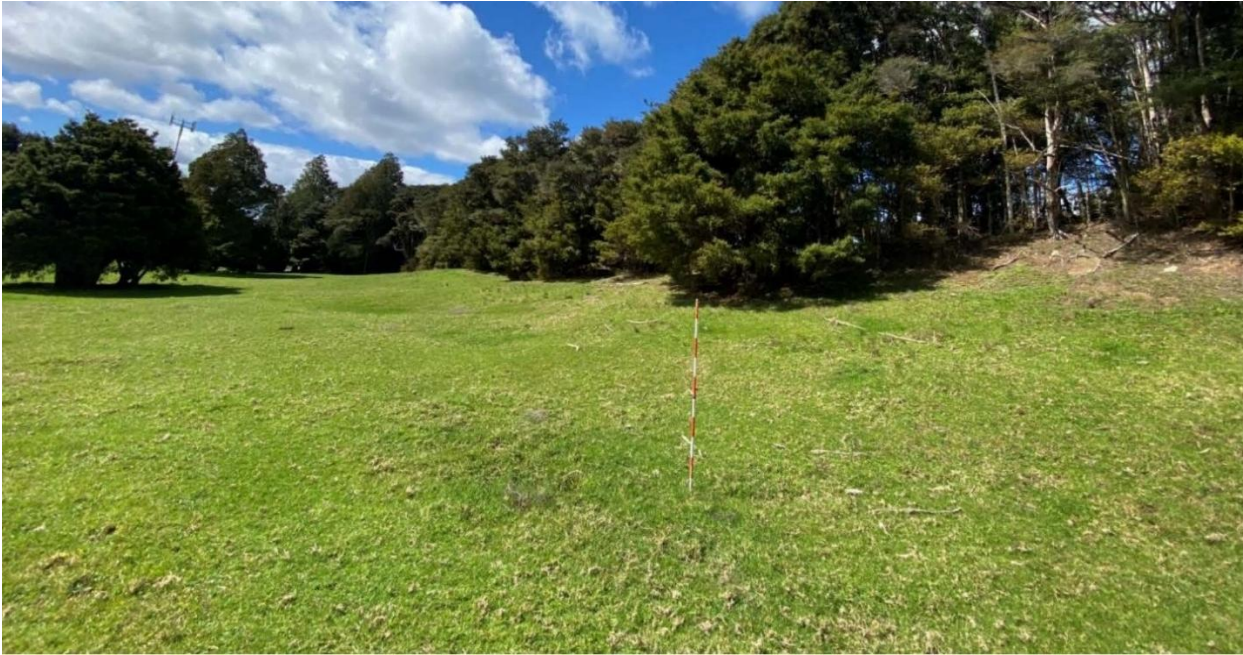
Figure 10: Q08/360, terraces and pits, from the NZAA site record.

Condition	Pā Q08/360 was not visited during this assessment but previous records indicate it is in good condition.
Rarity	Pā are a moderately common site type locally, regionally and nationally.
Context	Pā Q08/360 is part of a wider pre-European Māori archaeological landscape stretching from Pukekaroro to the Brynderwyns and the Kaipara Harbour.
Information	There is the potential for scientific information to be recovered by archaeological methods if Pā Q08/360 was affected by construction (it is not in the Indicative Alignment, and our recommendations are that it continue to be avoided).
Amenity	Pā Q08/360 has limited amenity – it is on private land and is not easily accessed, surface features have limited visibility, and it is not readily interpreted to the public.
Cultural	Pā Q08/360 is a pre-European Māori site, and its cultural values can only be determined by tangata whenua.

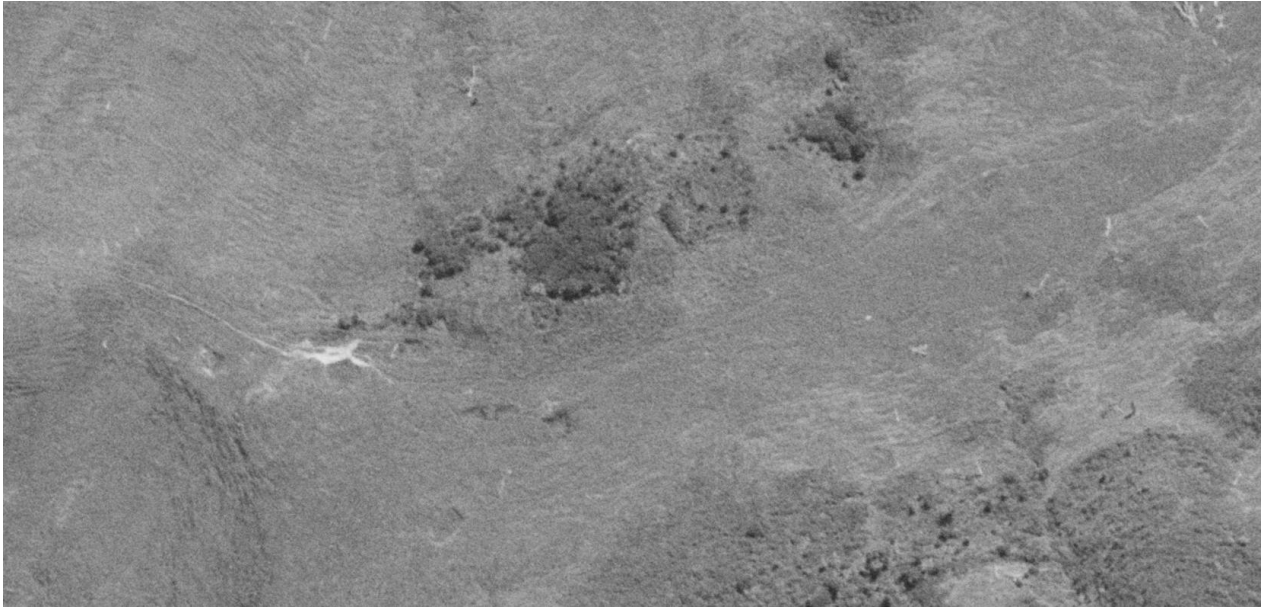
This pit site was recorded by Tony Walton (about the 1980s – no date is given on the site record form) from aerial photo SN212/425/48, flown 20 May 1963, and subsequently by Leigh Johnson in 1997. Johnson recorded that the site had been damaged, but some pits remained visible. These are not clear in the current aerial photography or LiDAR data. The site was not visited as part of the current assessment.

Figure 12: Q08/56 visible in aerial photo SN212/426/47, flown 20 May 1963.

Condition	Q08/56 was not visited during this assessment but a comparison of early aerial photos and modern photos indicates it is in poor condition. The survival of subsurface features is unknown.
Rarity	Pit sites are a common site type locally, regionally and nationally.
Context	Q08/56 is part of a wider pre-European Māori archaeological landscape stretching from Pukekaroro to the Brynderwyns and the Kaipara Harbour.
Information	There is the potential for scientific information to be recovered by archaeological methods if Q08/56 was affected by construction (it is not in the Indicative Alignment, and our recommendations are that it be avoided).
Amenity	Q08/56 has limited amenity – it is on private land and is not easily accessed, surface features have limited visibility, and it is not readily interpreted to the public.
Cultural	Q08/56 is a pre-European Māori site, and its cultural values can only be determined by tangata whenua.

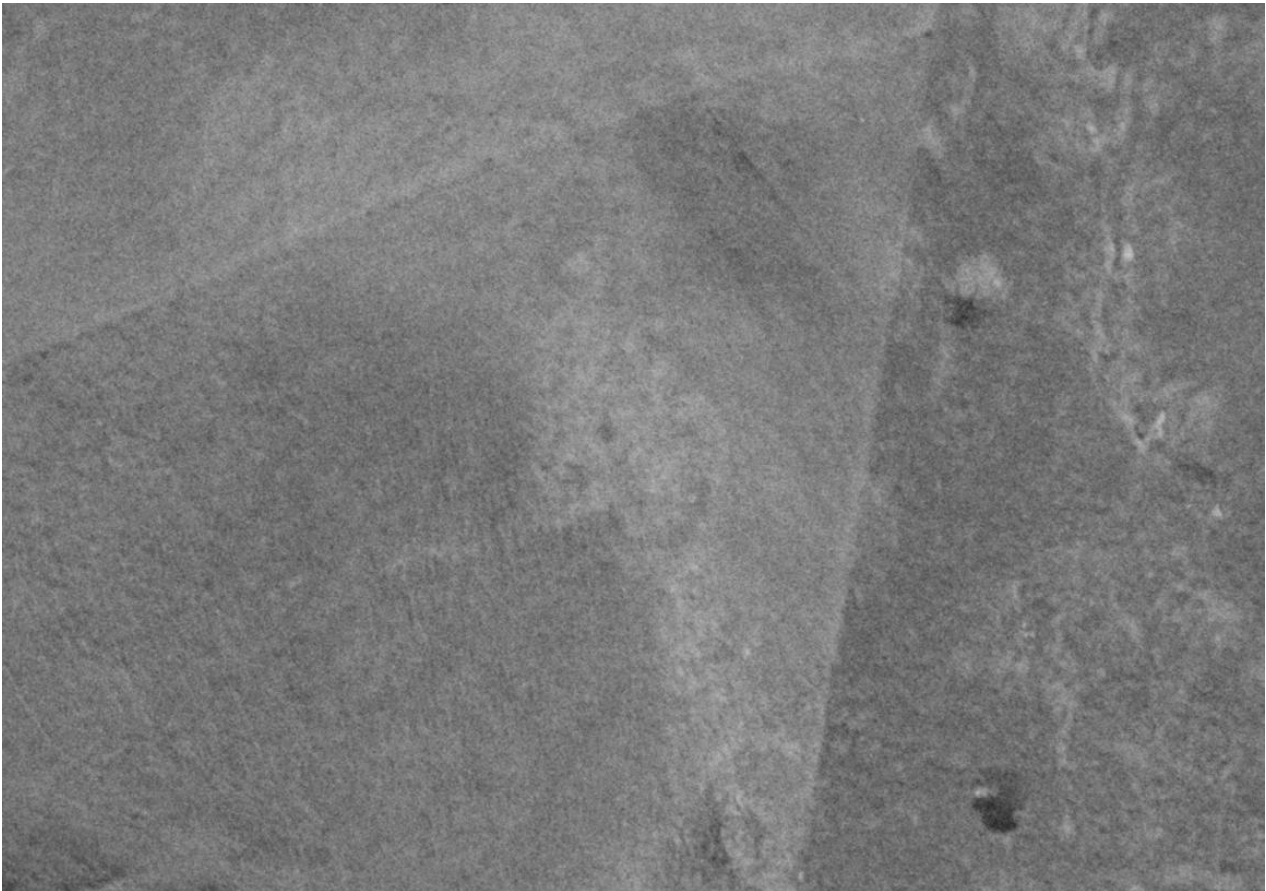
This pit site was recorded by Tony Walton (about the 1980s – no date is given on the site record form) from aerial photo SN212/425/48, flown 20 May 1963, and by Leslie Goodliffe and David Bulmer in 1983 during survey for a gas pipeline (Goodliffe and Bulmer 1983). They described “About ten poorly preserved depressions, the largest 3 m x 2 m x 0.5 m, some of the smaller depressions have very unclear outlines.”

Figure 16: Q08/57 visible in aerial photo SN212/414/51, flown 20 May 1963.

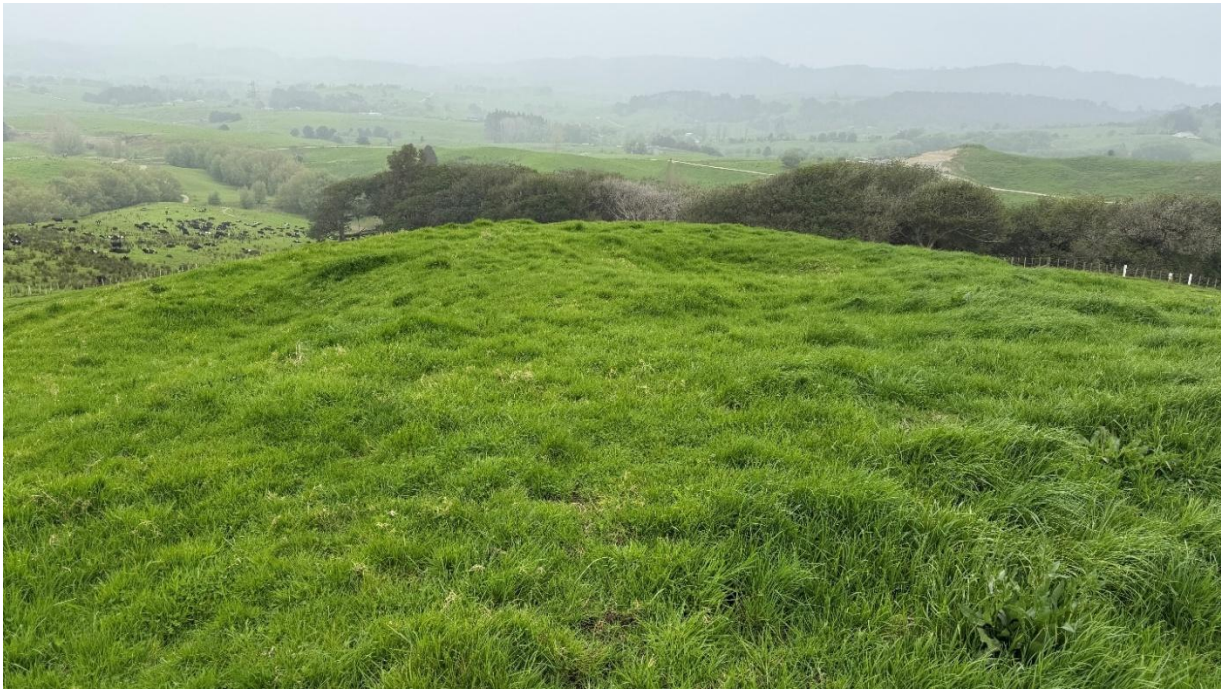
The site was inspected by Matthew Campbell and Te Uri o Hau kaitiaki Colin Flavell on 13 October 2025. The site is under low grass and ground surface visibility was reasonable. It remains much as they described it and the pits do not seem to have deteriorated much. The site is in fair condition.

Figure 18: Q08/57, pits looking north.

Condition	The pits remain visible and much as they were when first recorded in 1983. Subsurface survival of features is likely to be good.
Rarity	Pit sites are a common site type locally, regionally and nationally.
Context	Q08/57 is part of a wider pre-European Māori archaeological landscape stretching from Pukekaroro to the Brynderwyns and the Kaipara Harbour.
Information	There is the potential for scientific information to be recovered by archaeological methods if Q08/57 was affected by construction (it is in the Indicative Alignment and our recommendation is that any effects be mitigated through an archaeological authority).
Amenity	Q08/57 has limited amenity – it is on private land and is not easily accessed, and it is not readily interpreted to the public.
Cultural	Q08/57 is a pre-European Māori site, and its cultural values can only be determined by tangata whenua.

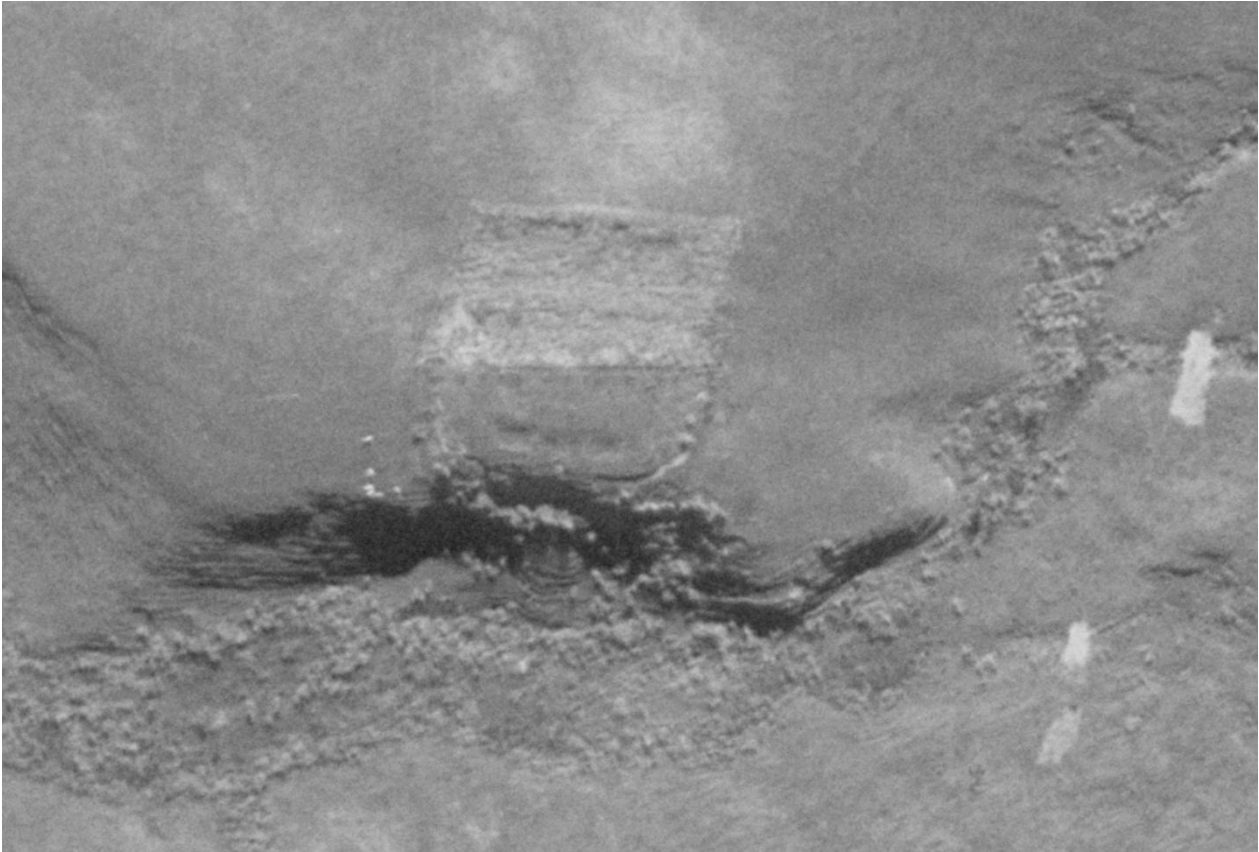
This unnamed pā was recorded by Tony Walton (about the 1980s – no date is given on the site record form) from aerial photo SN212/414/51, flown 20 May 1963, but not visited at the time. No description is given in the site record other than “Pa with pits” but the aerial photo shows terracing to the east and west ends on a low hill with two east-west running rows of pits. The north of the site is quite obscured by some farming activity, but there appears to be another row of pits (Figure 20).

Figure 20: Q08/39 visible in aerial photo SN212/424/51, flown 20 May 1963.

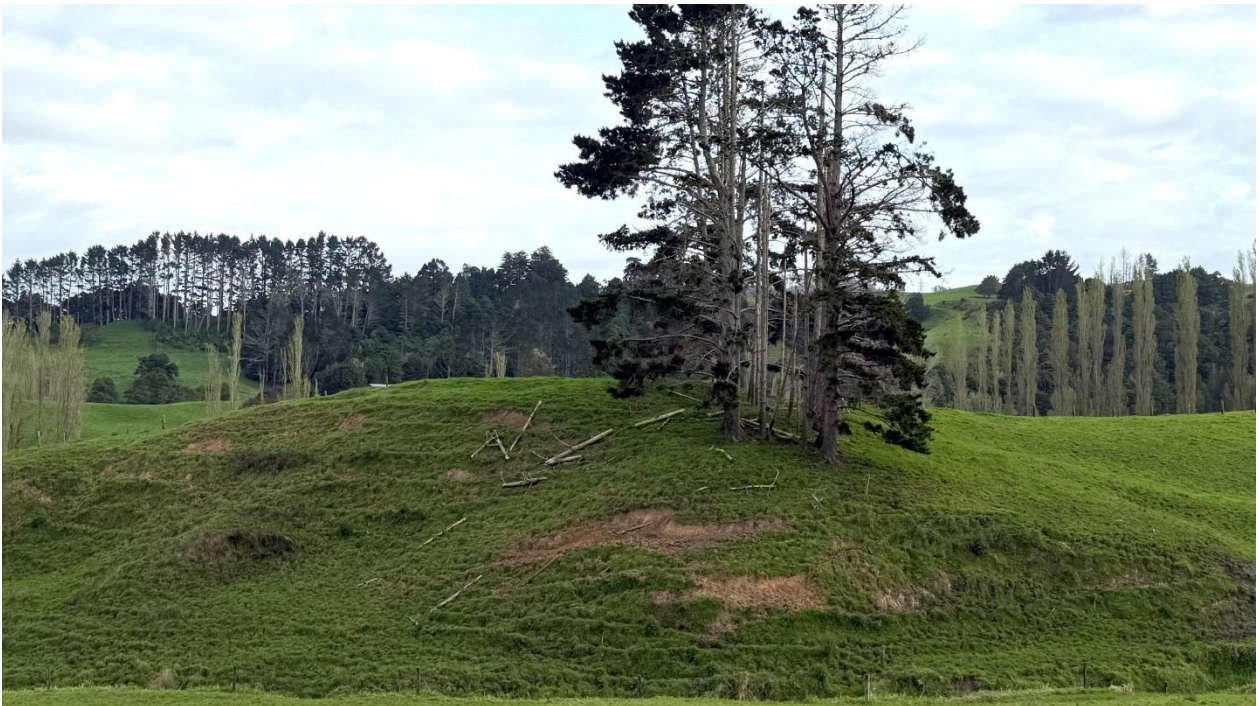
The site was inspected by Matthew Campbell and Te Uri o Hau kaitiaki Colin Flavell on 13 October 2025. The western end of the hill on which the site is located had been quarried for limestone, but this does not appear to have affected any archaeological features. A shallow, mostly infilled ditch was visible at the western end of the site with two pits on a shallow terrace east of this, two rows of four pits on the top of the hill and steepened banks to the north and east. The site is in fair condition.

Figure 21: Q08/39 viewed from the south. A row of pits is visible just below the crest of the hill.

Condition	Pā Q08/39 is currently under grass. The ditch has been partially filled but remains visible and ten pits are also clearly visible, though often shallow. Subsurface survival of features is likely to be good.
Rarity	Pā are a moderately common site type locally, regionally and nationally.
Context	Pā Q08/39 is part of a wider pre-European Māori archaeological landscape stretching from Pukekaroro to the Brynderwyns and the Kaipara Harbour.
Information	There is the potential for scientific information to be recovered by archaeological methods if Pā Q08/39 was affected by construction (it is not in the Indicative Alignment, and our recommendations are that it continue to be avoided).
Amenity	Pā Q08/39 has limited amenity – it is on private land and is not easily accessed, and although surface features are reasonably visible it is not readily interpreted to the public.
Cultural	Pā Q08/39 is a pre-European Māori site, and its cultural values can only be determined by tangata whenua.

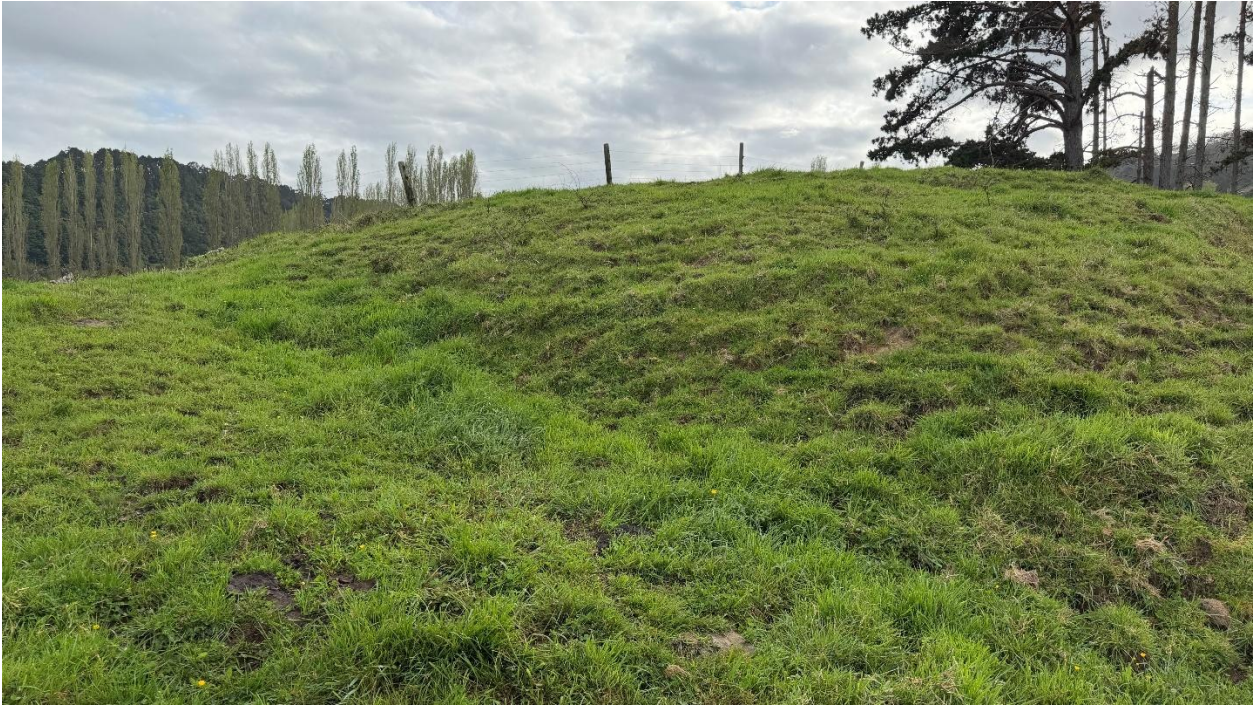
Figure 22: Q08/39, shallow infilled ditch.

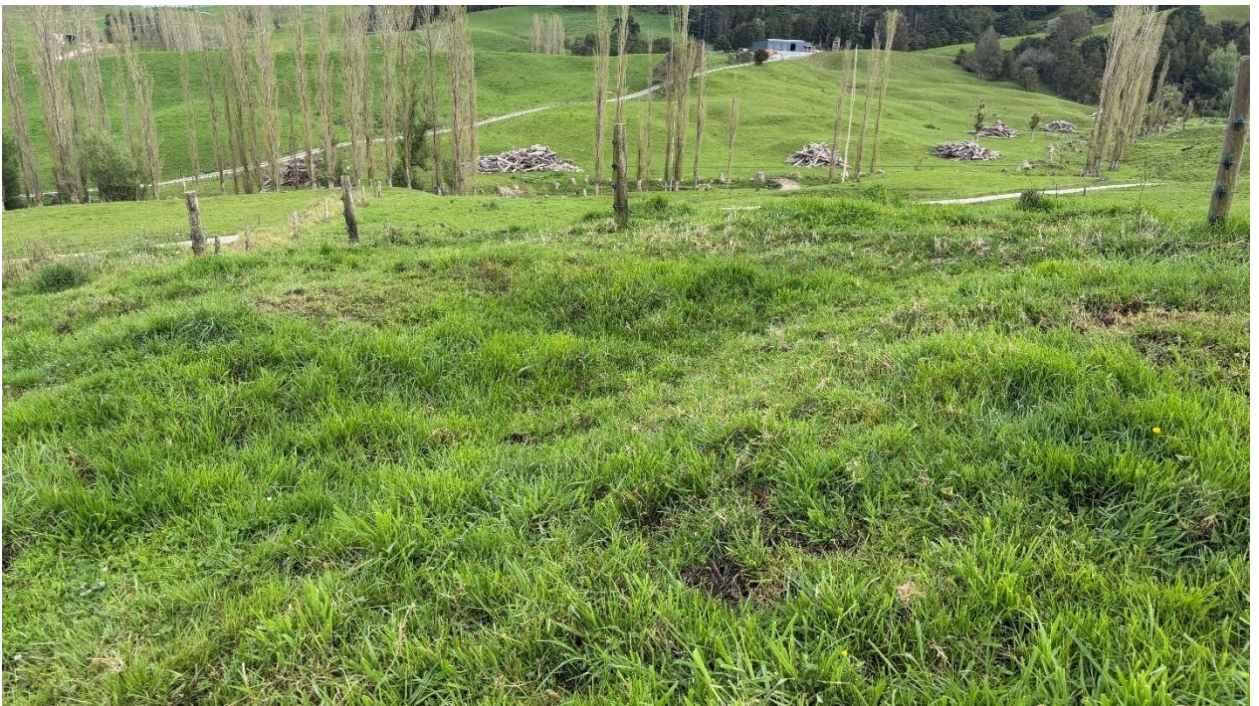
Figure 23: Q08/39, Pit 1, looking west.

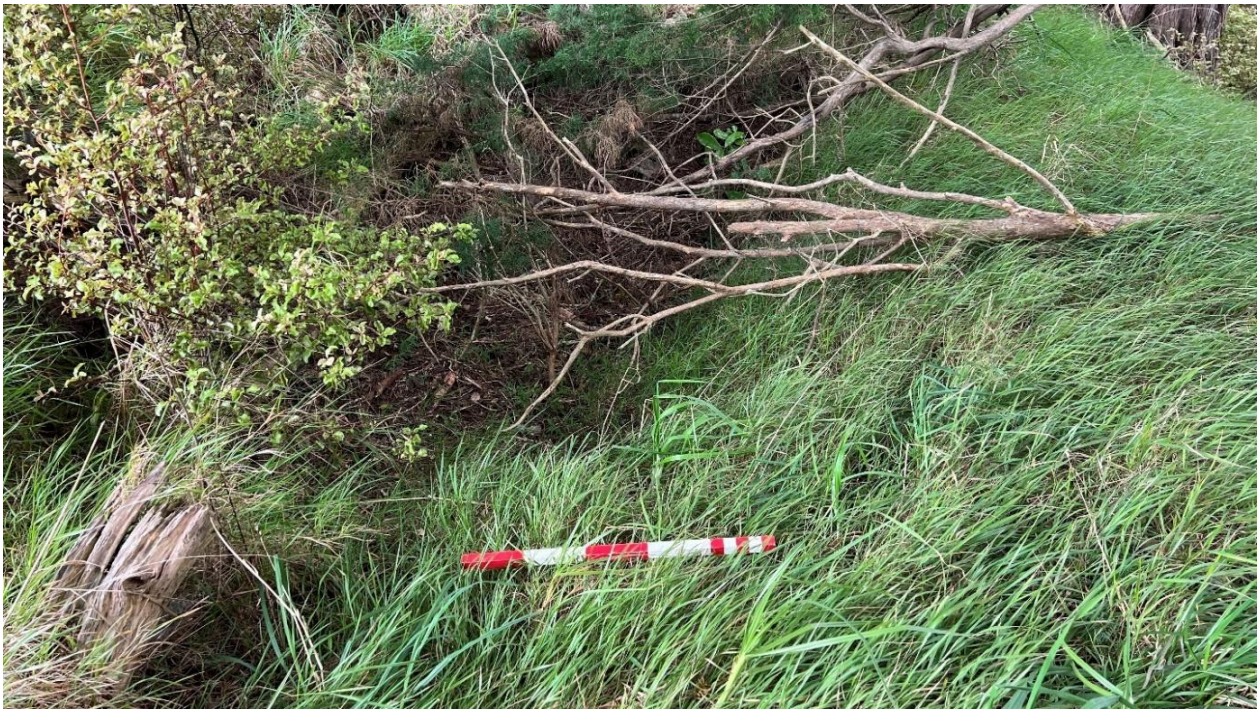
This pit site was recorded by Matthew Campbell, accompanied by Te Uri o Hau kaitiaki Tipene Ratima, on 22 September 2025 during a site visit for this assessment. It is located at the top of a steep south-facing escarpment under establishing second growth native bush. Ground surface visibility was good. The site consists of a row of five pits, one of which is in the fence line and quite shallow, while the other four are behind the fence and in better condition as they are not often accessed by stock. They are up to 0.5 m deep. The site is in fair condition.

Figure 26: Q08/703, Pit 3 (Figure 27), looking east. Photo scale = 0.5 m.

Condition	Five pits in good condition are visible. Subsurface survival of features is likely to be good.
Rarity	Pit sites are a common site type locally, regionally and nationally.
Context	Q08/703 is part of a wider pre-European Māori archaeological landscape stretching from Pukekaroro to the Brynderwyns and the Kaipara Harbour.
Information	There is the potential for scientific information to be recovered by archaeological methods if Q08/703 was affected by construction (it is not in the Indicative Alignment, and our recommendations are that it be avoided).

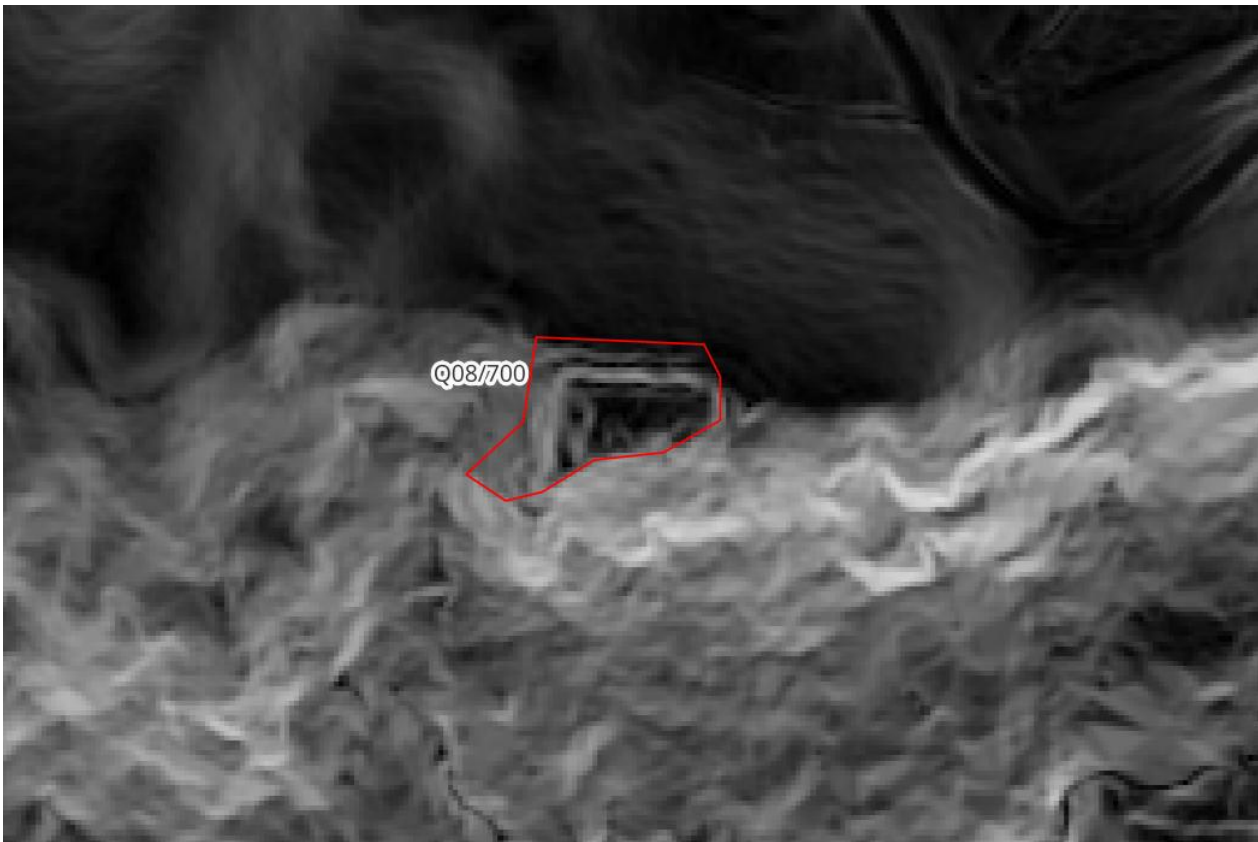
This unnamed pā was recorded by Matthew Campbell, accompanied by Te Uri o Hau kaitiaki Tipene Ratima, on 22 September 2025 during a site visit for this assessment. It is located at the top of a steep south-facing escarpment under dense second growth native bush. Ground surface visibility ranged from good to poor. The site is behind the fence and in variable condition – it is not often accessed by stock, and some features are well preserved although others are very shallow or filled by mature trees. The northern, east–west running ditch just behind the fence is in good condition, clearly visible, and 4 m wide, up to 2.5 m high with a 800 mm high bank behind it. As it bends to the south at its western end it becomes shallower. There are two large deep pits just behind the western ditch up to 1.5 m deep while other pits are shallower and quite vague in outline. The ditch and the two larger pits are visible in the LiDAR slope model. The steep drop off of the escarpment to south and east provided protection from those quarters. The site is in fair but variable condition.

Figure 29: Pā Q08/700 visible in LiDAR slope data.

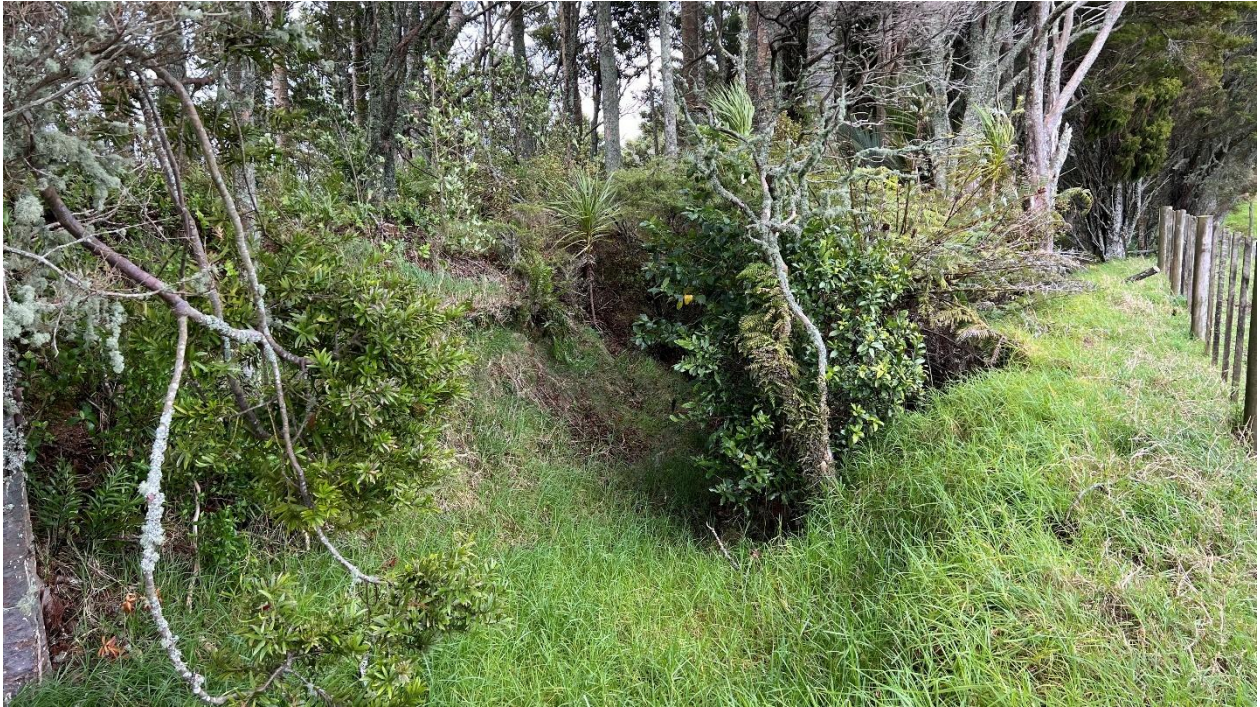
Figure 30: Northern, east-west running ditch of pā Q08/700.

Condition	Pā Q08/700 is currently under regenerating bush – the ditch is in good condition as are two pits, but other internal features are difficult to make out. Subsurface survival of features is likely to be good.
Rarity	Pā are a moderately common site type locally, regionally and nationally.
Context	Pā Q08/700 is part of a wider pre-European Māori archaeological landscape stretching from Pukekaroro to the Brynderwyns and the Kaipara Harbour.
Information	There is the potential for scientific information to be recovered by archaeological methods if Pā Q08/700 was affected by construction (it is not in the Indicative Alignment, and our recommendations are that it be avoided).
Amenity	Pā Q08/700 has limited amenity – it is on private land and is not easily accessed, and it is not readily interpreted to the public.
Cultural	Pā Q08/700 is a pre-European Māori site, and its cultural values can only be determined by tangata whenua.

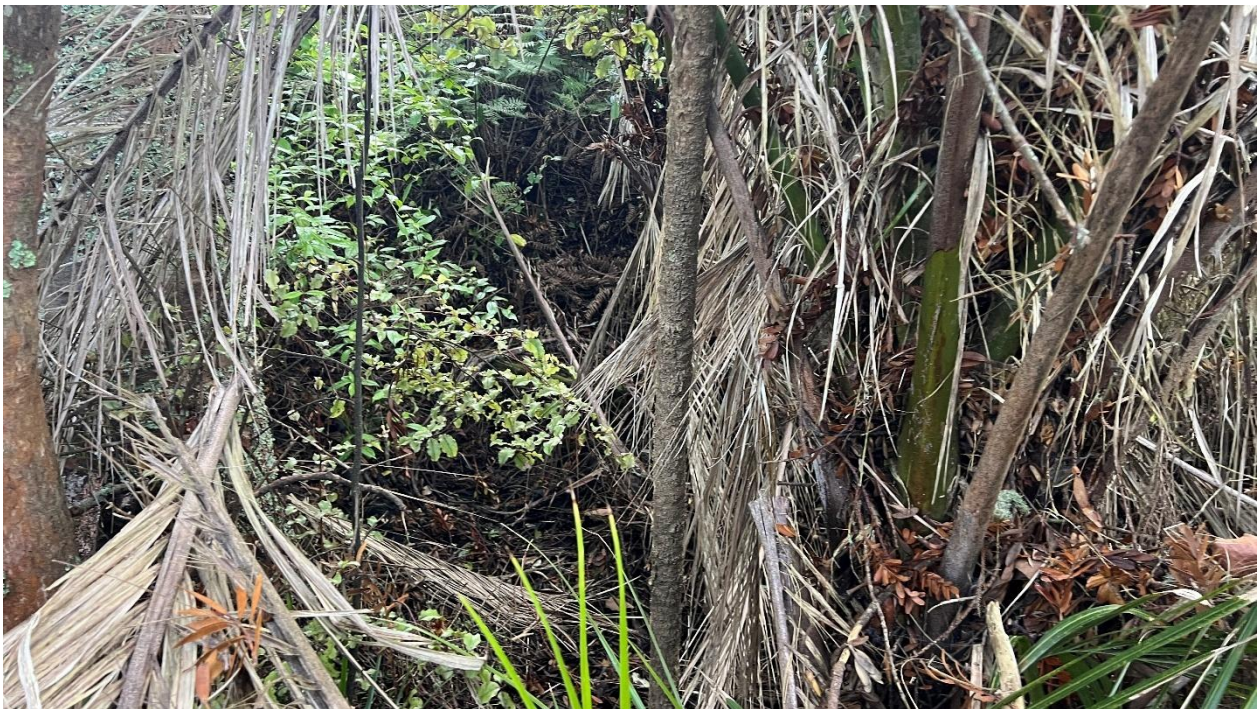
Figure 31: Pit 2 (Figure 32), looking south.

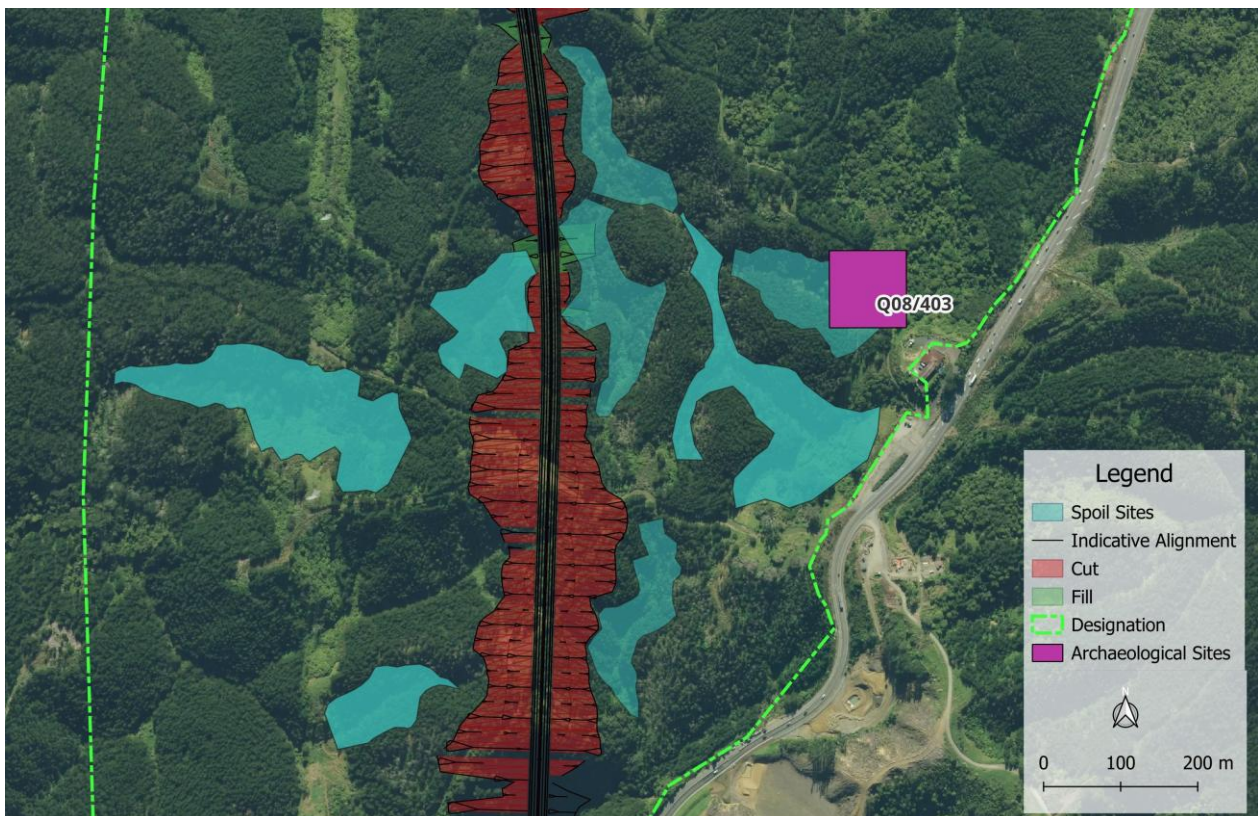
Figure 34: Location of Q08/403 in relation to currently designed earthworks.

The recorded location of Q08/403 is outside the Indicative Alignment, but on the margin of a spoil site. At least two rotations of forestry operations have resulted in considerable landscape modification such that, if ever present, features associated with the findspot were not visible. Nevertheless, given the level of proposed earthworks in this zone, it is reasonable to suspect unrecorded, subterranean features may be impacted by works.

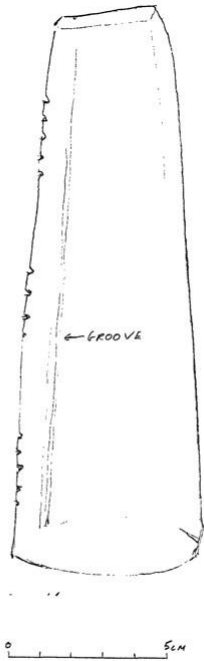
ROUGH SKETCH OF NEPHRITE ADZE

Q08/403 is a findspot for a pounamu toki. The site was recorded by Joan Maingay in 1999 on the basis of a report from a member of the public. The toki measured 17.9 x 5.8 cm with notching along one edge (Figure 35). No evidence of occupation was noted where the artefact was found, and its recorded location represents a best estimate.

Figure 35: Sketch of toki.

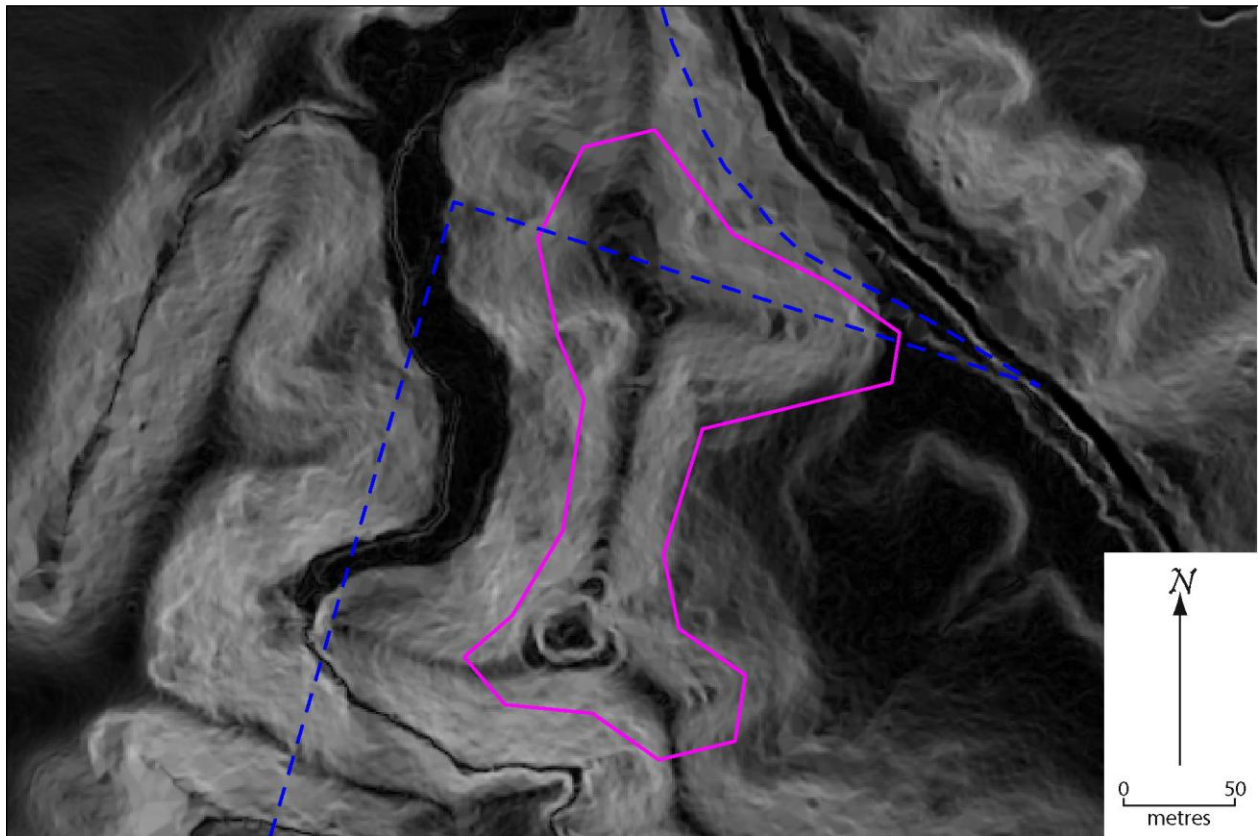
Figure 37: LiDAR-derived slope map showing the extent of Q08/546.

Condition	High. Q08/546 is currently under regenerating bush – based on LiDAR data the site appears to be in good condition. Subsurface survival of features is likely to be good.
Rarity	Medium. Pā are a common site type locally, regionally and nationally.
Context	High. Q08/546 is part of a wider pre-European Māori archaeological landscape, which includes a string of pā on the lower slopes of the Brynderwyn and Mareretū hills overlooking Waipū.
Information	High. There is the potential for significant scientific information to be recovered by archaeological methods if Pā Q08/546 was affected by construction (it is not in the Indicative Alignment, and our recommendations are that it be avoided).
Amenity	Low. Q08/546 has limited amenity – it is on private land and is not easily accessed, and it is not readily interpreted to the public.
Cultural	Pā Q08/546 is a pre-European Māori site, and its cultural values can only be determined by tangata whenua.

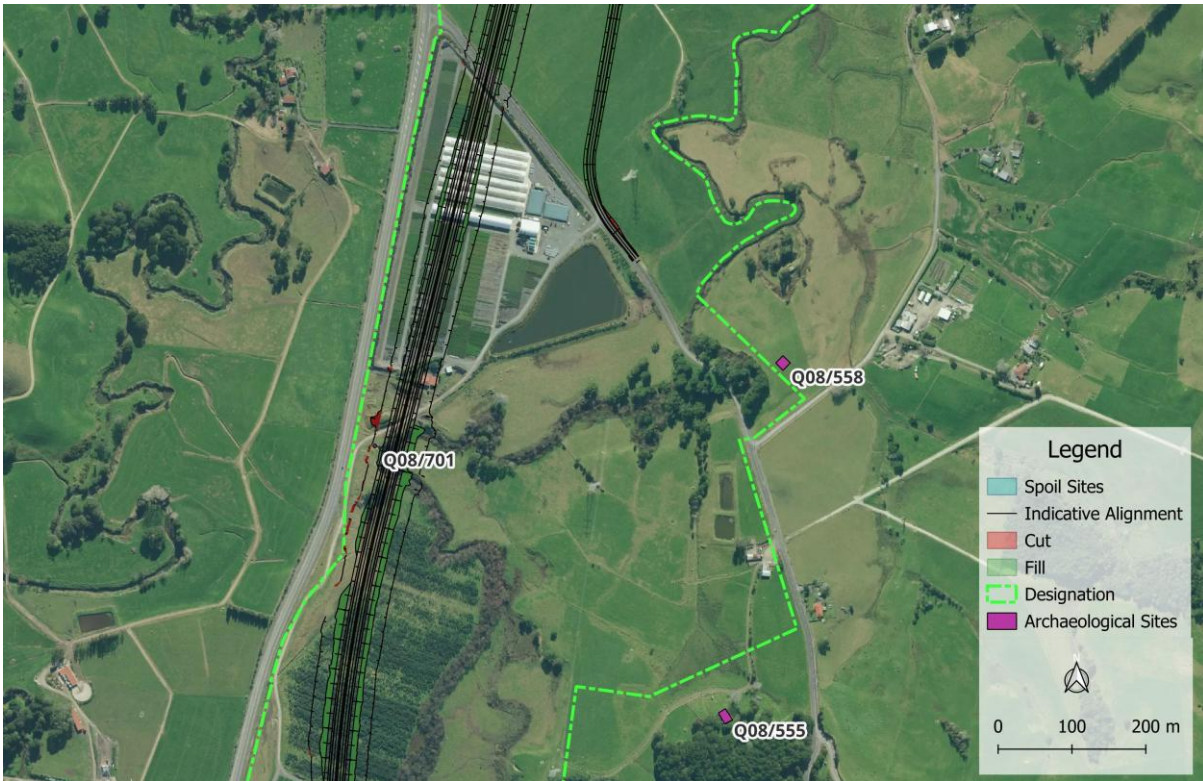
Figure 38: Location of Q08/701 in relation to currently designed earthworks.

This site was recorded by Andy Brown and Reese Newton during the present survey. The site is a small (c. 1m²) shell midden exposed in a drain cutting approximately 5 m west of the Waihoihoi Stream. The site is currently located on the margin of the Indicative Alignment.

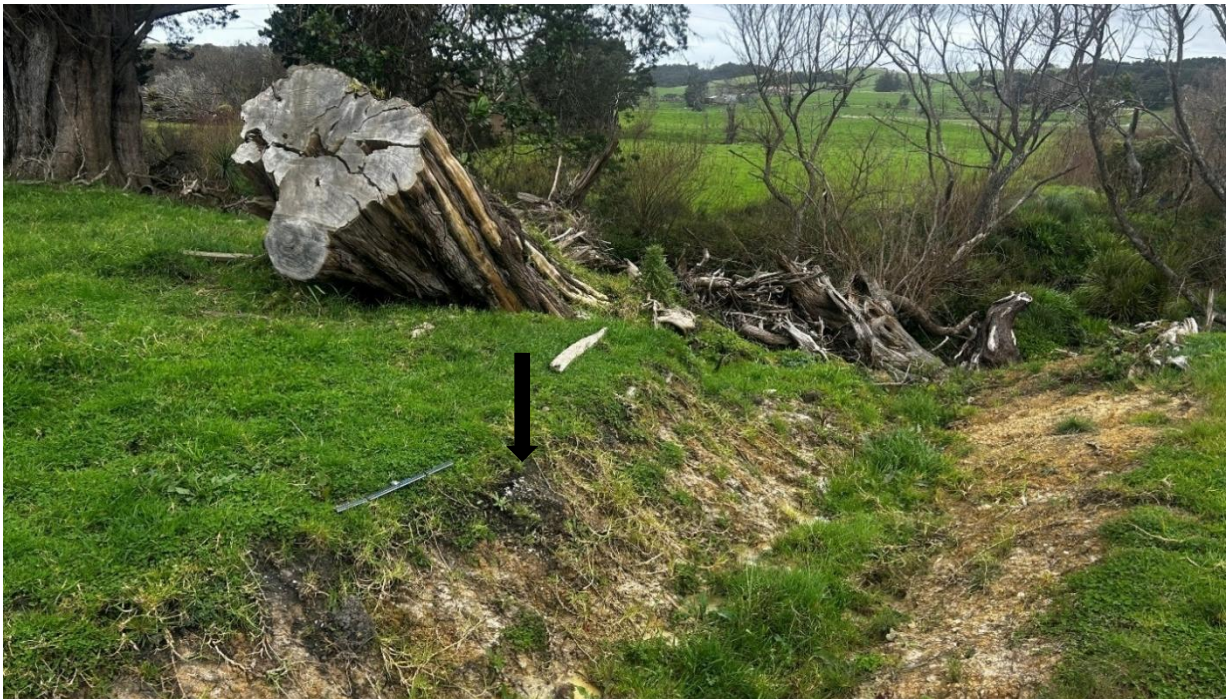
Figure 39: Q08/701, a small midden exposed in a drain adjacent to the Waihoihoi River.

Condition	Medium/Low. The site is small and has been significantly damaged by the drain cutting.
Rarity	Medium. Midden are common nationally and regionally, but relatively uncommon in the inland river system around Waipū.
Context	Medium. The site is part of a small, but growing collection of sites in the alluvial plains around Waipū that attest to Māori occupation of the area.
Information	Medium. The site is relatively small, but in the absence of other midden, it has the potential to contribute an out weighted amount of information to the understanding of Māori subsistence.
Amenity	The site has limited amenity value.
Cultural	Midden Q08/701 is a pre-European Māori site, and its cultural values can only be determined by tangata whenua.
