# SHALLOW INVESTIGATION LOG

**TP2B\_1103**

Client: **New Zealand Transport Agency**  
 Project: **Northland Corridor, Alternative to Brynderwyn Hills**  
 Location: **4245 State Highway 1, Waipu**  
 Contractor: **Wharehine Construction Ltd**

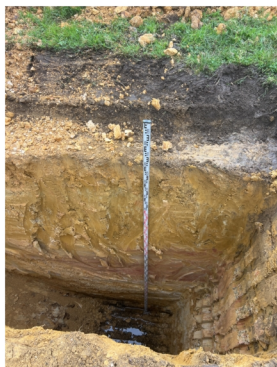
| GEO CODE | MATERIAL DESCRIPTION<br>(See Classification & Symbology sheet for details) | SAMPLES | DEPTH (m) | GRAPHIC LOG | SCALA PENETROMETER<br>(Blows / mm) | | | | | | | | | | VANE SHEAR STRENGTH<br>(kPa)<br>Vane: | | | | Peak<br>Residual | WATER |
|---|---|---|---|---|---|---|---|---|---|---|---|---|---|---|---|---|---|---|---|---|
| RW | Highly weathered, dark grey with orangish brown, SILTSTONE, very weak, breaks down to angular gravel while handling [HIGHLY TO MODERATELY WEATHERED RUARANGI FORMATION].<br>End Of Hole: 5.00m | B | 5 | | | | | | | | | | | | | | | | | |

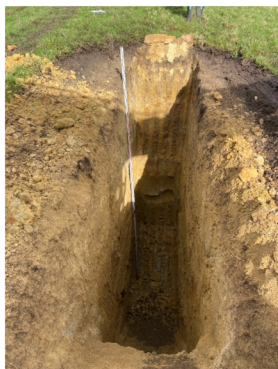
**TP2B\_1104**

| GEO CODE | MATERIAL DESCRIPTION<br>(See Classification & Symbolology sheet for details) | SAMPLES | DEPTH (m) | GRAPHIC LOG | SCALA PENETROMETER<br>(Blows / mm) | VANE SHEAR STRENGTH<br>(kPa)<br>Vane: | Peak<br>Residual | WATER |
|---|---|---|---|---|---|---|---|---|
| RW | Highly weathered, dark grey with orangish brown, SILTSTONE, very weak, breaks down to angular gravel while handling [HIGHLY TO MODERATELY WEATHERED RUARANGI FORMATION].<br>4.20m: Highly FeO stained relict joints, rustic orange. | B | 3 | | | | | |

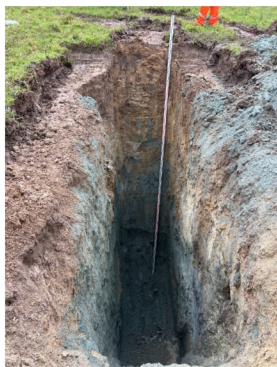
**TP2B\_1107**

| GEO CODE | | MATERIAL DESCRIPTION<br><small>(See Classification &amp; Symbology sheet for details)</small> | SAMPLES | DEPTH (m) | GRAPHIC LOG | SCALA PENETROMETER<br><small>(Blows / mm)</small> | | | | | | | | | | VANE SHEAR STRENGTH<br><small>(kPa)</small><br><small>Vane:</small> | | | | WATER | |
|---|--|---|---|---|---|---|--|--|--|--|--|--|--|--|--|---|--|--|--|---|--|
| | | SILT, with some clay; light blueish grey. Very stiff, moist, low plasticity. Slightly calcareous. | | 2 | | | | | | | | | | | | | | | | | |

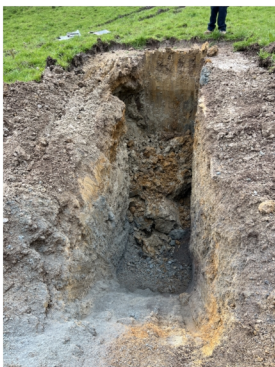
**TP2B\_1110**

| GEO CODE | MATERIAL DESCRIPTION<br>(See Classification & Symbology sheet for details) | SAMPLES | DEPTH (m) | GRAPHIC LOG | SCALA PENETROMETER<br>(Blows / mm) | VANE SHEAR STRENGTH<br>(kPa)<br>Vane: | | | | WATER |
|---|---|---|---|---|---|---|---|---|---|---|
| | Clayey SILT; light blue with some light grey. Stiff, moist, high plasticity; relict joints and rock fabric. | | | | | | | | | 52<br>15 |

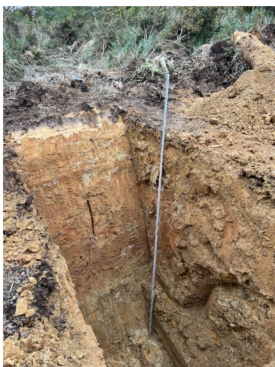
**TP2B\_1113**

| GEO CODE | MATERIAL DESCRIPTION<br>(See Classification & Symbology sheet for details) | SAMPLES | DEPTH (m) | GRAPHIC LOG | SCALA PENETROMETER<br>(Blows / mm) | VANE SHEAR STRENGTH<br>(kPa)<br>Vane: | | | | Peak<br>Residual | WATER | |
|---|---|---|---|---|---|---|--|--|--|---|---|---|
| | 2.50m - 3.50m: 2x tree logs, 2000x 300 mm, slightly decomposed on surface. | | 3 | | | | | | | | 52 | - |
| WPR | Clayey SILT, reddish brown with light grey. Firm moist, highly plastic. Preserved relict joints, highly FeO stained, jointed are cemented [RESIDUALLY TO COMPLETELY WEATHERED GREYWACKE]. | B | 4 | | | | | | | | 52 | 15 |

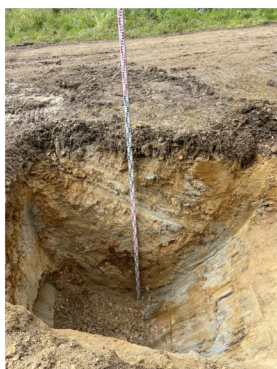
**TP2B\_1114**

| GEO CODE | MATERIAL DESCRIPTION<br>(See Classification & Symbology sheet for details) | SAMPLES | DEPTH (m) | GRAPHIC LOG | SCALA PENETROMETER<br>(Blows / mm) | VANE SHEAR STRENGTH<br>(kPa)<br>Vane: | Peak<br>Residual | WATER |
|---|---|---|---|---|---|---|---|---|
| OC | Clayey SILT, brownish orange. Very stiff, dry, low plasticity. Contains pockets of grey, hard, silt, very brittle [COLLUVIUM (UNDIFFERENTIATED)].<br>0.30m - 2.20m: Highly weathered relict joint @45 degrees, highly FeO stained. Width of joint weathering is ~150 mm. | B | 1 | | | | 207<br>52 | |
| WPH | Highly weathered, brownish orange SILTSTONE, very weak. Contains pockets of reddish pink highly weathered siltstone [HIGHLY WEATHERED GREYWACKE].<br>End Of Hole: 2.70m | B | 3 | | | | UTP<br>- | |

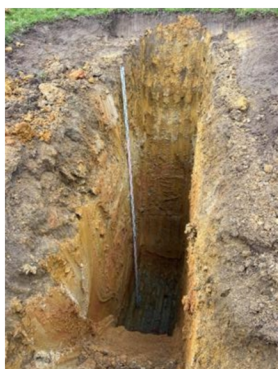
**TP2B\_1119**

| GEO CODE | MATERIAL DESCRIPTION<br>(See Classification & Symbology sheet for details) | SAMPLES | DEPTH (m) | GRAPHIC LOG | SCALA PENETROMETER<br>(Blows / mm) | | | | | | | | | | | VANE SHEAR STRENGTH<br>(kPa) | | | | WATER |
|---|---|---|---|---|---|---|---|---|---|---|---|---|---|---|--|---|--|--|--|---|
| | Clayey SILT, with some sand; orangey brown with mottled light grey with some red. Firm, moist, highly plastic. Sub-horizontal banding of light grey with reddish brown. | | 3 | | | | | | | | | | | | | | | | | |
| | Sandy SILT, with minor clay; light grey. Firm, moist, low plasticity. | | 5 | | | | | | | | | | | | | | | | | |

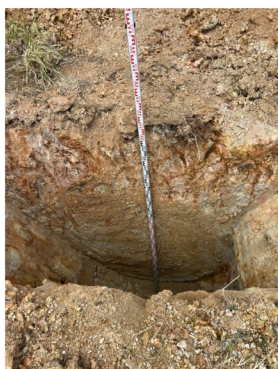
**TP2B\_1121**

| GEO CODE | MATERIAL DESCRIPTION<br>(See Classification & Symbology sheet for details) | SAMPLES | DEPTH (m) | GRAPHIC LOG | SCALA PENETROMETER<br>(Blows / mm) | VANE SHEAR STRENGTH<br>(kPa) | | | | WATER | |
|---|---|---|---|---|---|---|--|--|--|---|---|
| | CLAY with some sandy silt, brownish orange, with some mottled pink with light grey. Very stiff, moist, low plasticity. Contains relict jointing, joints highly oxidized with rustic orange staining [RESIDUALLY TO COMPLETELY WEATHERED GREYWACKE]. | B | | | | | | | | | 133<br>15 |

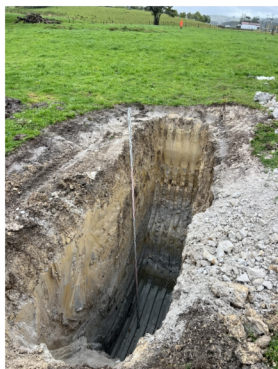
| GEO CODE | MATERIAL DESCRIPTION<br>(See Classification & Symbolology sheet for details) | SAMPLES | DEPTH (m) | GRAPHIC LOG | SCALA PENETROMETER<br>(Blows / mm) | VANE SHEAR STRENGTH<br>(kPa)<br>Vane: Peak<br>Residual | WATER |
|---|---|---|---|---|---|---|---|
| TA | CLAY, greyish light blue. Stiff, moist highly plastic. Contains minor organics (5-20 x 100mm) [RECENT (HOLOCENE) ALLUVIUM]. | | 2 | | | | |

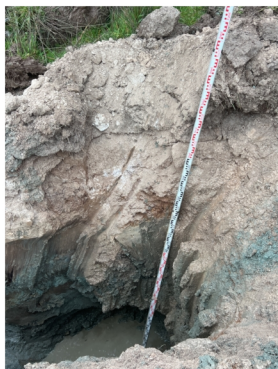
| GEO CODE | MATERIAL DESCRIPTION<br>(See Classification & Symbology sheet for details) | SAMPLES | DEPTH (m) | GRAPHIC LOG | SCALA PENETROMETER<br>(Blows / mm) | | | | | | | | | | VANE SHEAR STRENGTH<br>(kPa)<br>Vane: | | | | Peak<br>Residual | WATER |
|---|---|---|---|---|---|---|---|---|---|---|---|---|---|---|---|---|---|--|---|---|
| TA | Silty GRAVEL with minor clay; light blueish grey. Loosely packed; subangular to subrounded, slightly weathered [RECENT (HOLOCENE) ALLUVIUM]. | | 2 | | | | | | | | | | | | | | | | | |
| | Sandy GRAVEL with minor cobbles and silt; light blueish grey. Loosely packed; bedding, subhorizontal/imbricated, subangular to subrounded, slightly weathered greywacke gravel; sand, fine to coarse. | | 3 | | | | | | | | | | | | | | | | | |

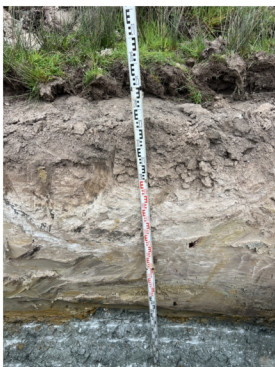
| GEO CODE | MATERIAL DESCRIPTION<br>(See Classification & Symbology sheet for details) | SAMPLES | DEPTH (m) | GRAPHIC LOG | SCALA PENETROMETER<br>(Blows / mm) | VANE SHEAR STRENGTH<br>(kPa)<br>Vane: | Peak<br>Residual | WATER |
|---|---|---|---|---|---|---|---|---|
| NAS | CLAY, orangey brown, with green/blue hue. Firm, moist, highly plastic [NORTHLAND ALLOCHTHON SOILS (RESIDUAL/CW)]. | B | 2 | | | | 37<br>7 | |

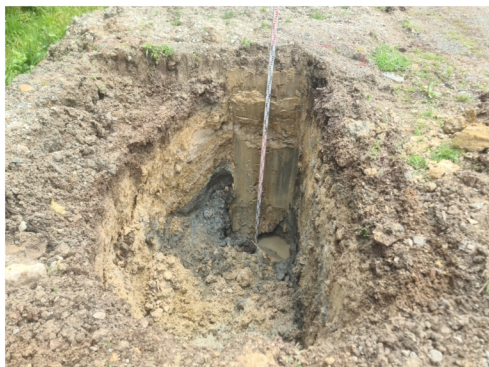
| GEO CODE | MATERIAL DESCRIPTION<br>(See Classification & Symbolology sheet for details) | SAMPLES | DEPTH (m) | GRAPHIC LOG | SCALA PENETROMETER<br>(Blows / mm) | | | | | | | | | | VANE SHEAR STRENGTH<br>(kPa)<br>Vane: AUK506 | | | | WATER |
|---|---|---|---|---|---|---|---|---|---|---|---|---|---|---|---|---|---|---|---|
| F | Gravelly CLAY, with minor sand, with trace boulders; brown and grey with pale grey mottles. Soft to firm, moist, high plasticity; gravel, fine to coarse, subrounded to subangular, highly weathered, very weak - moderately strong, sandstone, siltstone, limestone; sand, fine to coarse; boulders, up to 300mm; trace wood and logs up to 600mm long [FILL (UNDIFFERENTIATED)]. | B | 1 | | | | | | | | | | | | | | | 63<br>20 | ↙ |
| | CLAY, with minor sand, with trace gravel; grey and light brown. Stiff, moist; sand, fine to coarse; gravel, medium to coarse, subrounded, highly weathered, very weak to weak, siltstone.<br>0.80m: Firm.<br>1.00m: Grey, sandy CLAY pocket 500 mm in size on south wall of test pit. | | | | | | | | | | | | | | | | | 49<br>18 | |

1. Shear Vane number : 506
2. Shear Vane correction: 1.626
3. Shear vane values are corrected.
4. Test pit terminated at 3.0m due to wall collapse.
5. Test pit backfilled with arisings upon completion.
6. Coordinates captured using a Trimble R12i Receiver and TSC5 Controller, with a horizontal accuracy +/- 85mm and vertical accuracy +/- 107mm.
