**Project Number: 13451.003.001**

**Remedial Action Plan**

Drury - Stage 2, Drury, Auckland

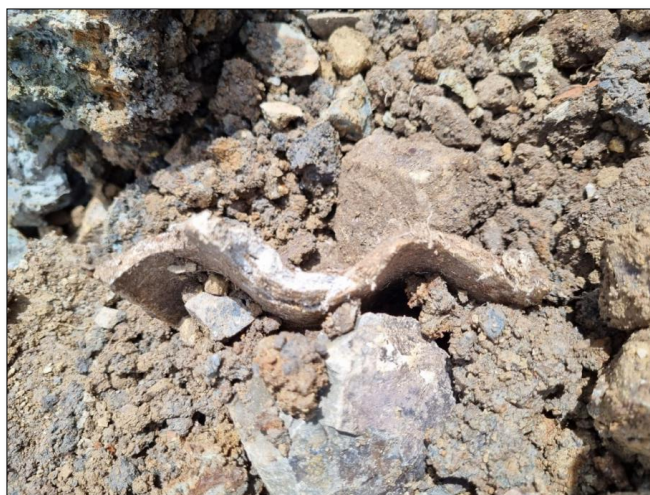
Photo 1: Fibre cement fragment ('Super-6' roofing tile)

Locations TP05 and TP06 encountered fill material below topsoil which contained mixed refuse including broken glass, iron and plastic. Fragments of corrugated fibre cement tile (suspected to contain asbestos) were encountered at TP05 (shown in Photo 1 below).

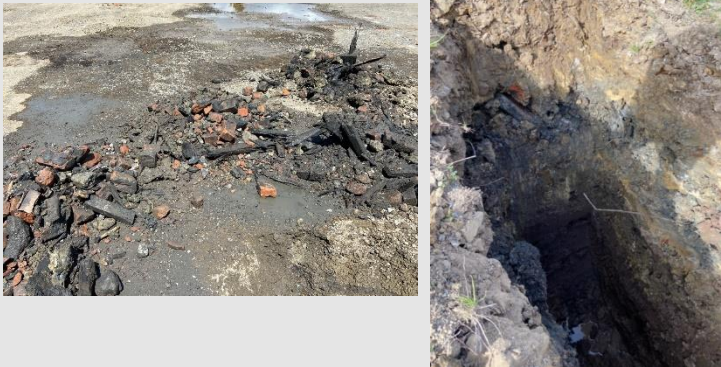
<p><b>Uncontrolled Filling</b></p> <p>Building debris may contain asbestos or other contaminants.</p>

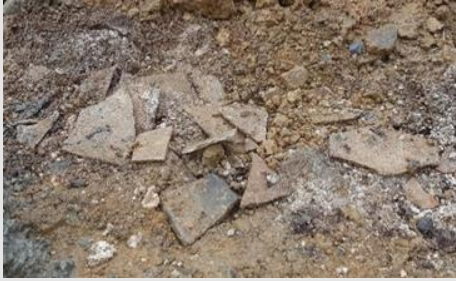
<p><b>Asbestos Containing Material</b></p> <p>Intact sheets or broken into smaller pieces, may be mixed with other material.</p>

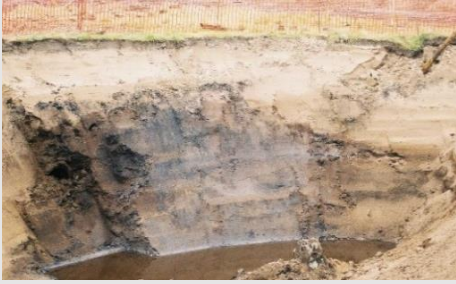
<p><b>Separate-phase Hydrocarbons</b></p> <p>Black liquid, odours, sheen</p>

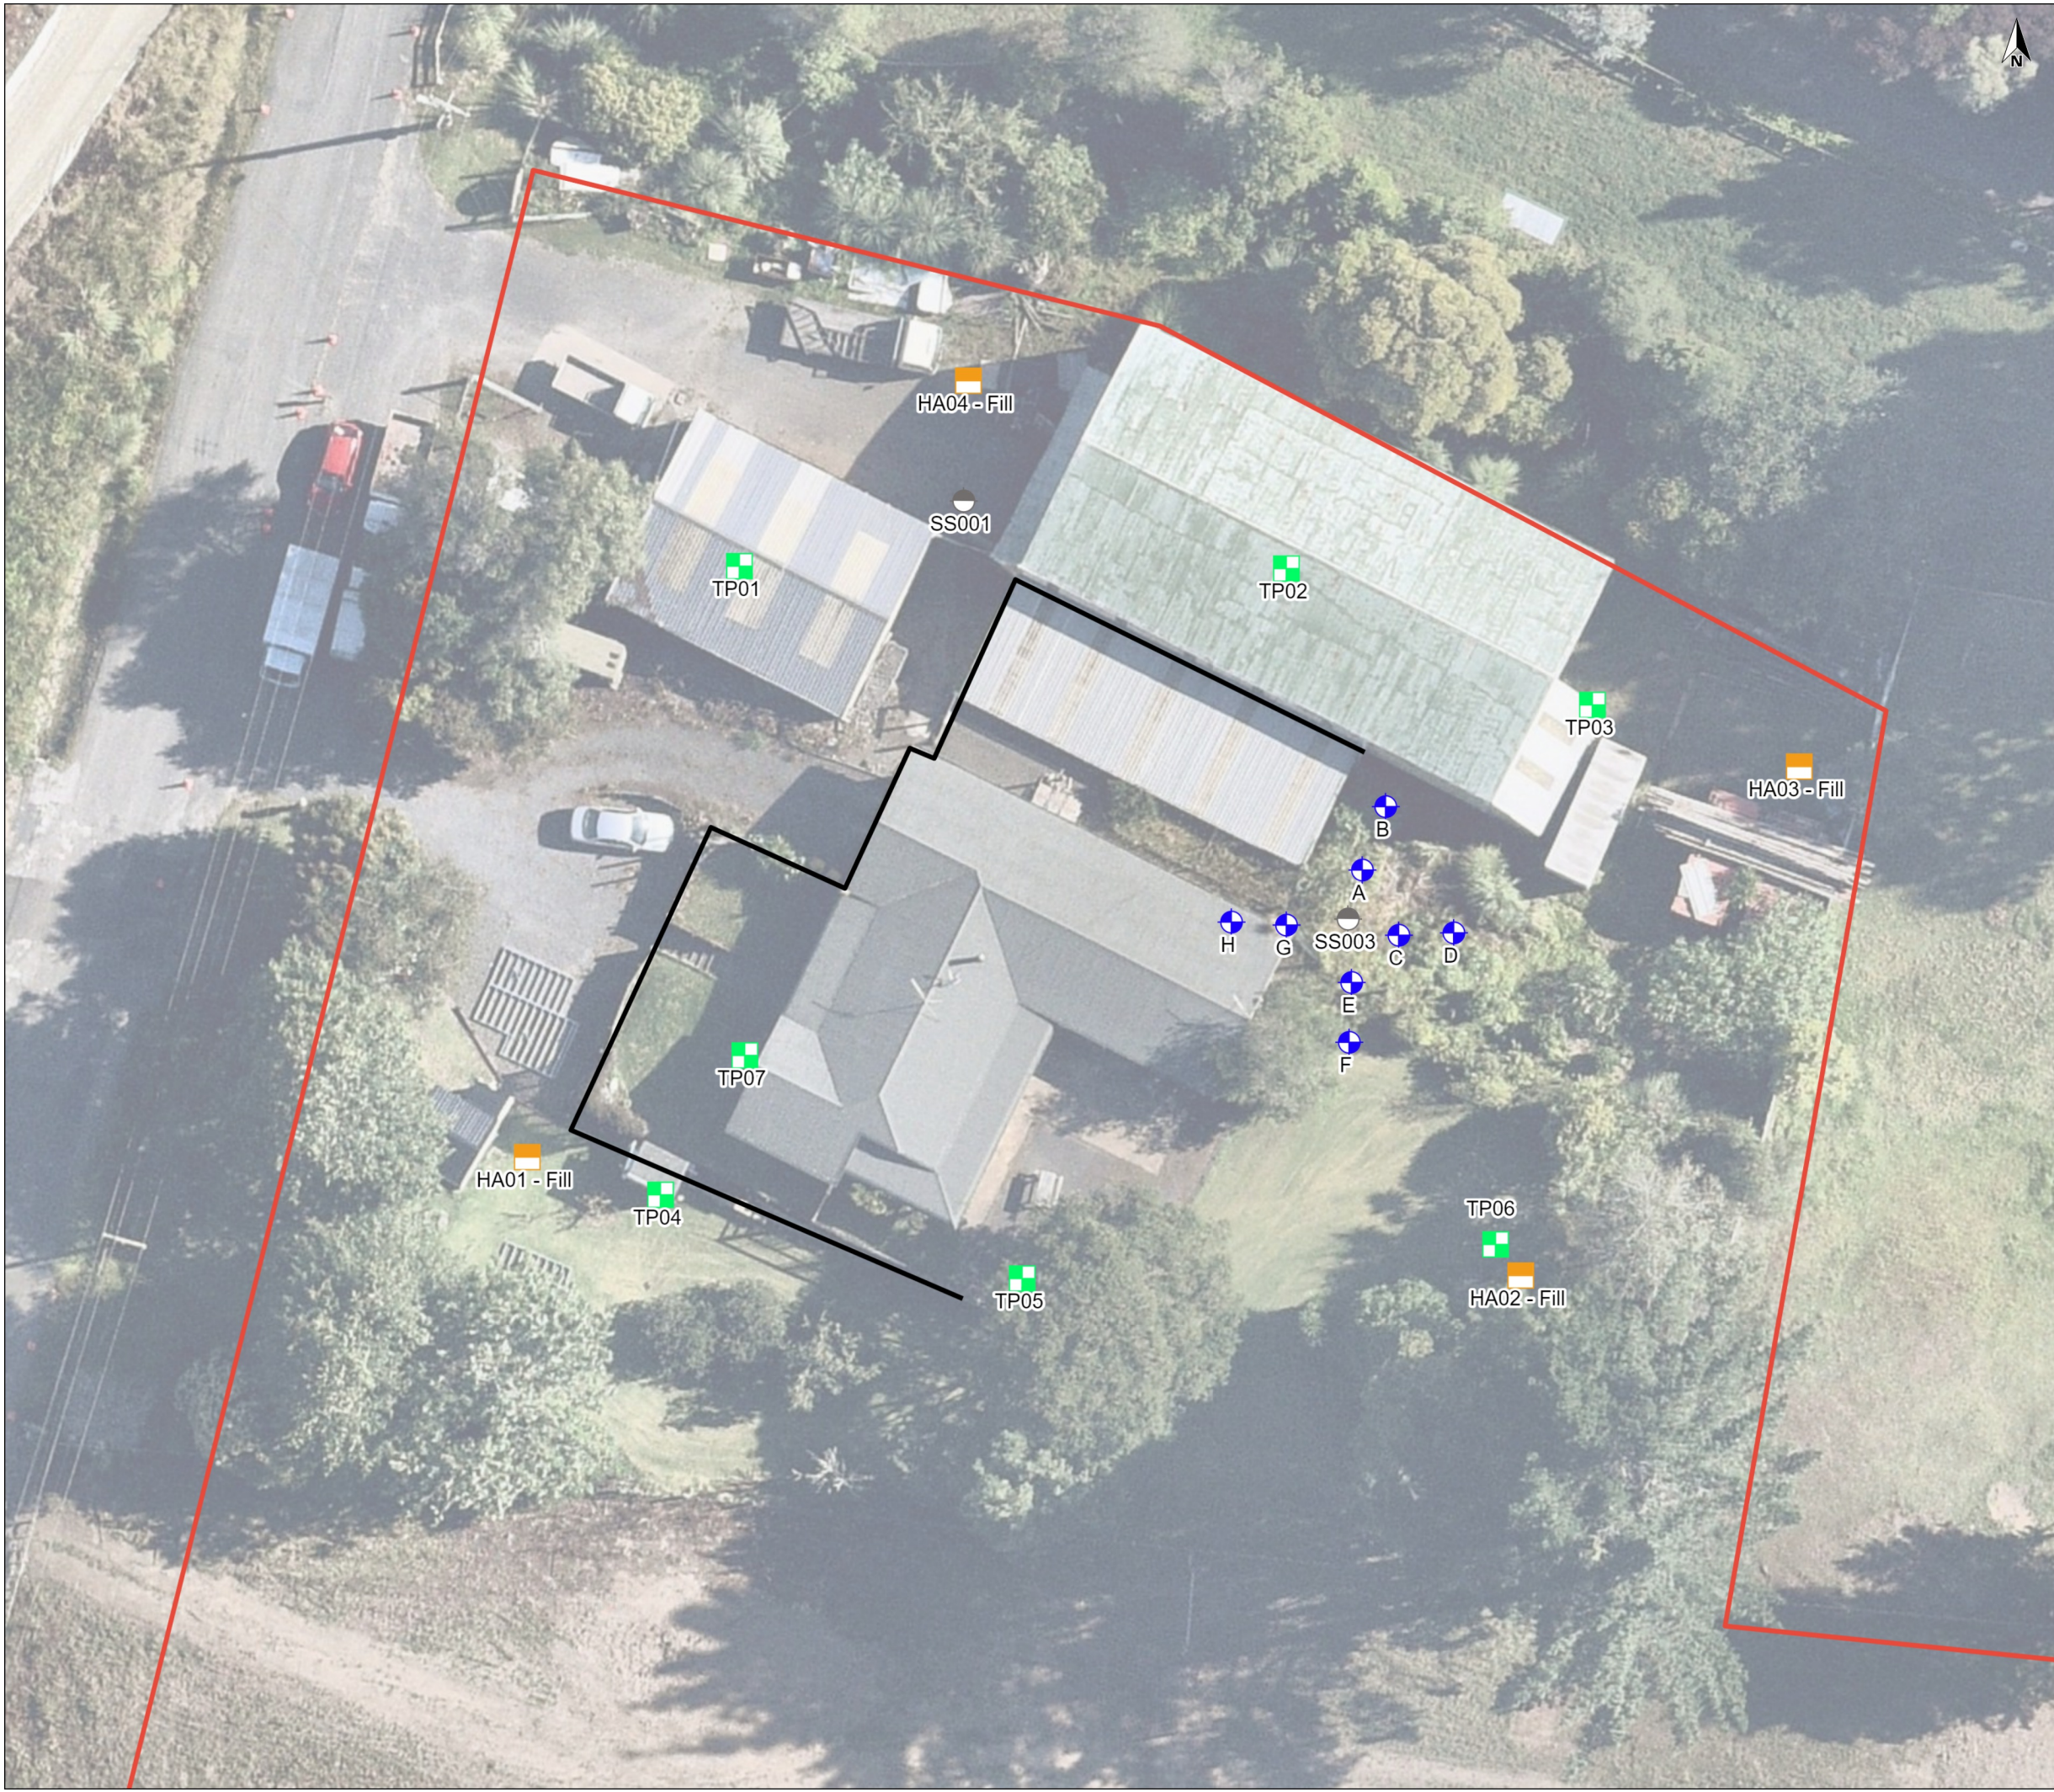
- Legend**
- Site Boundary
  - ENGEO (2017) Fill Characterisation
  - Aurecon (2021) Investigation Locations
  - ENGEO (2024) Delineation Sample Locations
  - CMW (2024) Test Pit Excavation
  - Former Retaining Wall

Locations TP01, TP02 and TP03 in the north of the site (Figure 2) had GAP gravel at the surface to approximately 0.3 m below ground level (bgl), which had a brown silty matrix sampled for chemical and asbestos analysis. Below this unit was inferred native East Coast Bays Formation residual soils.

Location TP07 was not included in the geotechnical scope of works but was included in the investigation as it was in the centre of the retained material behind the former wall and the front of the former dwelling (indicated on Figure 2). The excavation encountered rock fill containing concrete bricks and tiles between the surface and 1.0 m bgl, after which native East Coast Bays Formation was observed.

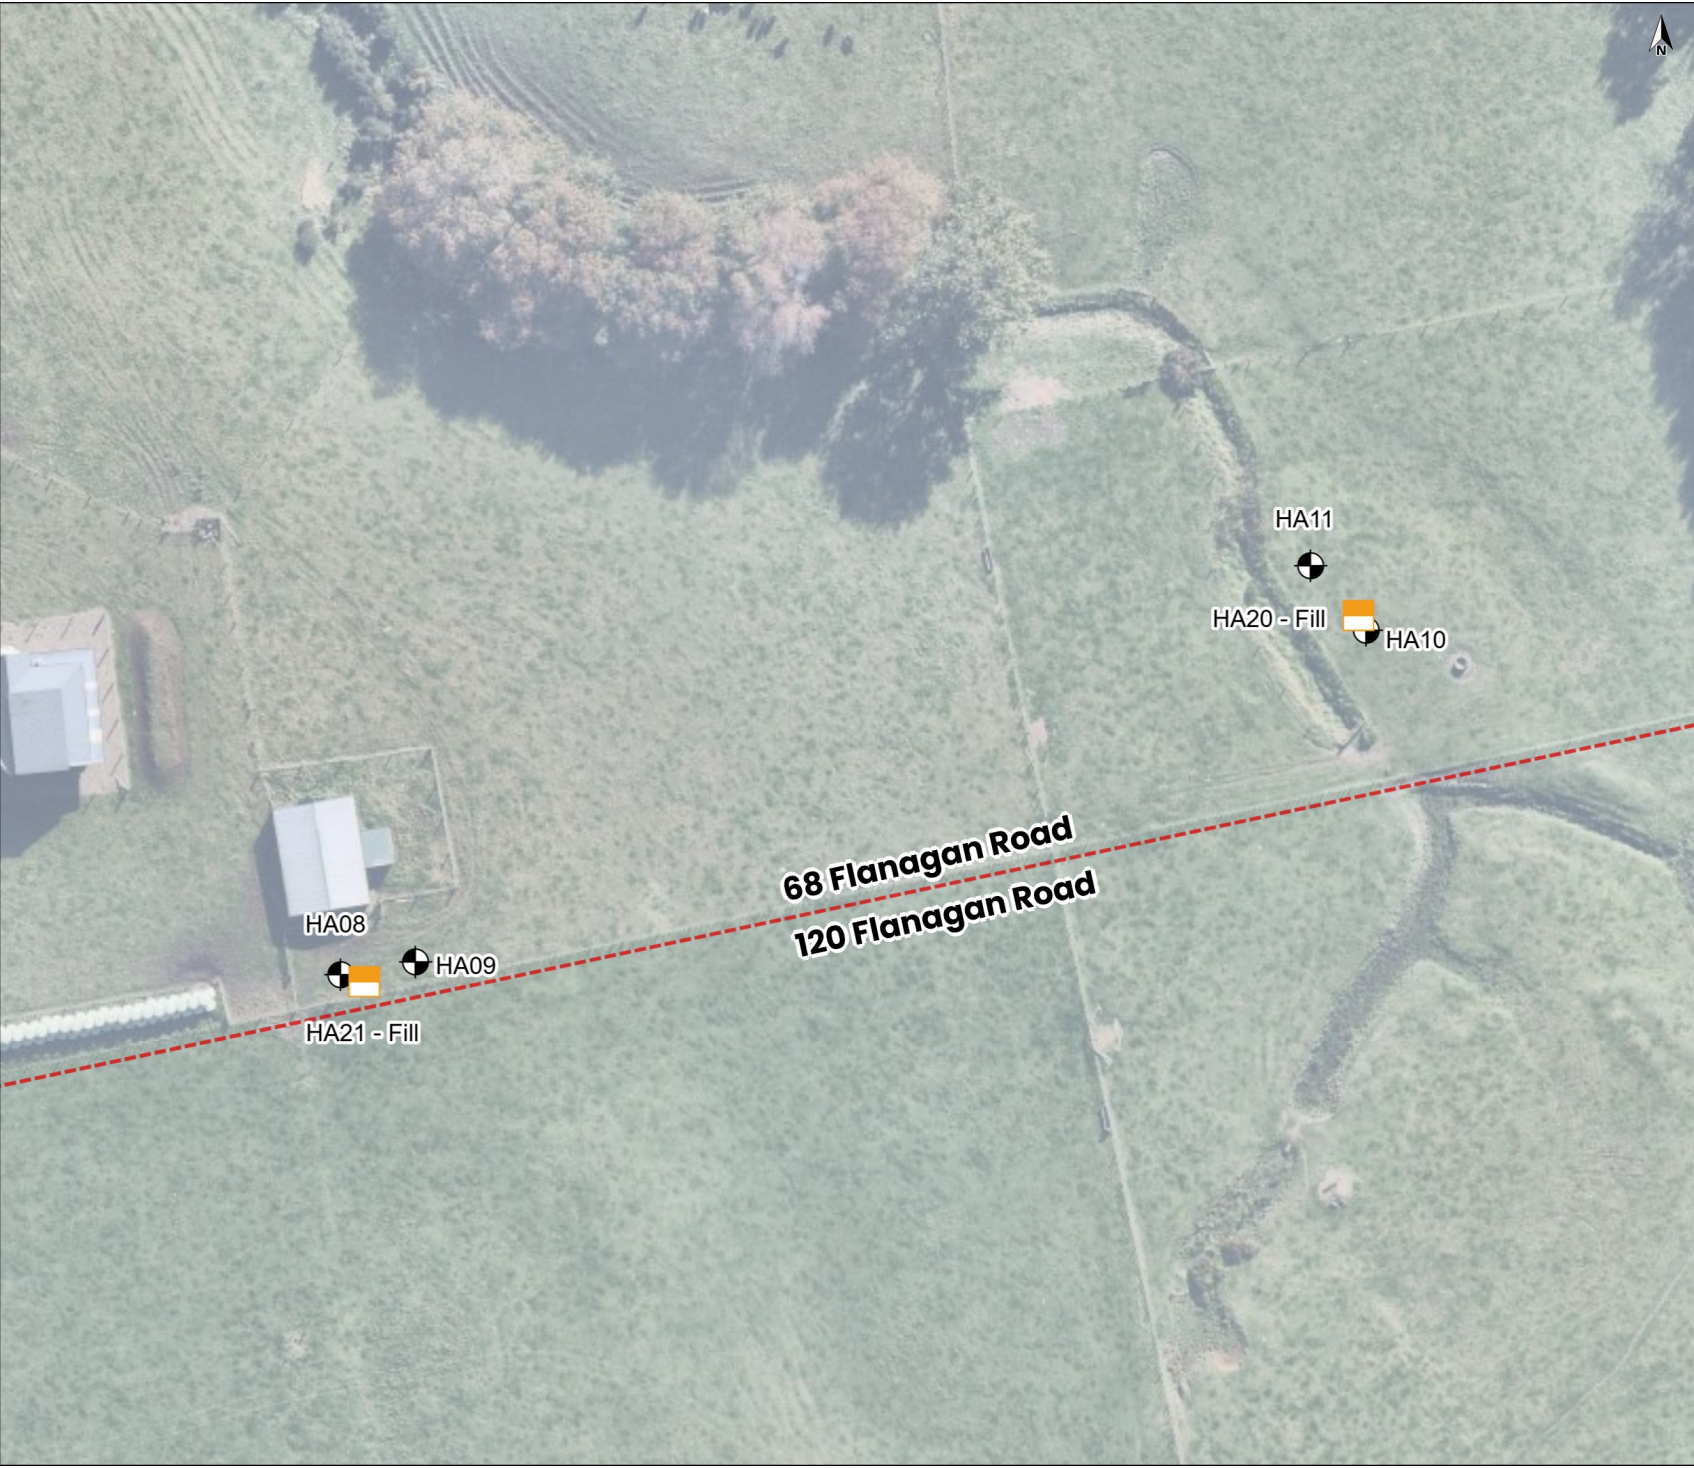
Title: 68 Flanagan Road – Identified Fill Locations		
Client: Woods Limited		Size: A4
Project: Drury – Stage 2 Fast Track	Drawn: VP	Figure No.: 3
Date: 03-12-2024	Checked: EM	
Proj No: 13451.002.001	Scale: 1:850	Version: 2.0

- Legend**
- Site Boundary
  - ENGEO (2017) Fill Characterisation
  - ENGEO (2023) Characterisation Samples

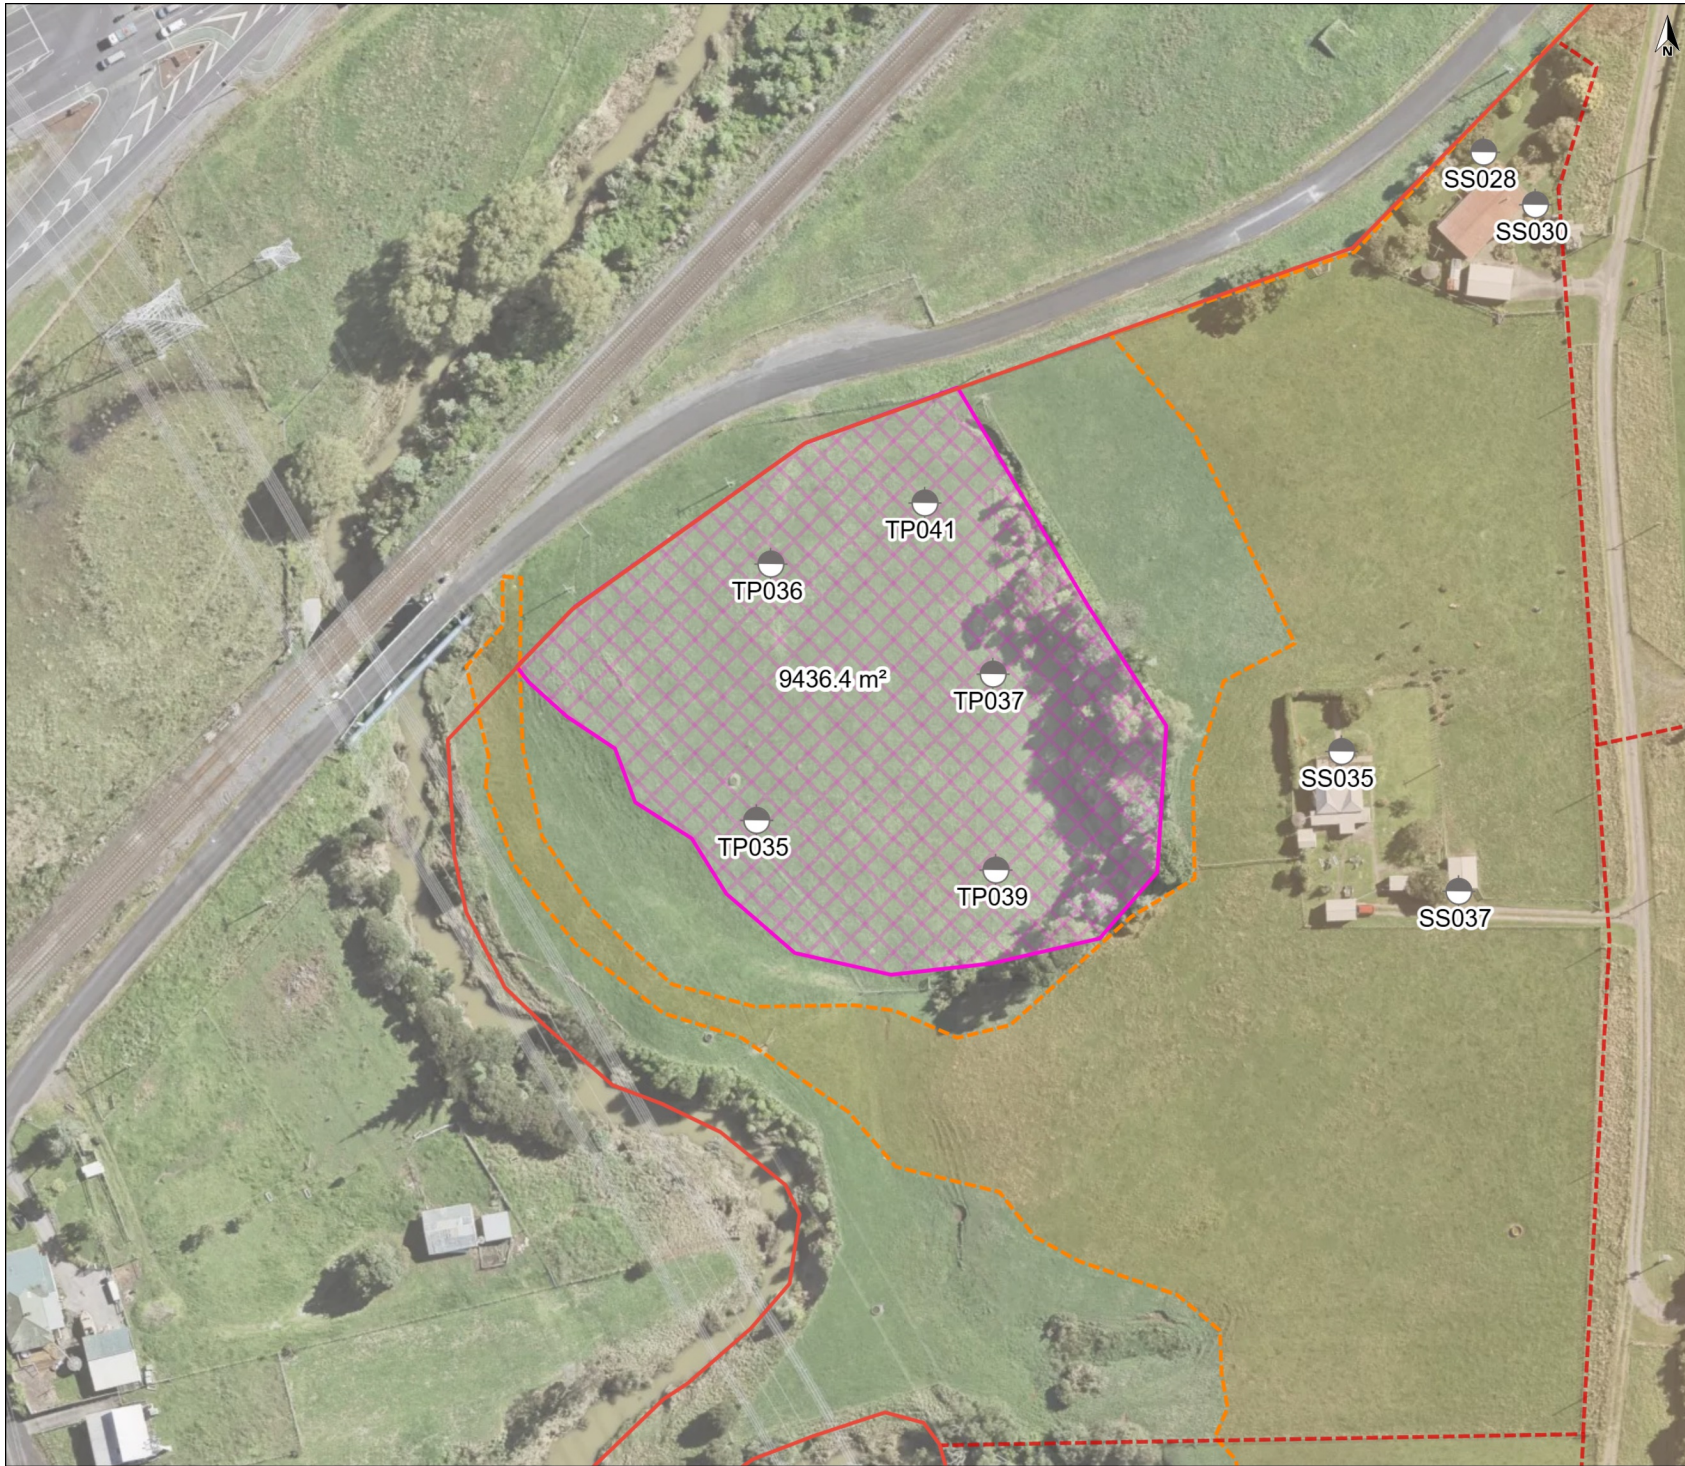
Title: 108 Flanagan Rd - Historical Fill Extent		
Client: Woods Limited		Size: A4
Project: Drury - Stage 2 Fast Track	Drawn: VP	Figure No.: 4
Date: 26-02-2025	Checked: EM	
Proj No: 13451.003.001_01	Scale: 1:1500	Version: 3.0

- Legend**
- Site Boundary
  - Aurecon (2021) Investigation Locations
  - Historical Fill Area (Aurecon DSI, 2021)
  - Cut / Fill Extent (Woods: P23-315-02-1200-EW and P23-315-04-2000-RD)
