# Supplementary Detailed Site Investigation (DSI)

86, 108 & 122 Arataki Road, Havelock North

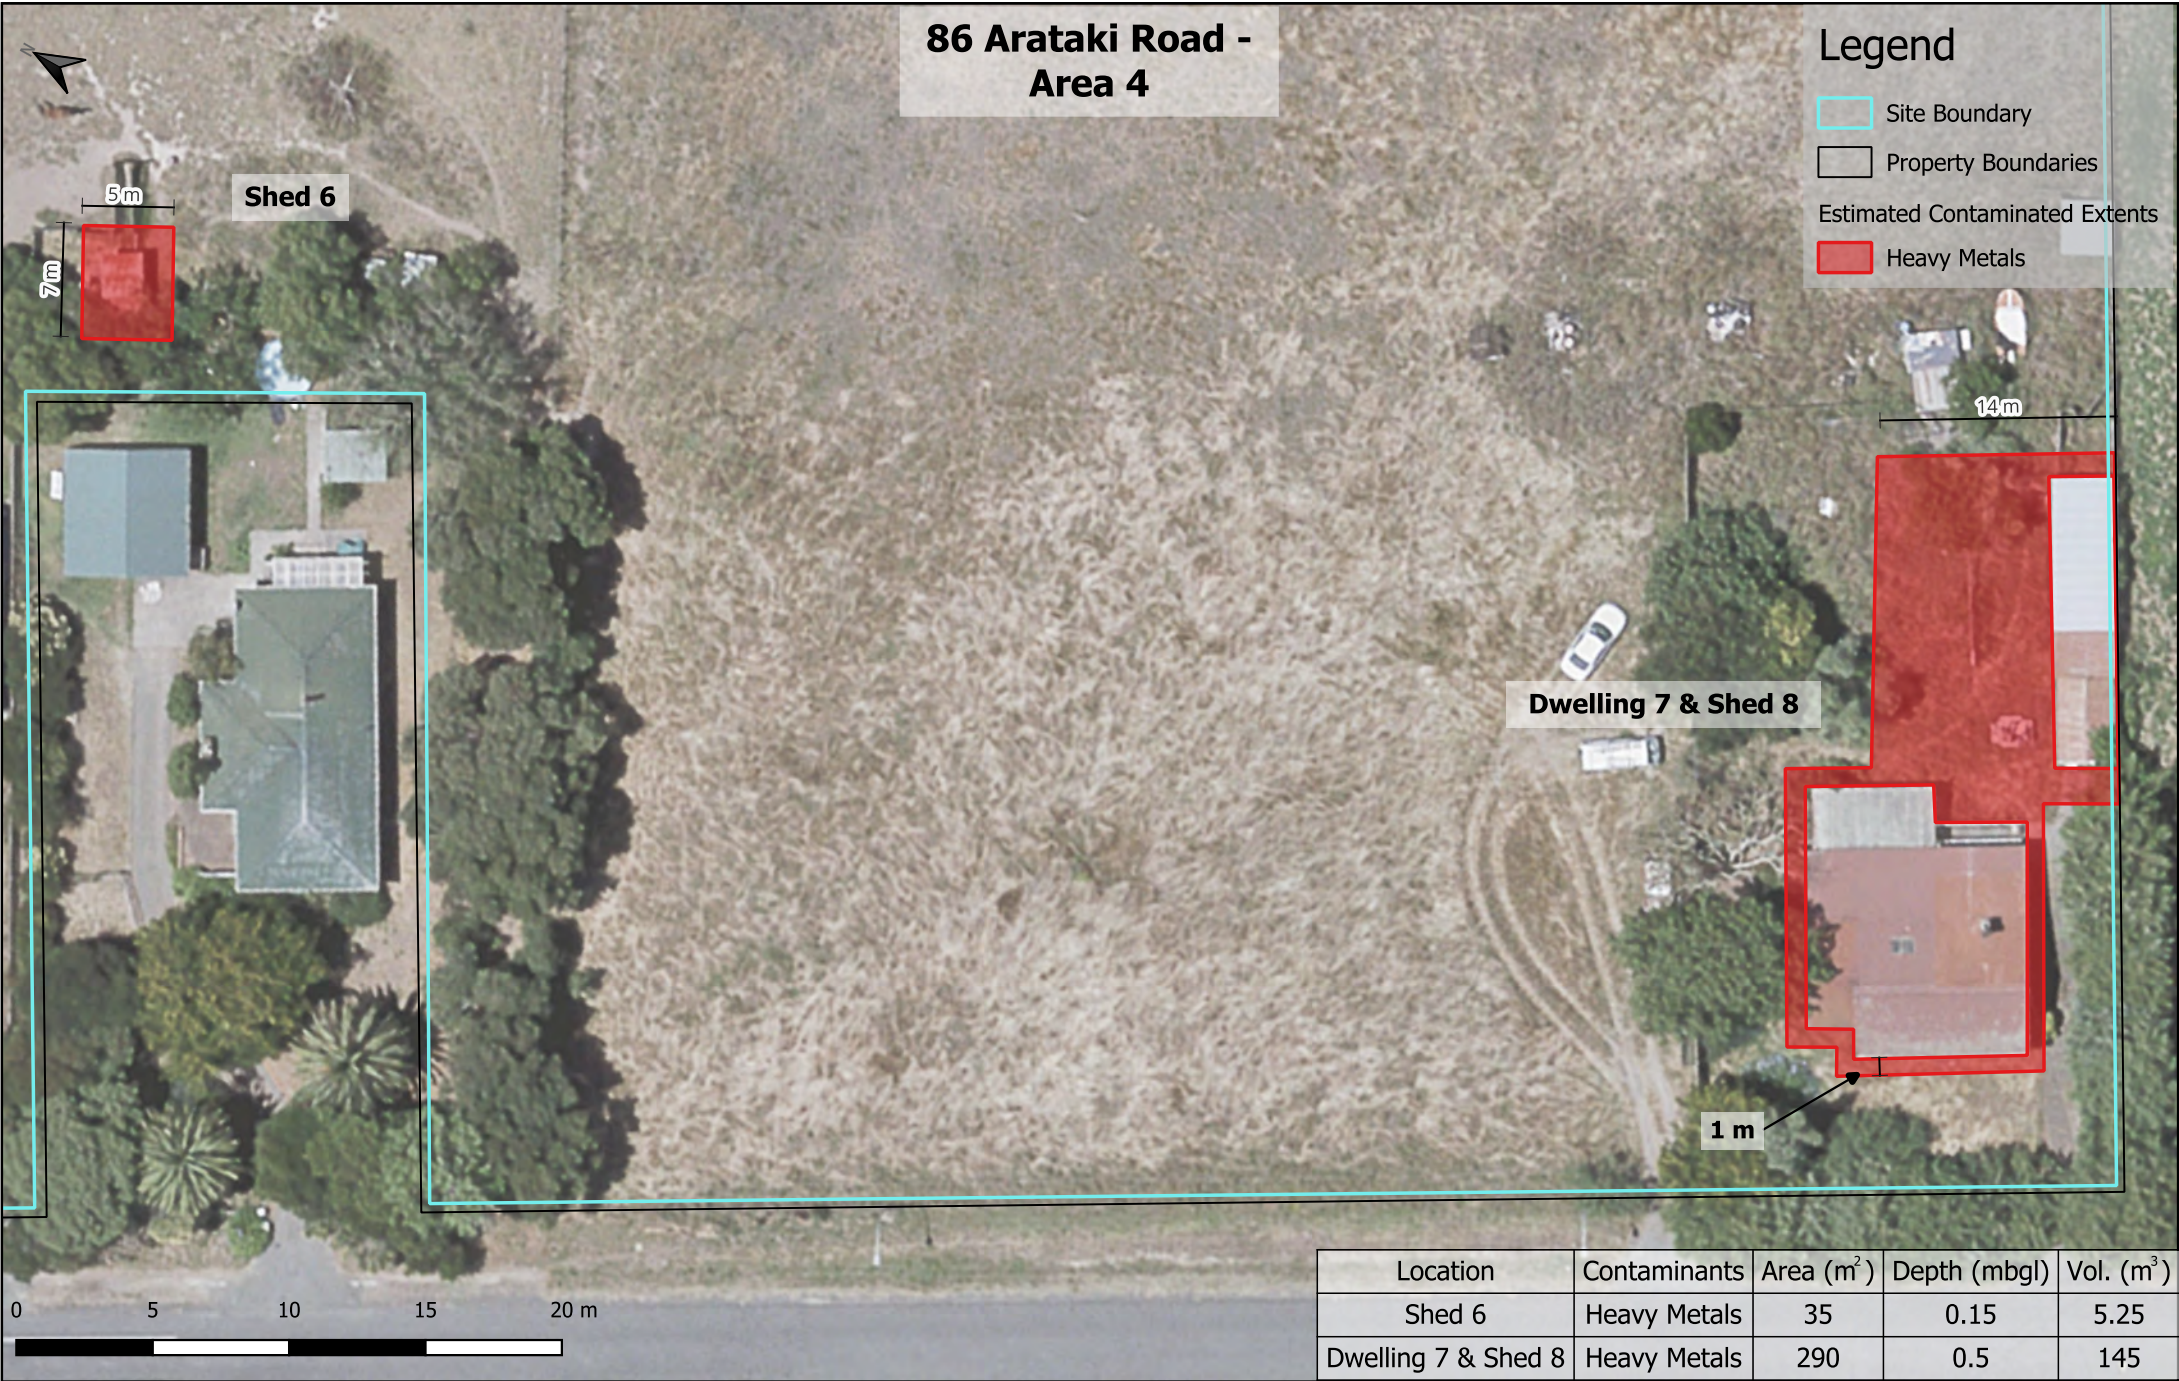
| Location | Contaminants | Area (m <sup>2</sup> ) | Depth (mbgl) | Vol. (m <sup>3</sup> ) |
| Shed 6 | Heavy Metals | 35 | 0.15 | 5.25 |

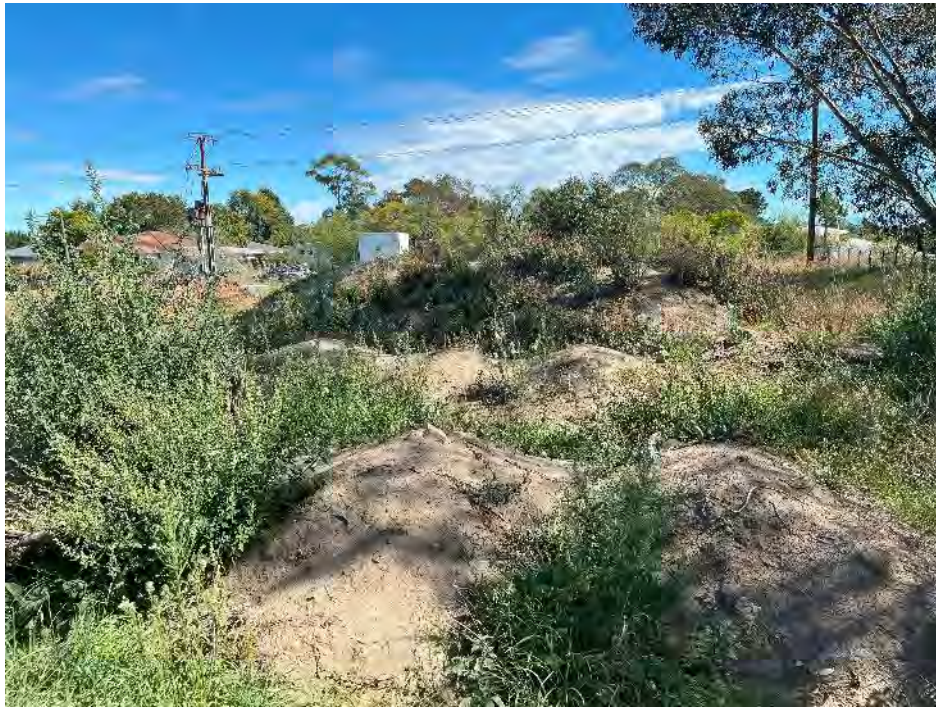
**PLATE 1: Several small stockpiles of consistent material (Stockpile 1) in the western portion of Area 1**

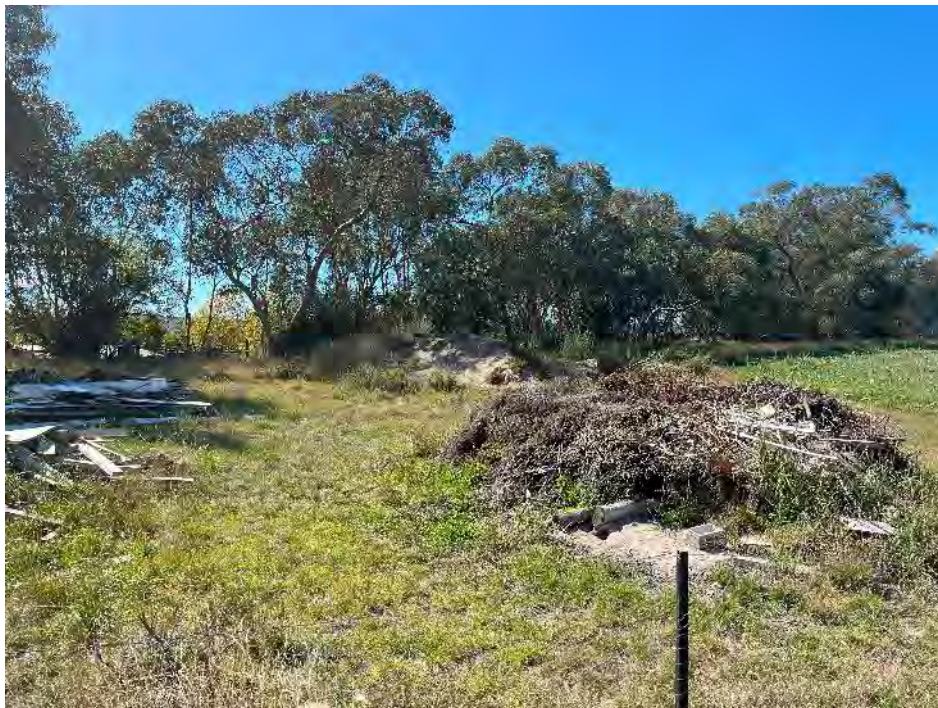
**PLATE 2: Western portion of Area 1 with Burn Pile 1 in the foreground and Stockpile 1 in the background.**

- ***Burning of building materials and/or refuse:***
  - The burn pile located in Area 1 (SS7) contains arsenic in exceedance of the applicable human health criteria for the proposed residential land use, and commercial/industrial land use.

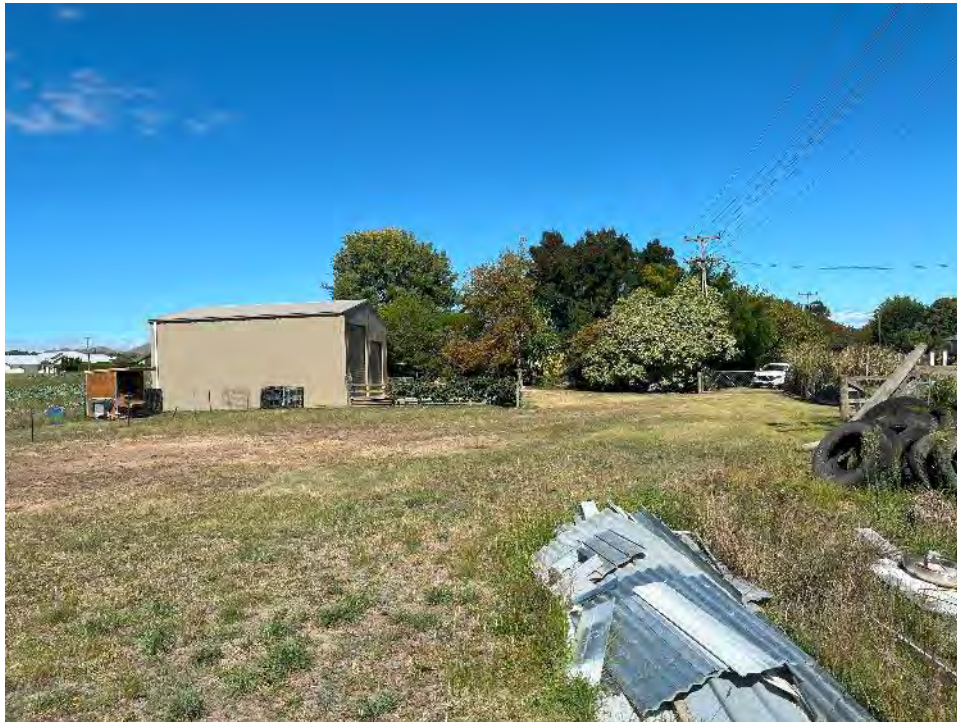
**PLATE 3: Area 1, looking from the eastern end towards Shed 1, with historic horticultural area in the foreground, and stockpiled materials visible on the right.**

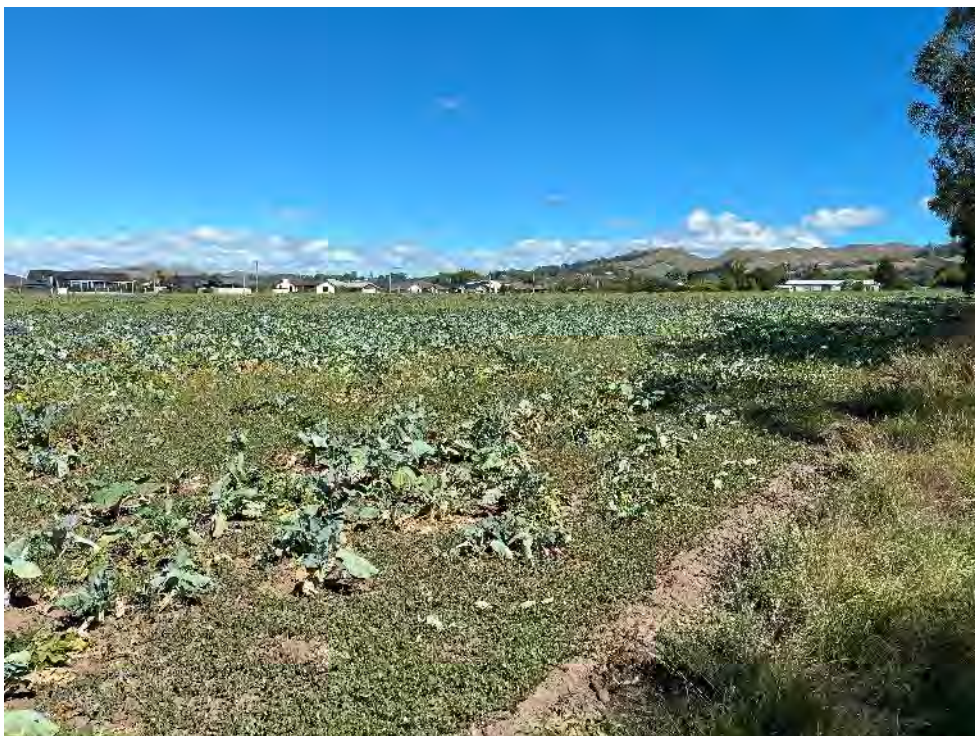
**PLATE 4: Inactive horticultural activity across Area 2.**

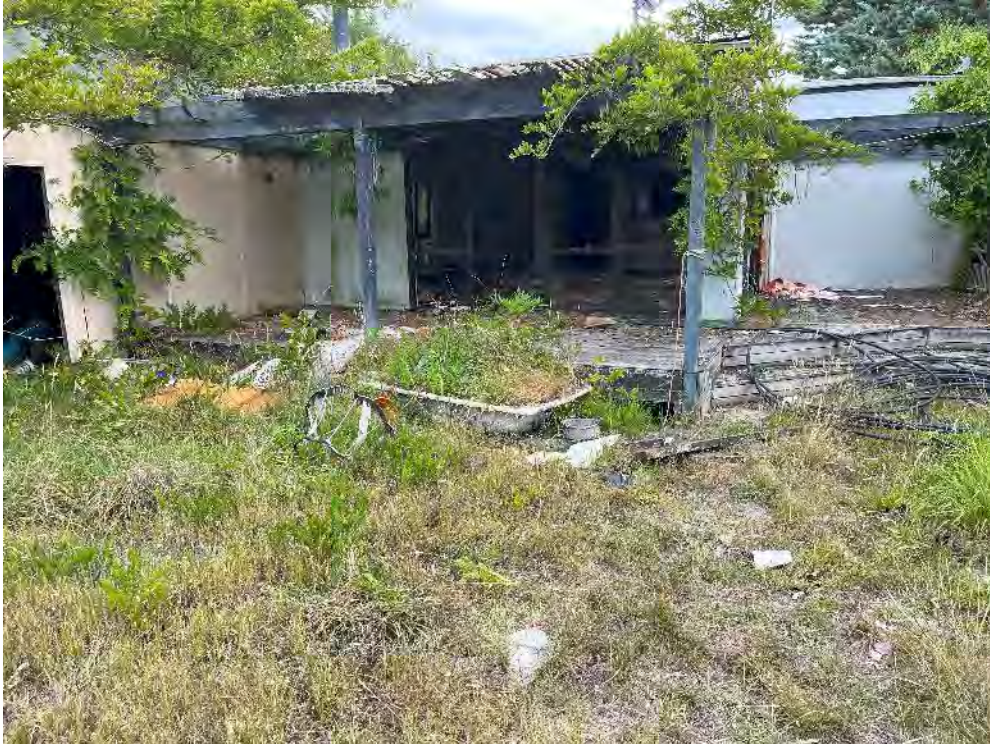
- **Deterioration and/or improper demolition of historic structures (HAIL item I/E.1):**
  - Lead and/or asbestos contamination at concentrations exceeding the adopted human health and/or environmental protection criteria was identified in shallow soil around the curtilage of multiple site structures within the 86 and 108 Arataki Road properties. Additionally, asbestos containing materials (ACM) in the form of fibre cement debris was identified around Dwelling 5 at 108 Arataki Road.

**PLATE 5: Dwelling 5 with fragments of suspected ACM within the yard in the foreground.**

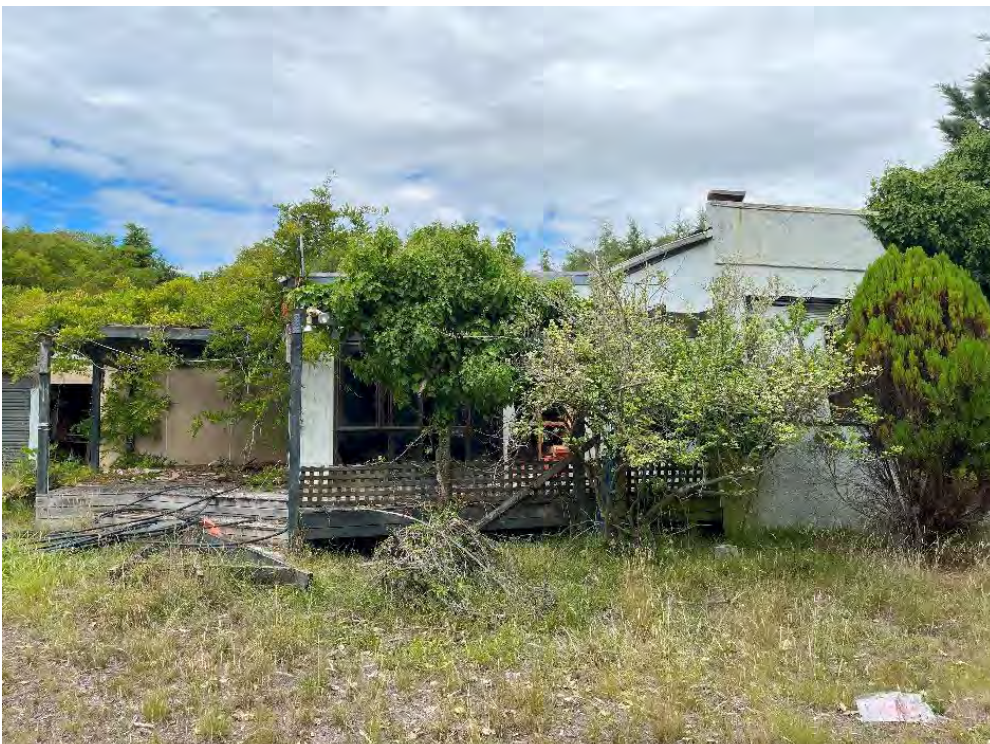
**PLATE 6: Northern aspect of Dwelling 5.**

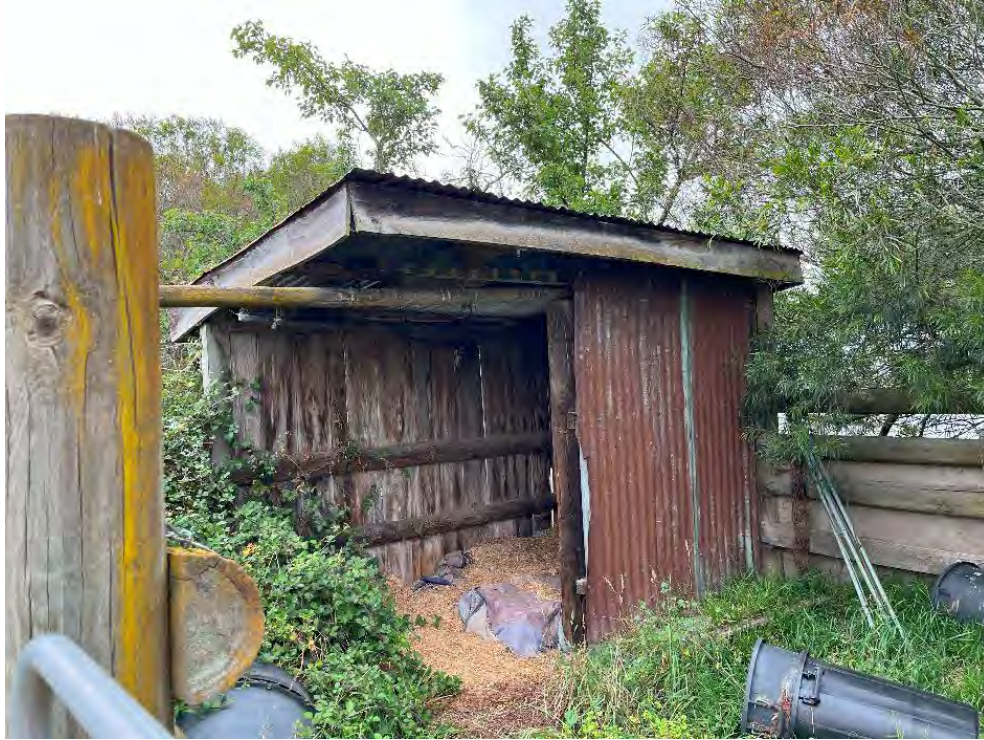
- A small painted corrugated iron shed (Shed 6) was noted to be in a state of minor deterioration, and a suspected ACM fragment was identified (collected as sample BM3).
- Burn Piles E and F are noted east of Dwelling 7 and Shed 8.
- A small shed (Shed 9) with mild paint deterioration is noted northeast of Shed 8.
- Stockpiles of branches and tree cuttings, as well as collections of household refuse are noted north of Shed 9.
- Dwelling 7 and Shed 8 appear consistent with most recent aerial imagery.

- ***Deterioration / potential burning of building materials:***
  - Soil from the northern curtilage of Shed 6 (SS11) contained arsenic above the applicable human health criteria, as well as zinc above the environmental protection criteria.

- o A bulk potentially asbestos-containing fragment (BM3) also located at SS11, tested positive for asbestos, however, soil from underneath the fragment (SS11) did not contain asbestos. It is noted that only one fragment of ACM was identified, which was collected for analysis.
- **Burning of building materials and/or refuse:**
  - o No analytes were detected above the applicable human health and/or environmental protection criteria.
  - o Soil underlying two burn piles located along the southern boundary of Area 4 / the site (SS12 & SS13), contained lead and zinc above the expected background concentrations, with SS12 additionally detecting arsenic and pyrene above expected background concentrations/laboratory reporting limits.

**PLATE 7: North-eastern aspect of Shed 6.**

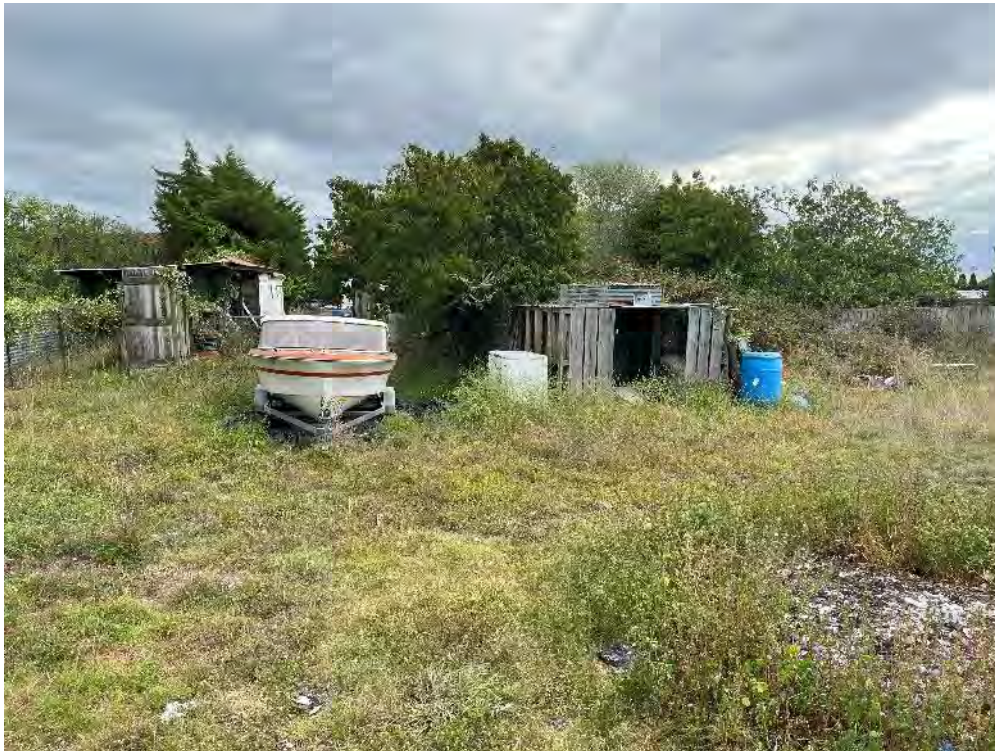
**PLATE 8: West of Shed 8 and Dwelling 7, where Burn Piles are location. Burn Pile F visible in the lower right-hand side.**
