Stream Realignment Management Plan

HUNUA QUARRY DEVELOPMENT

MANGAPŪ STREAM TRIBUTARY REALIGNMENT MANAGEMENT PLAN

30 MARCH 2026

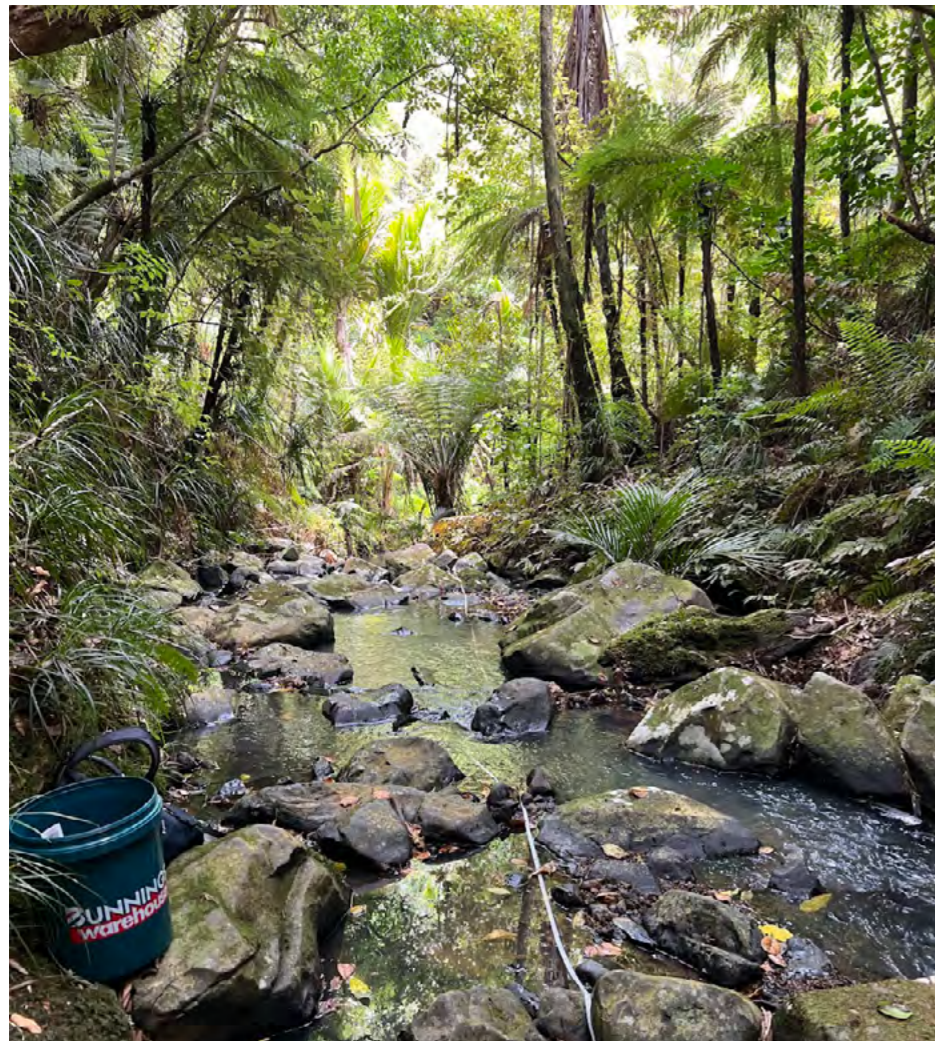
In the lower reaches of the Mangapū Stream Tributary, the stream channel ranges from 0.9 – 5.7 m wide, with depths ranging from 0.02 - 0.90 m. Hydrological heterogeneity is high along the reach with a mix of slower runs, riffles and deep and shallow pools present. Large boulders and bedrock are abundant, with cobbles and gravels common. Small streamside gravel bars are present. Stream banks are highly variable, from 0.2 m in some locations to >2m high near vertical in other areas. Riparian vegetation is well established with a thick canopy and abundant understorey, providing shade to over 90% of the stream surface. The riparian community consists of abundant nikau and ponga and abundant parataniwha (*Elatostema rugosum*) along the stream banks. Bryophytes are abundant on large boulders and bedrock banks.

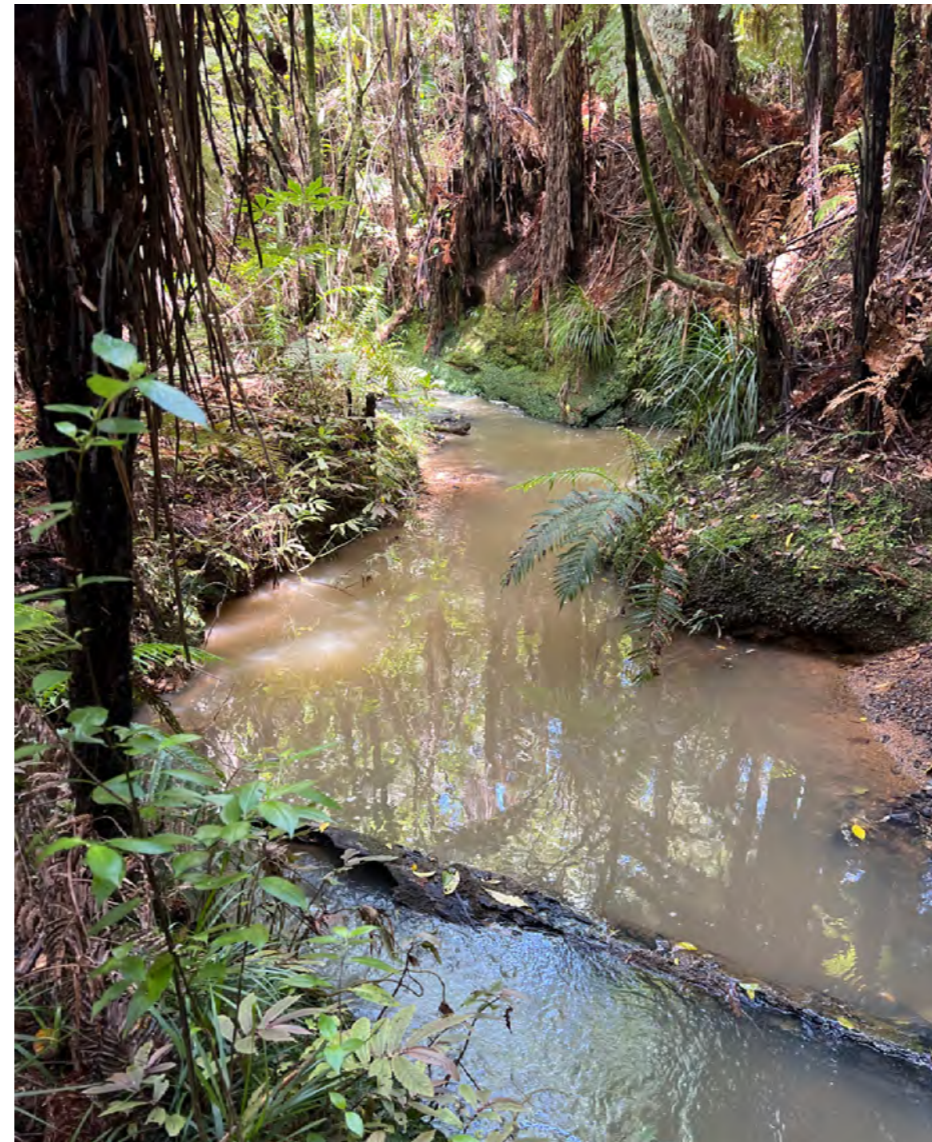
In the mid-reaches of the Mangapū Stream tributary (upper reaches of the stream to be realigned), the channel is some 1.5 – 5.5 m wide, with a depths ranging from 0.41 - 0.49 m. Hydrological heterogeneity is high along the reach with a mix of riffles, runs and deep and shallow pools present. The stream substrate is dominated by a strong mix of cobbles, gravel, bedrock and silt /sand with fewer large boulders than the lower reaches. Riparian vegetation is well established with a well-developed canopy and abundant understorey. This vegetation provides shade to approximately 75-85% of the water surface, with some areas of open sunlight. The riparian community consists of abundant nikau and ponga and abundant smaller ferns along the stream margin. Wood debris and undercut banks are present within the mid-reaches.

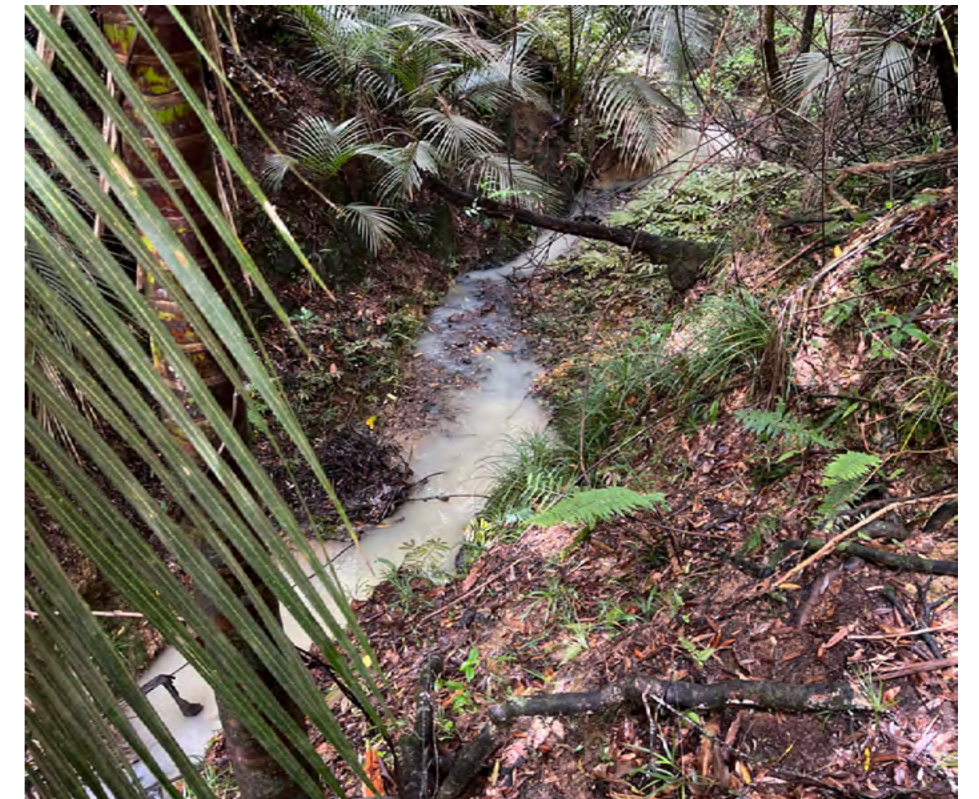
The headwater streams occur in an area of varied topography including a series of gullies running generally north to south through the SEA_T_5323. Most headwater watercourses were classified as ephemeral, with some intermittent reaches also identified. This classification was based on the overland flow path GIS layer, observations from the ecologists and sampling on site. The headwaters of the gully features were formed with a mix of broad and narrow gullies, with mostly no evidence of stream channels or banks. The classification of intermittent streams commenced where incised stream channels were apparent and/or shallow pools were evident in accordance with AUP stream classification criteria.

Where intermittent streams were evident, the channel was typically shallow, with a streambed that was predominantly silt/sand with areas of small gravels and woody debris. The stream channel was narrow, with low immediate channel banks within the wider gully. Stream shade was relatively high, with some open patches in the lower reaches.

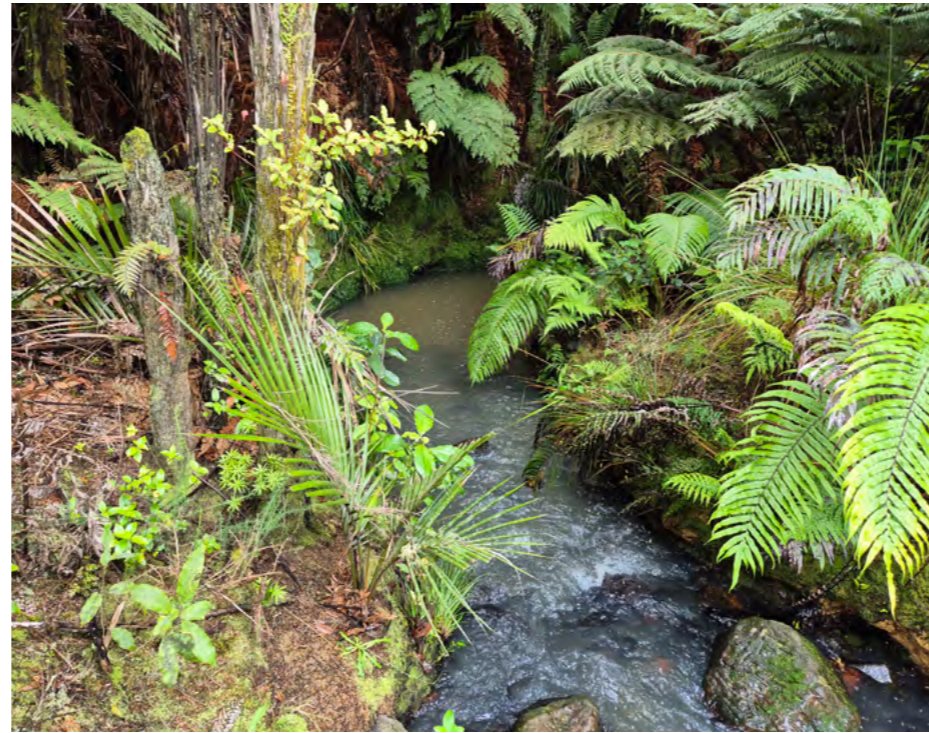
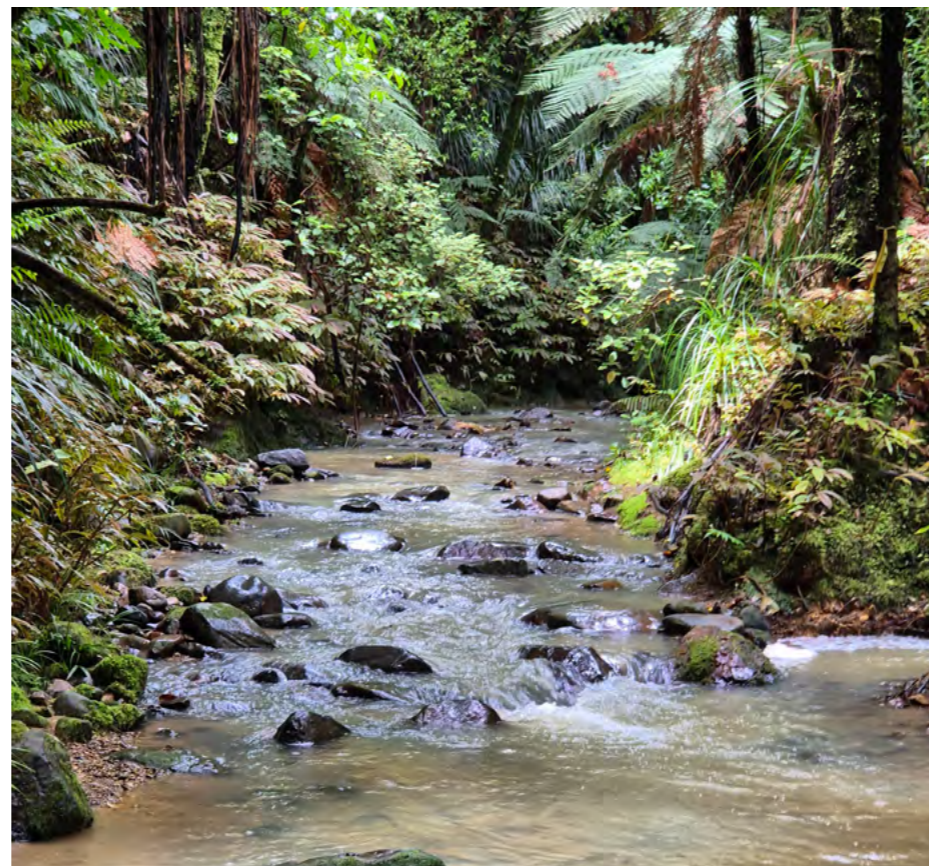
Figure 5: Character images of the Mangapū Stream Tributary.

- The form and behaviour of the Mangapū Stream Tributary are strongly influenced by the surrounding landform, with geomorphology and surface topography guiding channel alignment, gradient, and flow dynamics.

- The tributary and Mangapū Stream are partly located within an ONL, which also reinforces its high natural character.

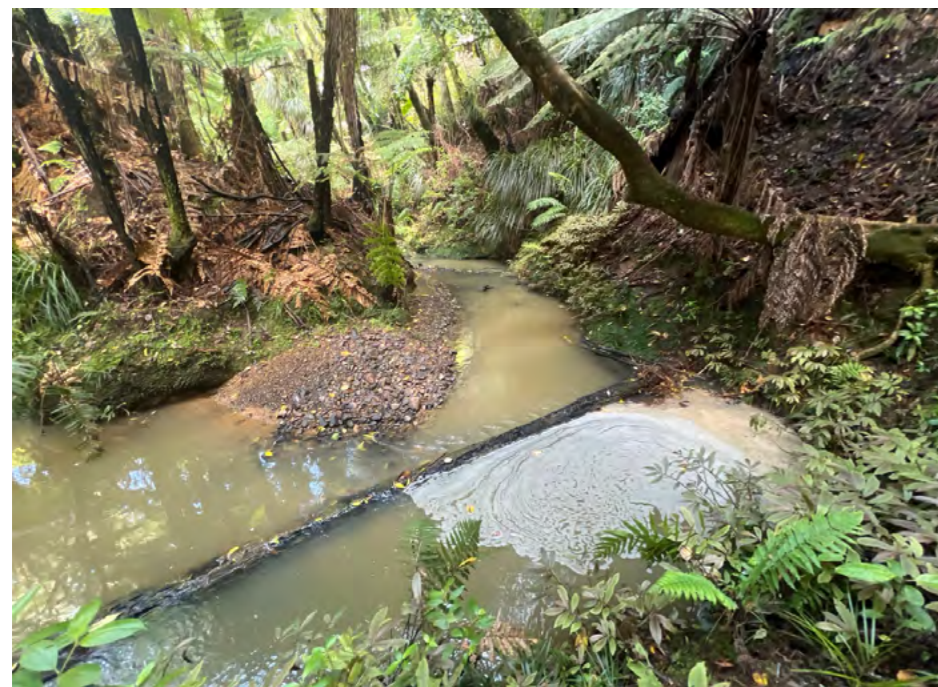
Figure 11: Photo of upper Mangapū Tributary, large meander, slow flow pool

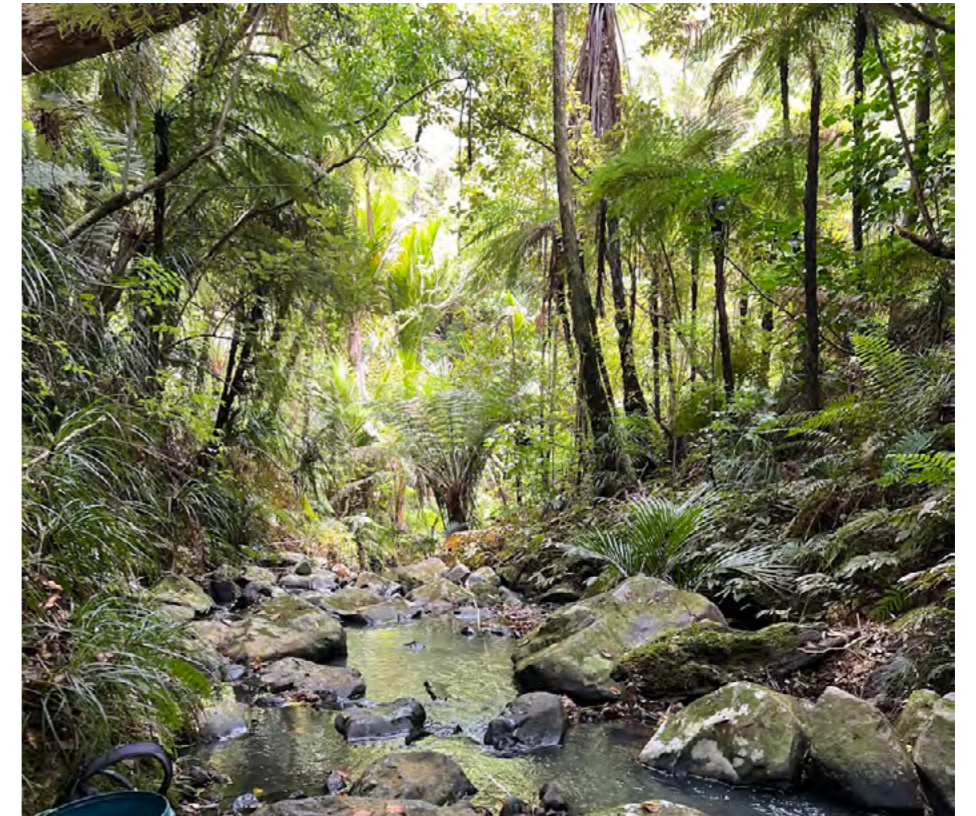
Figure 12: Mangapū Tributary

- Riparian vegetation is to be planted along the length of the stream realignment, to the extent practicable. Appropriate riparian species selection will enhance stream ecology through providing shade to the stream, reducing water temperature, producing habitat and providing a food source. As much as possible, riparian vegetation will extend along either side of the realignment channel.

When implemented, the recommended principles and actions will provide acceptable remediation for the loss of the extent and values of Mangapū Stream Tributary.

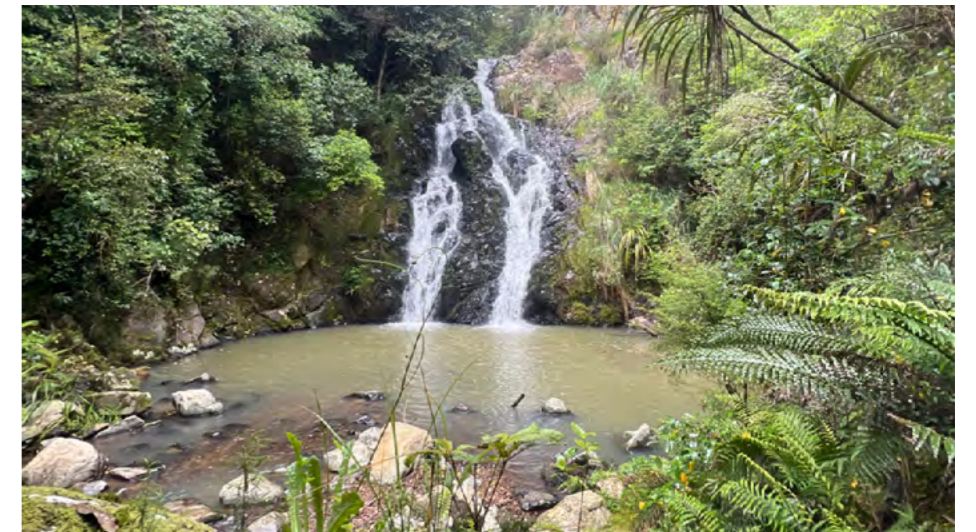
Figure 13: Waterfall within the Mangapū Tributary

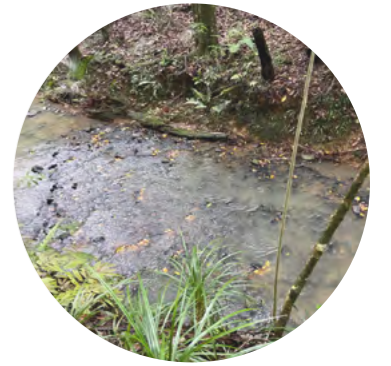
1 RIFFLES / COBBLES
 Medium sized substrate mobilised in moderate to high flows. Habitat on surface and below the cobbles create habitat for different algae and invertebrates.

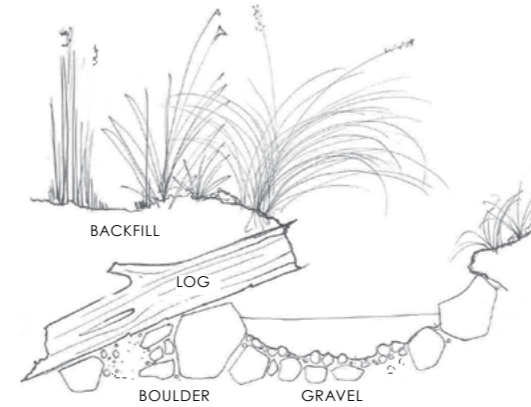
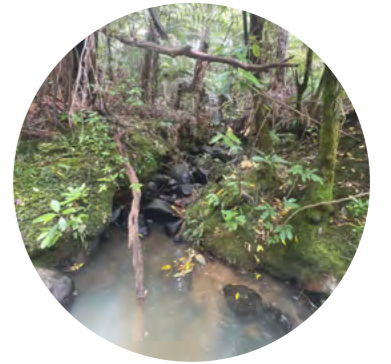
2 UNDERCUT BANK FEATURES
 To create refuge for fish during daytime and periods of high flow.

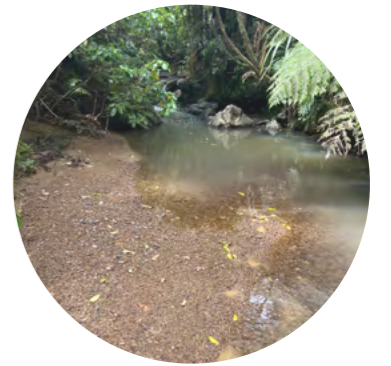
3 GRAVEL FANS
 Potential habitat for Hochstetter's frogs, and additional refuge for fish in higher flows.

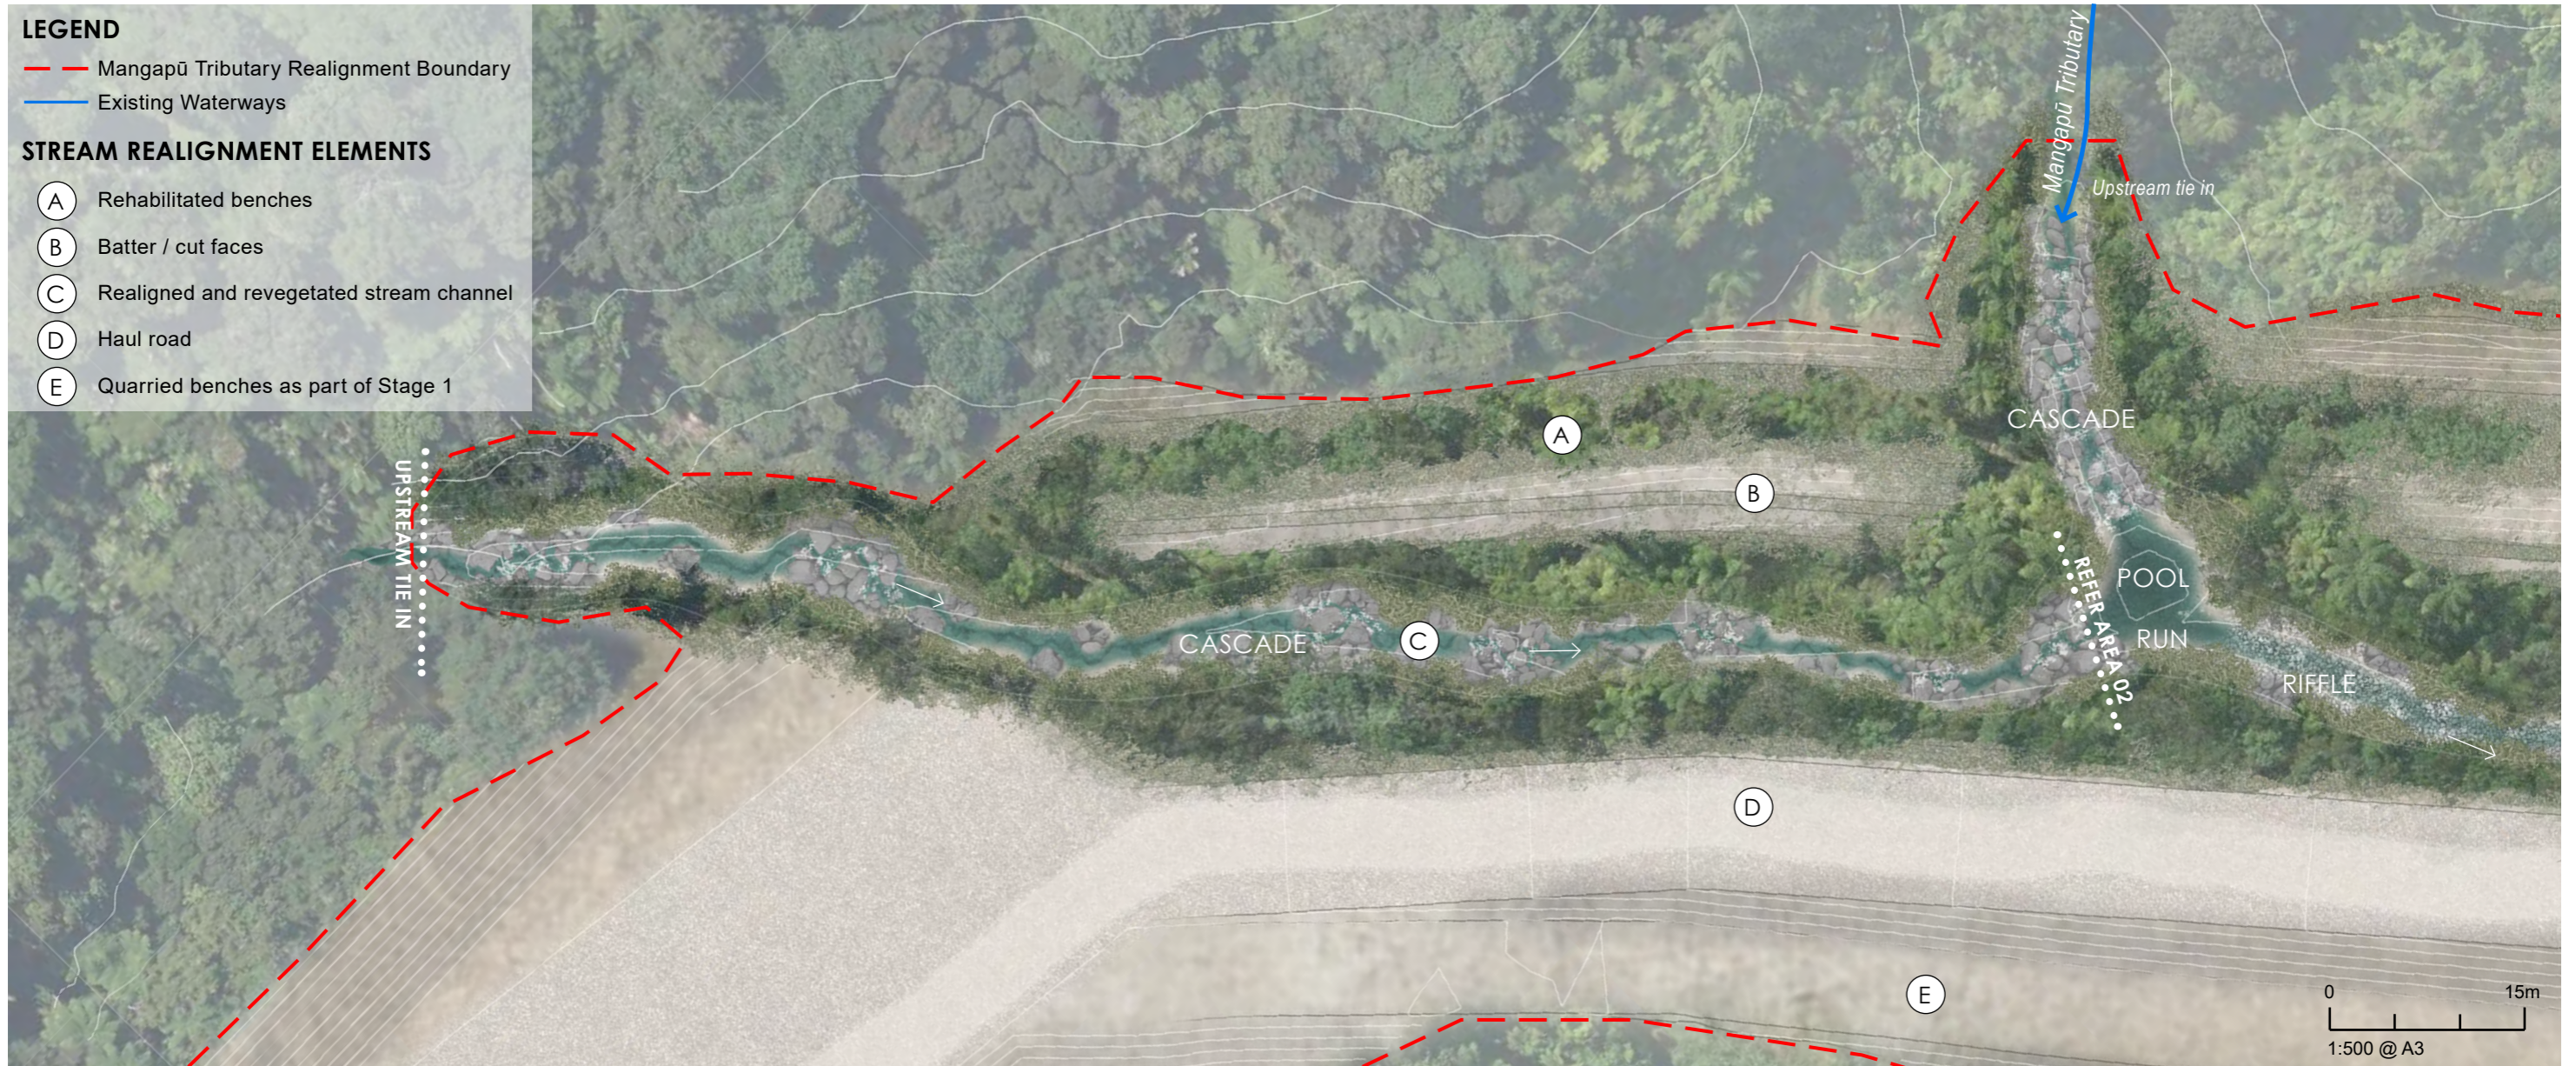
AREA 01 PLAN VIEW
SCALE 1:500 (A3)

Note: Design based on PDP technical drawings illustrated as the mean annual flood channel.

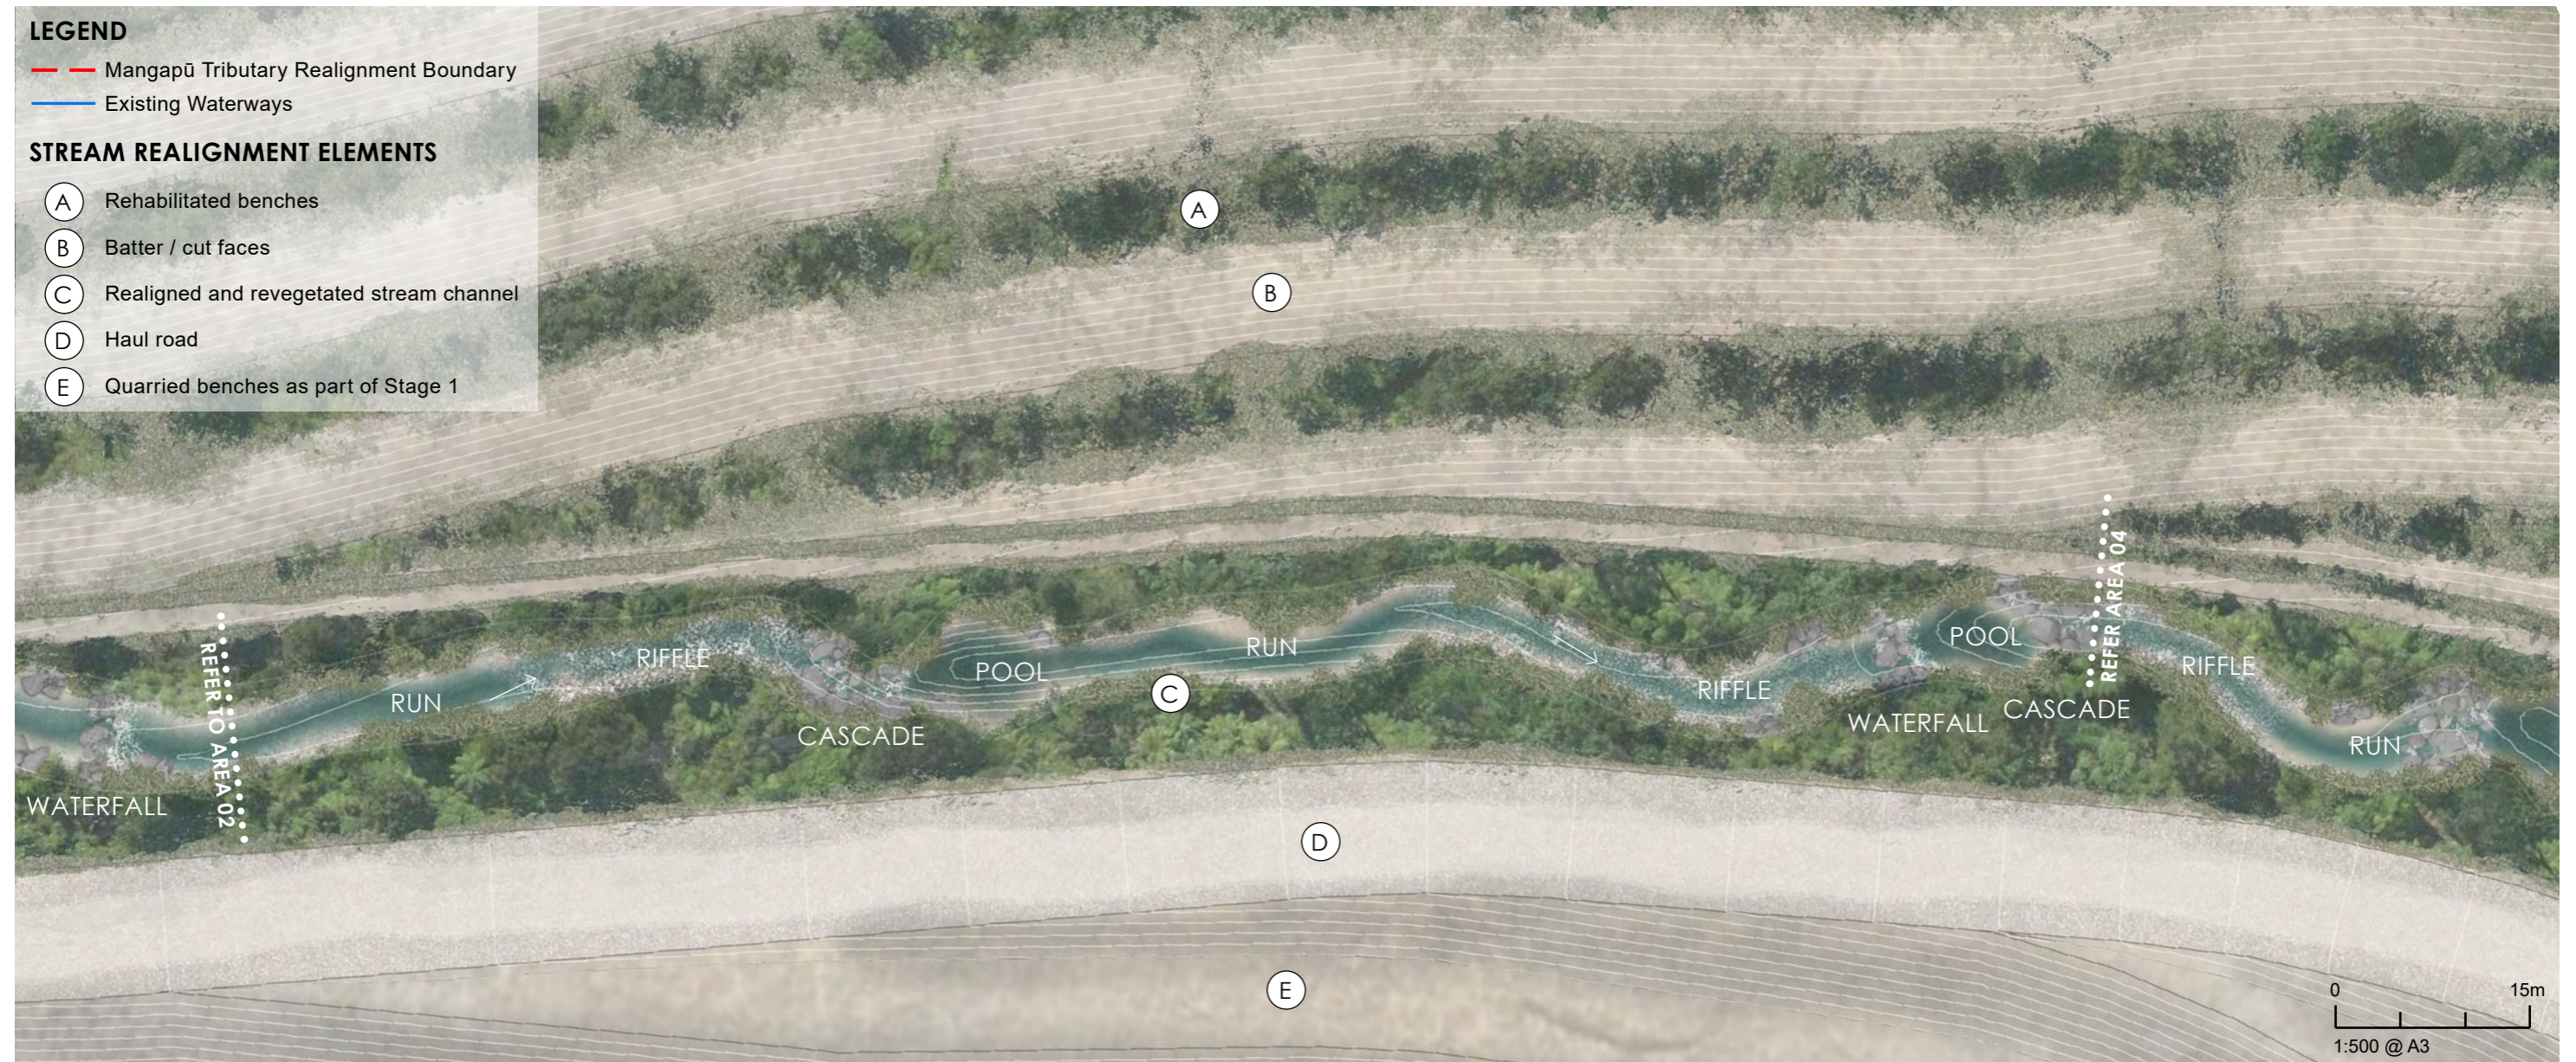
AREA 03 PLAN VIEW
SCALE 1:500 (A3)

Note: Design based on PDP technical drawings illustrated as the mean annual flood channel
