# **BULLER PLATEAUX CONTINUATION PROJECT, WESTPORT, SOUTH ISLAND: ARCHAEOLOGICAL AND HISTORIC HERITAGE ASSESSMENT (PART 1 – ESCARPMENT EXTENDED)**

Prepared for Bathurst Resources Ltd

April 2026

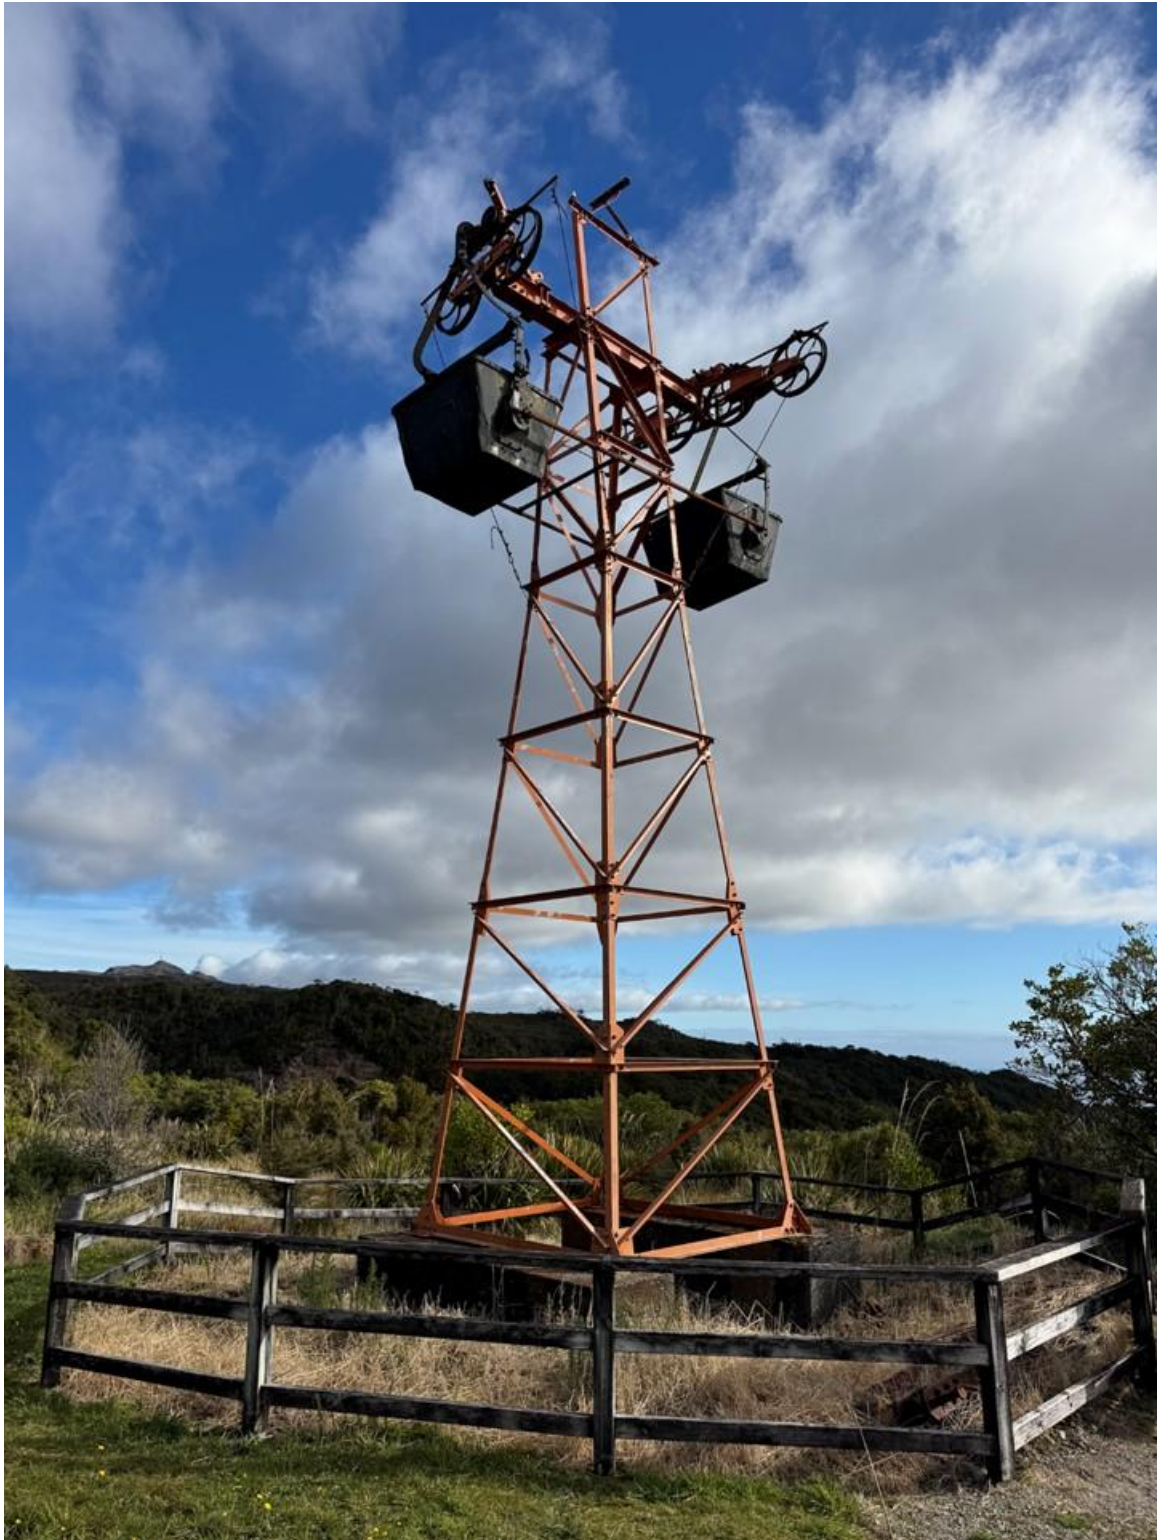
**Figure 8. A surviving aerial cableway support tower above the Denniston Brakehead (Feature A39). This tower is maintained by DOC, and the two buckets have been mounted on the tower to give the impression of how it would have appeared when working**

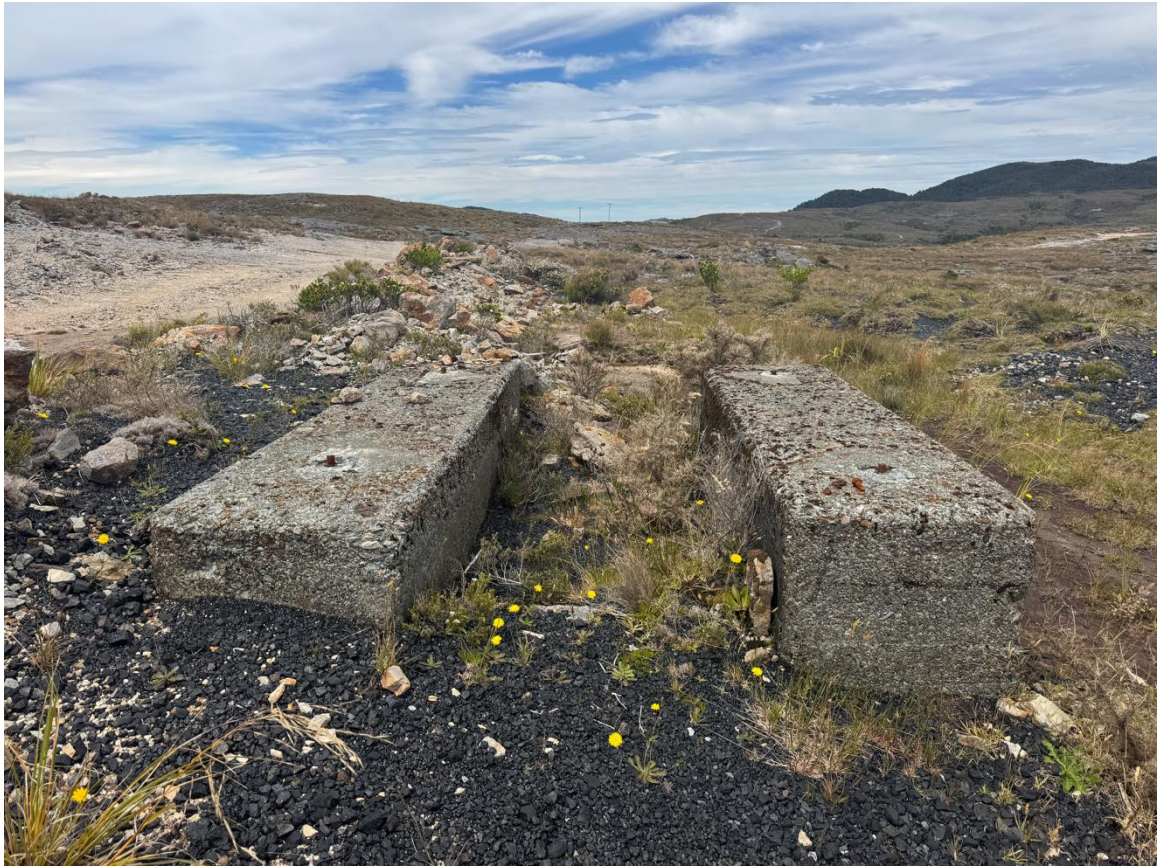
**Figure 9. Double support tower foundation for the aerial cableway near Sullivan Mine (Feature A13)**

| Feature No. | NZTM East | NZTM North | Description |
|---|---|---|---|
| A13 | | | Foundation slabs only. 677m asl.<br>See Figure 9 |

The Top Loading and Aerial Drive Station (Feature A1) at the Whareatea Mine is located immediately adjacent to the proposed ESE disturbance footprint but will be avoided and protected (see Figure 20). The associated Monocable Aerial Cableway foundations at Sullivan's Mine (Features A12 – A14) will also be avoided (see Figure 25).

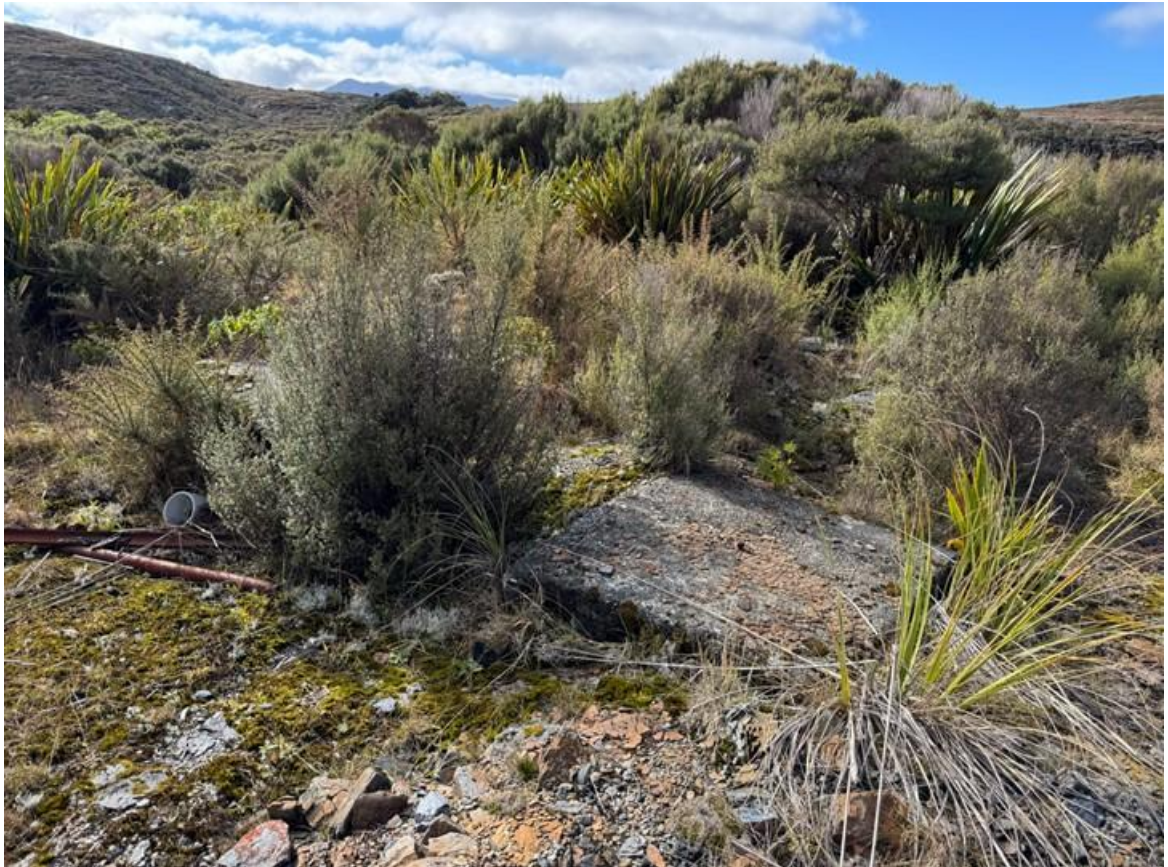
**Figure 10. Monocable Aerial Cableway Feature A2 concrete slab foundations beside Whareatea Road that will be removed by the ESE**

Remnants of the aerial system within the ESE Project sub-area that will be removed by the proposed activity include concrete foundations slabs for the towers – Features A2, A3, A4 and A5, located north of the Whareatea Mine site (Figure 11 and Figure 21). These features that will be affected are highlighted on Table 2 and shown on Figure 7.

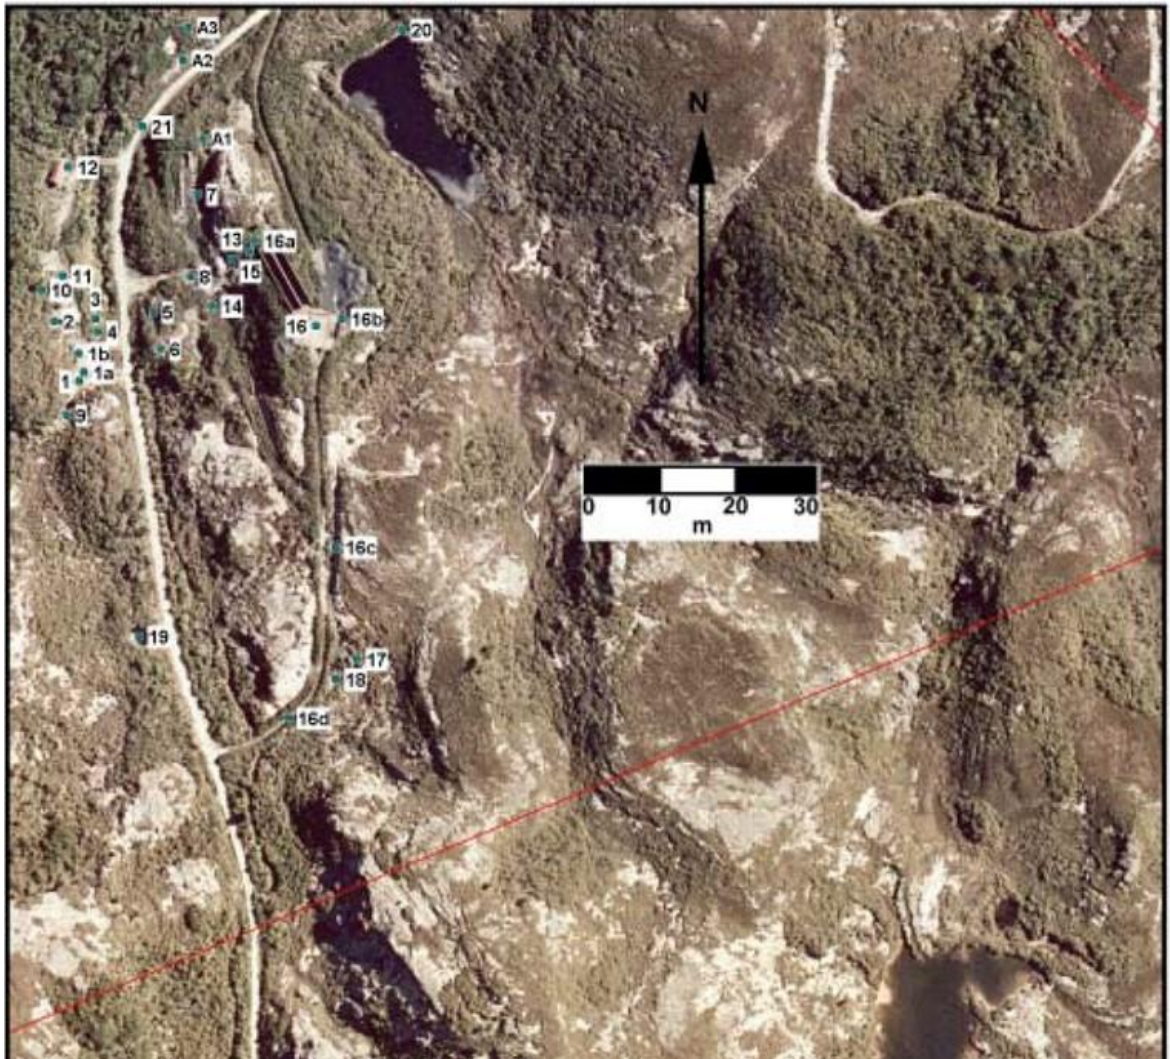
Figure 11. Aerial view of Whareatea Mine showing historic features labelled and described in Table 3 (source: Watson and Wright May 2004: fig. 4)

The remains of the Whareatea Mine recorded in 2004 by Watson and Wright and in 2014 by Clifford and Barr are shown in Figure 11 and Figure 12 and described in Table 3. Site inspection by the authors in 2020 and 2025 confirmed that the previously recorded surface infrastructure associated with the Whareatea Mine remains in situ (Figure 13 – Figure 20). The extent of the underground workings at Whareatea Mine are shown in Figure 22. Their state and condition are unknown.

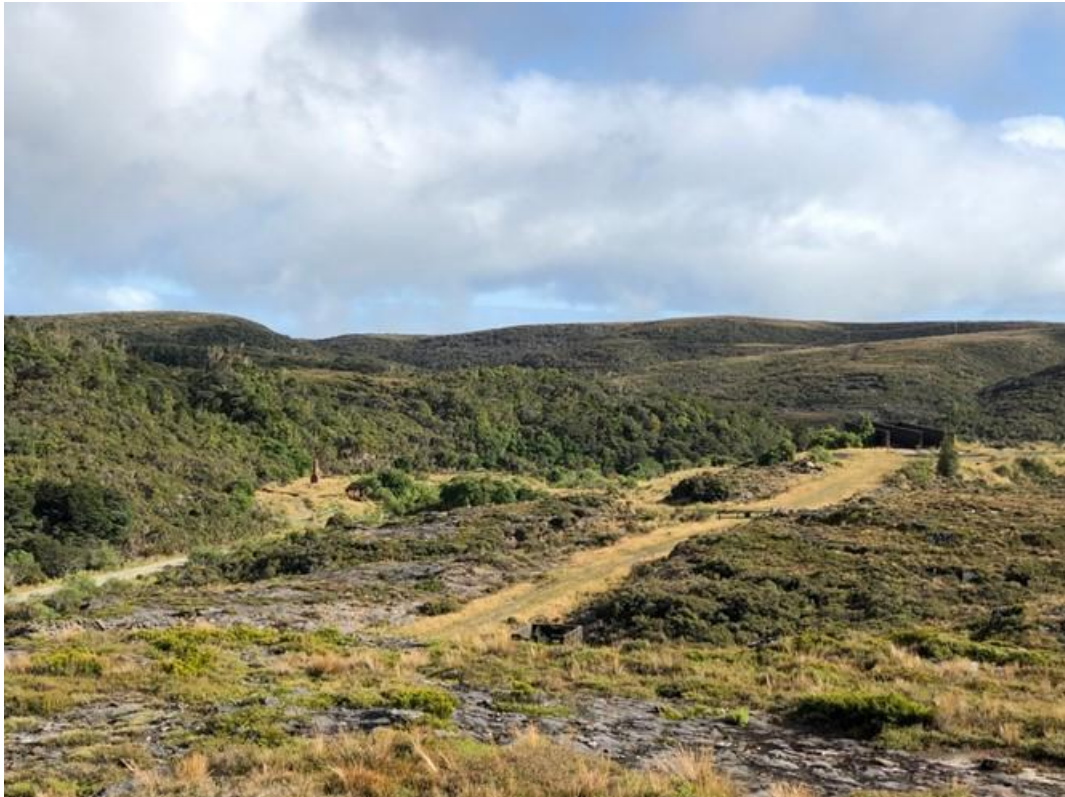
**Figure 13. Looking northwest over the Whareatea Mine site. The Whareatea Road is left, the office chimney (Feature 11) is left centre, and the dewatering pads (Feature 16) right centre**

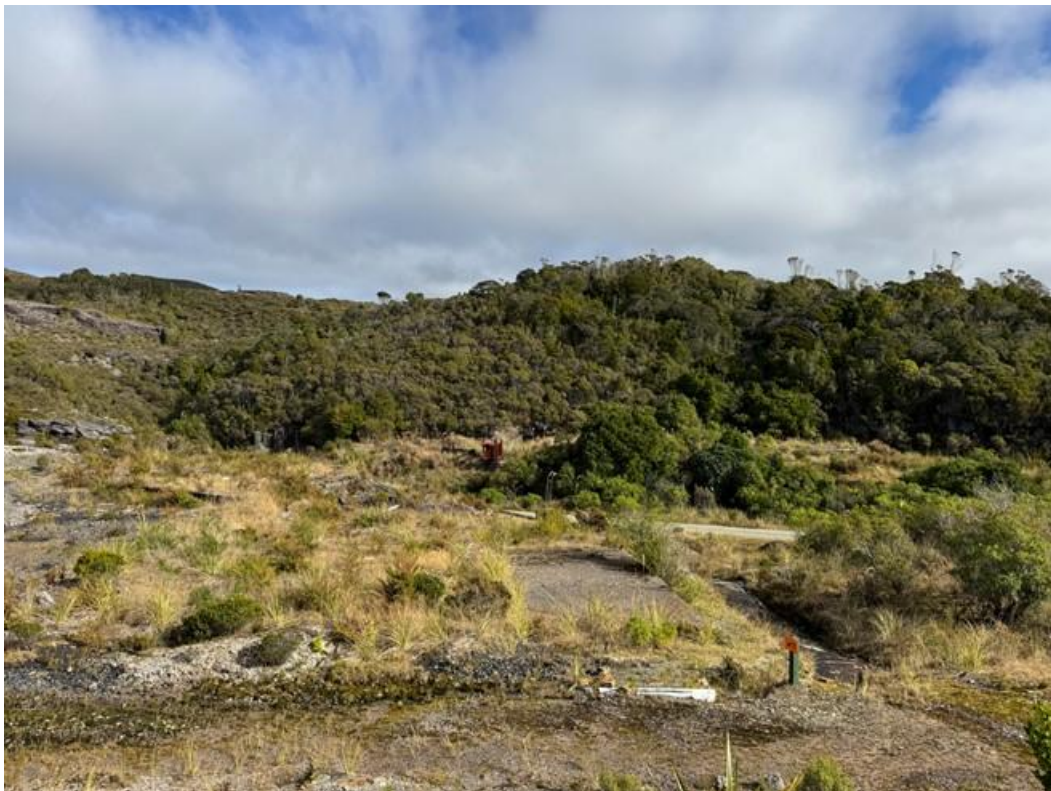
**Figure 14. Looking from the electrical substation foundations across Whareatea Road towards the mine entrances, winch foundations (Feature 3) and office and workshop foundations (Feature 11)**

| Feature No. | Feature | Description |
|---|---|---|
| 3 | Winch foundations | Cocky Coburn's winch foundation. 3.1 x 3.1m. See Figure 14 |

| Feature No. | Feature | Description |
|---|---|---|
| 11 | Office and workshop foundations | Administration building (this replaced 2 earlier buildings on the same site). There is a brick chimney and steps along the front. The top of the chimney has fallen off and lies beside it. The foundation is 23.65m long and 8.35m wide (not including the steps). There are also steps at both ends and there was possibly a verandah.<br>See Figure 14 and Figure 18 |

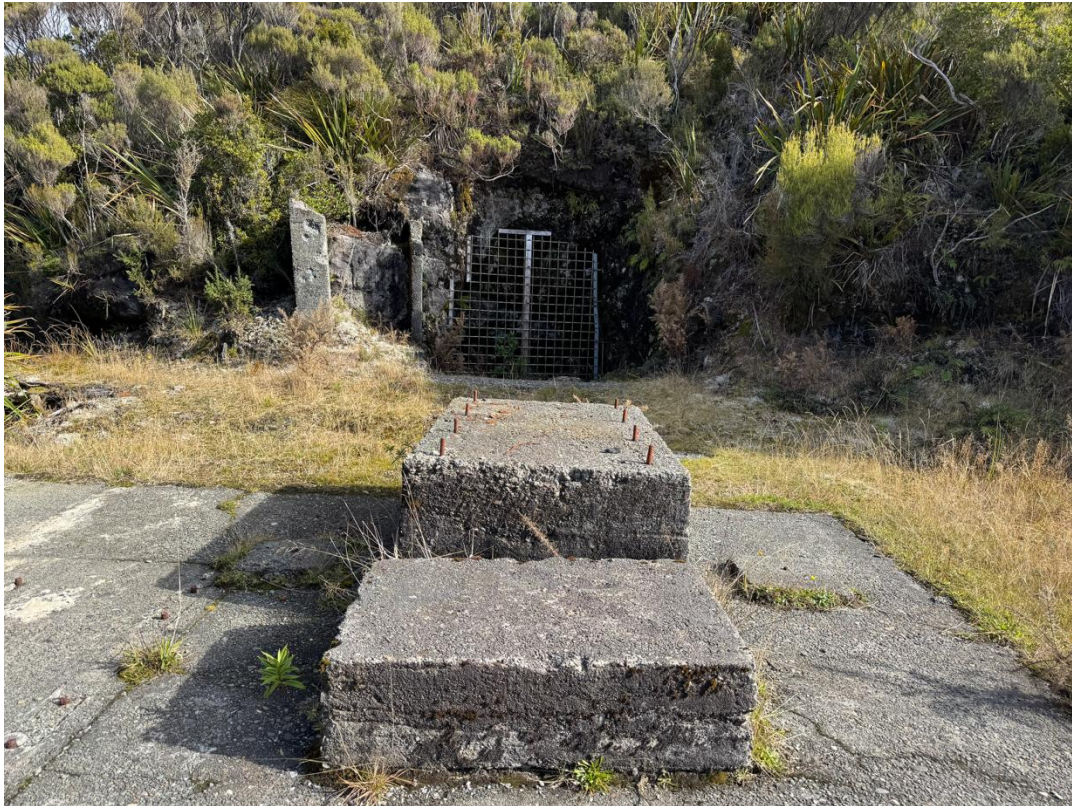
**Figure 15. Looking from Whareatea Road to the ‘The Steps’ entrance (Feature 1) with the fanhouse foundations (Feature 1a) in front**

| Feature No. | Feature | Description |
|---|---|---|
| 1a | Fan house foundations | Concrete foundation of the fan house (5.6 x 4.75m). The large block that supported the fan is still in place. There are metal items sitting on the foundations. See Figure 15 |

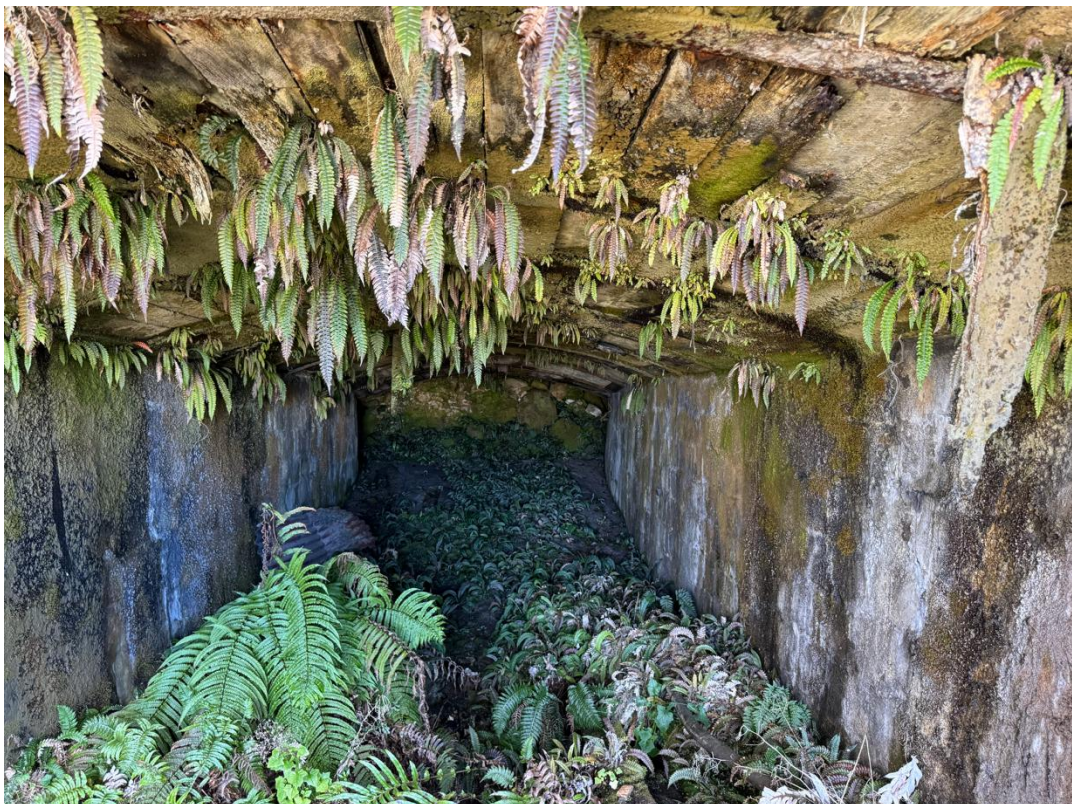
**Figure 16. Looking down the ‘The Steps’ entrance (Feature 1)**

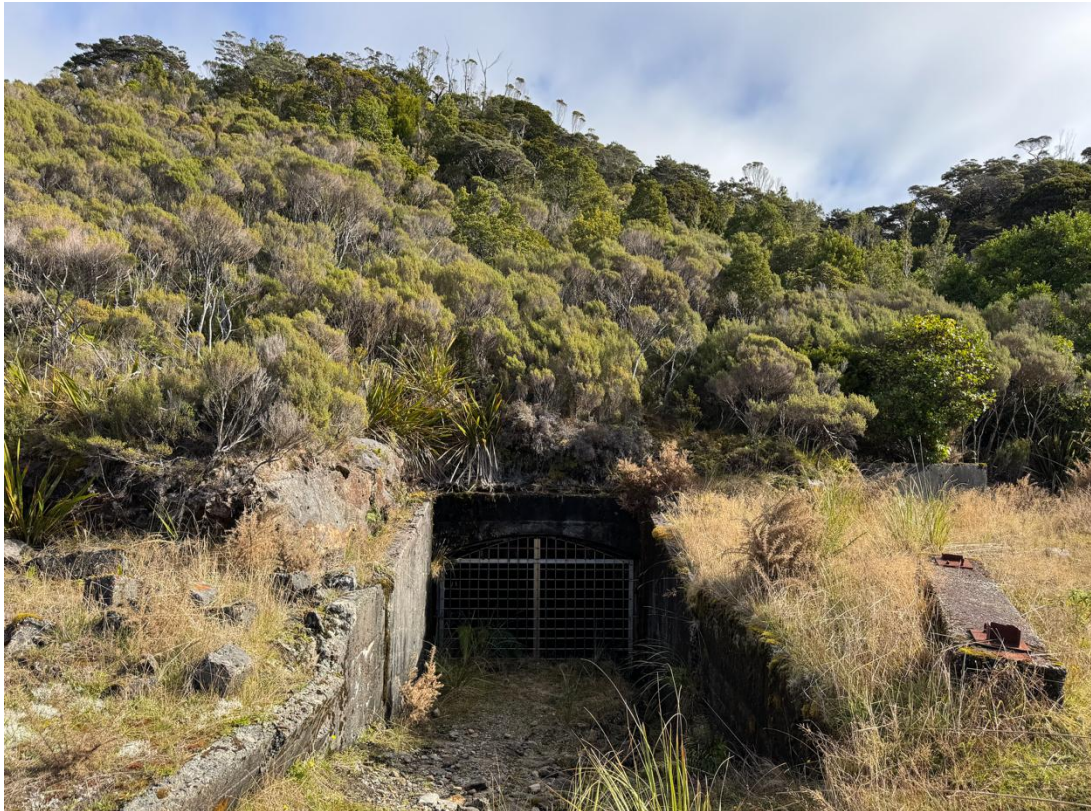
**Figure 17. Whareatea men and materials entrance (Feature 2)**

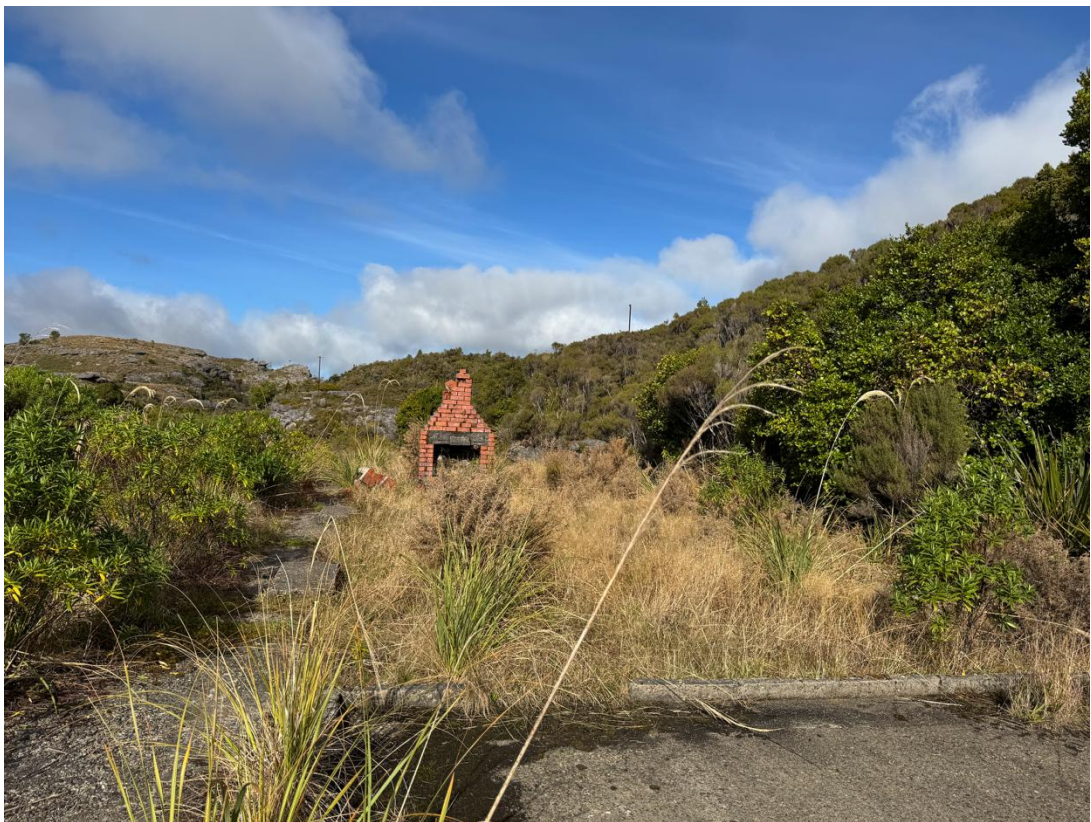
**Figure 18. Whareatea office and workshop foundations (Feature 11) and office chimney**

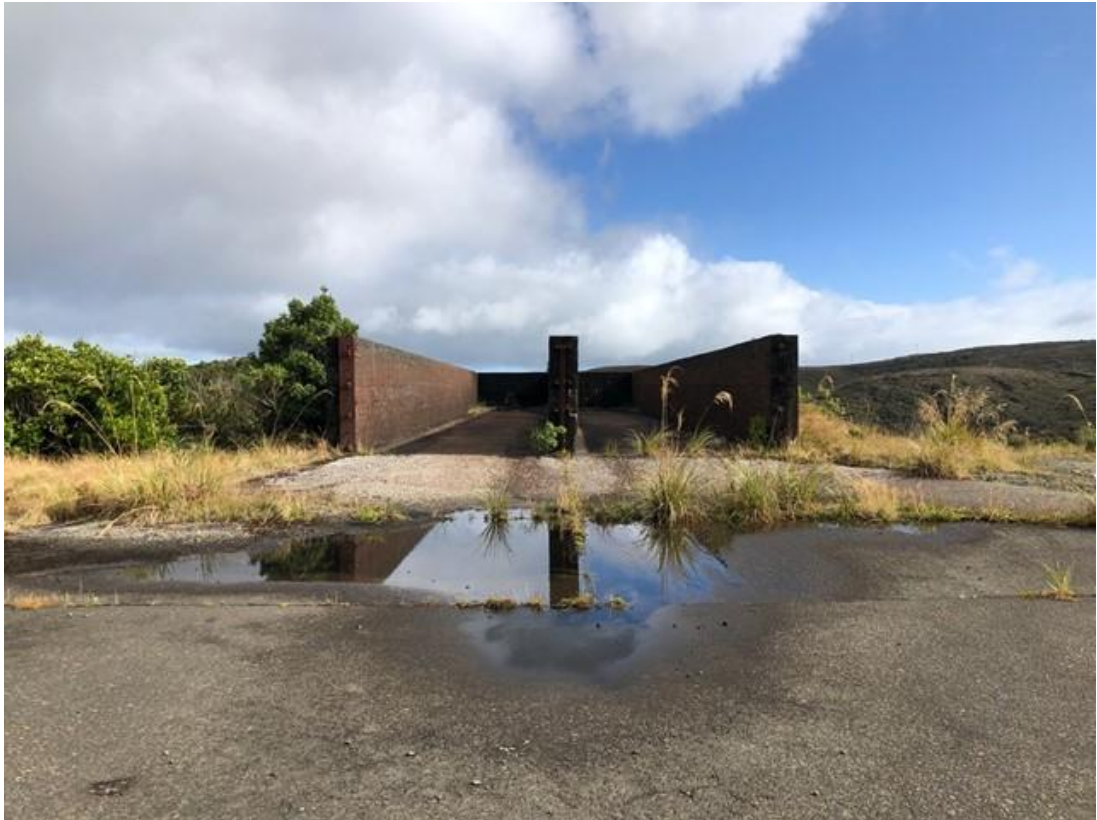
**Figure 19. Whareatea dewatering pads (Feature 16) from the lower part of the truck loading apron**

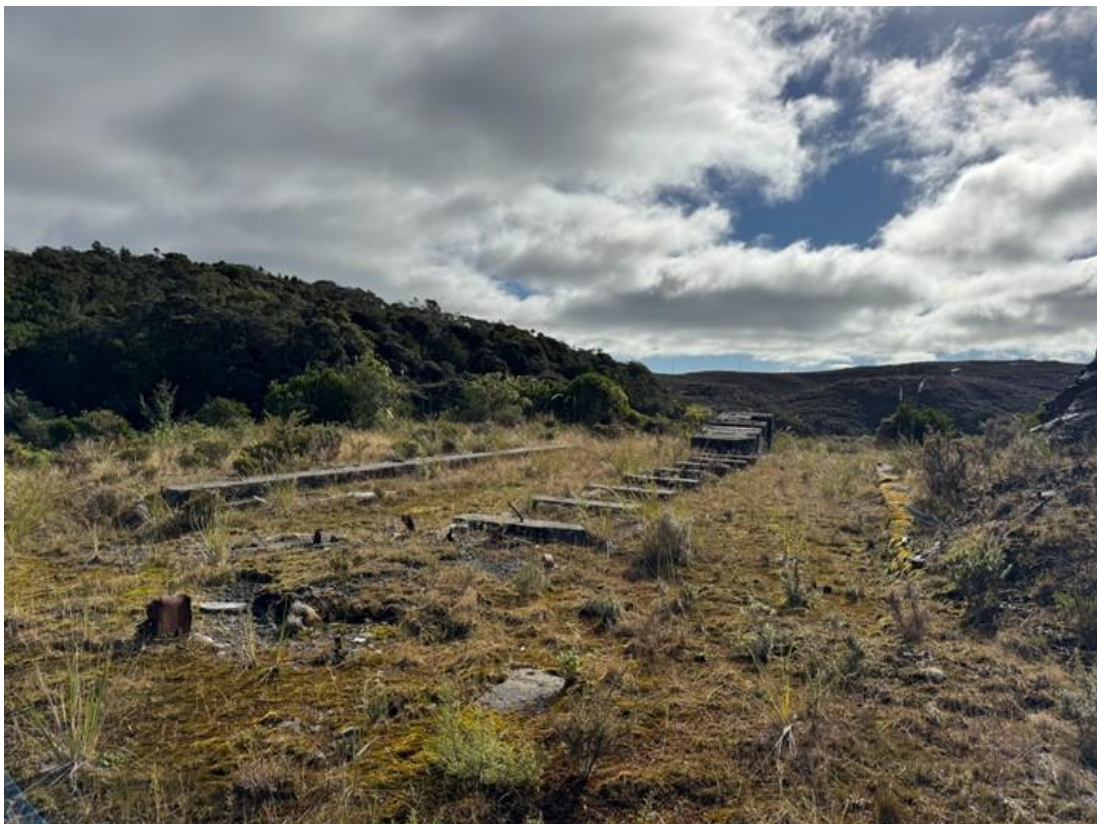
**Figure 20. Bin and aerial drive station foundations (Feature 7) for Monocable Aerial Cableway Drive Station (Feature A1)**

| Feature No. | Feature | Description |
|---|---|---|
| 7 | Bin and aerial drive station foundations | There are 8 blocks in a parallel line (1.52 x 0.46m) with a single metal bolt (now bent over) in the middle of each. There is a large sloping block (6.2 x 1.85m) at the northwest end of these blocks and a well next to the block (for the weights associated with the operation of the aerial cableway.<br>See Figure 20 |

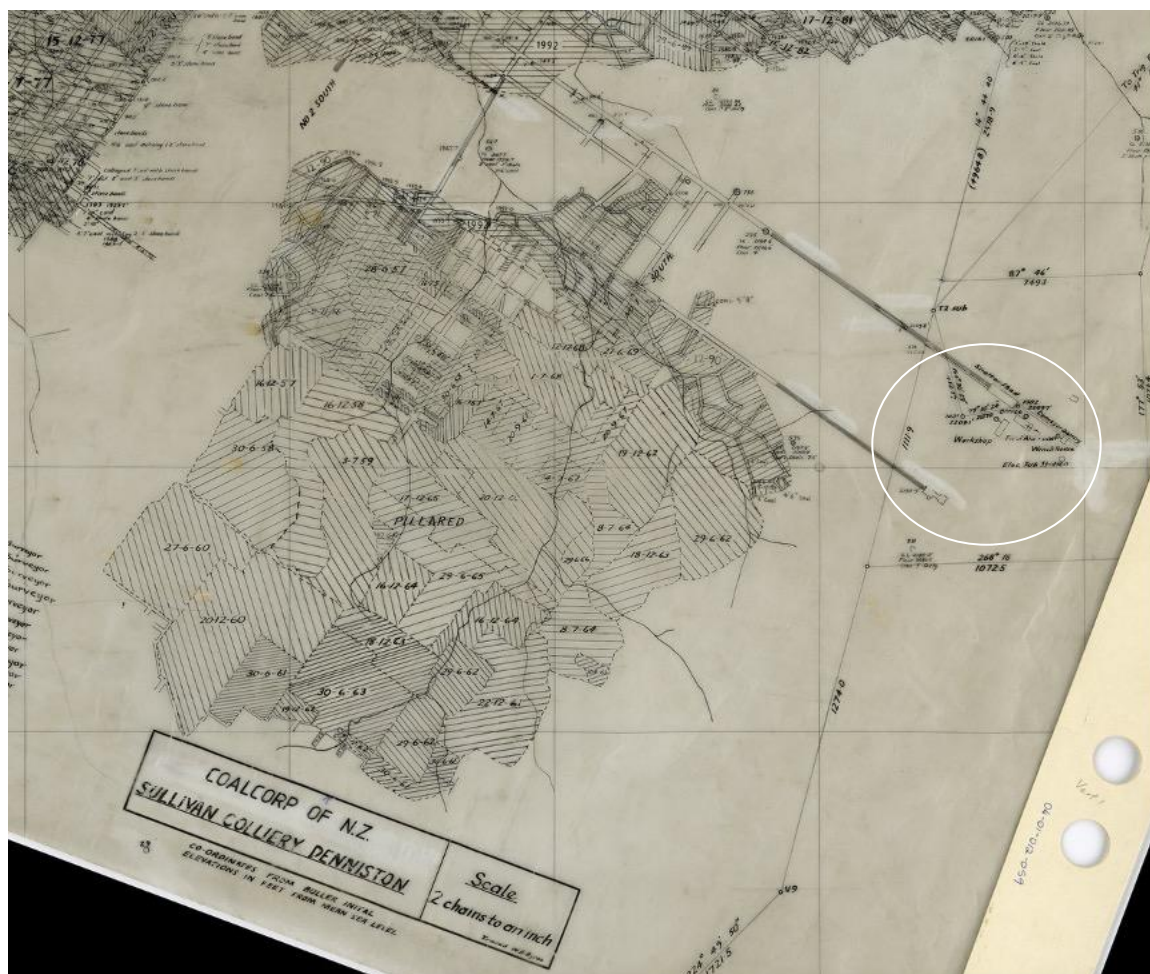
**Figure 26. Detail from the Coalcorp of NZ Sullivan Colliery Denniston plan of the No. 1 South Sullivan Mine underground workings. The Sullivan Mine surface features are circled, including the Men and Materials mine entrance and Fan Drift which provided access to the stone drives (source: Bathurst)**

Only a small area developed by bord and pillar method from 1958 remains in the northern section of No. 1 South, with the remaining mine further developed by pillar extraction (‘pillared’). Two stone drives, one from the Men and Materials Entrance to access the coal seam, and one from the Fan Drift to provide ventilation, link to a series of mine drives to the No. 1 South and No. 1 North underground workings (Figure 26).

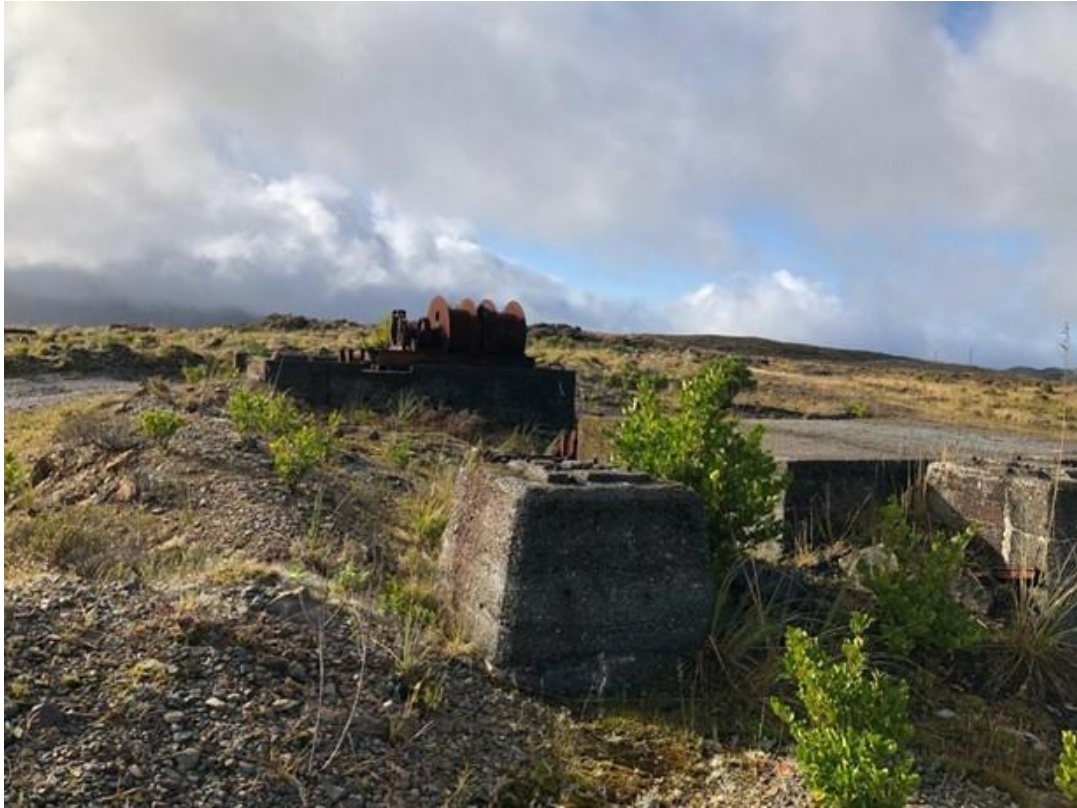
**Figure 27. The Sullivan Mine gantry foundations (Feature 25b), winch house foundation (Feature 29) (background) and landing platform (Feature 30)**

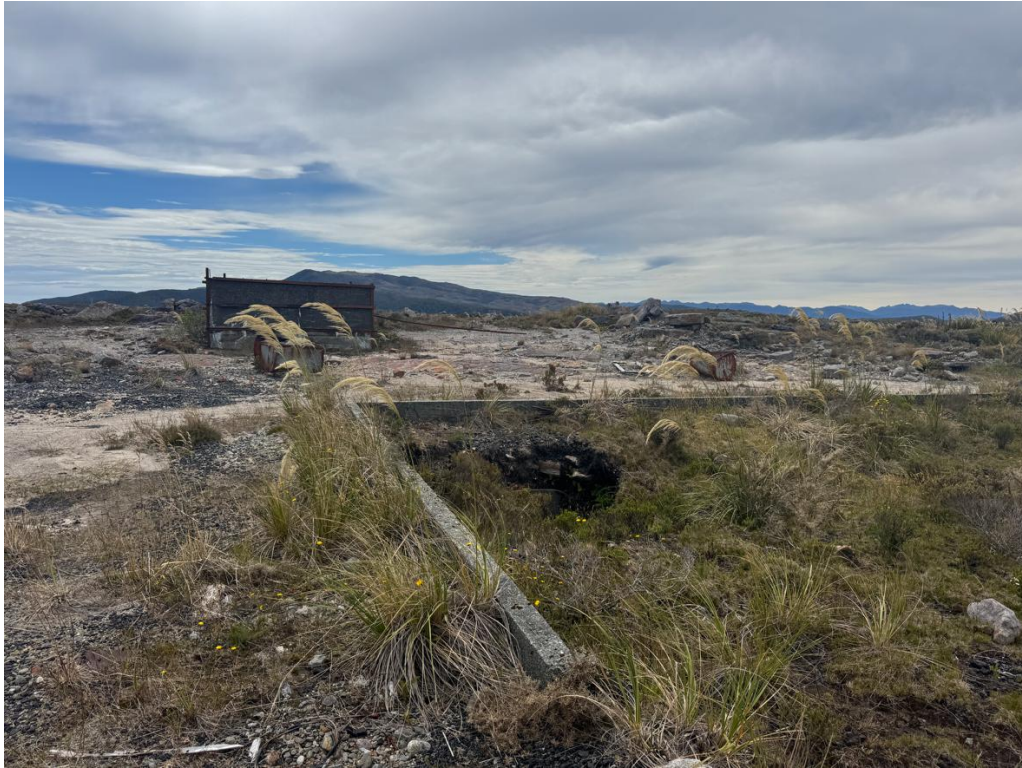
**Figure 29. Intact end and side kerbing at Sullivan Mine entrance (Feature 23), showing backfill (right of retaining). The concrete water tank (Feature 34) and some mine boxes or tubs are in the background**

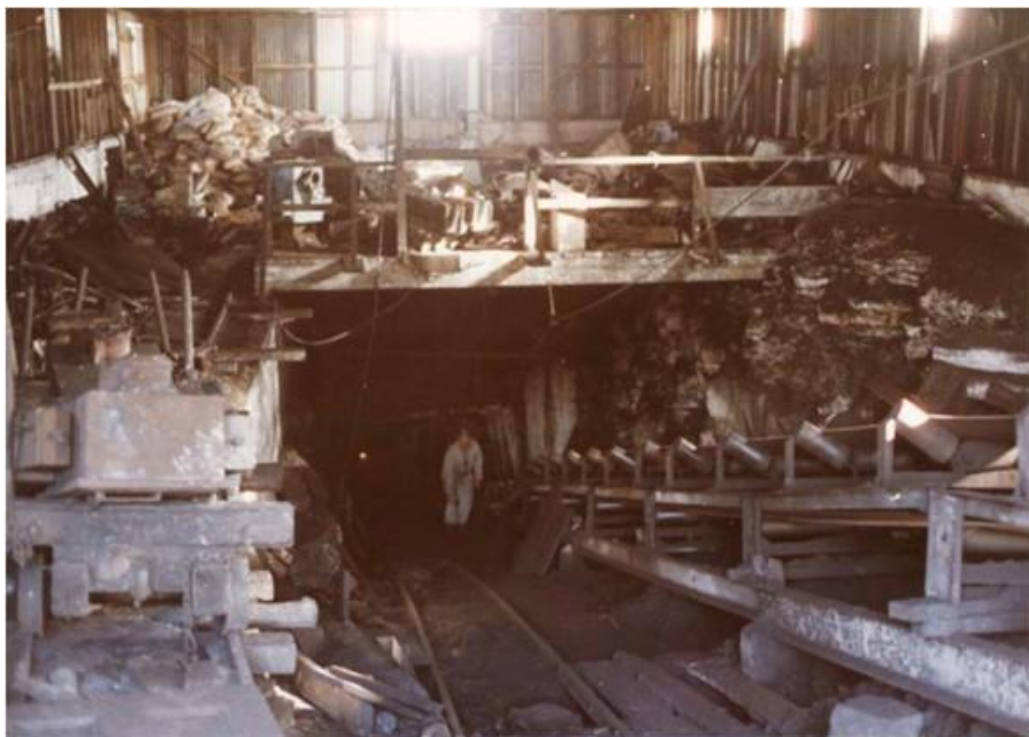
**Figure 30. A view down the Sullivan Mine entrance (Feature 23) late in the mine's life, with the rails at centre and conveyor at right. Materials and equipment were stored in the large entrance shed. (Solid Energy, Westport, photo B2020. In Watson and Wright May 2004: plate 29)**

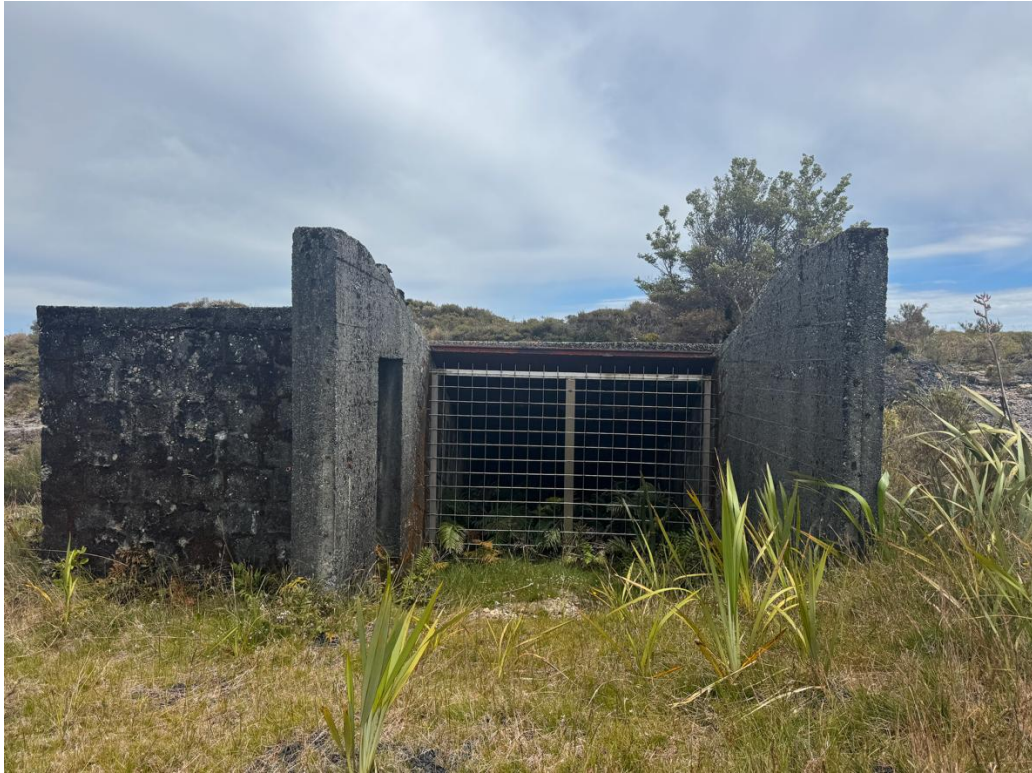
**Figure 31. The concrete/brick shell of the Sullivan Mine fan house with the incline tunnel inside (Feature 24)**

| Feature No. | Feature | Description |
|---|---|---|
| 24 | Fan drift | Closed-off shaft and concrete foundations.<br>See Figure 31 |

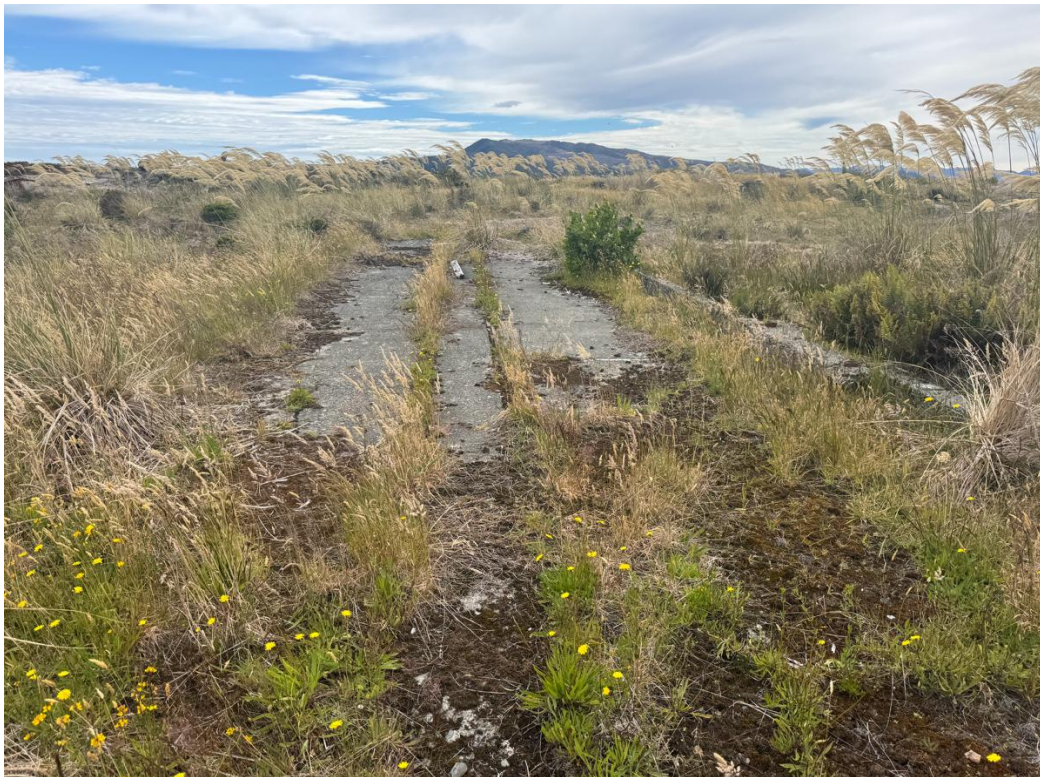
**Figure 32. The concrete foundation of the workshop/store at Sullivan Mine (Feature 32)**

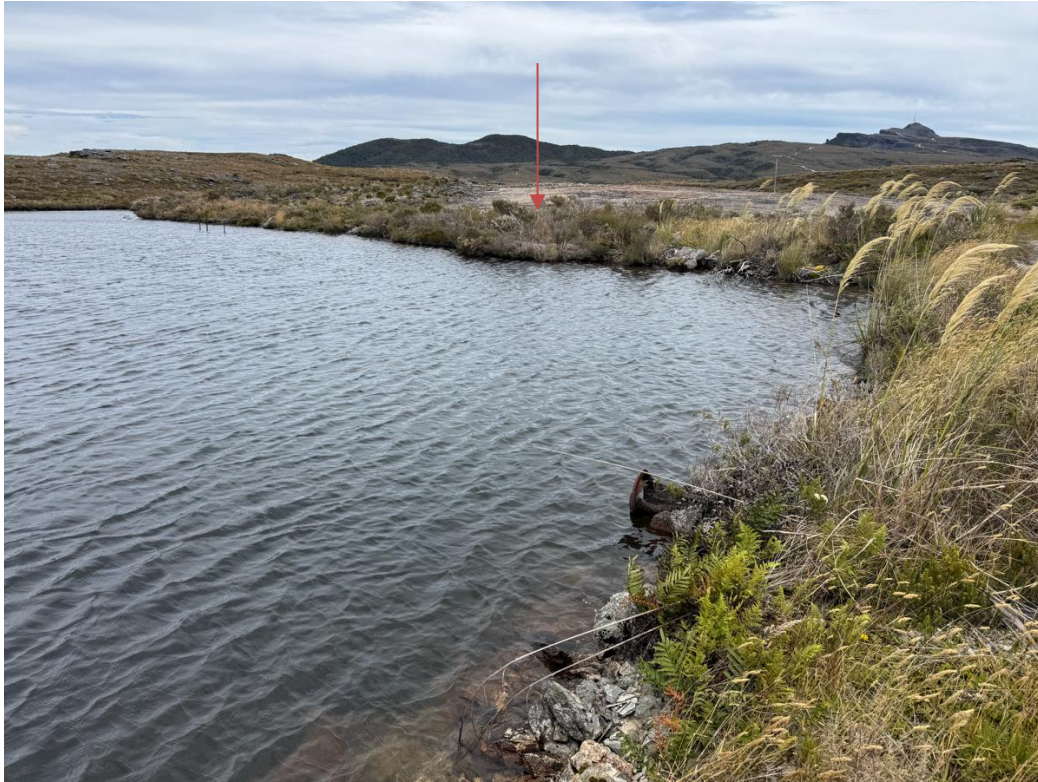
**Figure 33. The reservoir at Sullivan Mine (Feature 37) with the pump shed foundation on its edge (arrowed – Feature 38) and metal outlet pipe in the foreground. Fines from one of many Sullivan coal dumps are spread almost to the shore of the reservoir in the background**

| 38 | Pump shed foundation | A concrete foundation, 2.7 x 2.4m.<br>See Figure 33 |

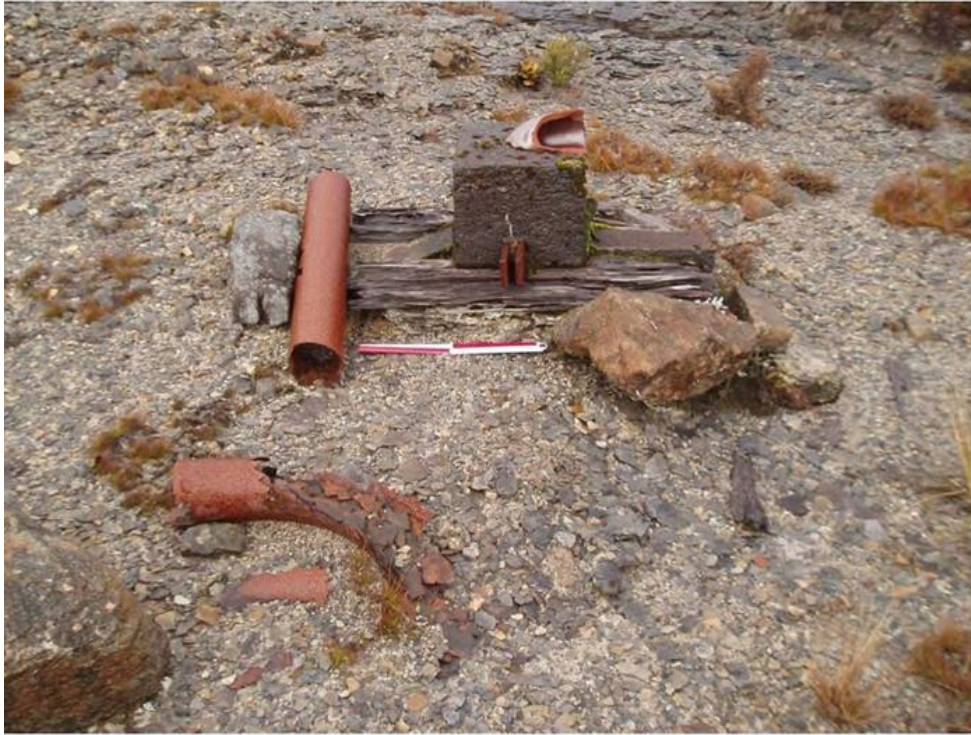
**Figure 34. Building remains to the west of Sullivan Mine**

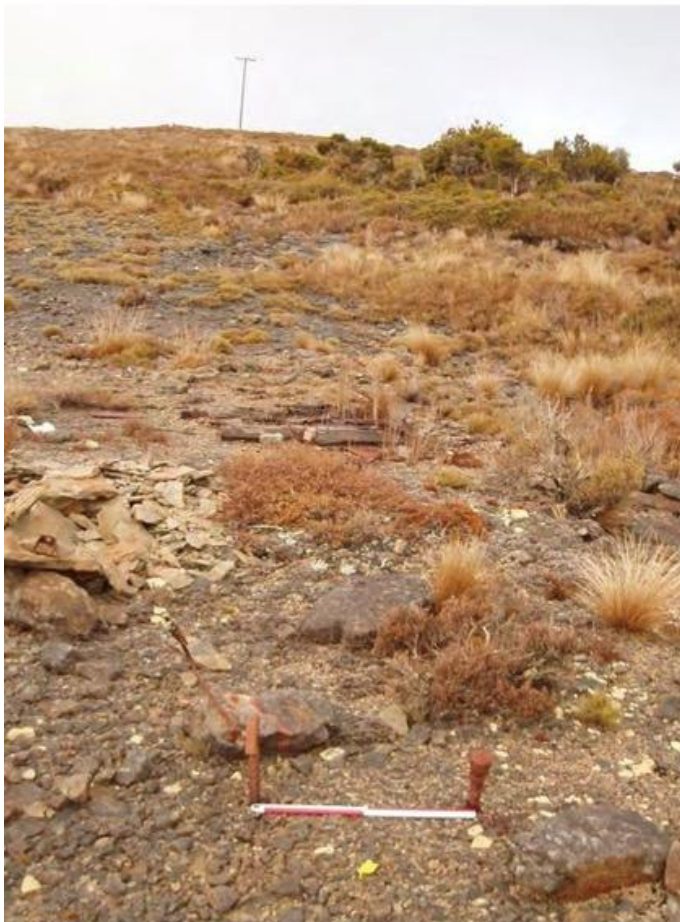
**Figure 35. Two metal bolts west of Sullivan Mine**

Watson (Aug 2010) recorded two in situ metal bolts that were found in the track to the west of the Sullivan Mine and there were scattered timbers in the vicinity (Figure 35 and Figure 36). It is possible that there was a small building here, although it has not been possible to establish anything about this site.

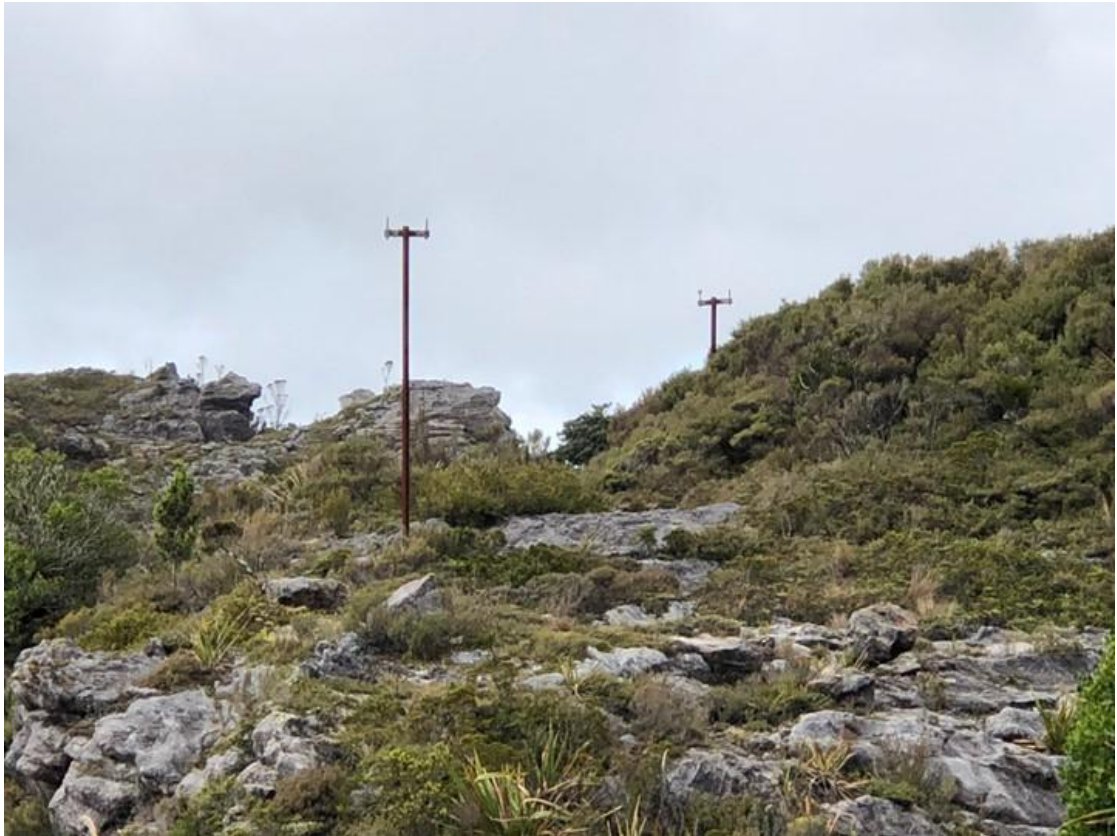
Figure 38. Power poles in the vicinity of the Whareatea Road within the ESE Project sub-area

Nine power poles were recorded along Whareatea Road, which are remnants of a power line that had provided power to either the Whareatea or Escarpment Mine (Figure 36). These power poles have vertical railway irons used as poles, with wooden cross pieces and ceramic insulators (Figure 38). The power poles are at varying distances from the road.
