# **SOUTHERN LINK 1: INDUSTRIAL DEVELOPMENT AREA A – CONTAMINATED SOILS AND REMEDIATION ACTION PLAN**

**Prepared by Swiftsure Consultants Ltd**

**30 August 2026**

# SOUTHERN LINKS 1: INDUSTRIAL DEVELOPMENT AREA B – REMEDIATION ACTION PLAN

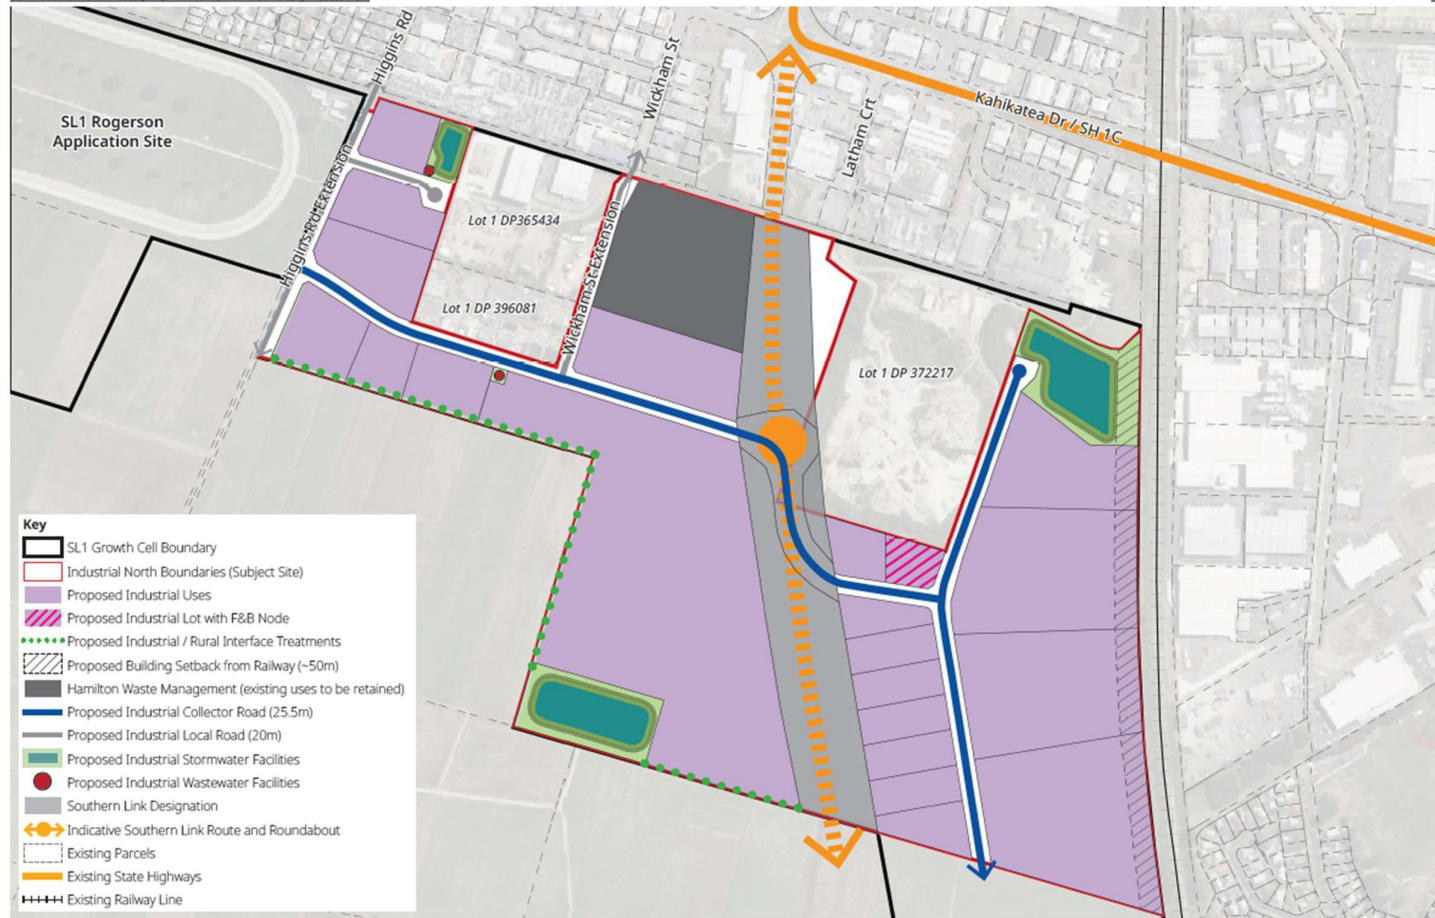
Drawing: Industrial North Overall Masterplan  
Version: Draft for UDA  
Date: June 2026

SL1 Industrial North Masterplan, Hamilton 1 For Urban Design Assessment

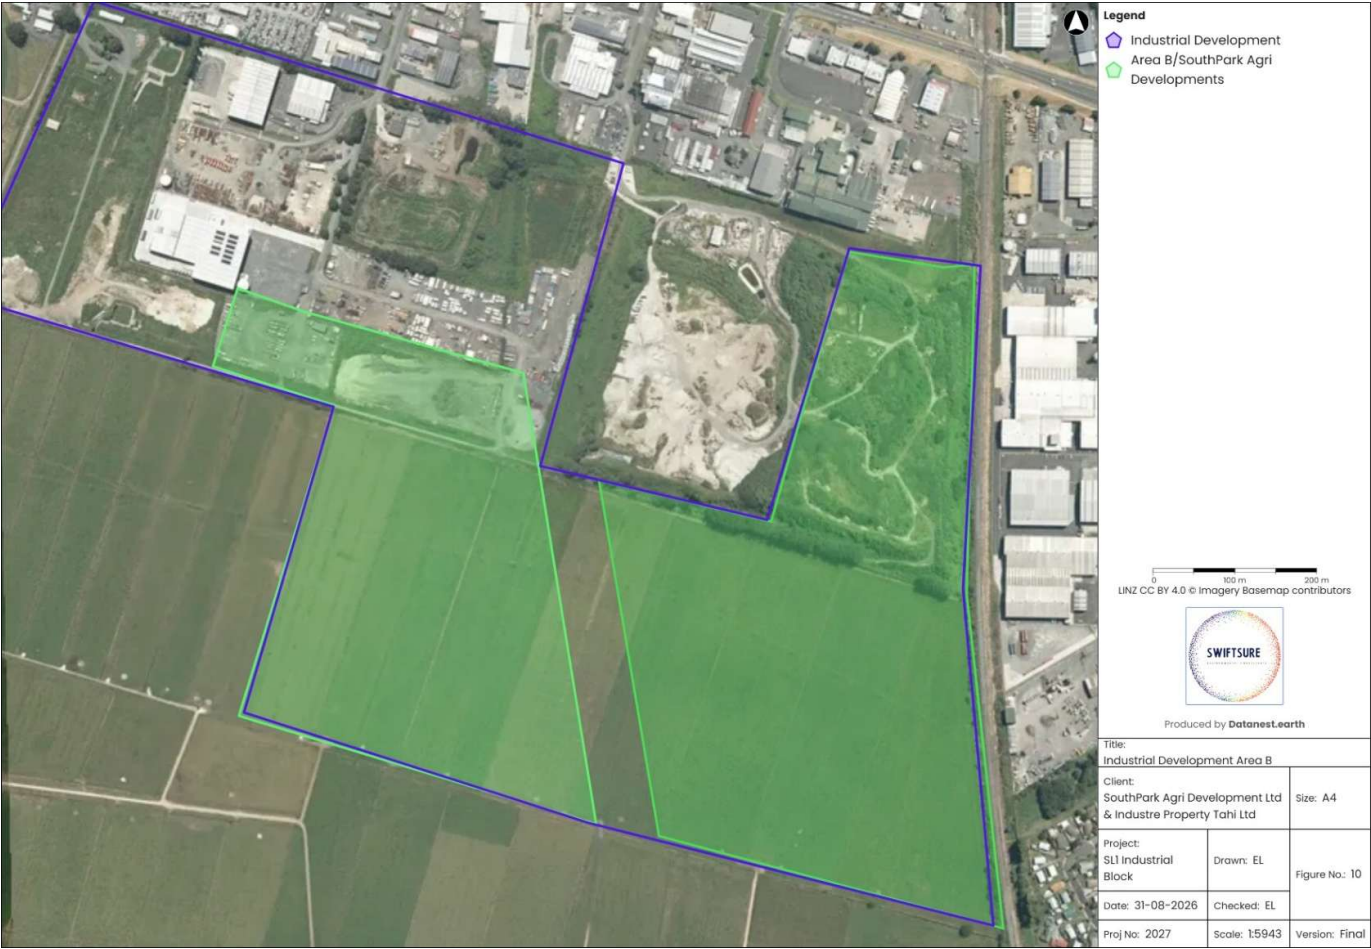
Figure 1: Area B

| Item | Description |
|---|---|
| Current use | Fill mountain, industrial use, truck yard. |
