# **SUNFIELD, AUCKLAND, PROPOSED FUTURE DEVELOPMENT (FUTURE DEVELOPMENT): PRELIMINARY ARCHAEOLOGICAL ASSESSMENT**

Prepared for Sunfield Developments Ltd  
April 2024

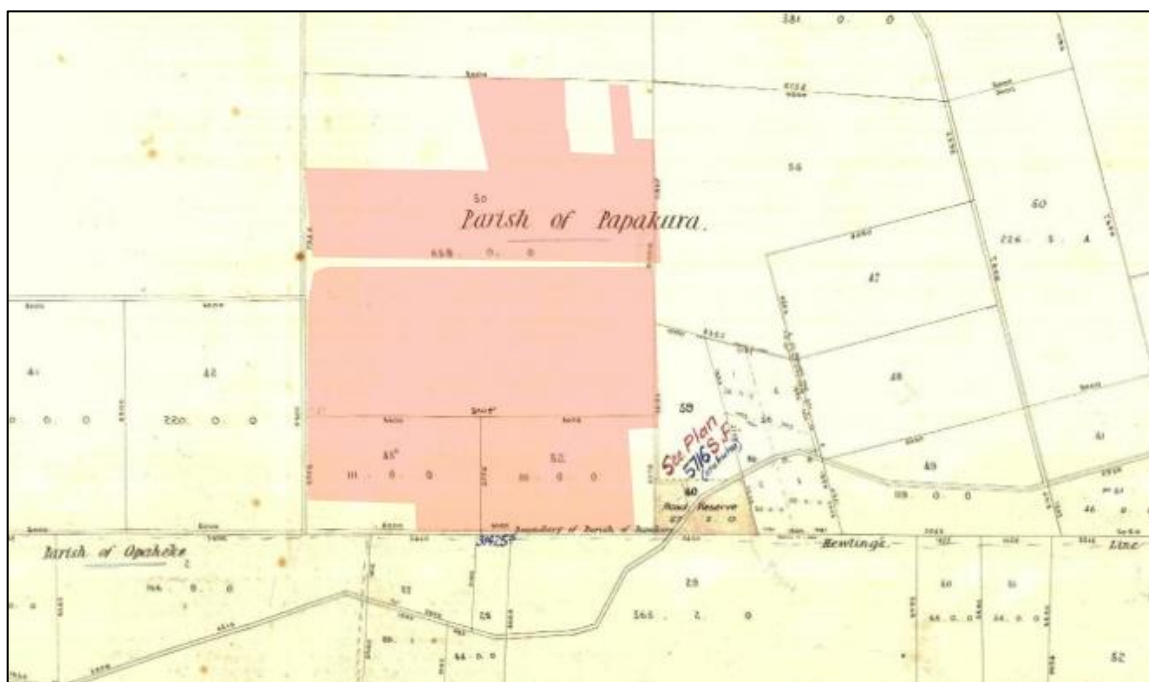
Figure 5. AKC SO 1122 F I undated map (possibly 1885 and drawn from an earlier plan) showing the Future Development area shaded in red containing Allotments 30, 32 and 43A with southern boundary being indicated by 'Hewling's Line' (source: Quickmap)

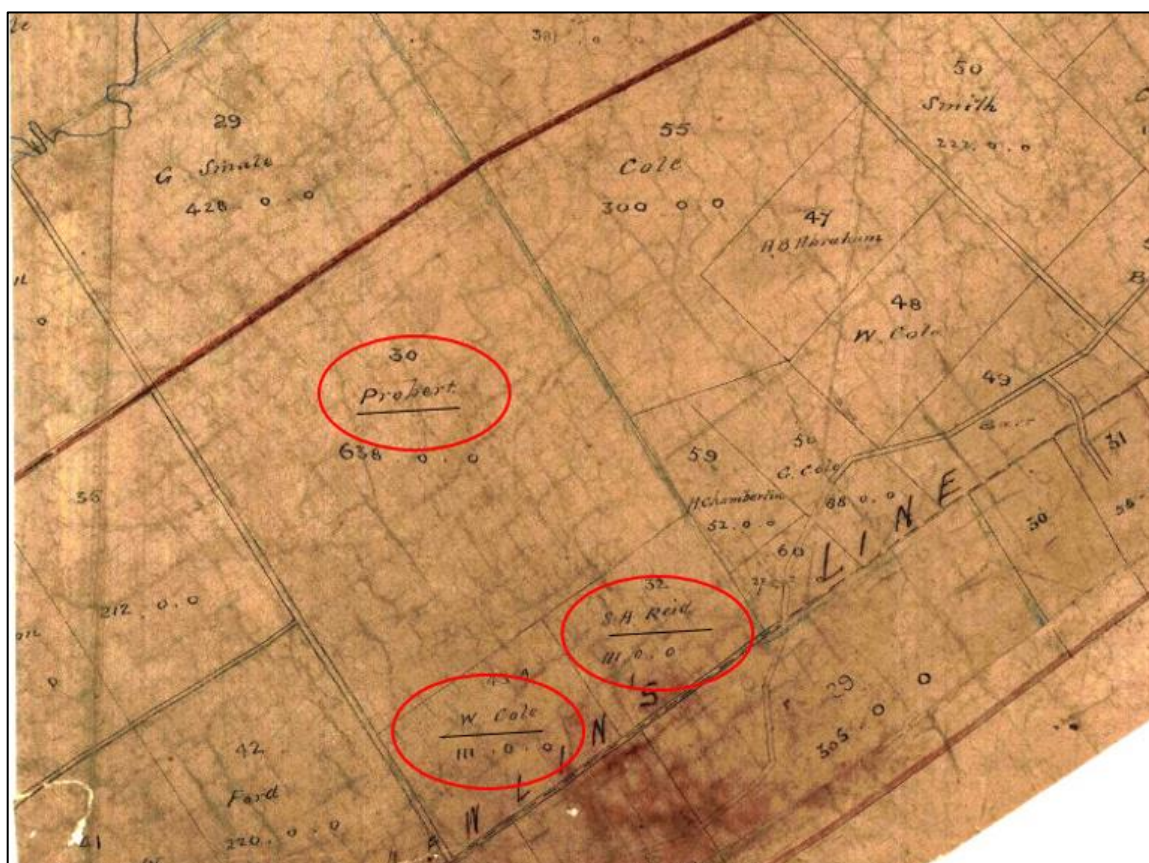
Figure 6. Detail from AKC Roll 65 I 4 921113 dated c.1860s to 1890s with the landowners' names in Allotment 30 (Probert), Allotment 32 (S.H. Reid) and 43A (W. Cole) circled in red (source: Quickmap)

Early land sale records for Allotment 43A indicate that it was granted to George Cole on 22 June 1854. It is noted that the plan in Figure 6 has the annotation W. Cole (considered possibly to be an error), as there is no record of a W. Cole as purchaser of this property during the 19th century. As well, a newspaper advertisement in *The New Zealander* 26 February 1862 announced the sale of ‘Sundry Farms in the District, The Property of Mr. George Cole, of Papakura, to be sold at Auction....’ which establishes George Cole as a landowner in the area. This Allotment was sold and transferred several times between 1859 and 1861, when it was bought by Aitken, who retained the property until 1899, when it was sold to Miller, who sold it on to Mr Schischka in 1902. The 1915 and 1916 plans in Figure 10 and Figure 11 confirm Mr Schischka’s ongoing ownership of this lot along with the western part of Allotment 30 to the south of Hamlin Road. It is also noted that the 1916 plan shows a house and shed in this allotment at the corner of Cosgrave and Old Wairoa Road, which is outside of the Future Development area. A slightly later plan dated 1919 in Figure 12 shows a subdivision drawn up for Mr Schischka which includes Allotment 43A, which has been subdivided into two lots. Later subdivisions dating to the mid to late 20<sup>th</sup> century created the distribution of lots that are seen today.

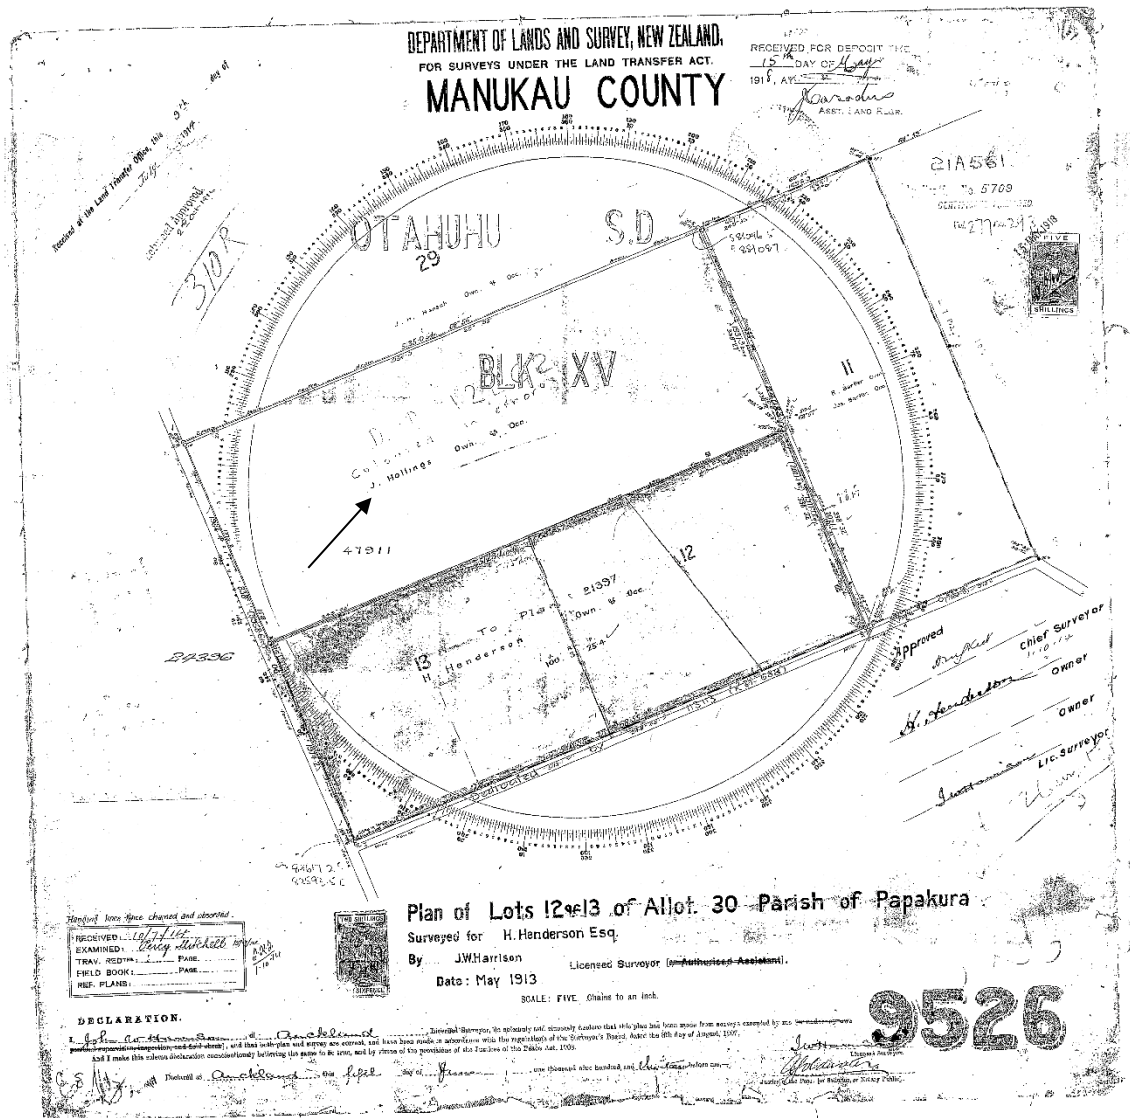
**Figure 7. AK DP 9526 I 1 dated 1913 showing a subdivision of Allotment 30 owned by H. Henderson and the property containing 279 Airfield Road with the annotation “J. Hollings” indicated by arrow (source: Quickmap)**

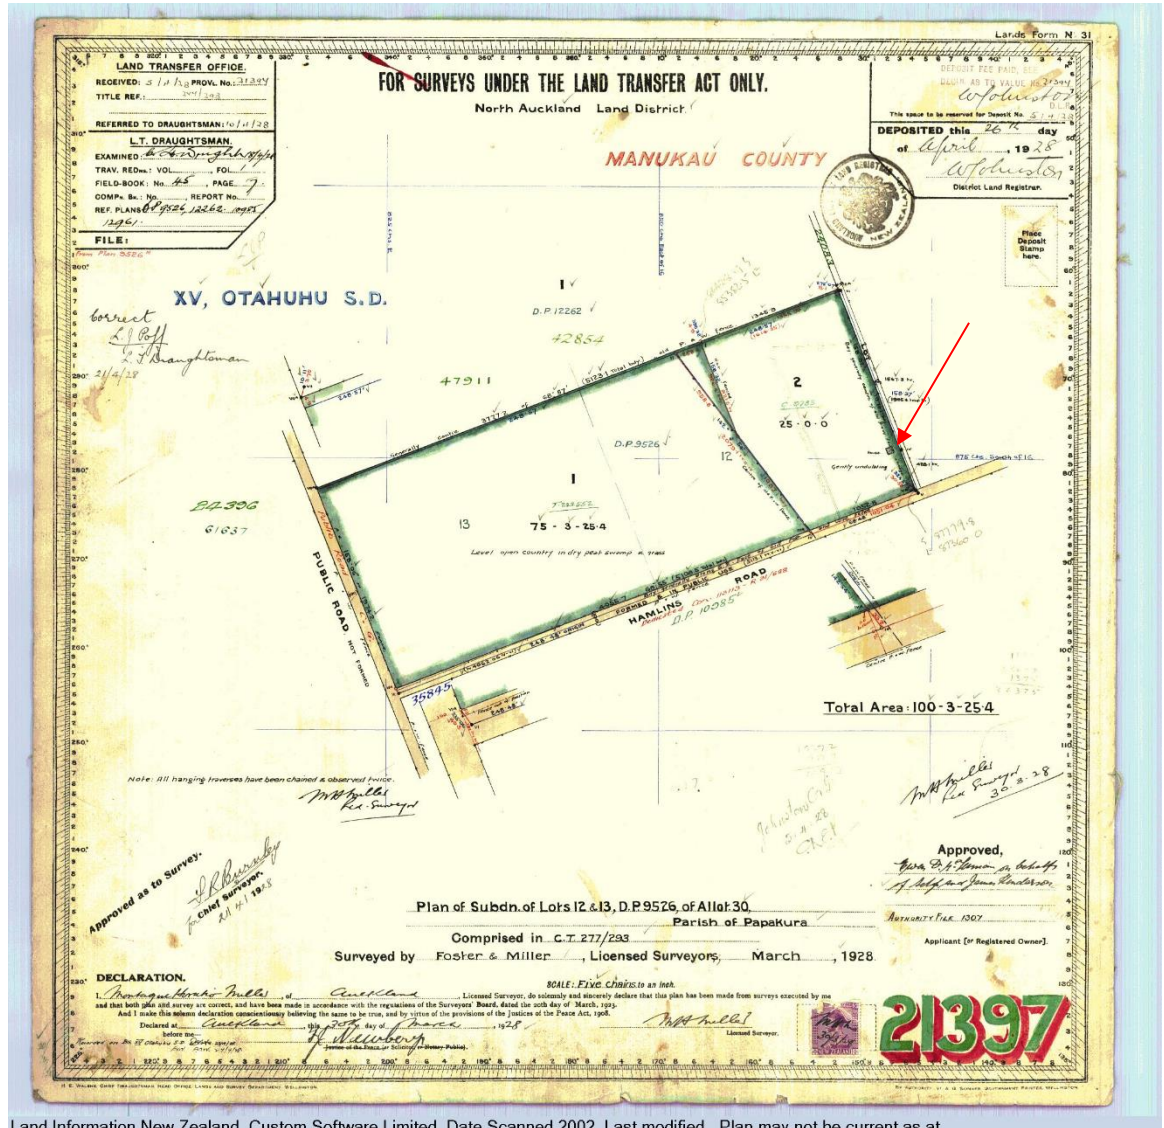
Figure 8. AKC DP 21397 dated 1928 showing the subdivision of part of Allotment 30 to the north of Hamlin's Road into Lots 1 and 2, with house along eastern boundary of Lot 2 indicated by red arrow (source: Quickmap)

According to old land titles this lot along with Lot 2 was purchased in the 1850s with two main owners retaining the lots throughout the rest of the 19th century. The 1928 plan in Figure 8 described Lot 1 as level open country in dry peat swamp and grass. The current landowners noted that swamp kauri remains were dug up and removed from this lot in the past. The current survey noted that the land was still in grassed paddocks with several shelter belts and deep cut drainage ditches. It was also noted that the paddocks in the eastern part of this lot had horses present whilst the western lots were not being utilised at the time of the survey. No evidence of any archaeological deposits or features was identified during the survey (photograph in Figure 20).

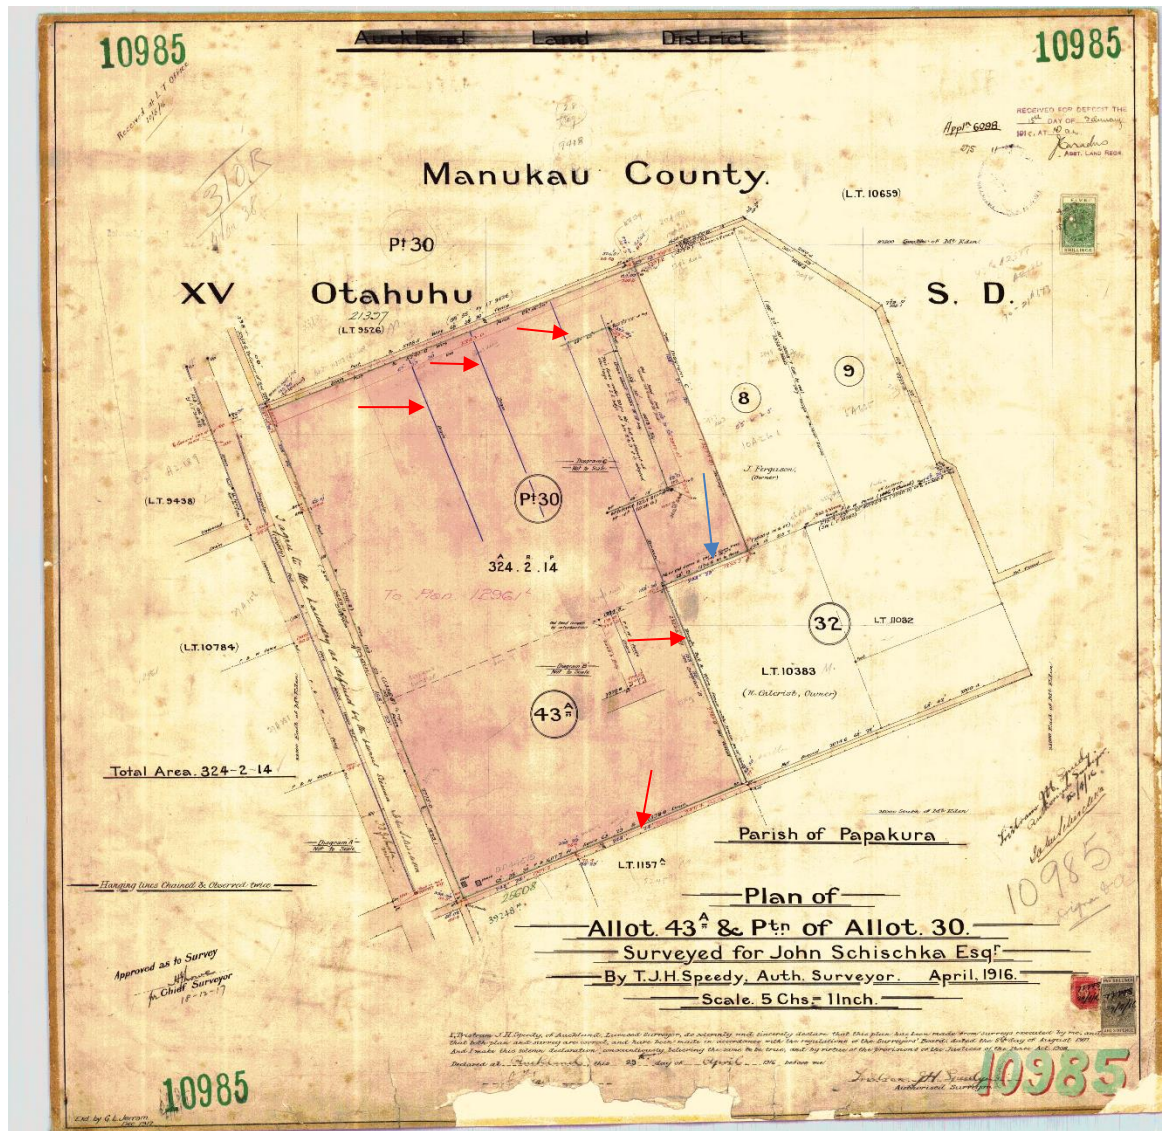
**Figure 11. AKC DP 10985 I dated 1916 surveyed for Mr John Schischka with line of gum trees over 20 years old indicated by blue arrow and farm drains by red arrows; annotation for owner of western part of Allotment 32 being 'R. Gilchrist' (source: Quickmap)**

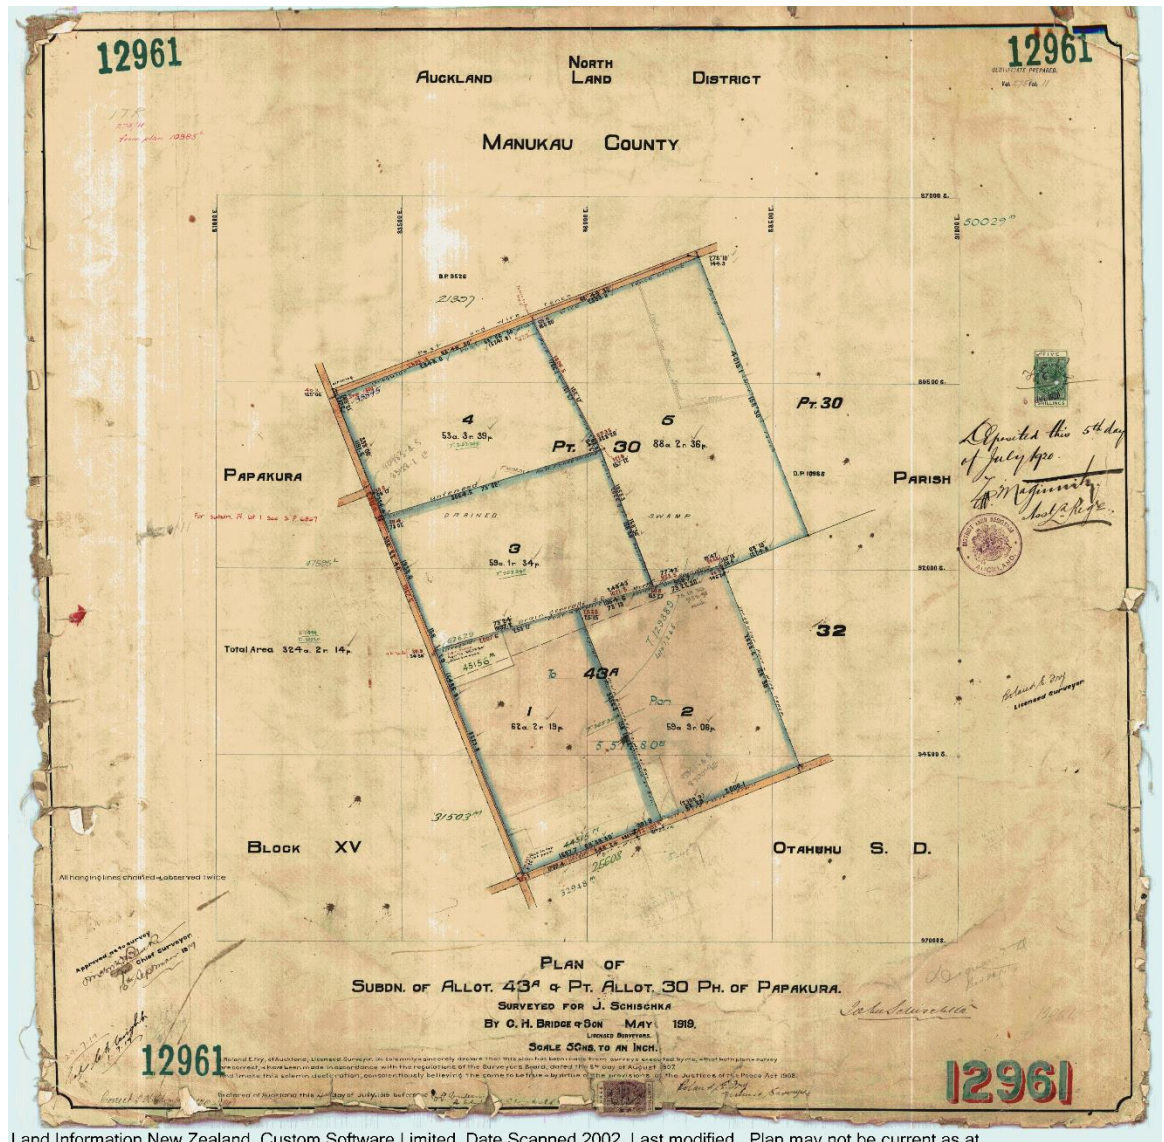
Figure 12. AK DP 12961 dated 1919 showing the subdivision of part of the Future Development area in former Allotments 43A and 30 with the annotation 'drained swamp' on the northern lots 3, 4 and 5 (source: Quickmap)

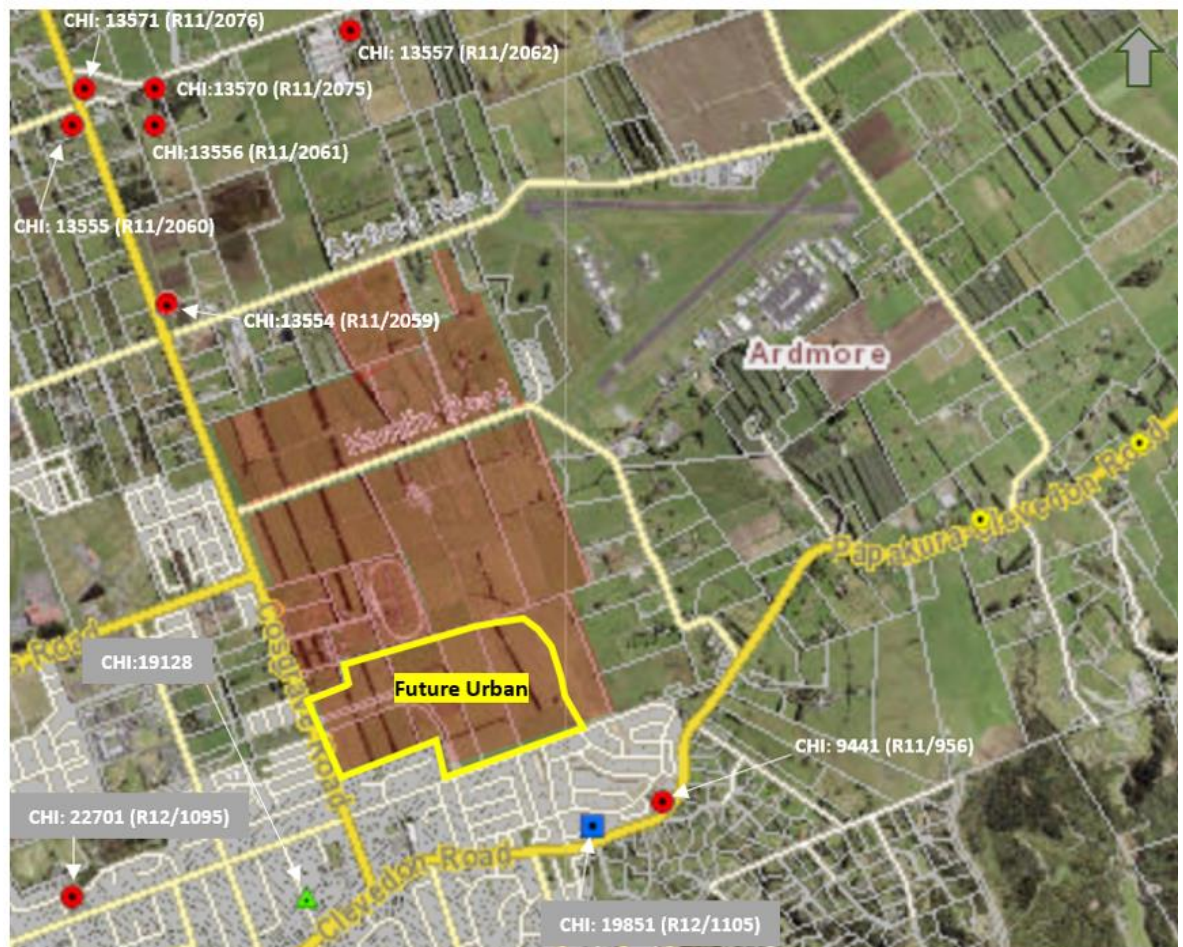
**Figure 13. Map showing the locations of recorded archaeological sites on the NZAA ArchSite database and included in the Auckland Council CHI located in the general vicinity (c.1200m) of the Future Development area, which is shaded in red with Future Urban area indicated (source: Auckland Council Geomaps)**

There are no recorded archaeological sites in the Future Development area. Nine sites have been recorded within c.1200m of the Future Development area boundary including homestead sites of early settlers and timber and flax mills and one redoubt associated with the New Zealand Wars Period. The locations of the recorded sites are shown in Figure 13 and a summary description is provided in Table 2.

The Auckland Council CHI contains all of the above described archaeological sites along with one additional site, a historic botanical site (CHI: 19128) which is a Magnolia tree located in a residential property, c.500m to the southwest of the Future Development area. The location of the historic botanical site is shown in Figure 13 and a summary description provided in Table 2.

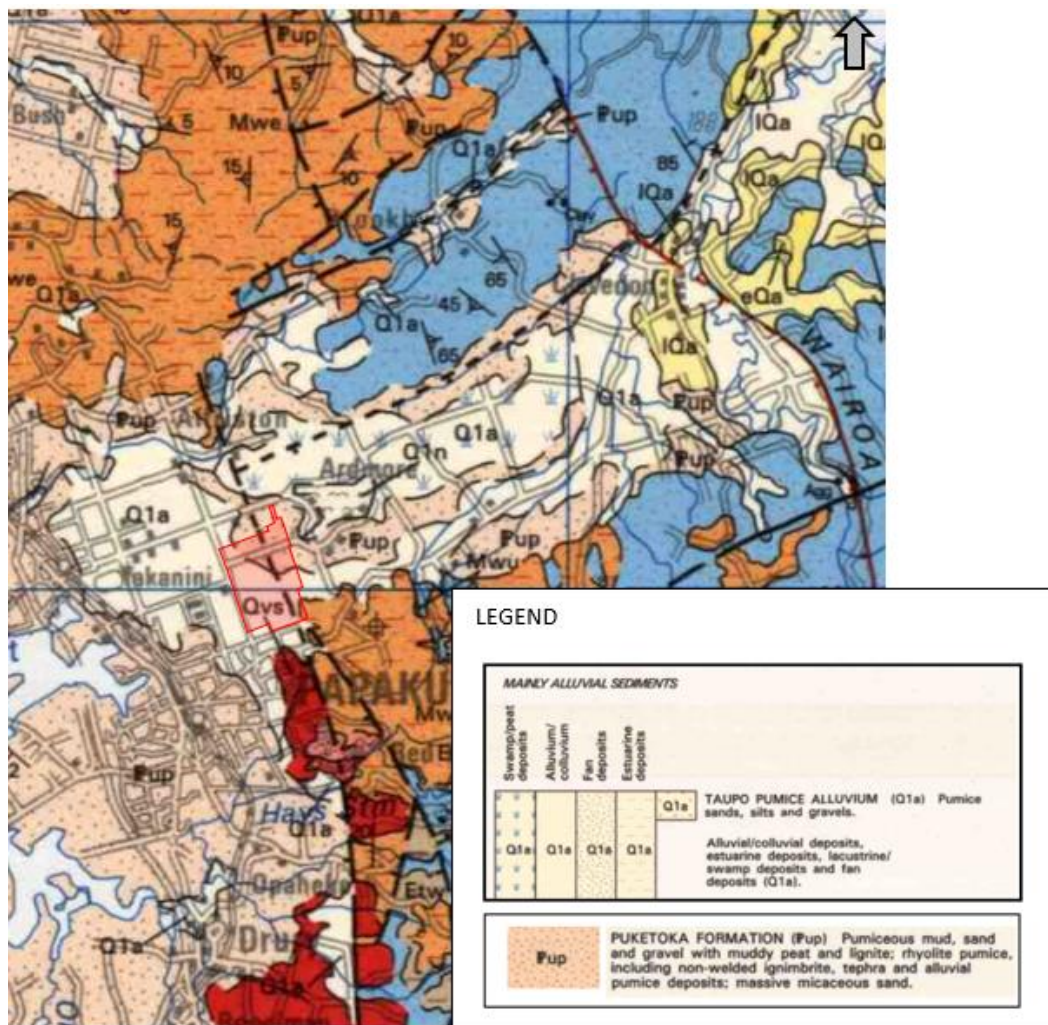
Figure 14. Detail from the 1:250 000 series geological map dated 2001 showing the geological setting of the Future Development area outlined and shaded in red (source: Institute of Geological and Nuclear Sciences Limited)

The Future Development area is underlain by mainly alluvial sediments of the Tauranga Group as shown in Figure 14. It is situated on alluvial/colluvial deposits in the south and central parts (Q1a) with an area of pumiceous mud, sand and gravel with muddy peat and lignite (PUP) in the northeast.

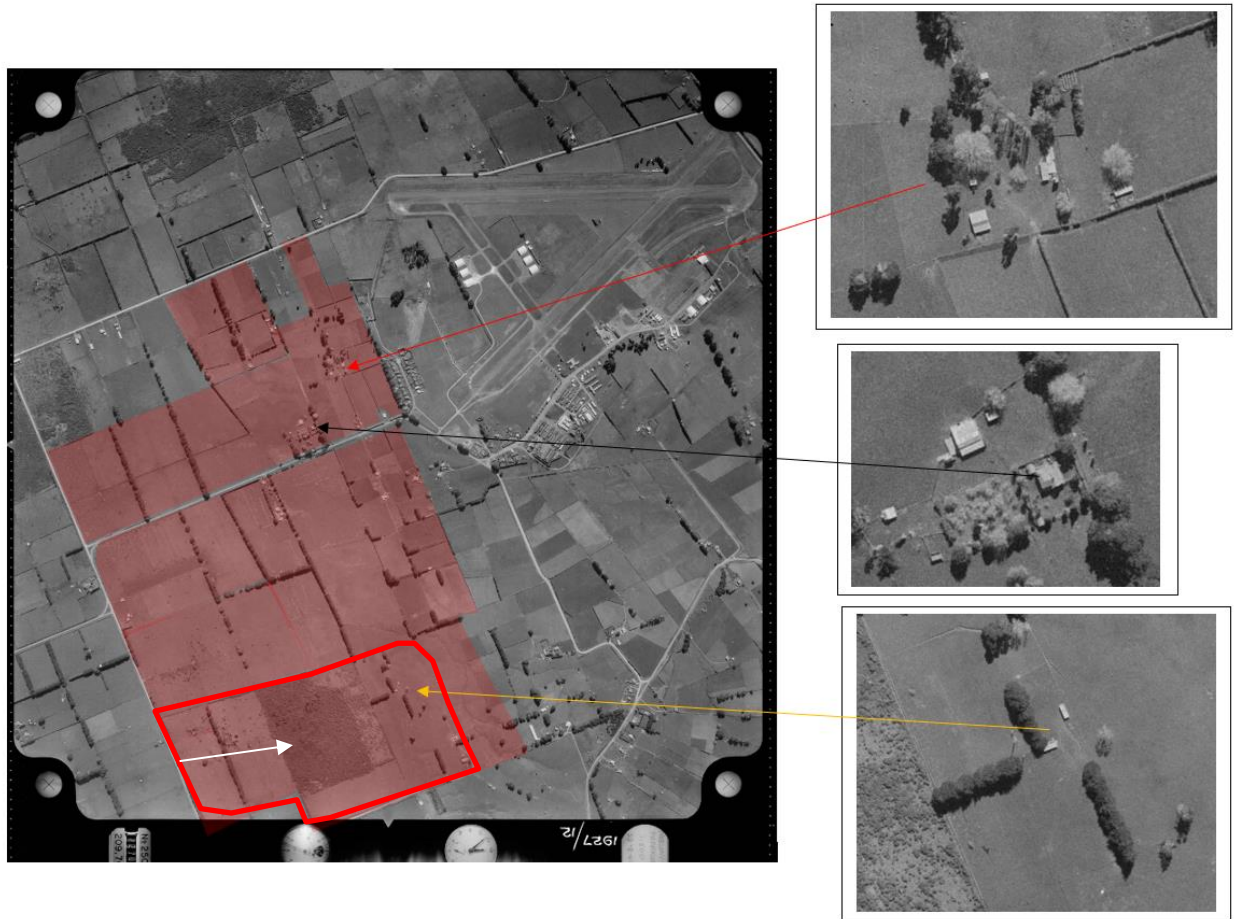
**Figure 16. Aerial photograph dated 1960 (Crown 583 1927 12) with the Future Development Area area shaded in red (with Future Urban area outlined in red) with flood-prone area covered by scrubby growth indicated by white arrow, house at 80 Hamlin Road indicated by black arrow, buildings and trees at 70 Hamlin Road indicated by red arrow and approximate location of house and shed shown in 1915 plan at 508 Wairoa Road indicated by orange arrow with detail shown in inserts (sourced from: <http://retrolens.nz> and licensed by LINZ CC-BY 3.0)**

As can be seen on the 1960 aerial photograph in Figure 16, a pattern of grassed paddocks is present with a flood-prone area in the southeast containing scrubby growth, which may indicate that it was still an uncleared swampy area at that time. The aerial photograph also shows a house and outbuildings present at the location of existing structures at 508 Wairoa Road, and there are two buildings in the general area of the old house and shed shown on the 1915 plan in Figure 10. In the northern part of the Future development area, a house can be seen at the same location at 80 Hamlin Road as shown in the 1928 plan in Figure 8 and there is a building with a number of trees around it where the modern house at 70 Hamlin Road is located.

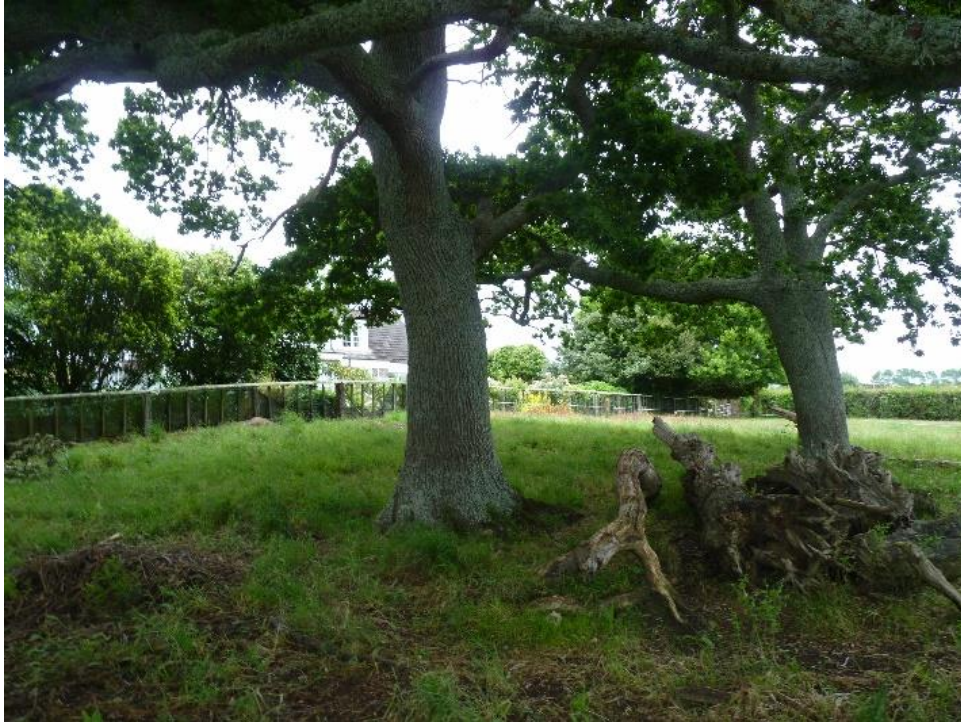
**Figure 17. Photograph of oak trees in Pt lot 2 DP 22141, looking southwest**

This lot makes up the north-eastern corner of the Future Development area. It contains a modern house with a landscaped garden and is surrounded by grassed paddocks that were in use for horse grazing at the time of the survey. Several large oak trees were observed in the paddock directly to the north of the house and large London Plane trees were located in several of the paddocks to the southeast of the house. An aerial photograph from 1960 showed the area around the modern house as having trees present and also several buildings which have the appearance of farm buildings/sheds rather than a house. During the survey, no evidence of any older buildings was observed. No evidence of any archaeological deposits or features was identified during the survey. Photographs are shown in Figure 17, Figure 18 and Figure 19.

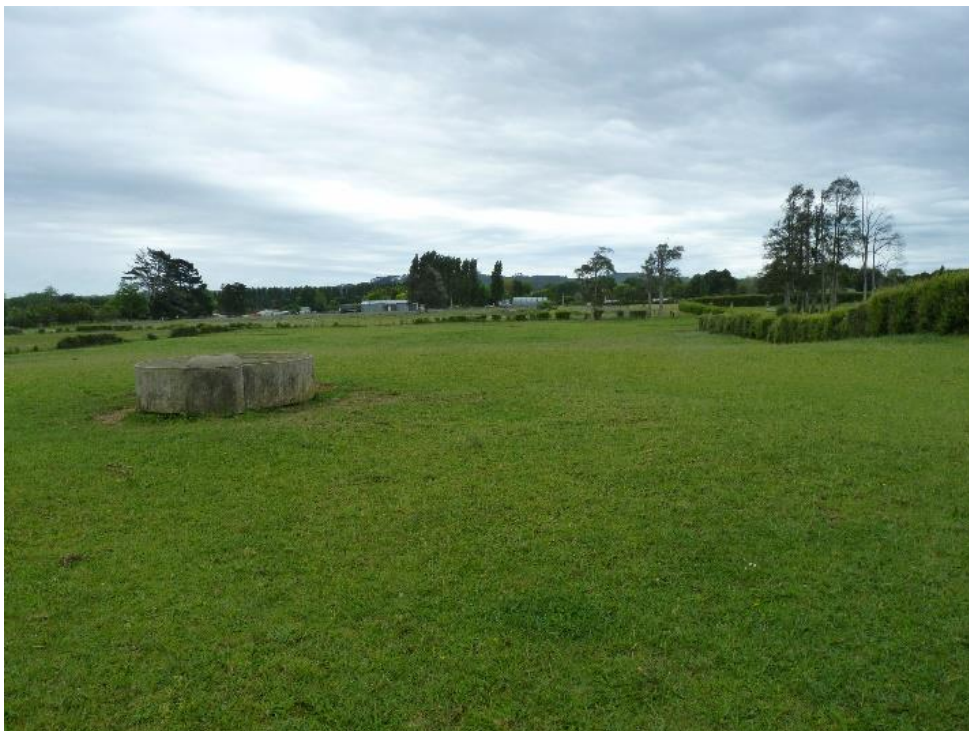
**Figure 18. Photograph showing the northernmost part of Pt Lot 2 DP 22141, taken from behind the modern house at 70 Hamlin Road, looking north**

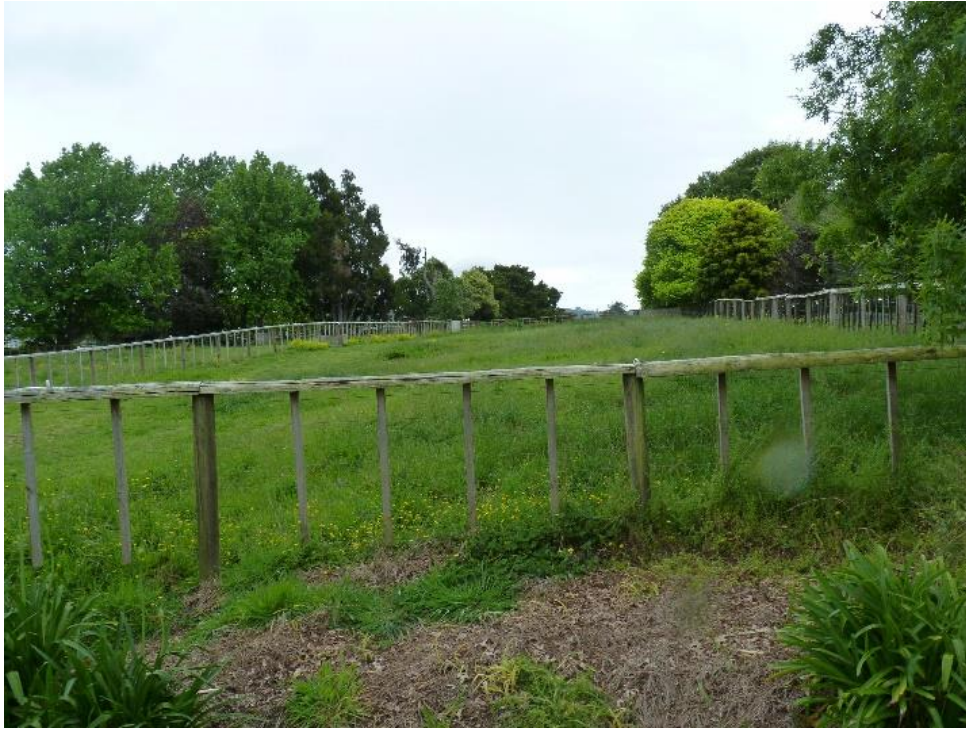
**Figure 19. Photograph showing one of the southernmost paddocks in Pt Lot 2 DP 22141, taken from Hamlin Road, looking north**

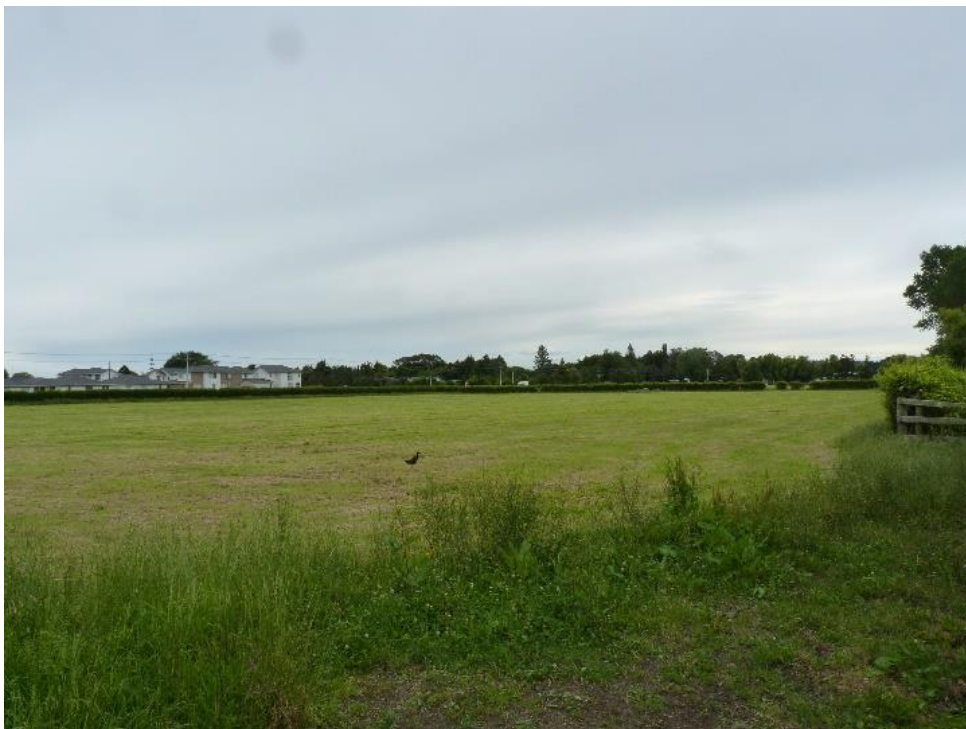
**Figure 20. Photograph showing the westernmost paddock in Lot 1 DP 21397 with houses along Cosgrave Road visible in the background, looking northwest**

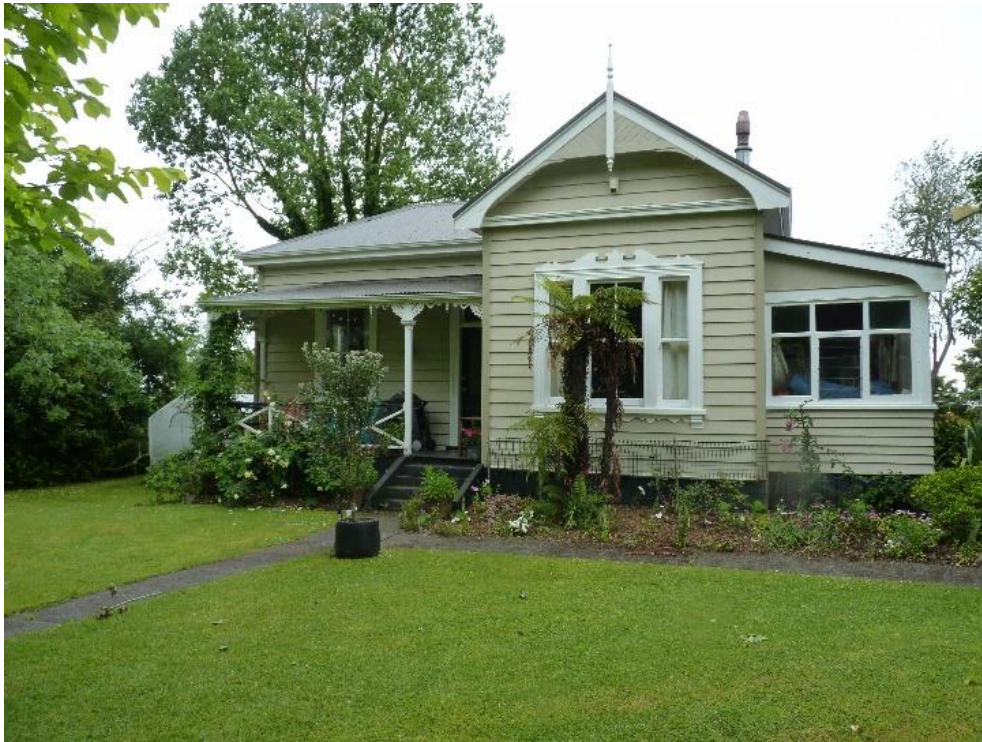
**Figure 21. Photograph showing the façade of the villa at 80 Hamlin Road (along the eastern side of Lot 2 DP 21397), looking north**

Value	Assessment
Condition	The building exterior retains a relatively high percentage of the original intact form. The interior shows some signs of modification. The condition of any subsurface remains is unknown
Rarity	The villa form is common nationally and regionally, but less so locally for the period of interest, as the area was rural and not heavily developed until the second half of the 20 <sup>th</sup> century.
Contextual value	The site has contextual value as an uncommon example locally of a Late Victorian villa homestead in the Ardmore area.
Information potential	The villa has high information potential because of the degree to which diagnostic features and architectural elements (both interior and exterior) survive in a relatively unaltered state. Archaeological investigation of subsurface remains has the potential to provide information on the locations, functions and lifestyle of the occupants and early settlers in the Ardmore area.

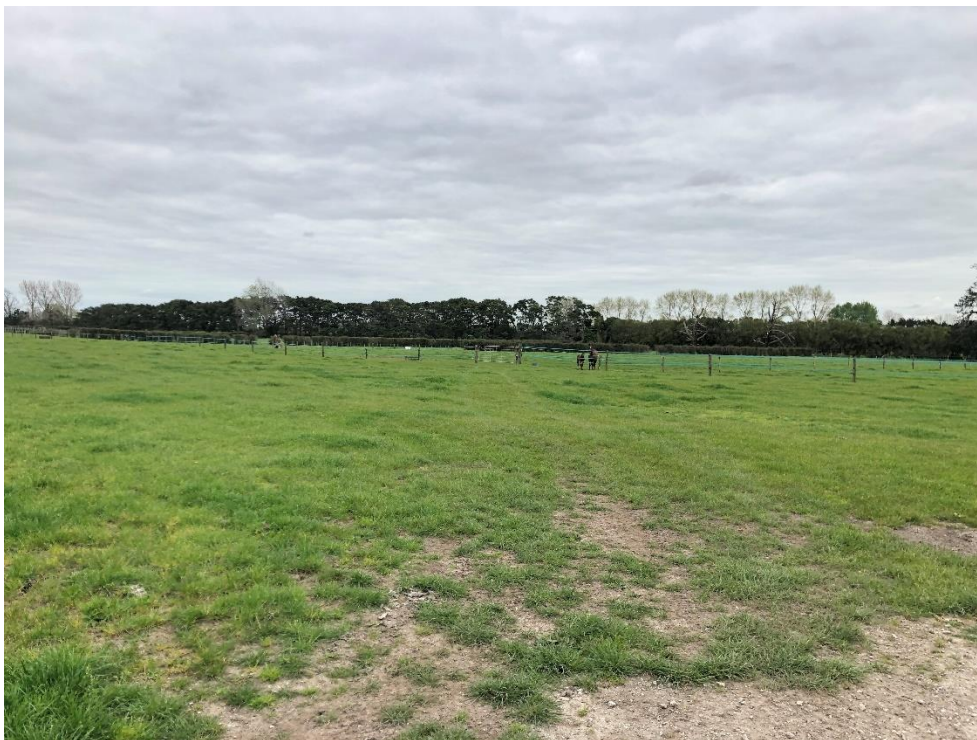
**Figure 22. Photograph showing a general view of the southern part of the property at 279 Airfield Road, looking southwest**

This property is located at 279 Airfield Road and is made up mostly of flat grassed paddocks with a modern barn and shed in the north central part of the property, accessed from Airfield Road. Some of the paddocks were separated by hedges and a few isolated trees were also present in several of the paddocks. In general, the ground surface was relatively dry and firm apart from the area bordering Airfield Road (in the north) which was observed to be slightly boggy during the survey. It was also noted that the northern part of the property appeared to have been used for crop growing as posts and irrigation tubes were present, although not in use at the time of the survey. A modern house and outbuildings were also noted along the eastern boundary, although this area was not entered and only observed from the paddocks to the west. A general photograph of the property is provided in Figure 22.

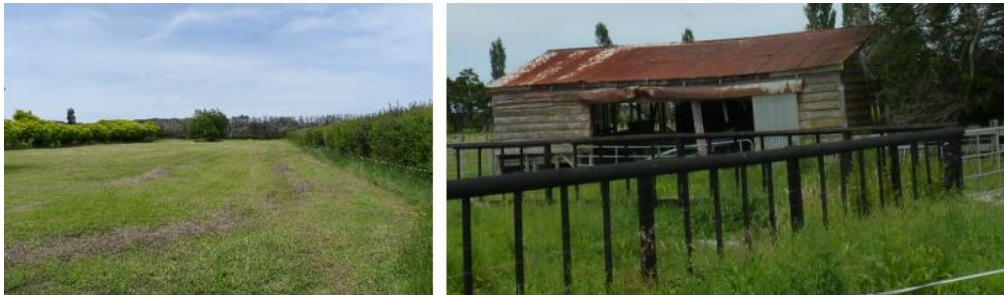
**Figure 23. Left photograph showing northern paddock bordering Hamlin Road in Lot 8 Deeds Reg Whau 38, looking south; and right photograph in same lot showing farm shed, looking southwest**

This lot marks the eastern boundary of the Future Development area and borders Hamlin Road to the north with paddocks on all other sides. The northernmost paddocks were flat and level with shelter belts dividing them into three sections. A farm shed was observed in the north central part of this lot, the structure consisted of a concrete and steel frame with timber board sides and a corrugated metal roof. The land in the central part of this lot could be seen to be more undulating with a stream running east /west. Visual inspection and probing around the stream did not indicate the presence of any archaeological deposits.

The central part of this lot also contained one house along the eastern boundary with access from Hamlin Road. The house appeared to be mid-20th century from the exterior view. The southern part of this lot also contained gently undulating land with a gradual rise upwards to the south. Farm drains had been cut along lot and some paddock boundaries with fences installed on both sides to prevent stock entry. As noted earlier in this report, plans dating to 1915 and 1916 (in Figure 10 and Figure 11, respectively) showed a fence and line of gum trees along the southern boundary of this lot. This feature was sought out during the survey and gum trees, along with a mixture of other tree species and some large stumps, were found to be present. The fencing was a modern post and wire fence. As well, a deep cut drain was located just to the south of the trees. It was noted that there was a rise (a low knoll rising up to c.35m asl) situated just to the north/northwest of the gum trees which continued over the eastern boundary of this lot into Lot 5 DP 12961. It was orientated northwest to southeast and a number of old tree stumps were present. The knoll was visually inspected and probed to see if any evidence of archaeological features or deposits could be detected. Probing was not able to identify any changes in the subsurface layers, although it was noted that the ground was very hard and limited the depth of probing to approximately 20cm (below surface). No evidence of any archaeological deposits or features was identified during the survey in this lot. Photographs are shown in Figure 23 to Figure 26.

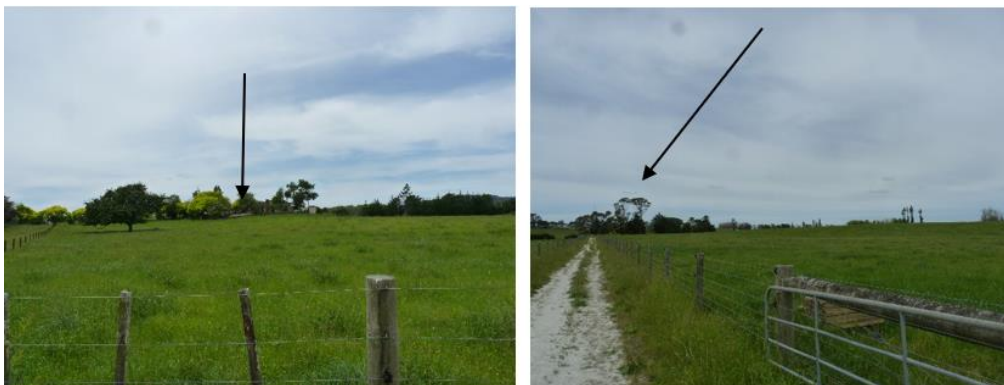
**Figure 24. Left photograph showing view of the central paddocks of Lot 8 Deeds Reg Whau 38 with location of modern house indicated by arrow; and right photograph showing the line of gum trees at the southern boundary of the lot indicated by arrow, looking south**

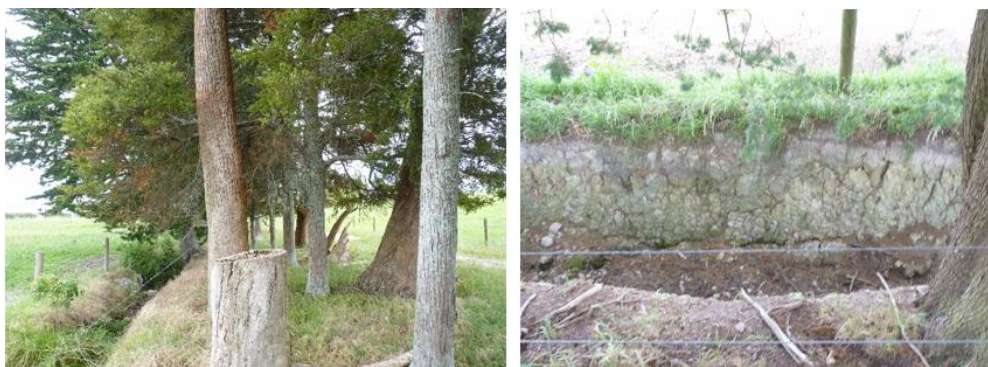
**Figure 25. Left photograph showing the line of gum trees (and other species) in Lot 8 Deeds Reg Whau 38 looking west; and right photograph showing a section of the drainage channel just to the south of the gum trees, looking south**

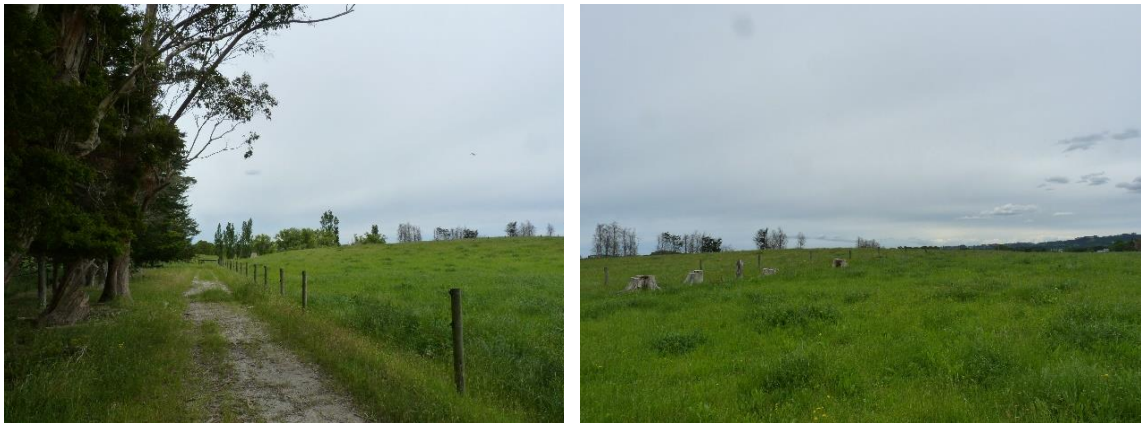
**Figure 26. Left photograph looking along the line of gum trees with low knoll to the north (looking west); and right photograph taken on top of the low knoll in the southern part of Lot 8 Deeds Reg, with old stumps along the western side, looking northwest**

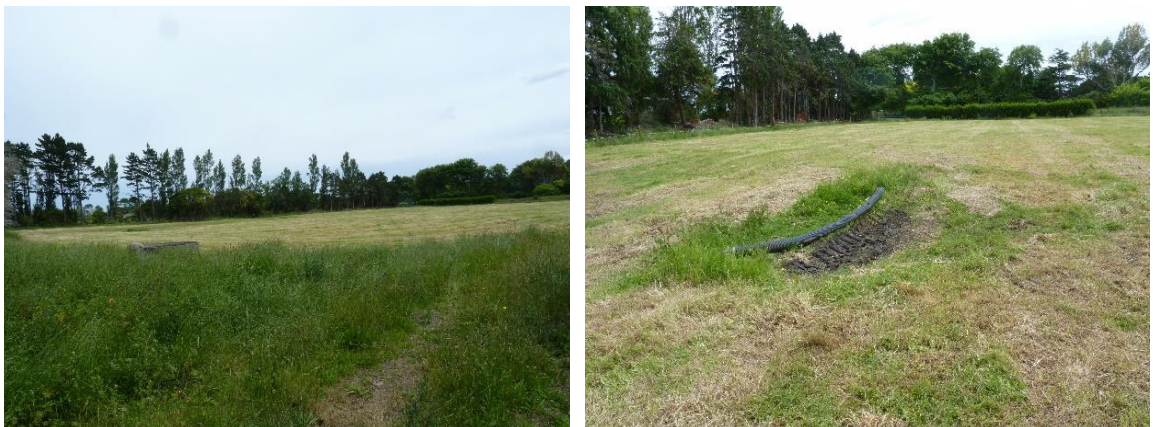
**Figure 27. Left photograph showing a view of a northern paddock in Lot 5 DP 12961, looking northwest; and right photograph showing an example of modern drainage pipe works, looking north**

This lot borders Hamlin Road to the north with the other three boundaries leading onto grassed paddocks. The northern part of this lot was generally flat although the ground was observed to be quite uneven in places, which upon closer inspection were found to be the result of works associated with modern drainage trenches and insertion of pipes. The western and southern boundary of the northern paddocks was also observed to have deep drainage channels cut along their lengths. This lot also contained a mid-20<sup>th</sup> century house adjacent to Hamlin Road with associated outbuildings and a disused greenhouse. The central part of this lot was generally flat with only a slight rise to the east. The south-eastern part of this lot was dominated by the low knoll described in the previous section. A stream and cut drainage channel were identified to the southeast of the knoll. The south-western part of this lot was observed to be very flat and was divided into four paddocks, with the southern two under strawberry cultivation and the northern two grass covered. It was noted that a modern dumping trench had been excavated into a hillside in the south central part of this lot. No evidence of any archaeological deposits or features was identified during the survey. Photographs are shown in Figure 27 and Figure 28.

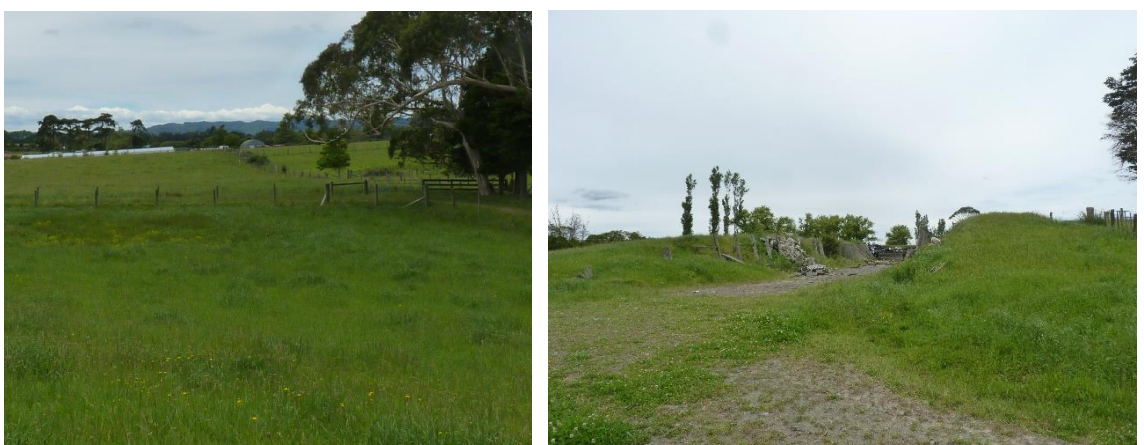
**Figure 28. Left photograph showing the north central part of Lot 5 DP 12961 showing the green house and associated buildings, looking north; and right photograph showing the hillside with dump trench, looking east**

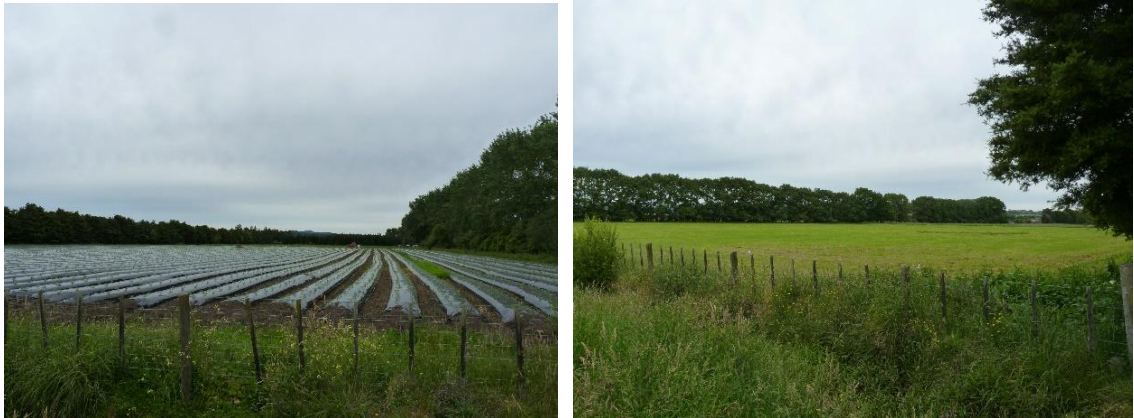
**Figure 29. Left photographs showing Lot 4 DP 12961 field with strawberry cultivation, looking south; and right photograph showing easternmost paddock in Lot 4 DP 12961, looking southeast**

This lot borders Hamlin Road to the north, Cosgrave Road to the west, with paddocks to the east and south. The land was observed to be flat and was divided into four paddocks with shelter belts and drainage ditches separating them. The three western paddocks were all in use for growing strawberries with the westernmost lot also containing a parking area and small café/ playground. The fourth paddock was grass covered. The lots containing the strawberries were observed from the edge of the cultivation and the eastern grassed paddock was walked over. No evidence of any archaeological deposits or features was identified during the survey. Photographs are shown in Figure 29.
