# **SUNFIELD, AUCKLAND, PROPOSED FUTURE DEVELOPMENT (FUTURE DEVELOPMENT): PRELIMINARY ARCHAEOLOGICAL ASSESSMENT**

Prepared for Sunfield Developments Ltd  
April 2024

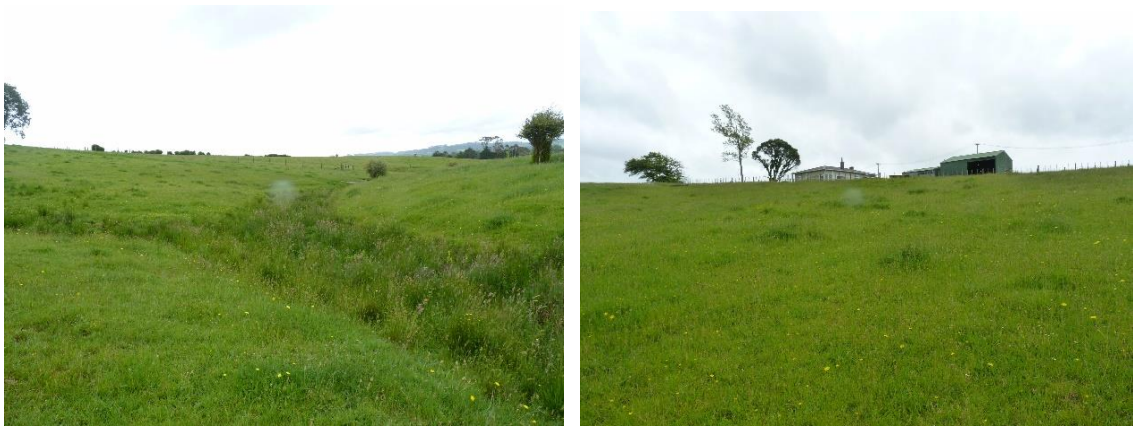
**Figure 30. Left photograph showing the stream in DP 10383, looking north and right photograph looking west from the stream gully up towards the mid-20<sup>th</sup> century house in DP 10383**

The western and central part of this lot are zoned Future Urban with the eastern side zoned Rural. The Rural section consists of hillsides to the east and west with a stream gully running through it from north to south. Probing along the stream did not identify any archaeological features or deposits. The Future Urban zoned part of this property contained the highest point in the Future Development area at 50m asl in the south central section just to the north of Old Wairoa Road. A mid-20th century house and outbuildings were located on this high point and a farm race ran through the centre of the lot from the house and outbuildings in the south to the northern boundary of the lot. The land in this lot sloped downwards from south to north and to the west, with the western edge and northernmost parts being quite flat. As mentioned earlier in this report a 1915 plan showed the presence of a house and shed in the west central part of this lot. It was not possible to tell exactly where this site was during the survey but the general area was walked over to see if any indications of the former structures could be detected from observation of the ground surface. No positive identification of the former buildings was able to be identified, although this does not preclude the presence of subsurface material not able to be detected from visual inspection. Photographs are shown in Figure 30 and Figure 31.

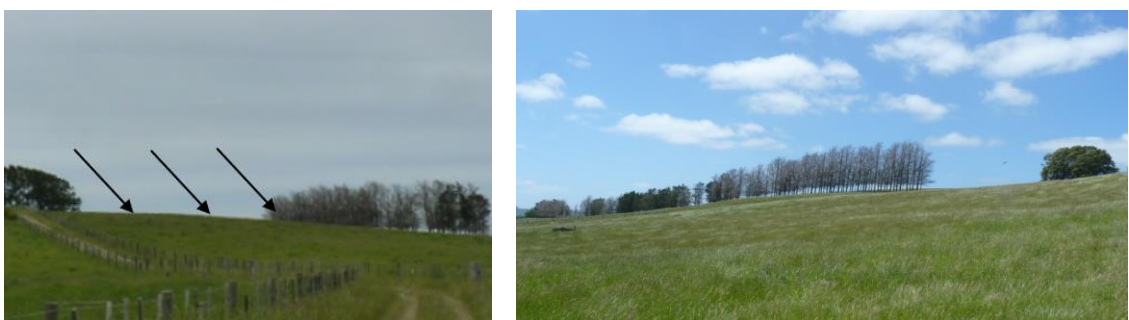
**Figure 31. Left photograph showing the general area where old house and shed (from 1915 plan) is believed to have been located, looking southwest and right photograph looking up at the area (line of trees) near to where the house on the 1915 plan is marked looking northeast from Old Wairoa Road**

currently Future Urban Zoned area, where a house and shed are indicated on a 1915 plan. Apart from the two locations identified above, there is also some potential for unrecorded subsurface archaeological remains to be present across the Future Development area. Although the full effects on archaeological and historic heritage values is not yet known, it is recommended that future development plans should take account of the recorded archaeological site and avoid it if possible. If avoidance is not possible, an authority would be required if demolition of the villa is proposed and before any modification or destruction of subsurface remains occurs as a result of future development.

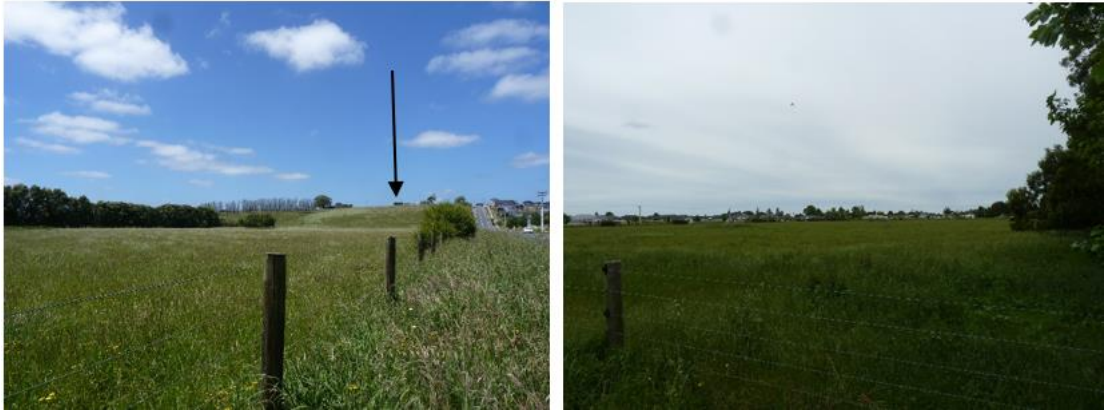
**Figure 32. Left photograph showing paddock in Lot 4 DP 55480 looking south with hill and mid-20<sup>th</sup> century house on raised area in background (indicated by arrow) and right photograph showing paddocks in Section 4 SO 495342, looking west**

These lots make up the southwestern corner of the Future Development area and from early plans and aerial photographs it would appear that most of this area was swampy terrain in the past. The land in this area was observed to be flat and consisted entirely of grassed paddocks, some of which were in use for grazing horses. As well, most of the paddocks were separated by shelter belts. The paddocks with horses were not entered, but empty paddocks were walked over and visually inspected. No archaeological features or deposits were identified. Photographs are shown in Figure 32.

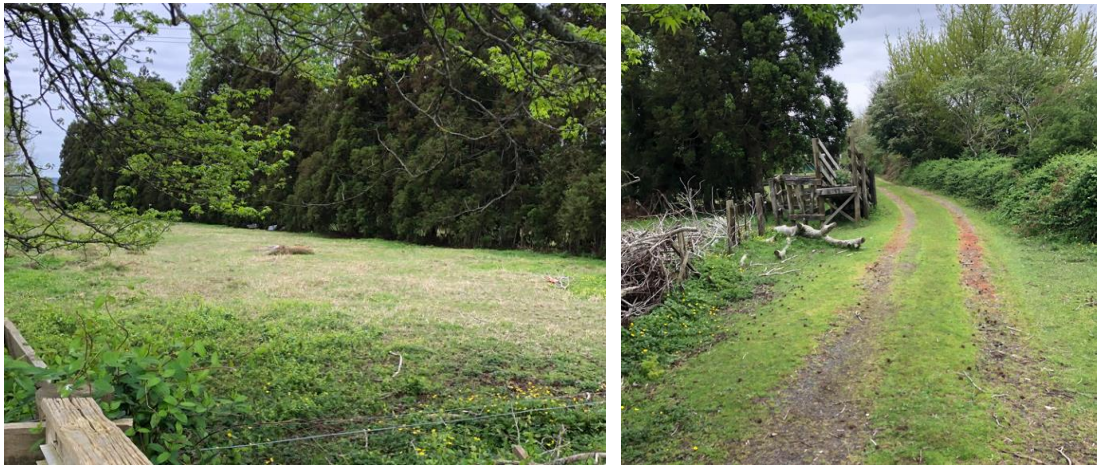
**Figure 33. Left photograph showing front part of 119 Cosgrave Road (Lot 6 DP 103787), looking north north-east and right photograph showing driveway between 119 and 131 Cosgrave Road (Lot 2 DP 103787) leading to the properties at 119A, 121 and 123 Cosgrave Road, looking east**

These lots were only able to be observed from the roadside and were not entered. The smaller property at 103 Cosgrave Road could be seen to contain a modern house and small fenced back garden. It was found that the larger property at 101 Cosgrave Road had relatively thick vegetation screening it from the roadside. In areas where gaps were visible the property could be seen to contain grassed paddocks. The house and other outbuildings was not visible from the roadside. Photographs in Figure 33.

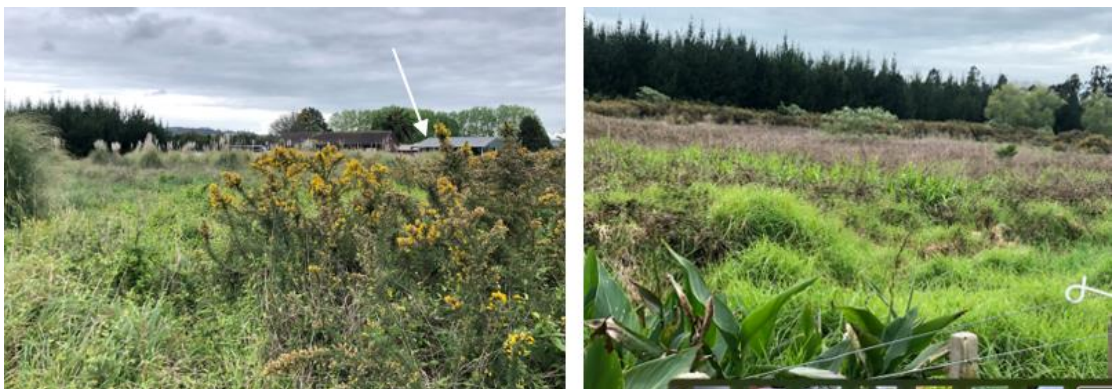
**Figure 34. Left photograph with roof of house at 143 Cosgrave Road (Lot 1 DP 103787) indicated by arrow and tree plantation visible, looking southeast and right photograph showing the back part of 131 Cosgrave Road (Lot 2 DP 103787) with scrubby undergrowth and neighbouring tree plantation also visible, looking northeast**

Only three of the lots were visible from the roadside with the remaining three being Lots 3,4 and 5 only accessible through private driveways and as such not able to be viewed. Lot

1 DP 103787 at 142 Cosgrave Road was observed to have a modern house in the southwest corner with the remainder of the part of the property fronting the road being overgrown with tall grass. The area visible towards the back of the property contained a tree plantation and a sign along the road side indicated the property was or had been in use a Christmas tree farm. The property just to the south at 131 Cosgrave Road (Lot 2 DP 103787) also had a house in the part of the property facing onto Cosgrave Road. The remainder of the property contained scrubby undergrowth. The third property that was observable from the roadside was Lot 6 DP 103787 at 119 Cosgrave Road. Only the front part of the property was observable as the remainder was blocked by a thick tree hedge. The area at the front was grassed and fenced off from the road. Photographs are shown in Figure 34.

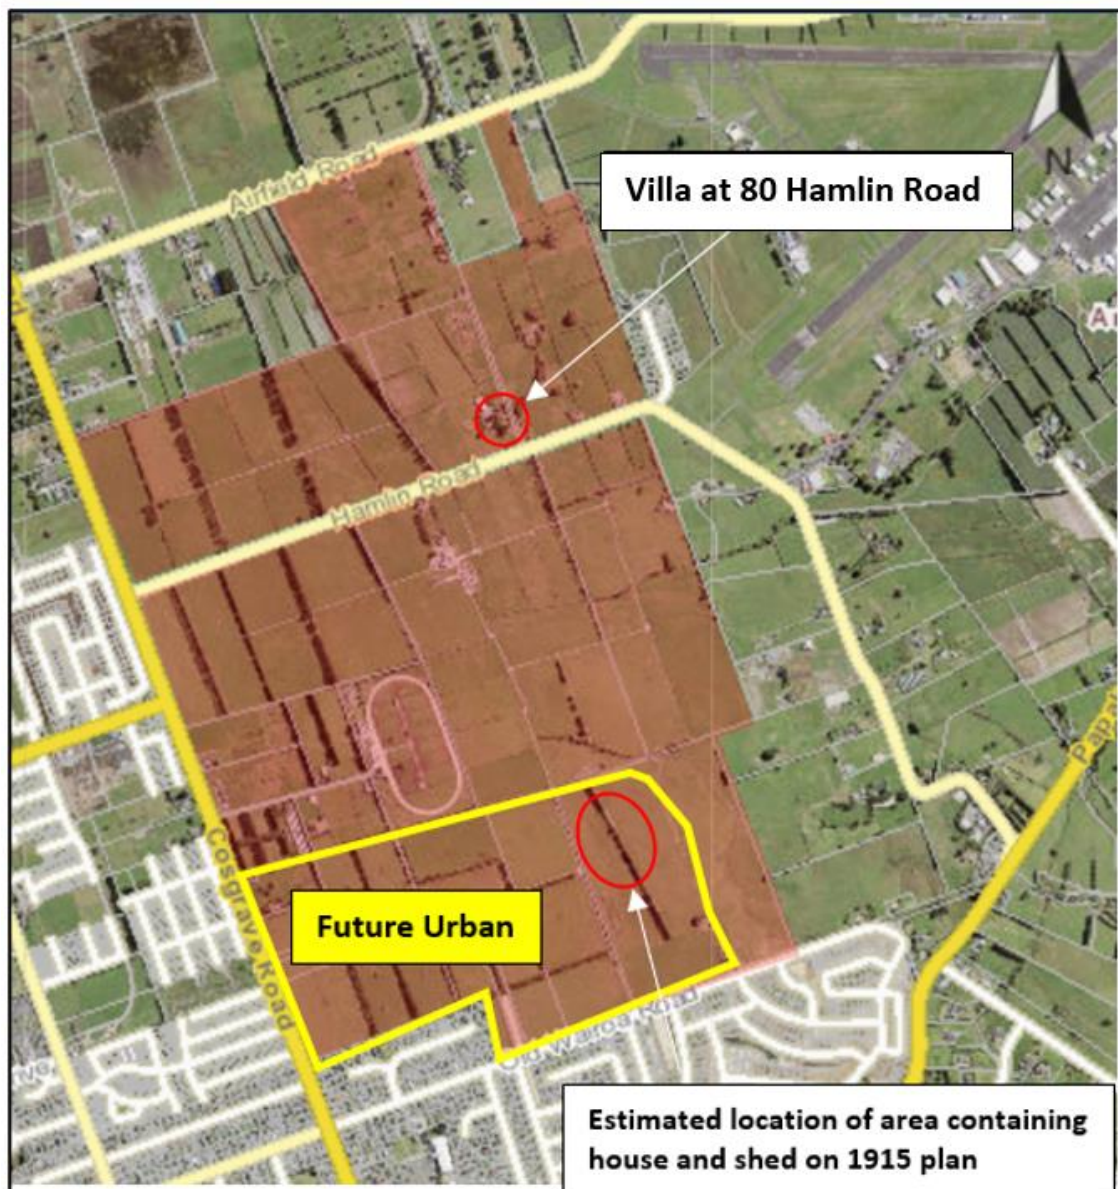
Figure 35. Aerial plan showing the Future Development area shaded red with area of archaeological potential and site R11/3435 (villa at 80 Hamlin Road) indicated (source: Auckland Council Geomaps)

Based on current knowledge, one recorded archaeological site, R11/3435 (villa at 80 Hamlin Road) may be affected by future development enabled by the proposed Future Development. The villa has been evaluated as having high potential to be a pre-1900 building and occupation site of European origin. It is noted that there is a possibility that the building was constructed after 1900, but that this would have been very early after this date, and most likely by 1902. Any earthworks carried out in the vicinity of the villa would also have the potential to affect subsurface archaeological remains associated with the 19<sup>th</sup> century or early 20<sup>th</sup> century usage of the villa. As there is high potential that the site meets the statutory requirements as an archaeological site under the provisions of the HNZPTA, an Authority granted by Heritage NZ would be required if the site is affected by future development (see below). As well, the background research and site visits for this report have identified the potential for archaeological sites associated with early European settlement to be present, specifically in the area shown as containing a house and shed on a plan dated to 1915. Locations of R11/3435 and the area of archaeological potential are shown in Figure 35. Once layout and design have been finalised it will be necessary to determine the level of effects and recommend appropriate mitigation measures. With regards to the presence of archaeological sites associated with Māori occupation and settlement, the Future Development area is for the most part low lying and would not be expected to contain complex sites such as pā. However, smaller sites such as shell middens as well as isolated finds could be present as the wetland environment in parts of the Future Development area would have provided a rich area for resource collection for people living nearby.

Future development has the potential to affect R11/3435 (villa at 80 Hamlin Road), as well as unidentified subsurface archaeological remains associated with the villa that may be exposed during development. There is also potential for additional unrecorded archaeological remains to be present within the Future Development area boundaries. Preliminary mitigation measures are included in this report, but further assessment and detailed mitigation recommendations will be required once future development plans have been prepared.

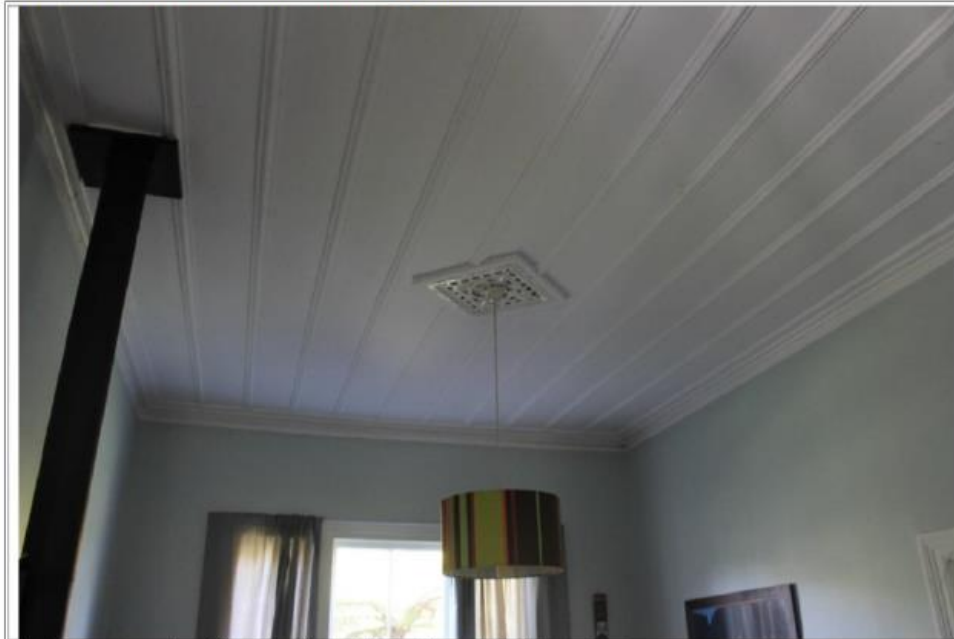
Living room board and batten ceiling with cast iron ventilation rose

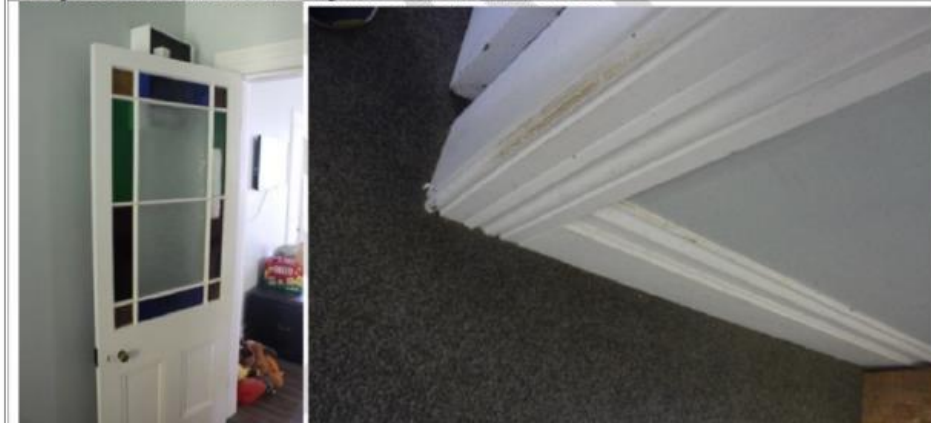
Interior joinery details
