## Remediation Action Plan (RAP)

86, 108, and 122 Arataki Road, Havelock

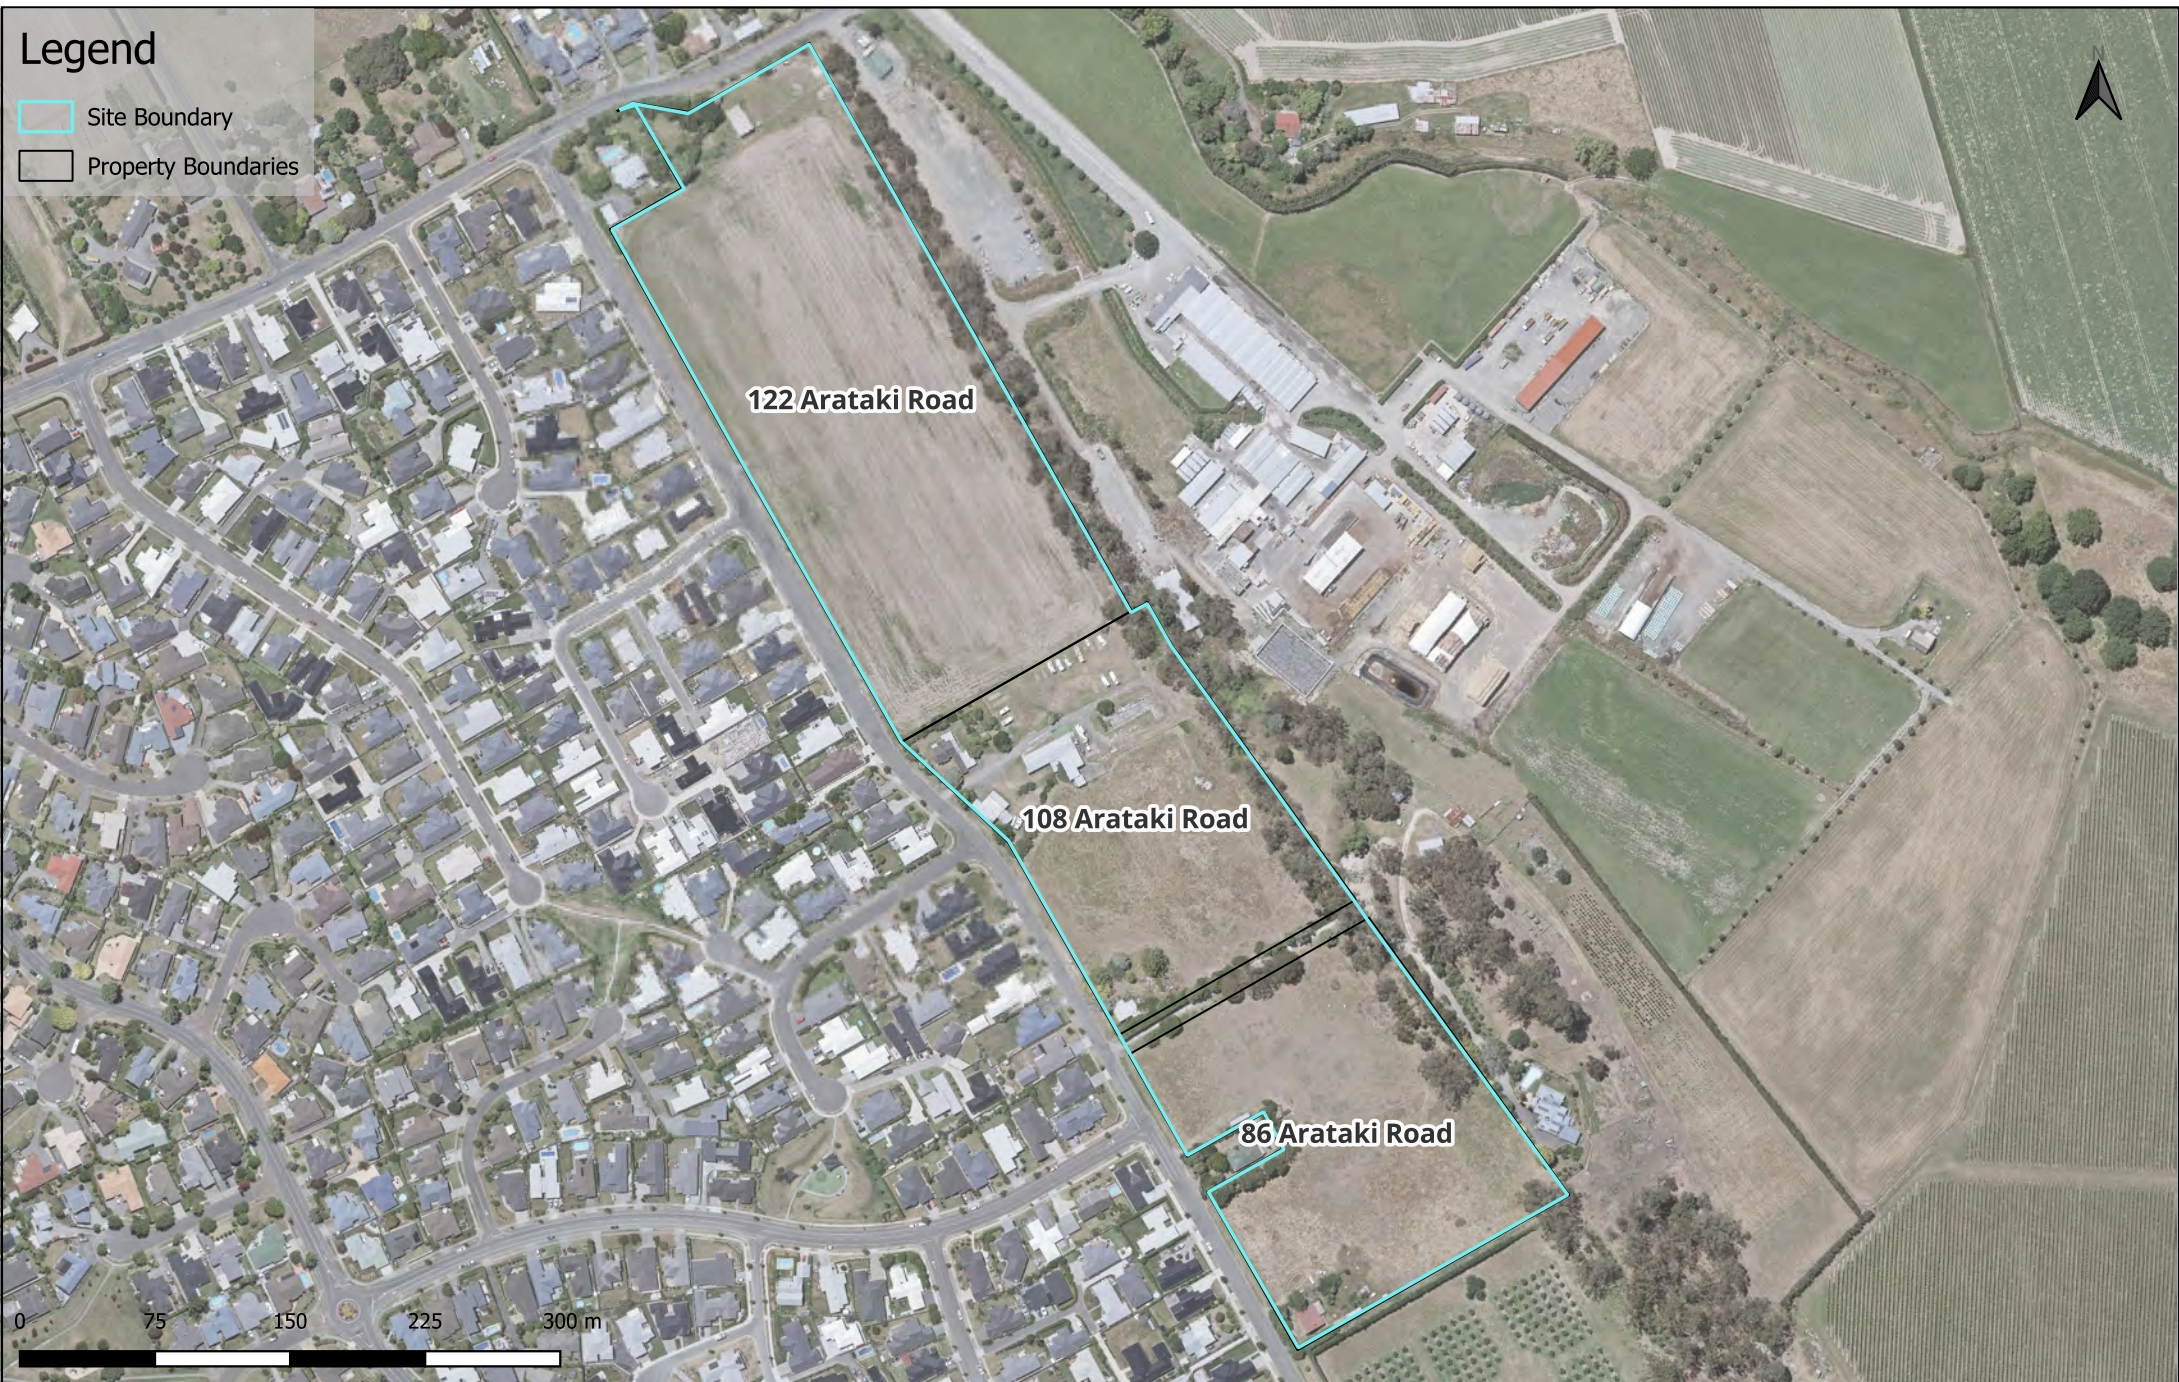
| FIGURE 2 | OVERALL SITE PLAN |

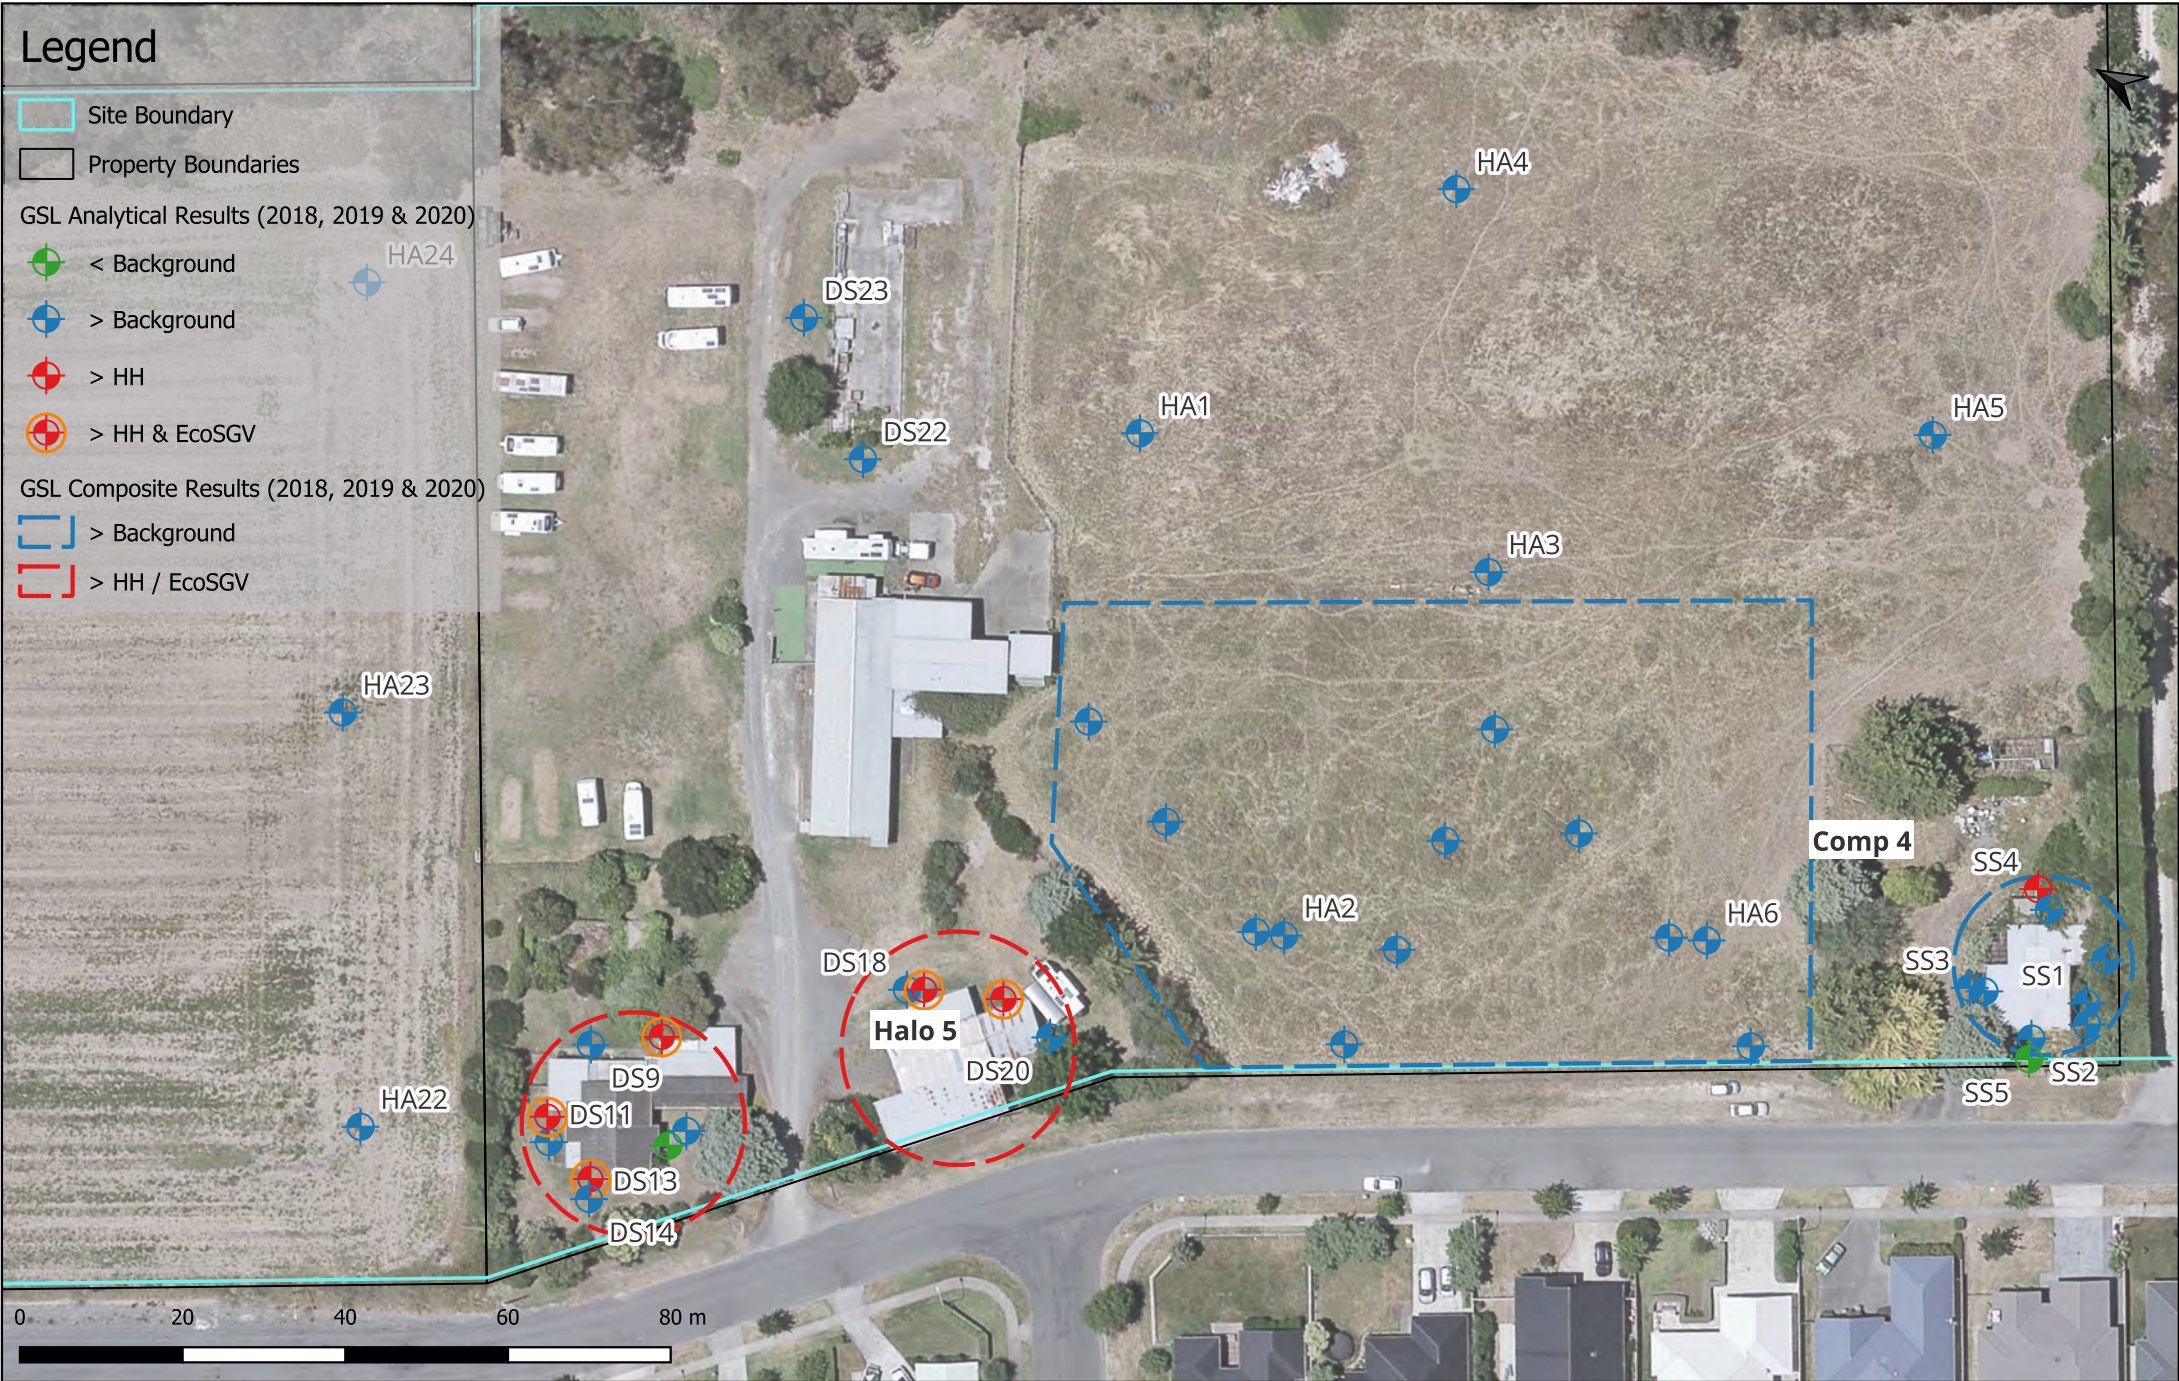
| FIGURE 3B | 108 ARATAKI ROAD – GSL ANALYTICAL RESULTS |

Sample locations and analytical results from the previous investigations are shown in Figures 2-4.

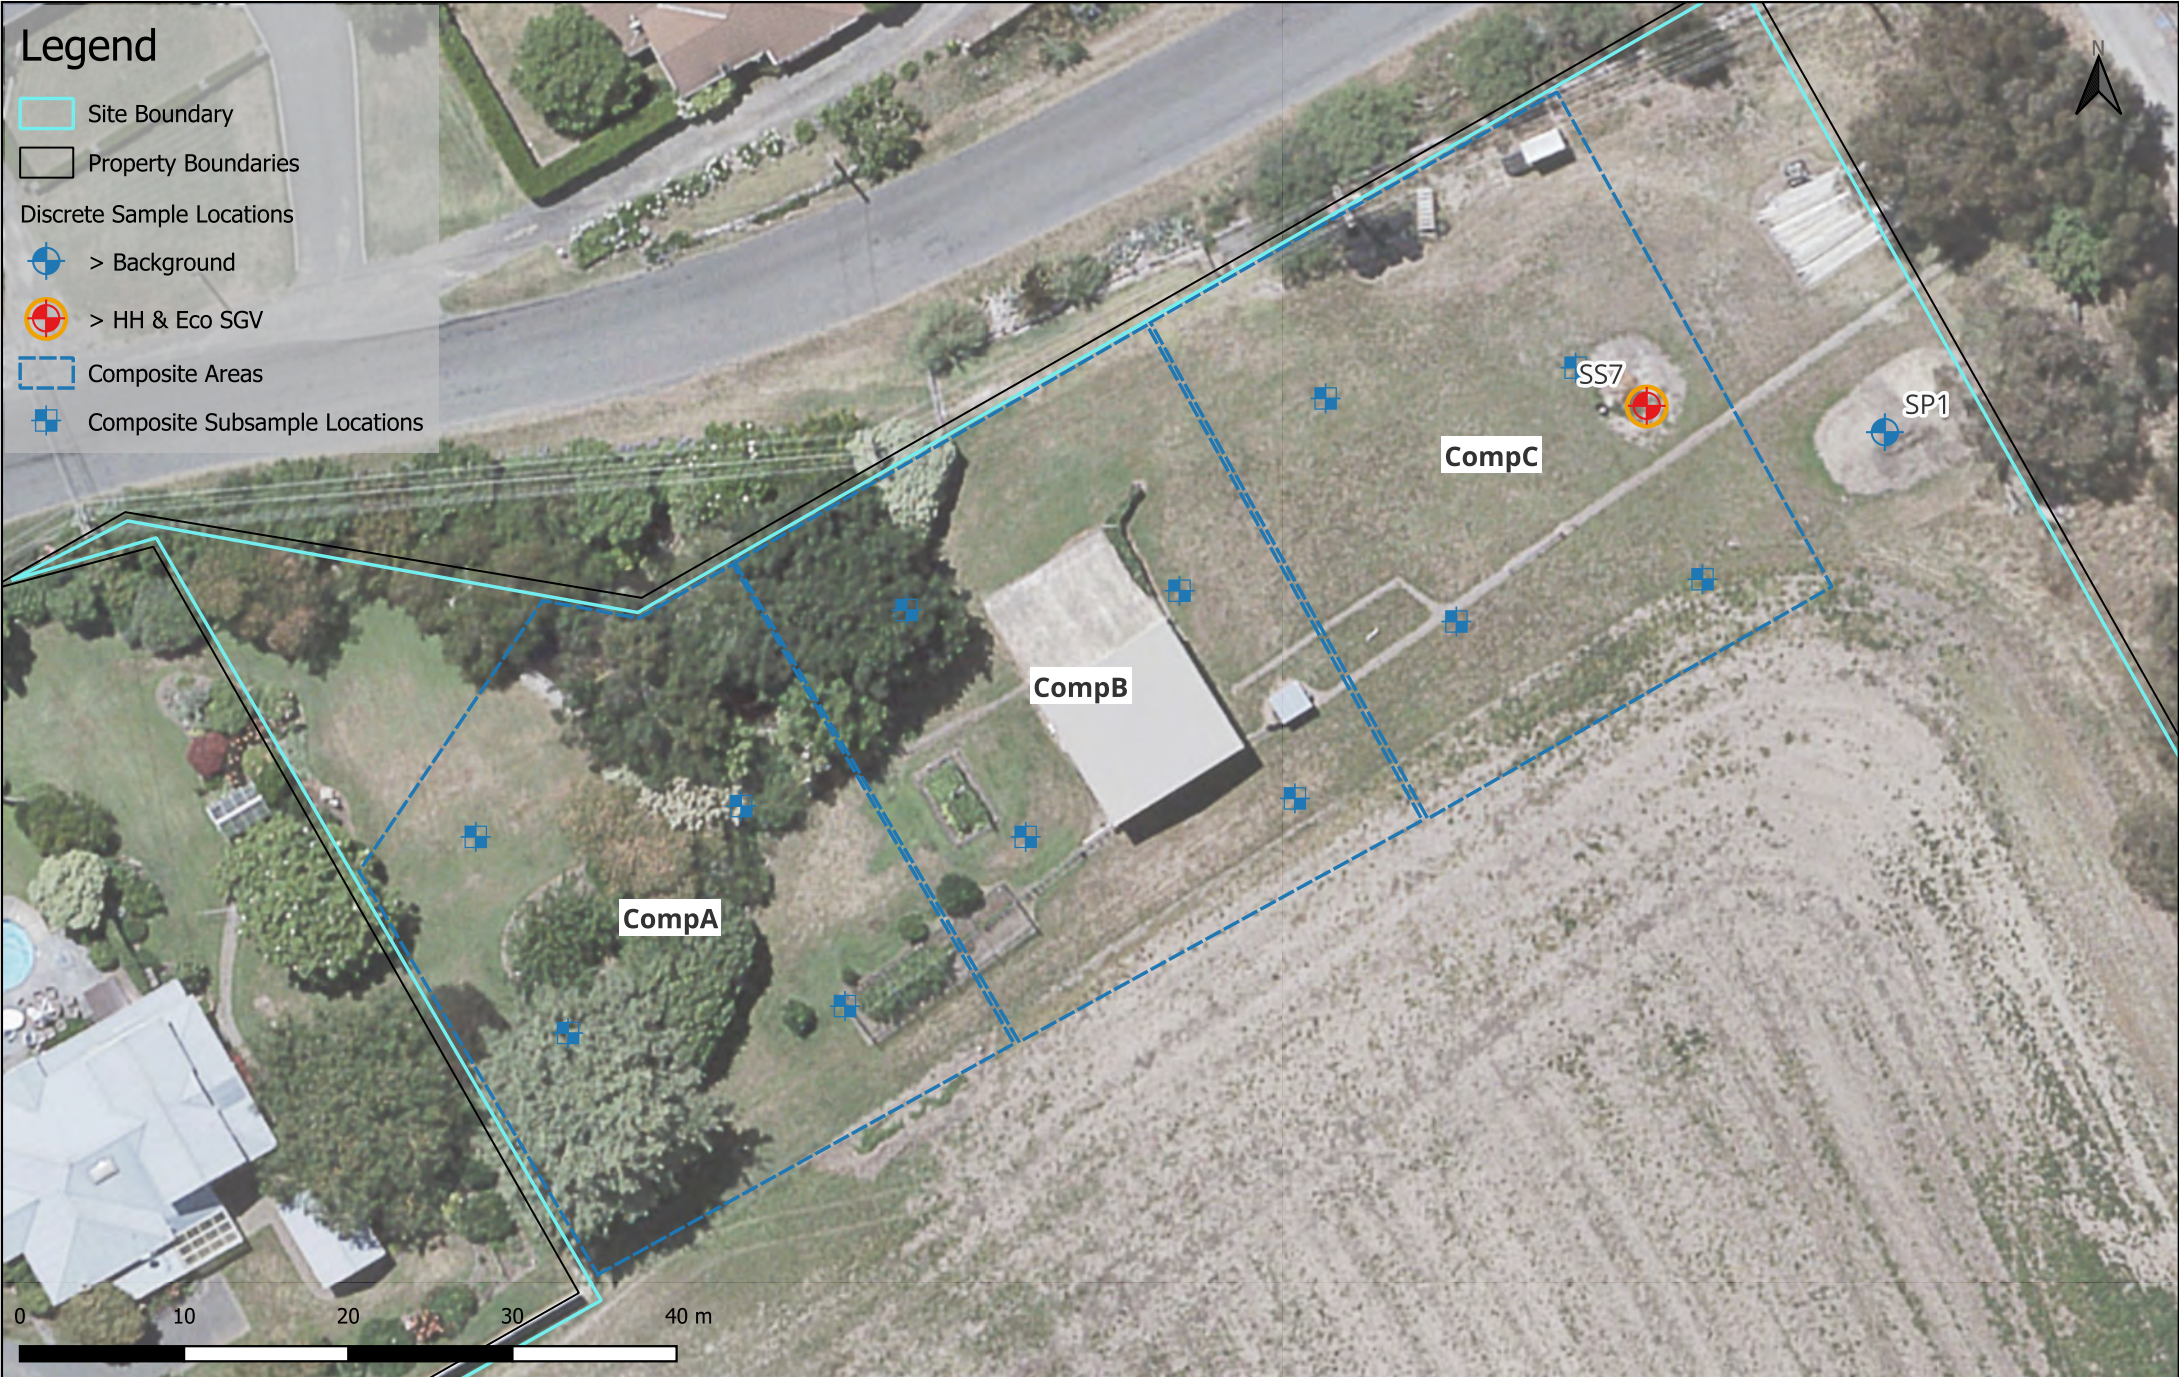
JOB No. J250030 DATE 2025-03-14  
SCALE 1:1200 (A4)  
DWG No. Figure 3c REV 0

- Site Boundary
- Property Boundaries
- Discrete Sample Locations
  - > Background
  - > HH & Eco SGV
- Composite Areas
- Composite Subsample Locations

As noted in the Supplementary DSI, Eco-SGV criteria have since been revised and updated expected background ranges published. Under the current guideline values, additional sample locations exceeded the expected background concentrations and environmental protection criteria for the site. Figures 3a-3c of this report show updated analytical results under the current applicable guideline values.

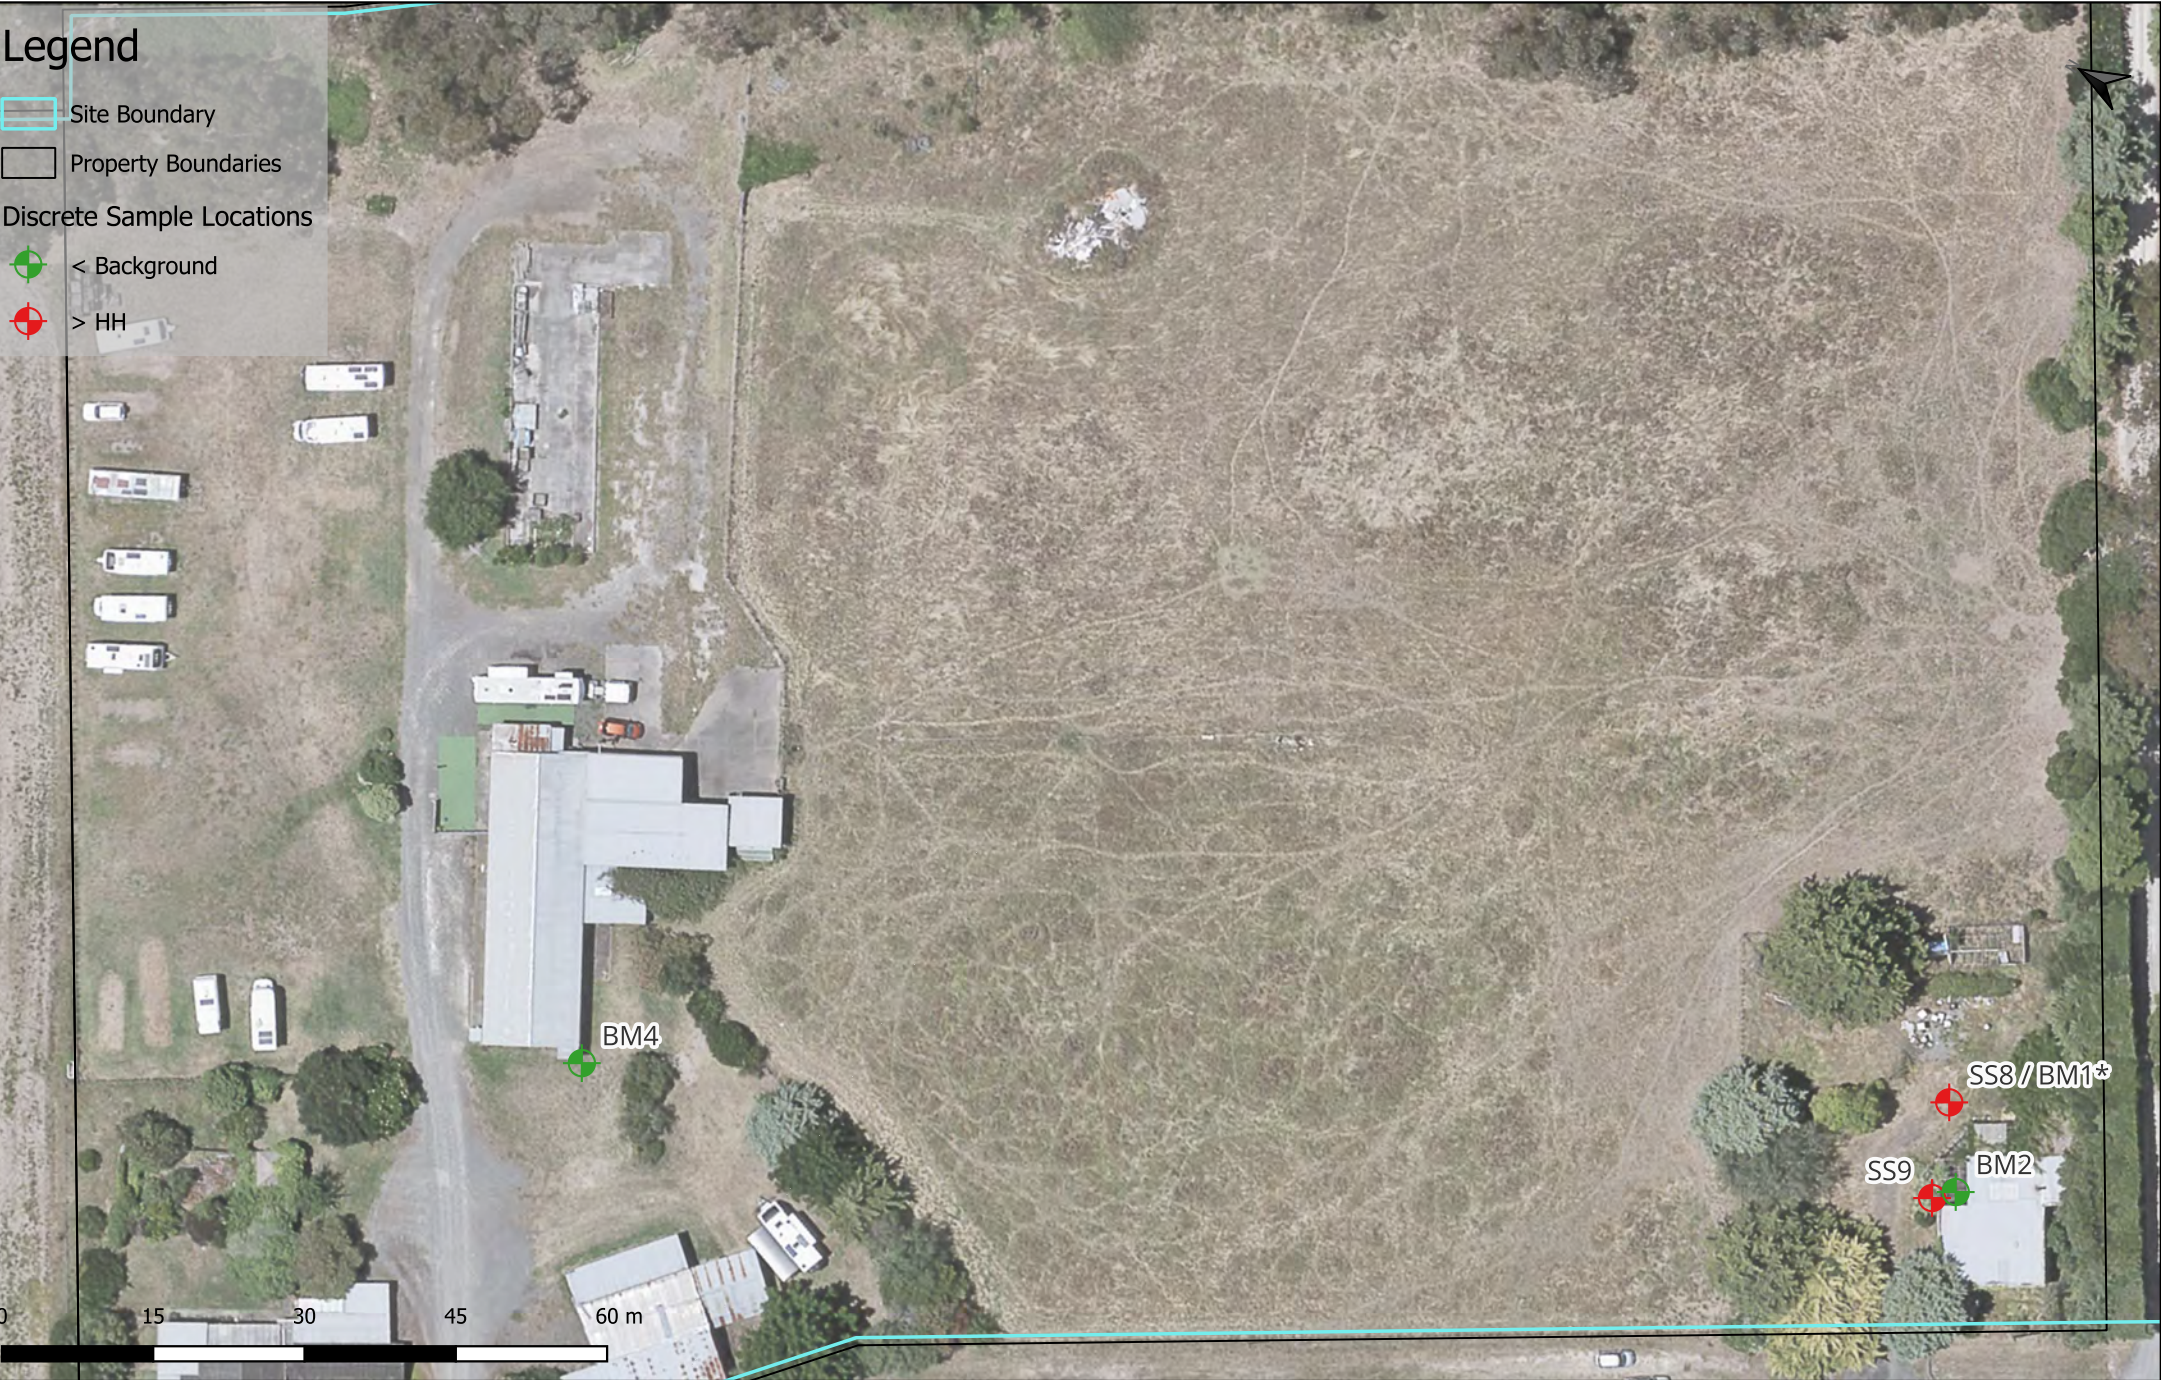
| <div><div>SQN</div><div>GeoSciences</div></div> | 108 ARATAKI ROAD - DSI | | DRAWN GC | APPROVED CD | JOB No. J250030 | DATE 2025-03-14 |

- Site Boundary
- Property Boundaries
- Discrete Sample Locations
- < Background
- > HH

| | ANALYTICAL RESULTS (SQN, 2025) | | NOTES | | SCALE 1:750 (A4) | |

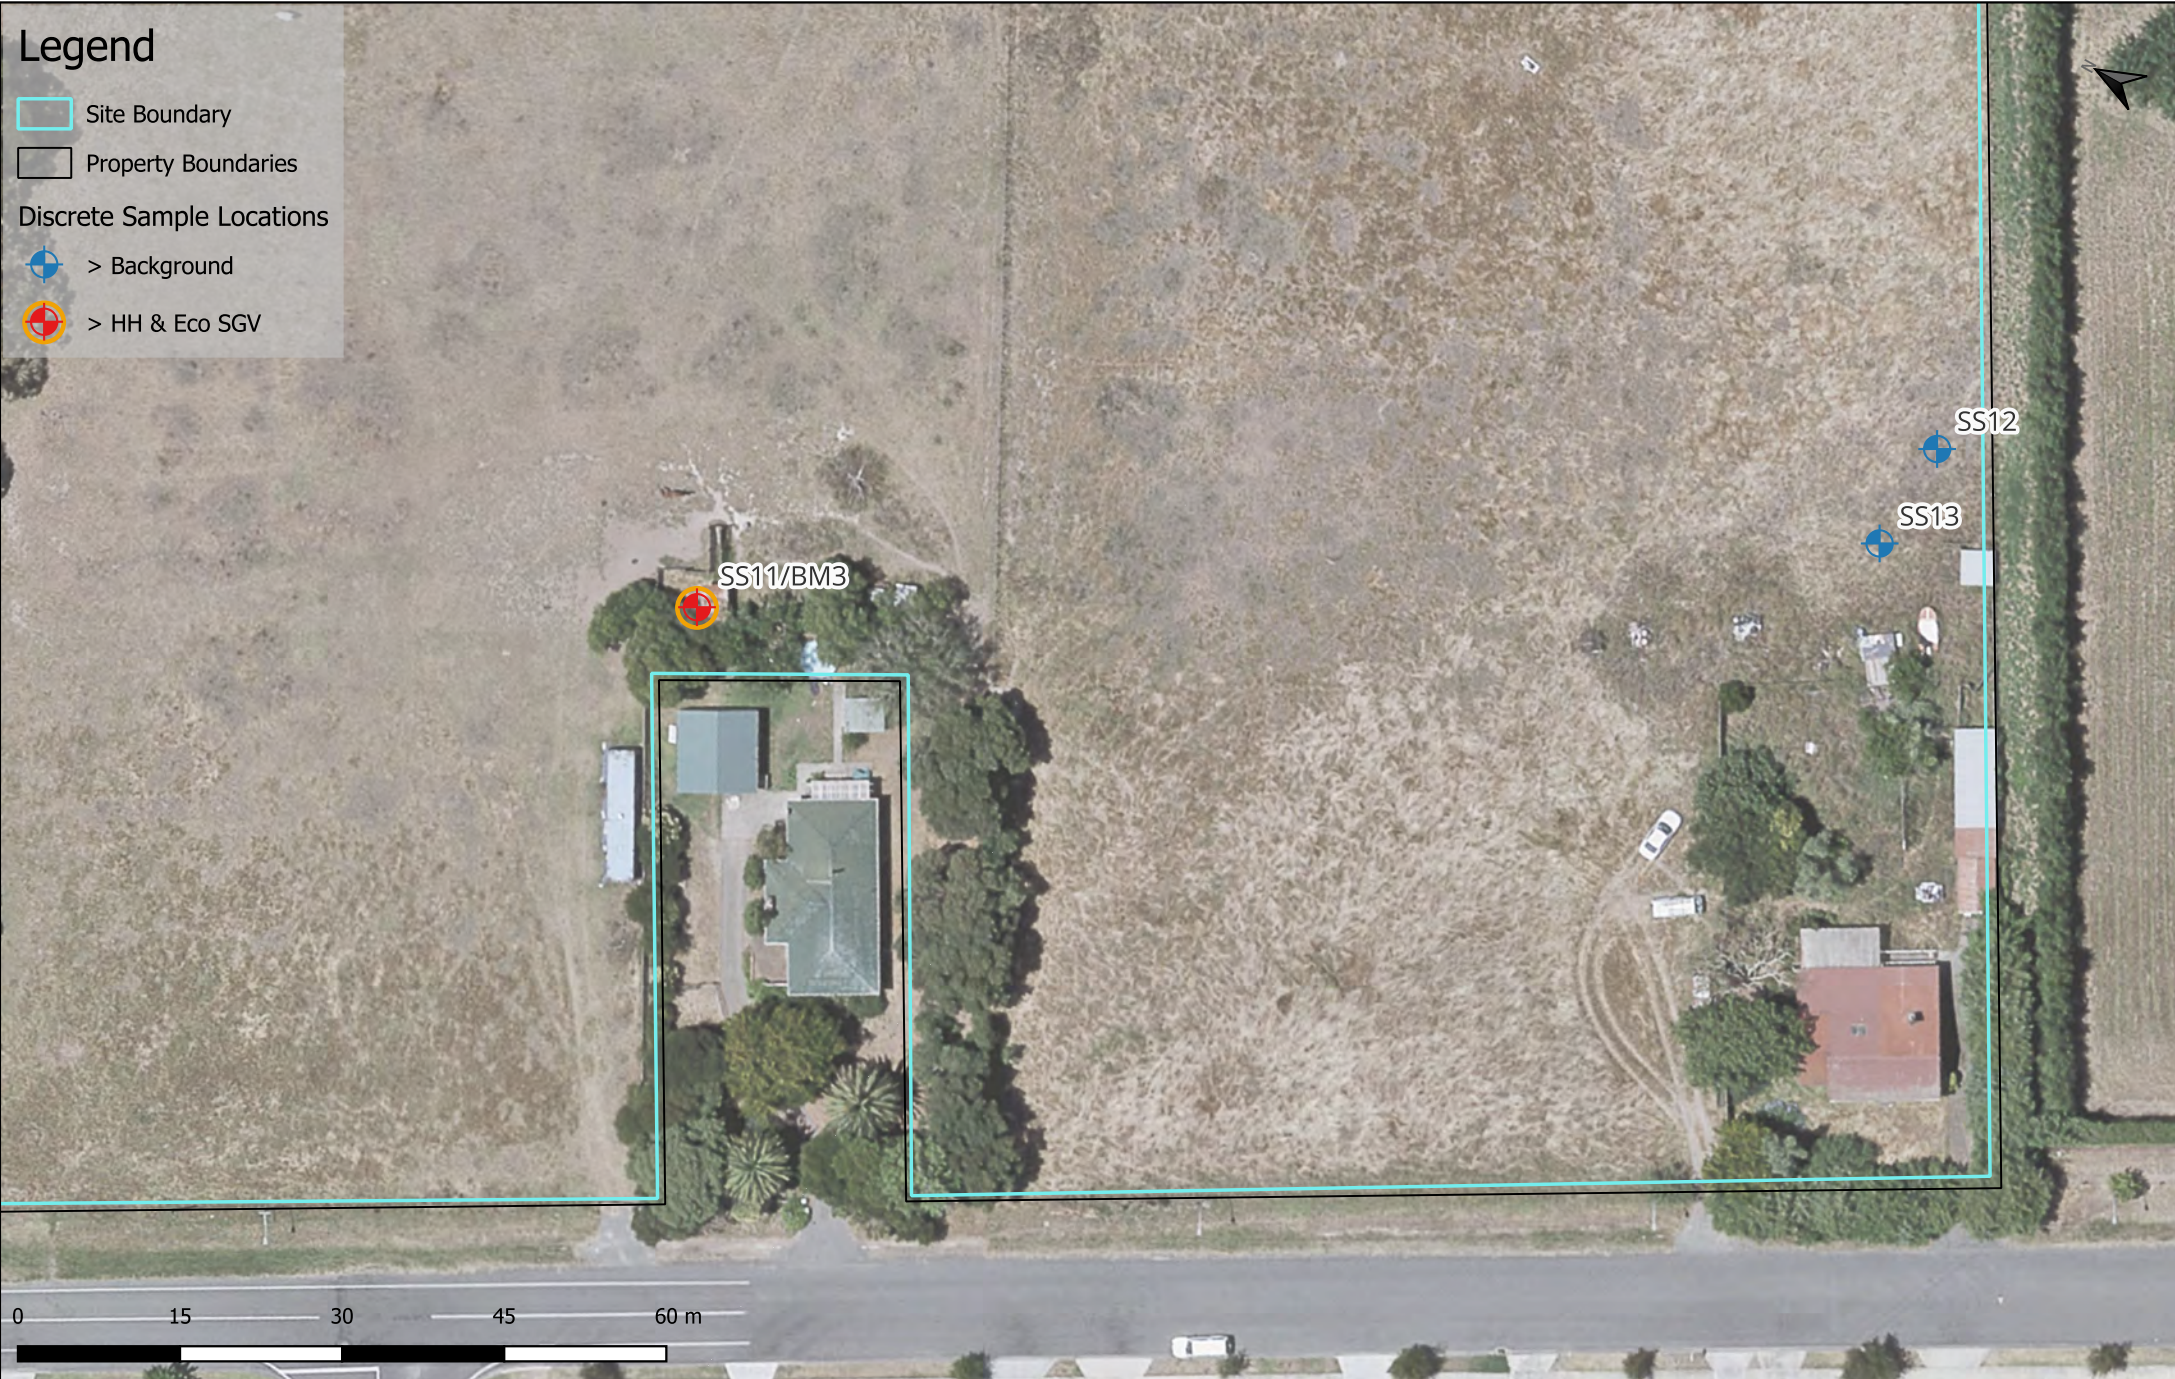
JOB No. J250030 DATE 2025-03-14  
SCALE 1:700 (A4)  
DWG No. Figure 4c REV 0

| FIGURE 4C | 86 ARATAKI ROAD – DSI ANALYTICAL RESULTS (SQN, 2025) |

86 ARATAKI ROAD - DSI  
ANALYTICAL RESULTS (SQN, 2025)  
86, 108 & 122 Arataki Road, Hastings

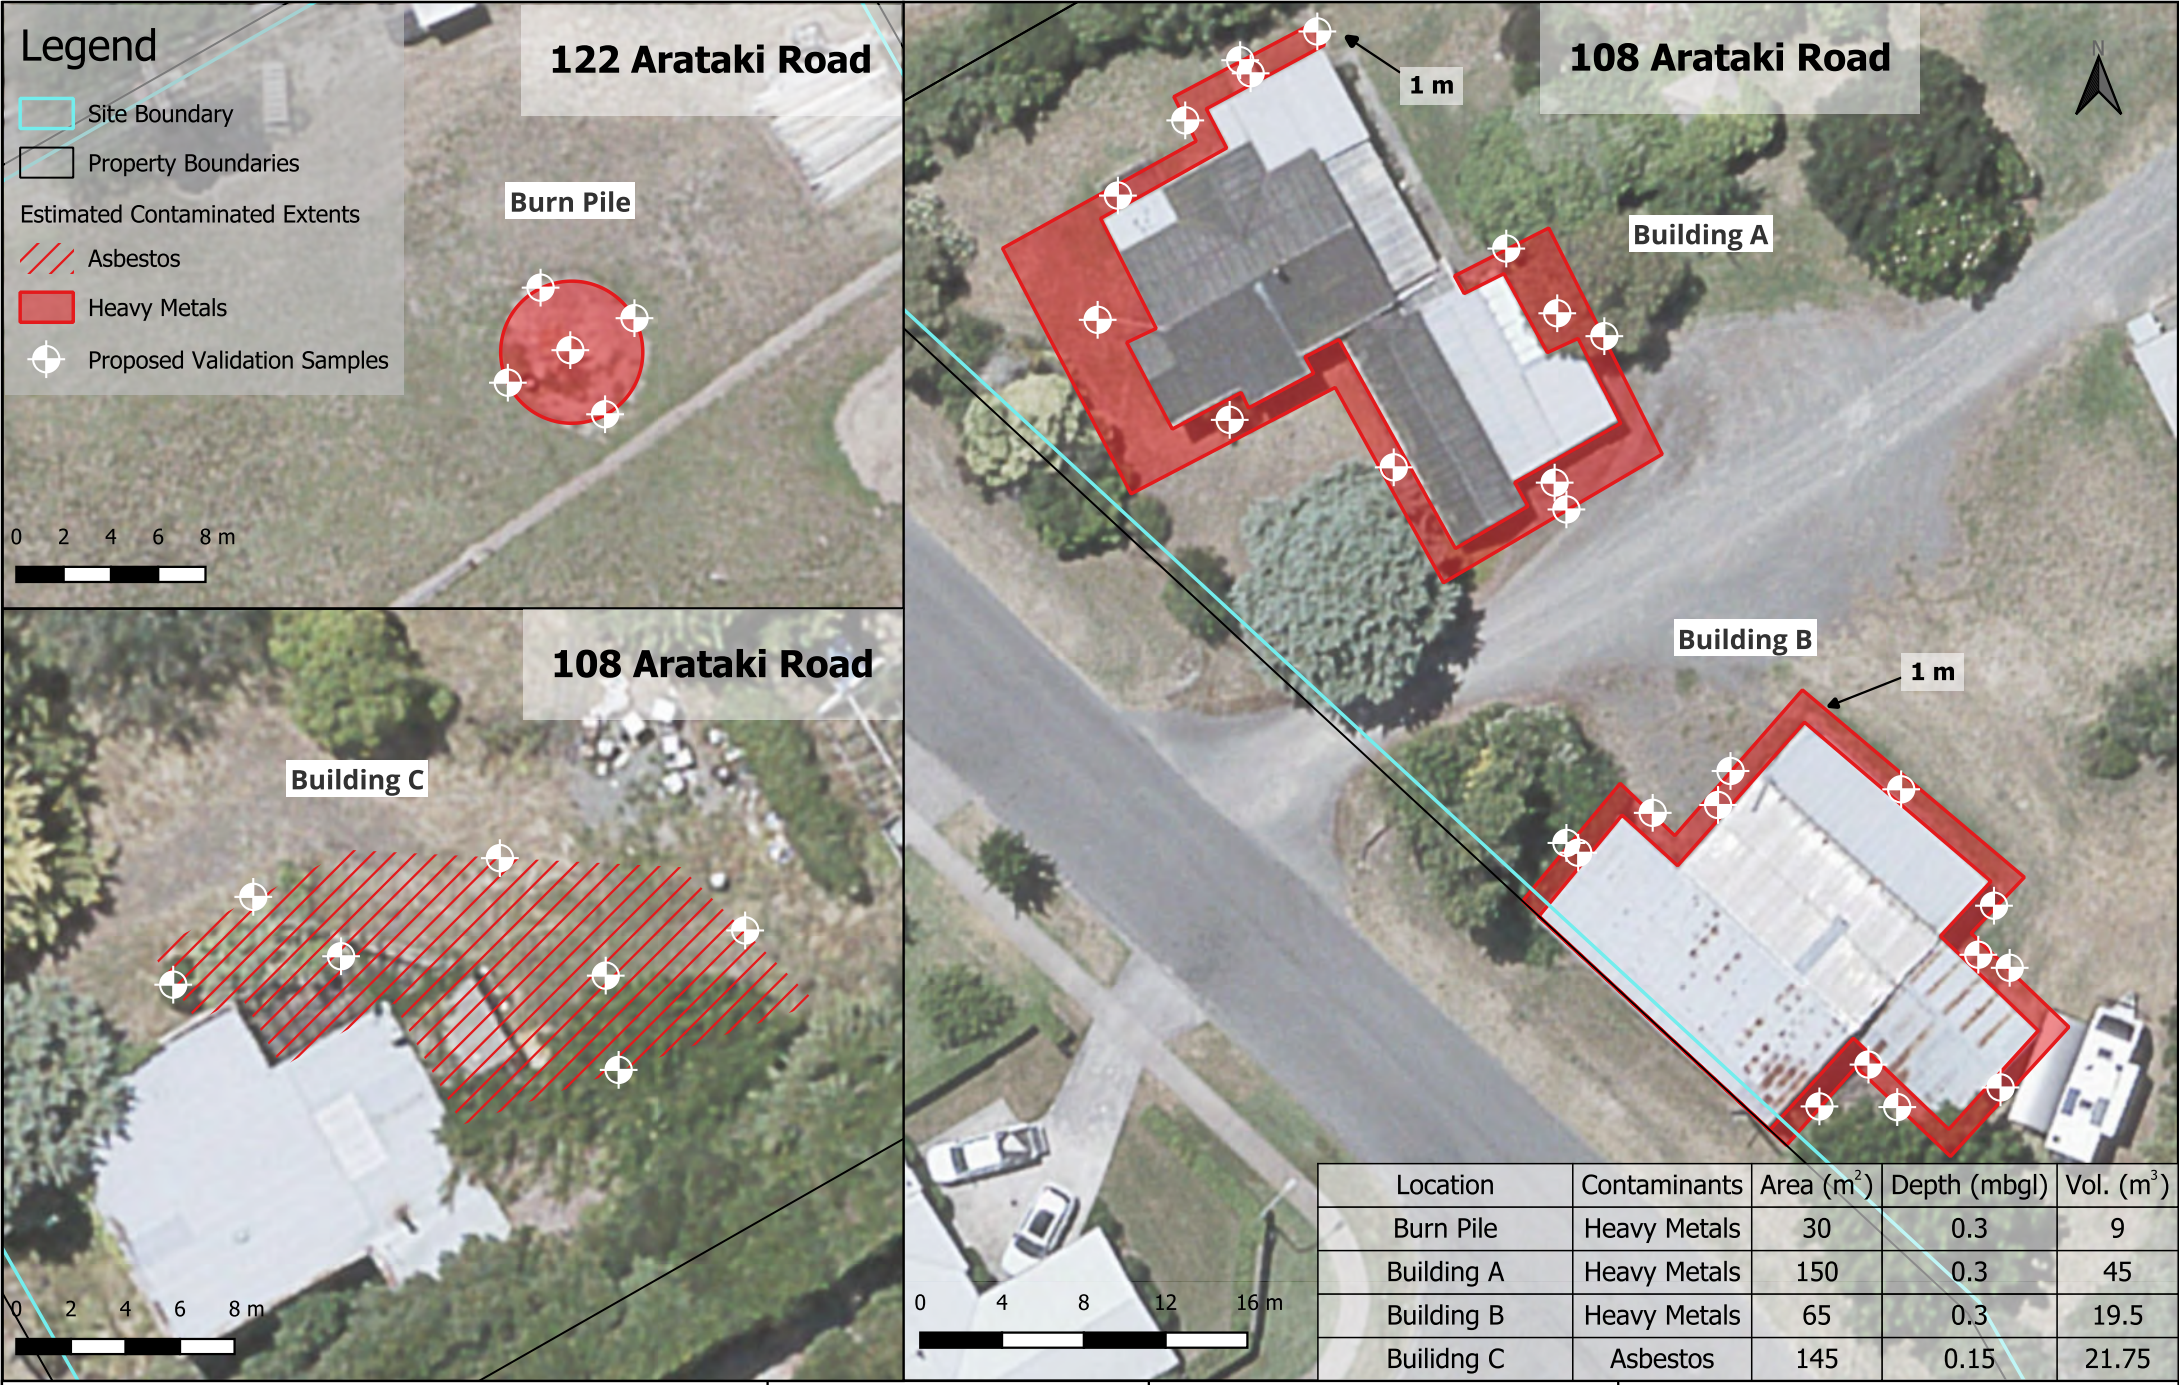
| FIGURE 5A | ESTIMATED REMEDIAL EXTENTS AND VALIDATION SAMPLE LOCATIONS |

| | | <div>86, 108 &amp; 122 Arataki Road, Hastings</div> | | <div>NOTES<br/>All extents are estimates only.<br/>Proposed validation sample locations are indicative and dependent on final remedial extents.</div> | | <div>SCALE 1:370 (A4)</div> | |

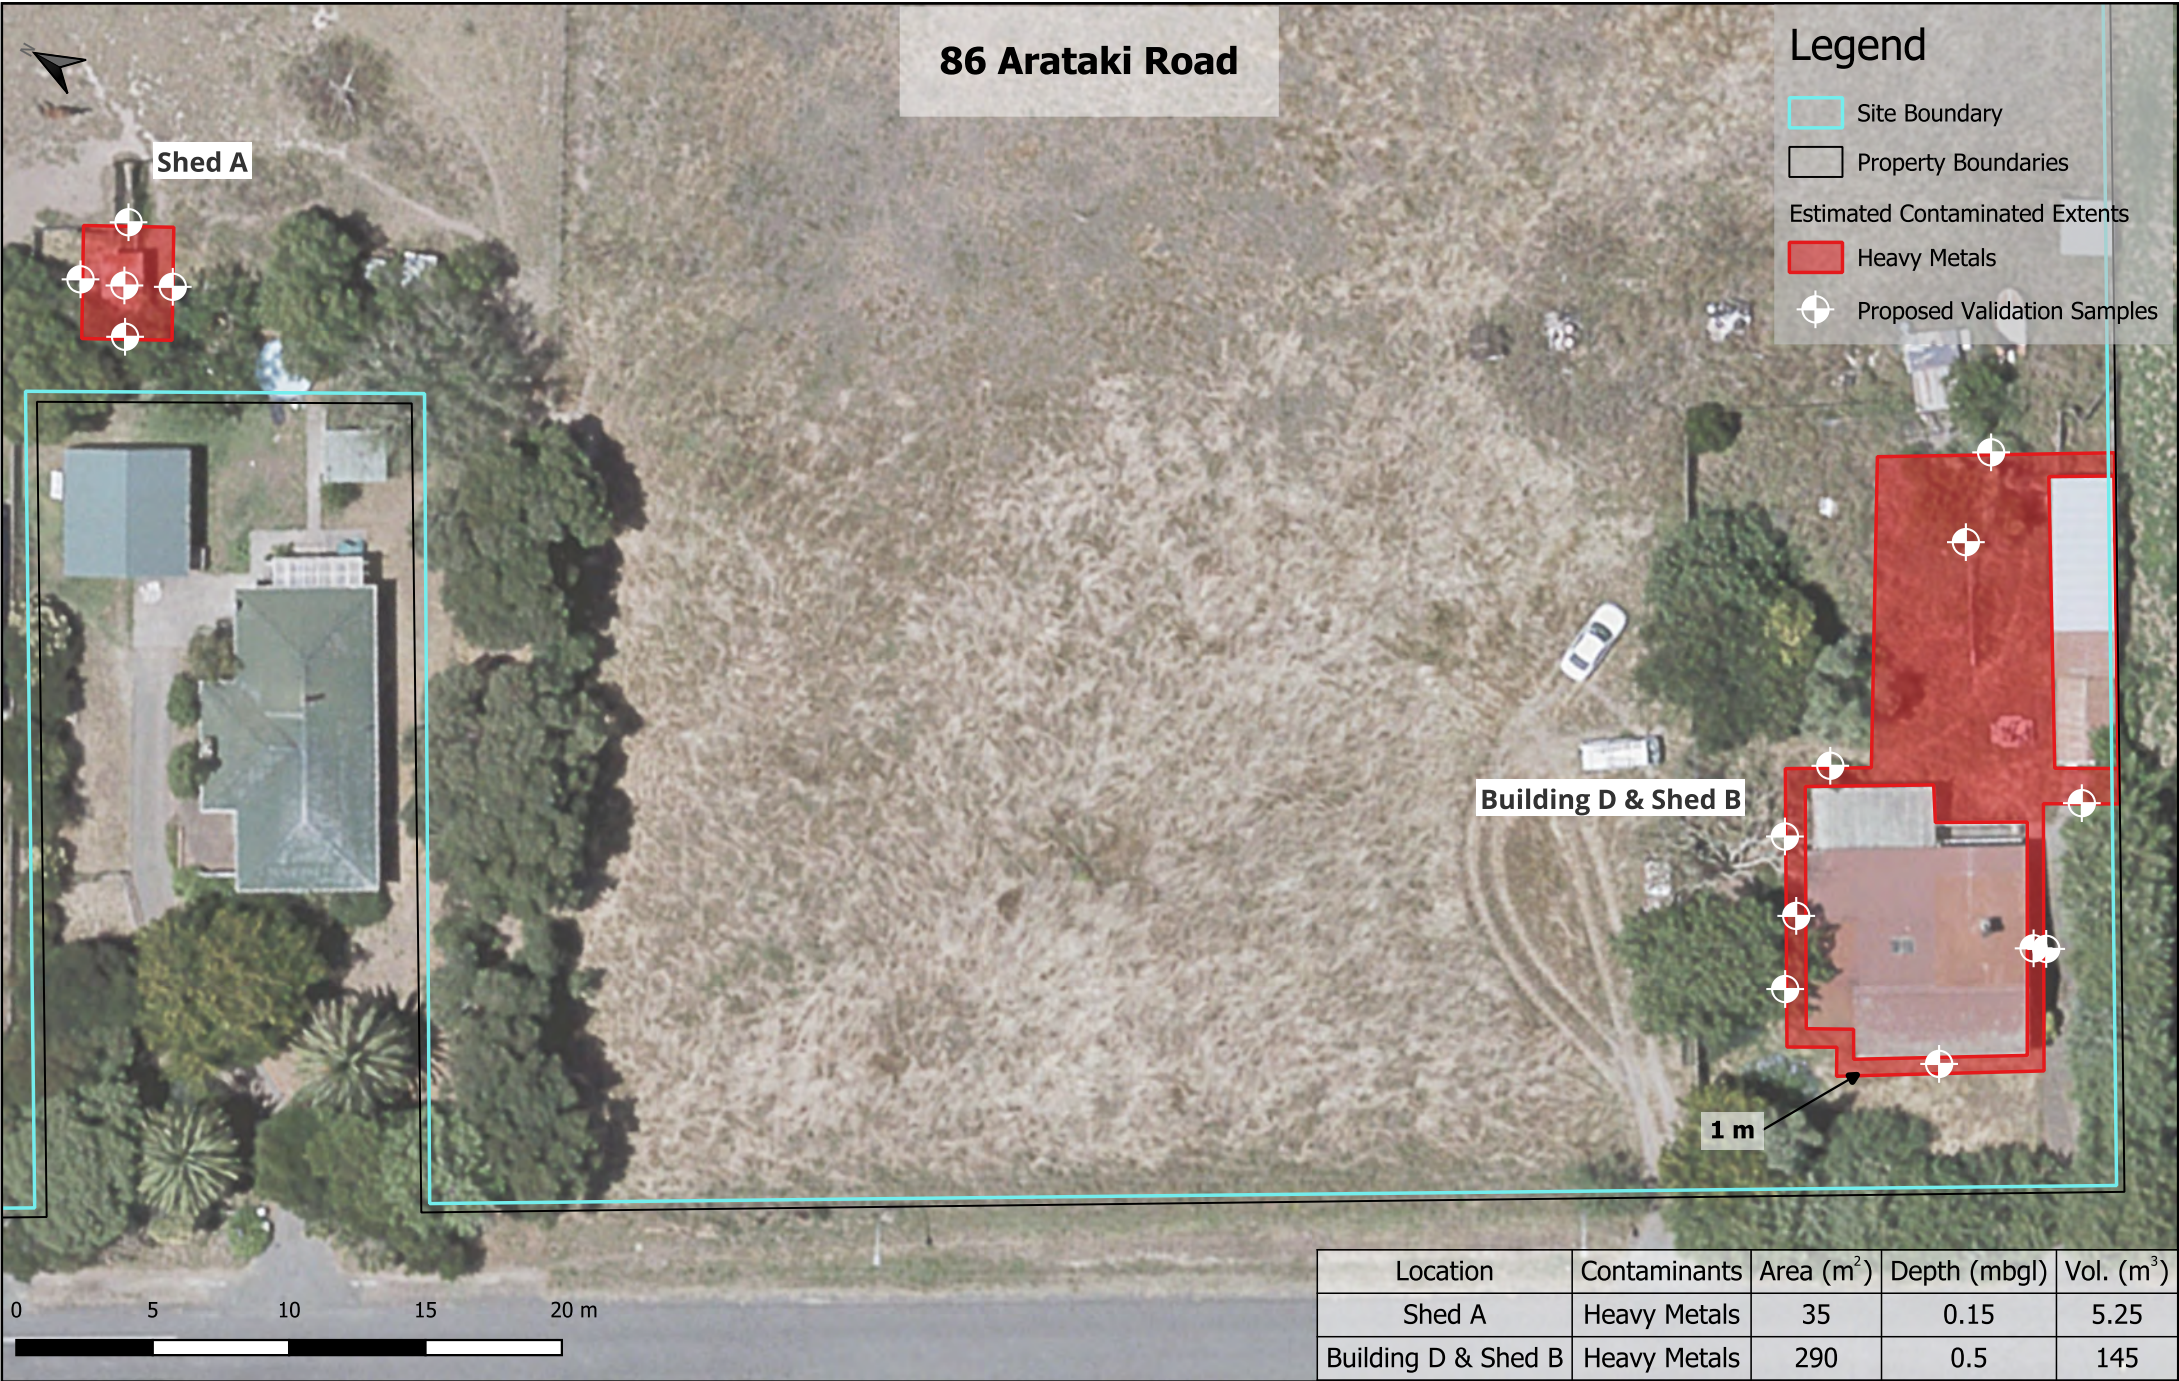
| | <b>86, 108 &amp; 122 Arataki Road, Hastings</b> | | NOTES<br>All extents are estimates only.<br>Proposed validation sample locations are indicative and dependent on final remedial extents. | | SCALE 1:450 (A4) | |
