## Remediation Action Plan (RAP)

86, 108, and 122 Arataki Road, Havelock

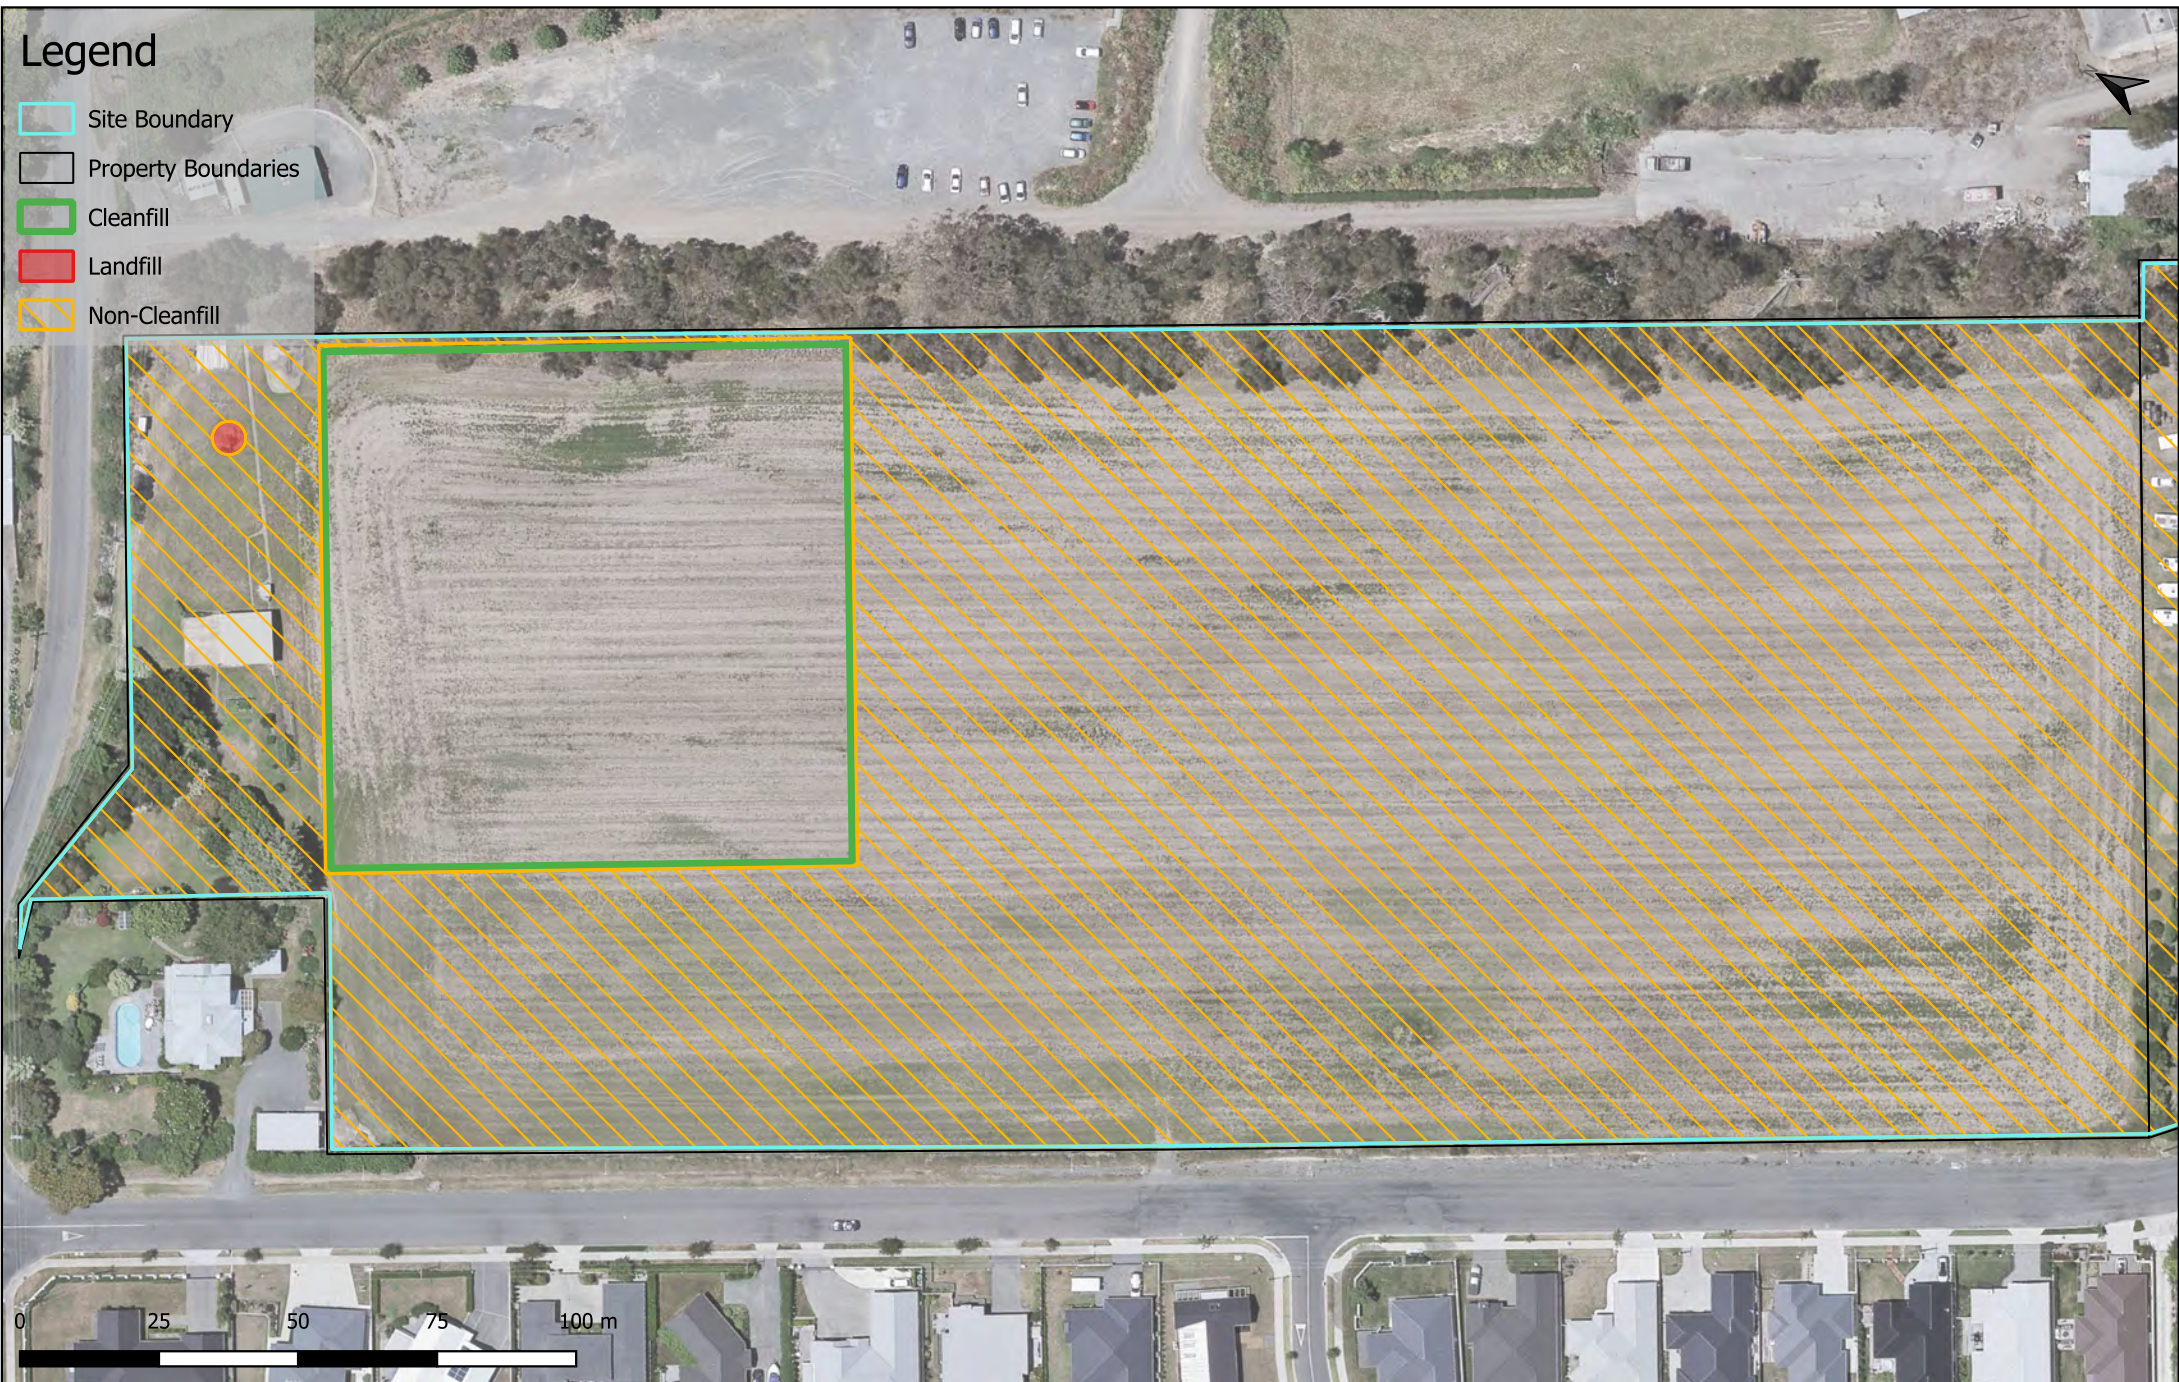
| FIGURE 6A | 122 ARATAKI ROAD – DISPOSAL CLASSIFICATIONS |

- Site Boundary
- Property Boundaries
- Cleanfill
- Landfill
- Non-Cleanfill

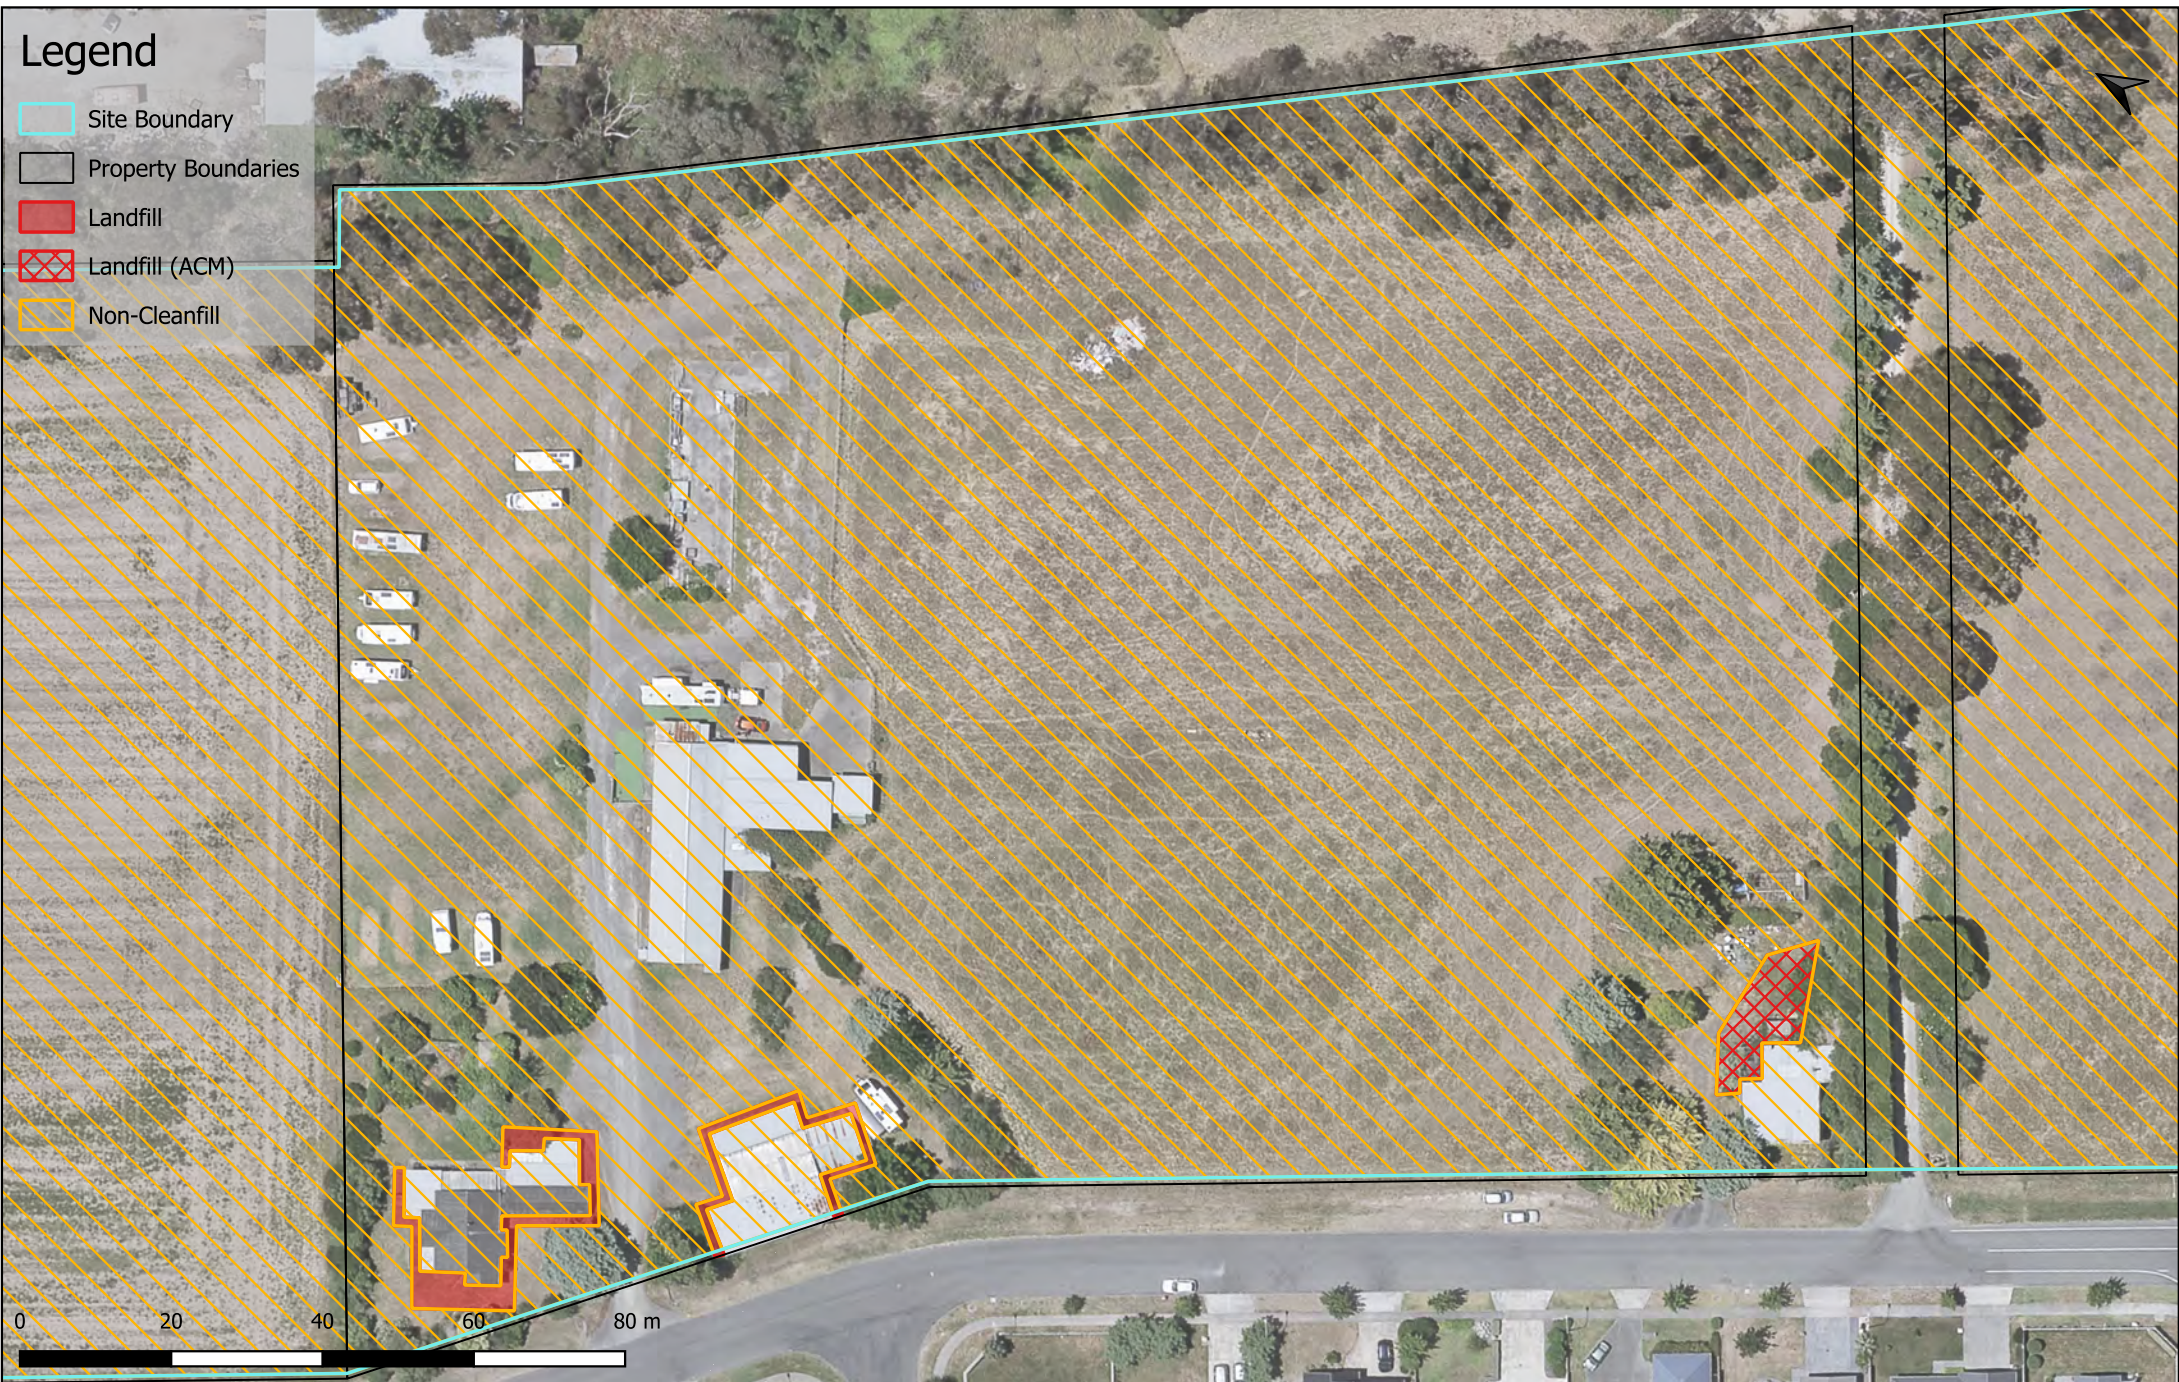
| | <b>86, 108 &amp; 122 Arataki Road, Hastings</b> | | NOTES<br>Classifications and extents are indicative only and may be subject to change. Pre-approval from nominated waste receiver required. | | SCALE 1:1000 (A4) | REV 0 |

- Site Boundary
- Property Boundaries
- Cleanfill
- Landfill
- Landfill (ACM)
- Non-Cleanfill
