# Assessment of Potential Effects on Birds of the Proposed Stella Passage Development for Port of Tauranga

Contract Report No. 7339a

April 2025

Port of Tauranga Ltd

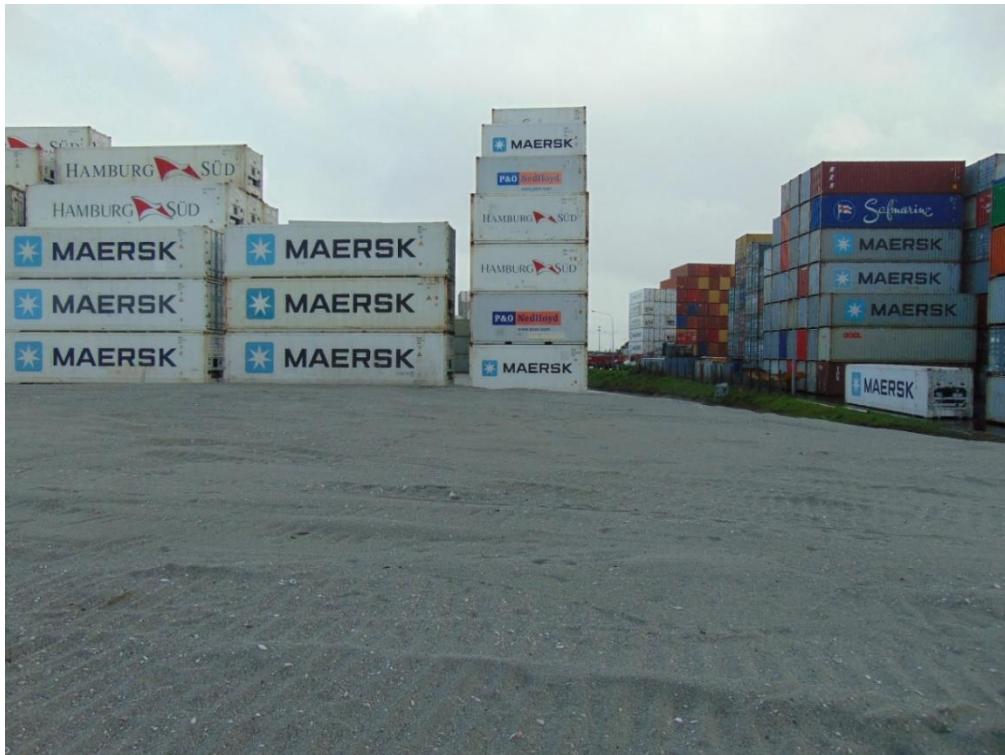
**Plate 1** – A view of the northern end of the sand pile, showing the proximity to wharf activities, and the recent use of the site by tracked vehicles.

The sand pile is an active work site (Plate 1); it is used for the deposition of dredged sand from the Stella Passage, and the sand is occasionally taken for use for beach regeneration around the Tauranga area.

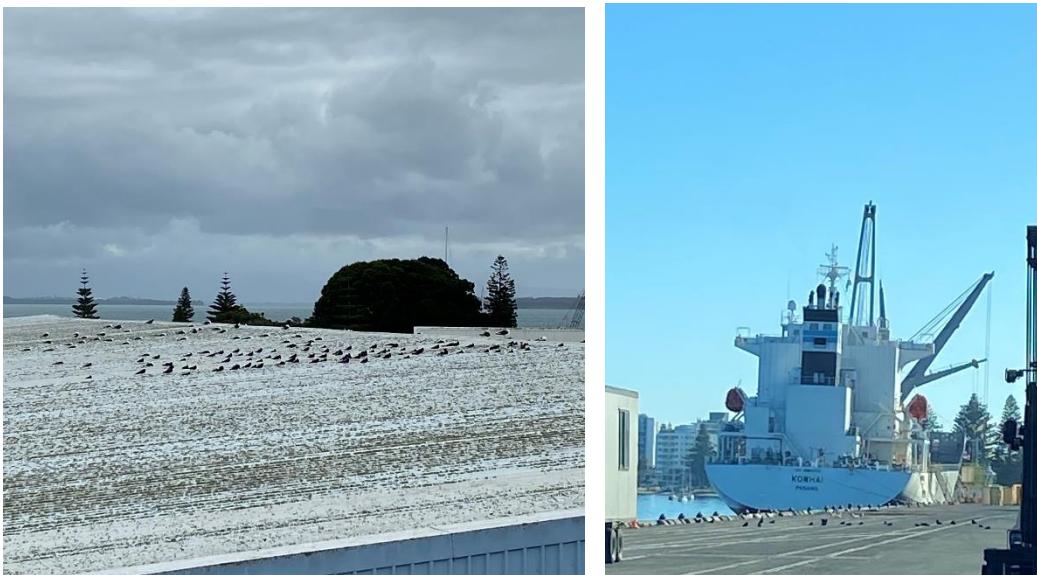
**Plate 3 –** Tōrea pango/variable oystercatcher roosting on the Container Terminal roof (left: 17 March 2023) and between Berths 1-8 (right: 20 February 2023).

been recorded roosting on cargo shed roofs (2010-2018), and tōrea pango/variable oystercatcher have been recorded roosting at various sites within the Port, including the container terminal and between Berths 1-8 (Plate 3). It is possible that these birds will temporarily relocate to a roof due to Project-related disturbances near the sand pile.

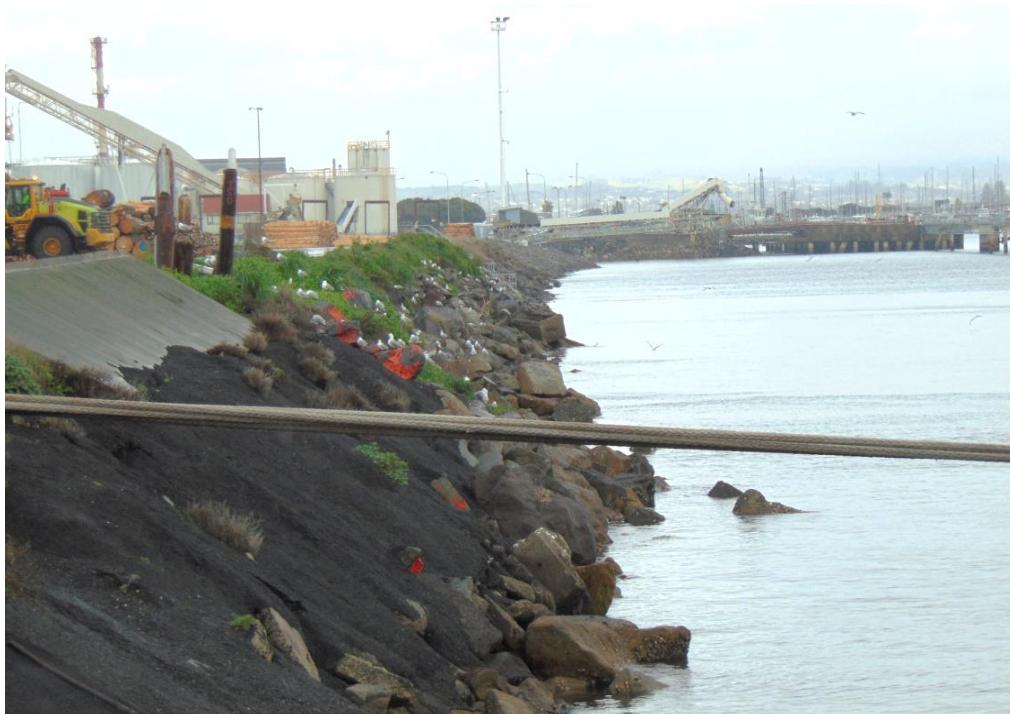
**Plate 4** – Tarāpunga/red-billed gull colony site at Mount Maunganui Wharf looking south, showing the proximity of the working wharf area including moorings. Also visible is an asphalt and concrete surface (left) installed to discourage birds from nesting. Photograph July 2019, before nesting.

The presence of the colony at the Mount Maunganui Wharf has created a health and safety issue for POTL. Dock workers are dive-bombed while working, and in particular, tying mooring ropes; mooring ropes and other surfaces are covered in gull faeces which become slippery when wet; and there is concern regarding the potential for spread of infectious organisms from faeces. Attempts have been made to reduce attacks by construction of overhead shelters to protect staff (Plate 5), and to encourage the birds to move by covering the seawall with concrete and asphalt (Plate 4). However, the birds have only moved slightly further south, and continue to dive-bomb dock workers.

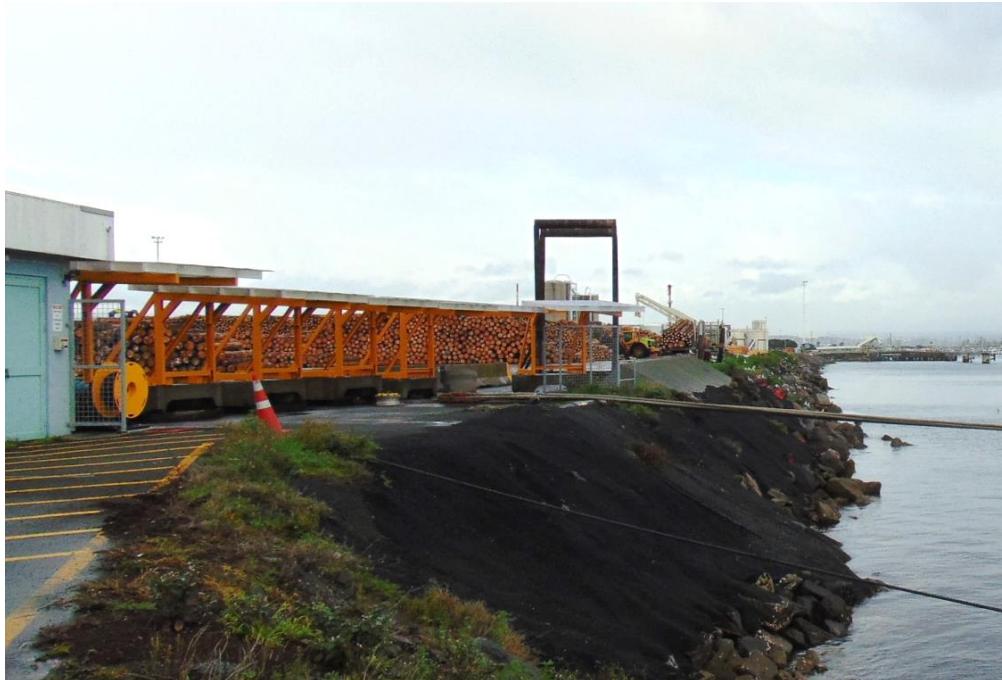
**Plate 5** Overhead shelters built to protect dock workers from tarāpunga/red-billed gull attacks during the breeding season. Red-billed gull colony site visible in far distance. Photograph in July 2019, before nesting.

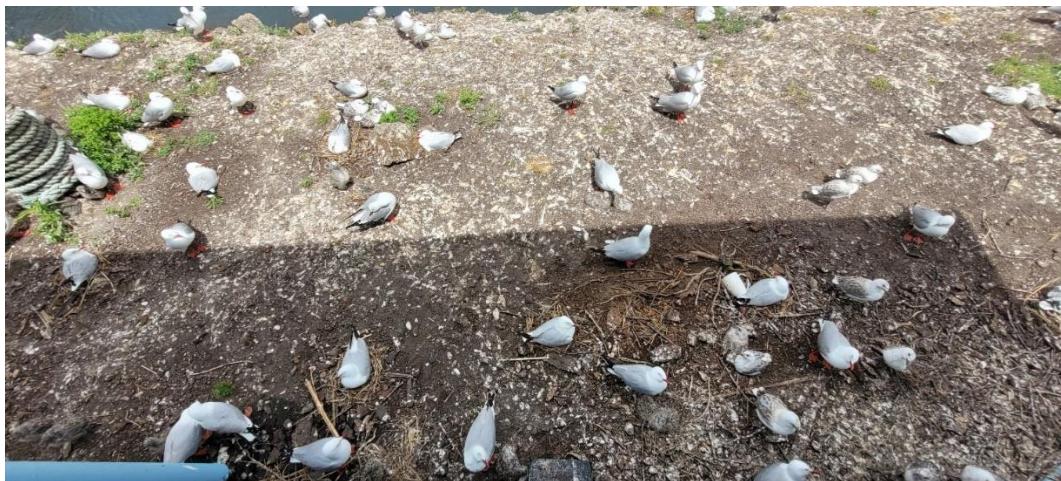
**Plate 6 – Newly establishing red-billed gull colony at Butters Landing.**

Photograph 27 January 2025.

Butters Landing has been identified as the site for a new penguin nesting box colony. Recently, a small tarāpunga/red-billed gull breeding colony has established itself at the site. There is potential for more permanent roosts and nests to be created in this location (Plate 6).
