WINSTONE
AGGREGATES

Boffa Miskell

Appendix B12.4.10d

Landscape Effects Assessment Appendix 4
Graphic Supplement

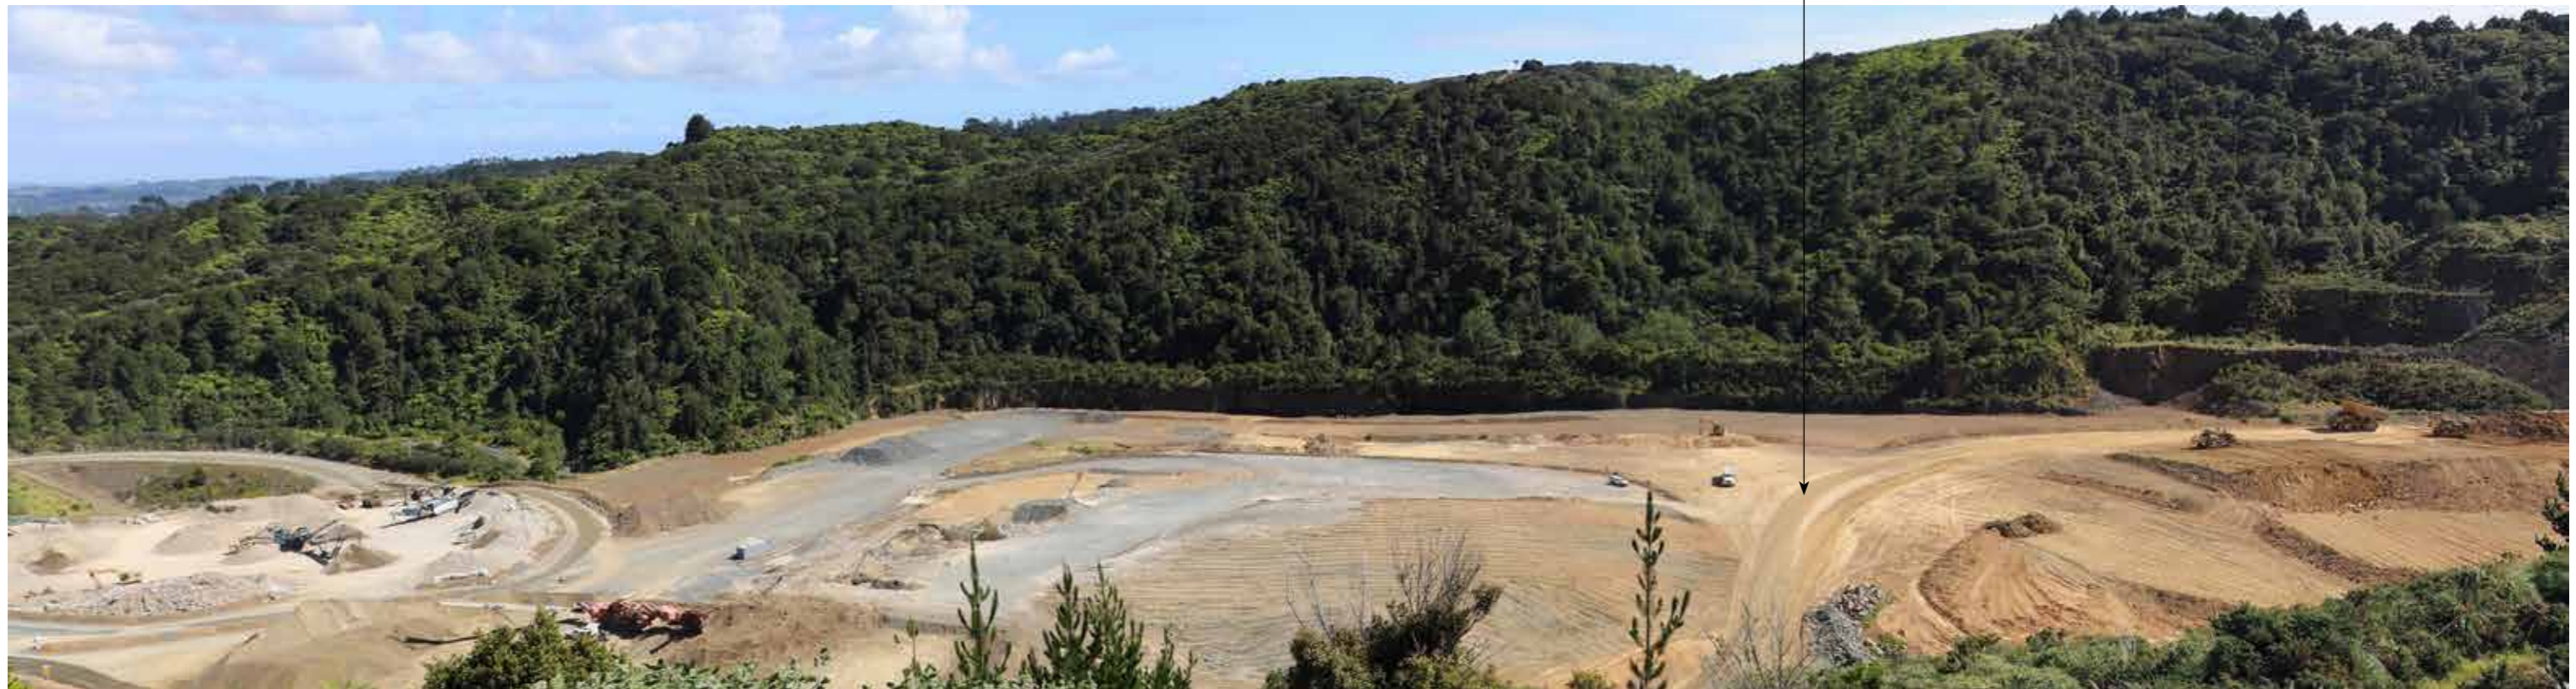
Existing Hunua Pit OBDA

Site Photograph 1 is located on the northern edge of the quarry development area, looking in a northerly direction.

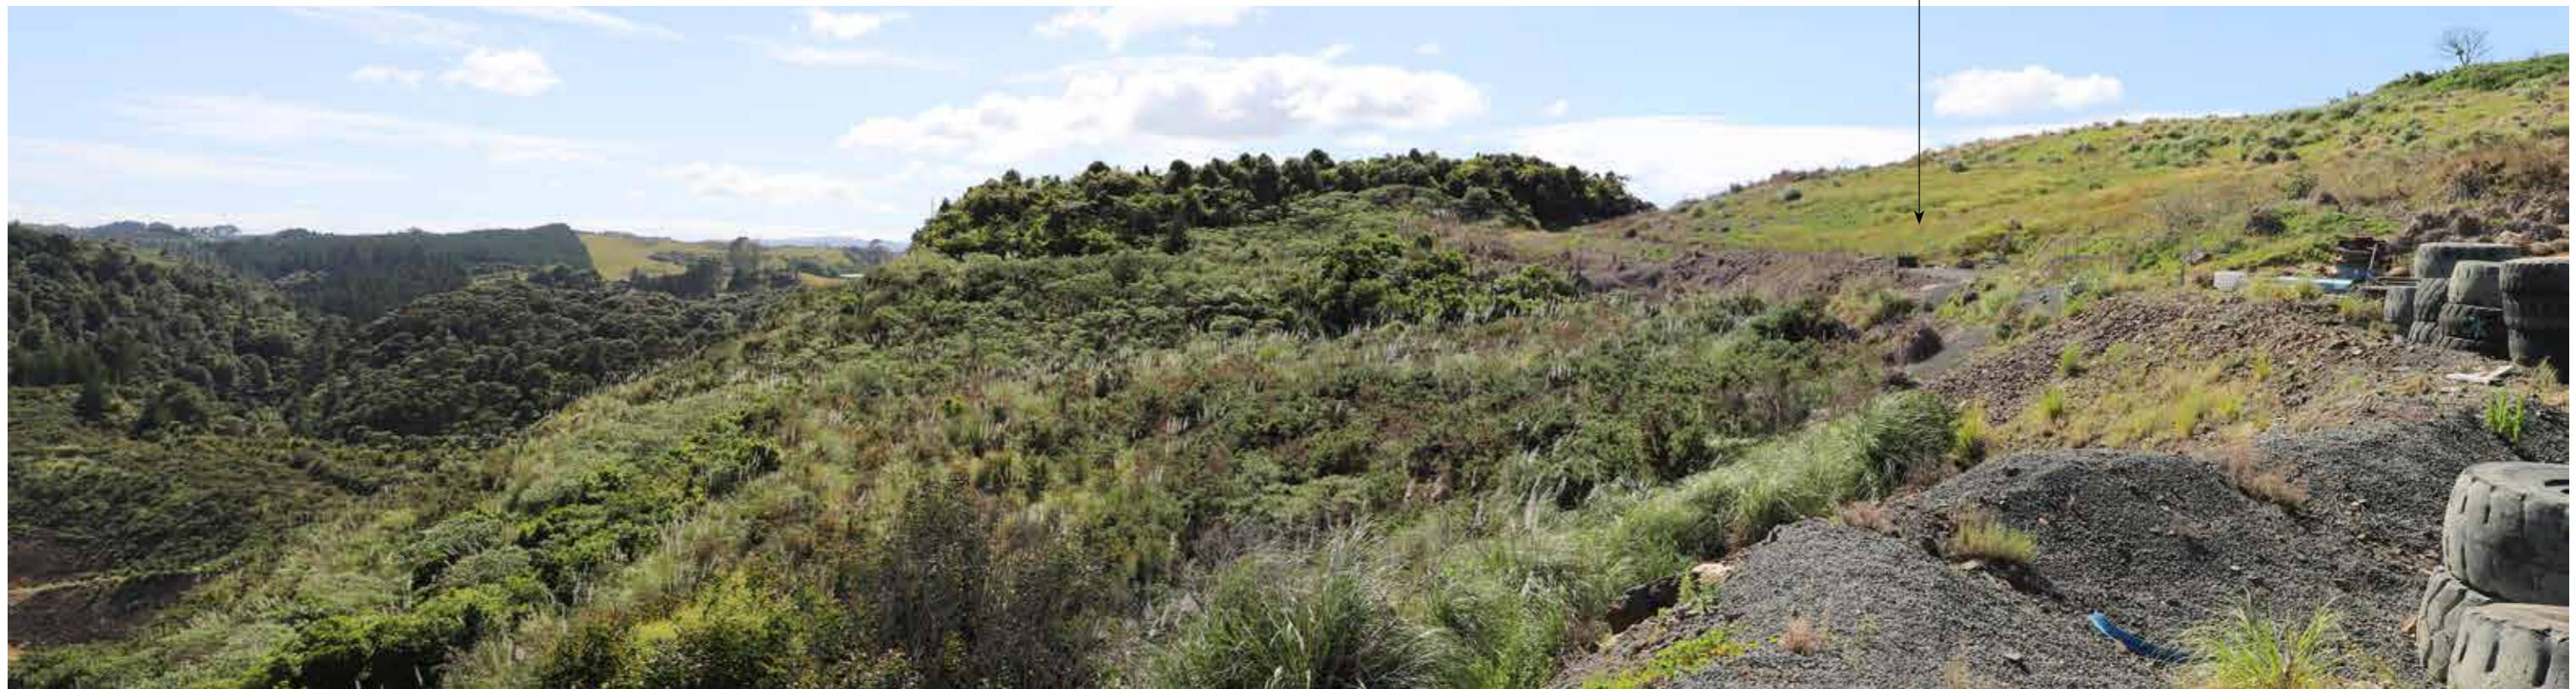
Hays Paddock

Site Photograph 2 is located on the northern edge of the quarry development area, looking in an easterly direction.

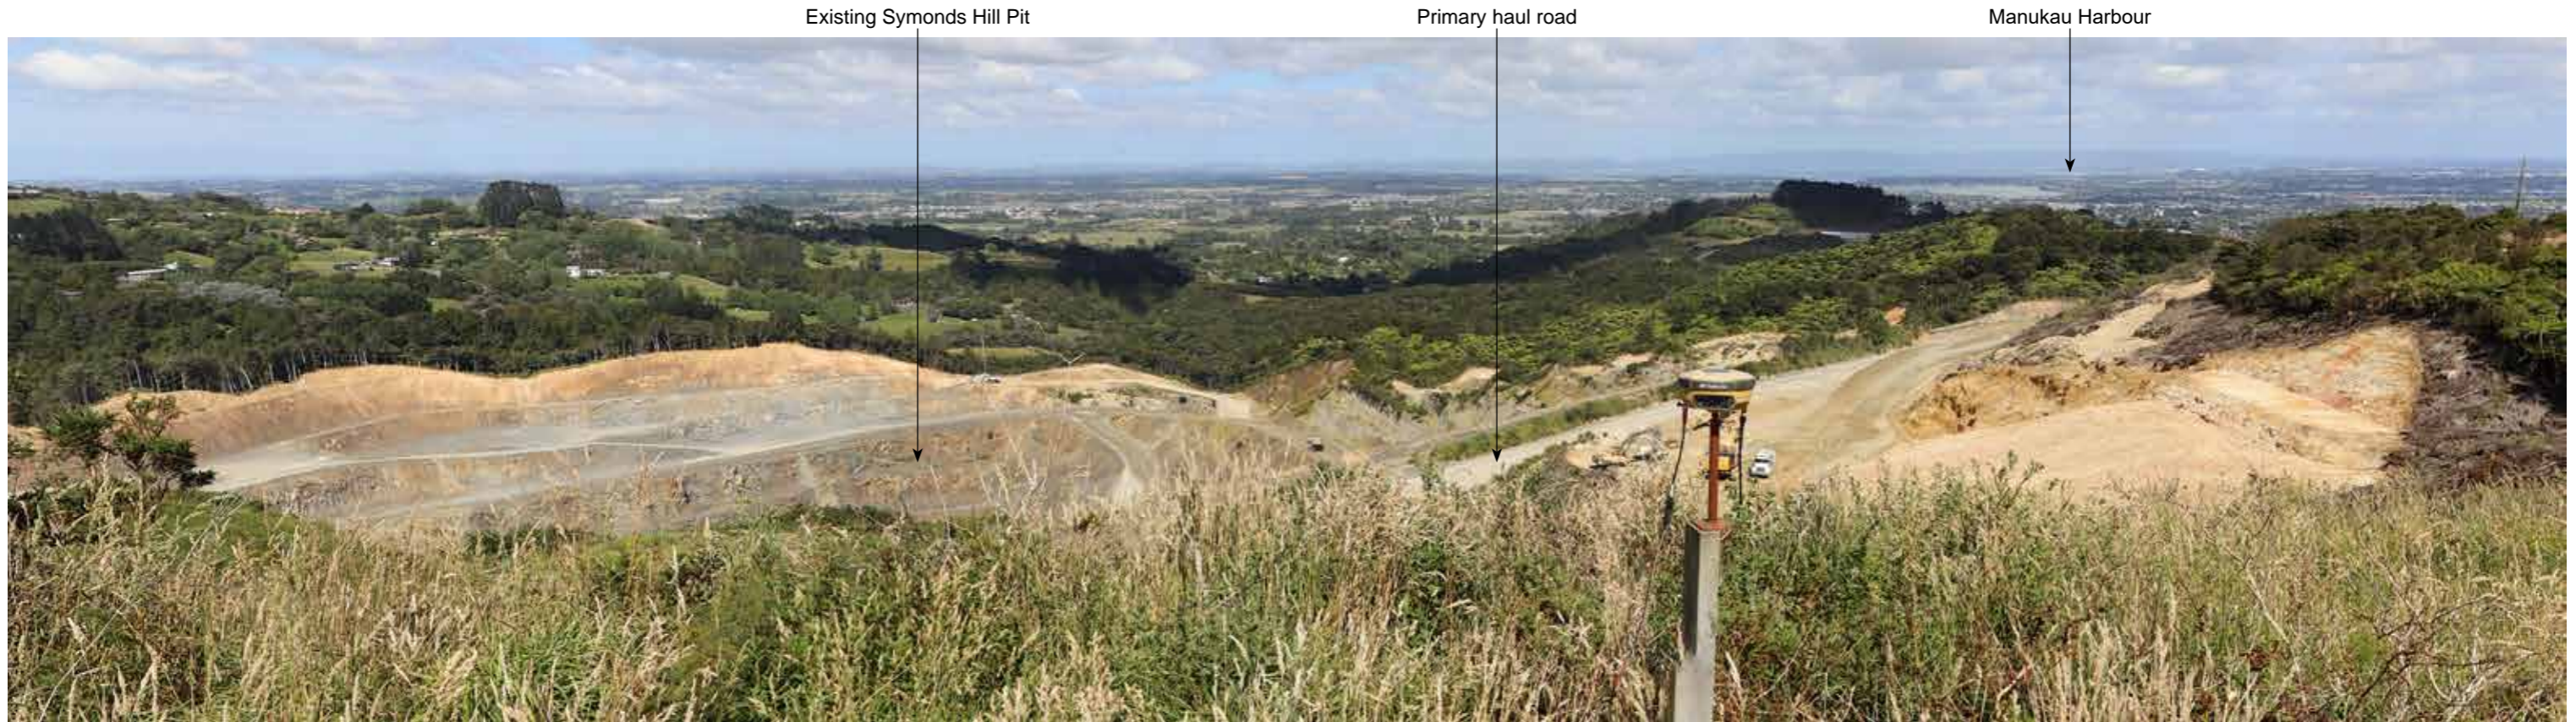
Site Photograph 3 is located on the existing access road, looking in a southwesterly direction.

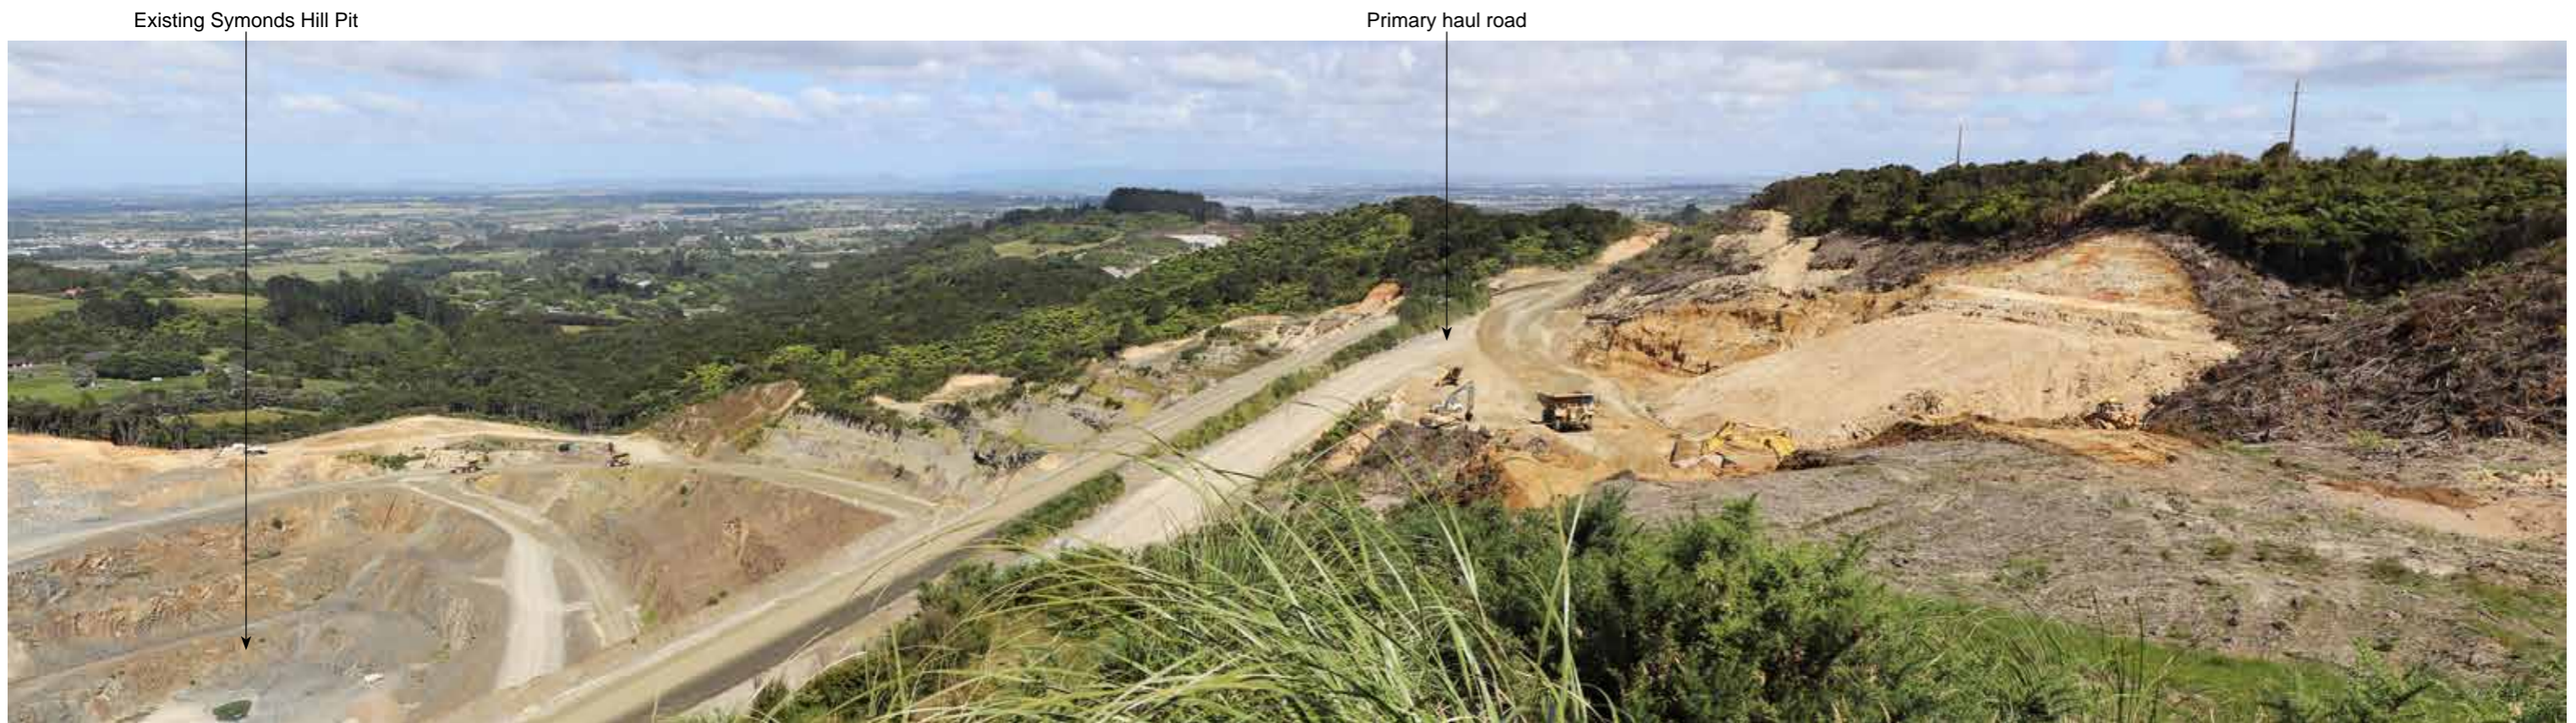
Site Photograph 4 is located near the eastern edge of the existing Symonds Hill Pit, looking in a northwesterly direction.

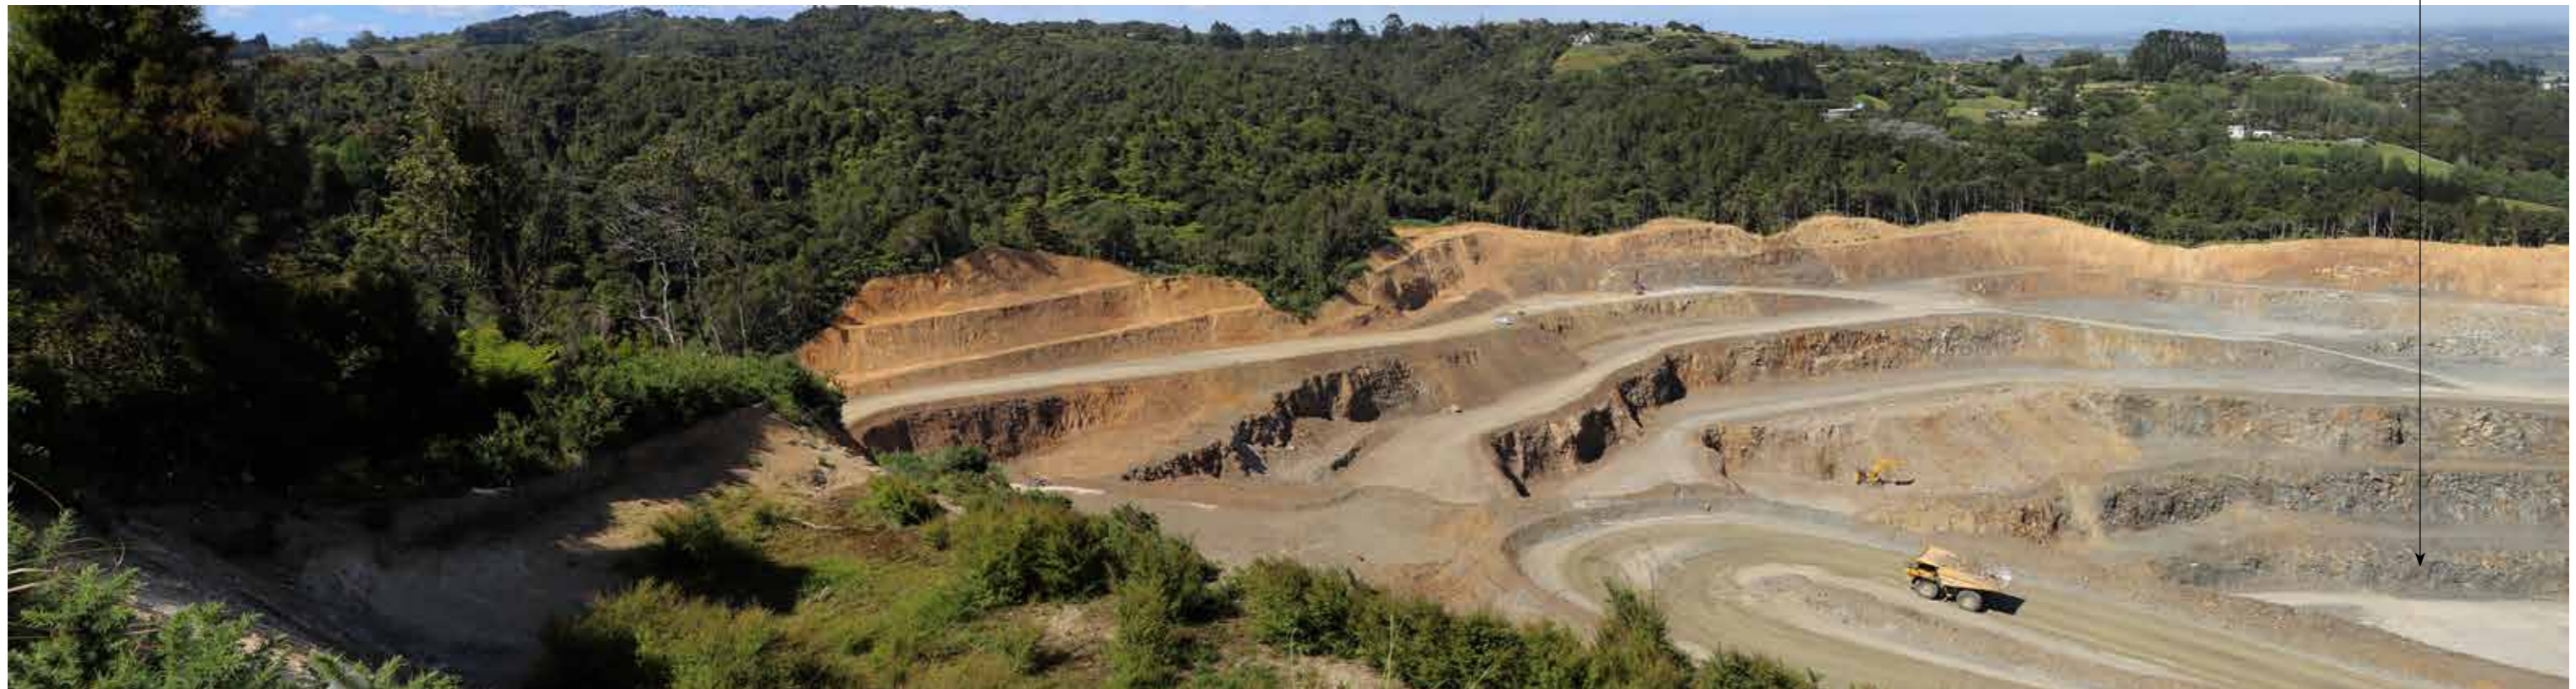
Site Photograph 5 is located near the eastern edge of the existing Symonds Hill Pit, looking in a southerly direction.

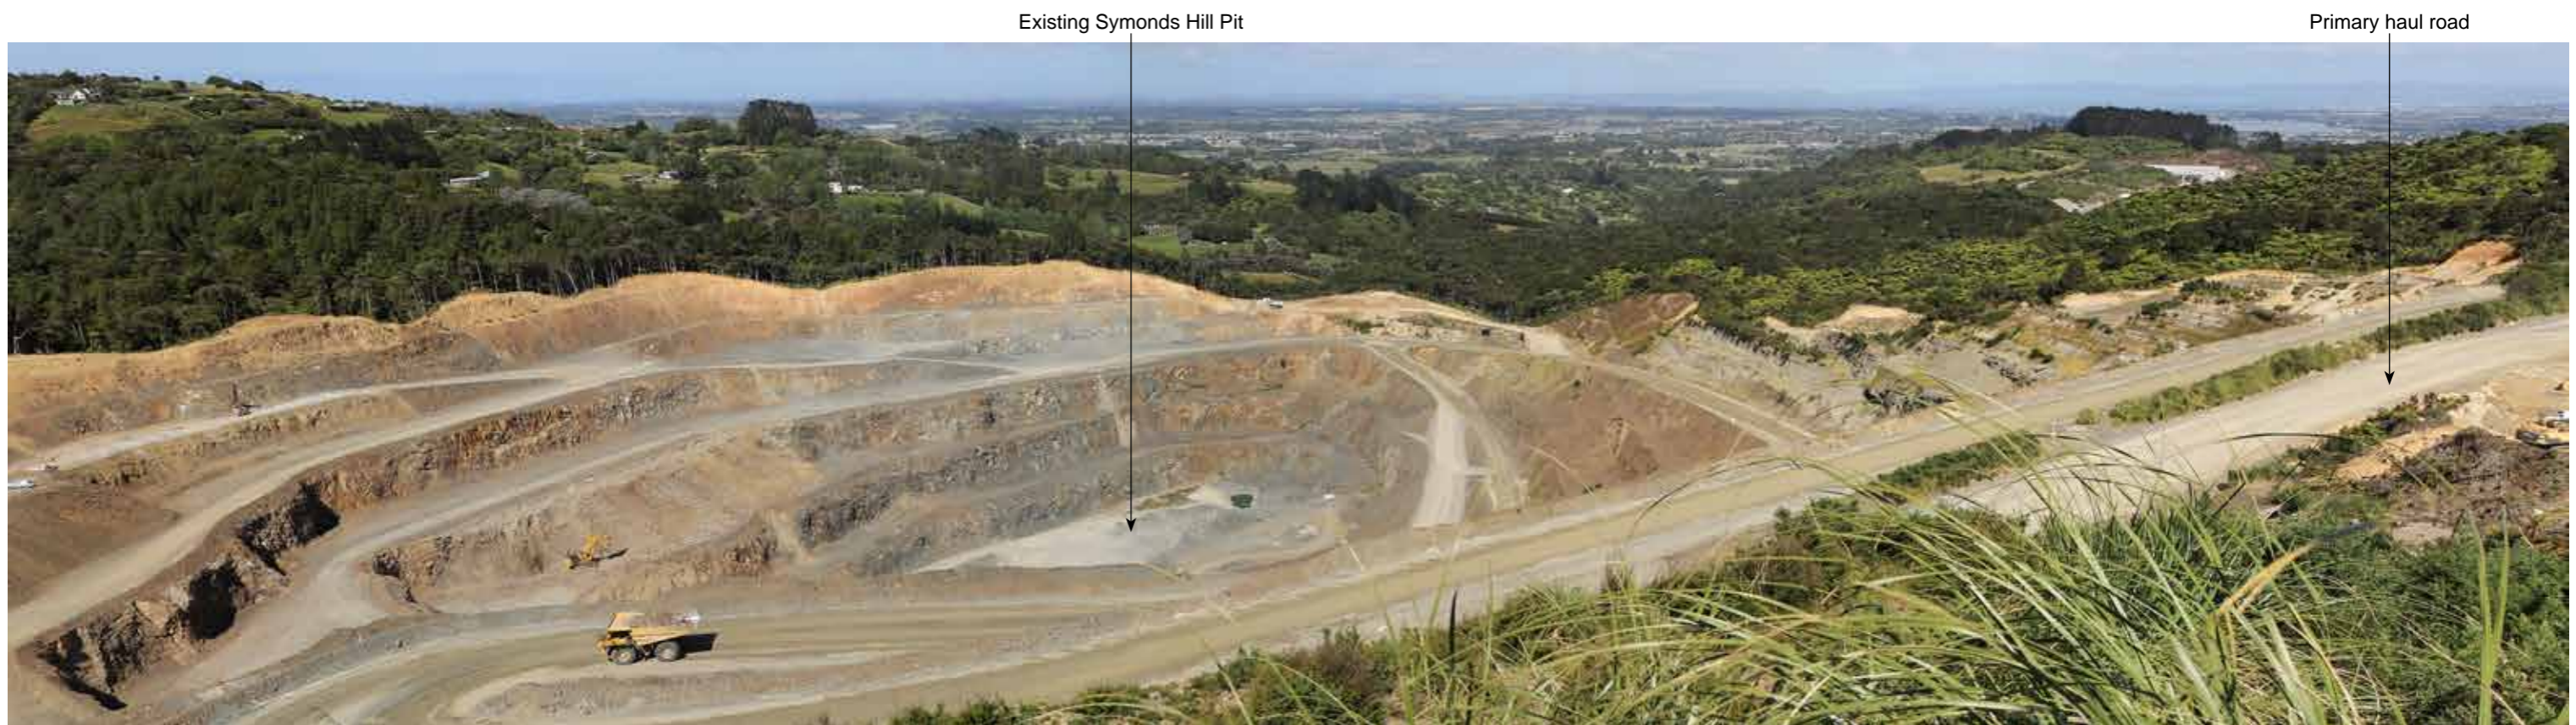
Site Photograph 6 is located near the eastern edge of the existing Symonds Hill Pit, looking in a southerly direction.

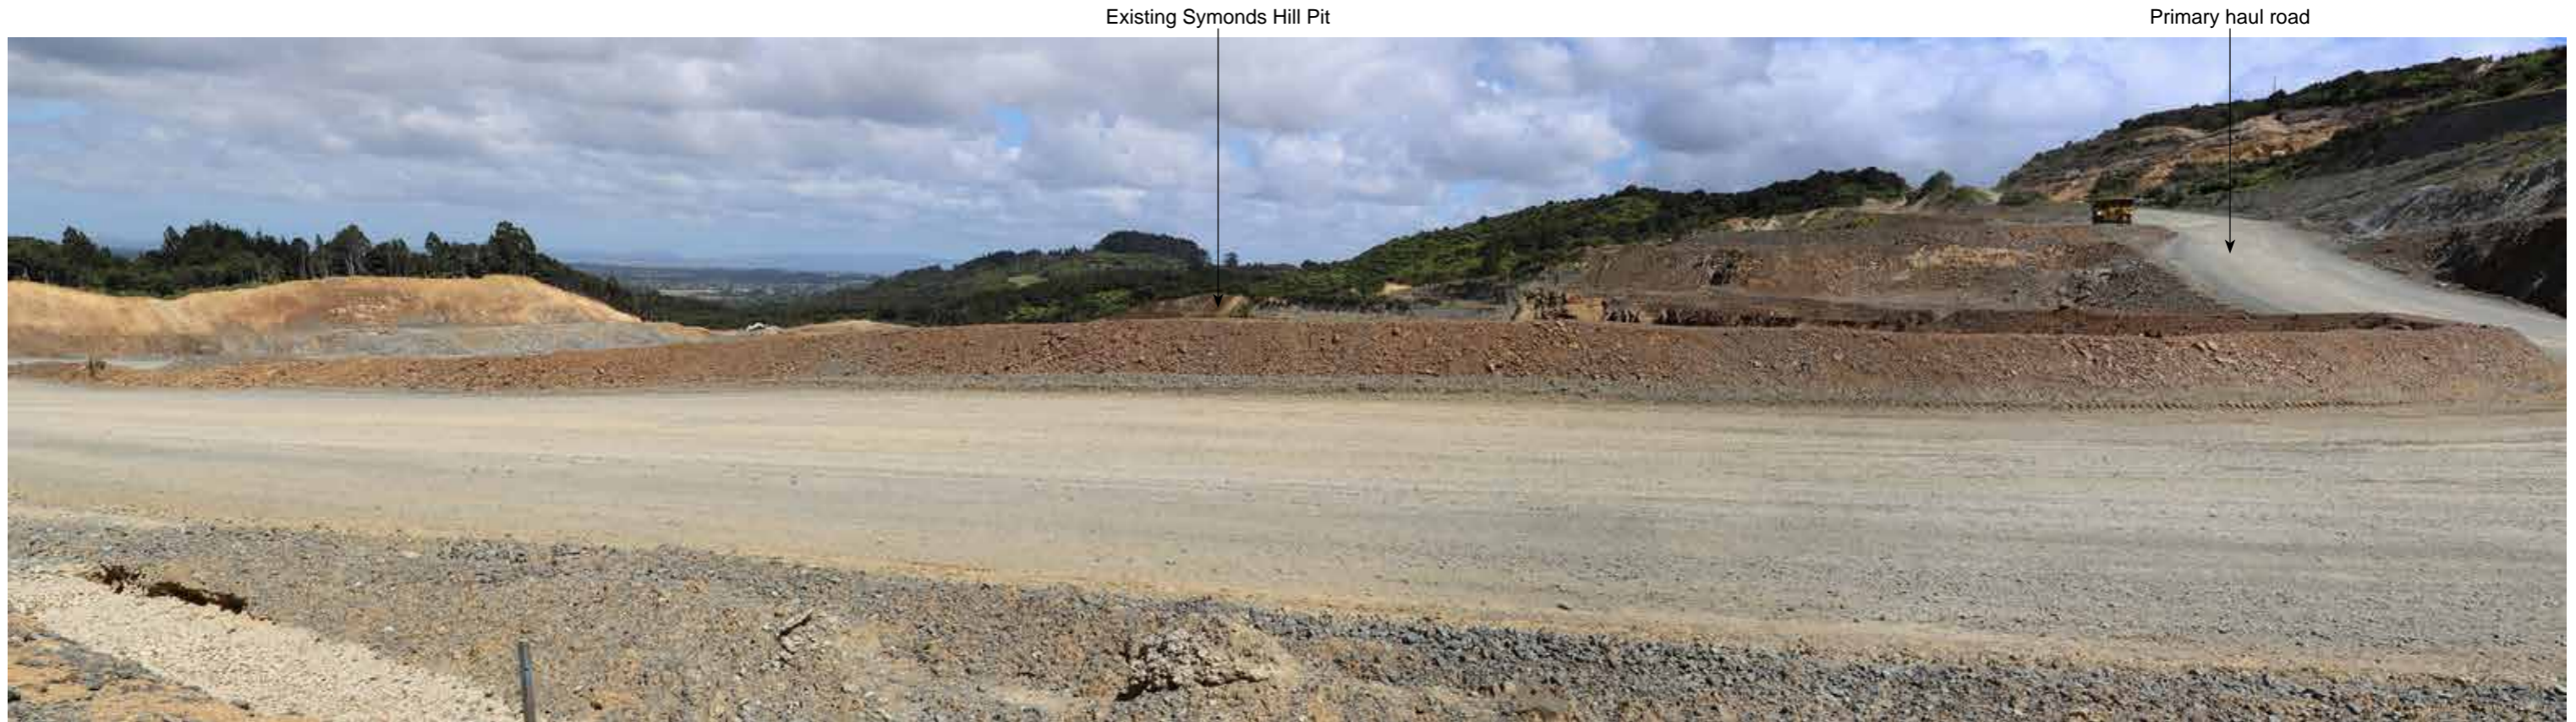
Site Photograph 7 is located south of the existing Symonds Hill Pit on a haul road, looking in a westerly direction.

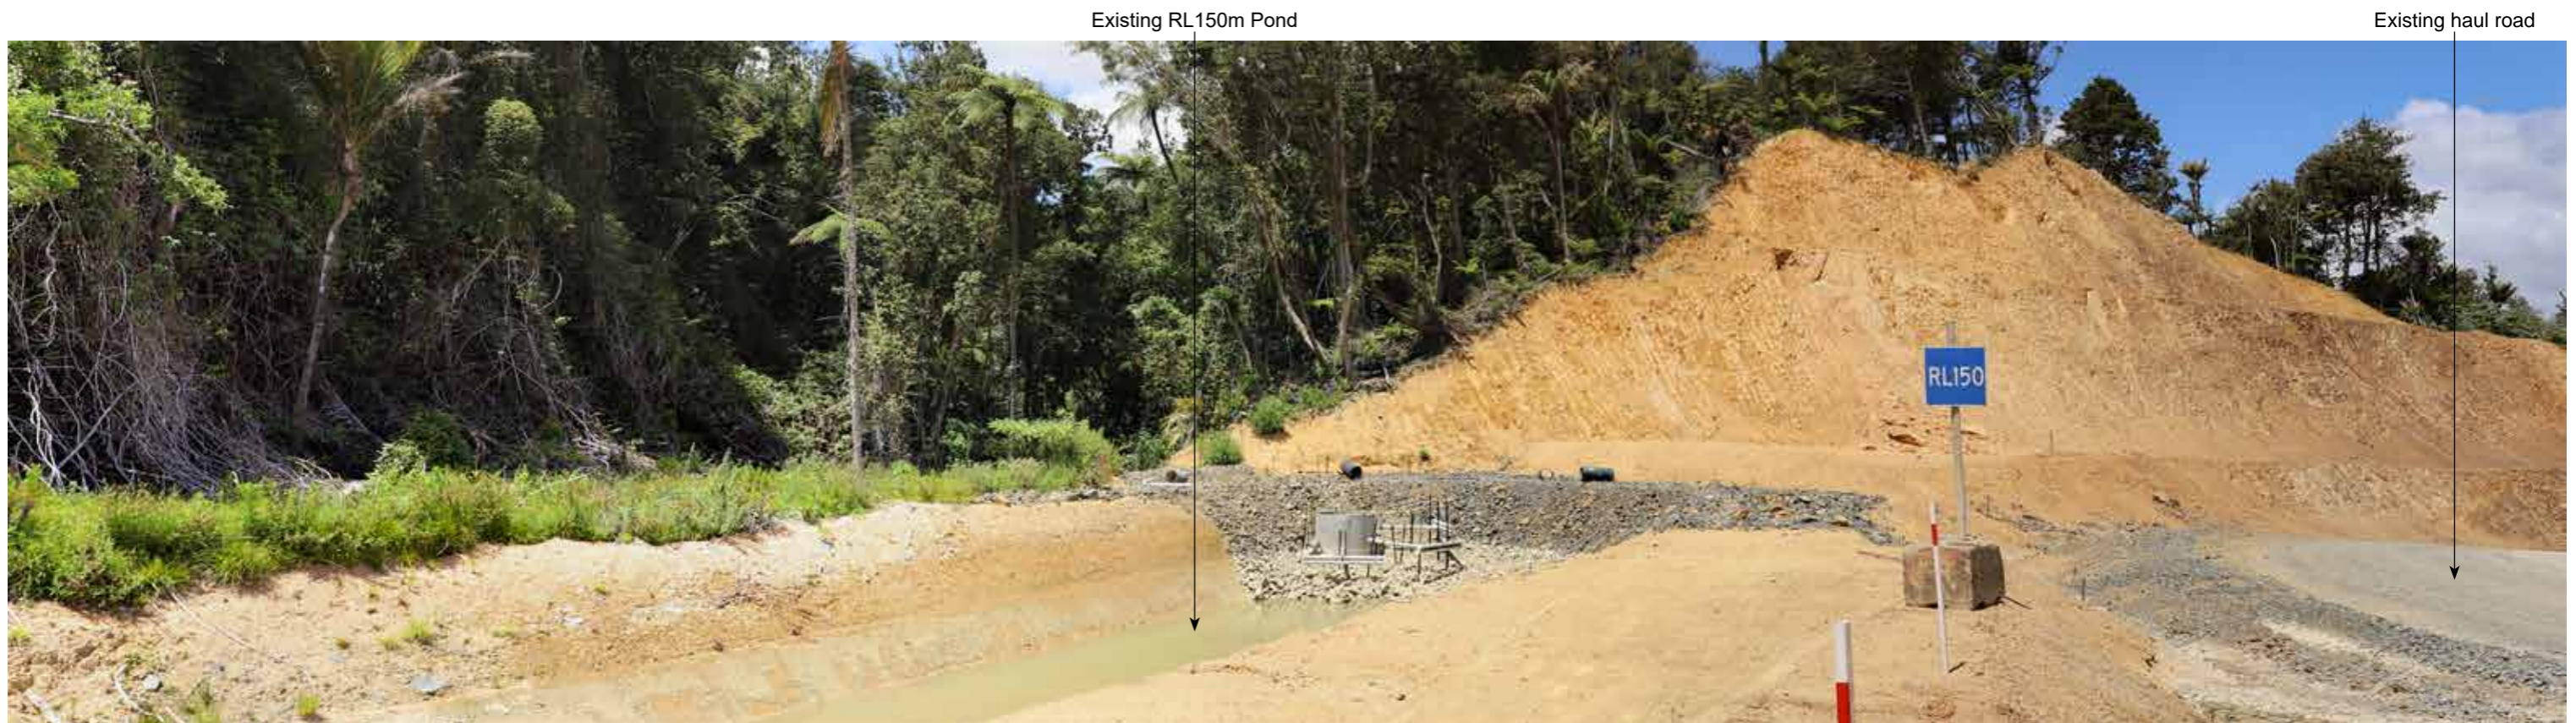
Site Photograph 8 is located south of the existing Symonds Hill Pit on a haul road, looking in a southerly direction.

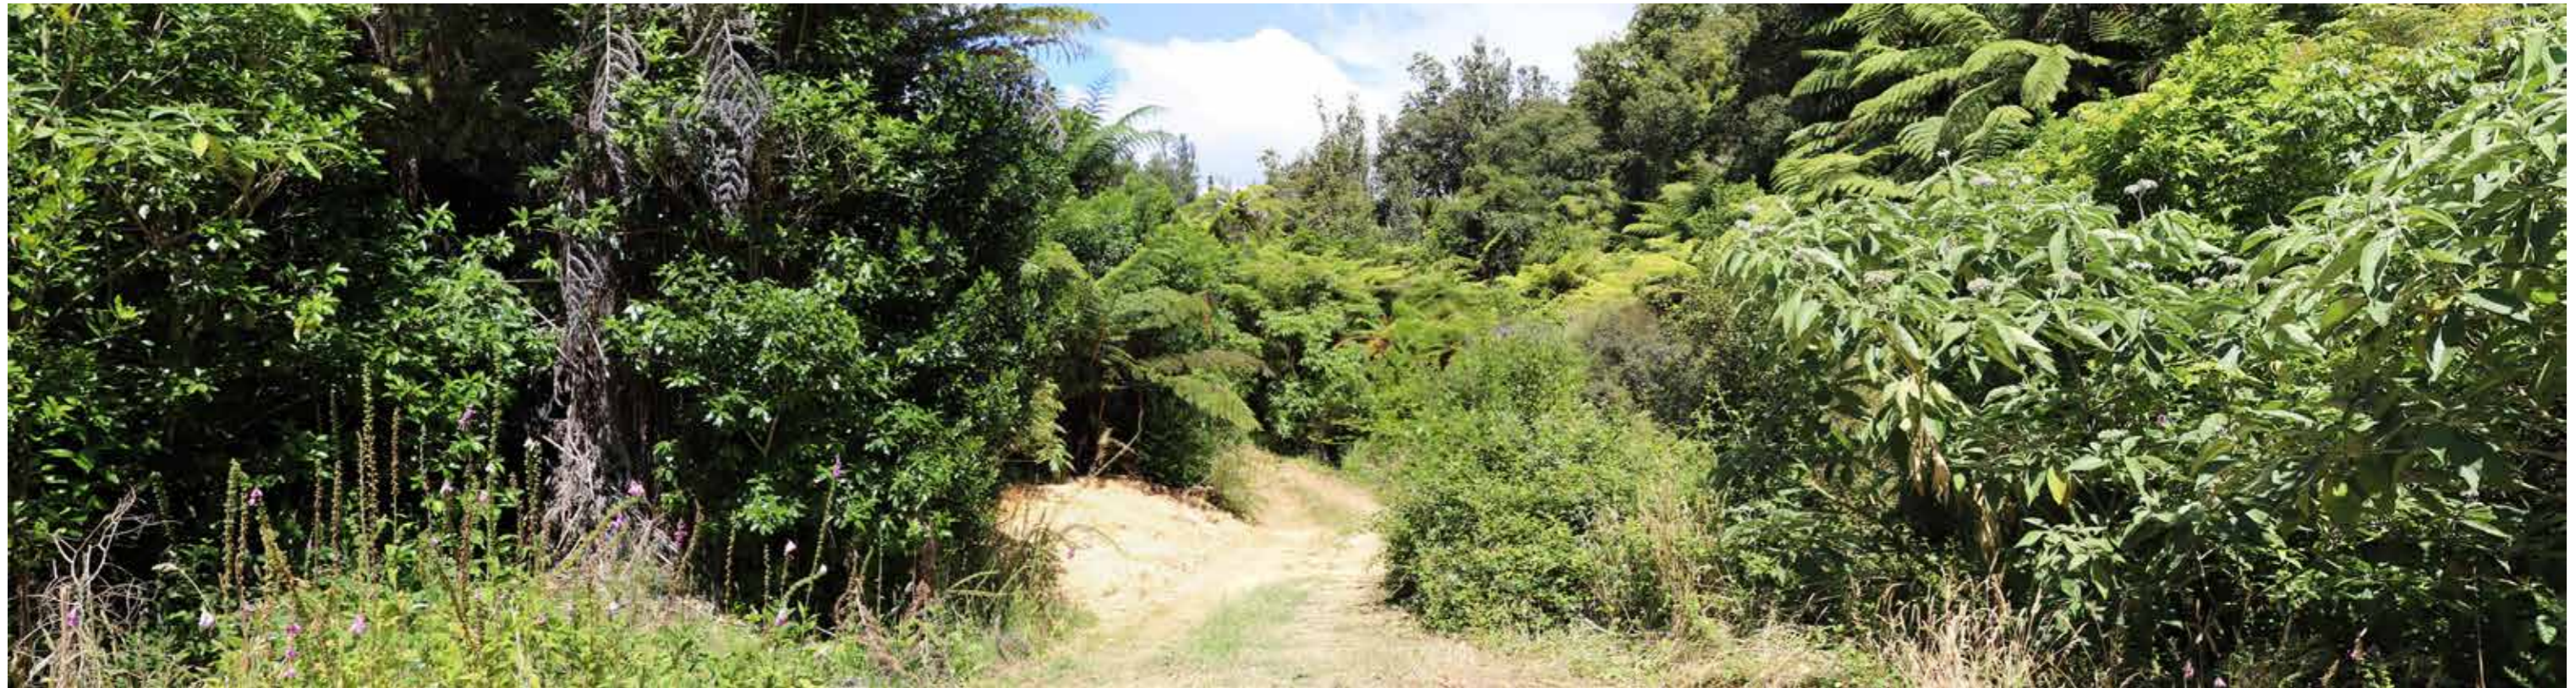
Site Photograph 9 is located near the southern edge of the quarry development area within the Ponga Road ONL, looking in a westerly direction. Existing vegetation will be removed during Stages 1 and 3.

Upper benches of the existing Symonds Hill Pit

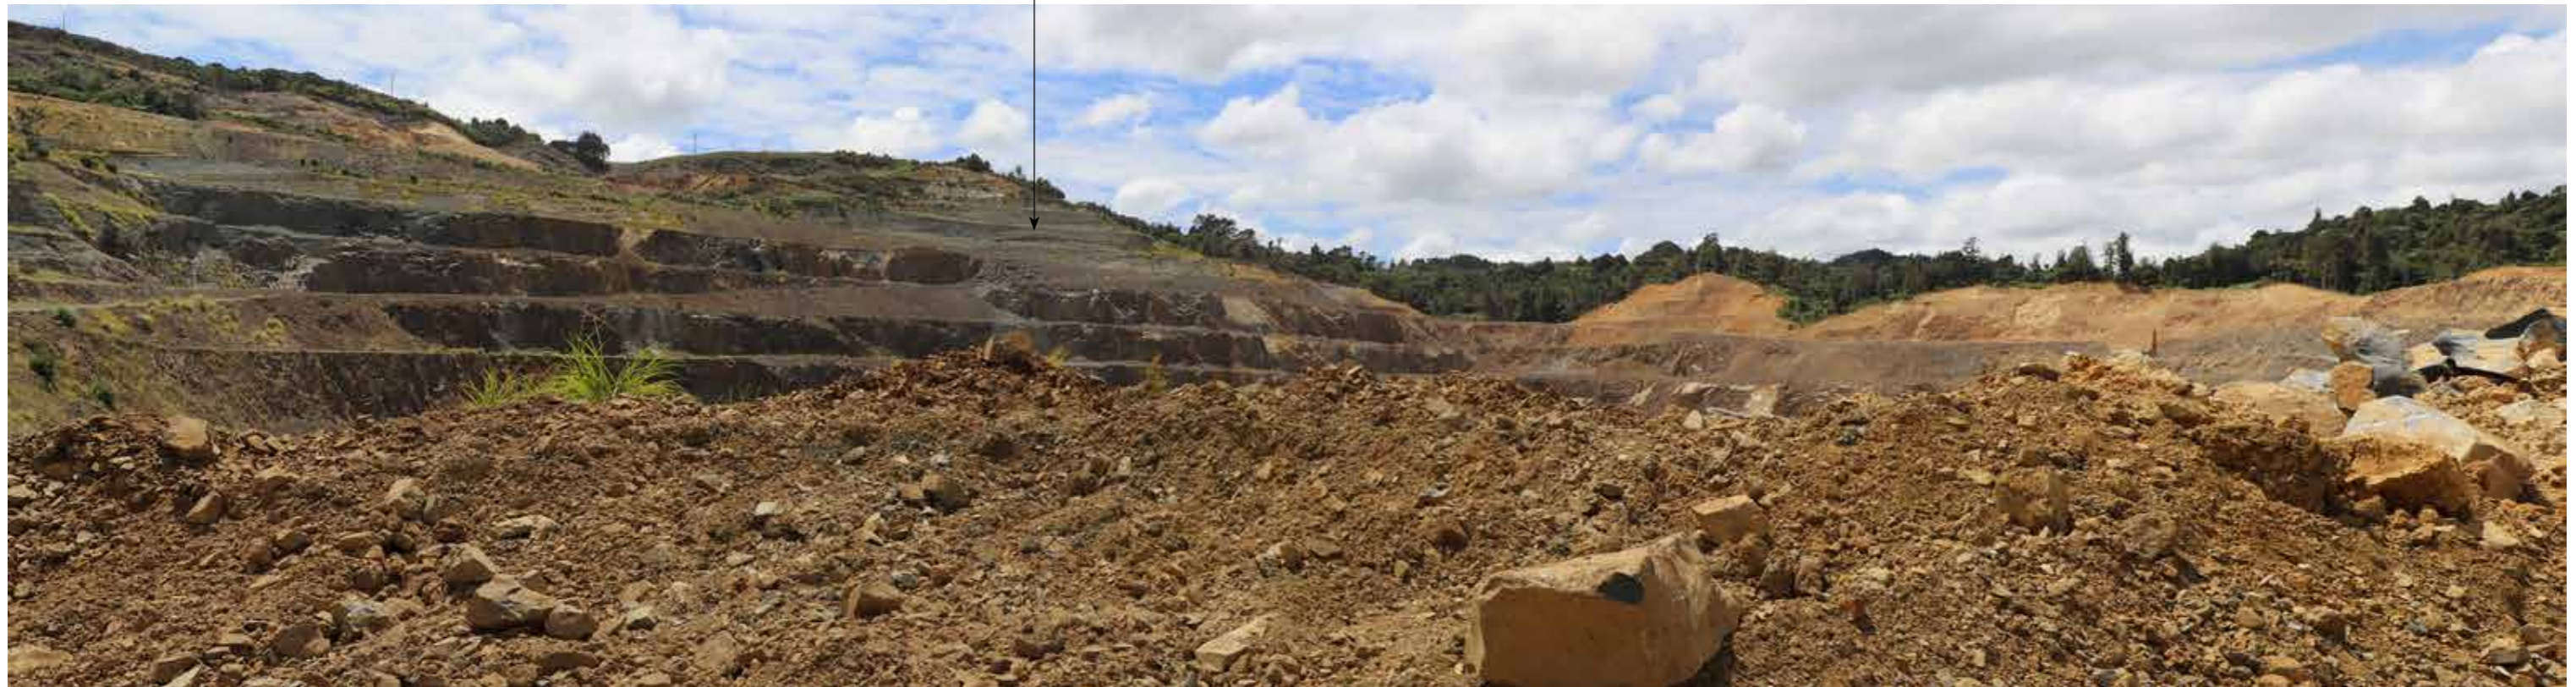
Site Photograph 10 is located near the western edge of the existing Symonds Hill Pit, looking in a southeasterly direction.

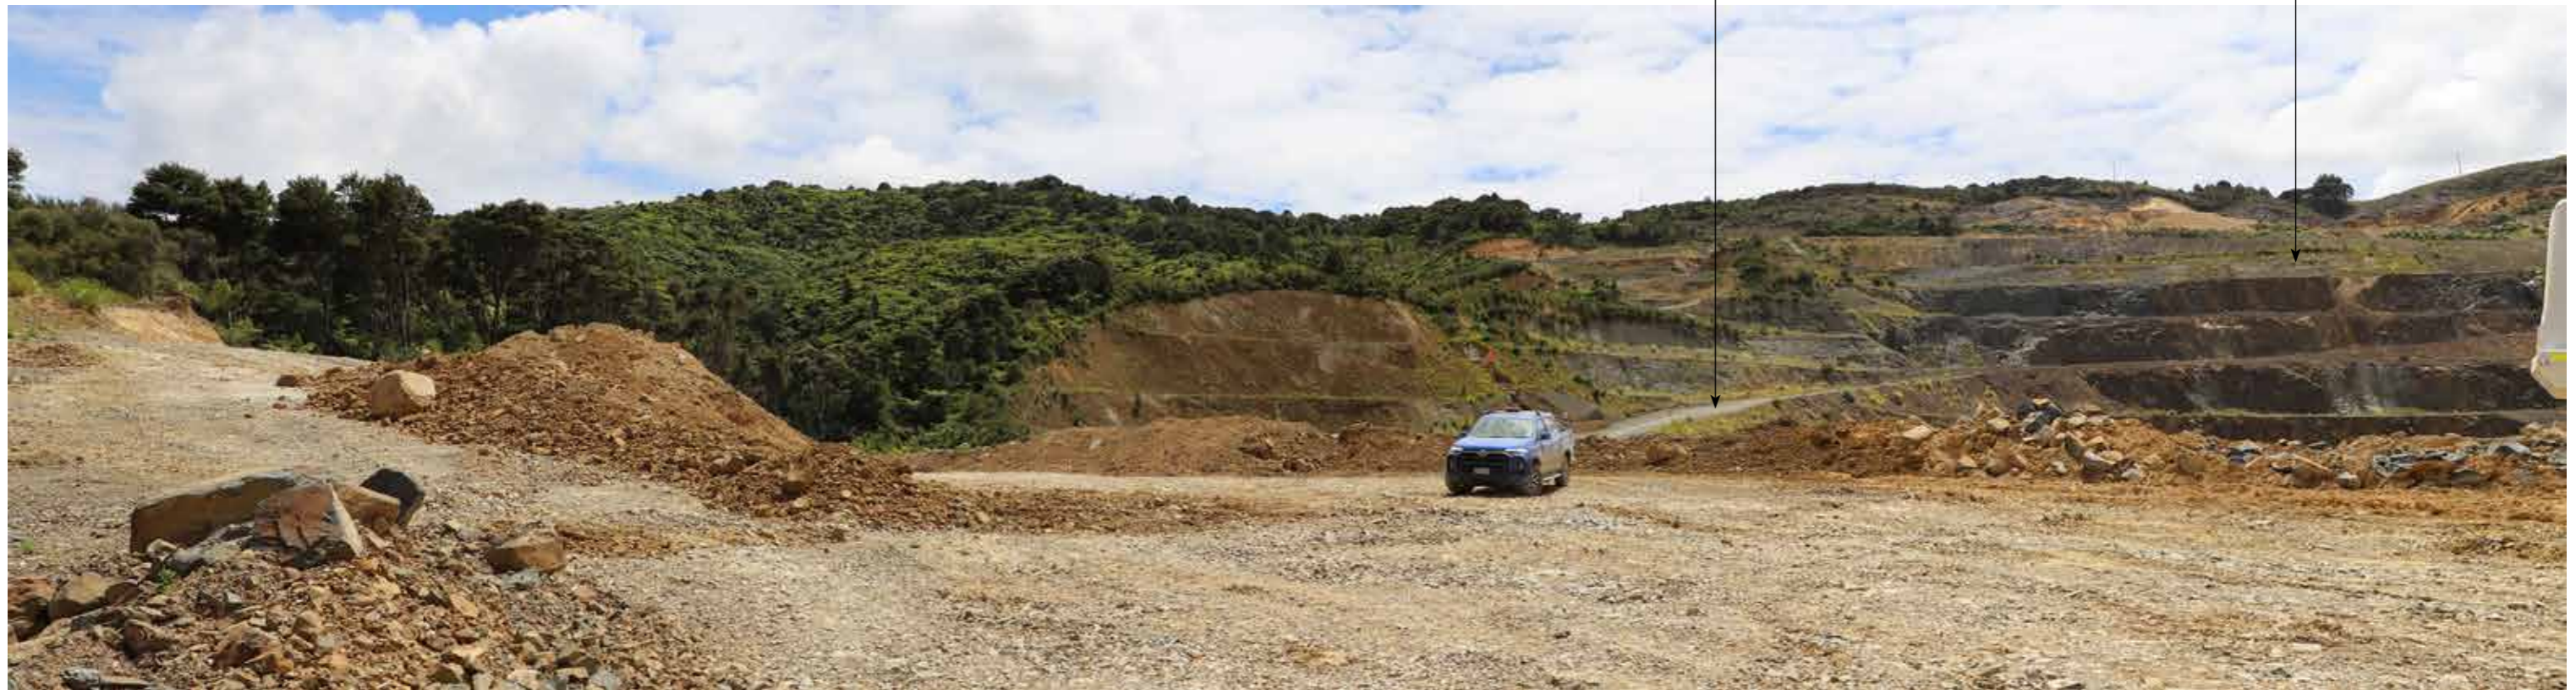
Existing haul road

Upper benches of the existing Symonds Hill Pit

Site Photograph 11 is located near the western edge of the existing Symonds Hill Pit, looking in a northeasterly direction.

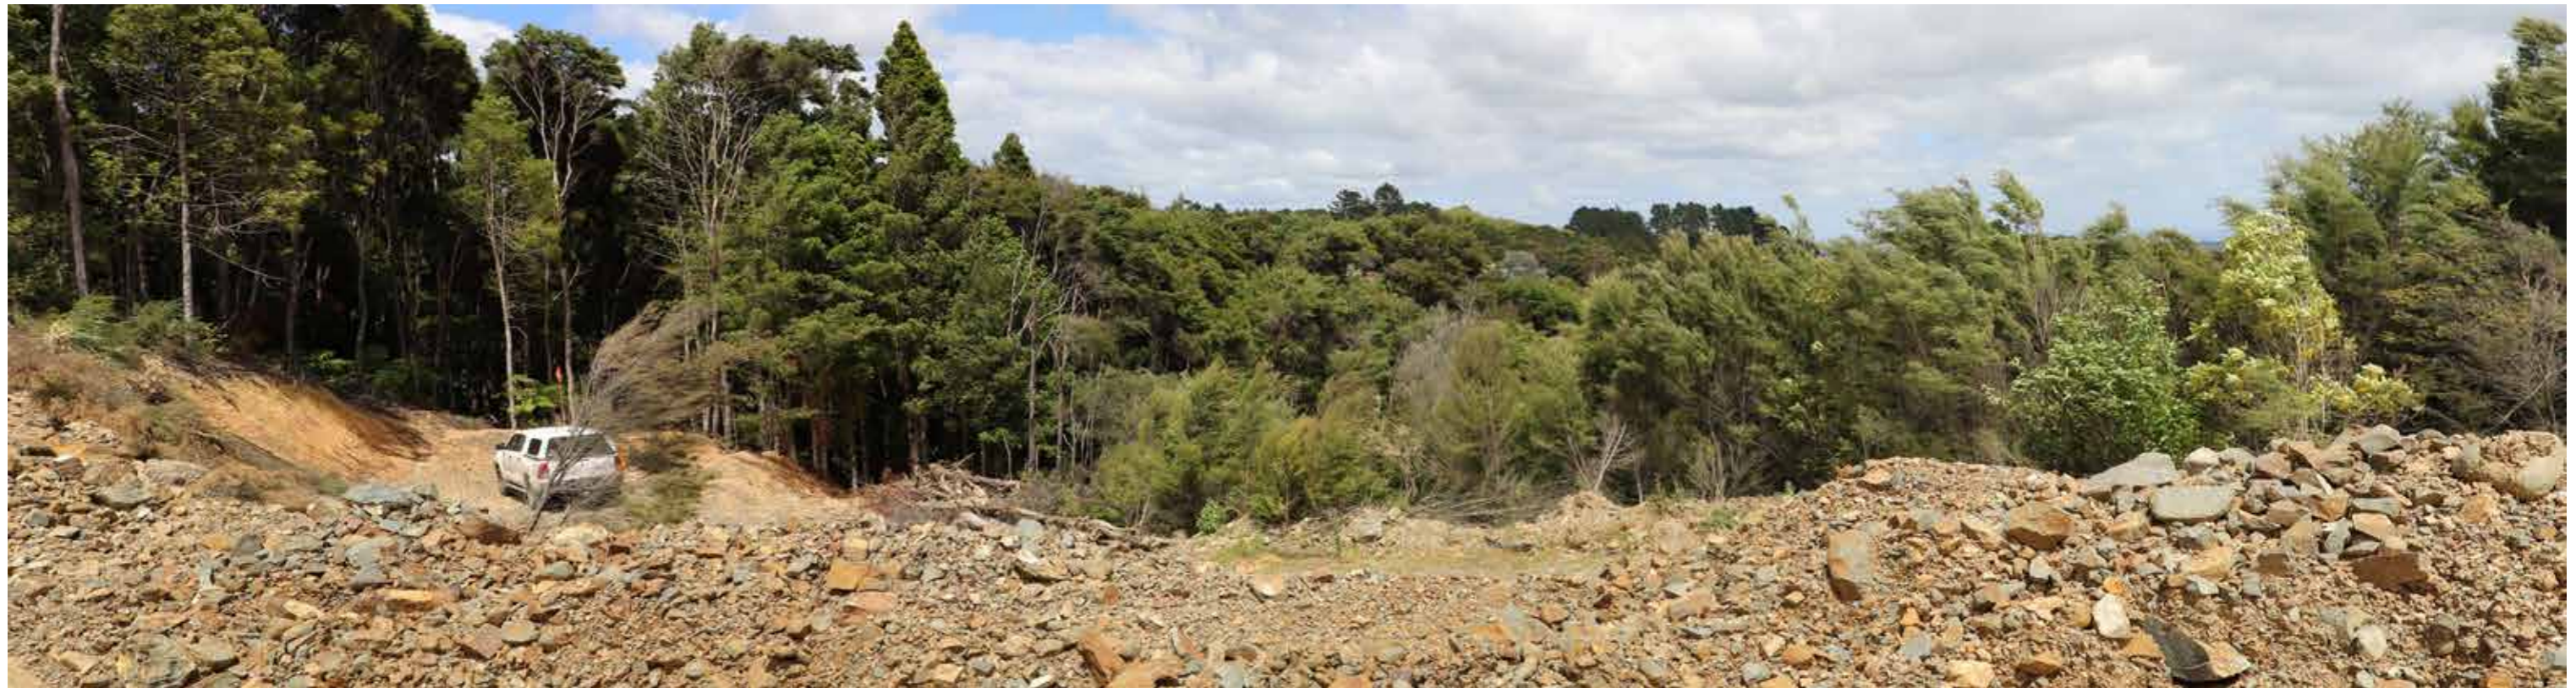
Site Photograph 12 is located near the western edge of the existing Symonds Hill Pit, looking in a southwesterly direction. Mangapū Stream is located at the base of this vegetation.
