WINSTONE
AGGREGATES

Boffa Miskell

Appendix B12.4.10d

Landscape Effects Assessment Appendix 4
Graphic Supplement

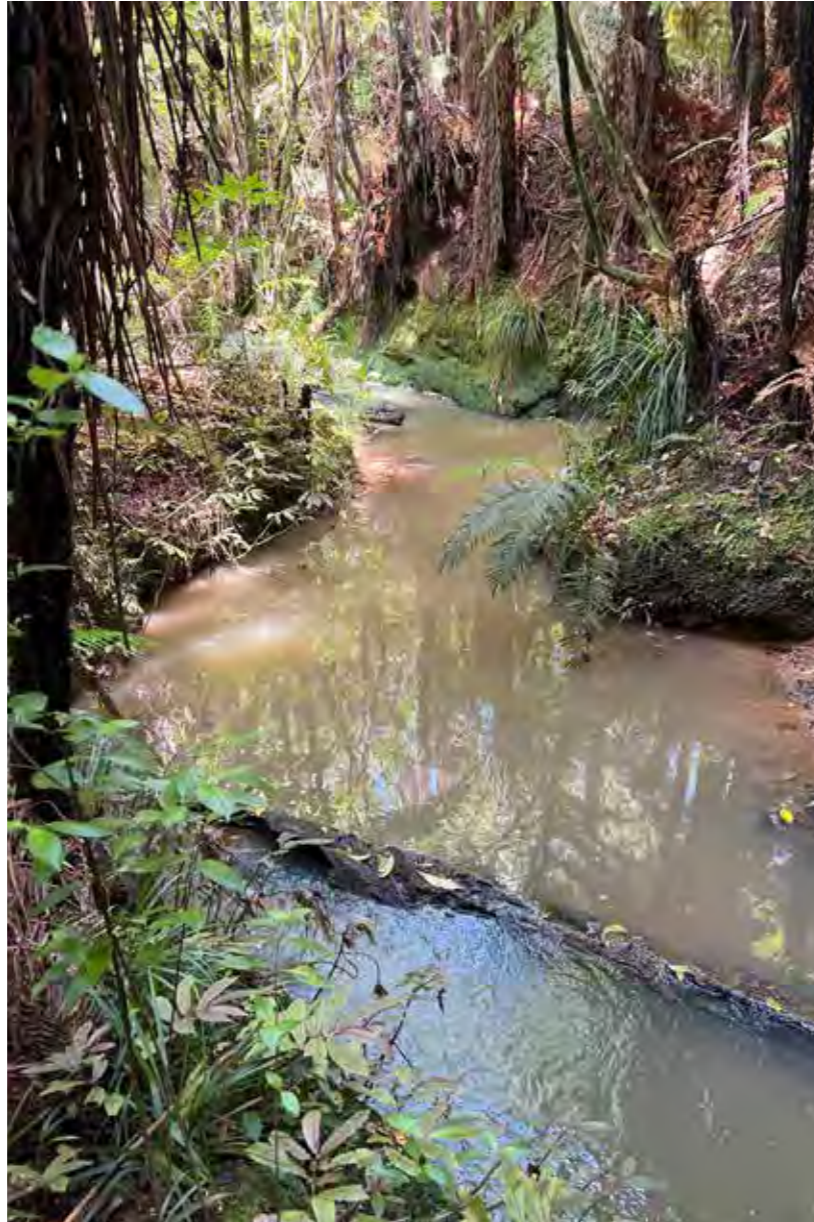
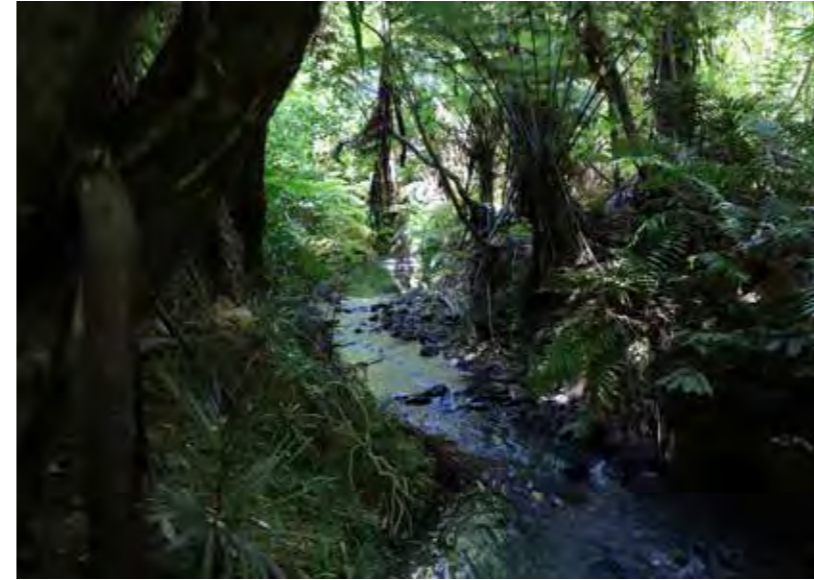
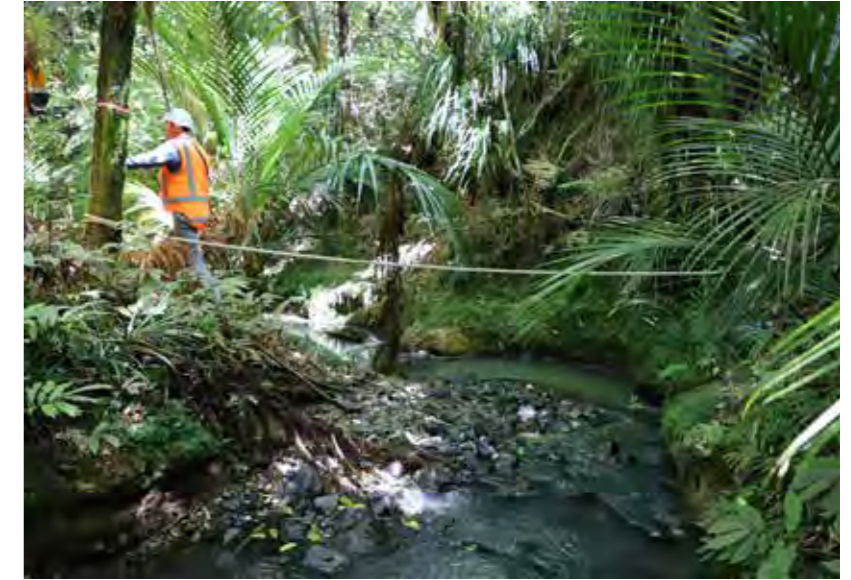
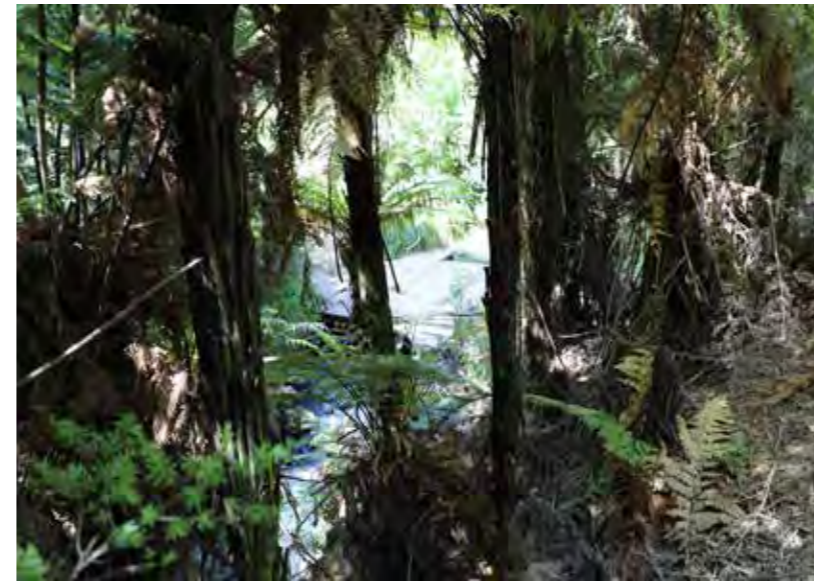
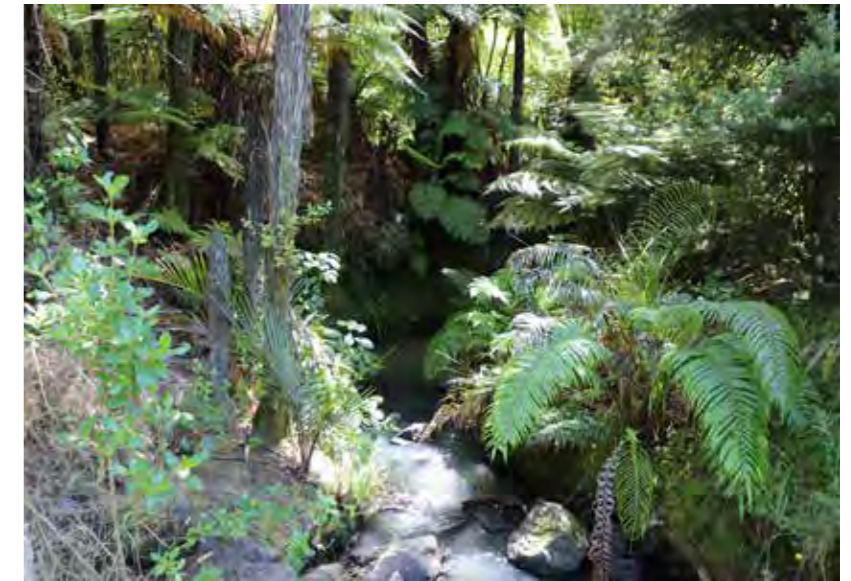
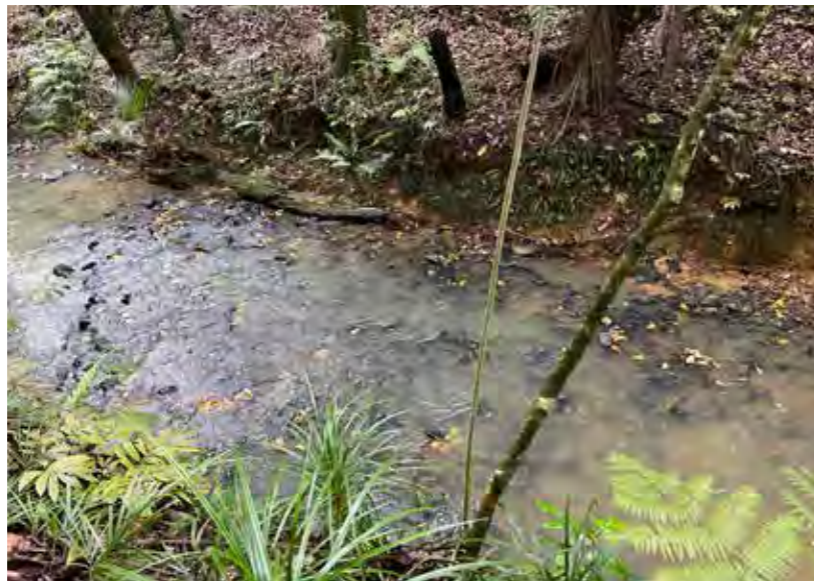
The character photographs of the Mangapū Stream Tributary illustrate the diverse range of geomorphic features present along its length, as well as the variation in riparian and adjacent vegetation types. Together, these images demonstrate changes in channel form, substrate, bank condition, and diverse habitats.

The character photographs of the Mangapū Stream Tributary illustrate the diverse range of geomorphic features present along its length, as well as the variation in riparian and adjacent vegetation types. Together, these images demonstrate changes in channel form, substrate, bank condition, and diverse habitats.

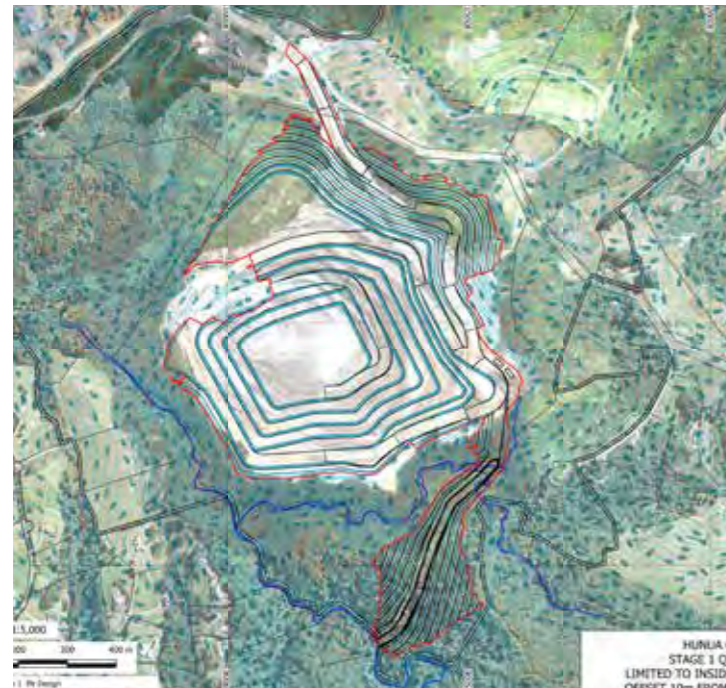
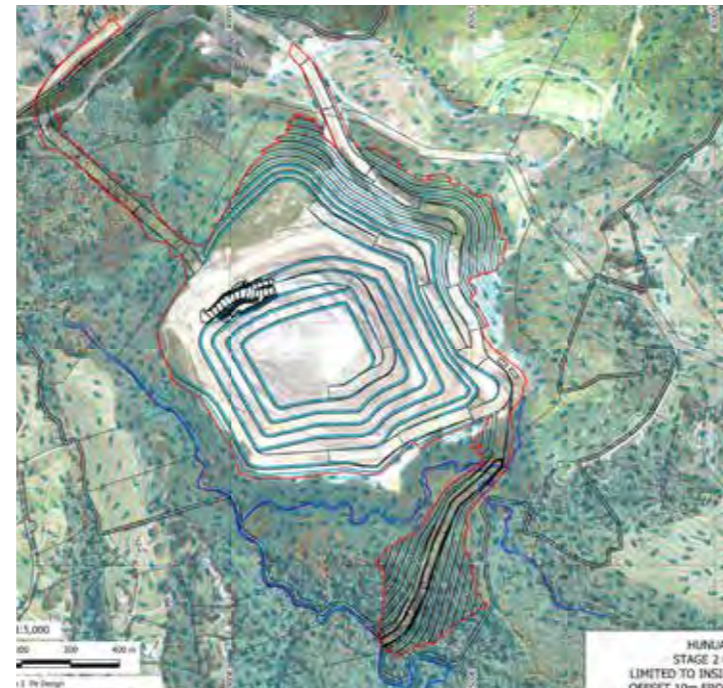
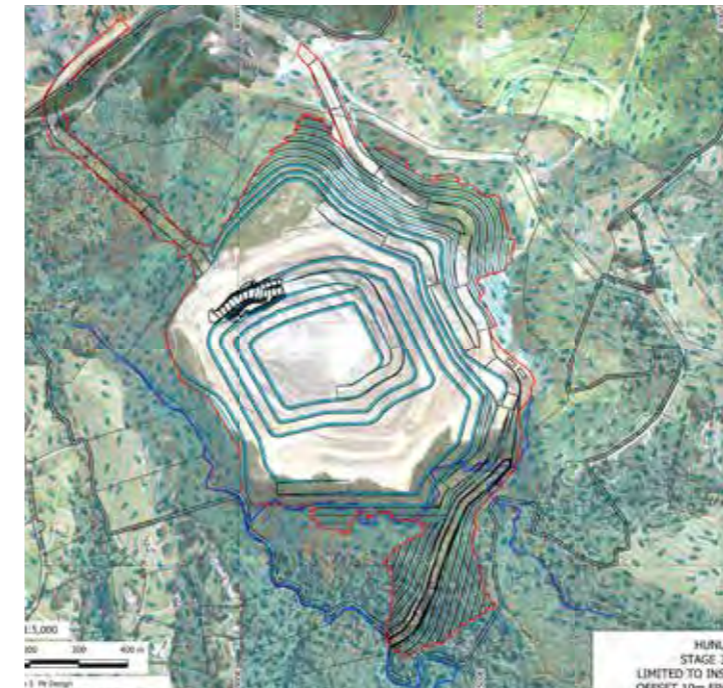
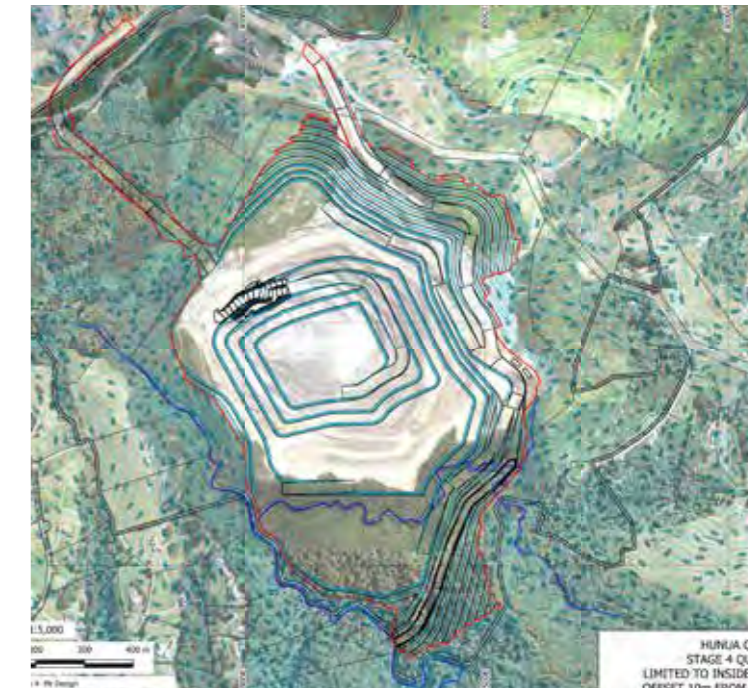
Figure 18

Stage 1

Stage 2

Stage 3

Stage 4

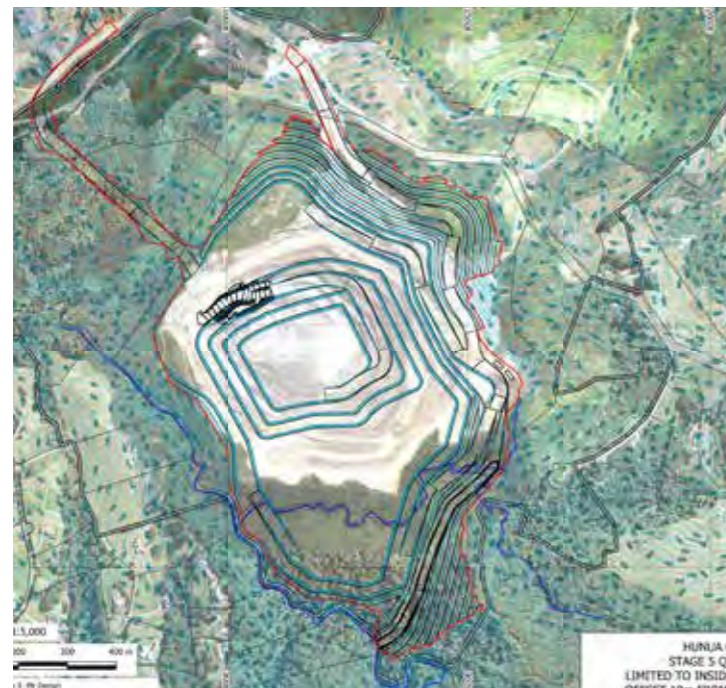
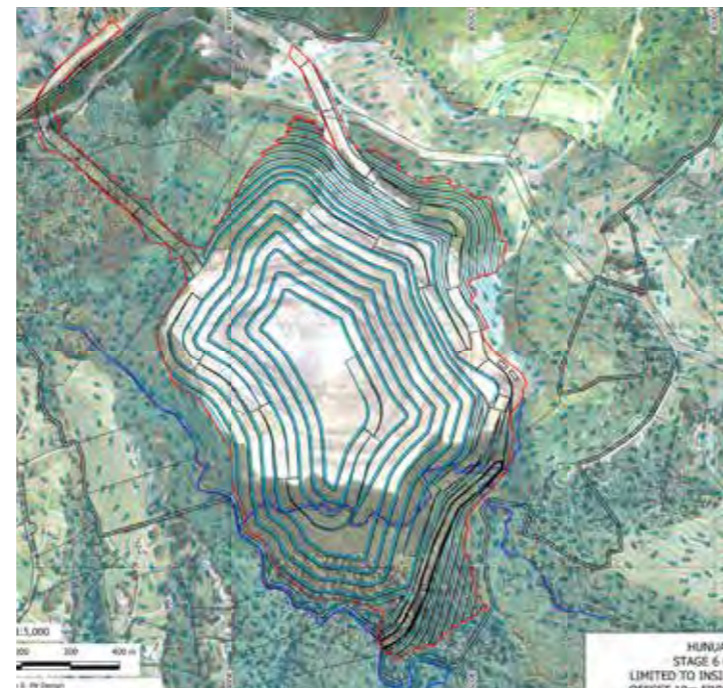
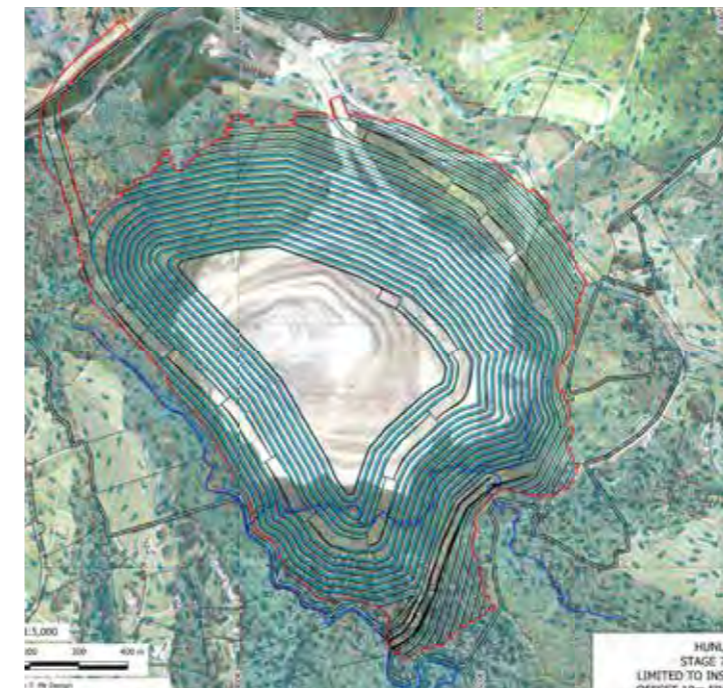
Note*: Stage 5 and 6 have the same extent as Stage 4

Stage 5

Stage 6

Stage 7

Stage 8

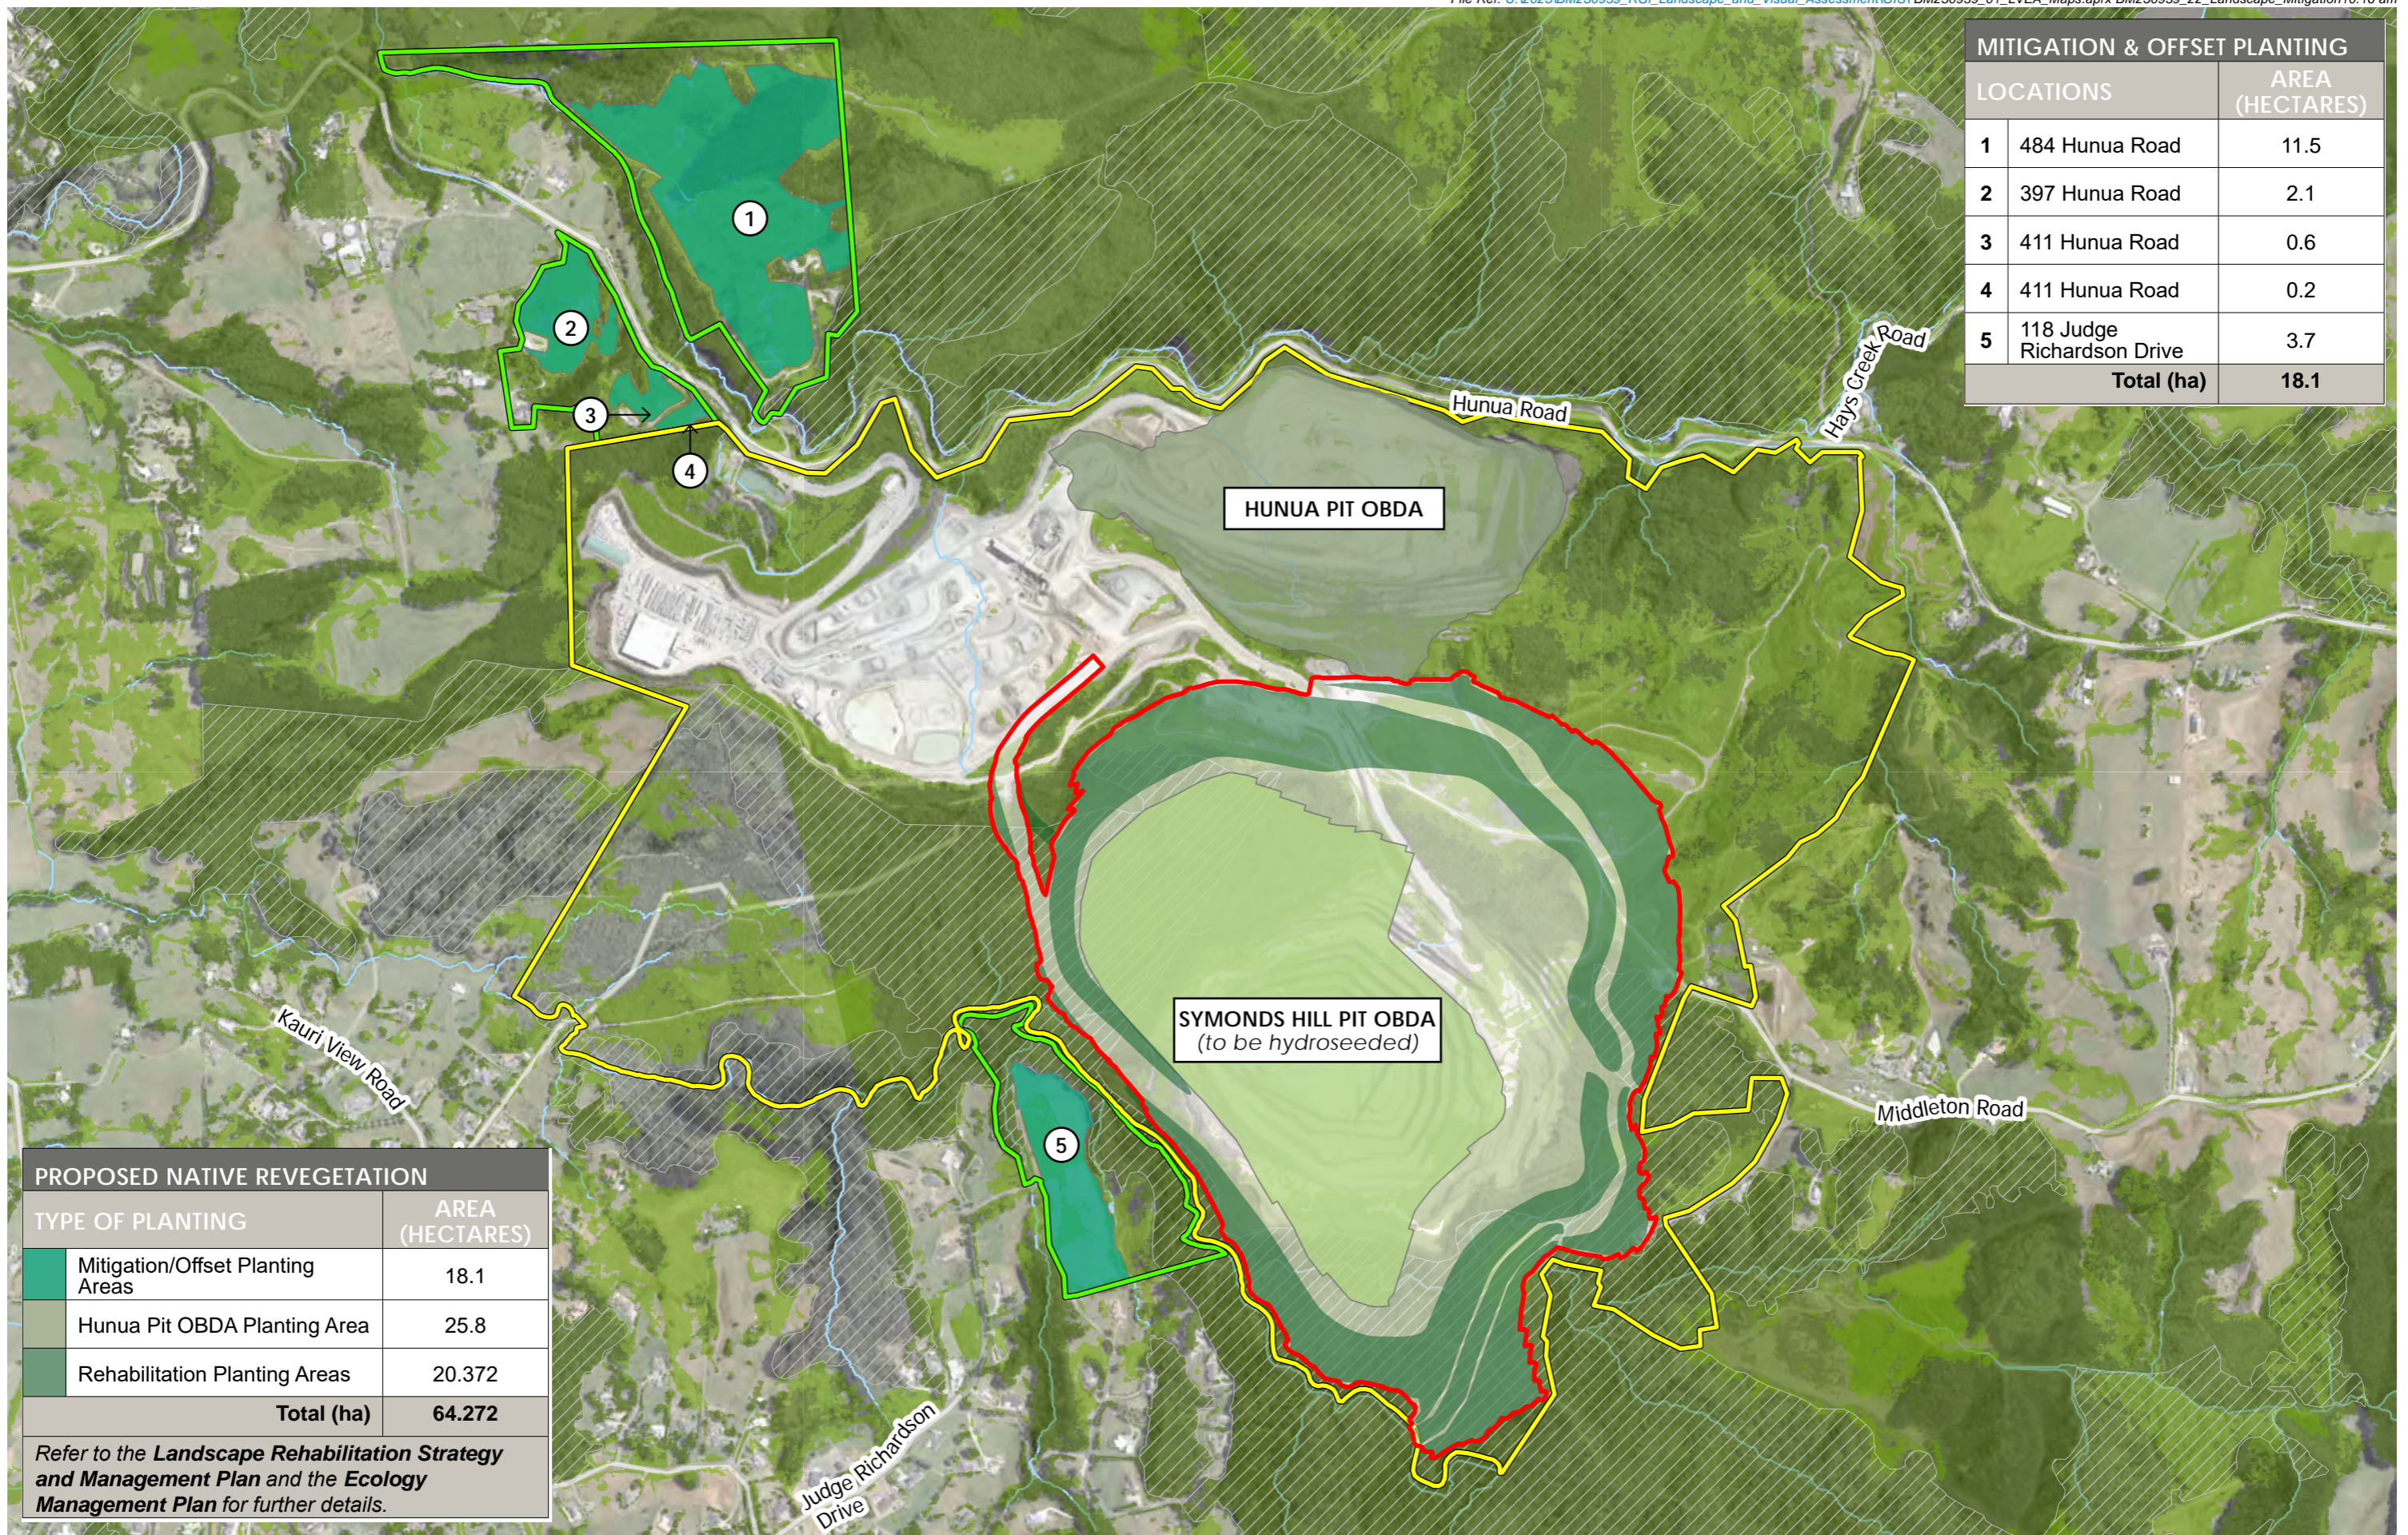
MITIGATION & OFFSET PLANTING		
LOCATIONS	AREA (HECTARES)	
1	484 Hunua Road	11.5
2	397 Hunua Road	2.1
3	411 Hunua Road	0.6
4	411 Hunua Road	0.2
5	118 Judge Richardson Drive	3.7
Total (ha)		18.1

PROPOSED NATIVE REVEGETATION	
TYPE OF PLANTING	AREA (HECTARES)
Mitigation/Offset Planting Areas	18.1
Hunua Pit OBDA Planting Area	25.8
Rehabilitation Planting Areas	20.372
Total (ha)	64.272

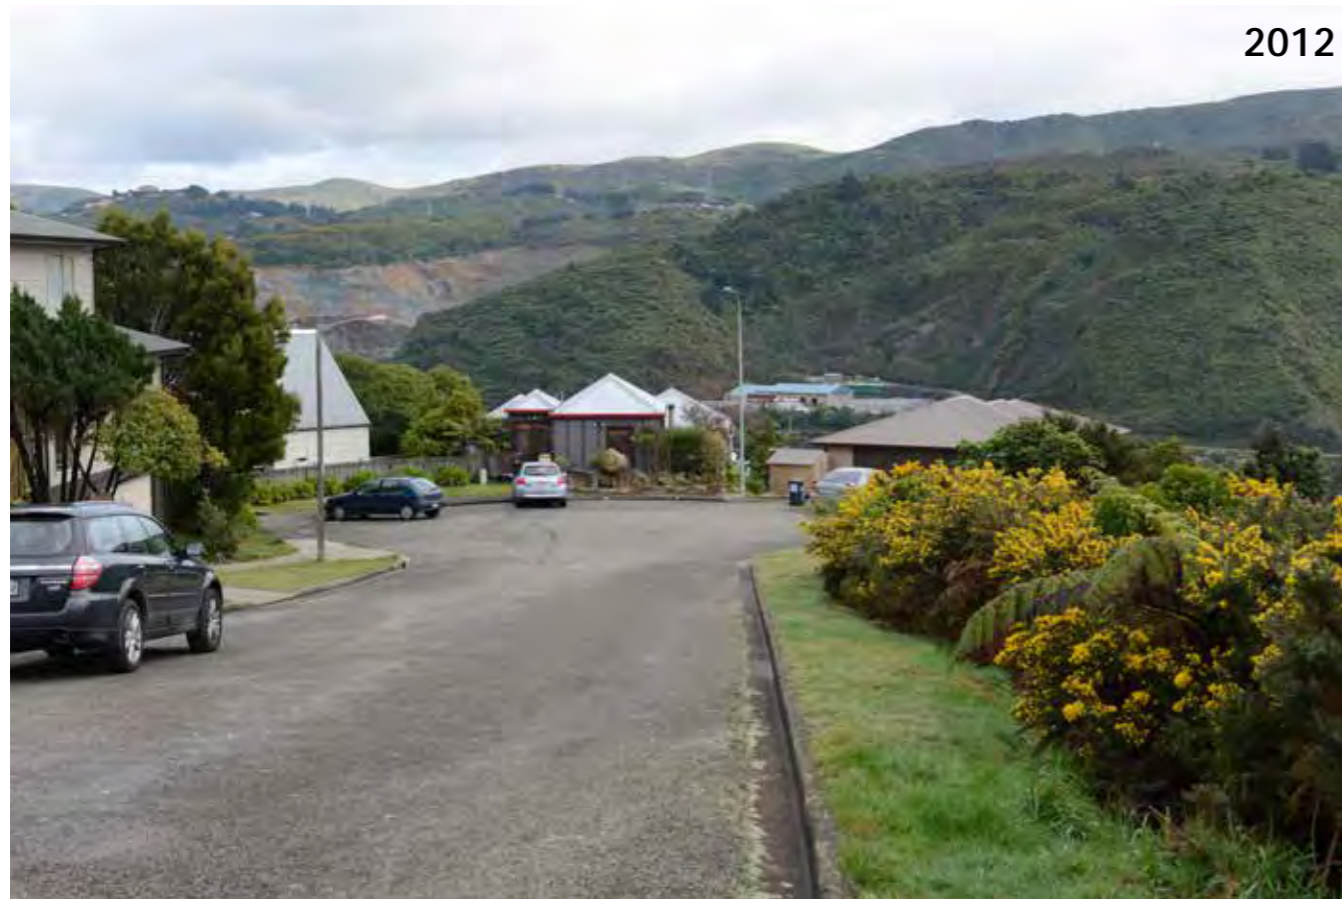
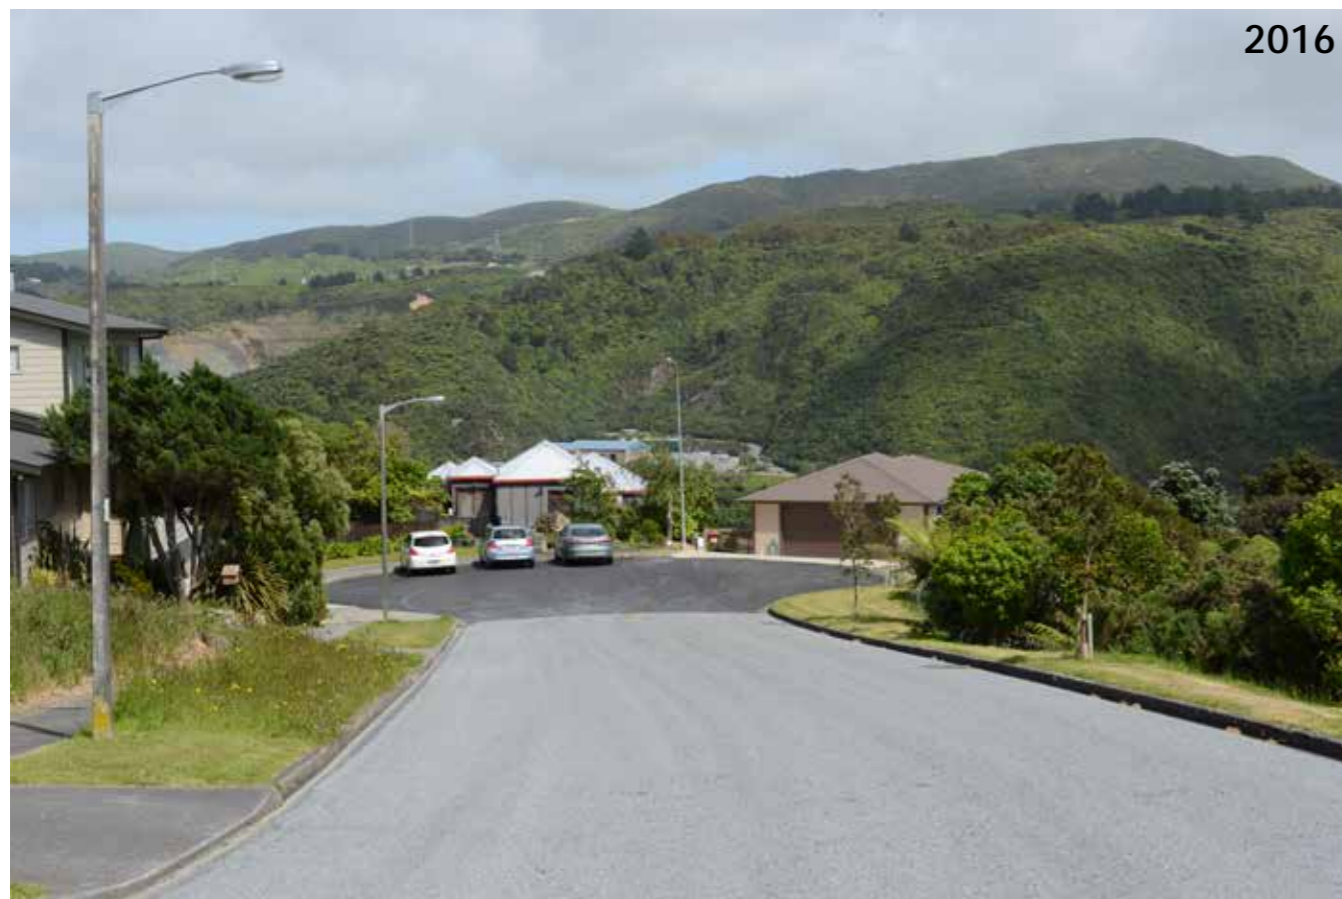
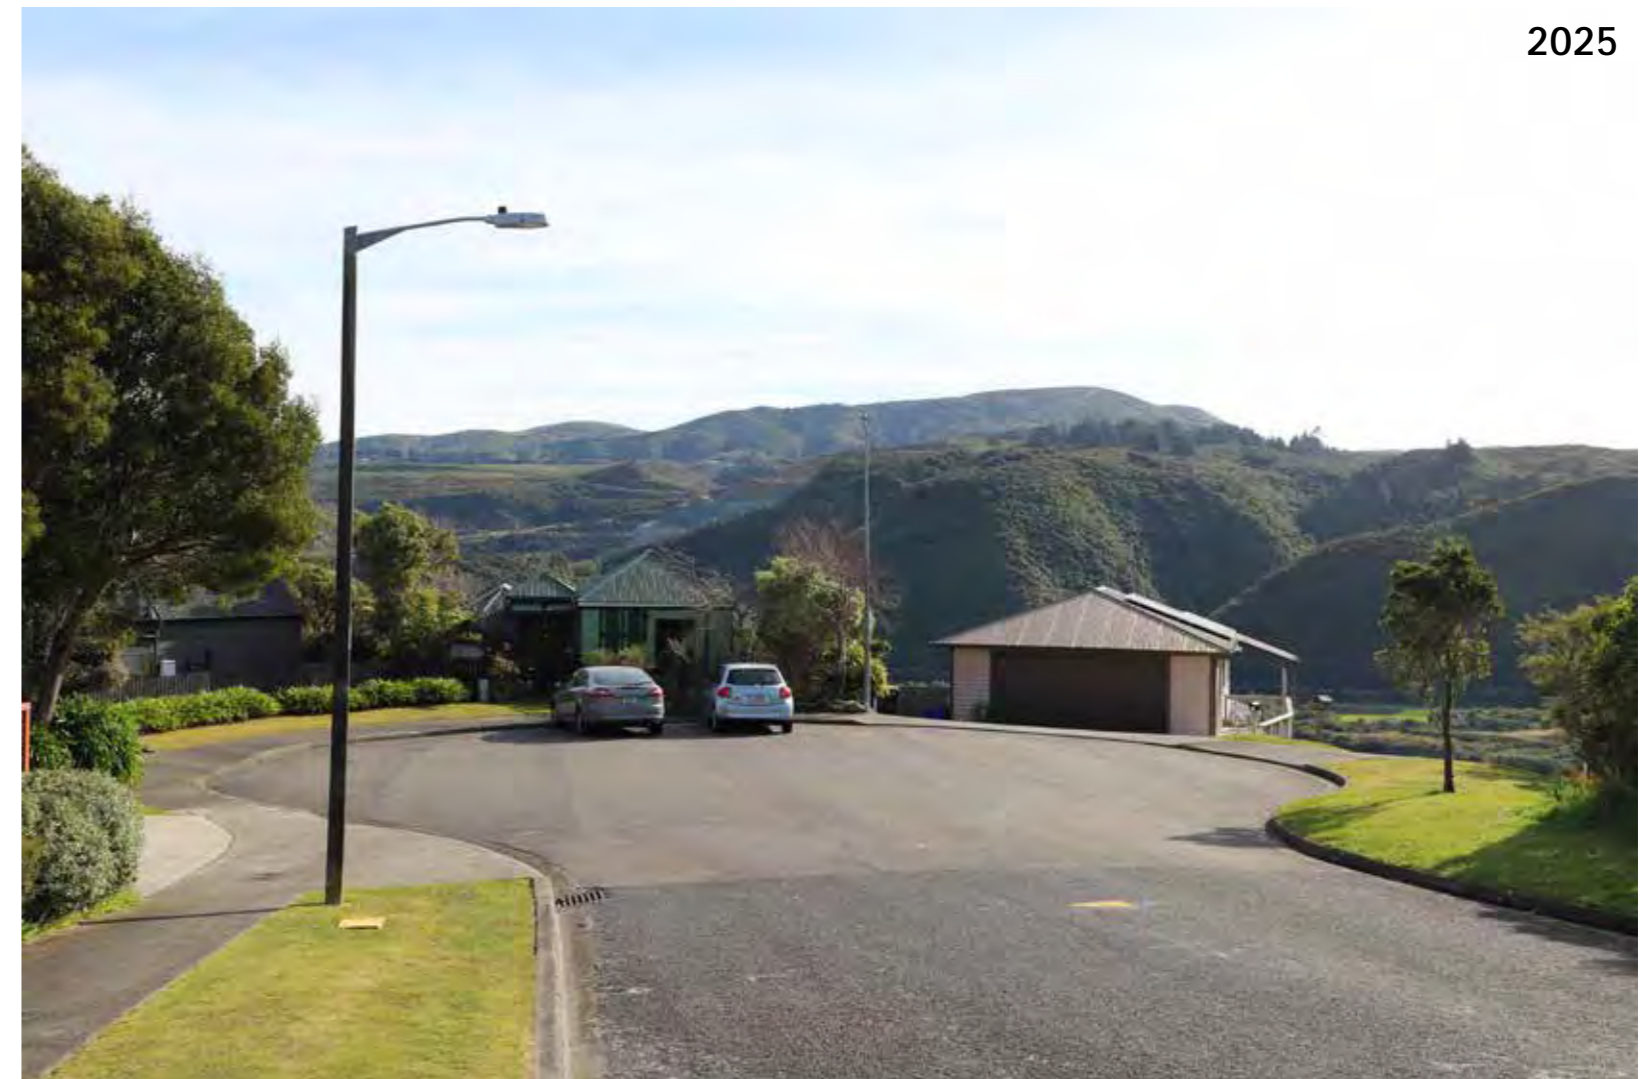
**PRECEDENT IMAGES OF QUARRY BENCH REHABILITATION:
BELMONT QUARRY, LOWER HUTT, WELLINGTON**

The images to the left and below illustrate how quarry bench rehabilitation can be successfully “re-greened” over time, helping to soften the appearance of exposed quarry faces. These examples show bench rehabilitation at Belmont Quarry, operated by Winstone Aggregates in Lower Hutt, Wellington, with photographs from 2012, 2016, and 2025.

landform. When care is taken with contouring, soil placement, and species selection, these benches can support hardy plant communities that soften visual impacts and accelerate landscape integration. In this way, well-planned treatment of each bench makes a measurable difference in the long-term appearance and performance of the rehabilitated quarry face.

Quarry bench rehabilitation can have a significant influence on how successfully the landscape recovers, even when viewed from a distance. The way benches are shaped, treated, and planted determines how well vegetation can establish, blend, and eventually naturalise into the wider

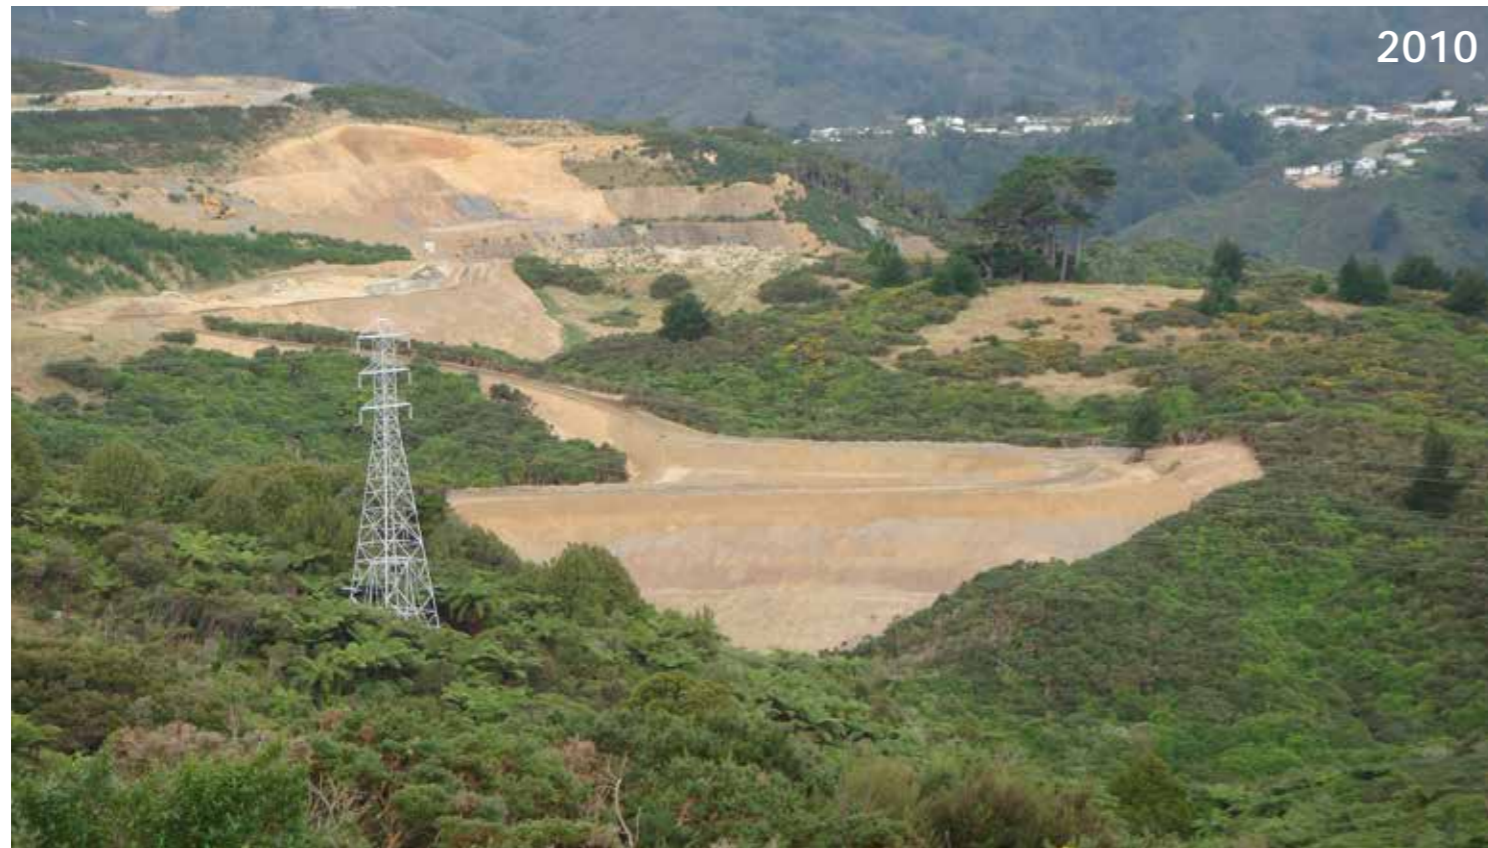
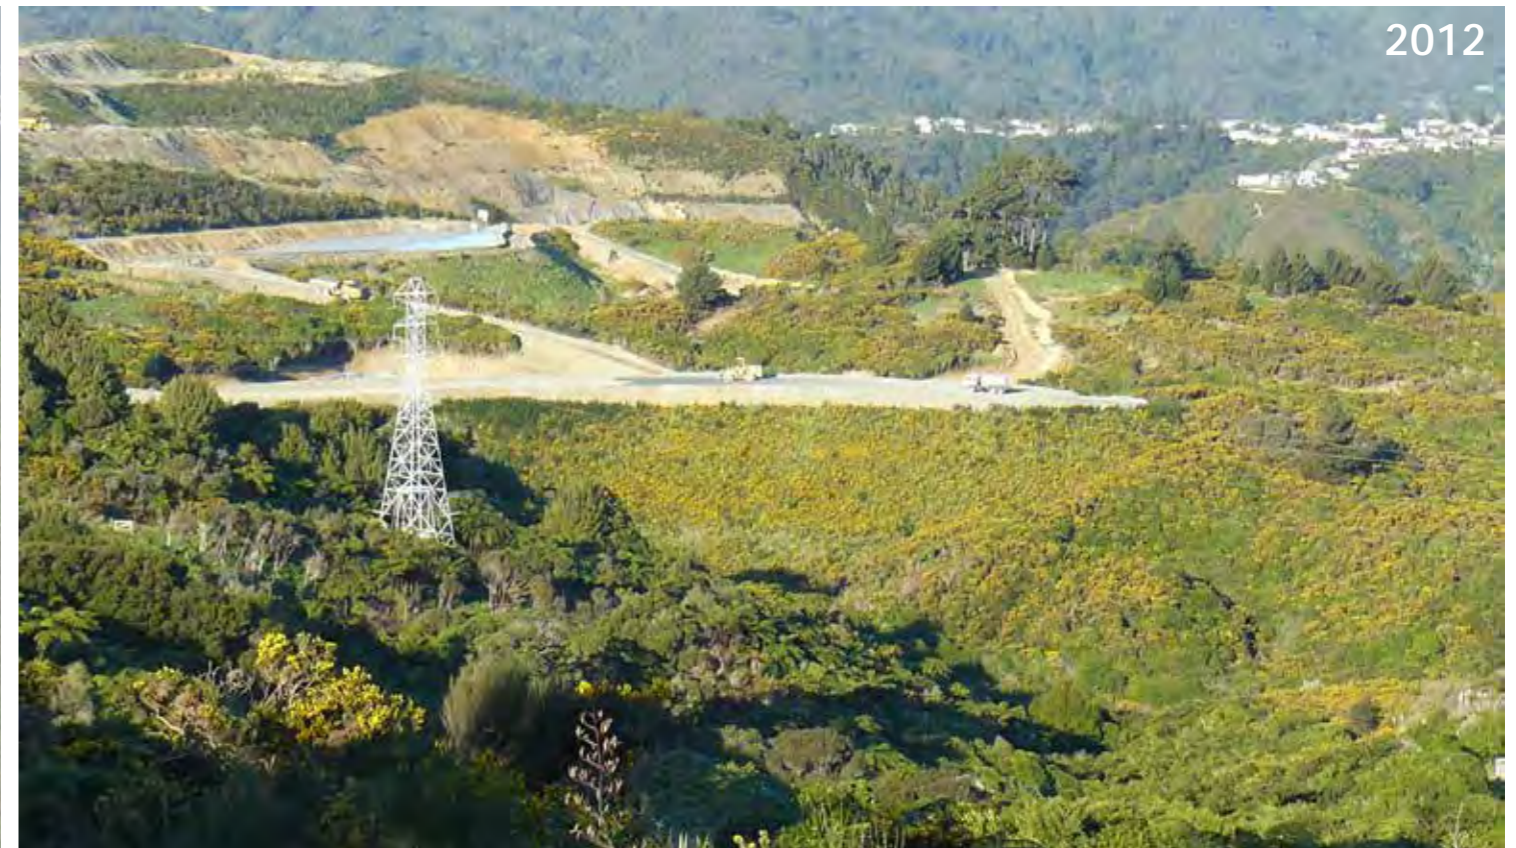
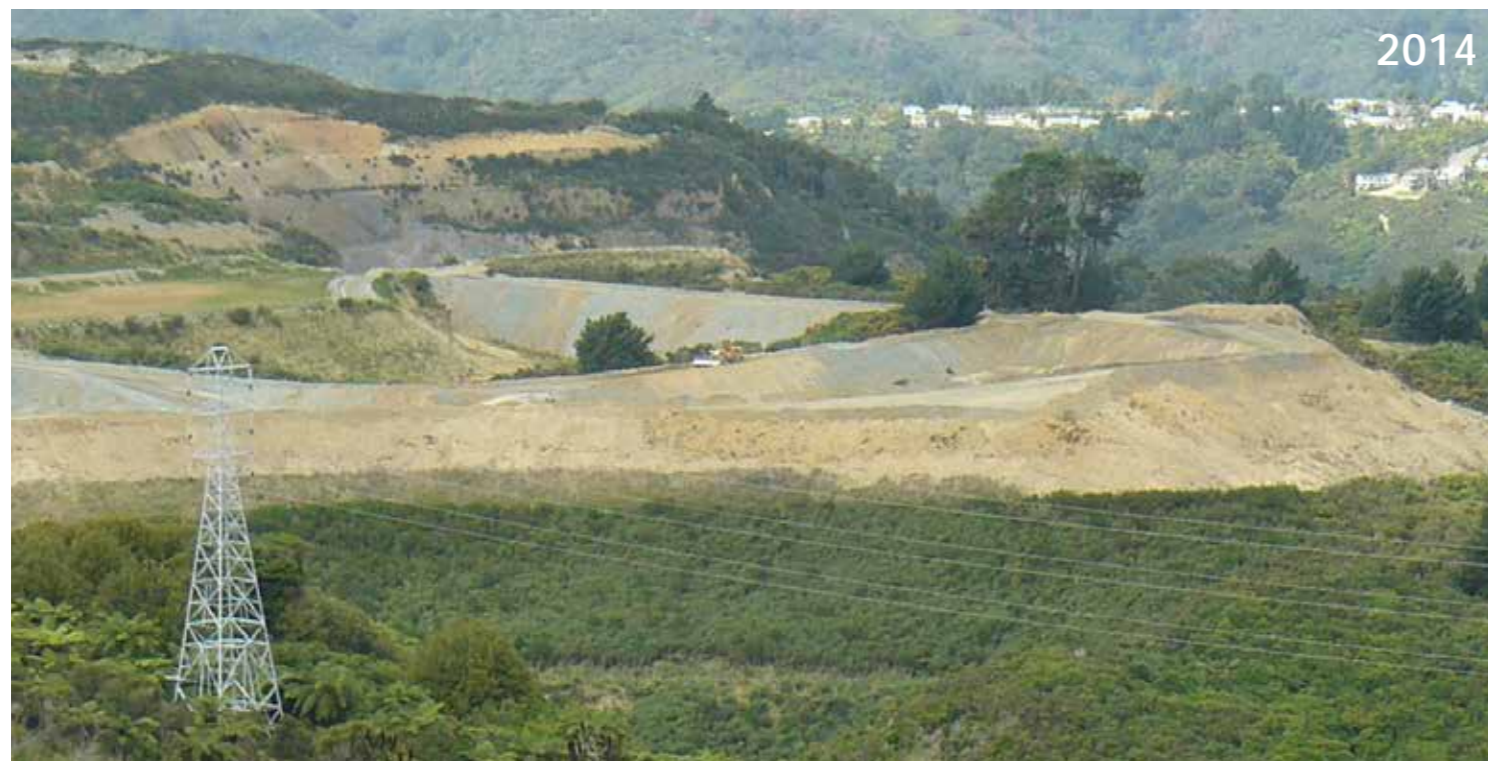
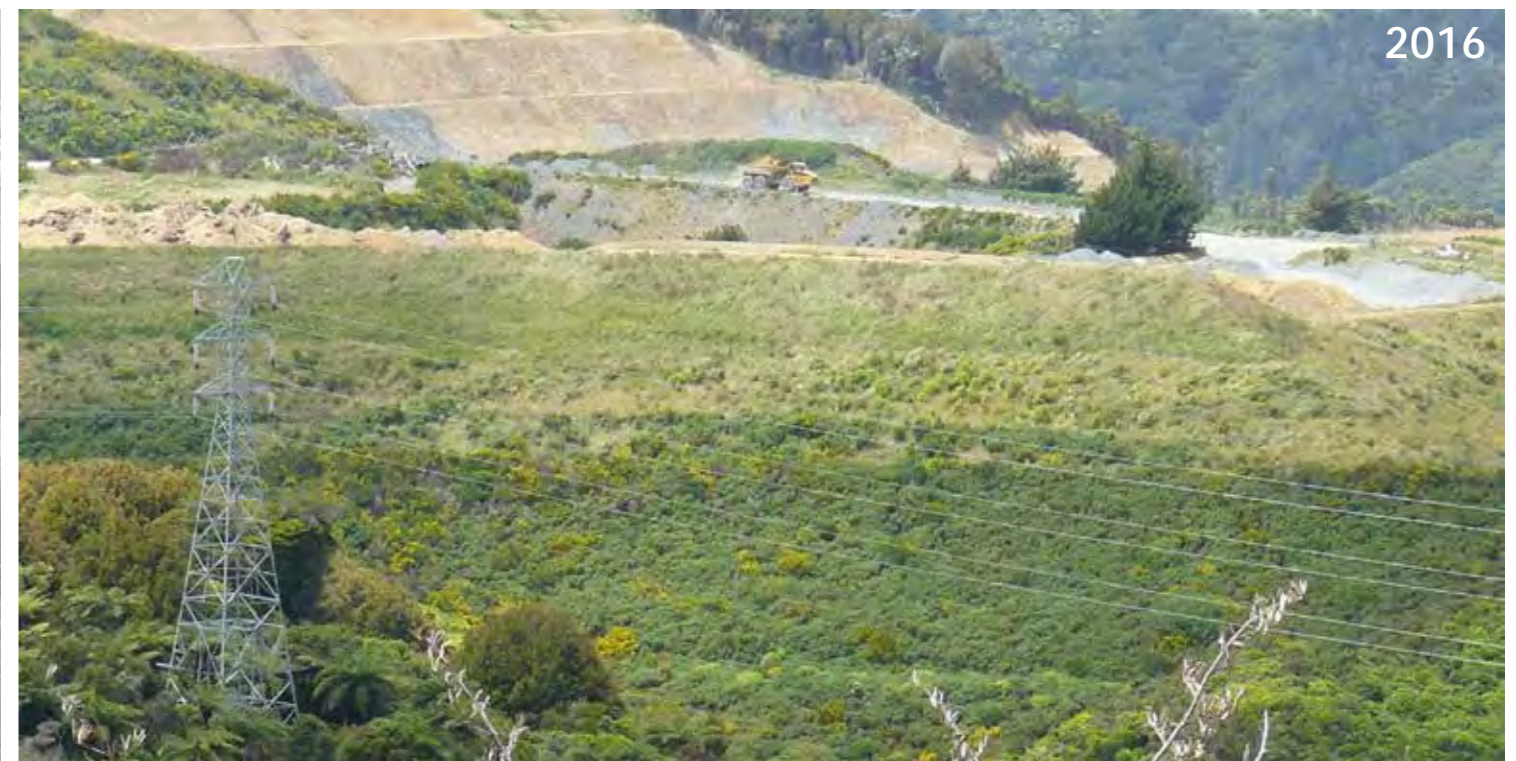
PRECEDENT IMAGES OF OBDA REHABILITATION: BELMONT QUARRY, LOWER HUTT, WELLINGTON

The images above illustrate how OBDA rehabilitation can be successfully “re-greened” over time, helping to integrate the exposed soil and earth. These examples show OBDA rehabilitation at Belmont Quarry, operated by Winstone Aggregates in Lower Hutt, Wellington,

with photographs from 2010, 2012, 2014, and 2016. OBDA rehabilitation can strongly influence how well the surrounding landscape recovers and integrates over time. The way batter slopes are shaped, stabilised, and planted determines how successfully vegetation can

establish, blend, and eventually naturalise across the modified landform. When care is taken with contouring, soil placement, and appropriate species selection, these slopes can support hardy, resilient plant communities that reduce visual contrast and promote long-term landscape

cohesion. In this way, well-planned treatment of each batter slope makes a measurable difference in the overall appearance, stability, and landscape integration of the rehabilitated OBDA.
