# Preliminary Geotechnical and Natural Hazards Review

Cherry Orchard Farm  
Ripponvale Road, Cromwell

**Report prepared for:**  
Rippon Holdings Limited

**May 2026**  
**GeoSolve Ref: 260149**

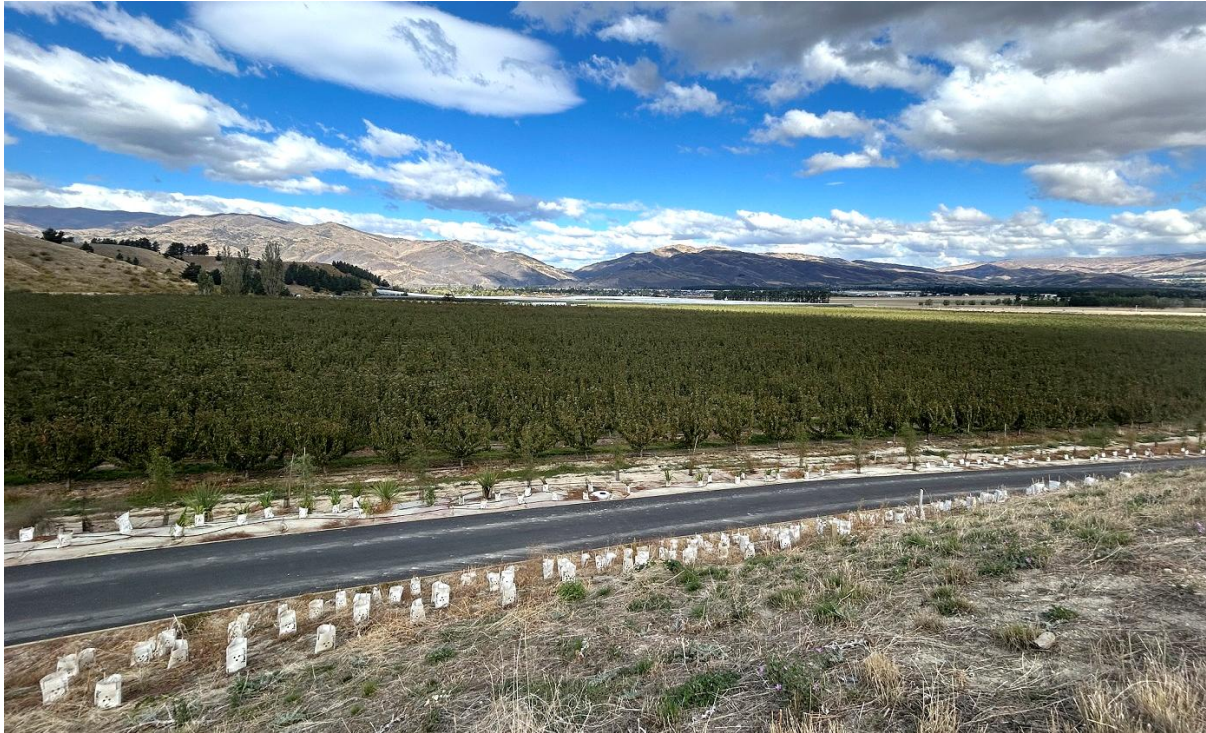
**Photo 1. Panoramic overview of the proposed development site looking southeast from the existing subdivision at Shannon Farm.**
