**Date:** 11 May 2026

**Project No.** 810.032031.00001

**RE: Rangitikei Solar Farm**  
**Technical Memorandum for Referral Application**  
**Ecology**

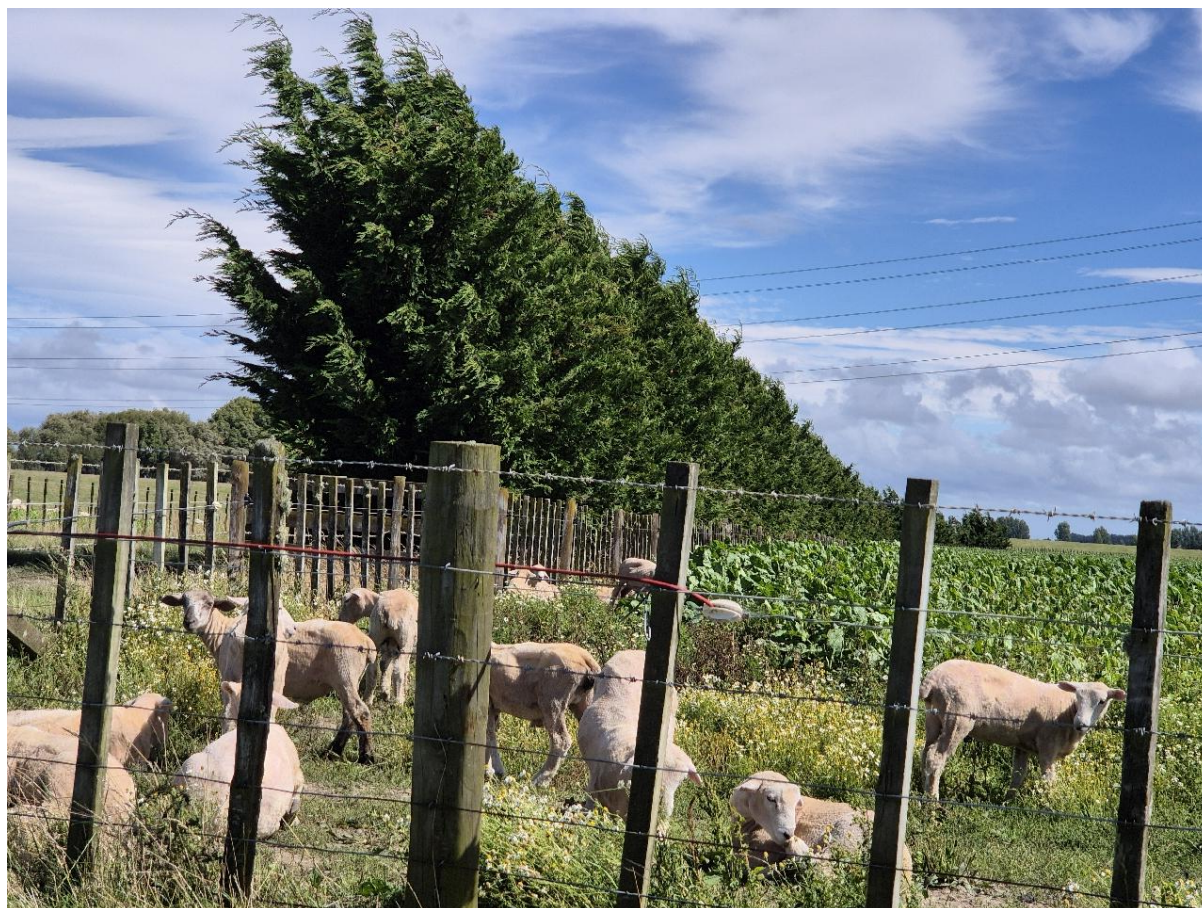
**Photo 1: Young *Cupressus* sp. shelterbelt with brassica crop observed.**

Pasture grass and crops were the dominant landcover, which is expected given that the predominant land use within the property is dry stock grazing and cropping. Common pasture grasses observed within this vegetation type included rye grass (*Lolium perenne*), *Poa annua*, Yorkshire fog (*Holcus lanatus*) and red clover (*Trifolium pratense*). Other exotic herbaceous species within pasture were in lower abundance but included buttercup (*Ranunculus repens*) and narrow leaved plantain (*Plantago lanceolata*). Crop species cultivated within the site included maize (*Zea mays*), barley (*Hordeum vulgare*) and brassica species. Shelterbelts were typically comprised of exotic species, including river red gum (*Eucalyptus camaldulensis*), *Cupressus* sp. (see Photo 1), *Poplar* sp. and *Pinus* sp. with one mixed shelterbelt also containing the native lemonwood (*Pittosporum eugenioides*). No smaller hedgerows were observed on site.

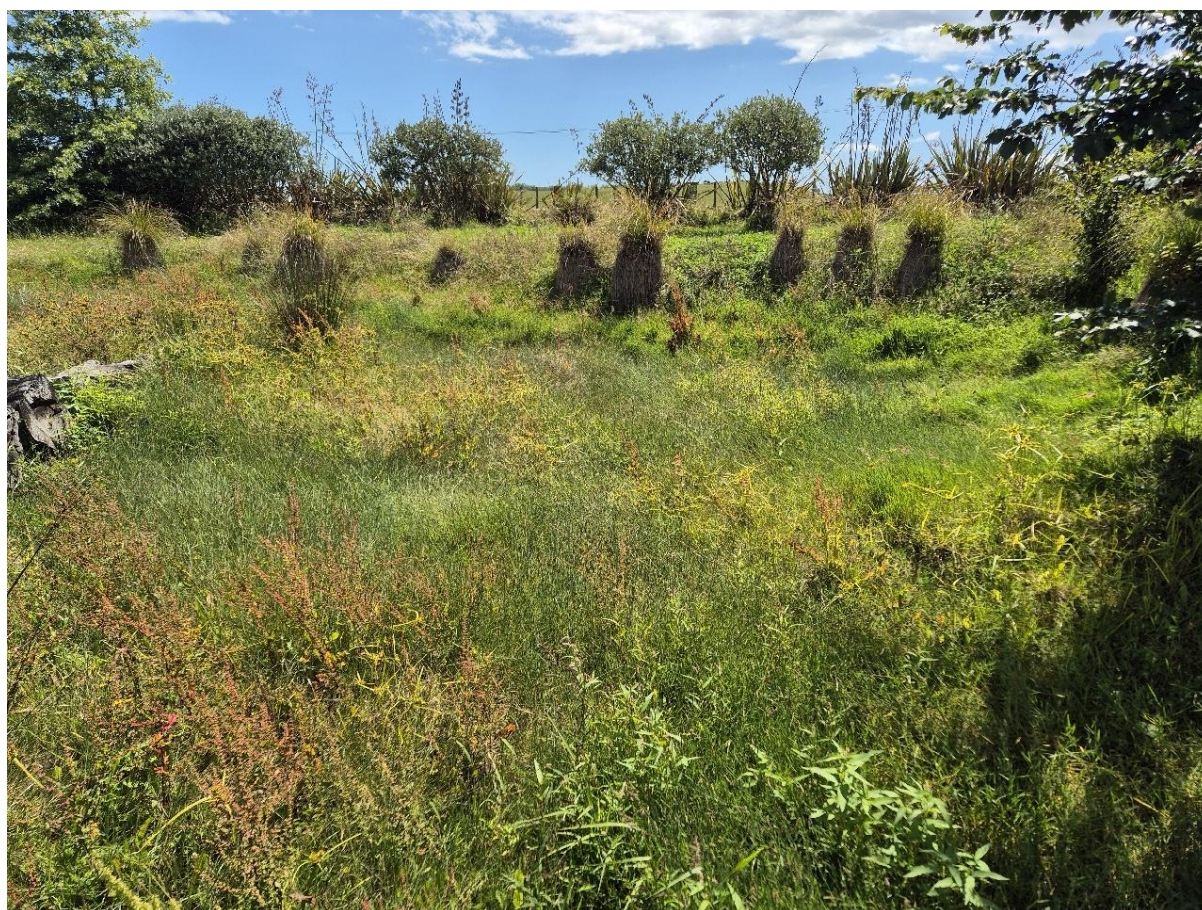
**Photo 2: View of wetland habitat associated with a former channel of the Tūtaenui Stream. Note this wetland forms part of the wider planned retention areas, and is outside of the solar farm activity area.**

All but one of the wetlands identified were dominated by exotic species, were highly degraded and/or were of overall low quality. The largest wetland, located in the northwestern corner of the site adjacent to the Tūtaenui Stream, was fenced and appeared to include some planted wetland species, including *Carex secta*.

Representative images of wetland habitat on site are included in Photo 2, below.

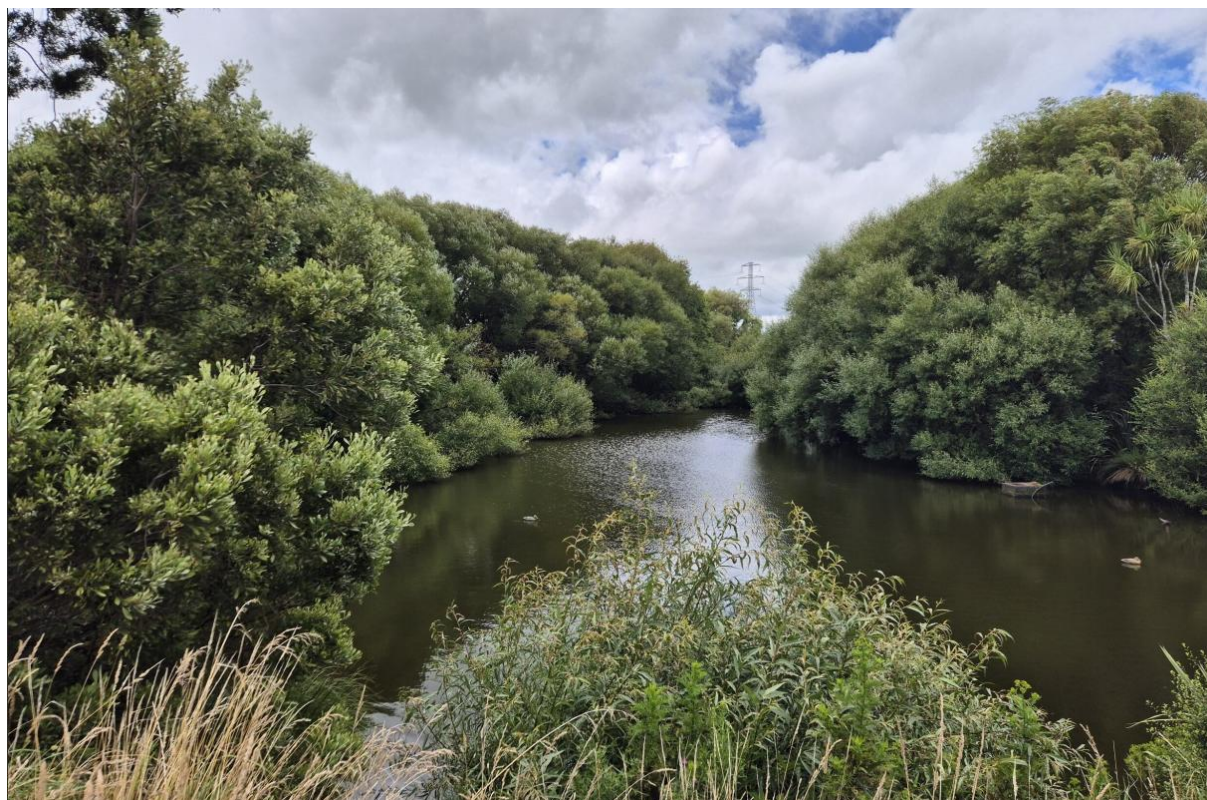
**Photo 3 An example of an artificial pond located within the site. Note this pond forms part of the wider planned retention areas, and is outside of the solar farm activity area.**

Nine artificial ponds were identified within the site. Although these ponds were all dominated by hydrophytic vegetation, it was clear that they had been constructed, and were either used for water abstraction and/or for duck shooting purposes. As a deliberately constructed wetland, these artificial ponds are excluded from the definition of 'natural inland wetland'. These ponds support some of the higher value biodiversity values present within the site, supporting numerous waterfowl species and a range of wetland plant species. They also

provide refuge habitat at drier times of year, when the streams that flow through these ponds reduce in flow and potentially dry up. One of these ponds was dry at the time of the site visit, with the bed of the pond being dominated by dense growths of *Persicaria sp.* and *Roripa palustris*. An example of these artificial ponds is shown in photo 3.

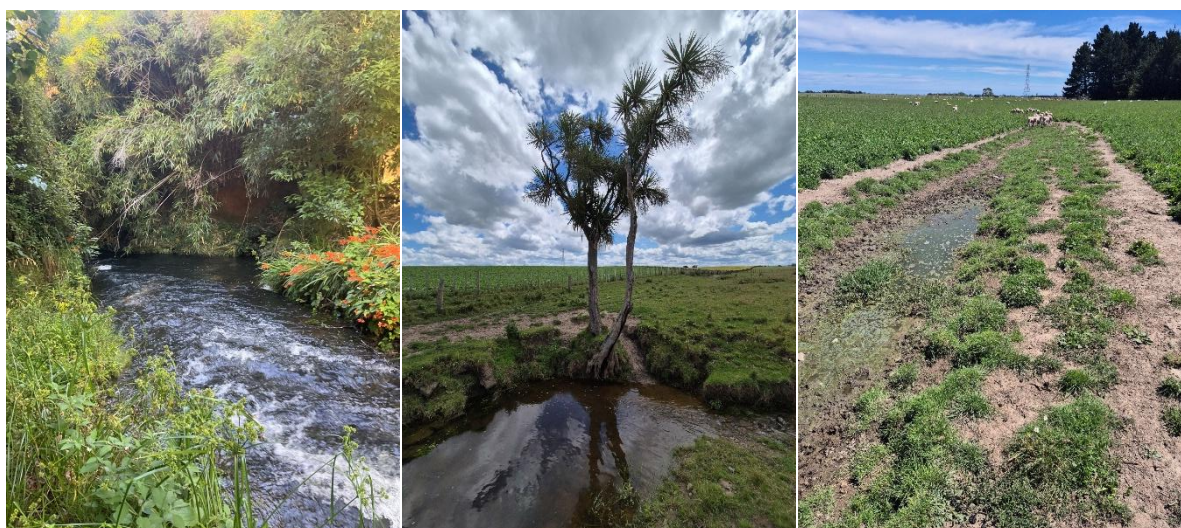
**Photo 4 Streams present within the site extent.**

**From left to right: Tūtaenui Stream, Foley Stream, Unnamed tributary**

The Tūtaenui Stream is the largest stream that flows through the broader site, but is located to the west of the actual solar farm proposed development area. This is a permanent stream, which includes diverse instream habitats, including pools, riffles and undercut banks. This habitat diversity is reflected in the RHA score of 89 units (out of a possible 100<sup>5</sup>). It is relatively well protected by mature vegetation along most of its length, although some of this vegetation is non-native and includes weed species.

The Foley Stream flows through the middle of the site, with the solar farm infrastructure intended to be set back from this stream. It is a relatively small stream, and based on aerial photo imagery, it appears that this is an intermittent stream, which ceases to flow during very dry periods. During the site visit, this stream was flowing well. This stream supports a range of different habitats, including deeper pools and shallow riffles in addition to stretches that are congested with macrophyte growth. This stream has been subject to historical modification activities, and in areas is experiencing erosion and slumping of the stream banks. It also supports two artificial ponds, one of which was formed by the installation of

flood detention infrastructure. Scores of 32-55 were recorded across the four RHA assessments undertaken in the Foley Stream, reflective of its poor condition.

There was one other stream observed on the site. This stream, which is located to the east of the Foley Stream, has been extensively drained, and appears to predominantly flow underground, through tile drains. There are areas where these tile drains have either blocked or at capacity from time to time, as there is a stream channel evident on the ground surface, which carries flowing water at wetter times of the year. This stream could be considered an intermittent stream, but is not protected from stock access and contains limited to no instream habitat. One RHA assessment was undertaken in this tributary, with this assessment completed where it leaves the site. The stream contained water at this location, but appeared stagnant, resulting in an RHA score of 41.

Example reaches of streams that flow through the site are shown in Photo 4.
