# Remarkables Ski Area Upgrade & Doolans Expansion - Tracks, Stream Crossings and Stormwater Freshwater Ecological and Hydrological Impact Assessment

Prepared NZSki Ltd

August 2026

**Prepared by e3Scientific Limited for NZSki Limited**

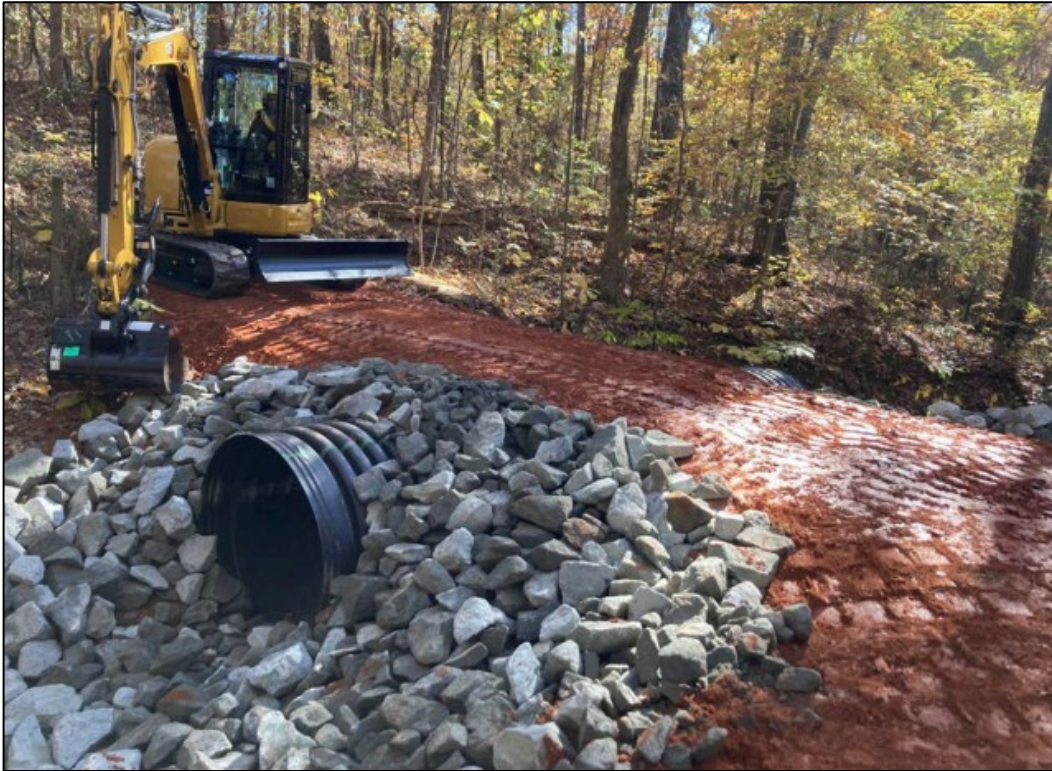
**Figure 6: Culvert example (Stantec, 2026b).**

1. Culverts are proposed at larger or incised stream crossings (Figure 6).
2. Splash crossings (fords) are proposed at permanent or intermittent stream crossings with low gradient and low approach angles (Figure 7).
3. Engineered permeable track crossings are proposed at smaller ephemeral or seepage wetlands crossings. These are designed to enable hydrologic connectivity to remain intact between upstream and downstream wetland areas (Figure 8).

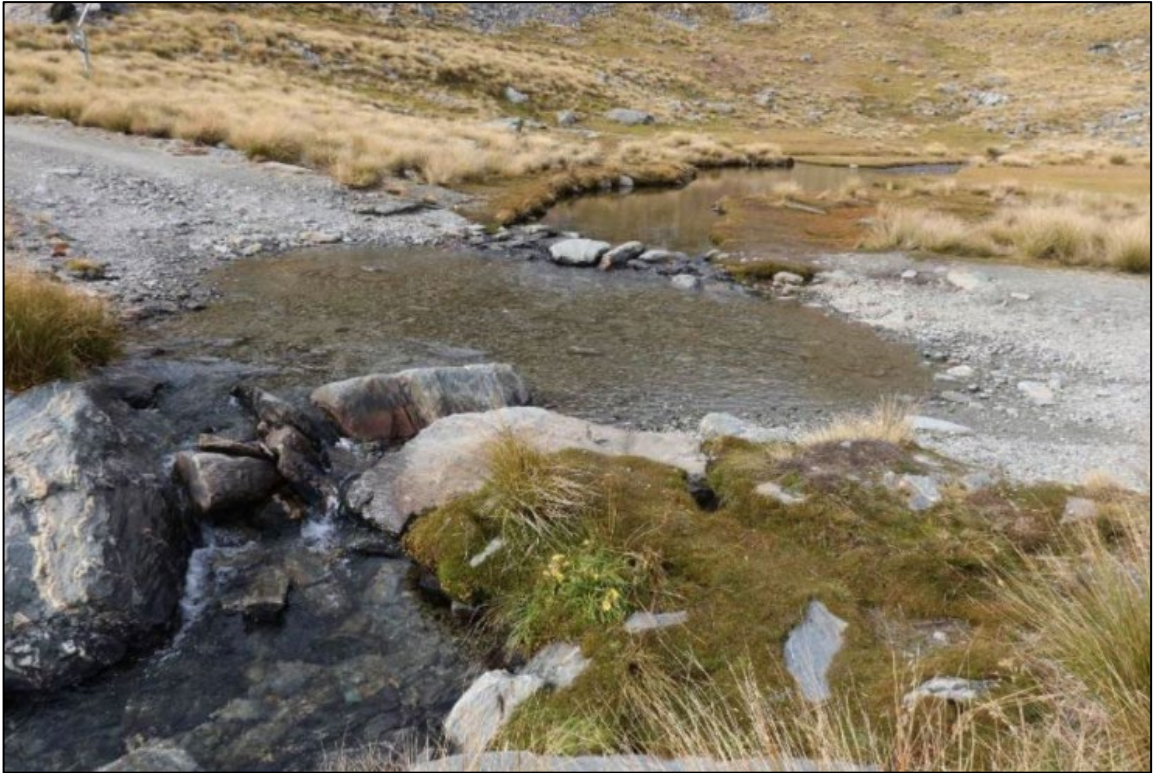
Figure 7: Splash crossing (ford) example (Stantec, 2026b).

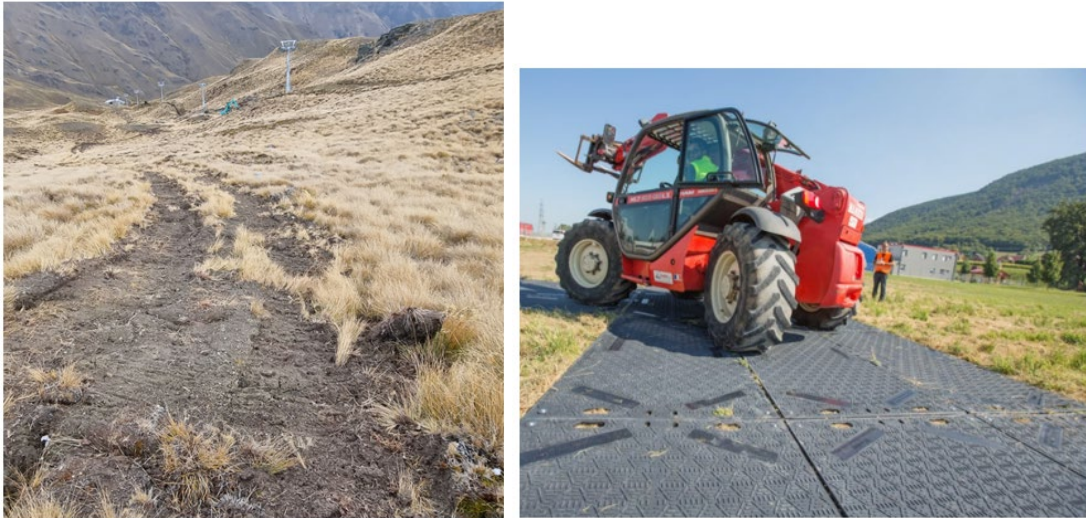
**Figure 11: Example of temporary access track (left), rubber matting for use near critical source areas (right).**

earthworks on these tracks as much as possible and the use of rubber matting near critical source areas (Enviroscope, 2026). The combination of these two measures and the temporary nature of the tracks will ensure there is no complete or partial drainage of wetlands between 10 m and 100 m and no change in water level of wetlands within 100 m of the earthworks.

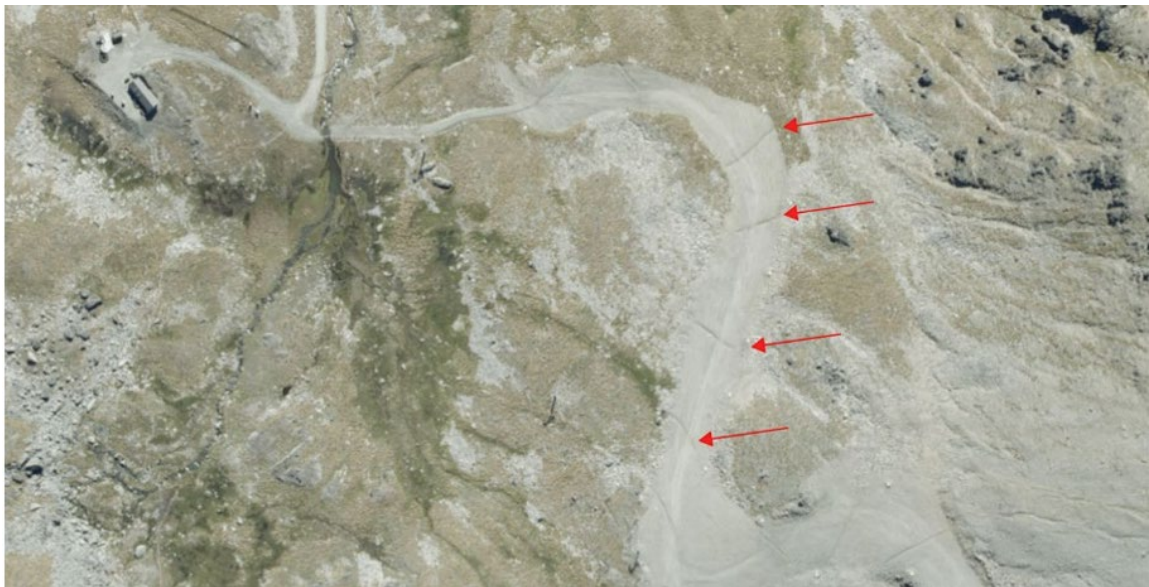
**Figure 12: Stormwater channels to maintain surface sheet flow as much as possible (Stantec New Zealand, 2026).**

be provided by side water channels across the track to catch flow from the track and surrounding slopes and move it across the track at discharge points. This will result in numerous very small discharges off the track rather than a lesser number of concentrated flows that require culverting. This approach has been proven to be successful in the Rastus Burn catchment (see Figure 12). While the placement of stormwater channels is subject to detailed design, in general this approach is considered the best way to avoid concentrating flows which may then result in scour and movement of material into the downgradient wetlands, or diversion of flows away from wetlands.

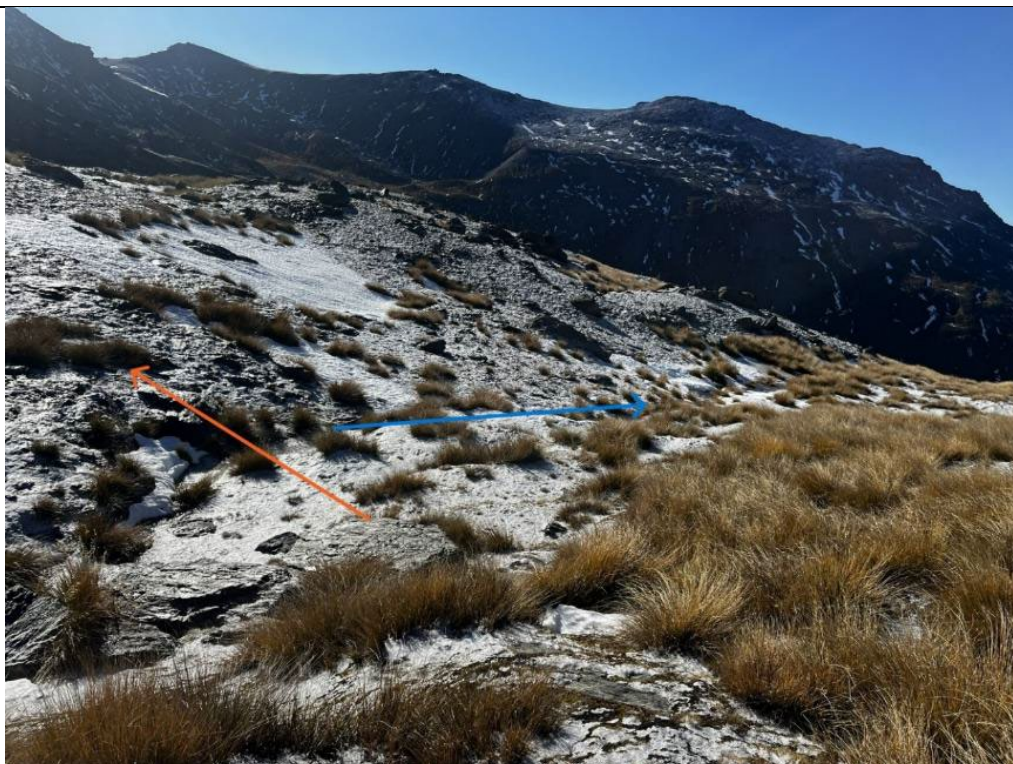
**Splash Crossing A:** Crosses outflow from a small tarn. There are no nearby wetlands, and the stream goes to ground soon after this location

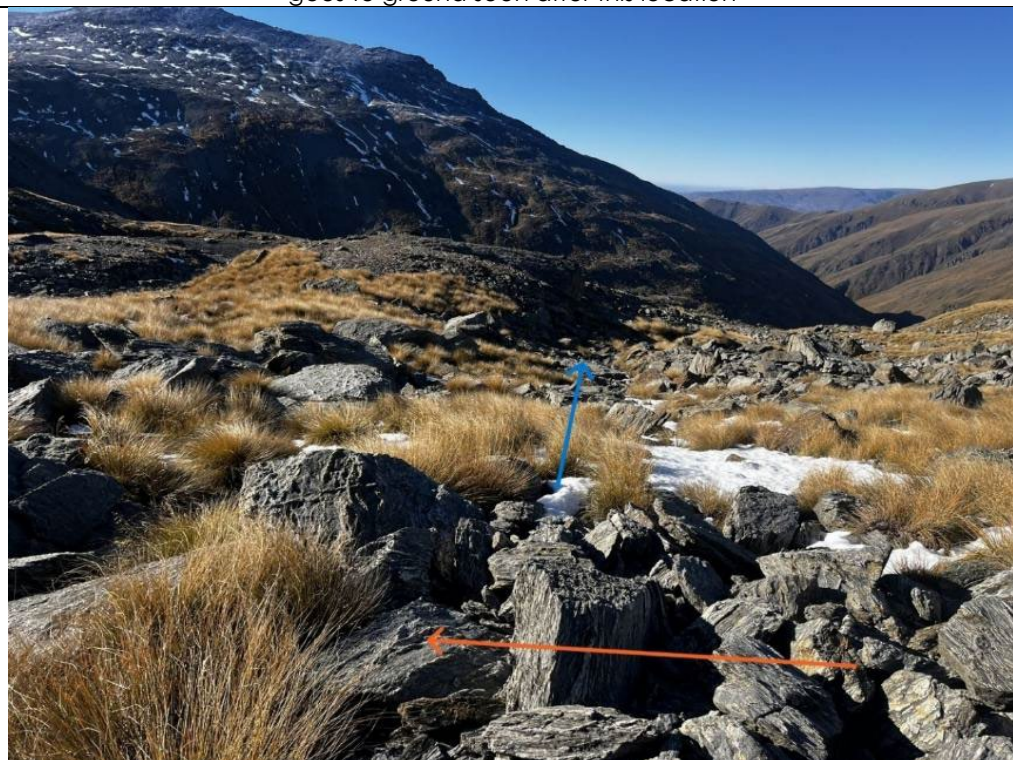
**Splash Crossing B:** There is a wetland immediately upgradient of this crossing. It is important that the crossing is placed, as mapped, where the gradient increases and the wetland becomes a intermittent stream. During the site visit the waterway was not observed on the surface but was instead heard running underneath the boulders.

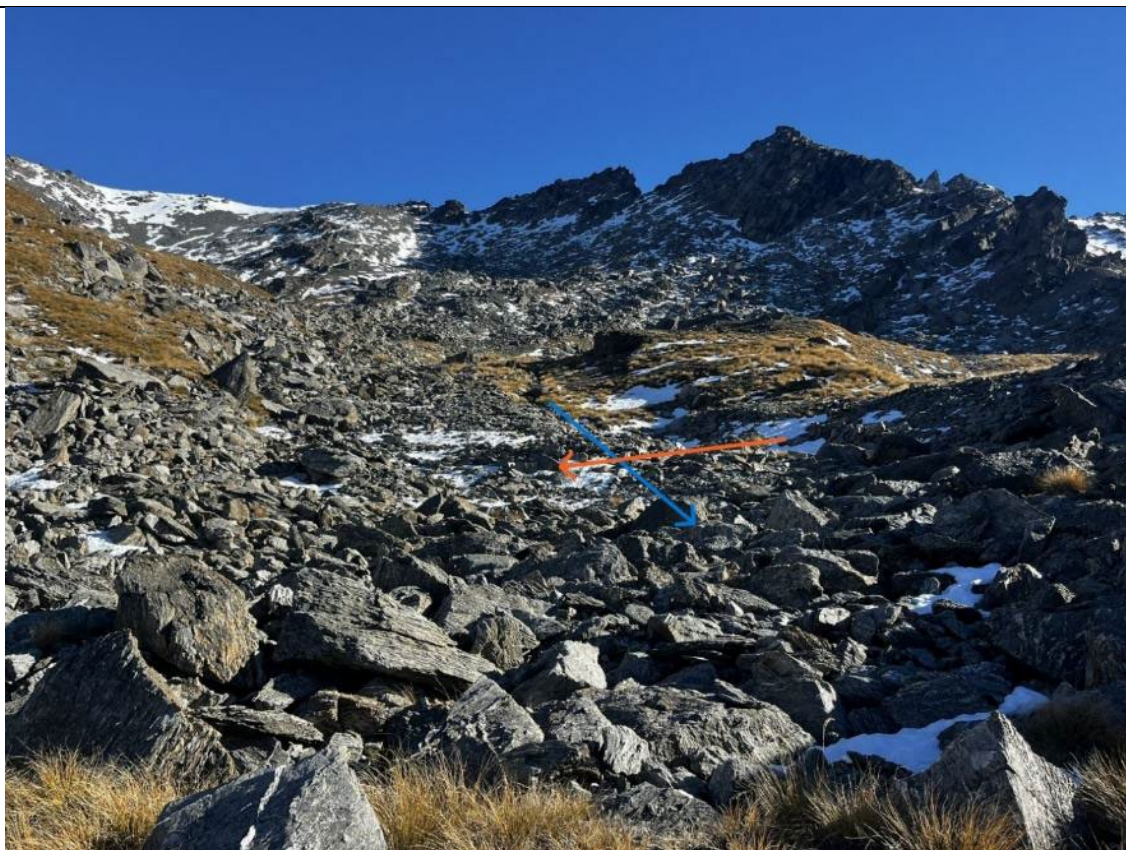
**Splash Crossing C:** This is downgradient on the same channel as Splash Crossing B. At the site visit water was heard passing underneath ground through the large boulders visible.

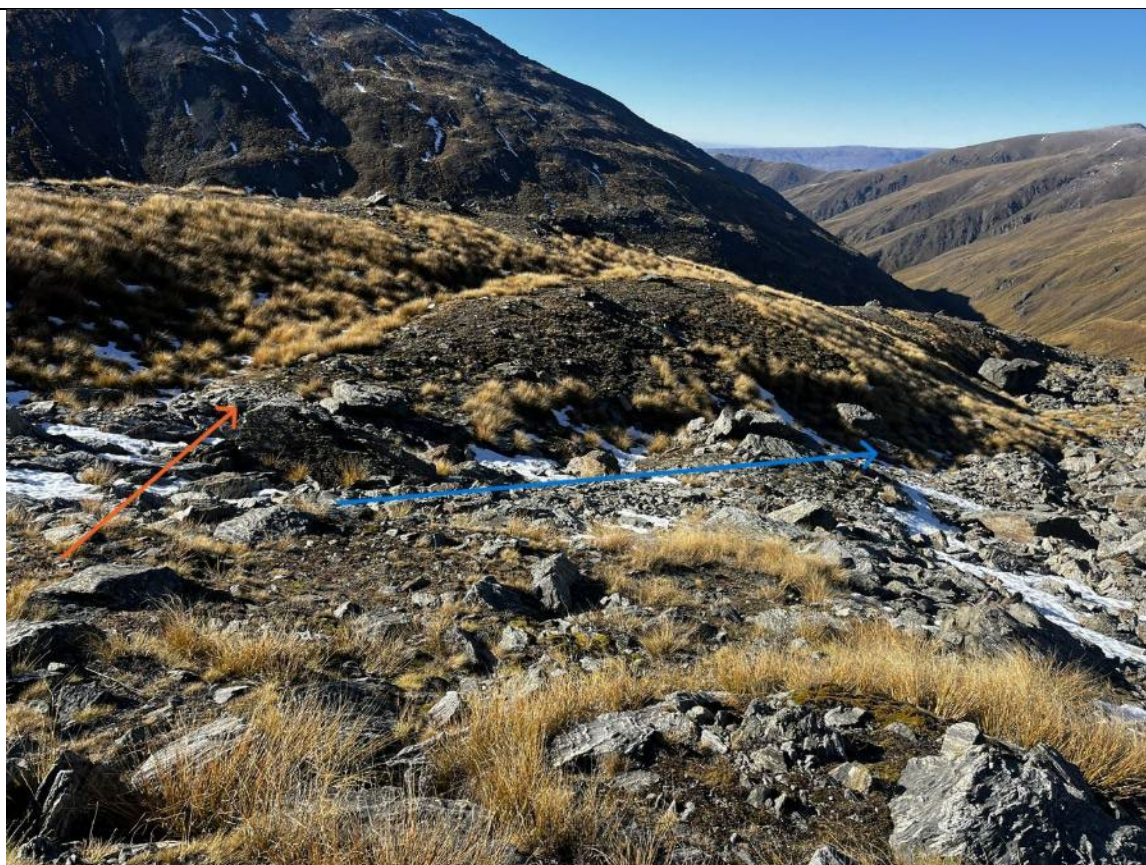
**Splash Crossing D:** downstream on the same channel as B and C. At the site visit no stream was visible, and no water was heard underground. Likely the stream had infiltrated to ground upgradient.

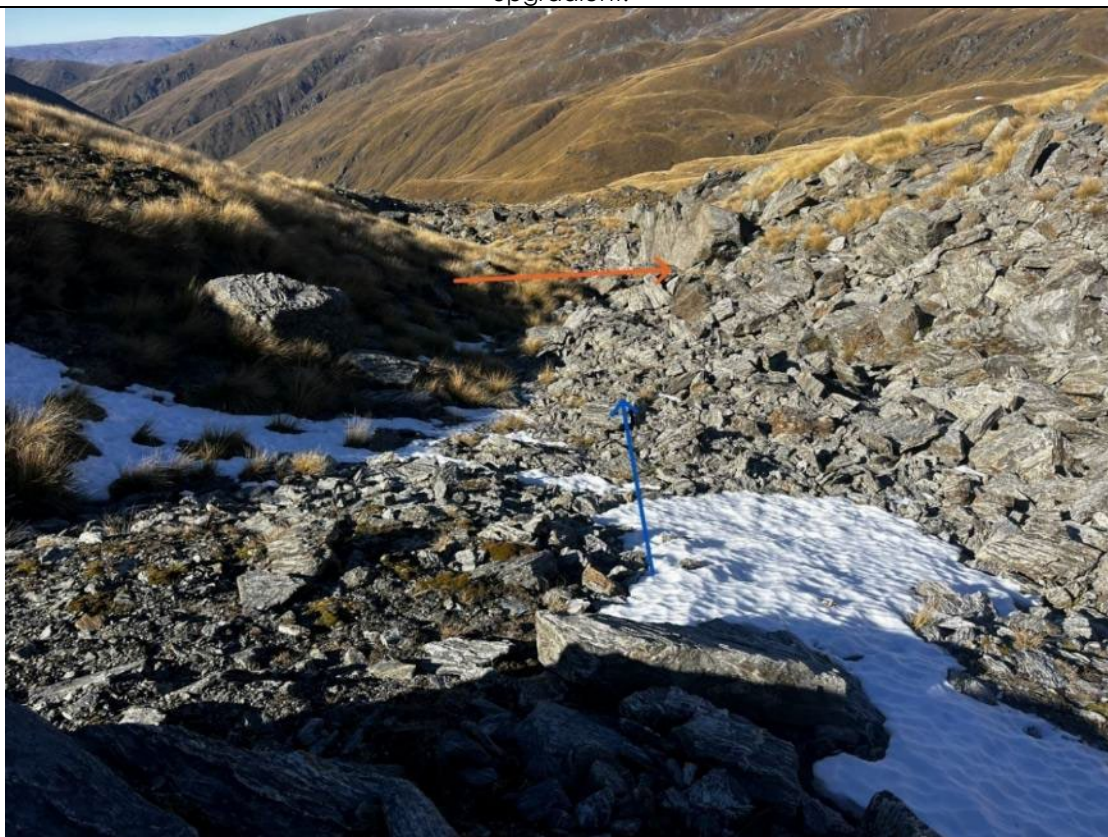
**Splashing Crossing E:** Final crossing downgradient of D. At the site visit no water was seen on the surface or heard moving through the boulders at this location.

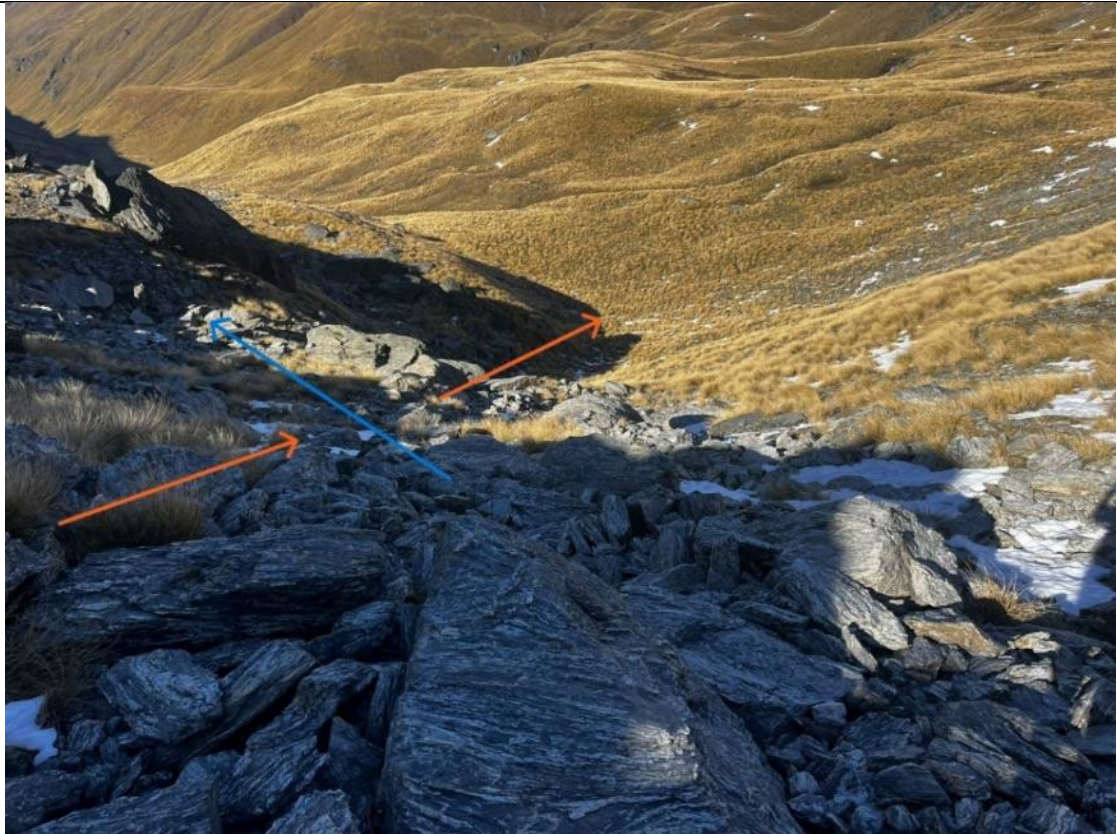
**Splash Crossing F:** Detailed design required to address how this will terminate in Armoured Swale C. At the site visit no water was observed on the surface or heard running through boulders.

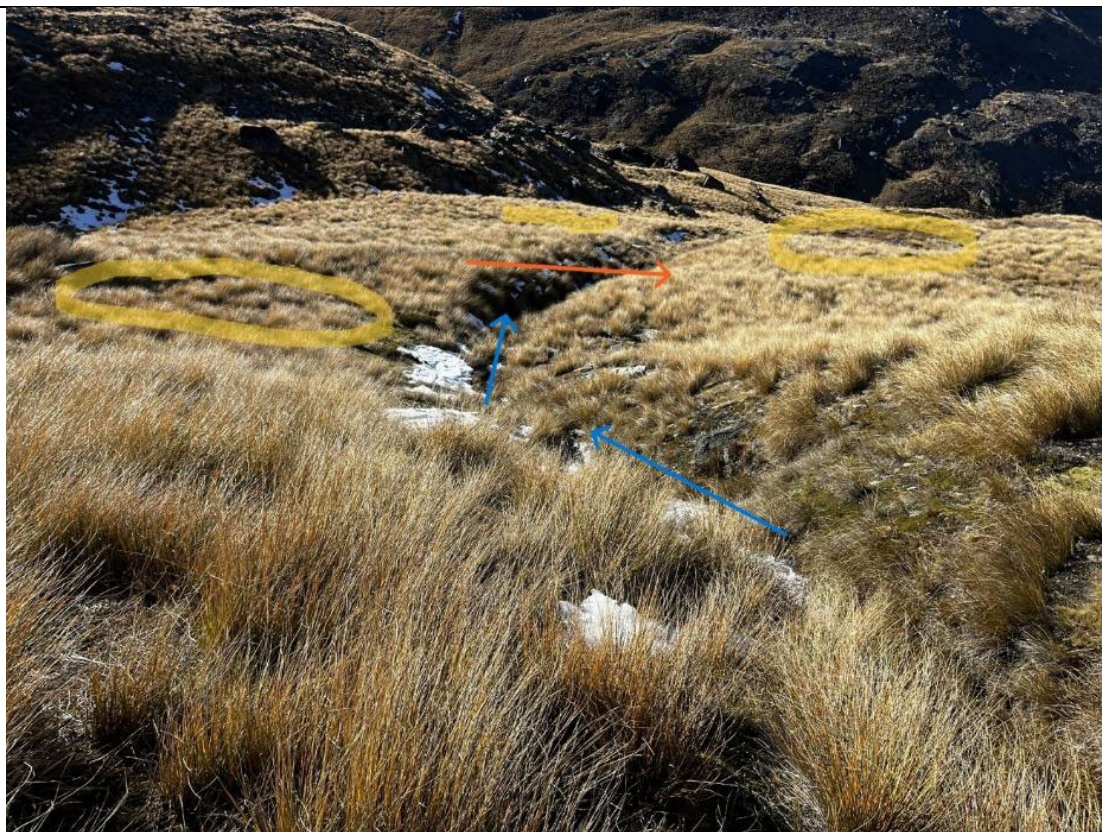
**Culvert C:** Yellow highlighted areas suggest approximate location of seepage wetlands relevant to Culvert Crossing (orange). A Permeable Track has been recommended by Stantec and is assessed in Table 3.

For RCP 8.5  $Q = 700 \text{ L/s}$ .

Culvert sizing 750 mm HDPE/RCP or twin 450 mm for redundancy and to reduce height

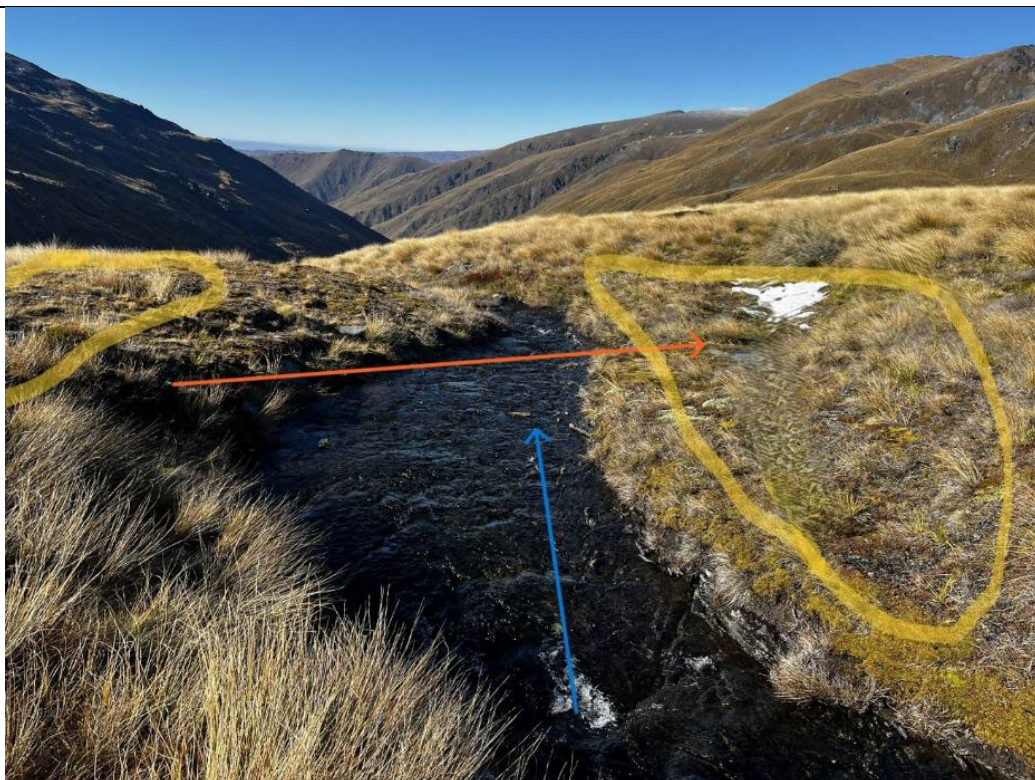
**Culvert B:** Yellow area represents approximate location of seepage wetlands relative to the culvert crossing (orange). Although the stream at Culvert B is less incised than the stream at Culvert C it is expected to convey significant flow from the catchment in spring and therefore is suited to a culvert. Two culverts are recommended here to reduce stream constriction and maintain hydrology.

For RCP 8.5  $Q = 710 \text{ L/s}$ .

Same rip rap and culvert sizing as Culvert C.

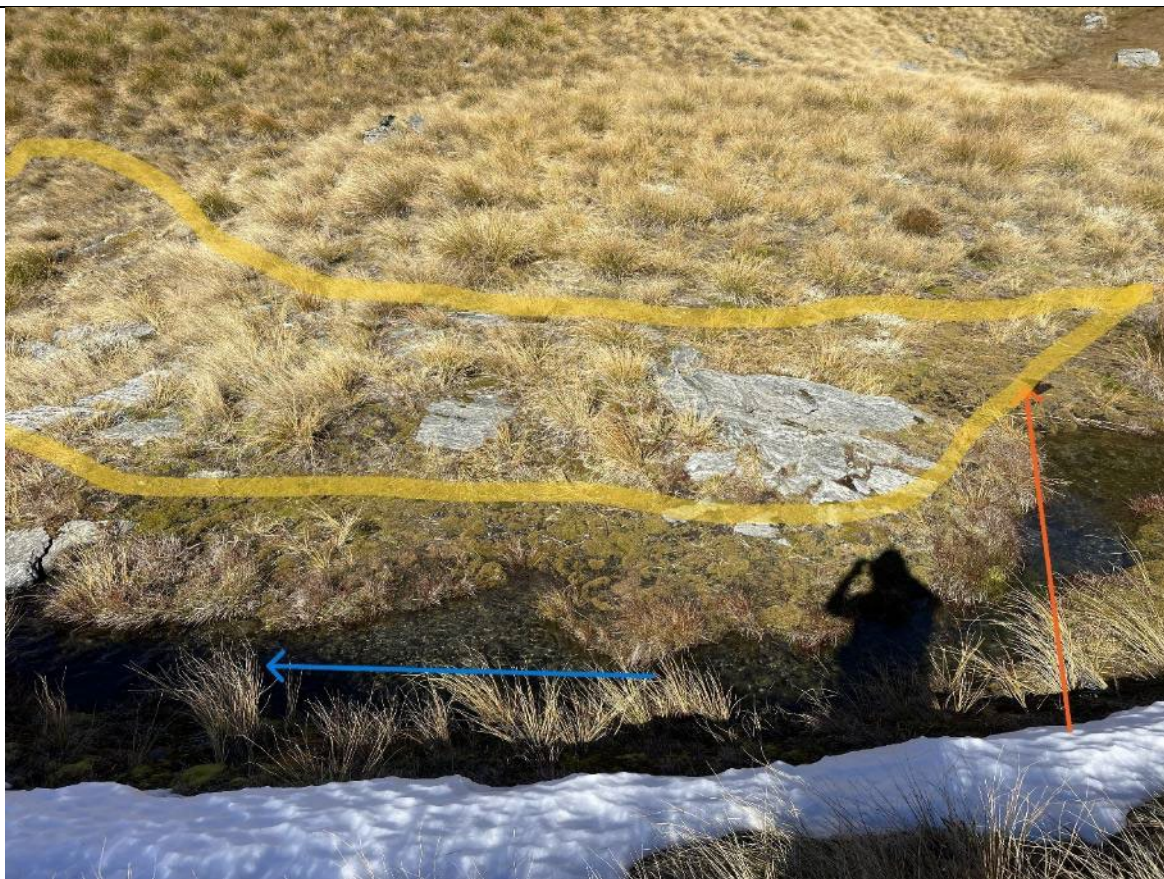
**Culvert I:** Yellow area represents approximate location of surrounding seepage wetland area. Culvert I is directly downstream of a tarn on the water take access track. Installation of a Permeable Access track is recommended if water flow is thought to be parallel to the stream rather than seeping out from the stream during detailed design,

For RCP 8.5  $Q = 700 \text{ L/s}$ .

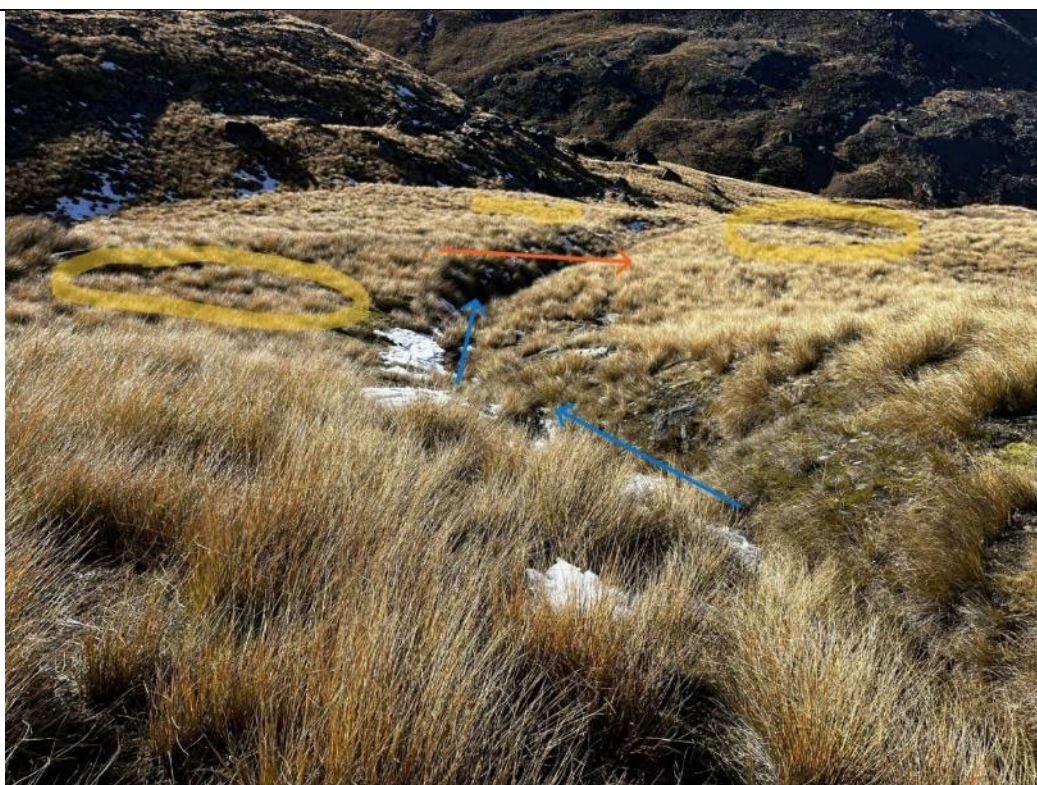
**Permeable Track C:** Wetland areas are highlighted in yellow. A Permeable Track has been recommended (Stantec New Zealand, 2026) with the placement adjacent to culvert C subject to detailed design as summarised in Section 0.

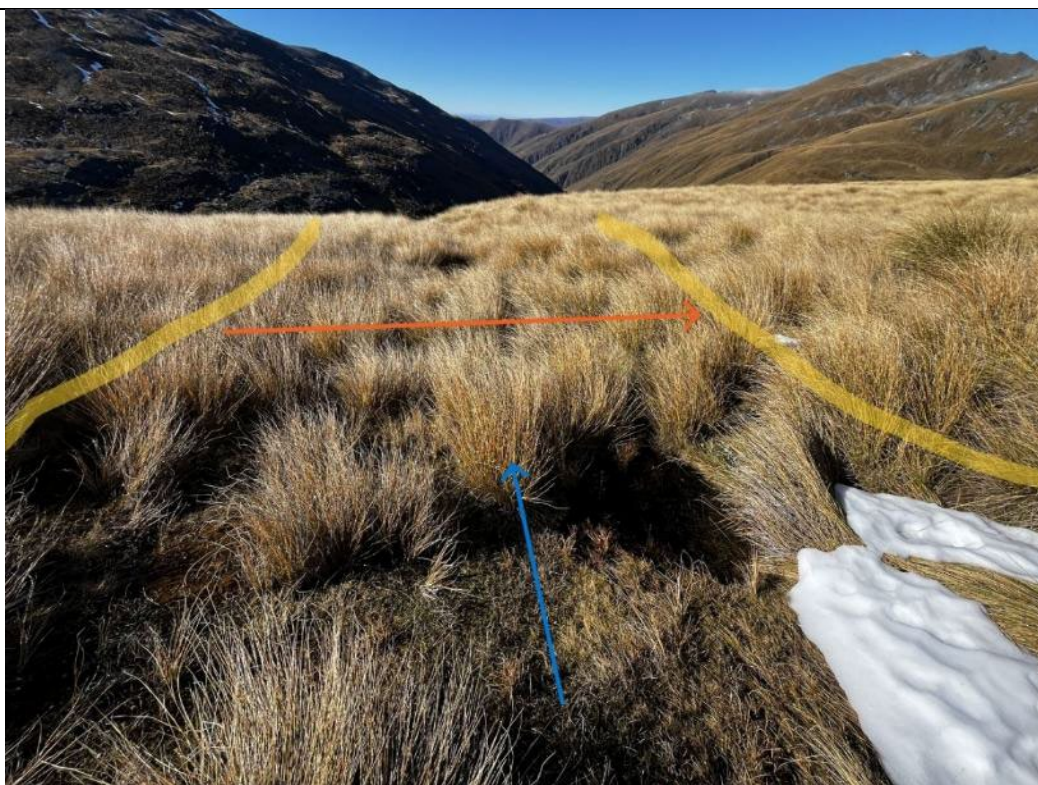
**Permeable Track C-3:** No waterway is present, a wetland crossing of approximately 10 m between the yellow lines will be required over the seepage wetland.

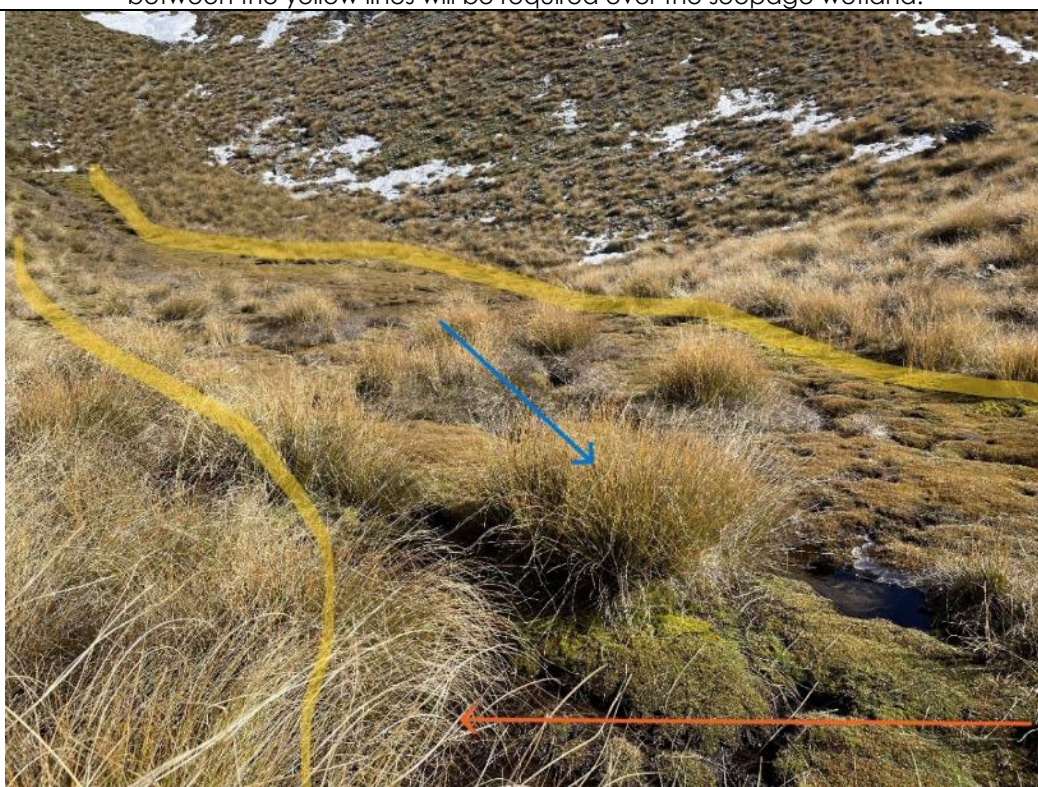
**Permeable Track D:** No waterway is present, a wetland crossing of approximately 15 m between the yellow lines will be required over the seepage wetland.

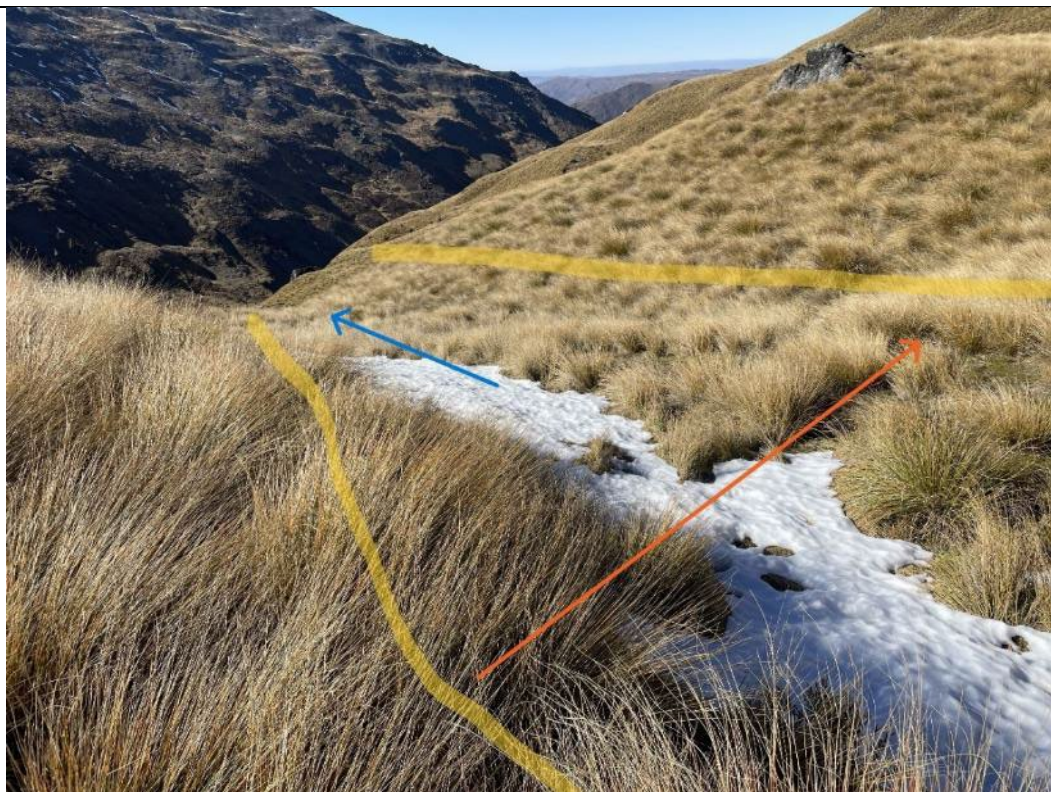
**Permeable Track E:** No waterway is present, a wetland crossing of approximately 10 m between the yellow lines will be required over the seepage wetland.

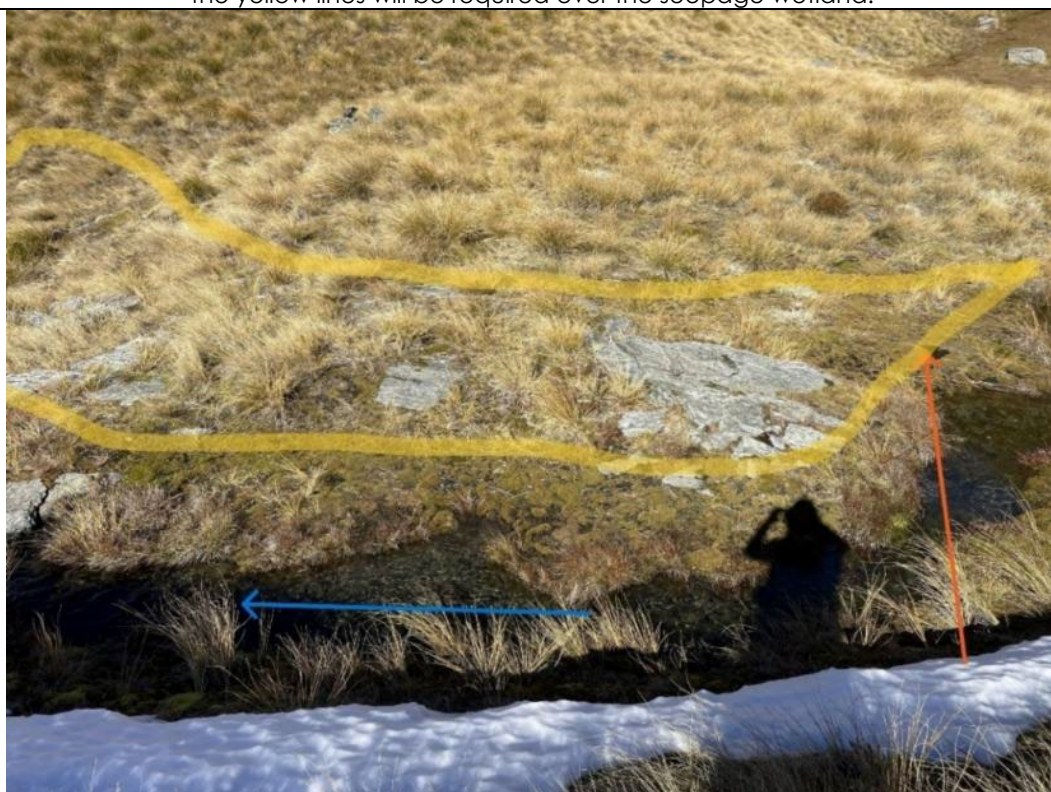
**Proposed Permeable Track I:** Review of Culvert I (Section 0) recommends a Permeable Track here, subject to detailed design.

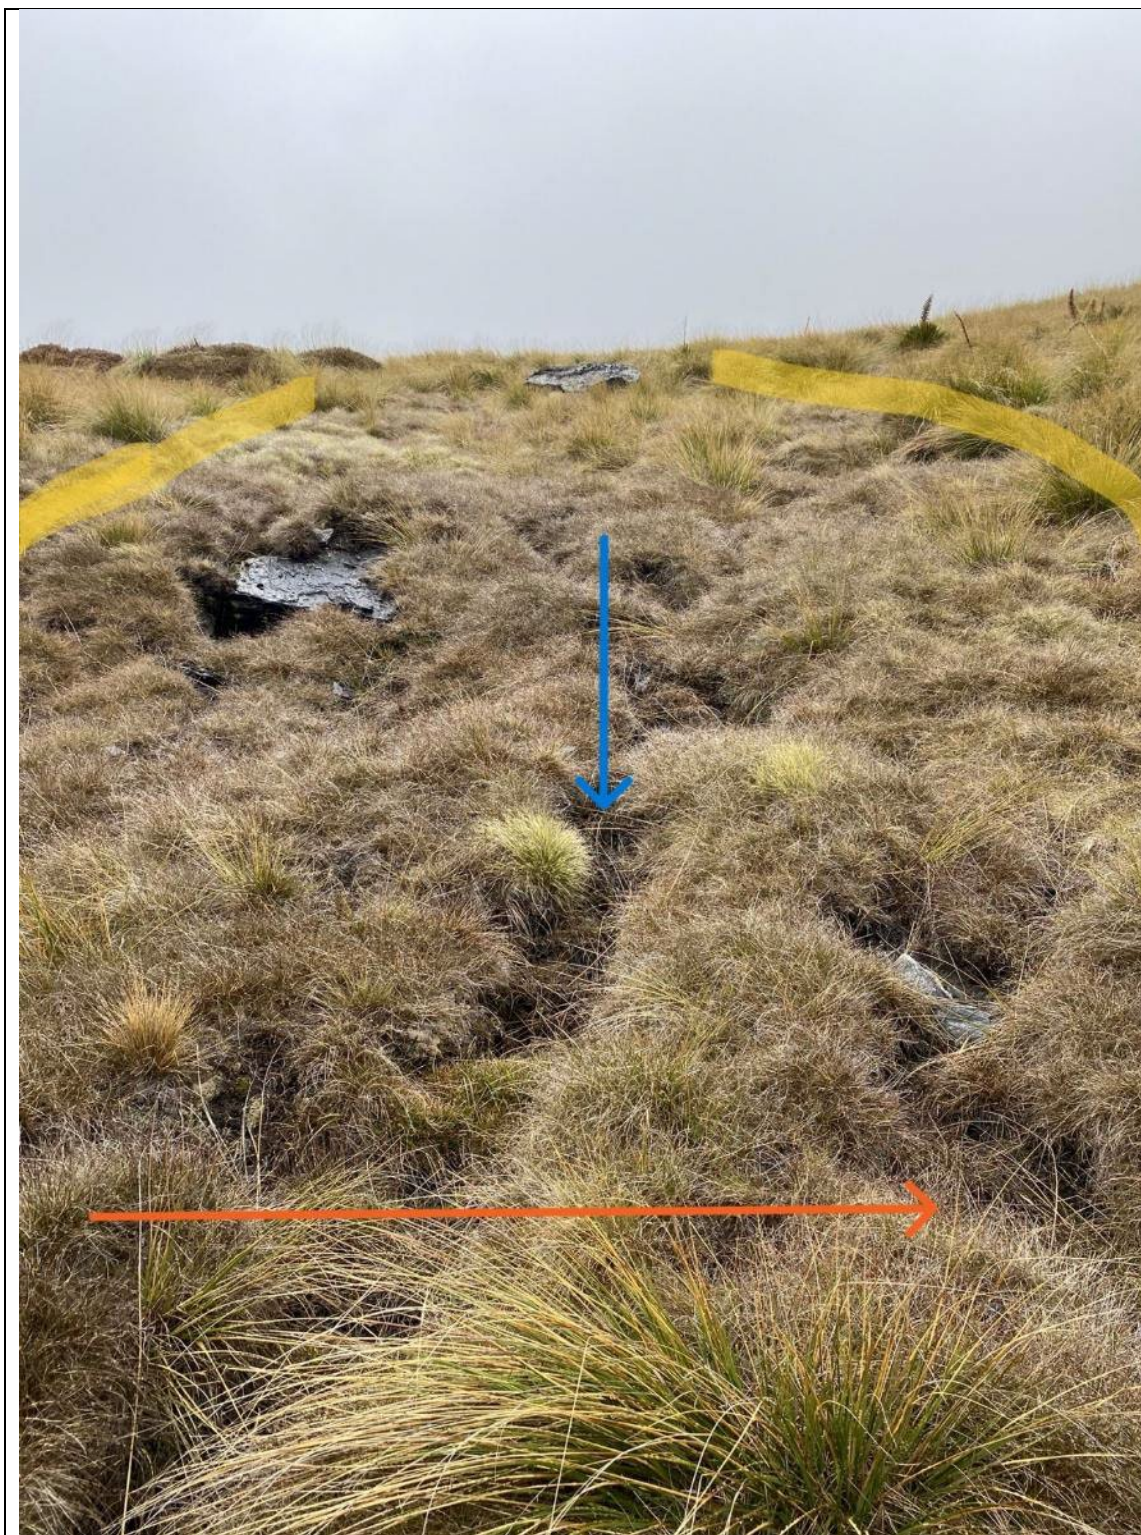
**Permeable Track F:** No waterway is present, a wetland crossing of approximately 5 m between the yellow lines will be required over the seepage wetland.

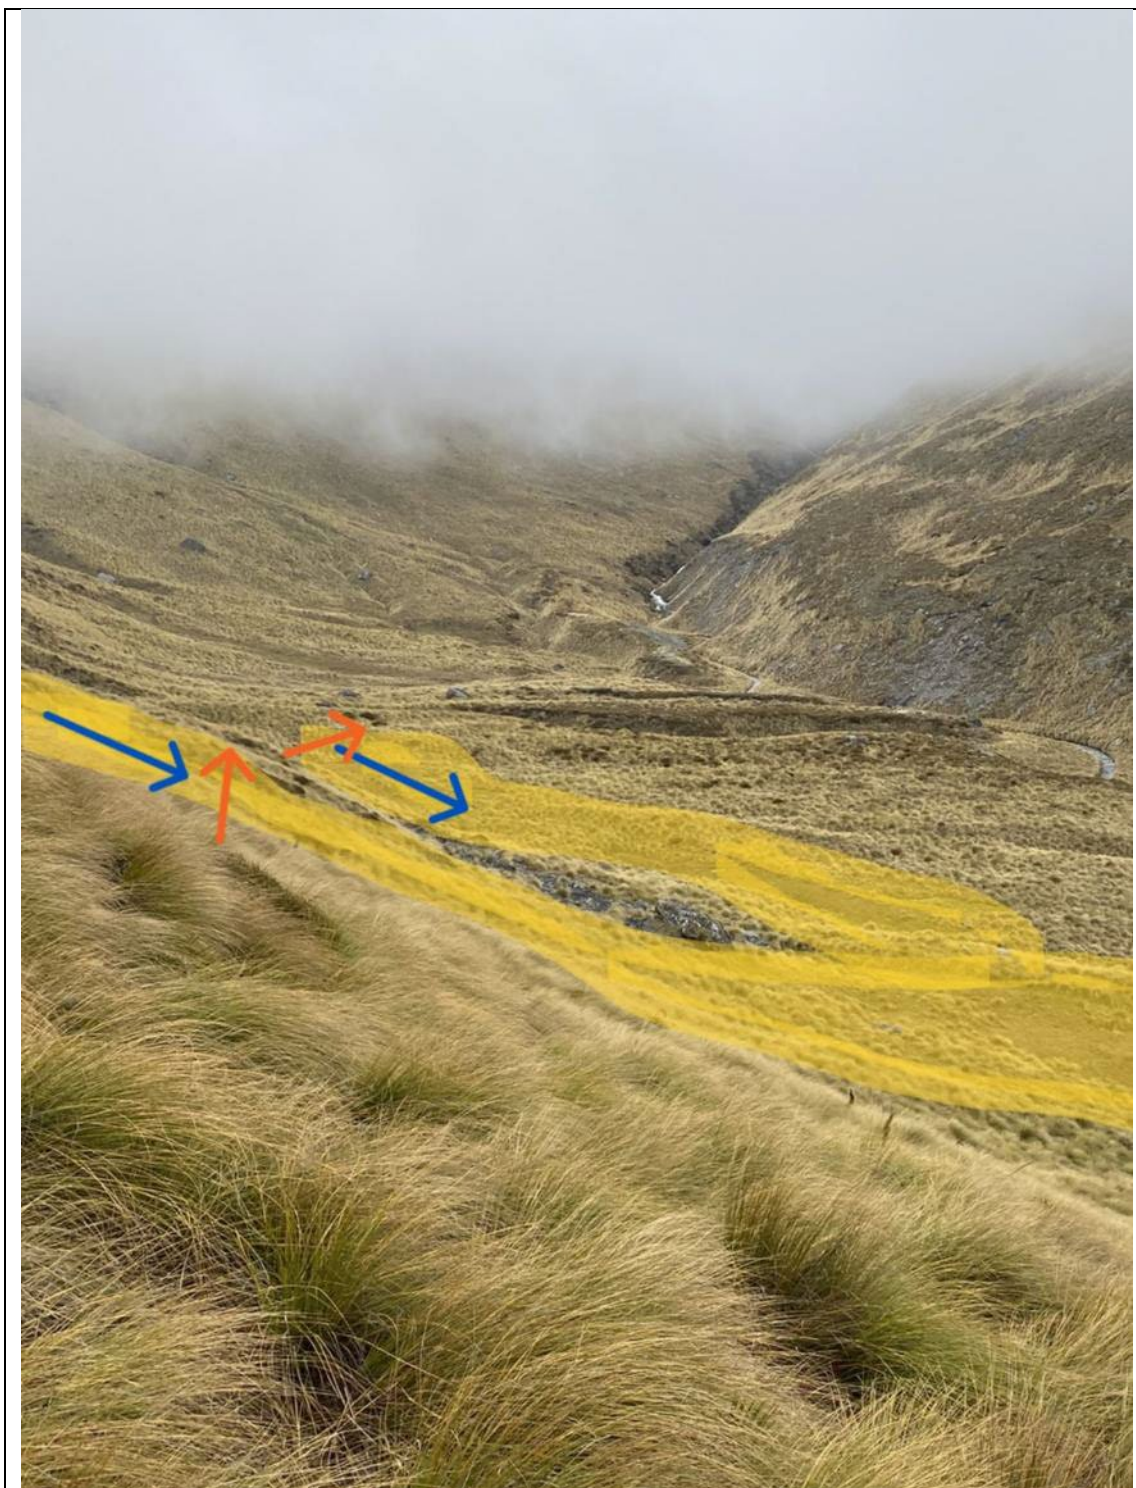
**Permeable Track G (foreground), Proposed Permeable Track H (background):** No waterways are present, however a wetland crossing of approximately 20 m will be required over the seepage wetland at Permeable Track G. Due to the contour of the access t upgradient of Proposed Permeable Track H there will also be an Armoured Swale (Table 4) that will carry stormwater past this wetland area.

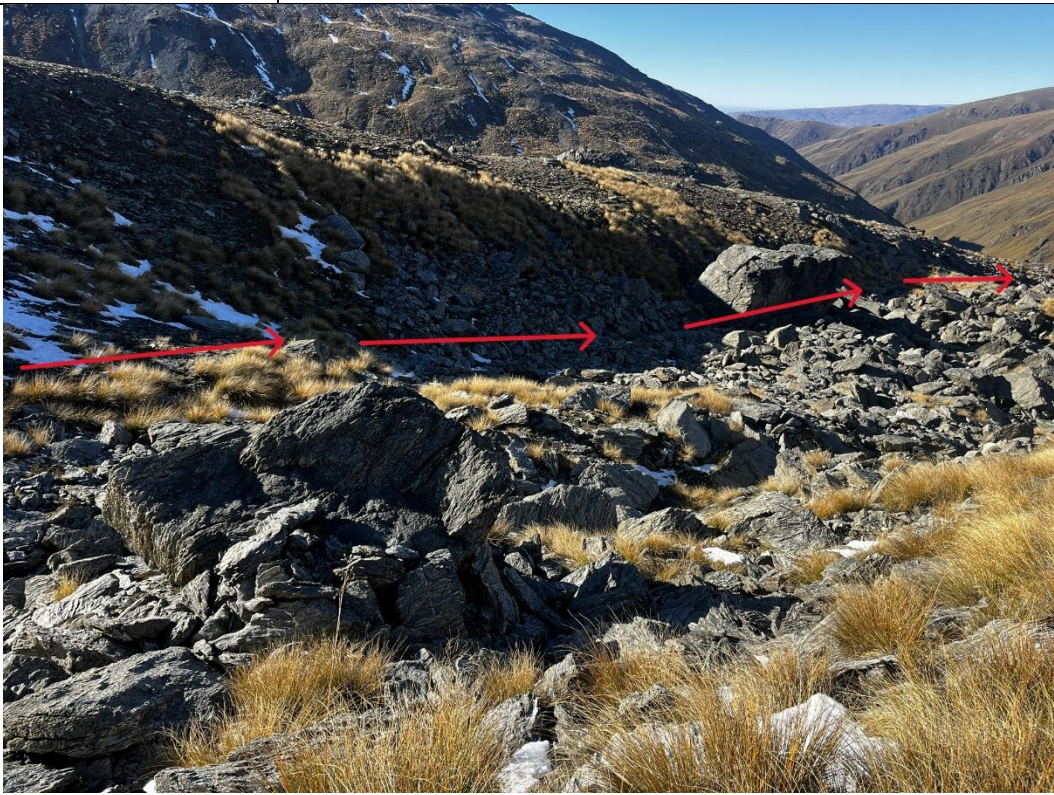
| <b>Armoured Swale C</b> | |
|---|---|
| <p><b>Armoured Swale C:</b> Approximate location of Armoured Swale C (red) to convey stormwater from the access track past the extent of the moraine wall before discharging it.</p> | |

| <b>Armoured Swale C</b> | |
|---|---|
| Loss of river or wetland extent | <p>Given the path of Armoured Swale C and recommendation for dispersal of the discharge water there should not be a loss of stream or wetland extent.</p> |

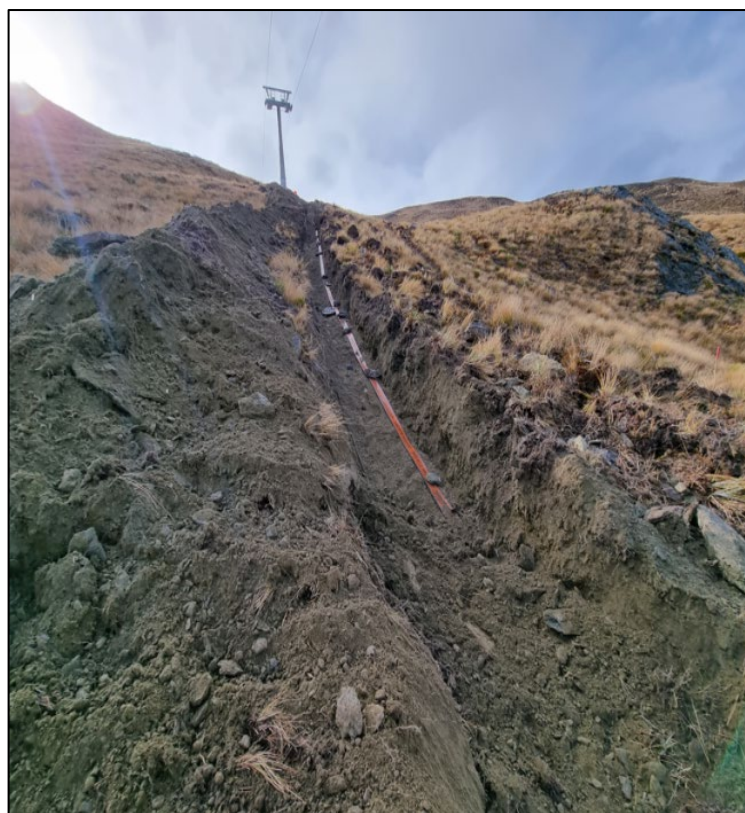
**Figure 22: Example of a section of trenching (Source: Enviroscope, 2026).**

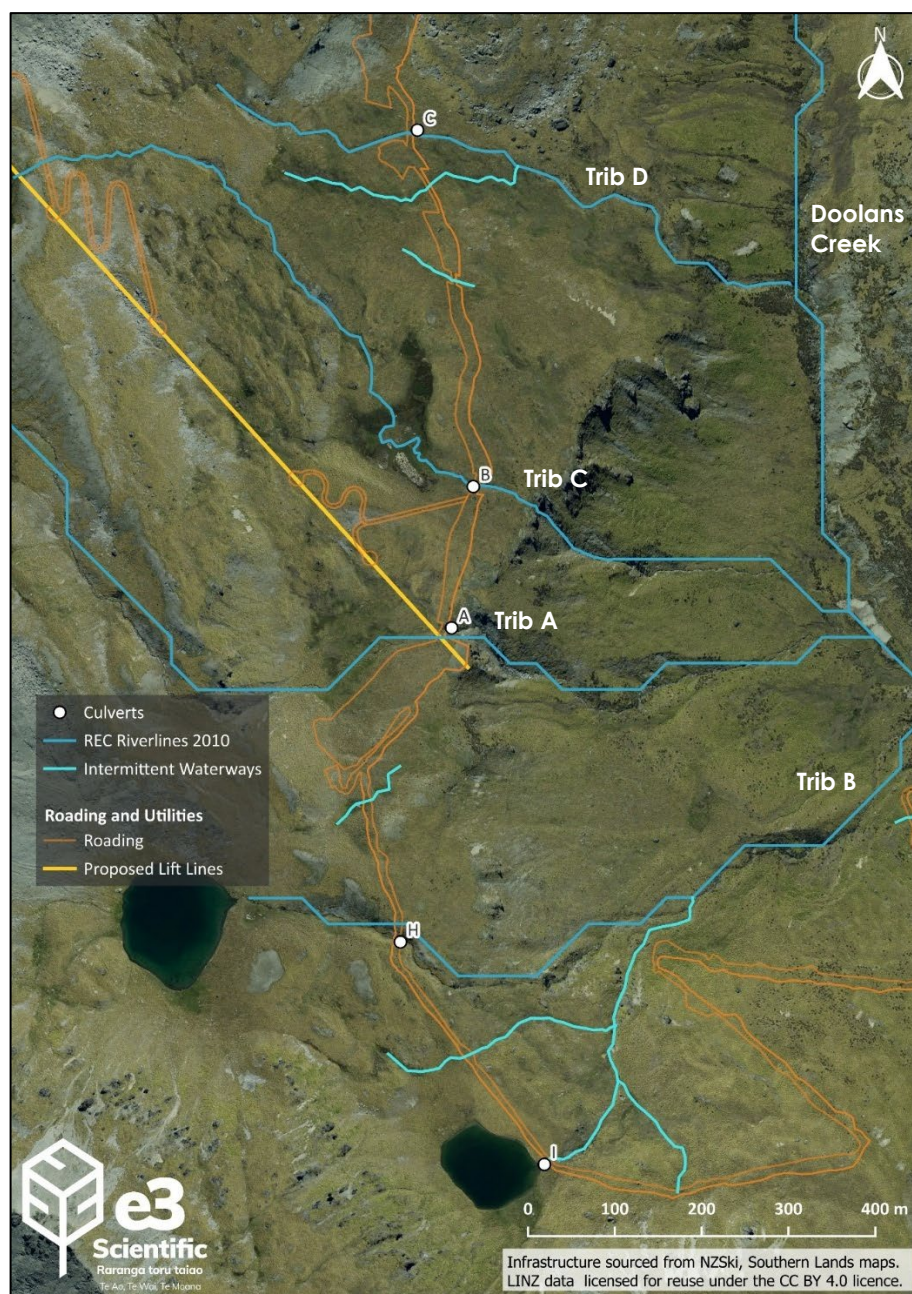
**Figure 23: Location of culverts and associated stream habitat loss.**
