# Remarkables Ski Area Upgrade & Doolans Expansion - Tracks, Stream Crossings and Stormwater Freshwater Ecological and Hydrological Impact Assessment

Prepared NZSki Ltd

August 2026

**Prepared by e3Scientific Limited for NZSki Limited**

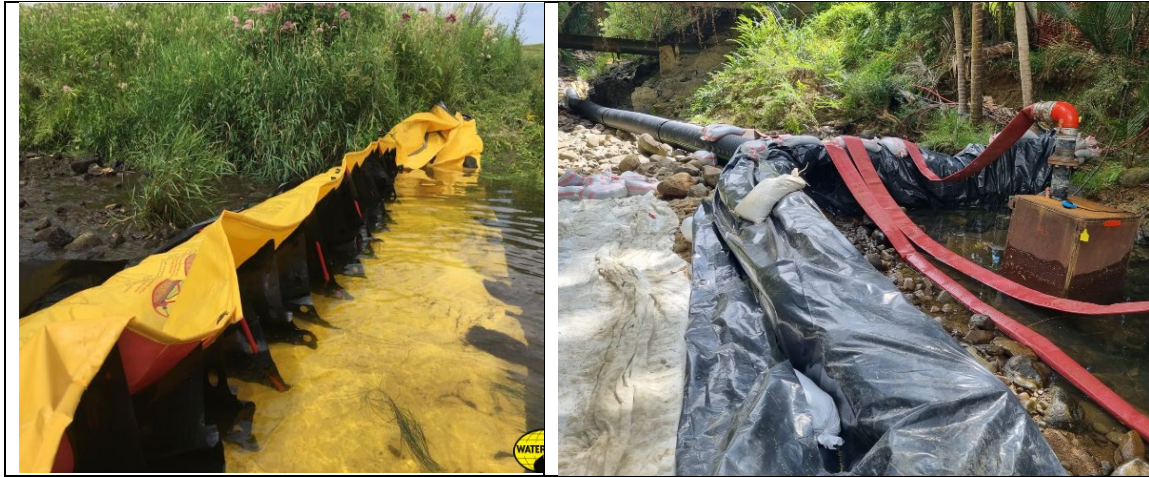
**Figure 24: Example of a hydro barrier (left) and sand bag coffer dam (right) <sup>iii</sup>**

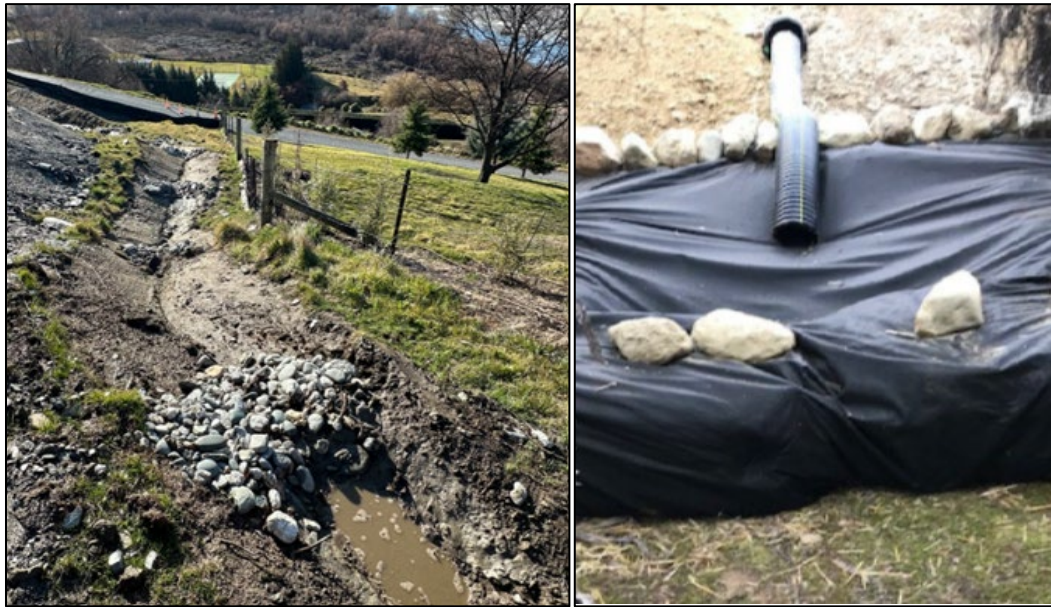
**Figure 26: Examples of sediment control devices (Source Enviroscope, 2026).**
